## APPENDIX 19

**Flooding Assessment Figures -  
Property 65**

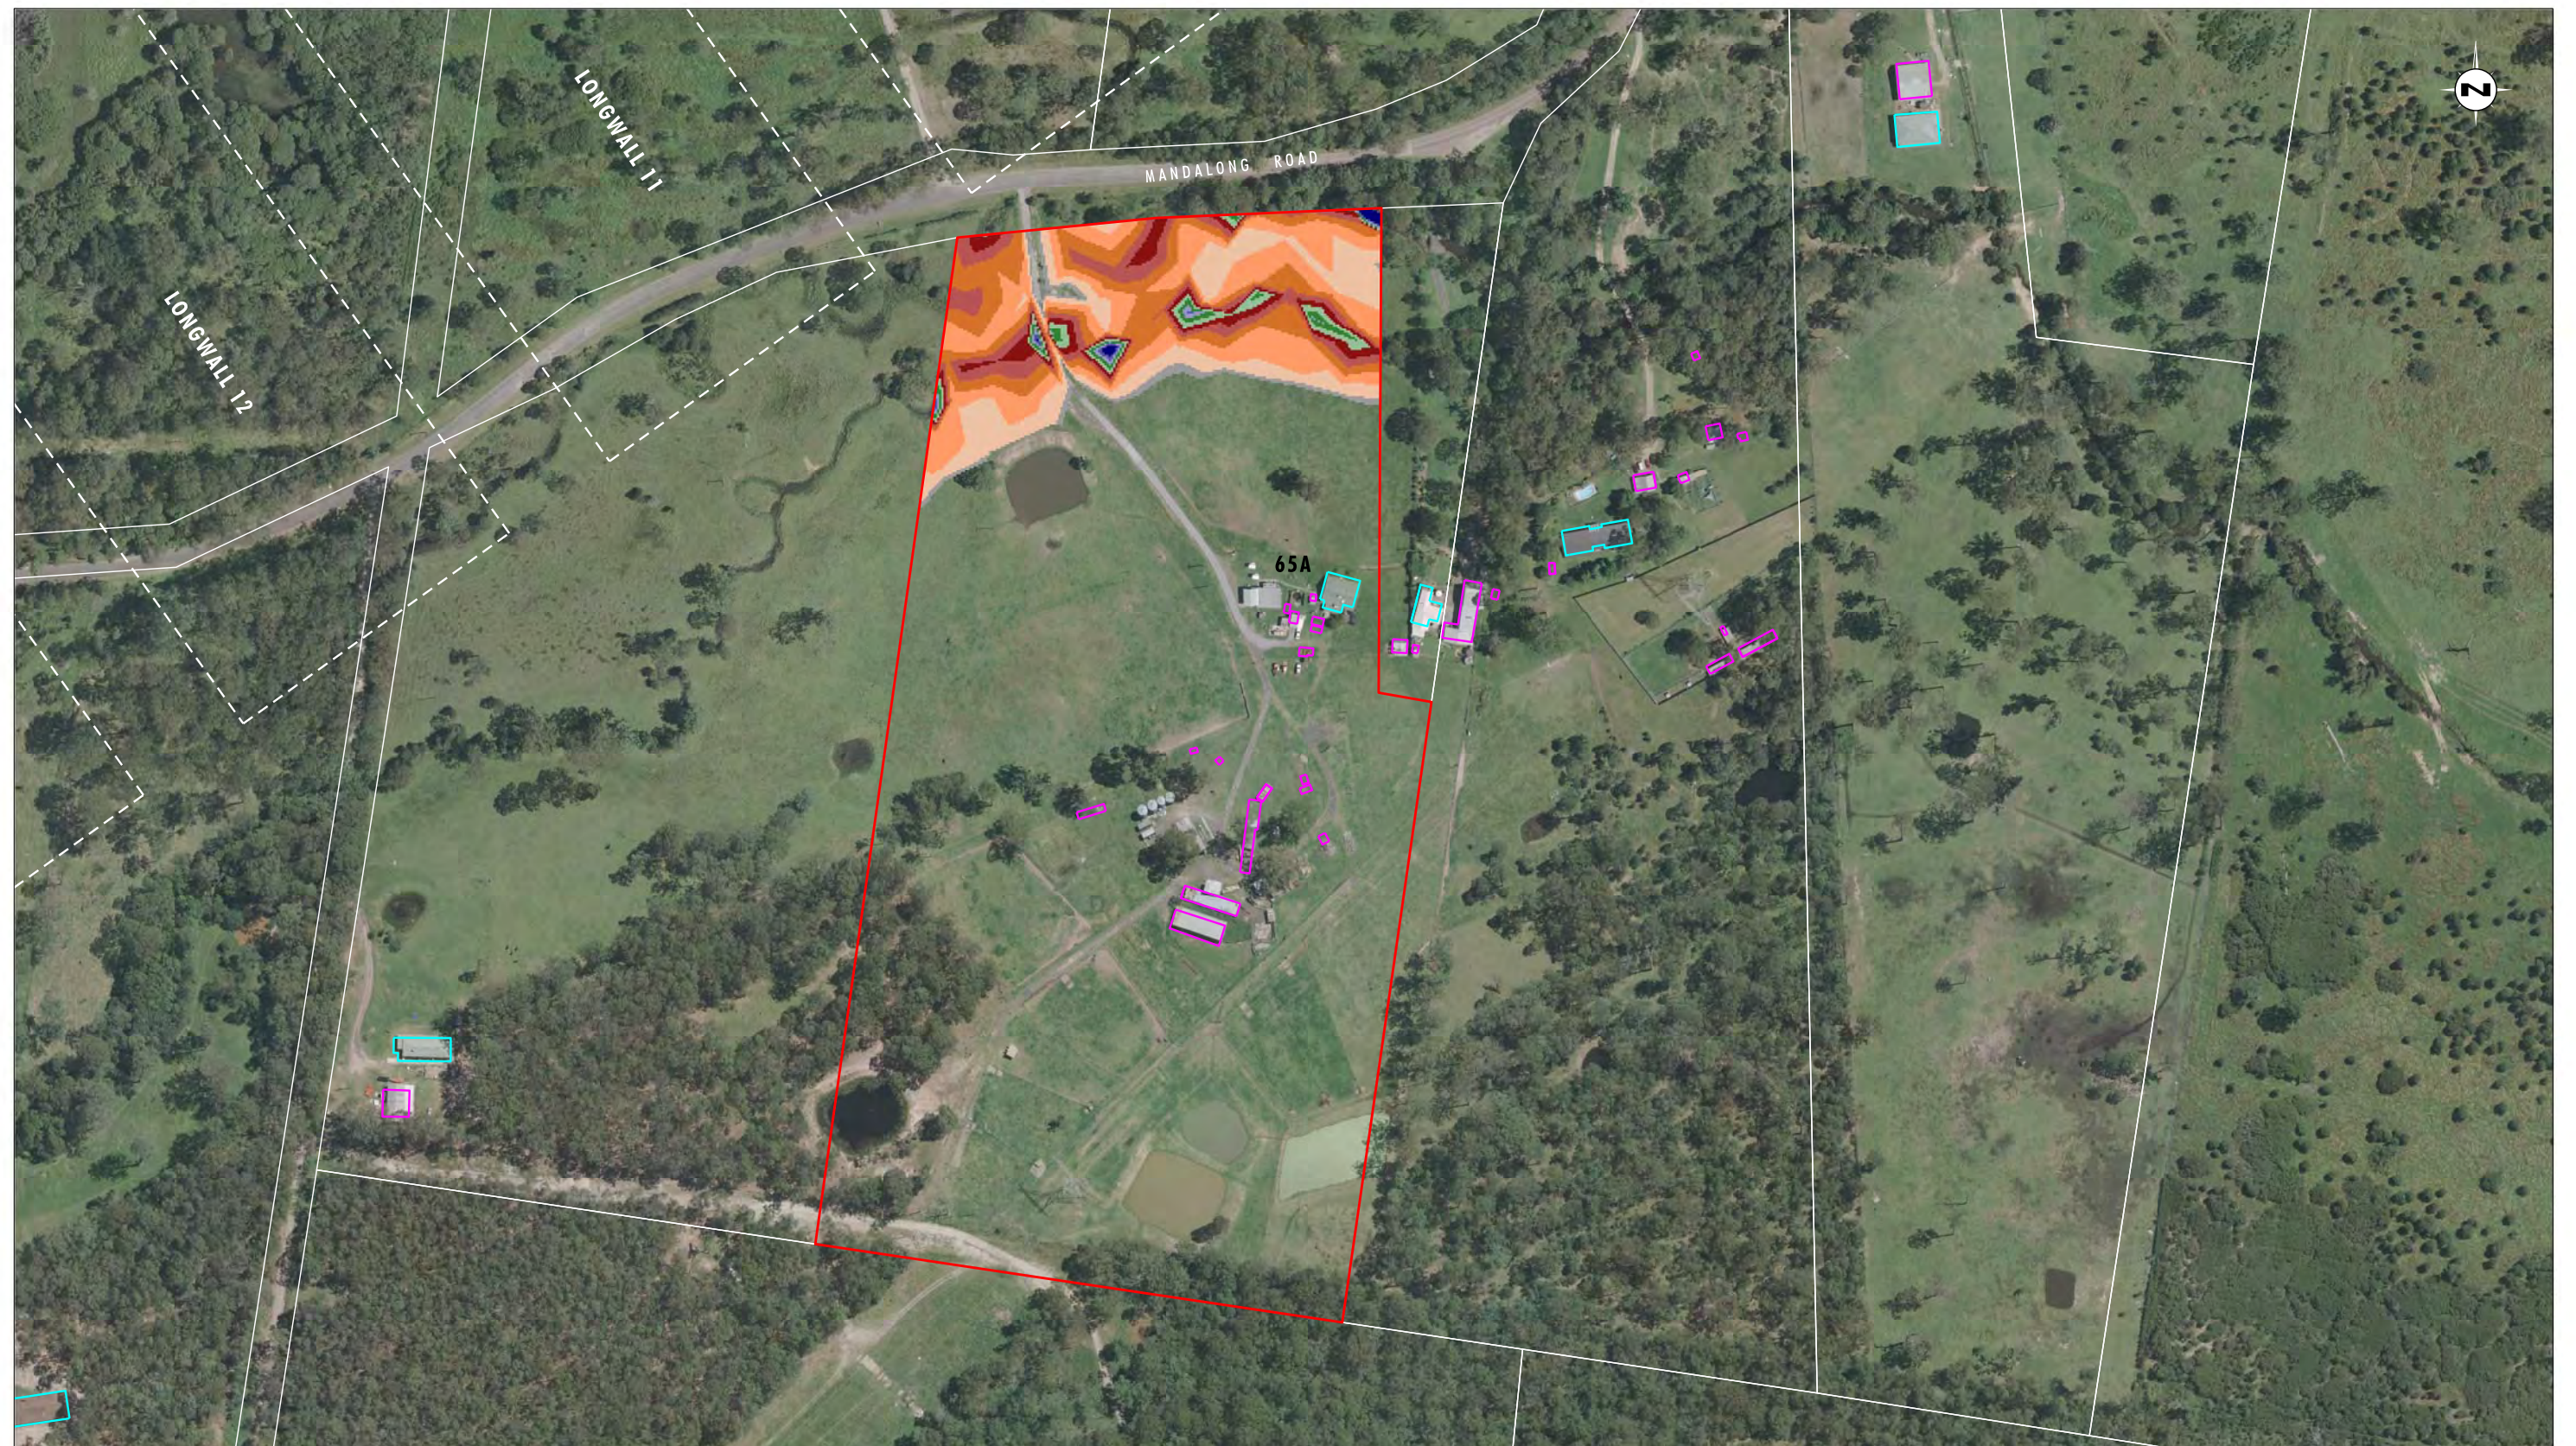
FIGURE 5

Property 65 - 1 year ARI Storm Event:  
Maximum Flood Depth Pre Mining Landform

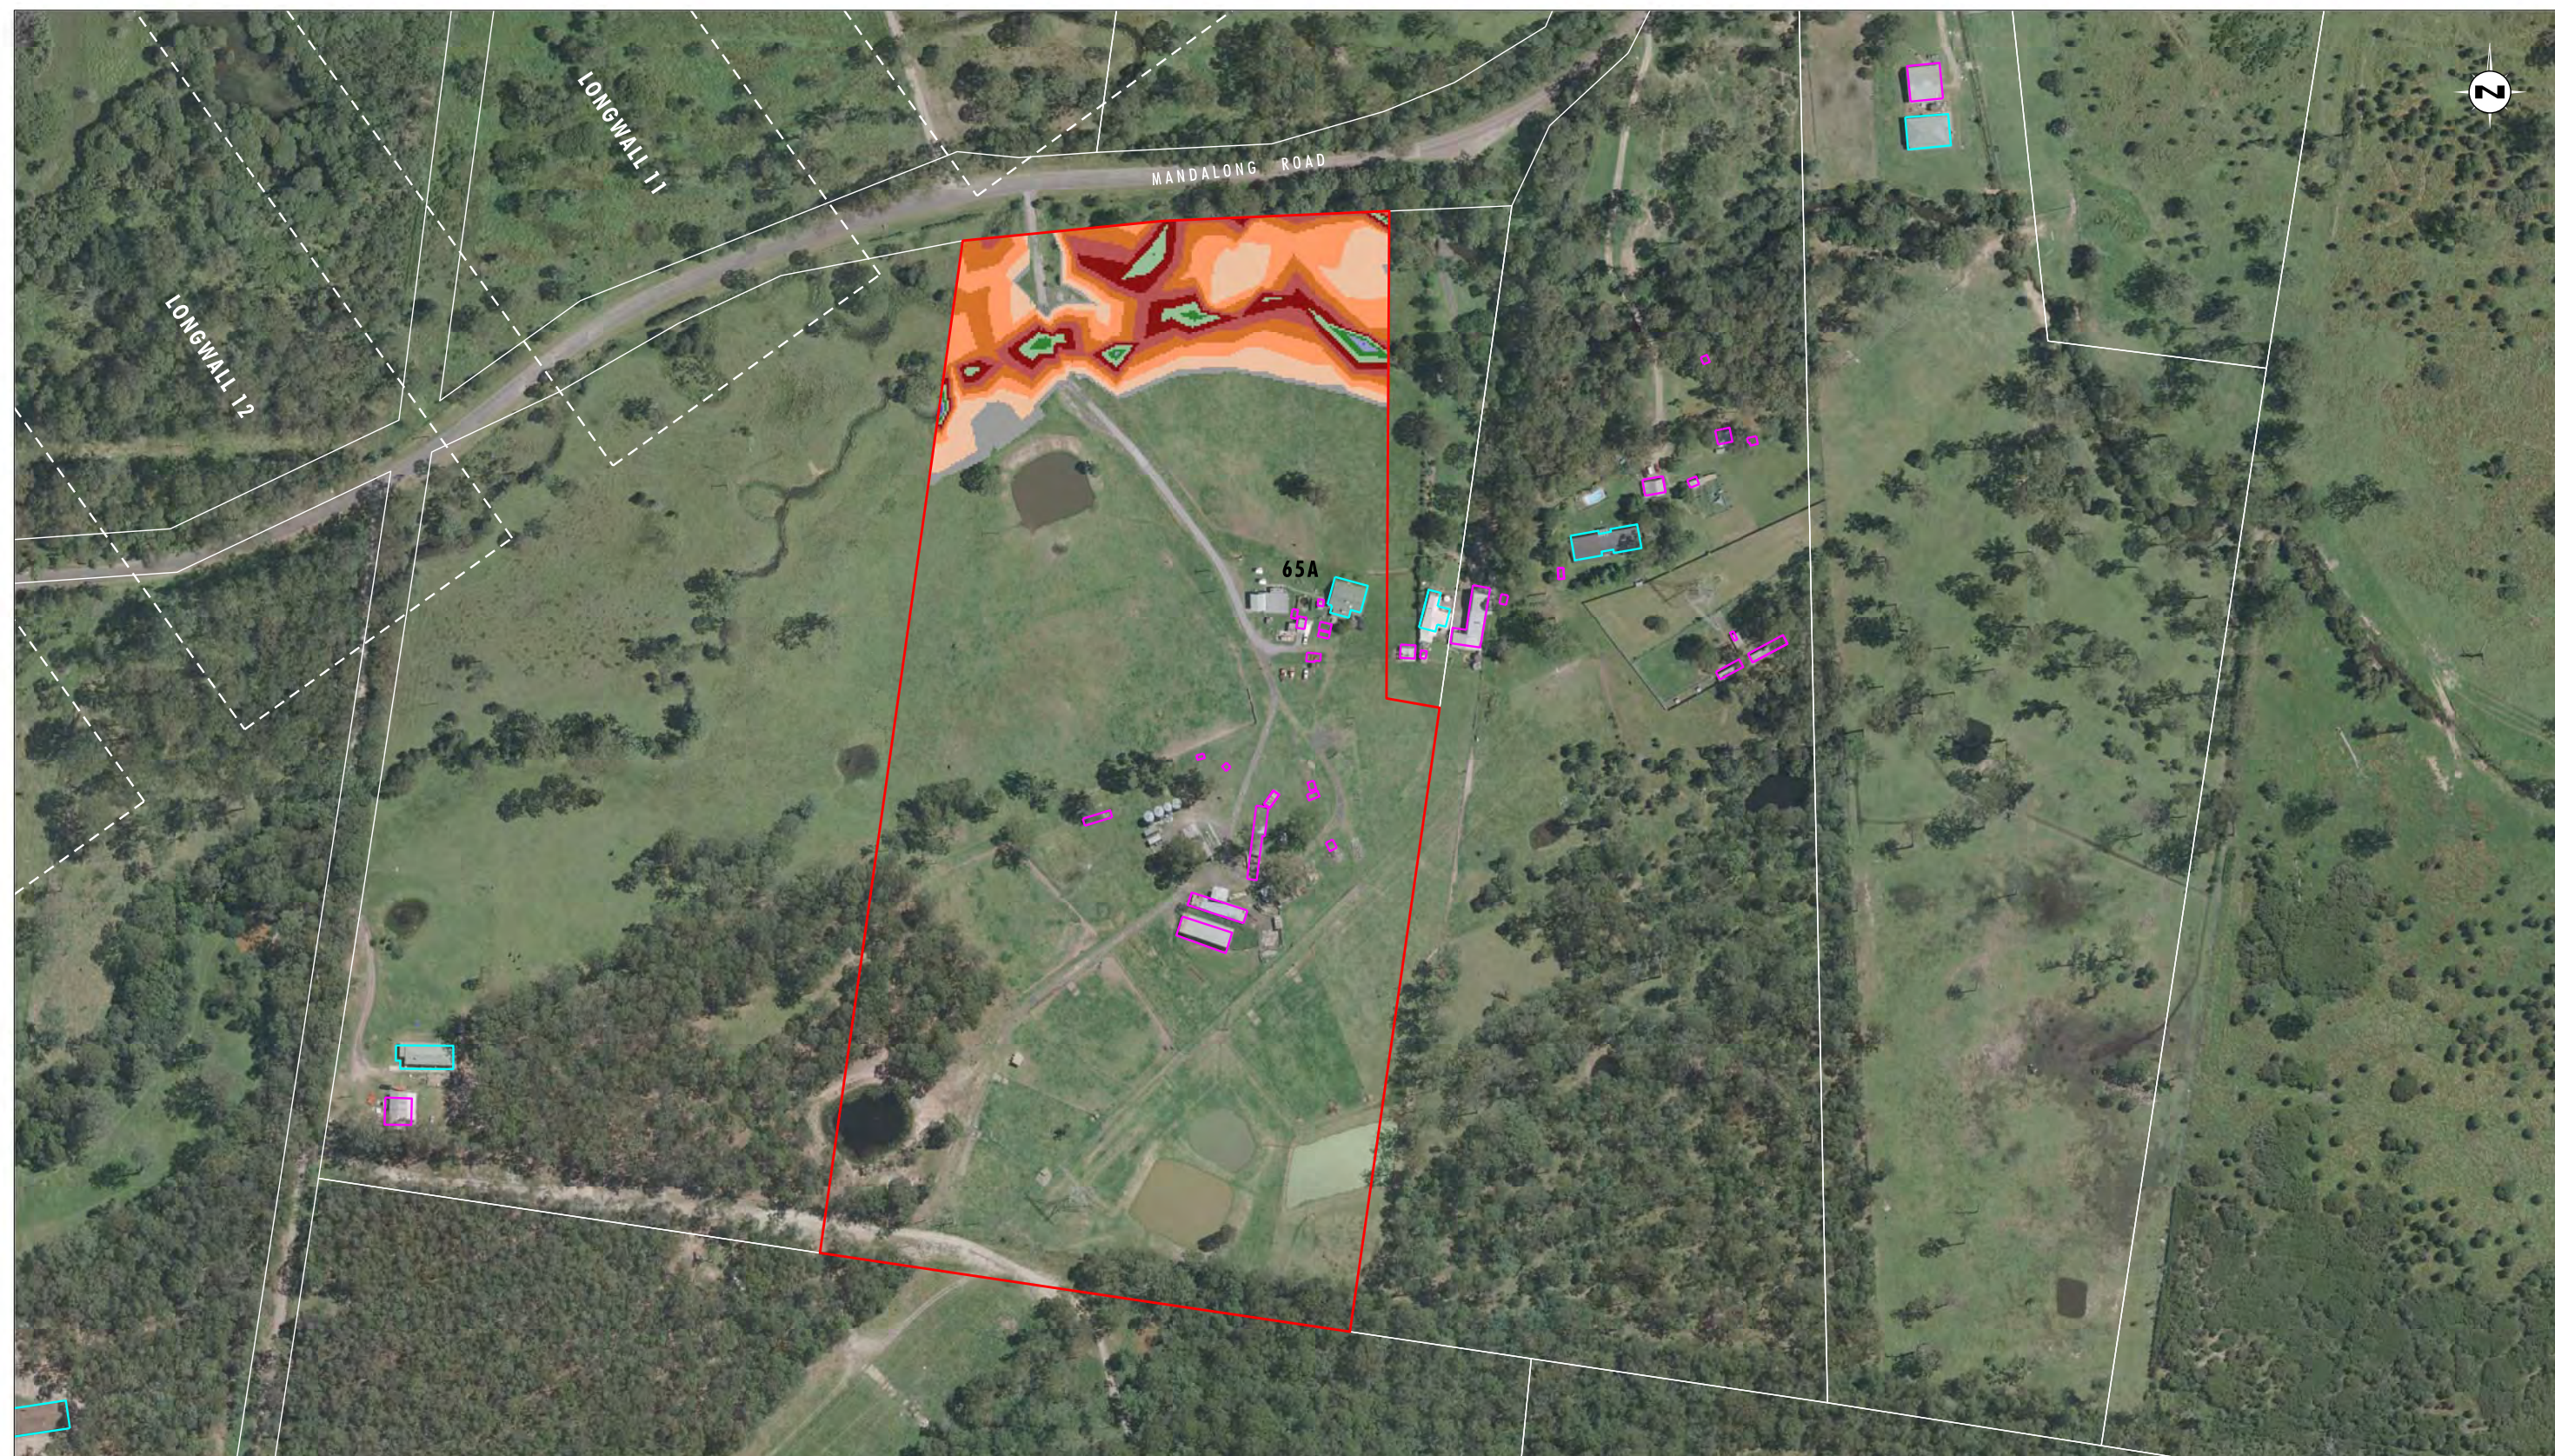
FIGURE 6

Property 65 - 1 year ARI Storm Event:  
Maximum Flood Depth Post Mining Landform  
(to Longwall 23)

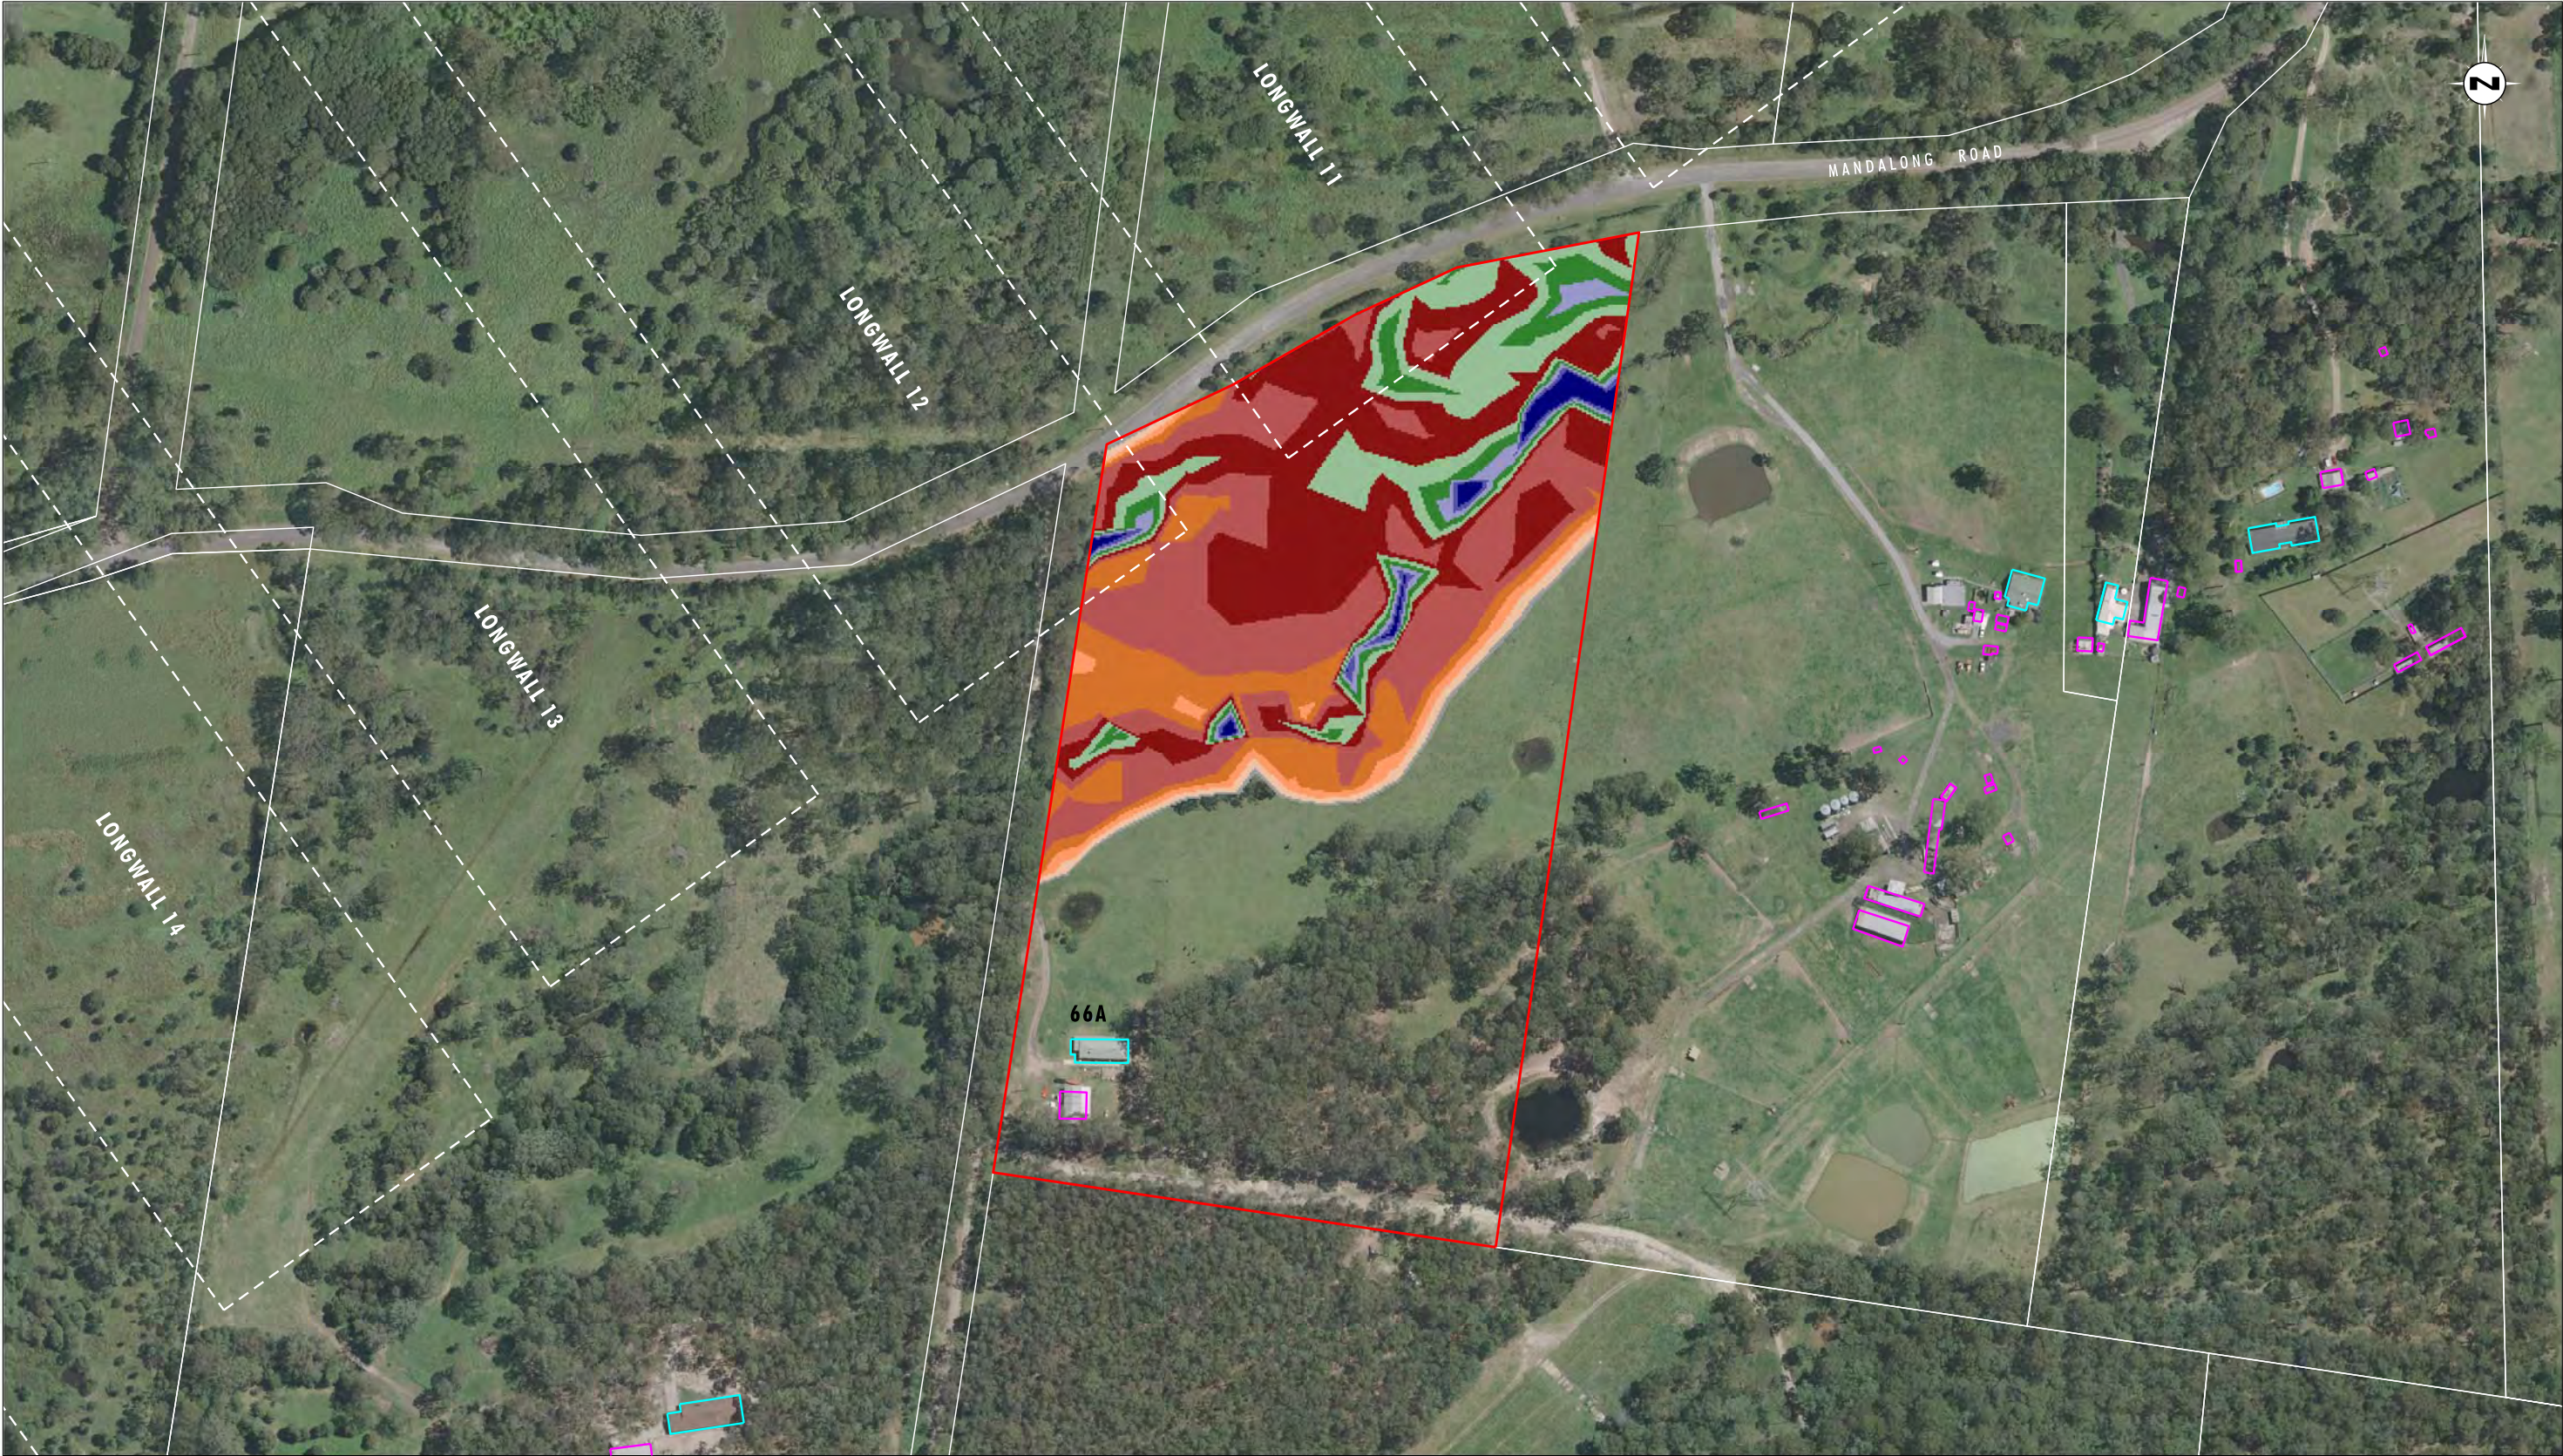
FIGURE 1  
Property 66 - 100 year ARI Storm Event:  
Maximum Flood Depth Pre Mining Landform

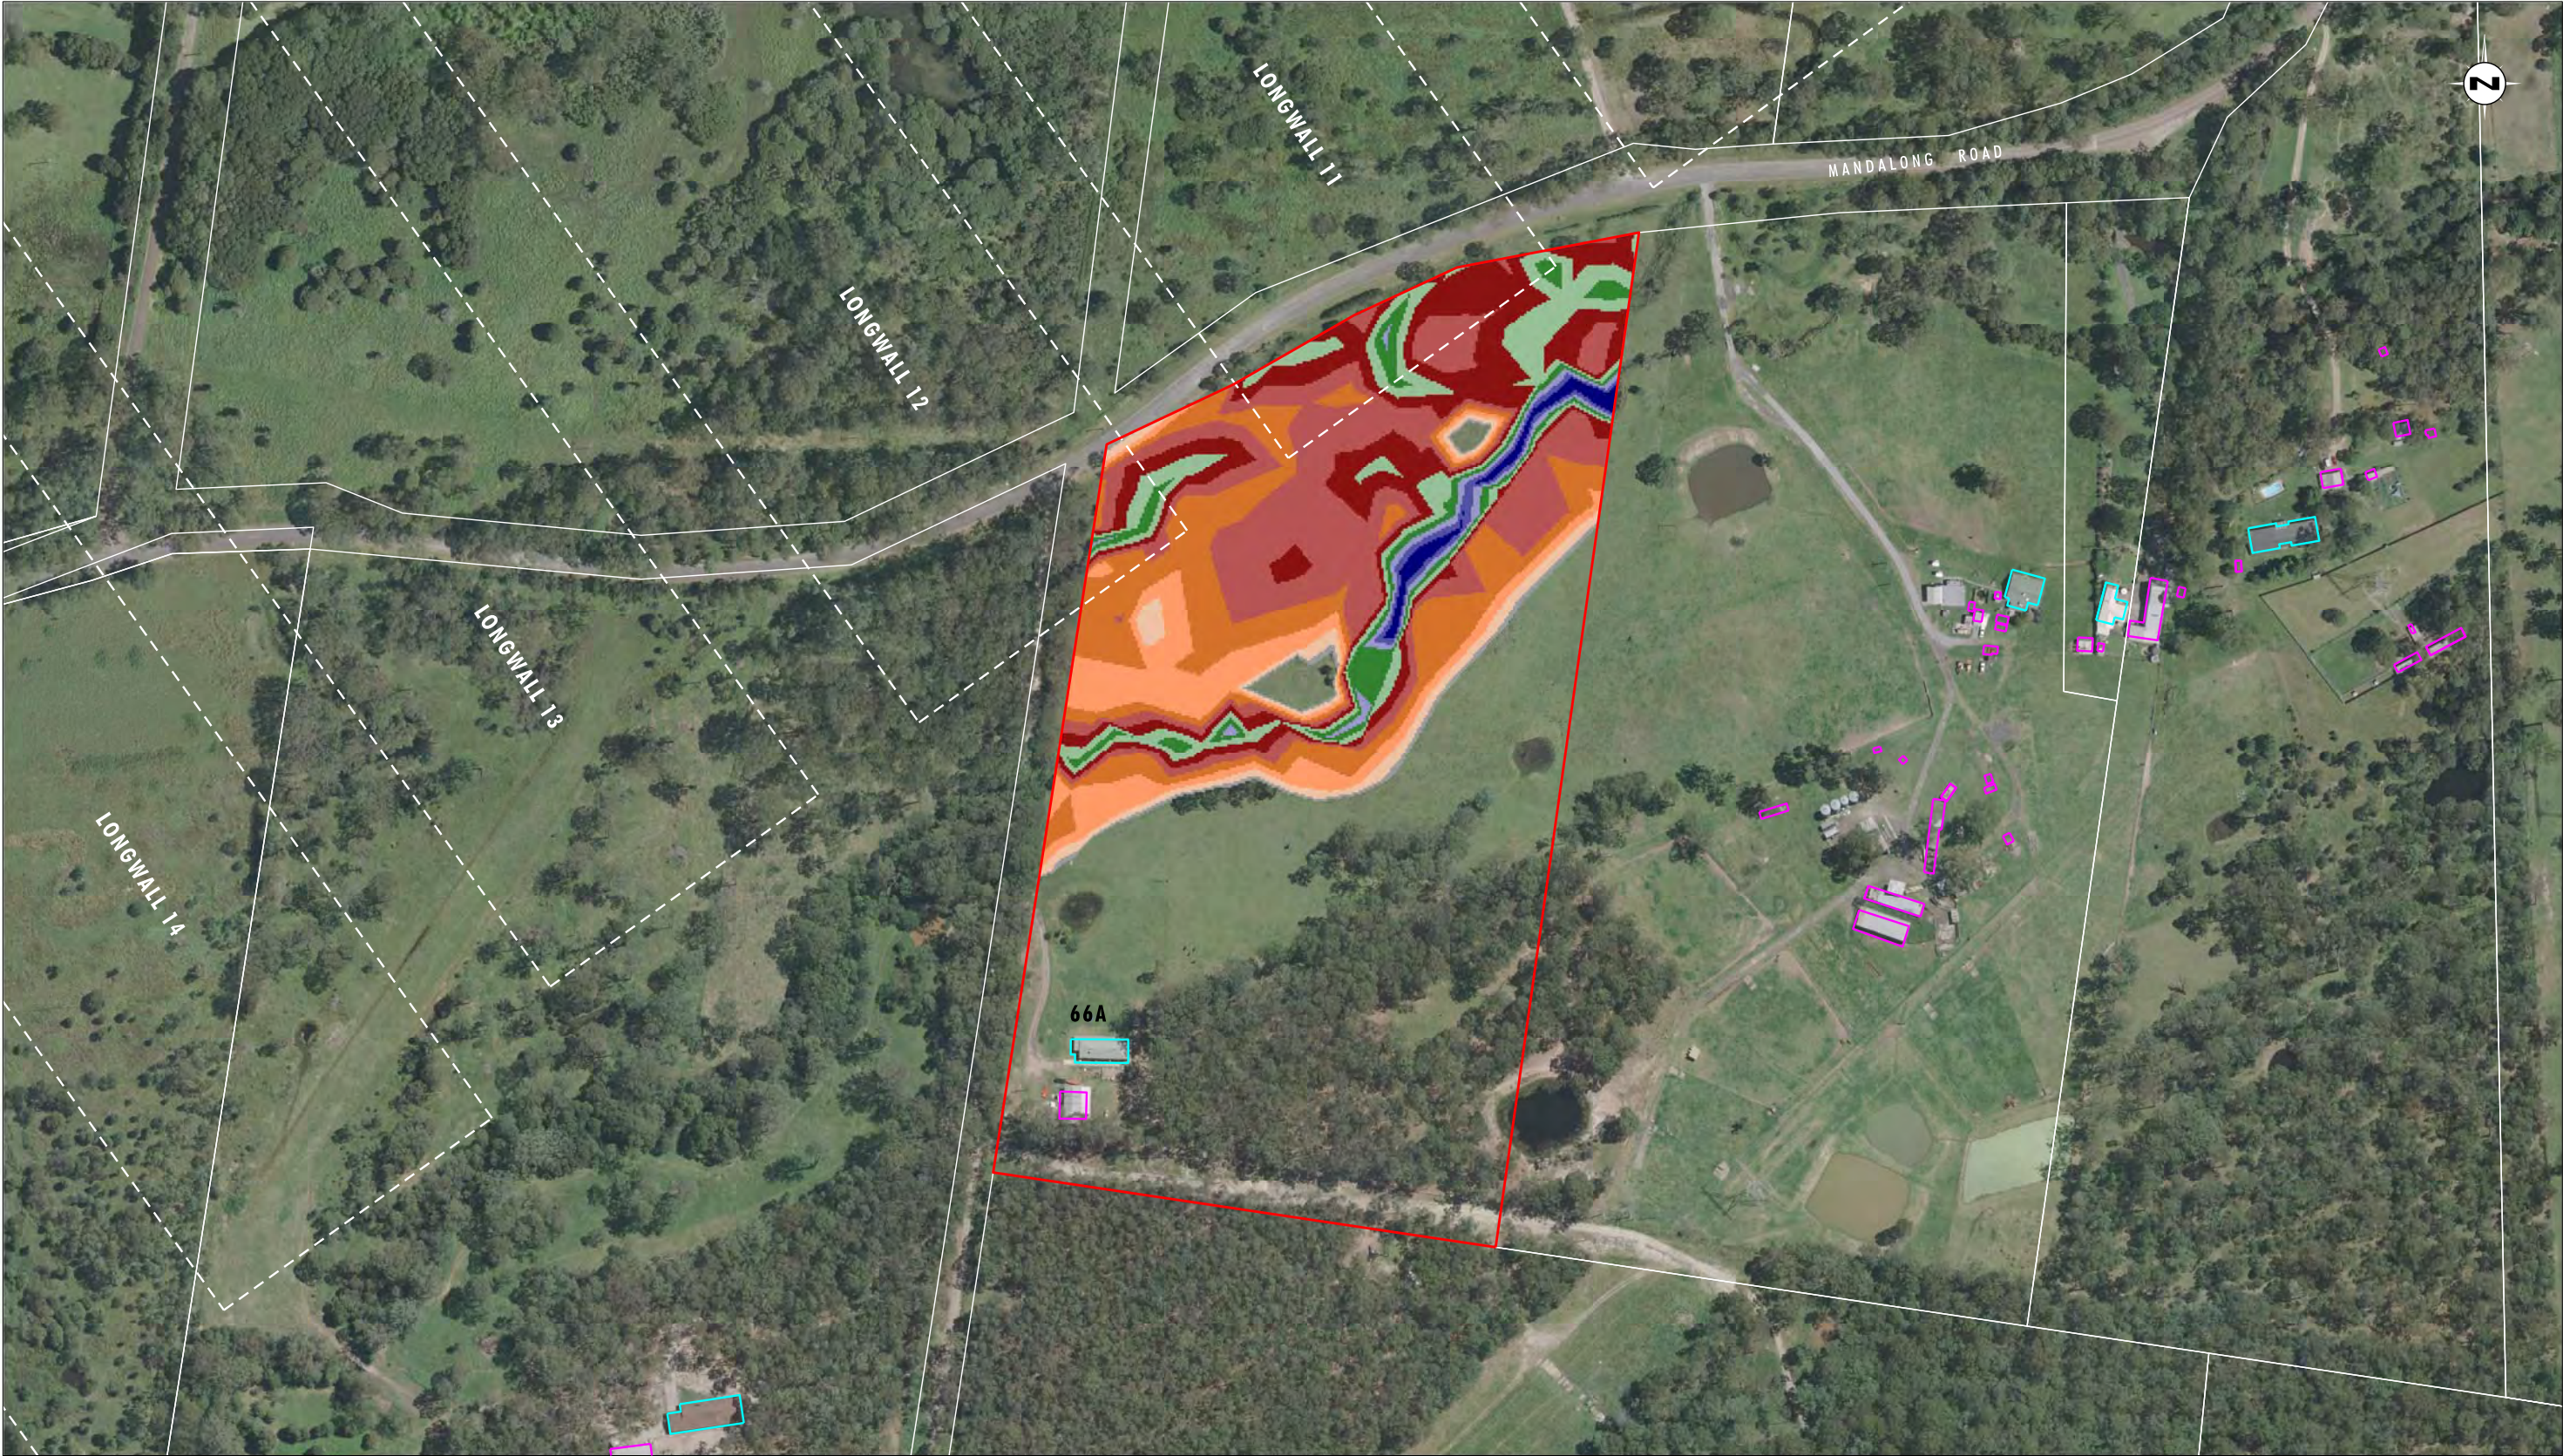
FIGURE 2  
Property 66 - 100 year ARI Storm Event:  
Maximum Flood Depth Post Mining Landform  
(to Longwall 23)

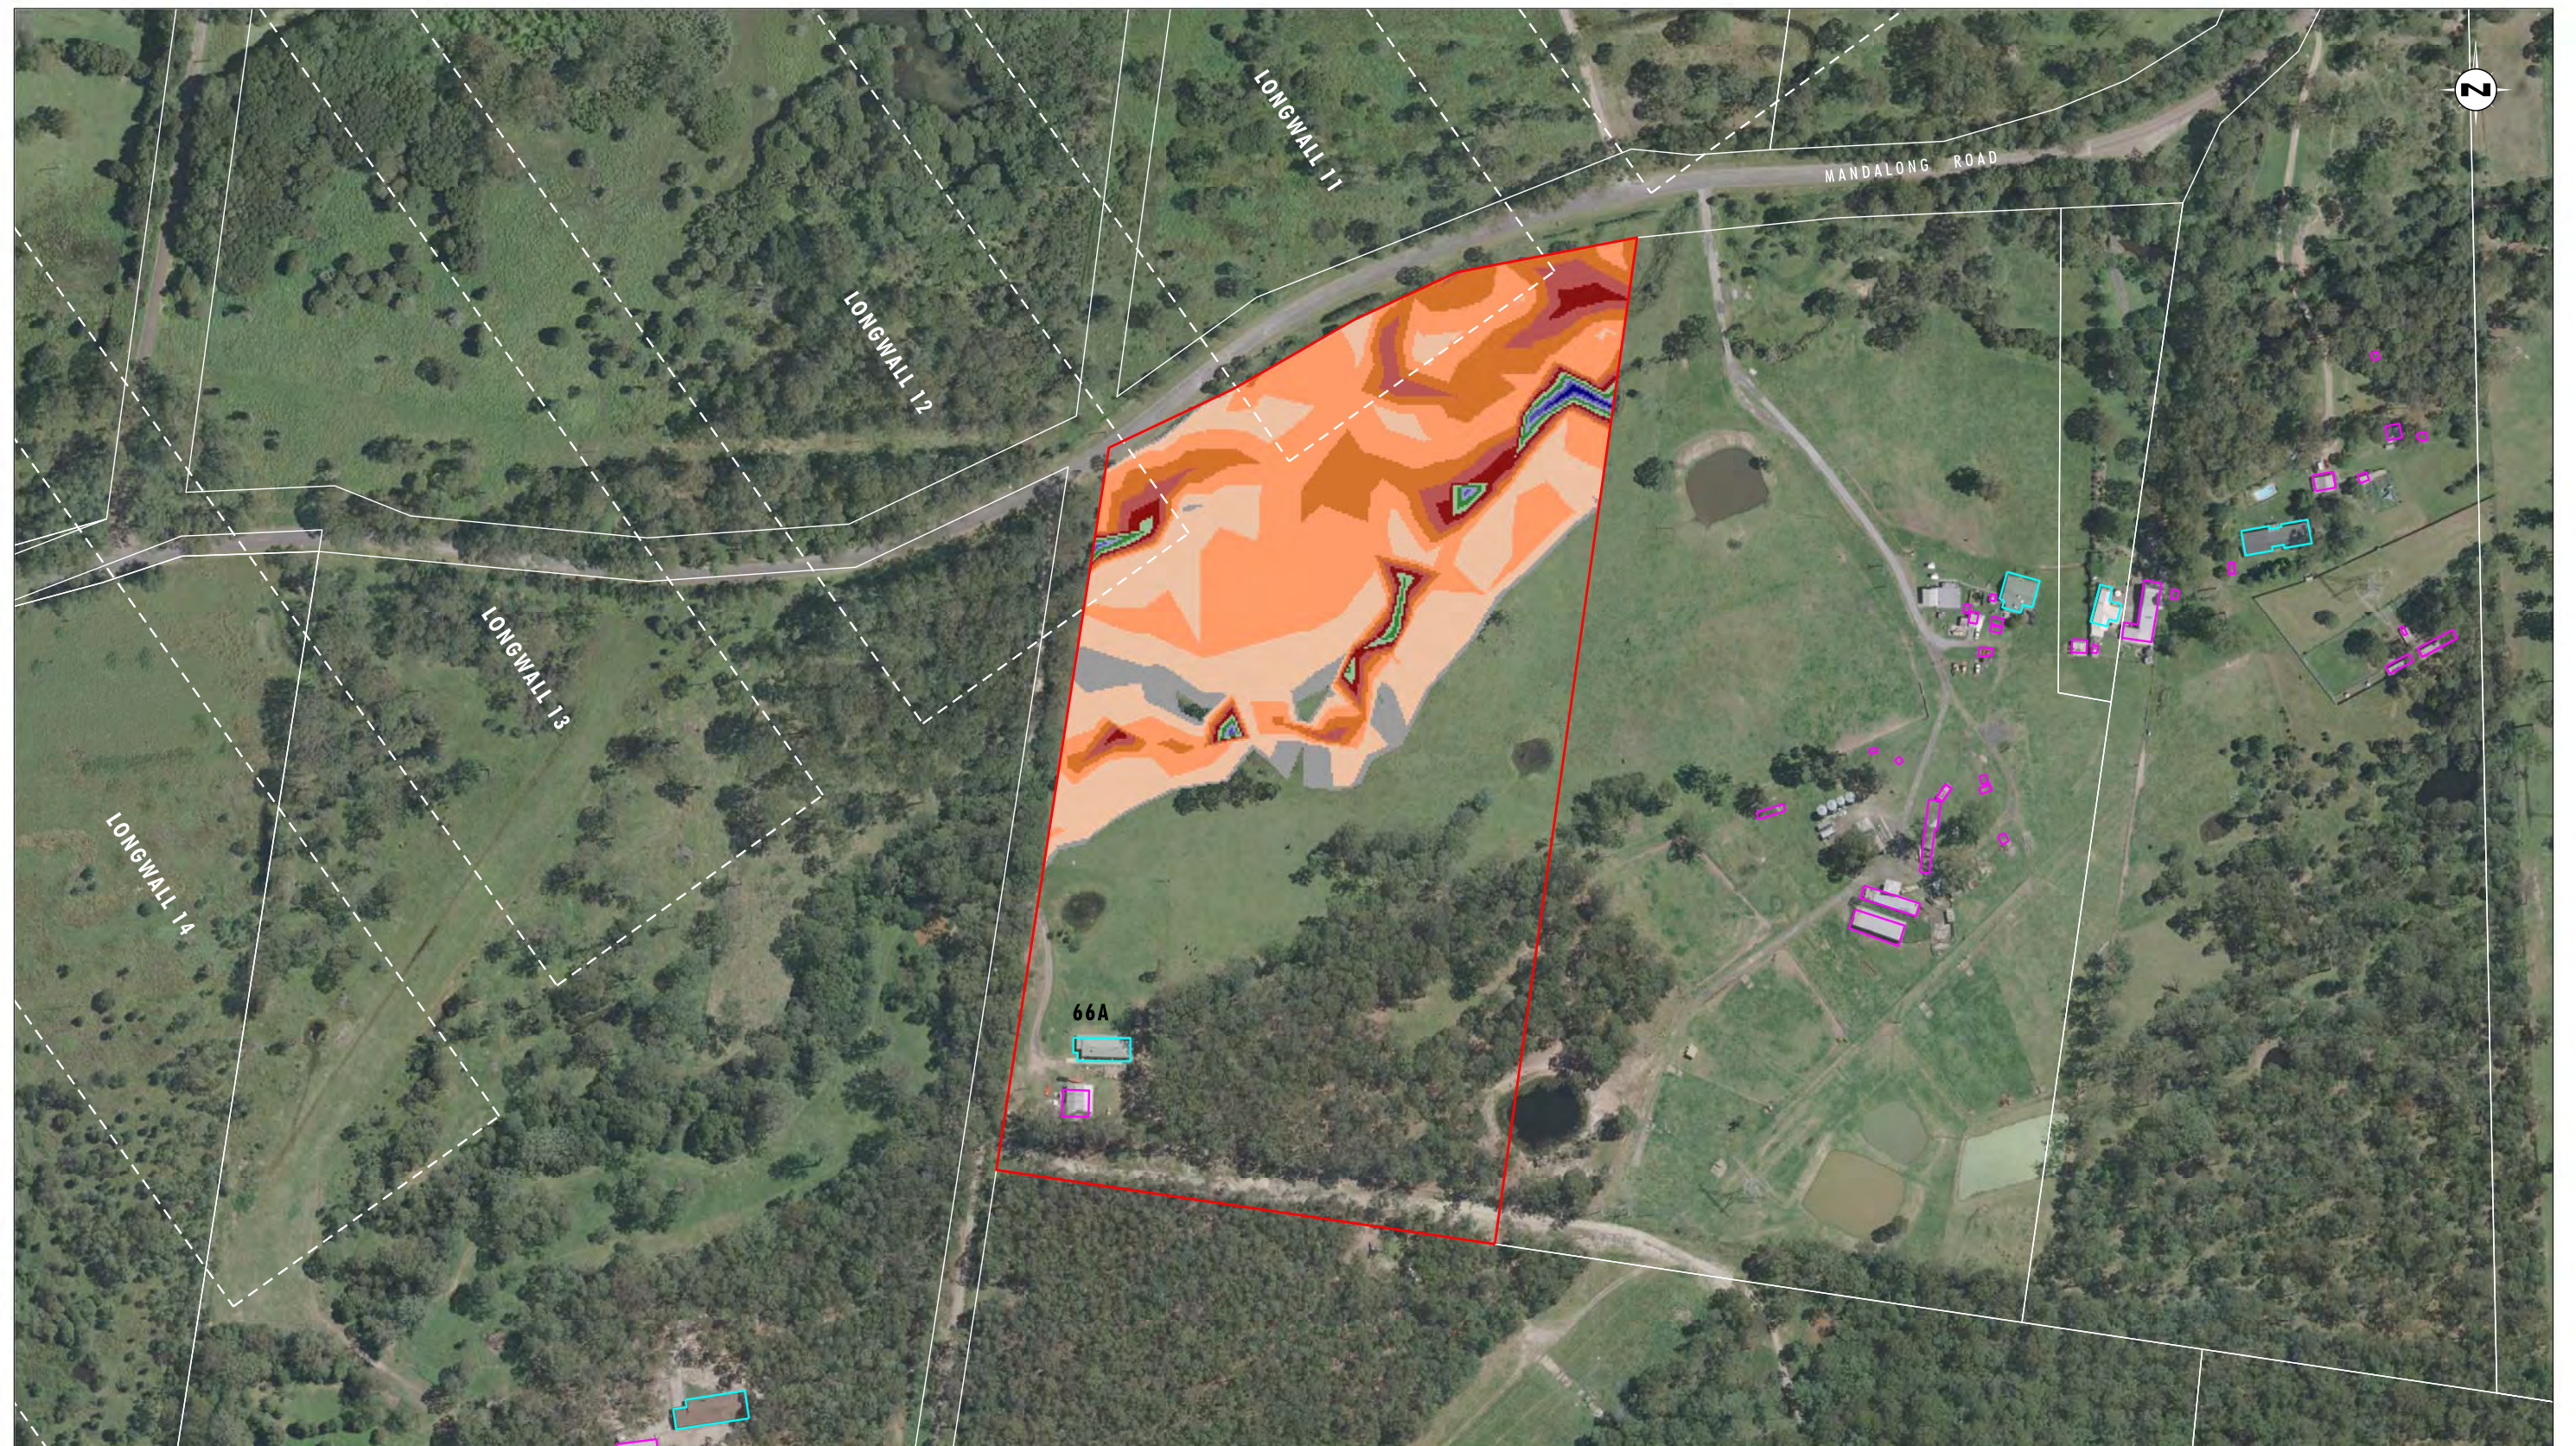
FIGURE 3

Property 66 - 1 year ARI Storm Event:  
Maximum Flood Depth Pre Mining Landform

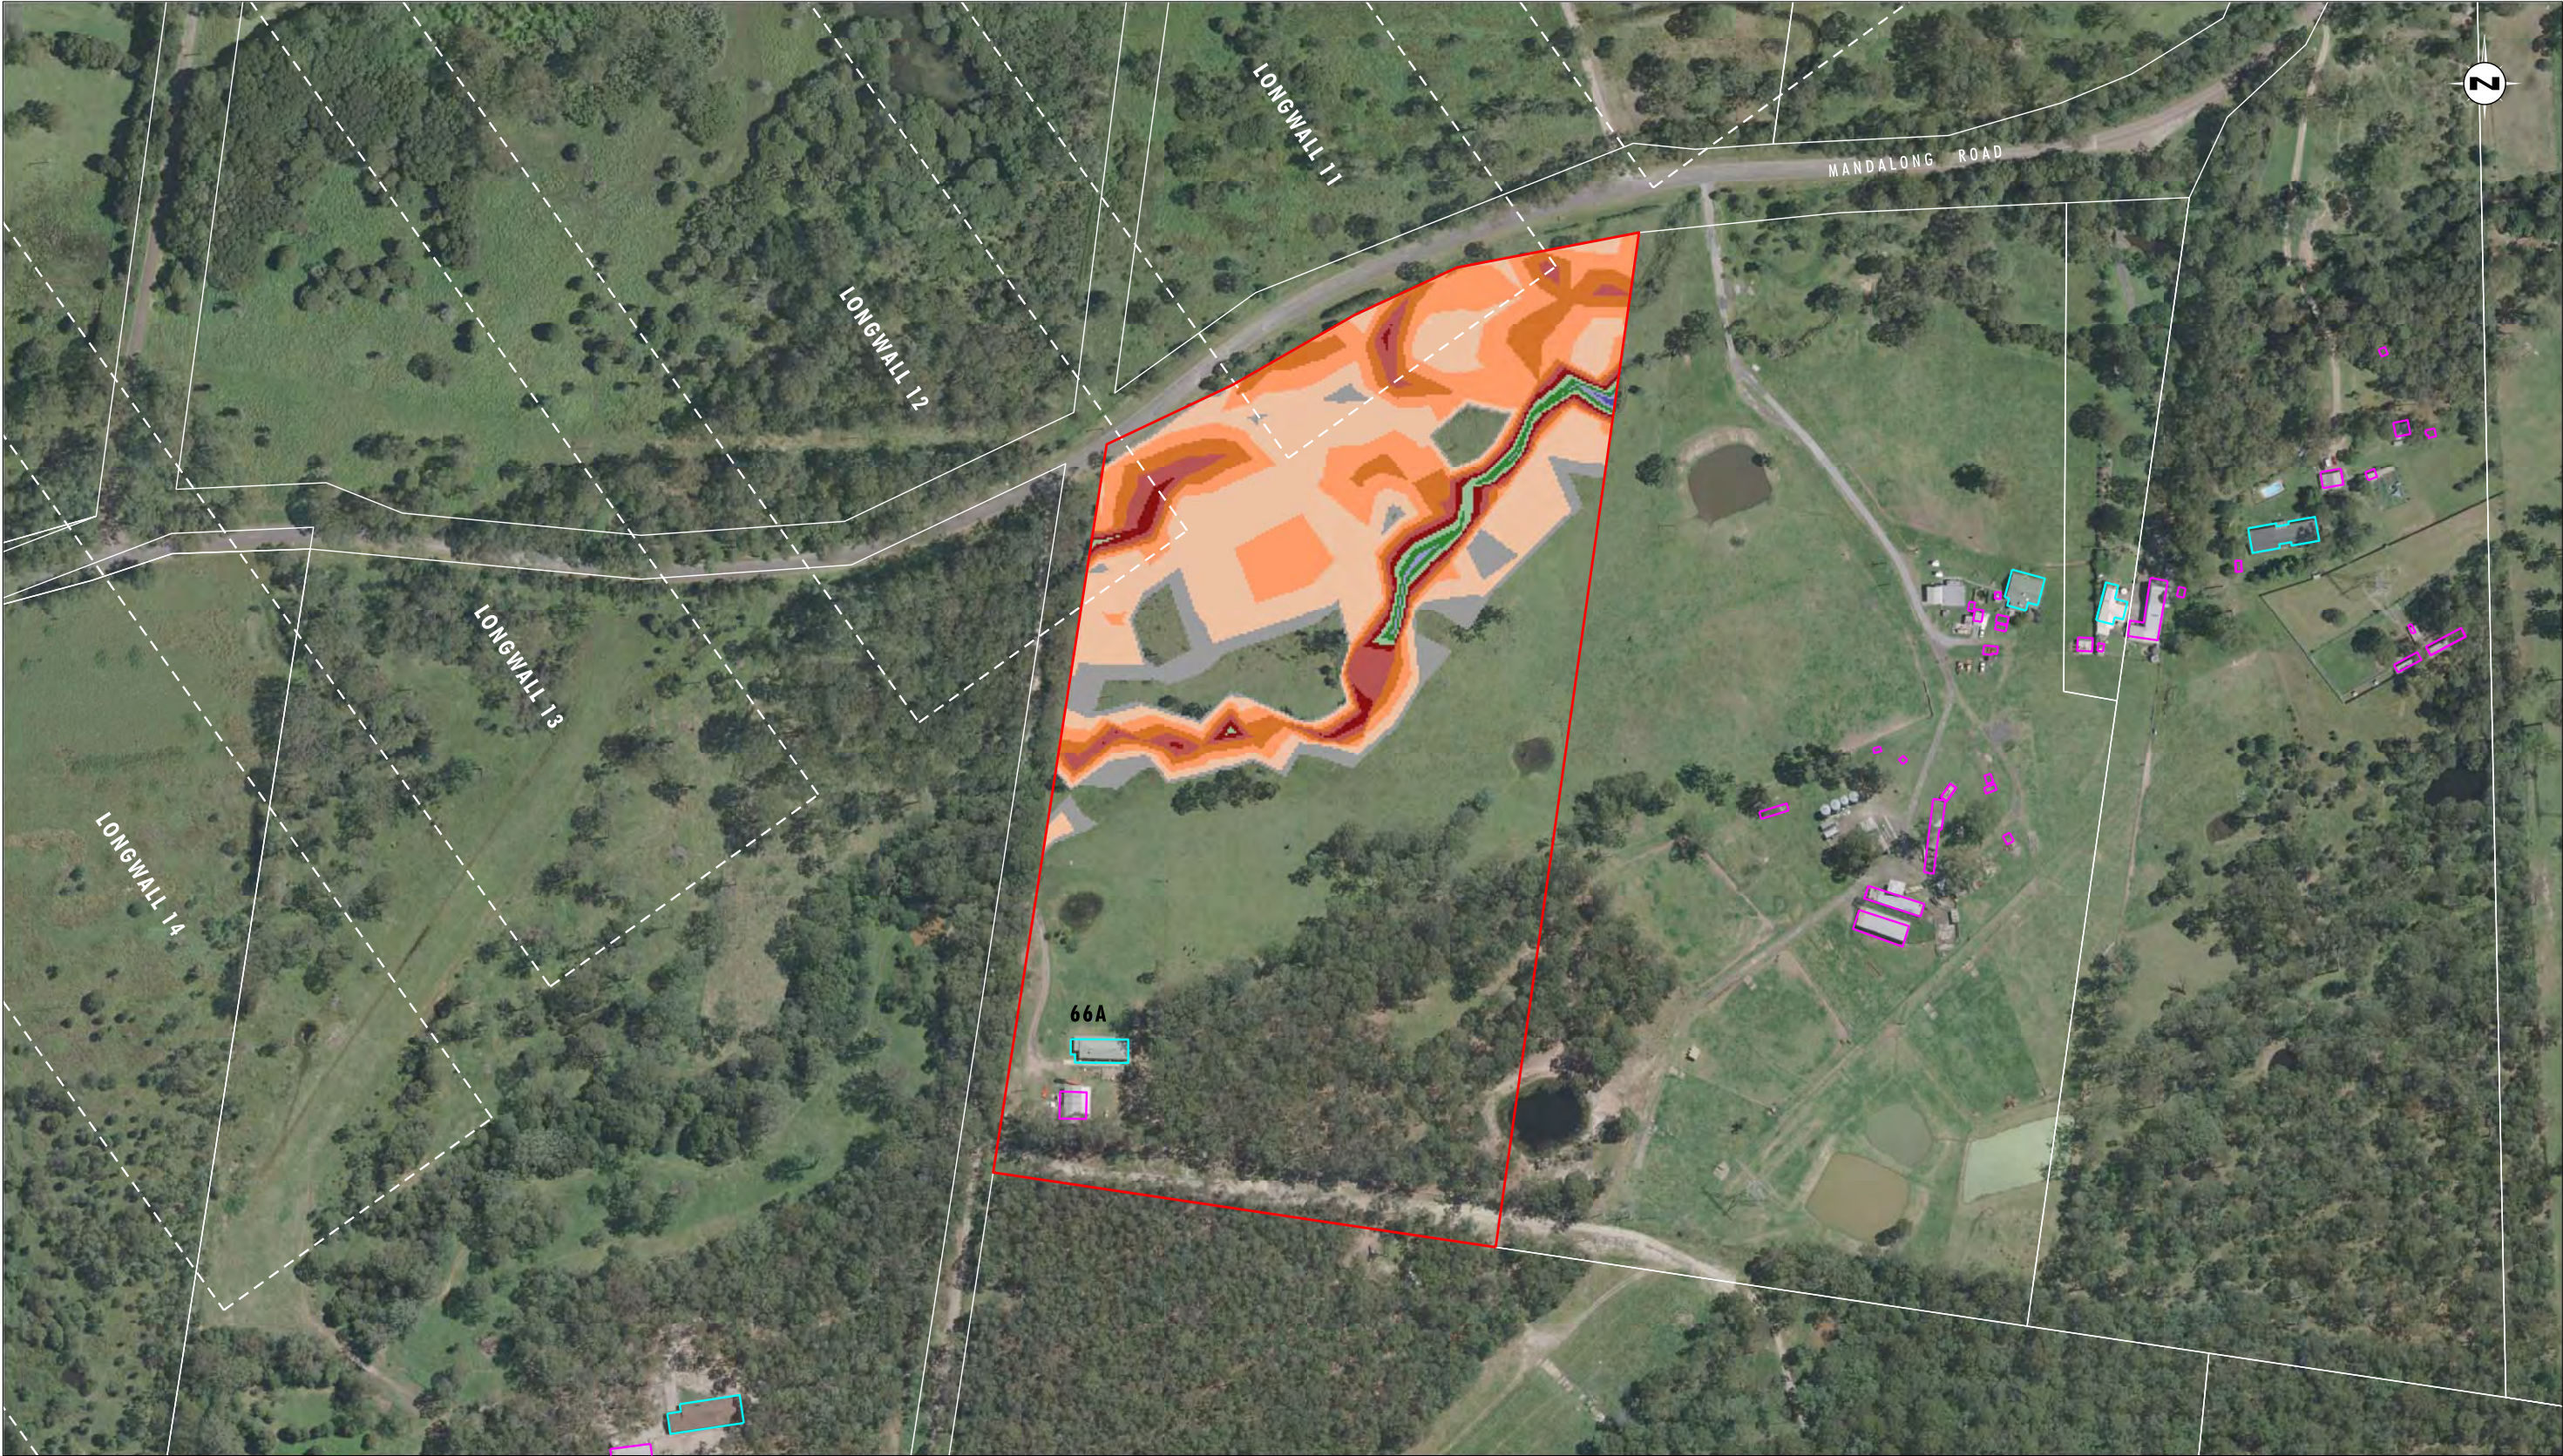
FIGURE 4  
Property 66 - 1 year ARI Storm Event:  
Maximum Flood Depth Post Mining Landform  
(to Longwall 23)
