## APPENDIX 19

**Flooding Assessment Figures -  
Property 65**

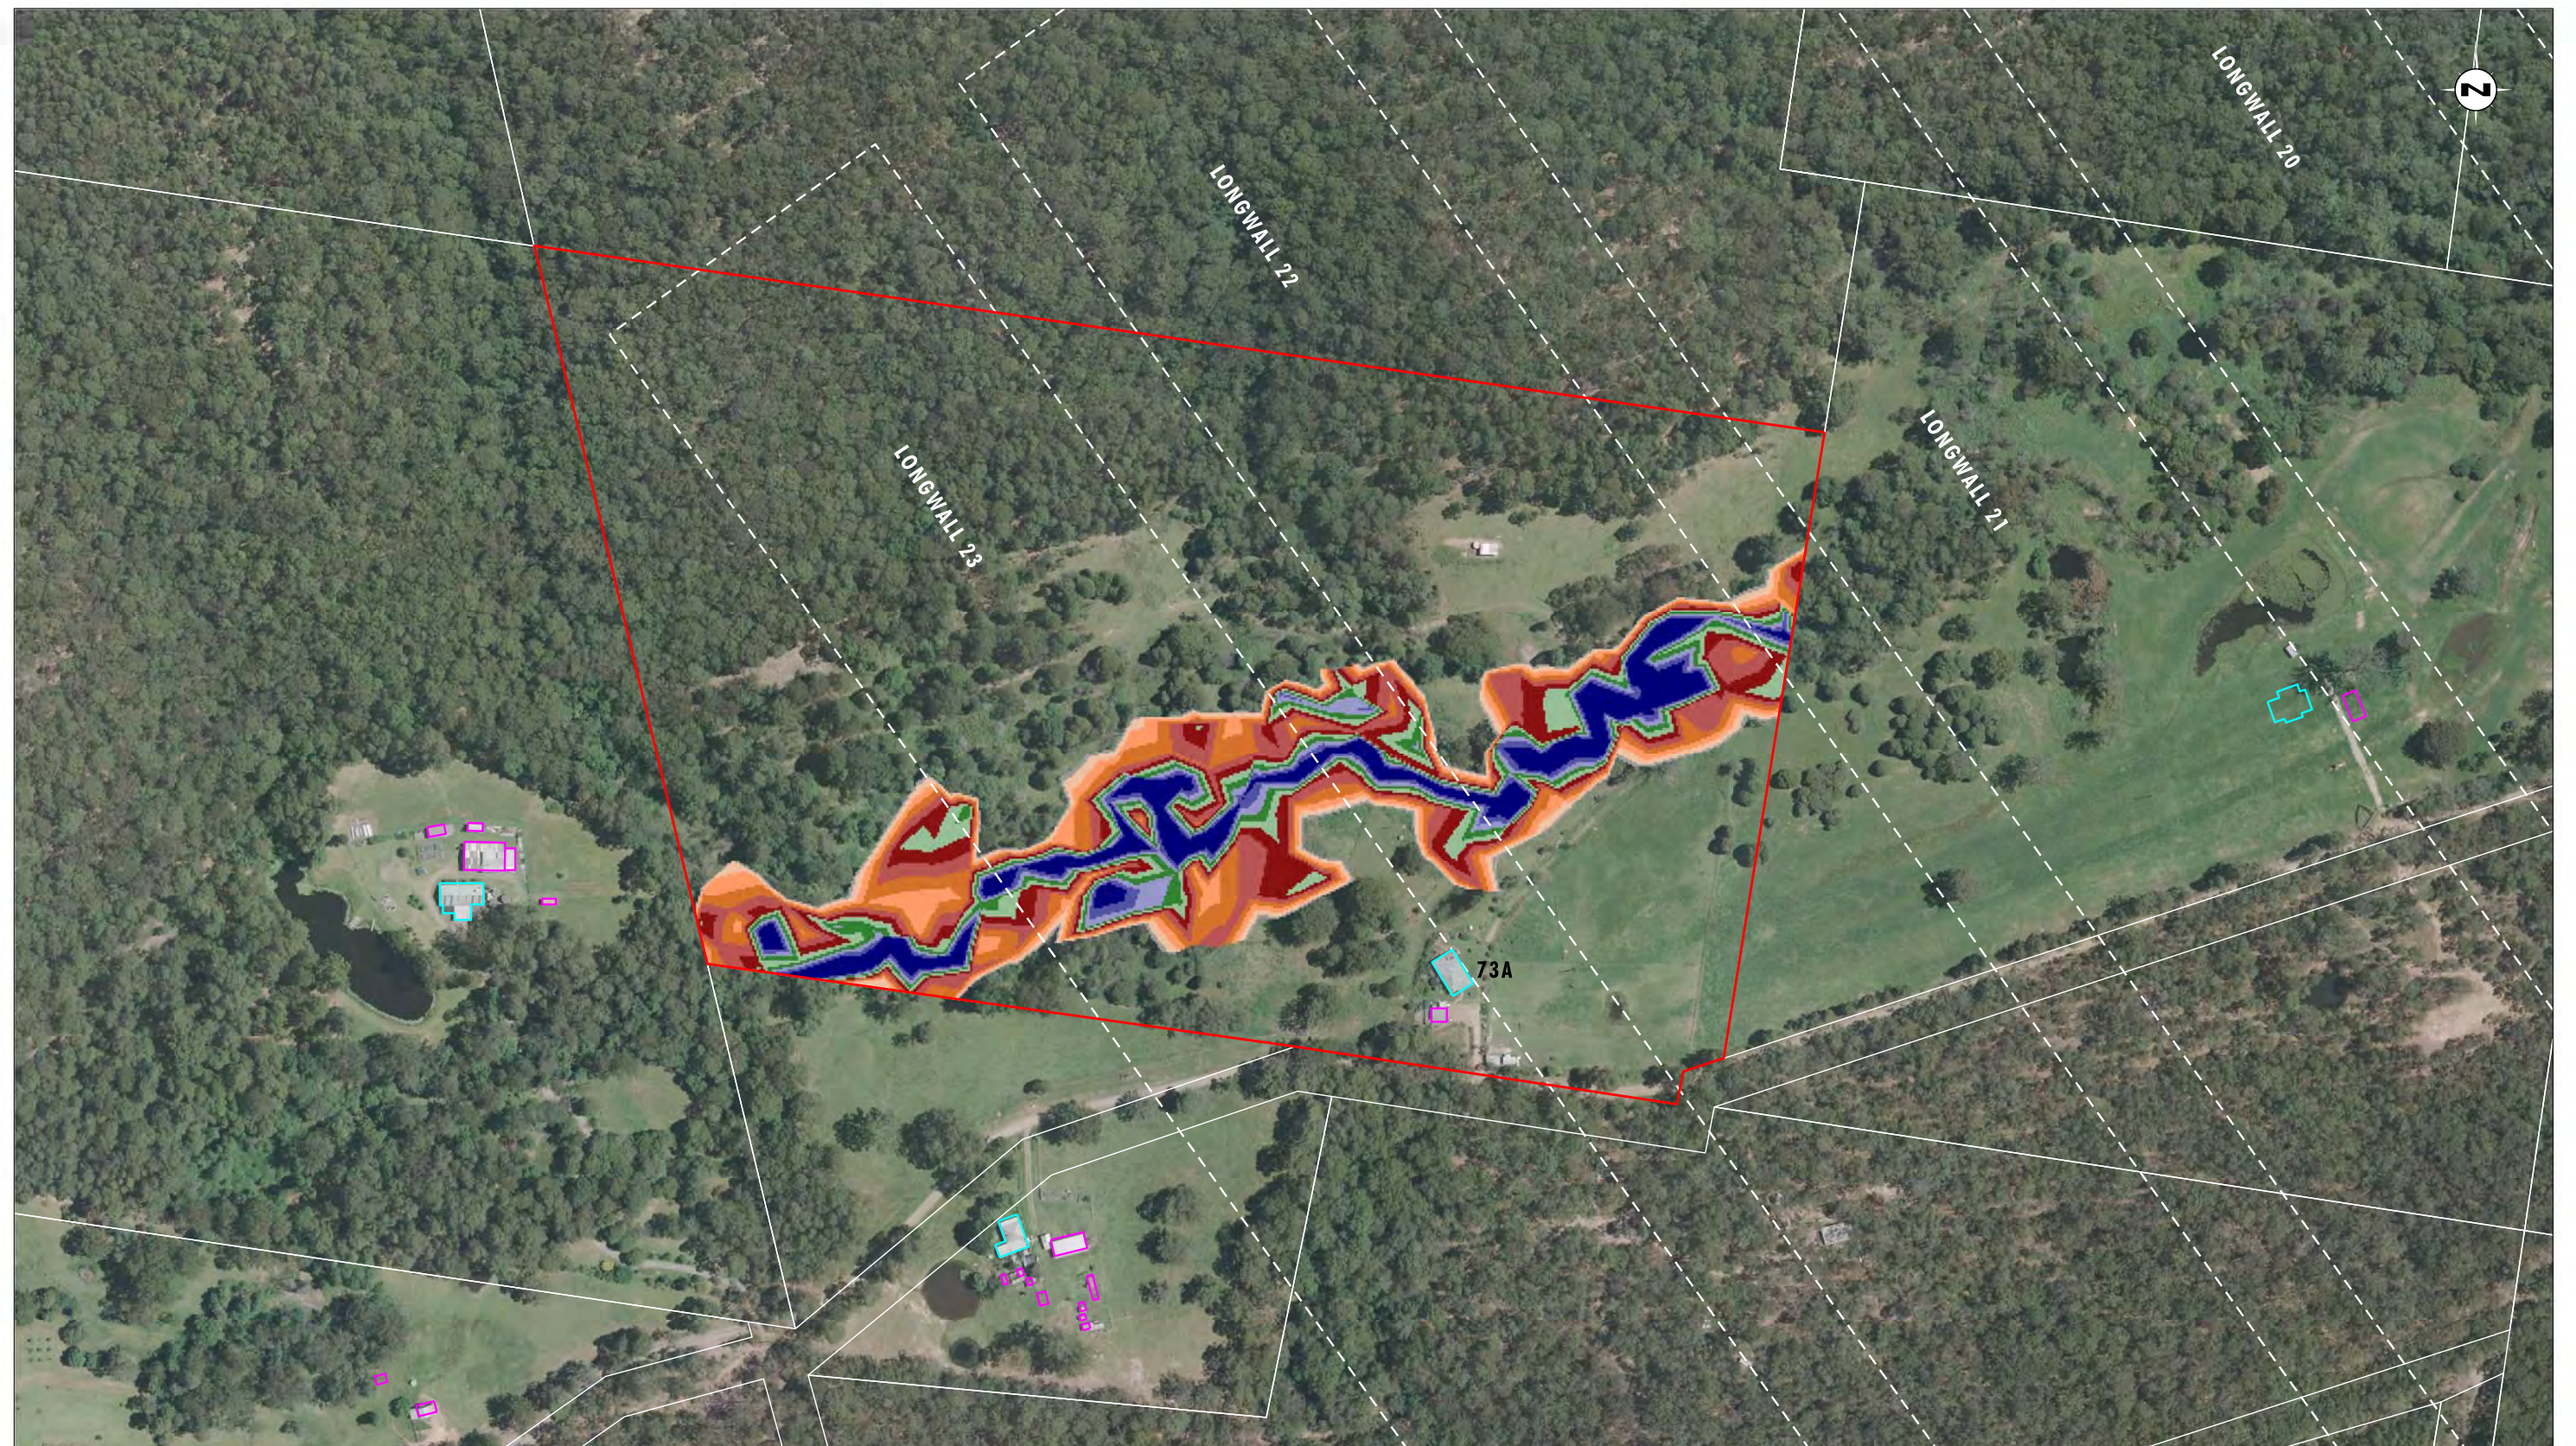
FIGURE 2

Property 73 - 100 year ARI Storm Event:  
Maximum Flood Depth Post Mining Landform  
(to Longwall 23)

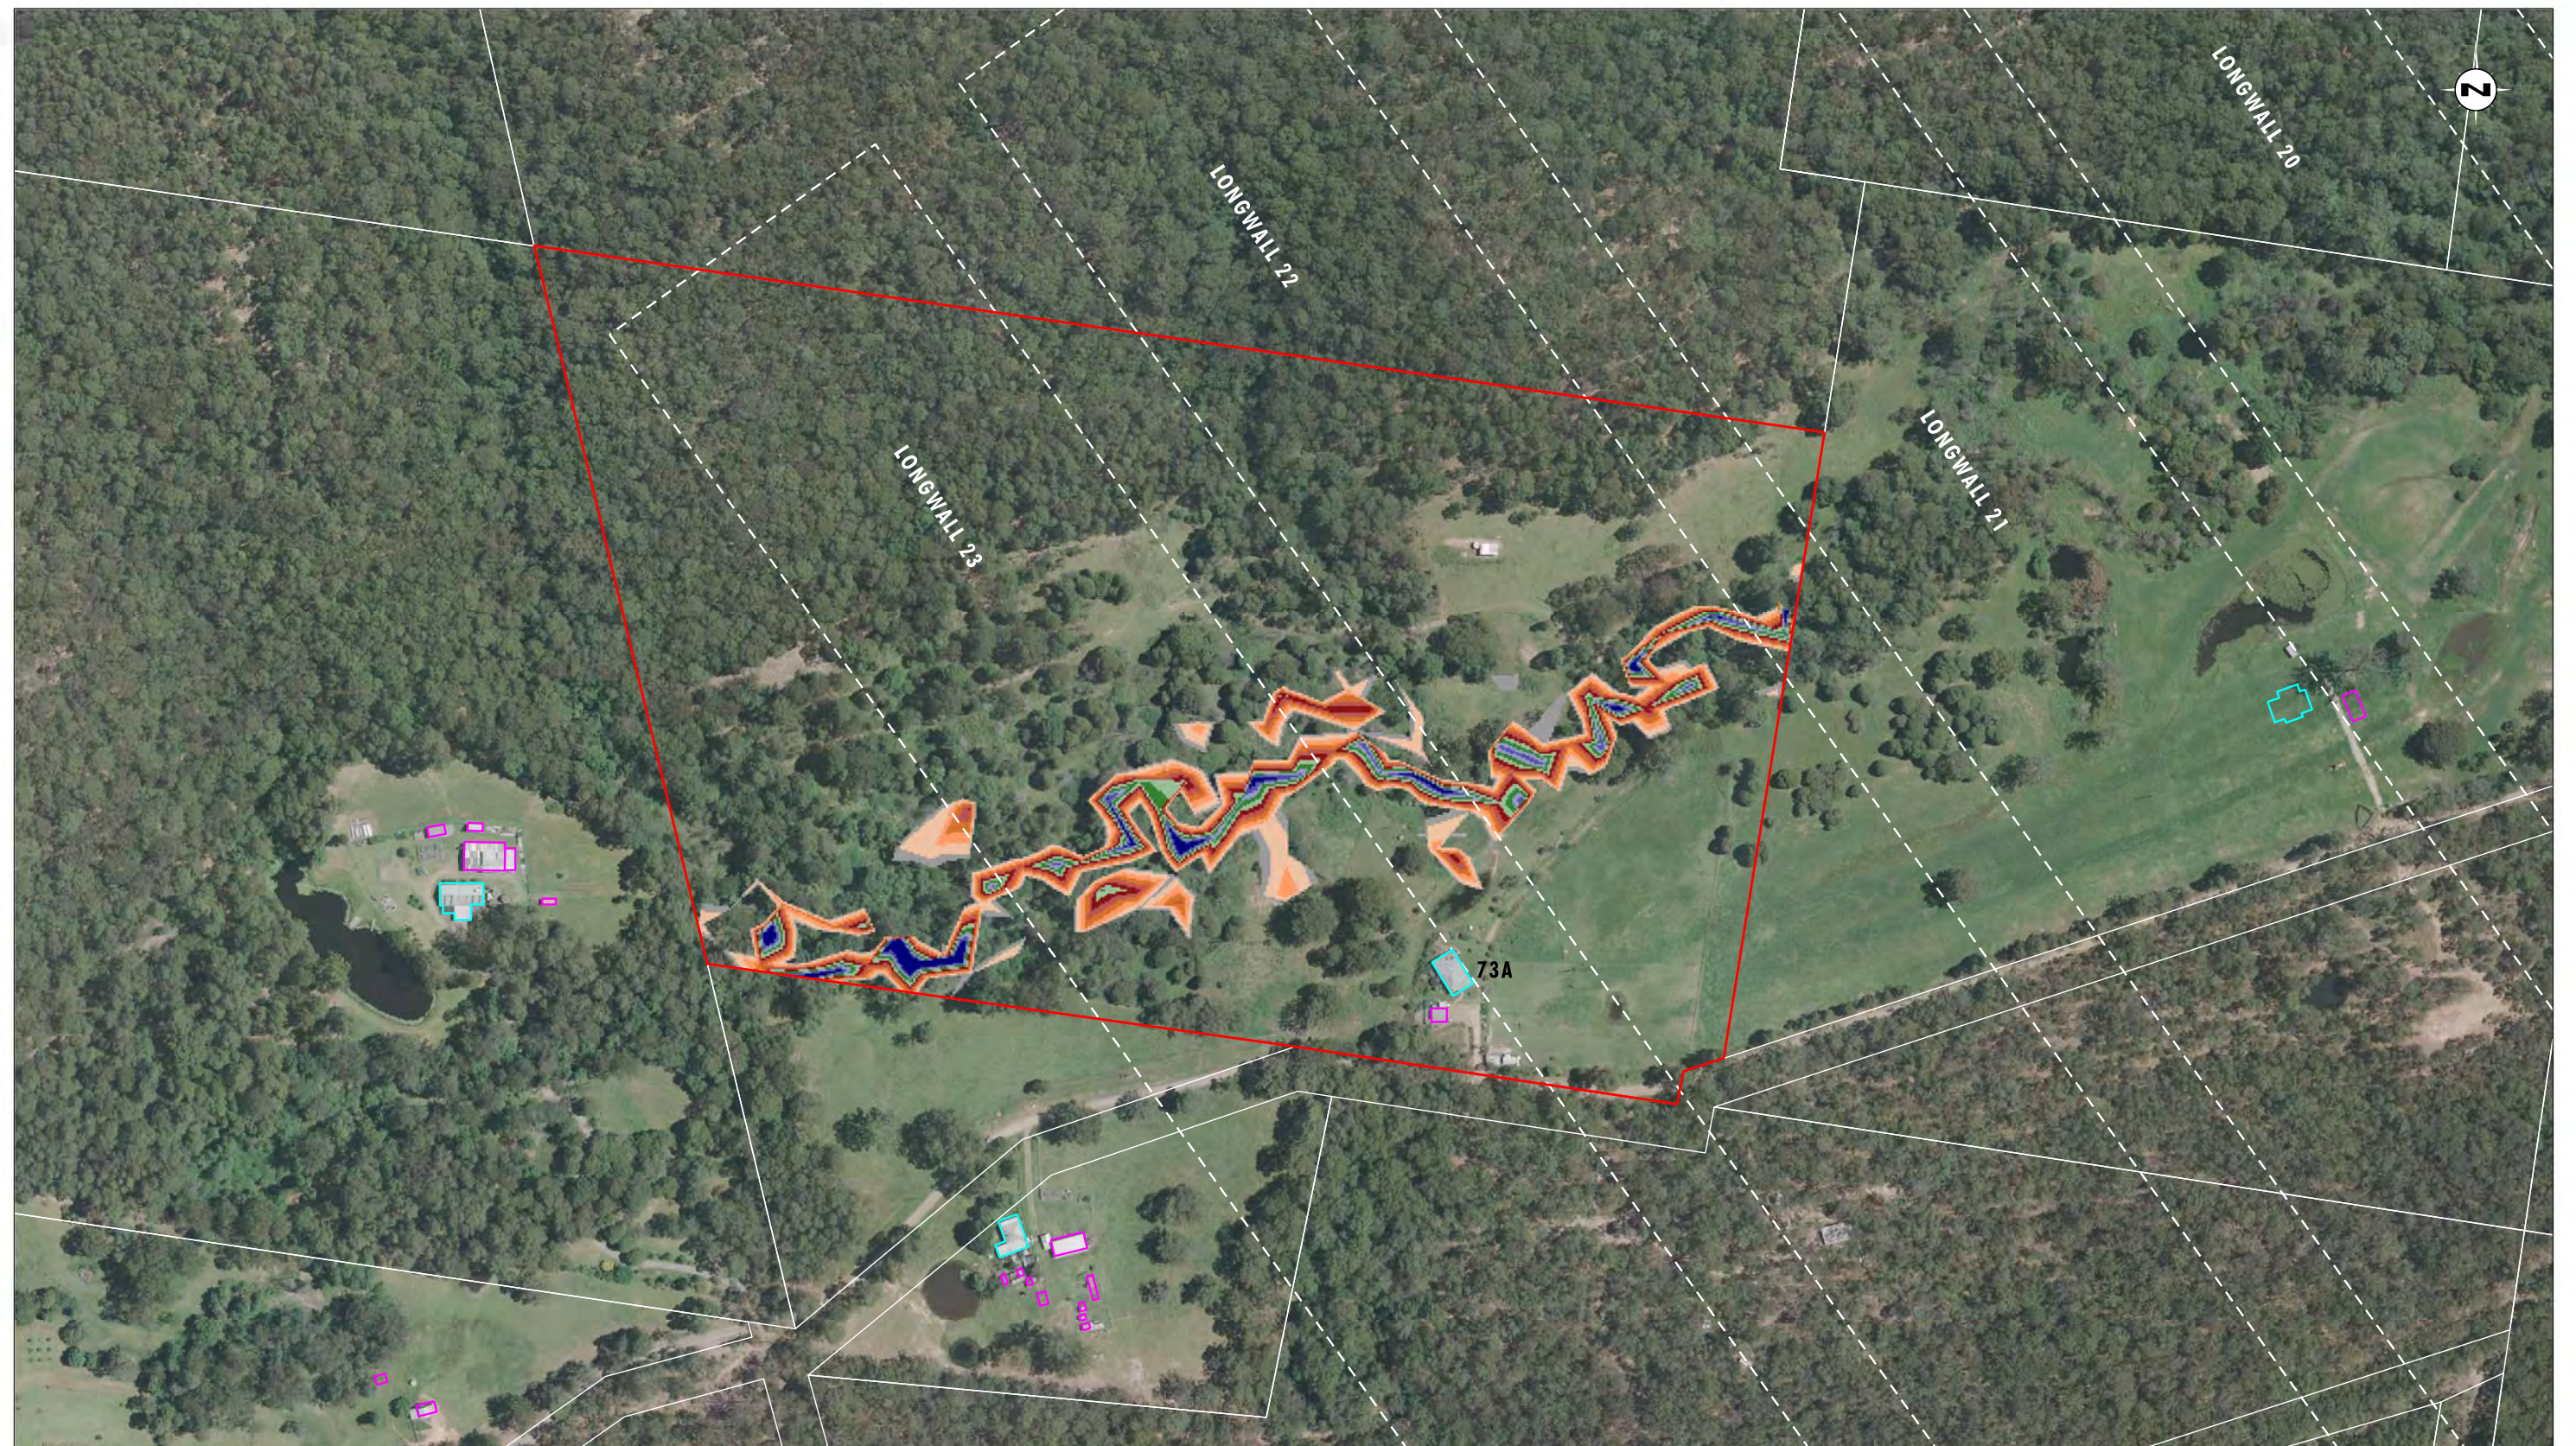
FIGURE 3

Property 73 - 1 year ARI Storm Event:  
Maximum Flood Depth Pre Mining Landform

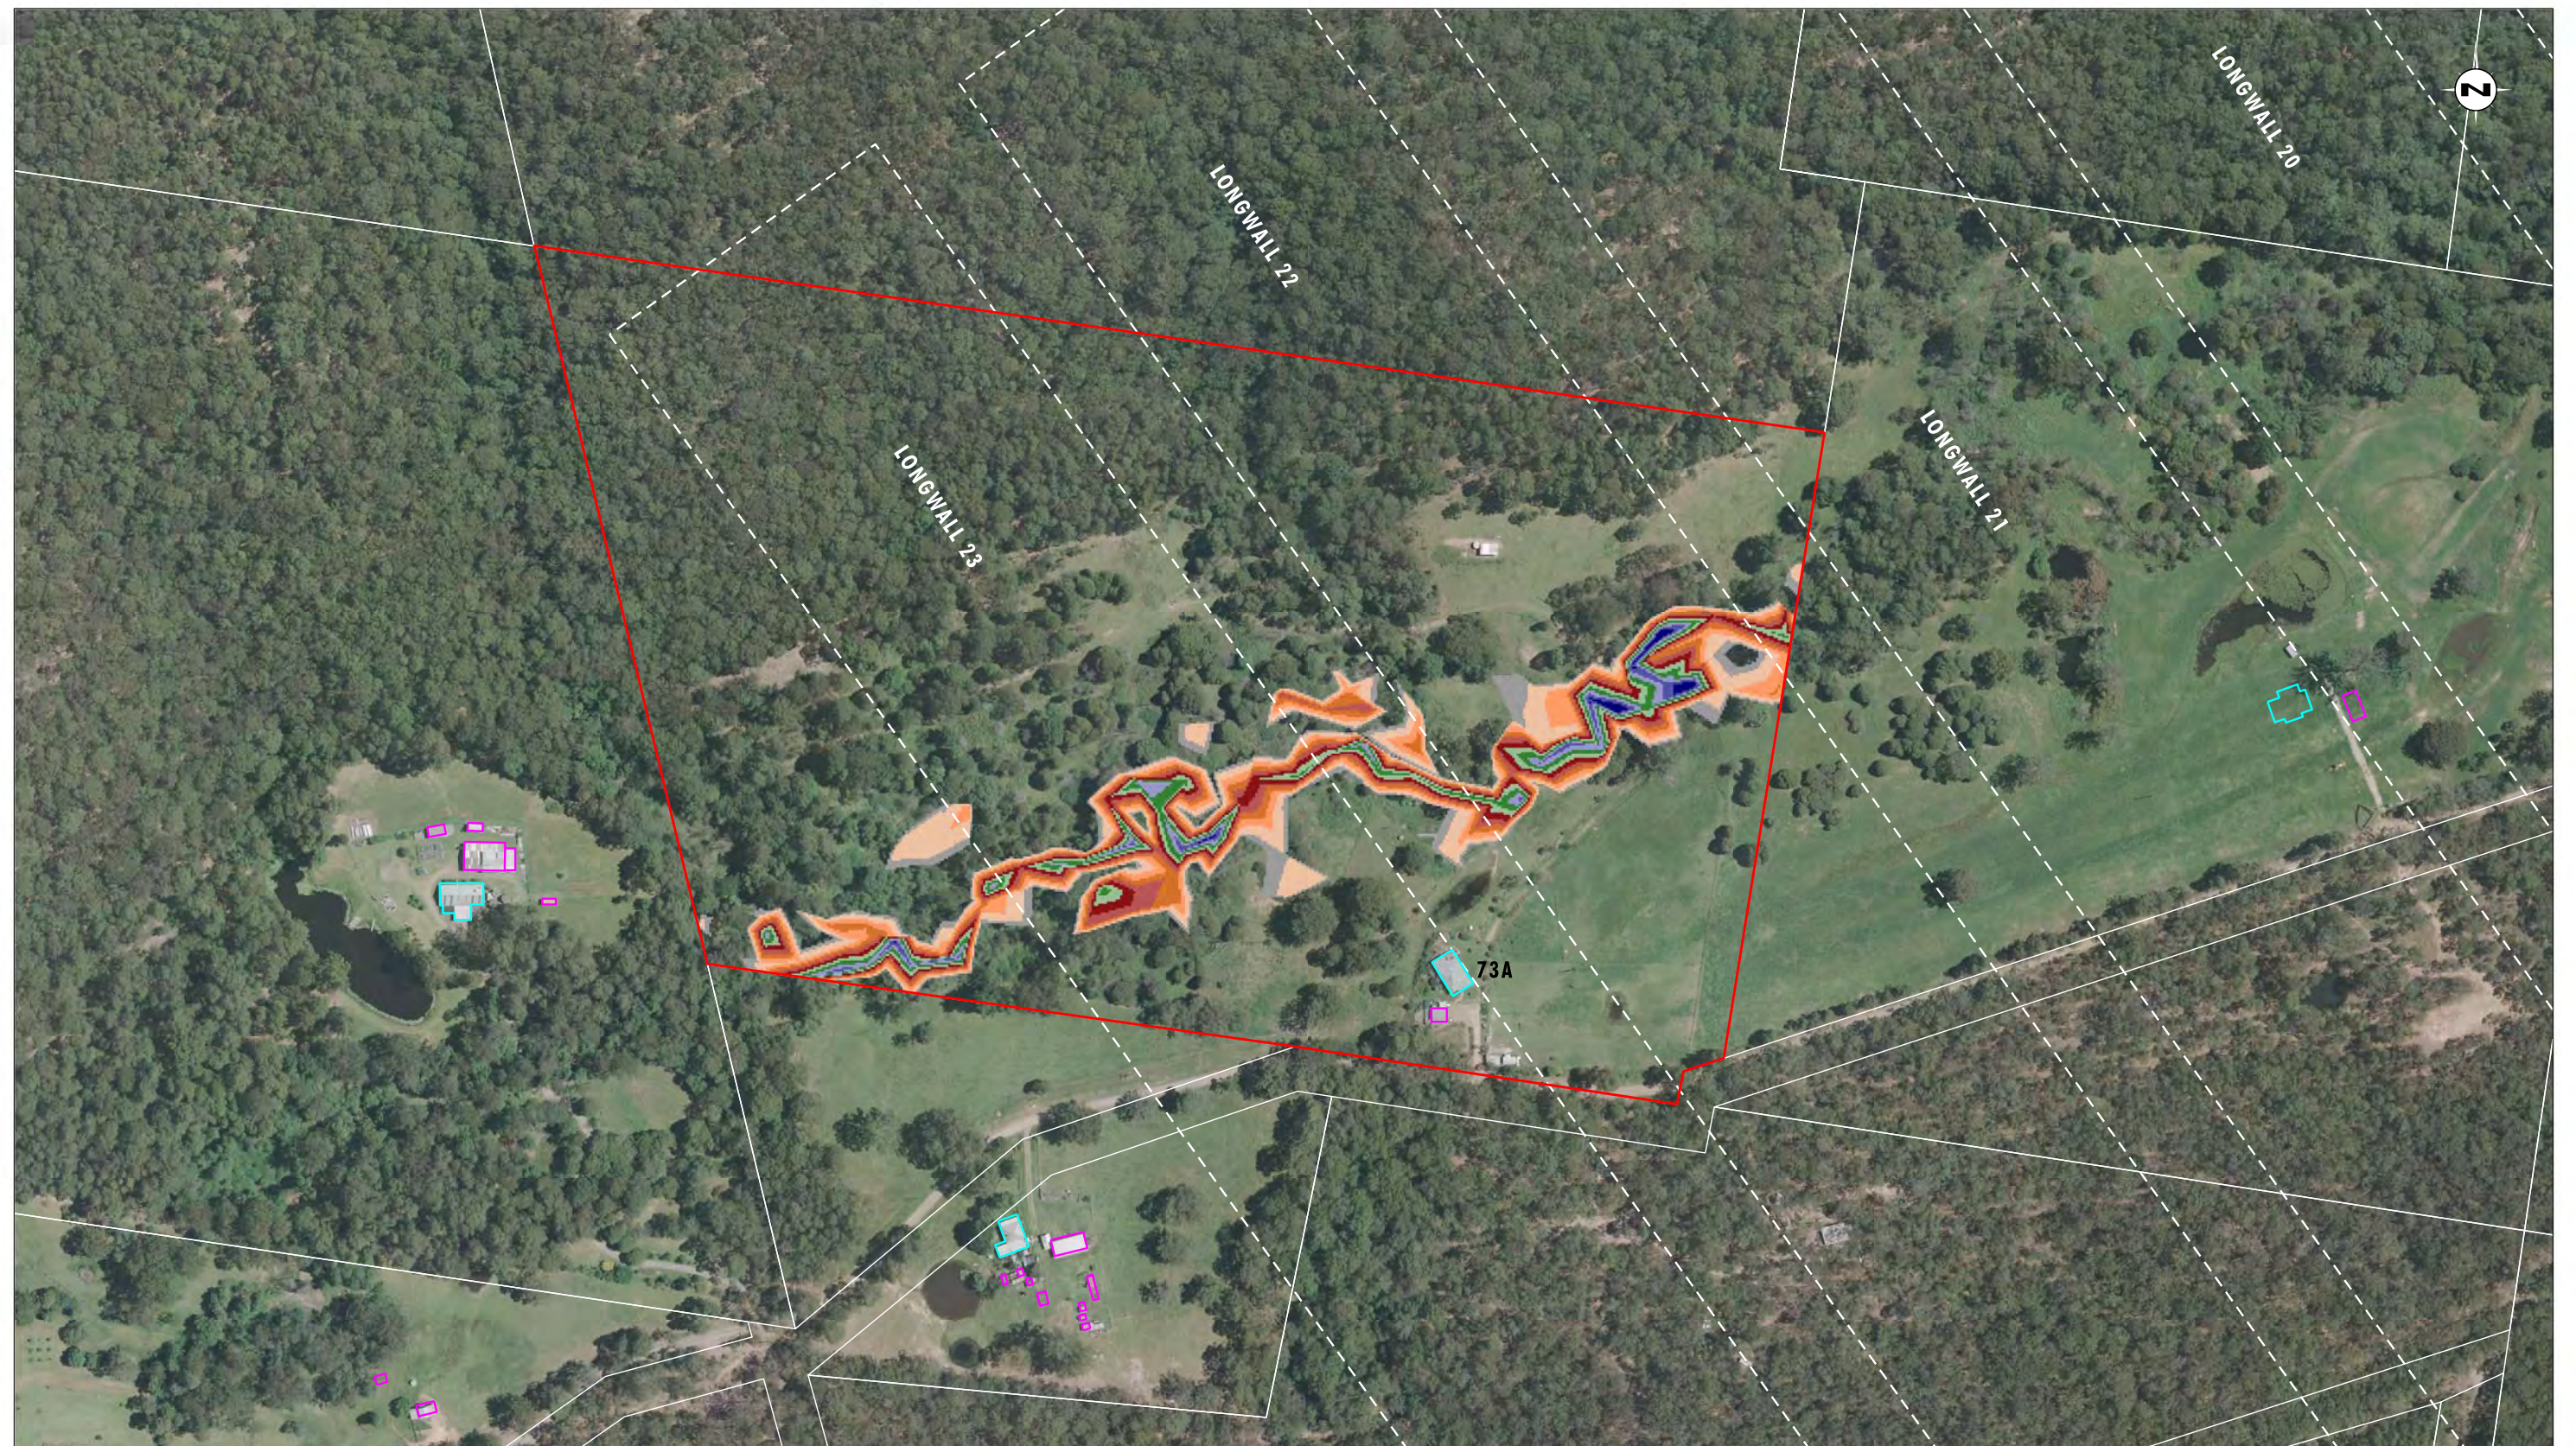
FIGURE 4

Property 73 - 1 year ARI Storm Event:  
Maximum Flood Depth Post Mining Landform  
(to Longwall 23)

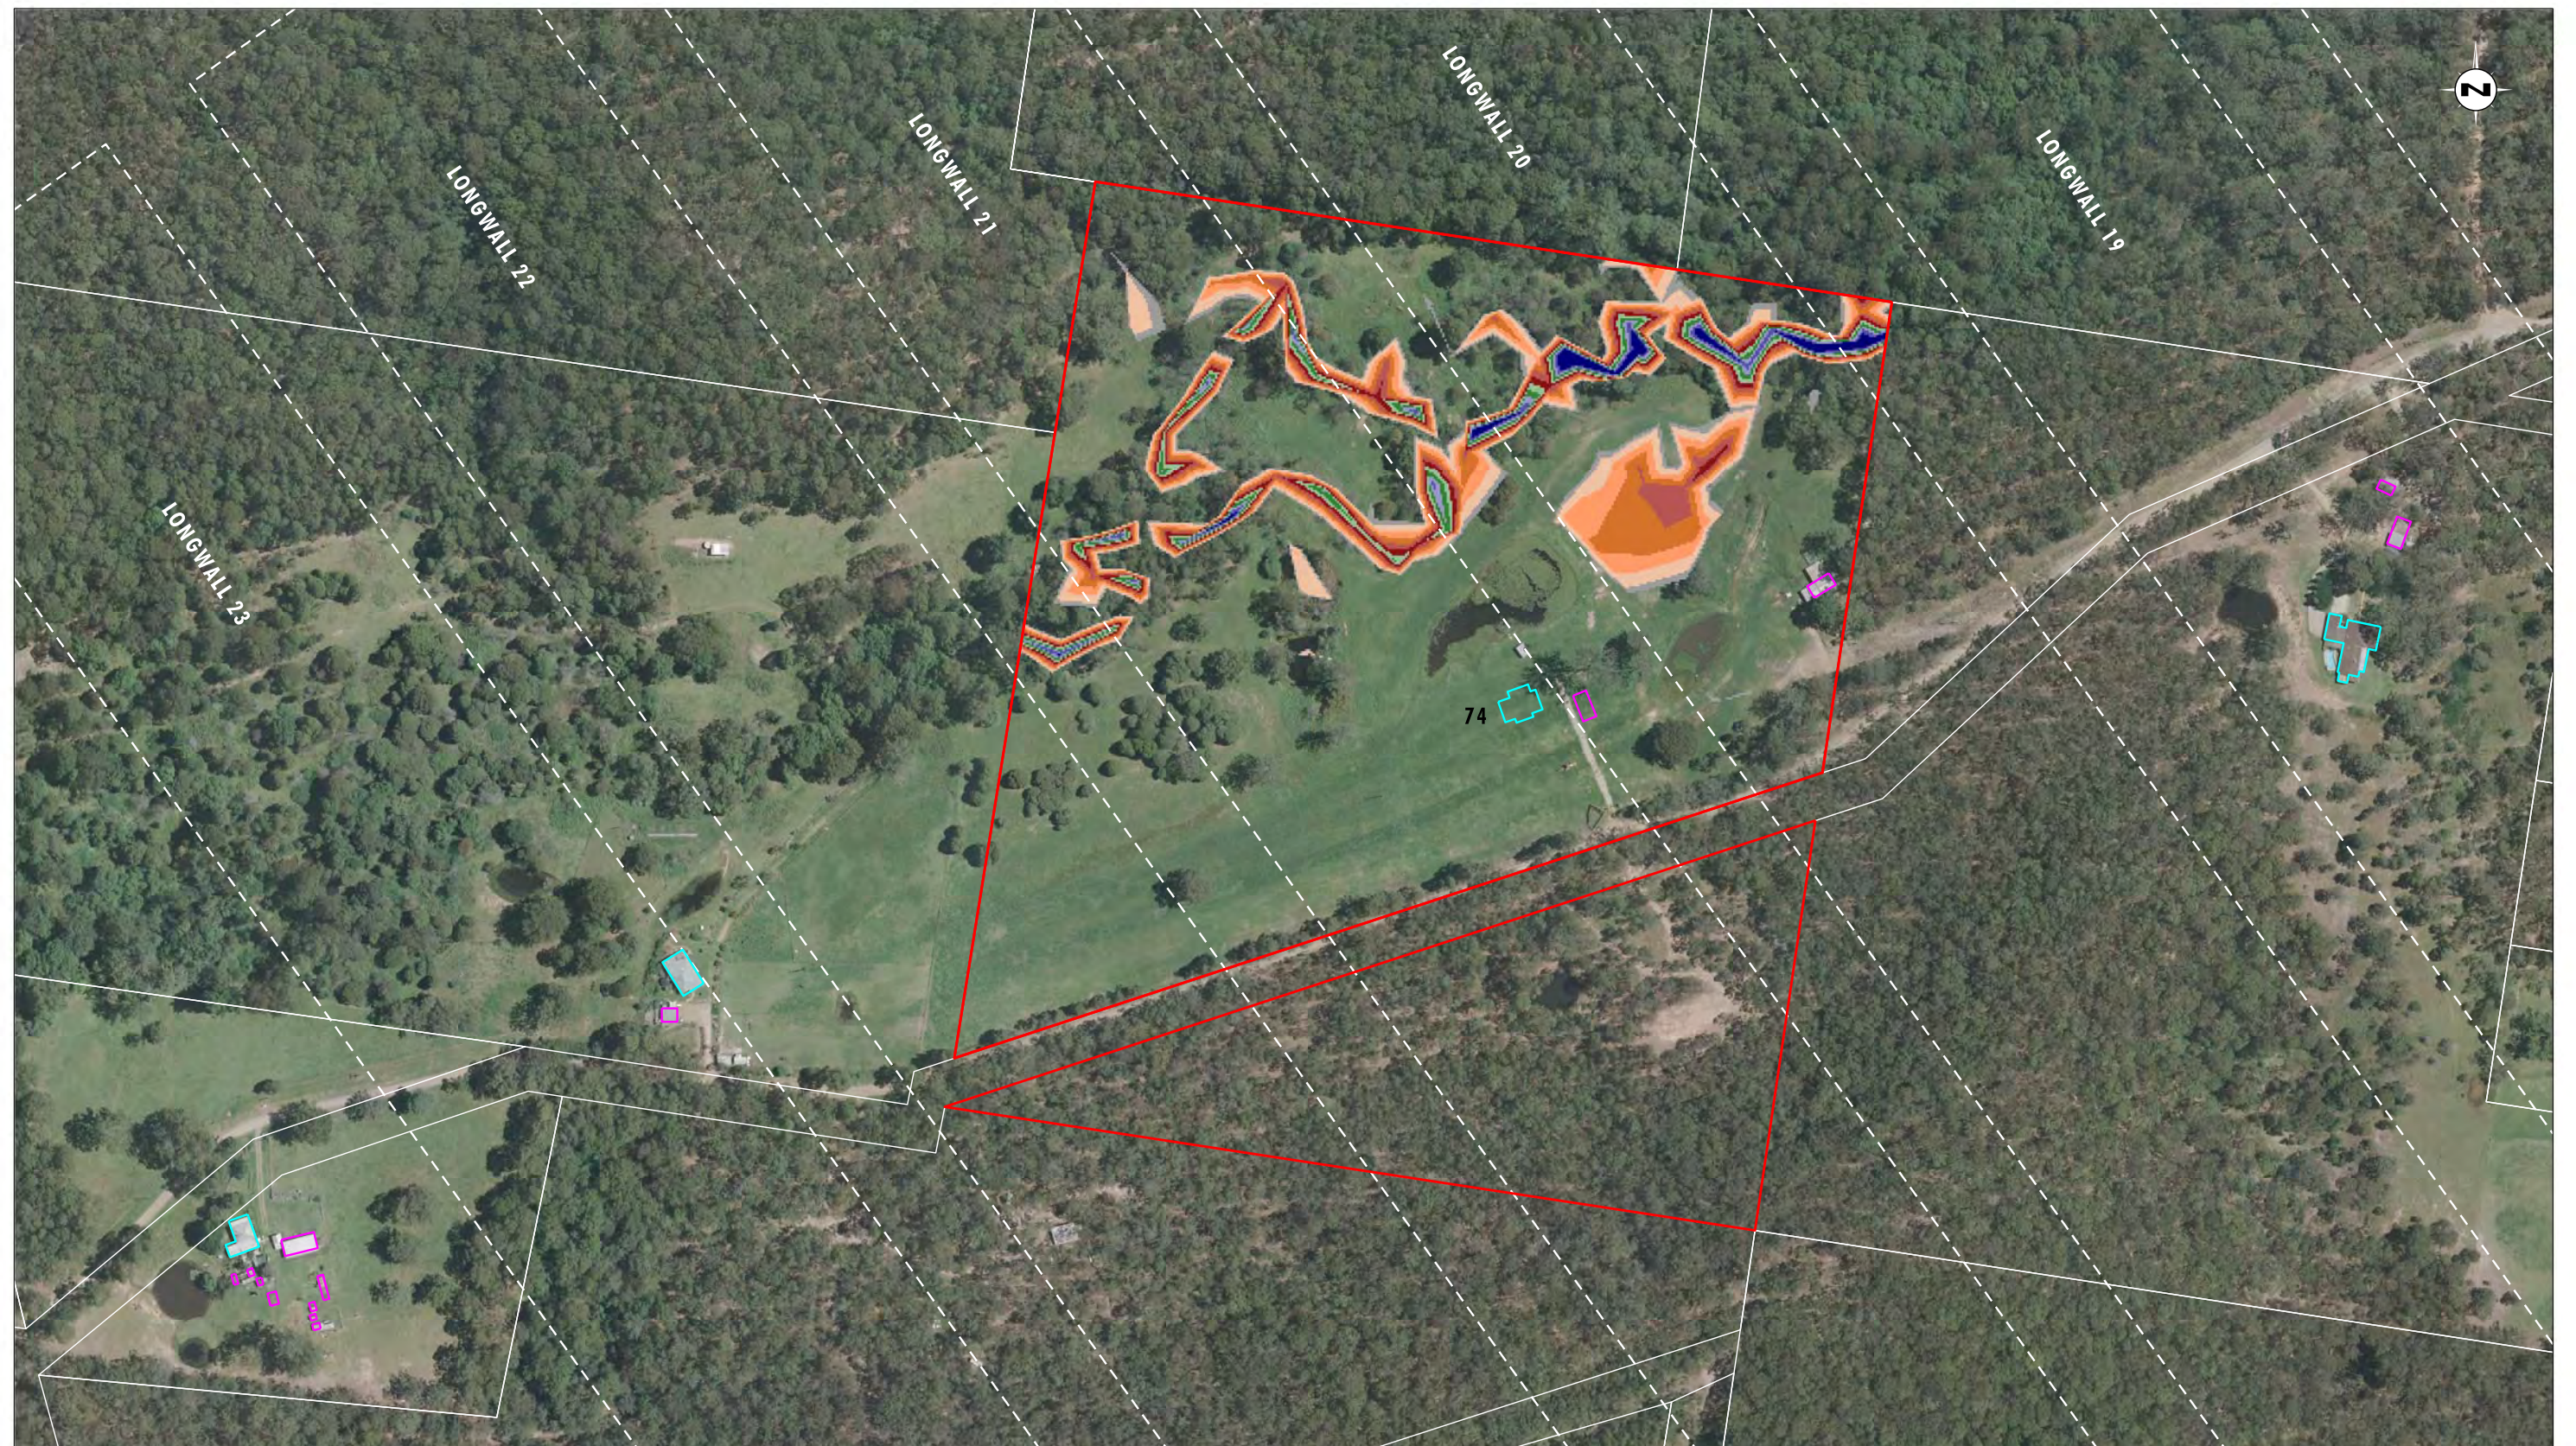
FIGURE 3

Property 74 - 1 year ARI Storm Event:  
Maximum Flood Depth Pre Mining Landform
