## APPENDIX 37

**Flooding Assessment Figures -  
Properties 86, 87, 88, 203 & 212**

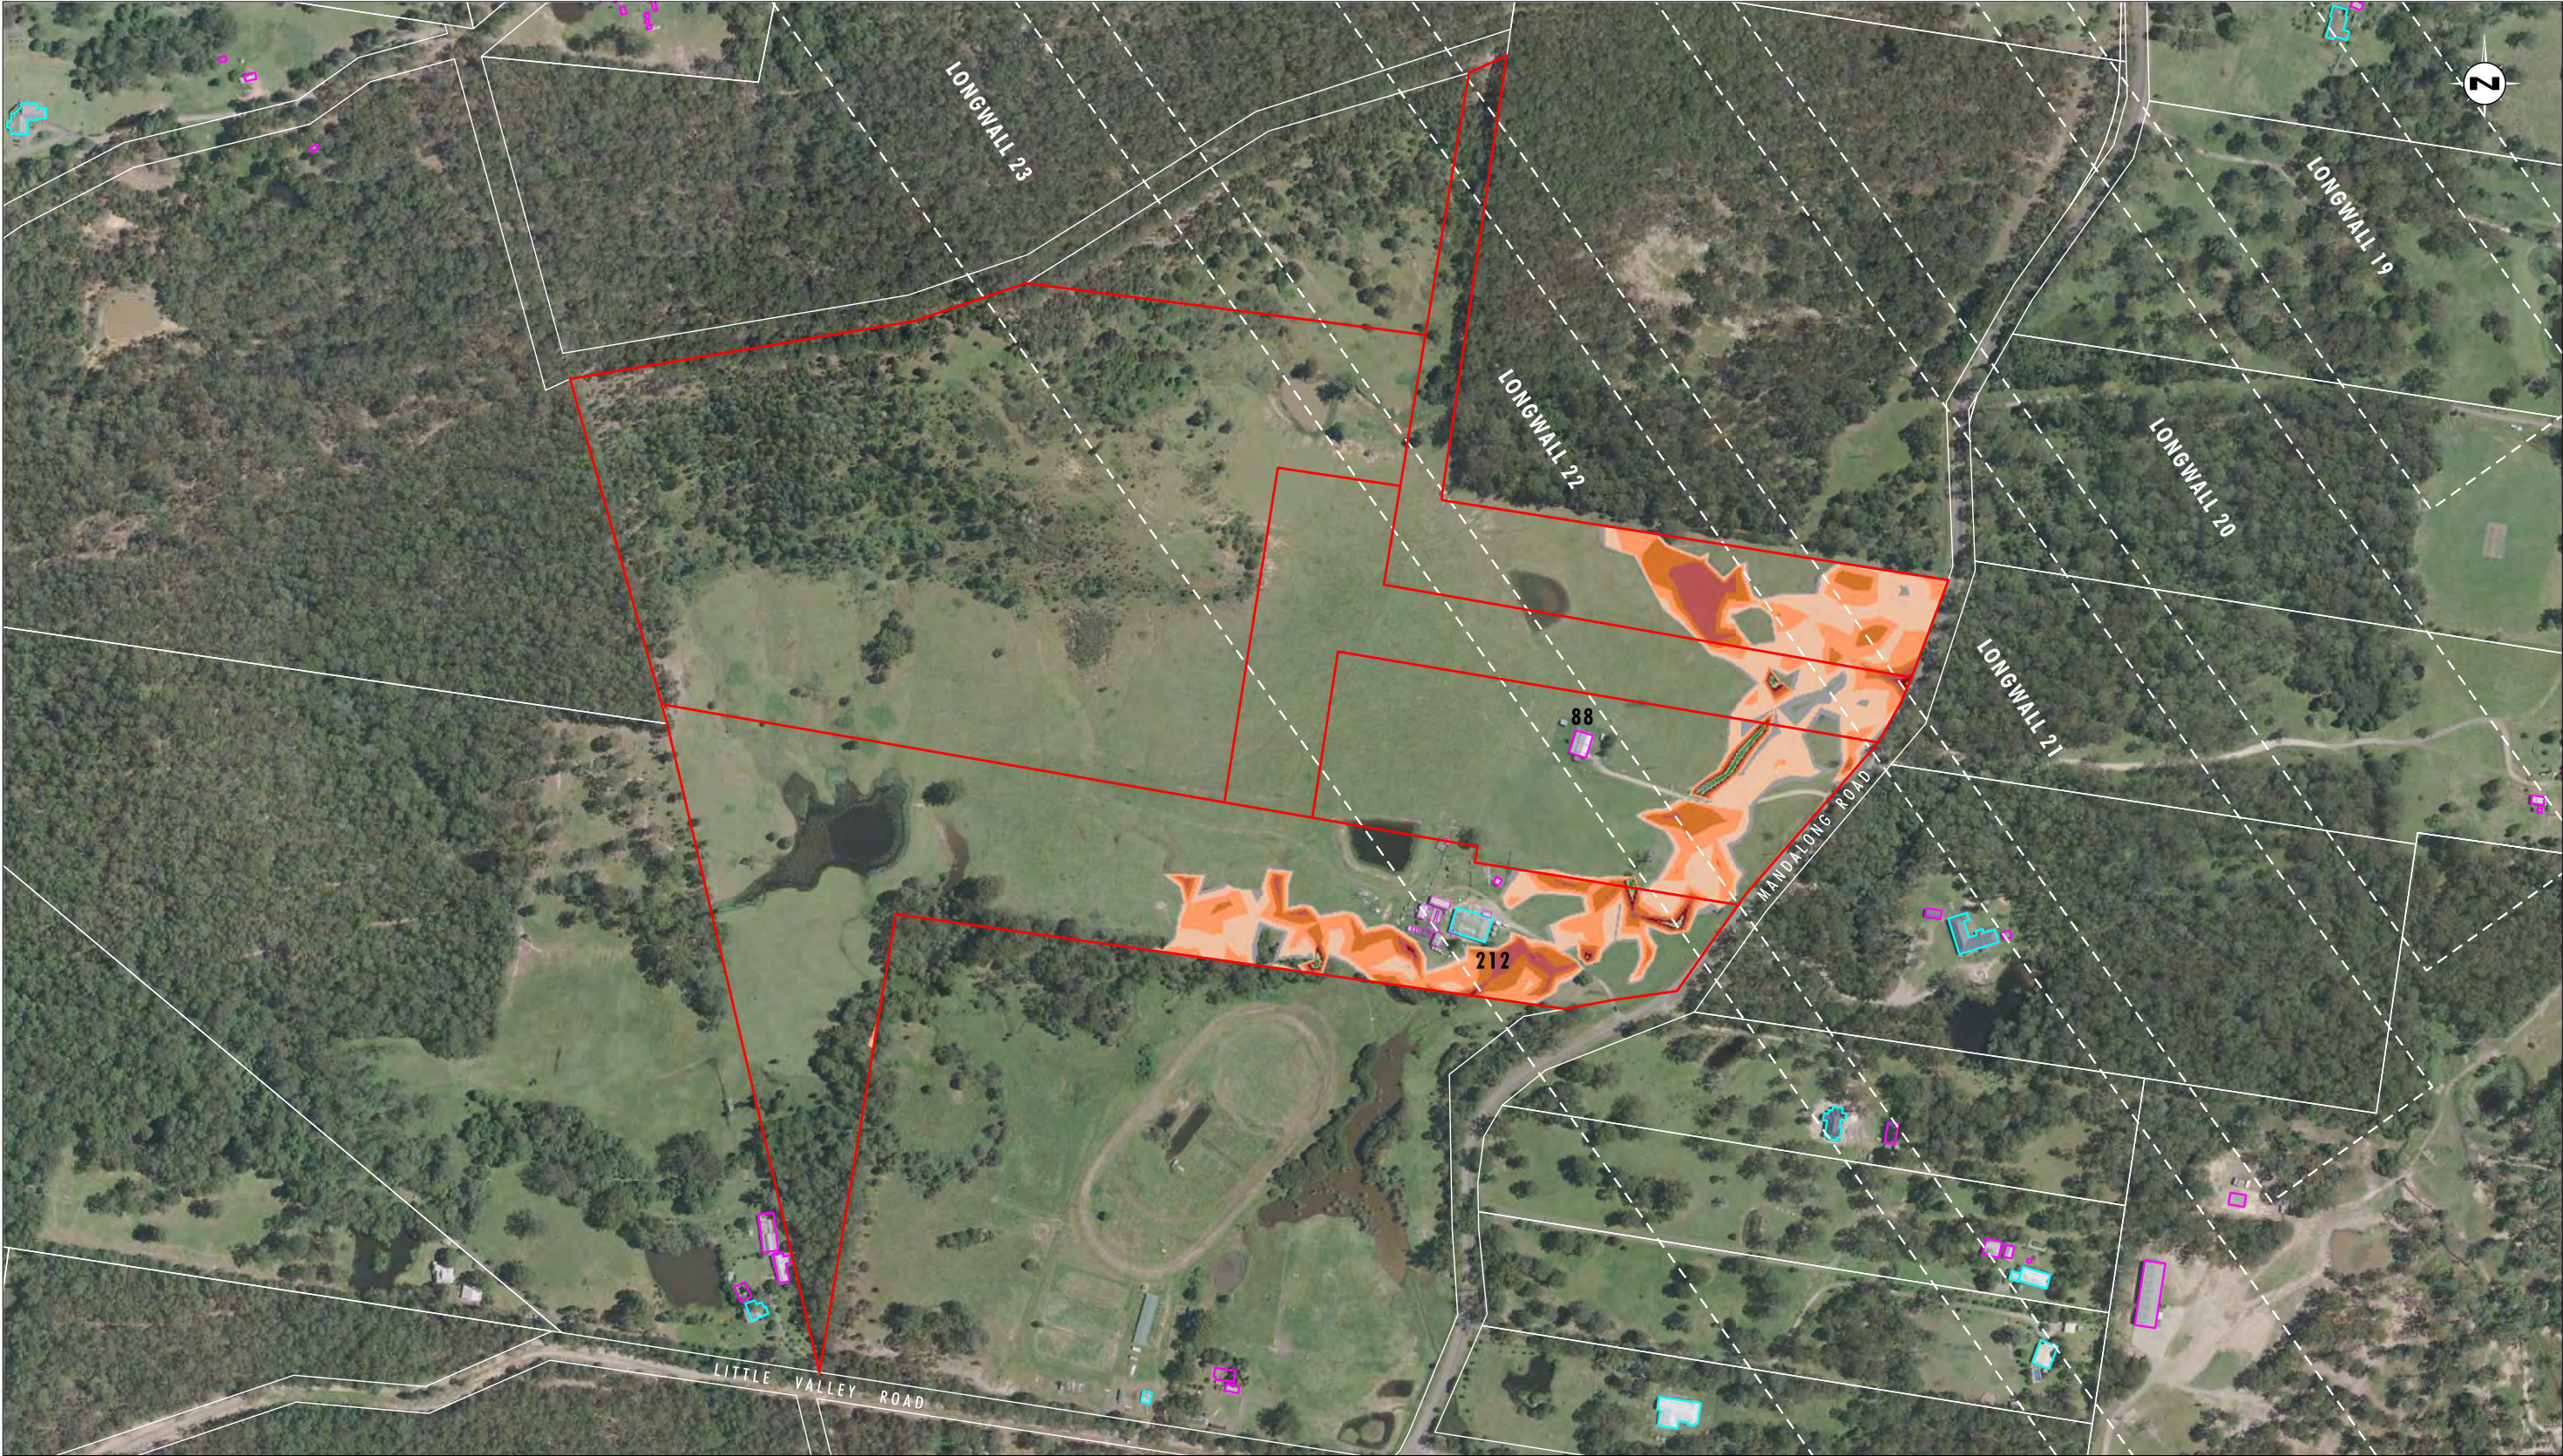
FIGURE 5  
Property 86, 87, 88, 203 & 212 - 1 Year ARI Storm Event:  
Maximum Flood Depth Pre Mining Landform

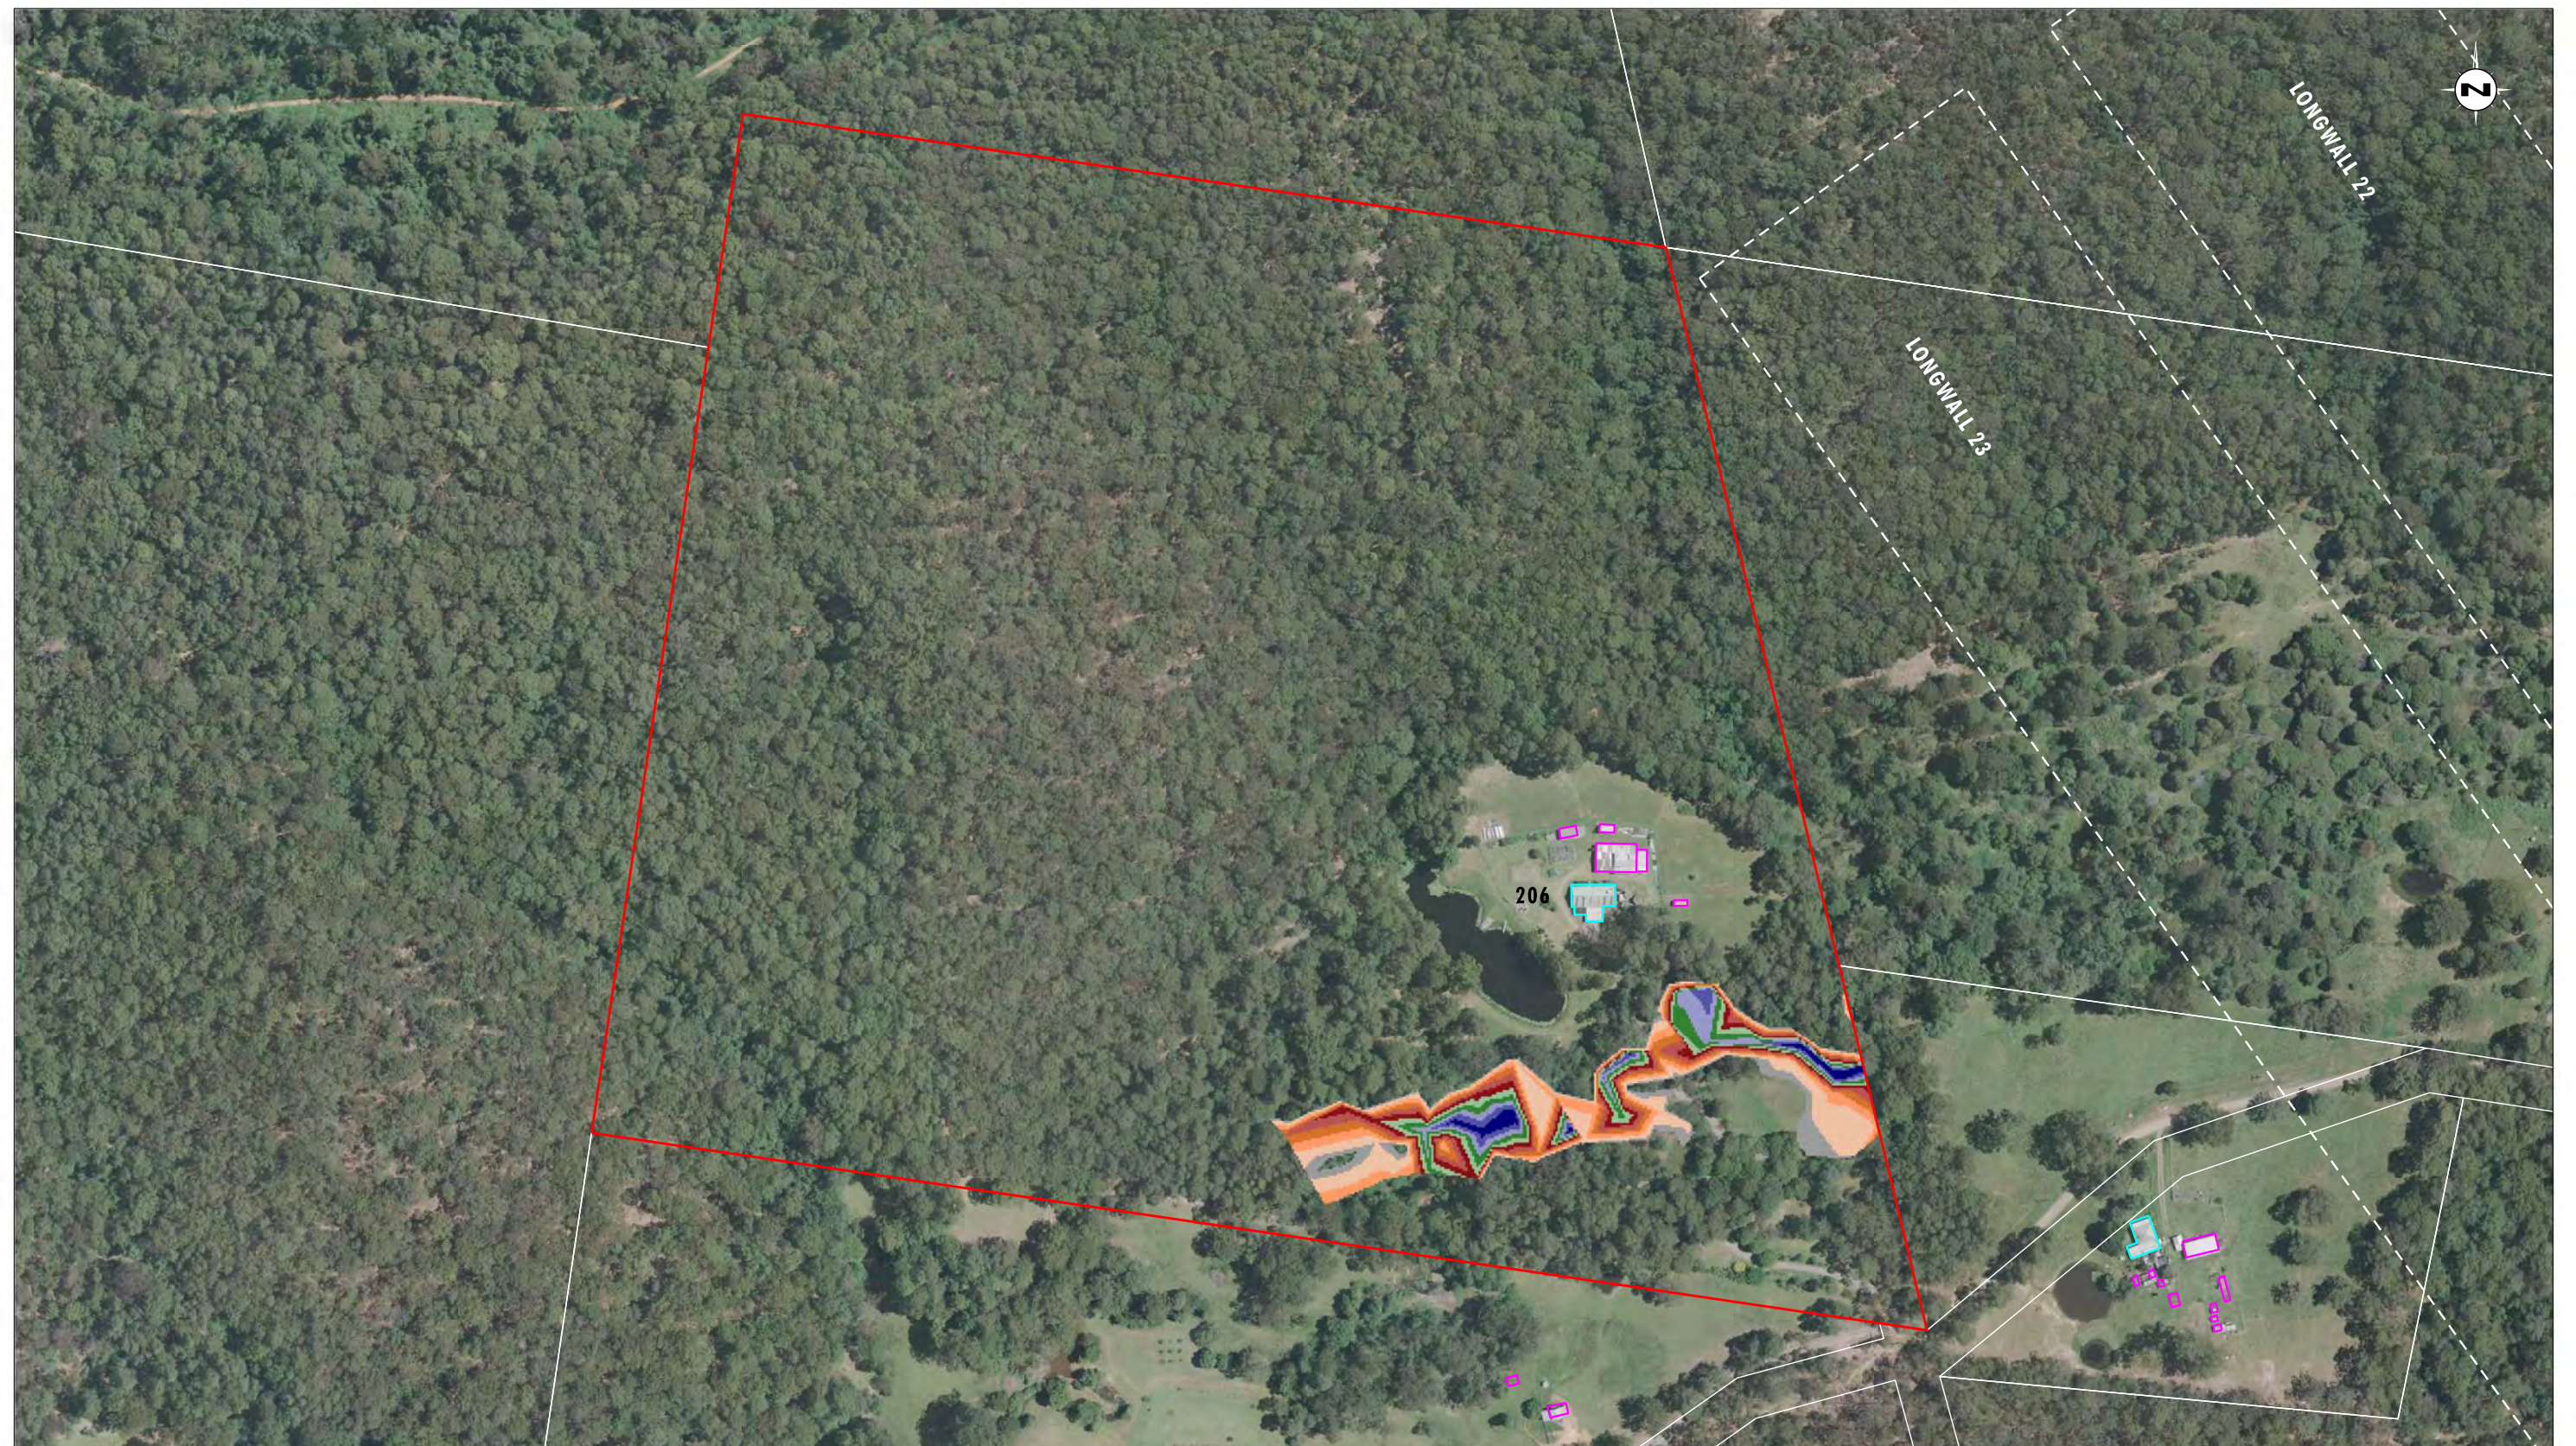
FIGURE 3

Property 206 - 1 Year ARI Storm Event:  
Maximum Flood Depth Pre Mining Landform

FIGURE 4

Property 206 - 1 Year ARI Storm Event:  
Maximum Flood Depth Post Mining Landform  
(to Longwall 23)
