## APPENDIX 7

**Flooding Assessment Figures -  
Property 25**

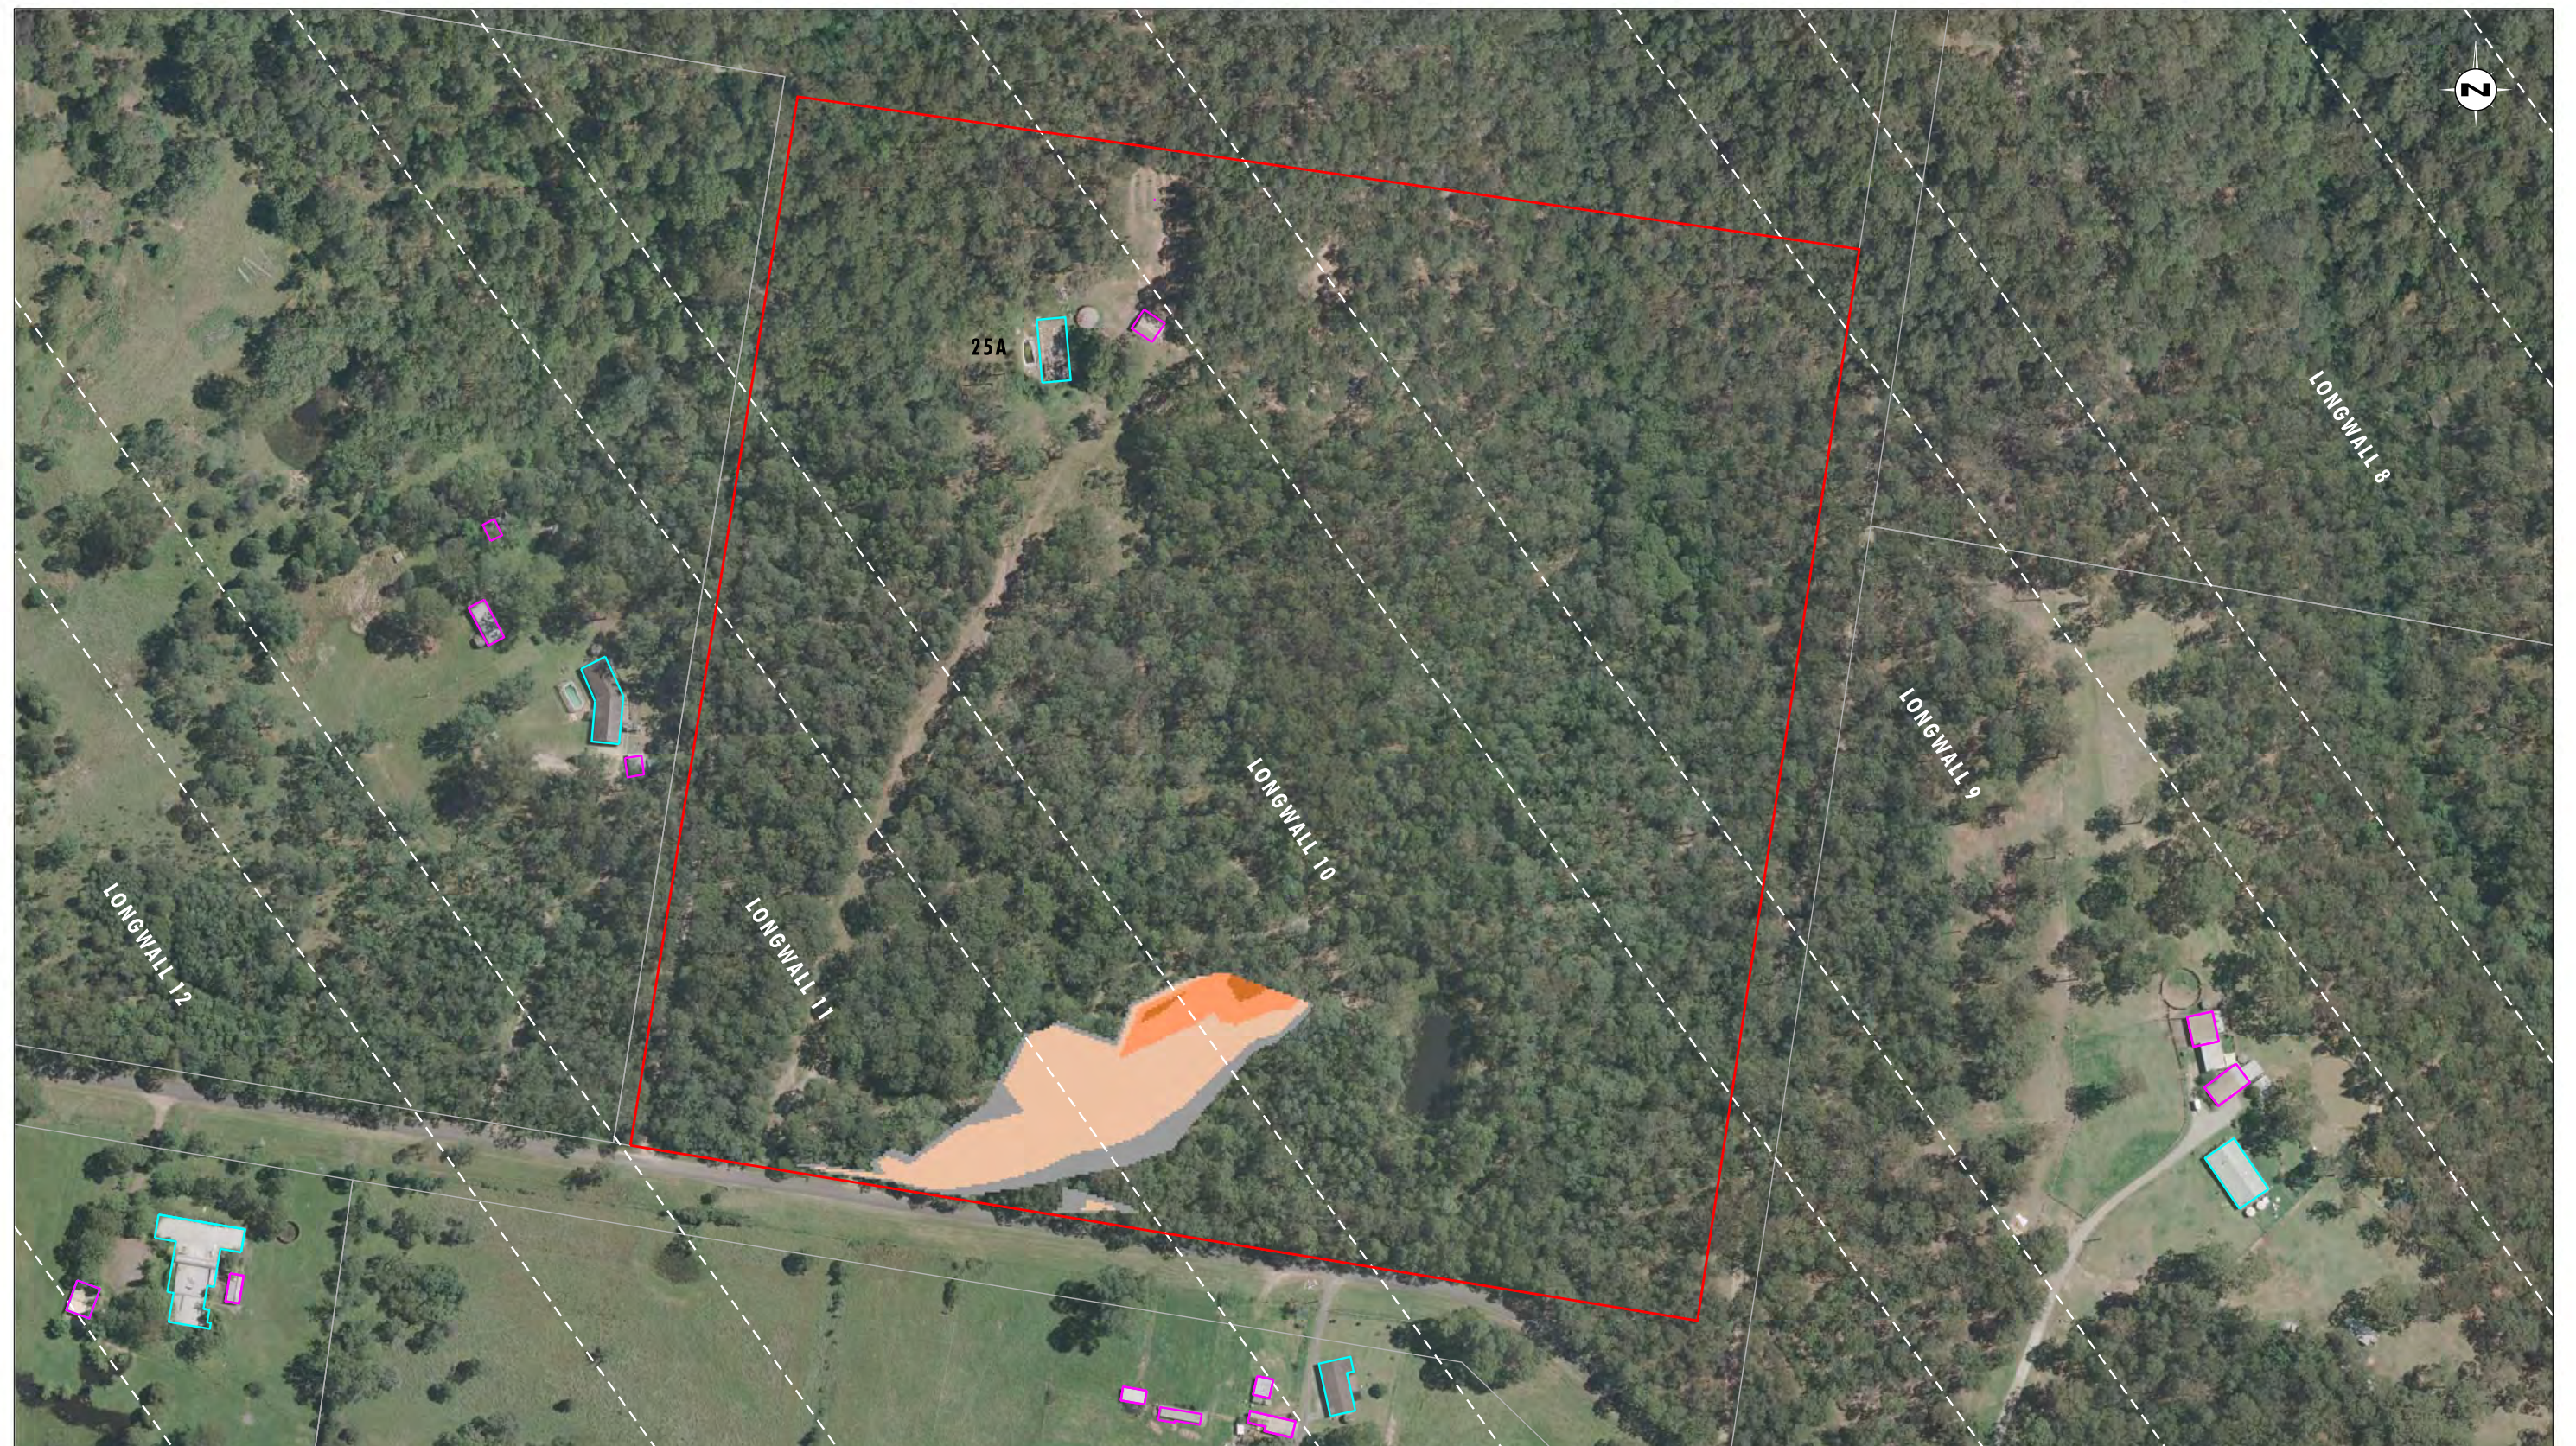
FIGURE 1

Property 25 - 100 year ARI Storm Event:  
Maximum Flood Depth Pre Mining Landform

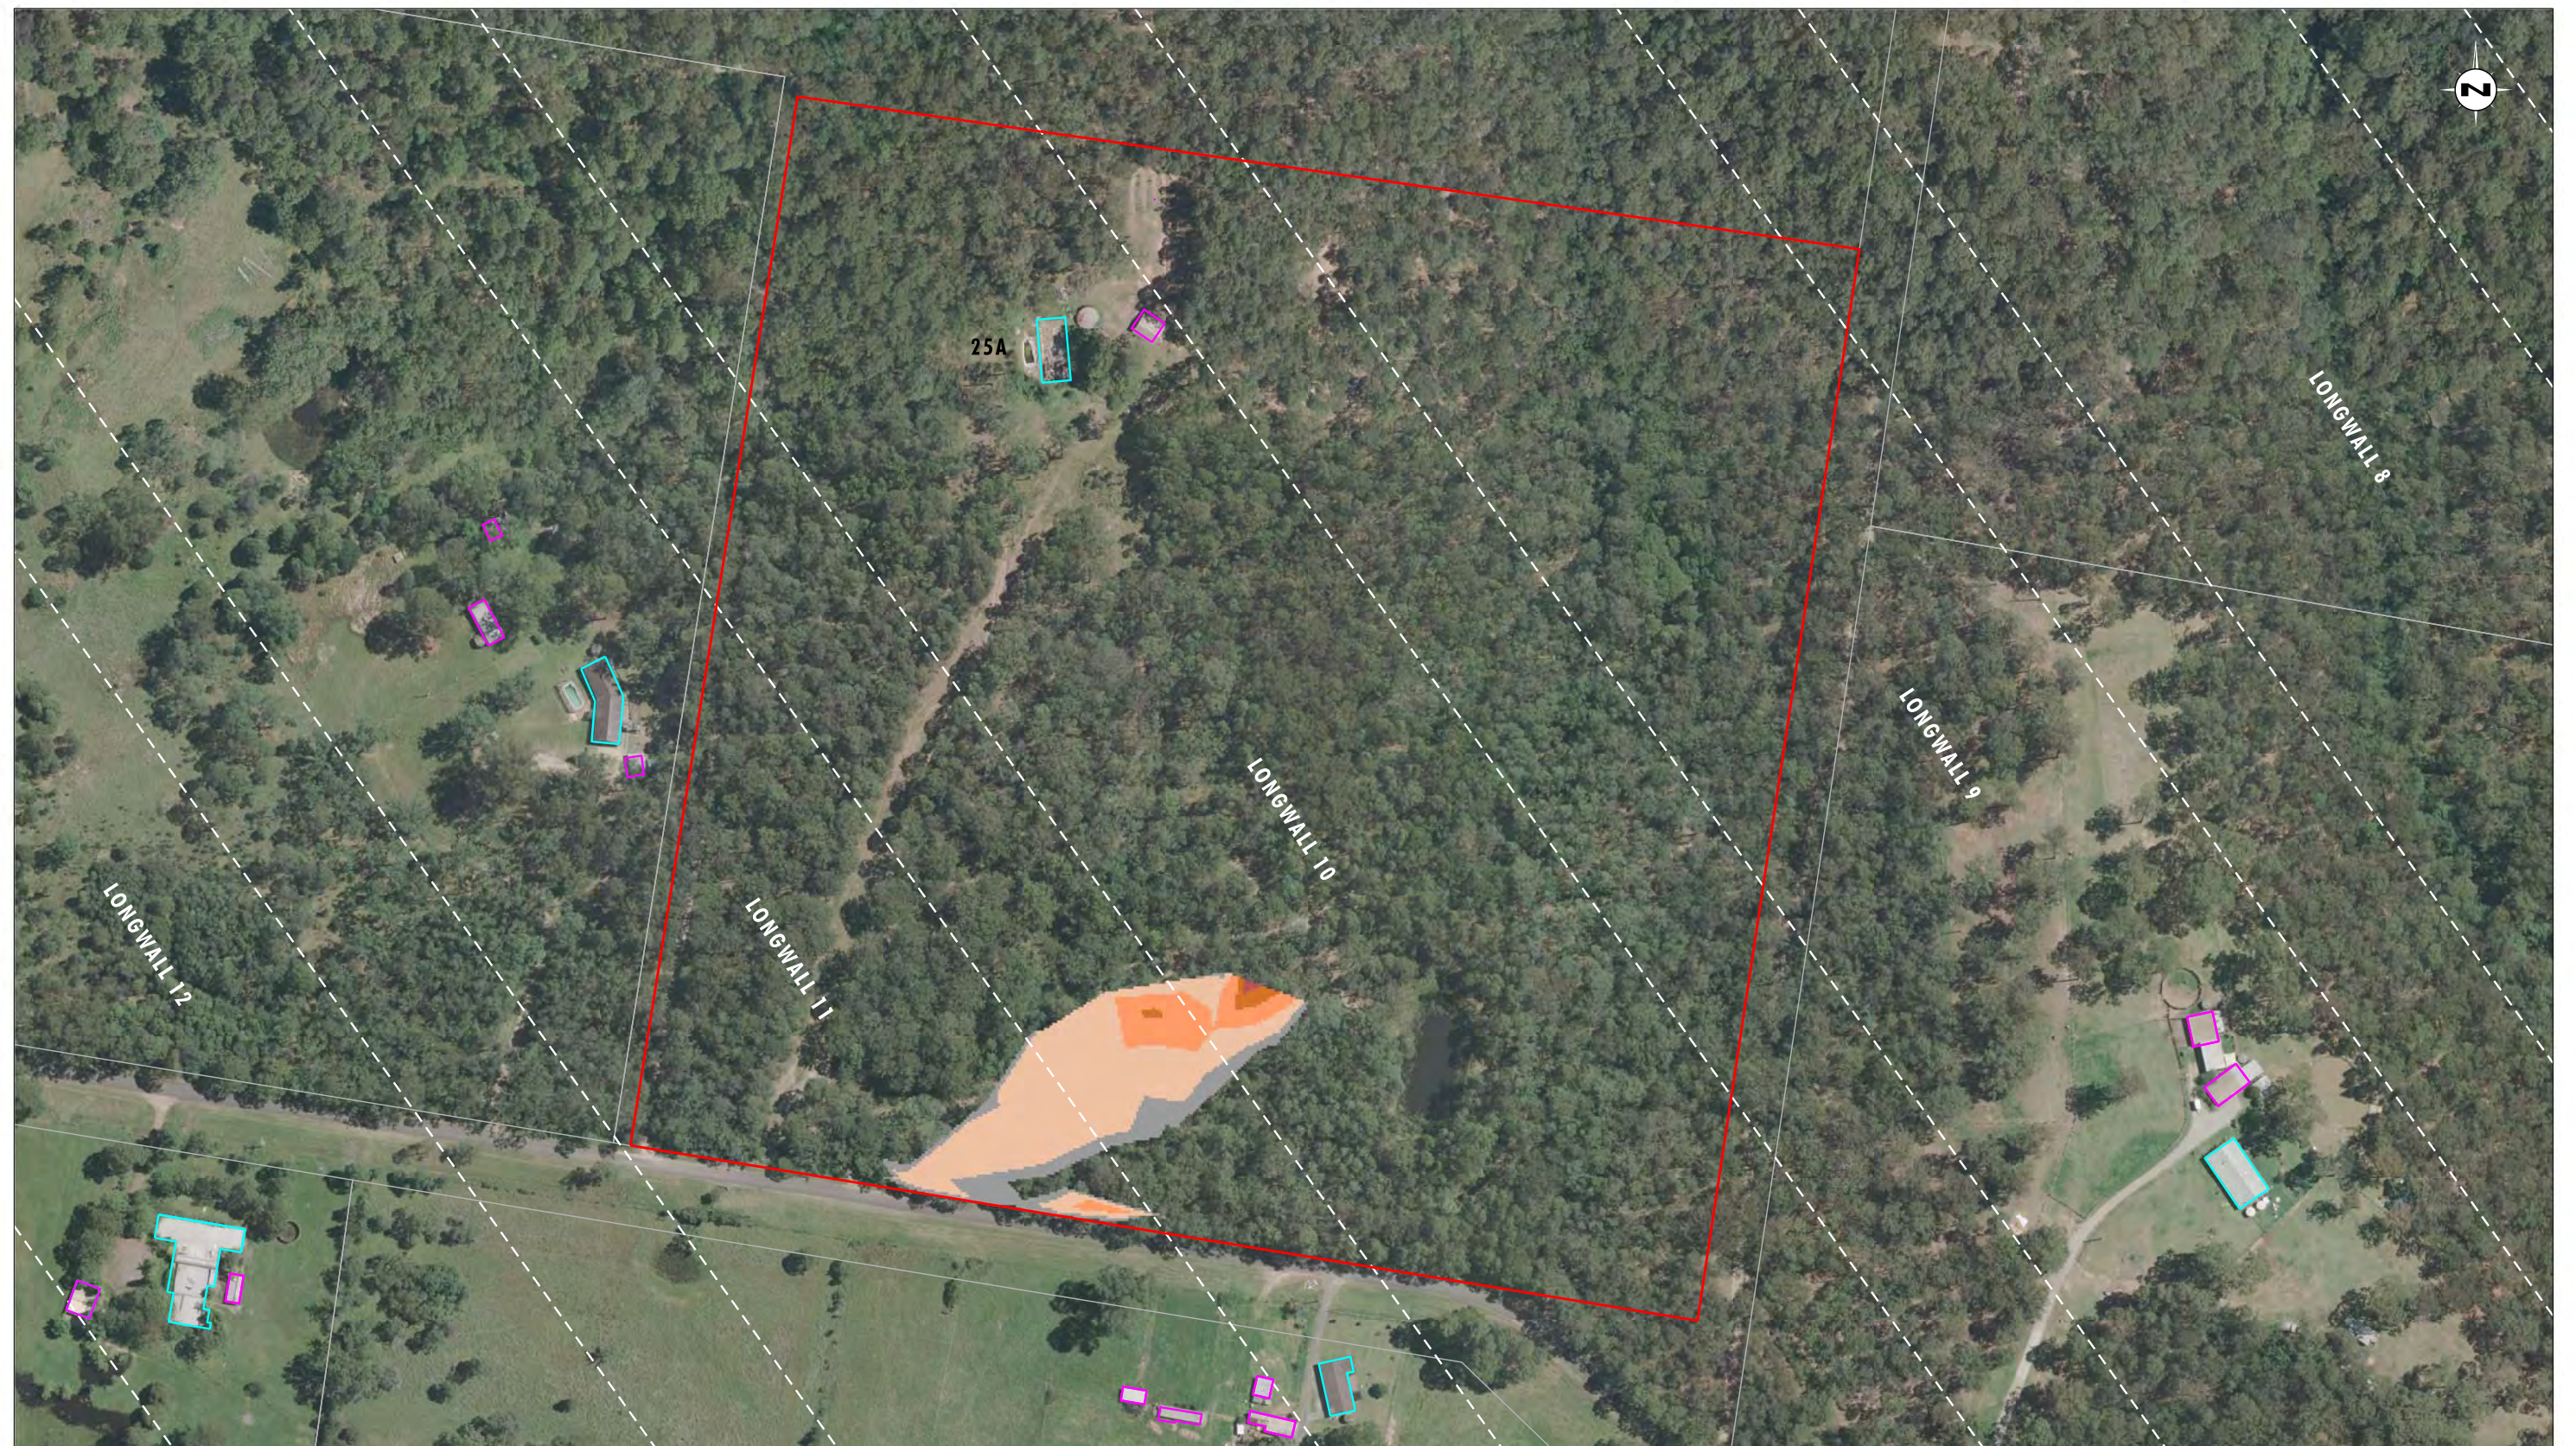
FIGURE 2

Property 25 - 100 year ARI Storm Event:  
Maximum Flood Depth Post Mining Landform  
(to Longwall 23)

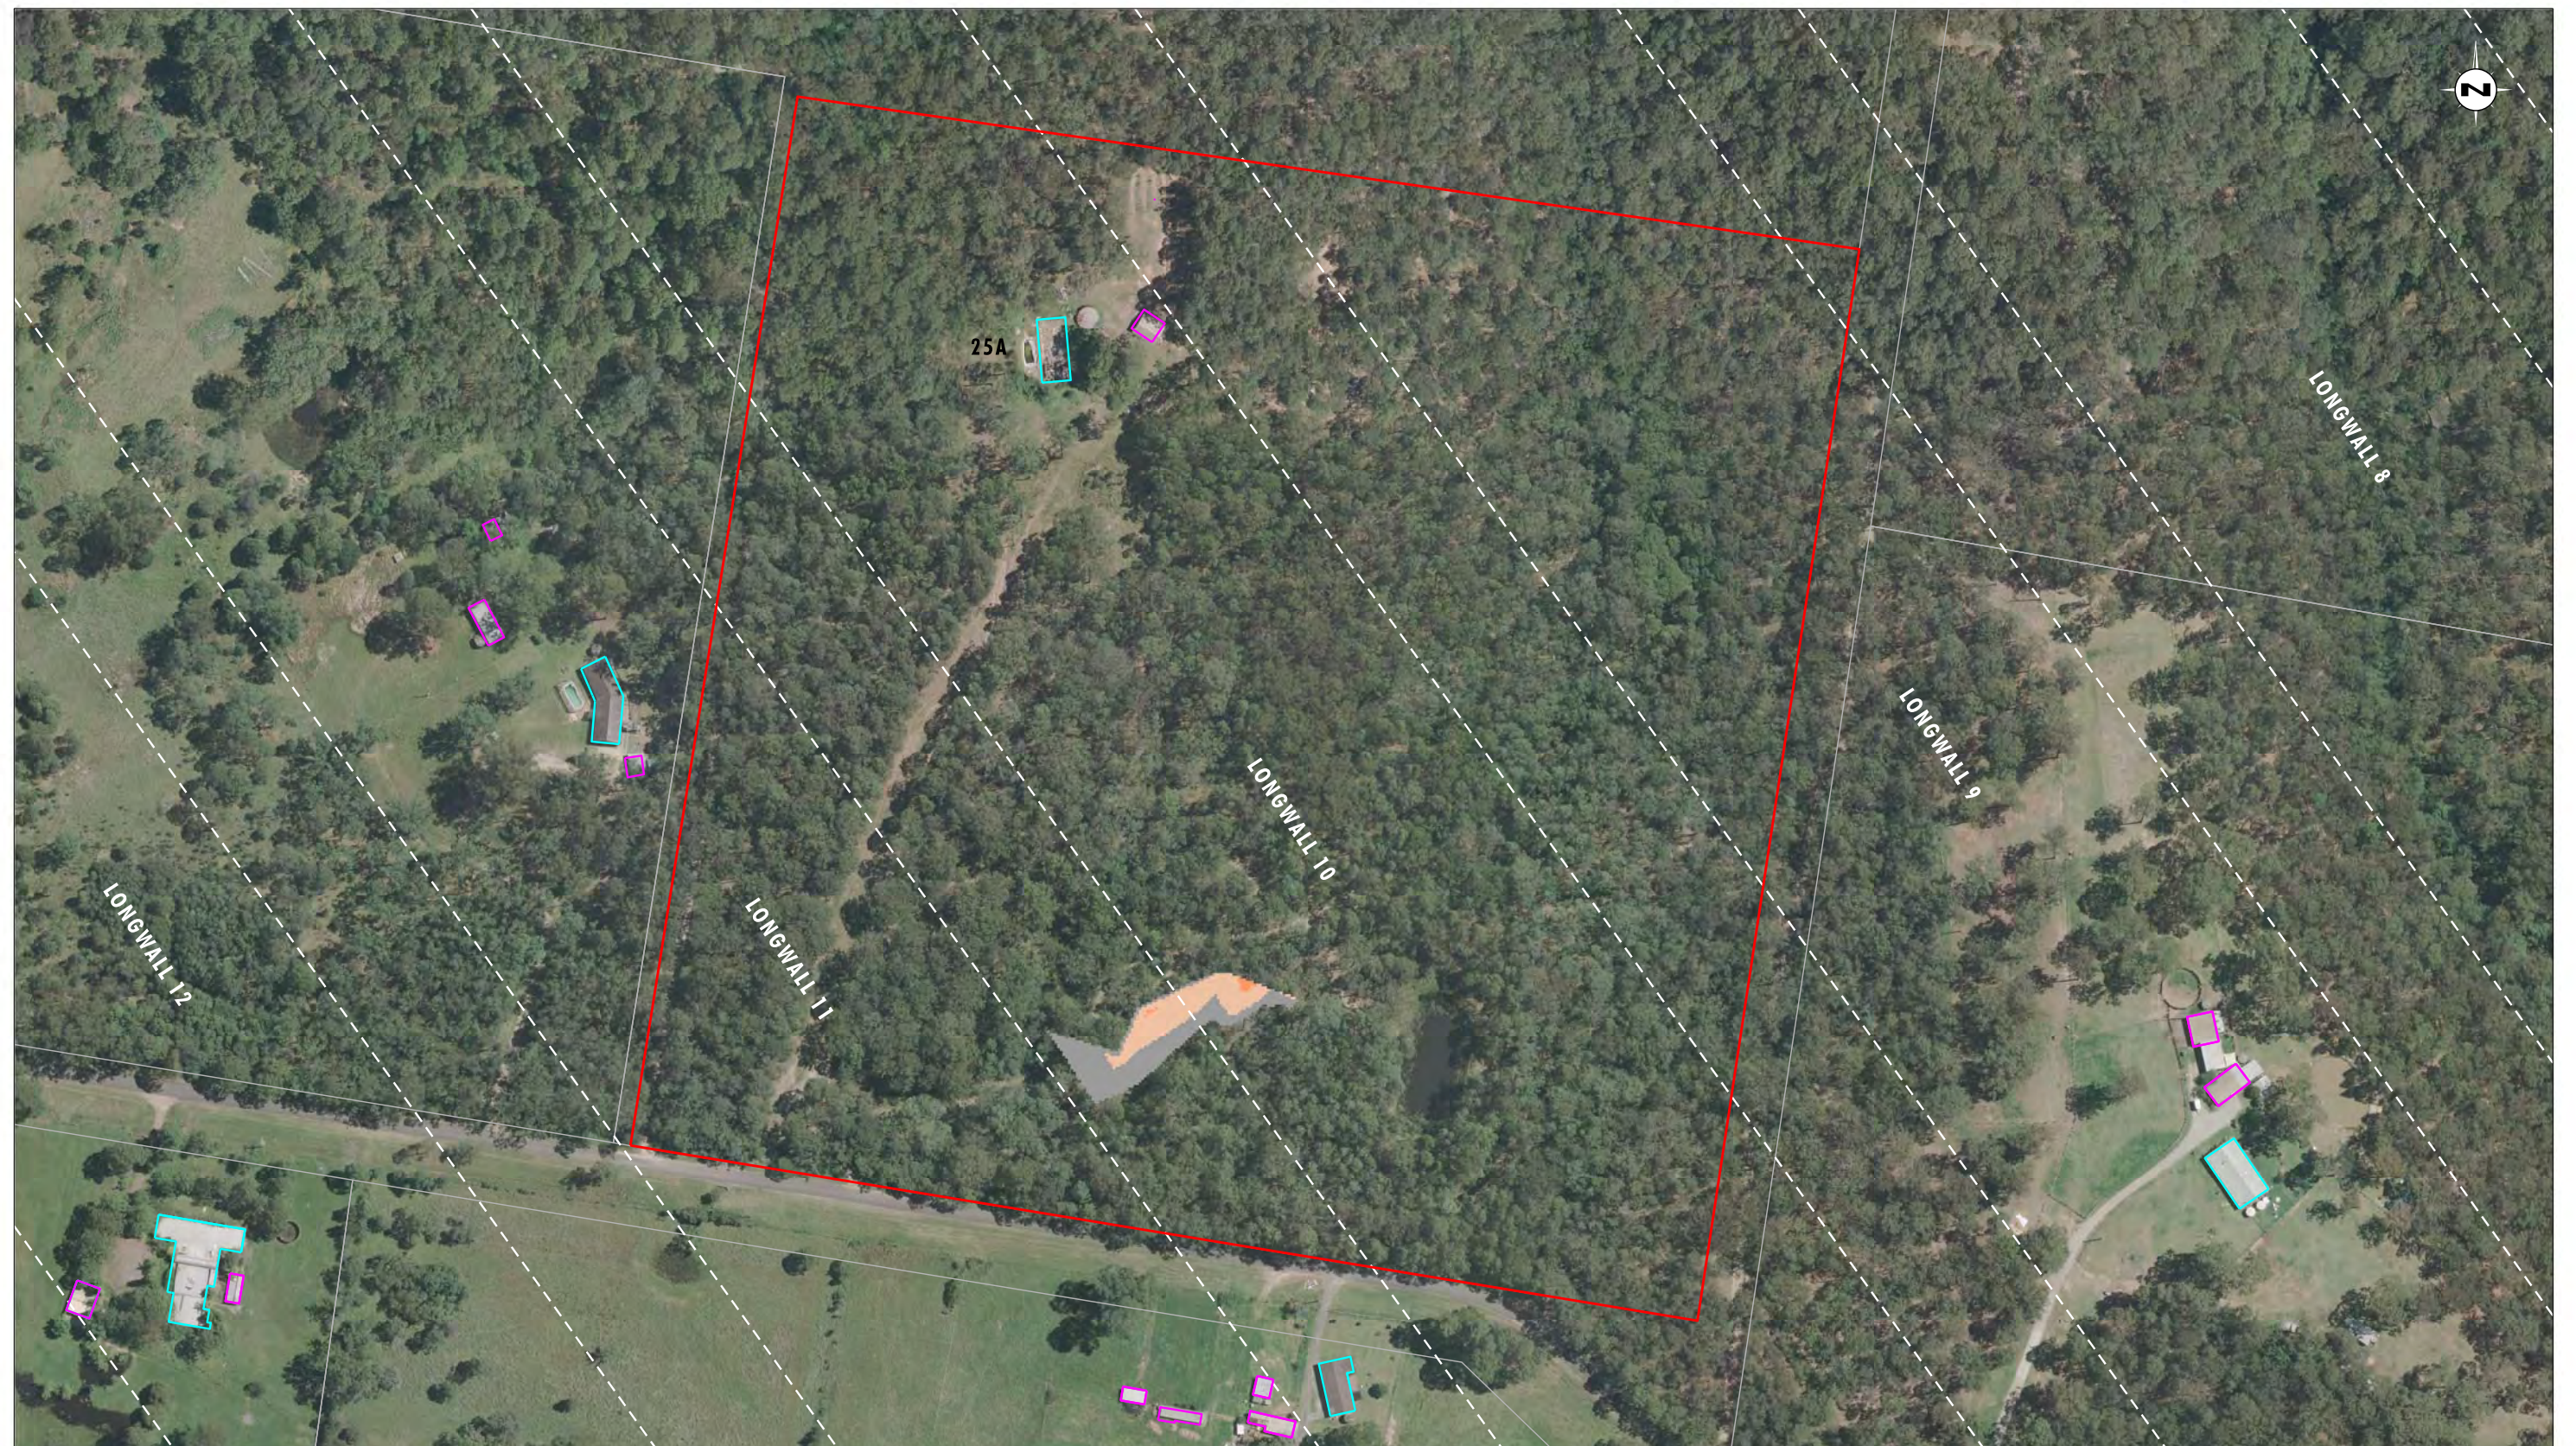
FIGURE 3

Property 25 - 1 year ARI Storm Event:  
Maximum Flood Depth Pre Mining Landform

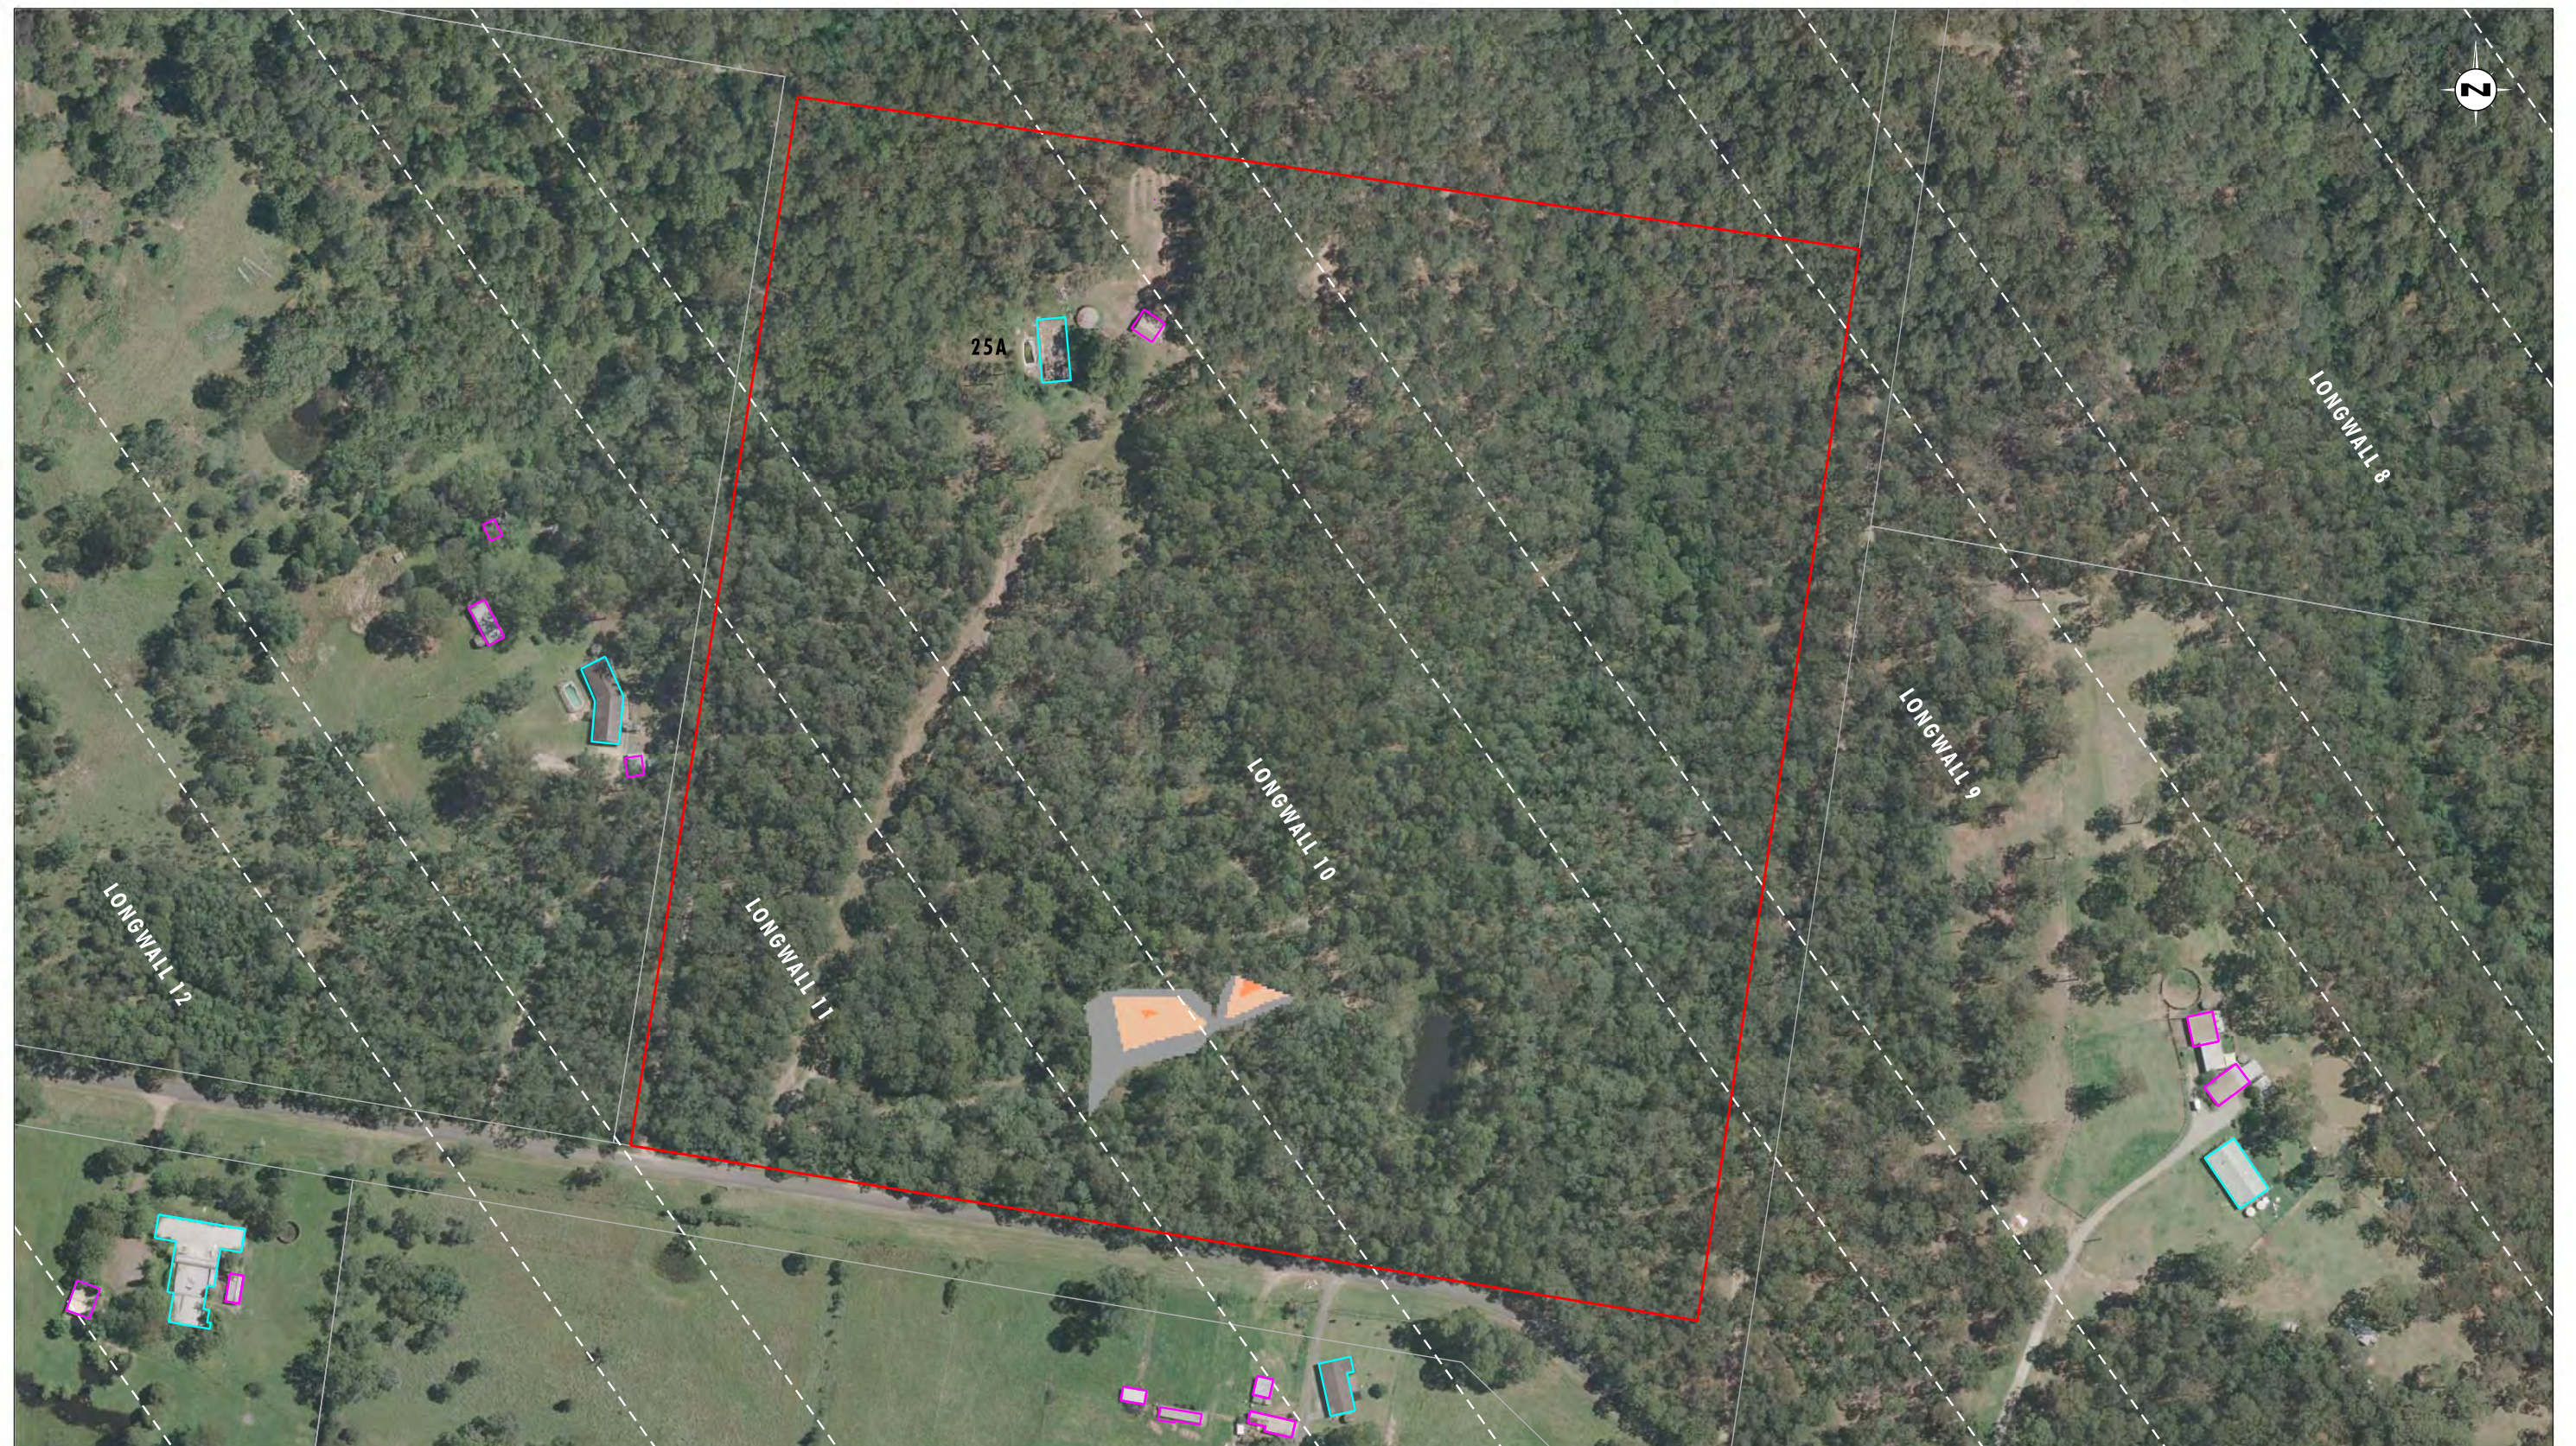
FIGURE 4

Property 25 - 1 year ARI Storm Event:  
Maximum Flood Depth Post Mining Landform  
(to Longwall 23)

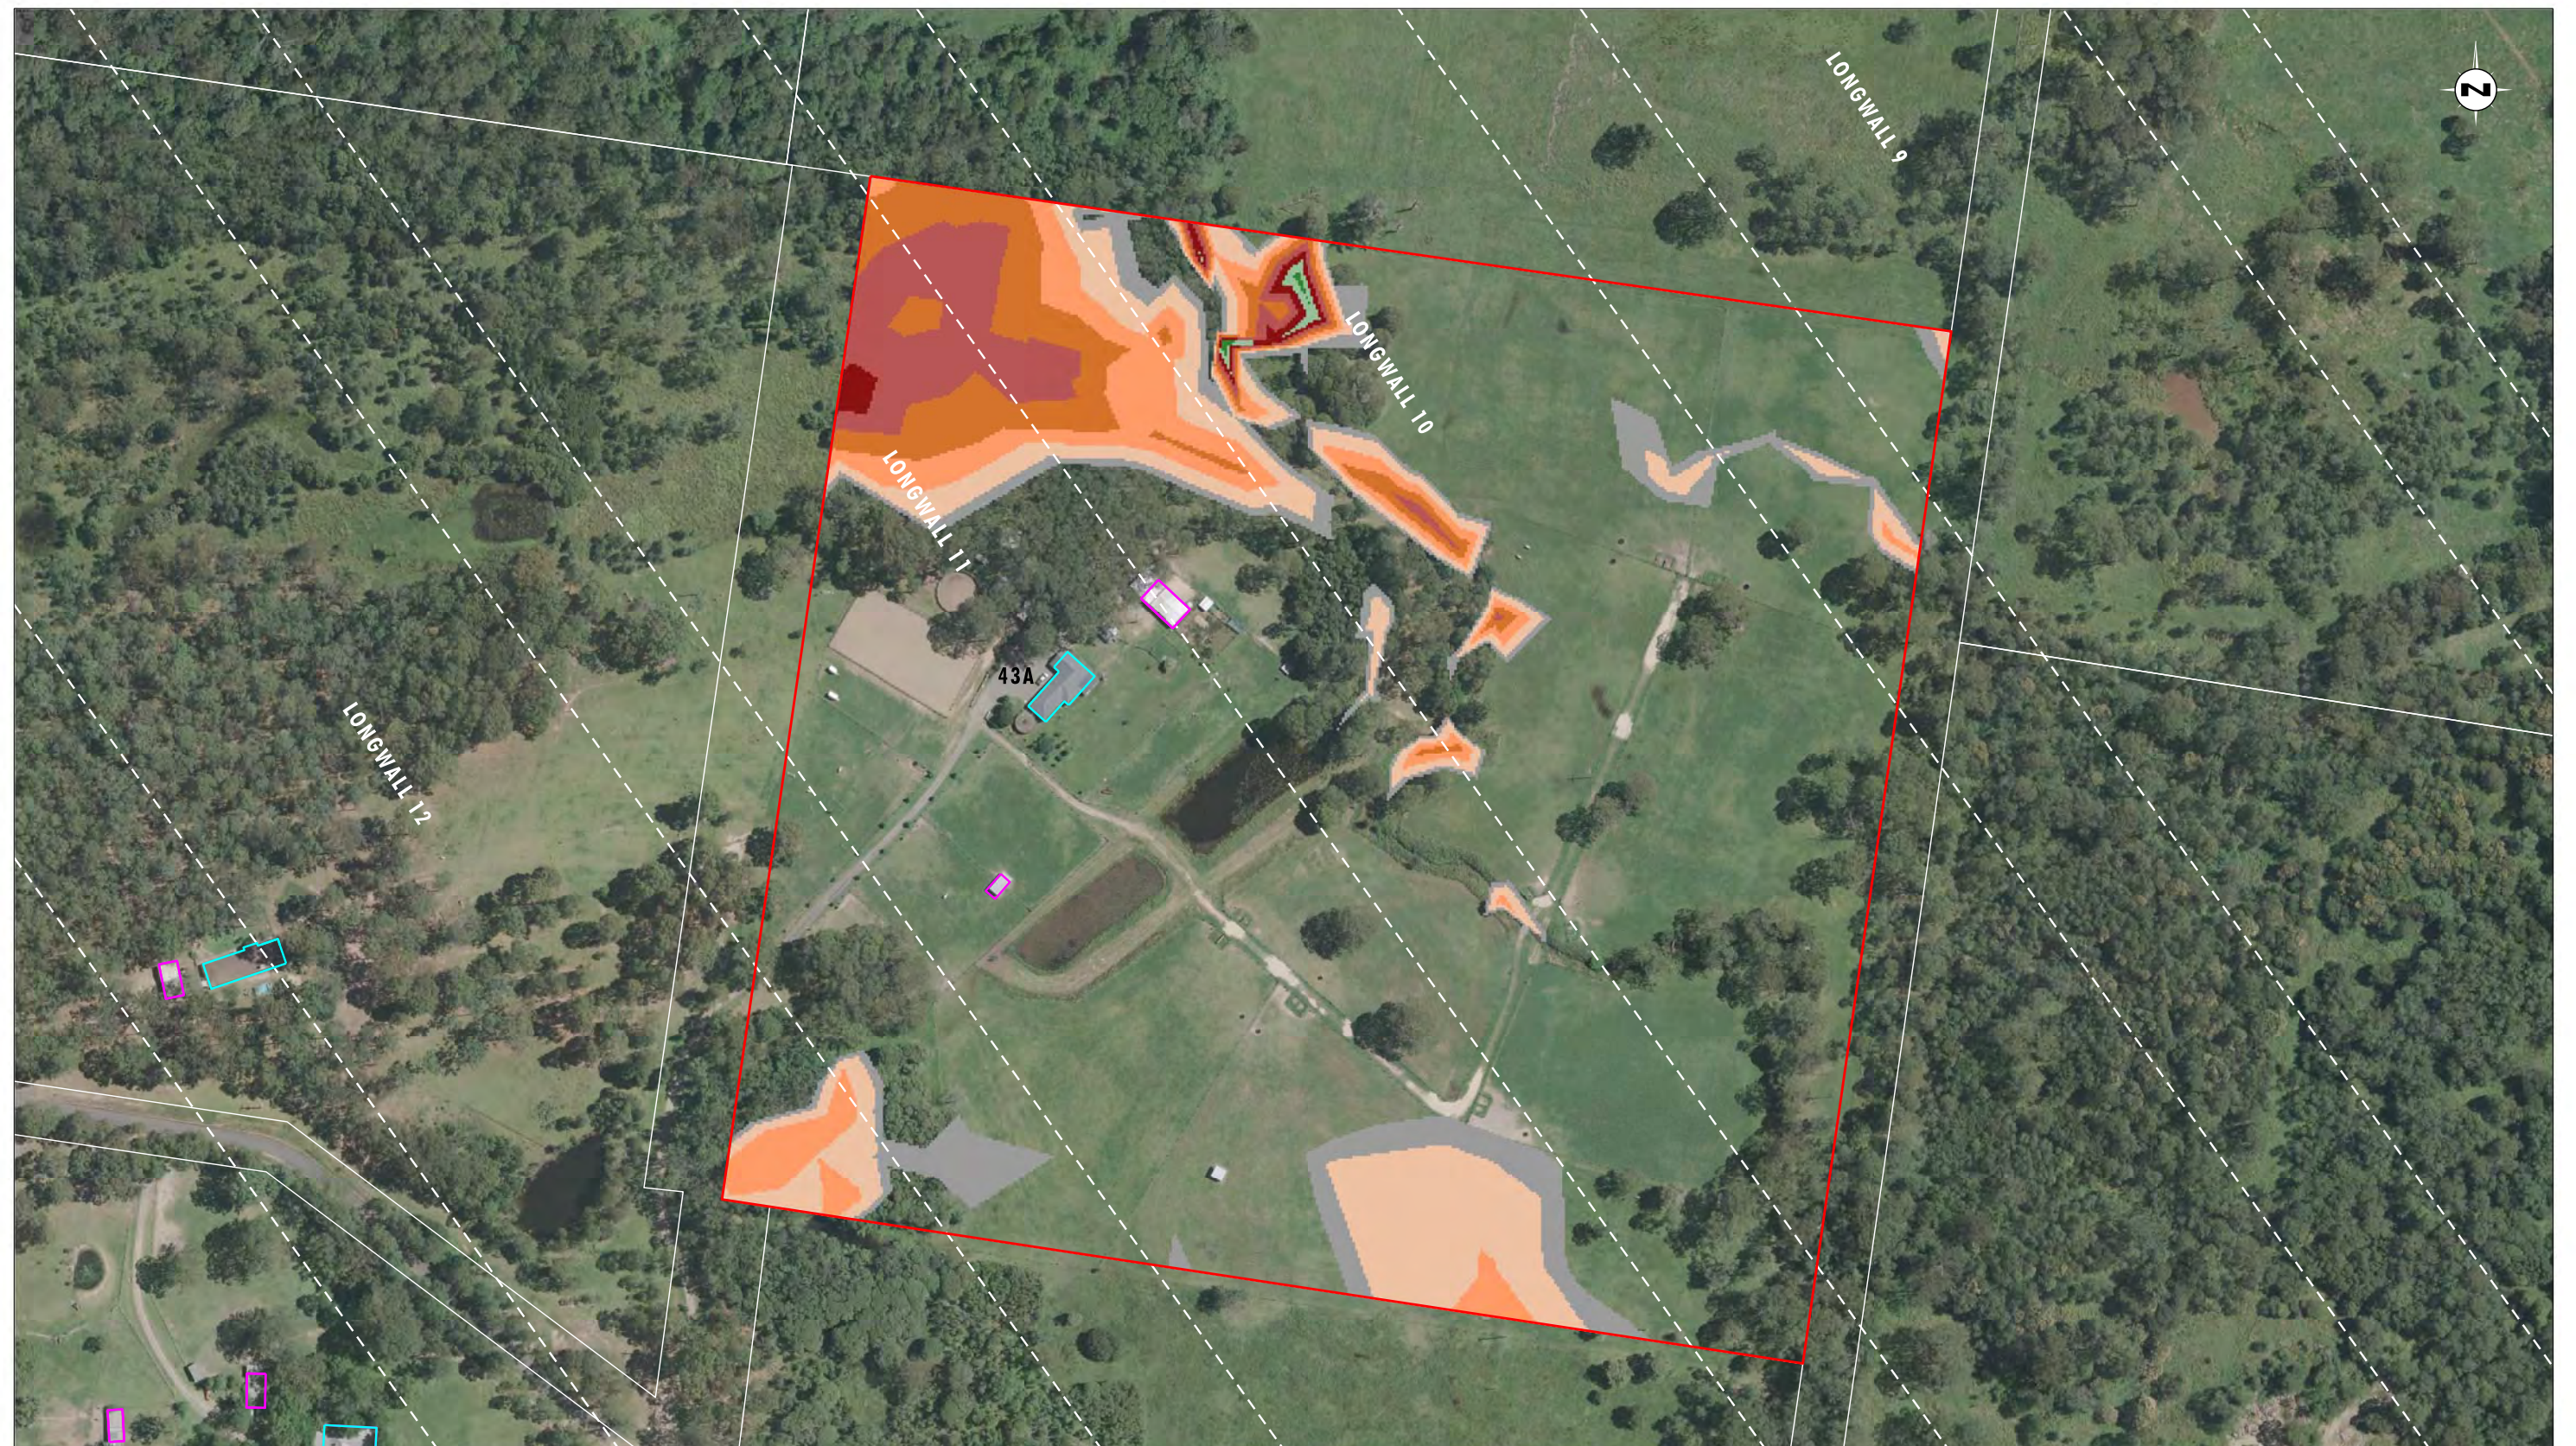
FIGURE 4

Property 43 - 1 year ARI Storm Event:  
Maximum Flood Depth Post Mining Landform  
(to Longwall 23)

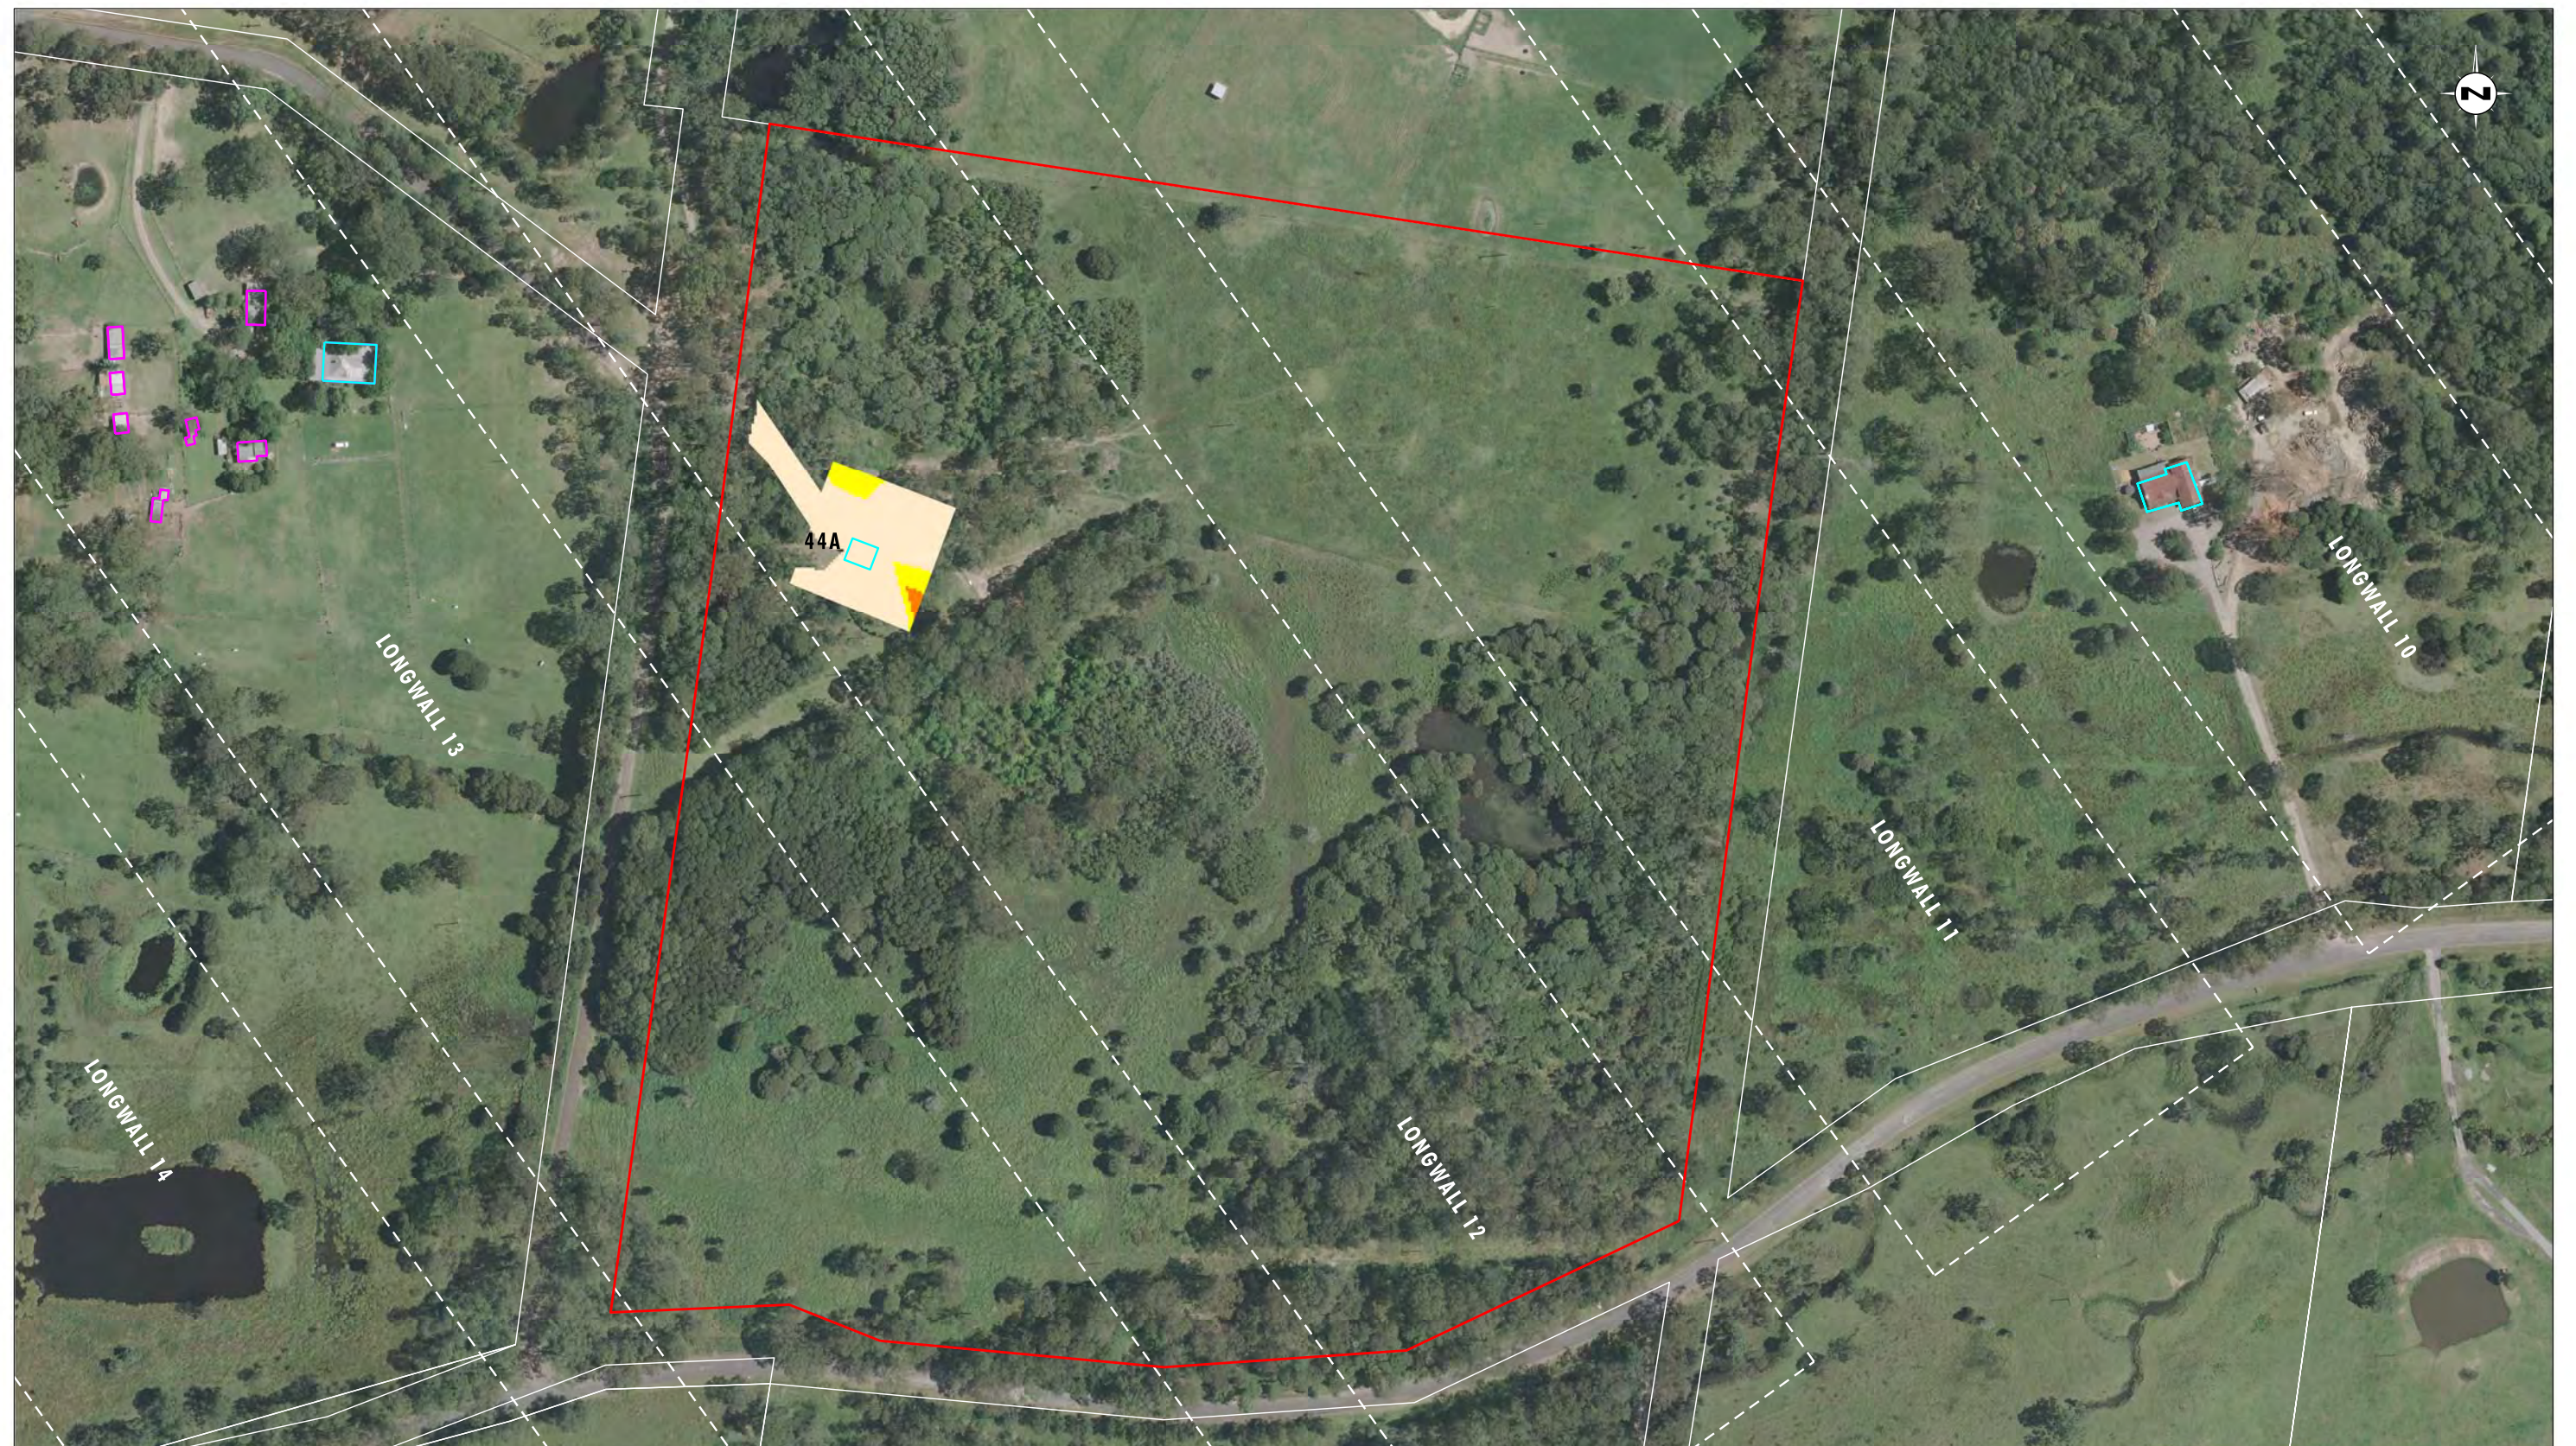
FIGURE 3

Property 44 - 100 year ARI Storm Event:  
 Maximum Flood Hazard Categories Pre Mining Landform
