## APPENDIX 7

**Flooding Assessment Figures -  
Property 25**

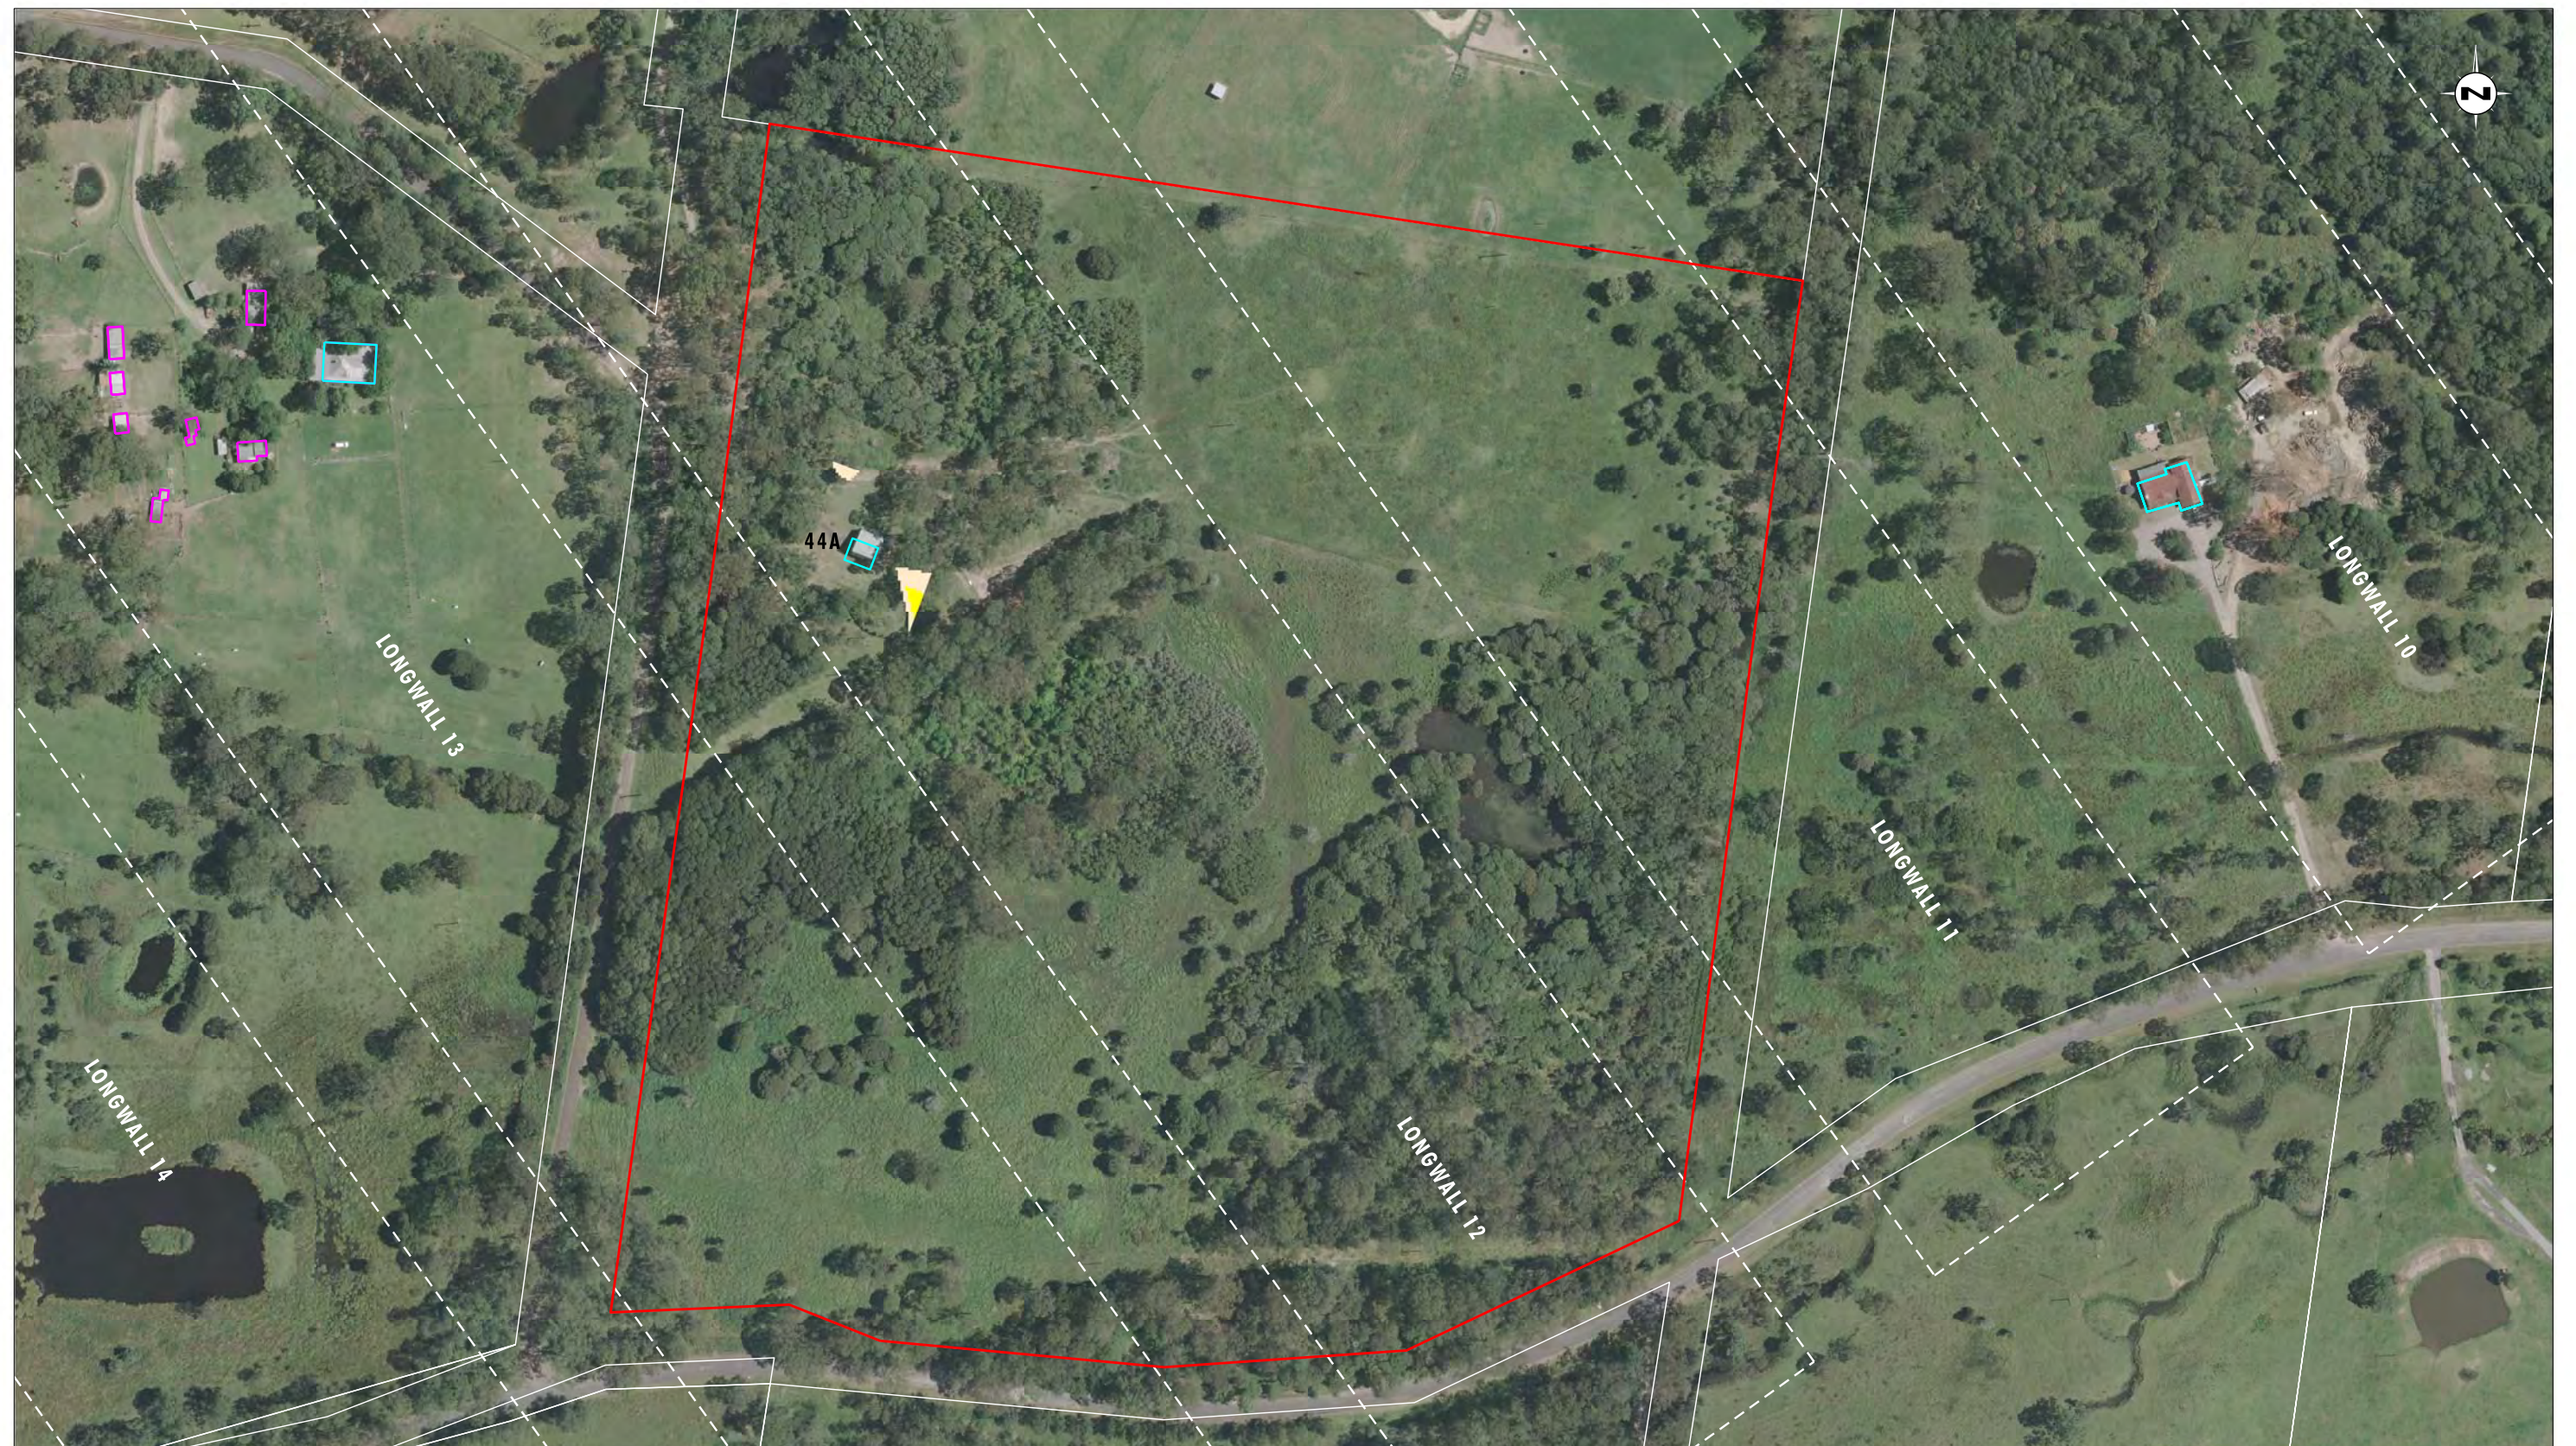
FIGURE 7

Property 44 - 1 year ARI Storm Event:  
 Maximum Flood Hazard Categories Pre Mining Landform

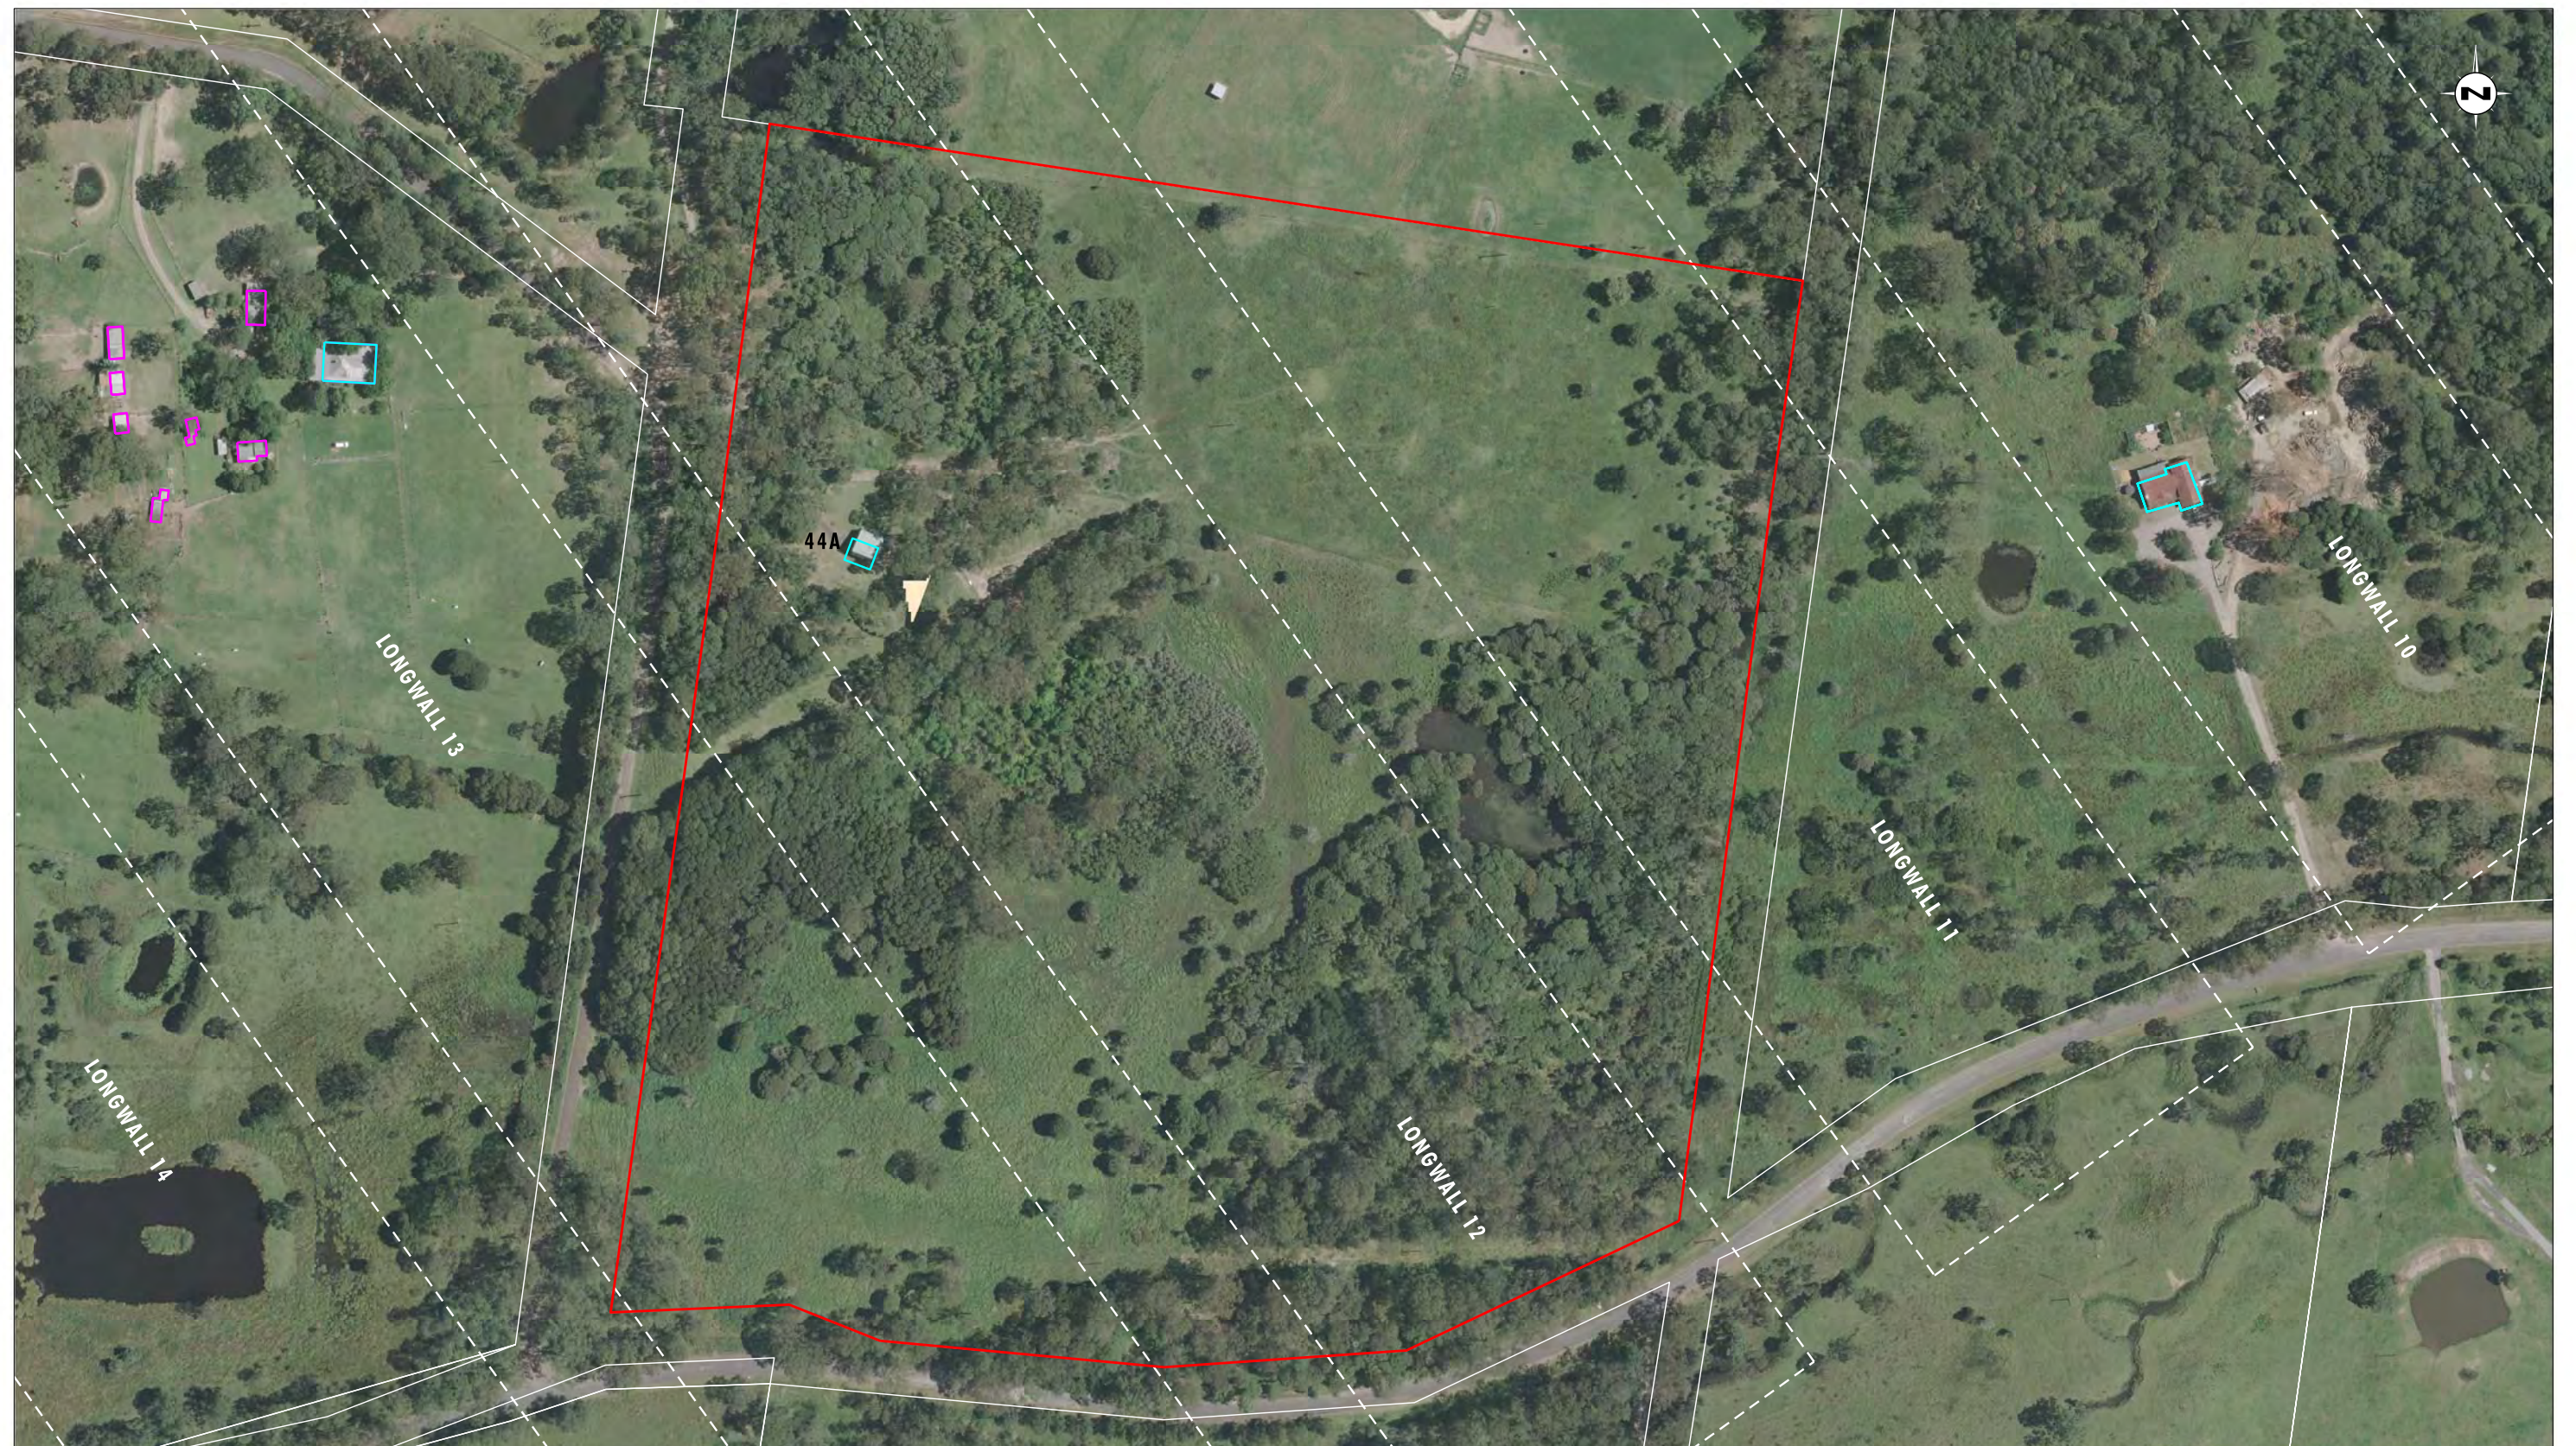
**FIGURE 8**  
 Property 44 - 1 year ARI Storm Event:  
 Maximum Flood Hazard Categories Post Mining Landform  
 (to Longwall 23)
