## APPENDIX 1

**Flooding Assessment Figures -  
Property 7 (Centennial)**

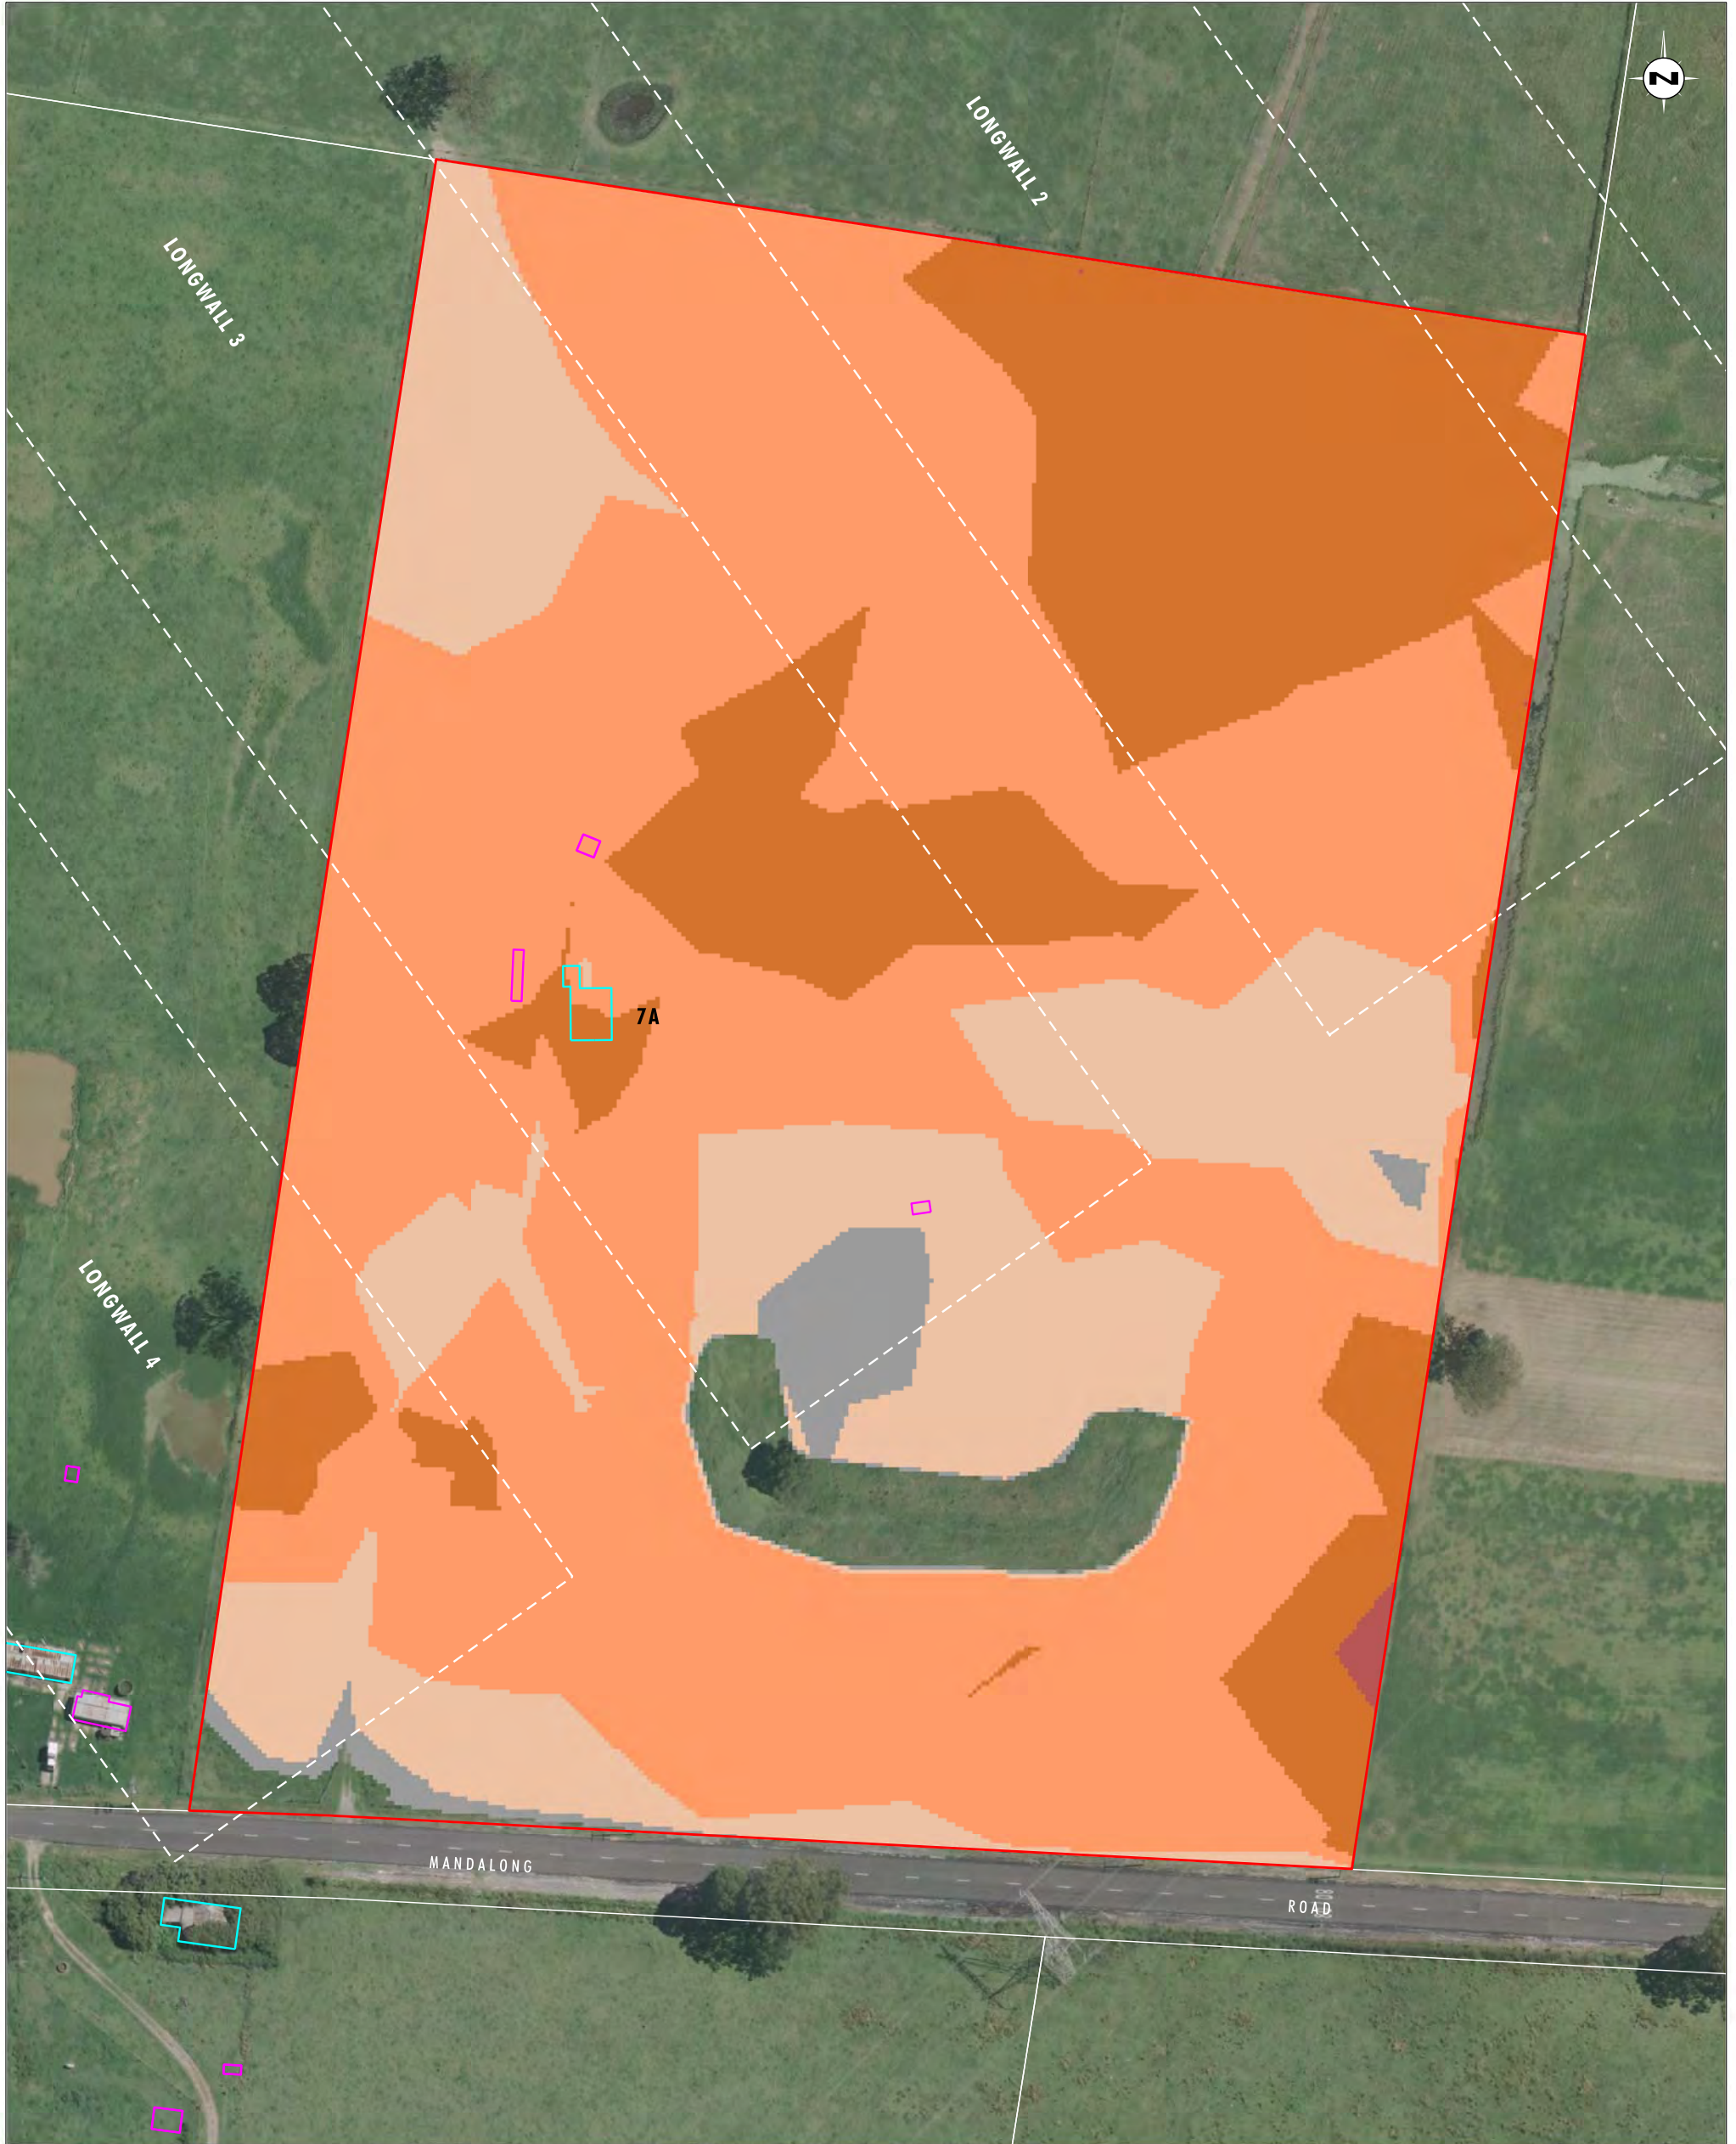
FIGURE 1  
Property 7 - 100 Year ARI Storm Event  
Maximum Flood Depth Pre Mining Landform

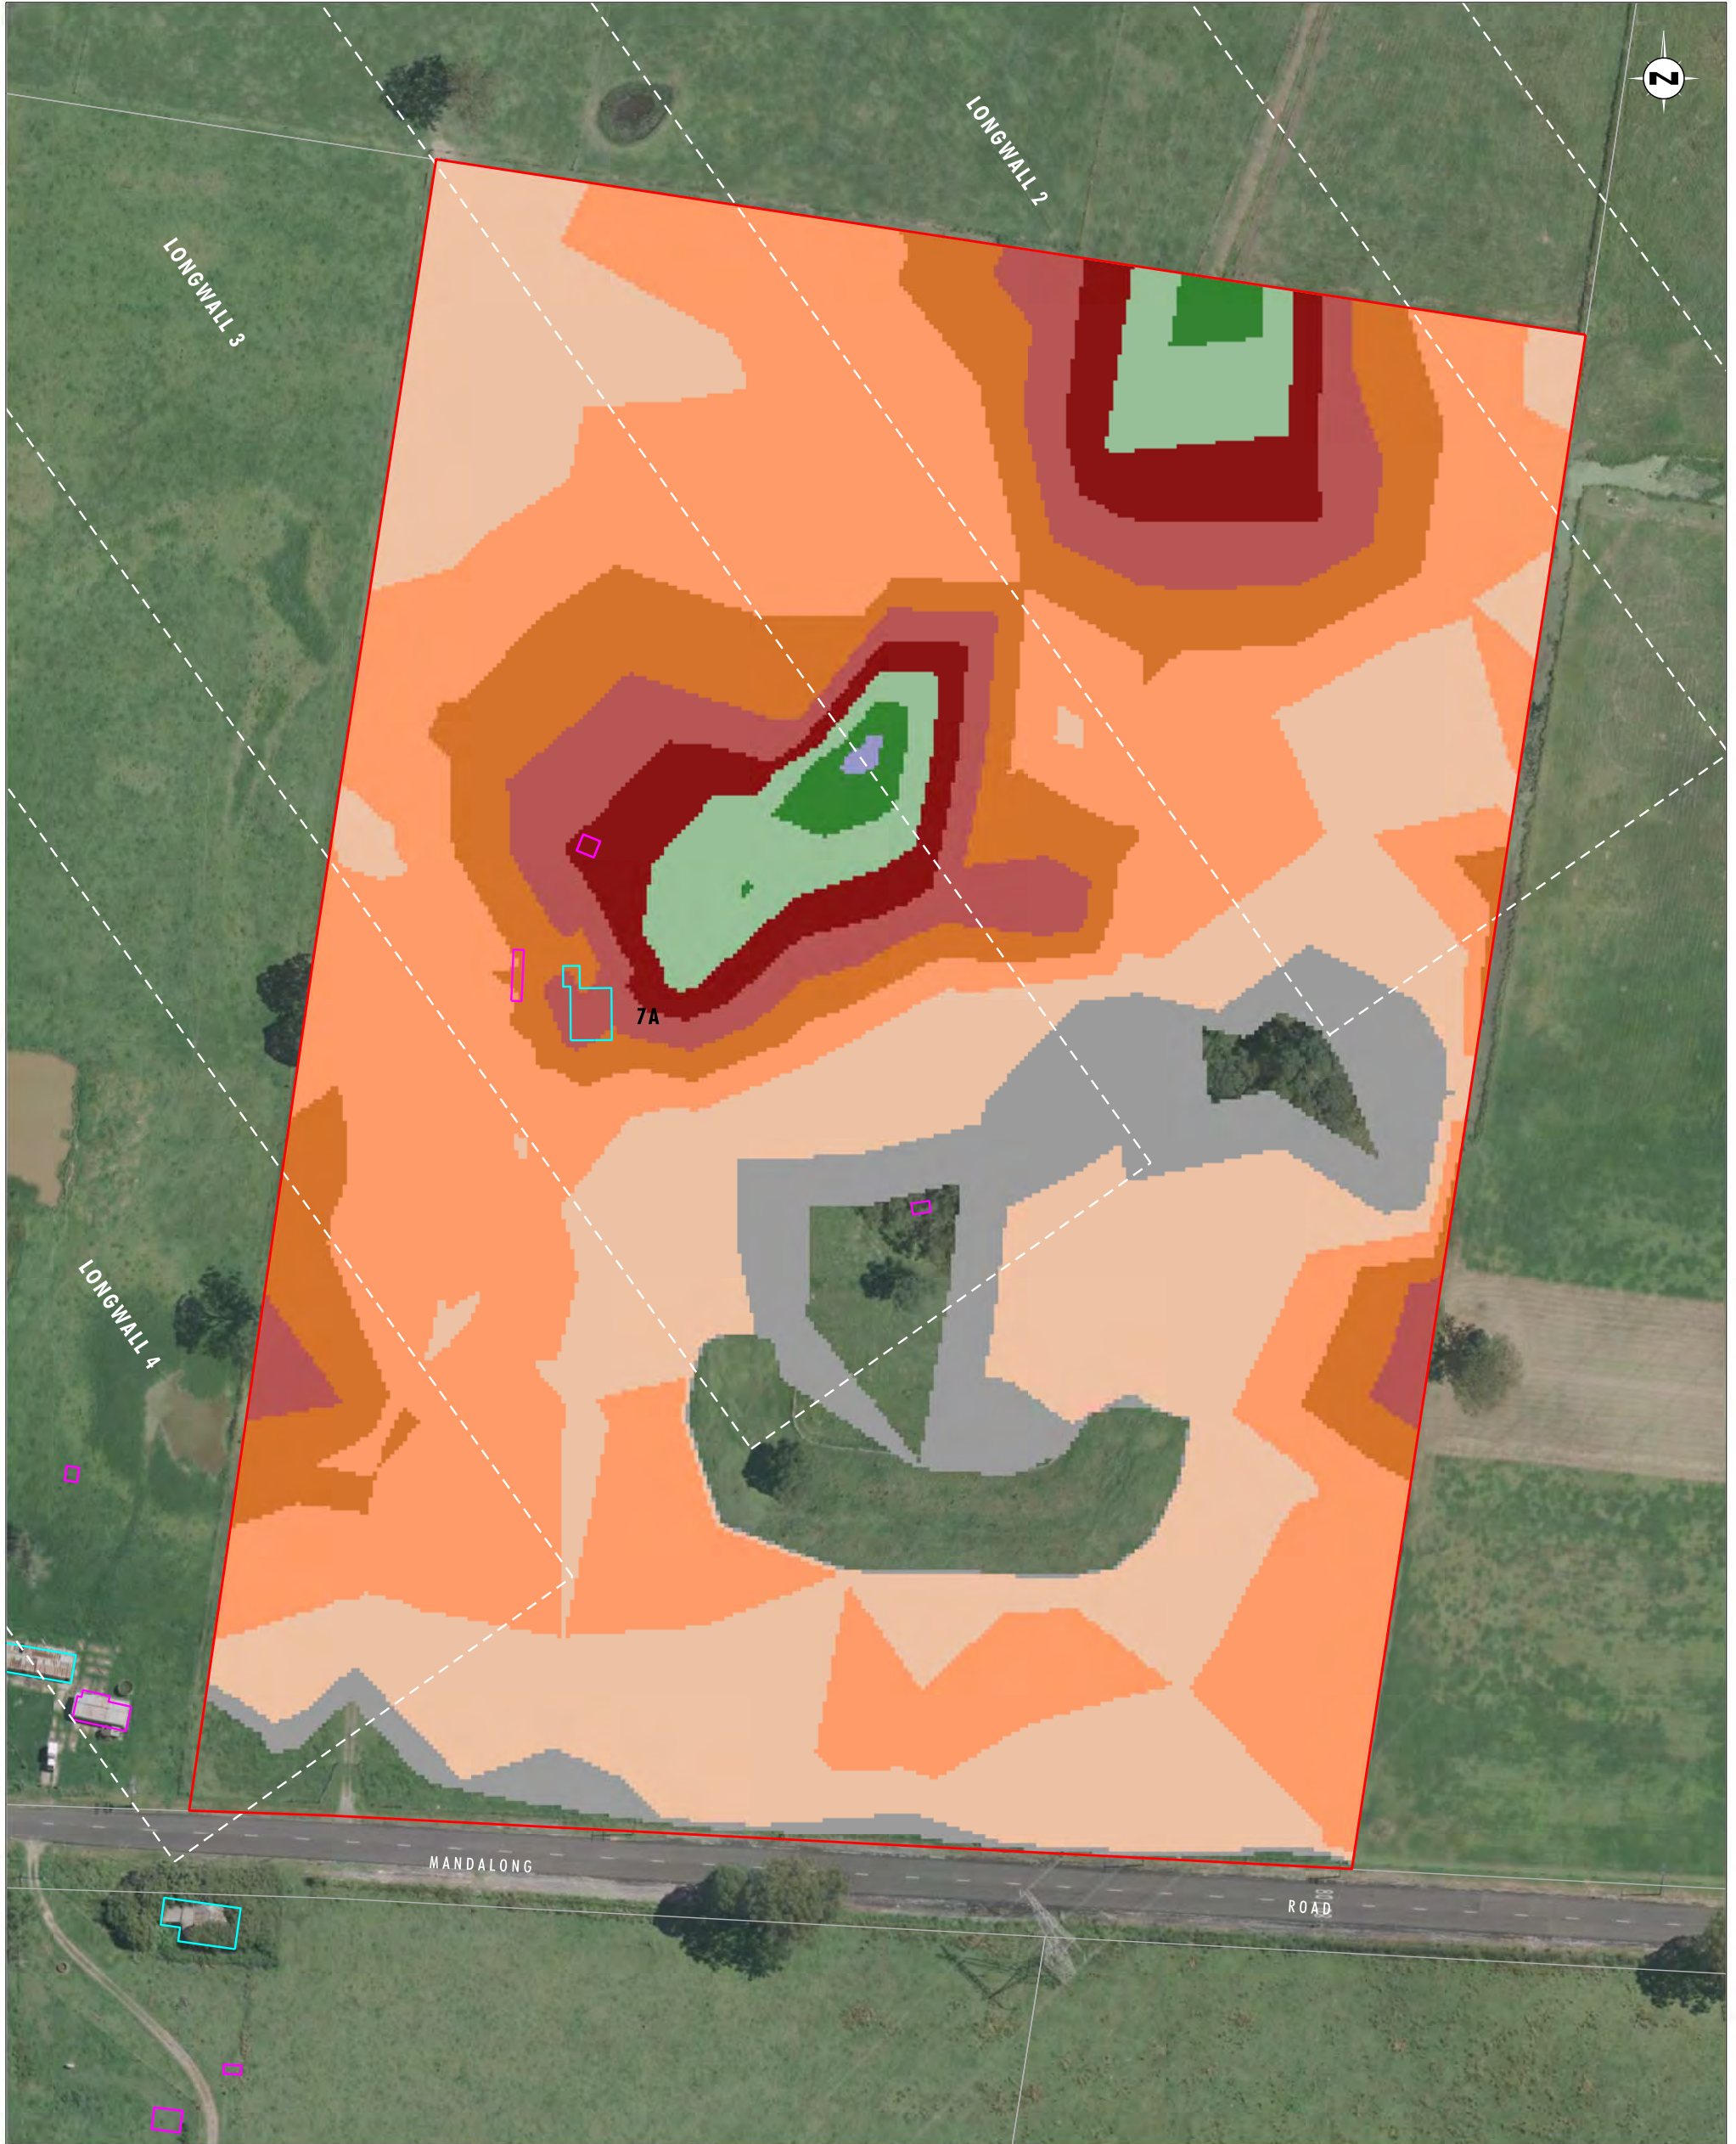
FIGURE 2

Property 7 - 100 Year ARI Storm Event  
Maximum Flood Depth Post Mining Landform  
(to Longwall 23)

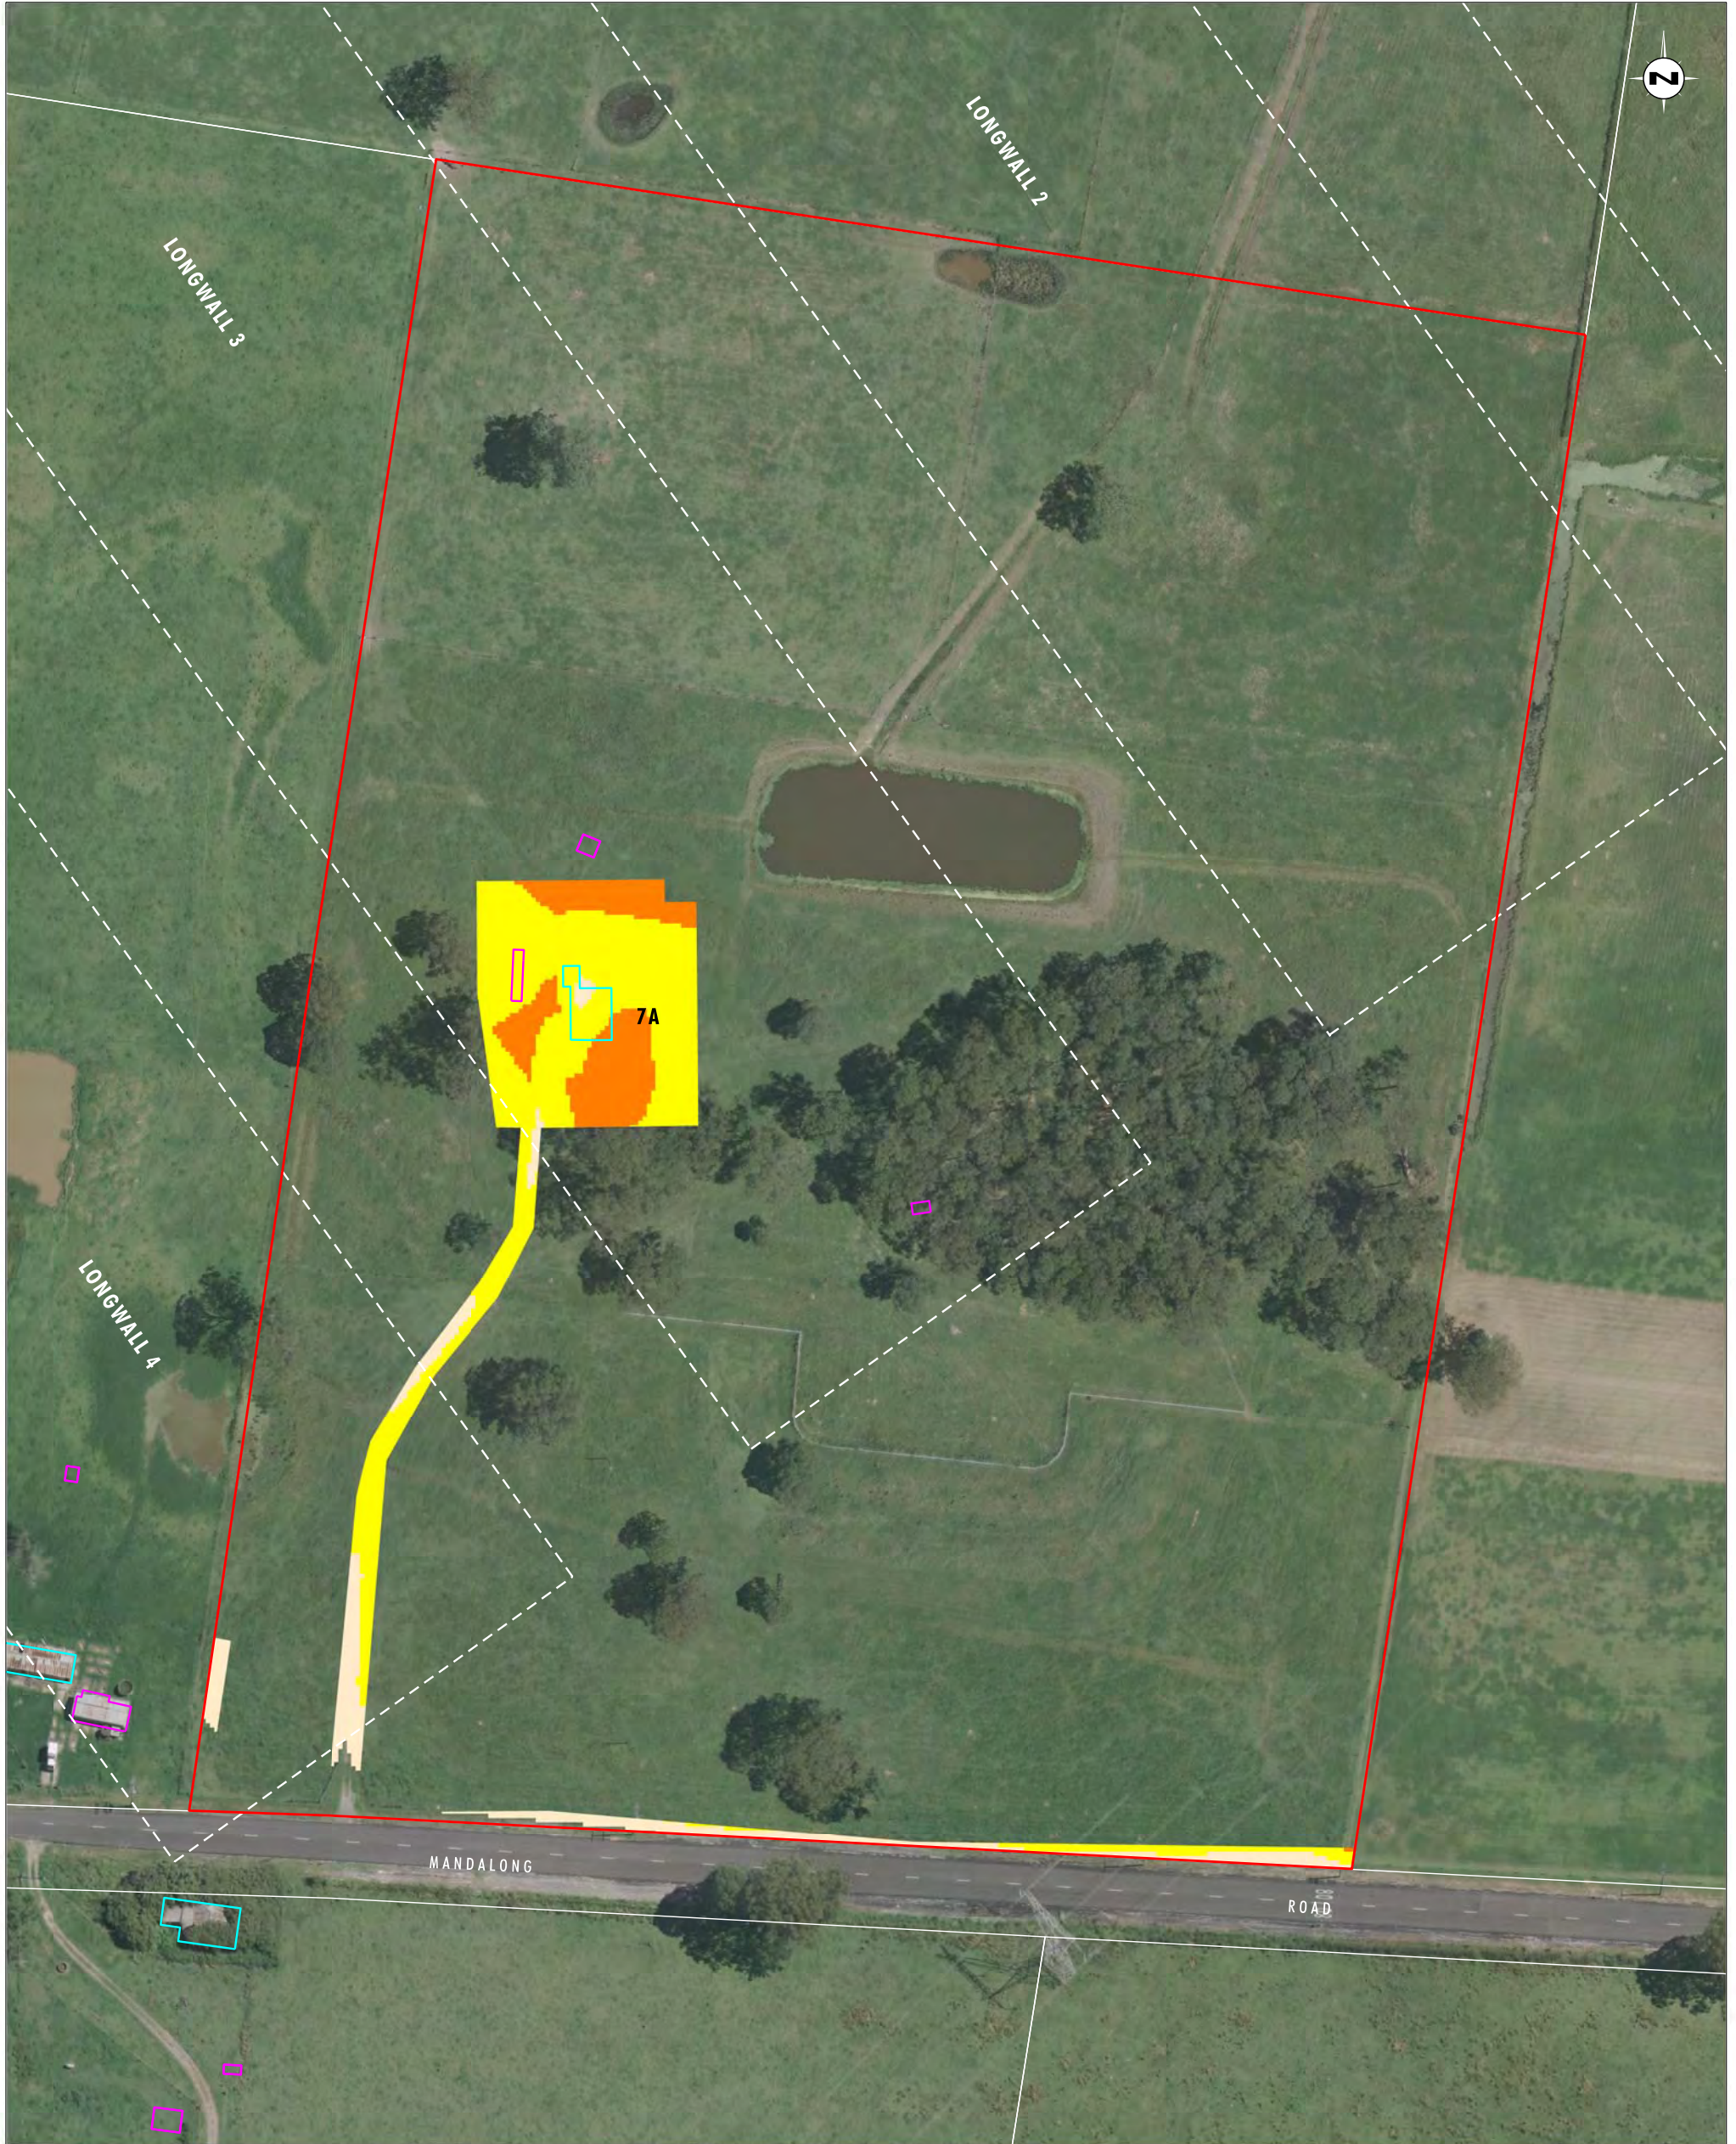
FIGURE 3

Image Source: Centennial Mandalong Pty Ltd (2009) - Aerial Photograph  
Data Source: Centennial Mandalong Pty Ltd, LPI - Cadastral Boundaries  
Note: Flood Hazard shown for access and dwellings only

Property 7 - 100 Year ARI Storm Event  
Maximum Flood Hazard Categories Pre Mining Landform

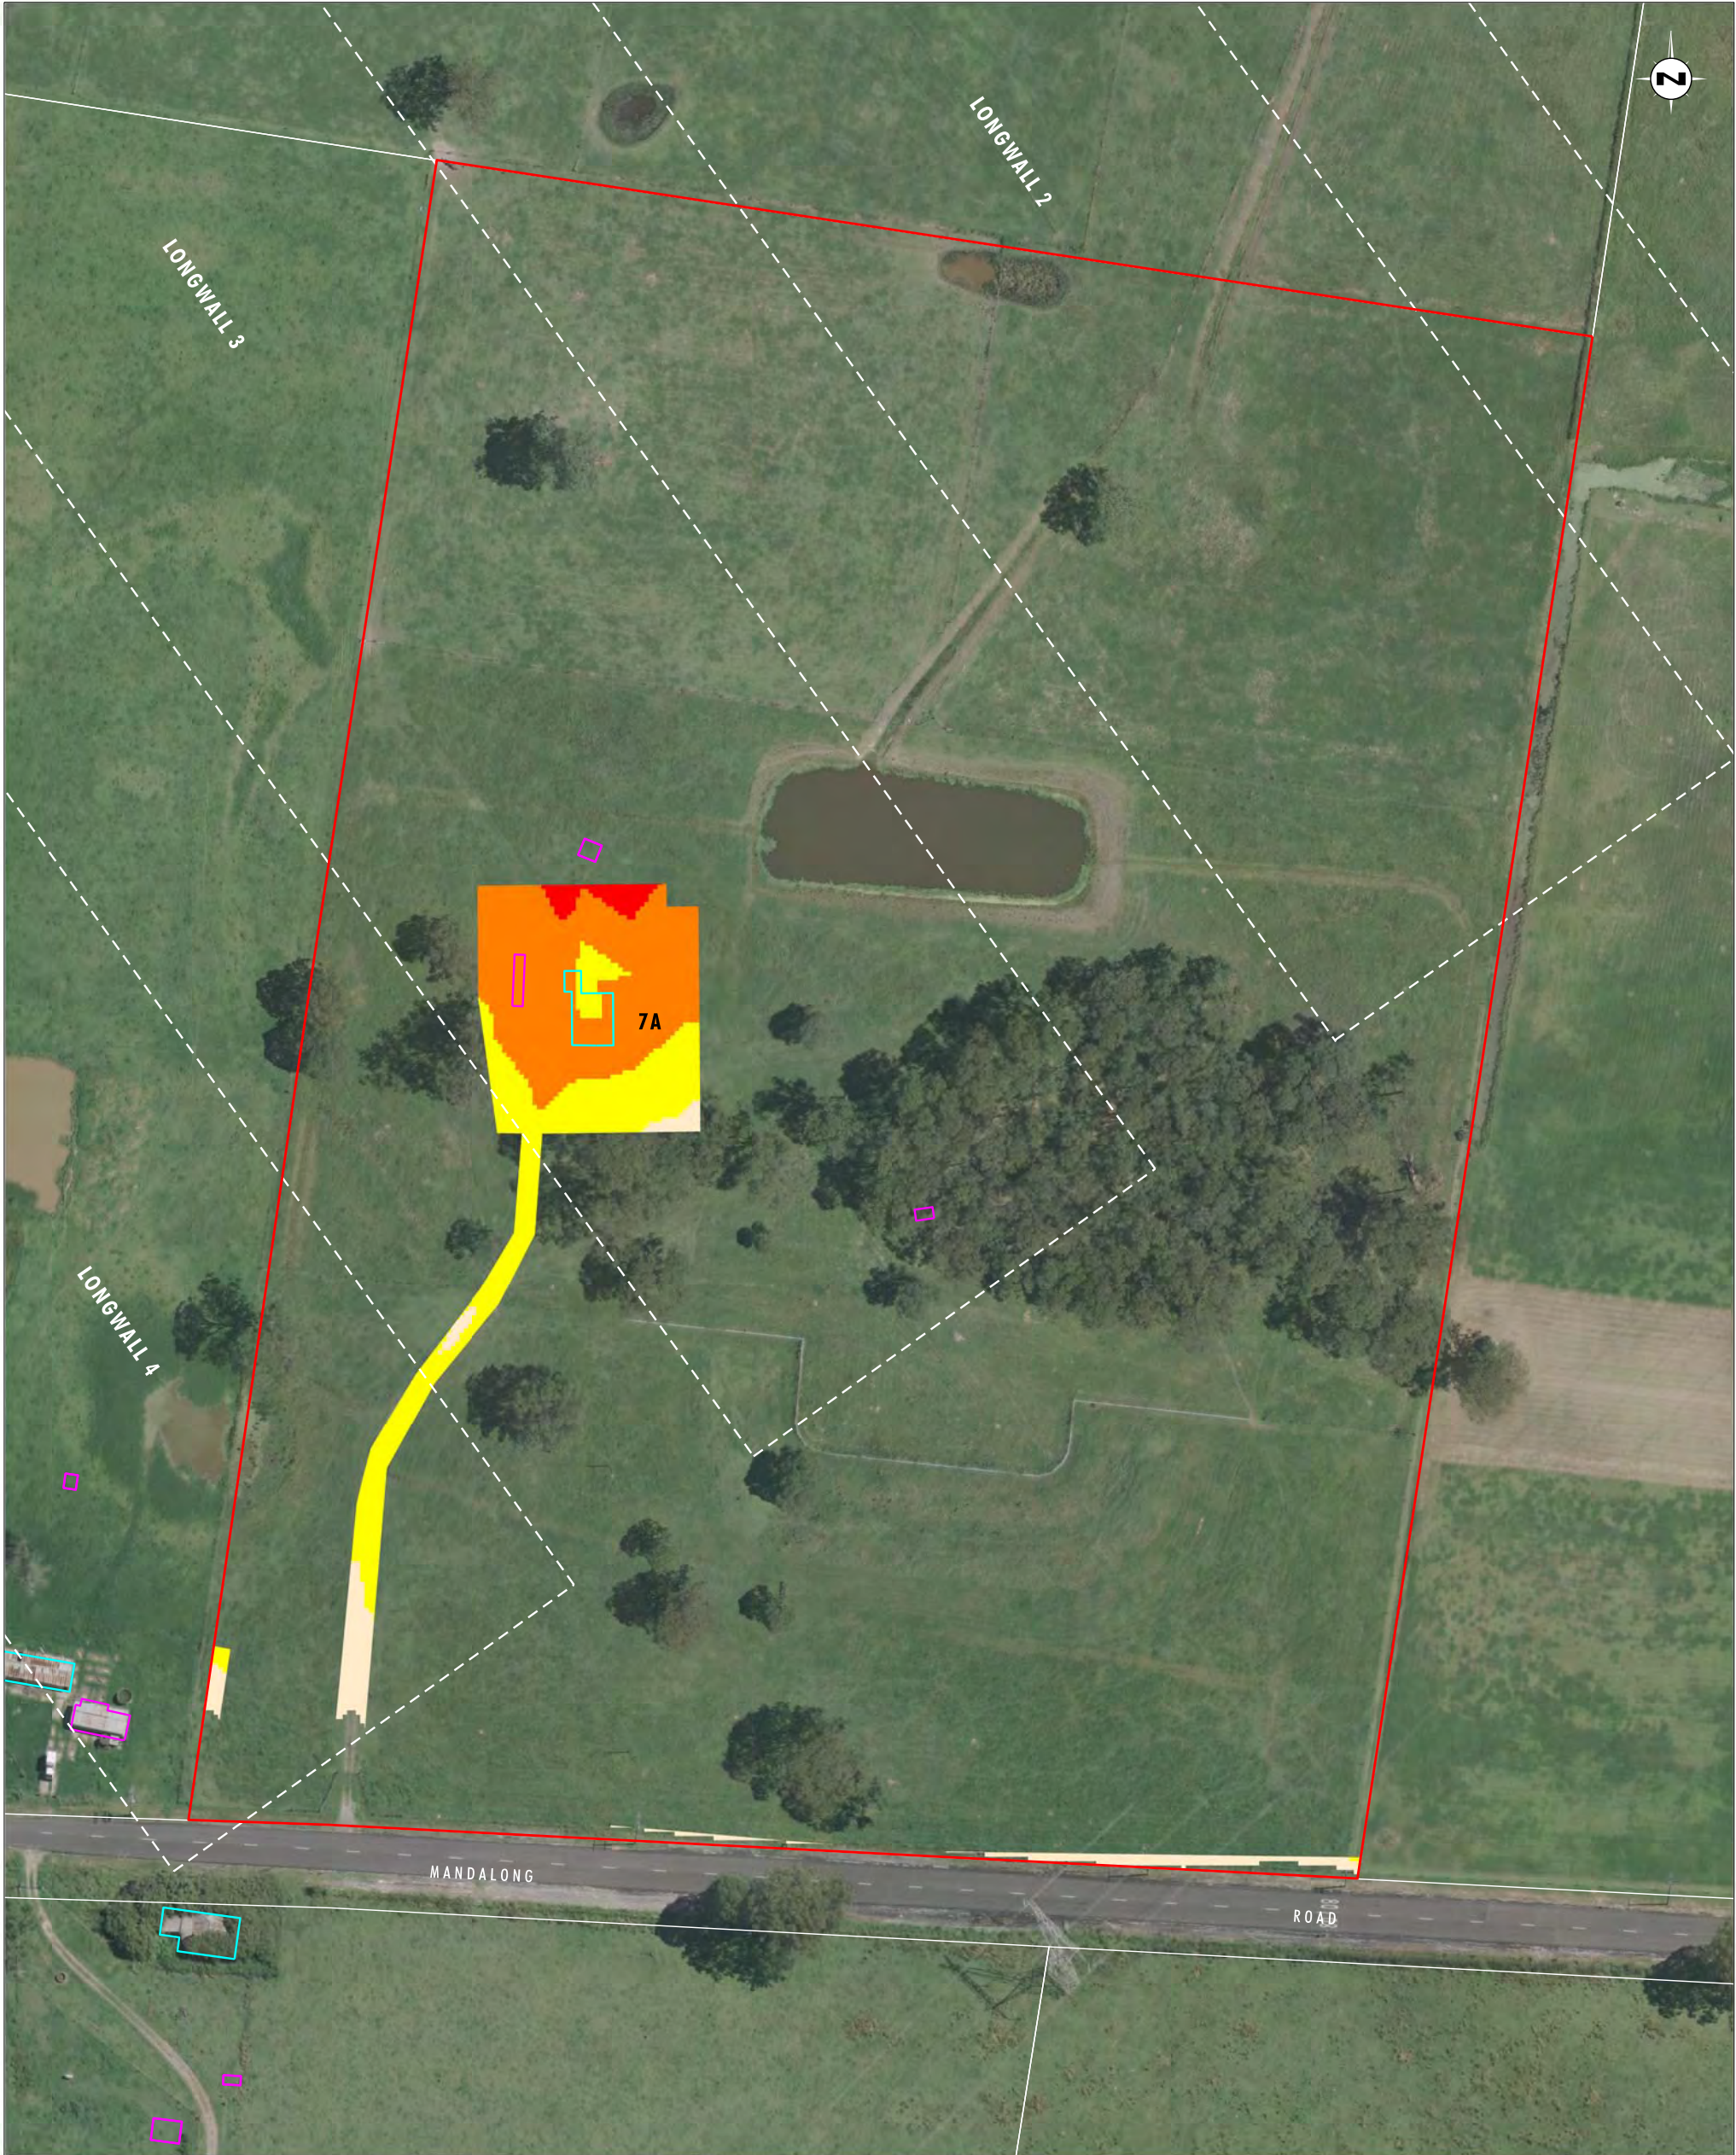
Image Source: Centennial Mandalong Pty Ltd (2009) - Aerial Photograph  
Data Source: Centennial Mandalong Pty Ltd, LPI - Cadastral Boundaries  
Note: Flood Hazard shown for access and dwellings only

FIGURE 4  
Property 7 - 100 Year ARI Storm Event  
Maximum Flood Hazard Categories Post Mining Landform  
(to Longwall 23)

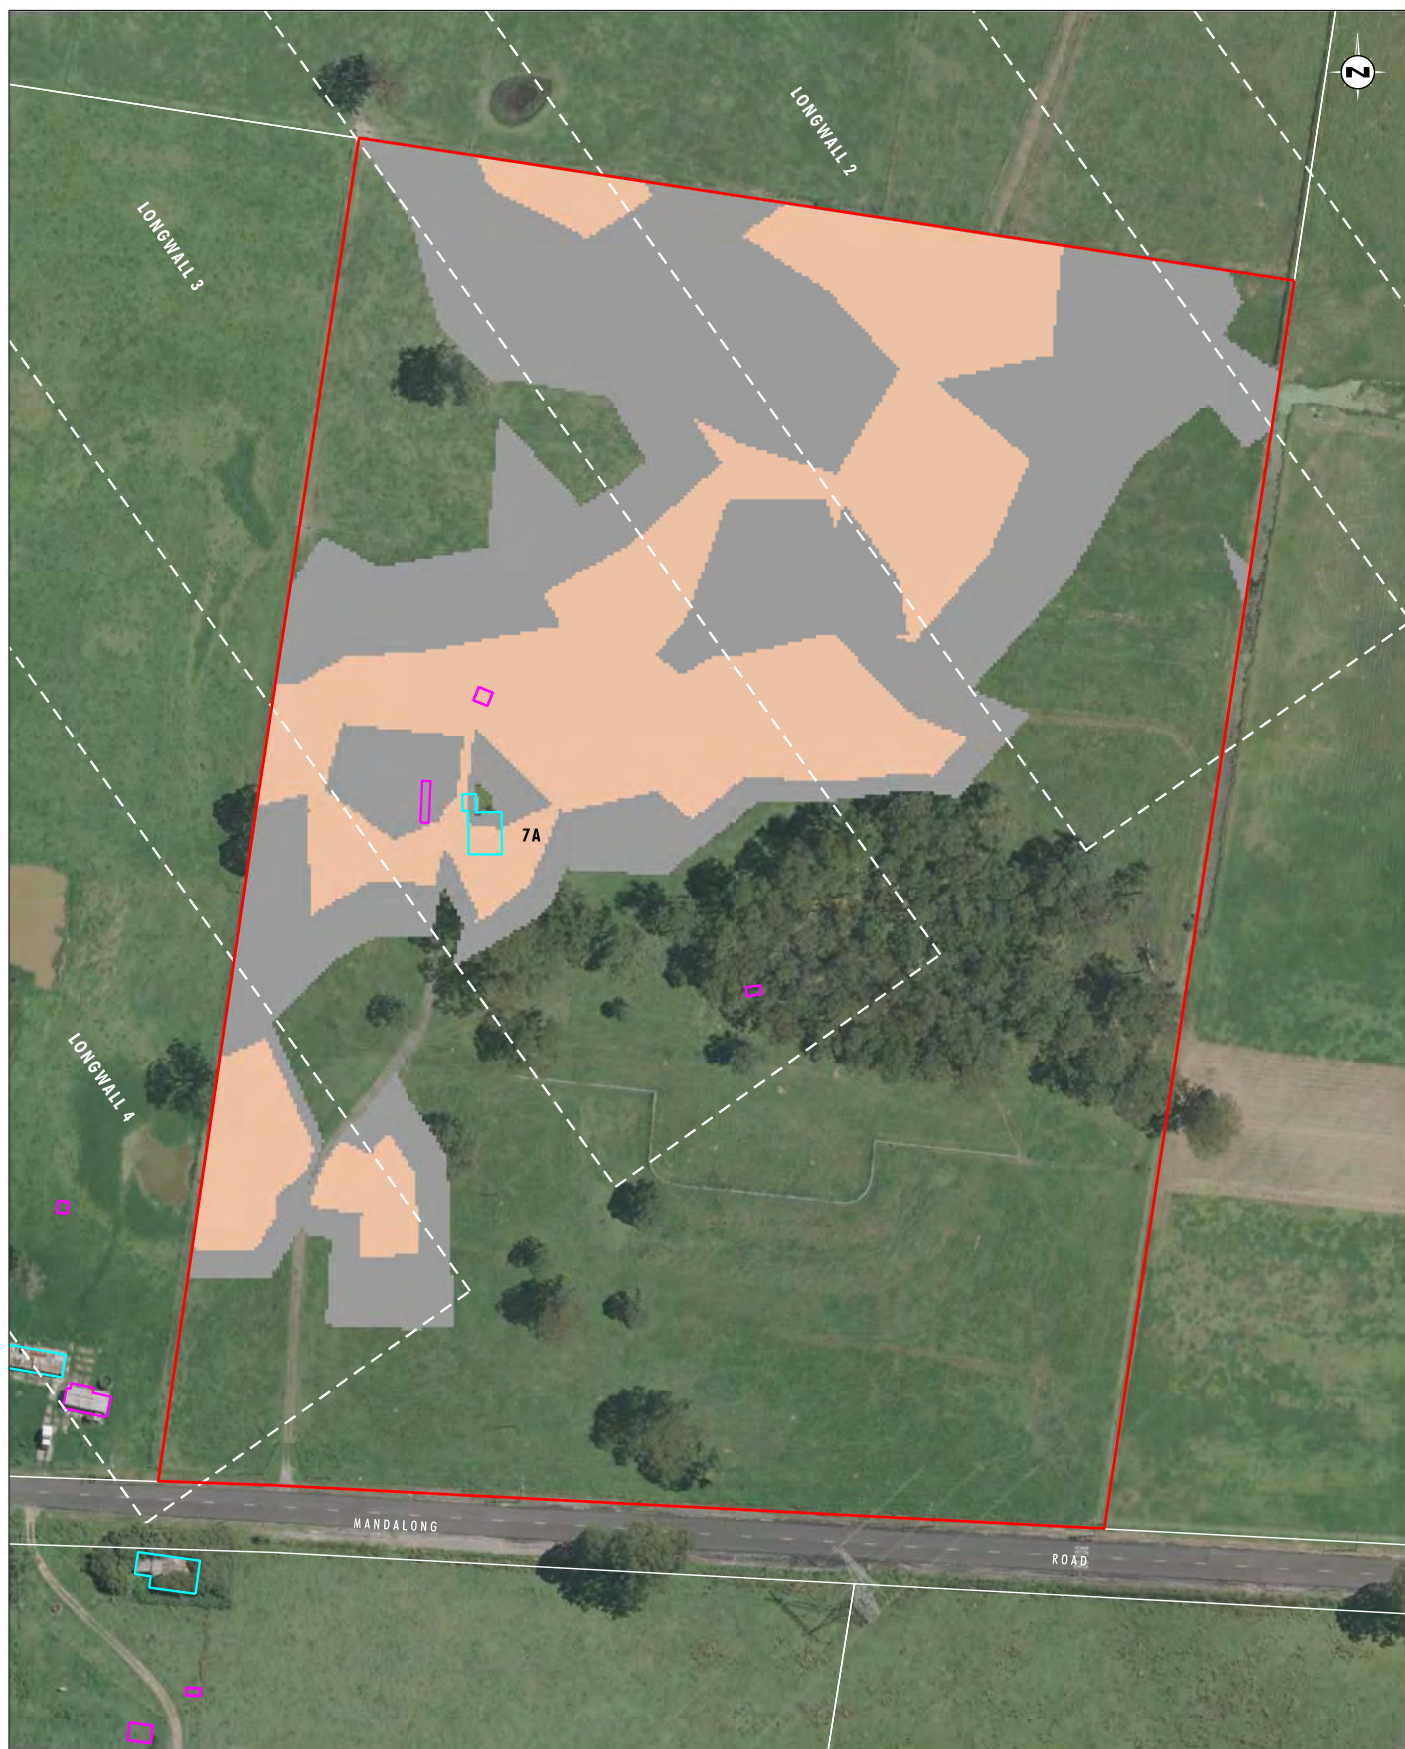
FIGURE 5

Property 7 - 1 Year ARI Storm Event  
Maximum Flood Depth Pre Mining Landform

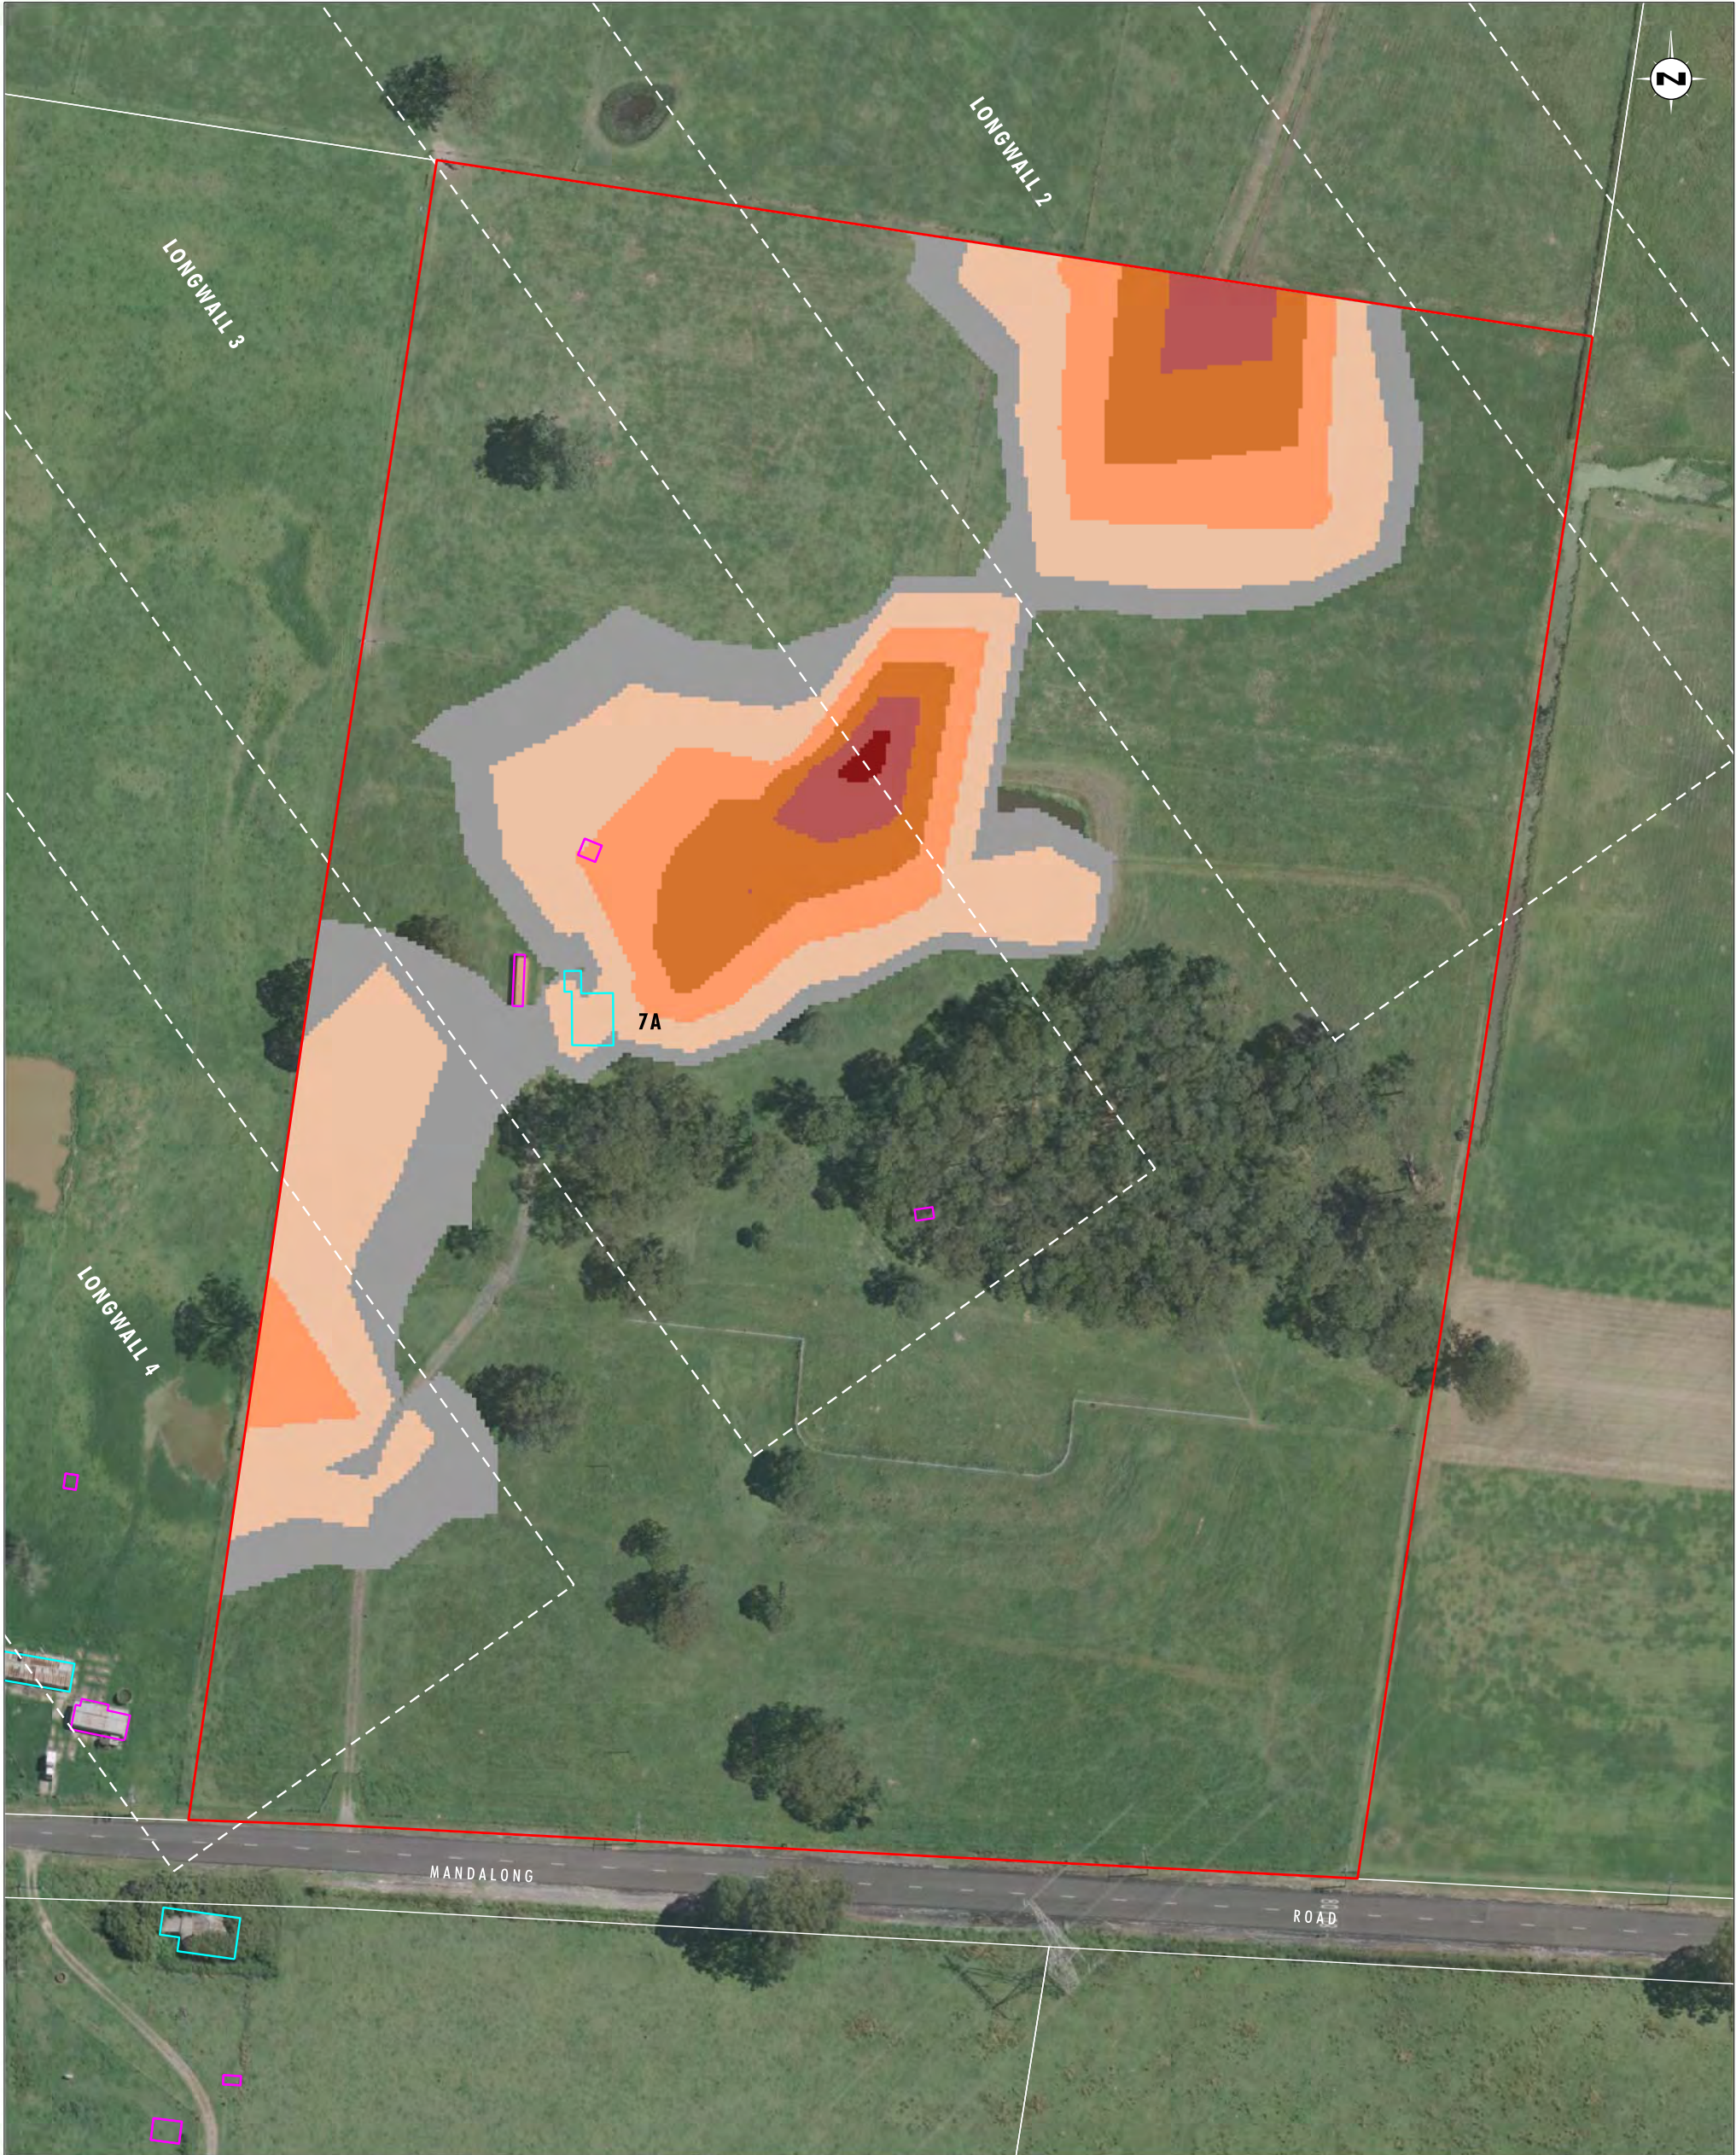
FIGURE 6  
Property 7 - 1 Year ARI Storm Event  
Maximum Flood Depth Post Mining Landform  
(to Longwall 23)
