## APPENDIX 1

**Flooding Assessment Figures -  
Property 7 (Centennial)**

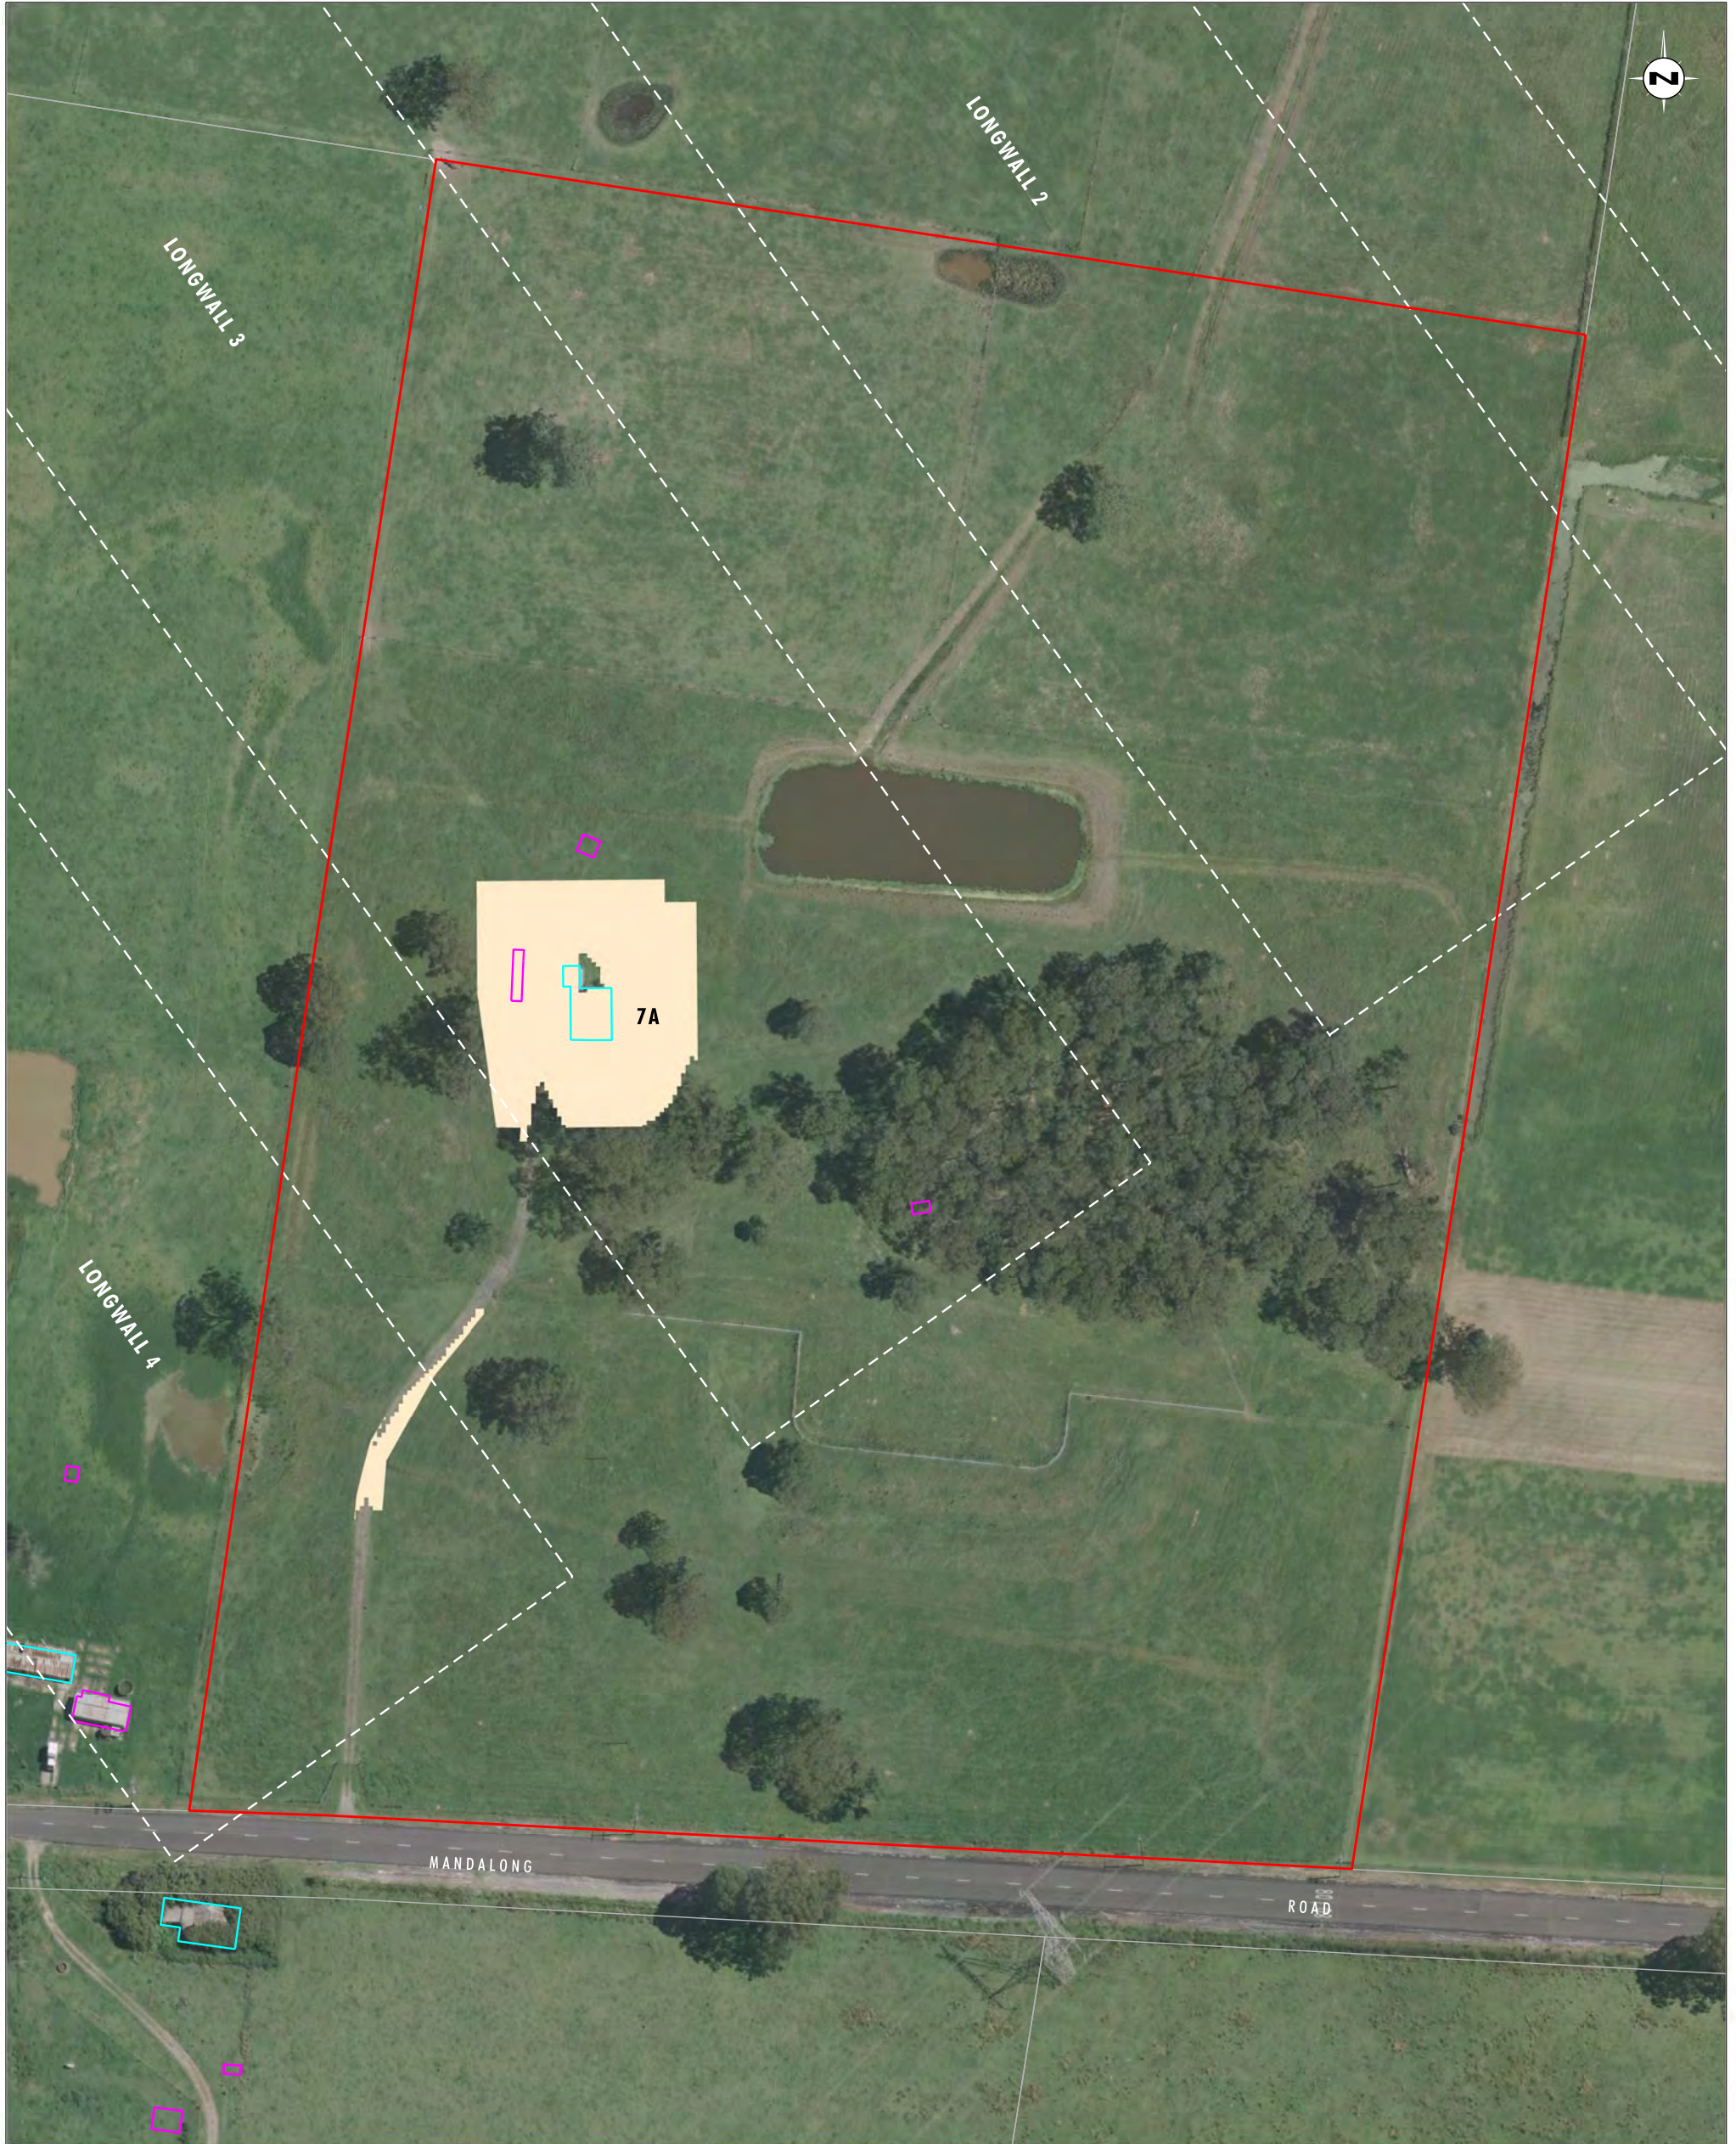
FIGURE 7

Image Source: Centennial Mandalong Pty Ltd (2009) - Aerial Photograph  
Data Source: Centennial Mandalong Pty Ltd, LPI - Cadastral Boundaries  
Note: Flood Hazard shown for access and dwellings only

Property 7 - 1 Year ARI Storm Event  
Maximum Flood Hazard Categories Pre Mining Landform

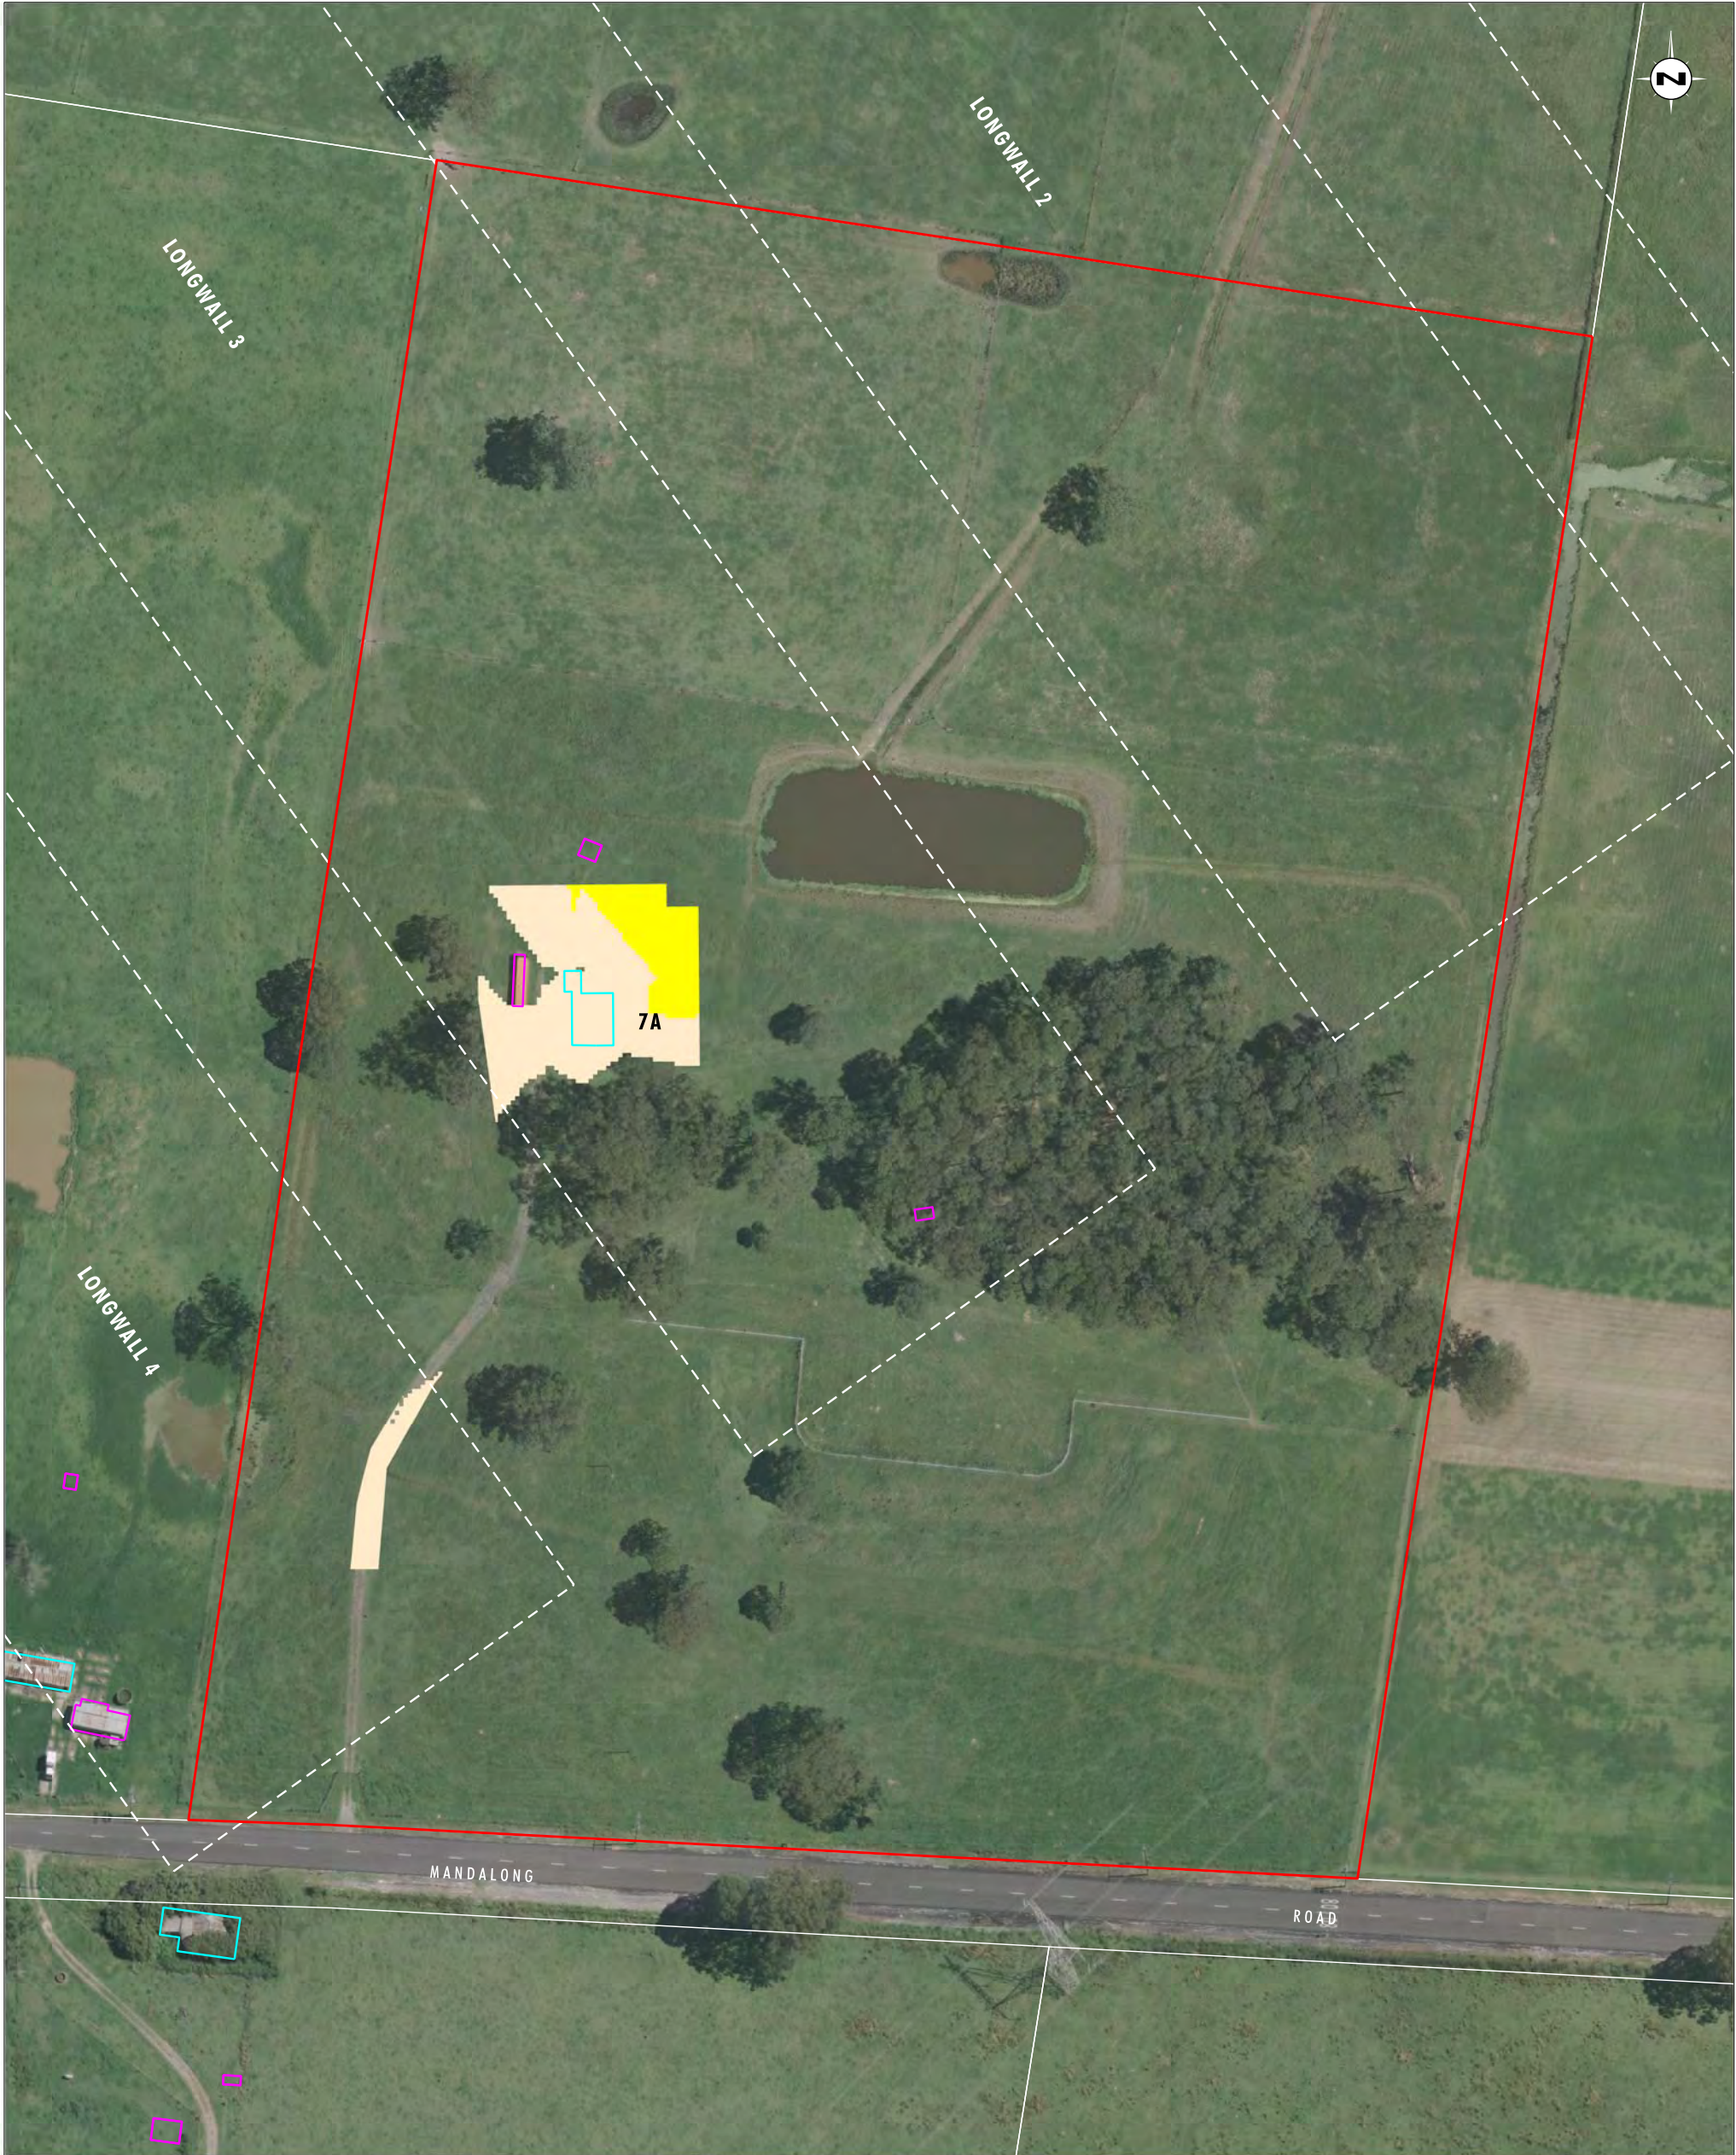
Image Source: Centennial Mandalong Pty Ltd (2009) - Aerial Photograph  
Data Source: Centennial Mandalong Pty Ltd, LPI - Cadastral Boundaries  
Note: Flood Hazard shown for access and dwellings only

FIGURE 8  
Property 7 - 1 Year ARI Storm Event  
Maximum Flood Hazard Categories Post Mining Landform  
(to Longwall 23)

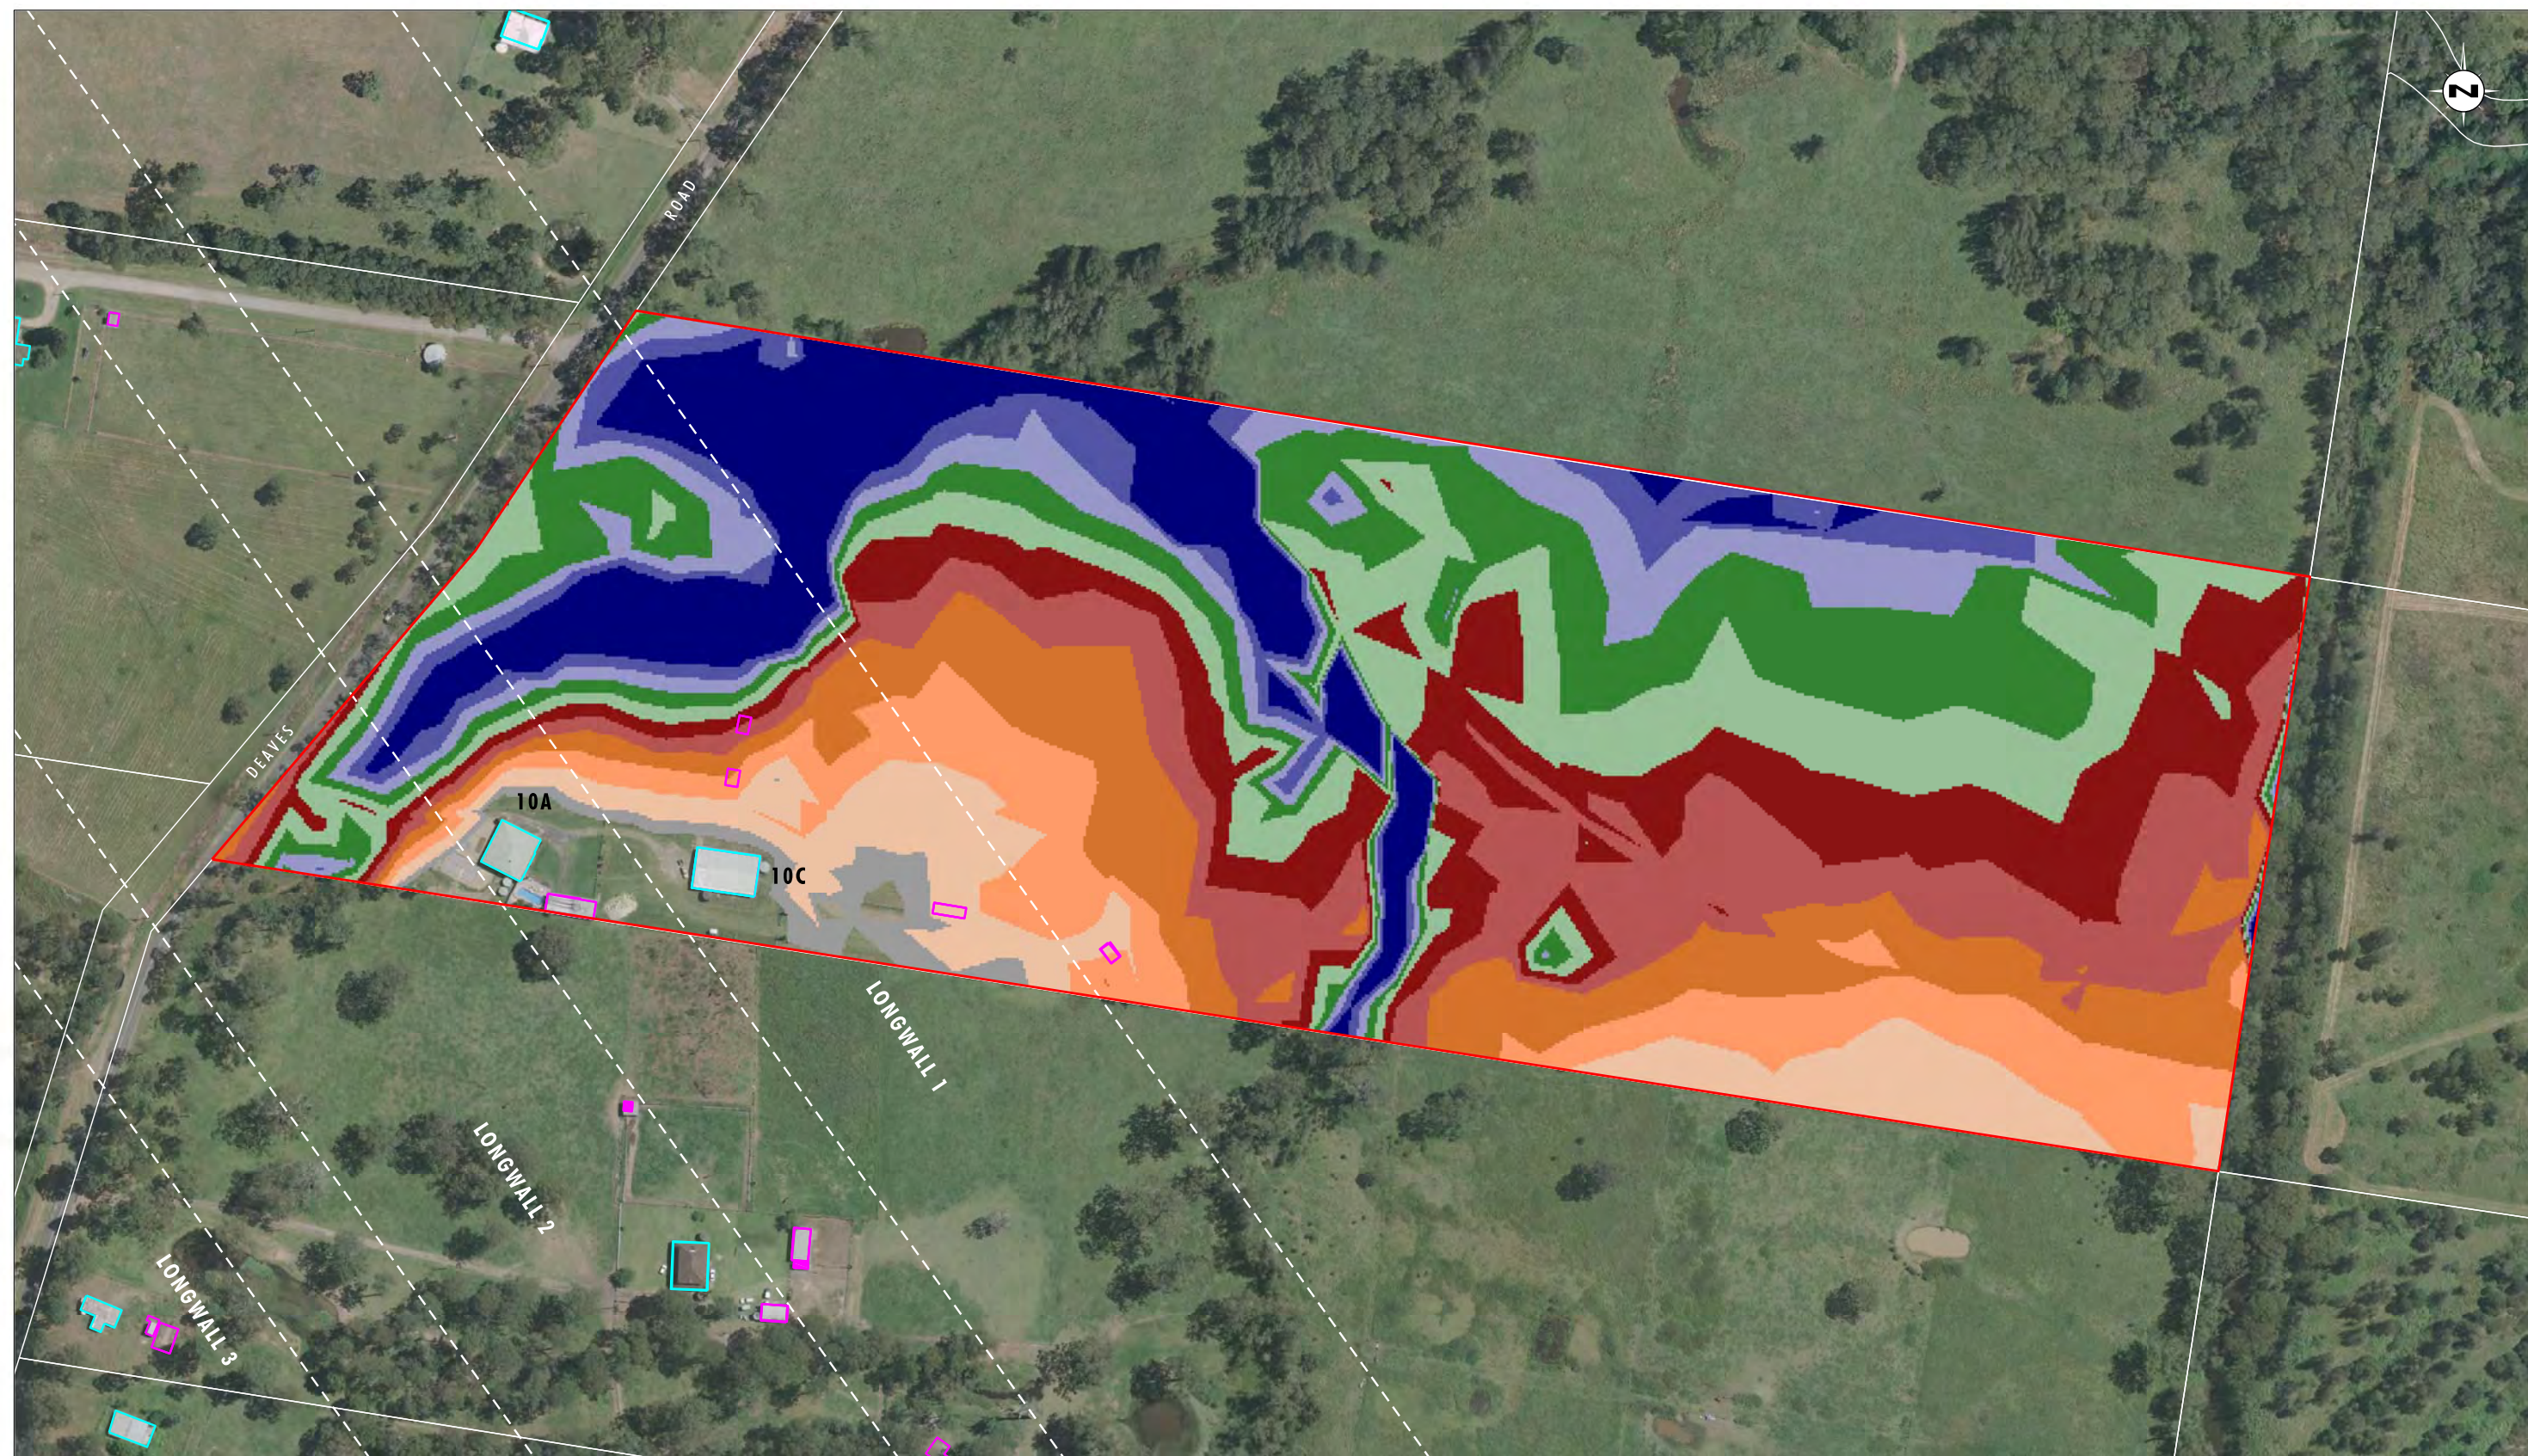
FIGURE 1

Property 10 - 100 Year ARI Storm Event  
Maximum Flood Depth Pre Mining Landform

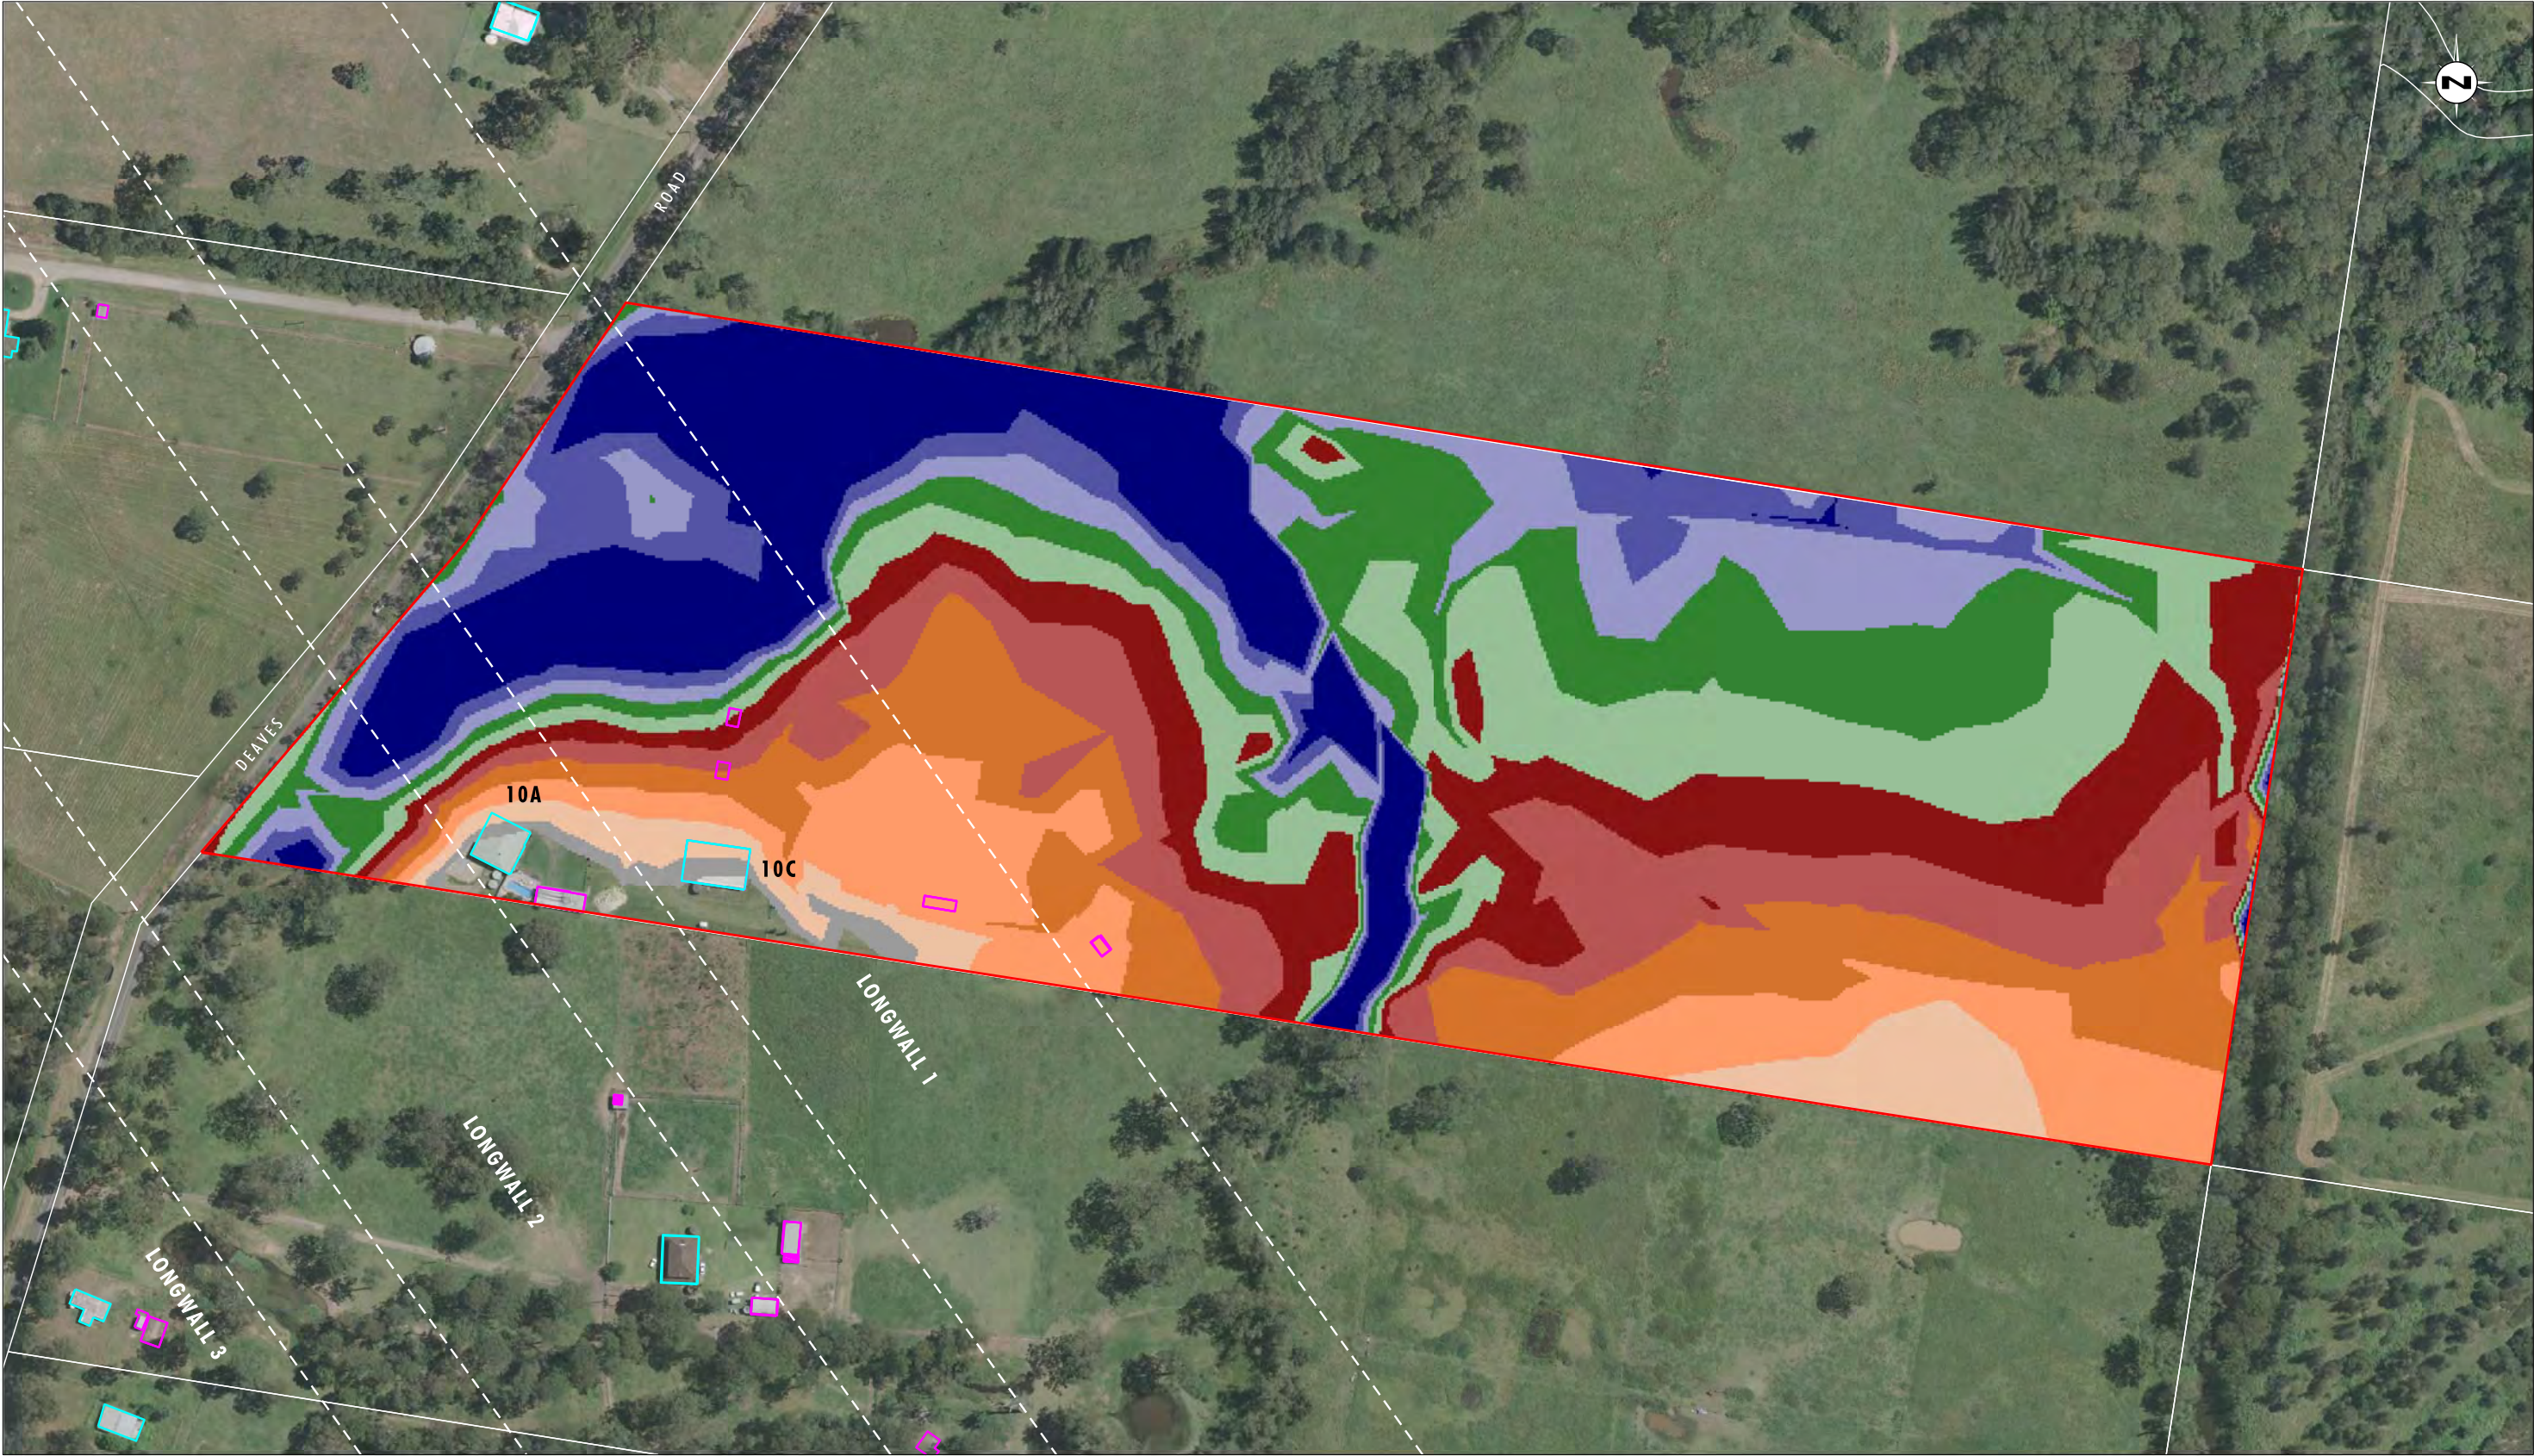
FIGURE 2

Property 10 - 100 Year ARI Storm Event  
Maximum Flood Depth Post Mining Landform  
(to Longwall 23)

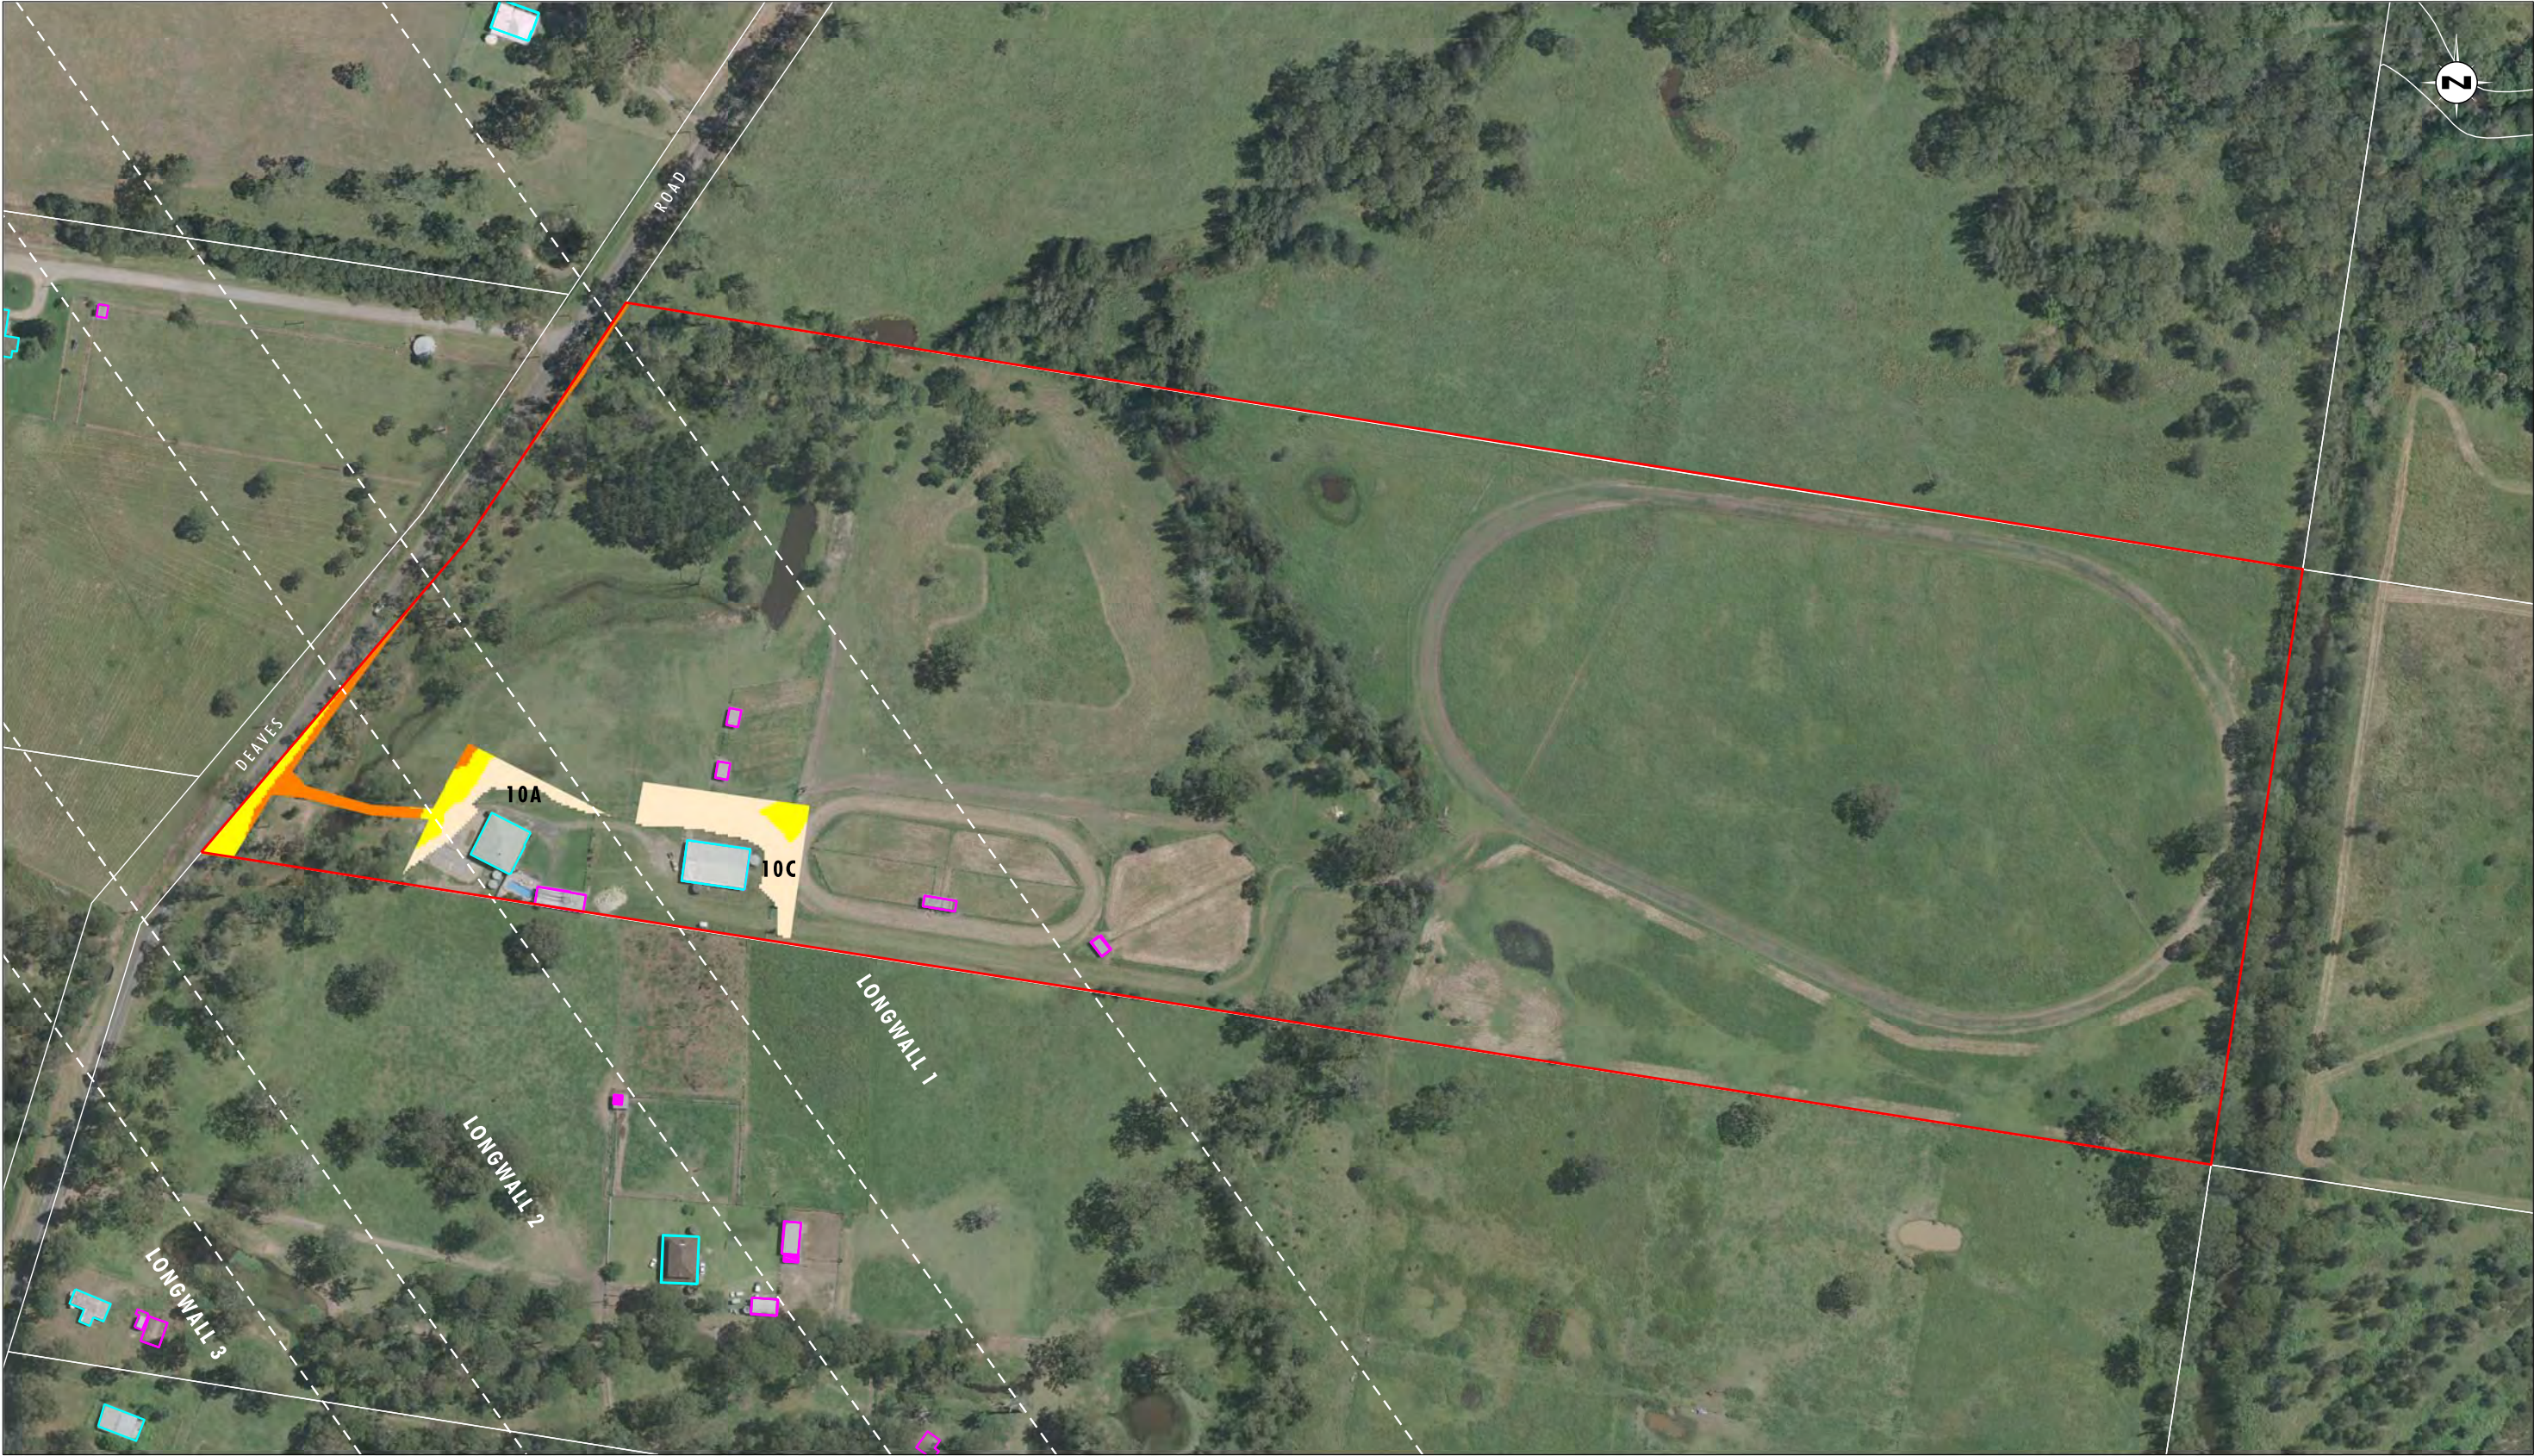
FIGURE 3

Image Source: Centennial Mandalong Pty Ltd (2009) - Aerial Photograph  
Data Source: Centennial Mandalong Pty Ltd, LPI - Cadastral Boundaries  
Note: Flood Hazard shown for access and dwellings only

Property 10 - 100 Year ARI Storm Event  
Maximum Flood Hazard Categories Pre Mining Landform

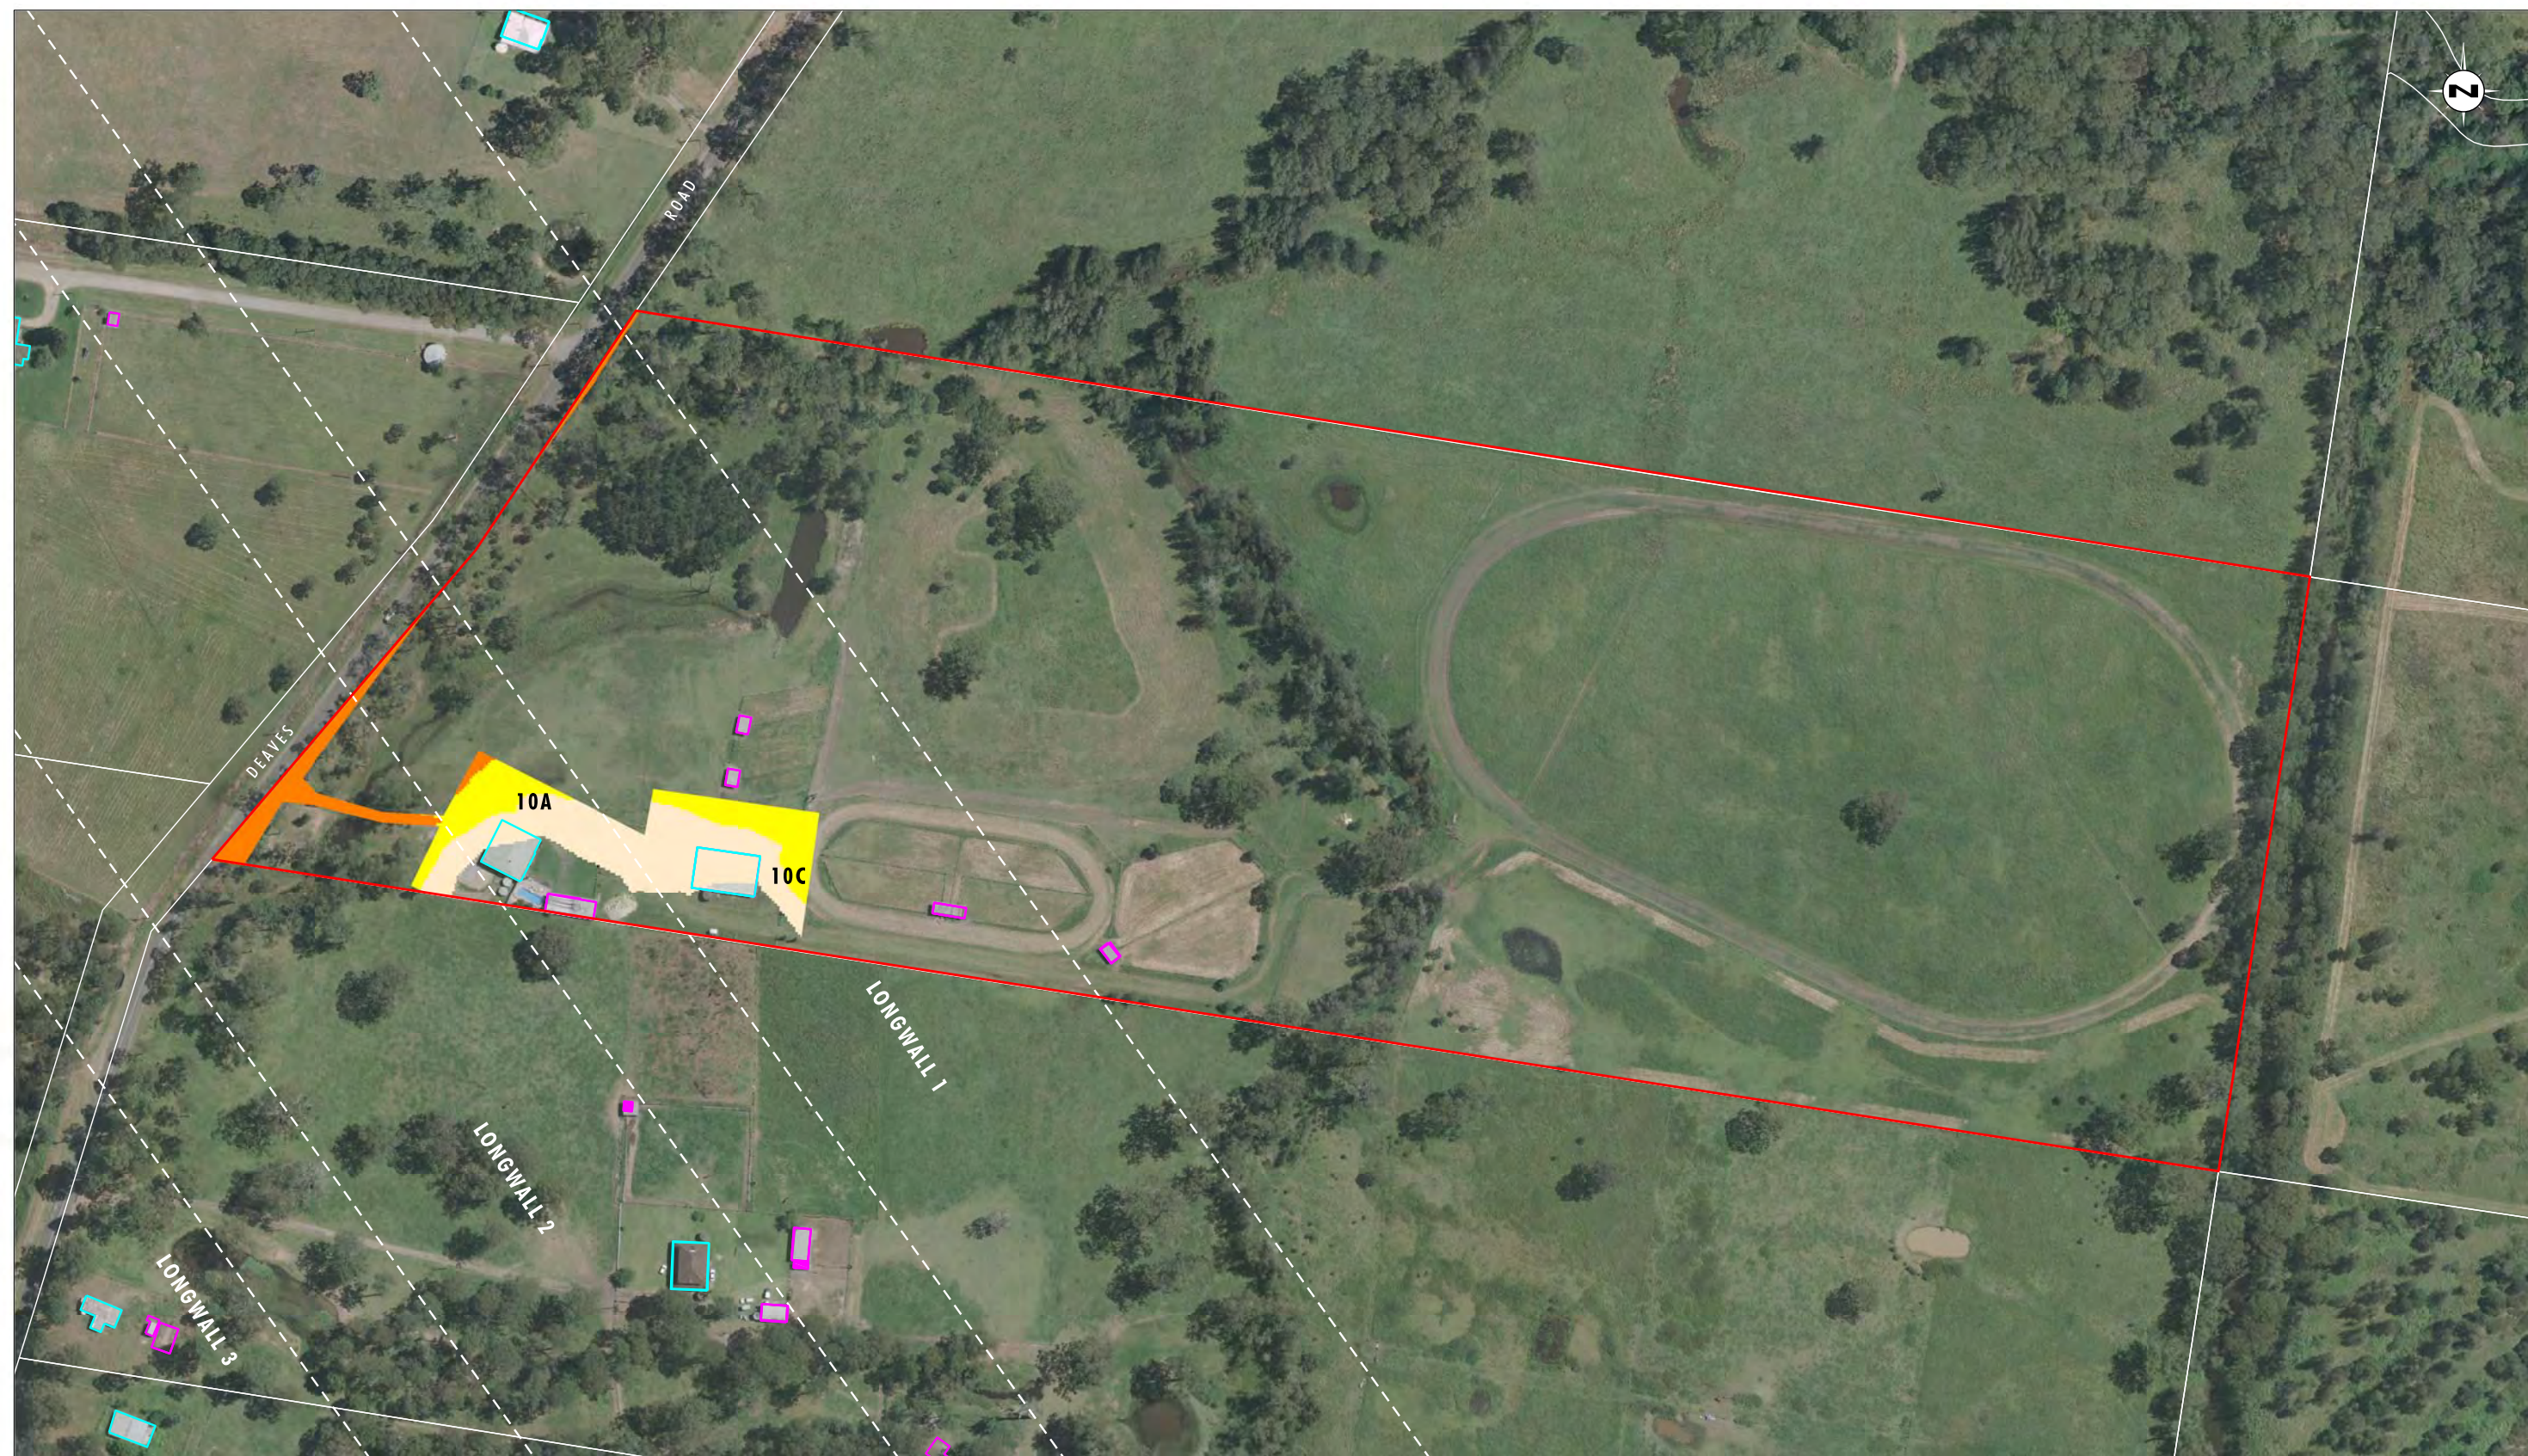
FIGURE 4

Image Source: Centennial Mandalong Pty Ltd (2009) - Aerial Photograph  
Data Source: Centennial Mandalong Pty Ltd, LPI - Cadastral Boundaries  
Note: Flood Hazard shown for access and dwellings only

Property 10 - 100 Year ARI Storm Event  
Maximum Flood Hazard Categories Post Mining Landform  
(to Longwall 23)
