## APPENDIX 1

**Flooding Assessment Figures -  
Property 7 (Centennial)**

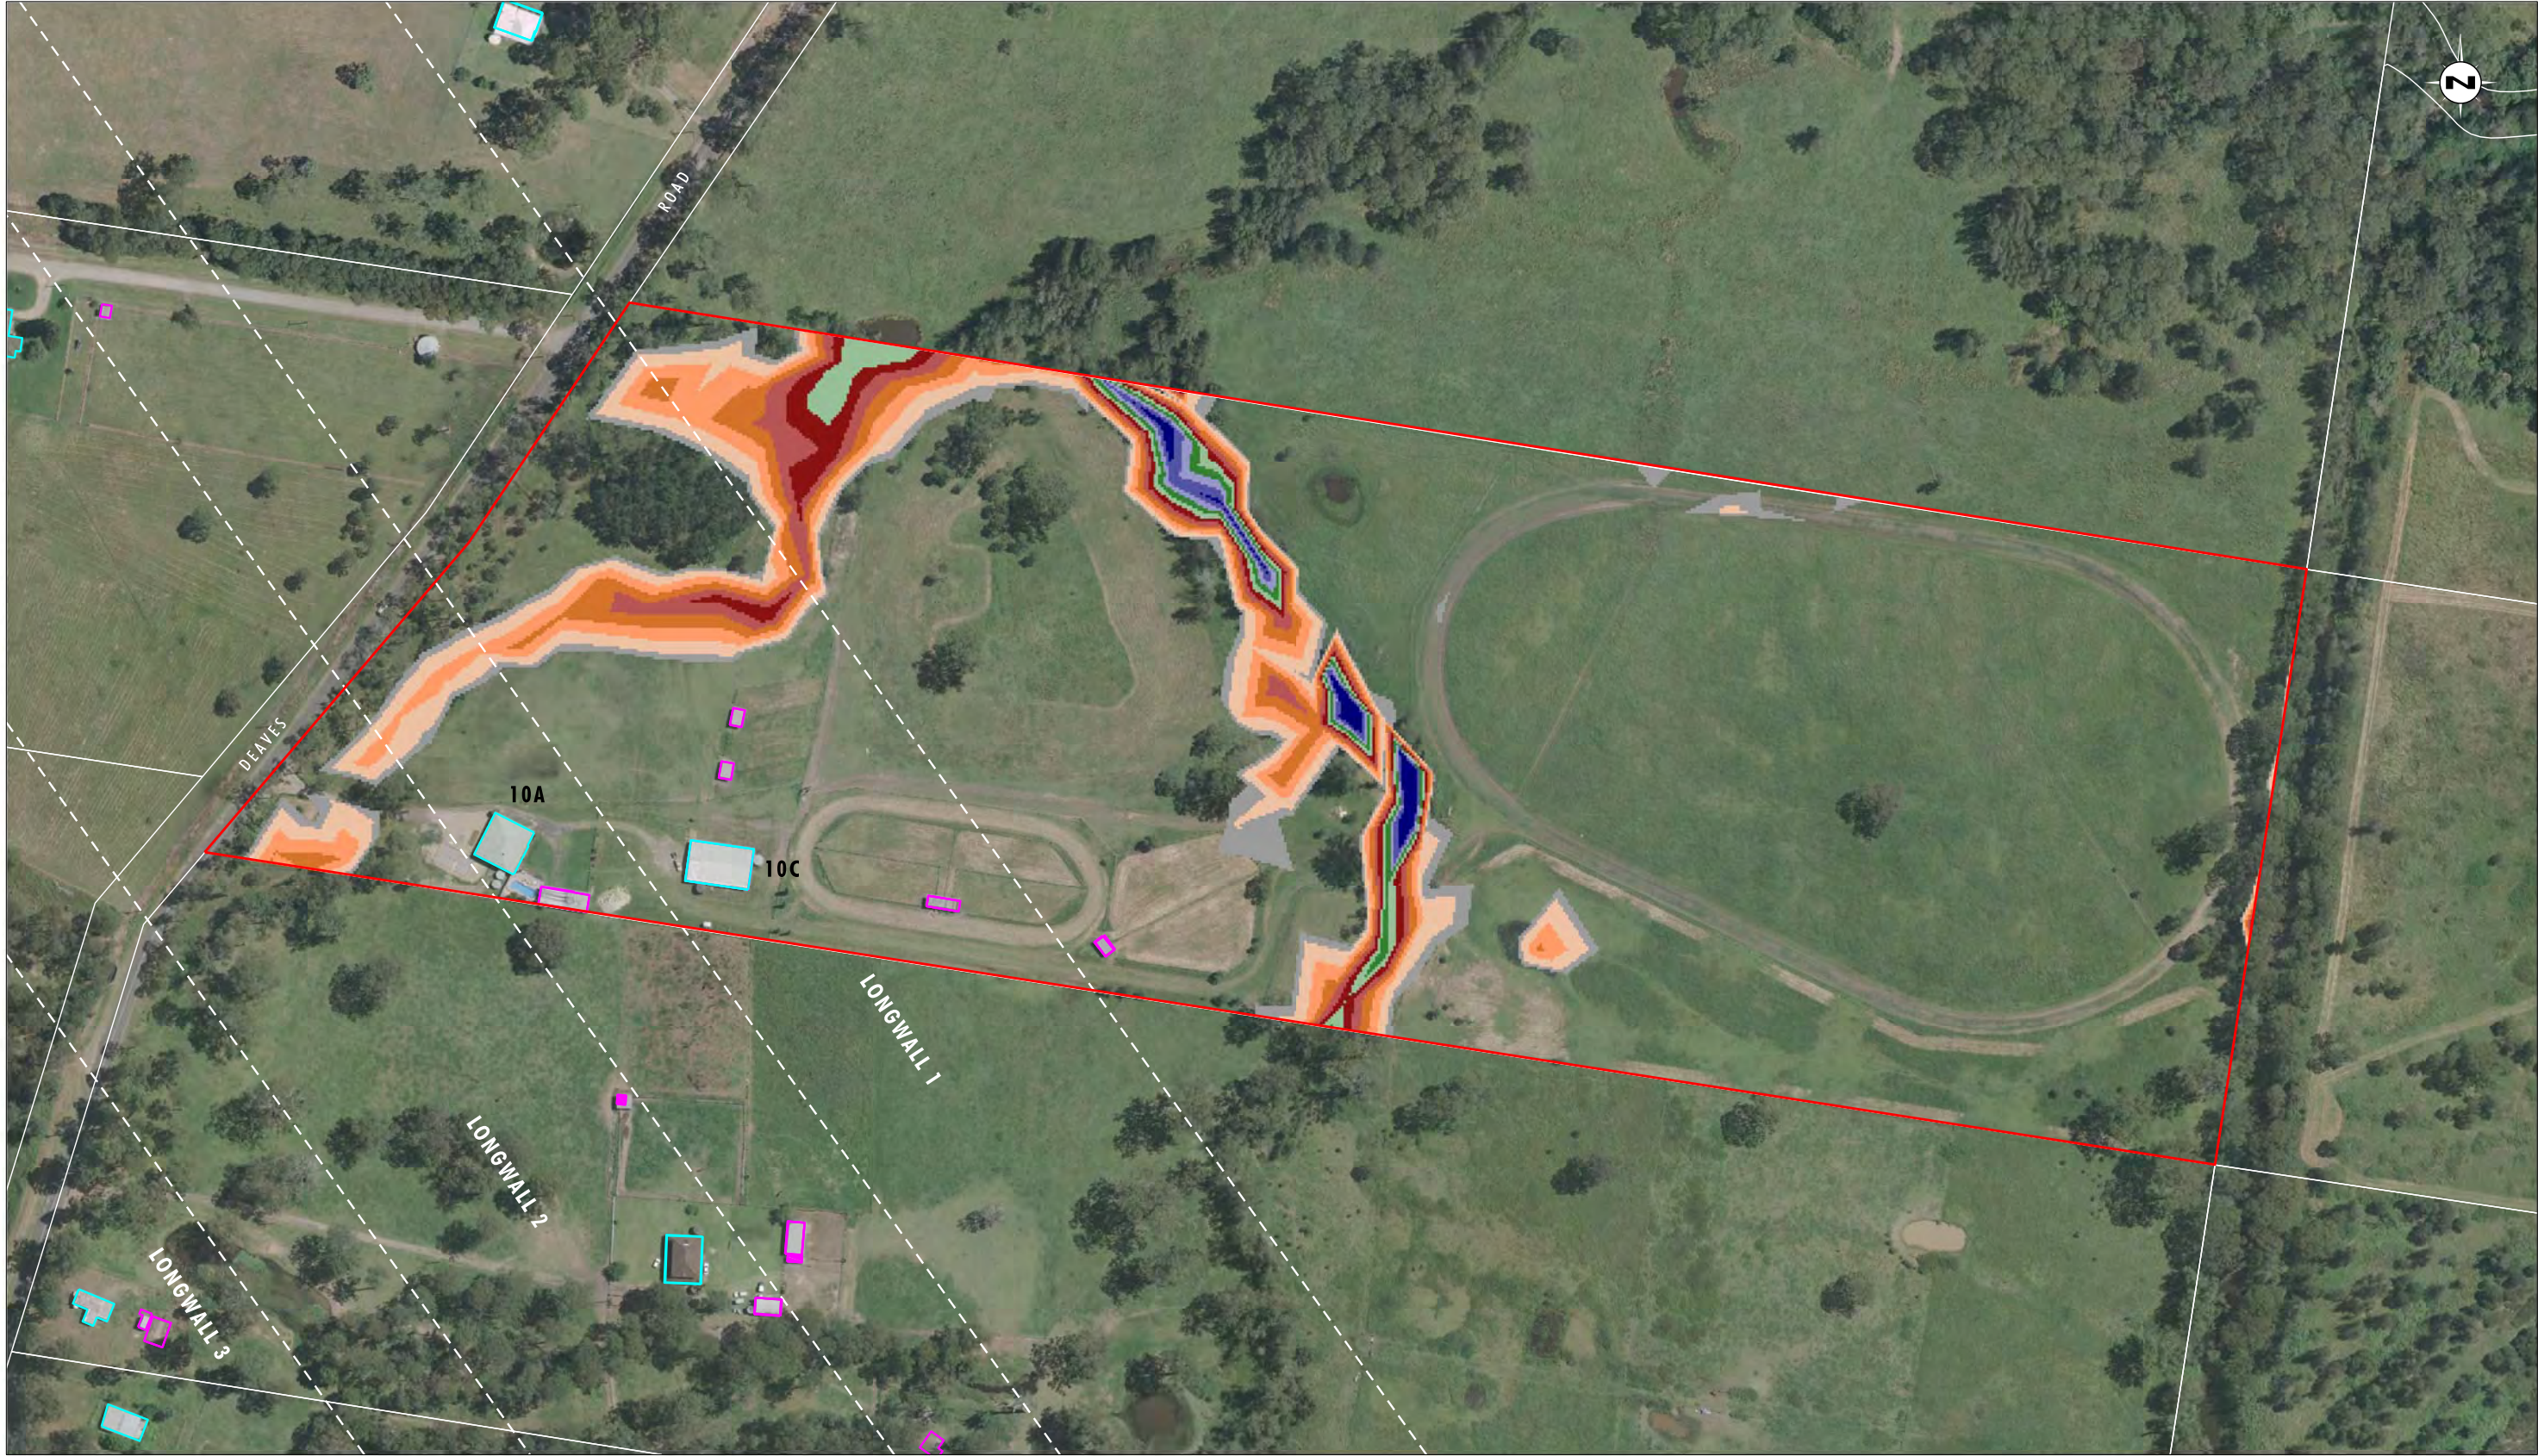
FIGURE 5

Property 10 - 1 Year ARI Storm Event  
Maximum Flood Depth Pre Mining Landform

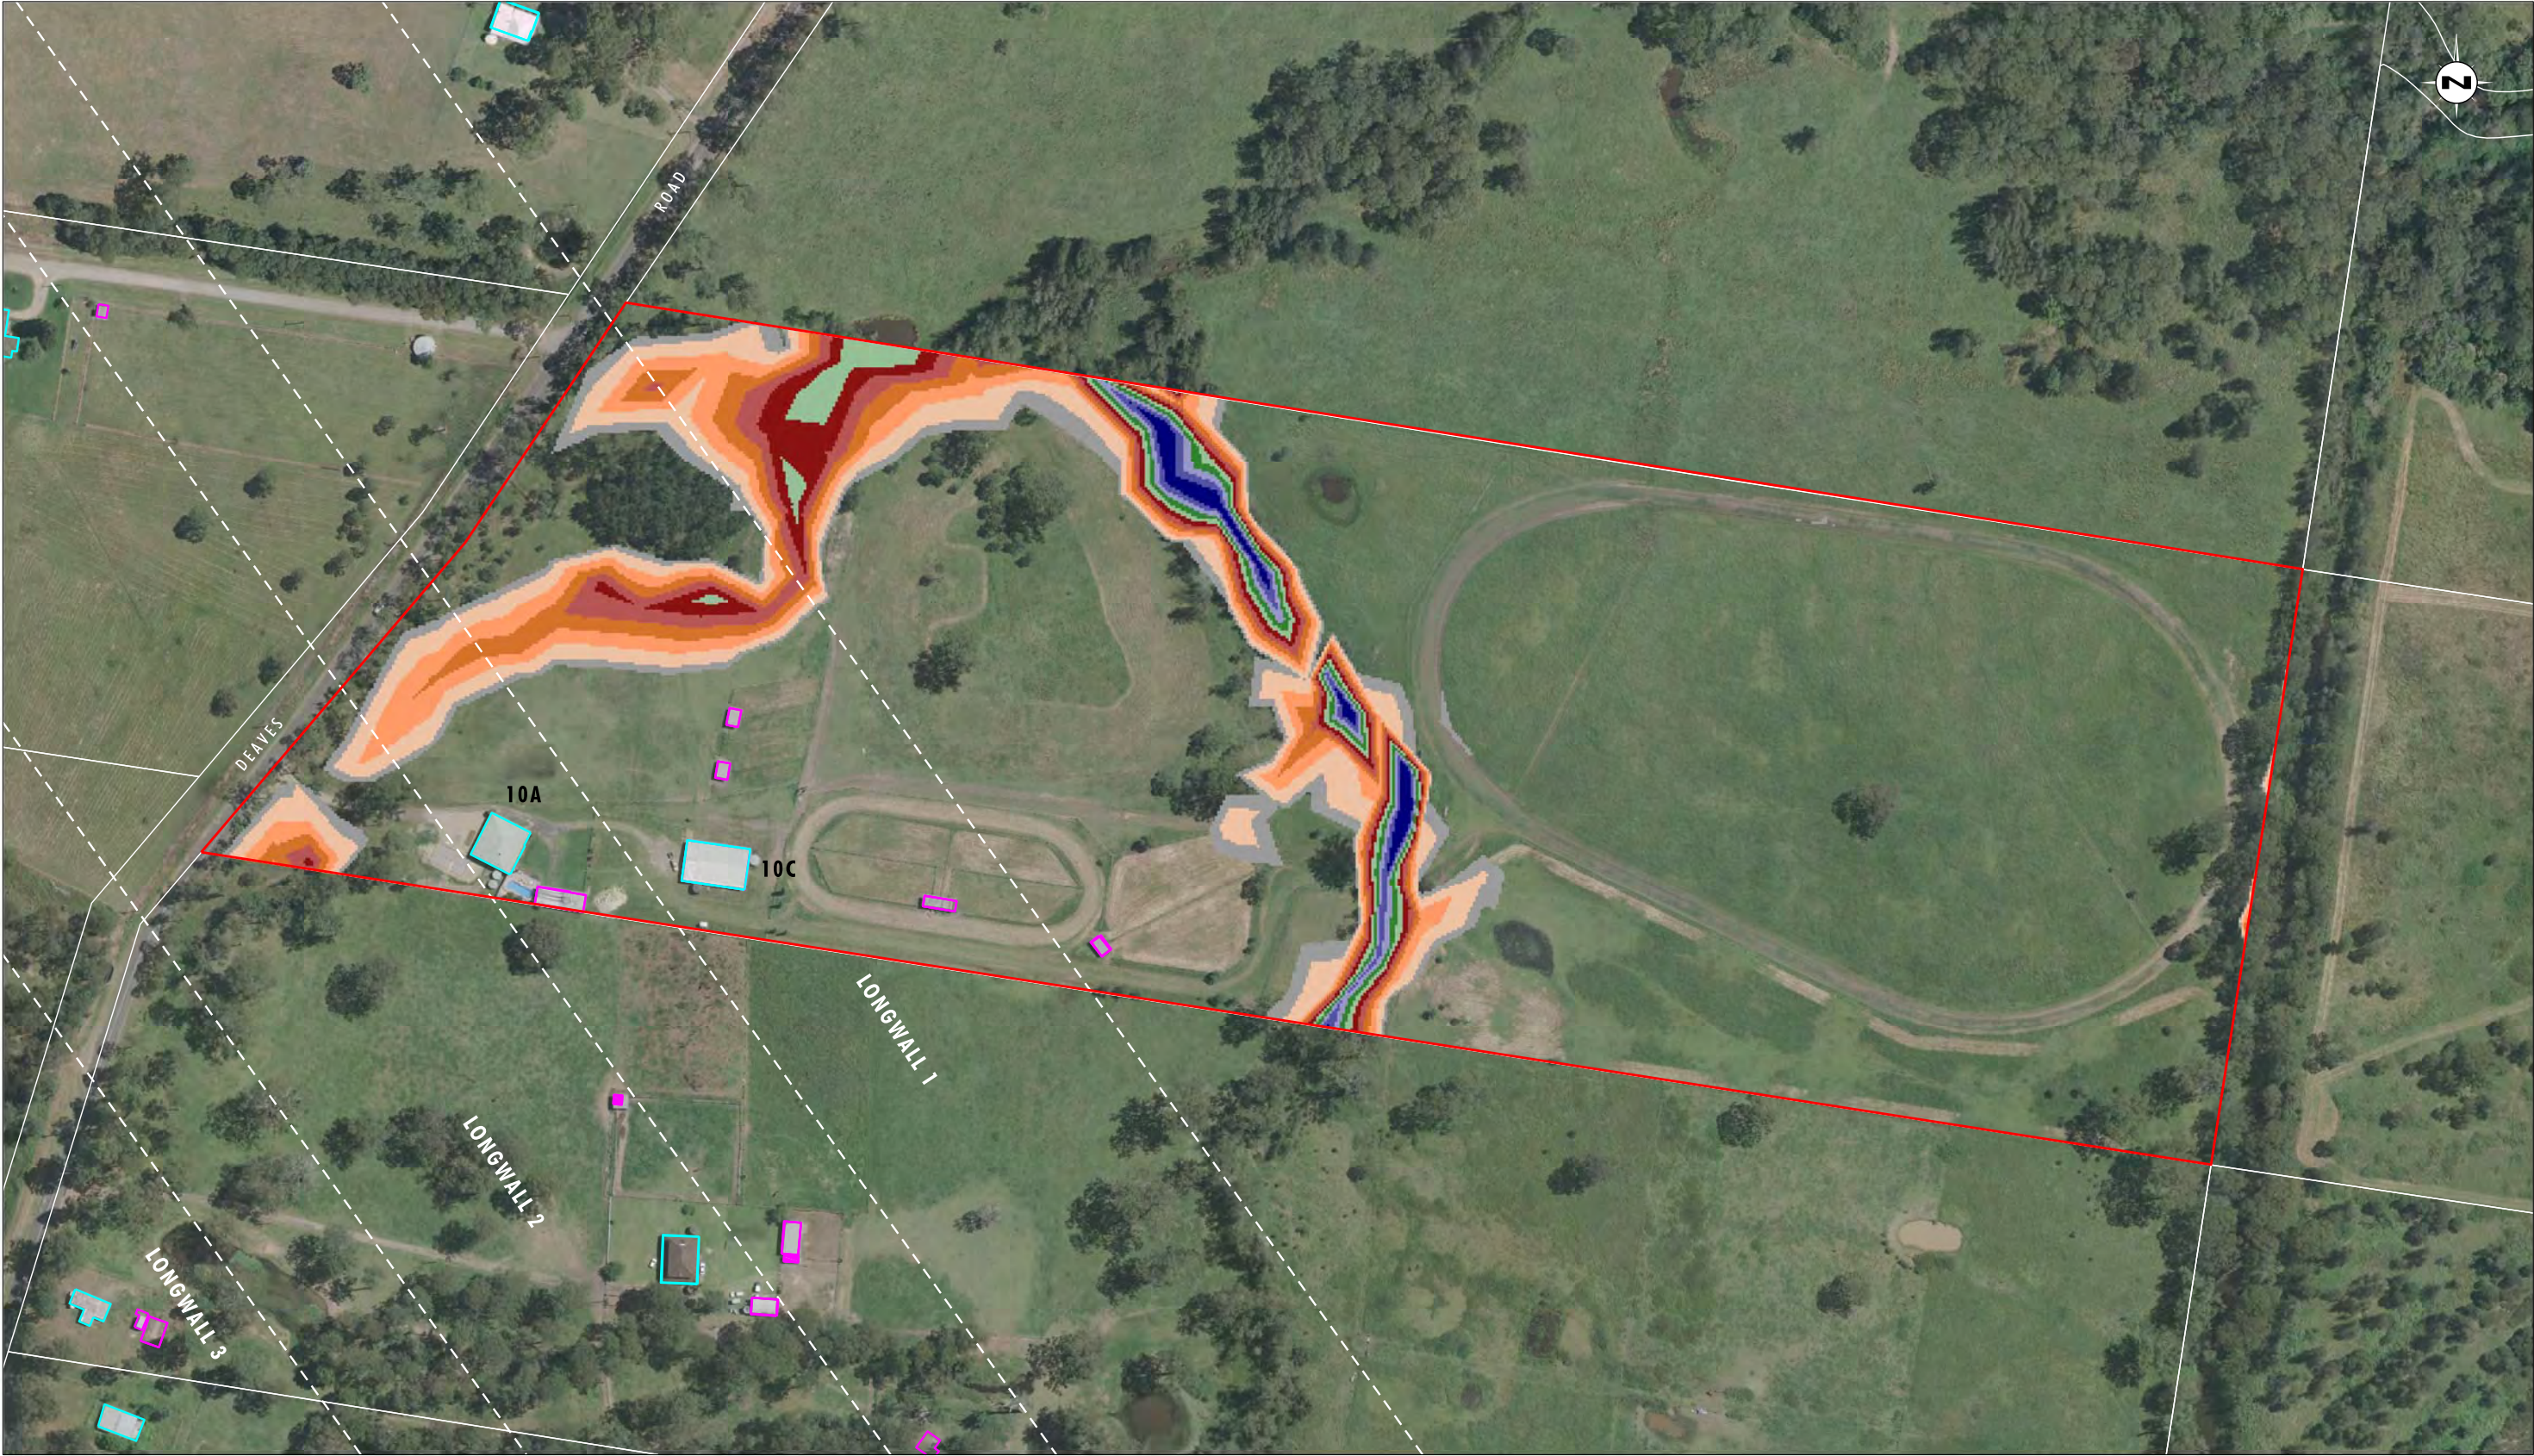
FIGURE 6

Property 10 - 1 Year ARI Storm Event  
Maximum Flood Depth Post Mining Landform  
(to Longwall 23)

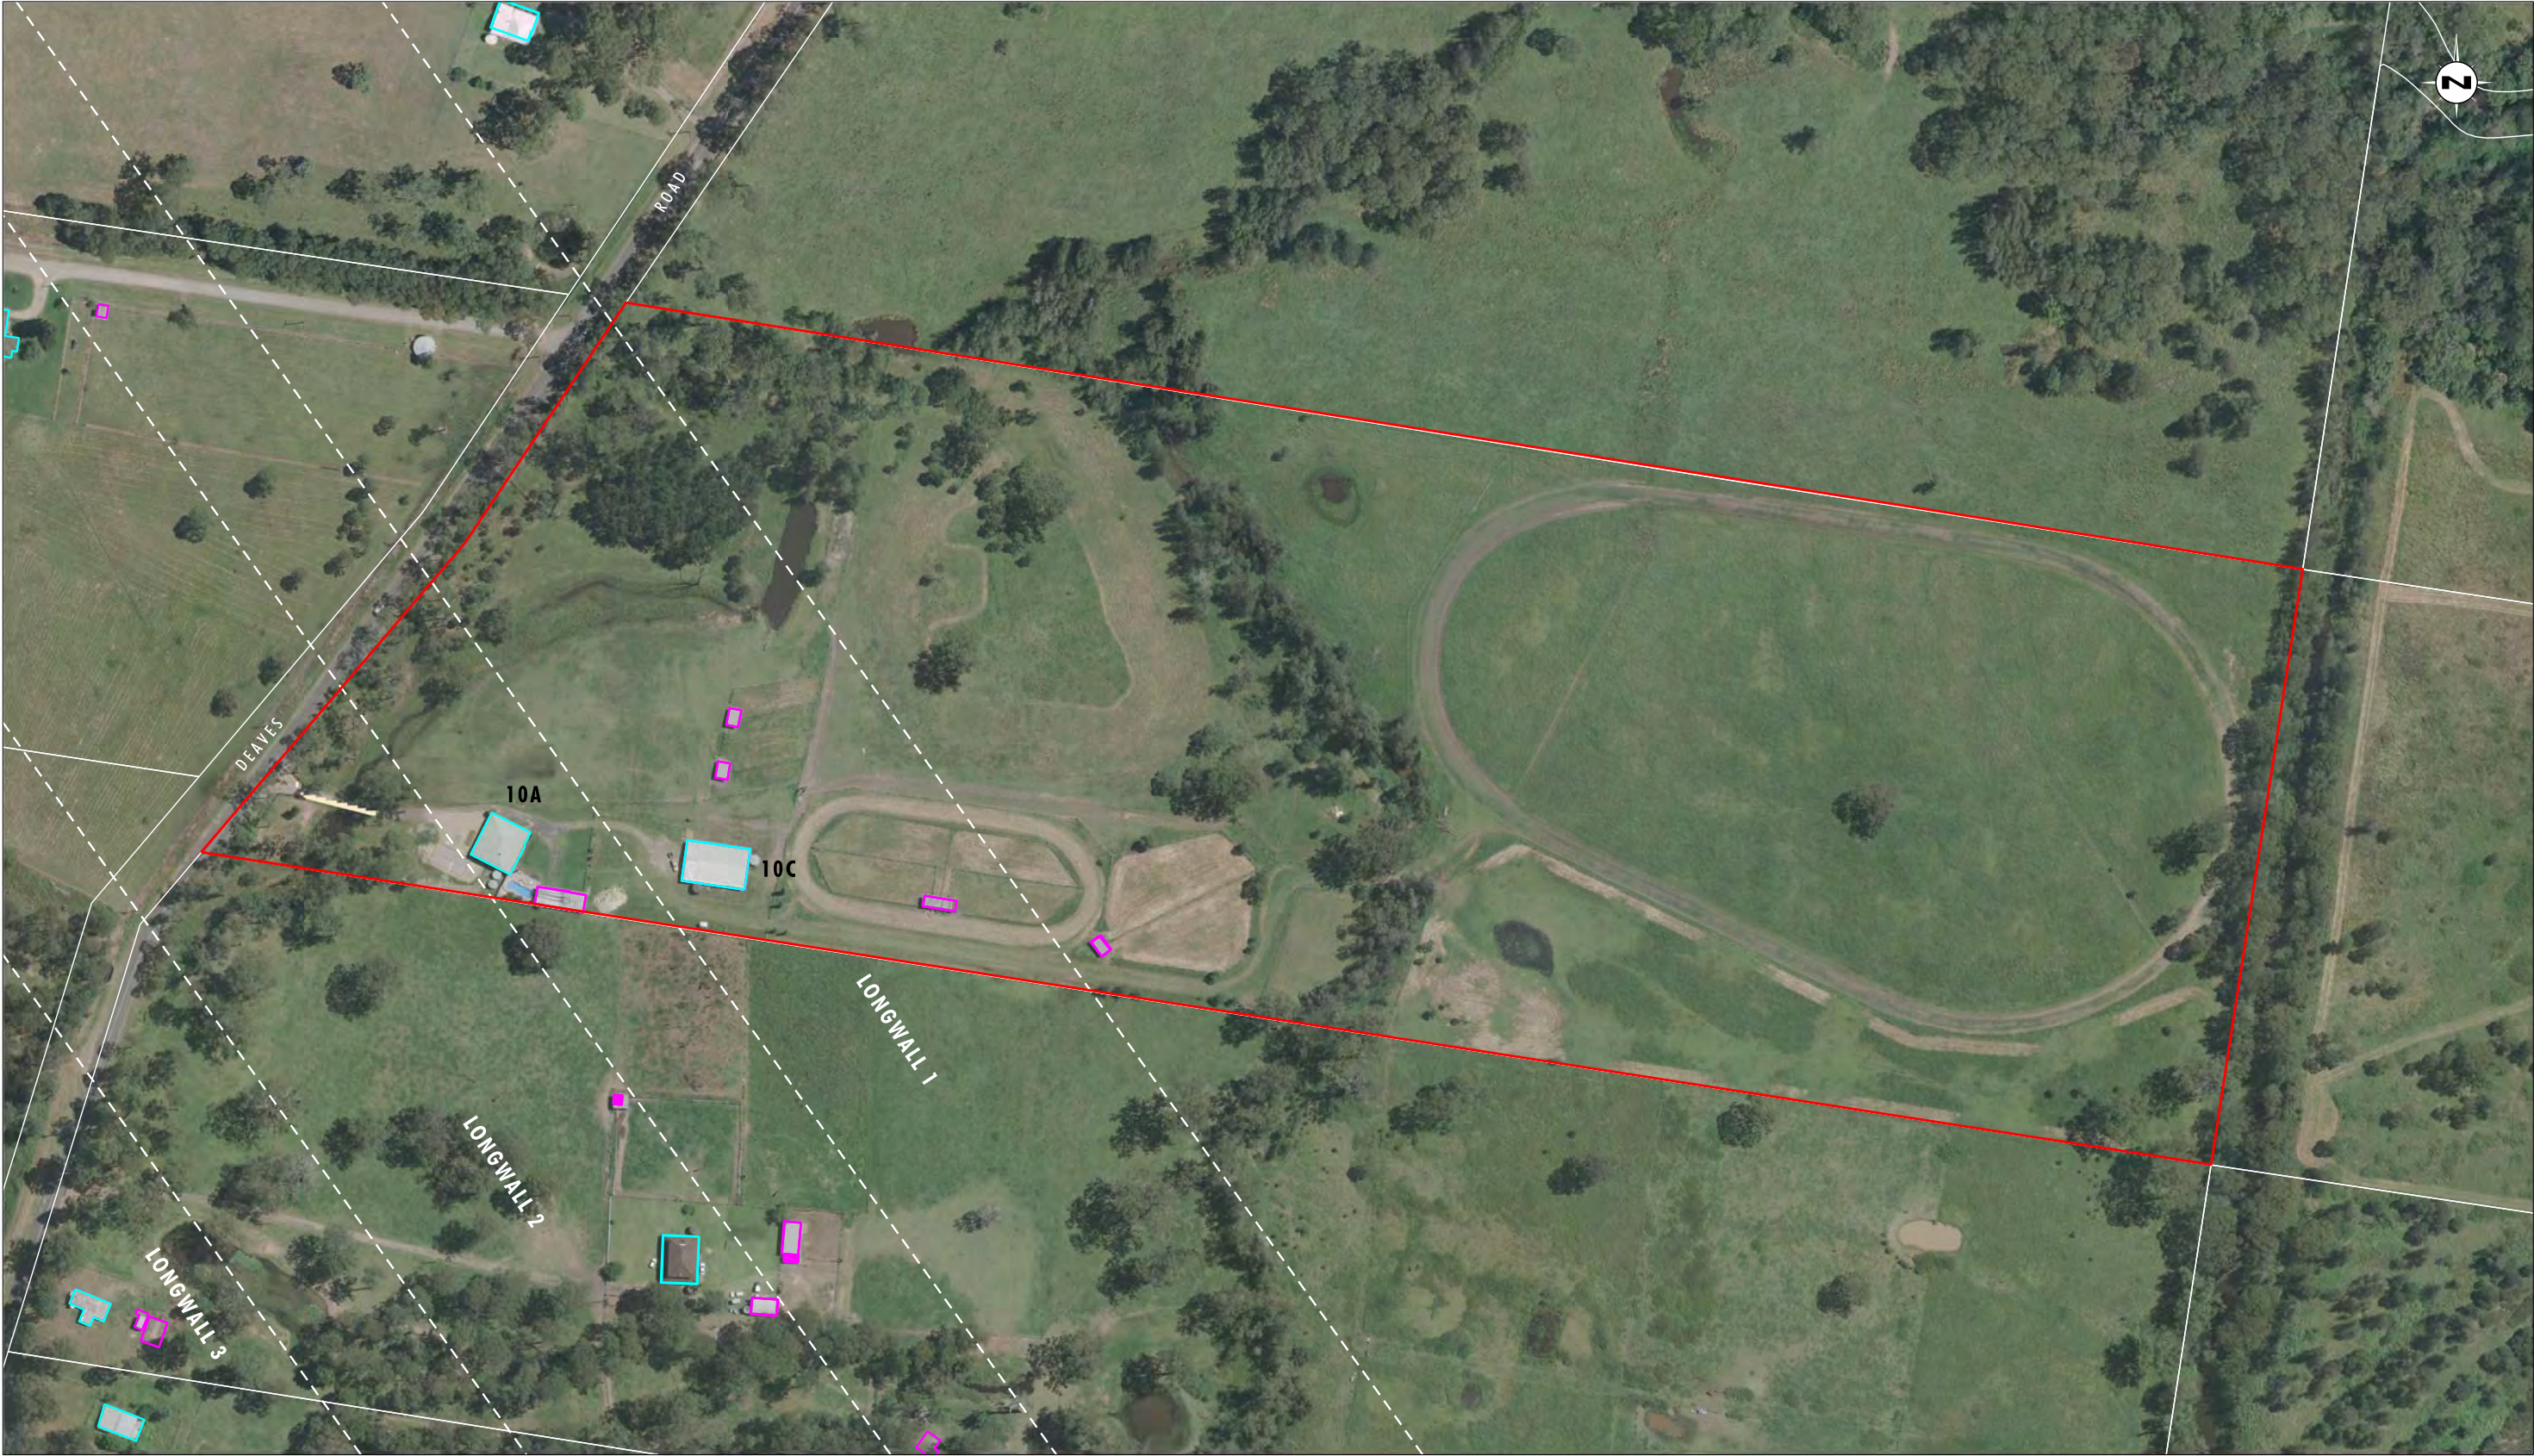
FIGURE 7

Image Source: Centennial Mandalong Pty Ltd (2009) - Aerial Photograph  
Data Source: Centennial Mandalong Pty Ltd, LPI - Cadastral Boundaries  
Note: Flood Hazard shown for access and dwellings only

Property 10 - 1 Year ARI Storm Event  
Maximum Flood Hazard Categories Pre Mining Landform

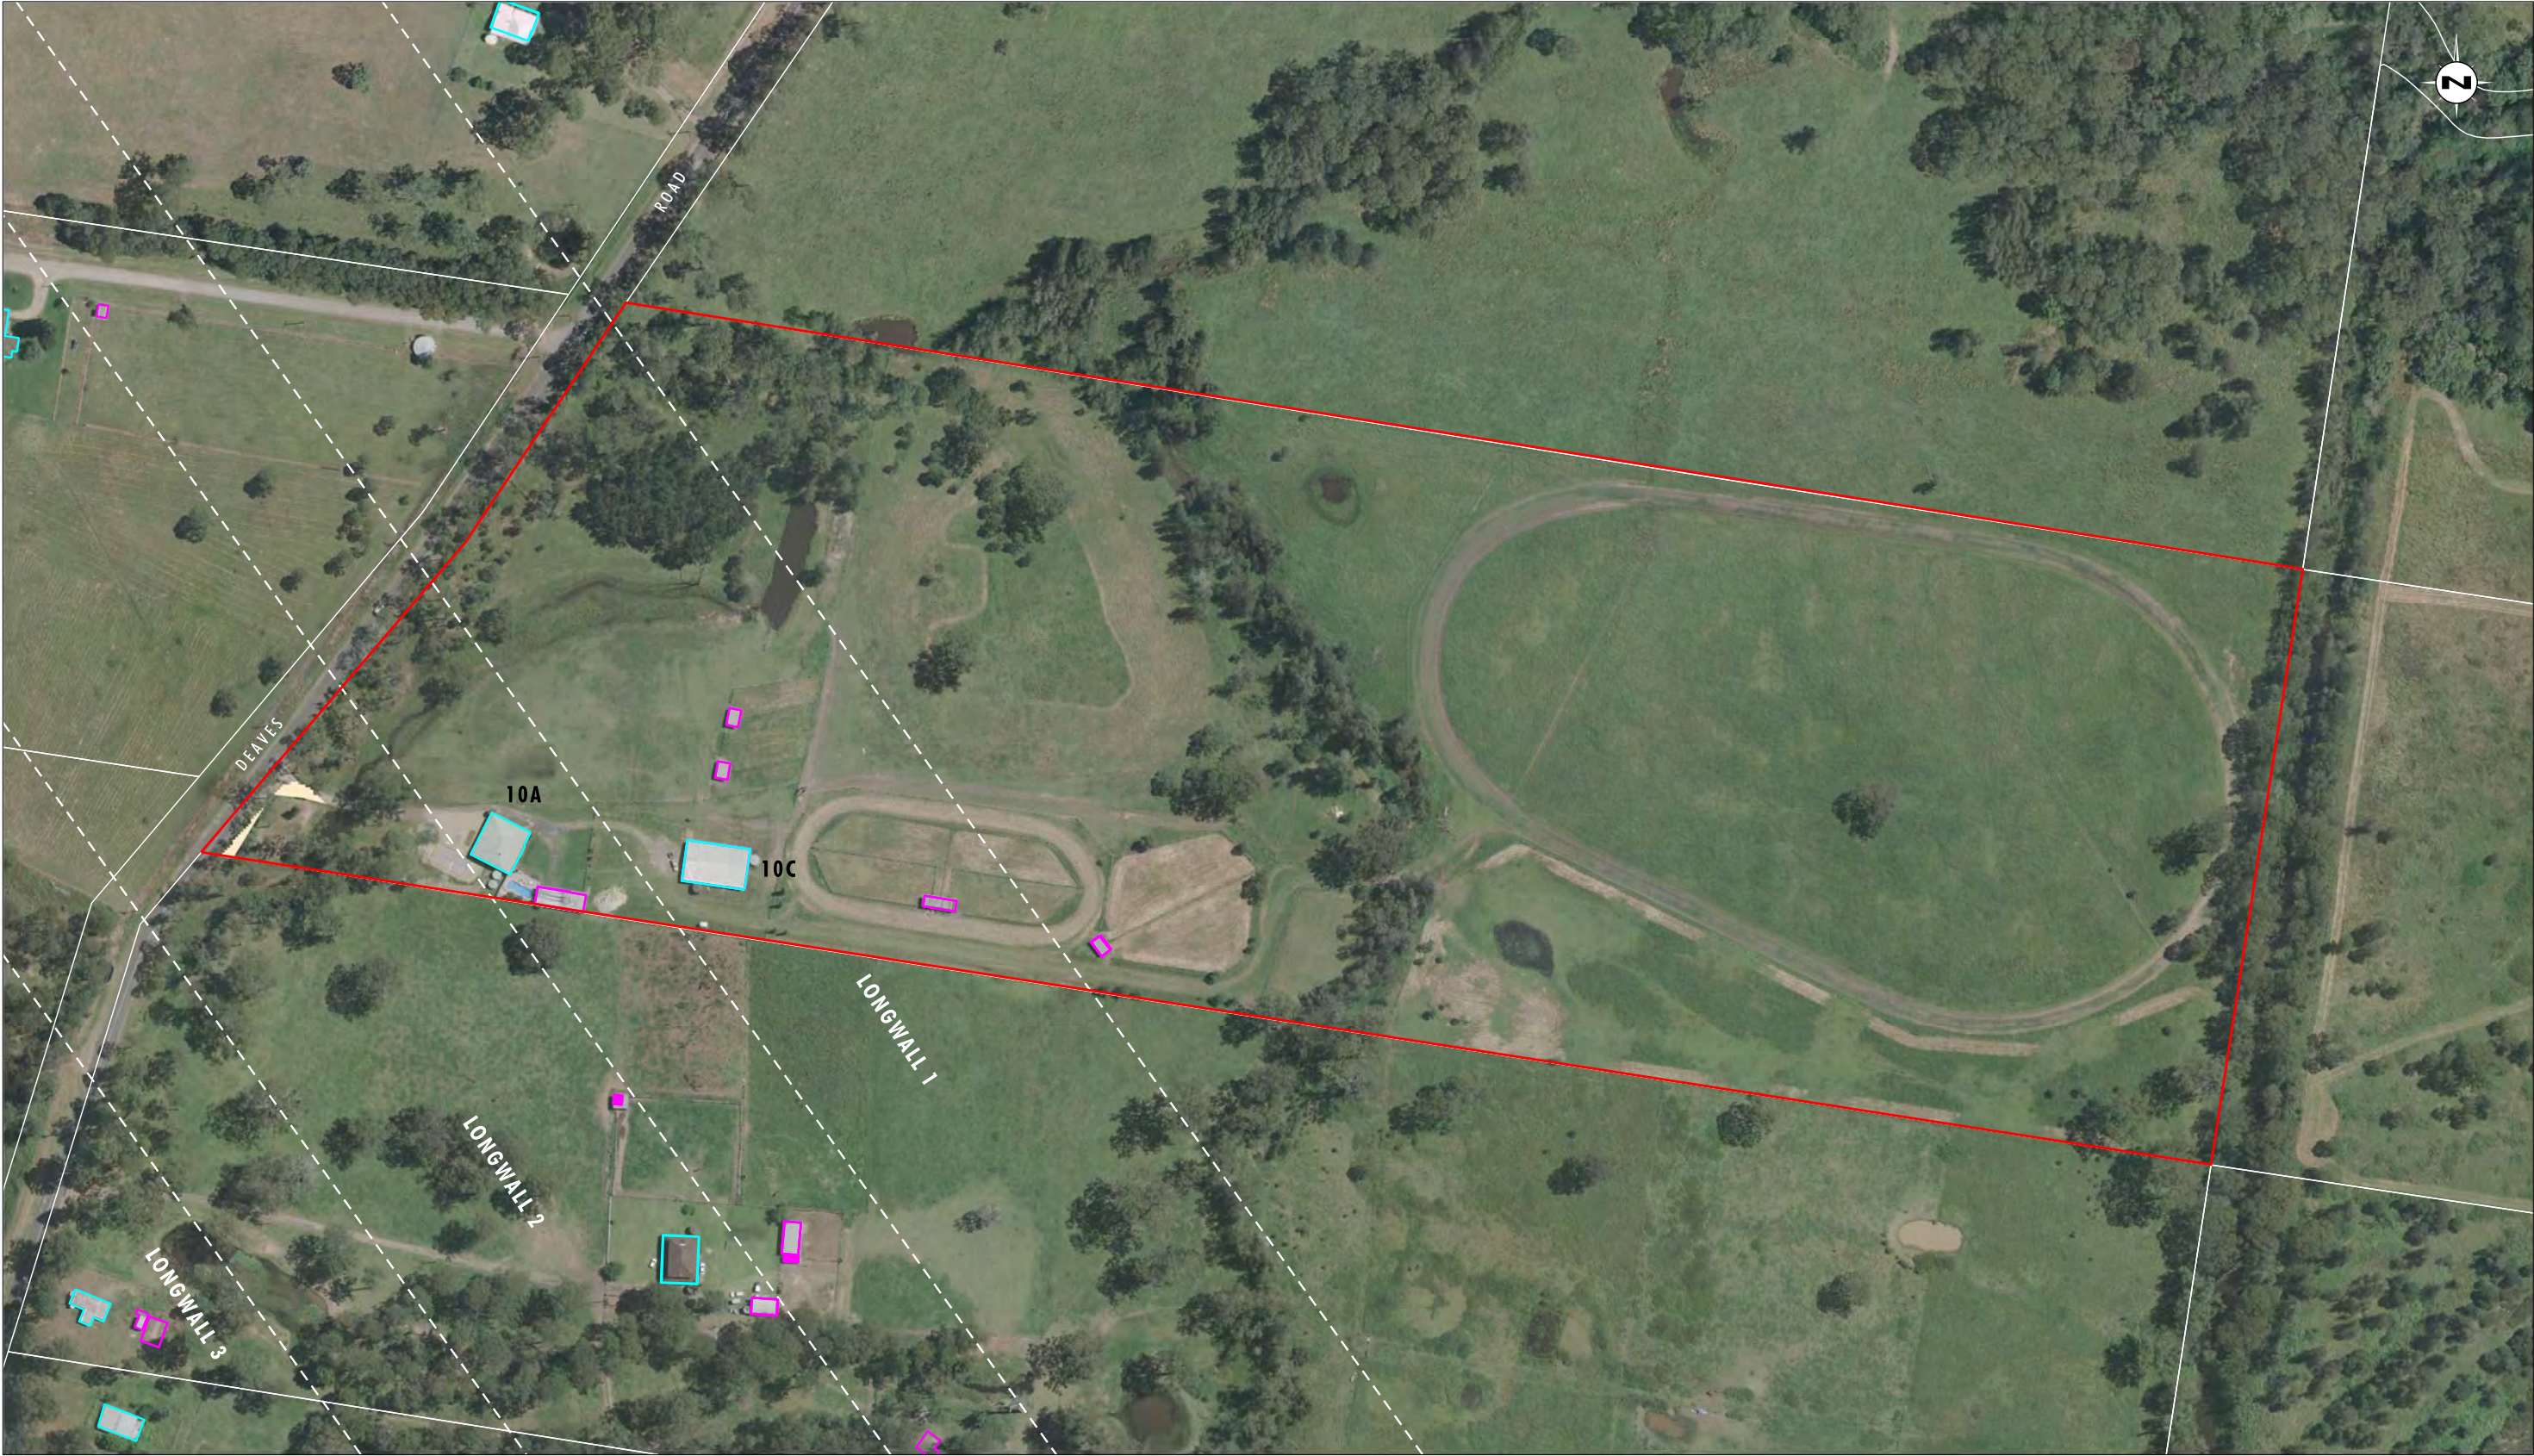
FIGURE 8

Image Source: Centennial Mandalong Pty Ltd (2009) - Aerial Photograph  
Data Source: Centennial Mandalong Pty Ltd, LPI - Cadastral Boundaries  
Note: Flood Hazard shown for access and dwellings only

Property 10 - 1 Year ARI Storm Event  
Maximum Flood Hazard Categories Post Mining Landform  
(to Longwall 23)

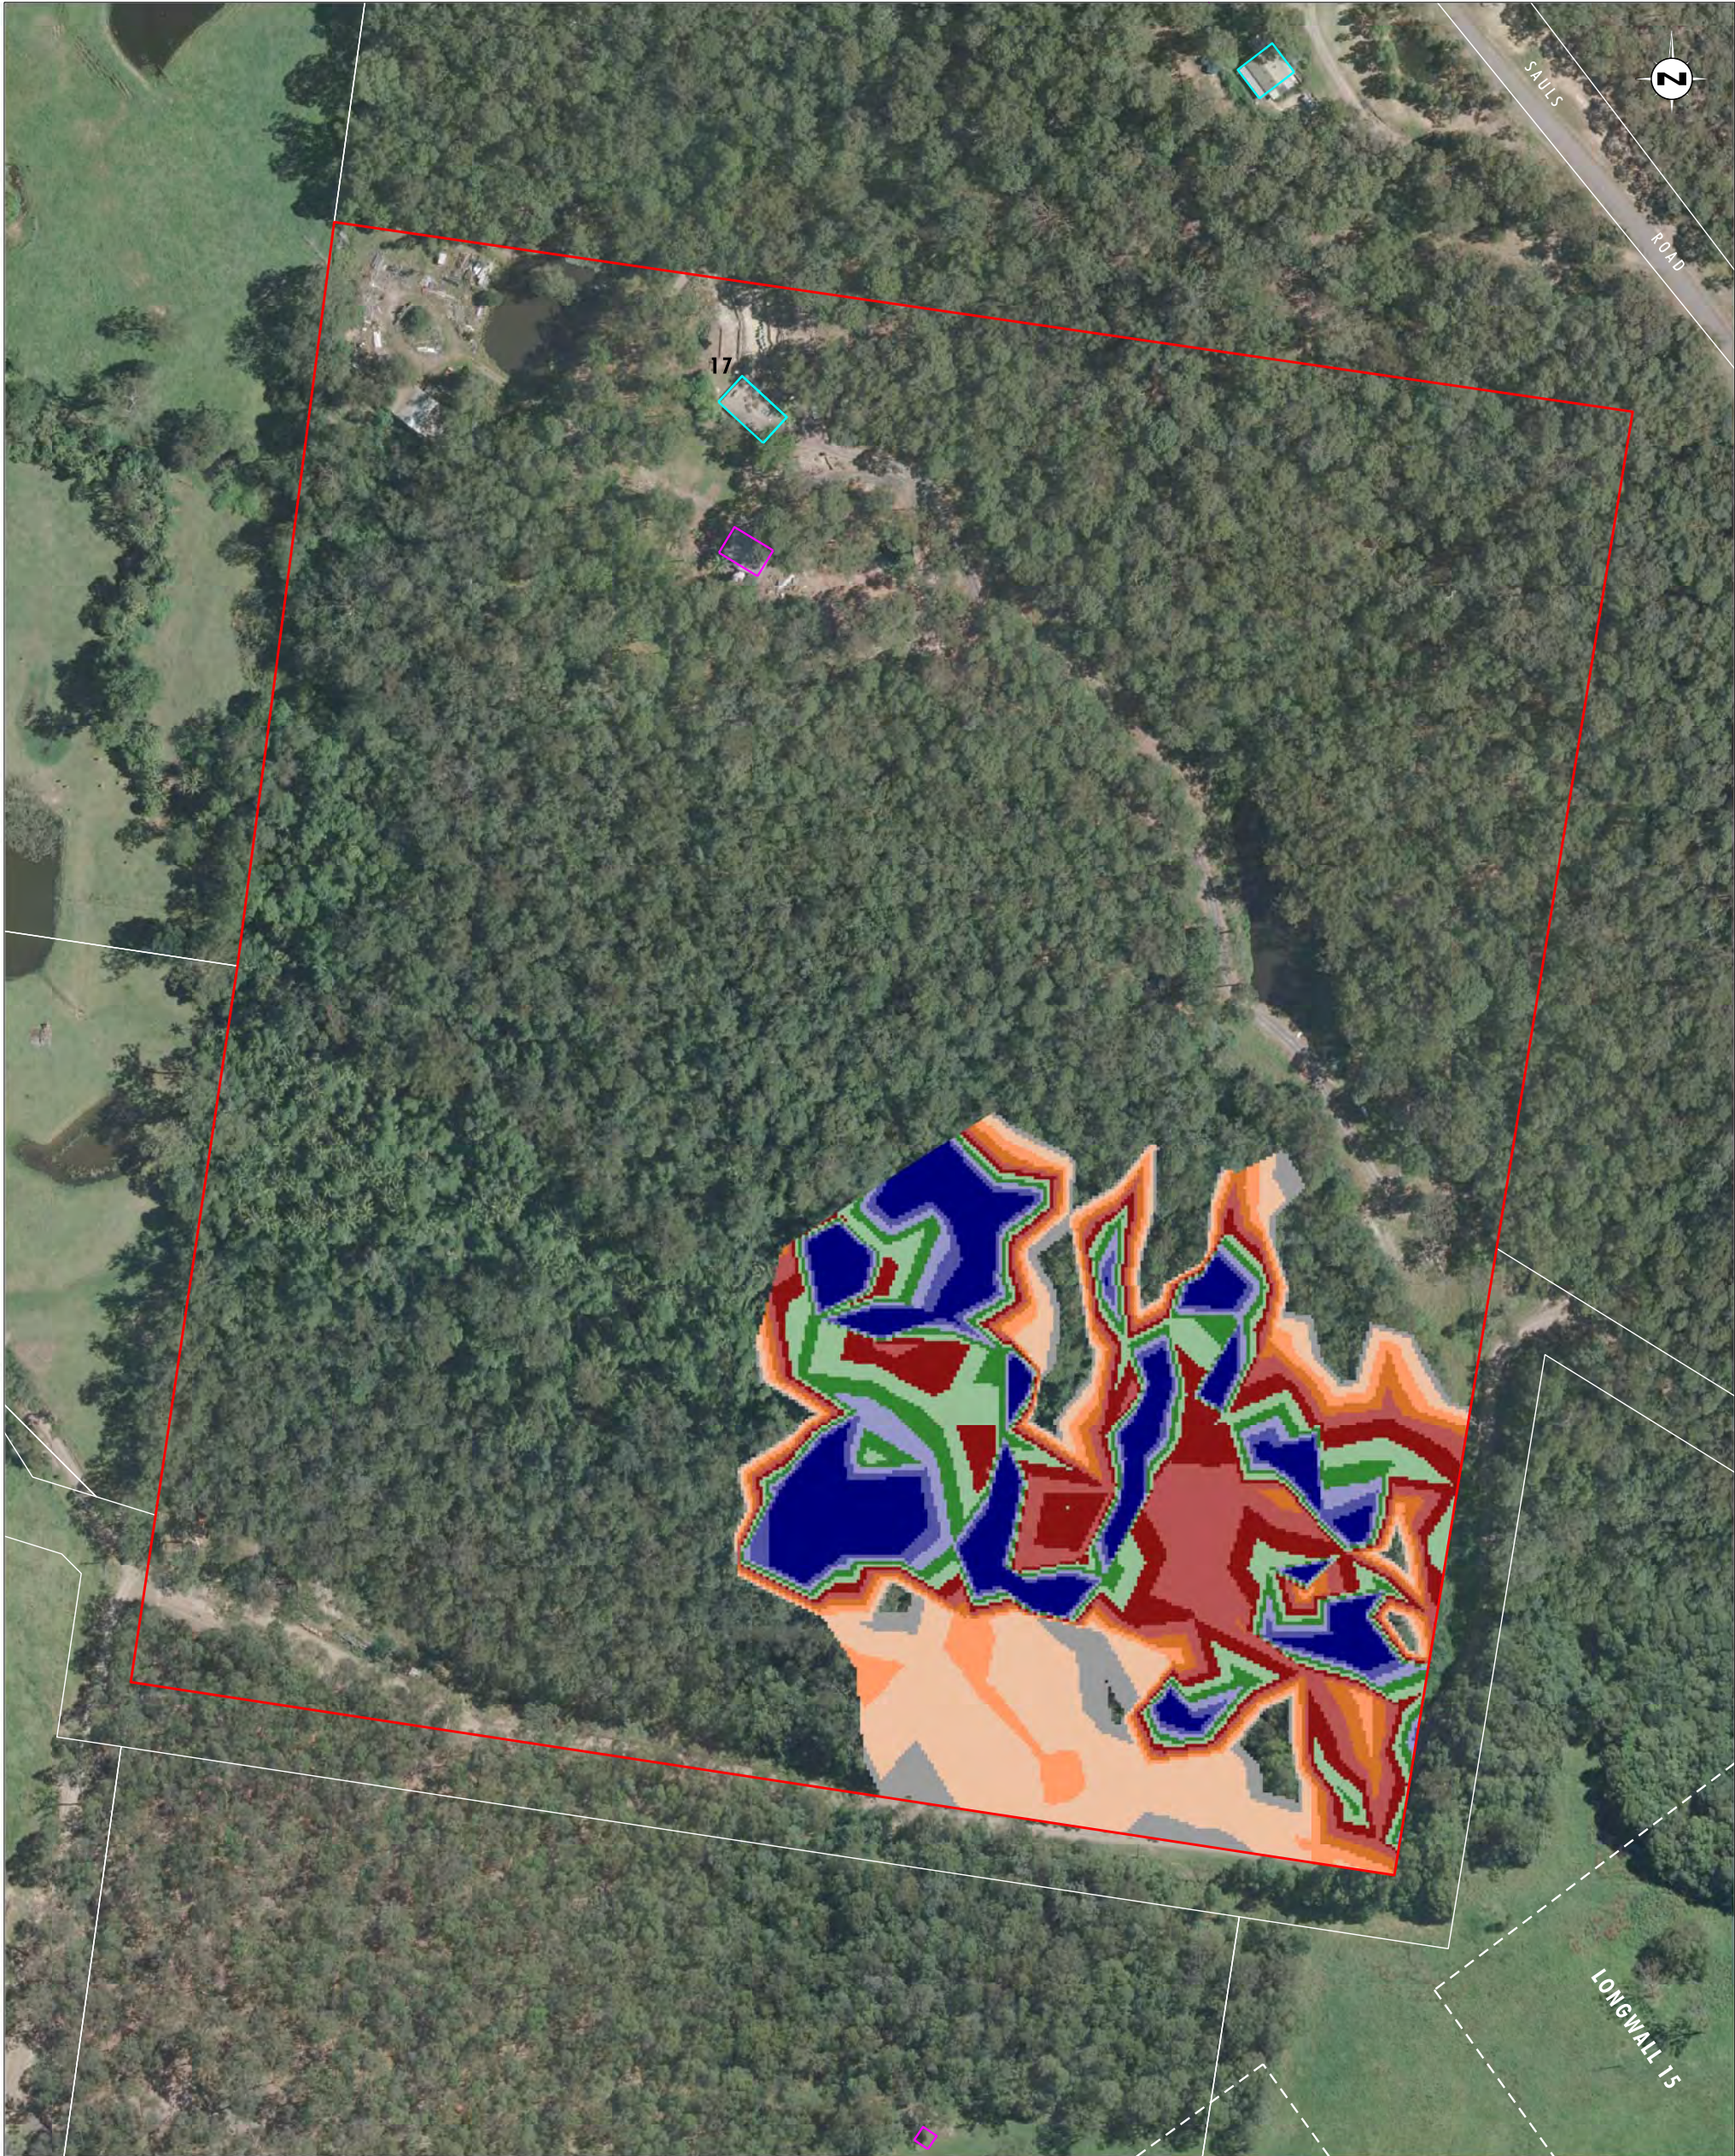
FIGURE 1  
Property 17 - 100 Year ARI Storm Event  
Maximum Flood Depth Pre Mining Landform

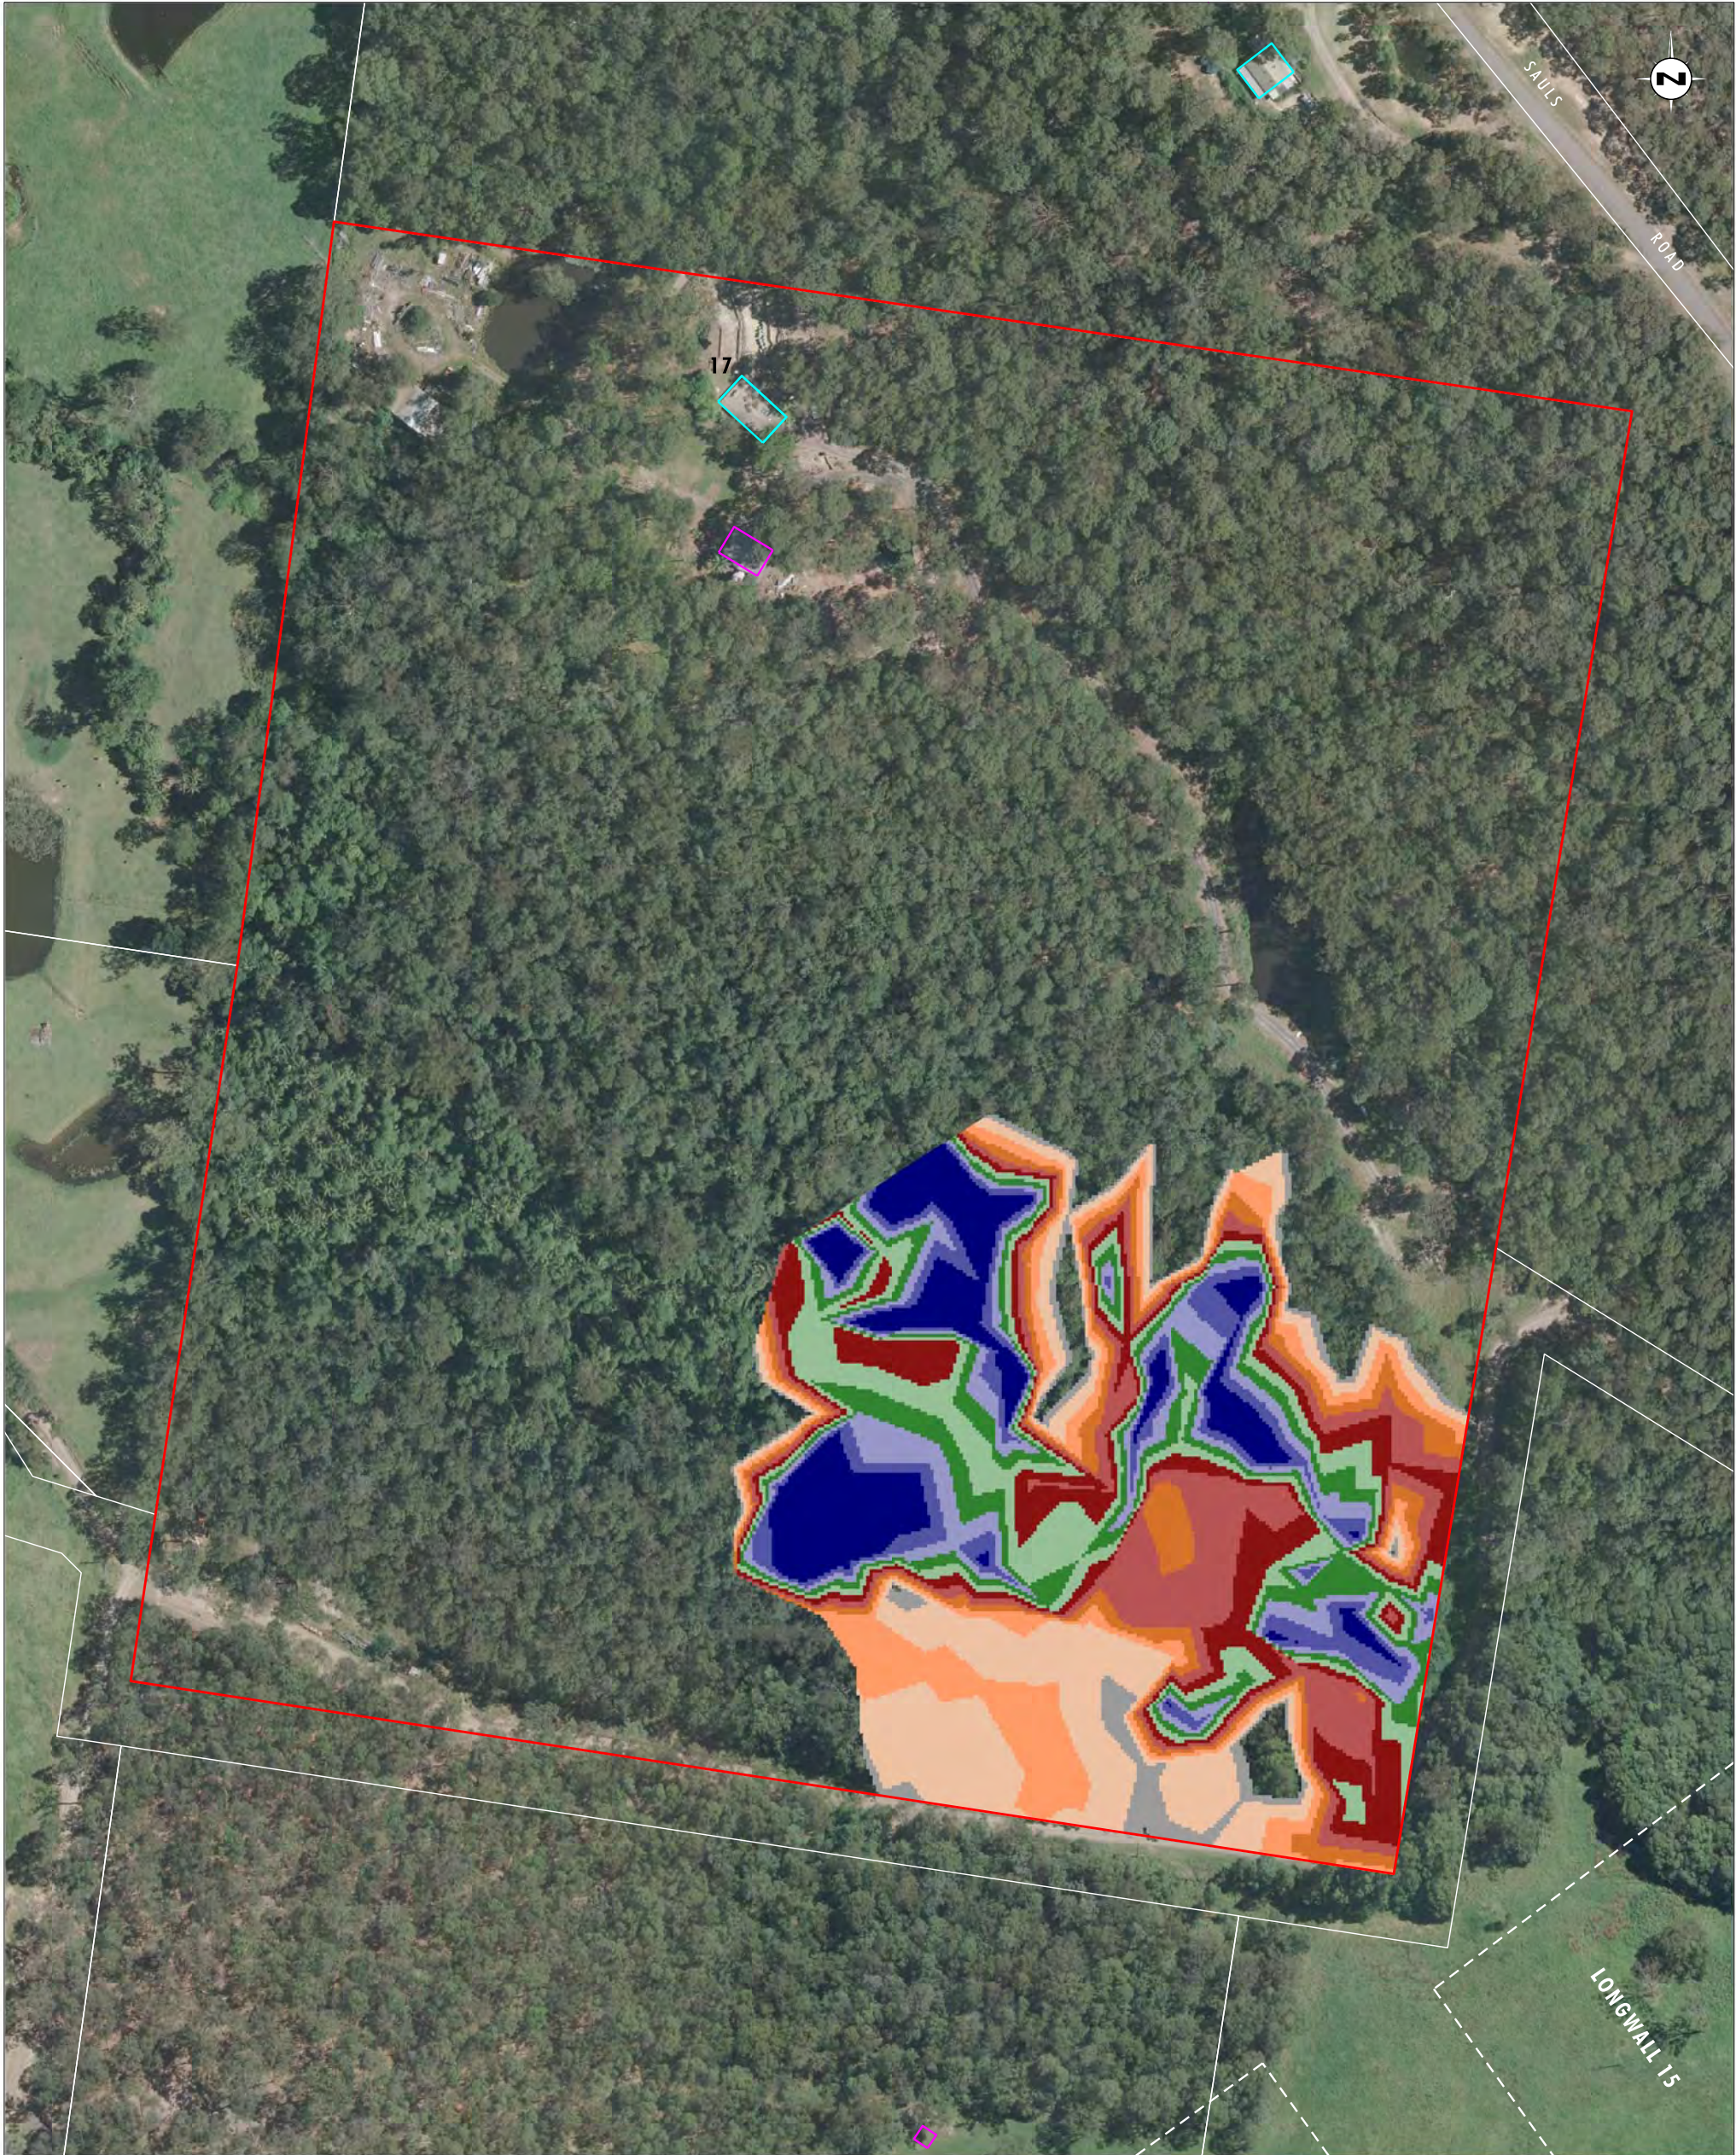
FIGURE 2  
Property 17 - 100 Year ARI Storm Event  
Maximum Flood Depth Post Mining Landform  
(to Longwall 23)
