## APPENDIX 1

**Flooding Assessment Figures -  
Property 7 (Centennial)**

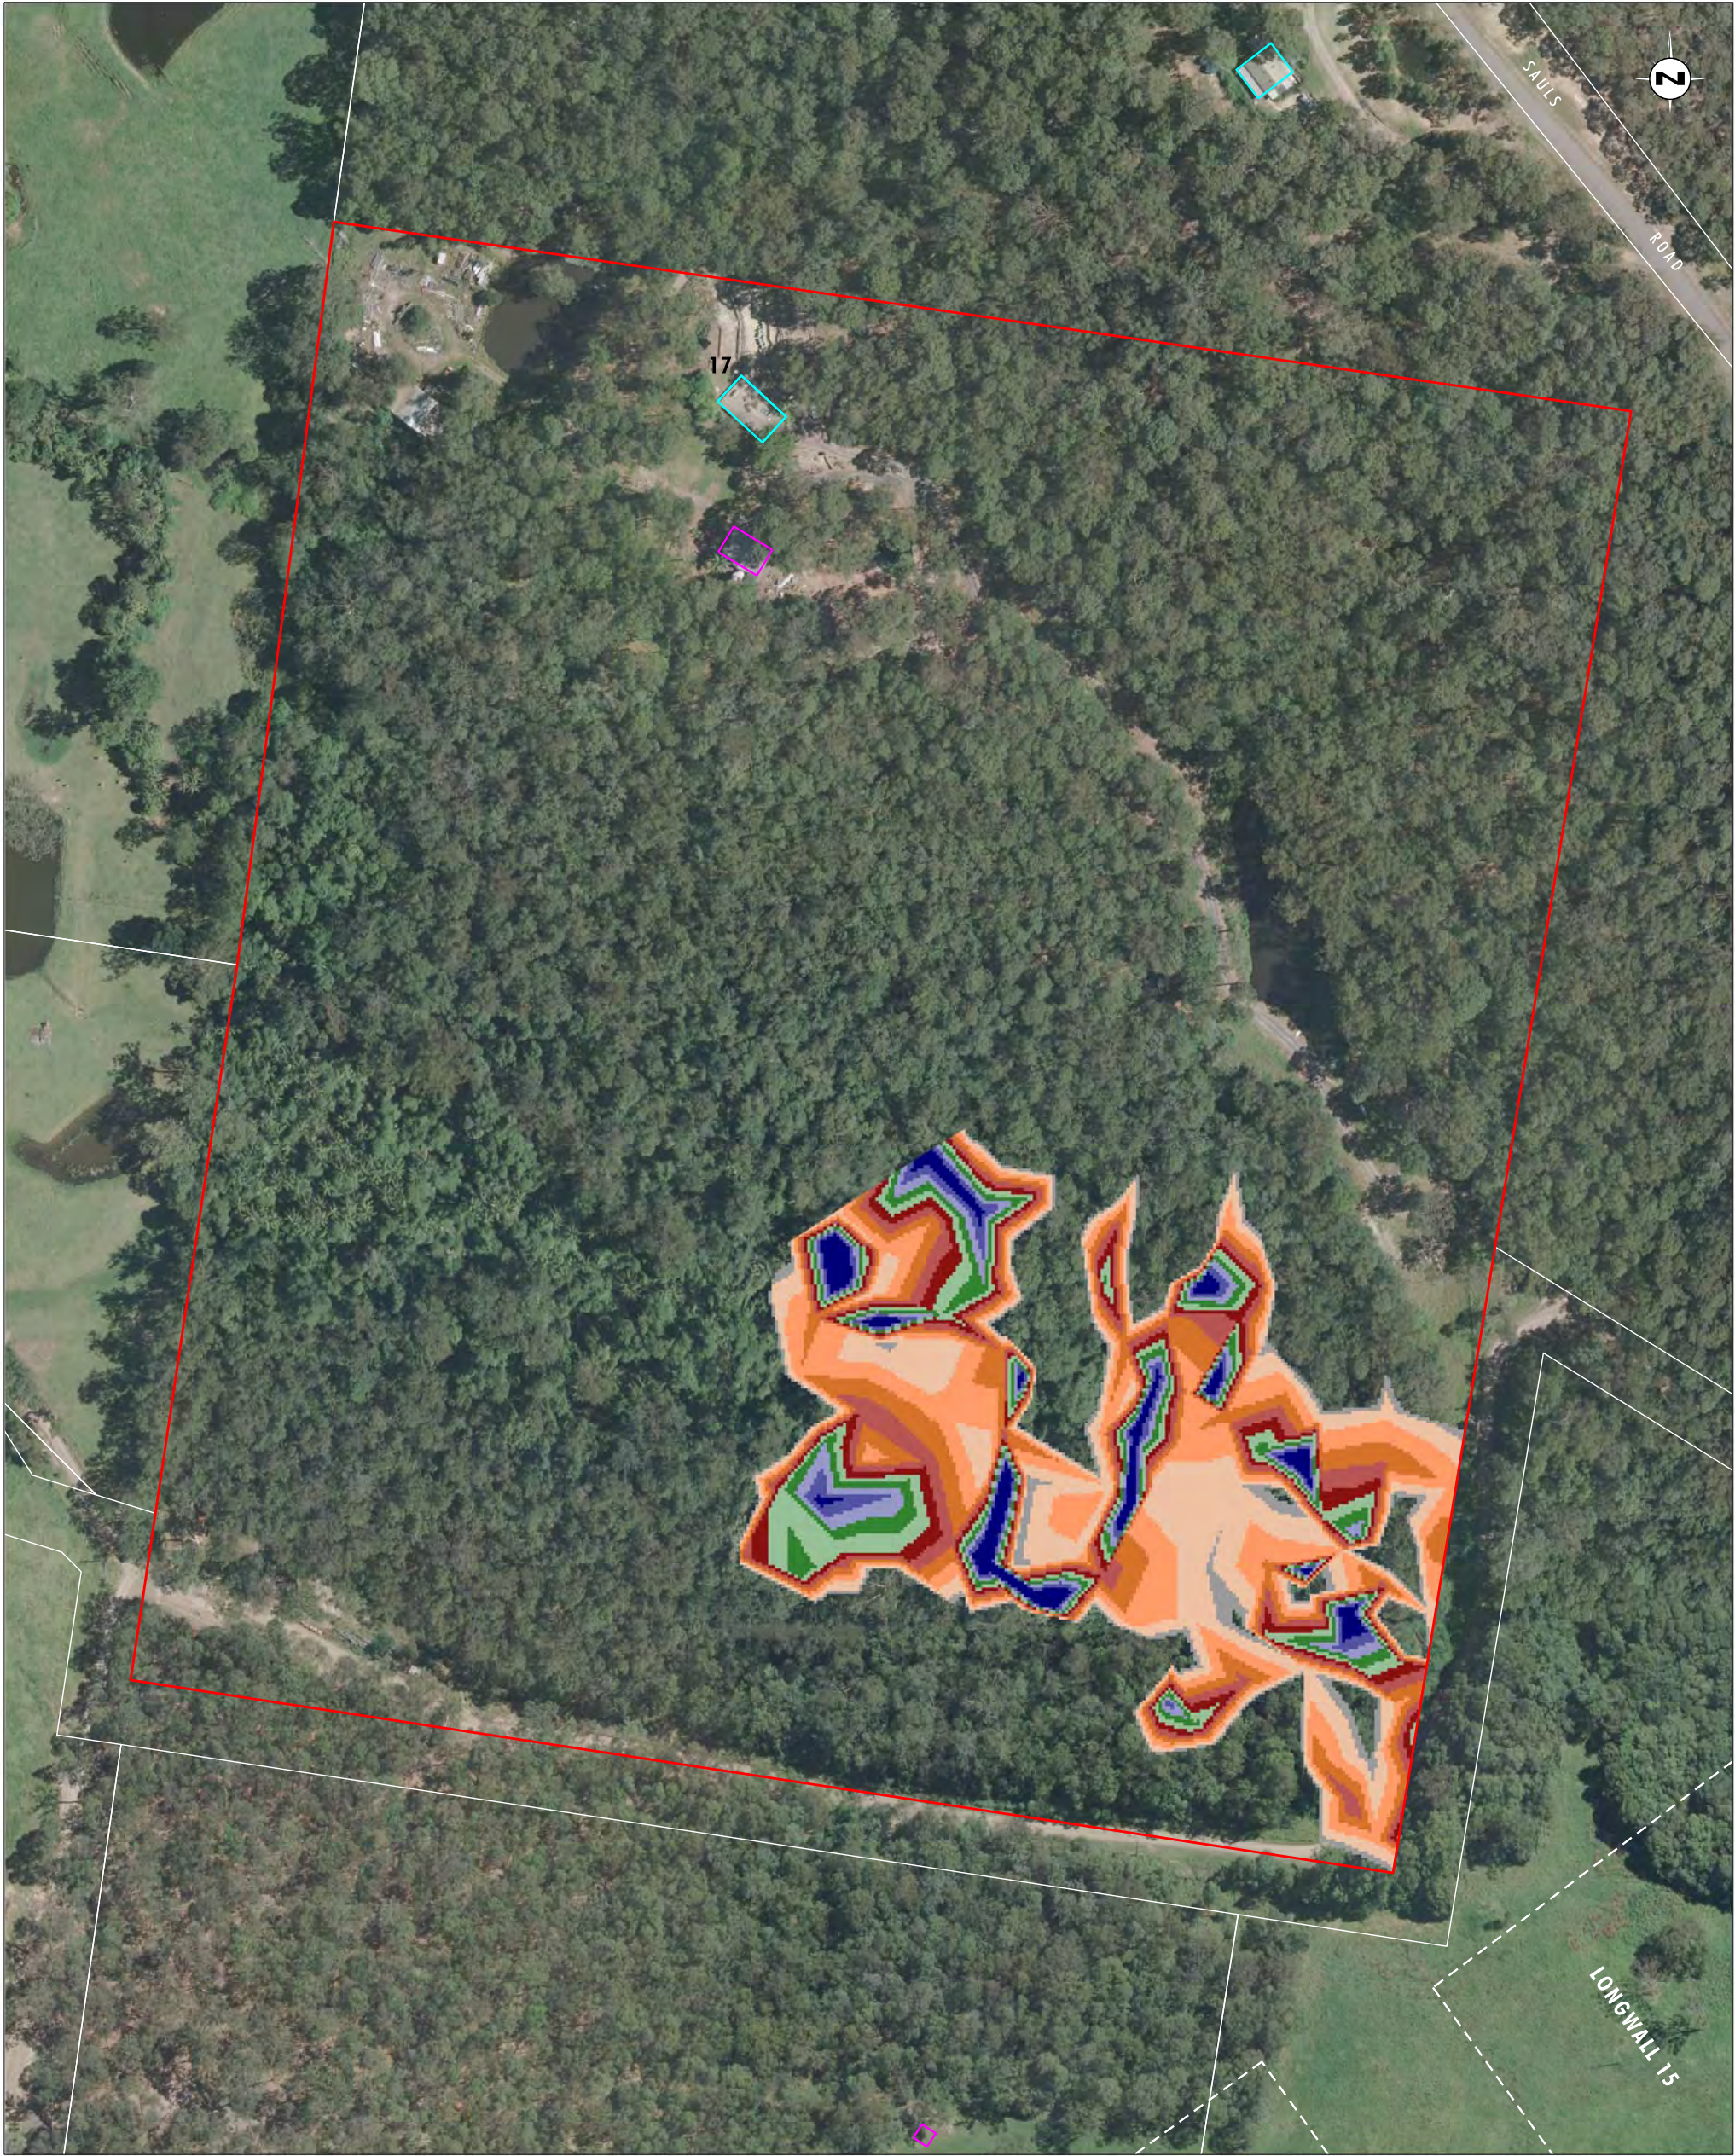
FIGURE 3  
Property 17 - 1 Year ARI Storm Event  
Maximum Flood Depth Pre Mining Landform

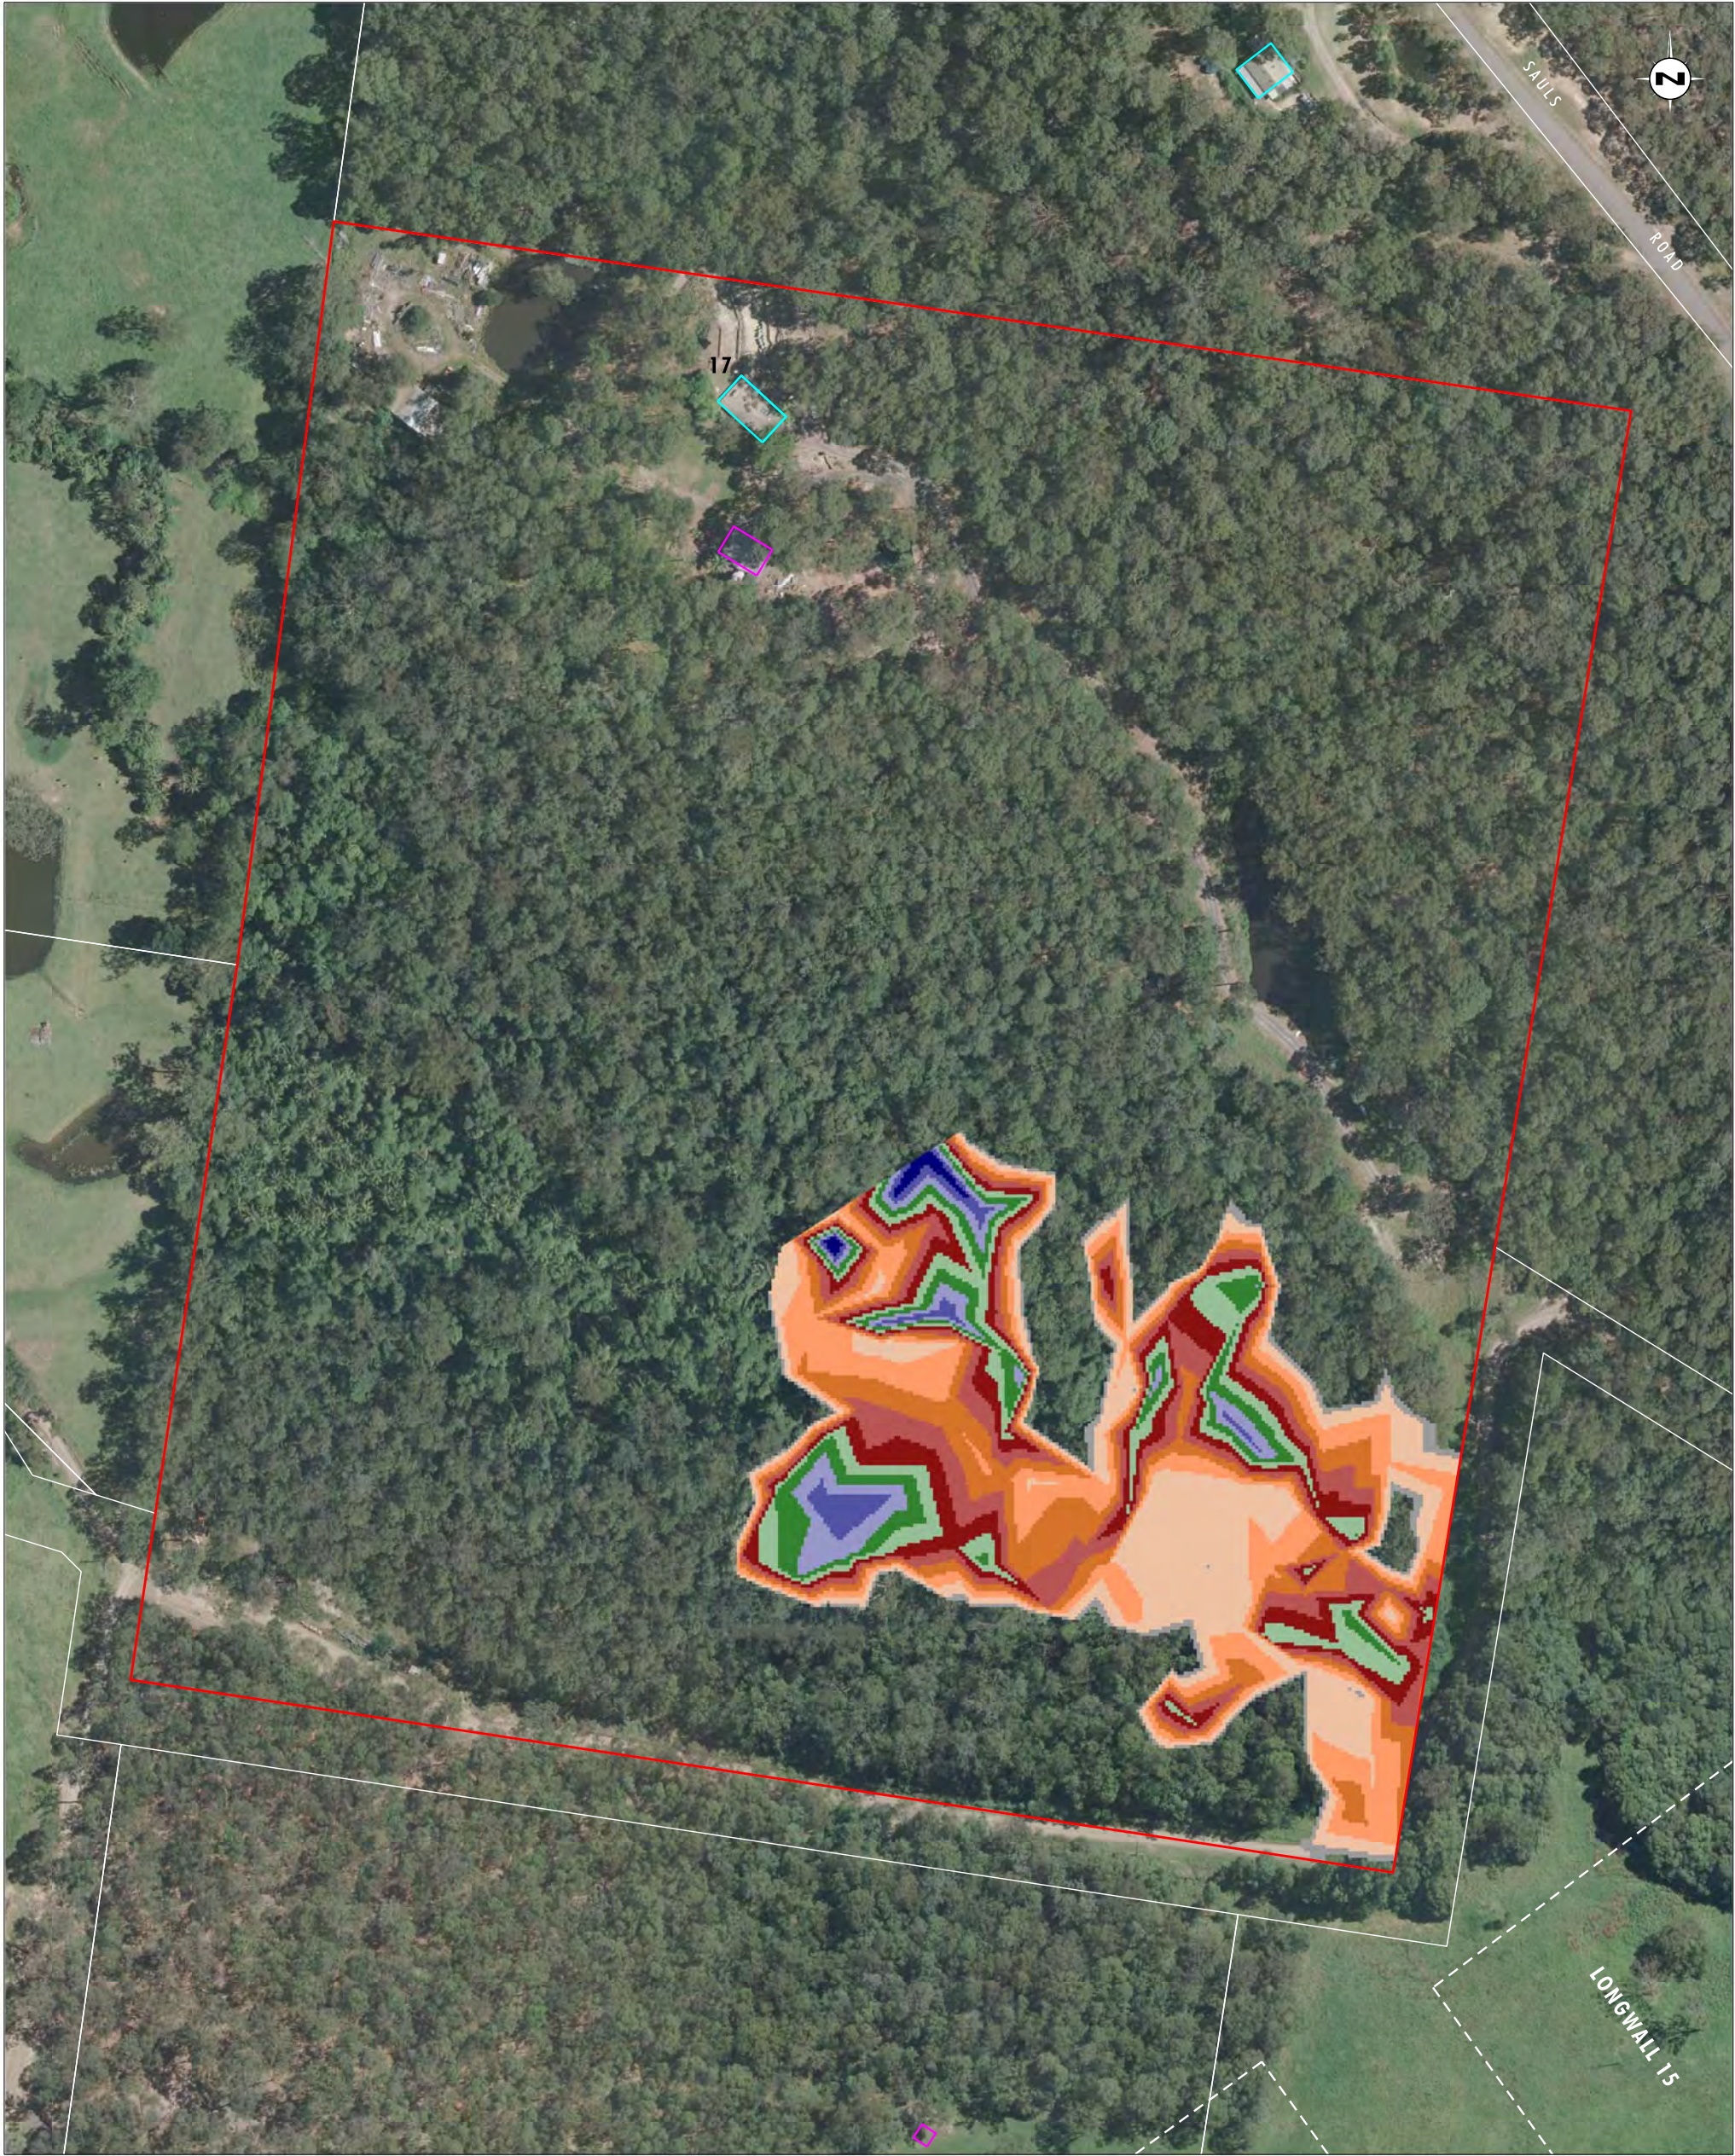
FIGURE 4  
Property 17 - 1 Year ARI Storm Event  
Maximum Flood Depth Post Mining Landform  
(to Longwall 23)

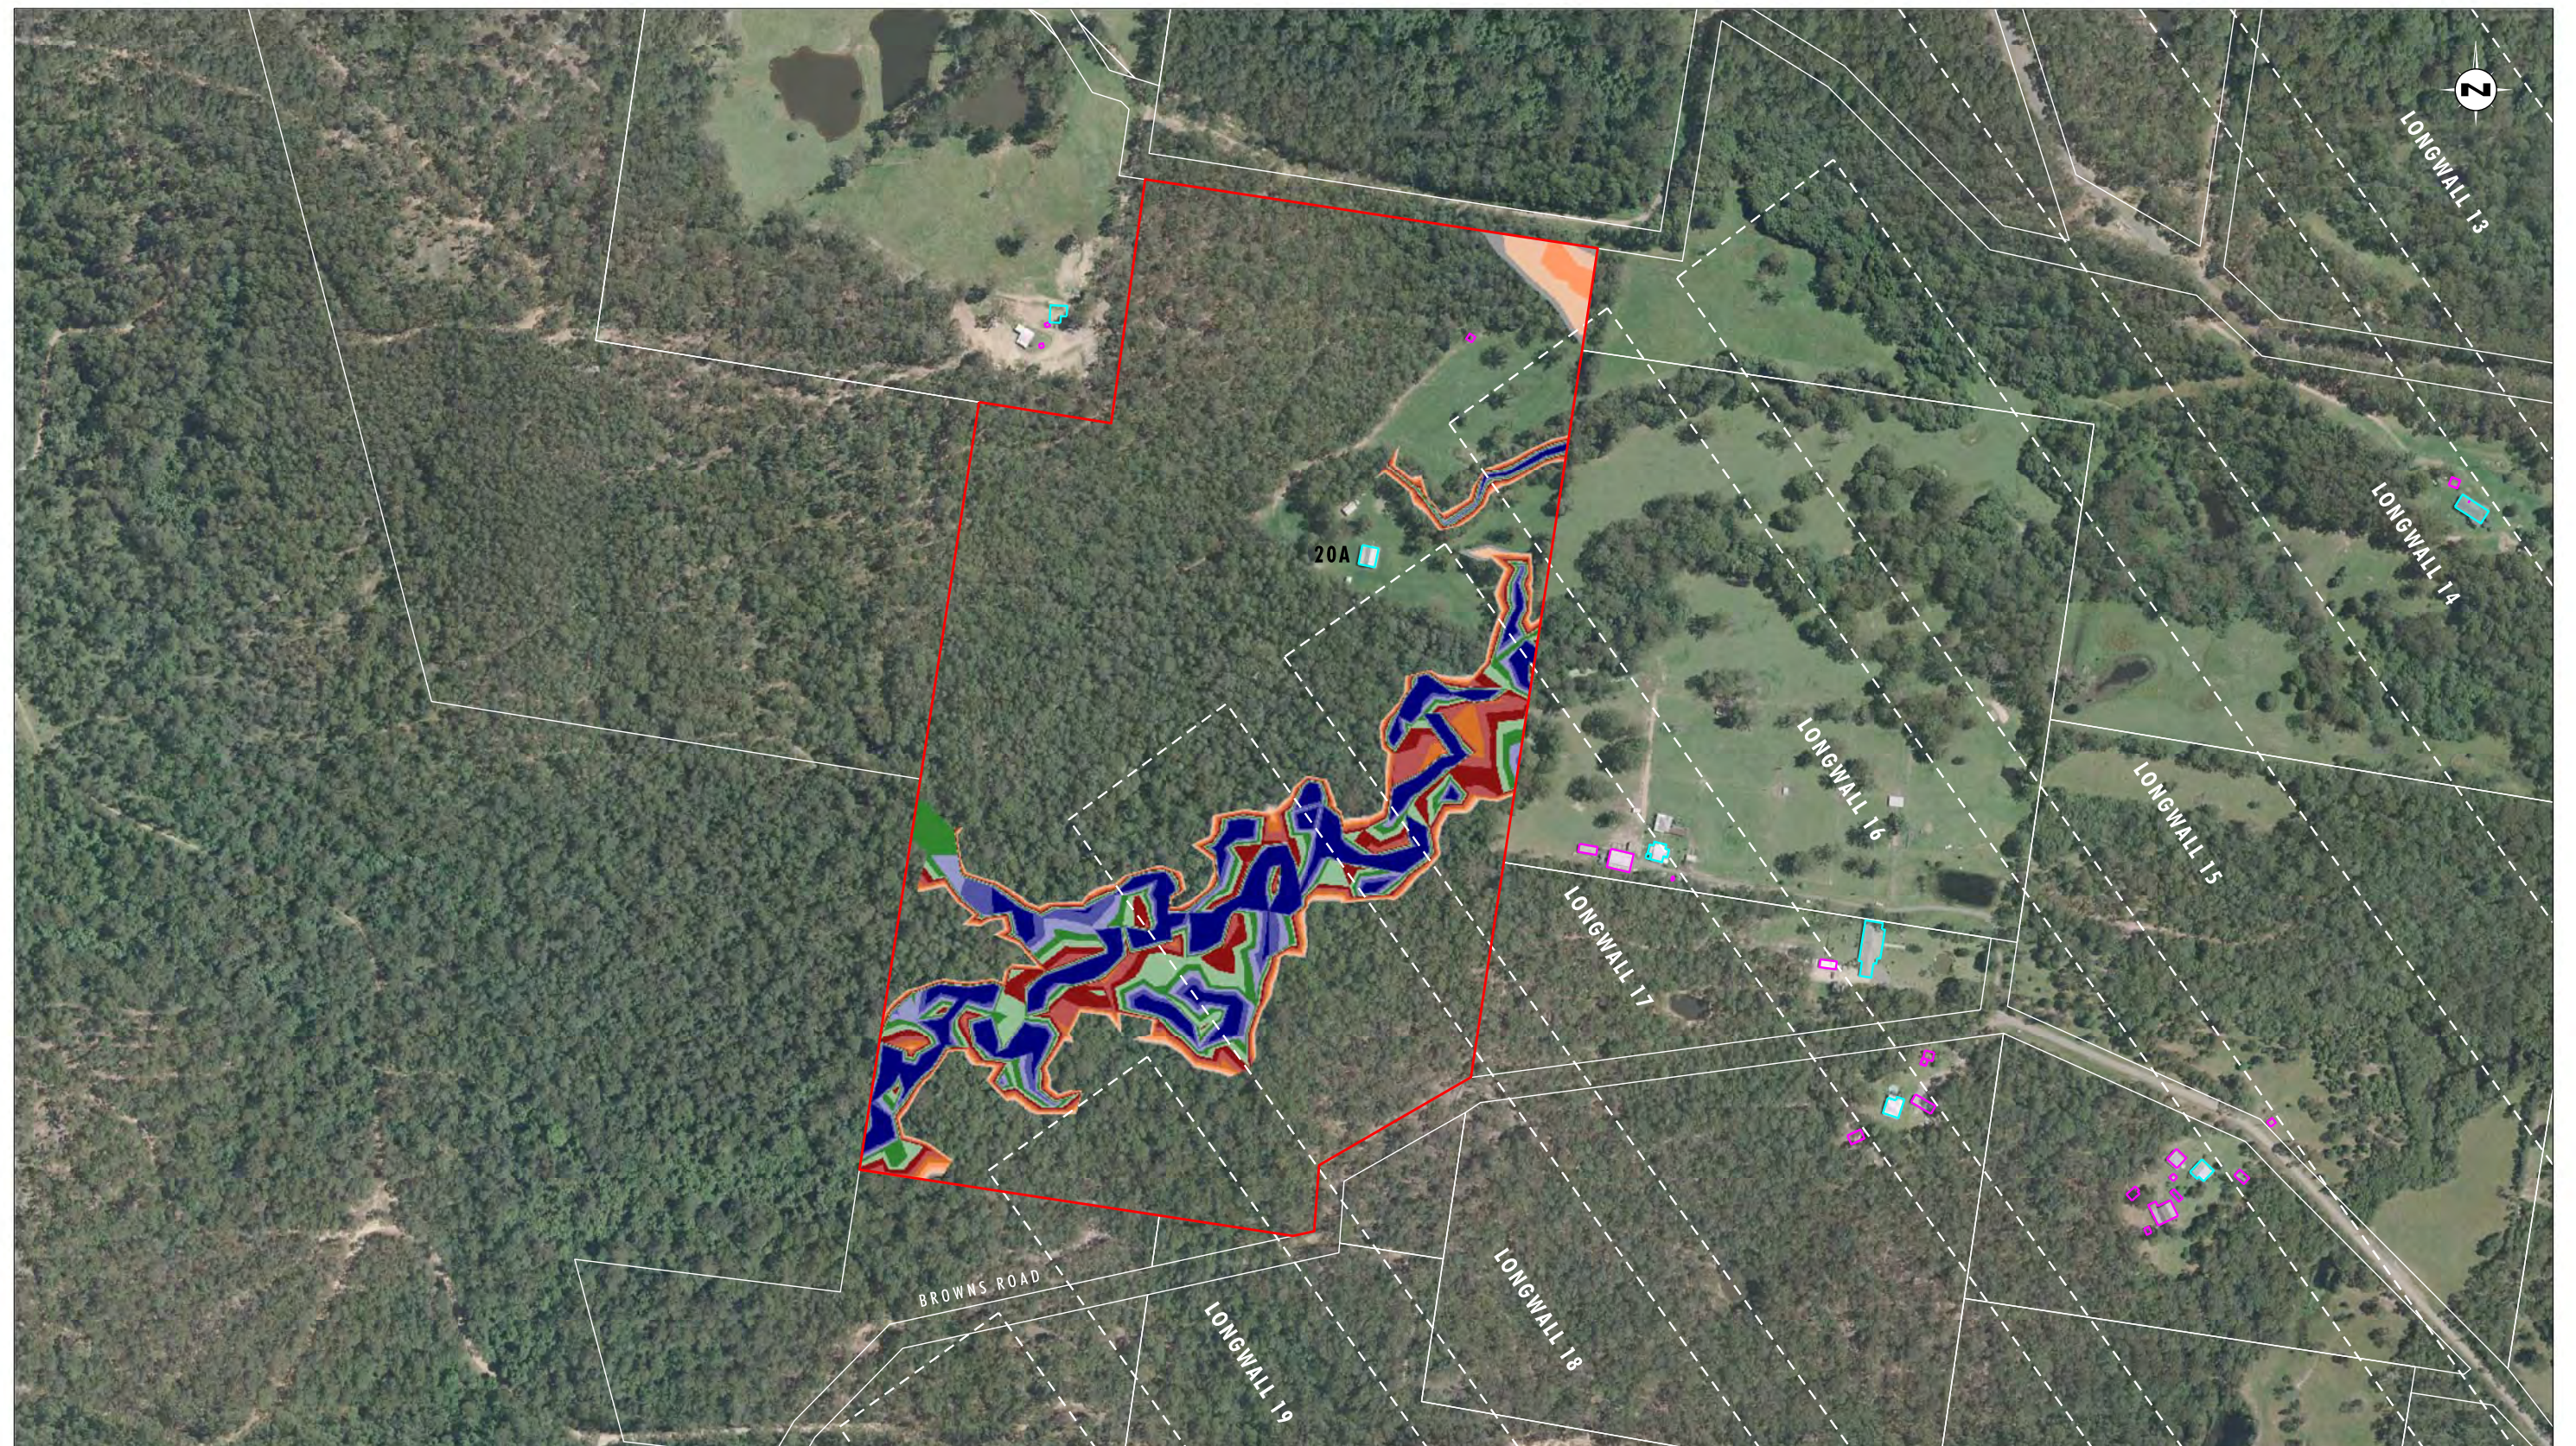
FIGURE 1

Property 20 - 100 year ARI Storm Event:  
Maximum Flood Depth Pre Mining Landform

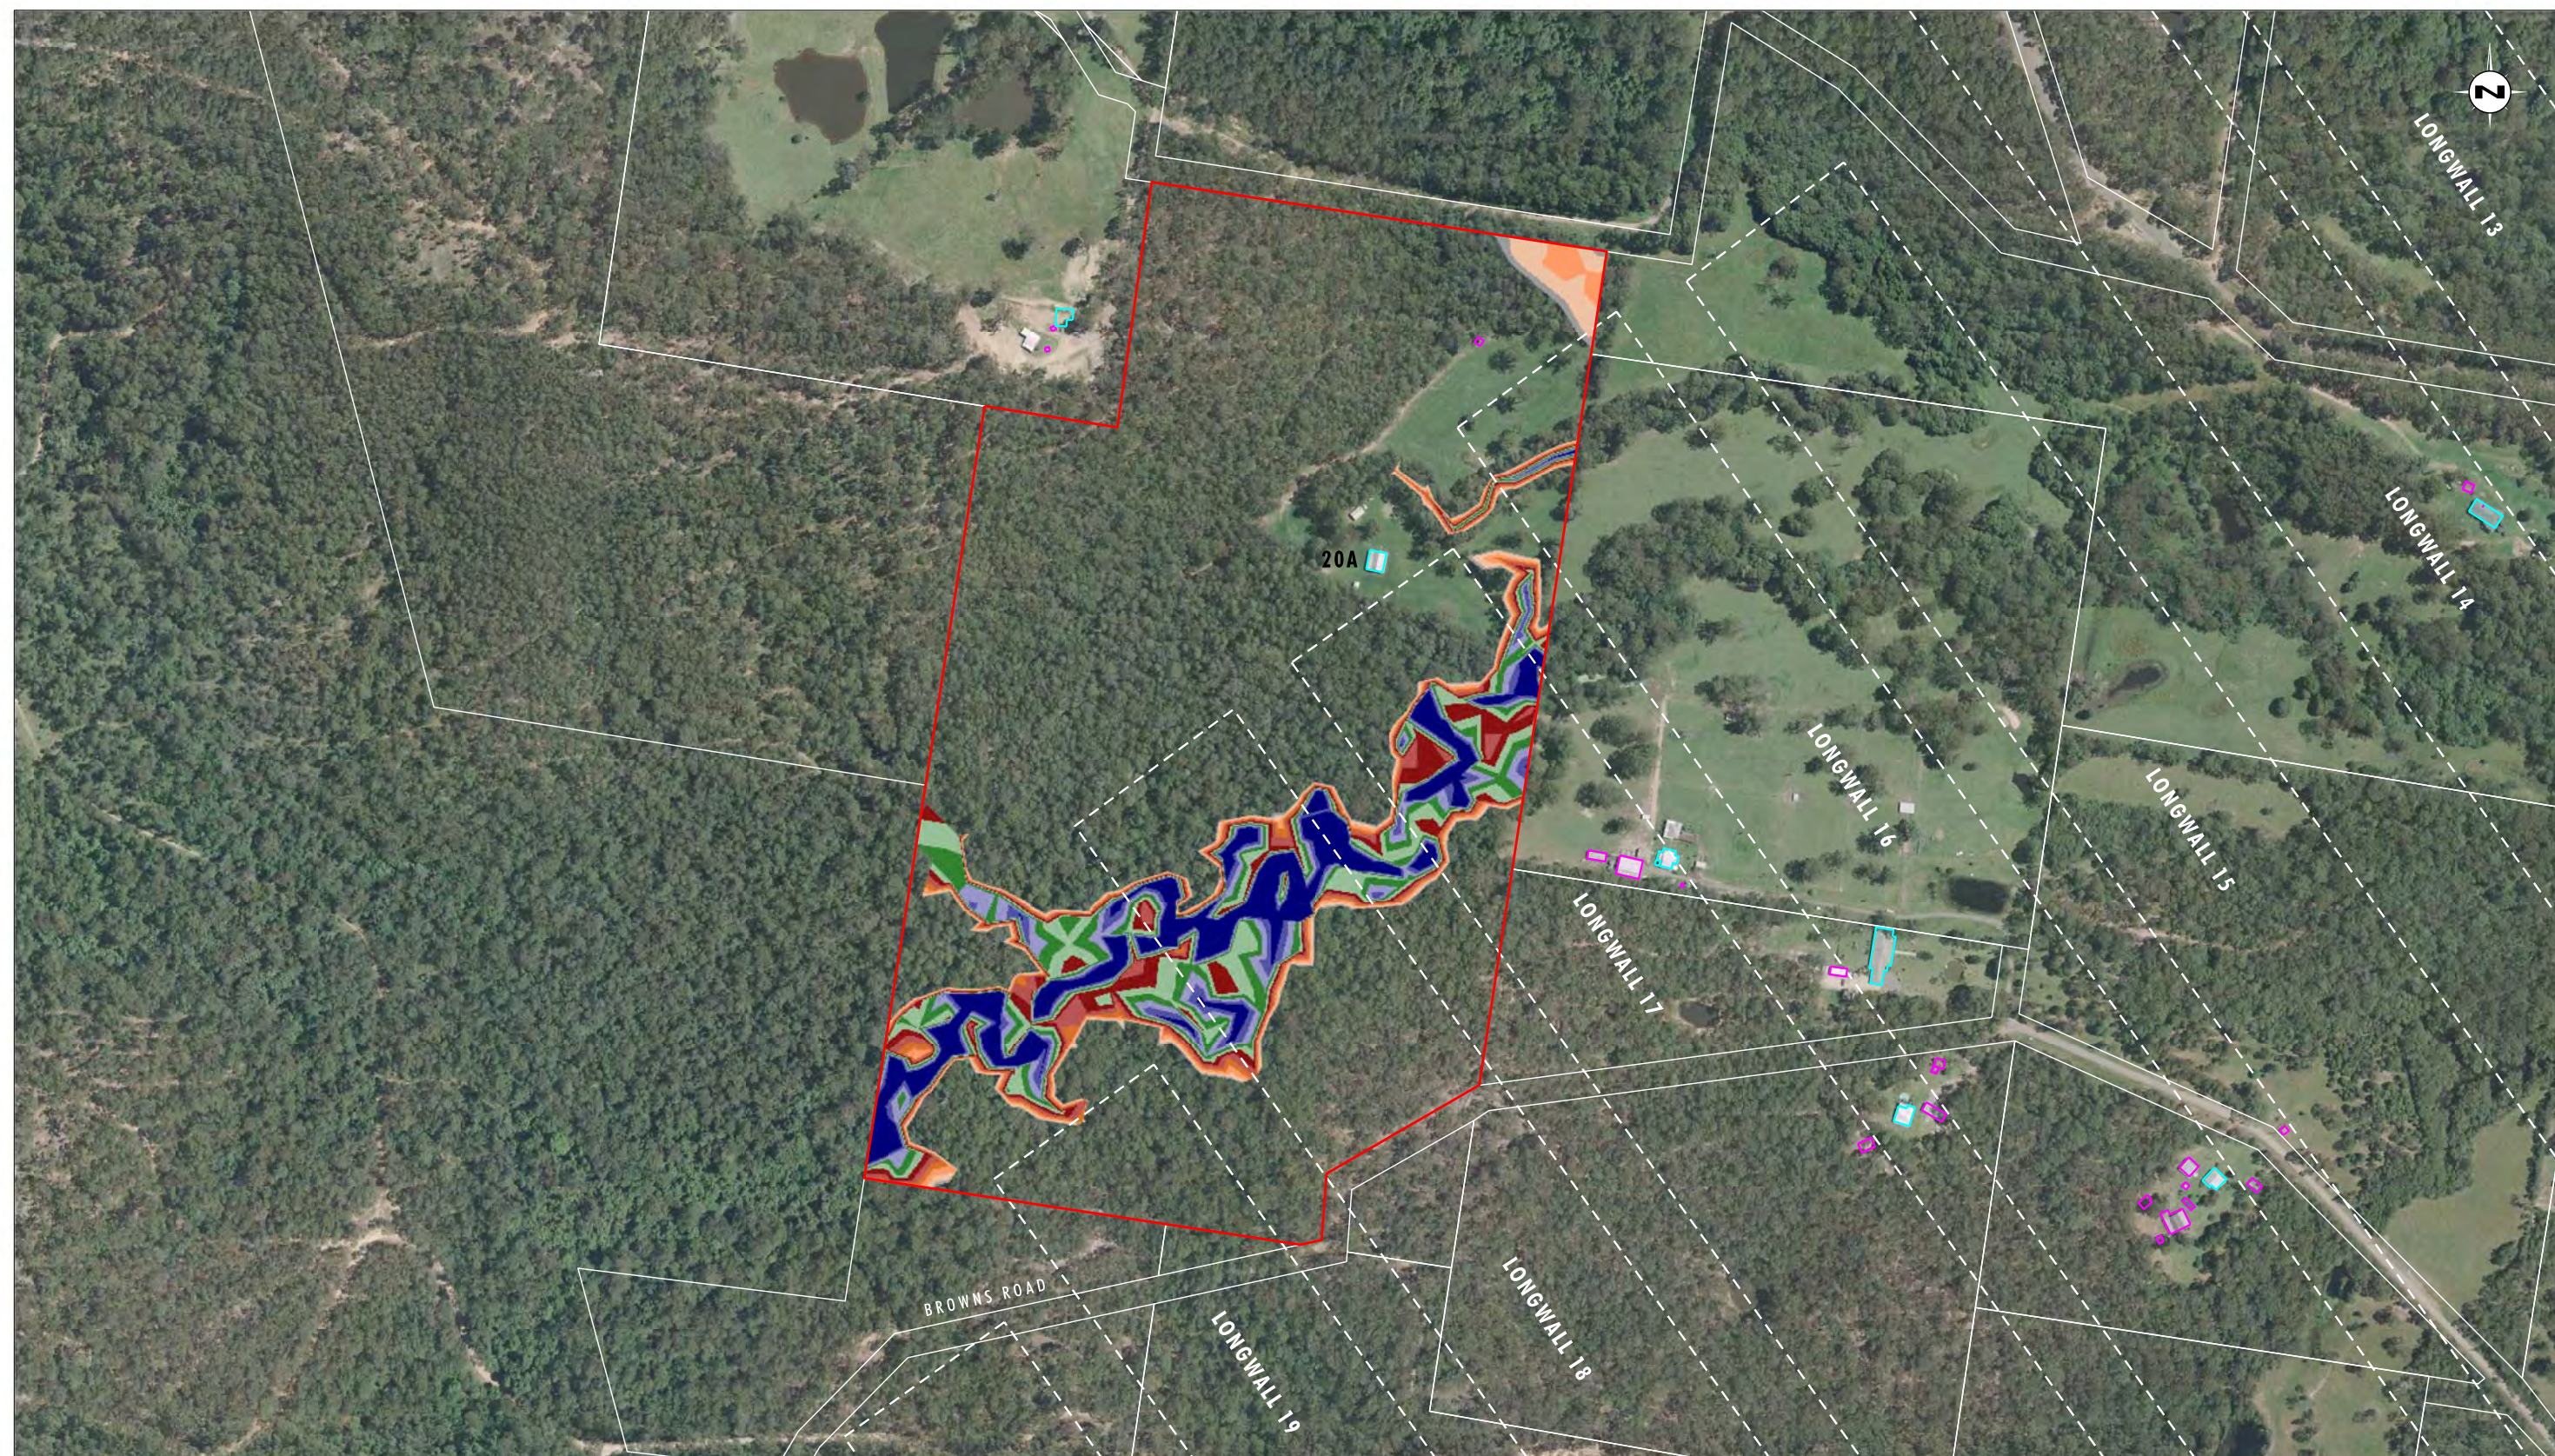
FIGURE 2

Property 20 - 100 year ARI Storm Event:  
Maximum Flood Depth Post Mining Landform  
(to Longwall 23)

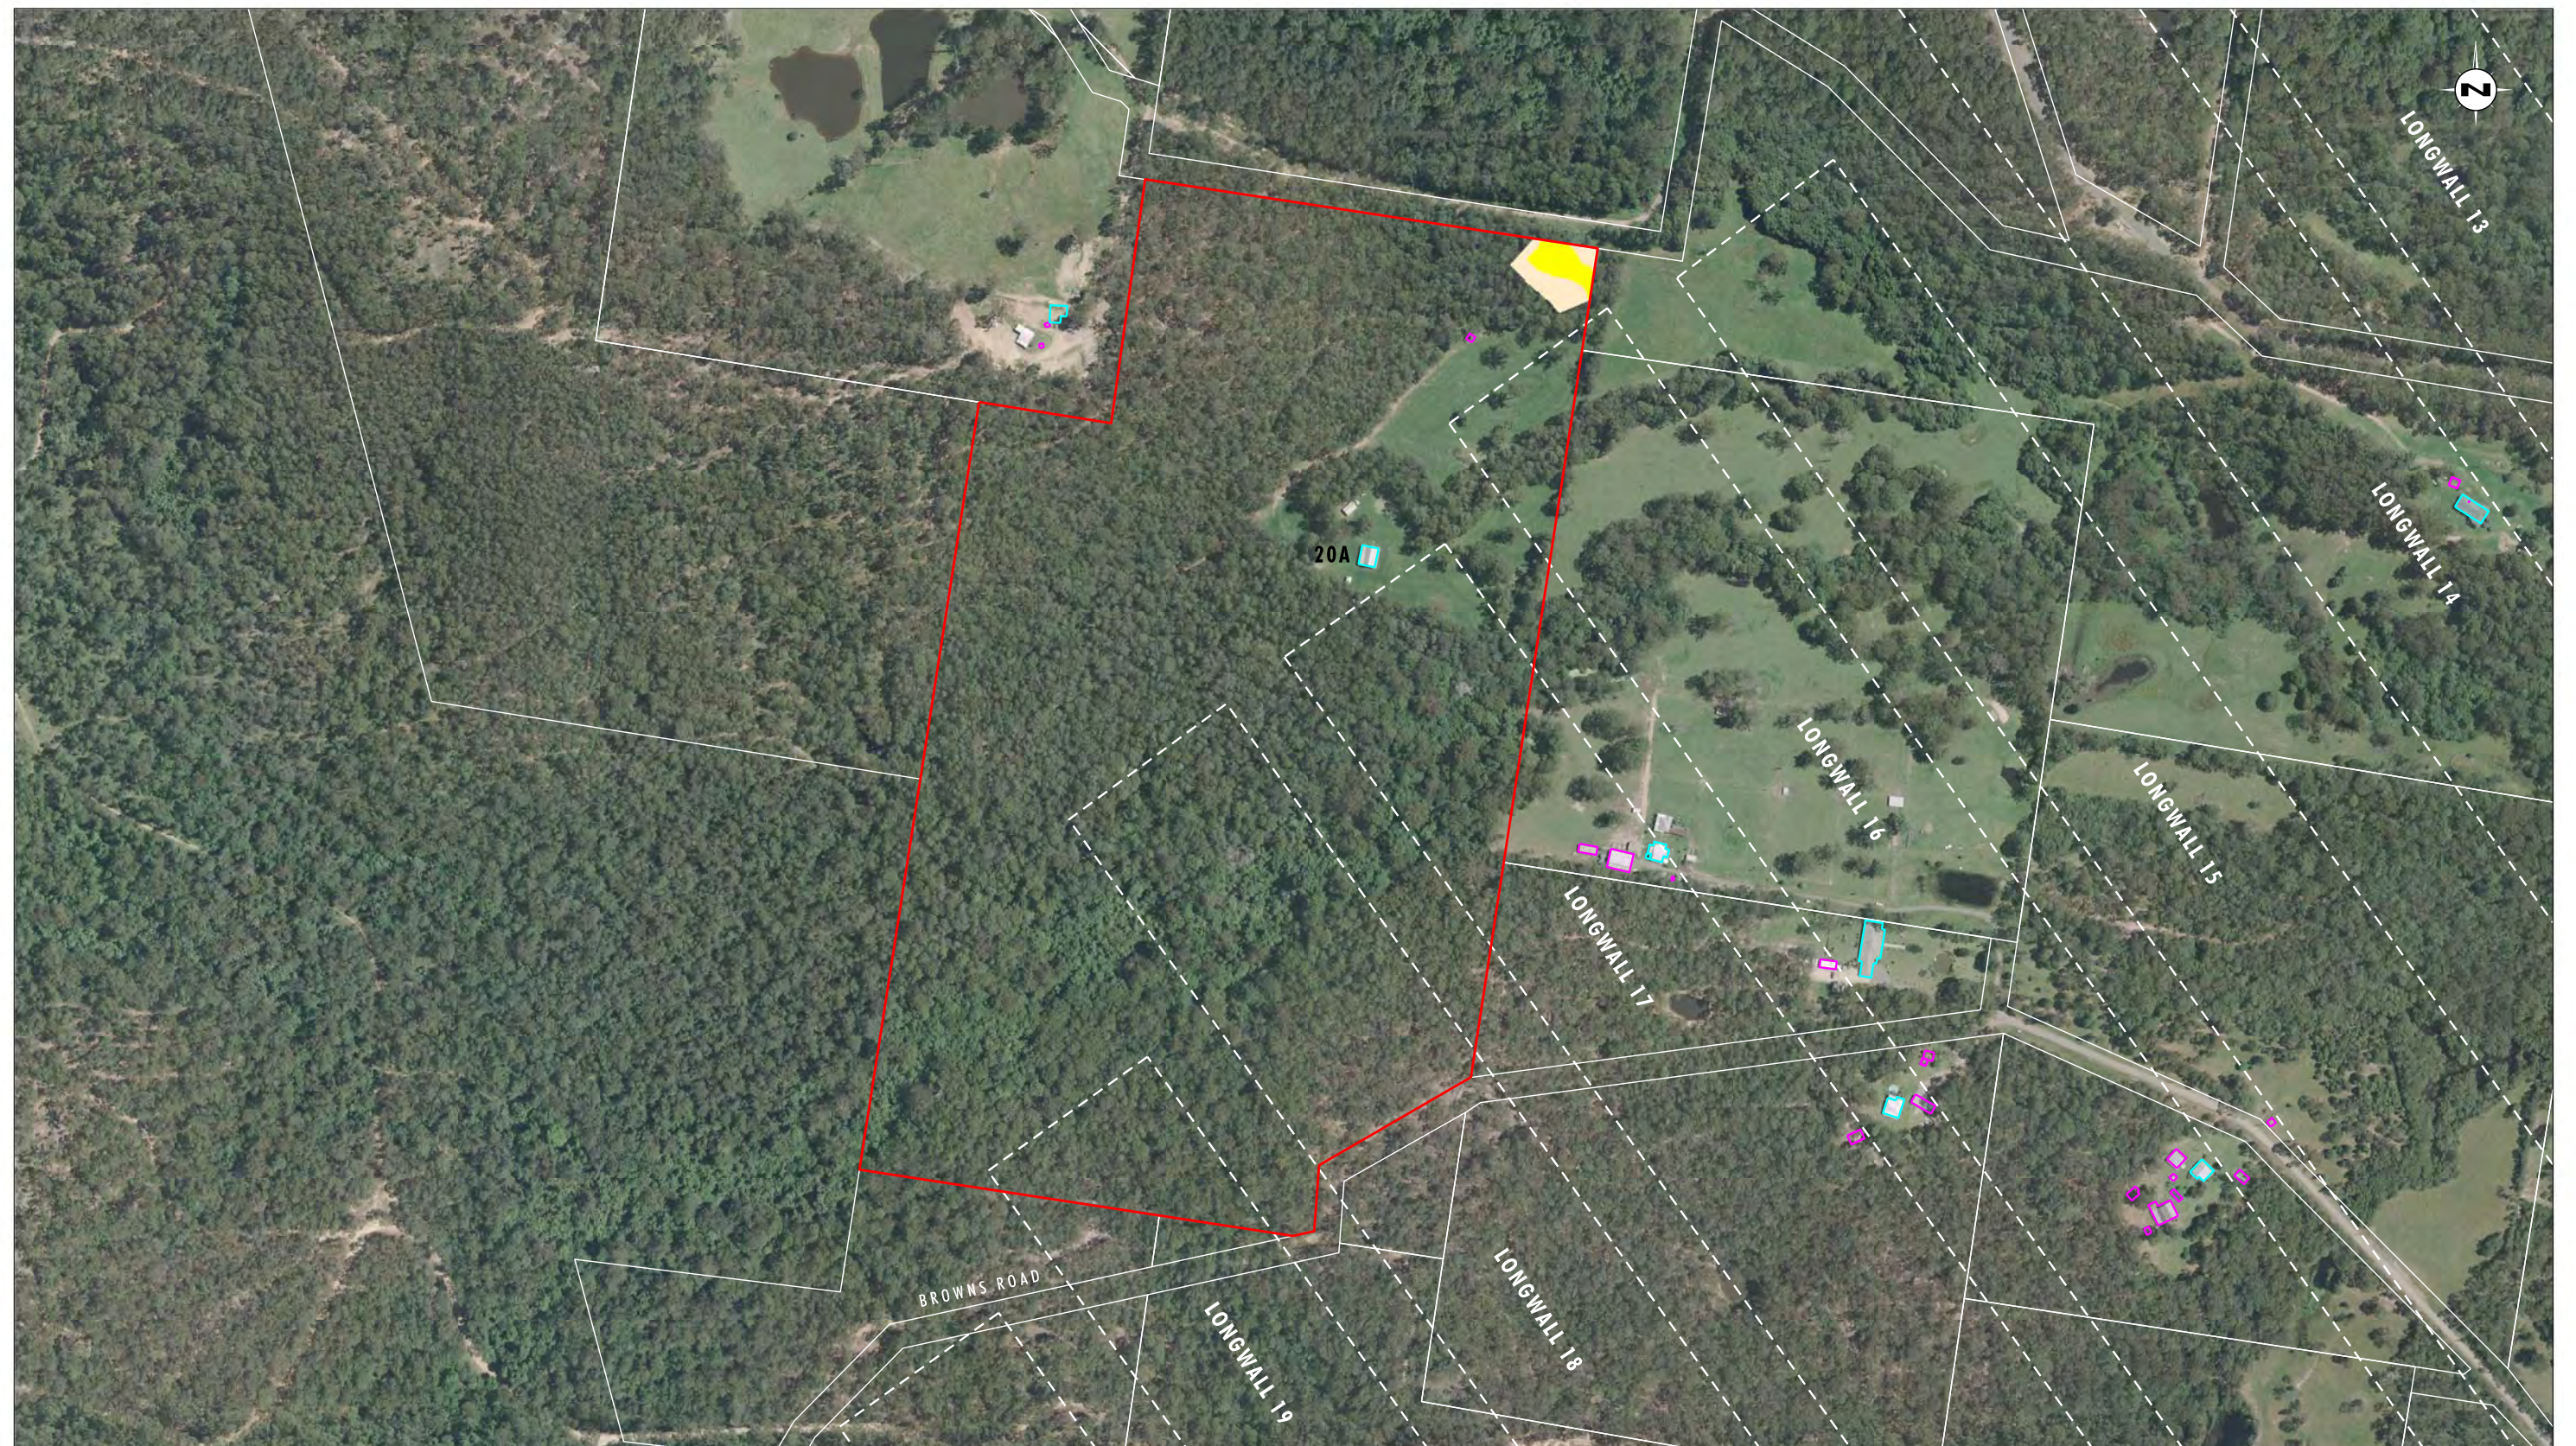
Image Source: Centennial Mandalong Pty Ltd (2009) - Aerial Photograph  
 Data Source: Centennial Mandalong Pty Ltd, LPI - Cadastral Boundaries  
 Note: Flood Hazard shown for access and dwellings only

Property 20 - 100 year ARI Storm Event:  
 Maximum Flood Hazard Categories Pre Mining Landform

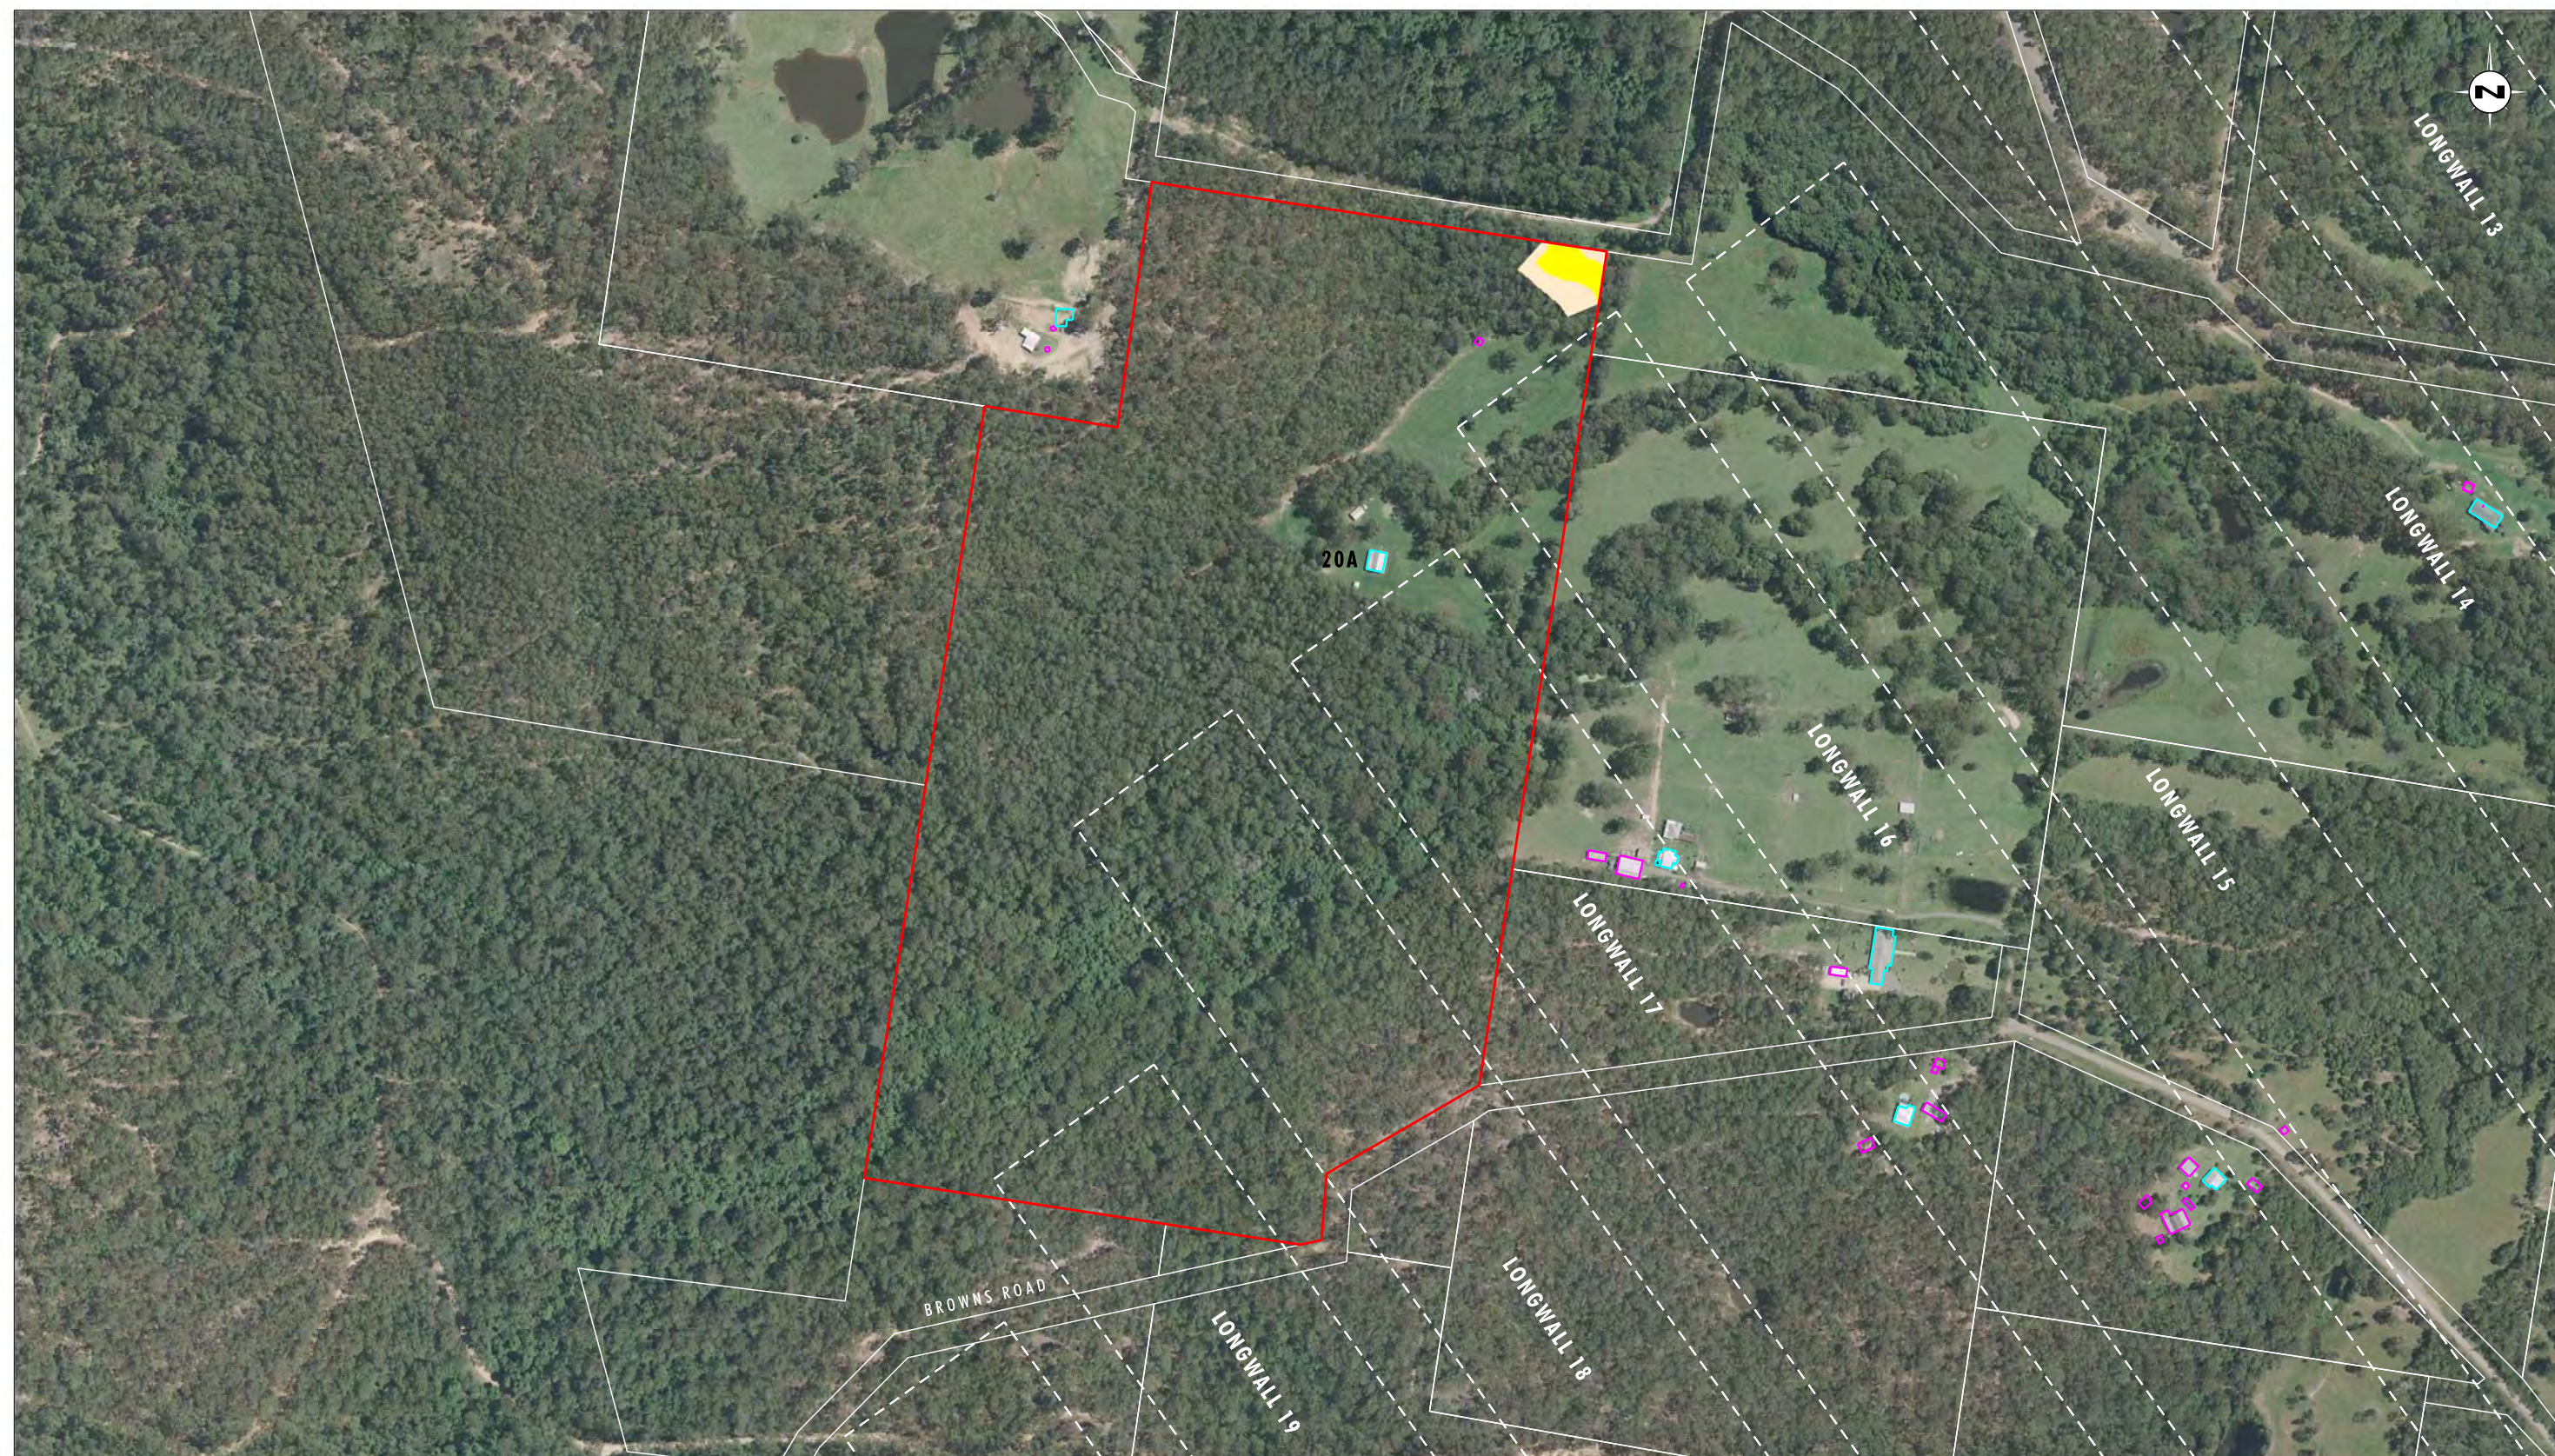
Image Source: Centennial Mandalong Pty Ltd (2009) - Aerial Photograph  
 Data Source: Centennial Mandalong Pty Ltd, LPI - Cadastral Boundaries  
 Note: Flood Hazard shown for access and dwellings only

Property 20 - 100 year ARI Storm Event:  
 Maximum Flood Hazard Categories Post Mining Landform  
 (to Longwall 23)
