## APPENDIX 1

**Flooding Assessment Figures -  
Property 7 (Centennial)**

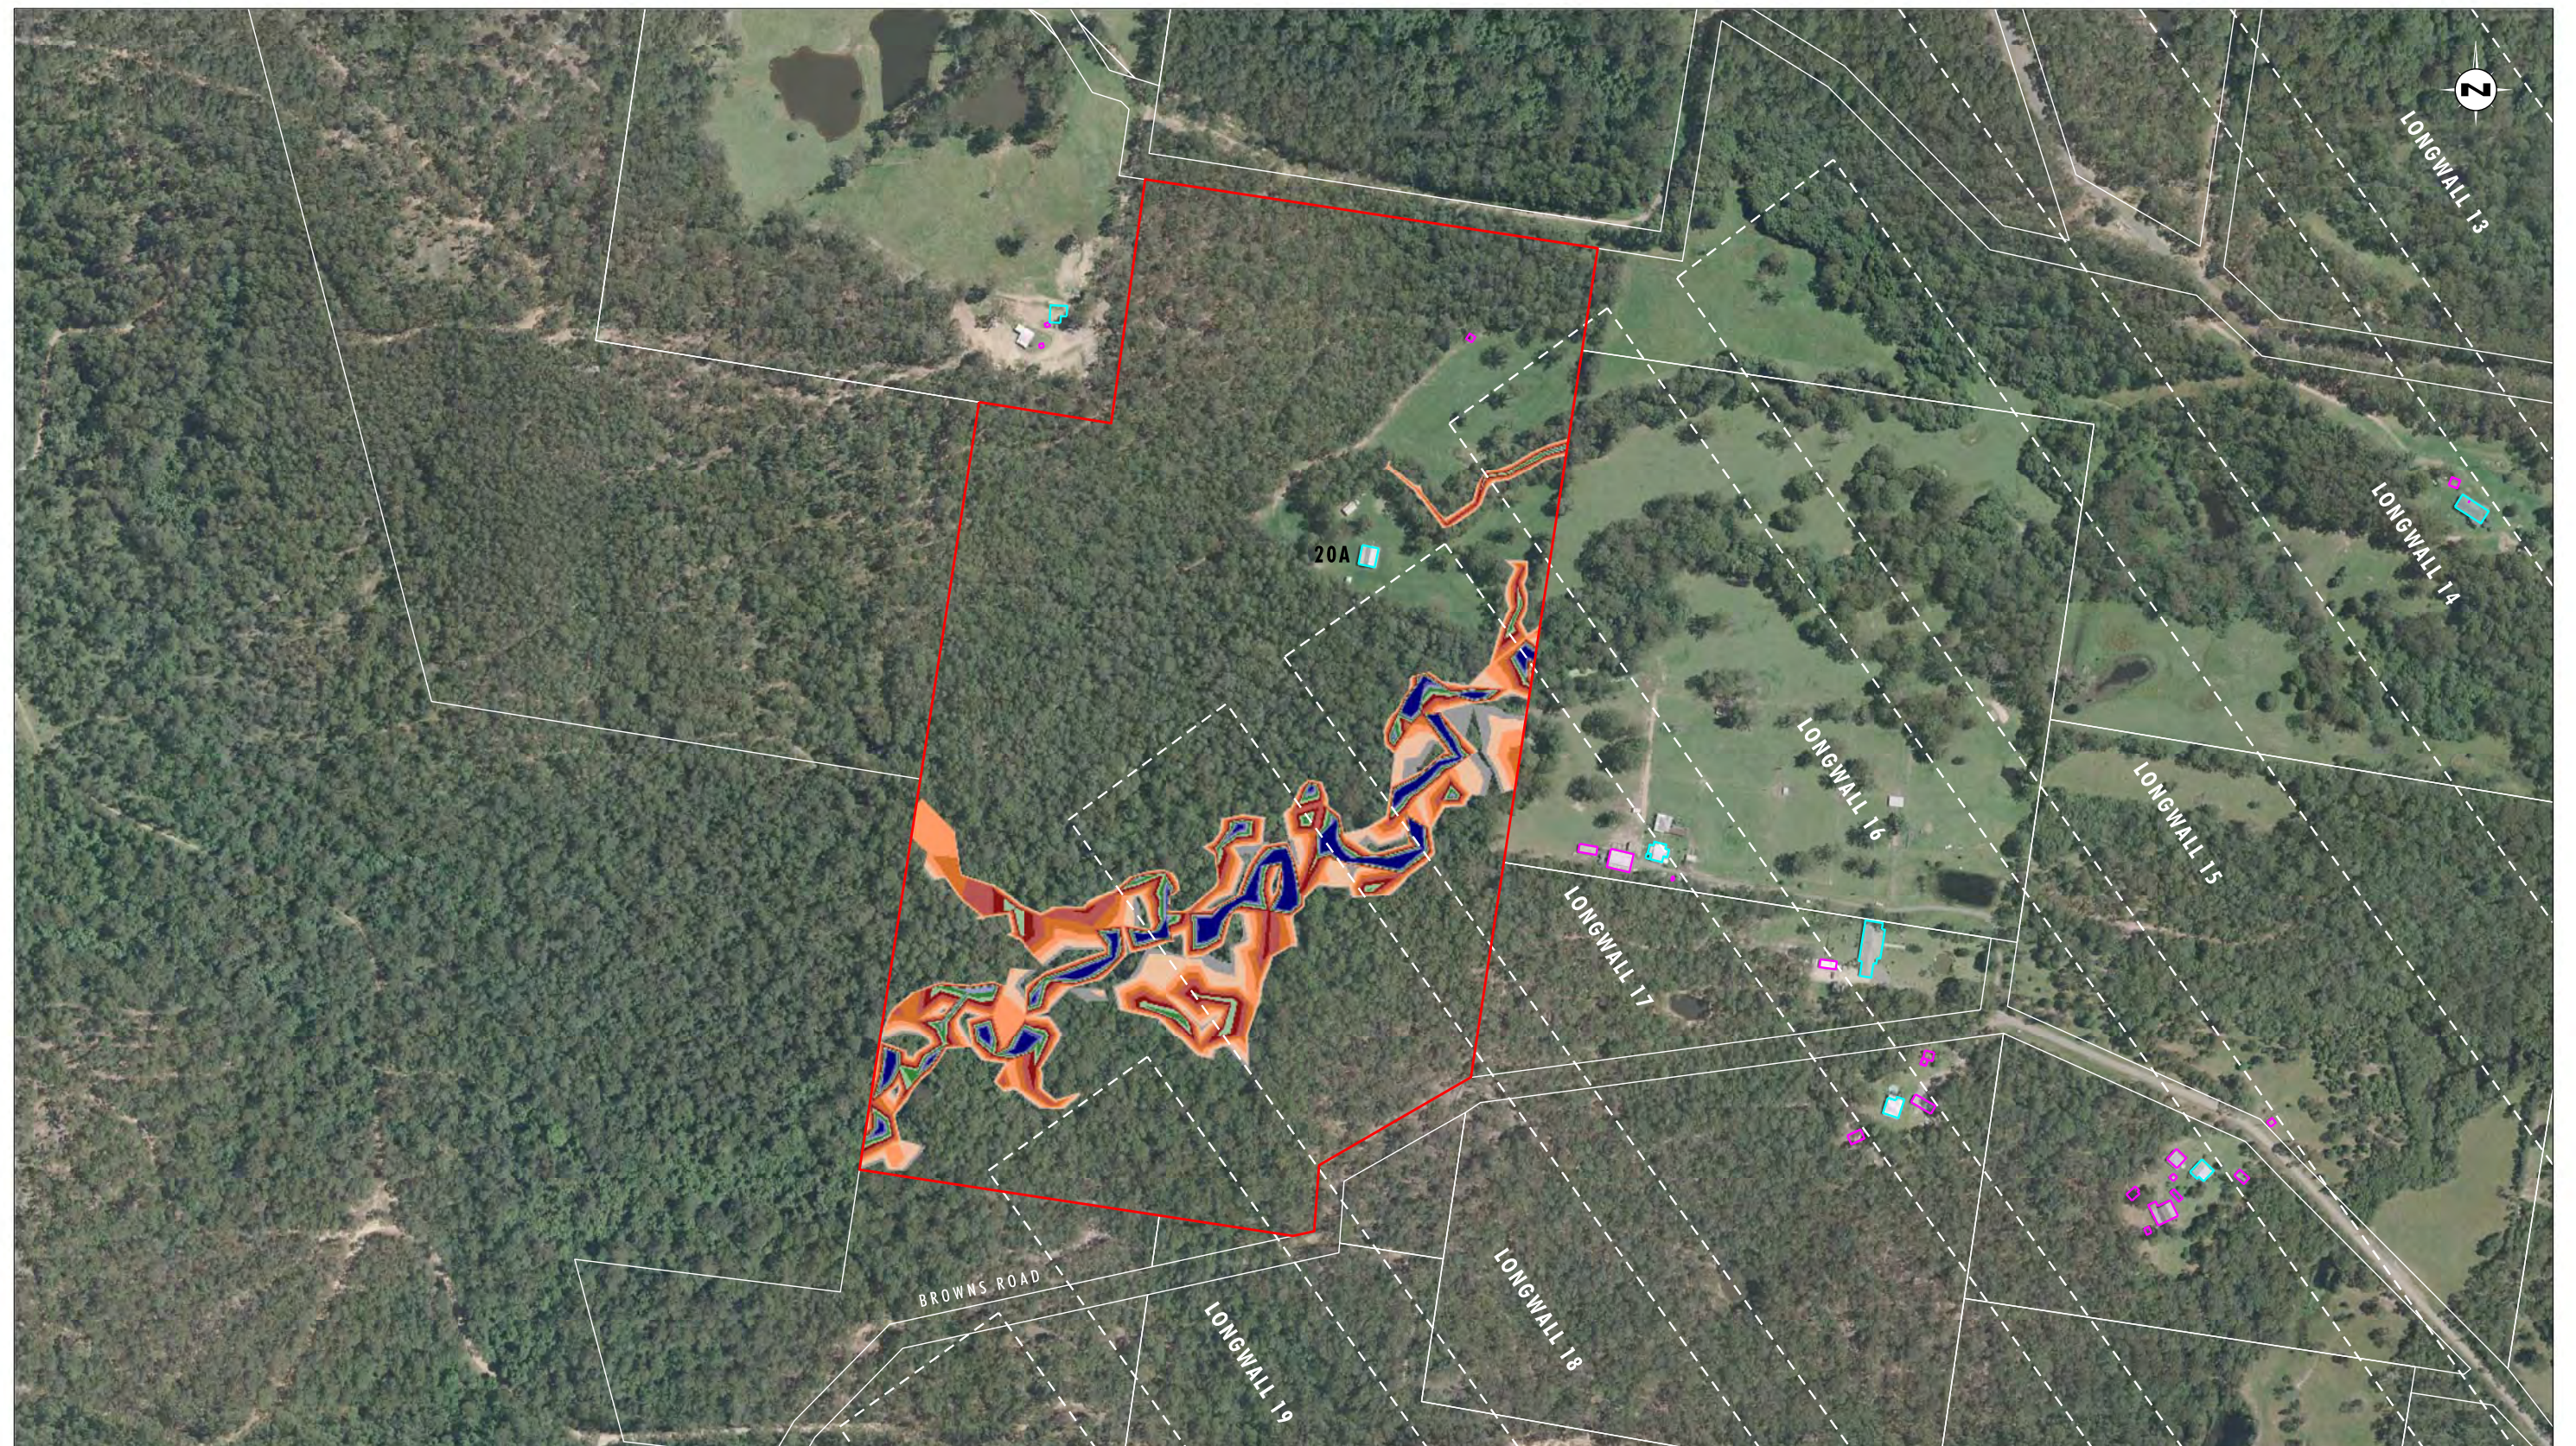
FIGURE 5

Property 20 - 1 year ARI Storm Event:  
Maximum Flood Depth Pre Mining Landform

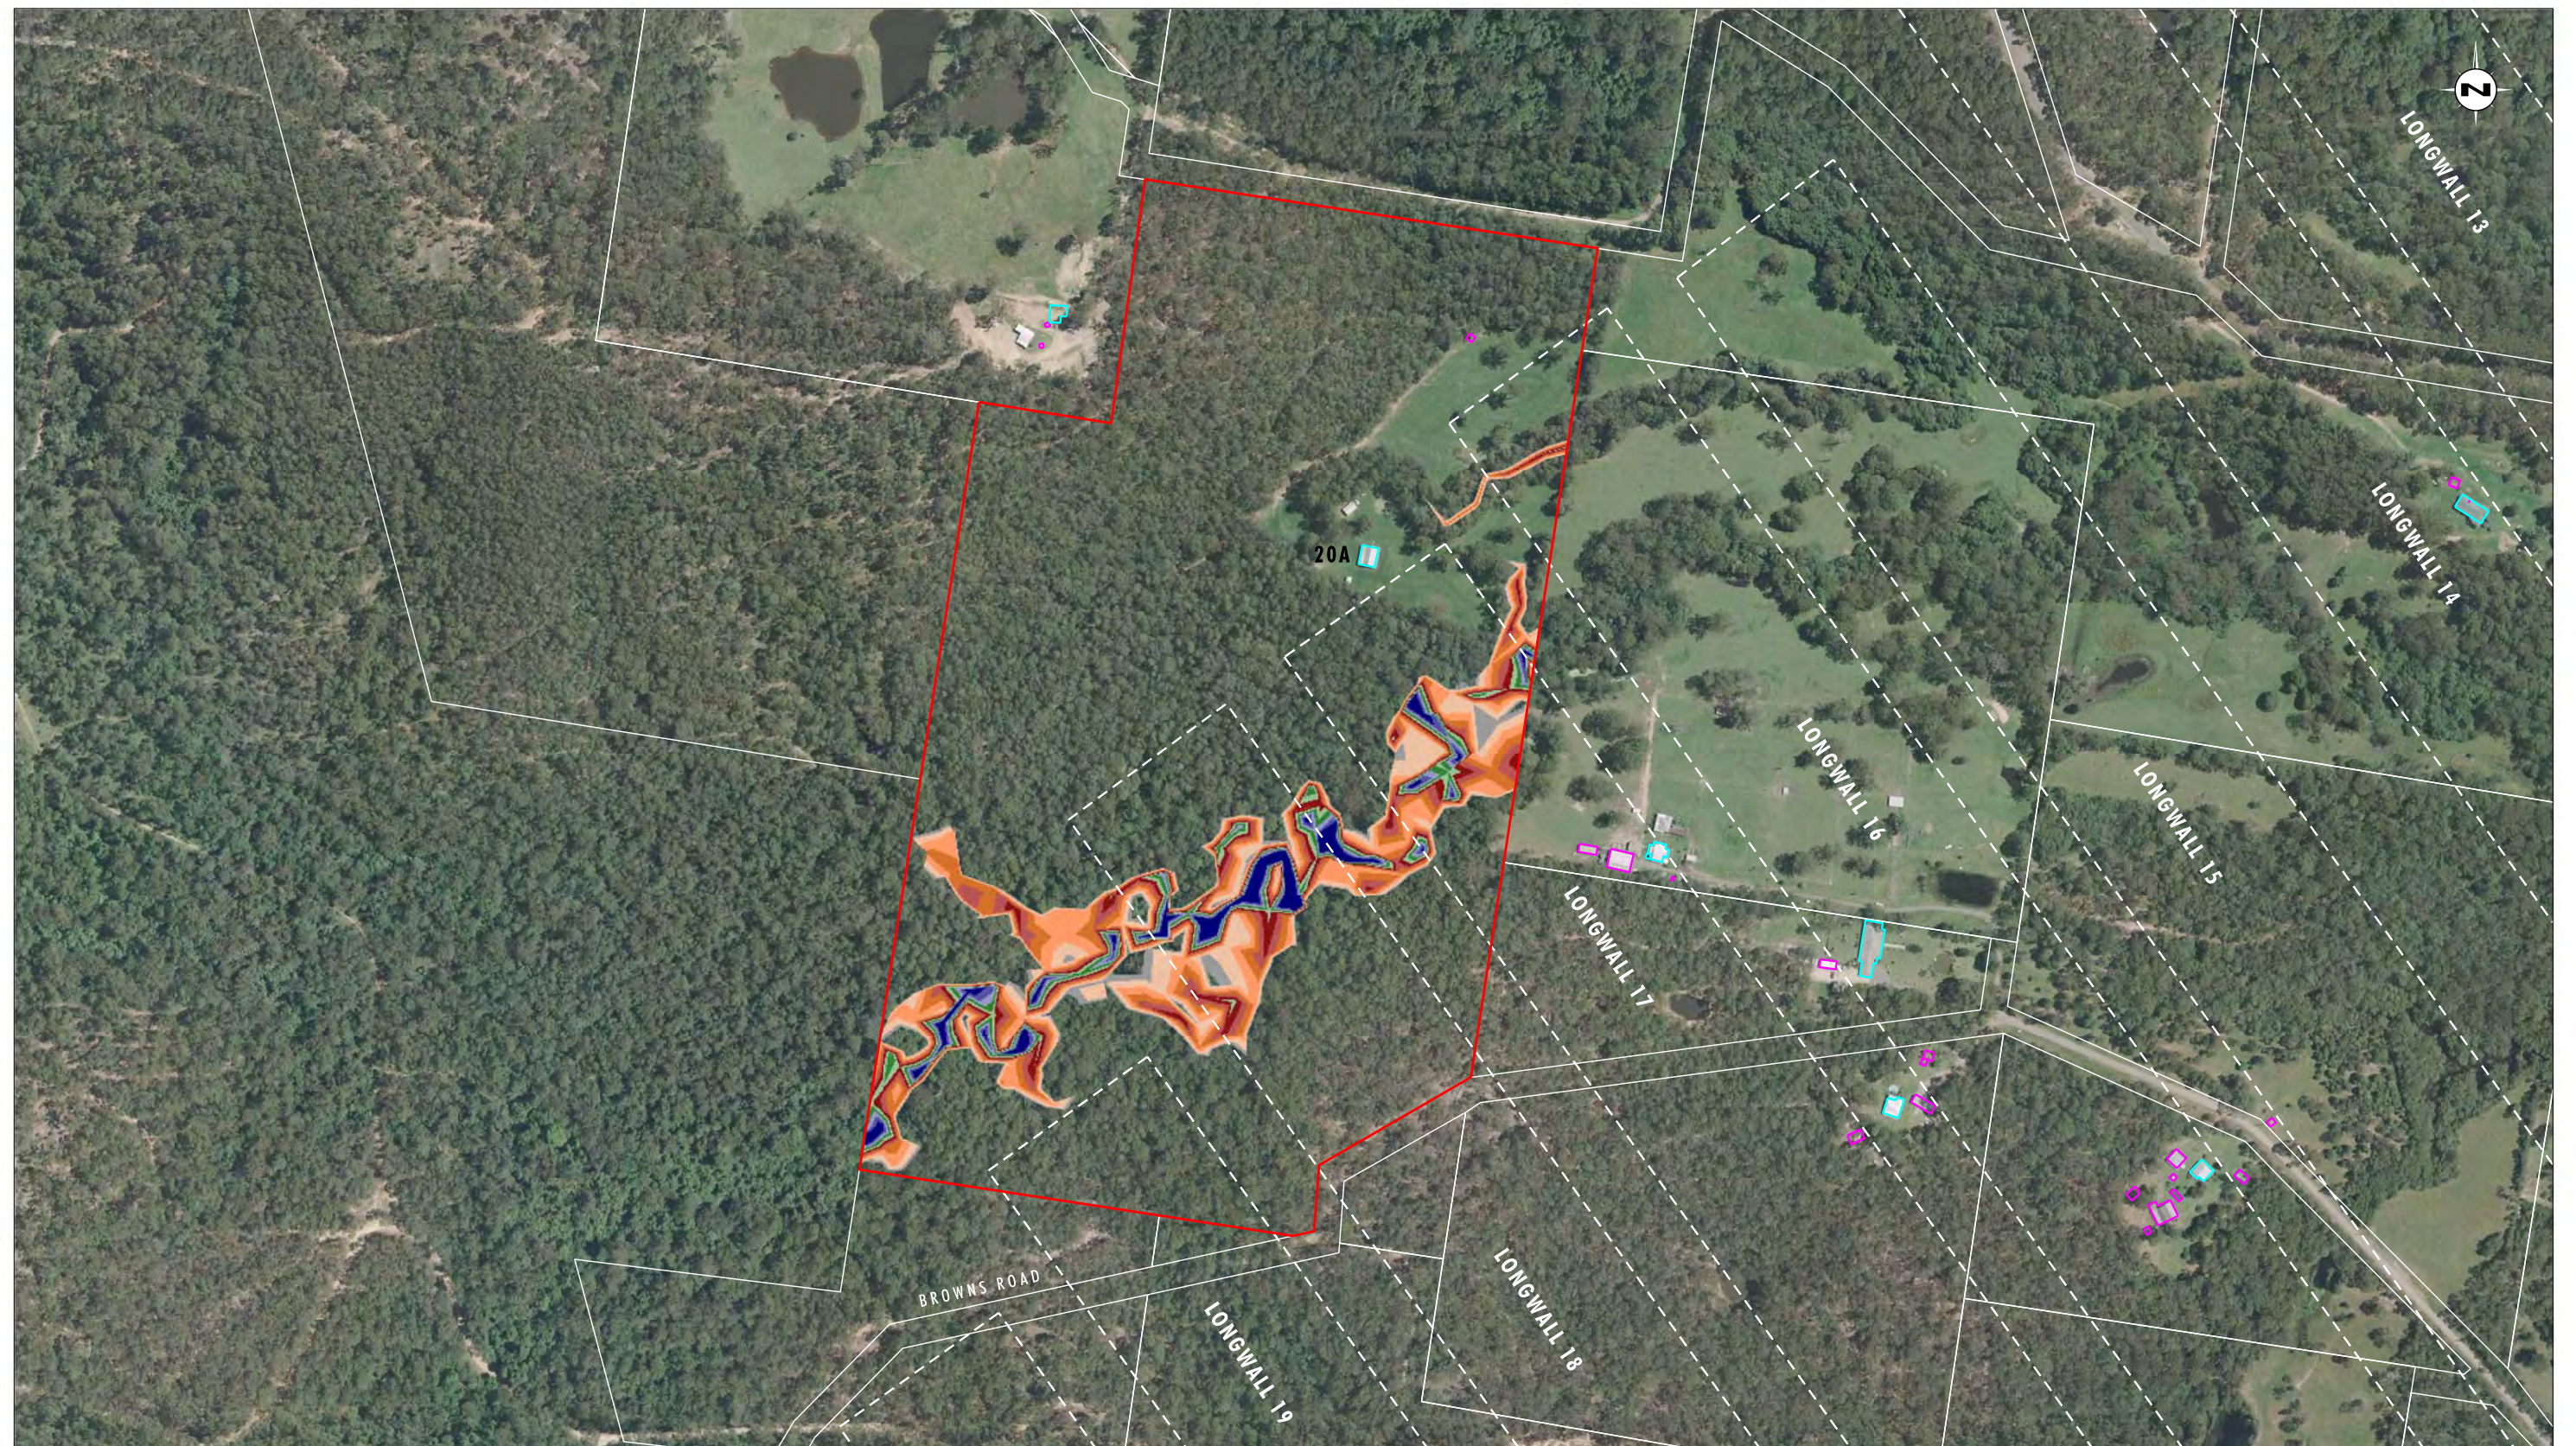
FIGURE 6

Property 20 - 1 year ARI Storm Event:  
Maximum Flood Depth Post Mining Landform  
(to Longwall 23)

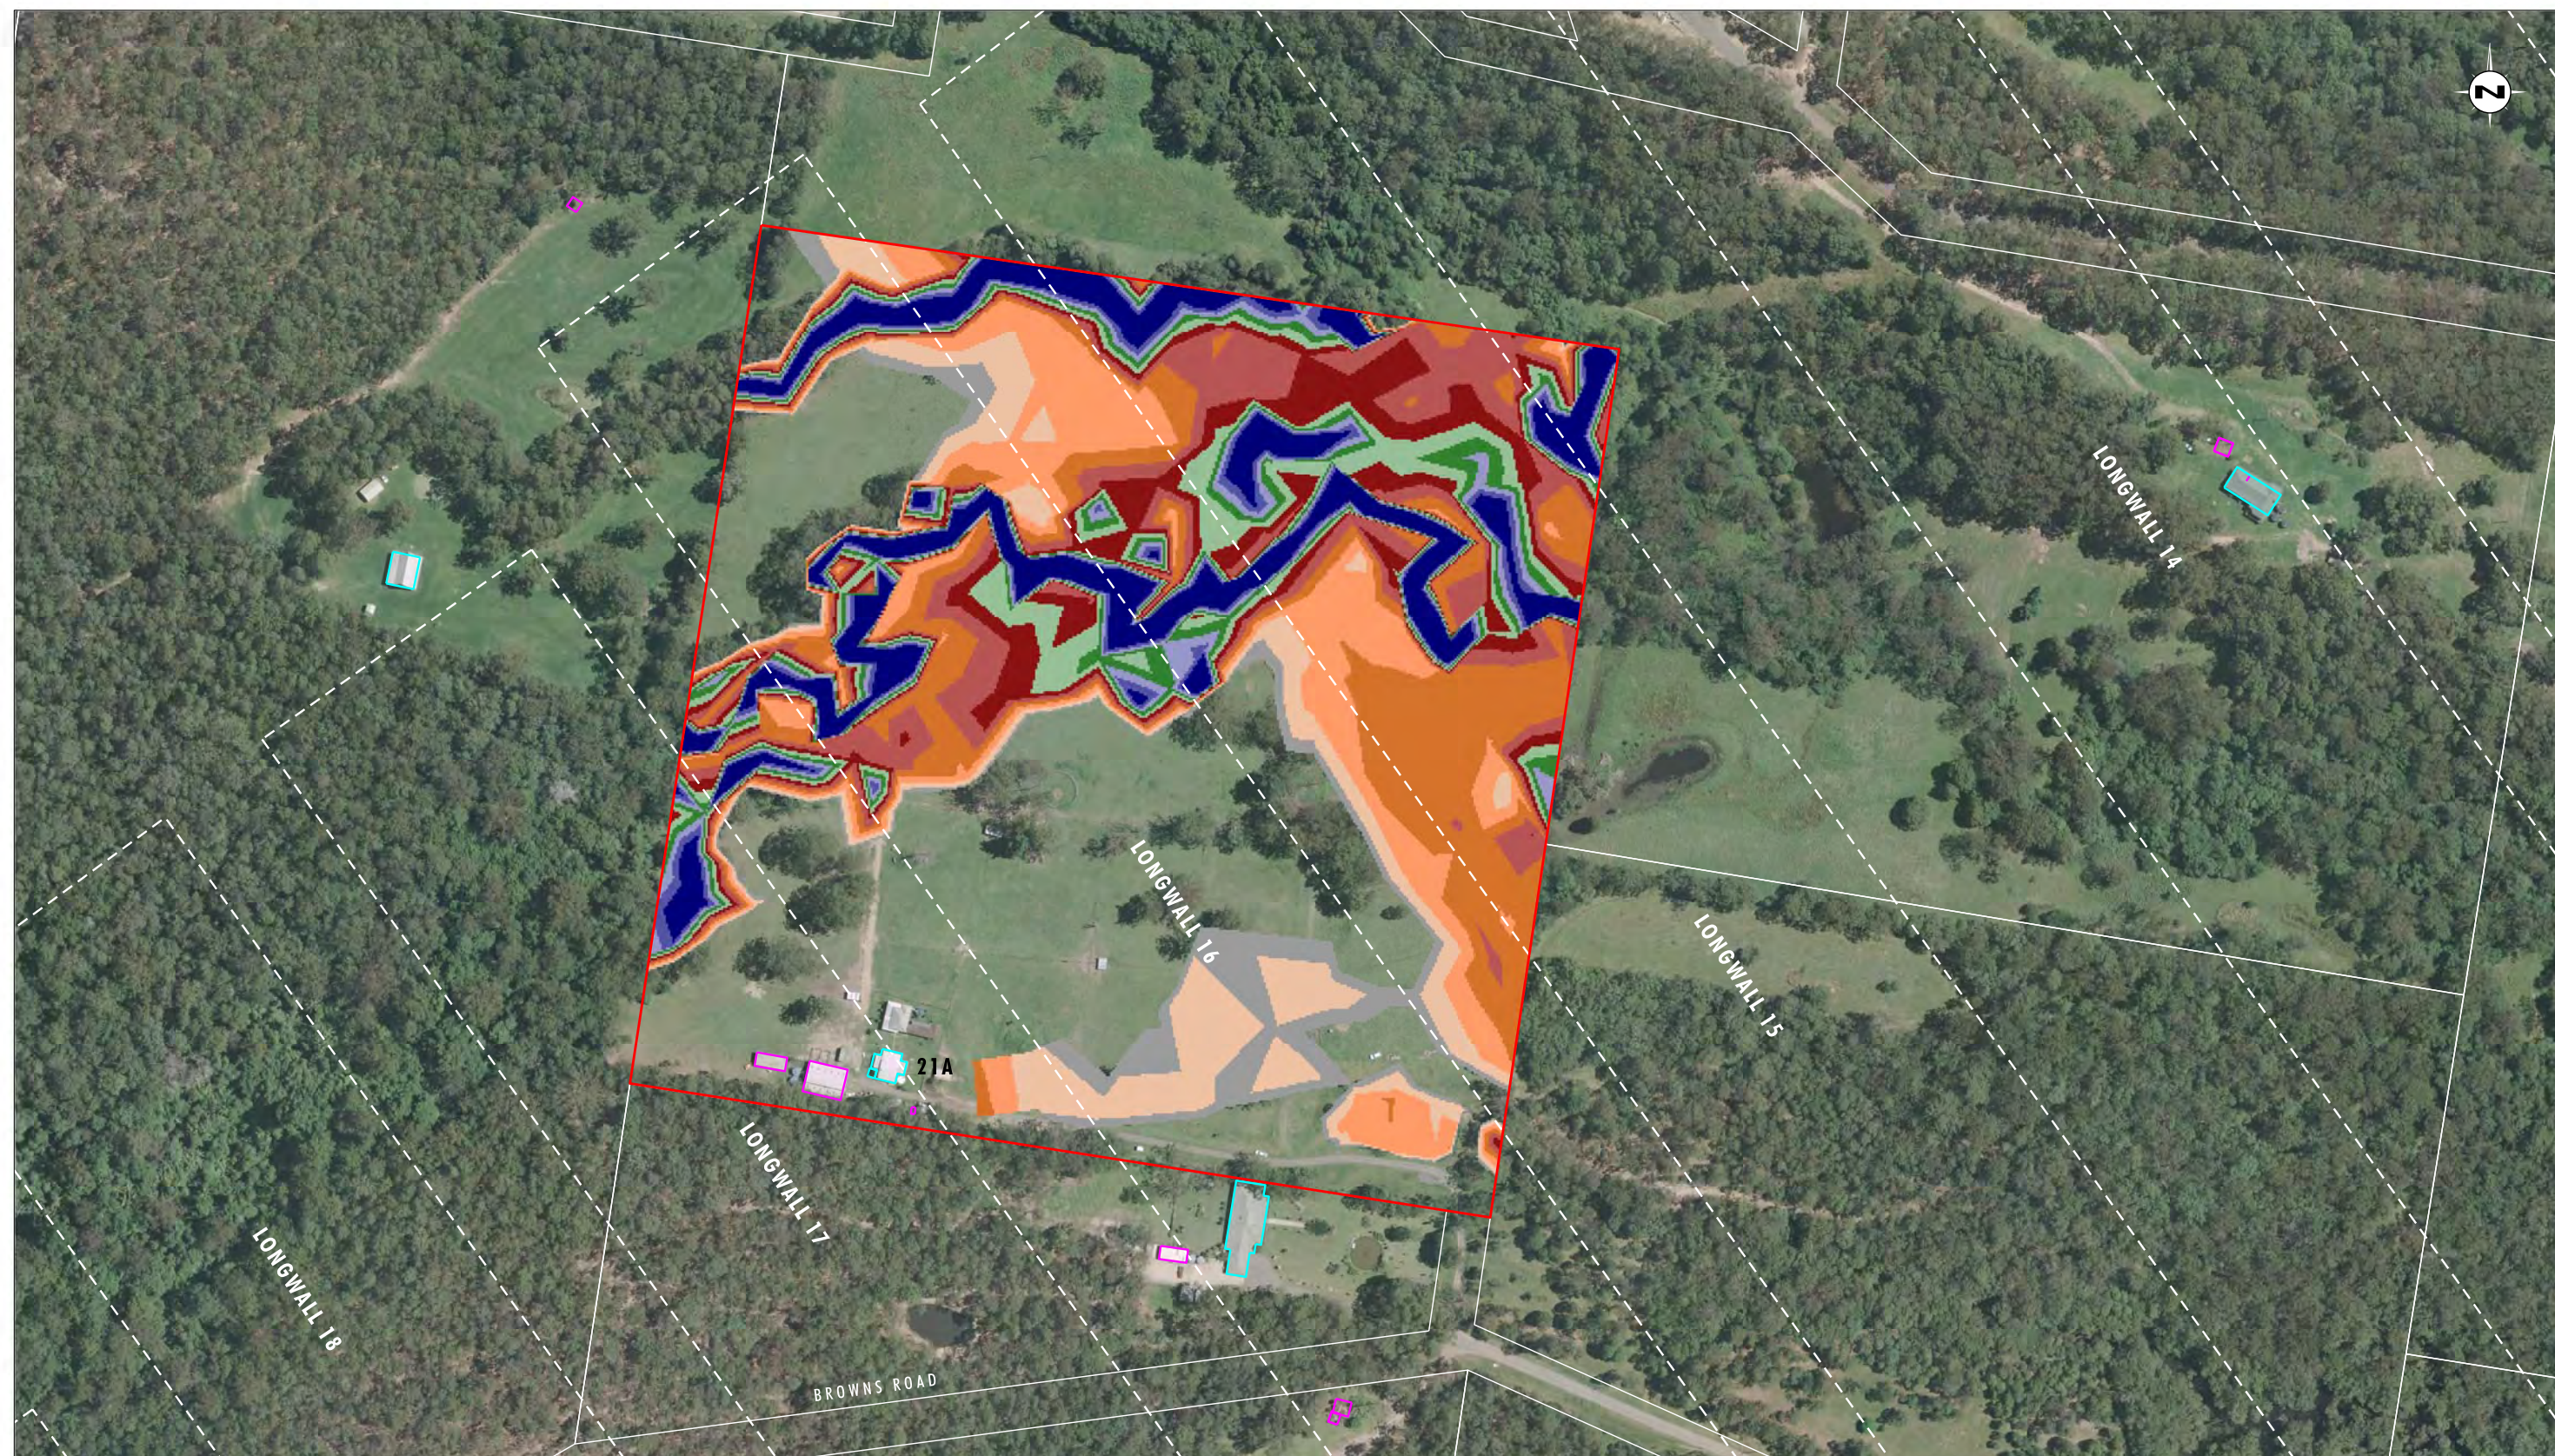
Property 21 - 100 year ARI Storm Event:  
Maximum Flood Depth Pre Mining Landform

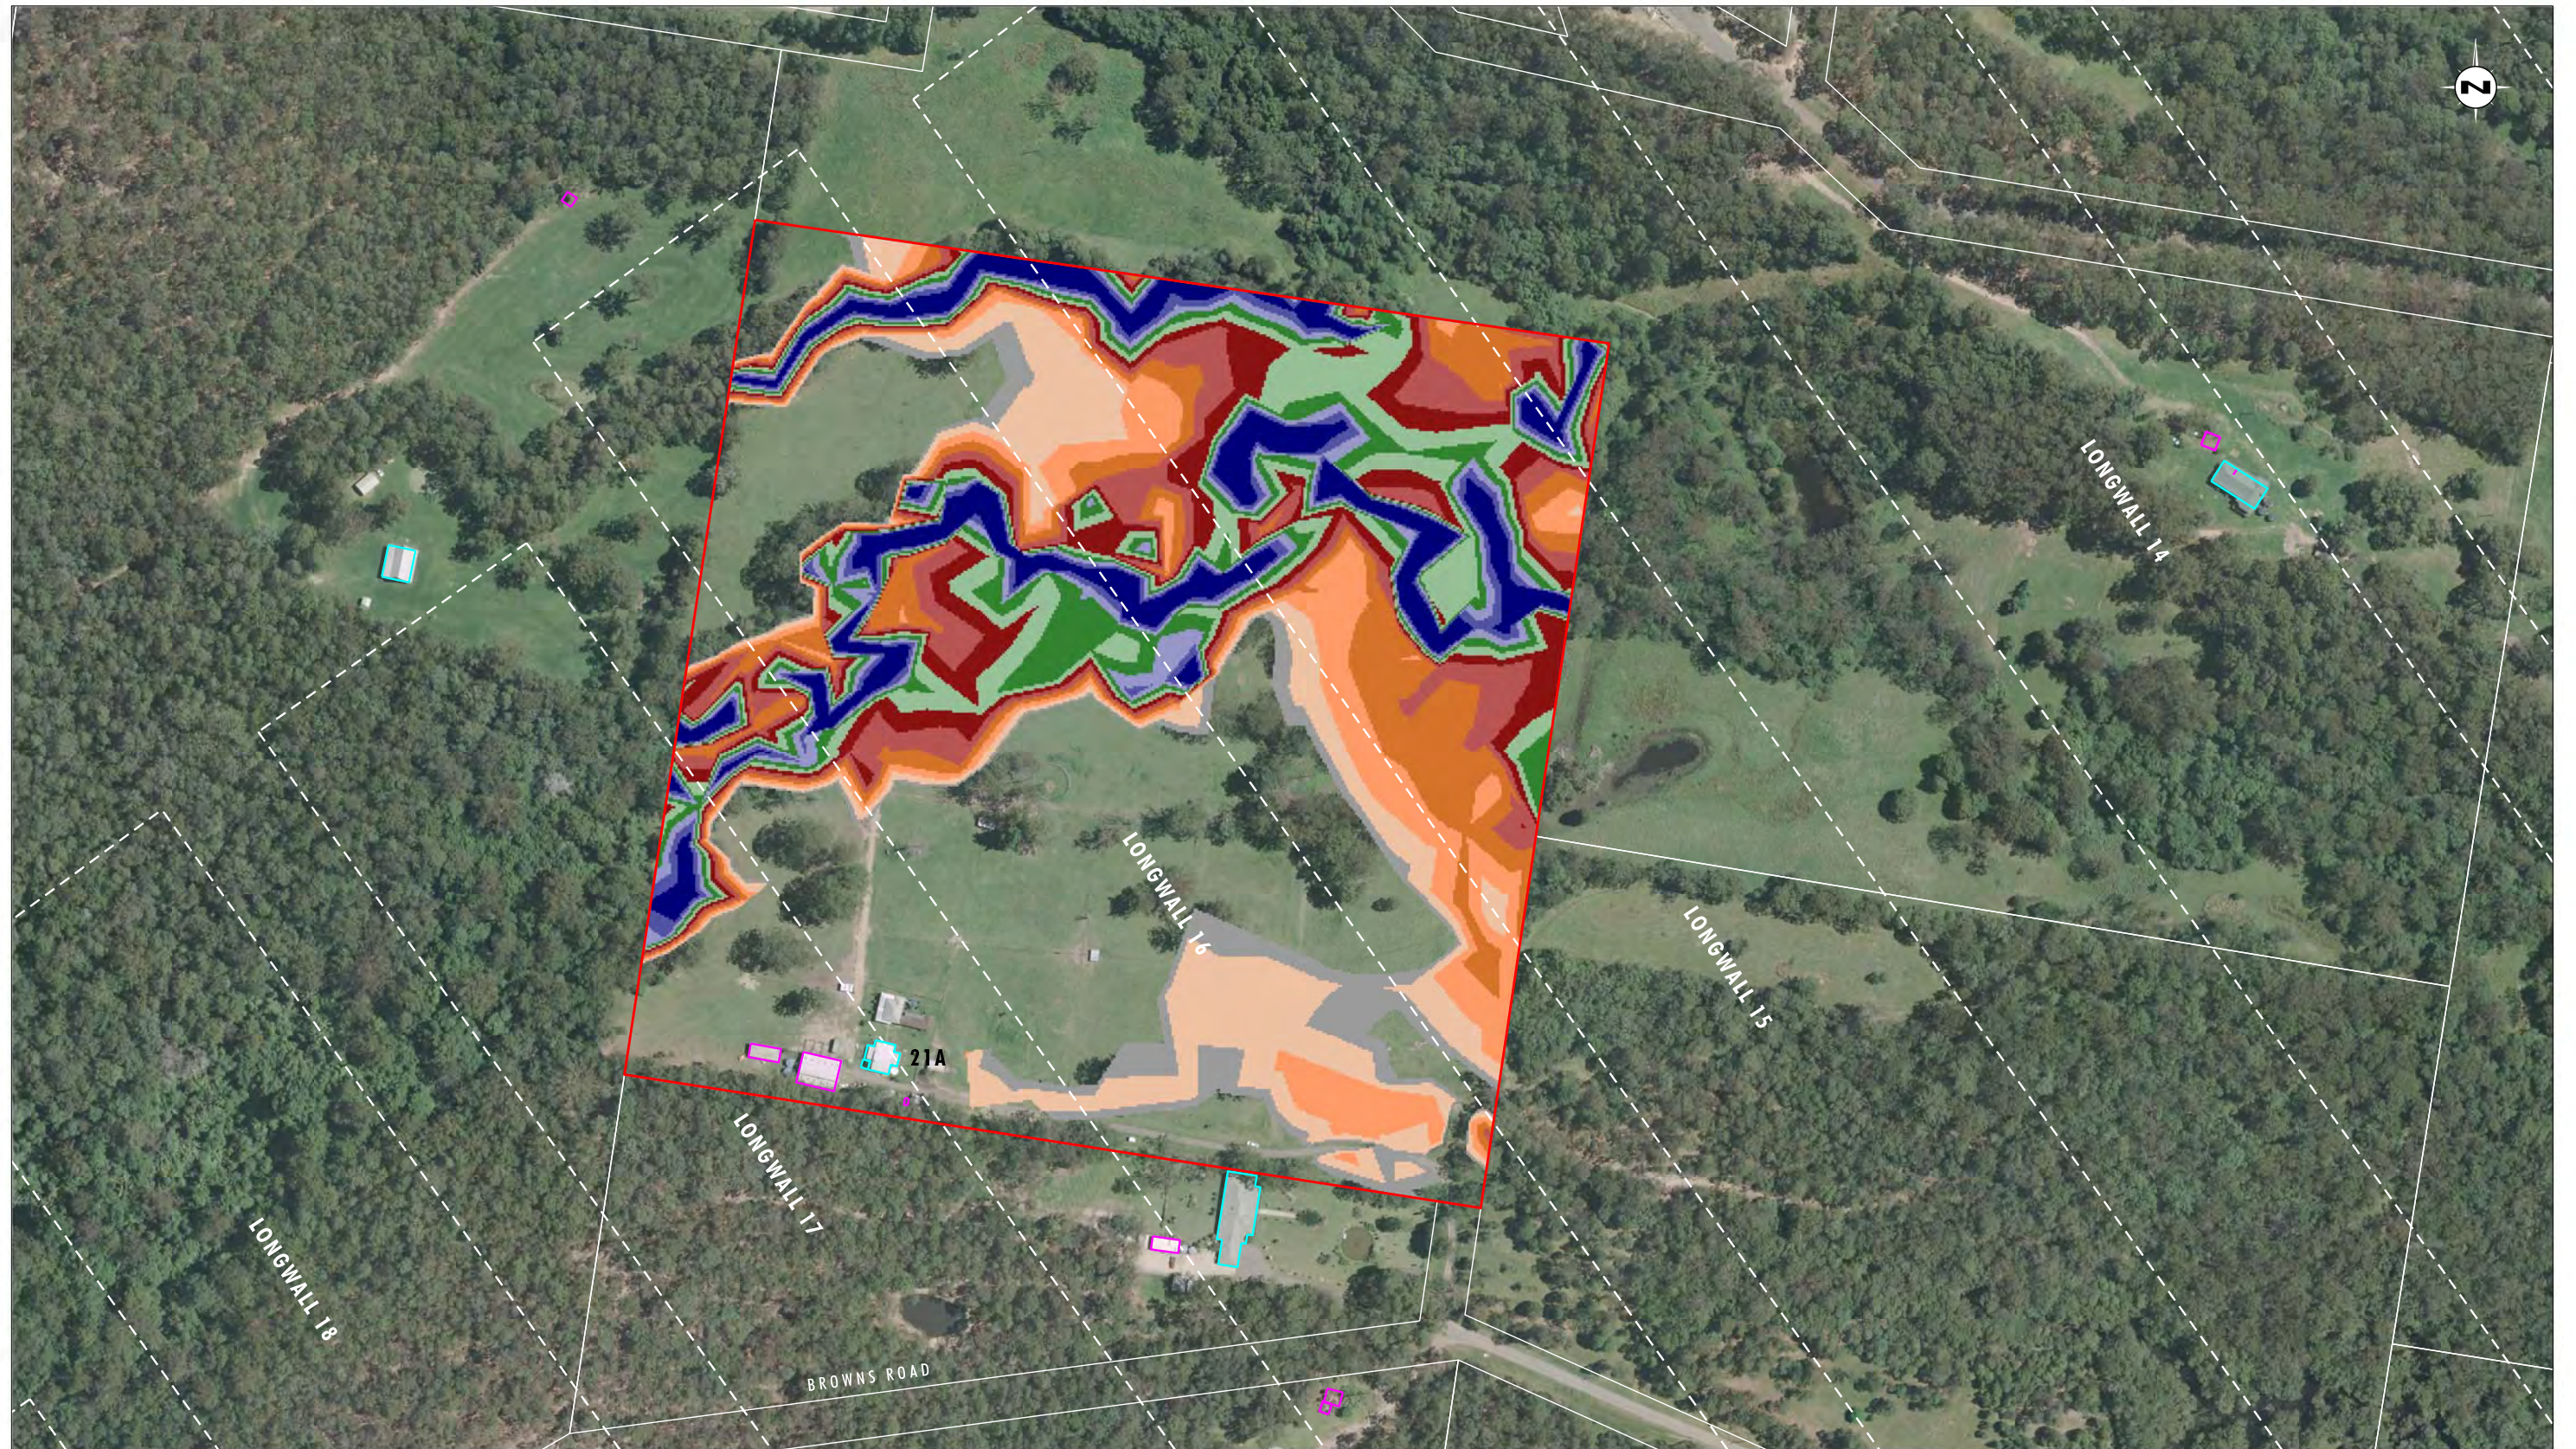
Property 21 - 100 year ARI Storm Event:  
Maximum Flood Depth Post Mining Landform  
(to Longwall 23)

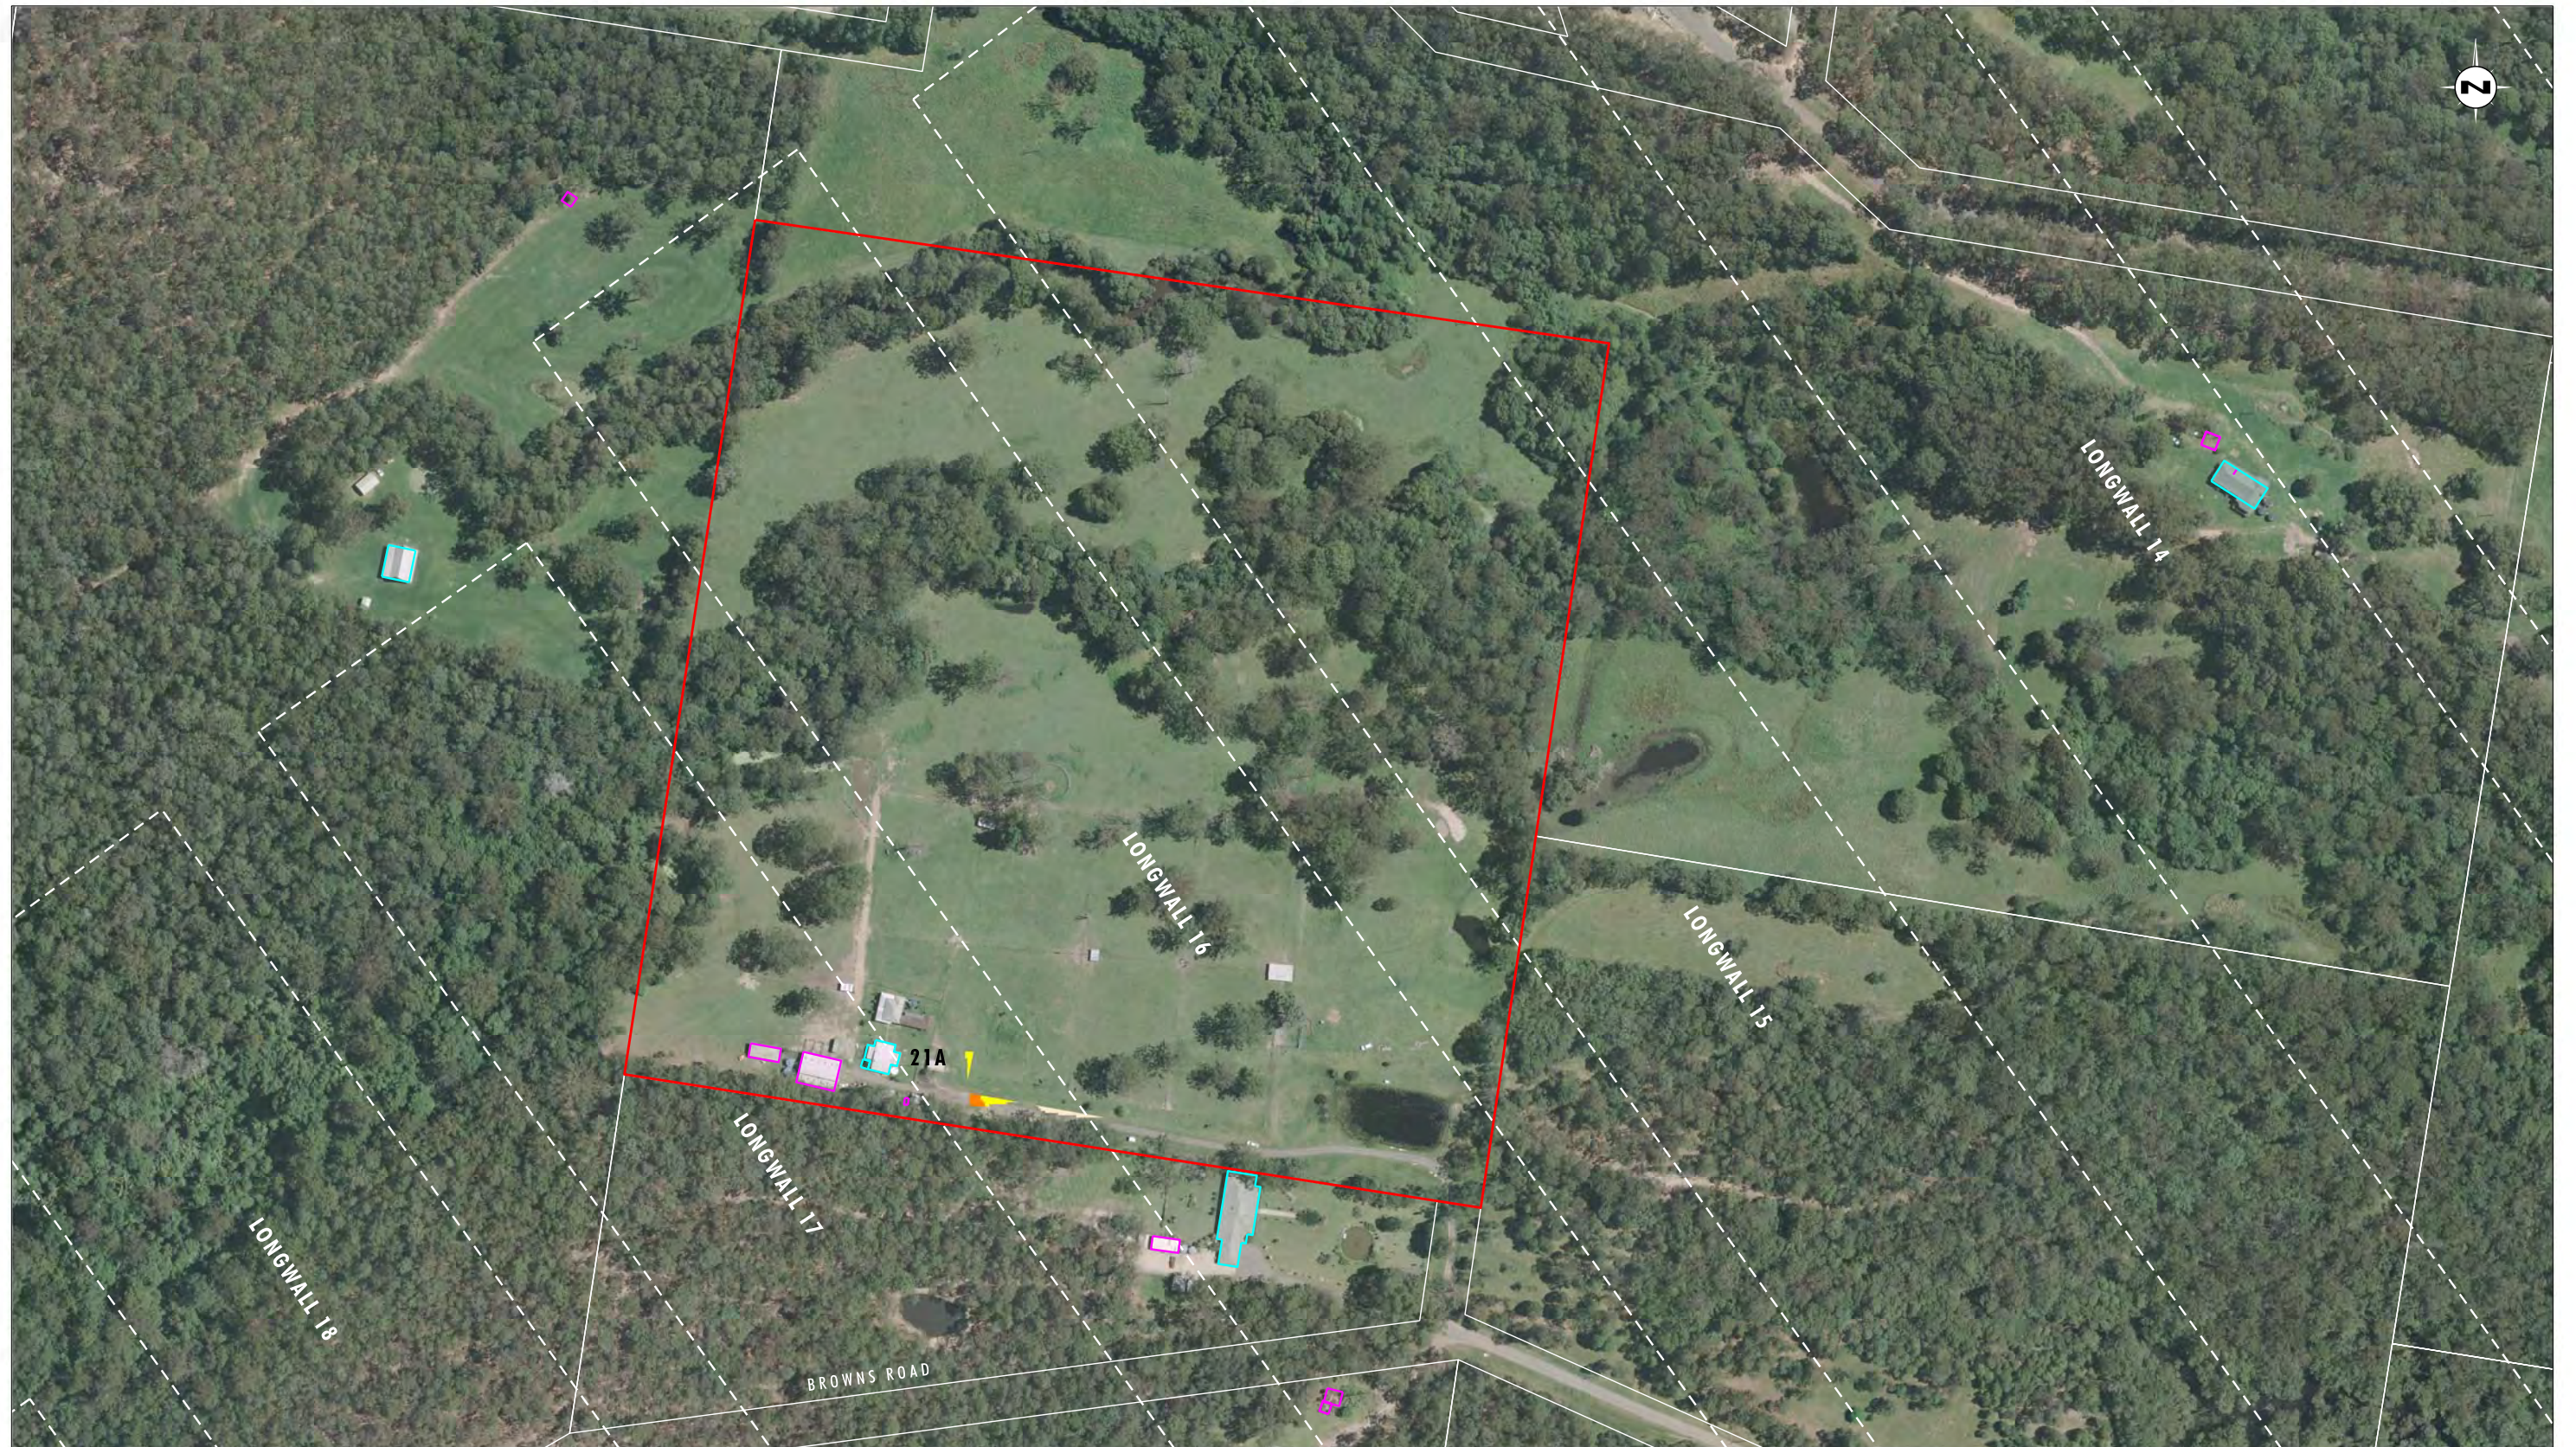
Image Source: Centennial Mandalong Pty Ltd (2009) - Aerial Photograph  
 Data Source: Centennial Mandalong Pty Ltd, LPI - Cadastral Boundaries  
 Note: Flood Hazard shown for access and dwellings only

Property 21 - 100 year ARI Storm Event:  
 Maximum Flood Hazard Categories Pre Mining Landform

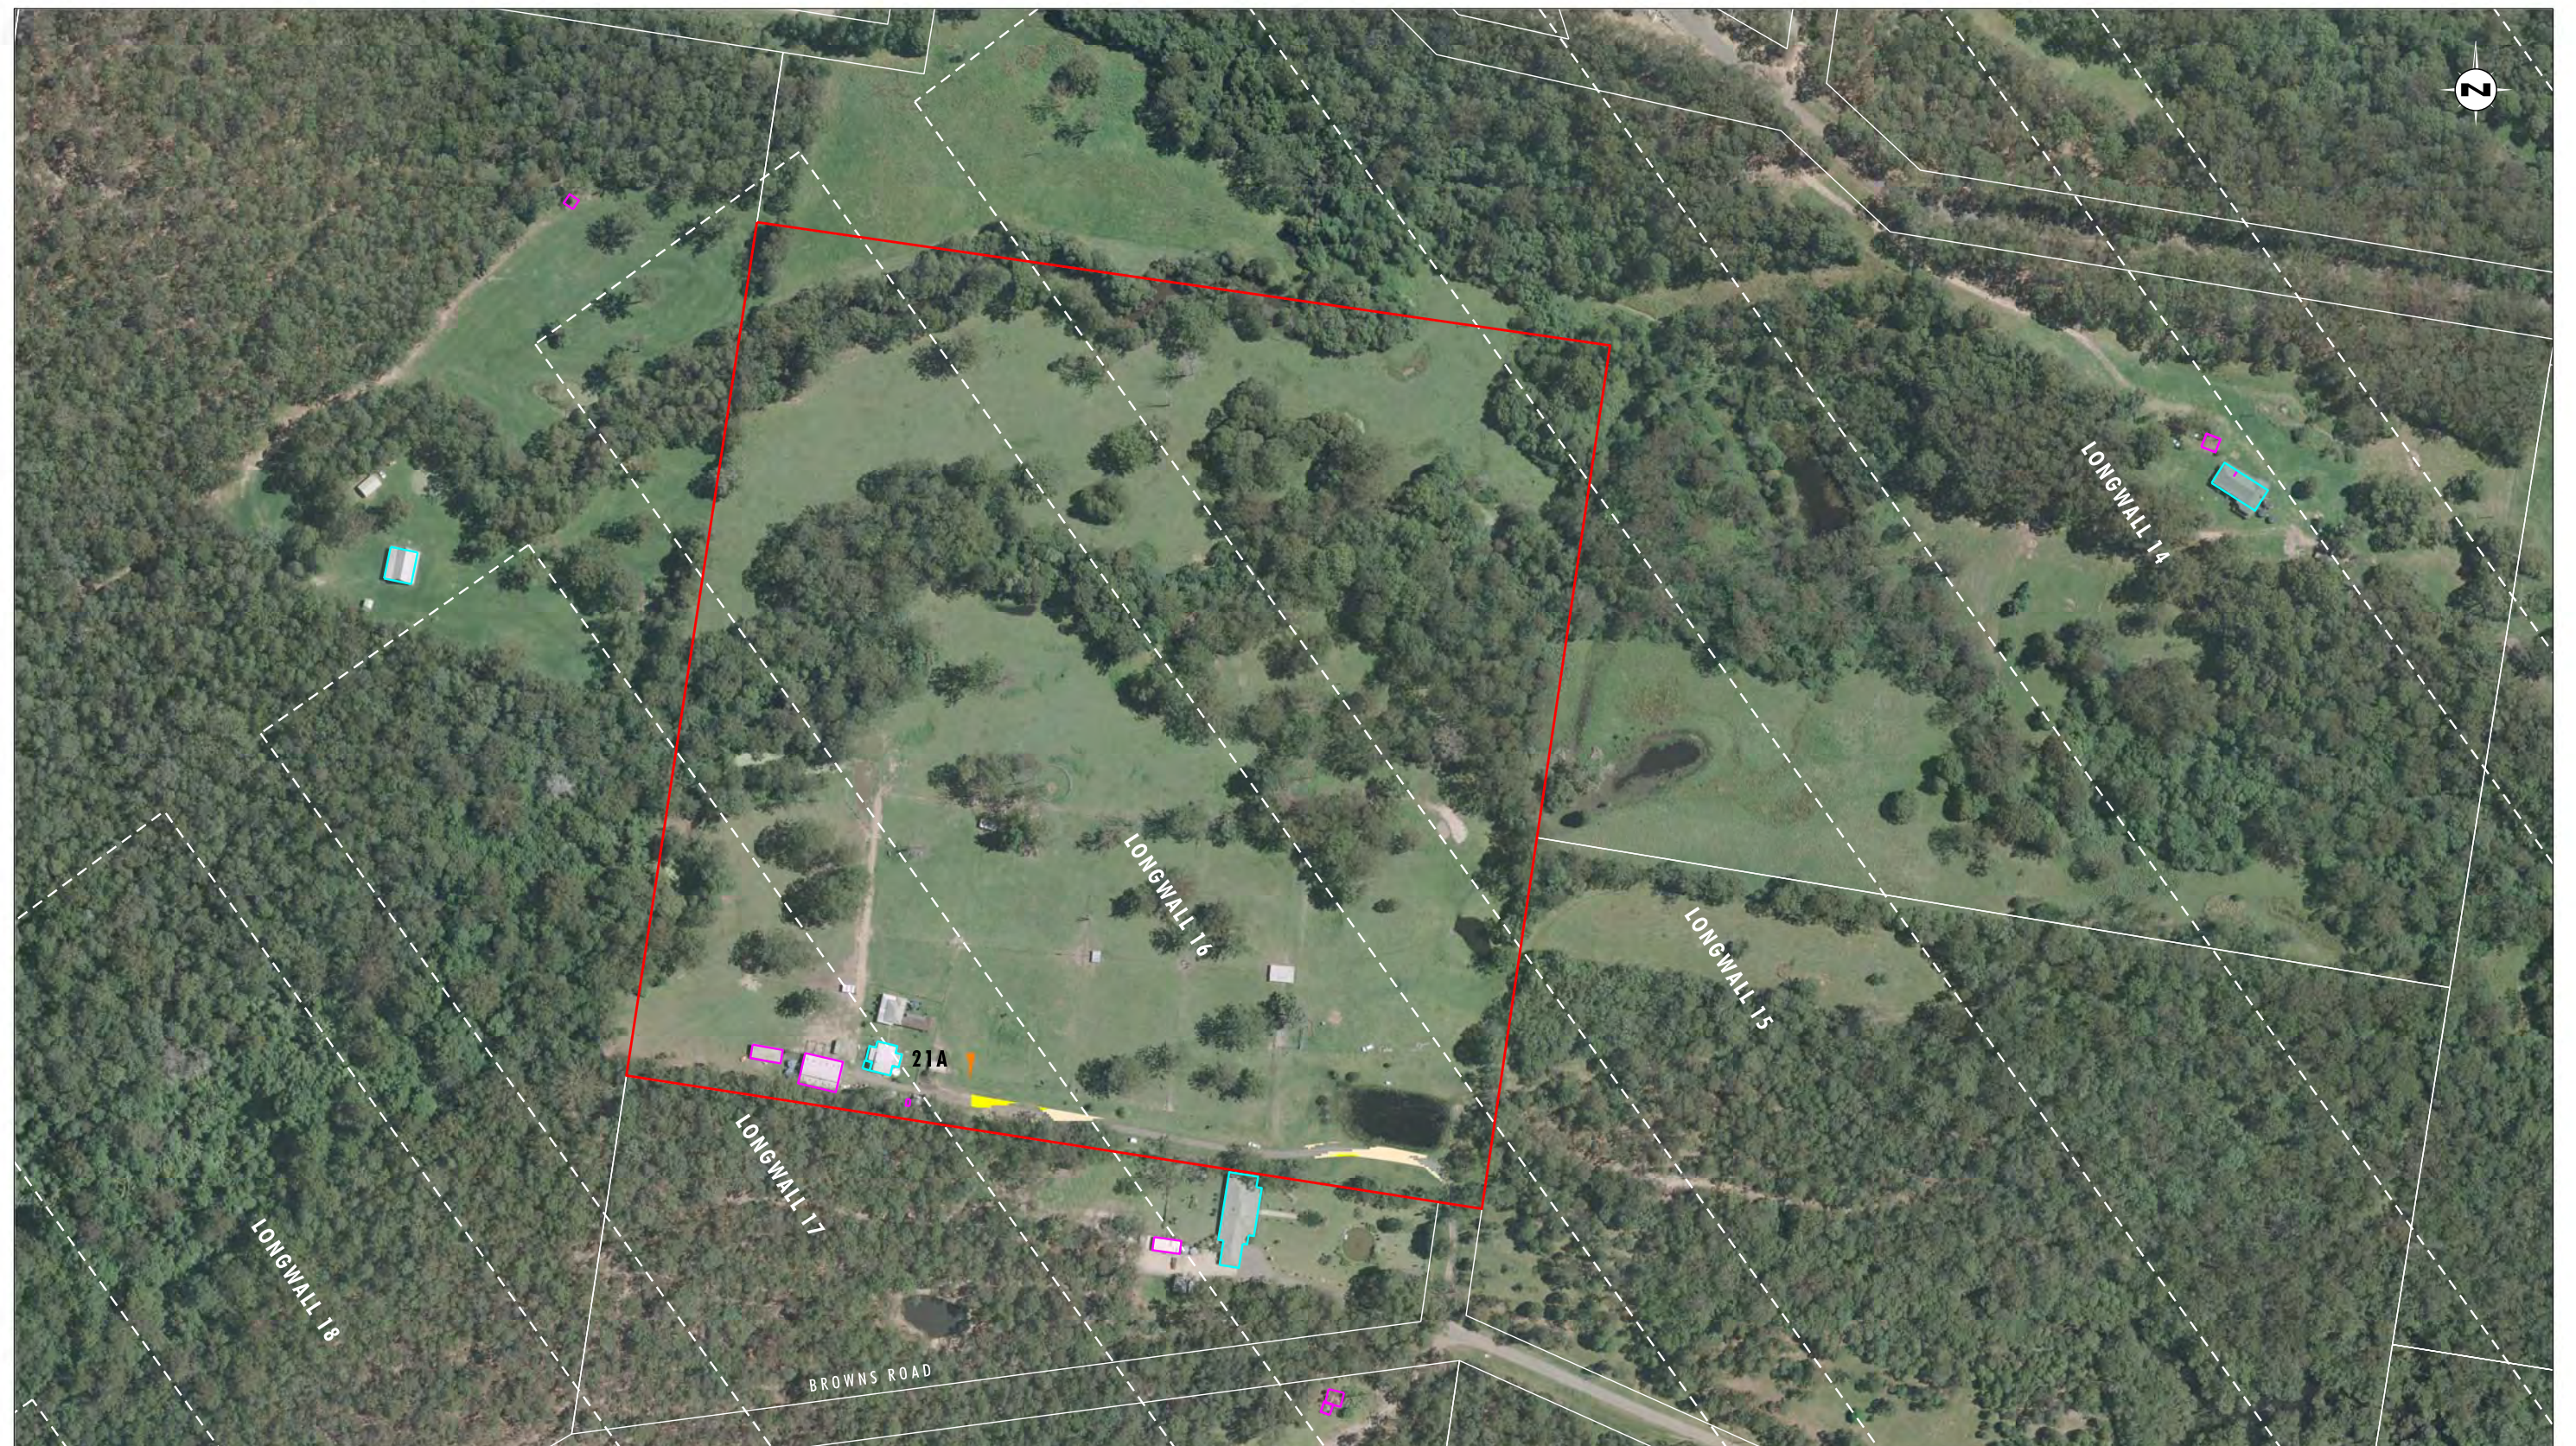
Image Source: Centennial Mandalong Pty Ltd (2009) - Aerial Photograph  
 Data Source: Centennial Mandalong Pty Ltd, LPI - Cadastral Boundaries  
 Note: Flood Hazard shown for access and dwellings only

Property 21 - 100 year ARI Storm Event:  
 Maximum Flood Hazard Categories Post Mining Landform  
 (to Longwall 23)
