## APPENDIX 1

**Flooding Assessment Figures -  
Property 7 (Centennial)**

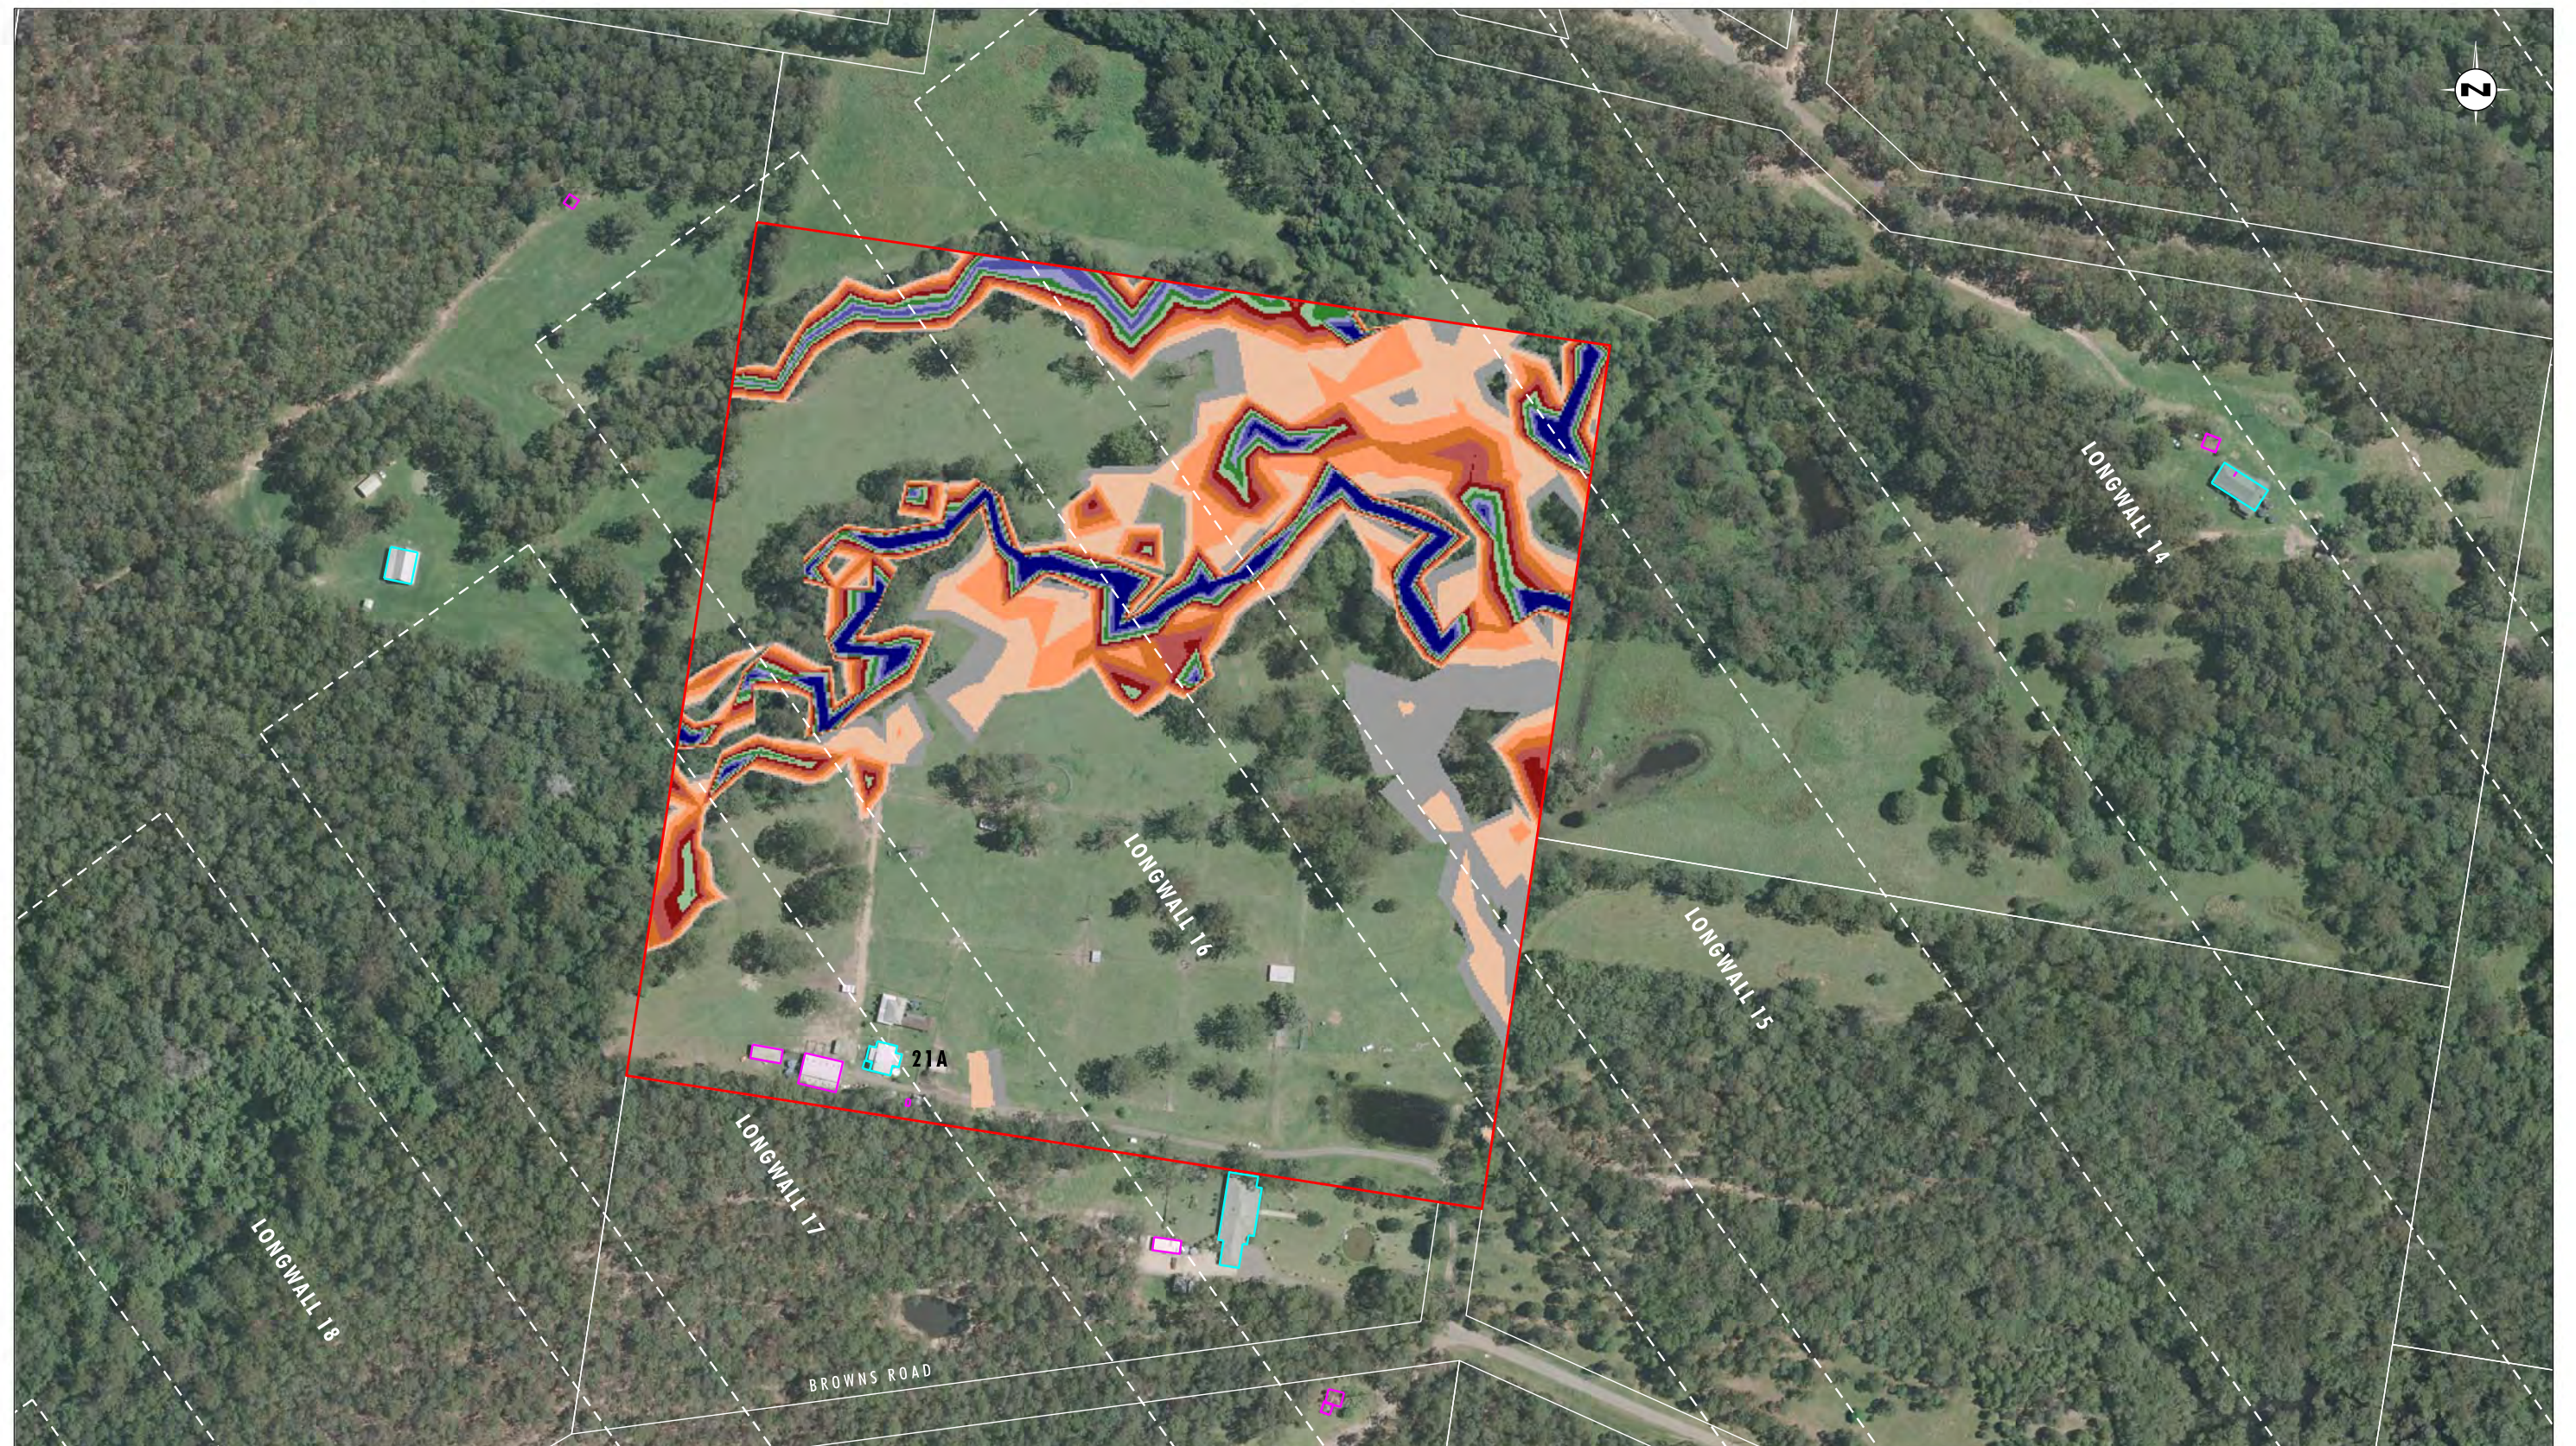
Property 21 - 1 year ARI Storm Event:  
Maximum Flood Depth Pre Mining Landform

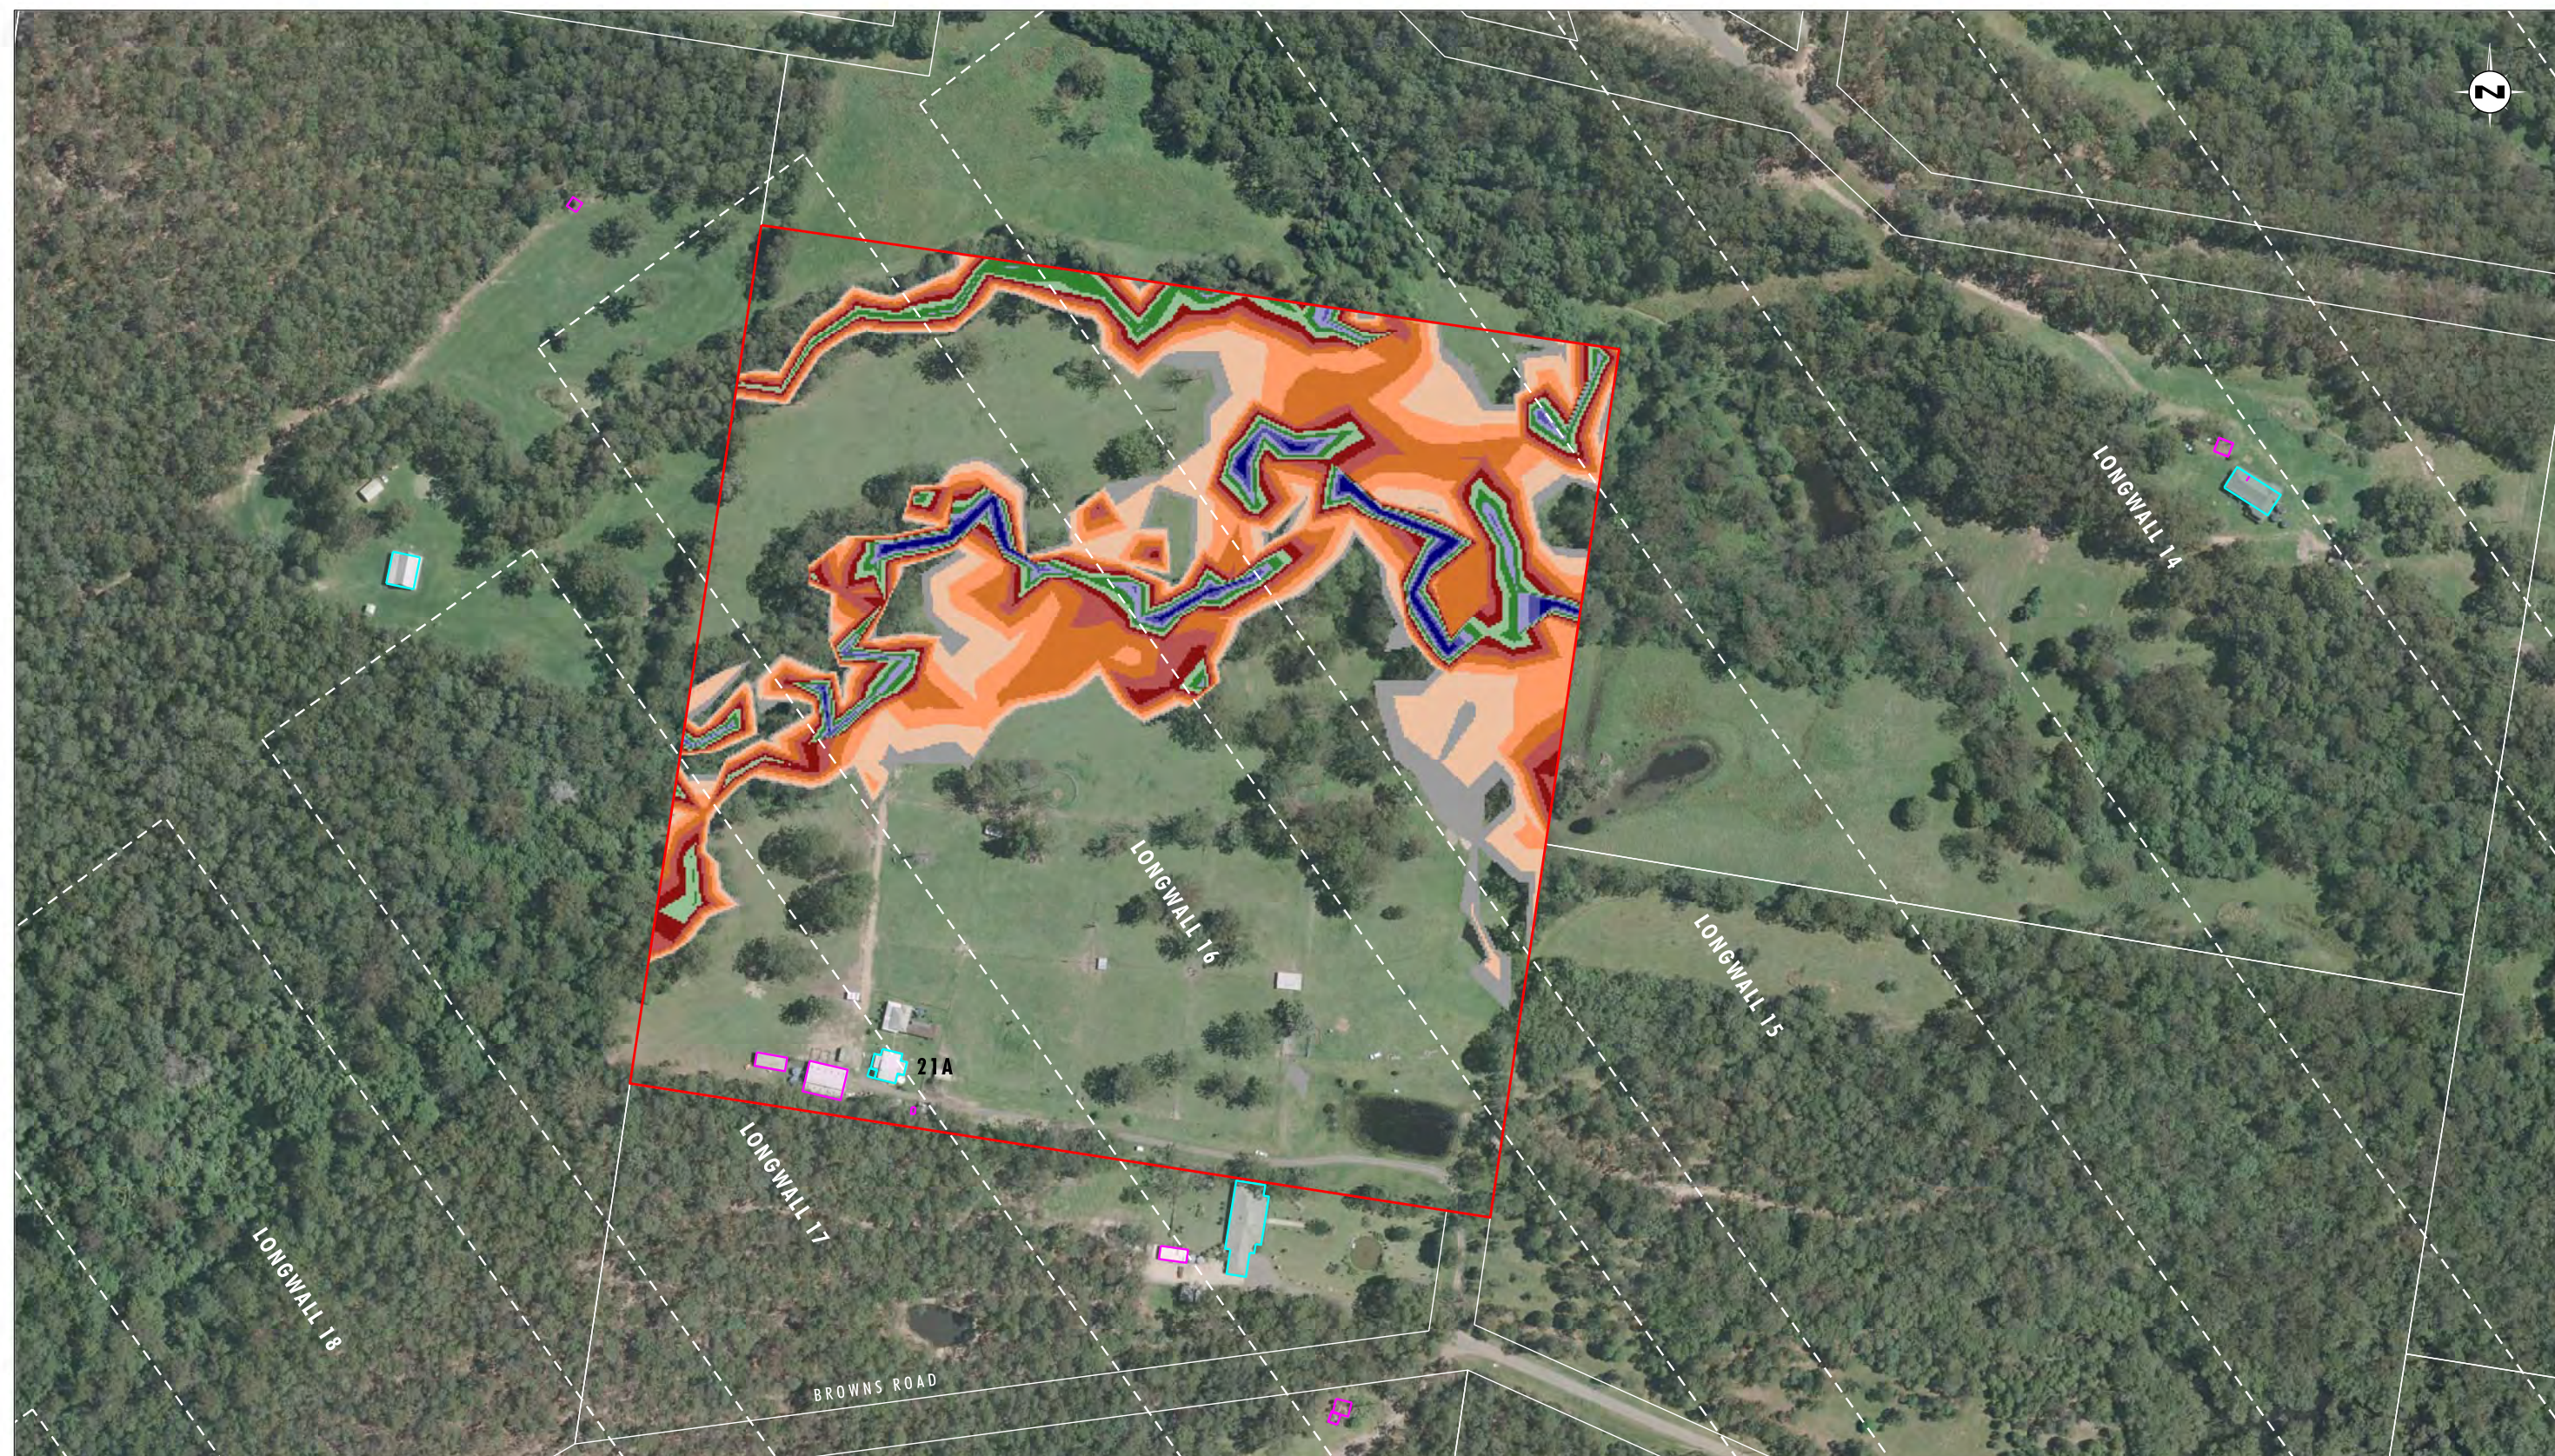
Property 21 - 1 year ARI Storm Event:  
Maximum Flood Depth Post Mining Landform  
(to Longwall 23)

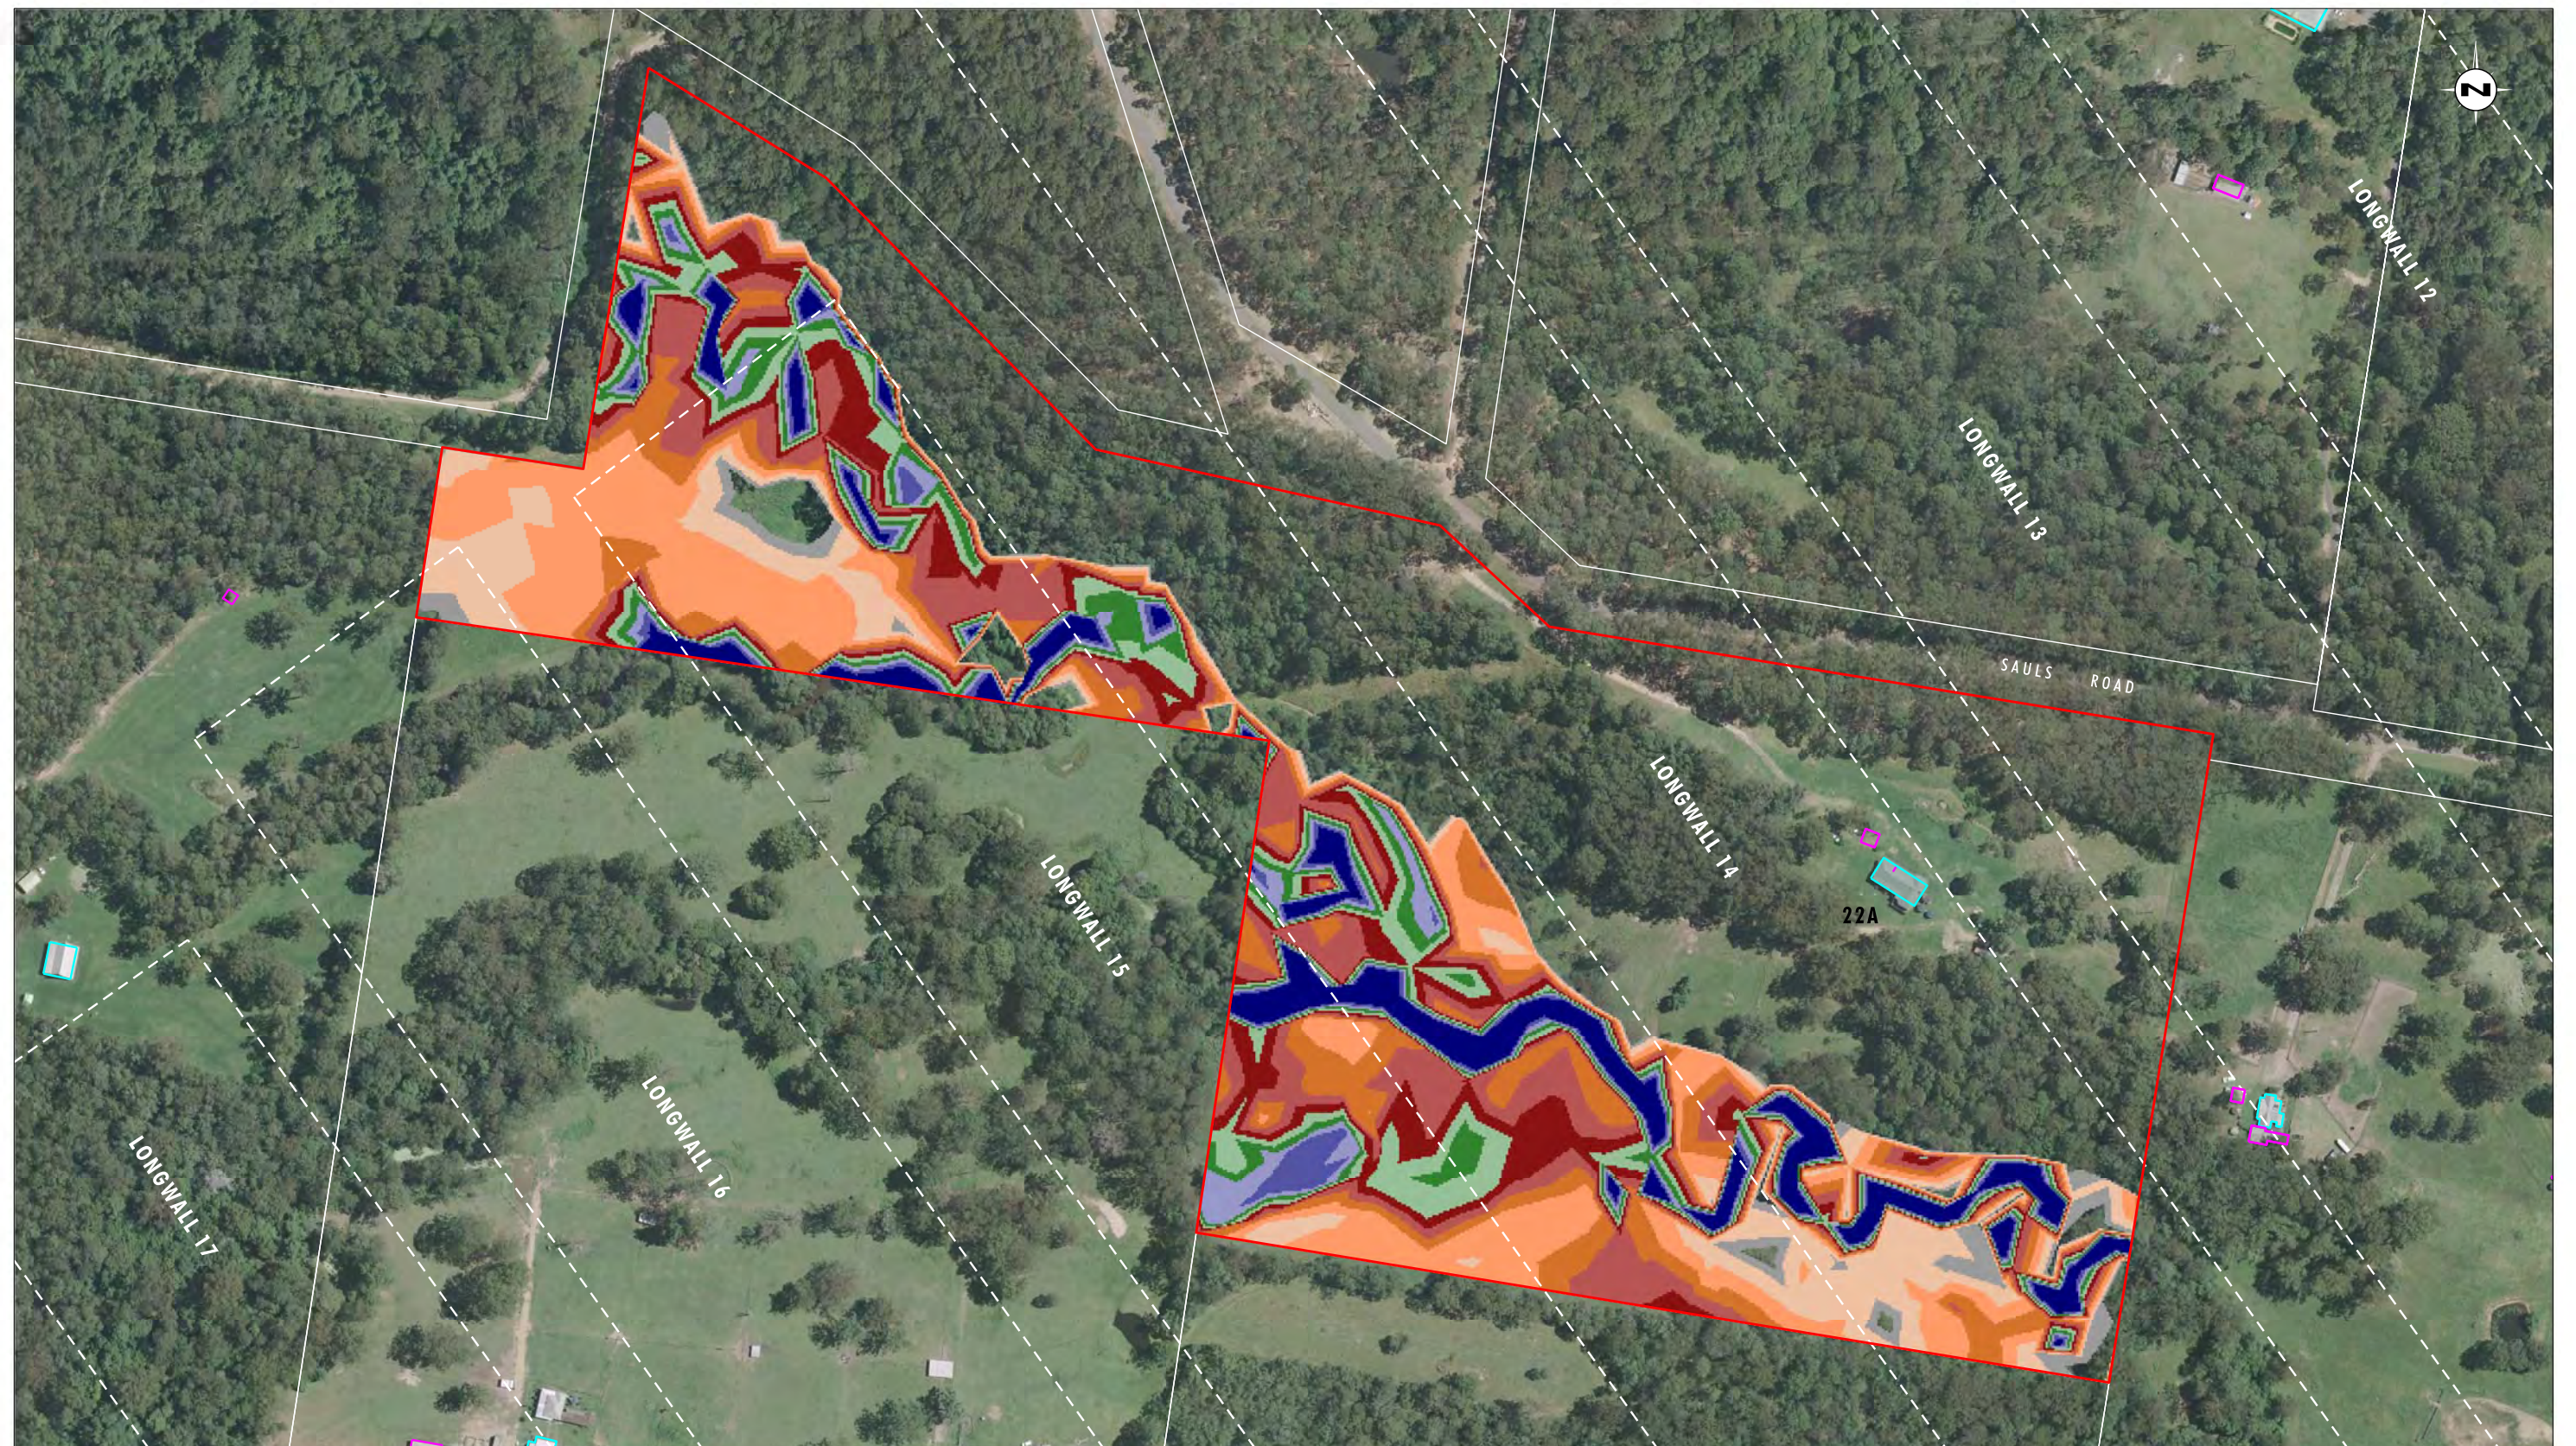
FIGURE 1

Property 22 - 100 year ARI Storm Event:  
Maximum Flood Depth Pre Mining Landform

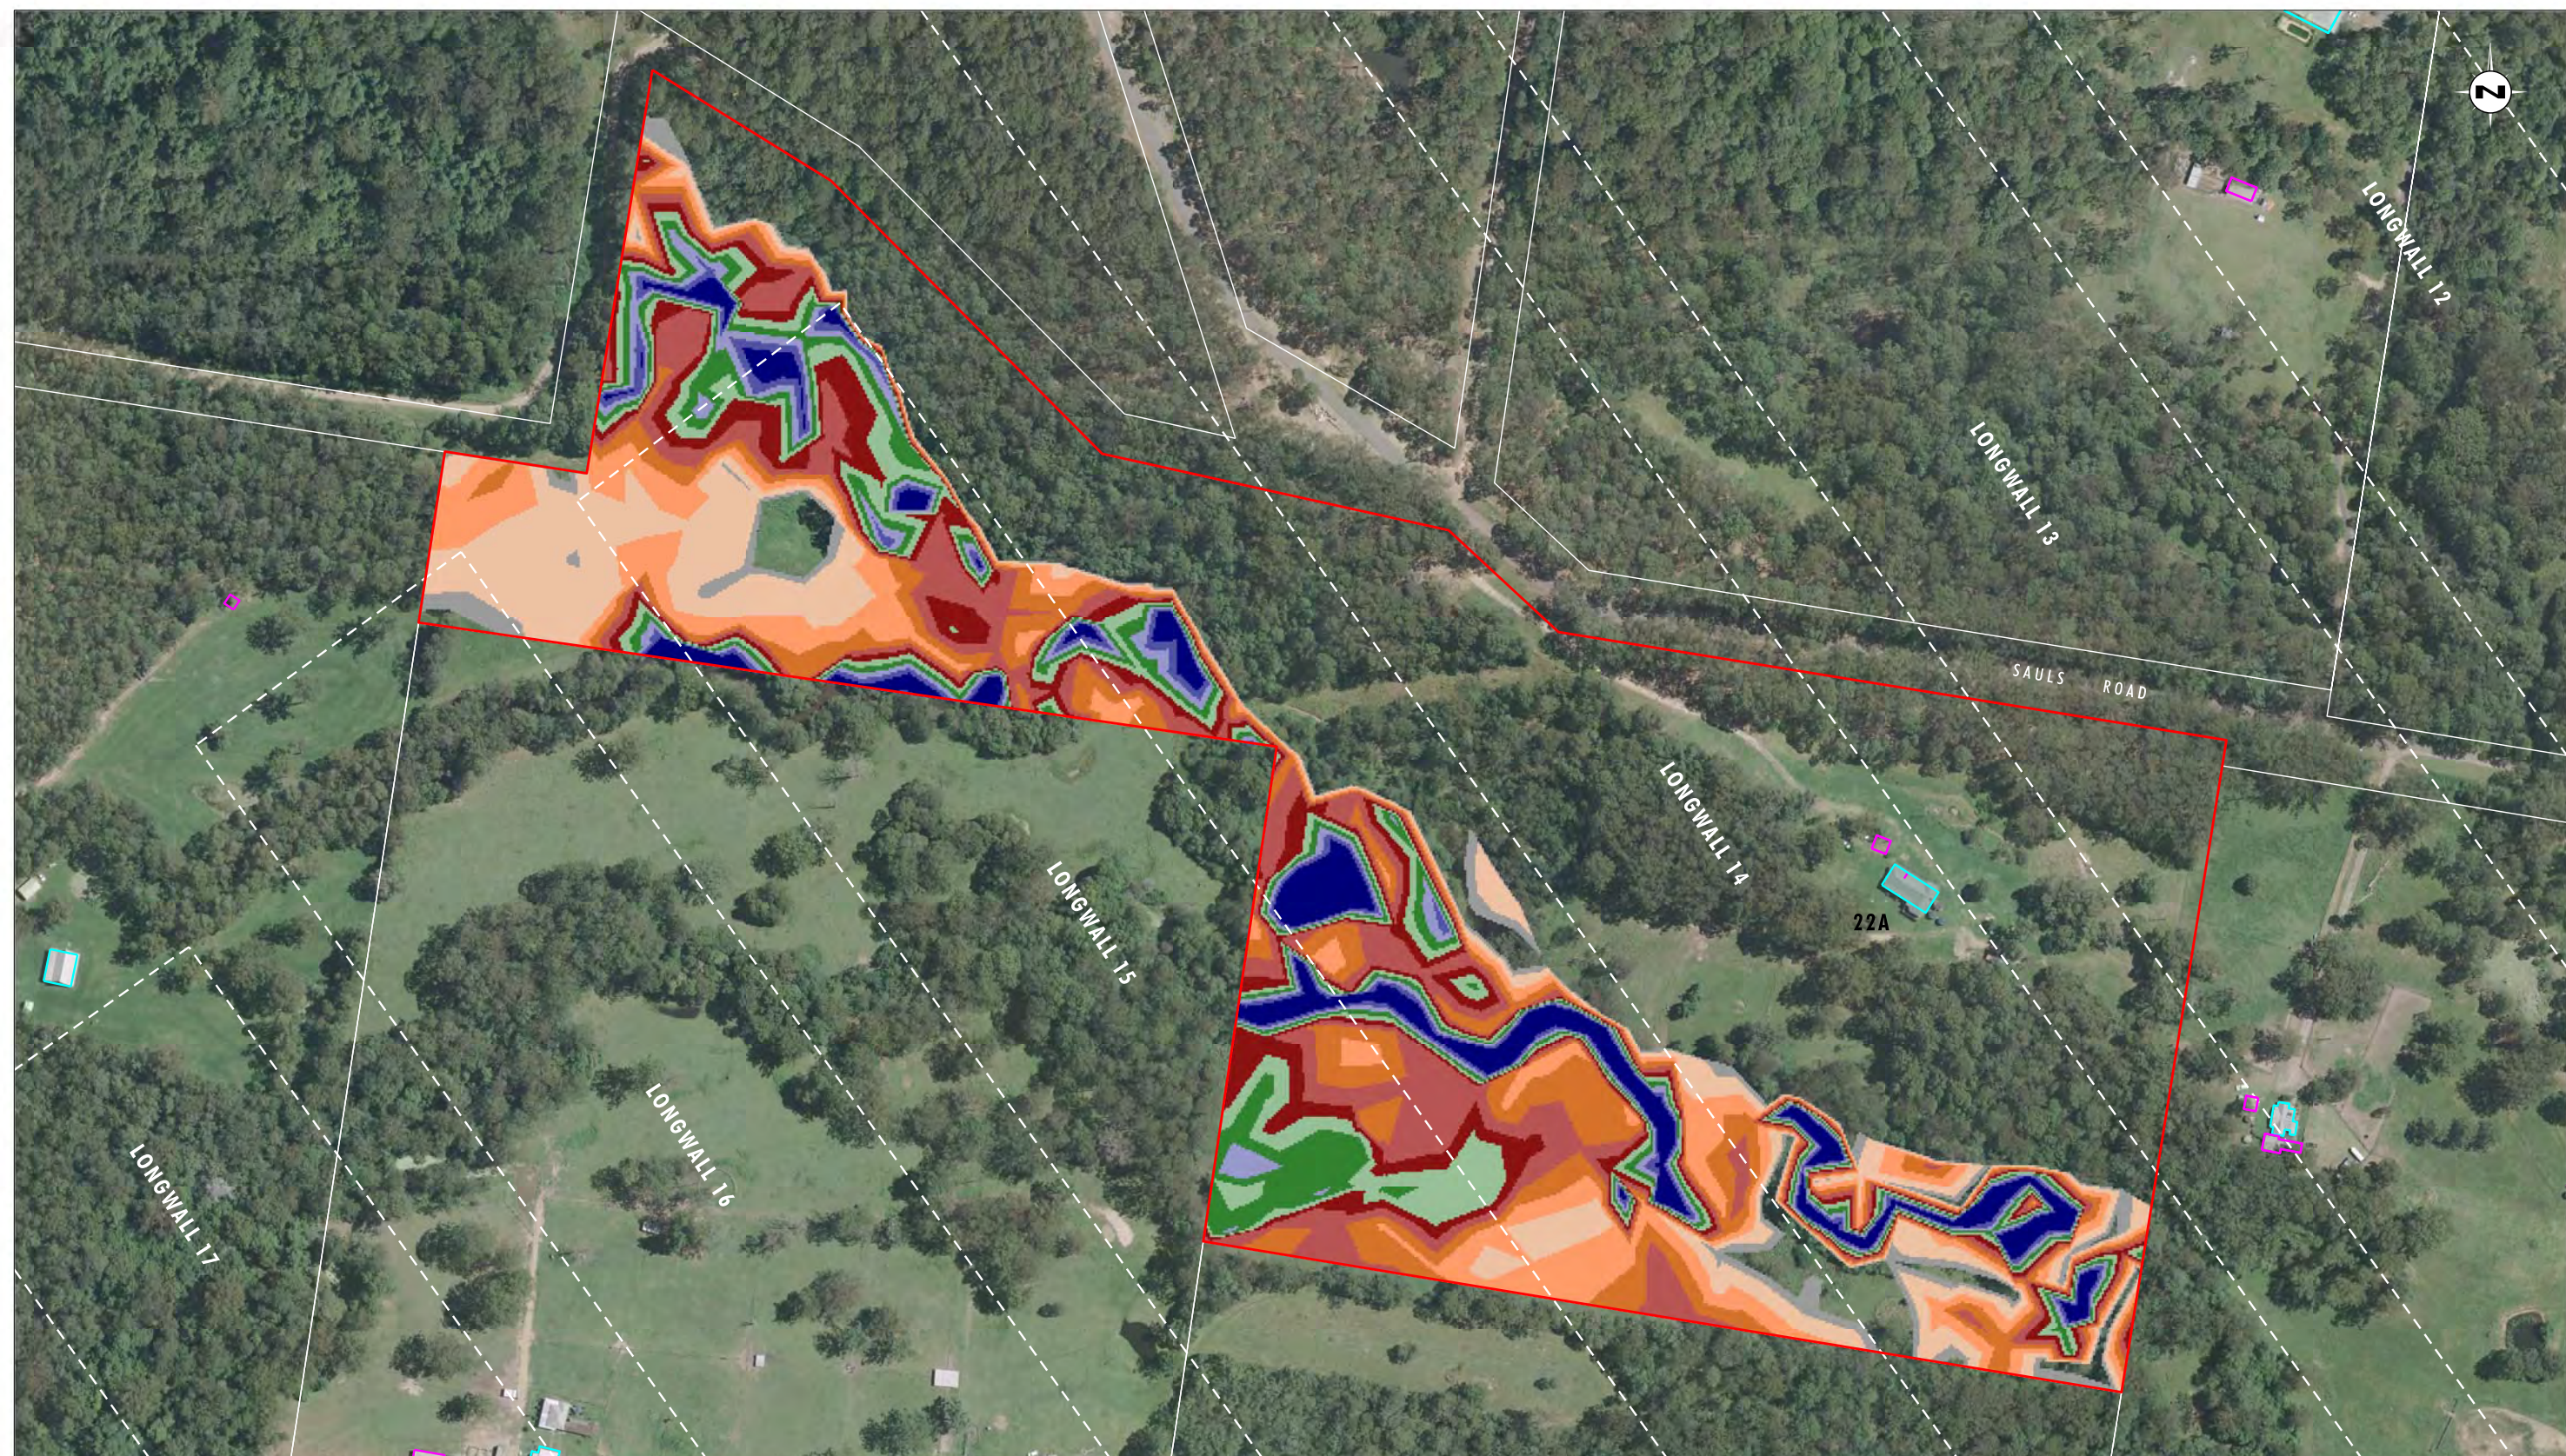
Property 22 - 100 year ARI Storm Event:  
Maximum Flood Depth Post Mining Landform  
(to Longwall 23)

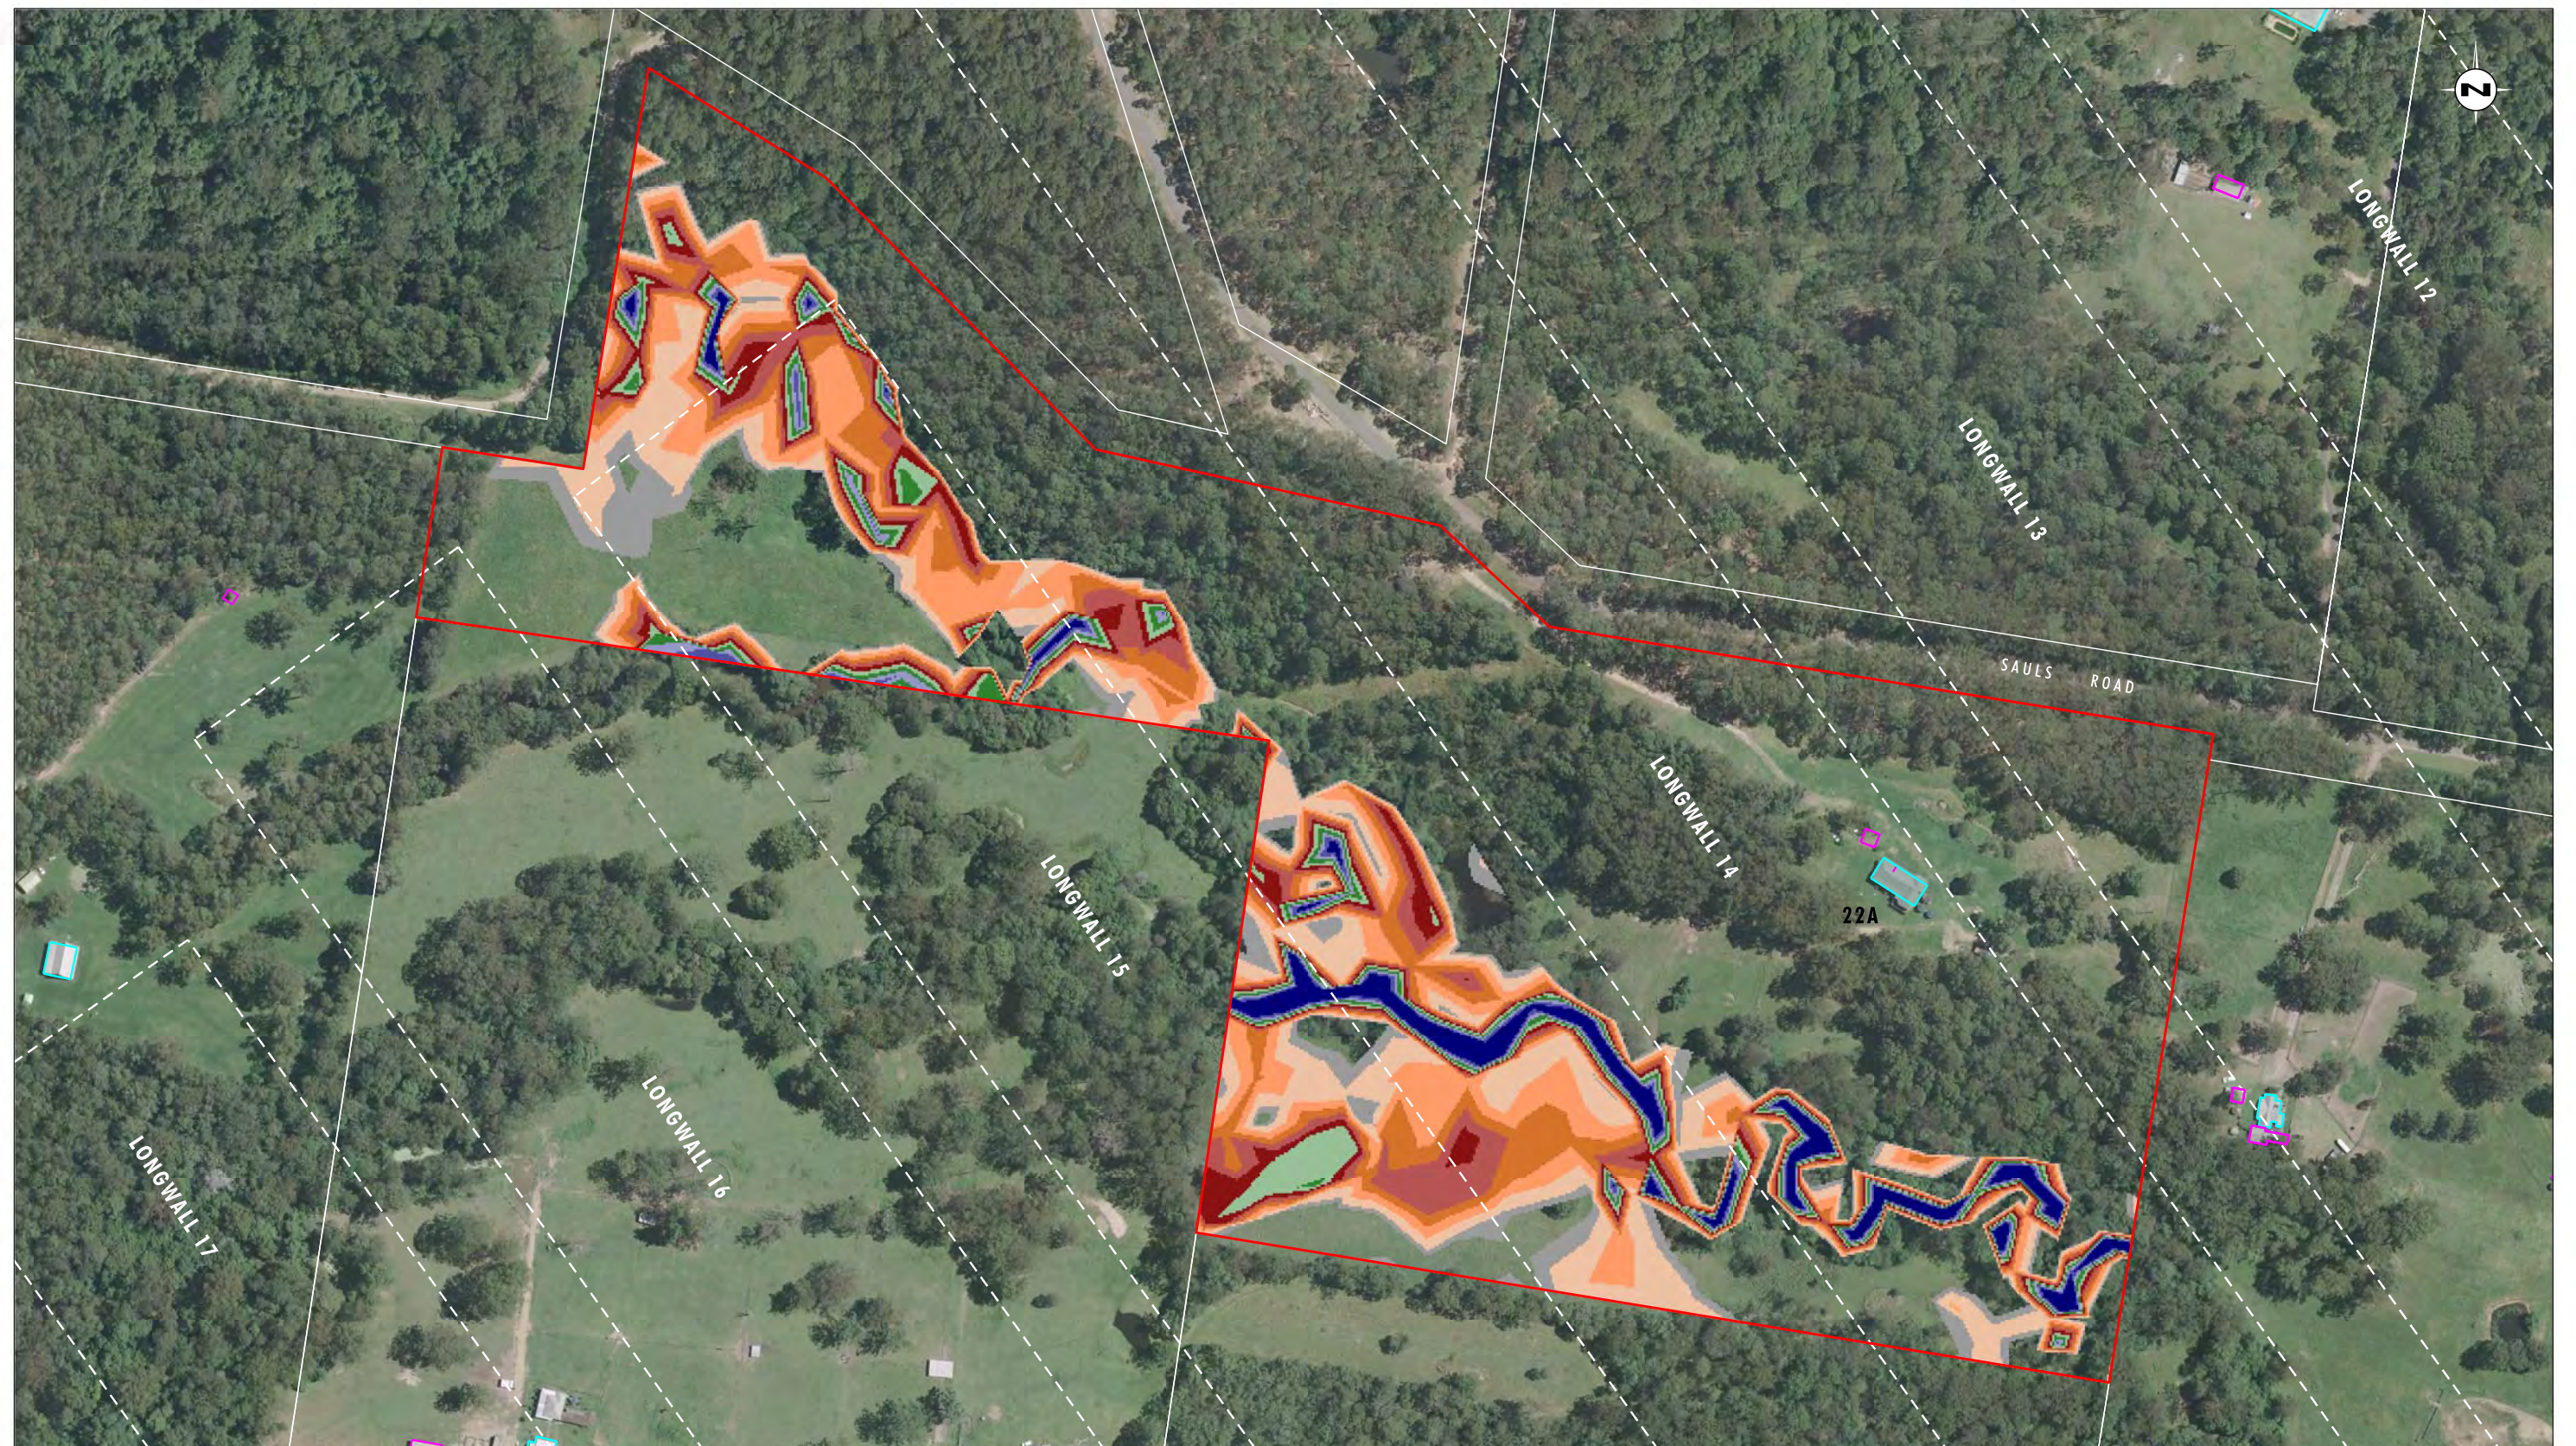
FIGURE 3

Property 22 - 1 year ARI Storm Event:  
Maximum Flood Depth Pre Mining Landform

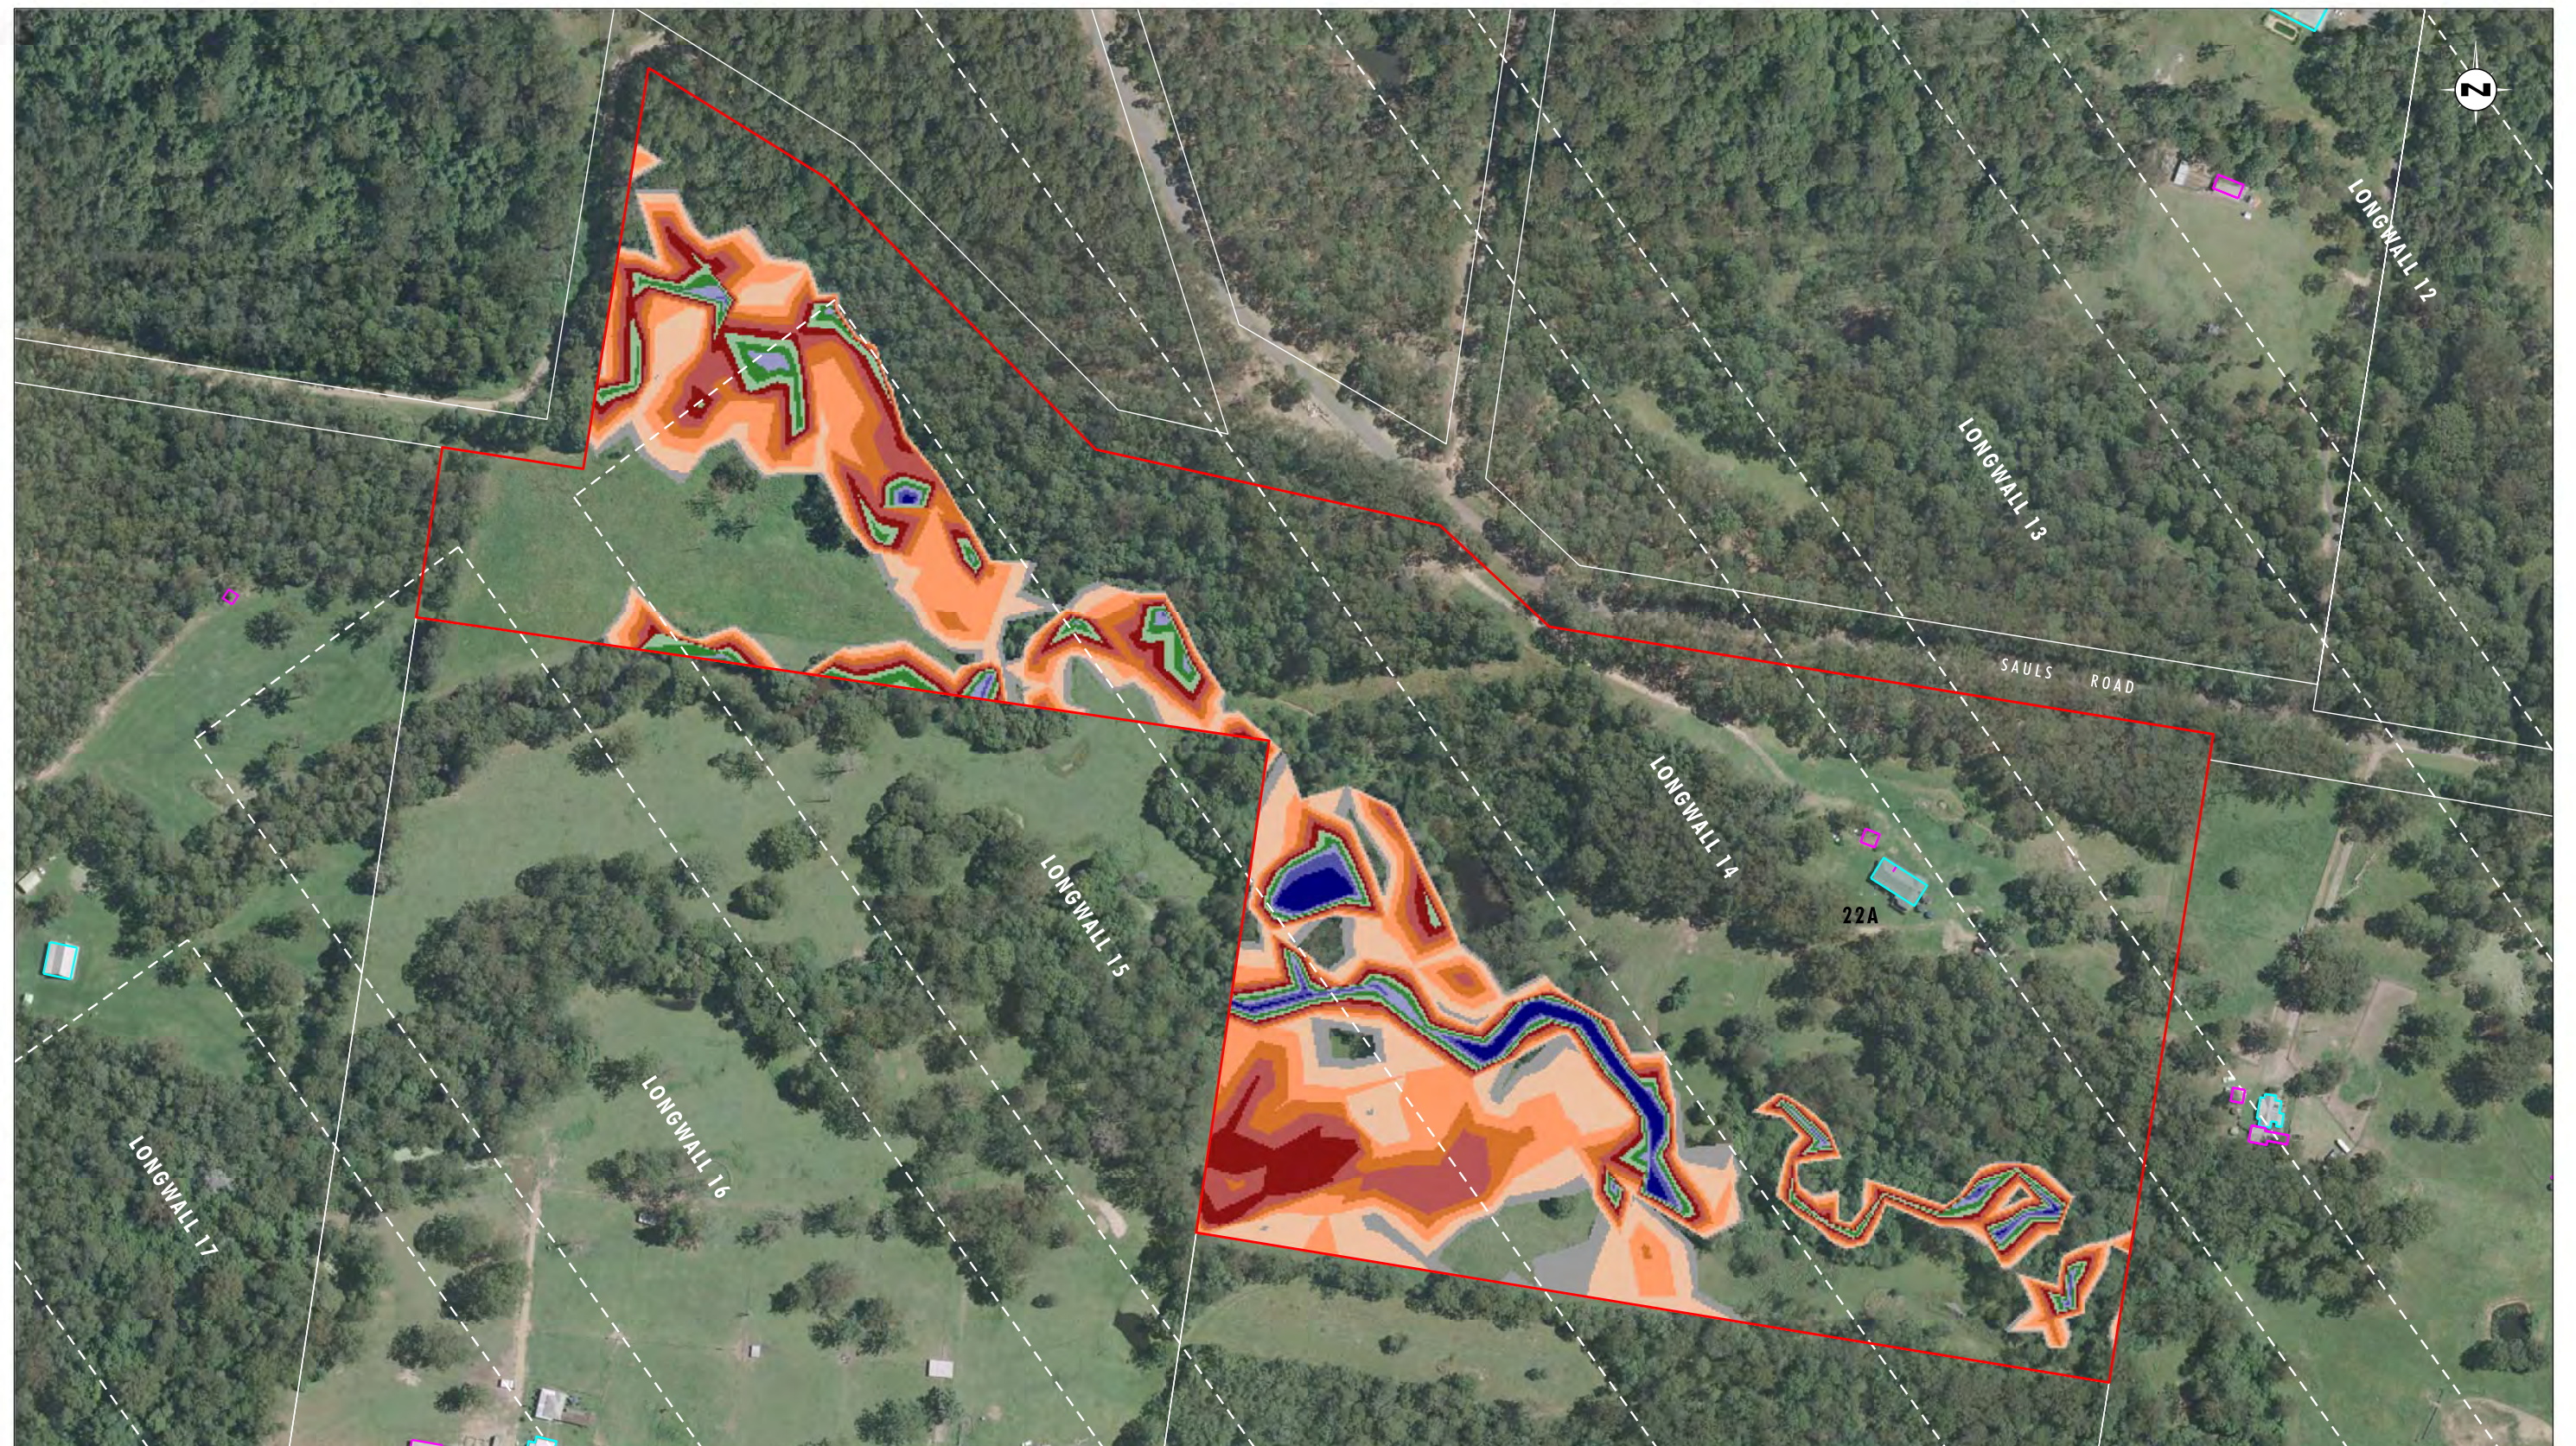
FIGURE 4

Property 22 - 1 year ARI Storm Event:  
Maximum Flood Depth Post Mining Landform  
(to Longwall 23)
