## APPENDIX 31

Flooding Assessment Figures -  
Property 213

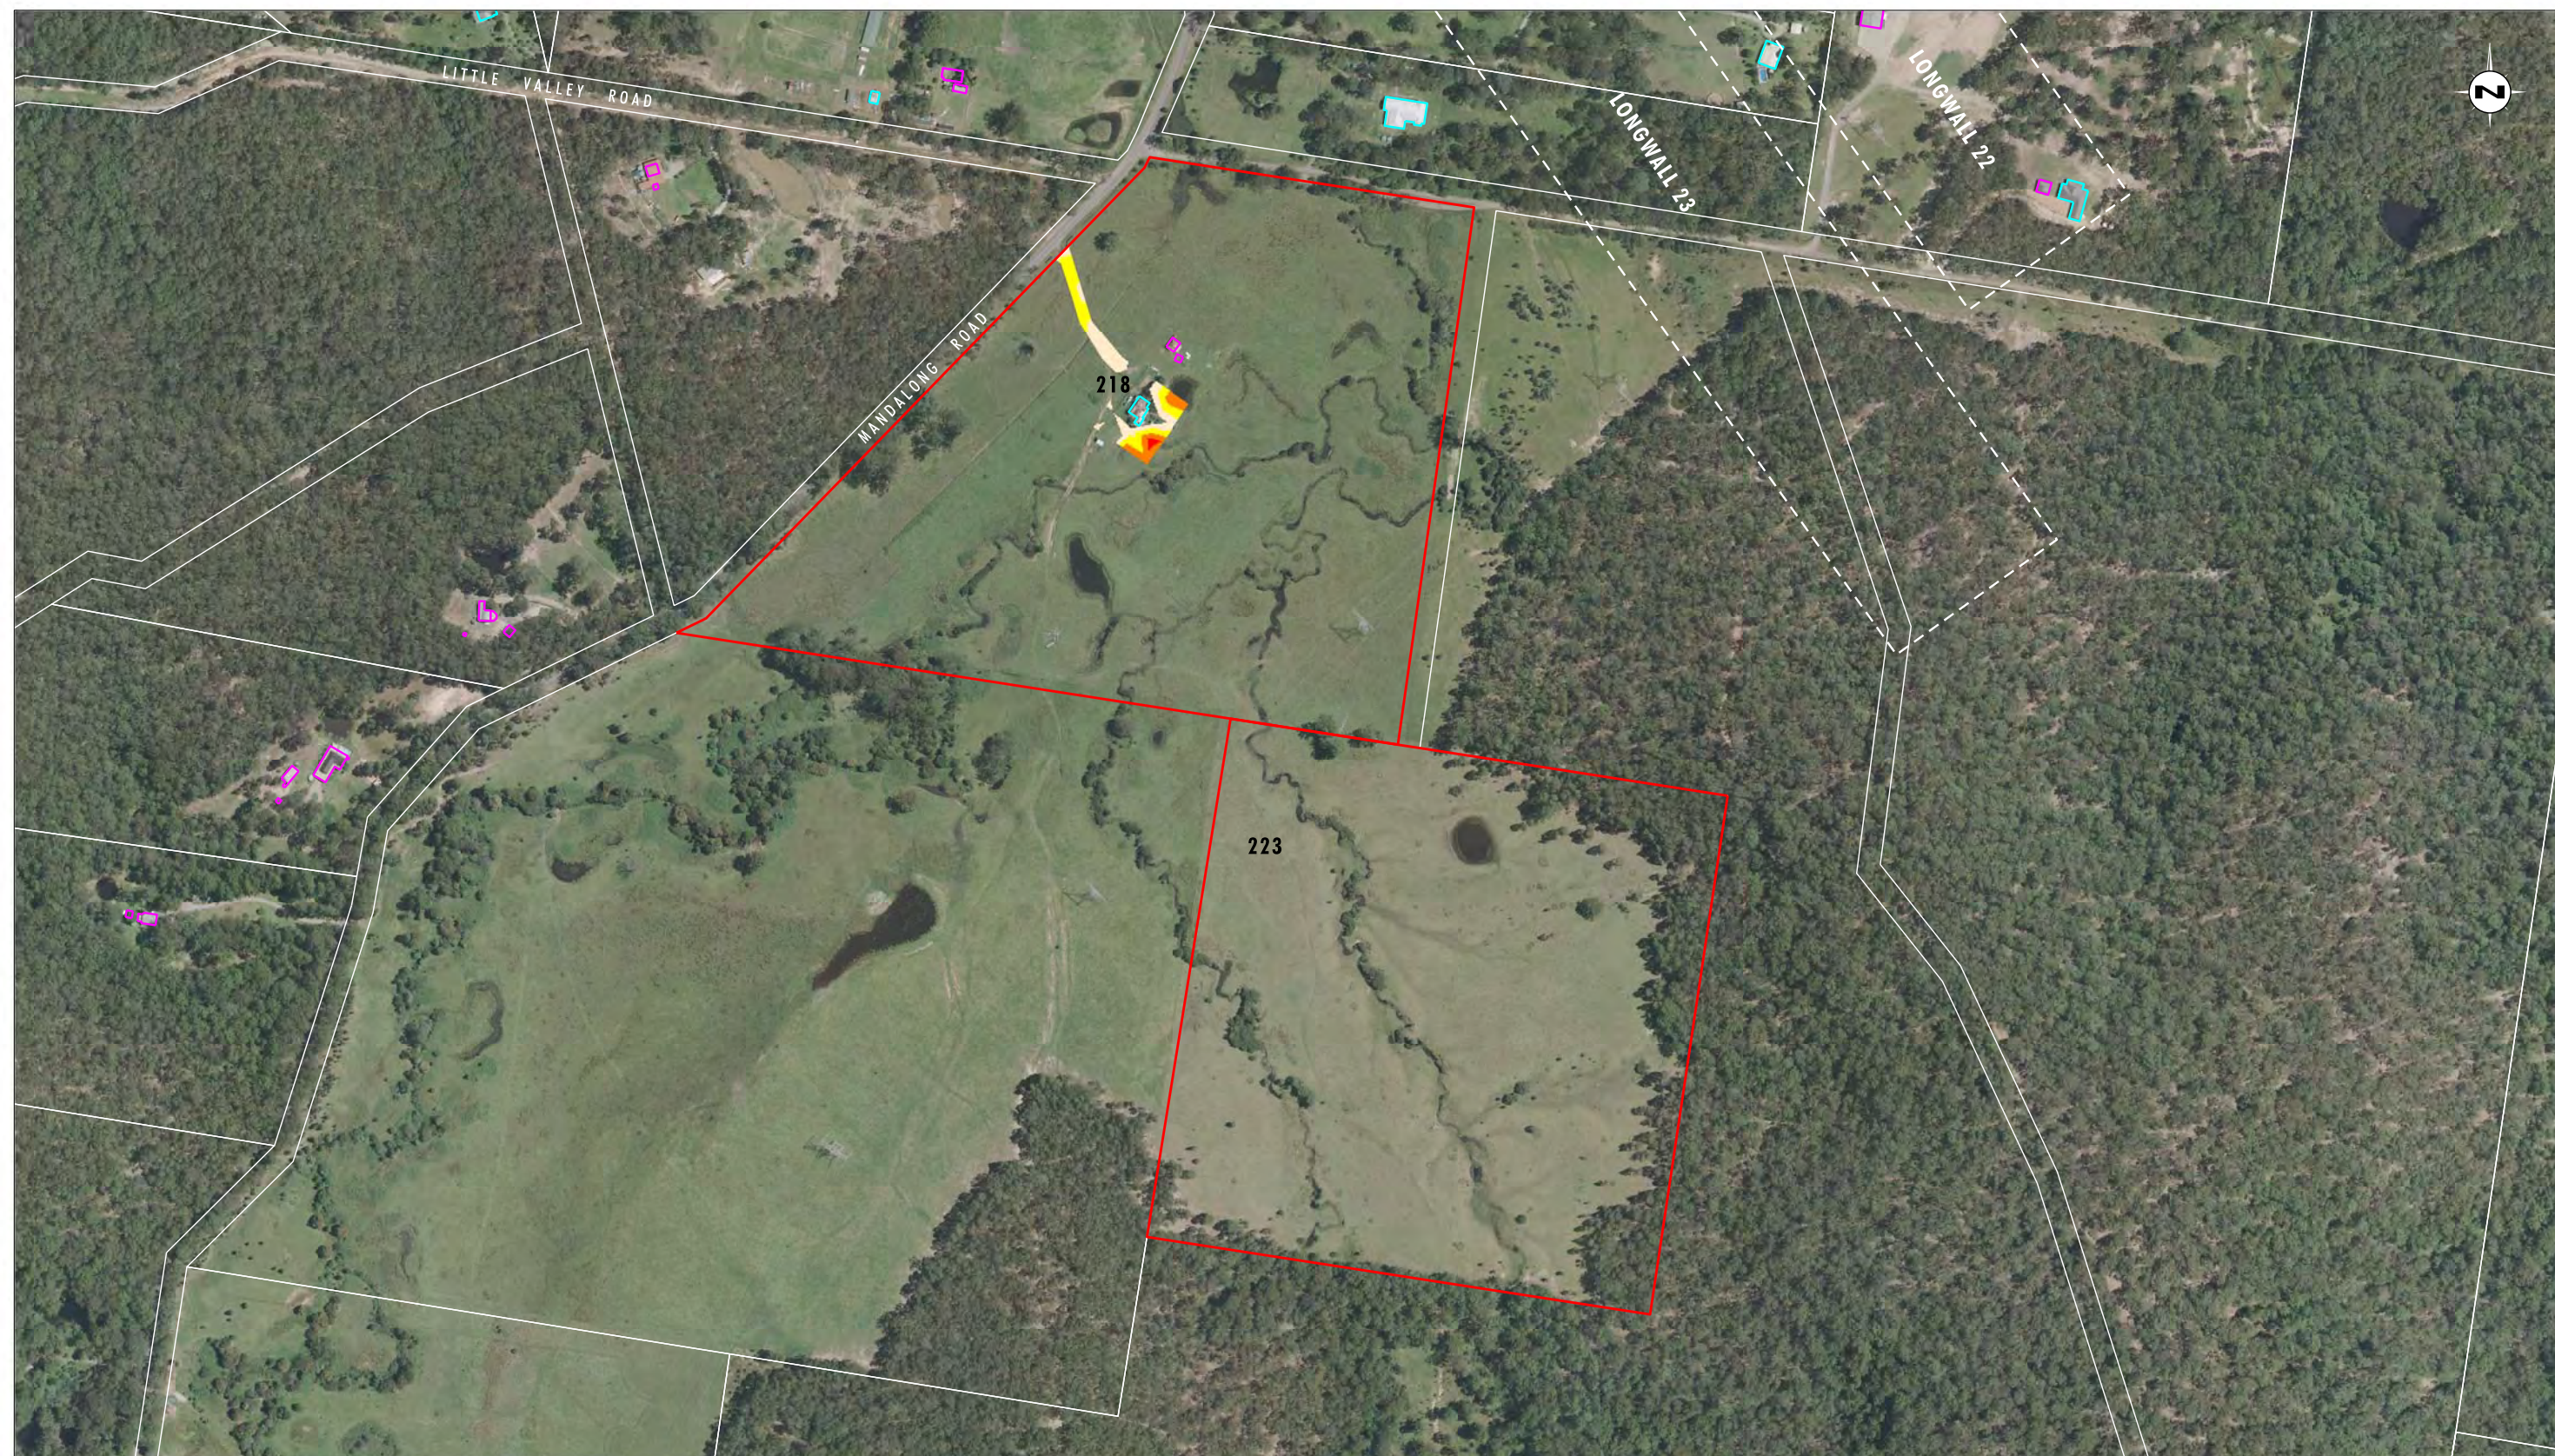
**FIGURE 3**  
 Property 218 & 223 - 100 Year ARI Storm Event:  
 Maximum Flood Hazard Categories Pre Mining Landform

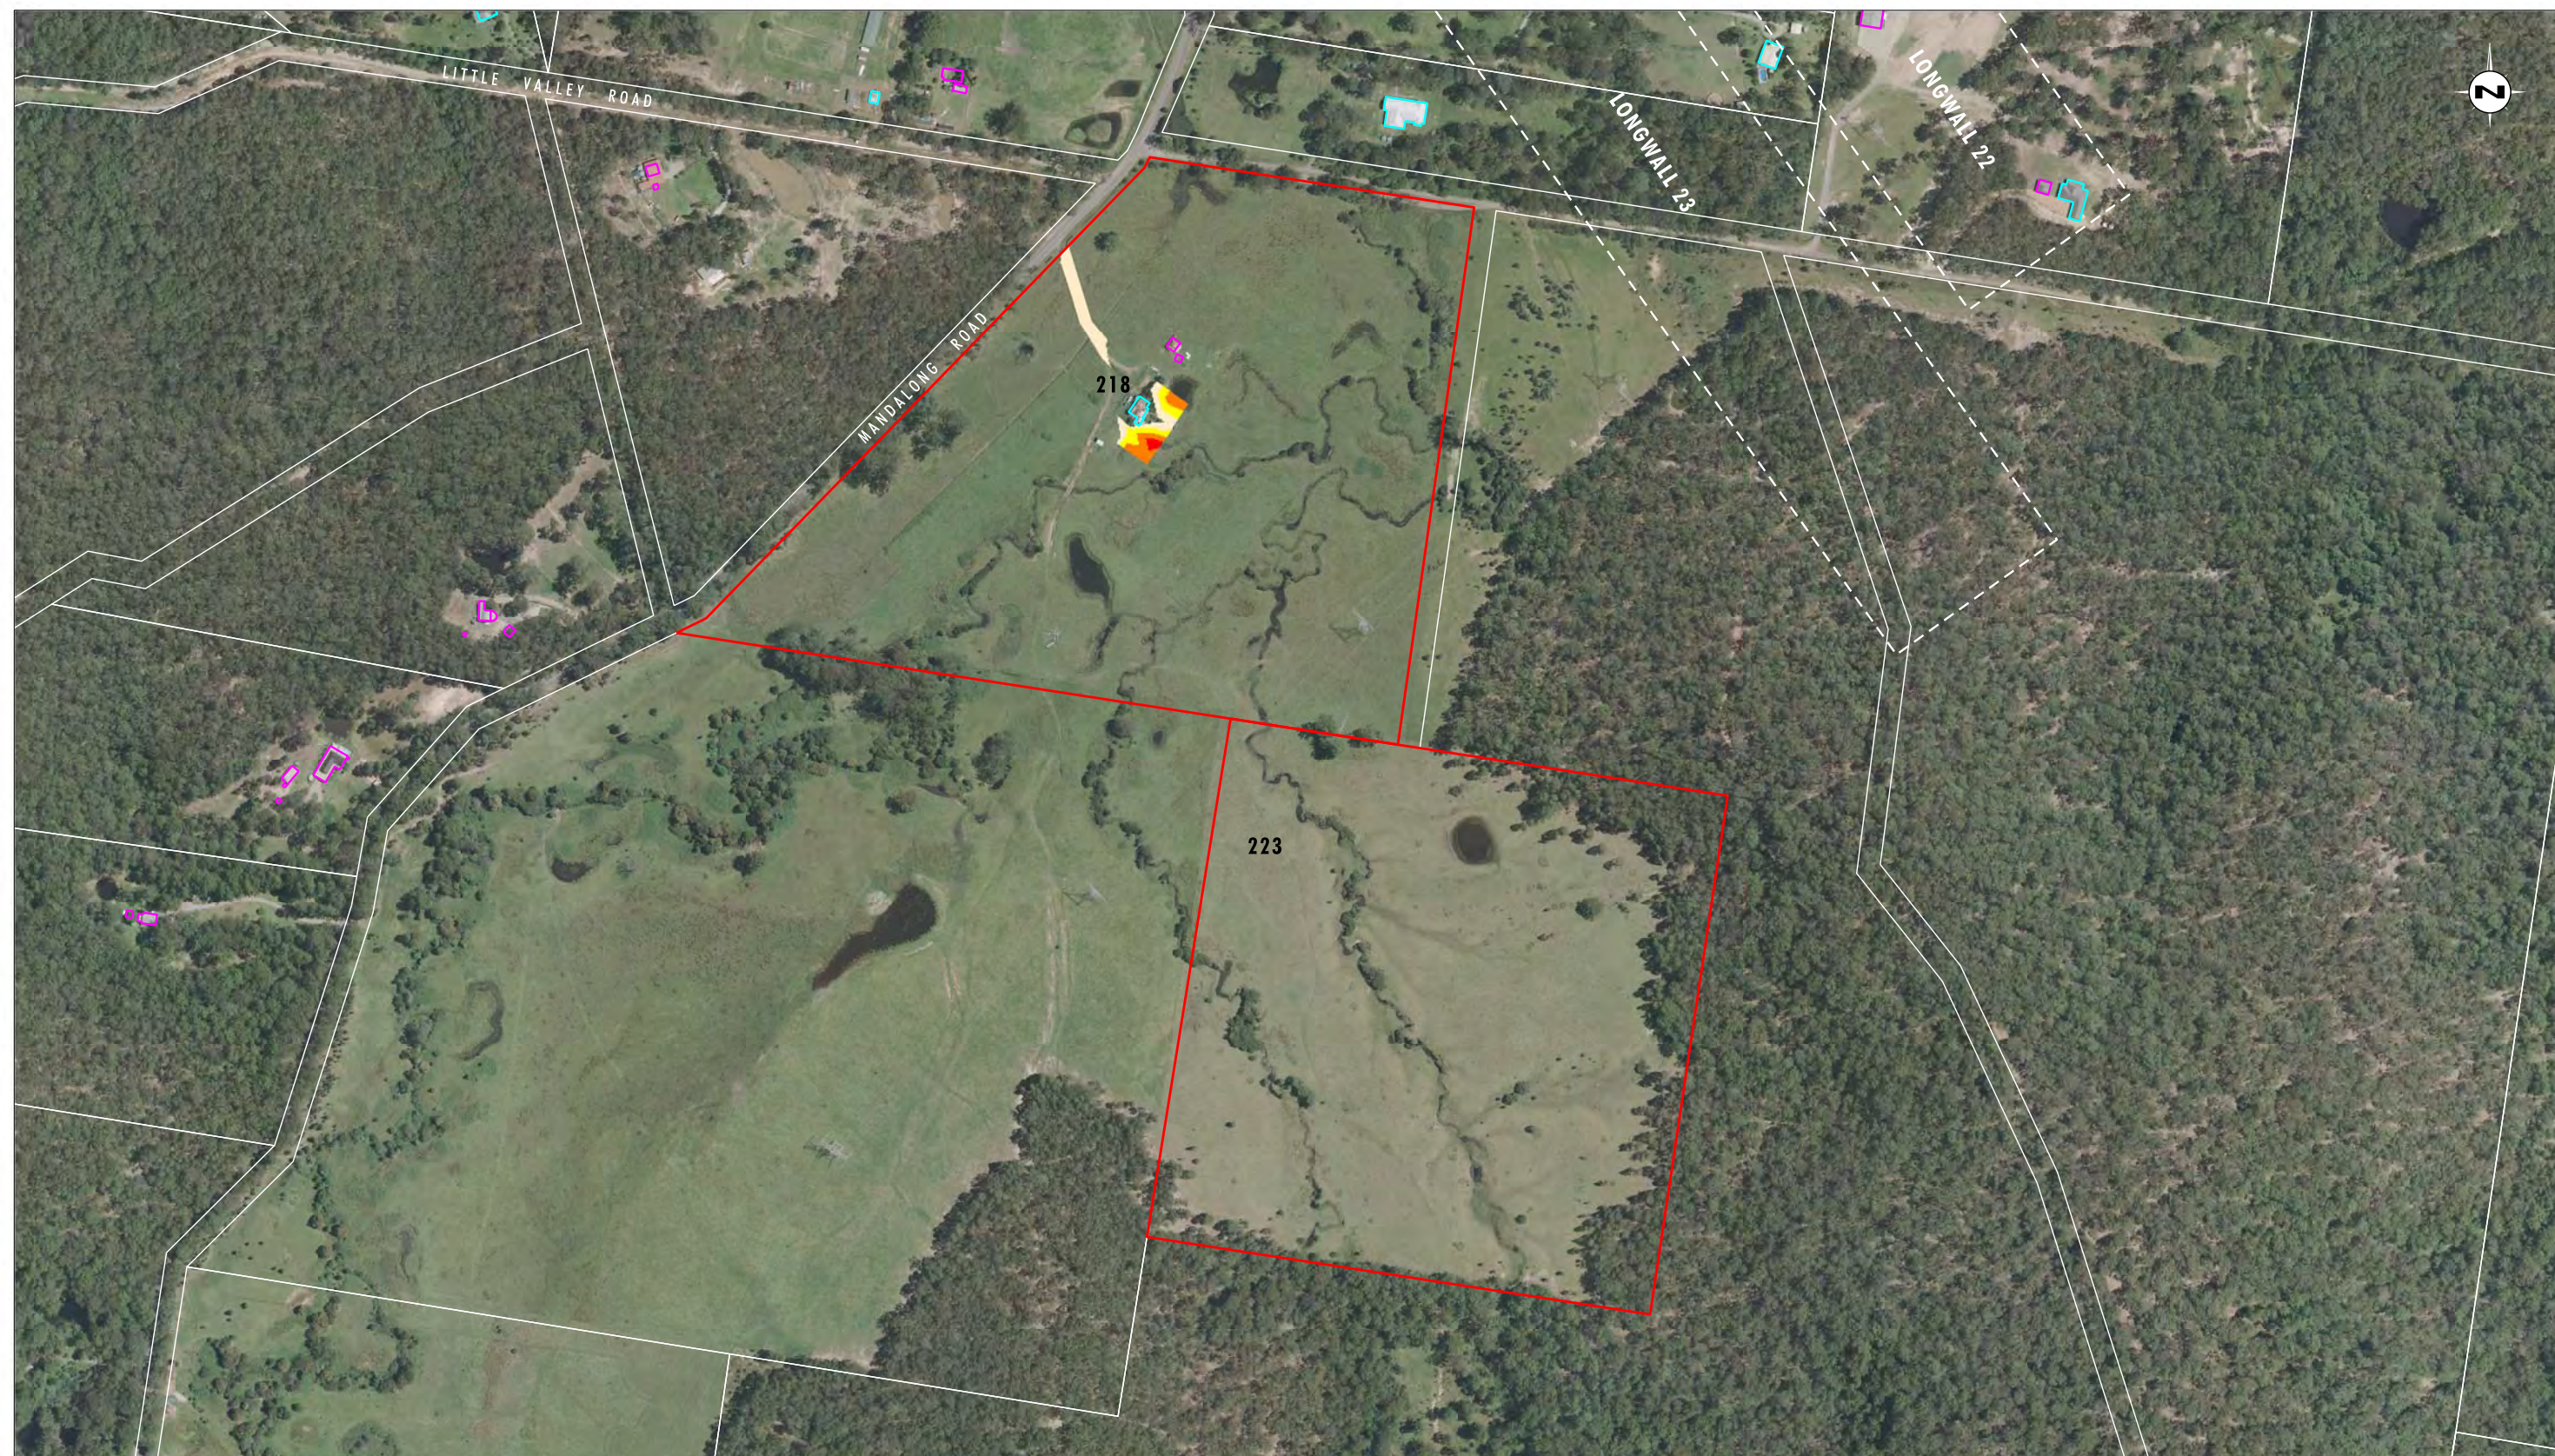
Property 218 & 223 - 100 Year ARI Storm Event:  
 Maximum Flood Hazard Categories Post Mining Landform  
 (to Longwall 23)

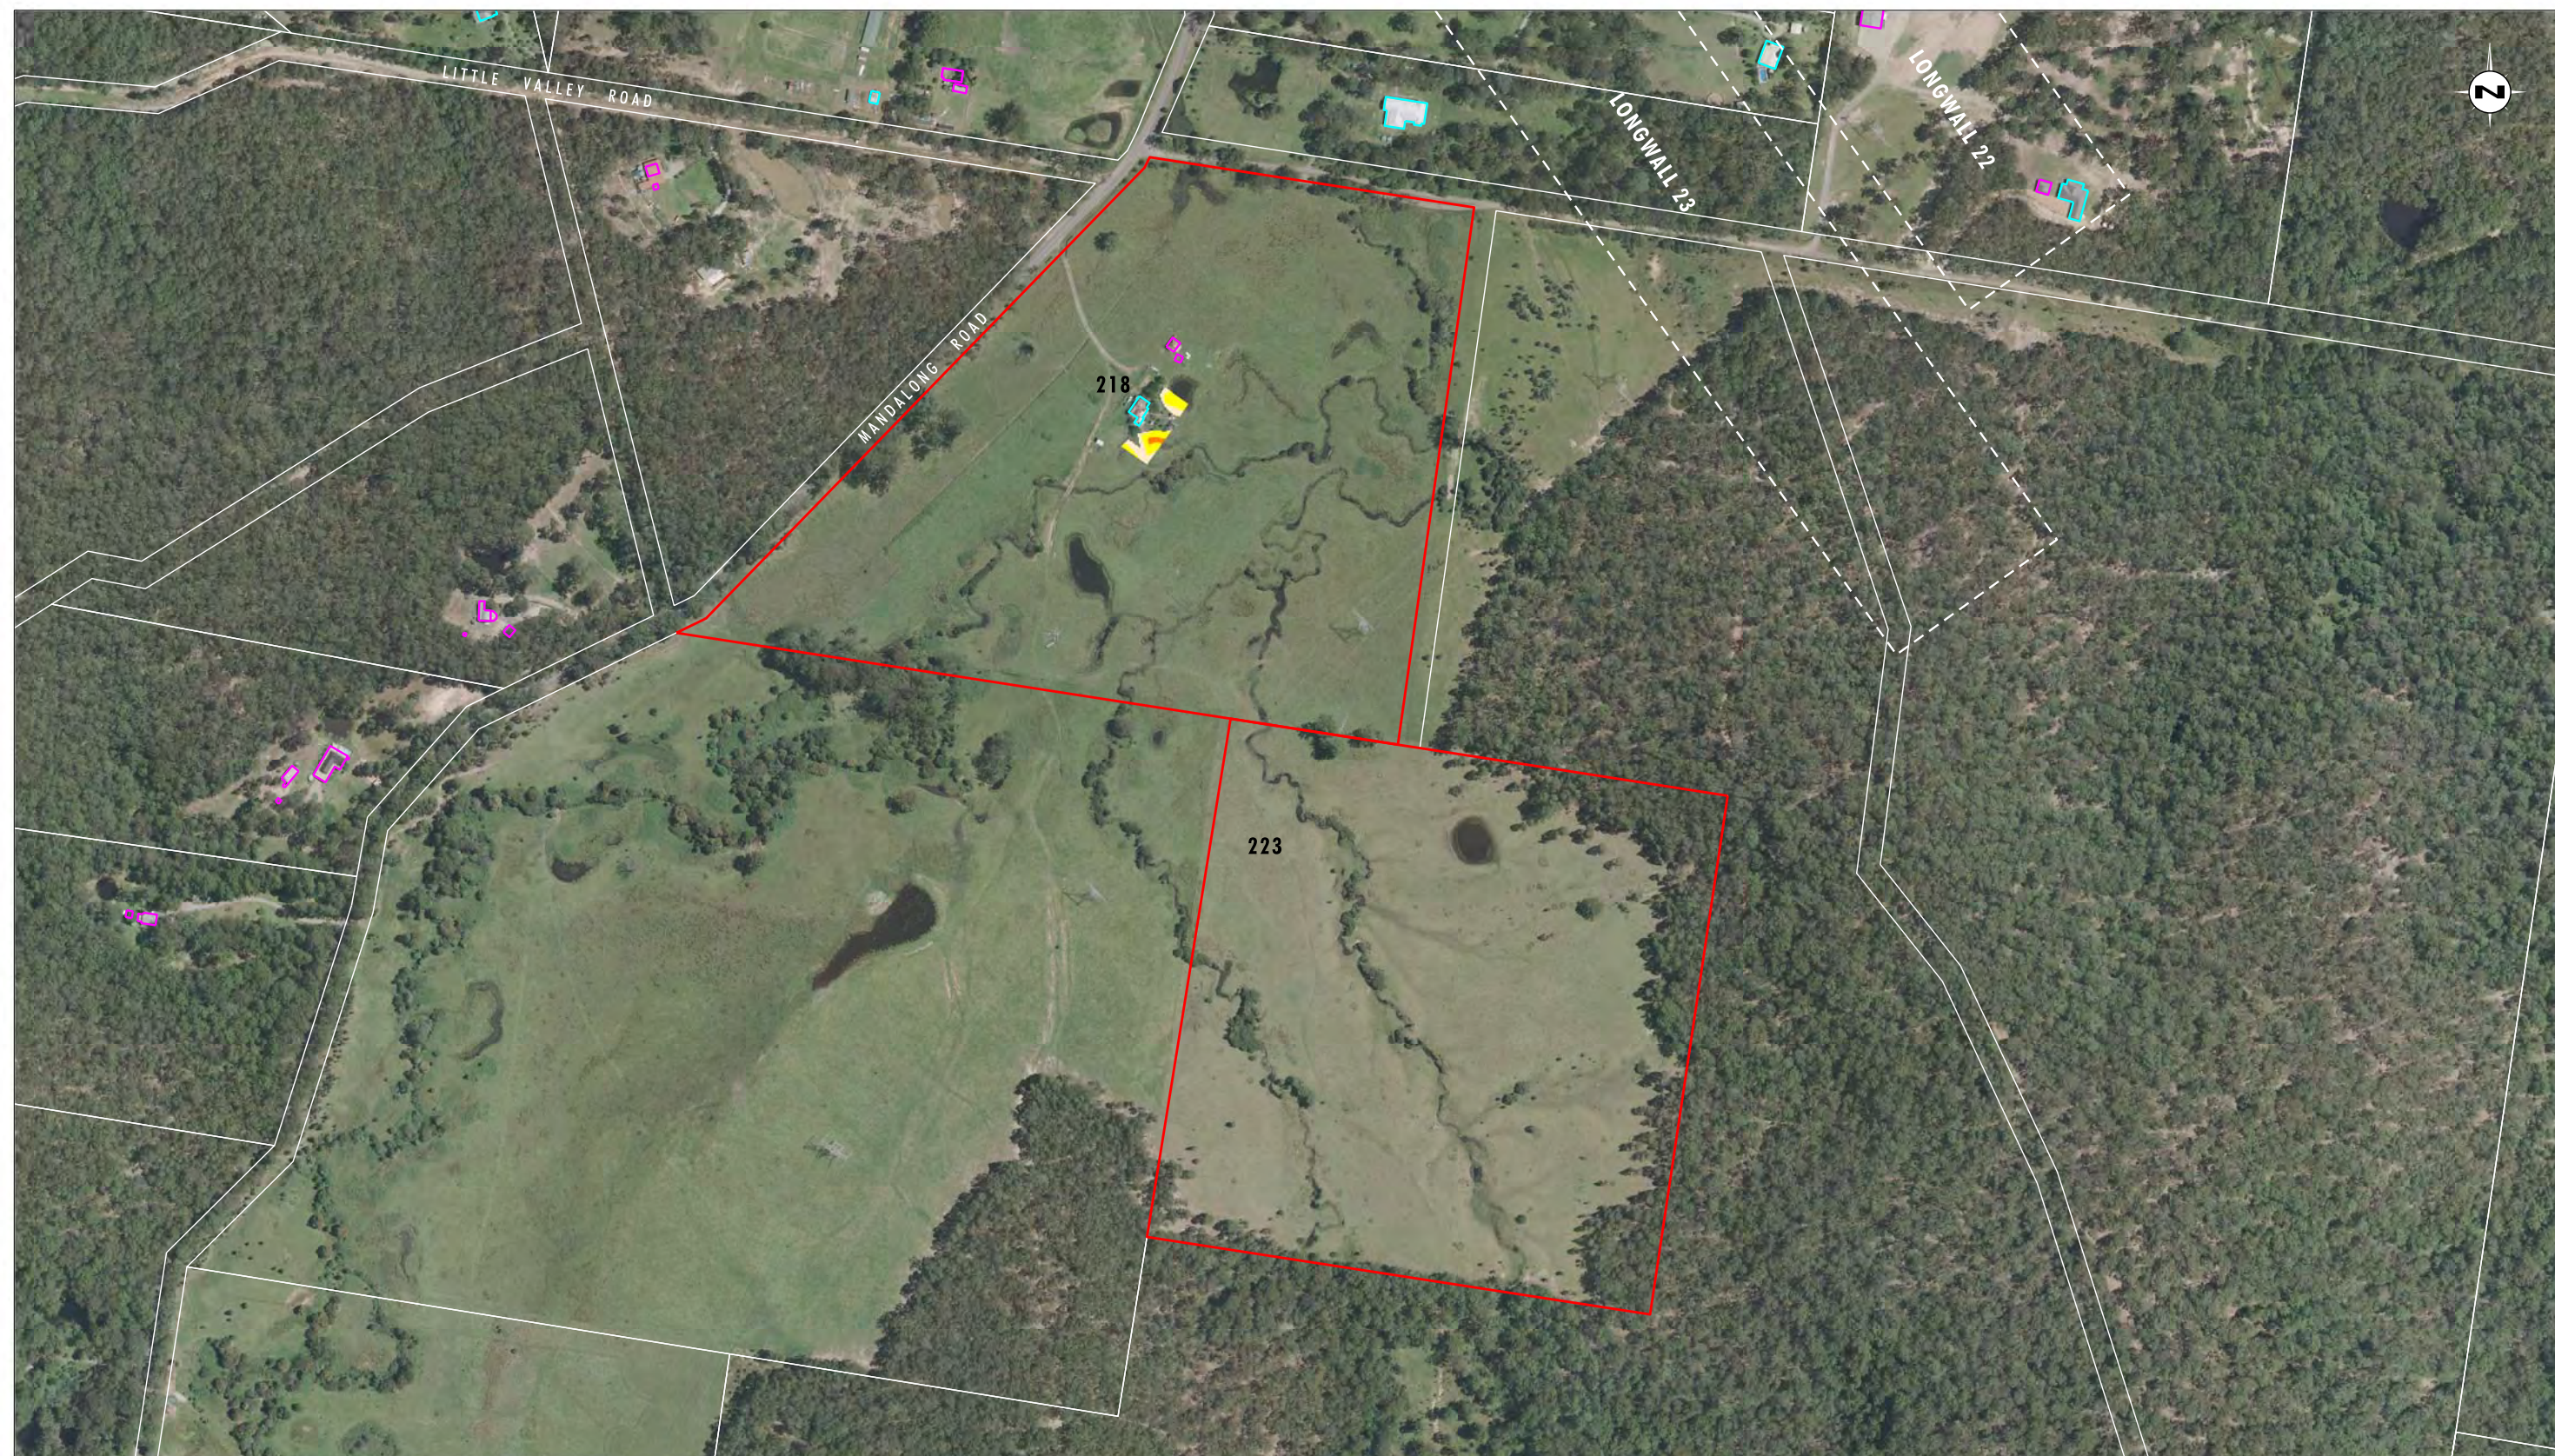
Property 218 & 223 - 1 Year ARI Storm Event:  
 Maximum Flood Hazard Categories Pre Mining Landform

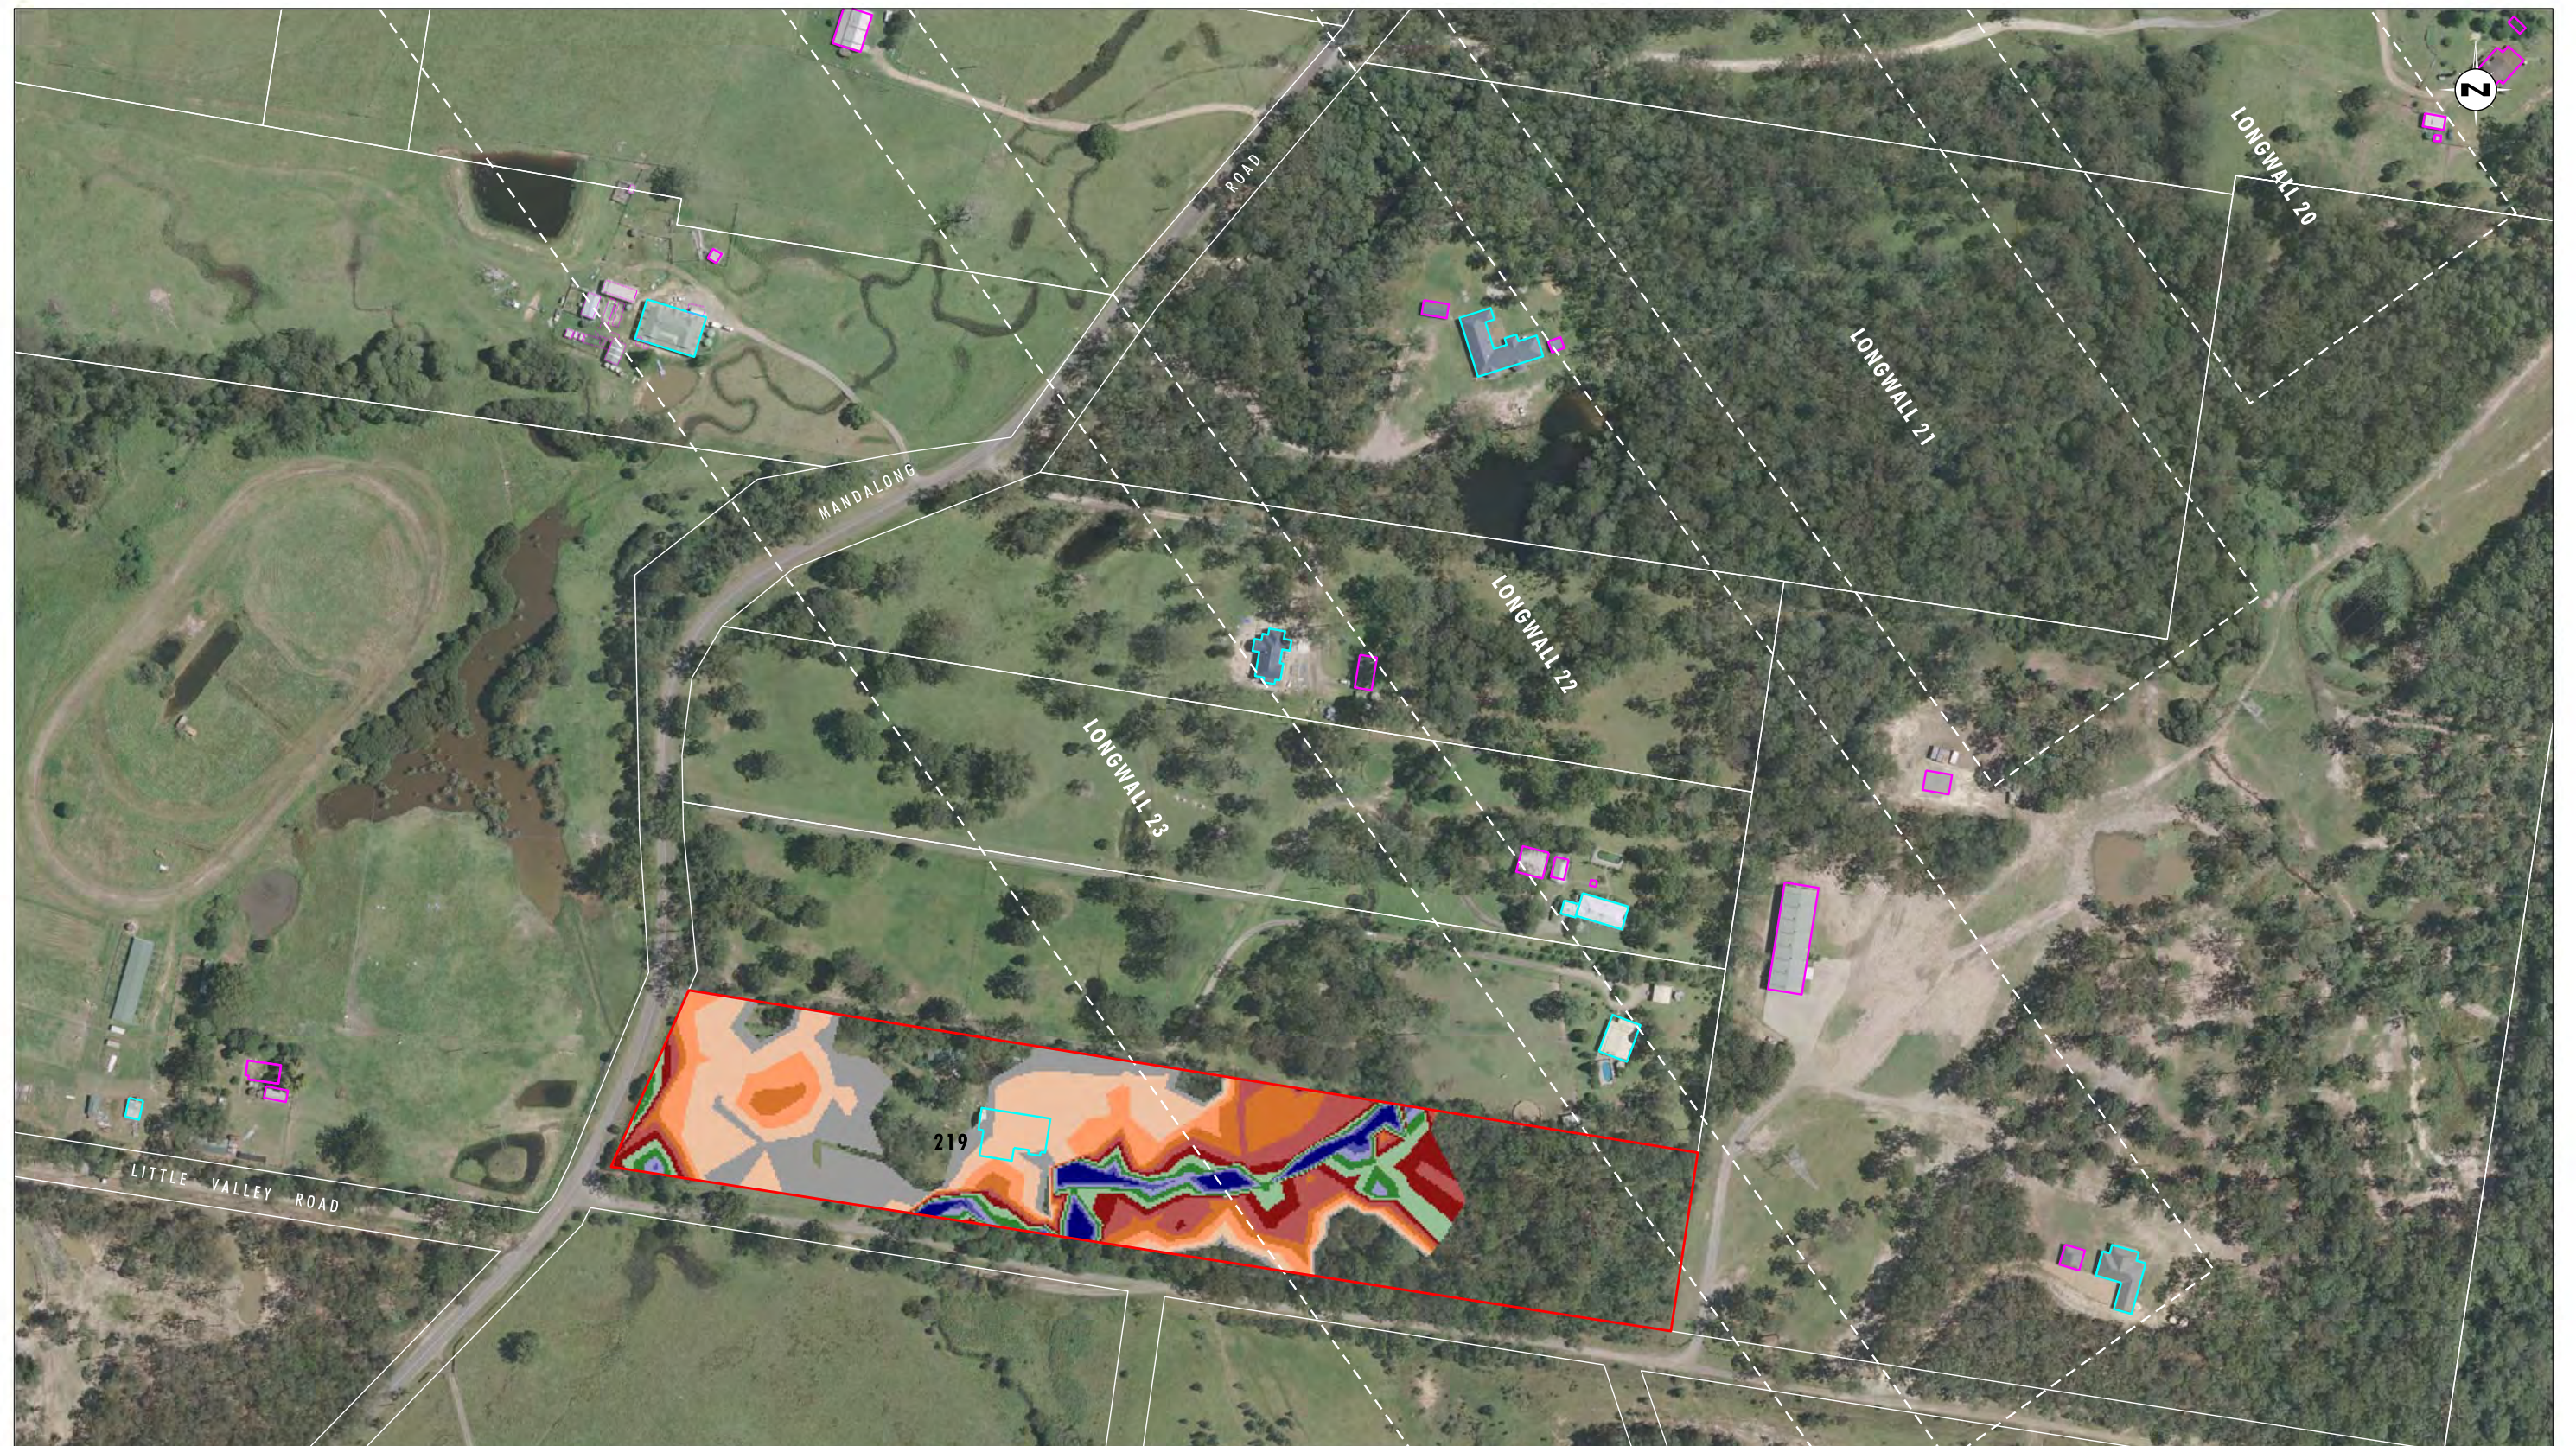
Property 219 - 100 Year ARI Storm Event:  
Maximum Flood Depth Pre Mining Landform

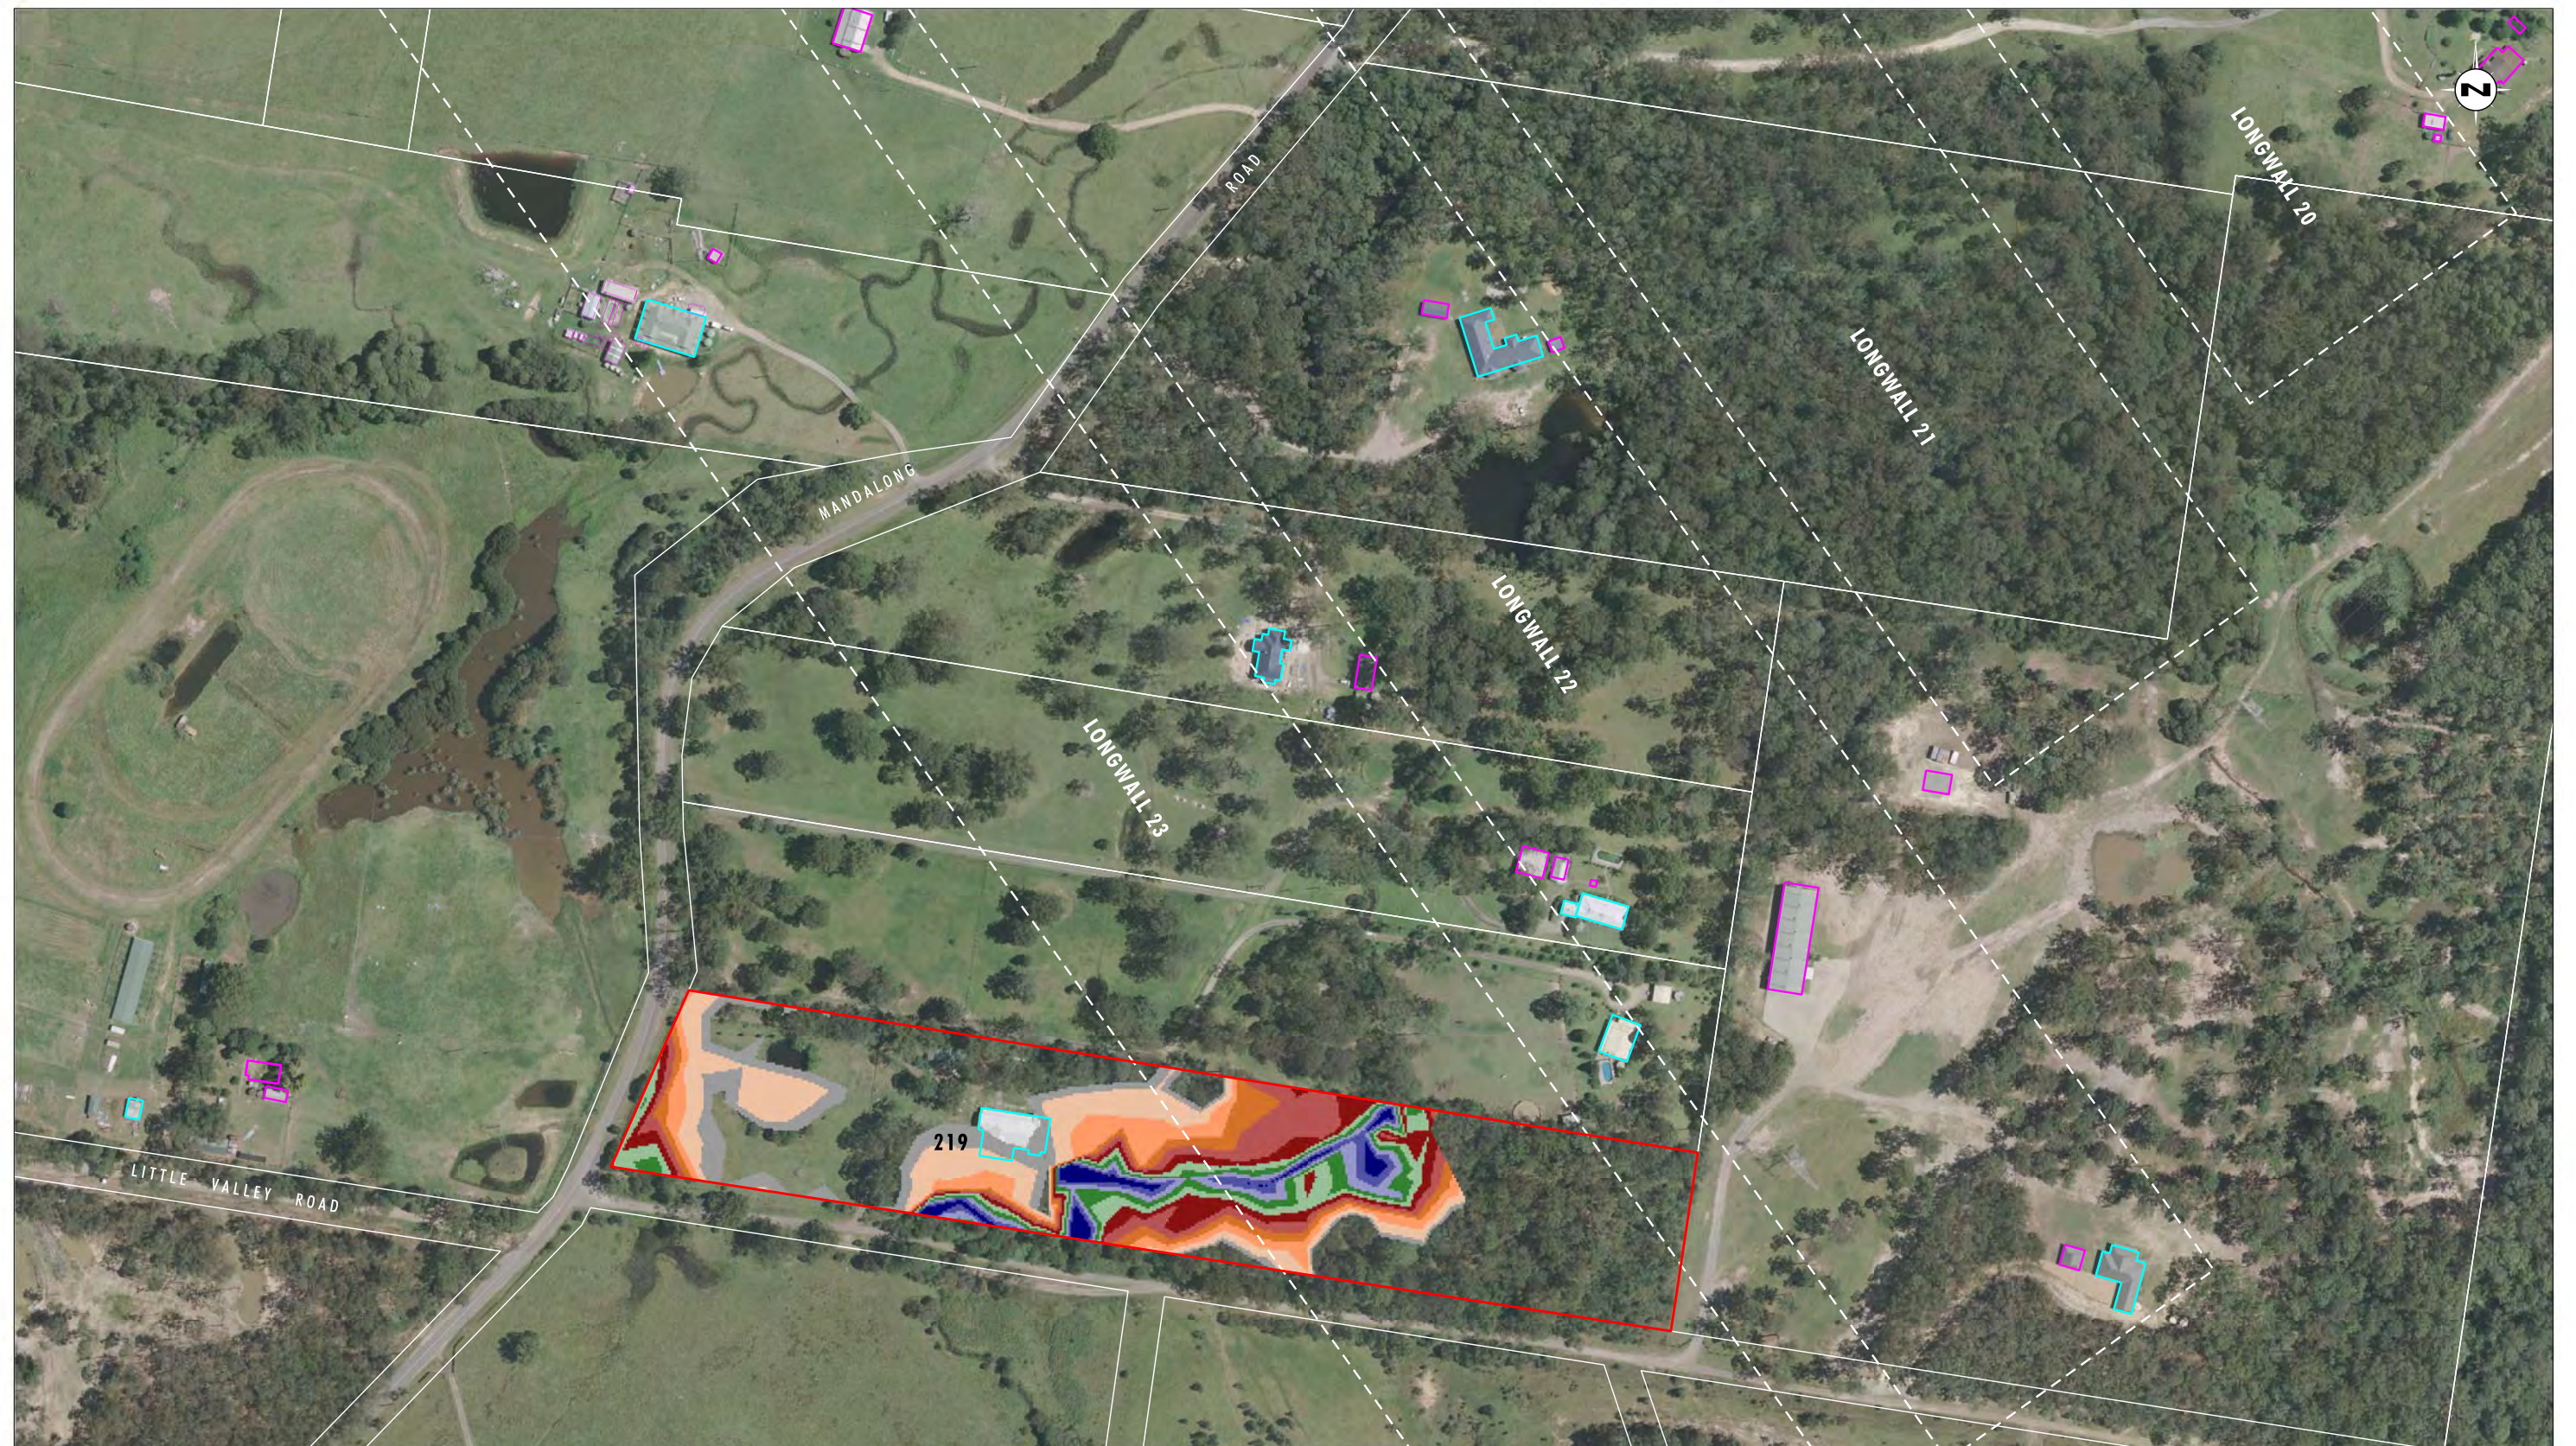
Property 219 - 100 Year ARI Storm Event:  
Maximum Flood Depth Post Mining Landform  
(to Longwall 23)

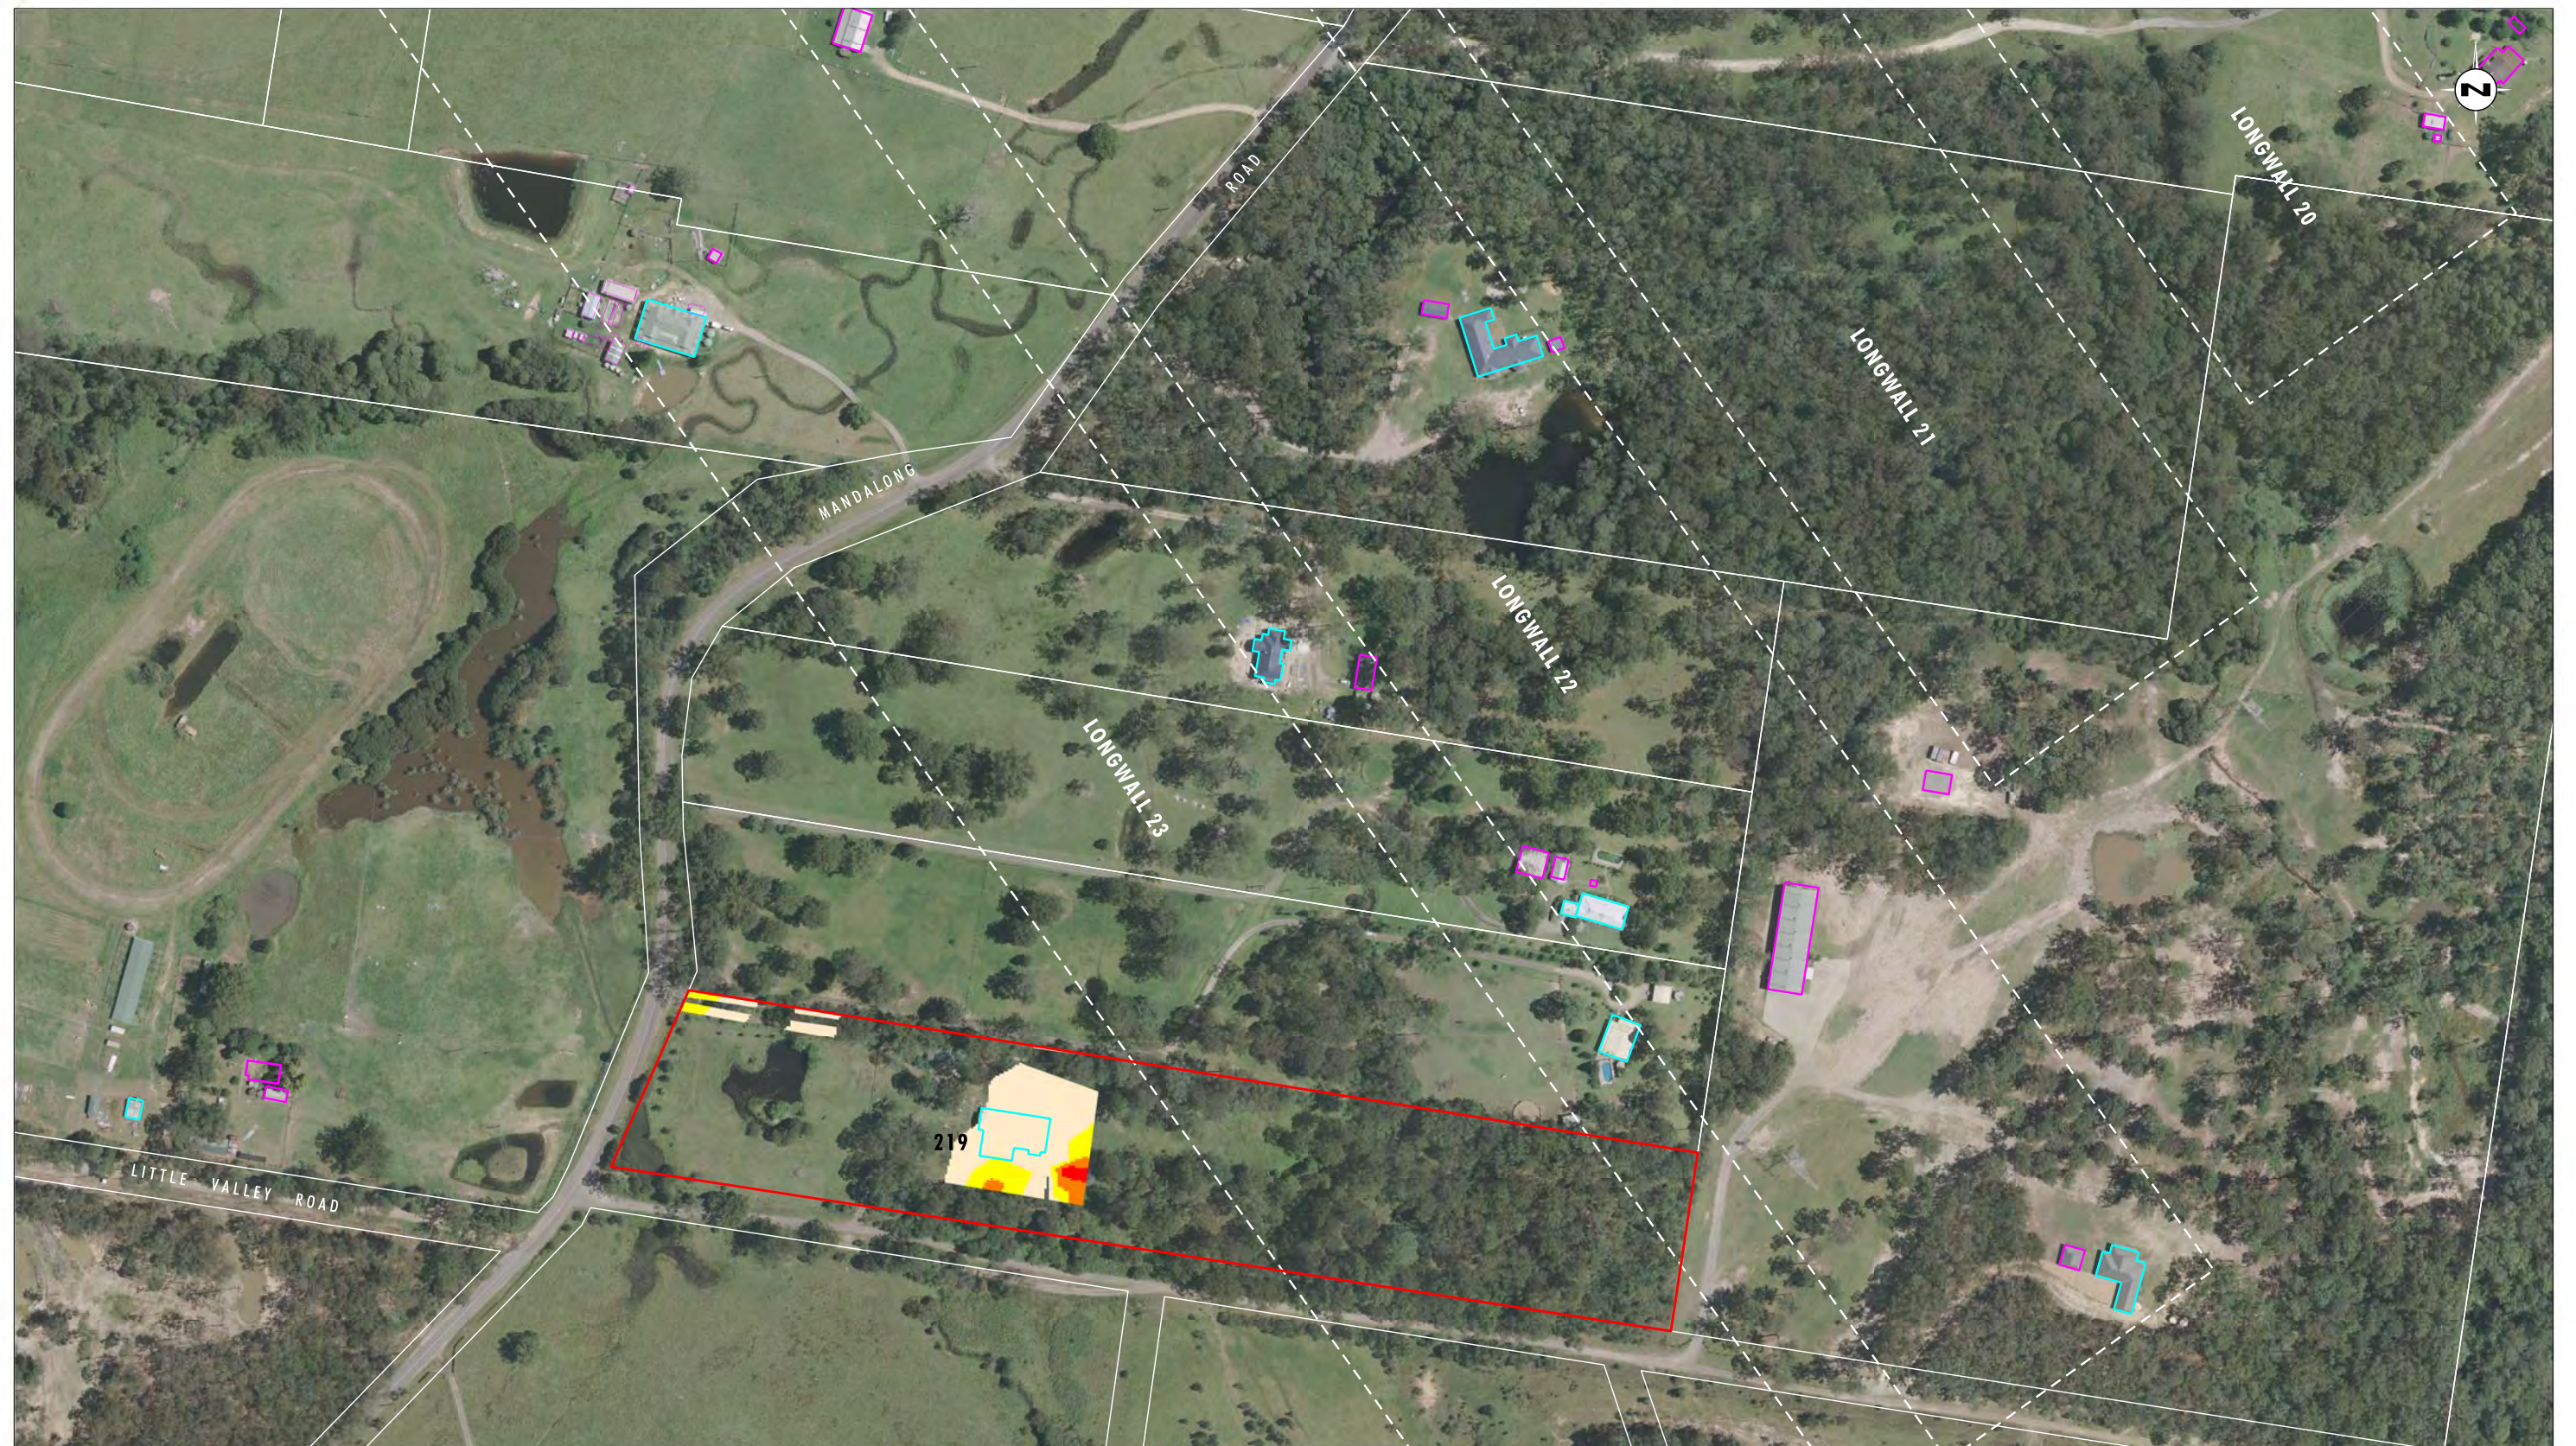
Property 219 - 100 Year ARI Storm Event:  
 Maximum Flood Hazard Categories Pre Mining Landform
