## APPENDIX 31

Flooding Assessment Figures -  
Property 213

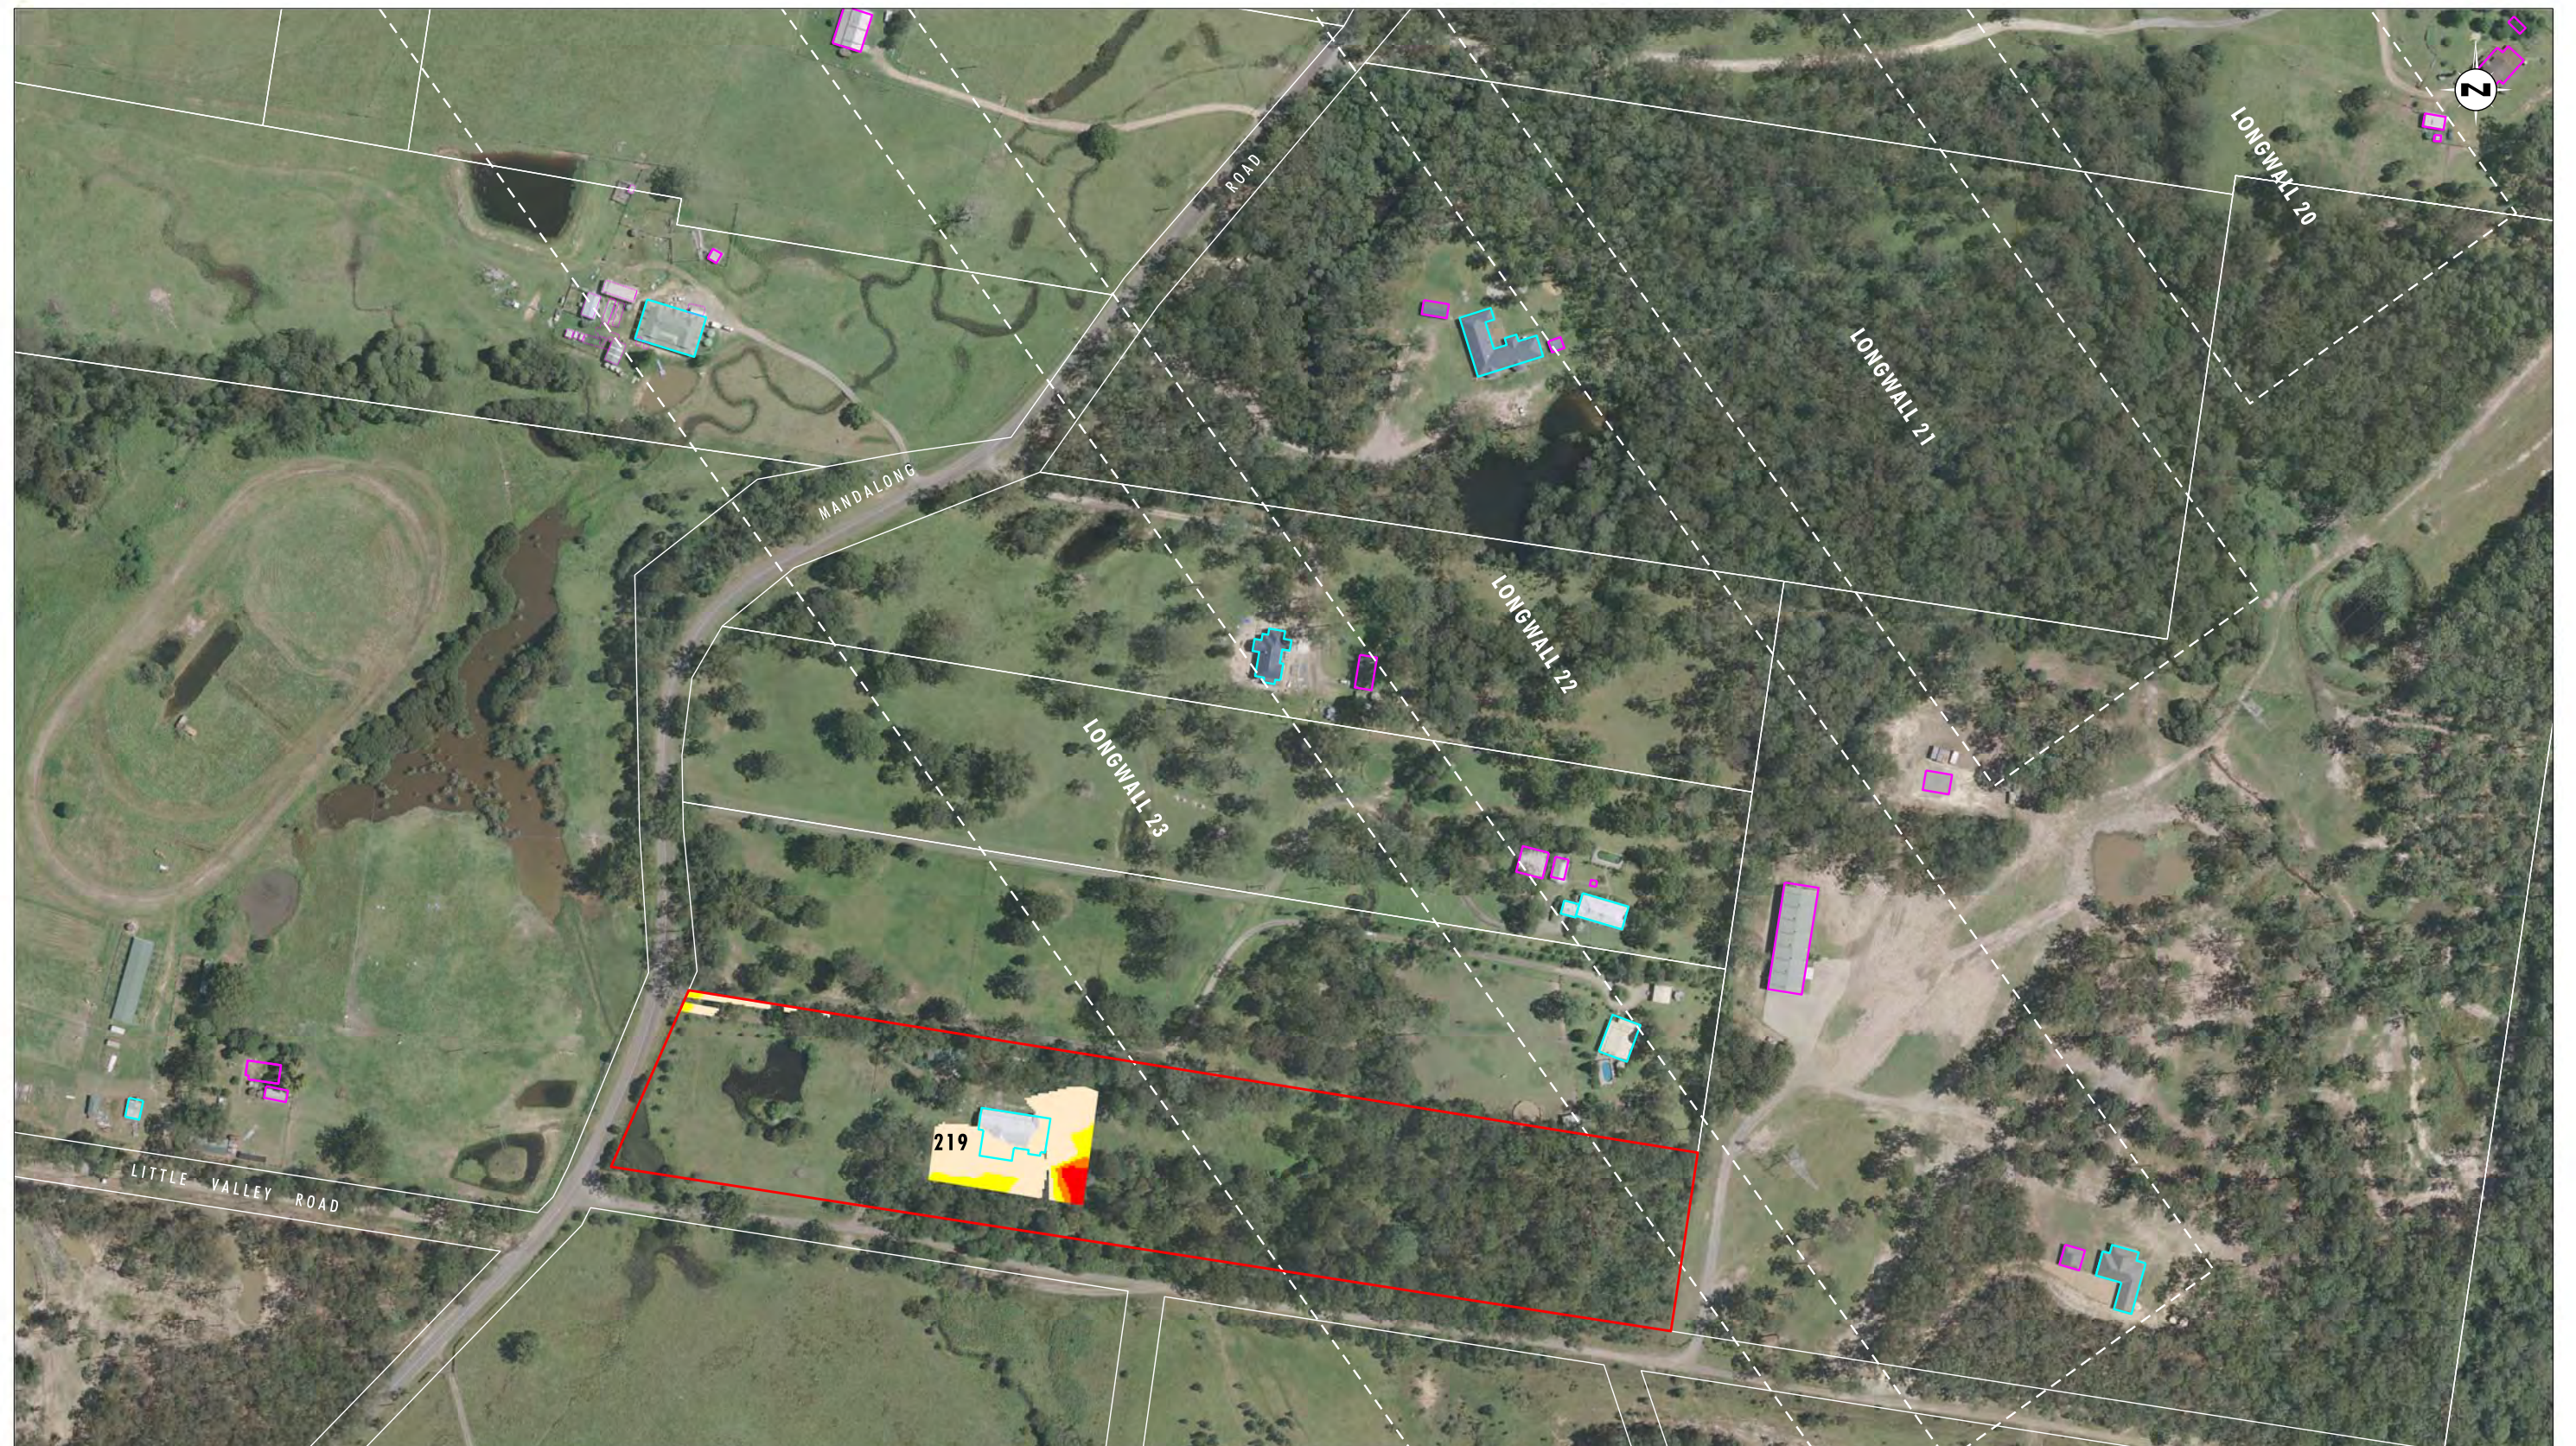
**FIGURE 4**  
 Property 219 - 100 Year ARI Storm Event:  
 Maximum Flood Hazard Categories Post Mining Landform  
 (to Longwall 24A)

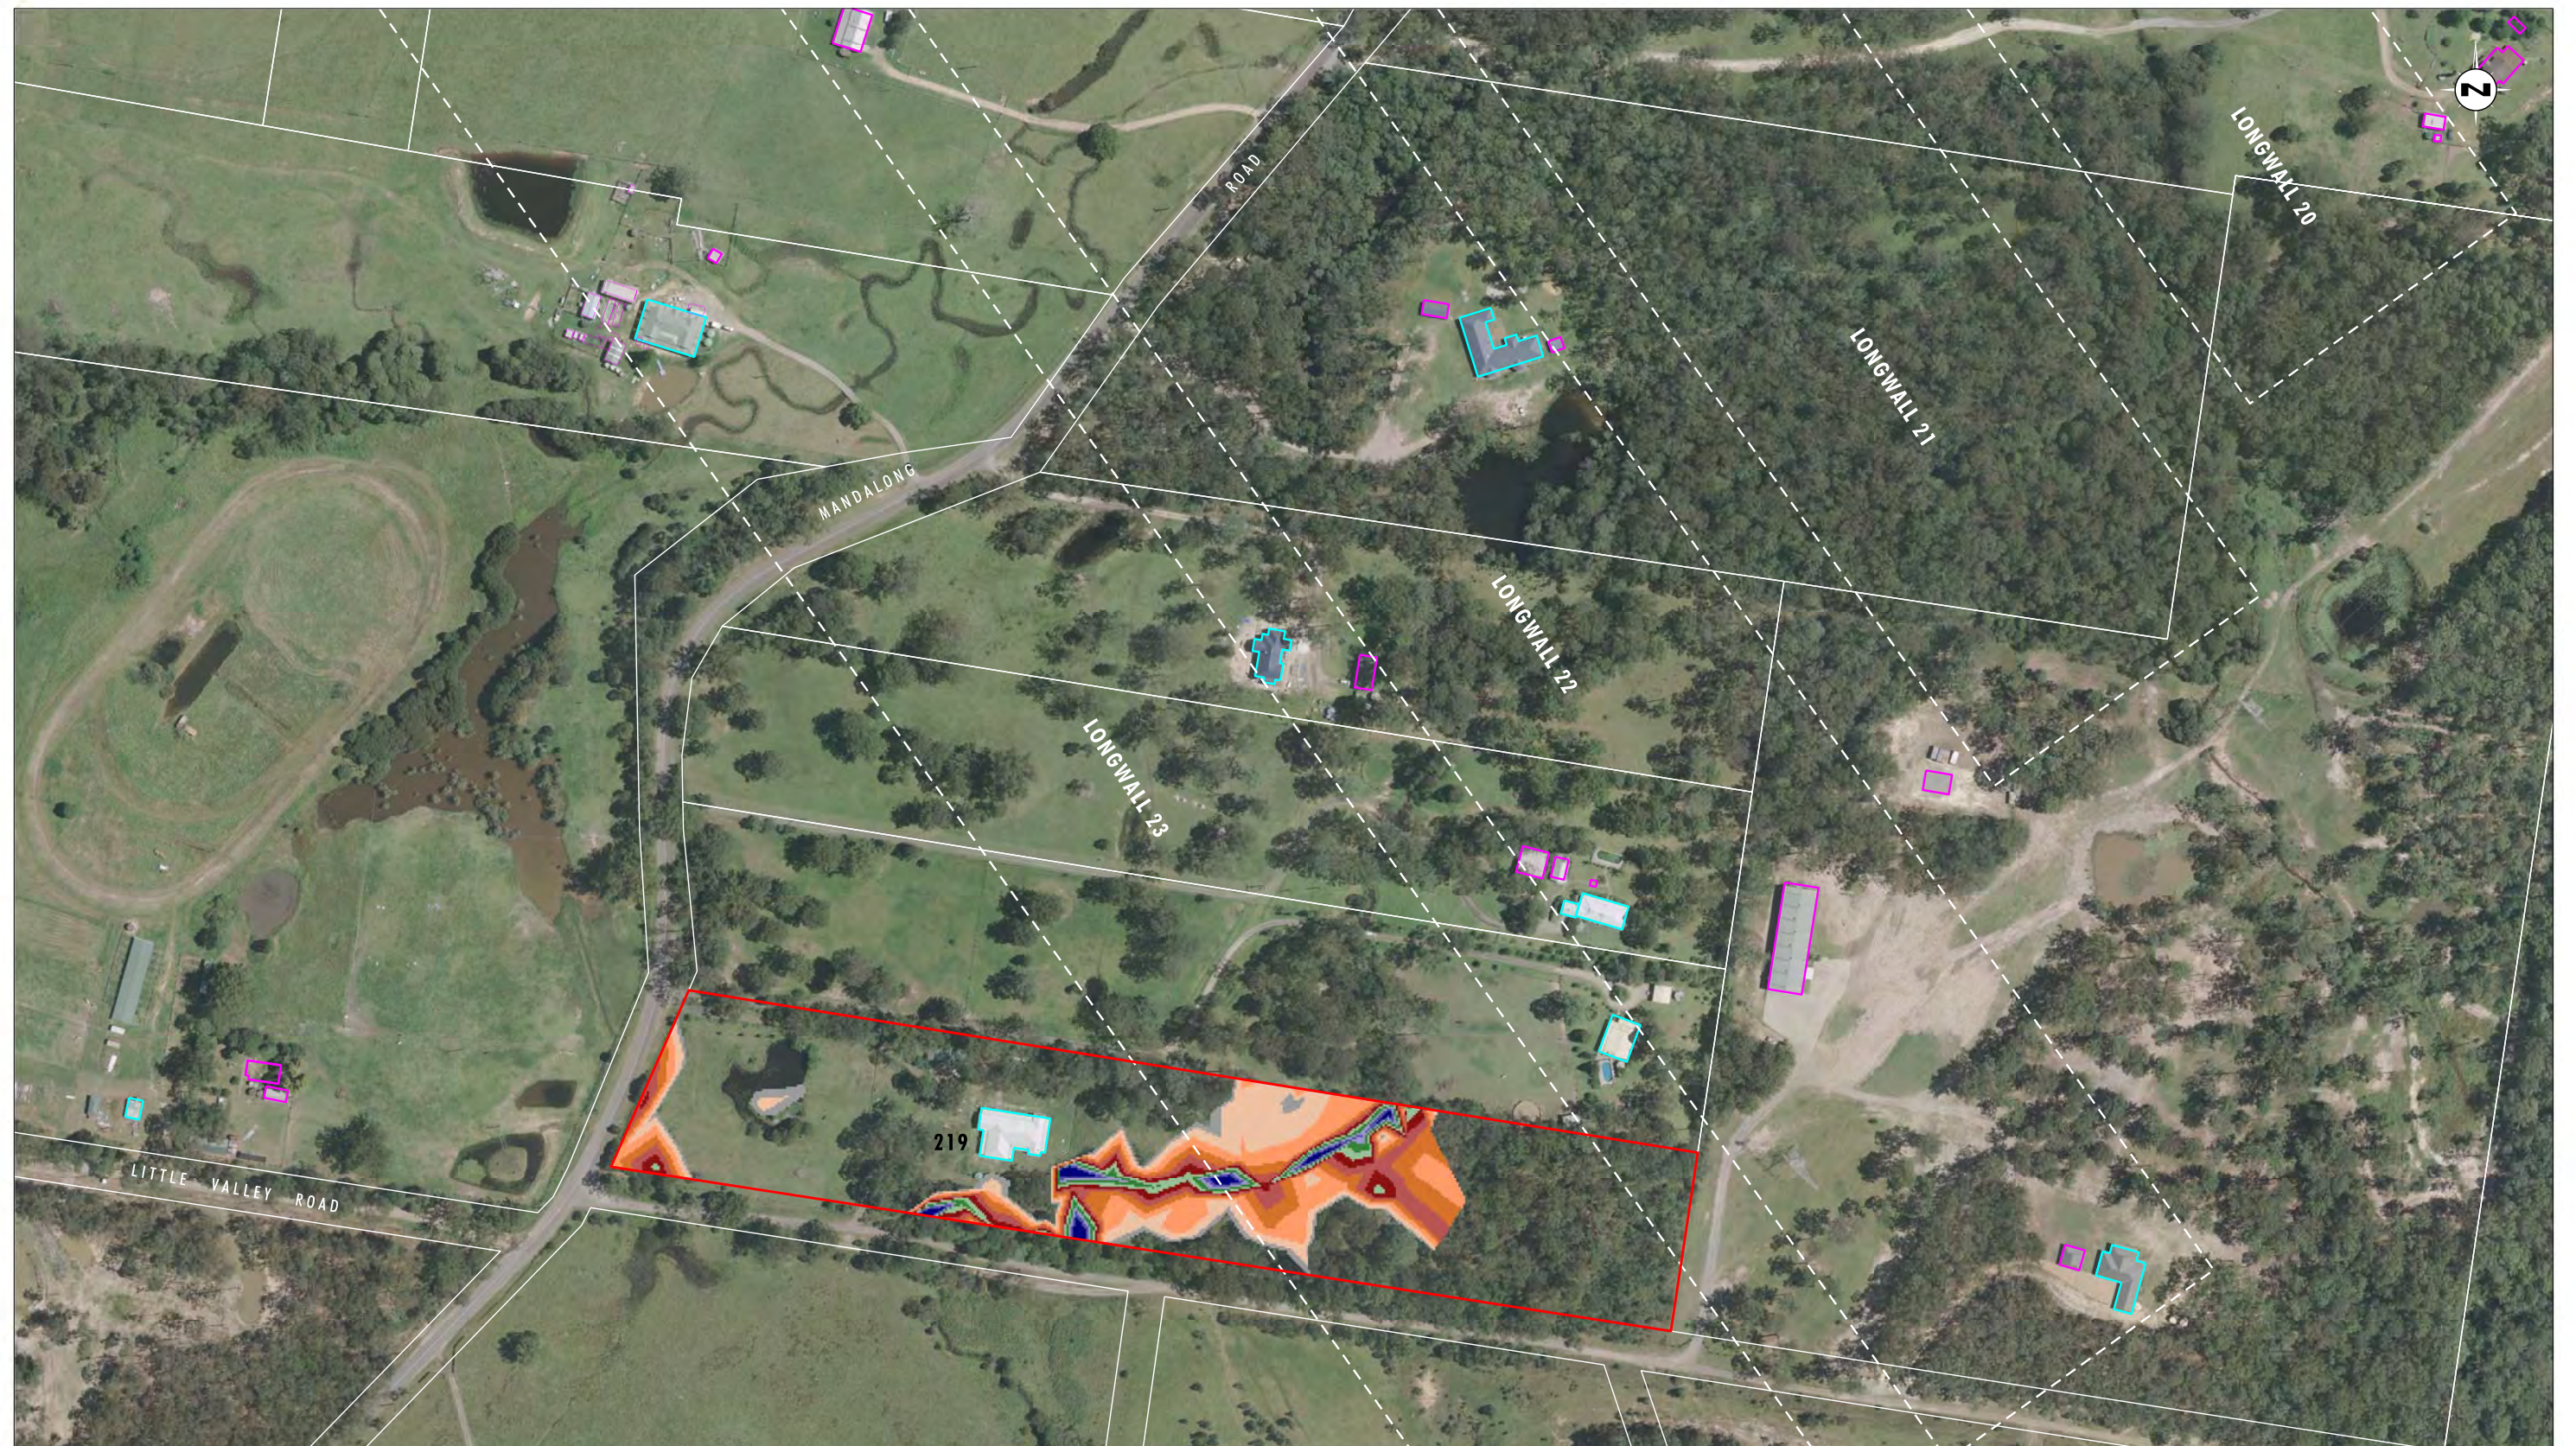
Property 219 - 1 Year ARI Storm Event:  
Maximum Flood Depth Pre Mining Landform

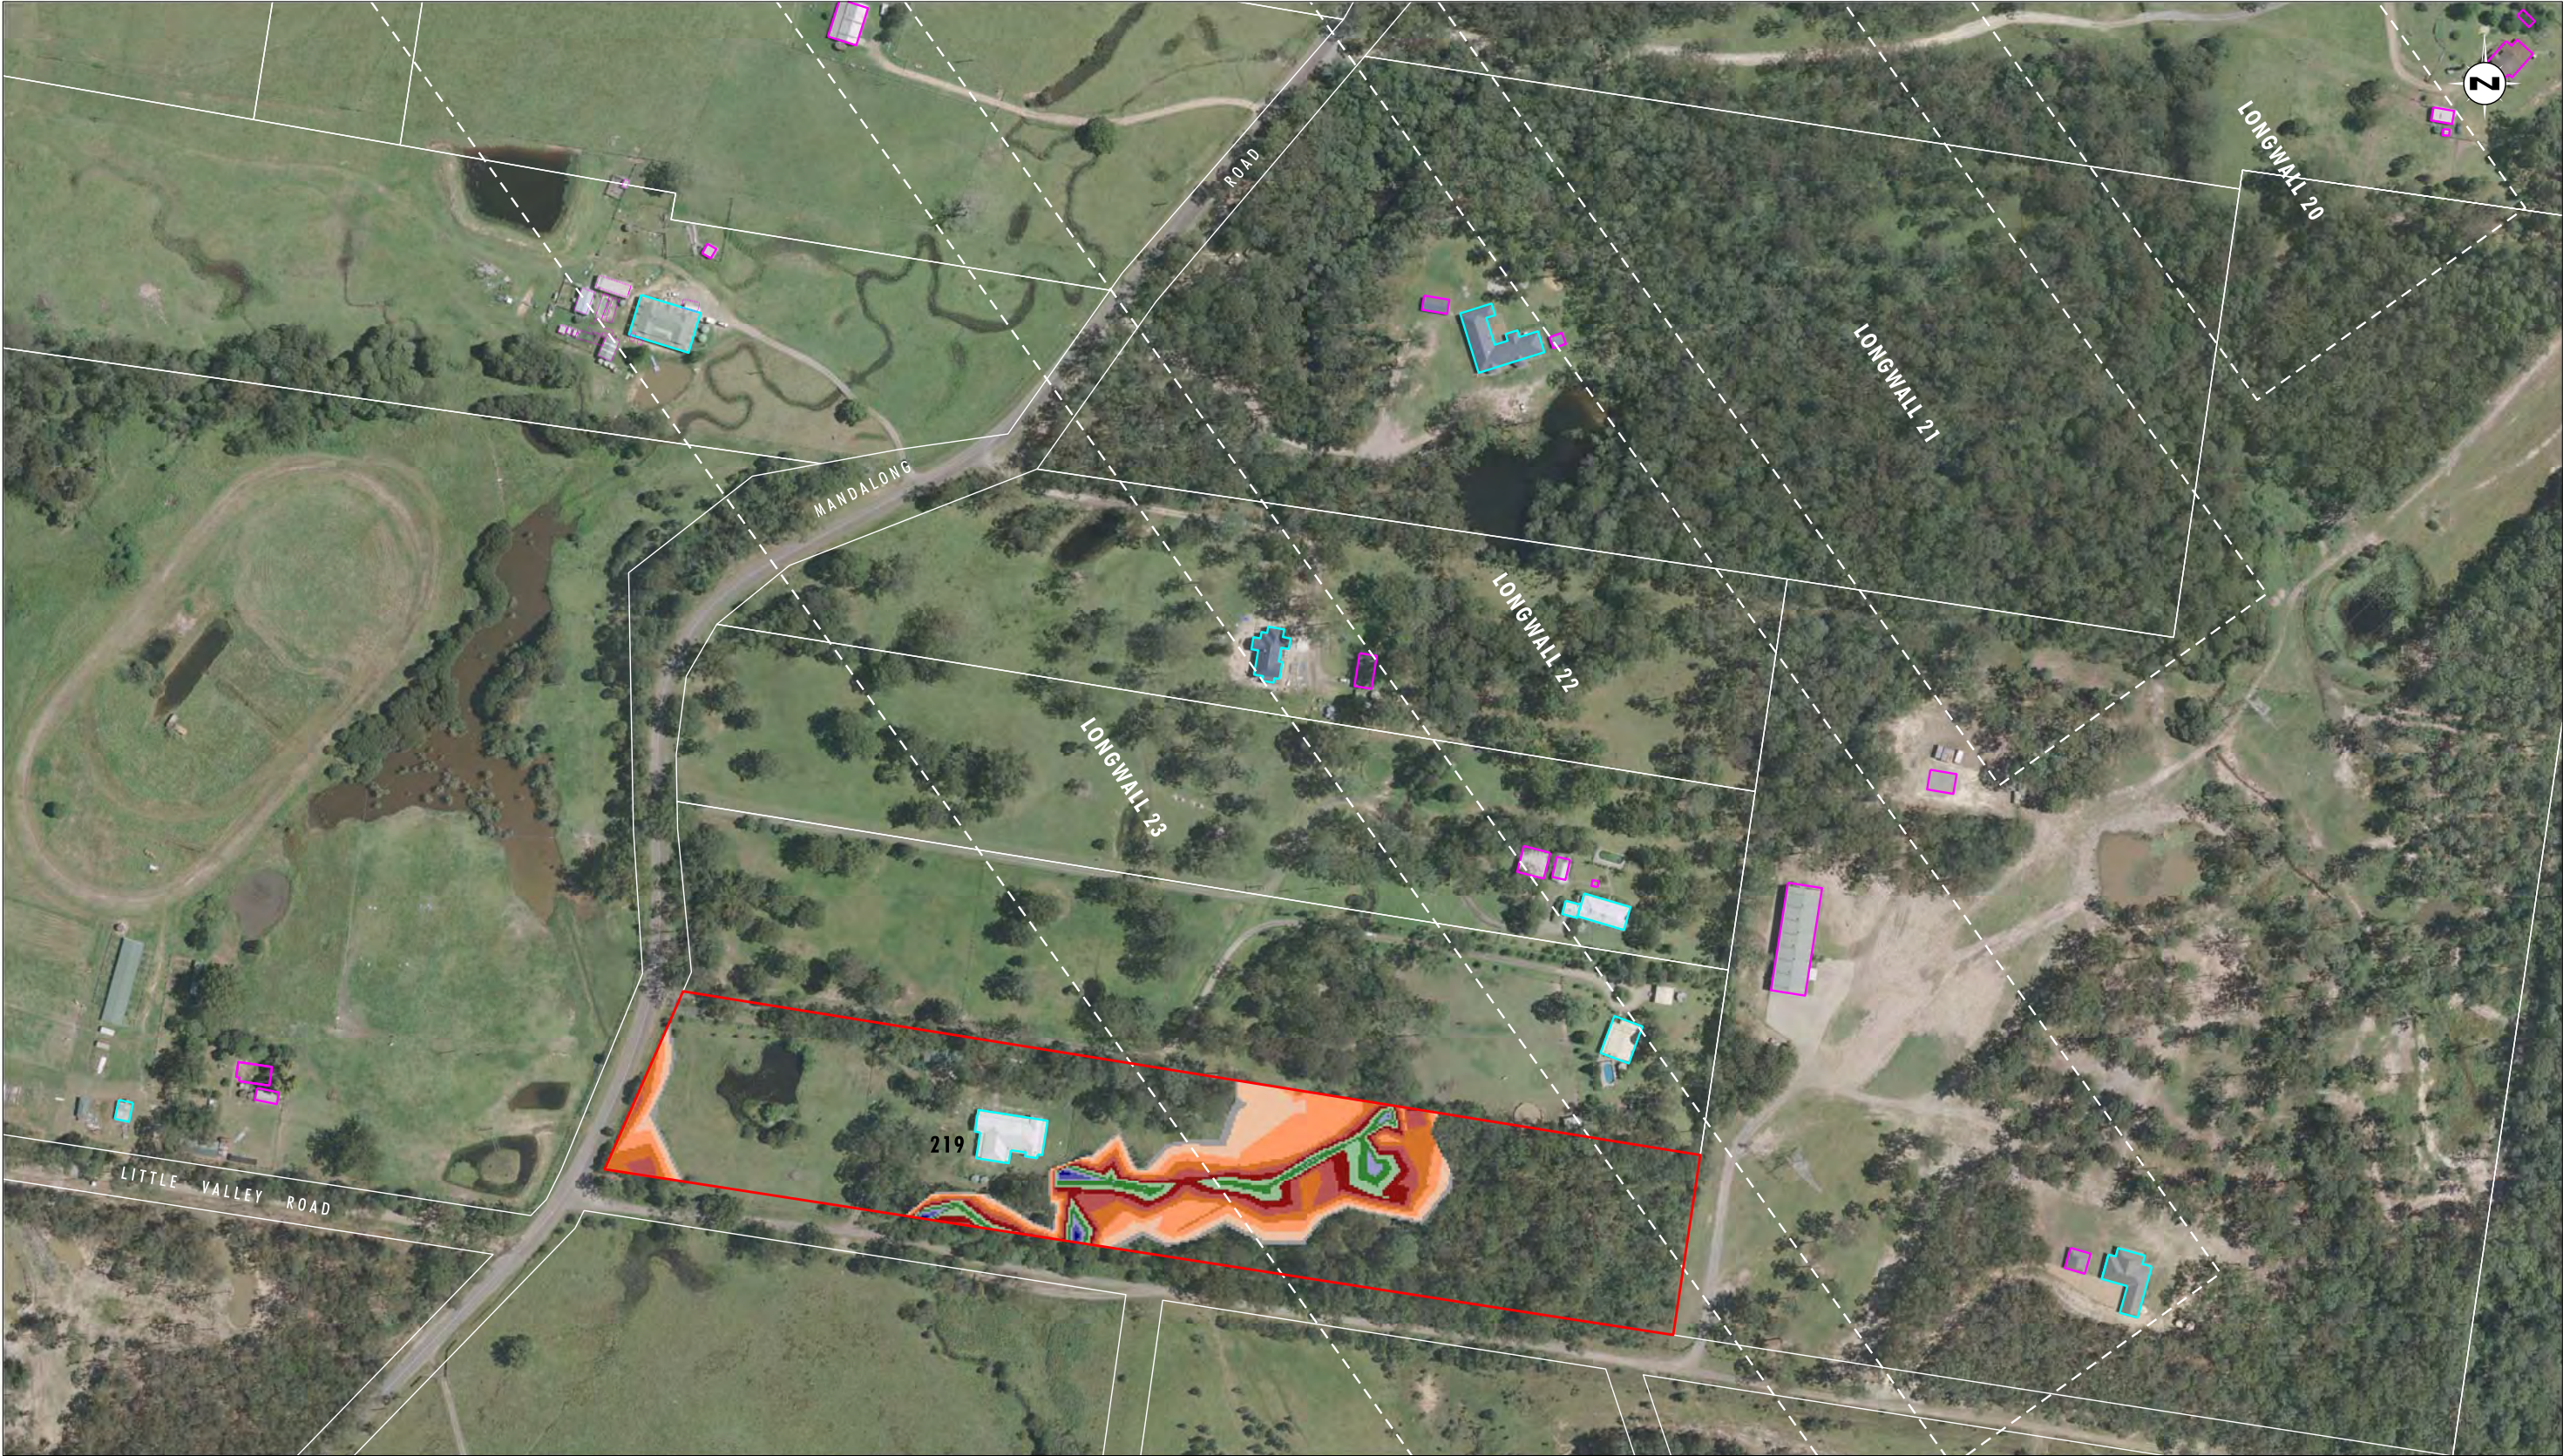
Property 219 - 1 Year ARI Storm Event:  
Maximum Flood Depth Post Mining Landform  
(to Longwall 23)

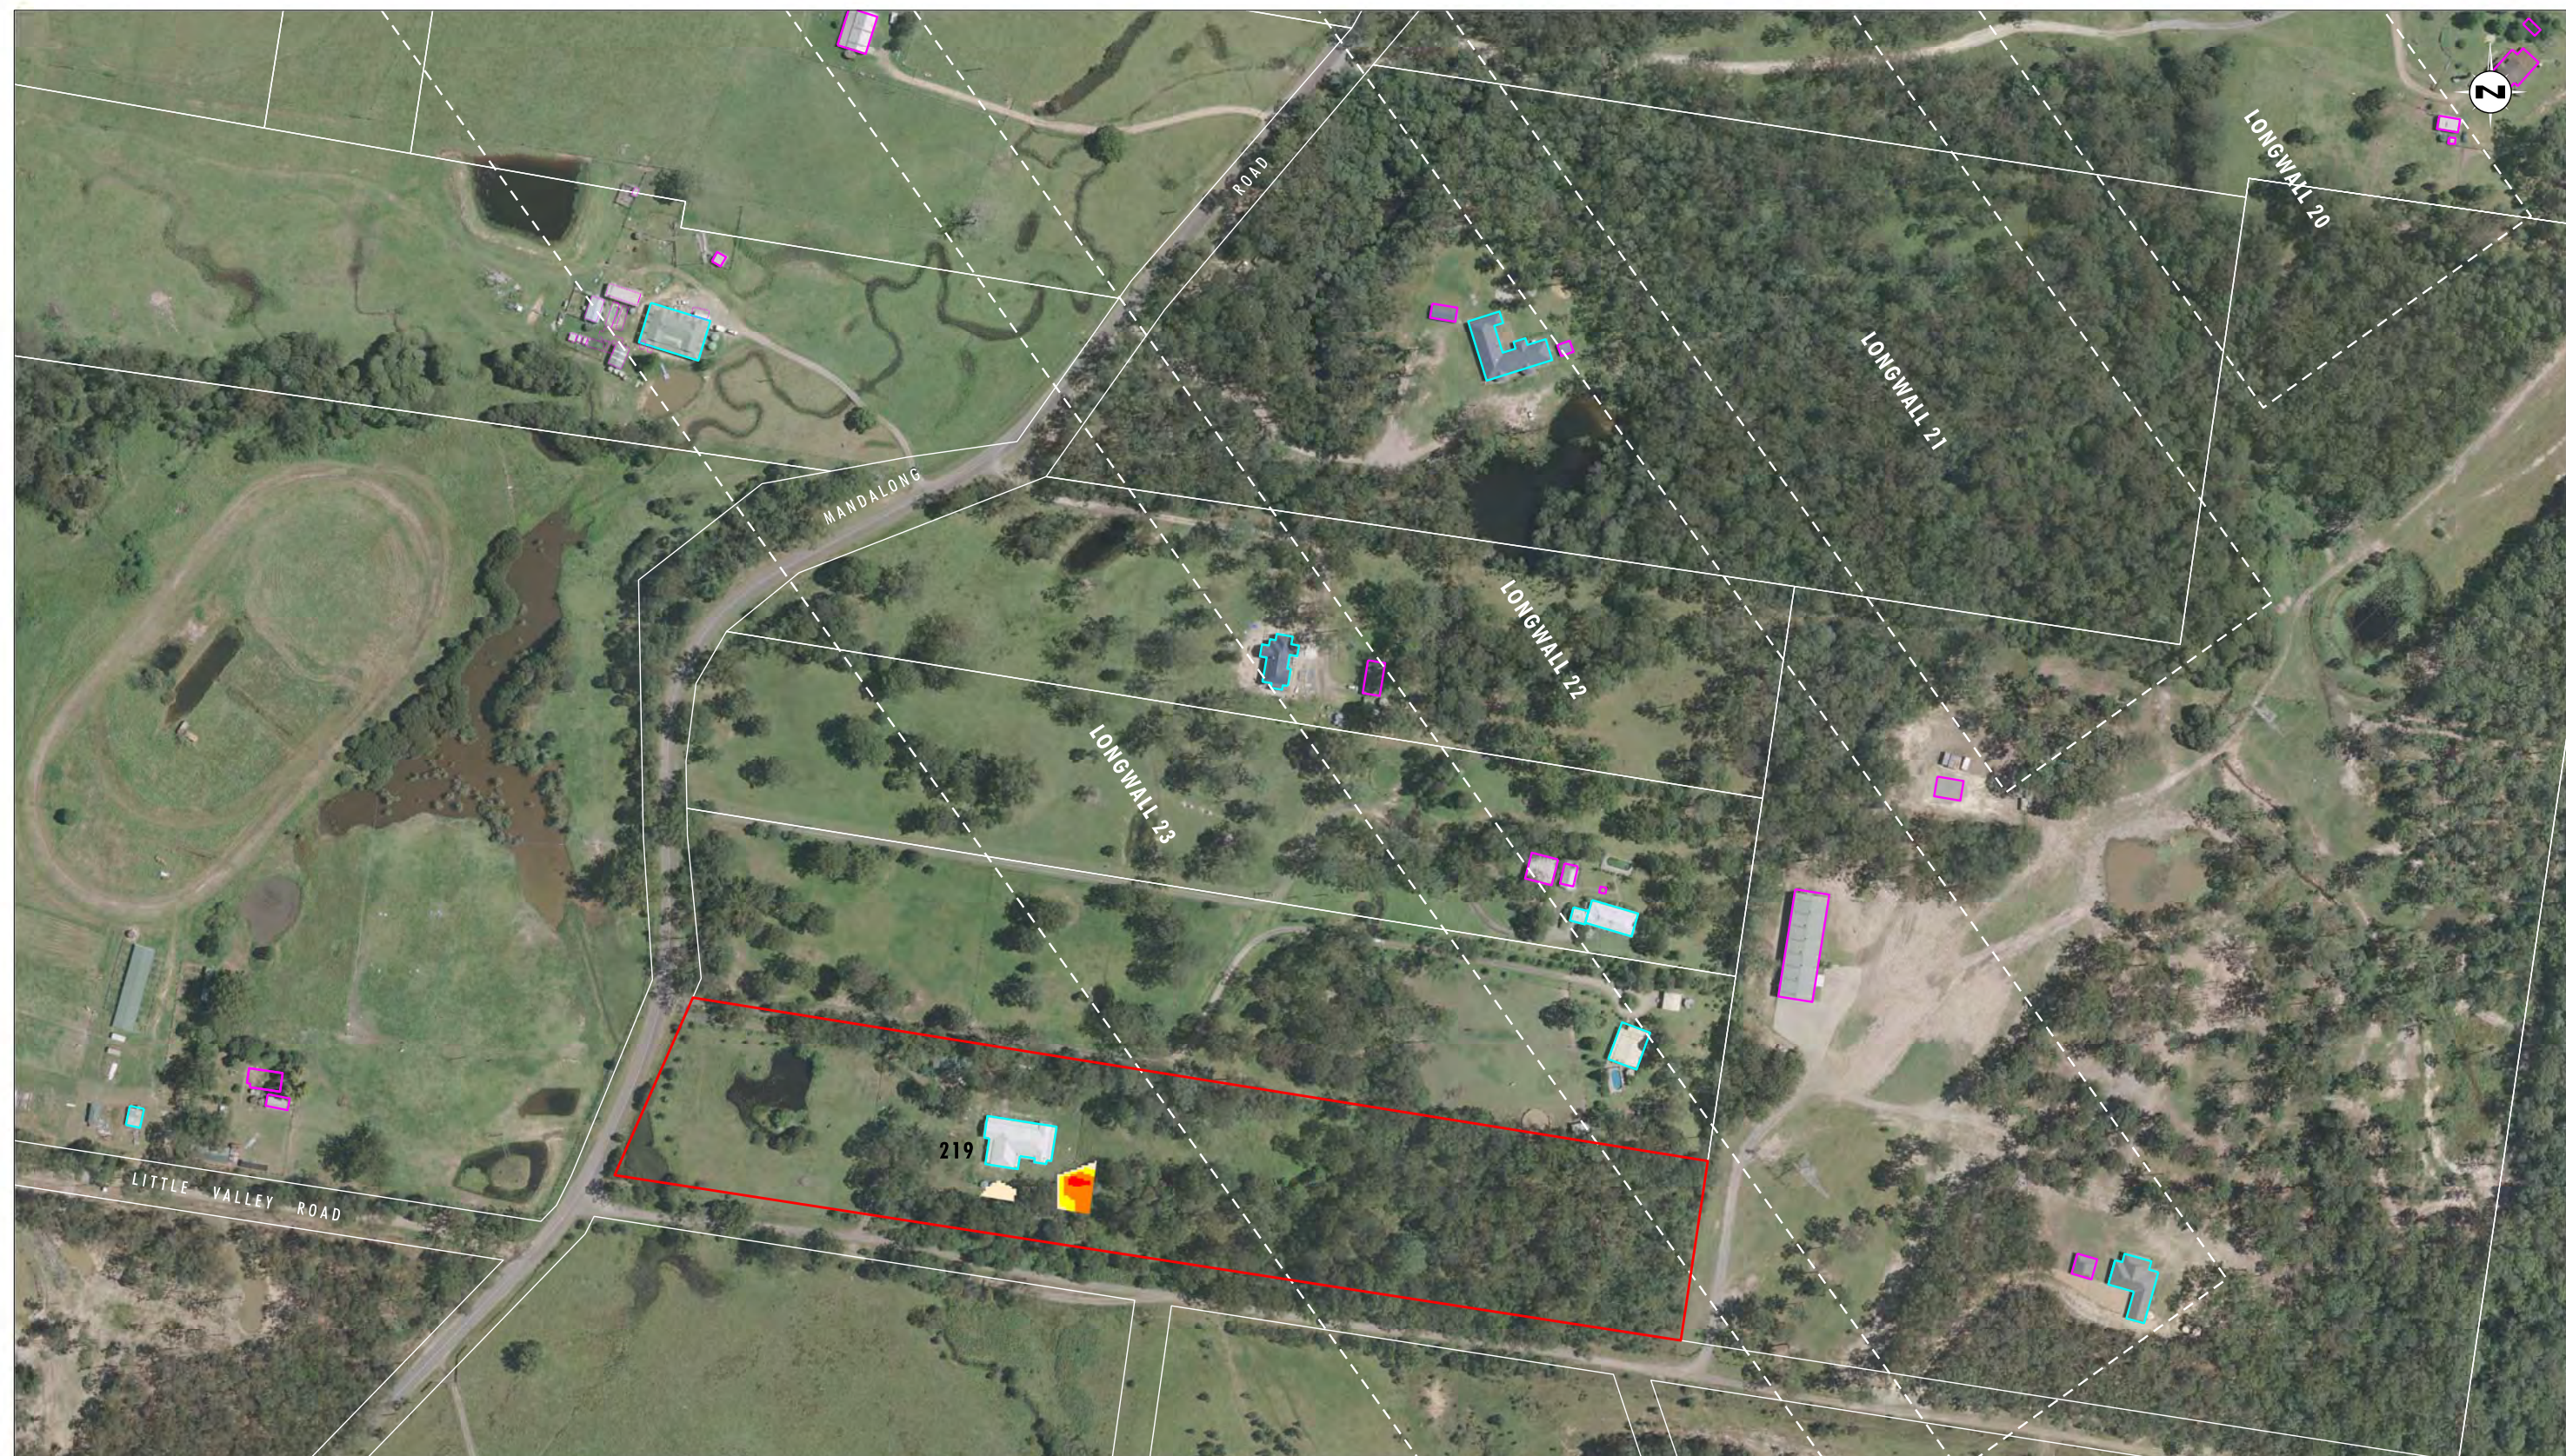
Property 219 - 1 Year ARI Storm Event:  
 Maximum Flood Hazard Categories Pre Mining Landform

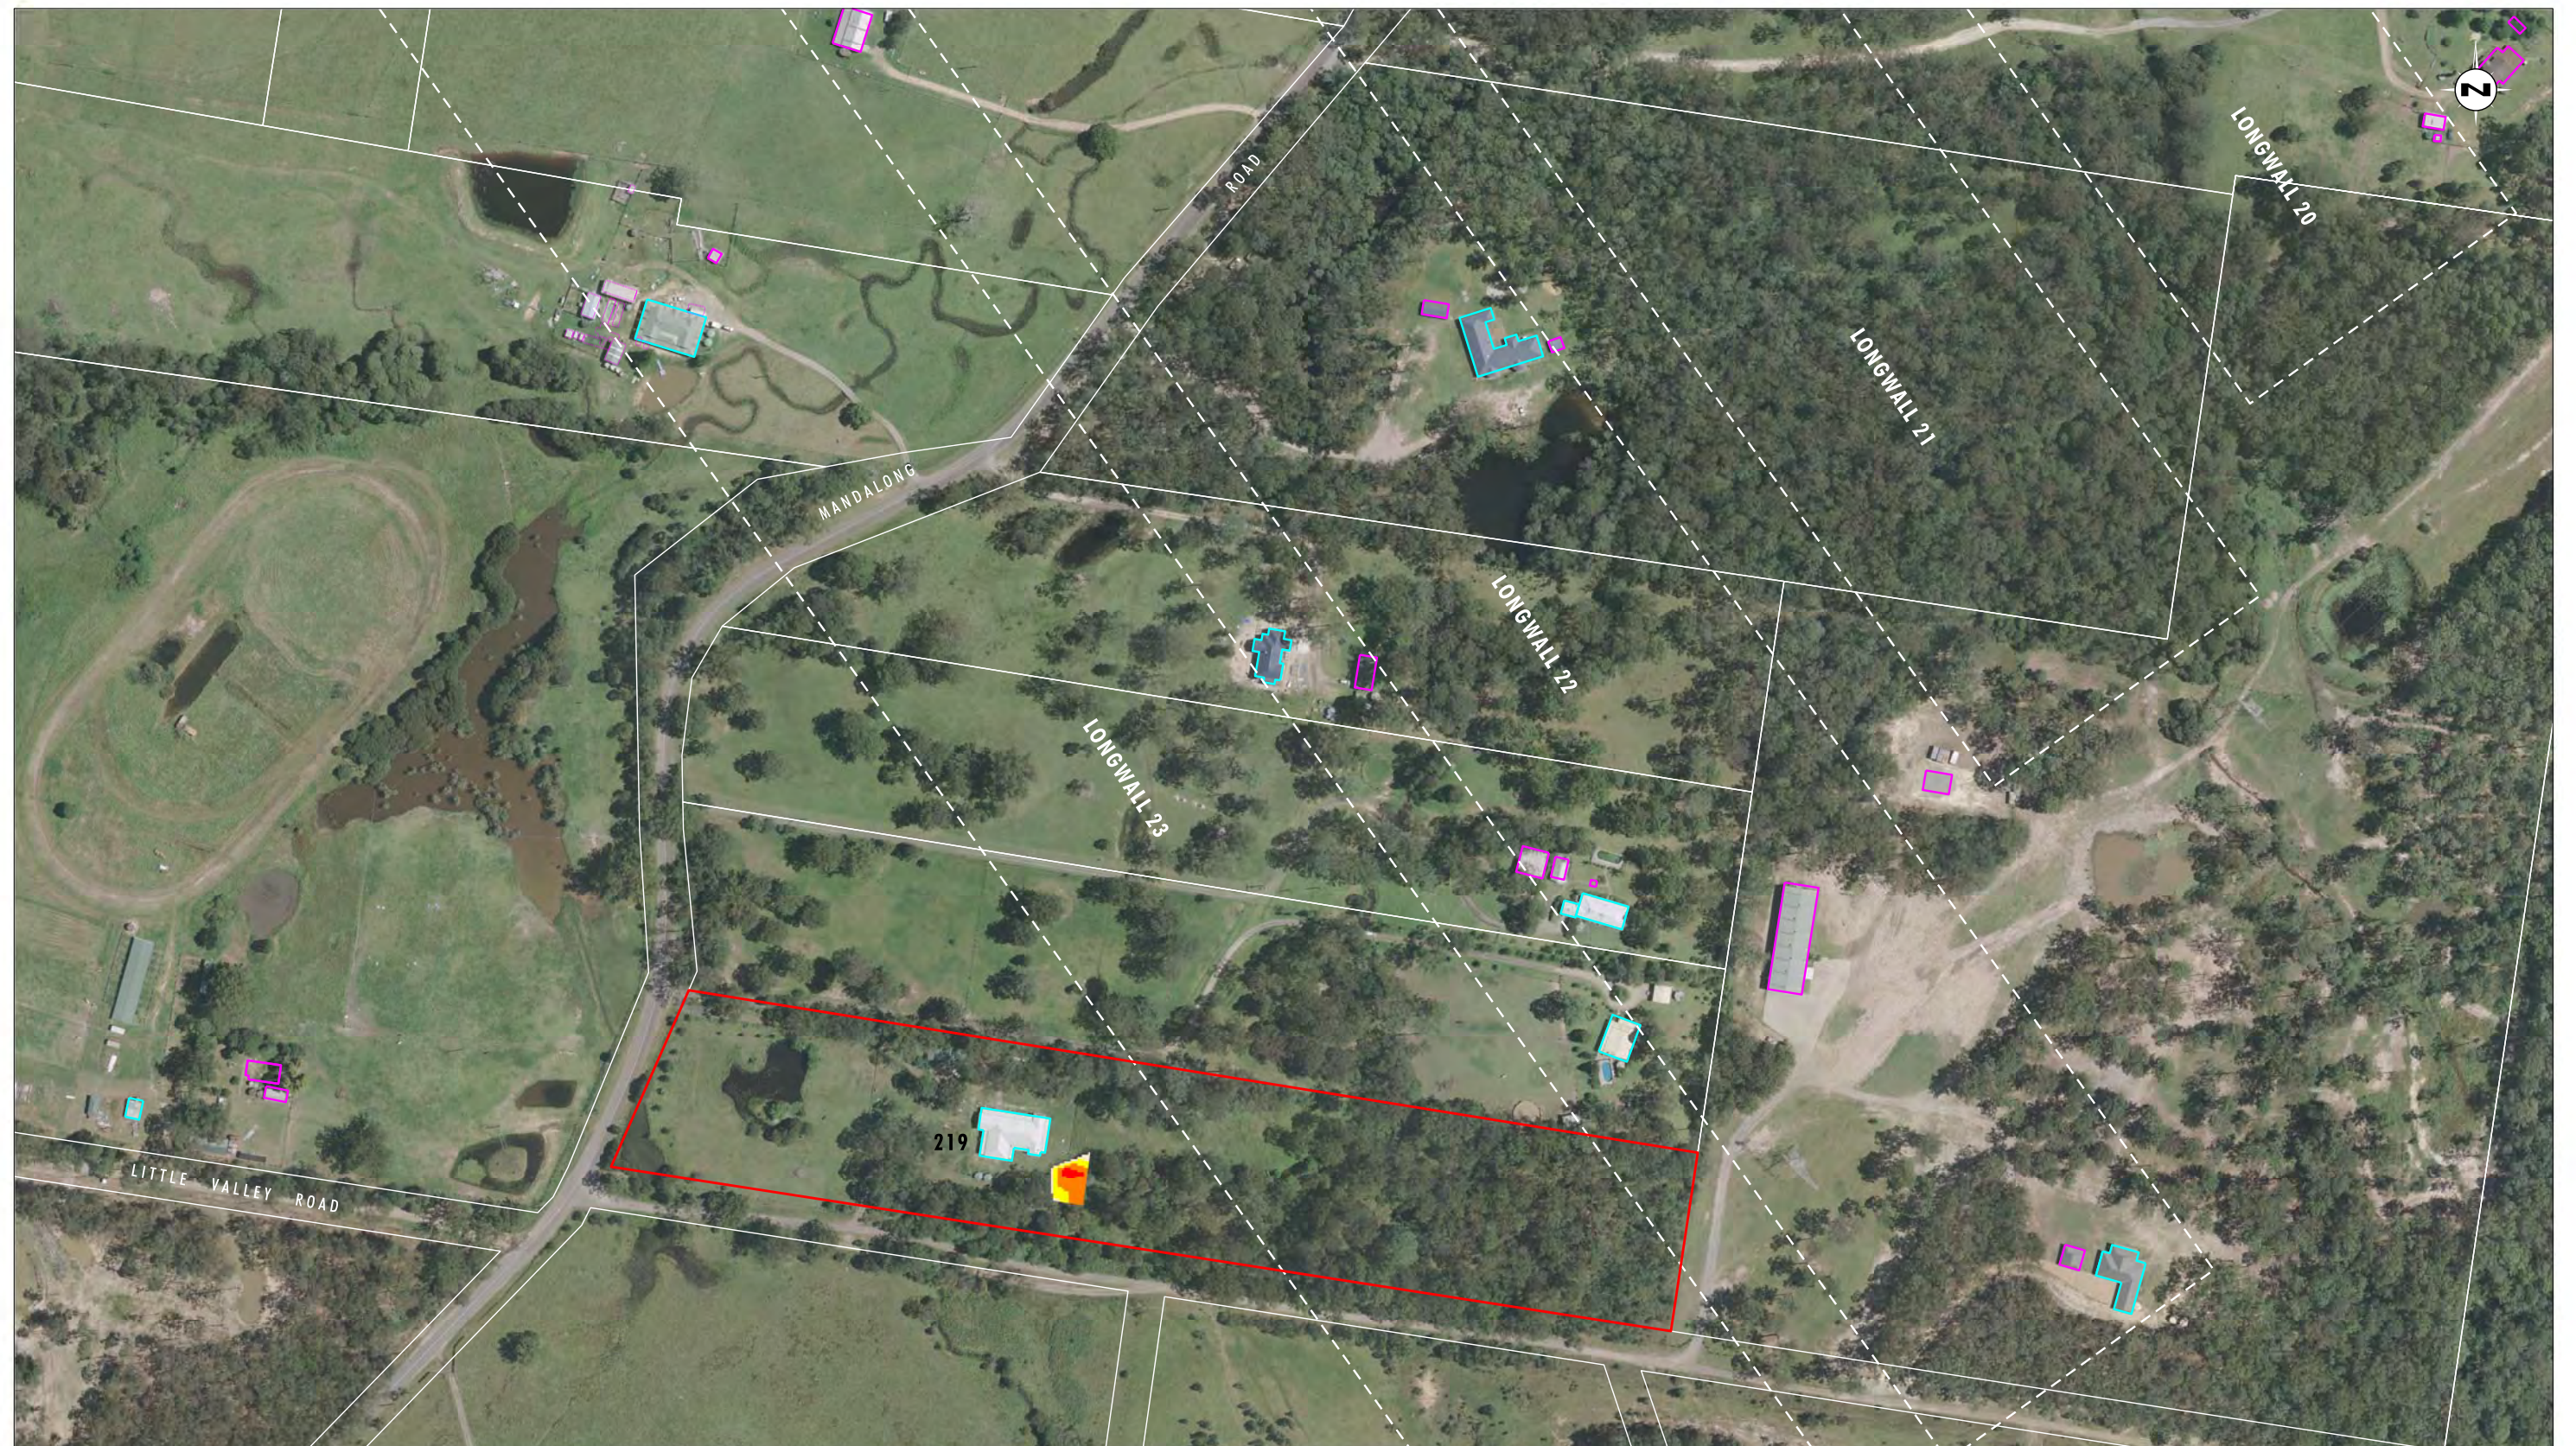
**FIGURE 8**  
 Property 219 - 1 Year ARI Storm Event:  
 Maximum Flood Hazard Categories Post Mining Landform  
 (to Longwall 23)

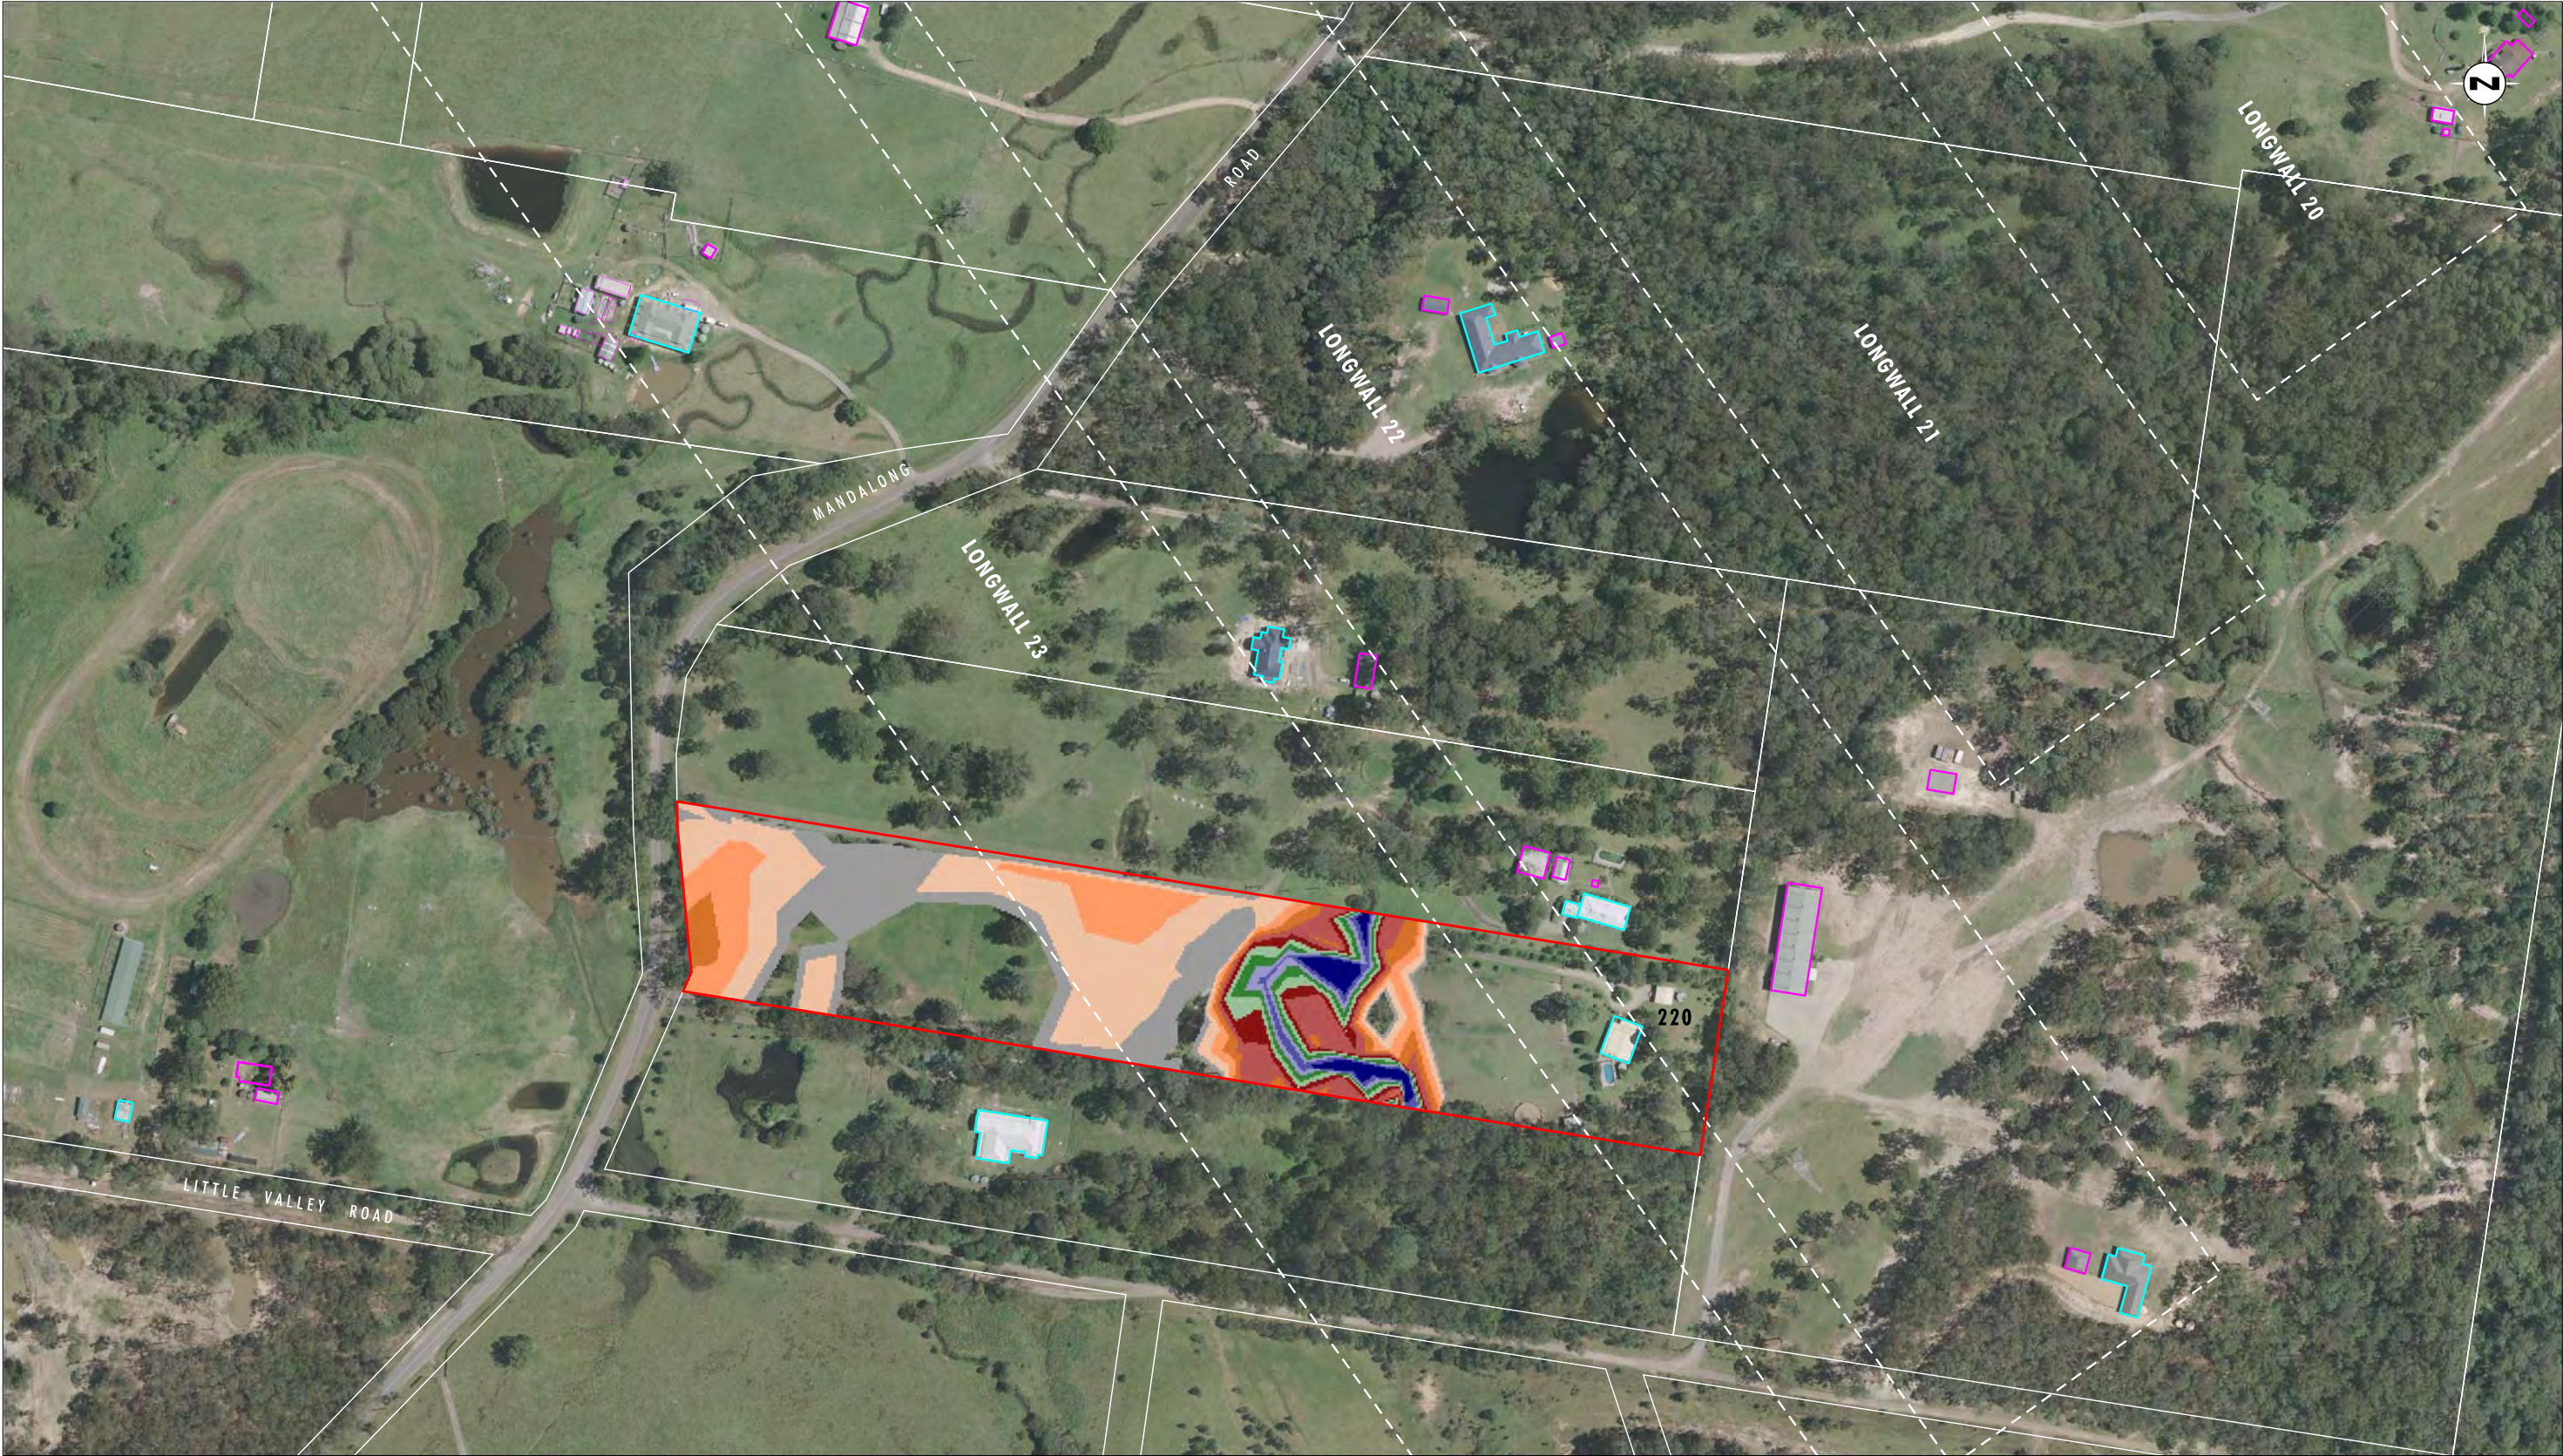
Property 220 - 100 Year ARI Storm Event:  
Maximum Flood Depth Pre Mining Landform
