## APPENDIX 31

Flooding Assessment Figures -  
Property 213

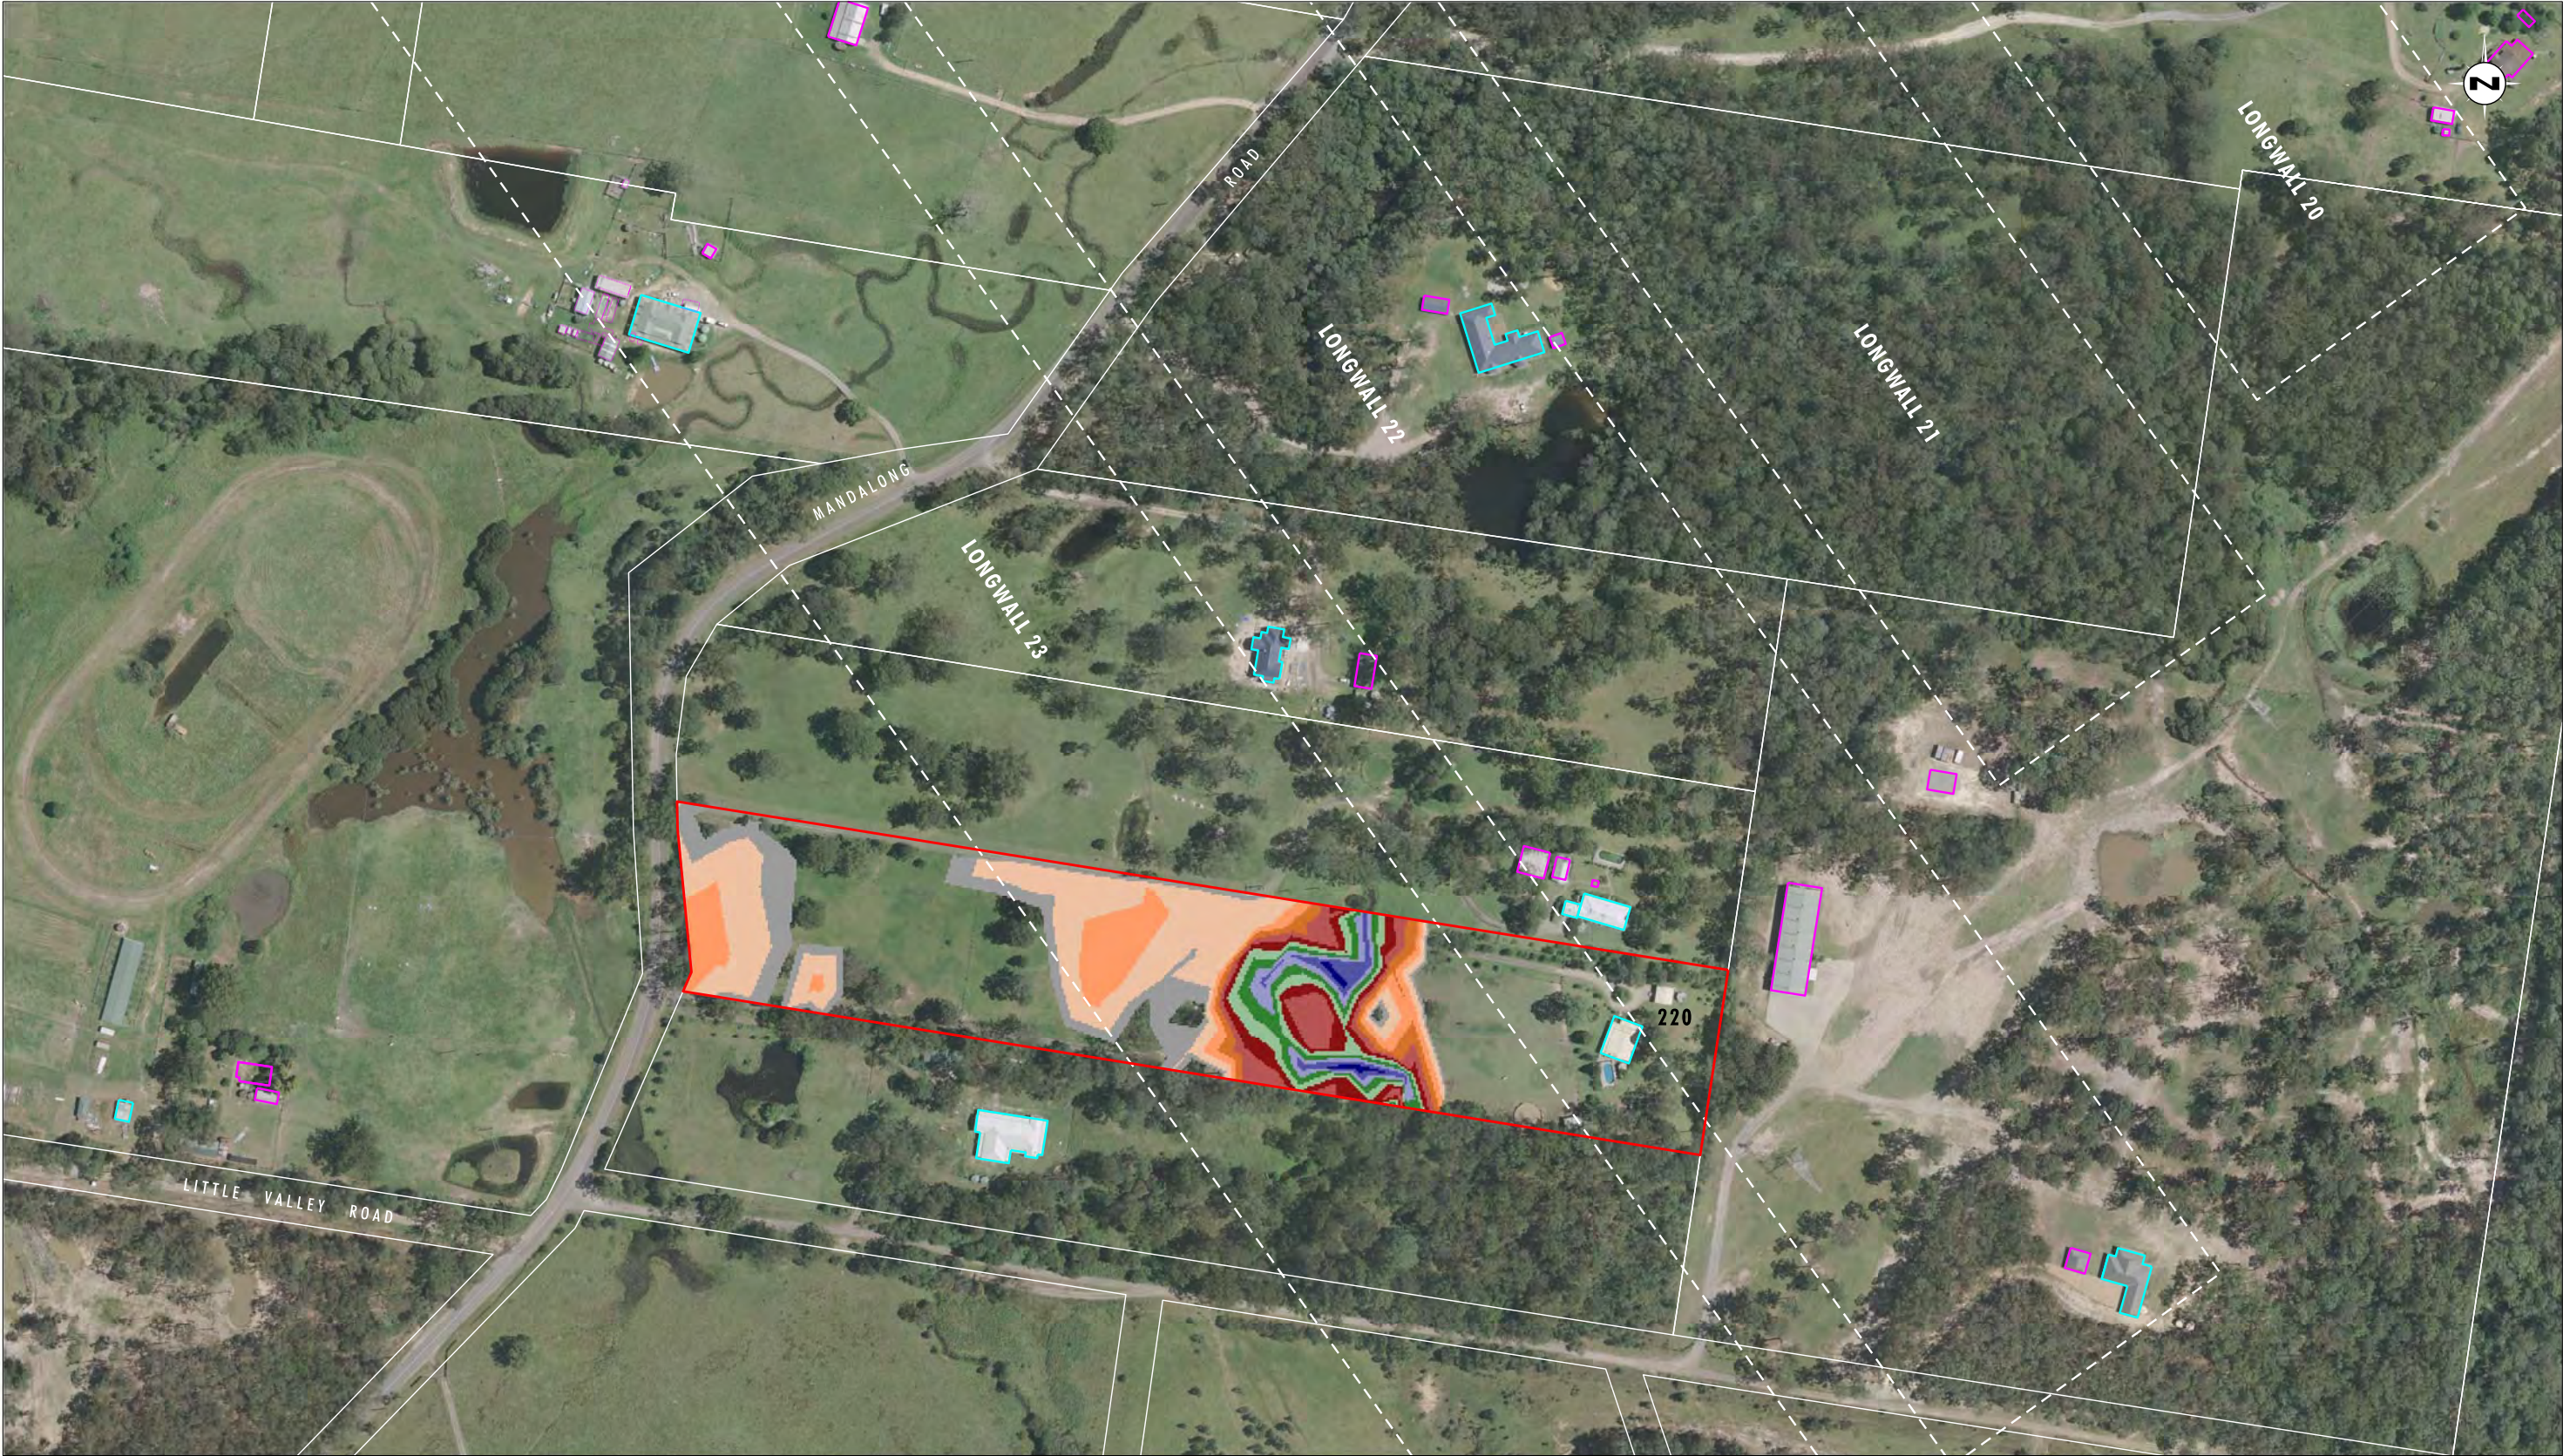
Property 220 - 100 Year ARI Storm Event:  
Maximum Flood Depth Post Mining Landform  
(to Longwall 23)

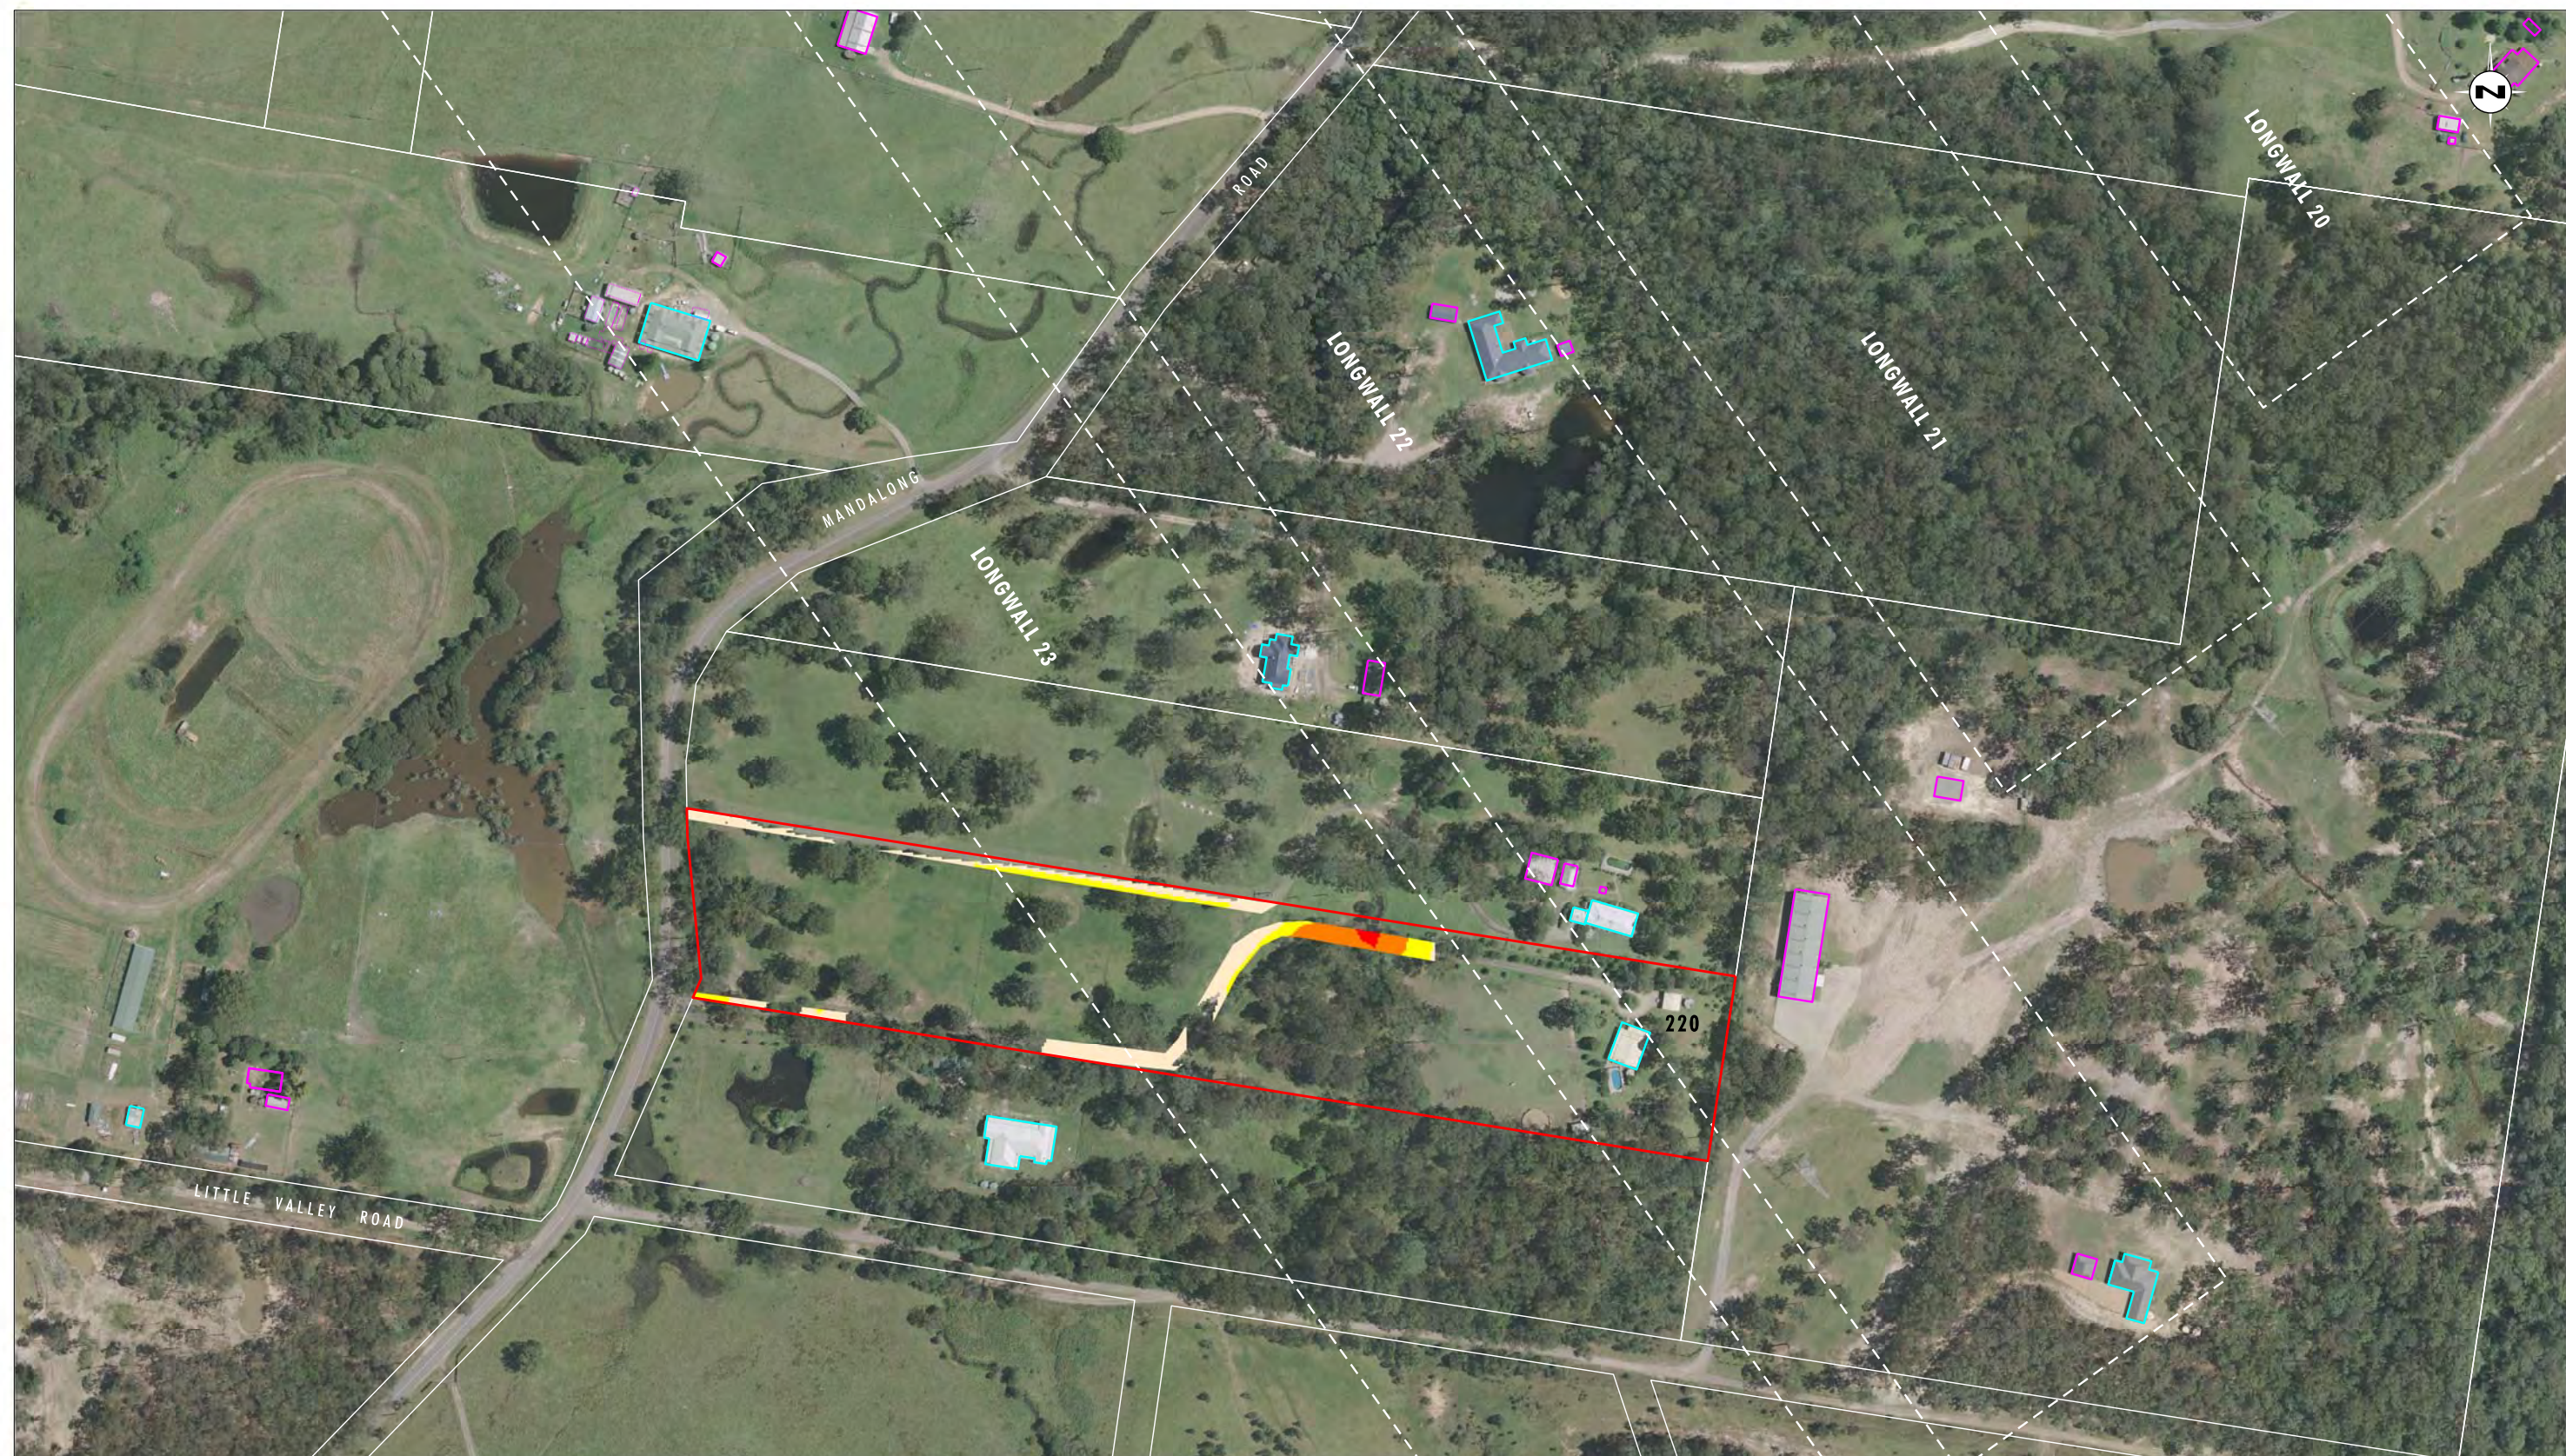
Property 220 - 100 Year ARI Storm Event:  
Maximum Flood Hazard Categories Pre Mining Landform

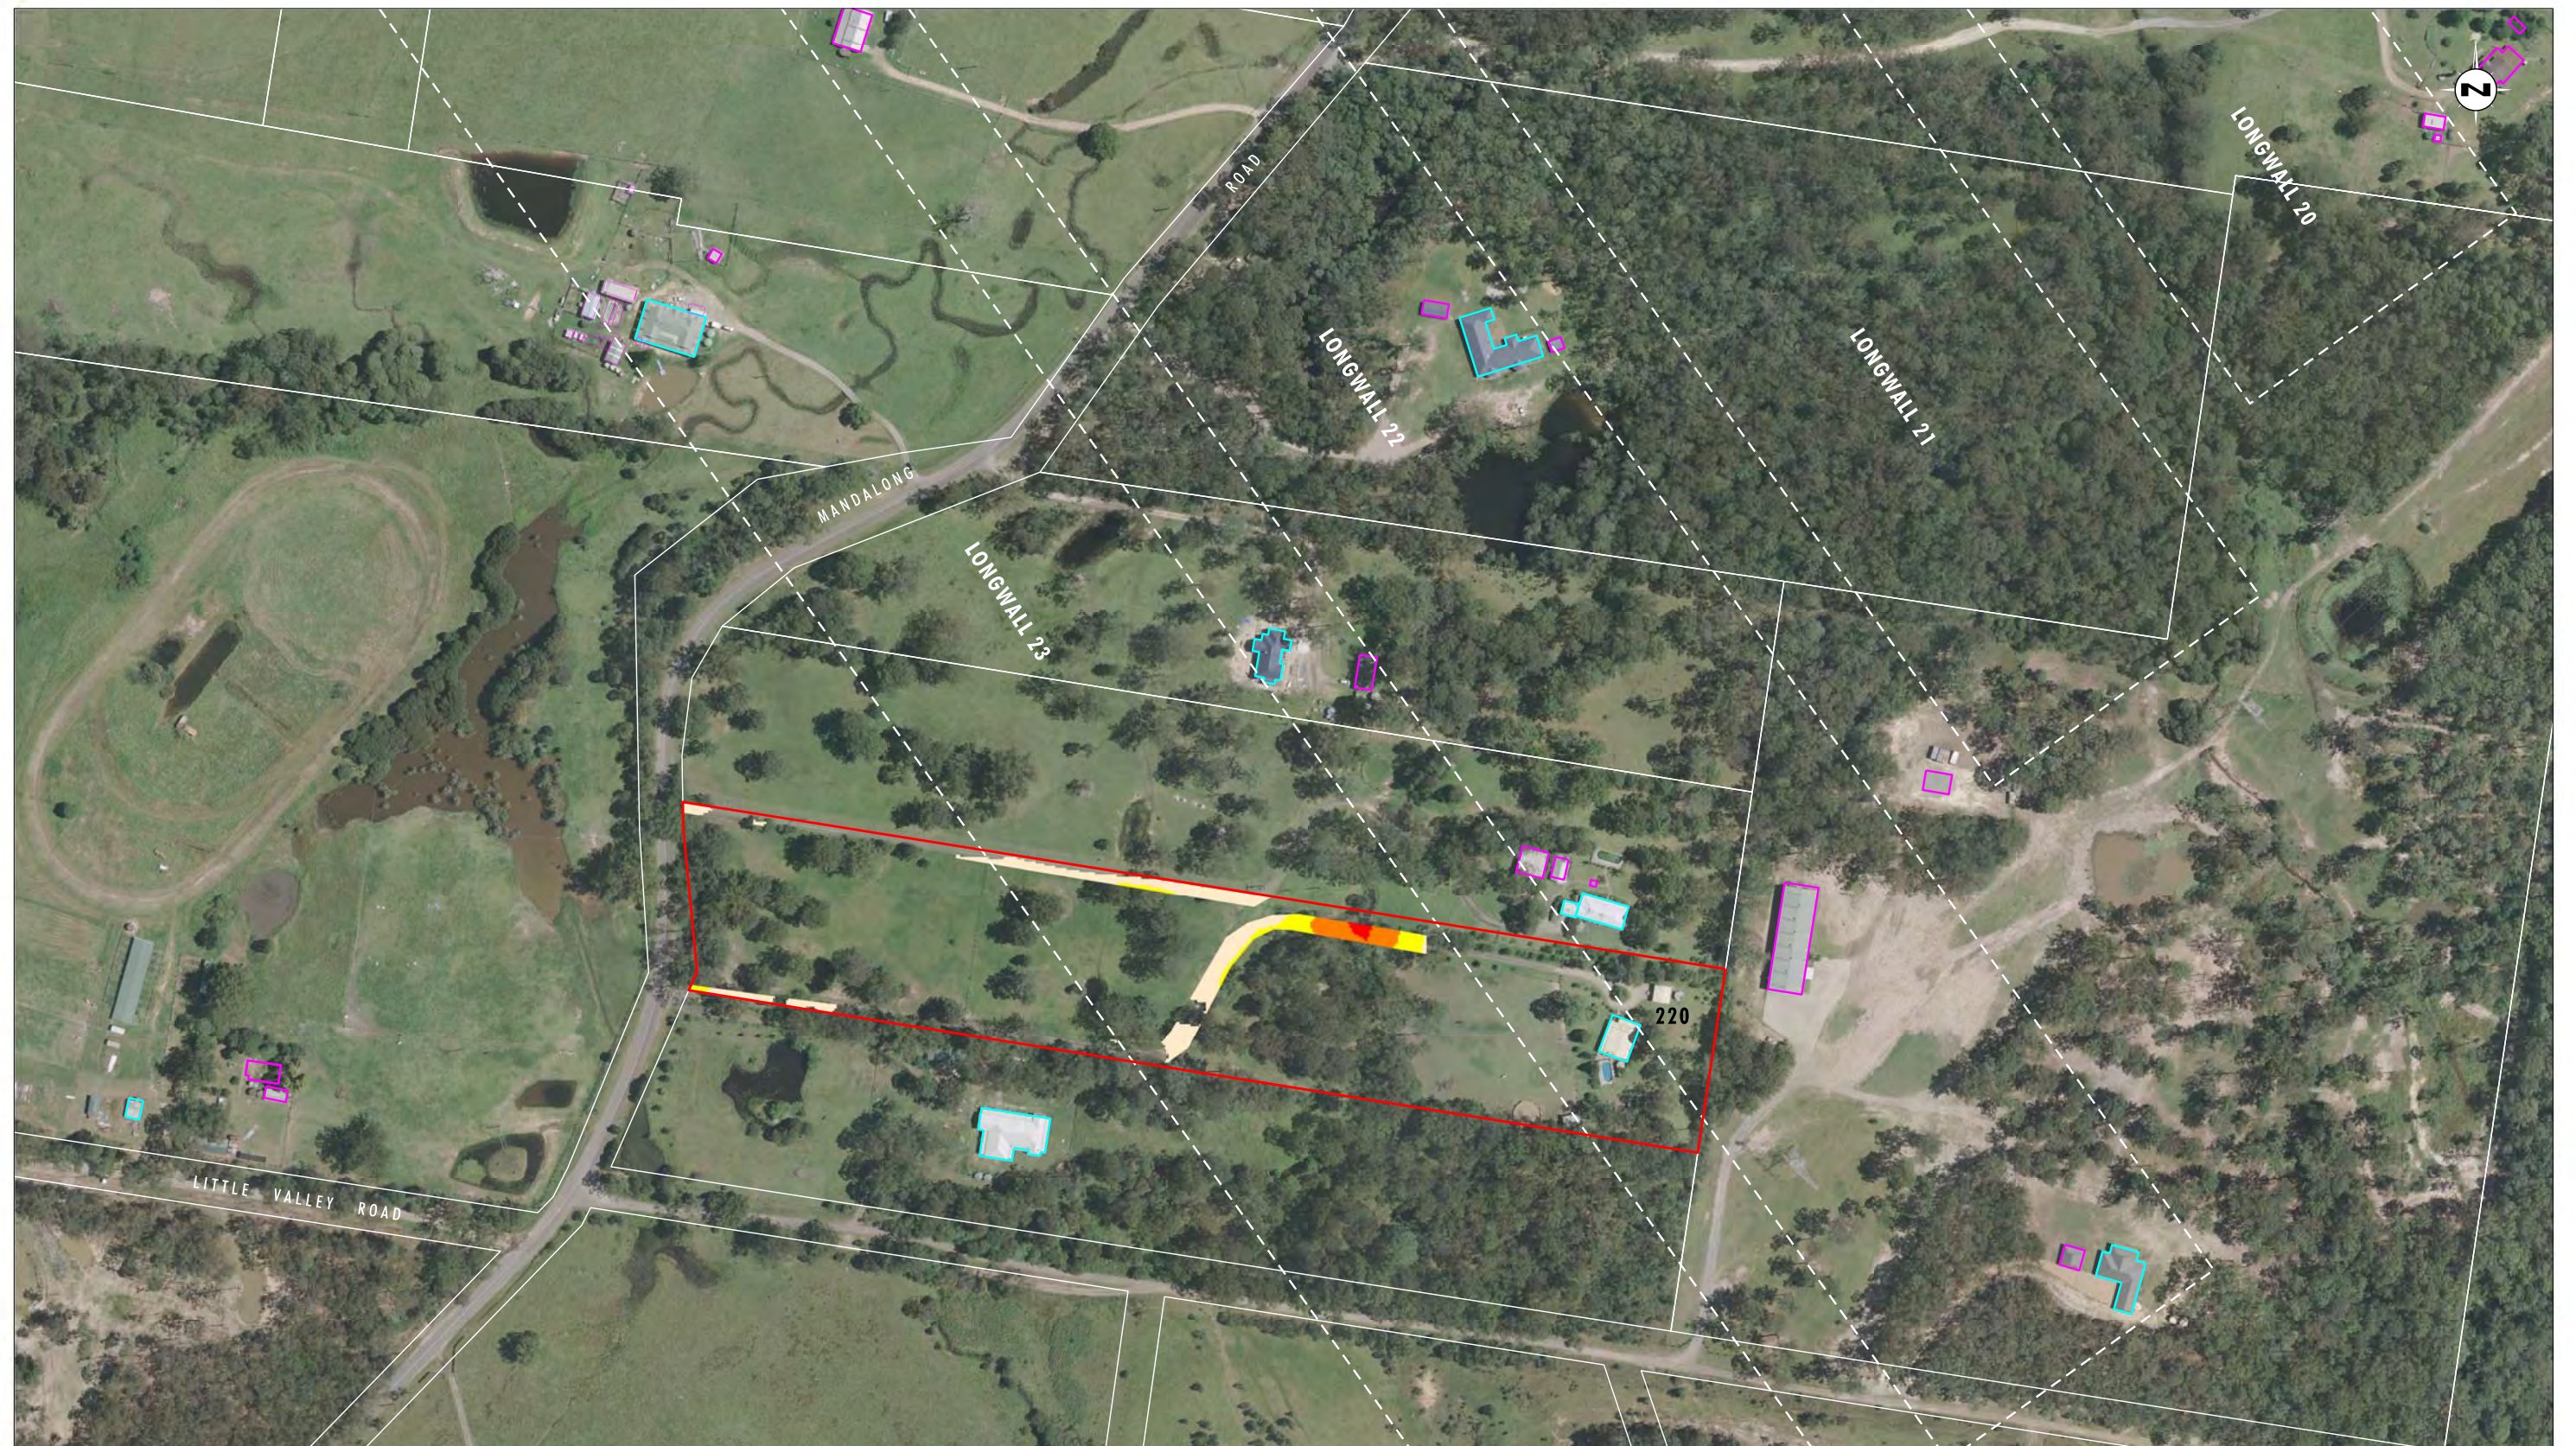
Property 220 - 100 Year ARI Storm Event:  
 Maximum Flood Hazard Categories Post Mining Landform  
 (to Longwall 23)

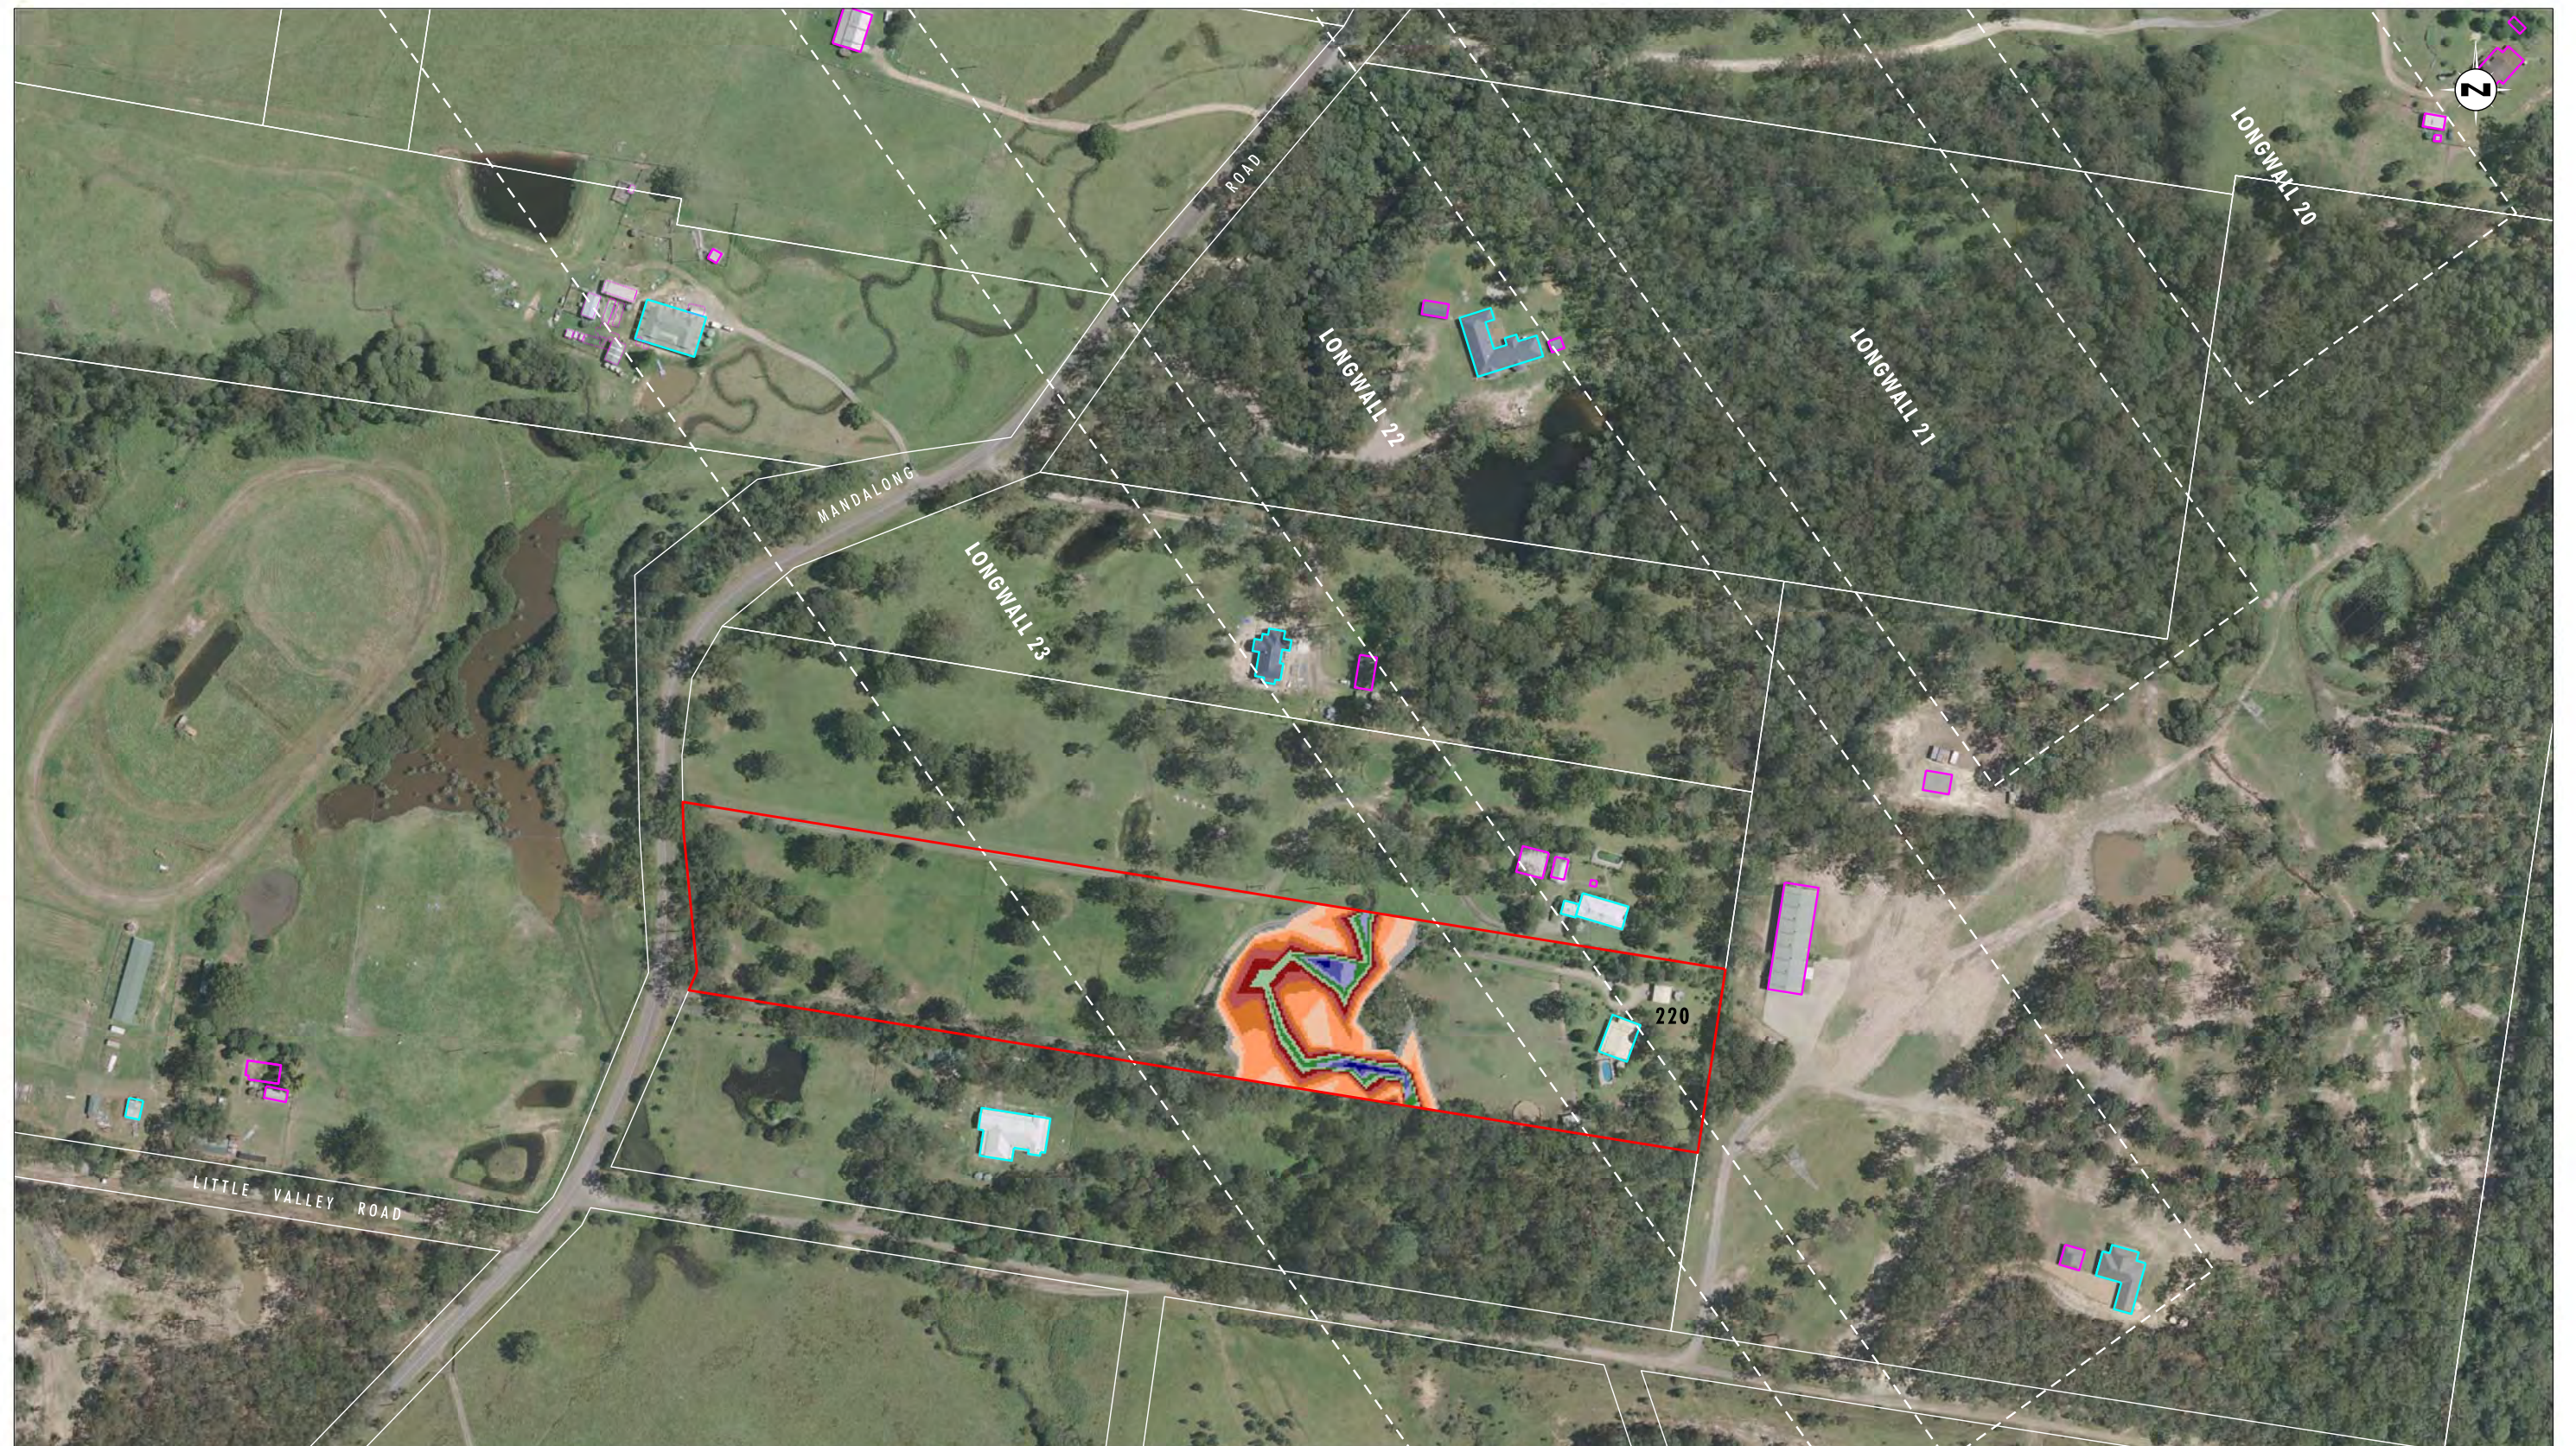
Property 220 - 1 Year ARI Storm Event:  
Maximum Flood Depth Pre Mining Landform

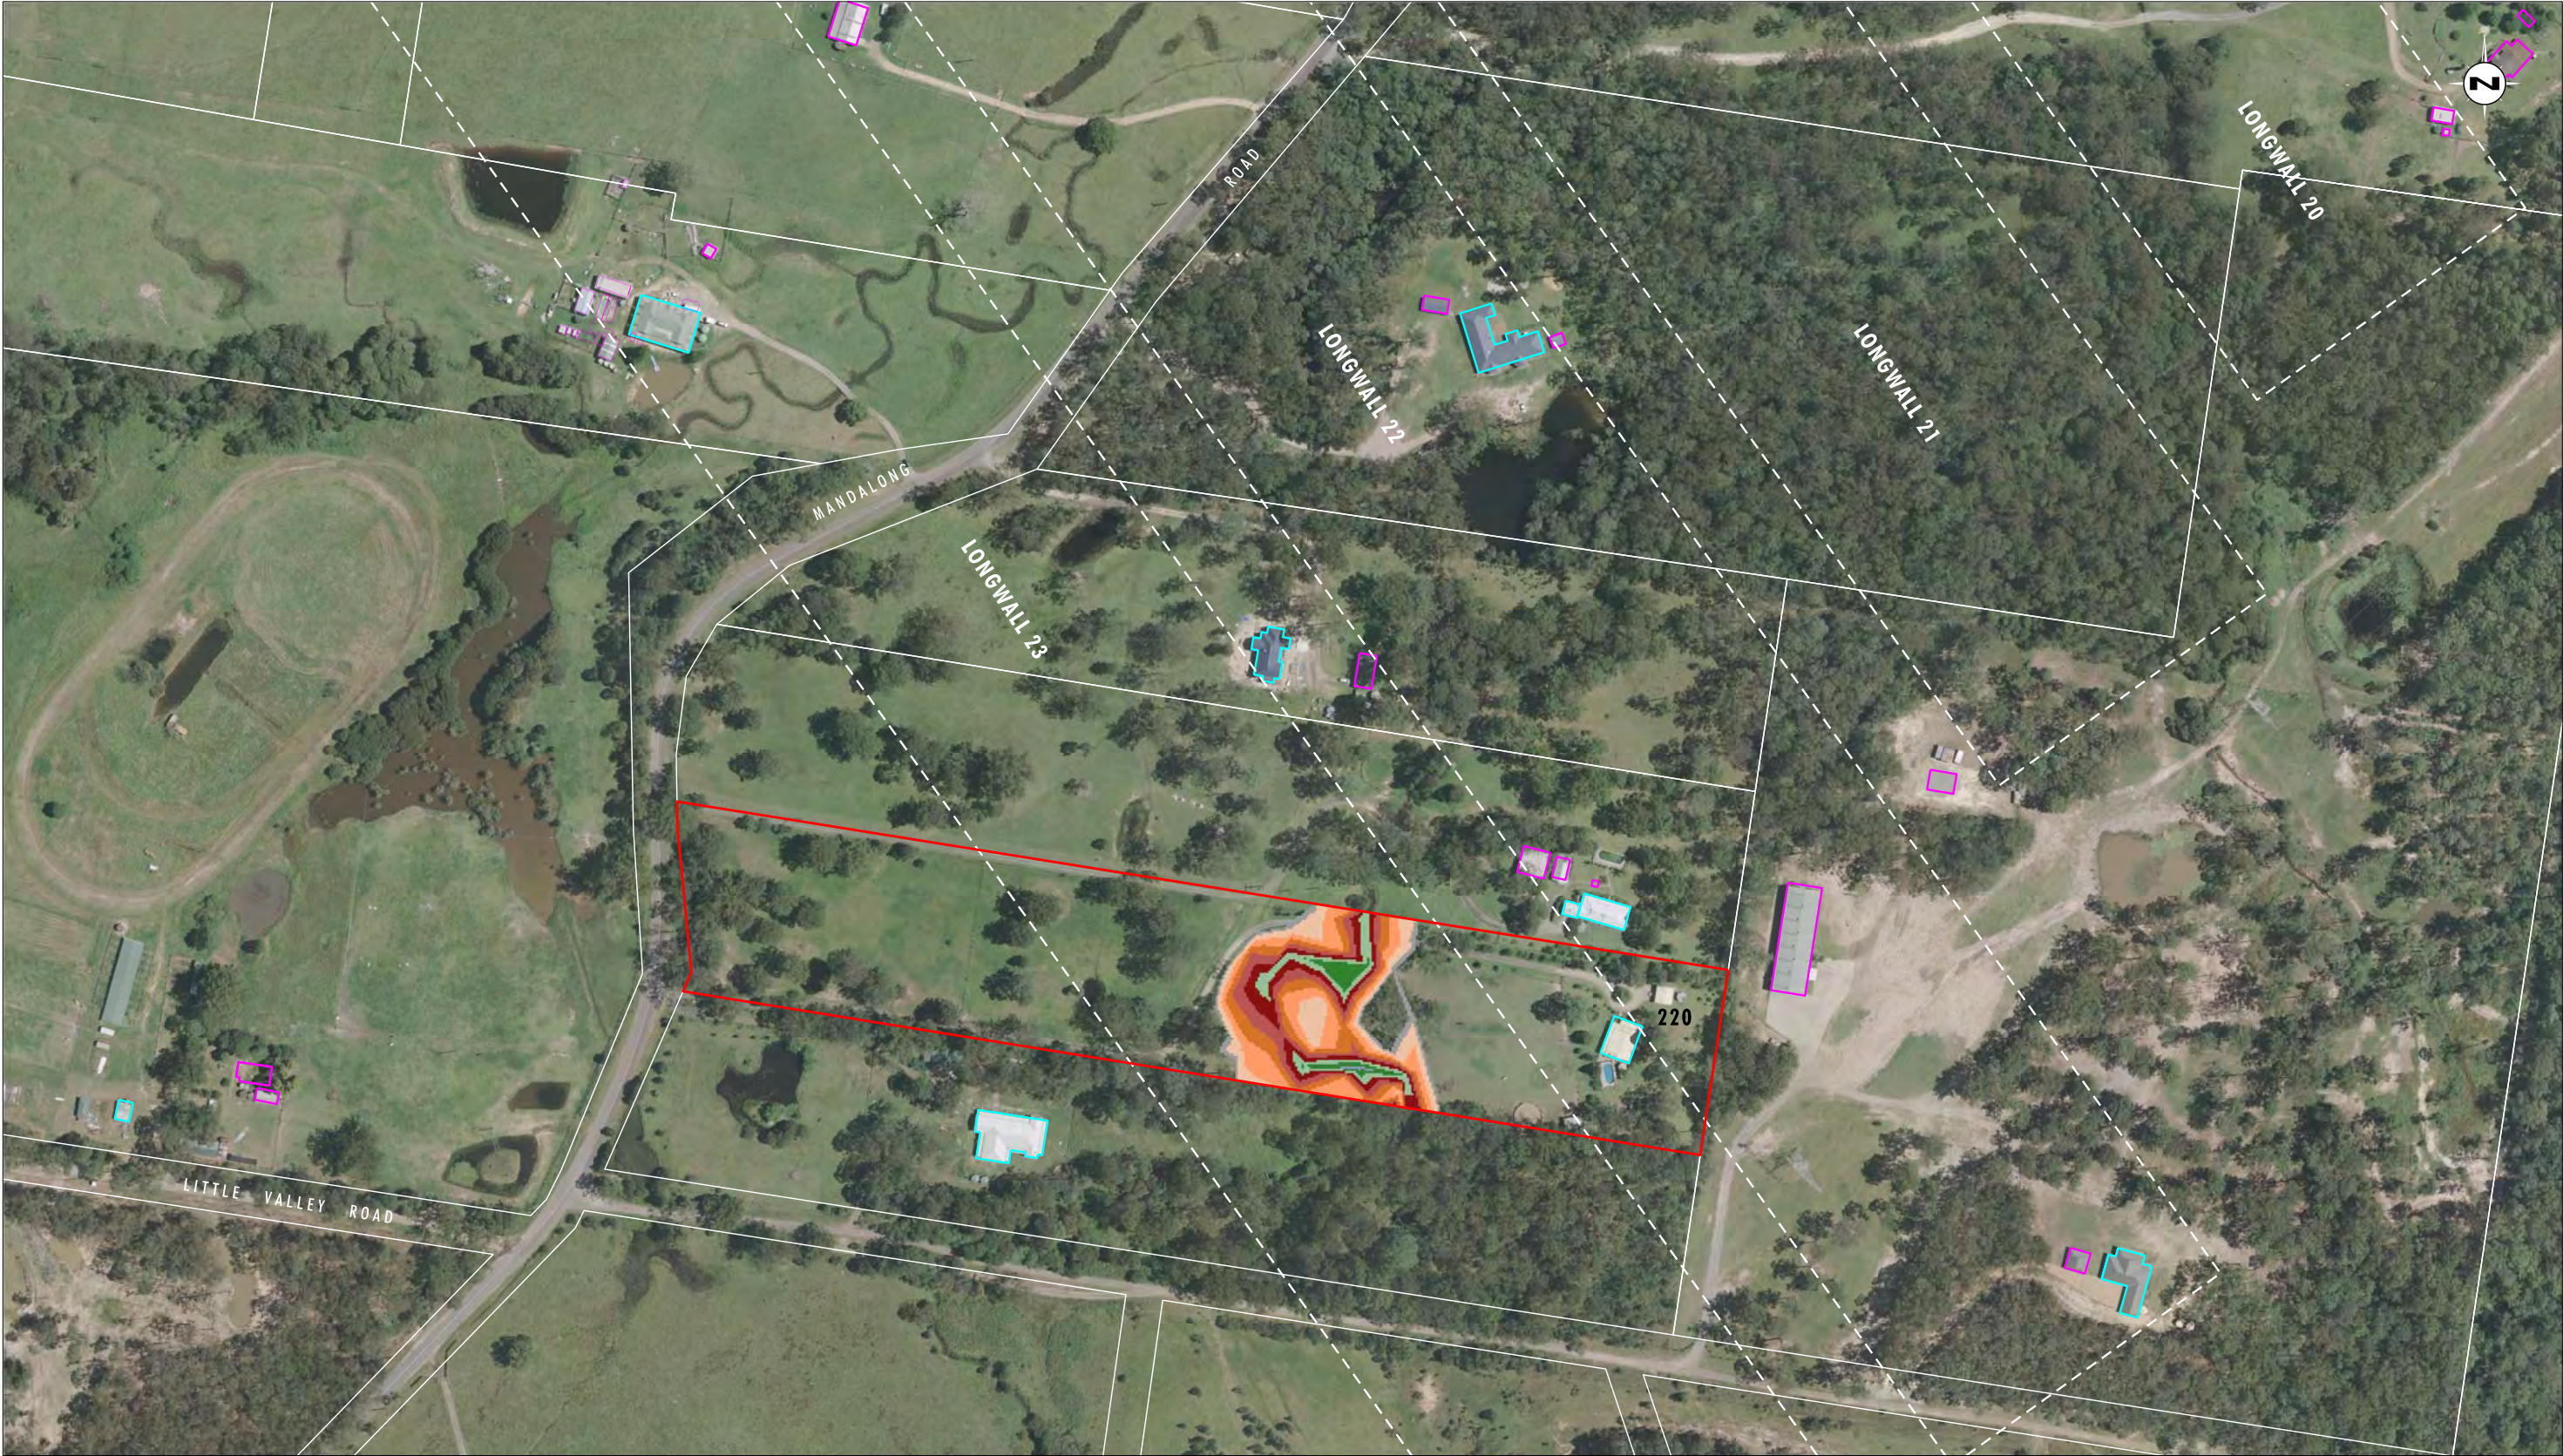
Property 220 - 1 Year ARI Storm Event:  
Maximum Flood Depth Post Mining Landform  
(to Longwall 23)

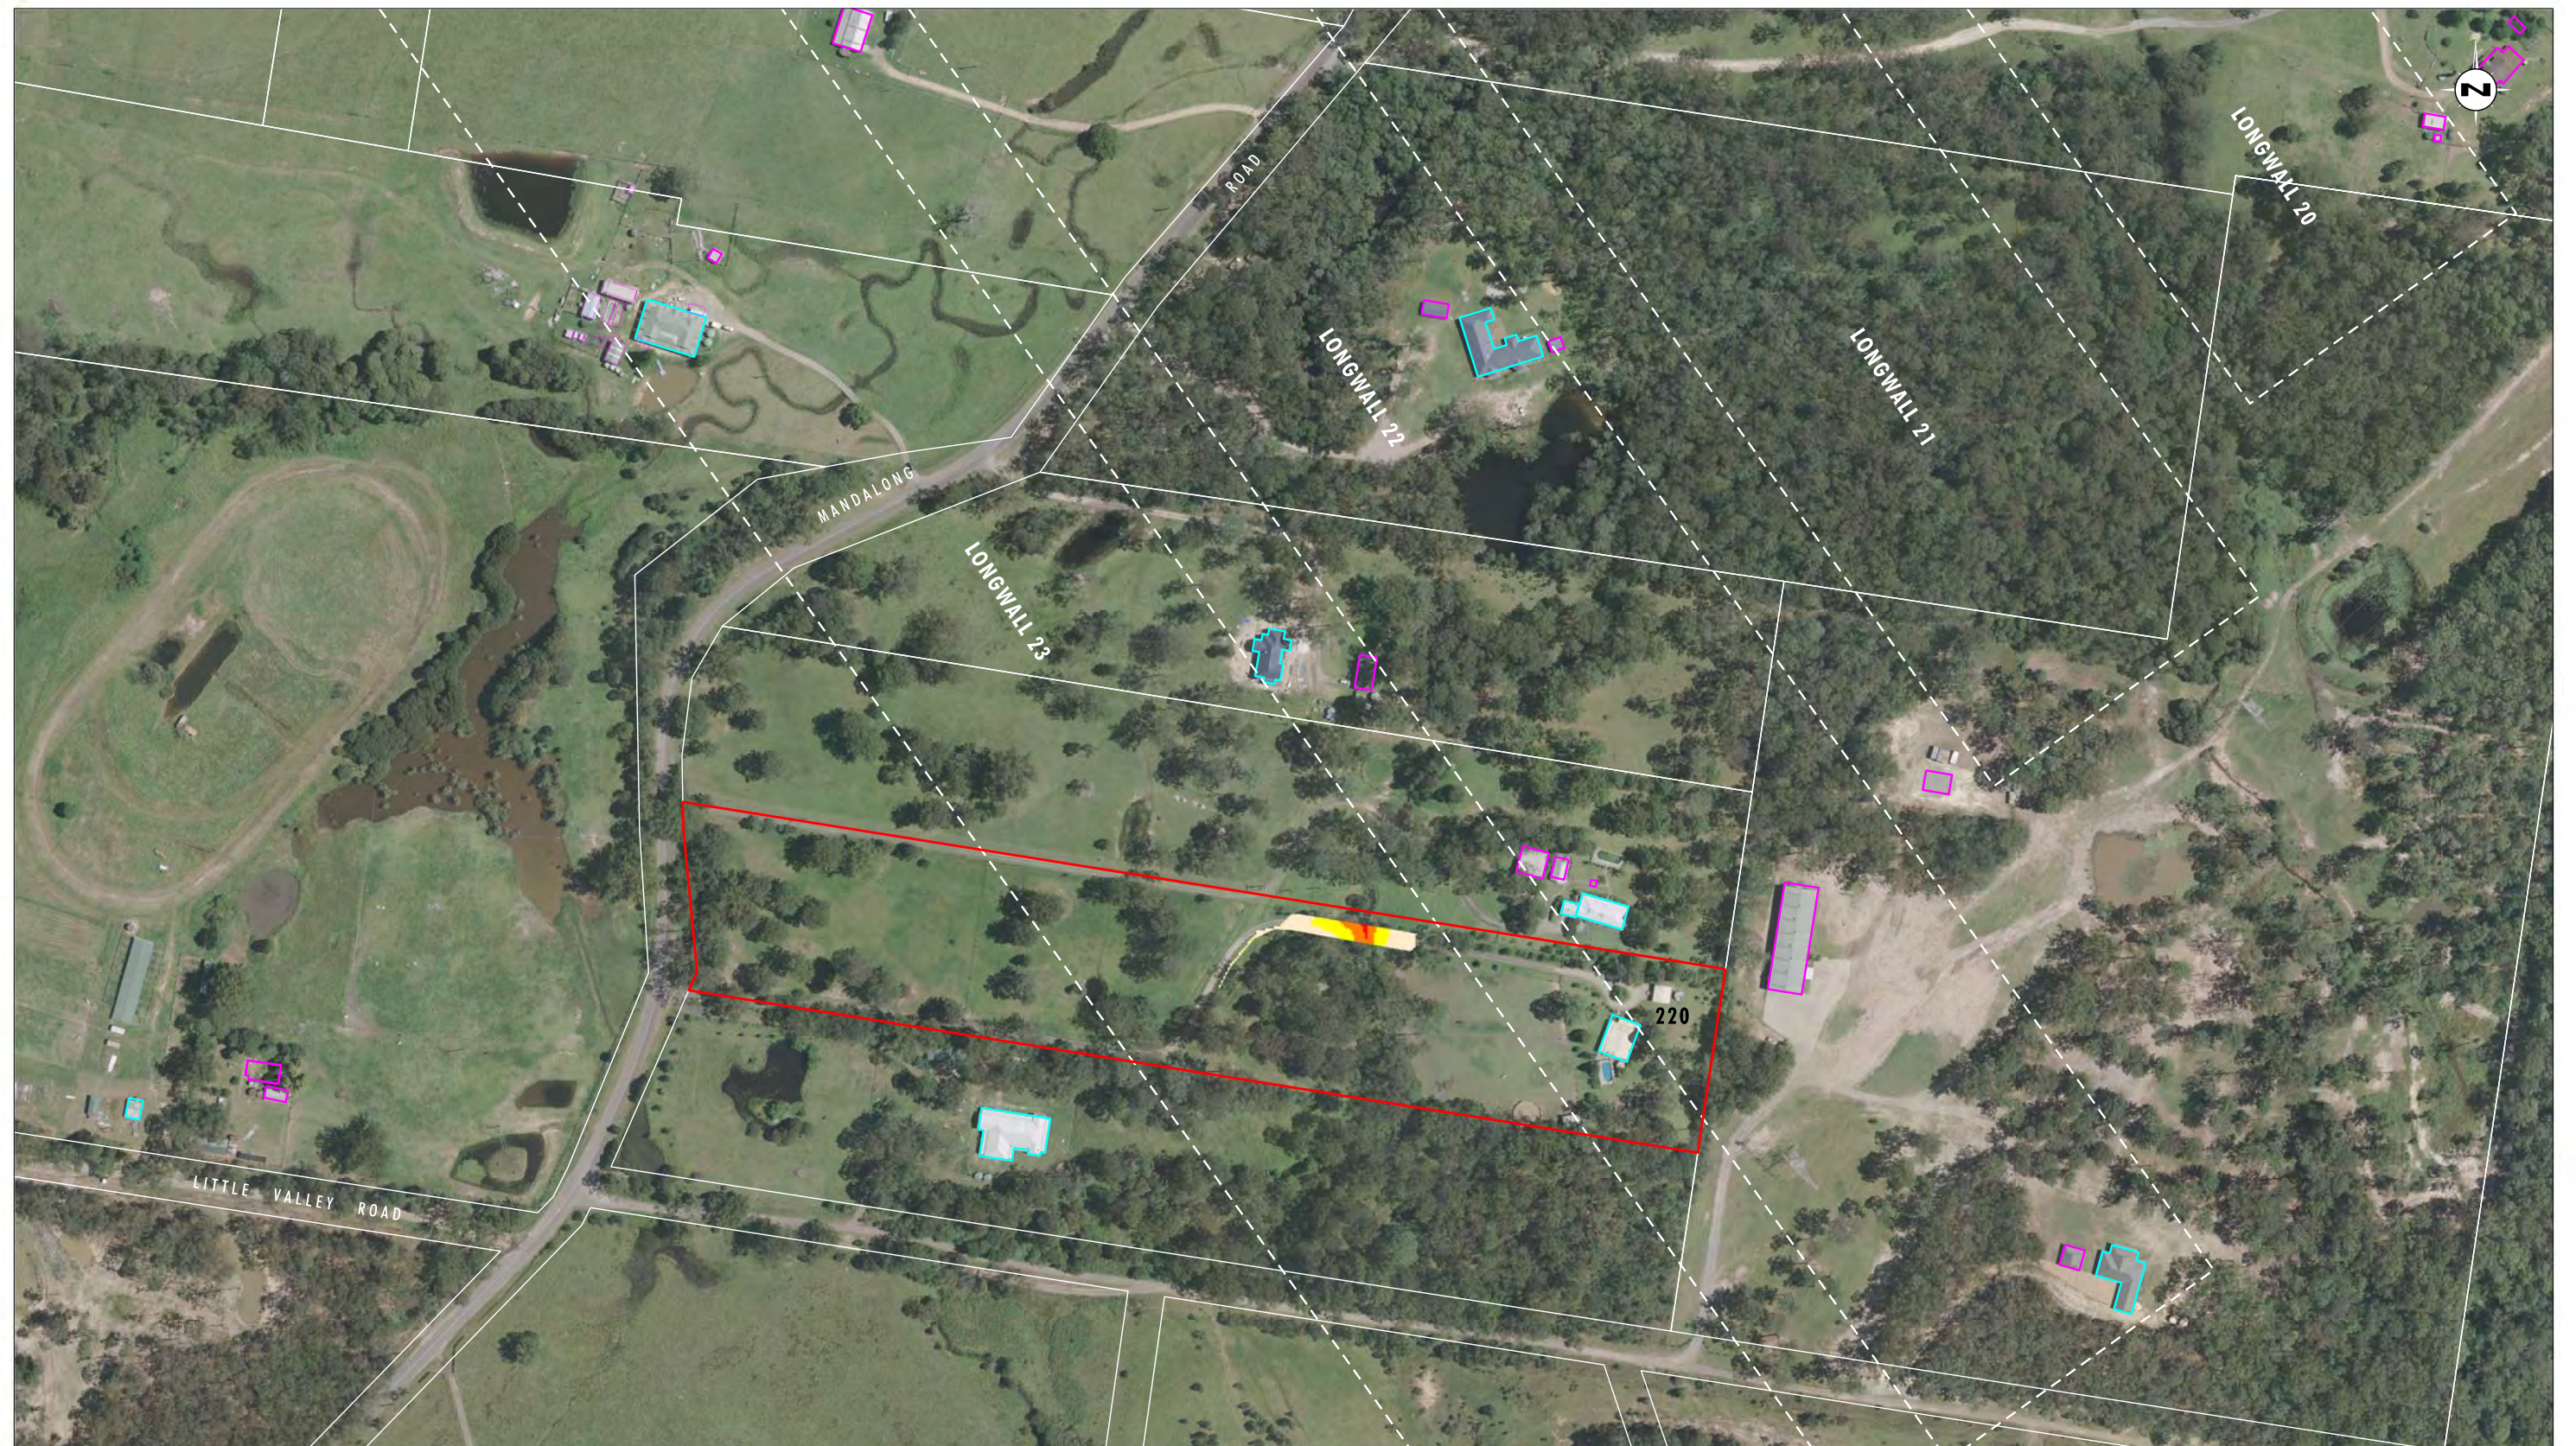
Property 220 - 1 Year ARI Storm Event:  
 Maximum Flood Hazard Categories Pre Mining Landform
