## APPENDIX 31

Flooding Assessment Figures -  
Property 213

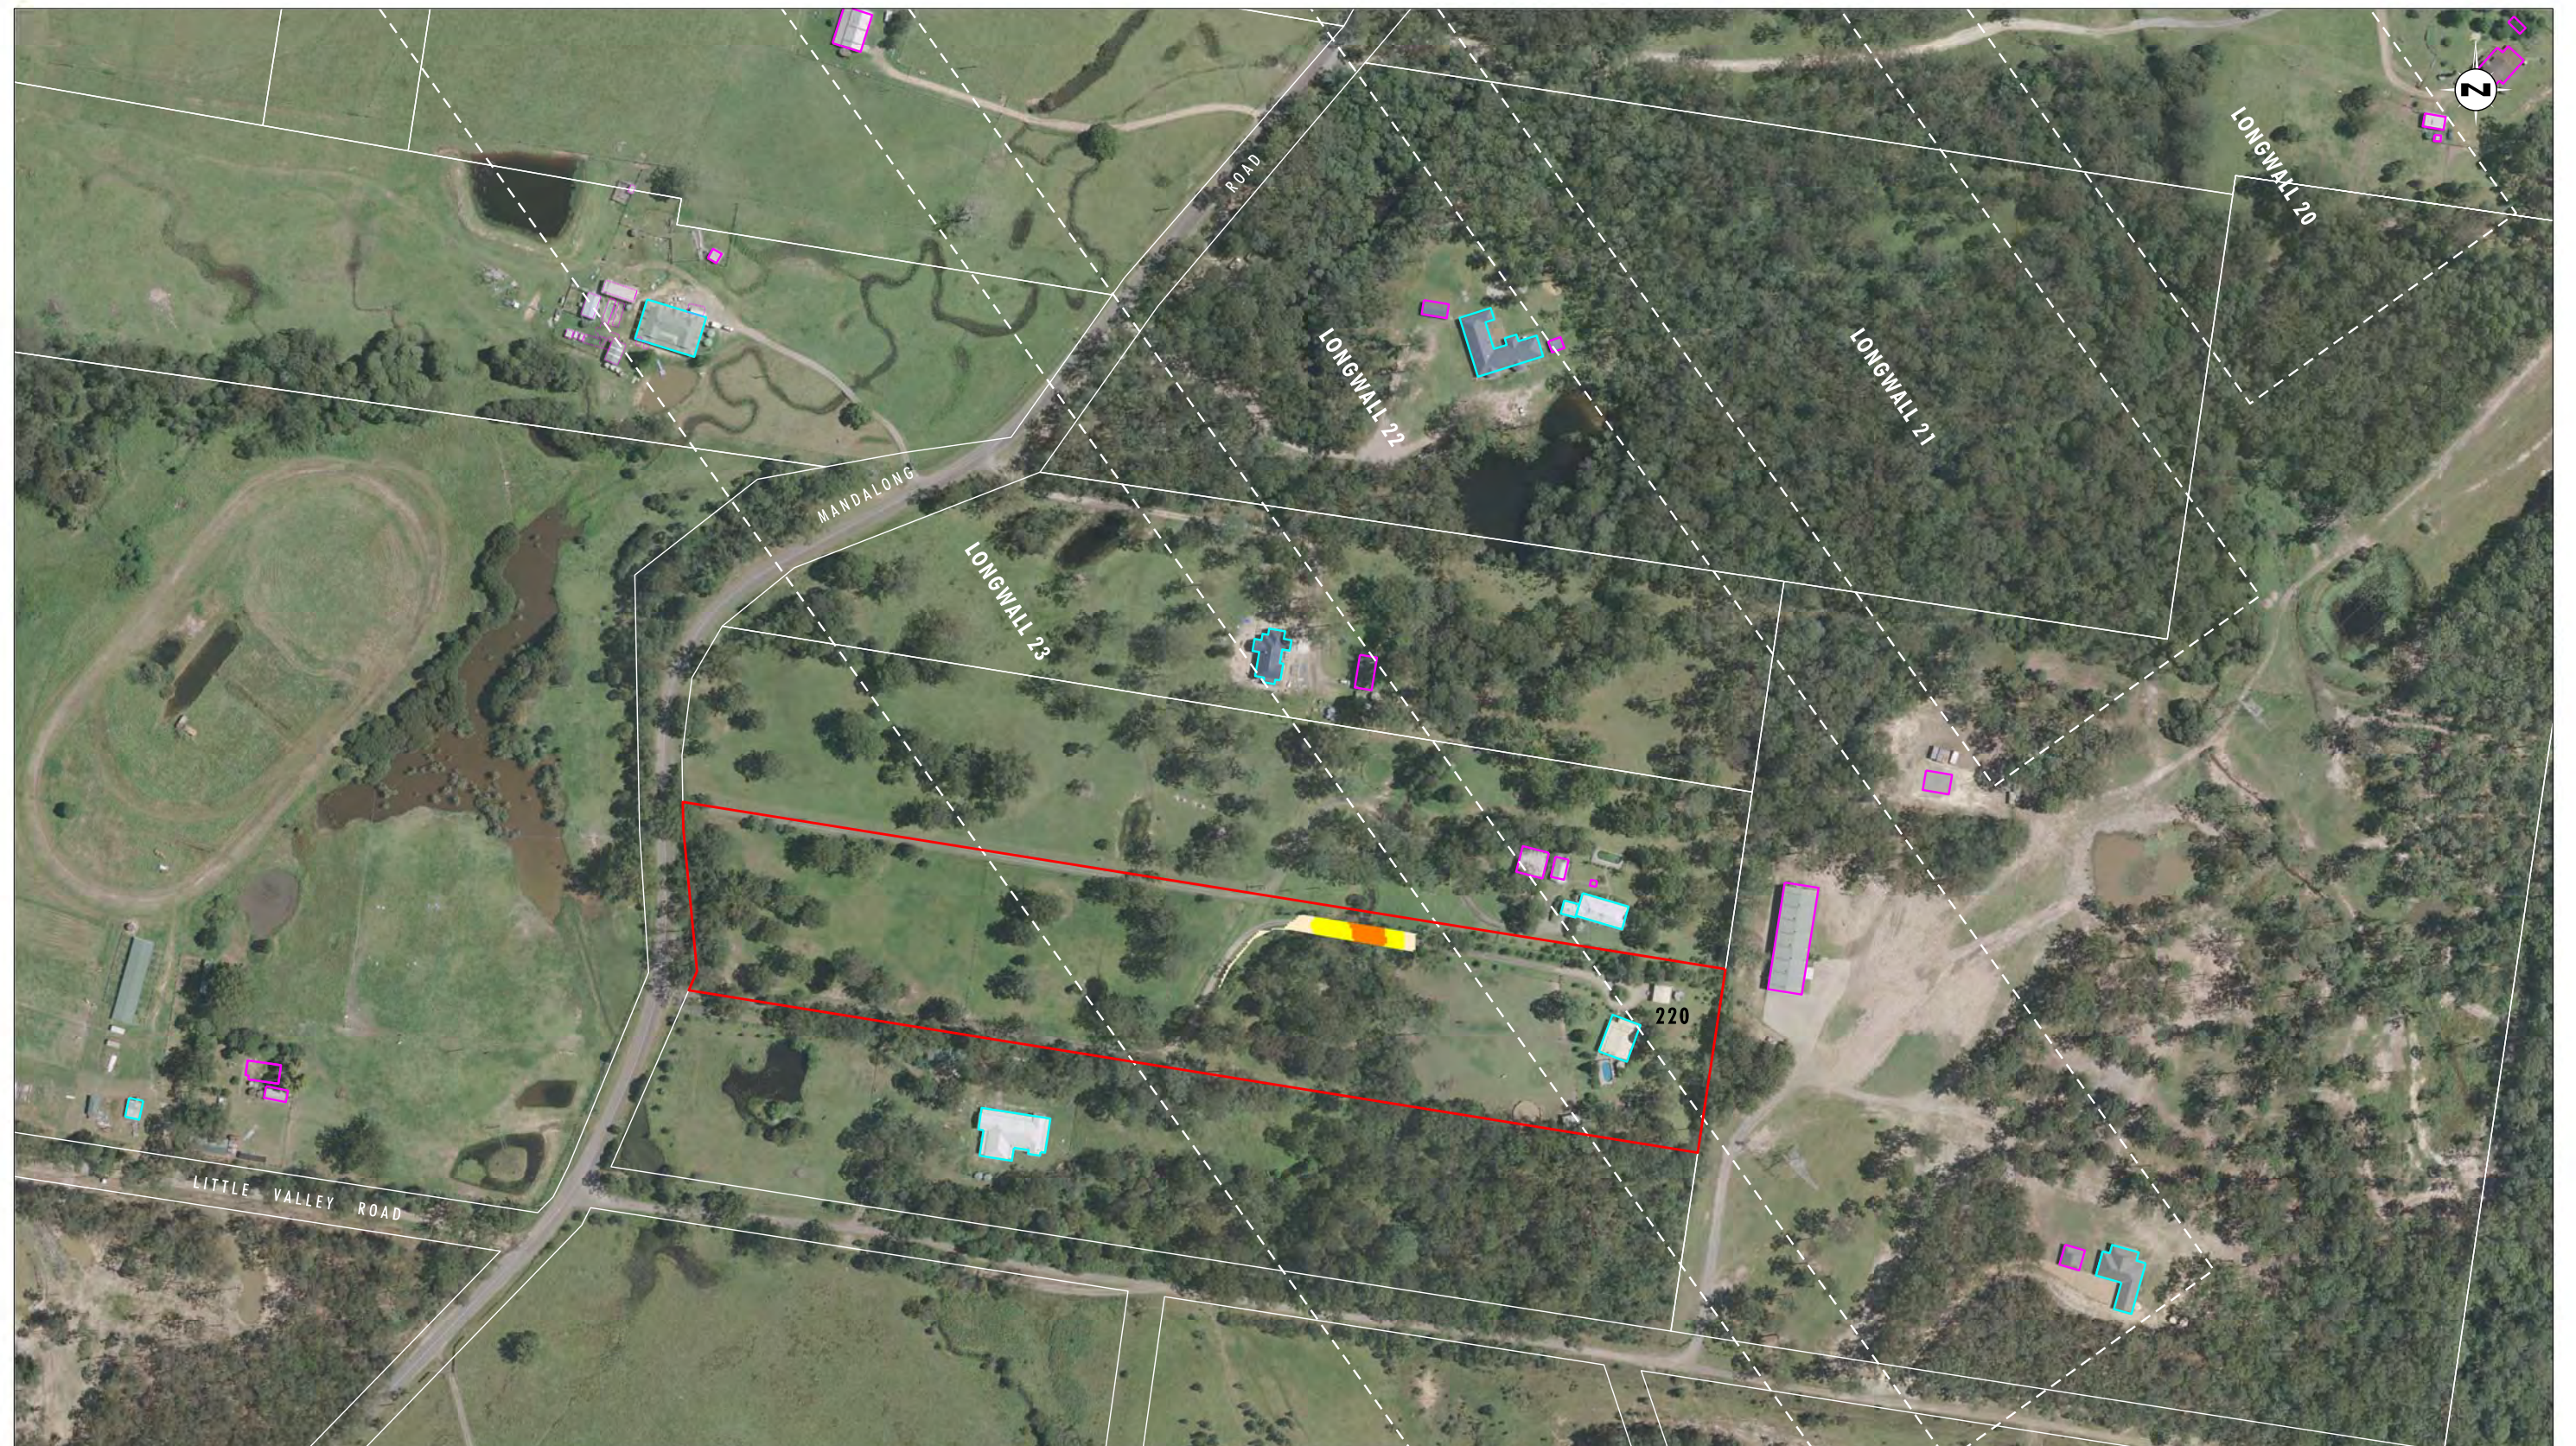
**FIGURE 8**  
 Property 220 - 1 Year ARI Storm Event:  
 Maximum Flood Hazard Categories Post Mining Landform  
 (to Longwall 23)

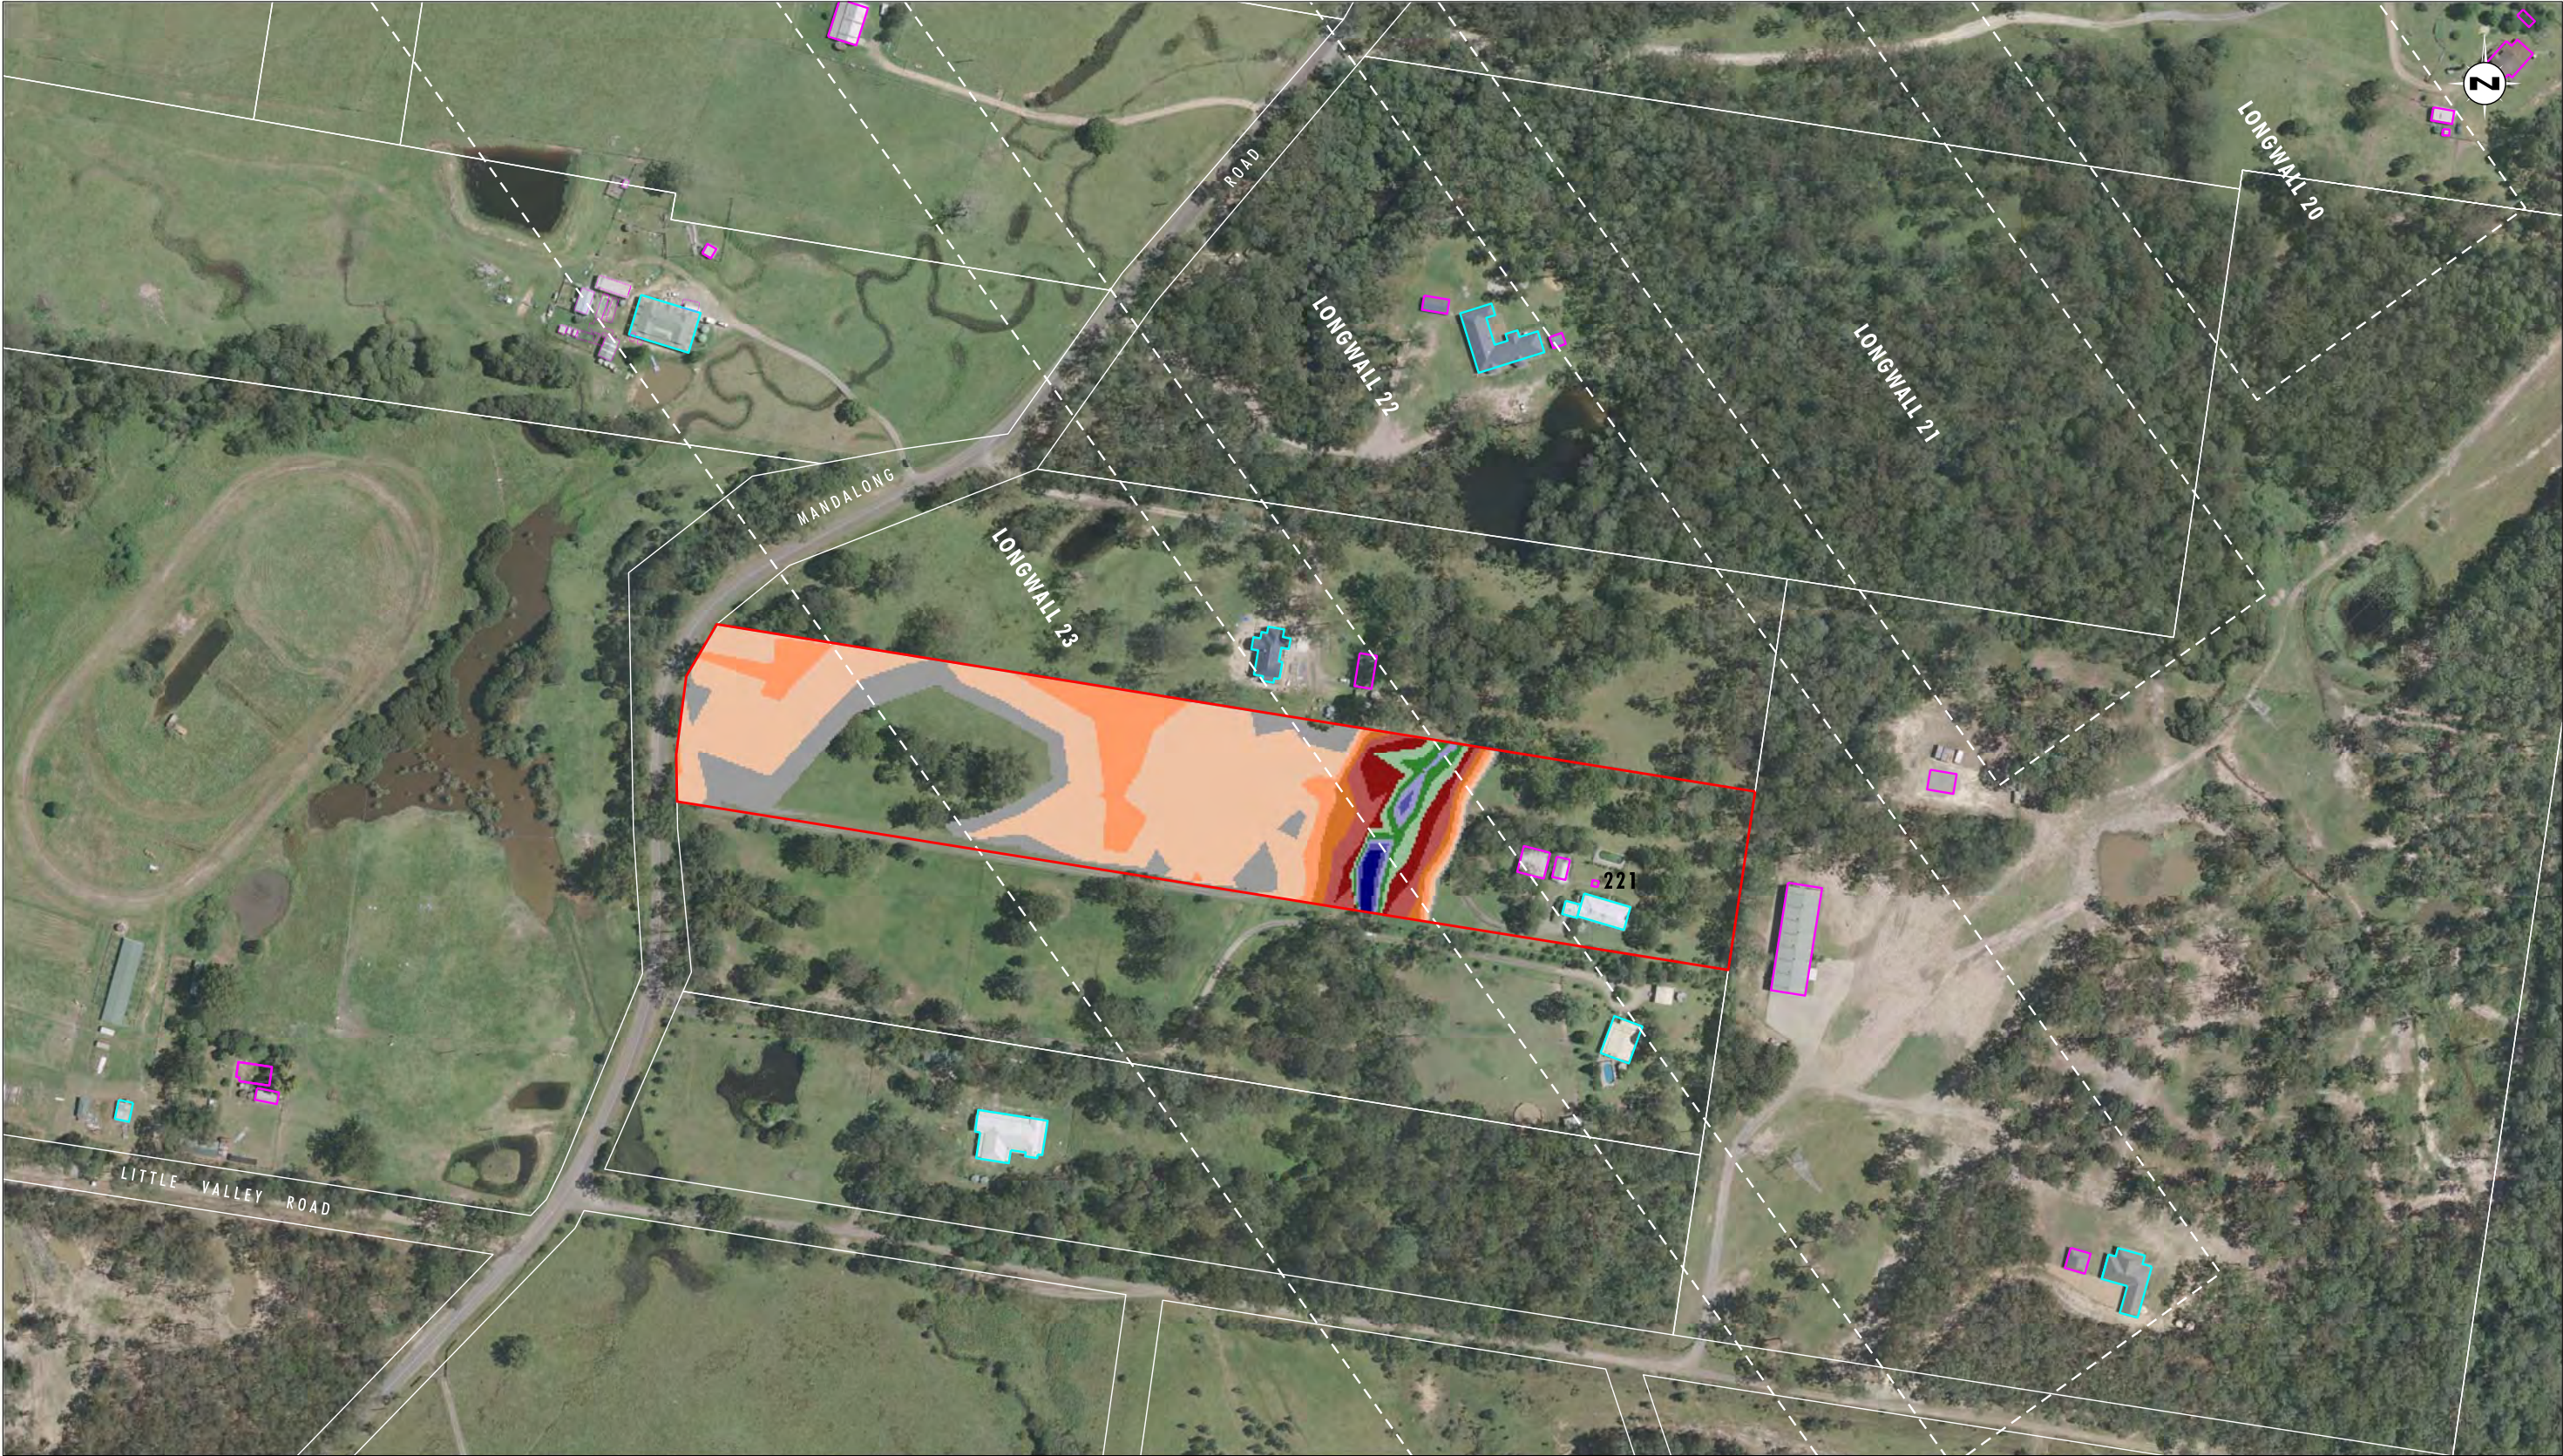
Property 221 - 100 Year ARI Storm Event:  
Maximum Flood Depth Pre Mining Landform

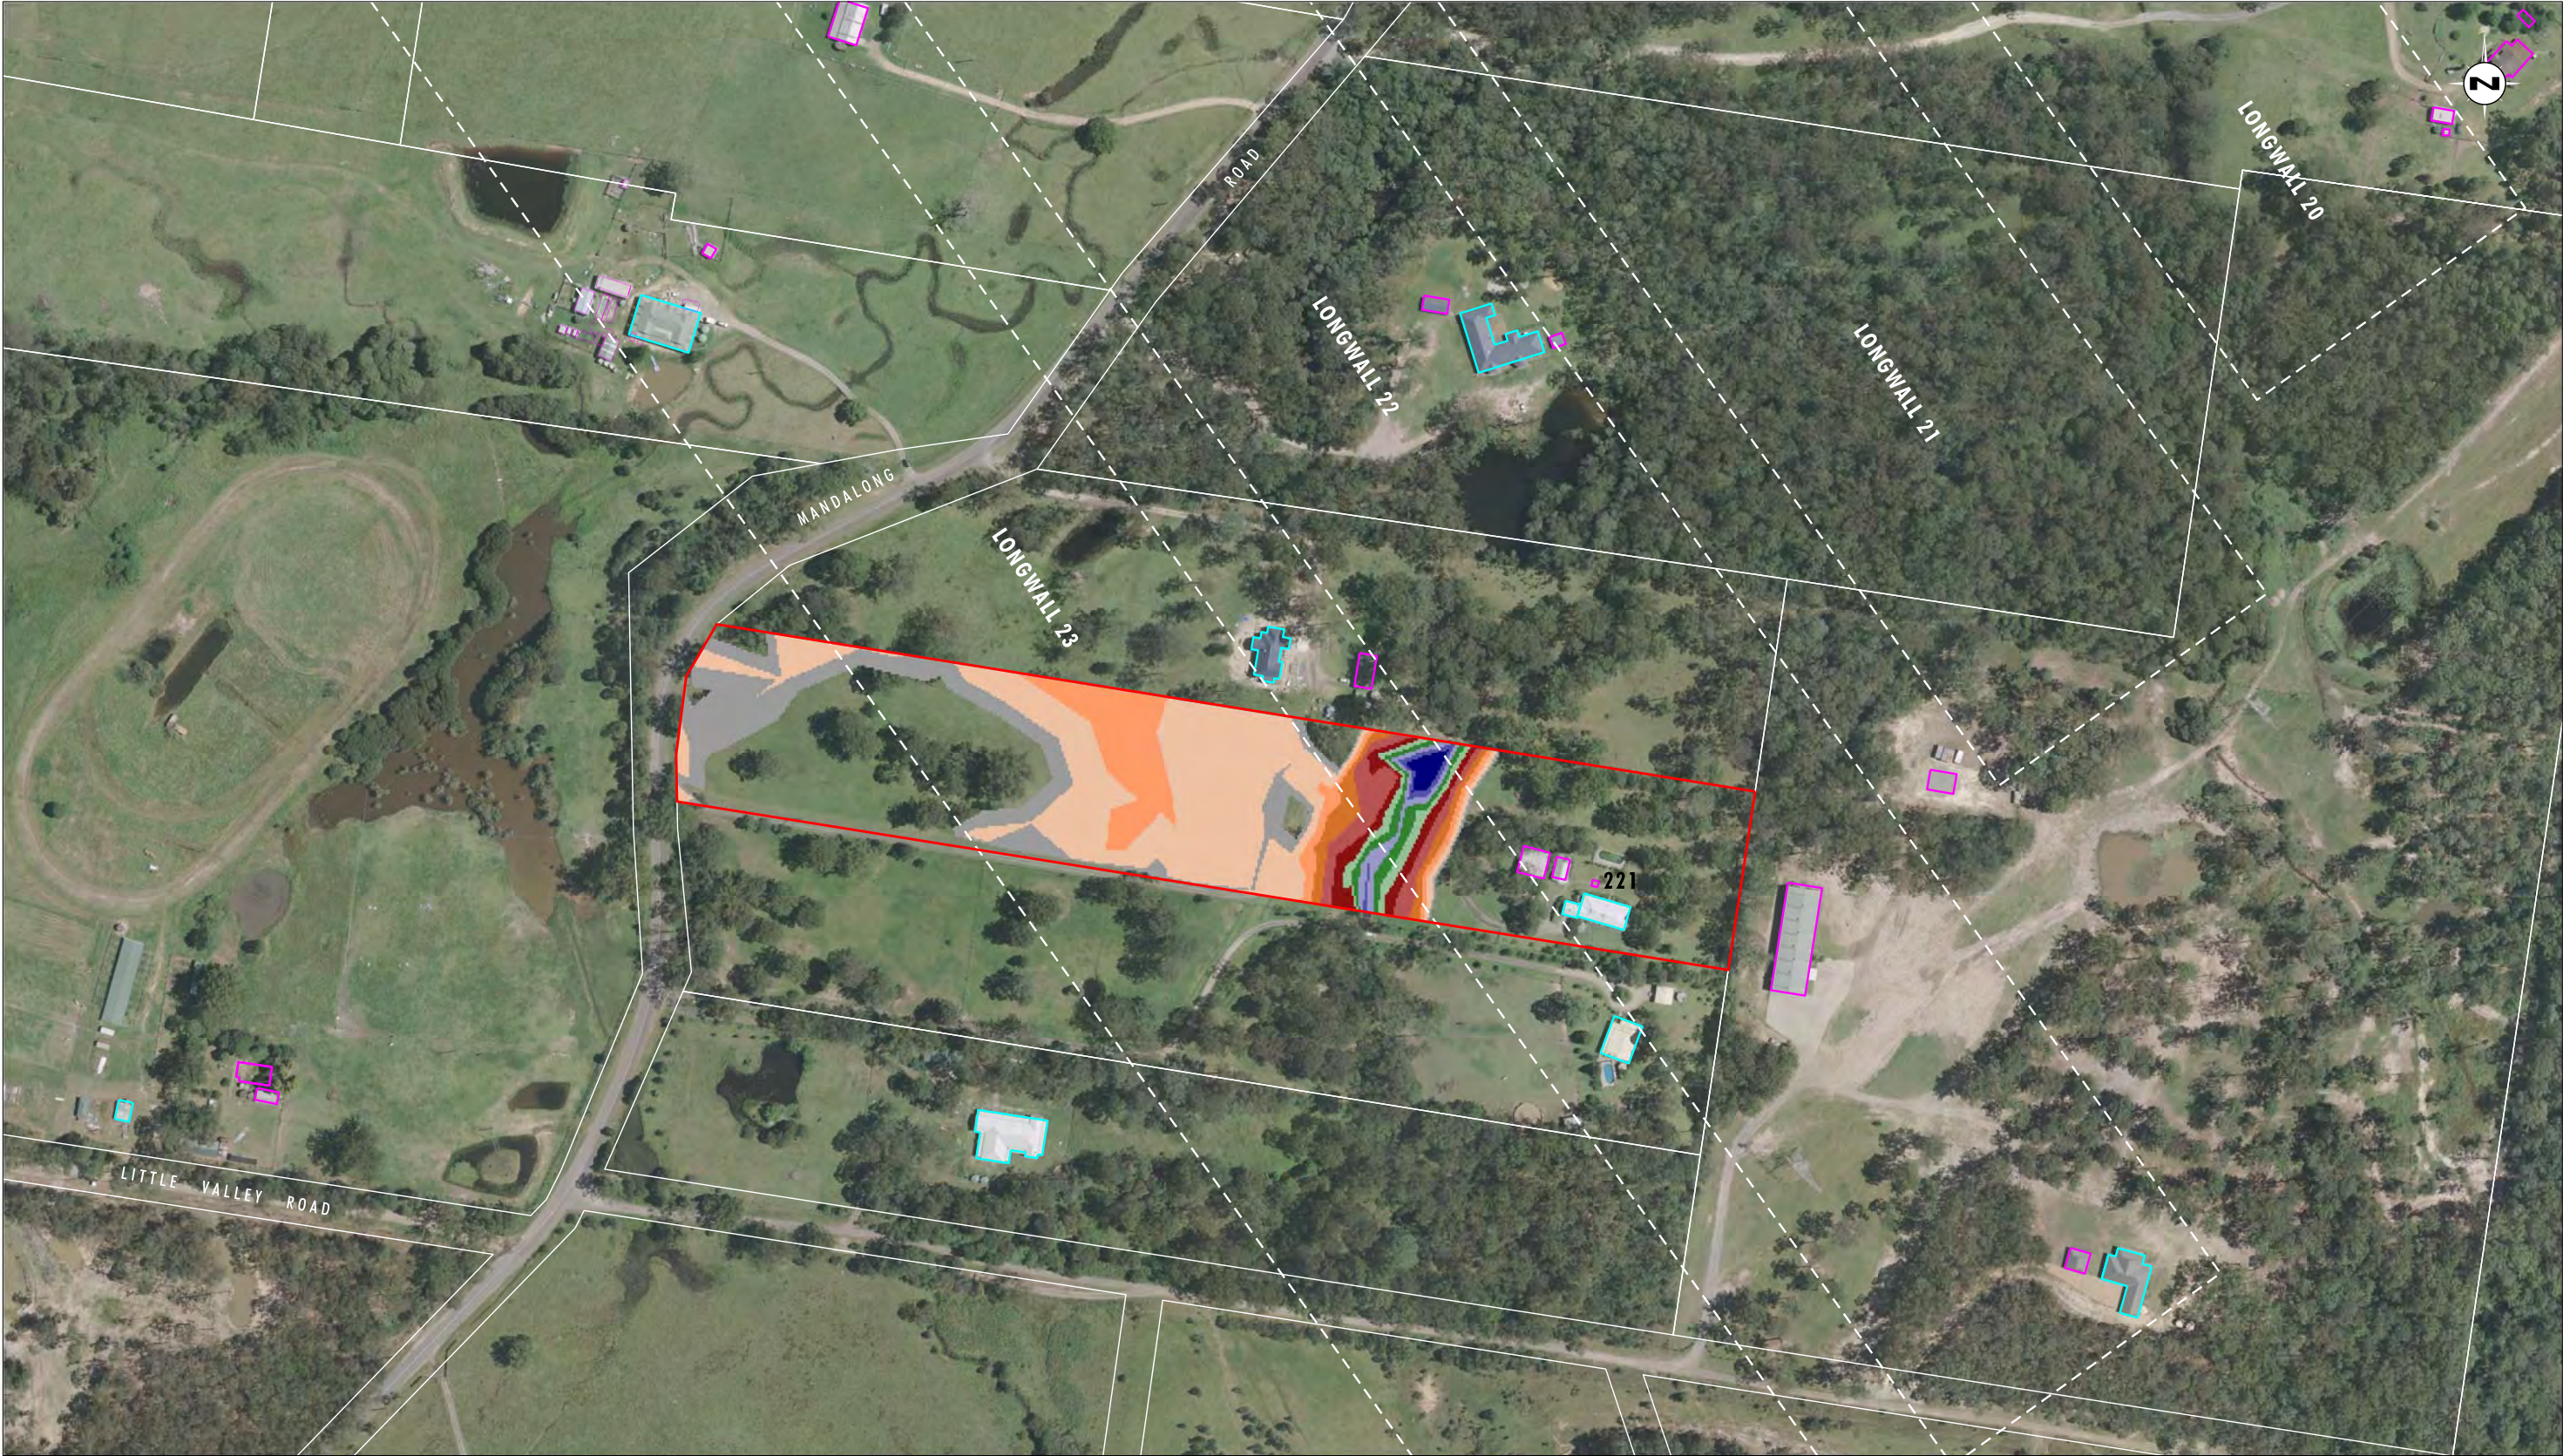
Property 221 - 100 Year ARI Storm Event:  
Maximum Flood Depth Post Mining Landform  
(to Longwall 23)

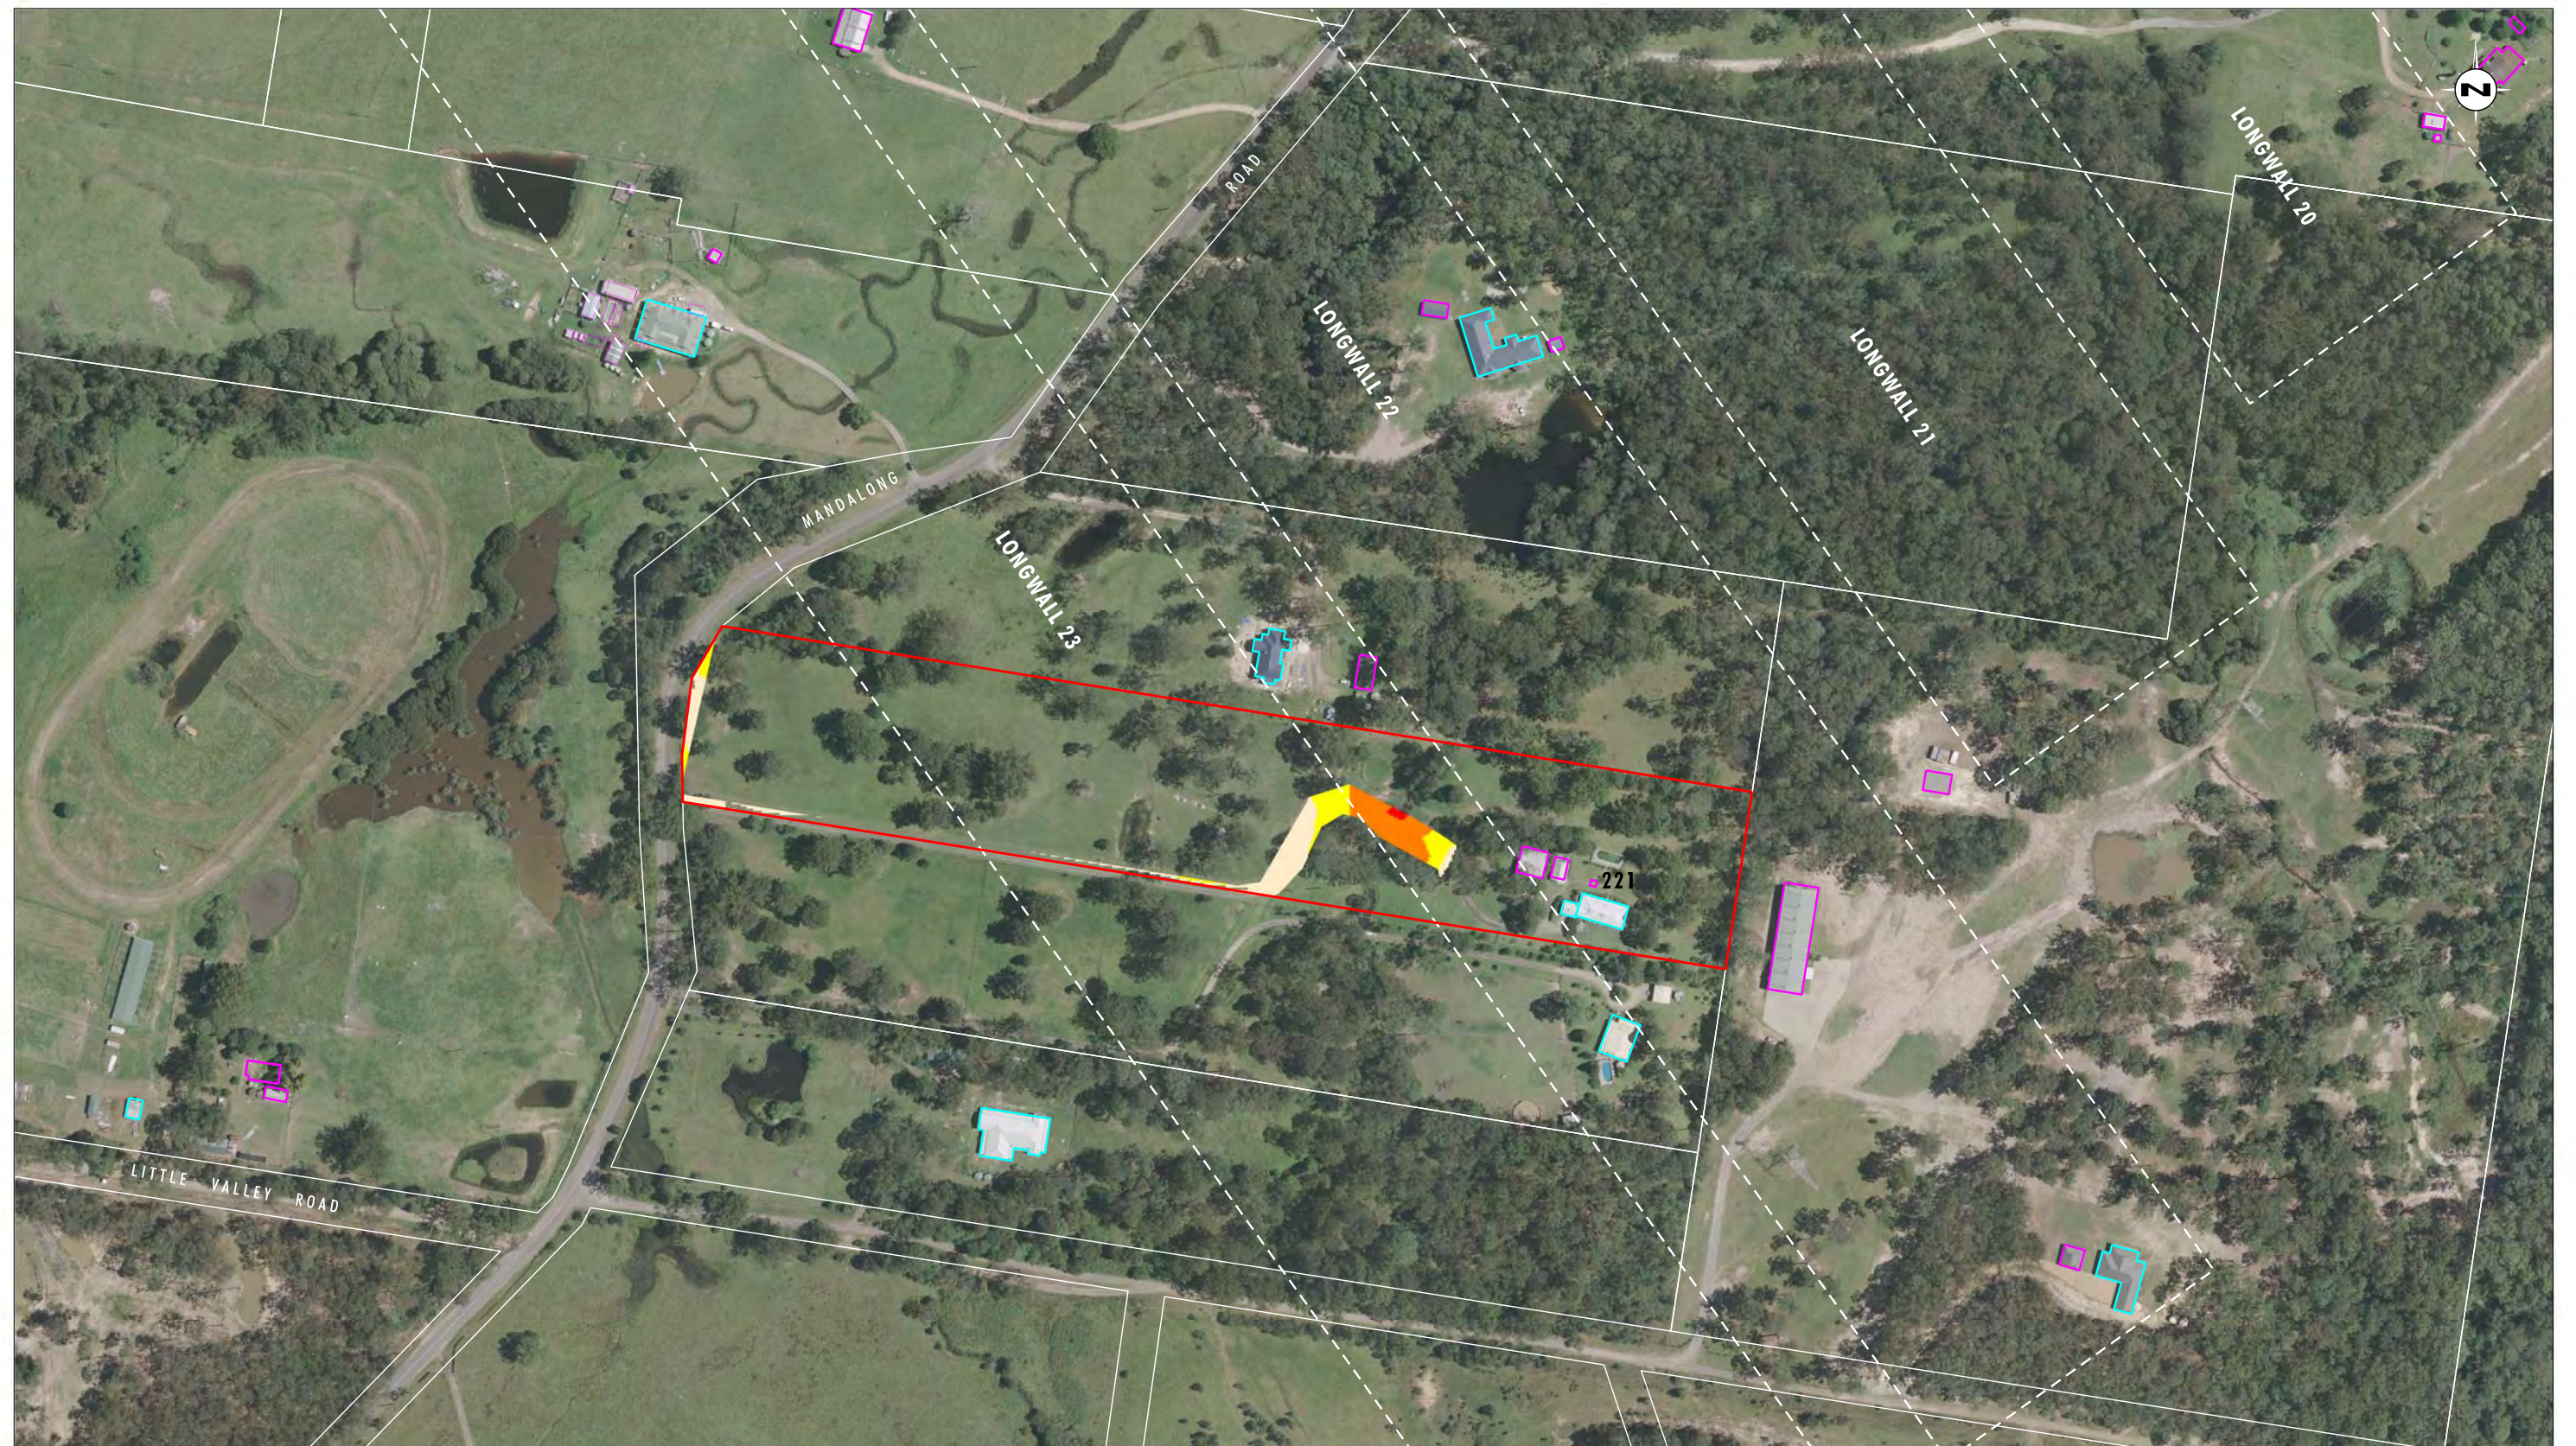
Property 221 - 100 Year ARI Storm Event:  
 Maximum Flood Hazard Categories Pre Mining Landform

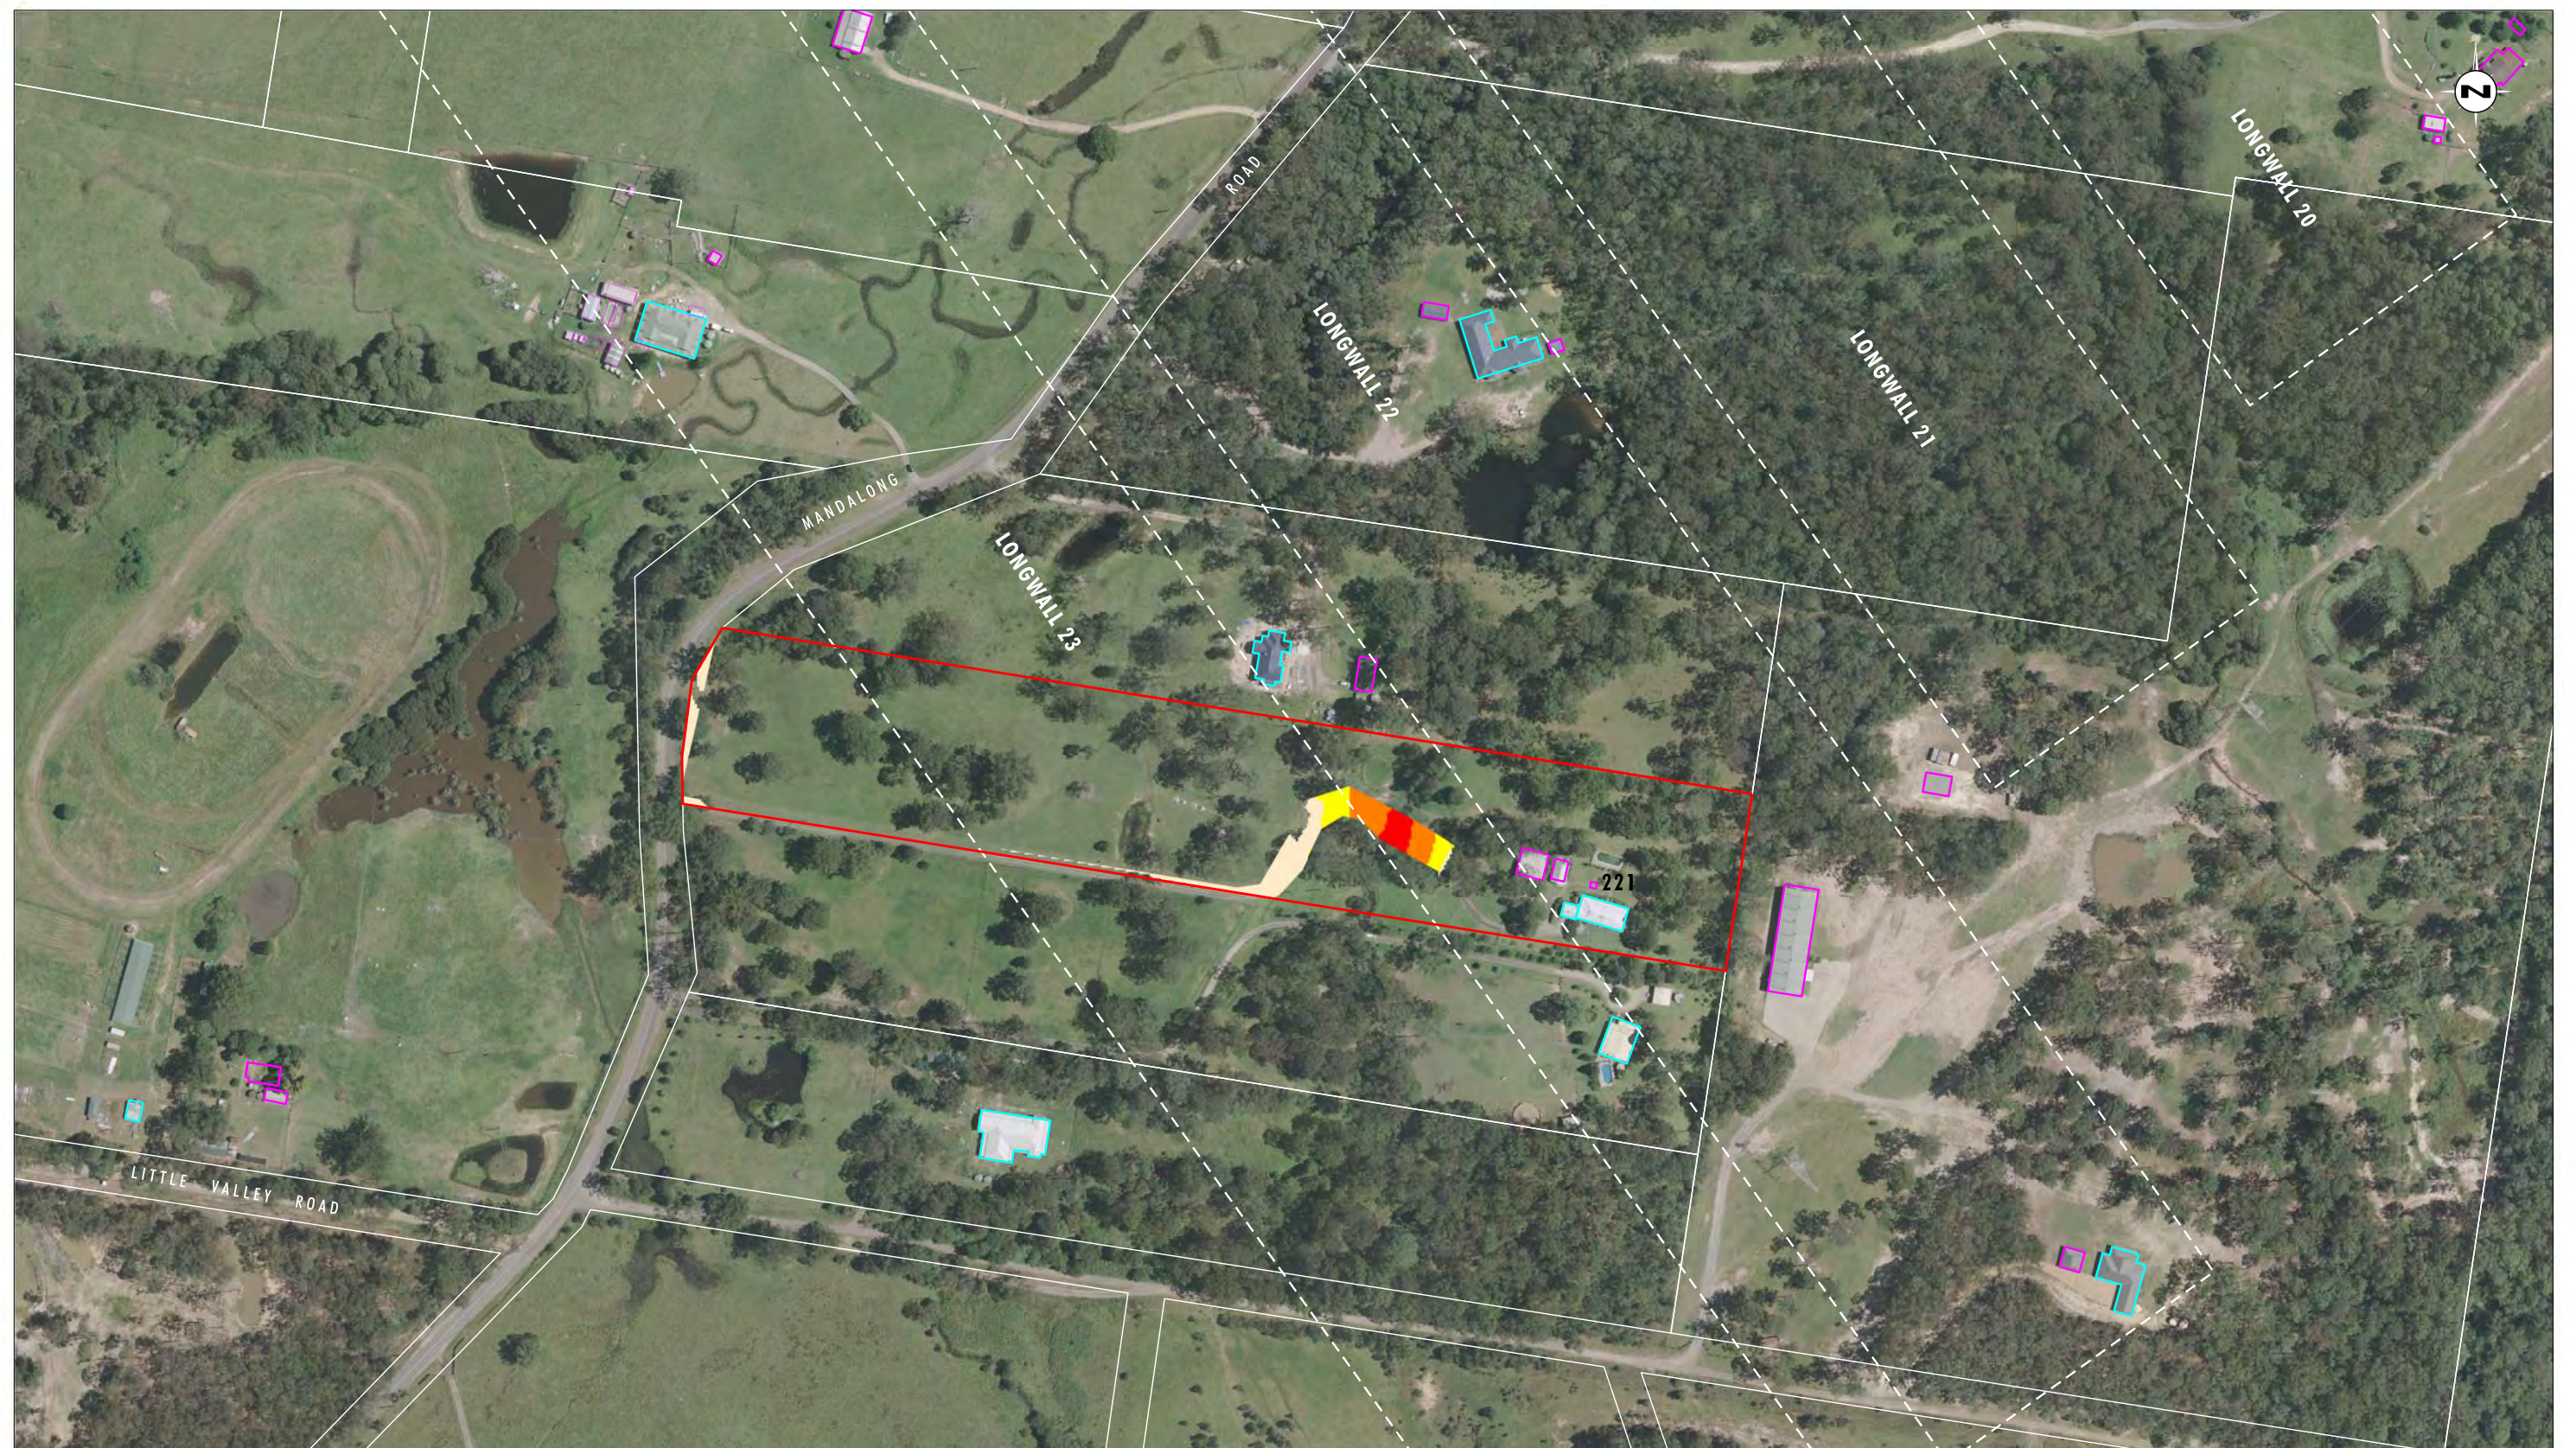
Property 221 - 100 Year ARI Storm Event:  
 Maximum Flood Hazard Categories Post Mining Landform  
 (to Longwall 23)

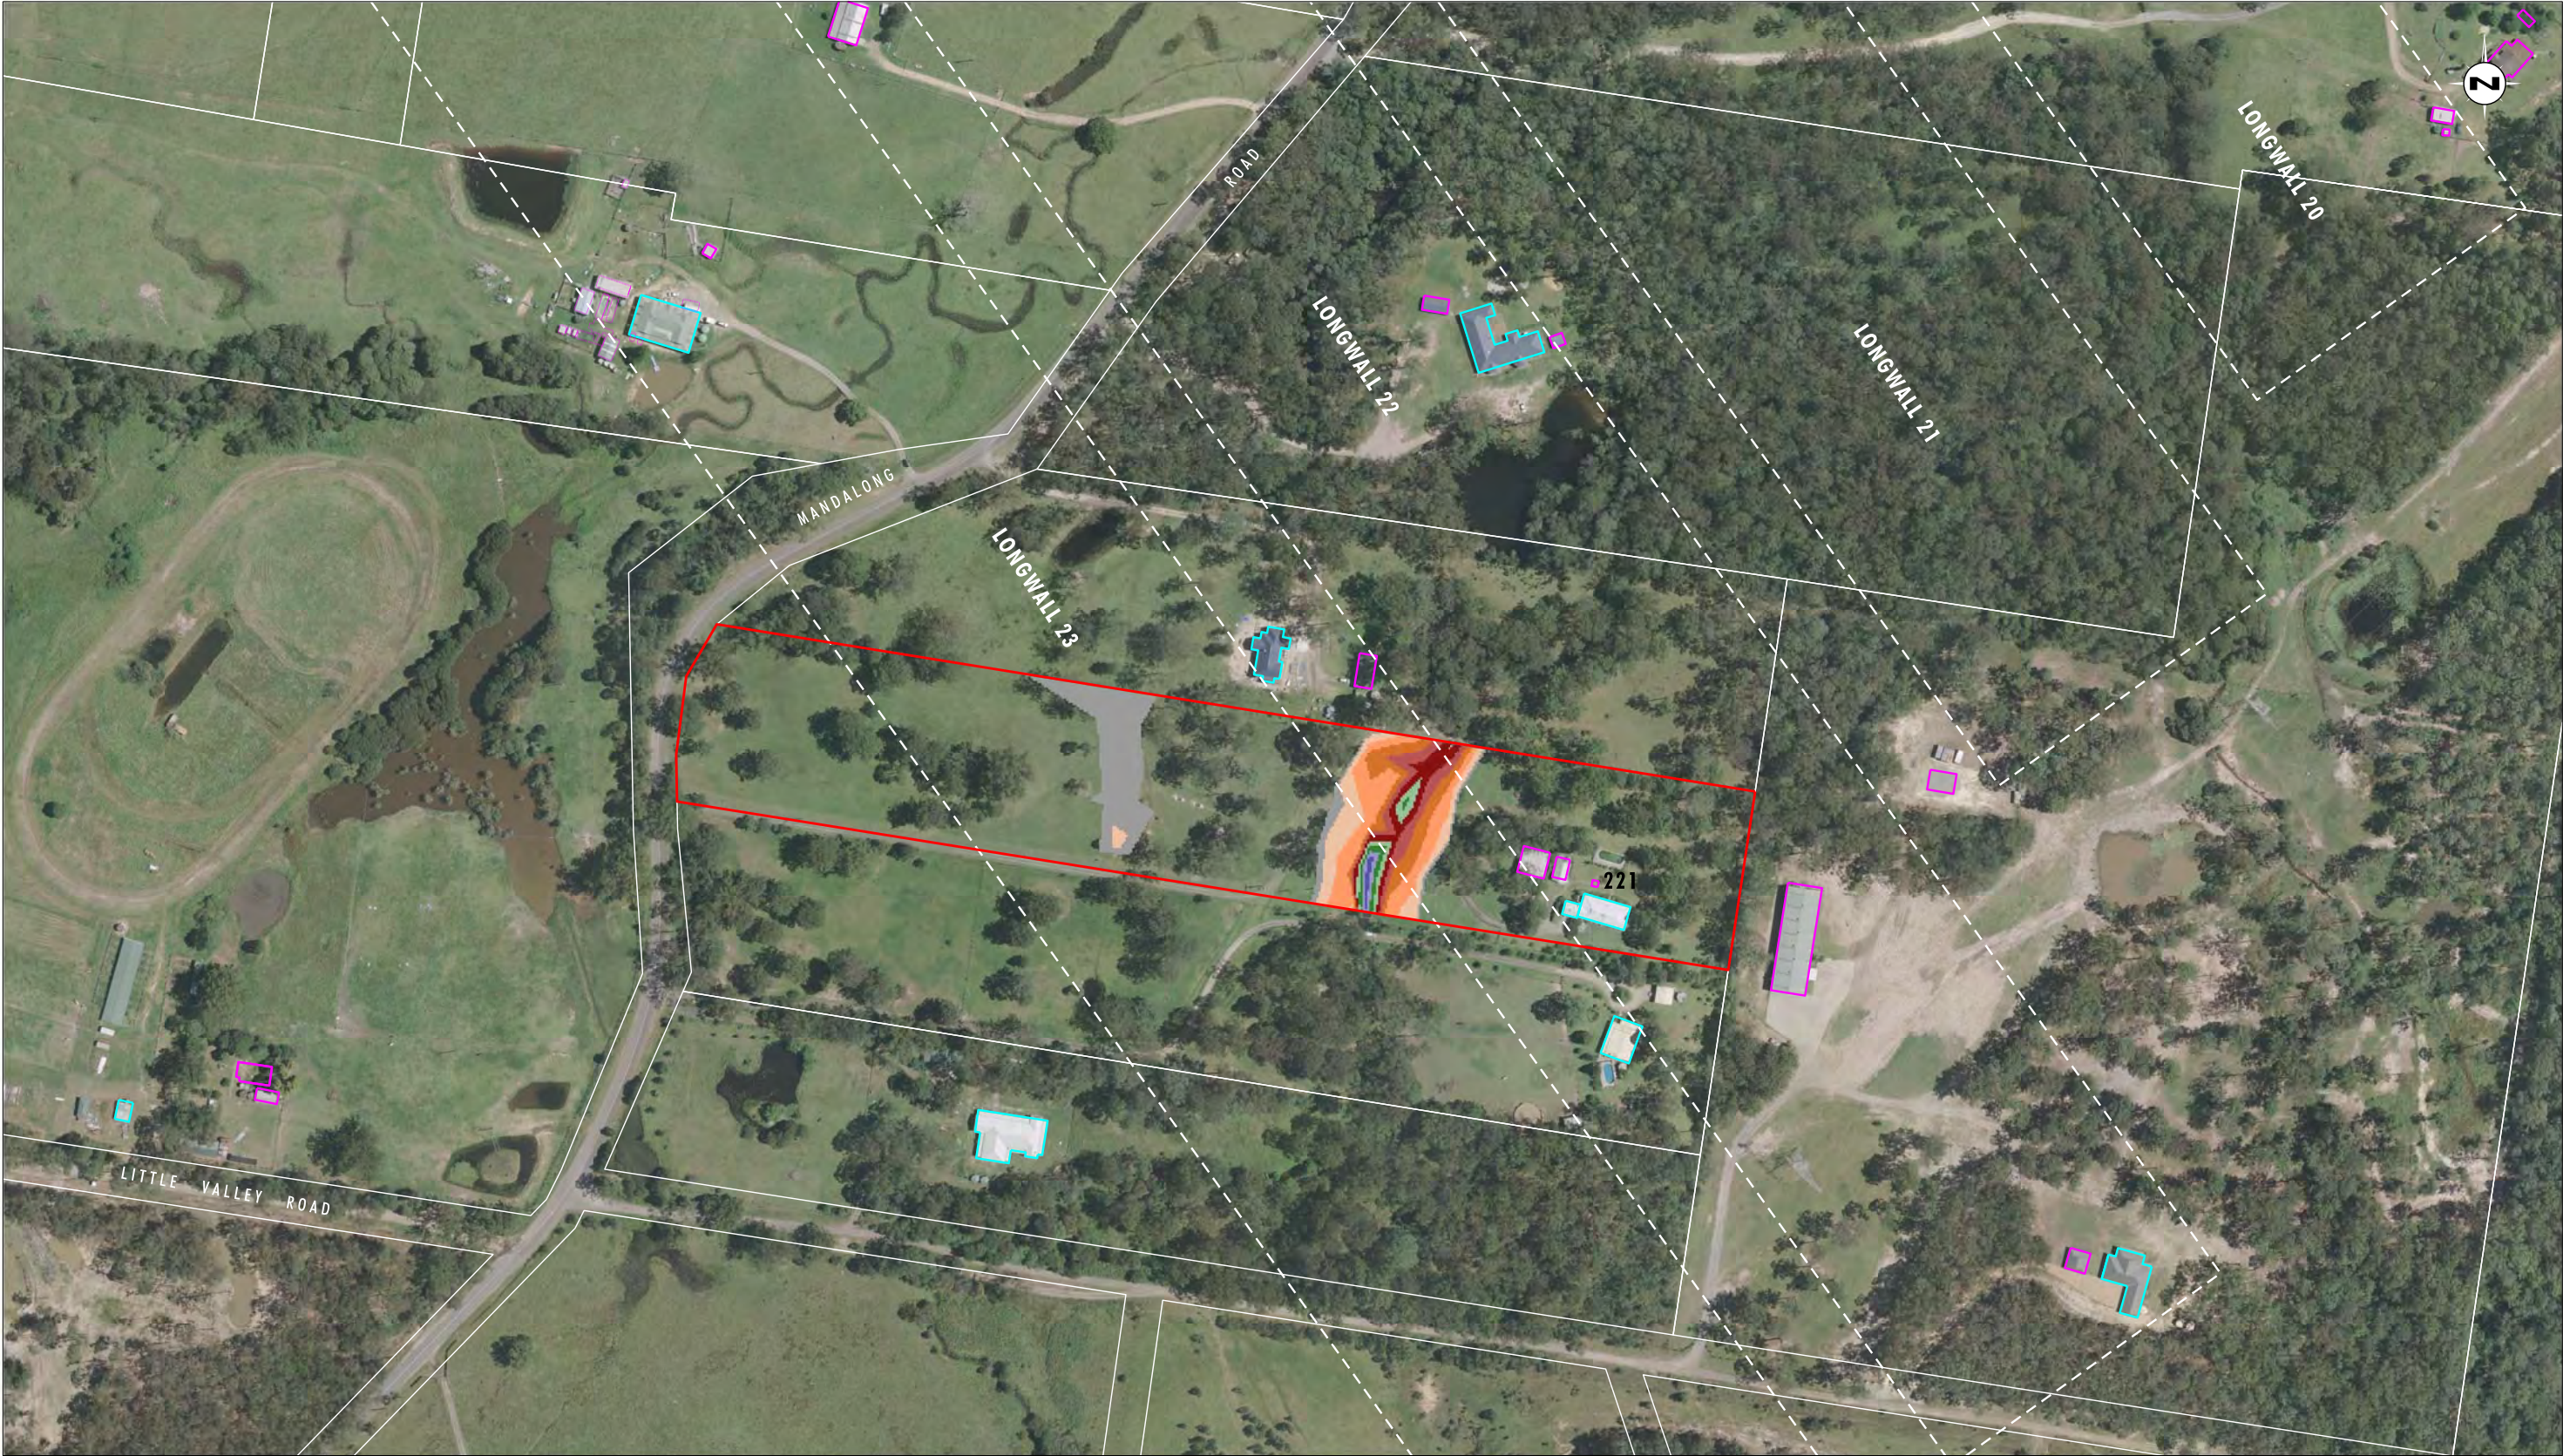
Property 221 - 1 Year ARI Storm Event:  
Maximum Flood Depth Pre Mining Landform
