## APPENDIX 31

Flooding Assessment Figures -  
Property 213

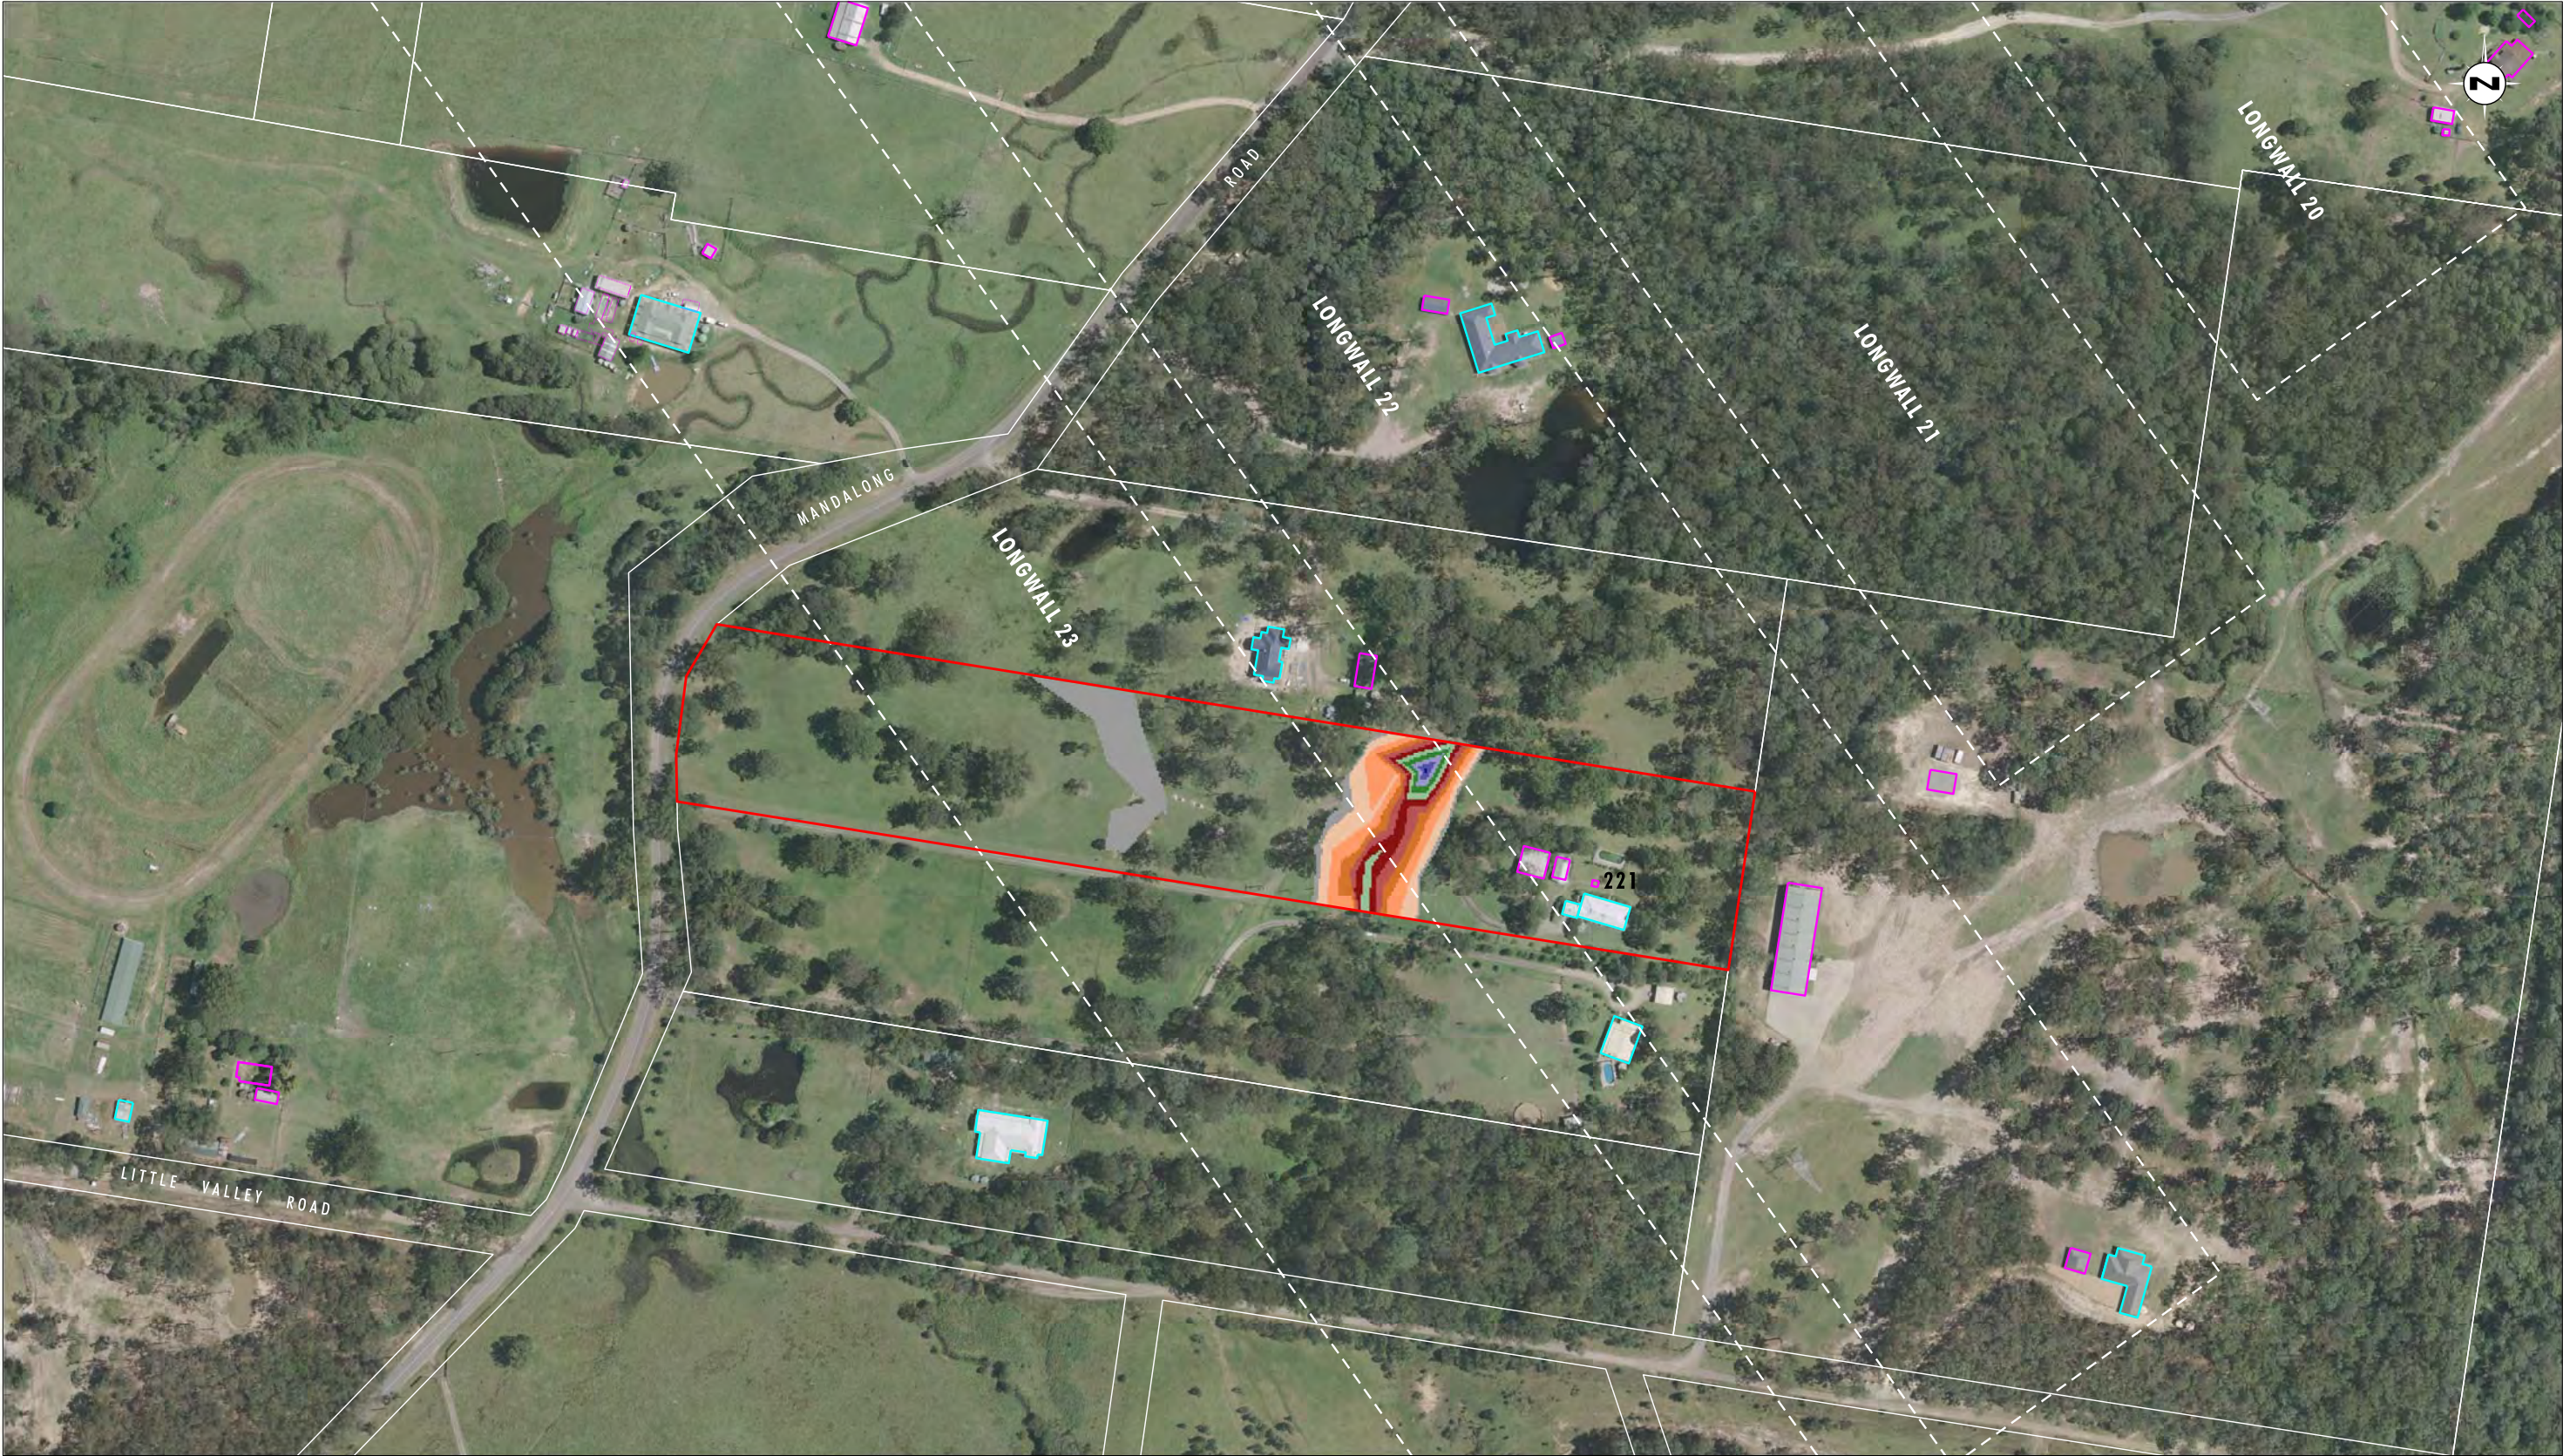
Property 221 - 1 Year ARI Storm Event:  
Maximum Flood Depth Post Mining Landform  
(to Longwall 23)

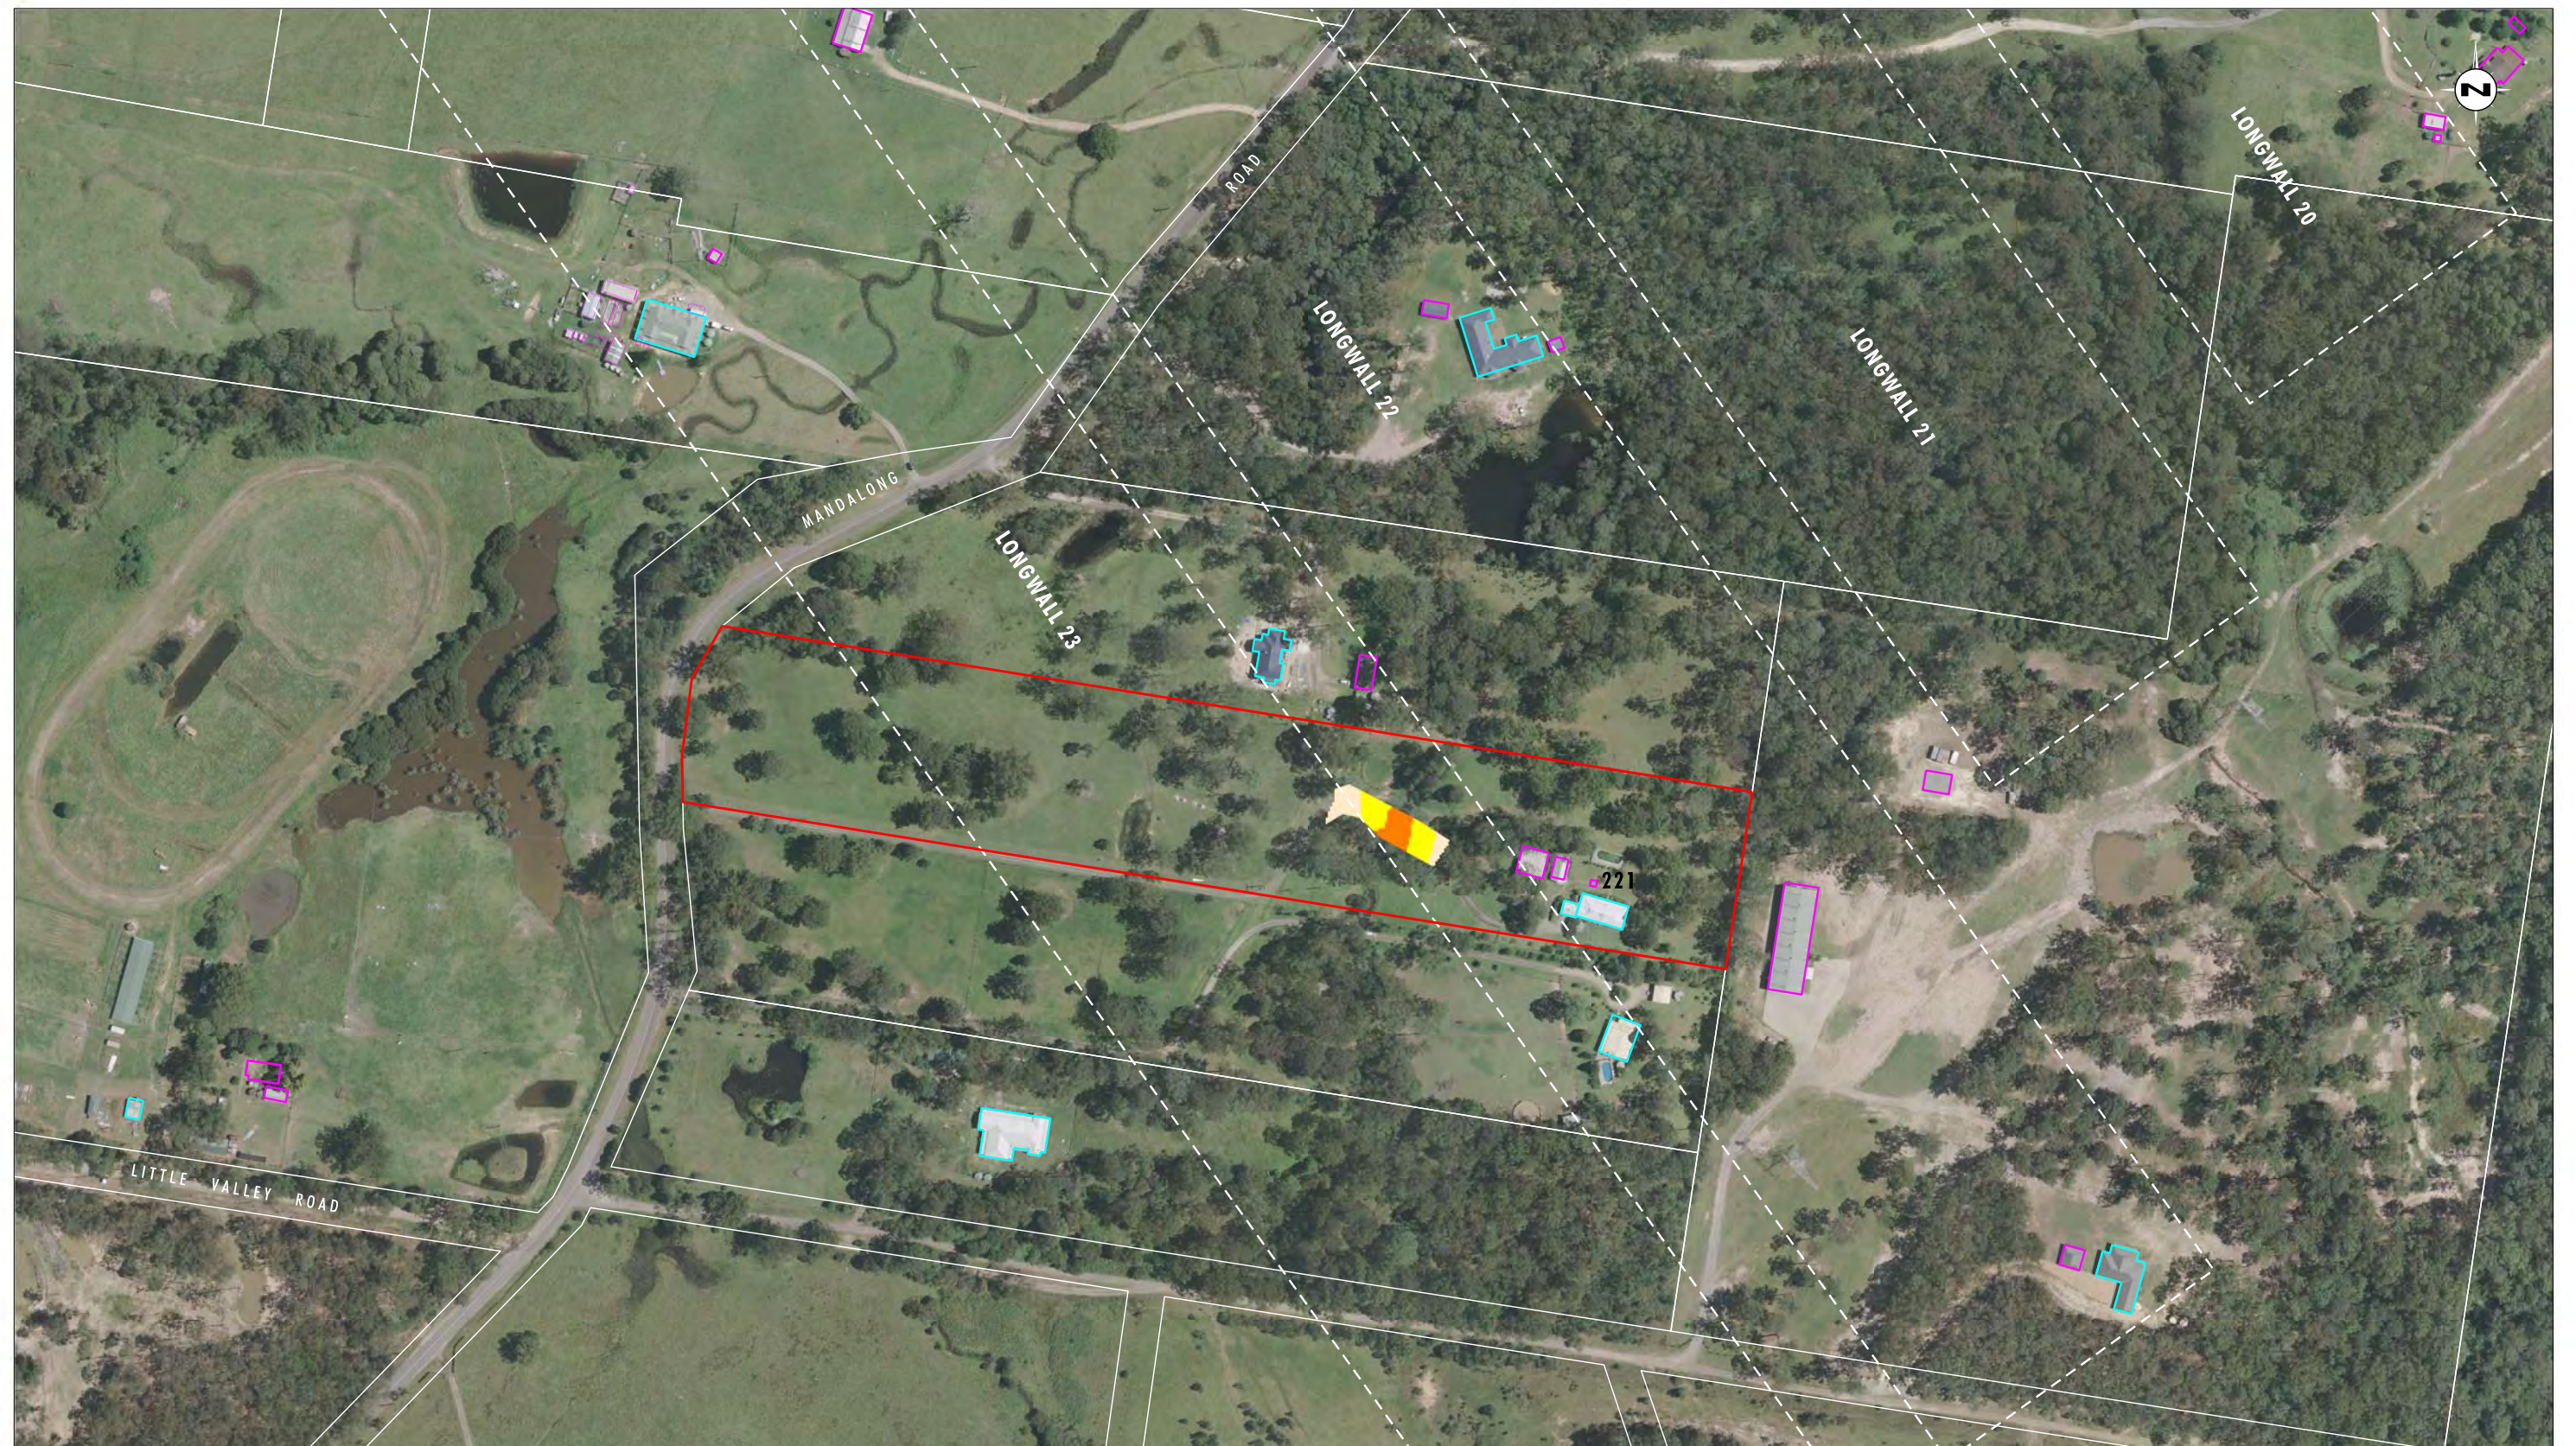
Property 221 - 1 Year ARI Storm Event:  
 Maximum Flood Hazard Categories Pre Mining Landform

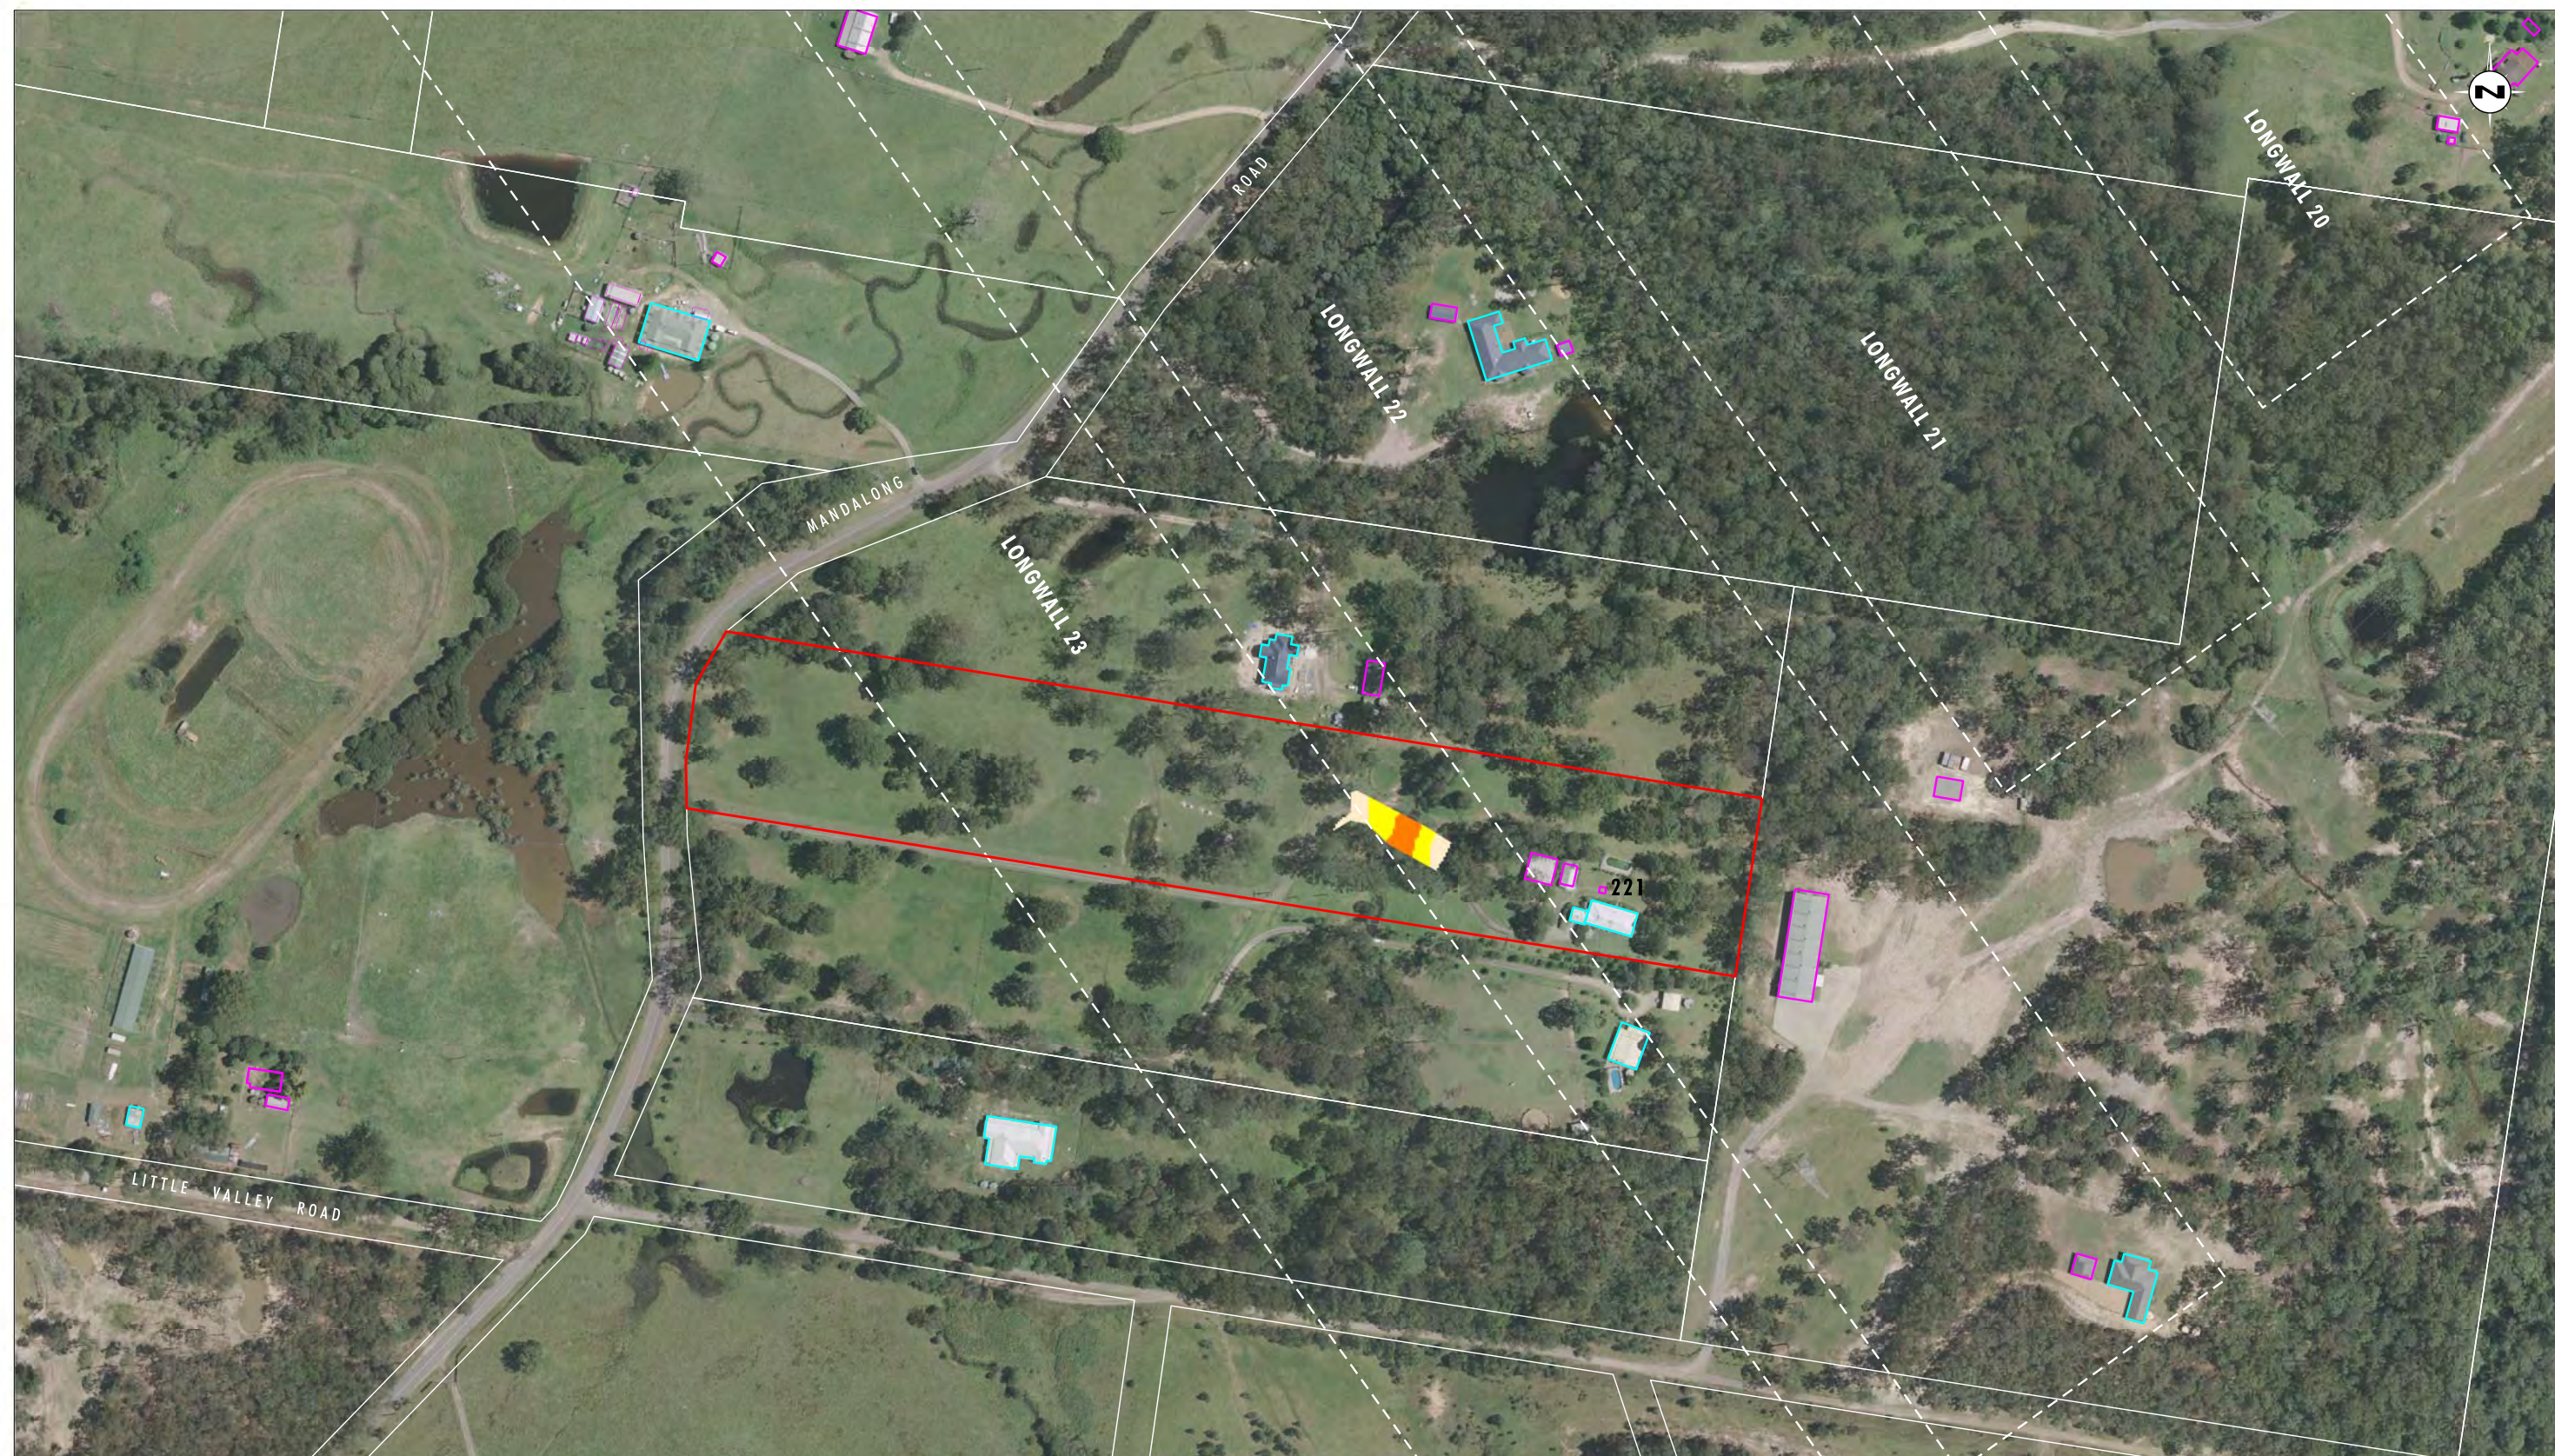
Property 221 - 1 Year ARI Storm Event:  
 Maximum Flood Hazard Categories Post Mining Landform  
 (to Longwall 23)

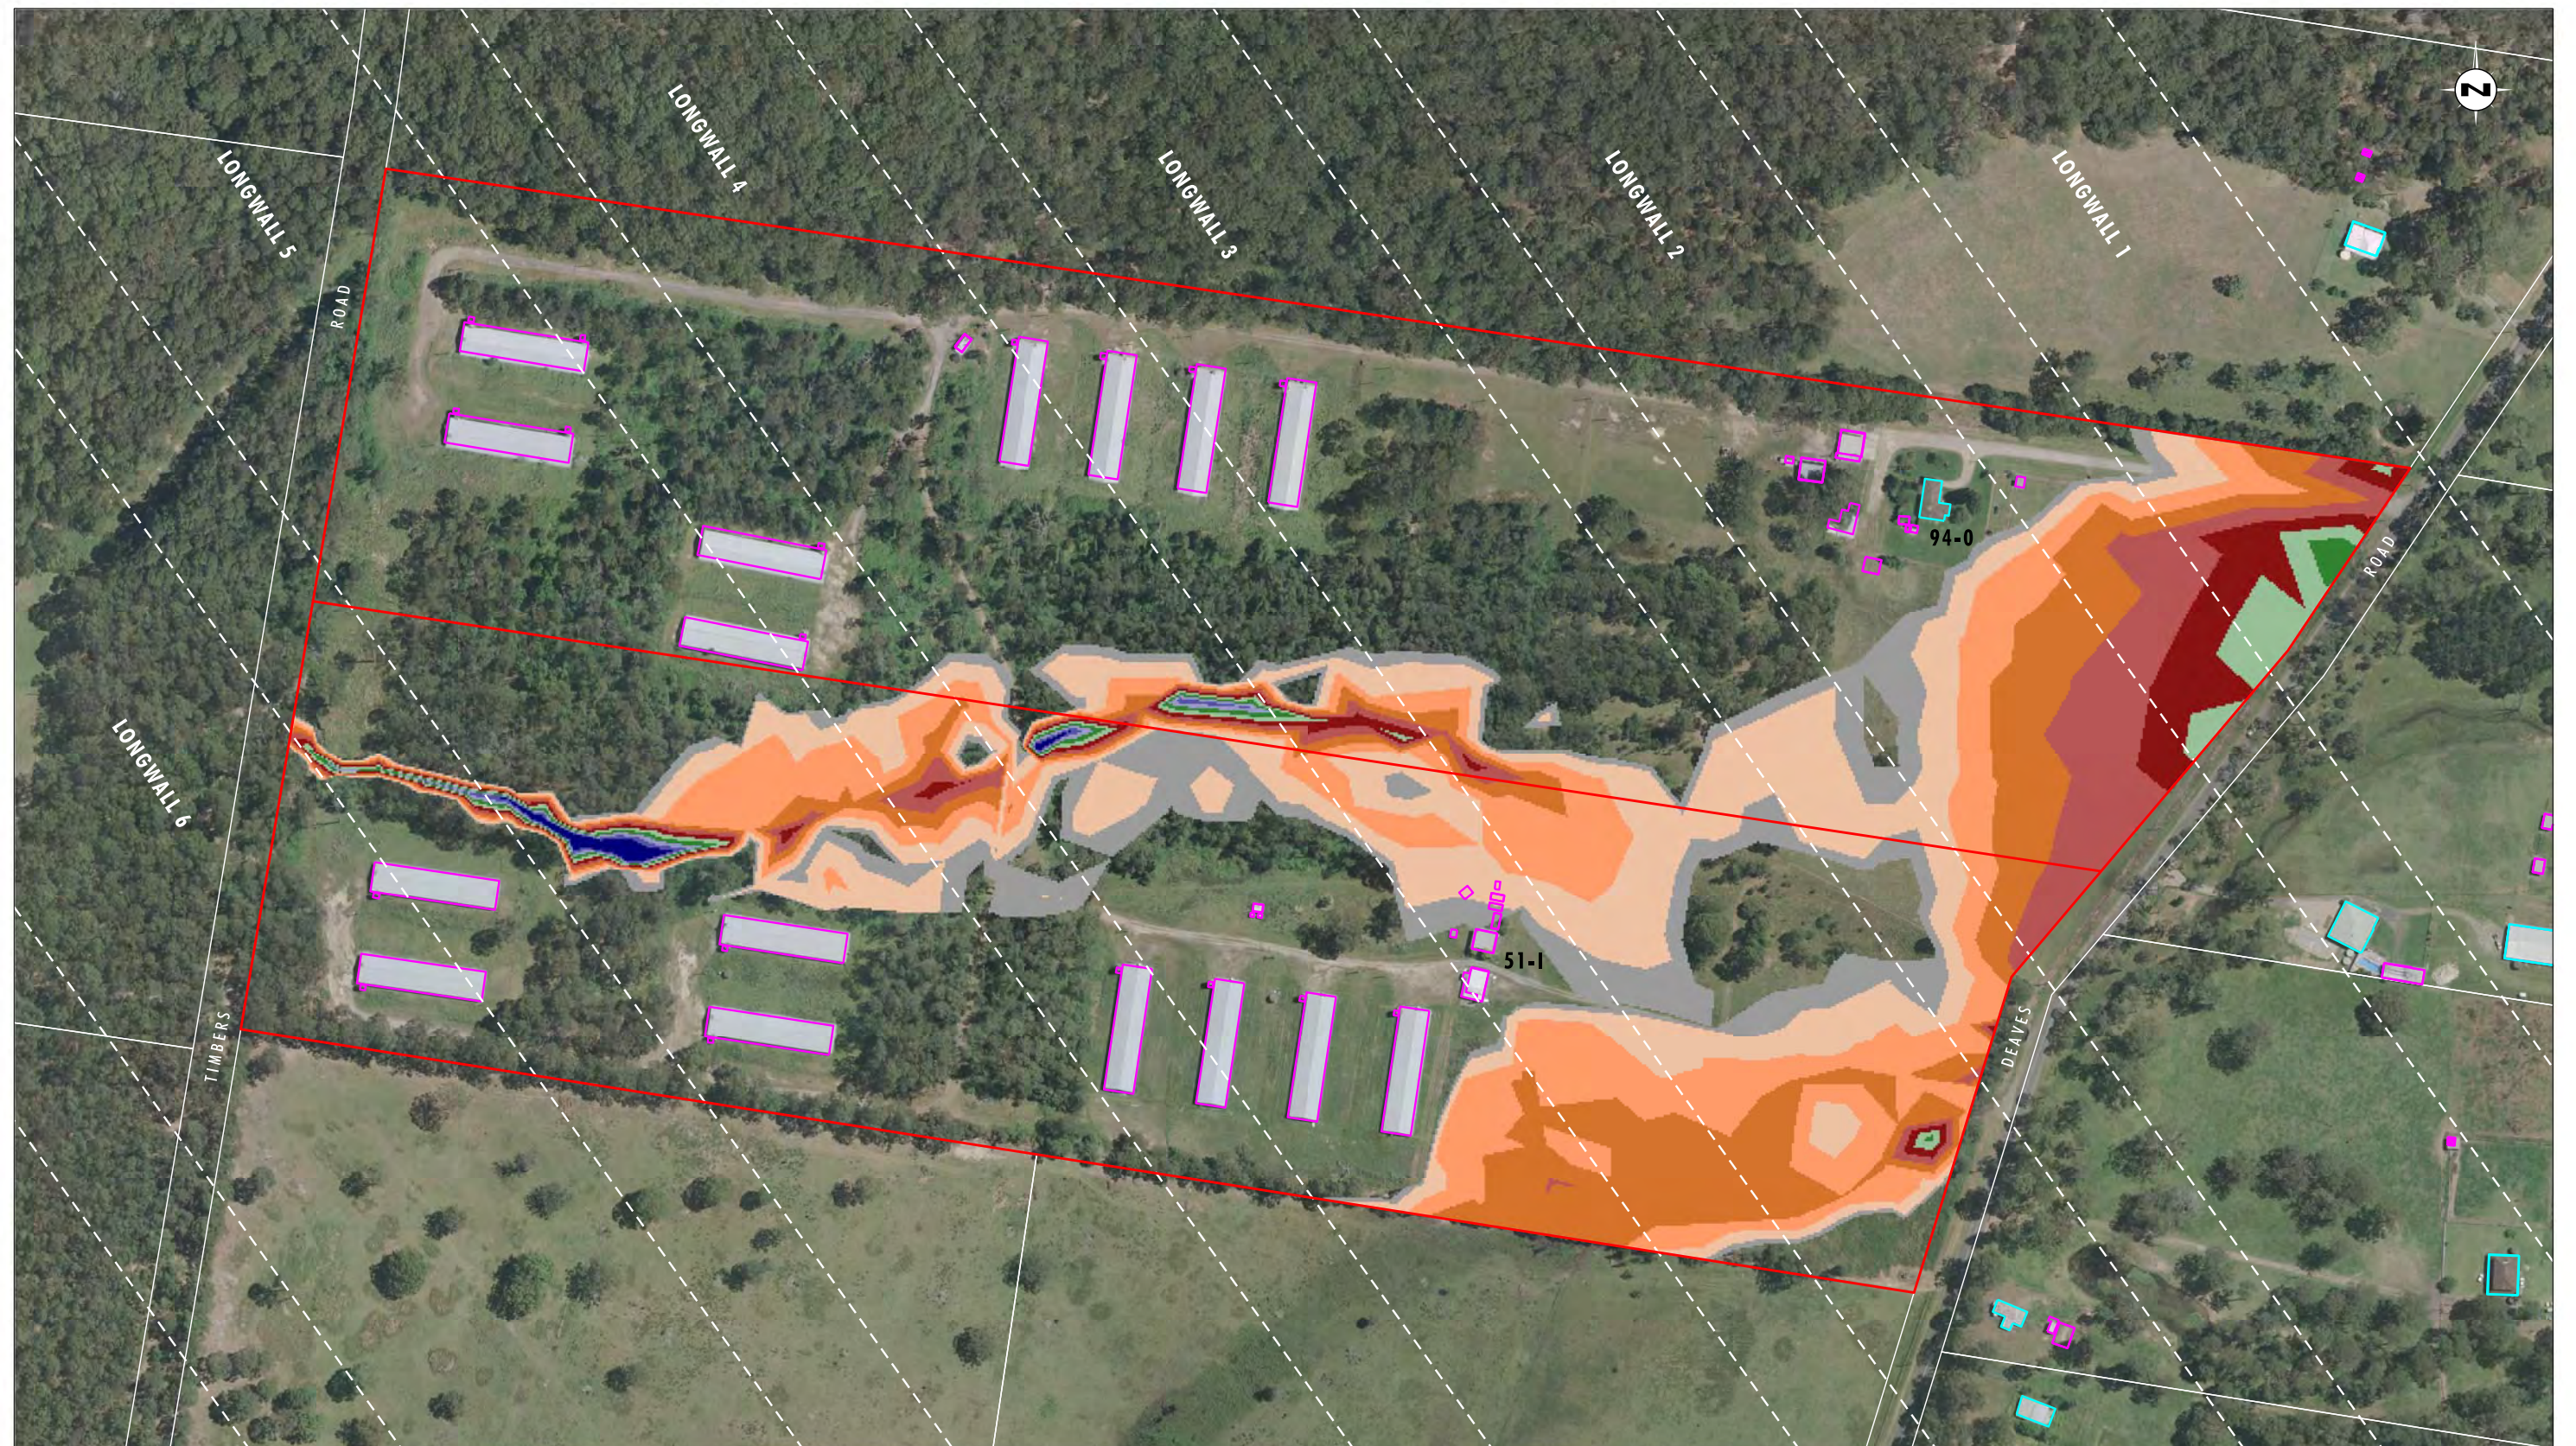
Property 51 & 94 - 100 Year ARI Storm Event:  
Maximum Flood Depth Pre Mining Landform

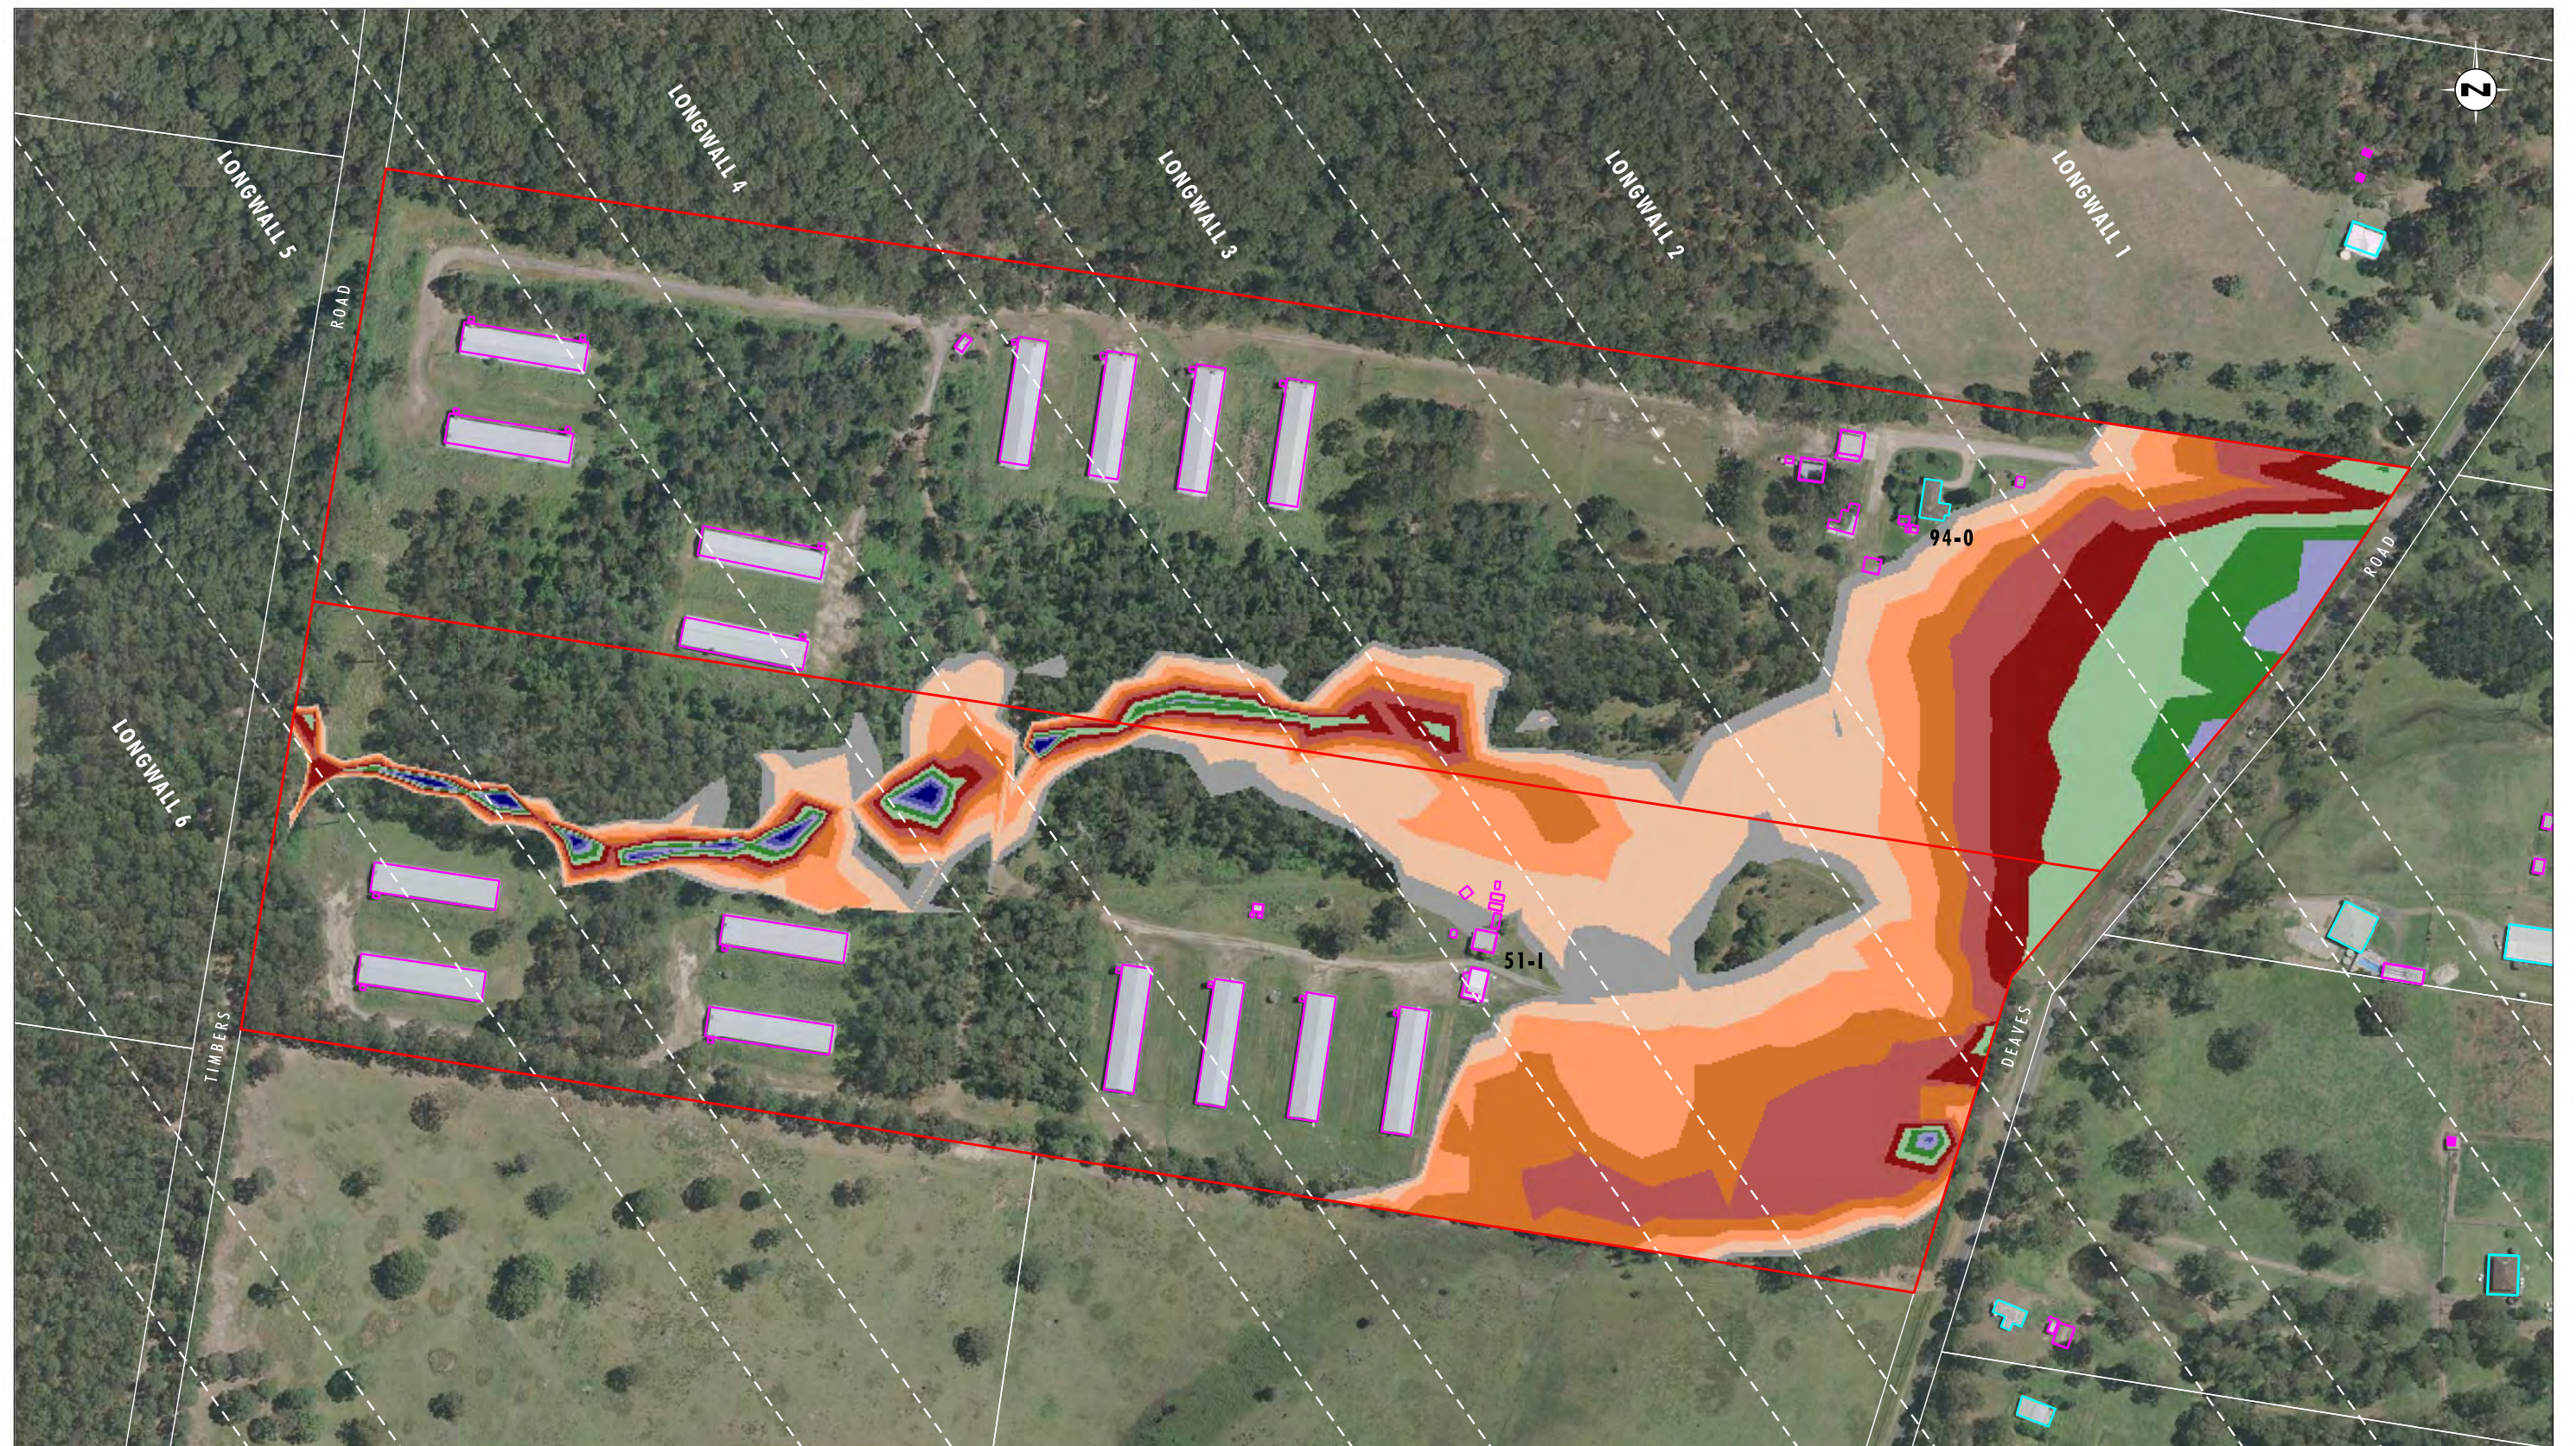
Property 51 & 94 - 100 Year ARI Storm Event:  
Maximum Flood Depth Post Mining Landform  
(to Longwall 23)

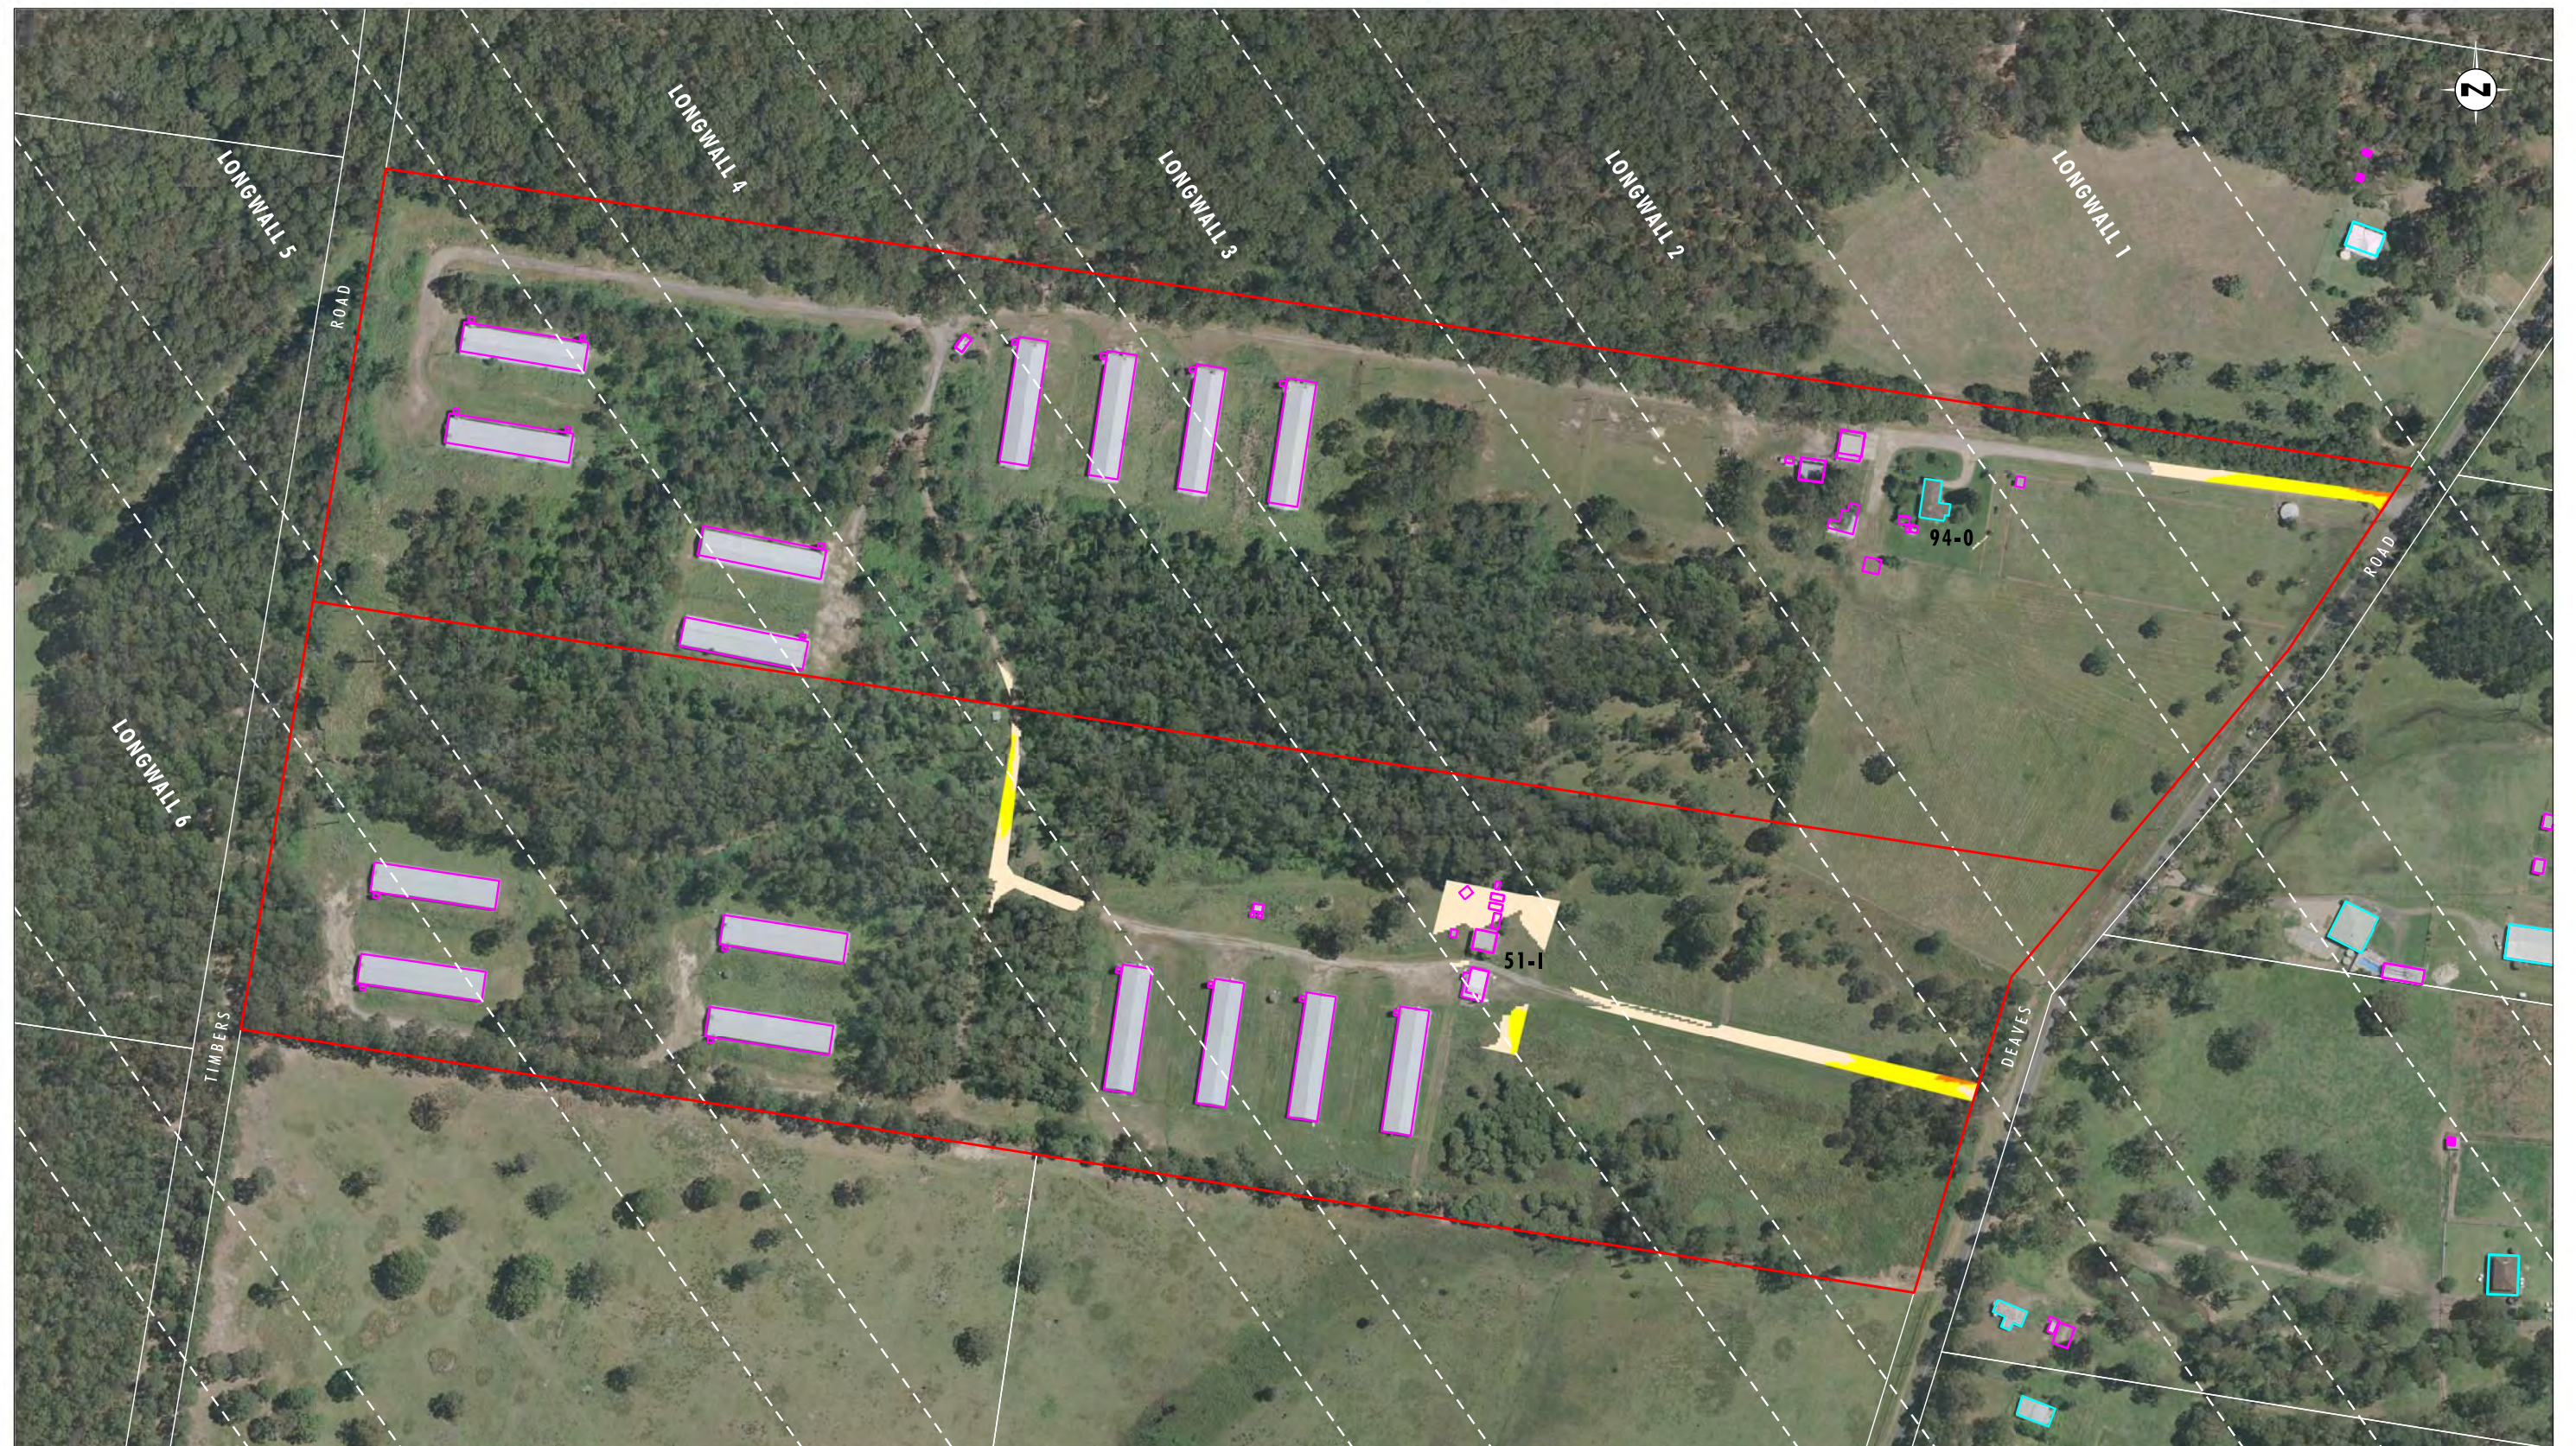
Property 51 & 94 - 100 Year ARI Storm Event:  
 Maximum Flood Hazard Categories Pre Mining Landform
