## APPENDIX 31

Flooding Assessment Figures -  
Property 213

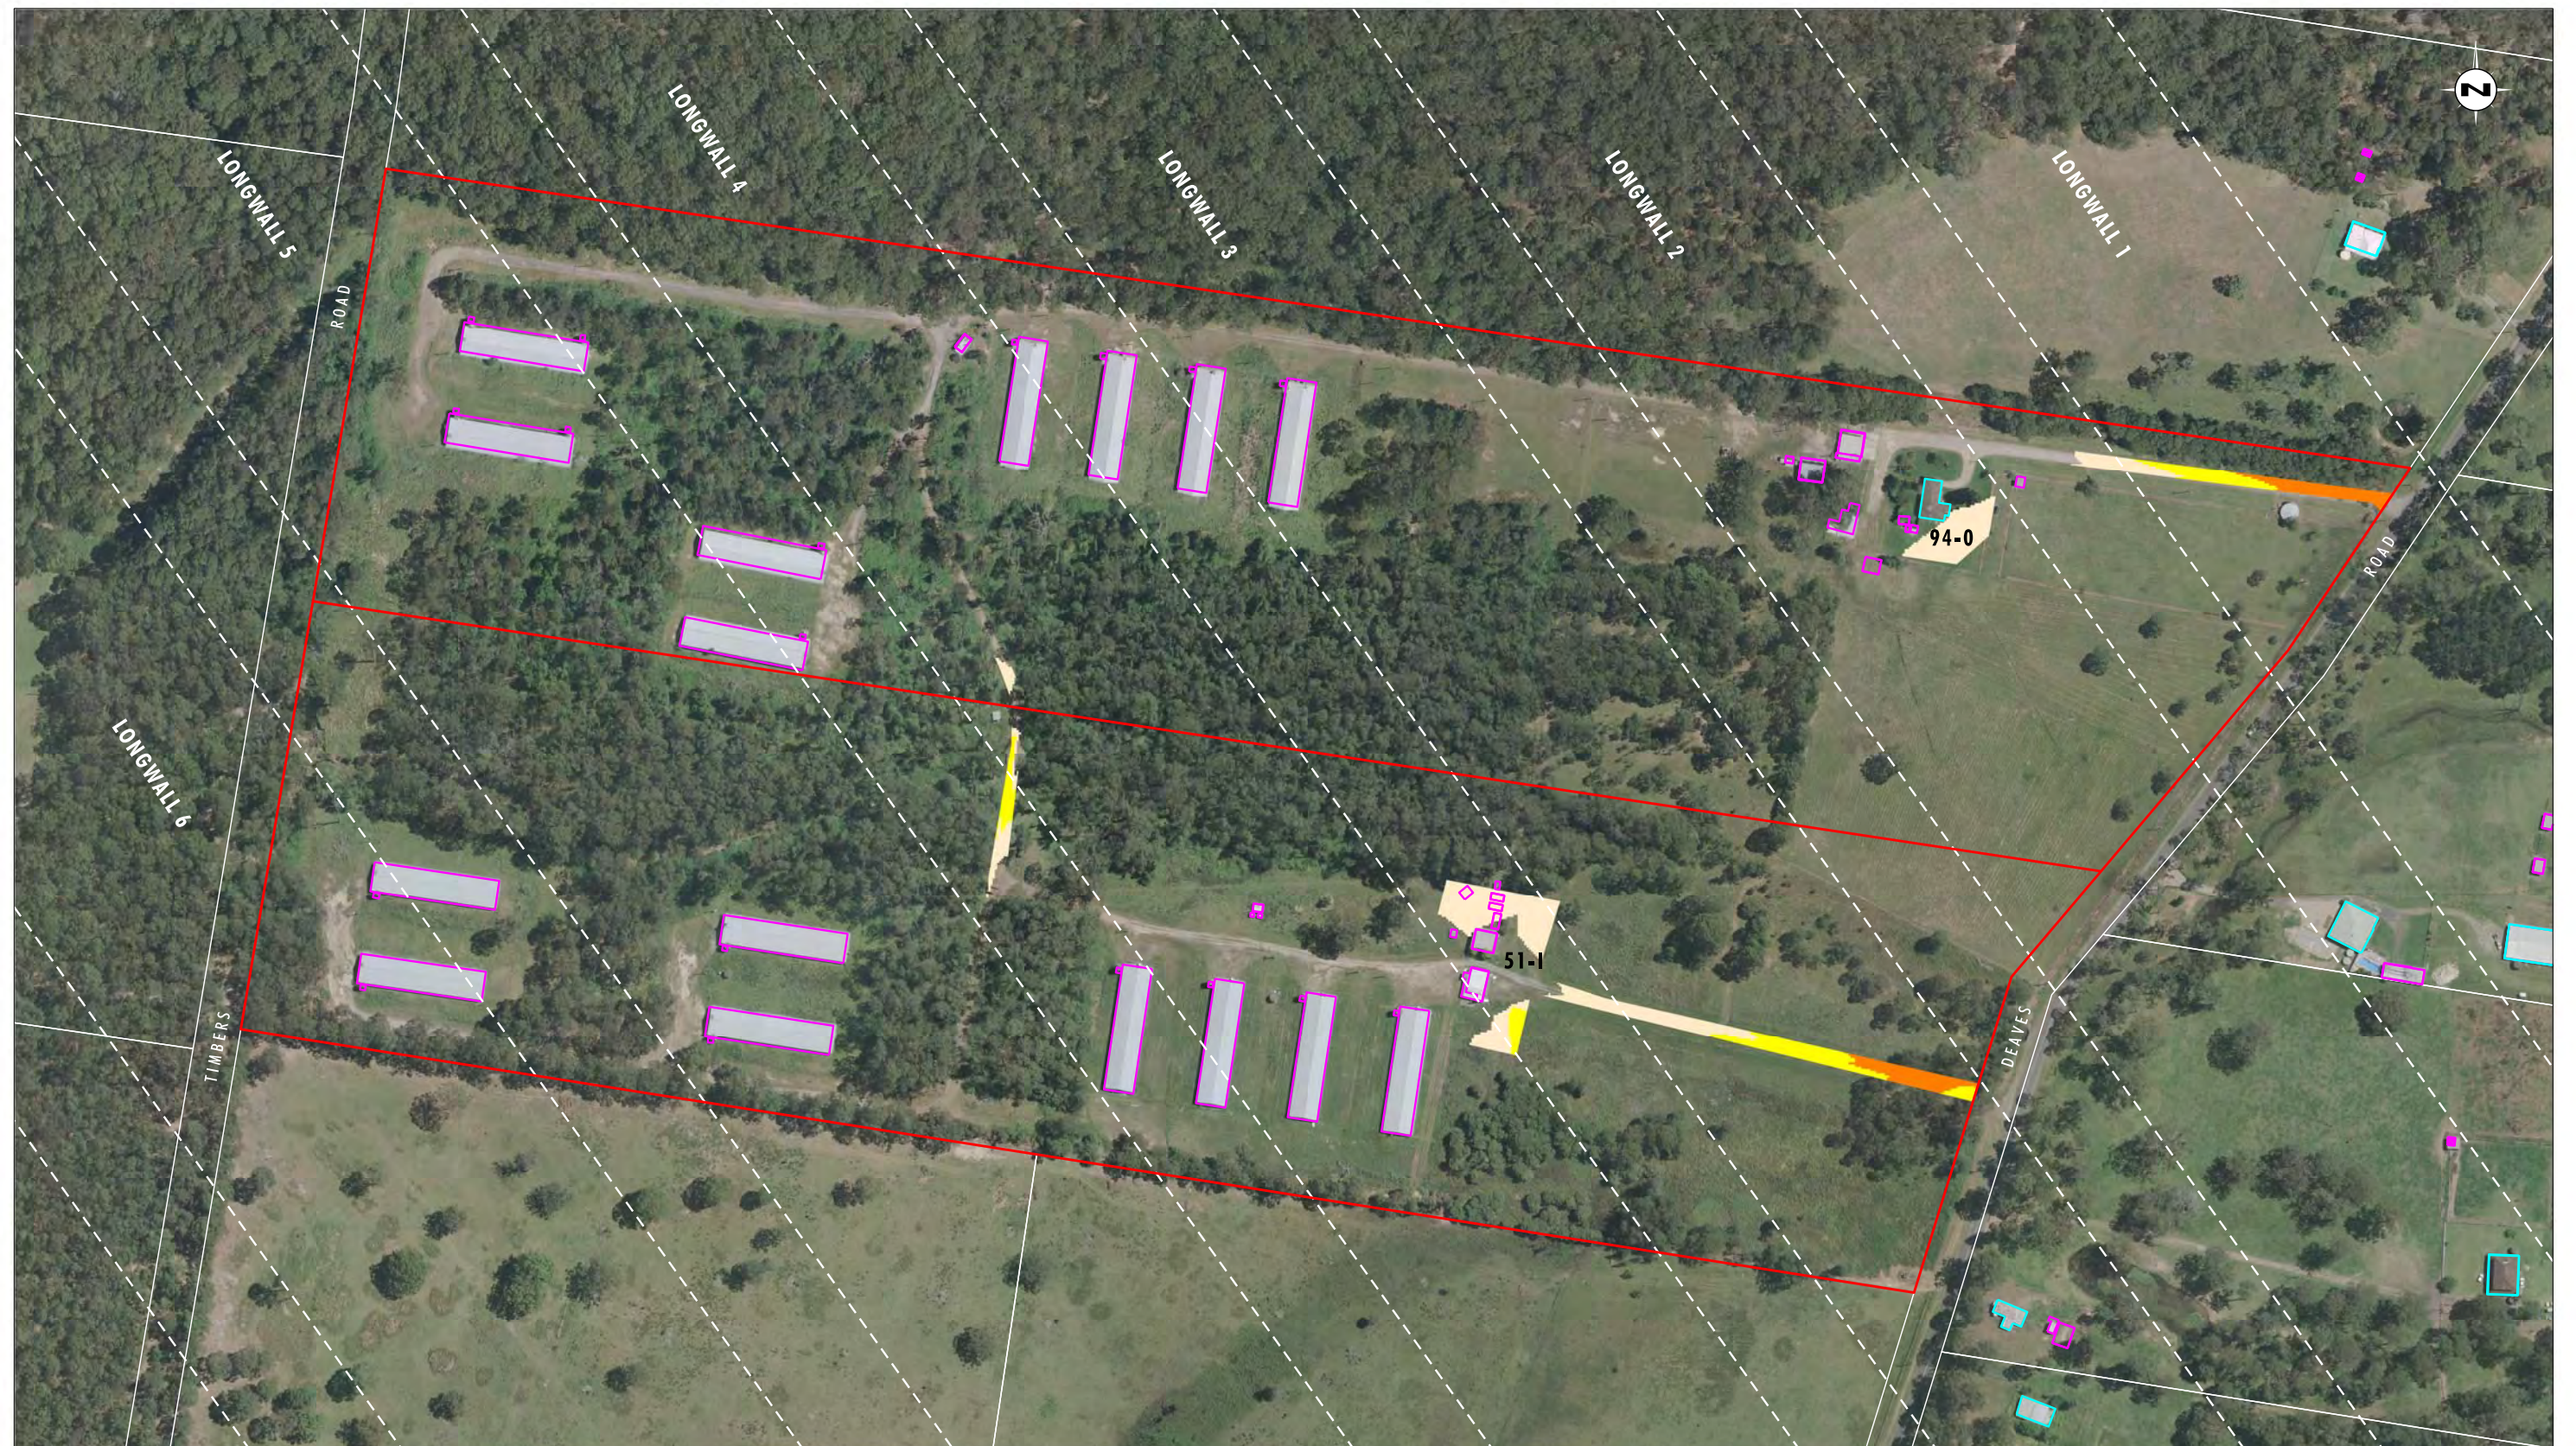
**FIGURE 4**  
 Property 51 & 94 - 100 Year ARI Storm Event:  
 Maximum Flood Hazard Categories Post Mining Landform  
 (to Longwall 24A)

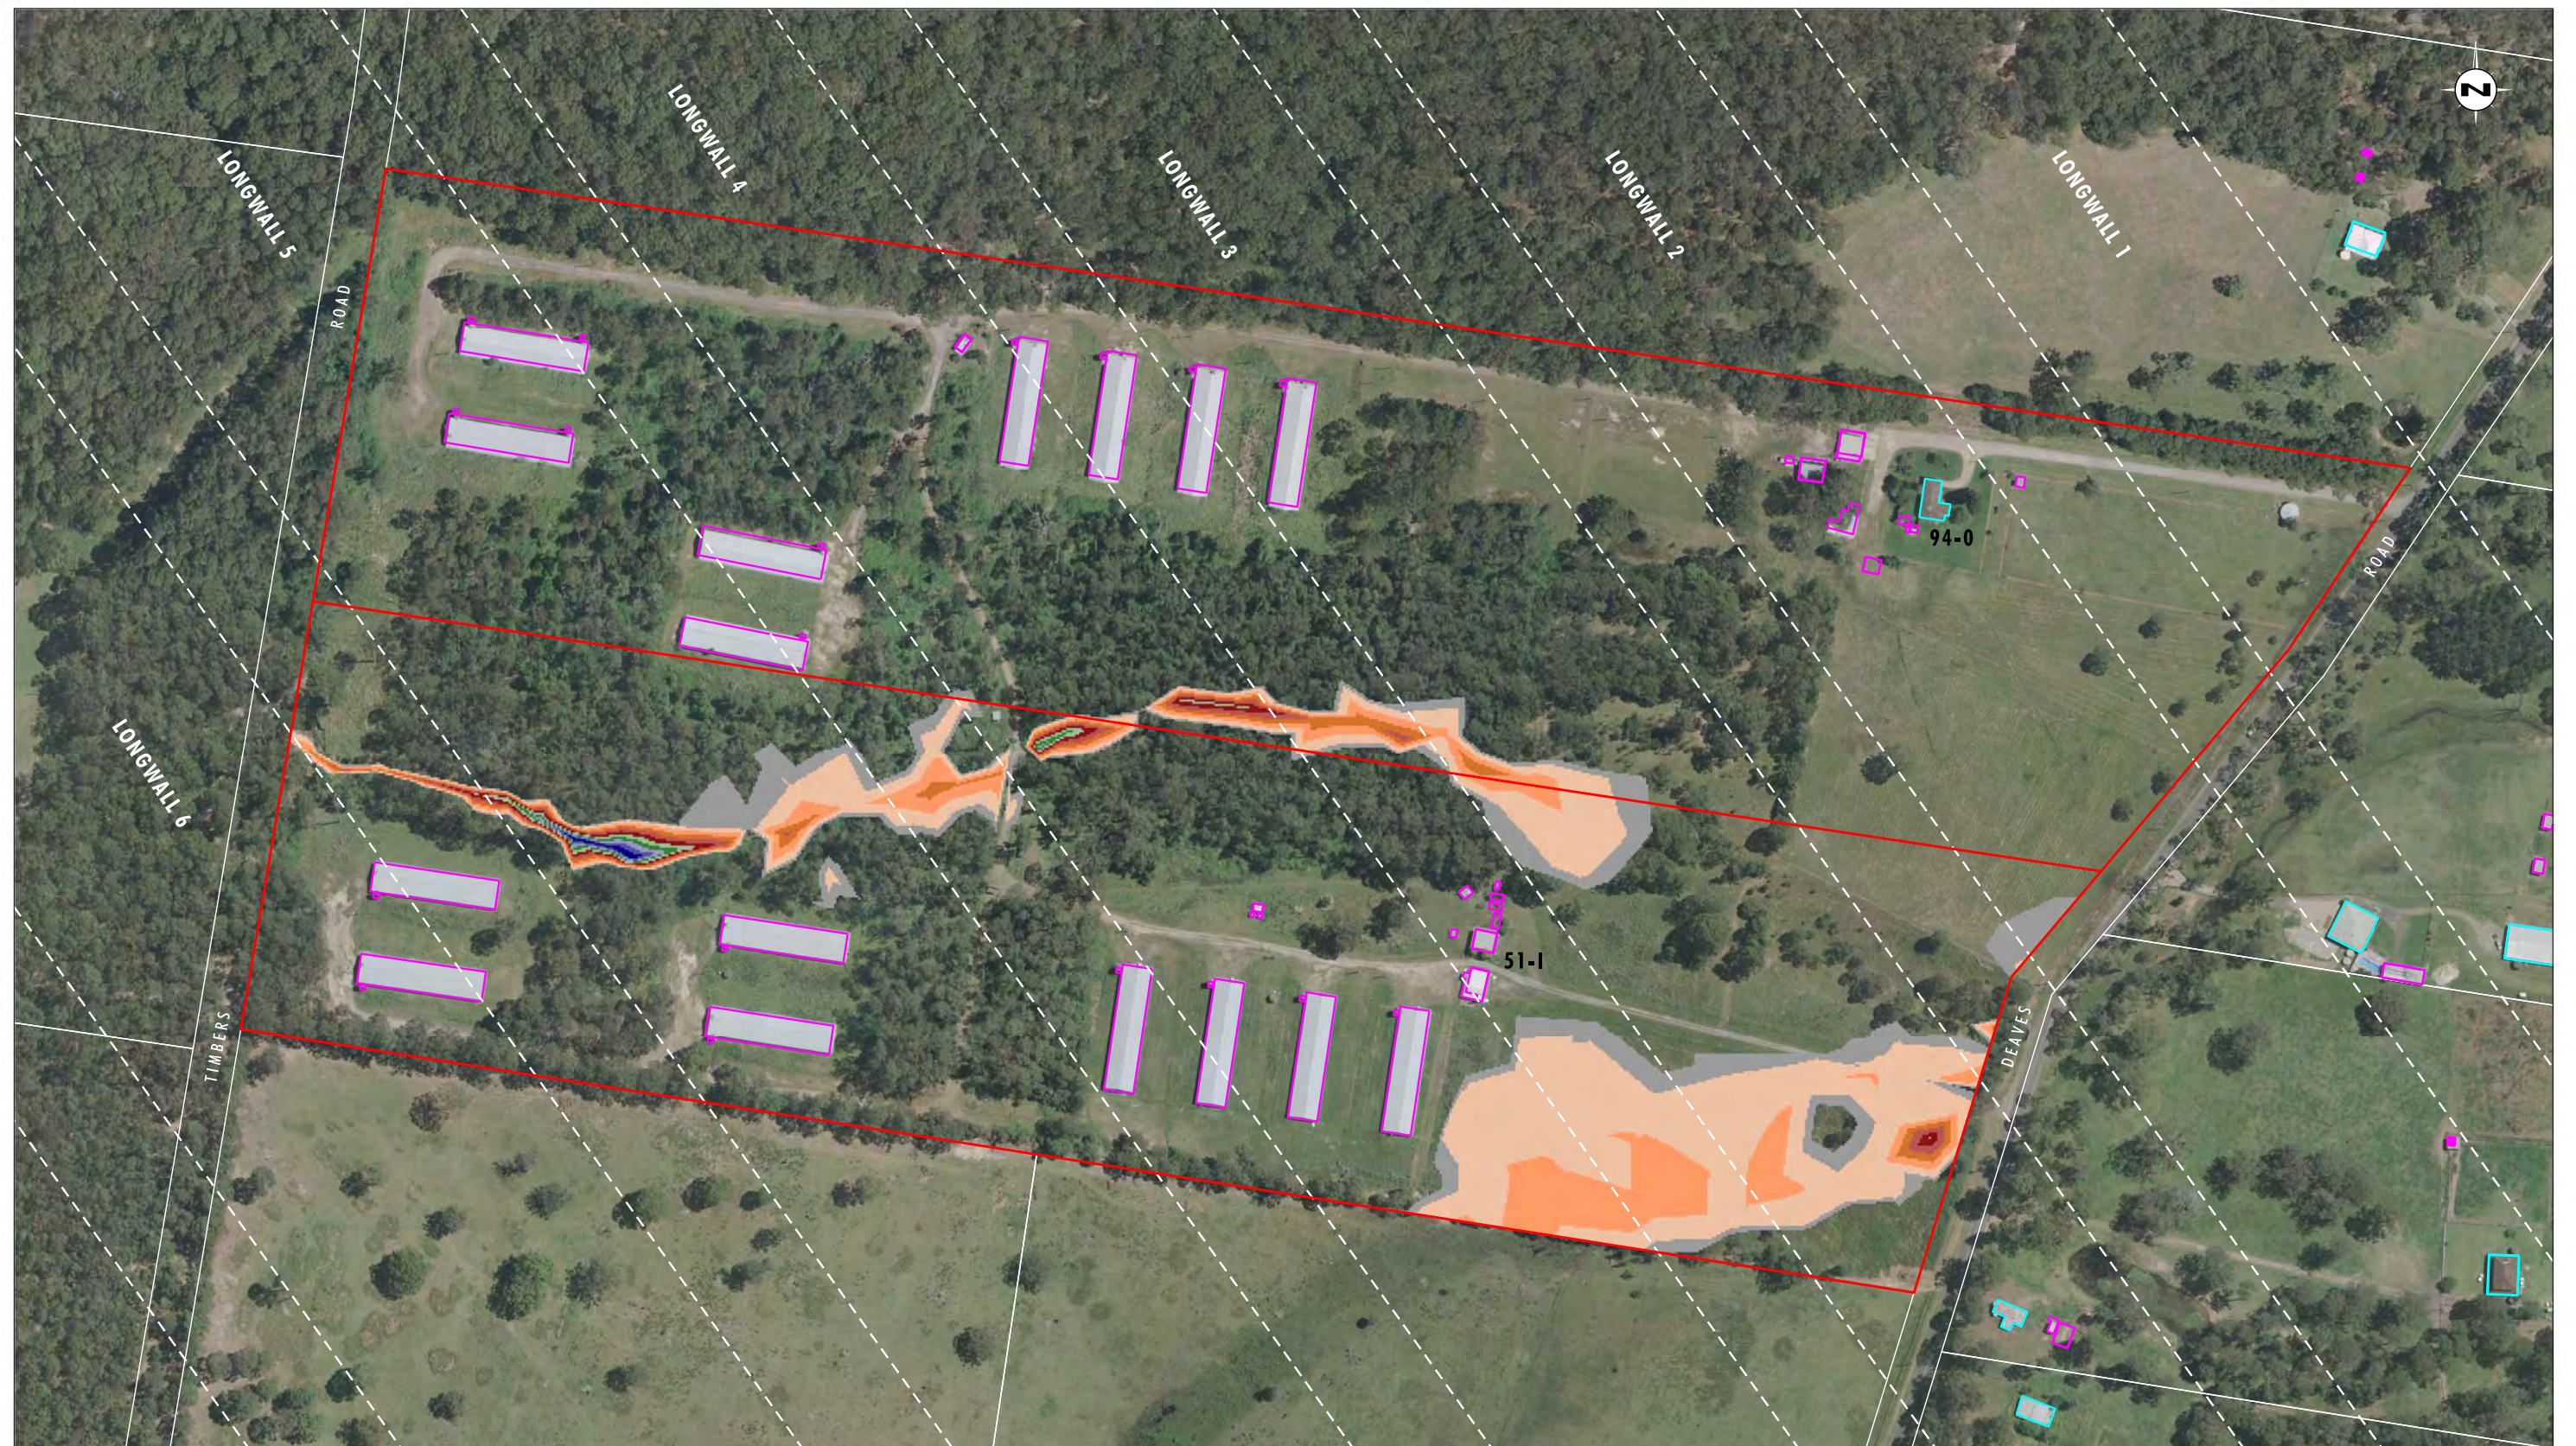
Property 51 & 94 - 1 Year ARI Storm Event:  
Maximum Flood Depth Pre Mining Landform

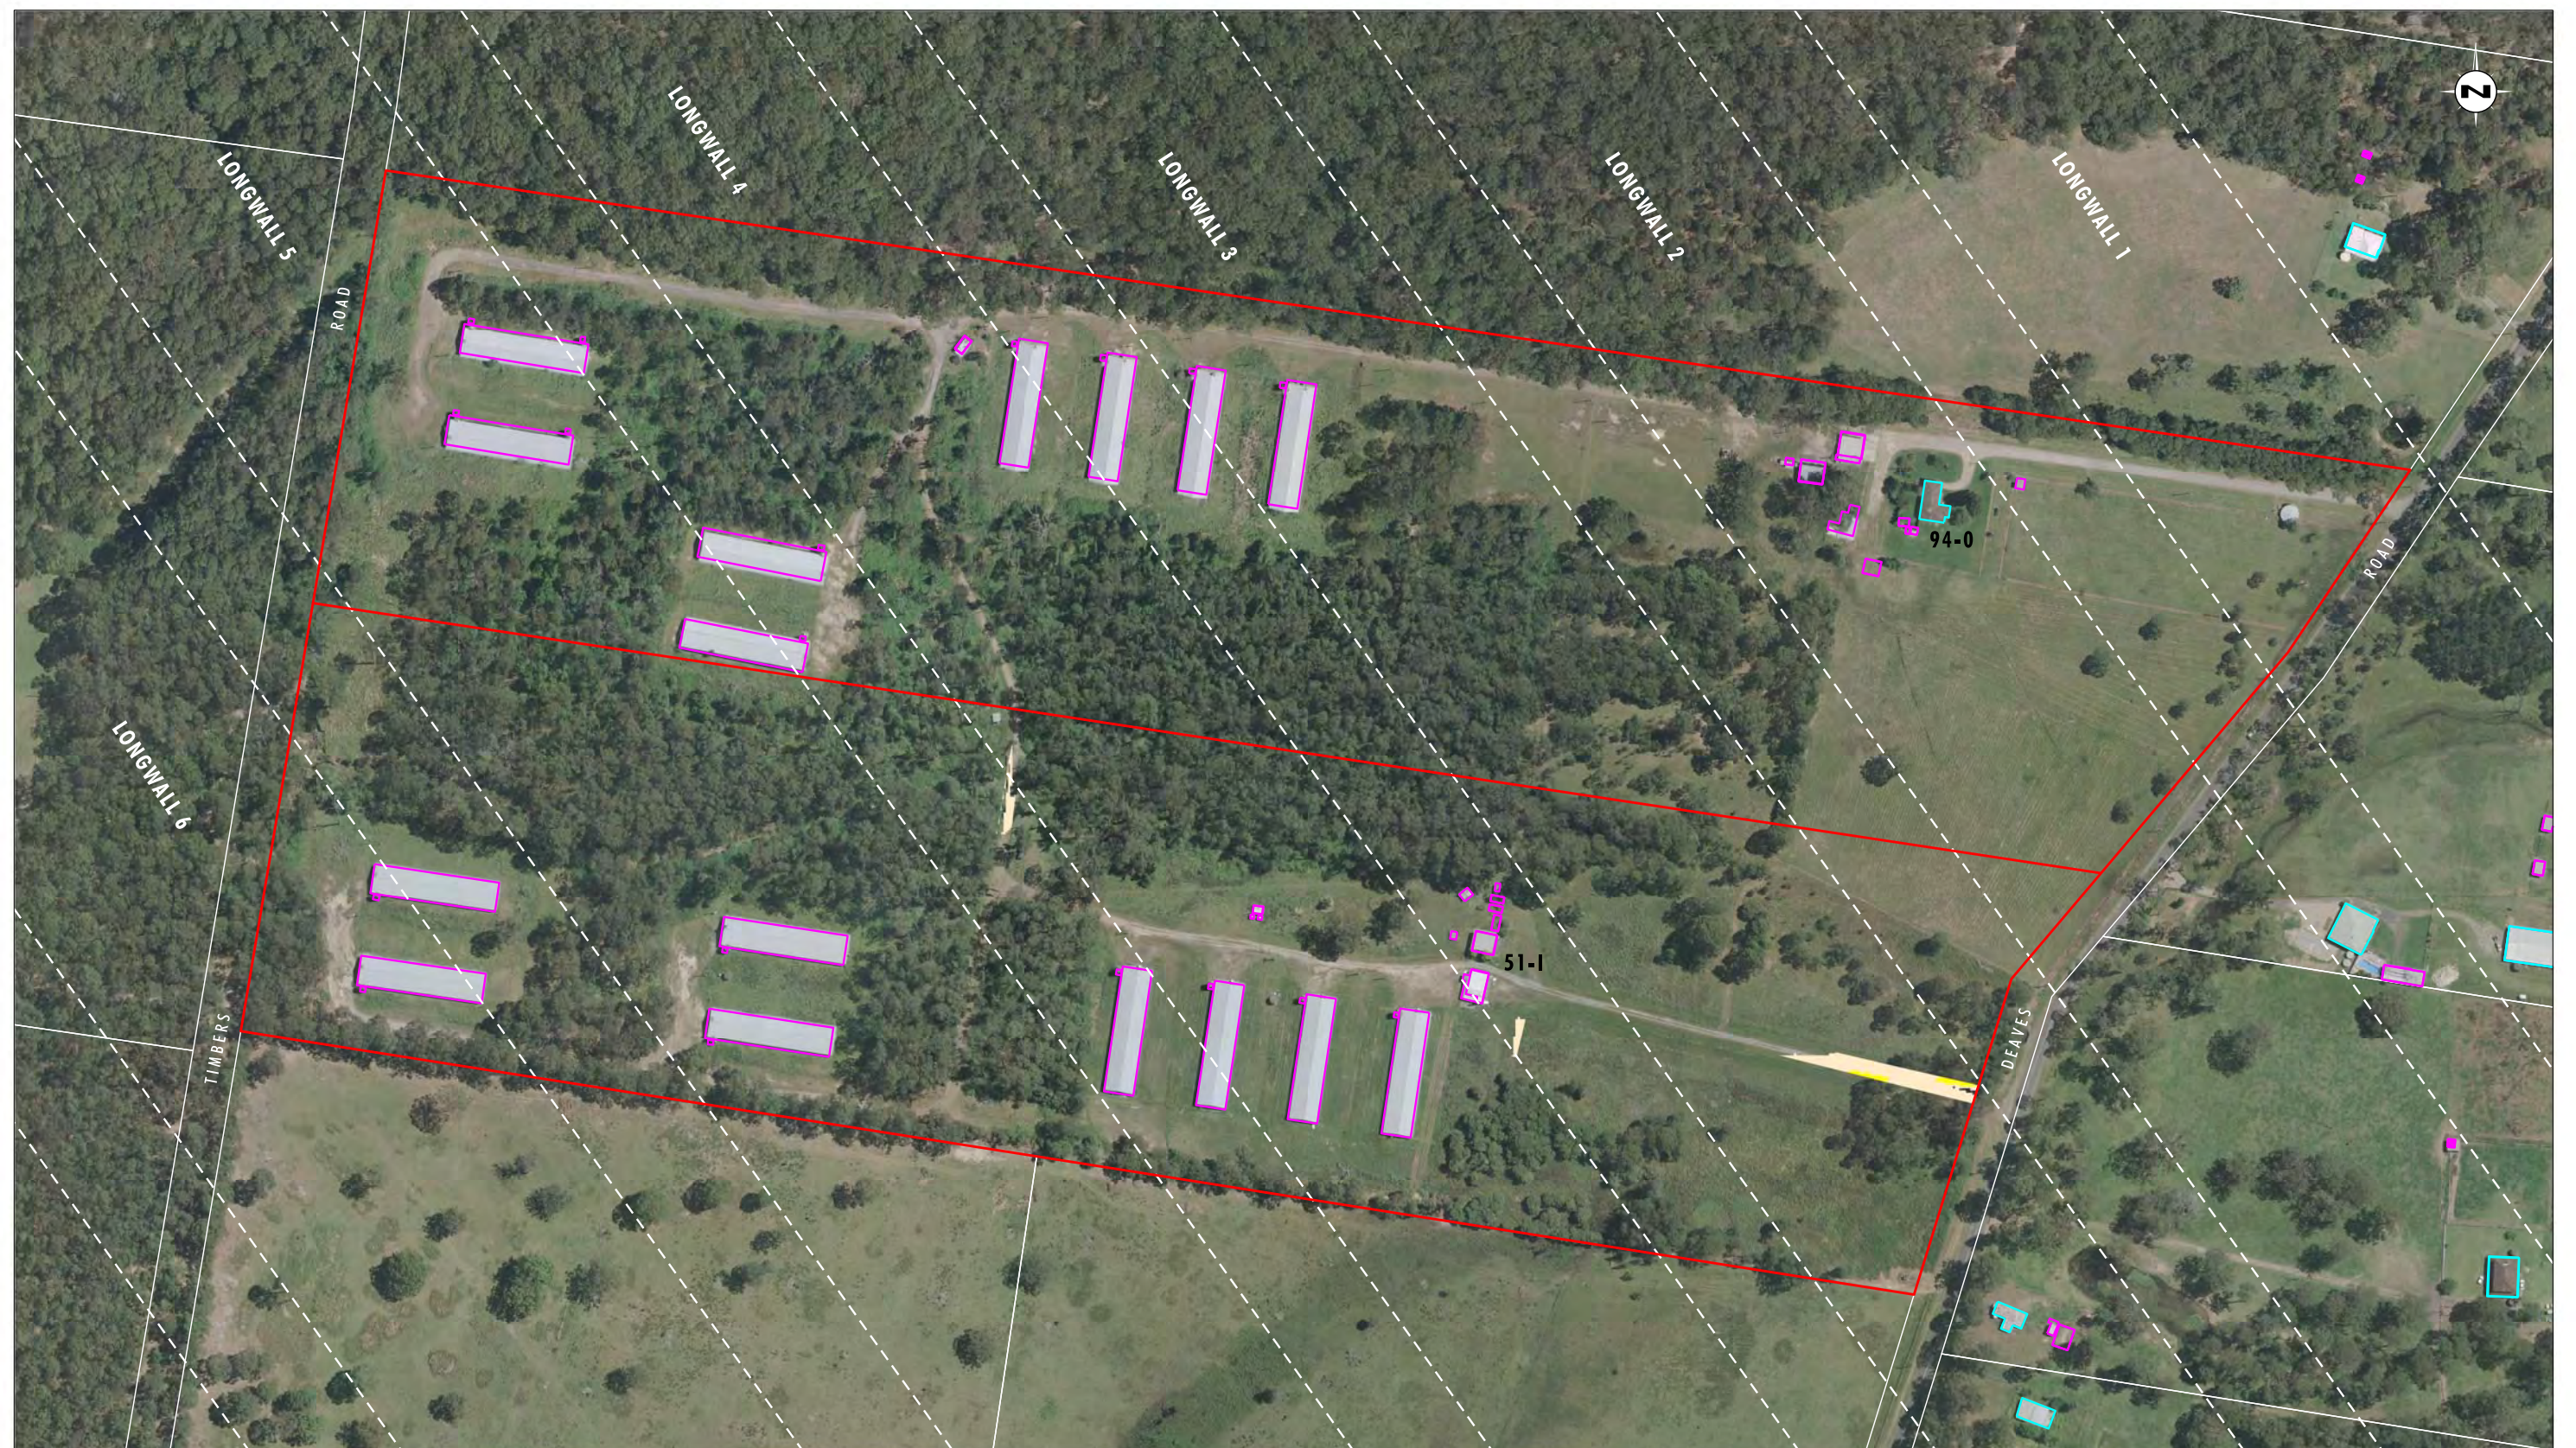
**FIGURE 7**  
 Property 51 & 94 - 1 Year ARI Storm Event:  
 Maximum Flood Hazard Categories Pre Mining Landform
