## APPENDIX 13

Flooding Assessment Figures -  
Property 46

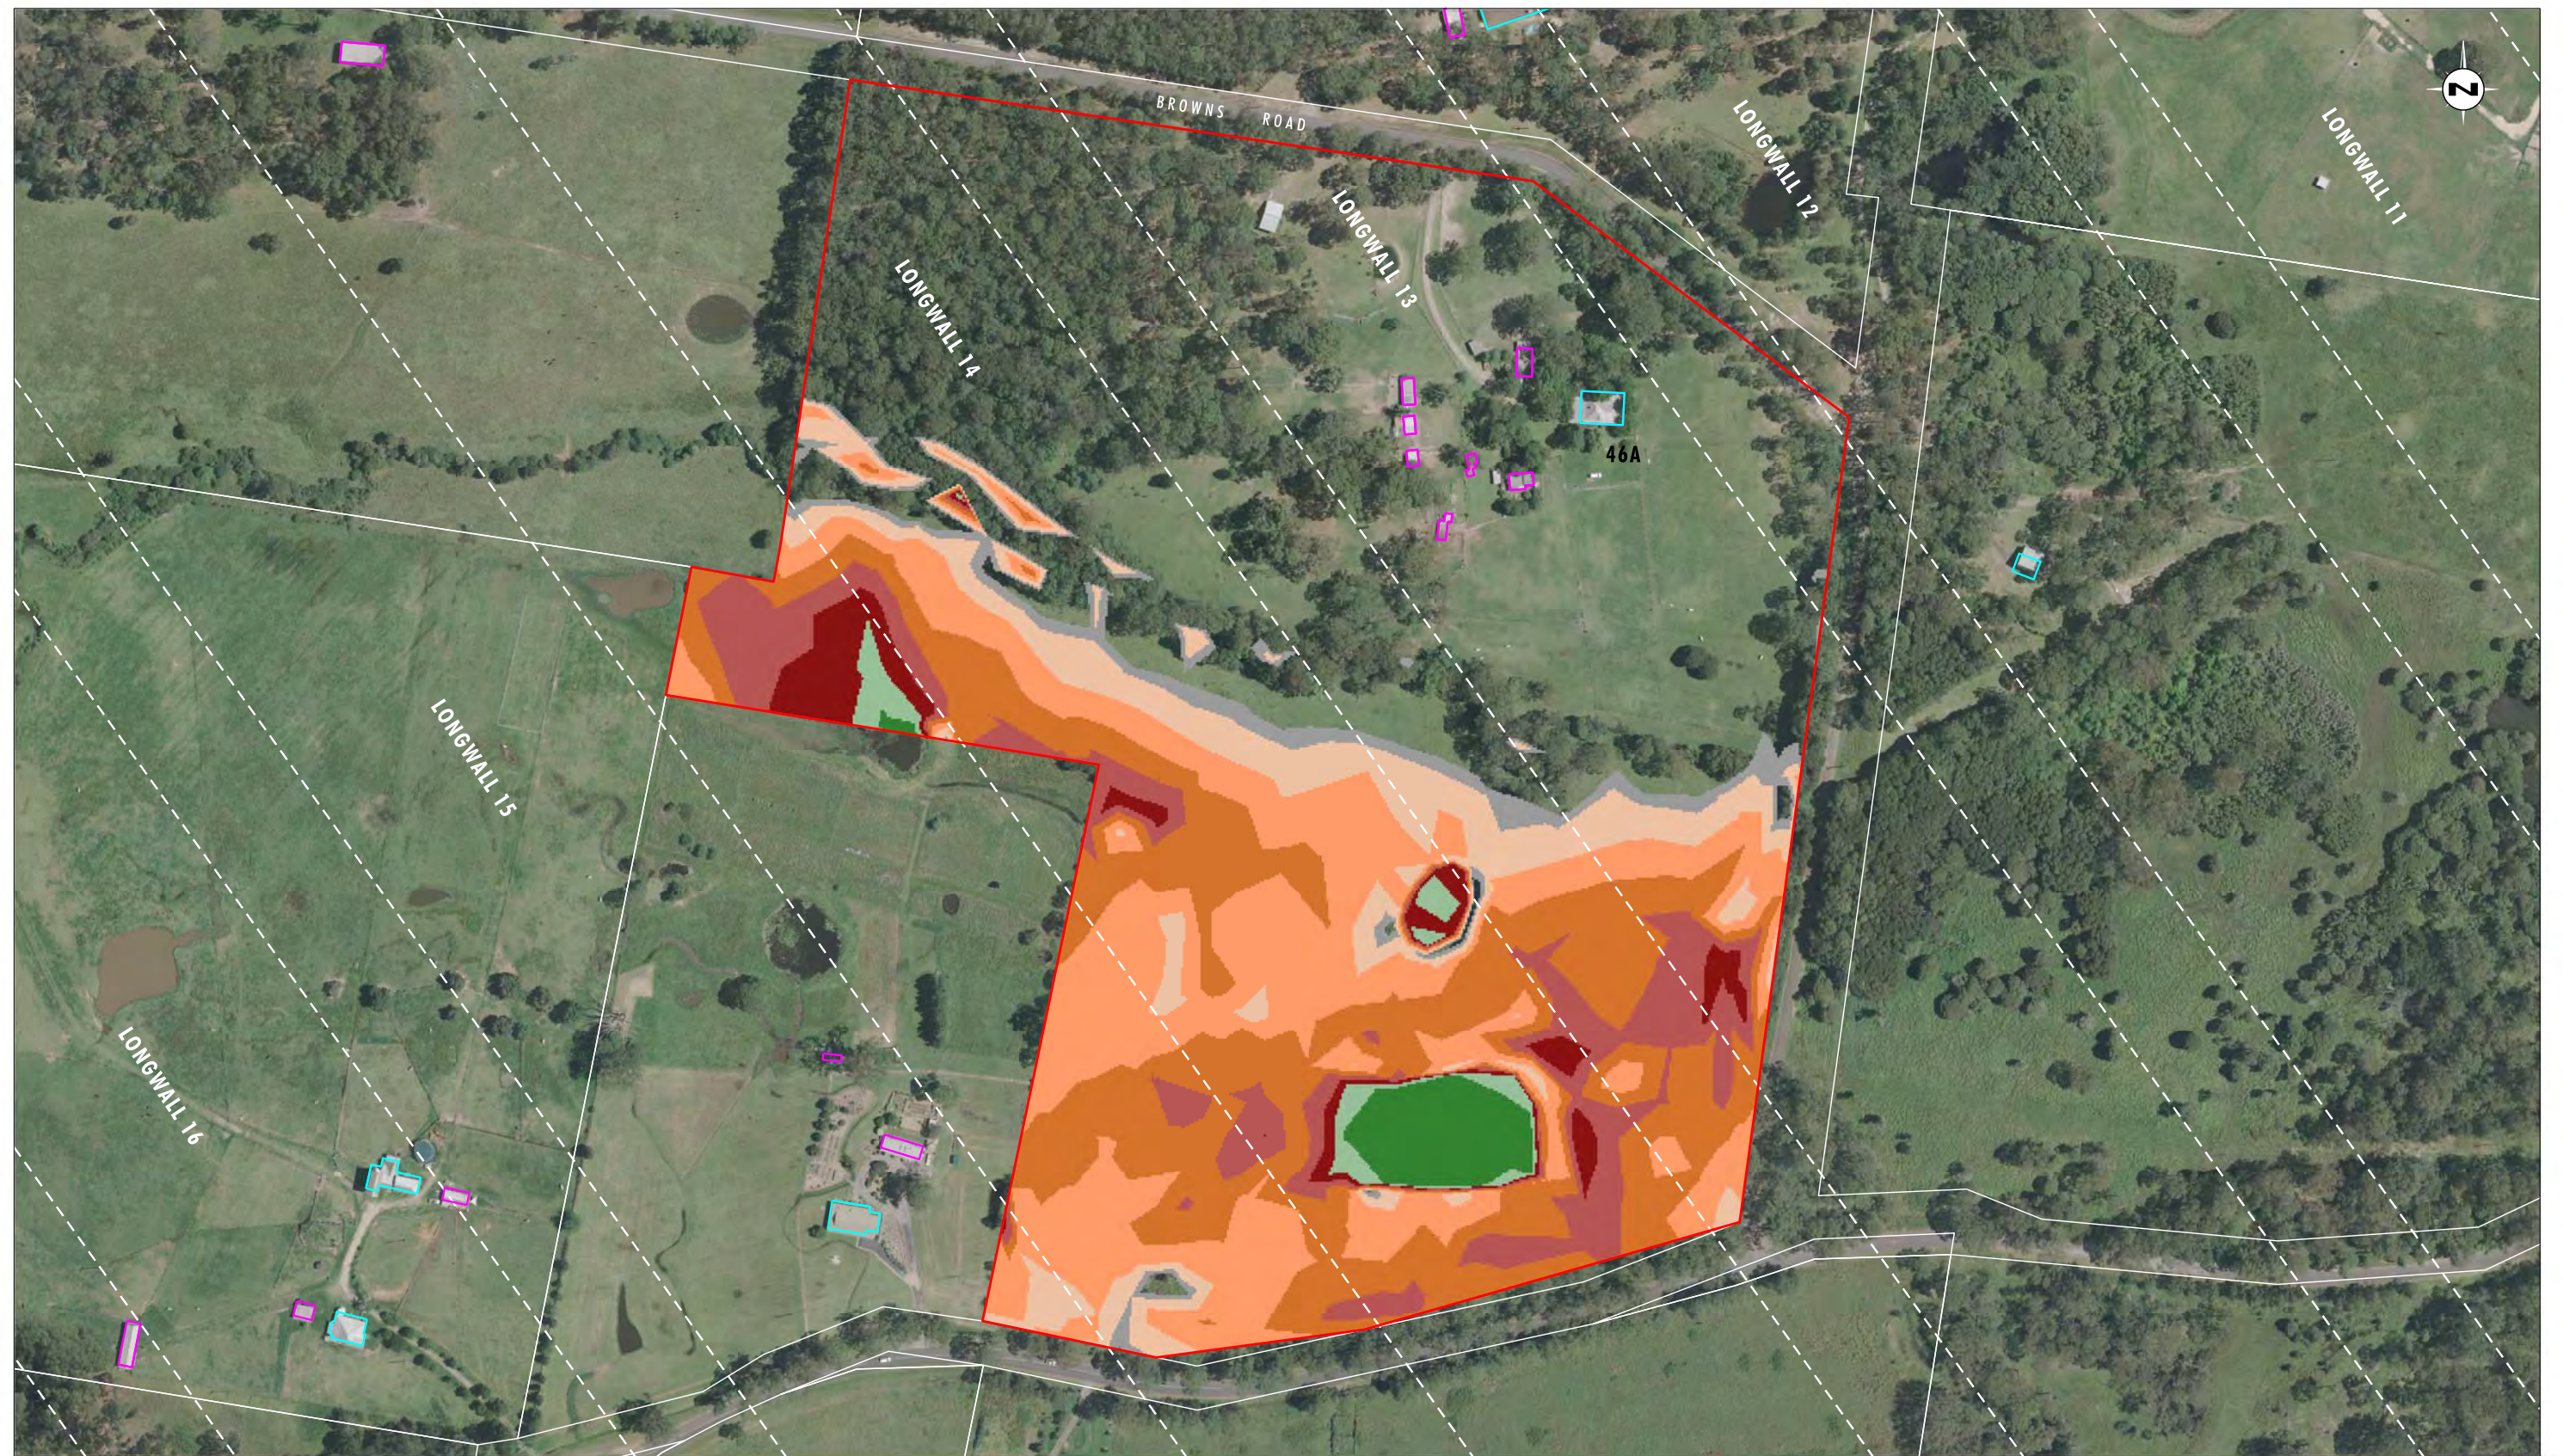
FIGURE 1

Property 46 - 100 year ARI Storm Event:  
Maximum Flood Depth Pre Mining Landform

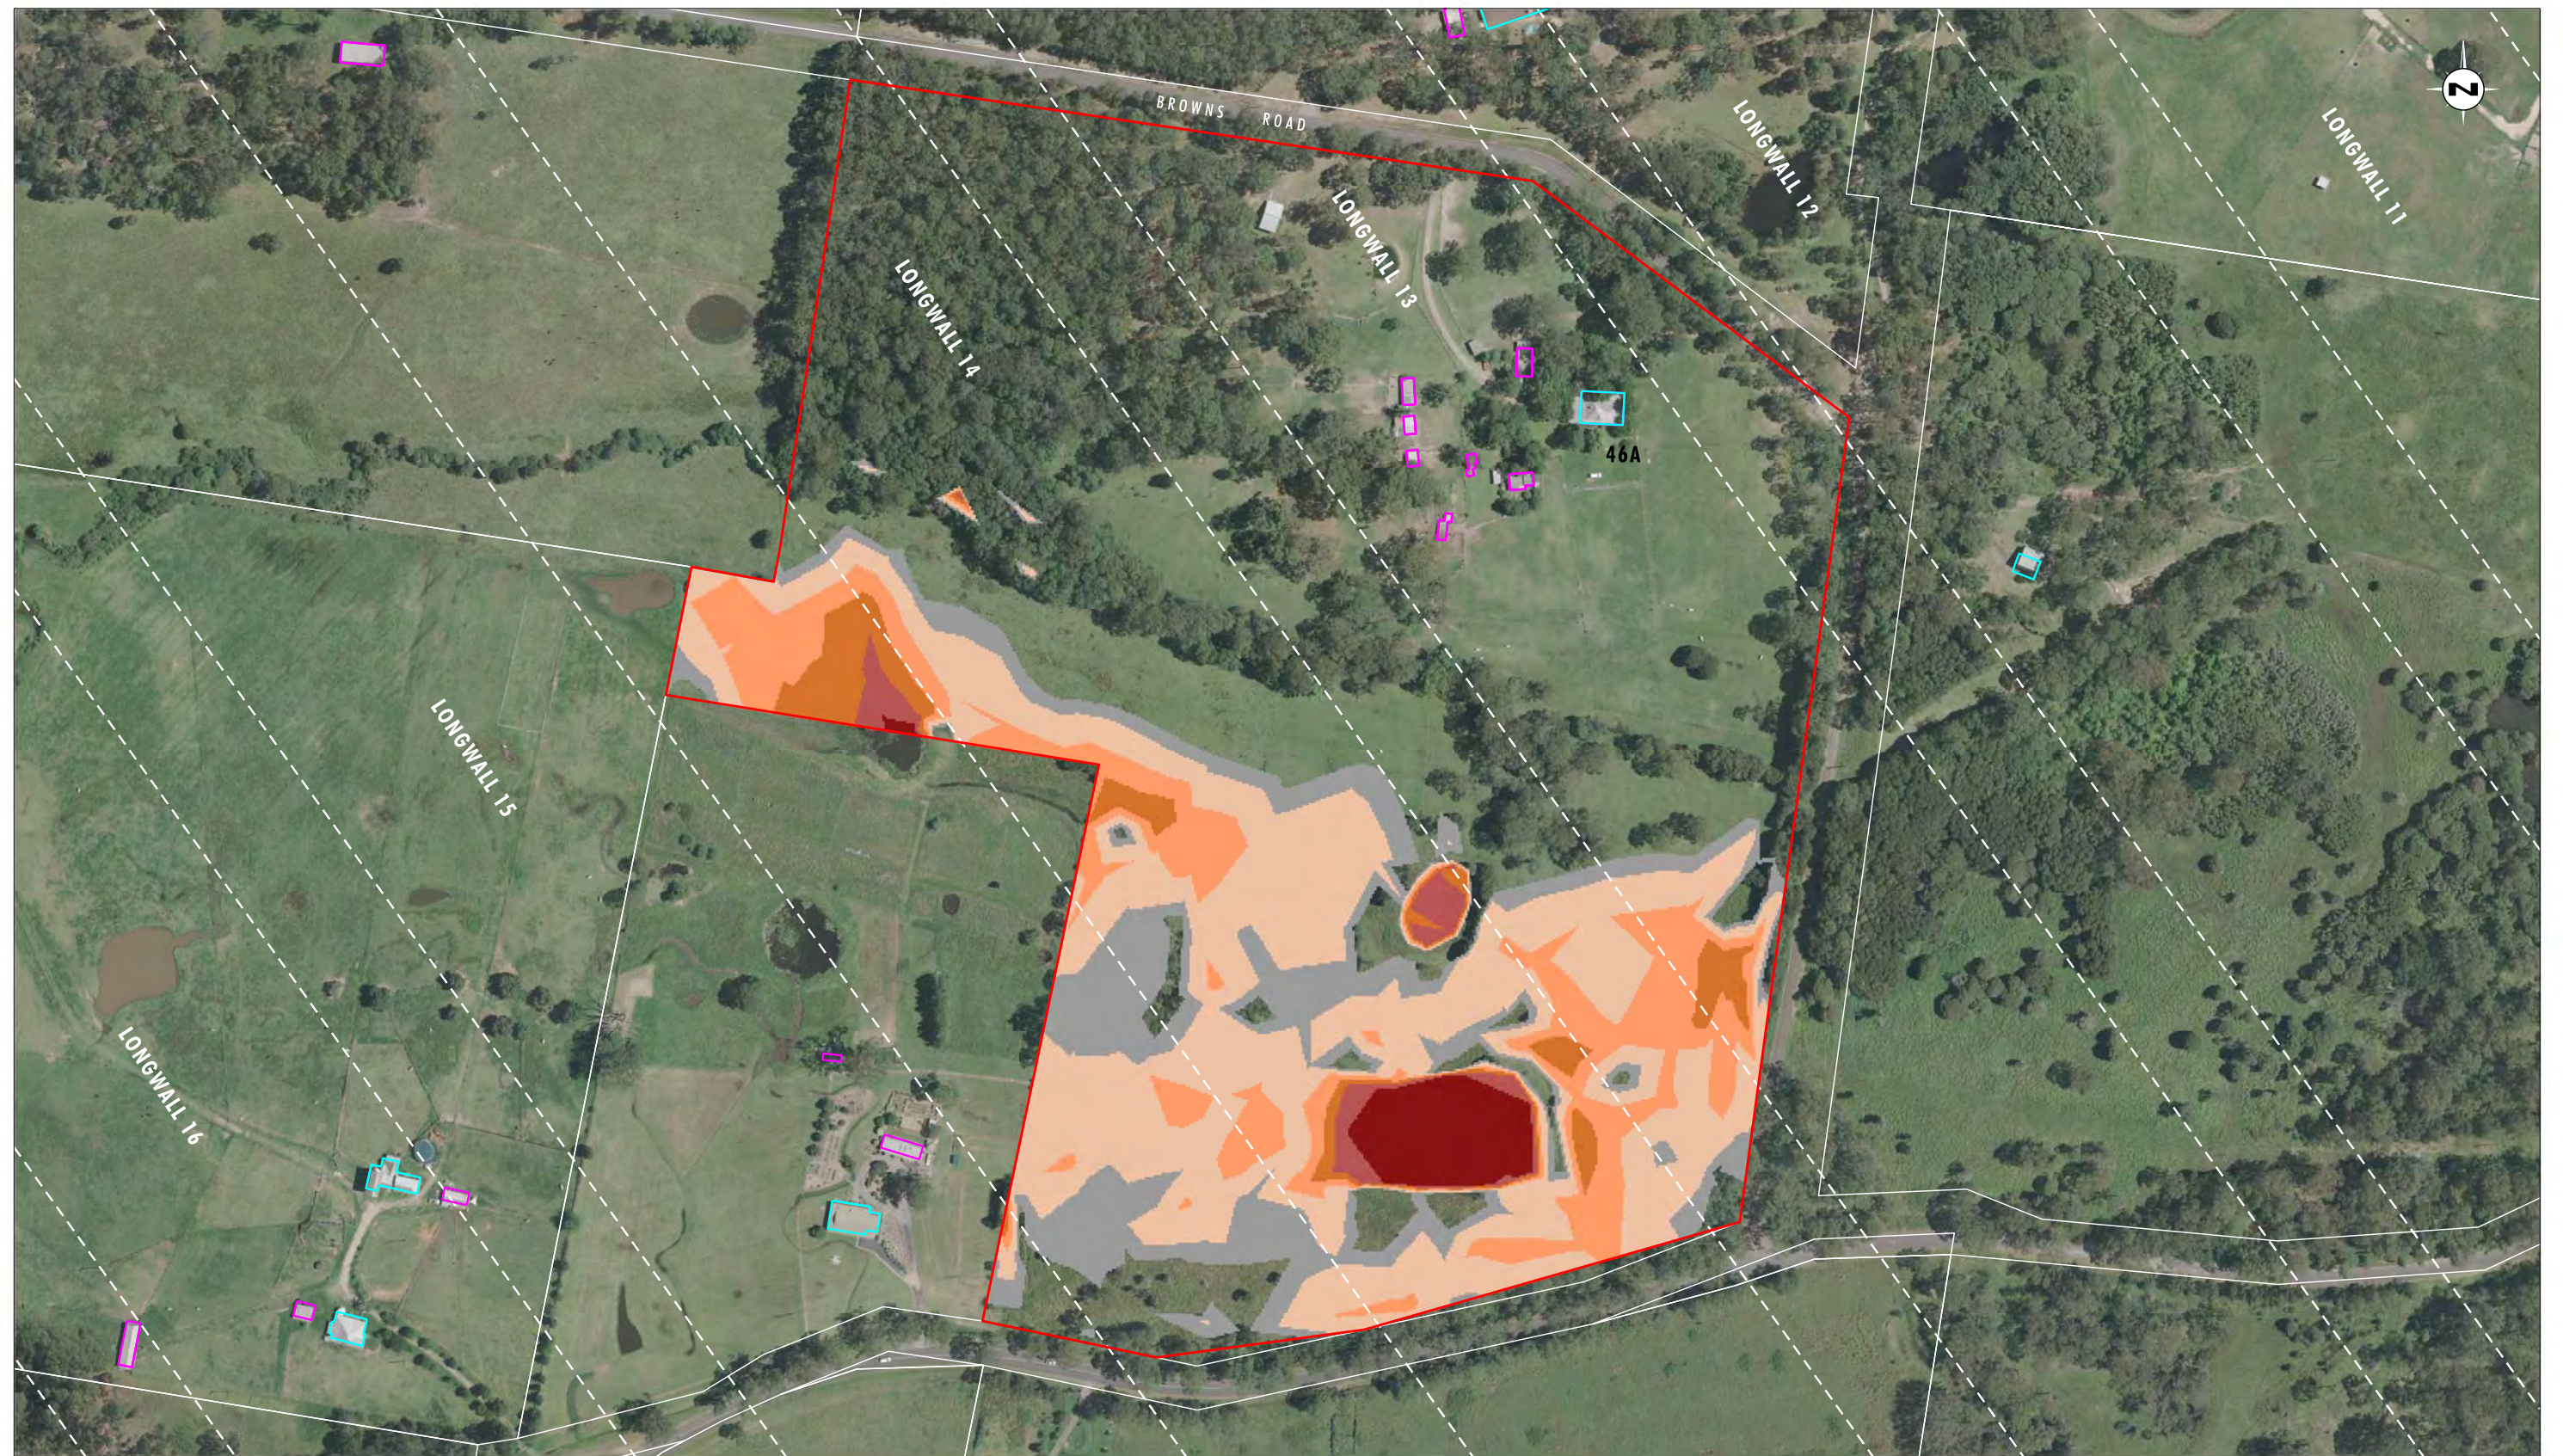
FIGURE 3

Property 46 - 1 year ARI Storm Event:  
Maximum Flood Depth Pre Mining Landform

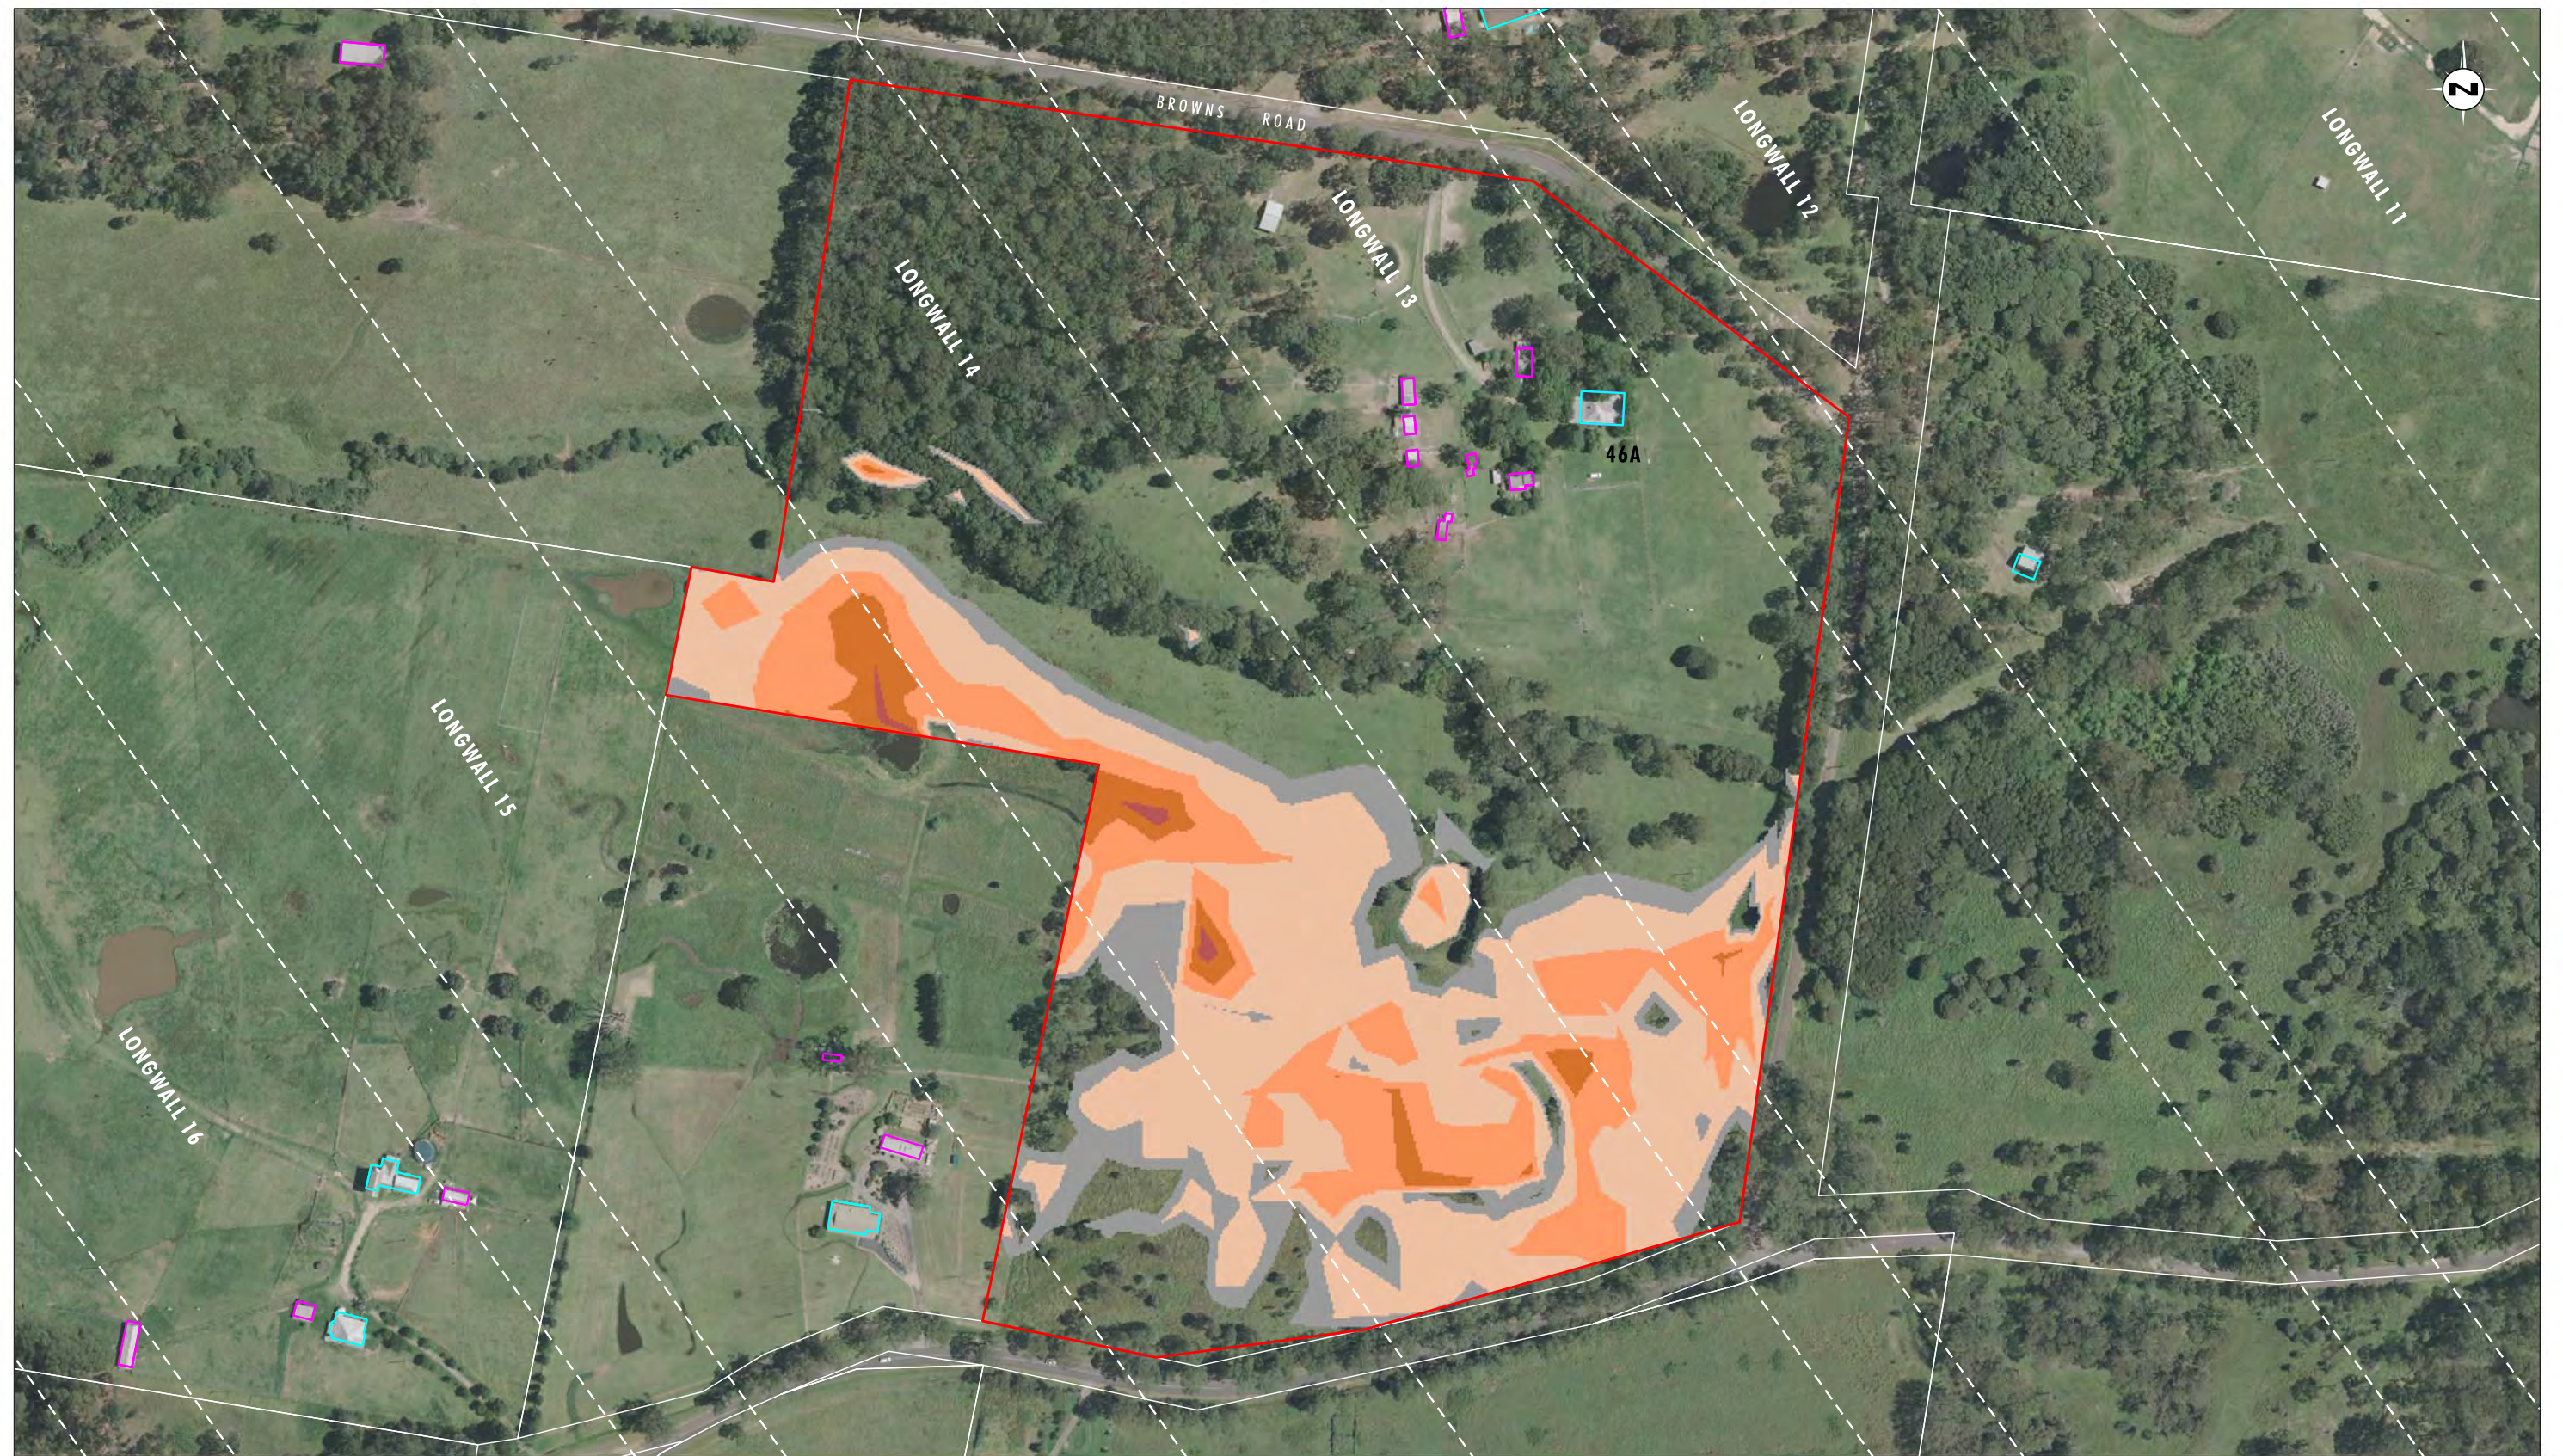
Property 46 - 1 year ARI Storm Event:  
Maximum Flood Depth Post Mining Landform  
(to Longwall 23)

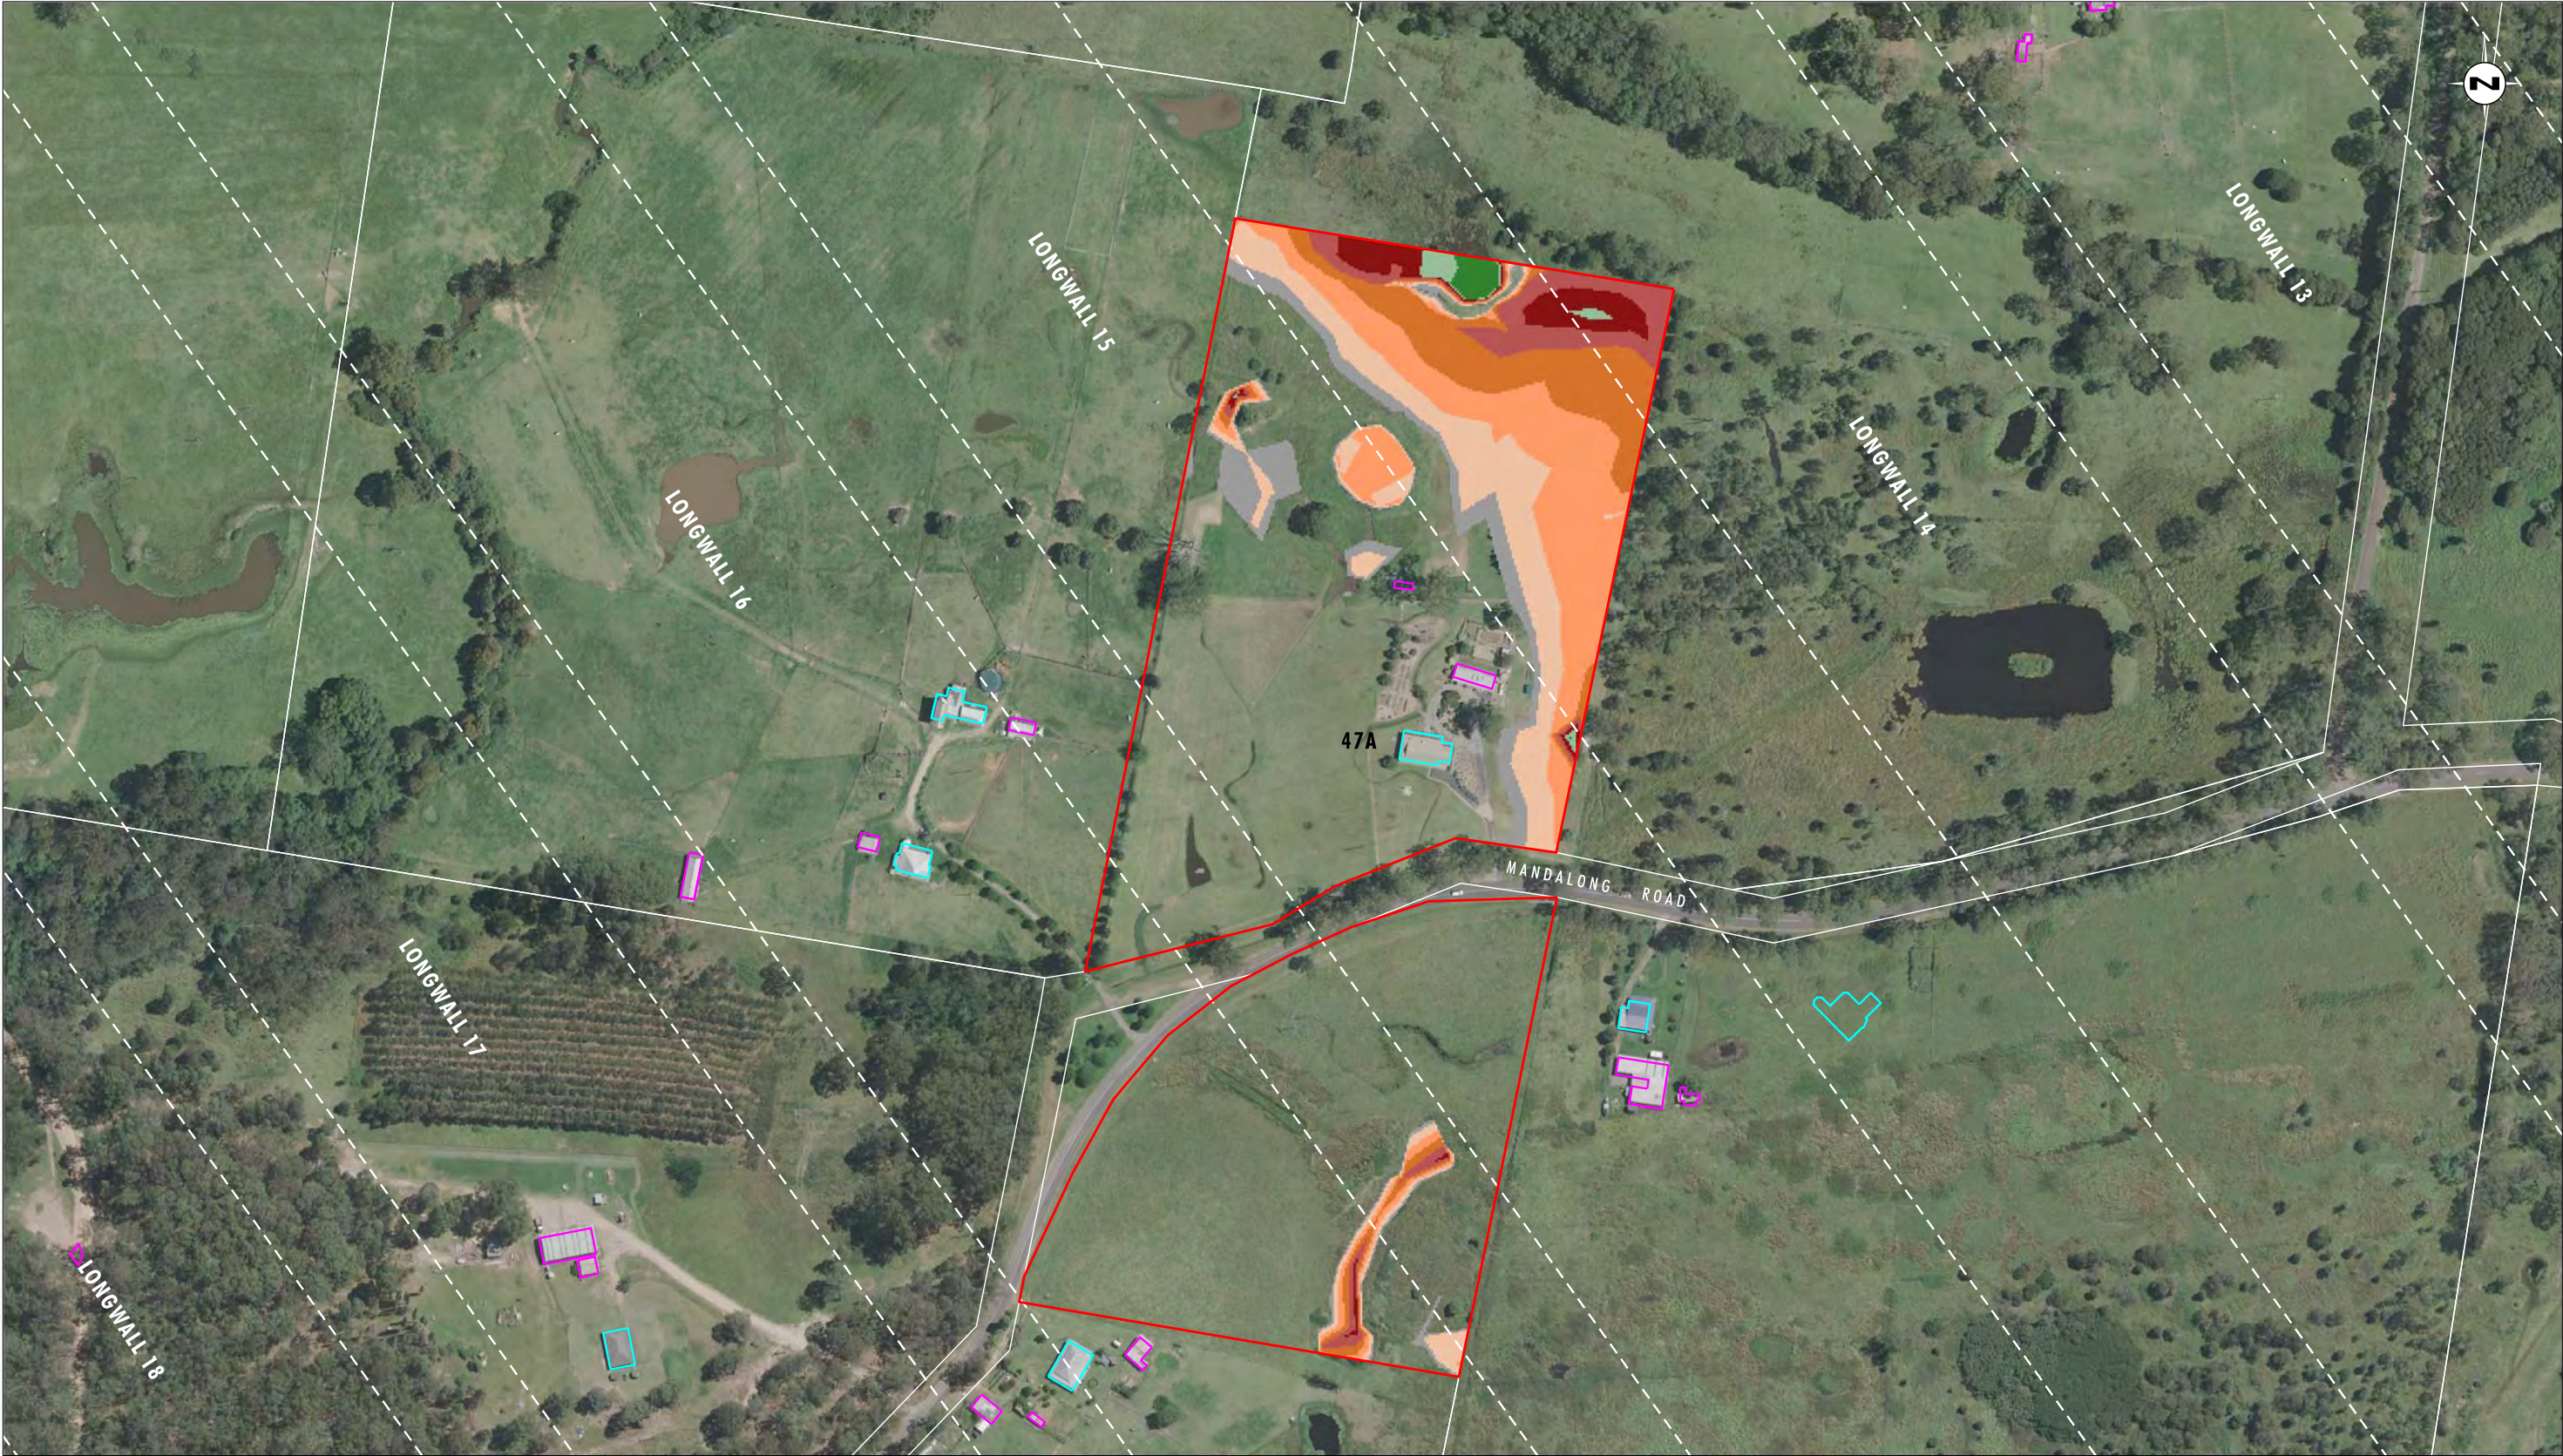
Property 47 - 100 year ARI Storm Event:  
Maximum Flood Depth Pre Mining Landform

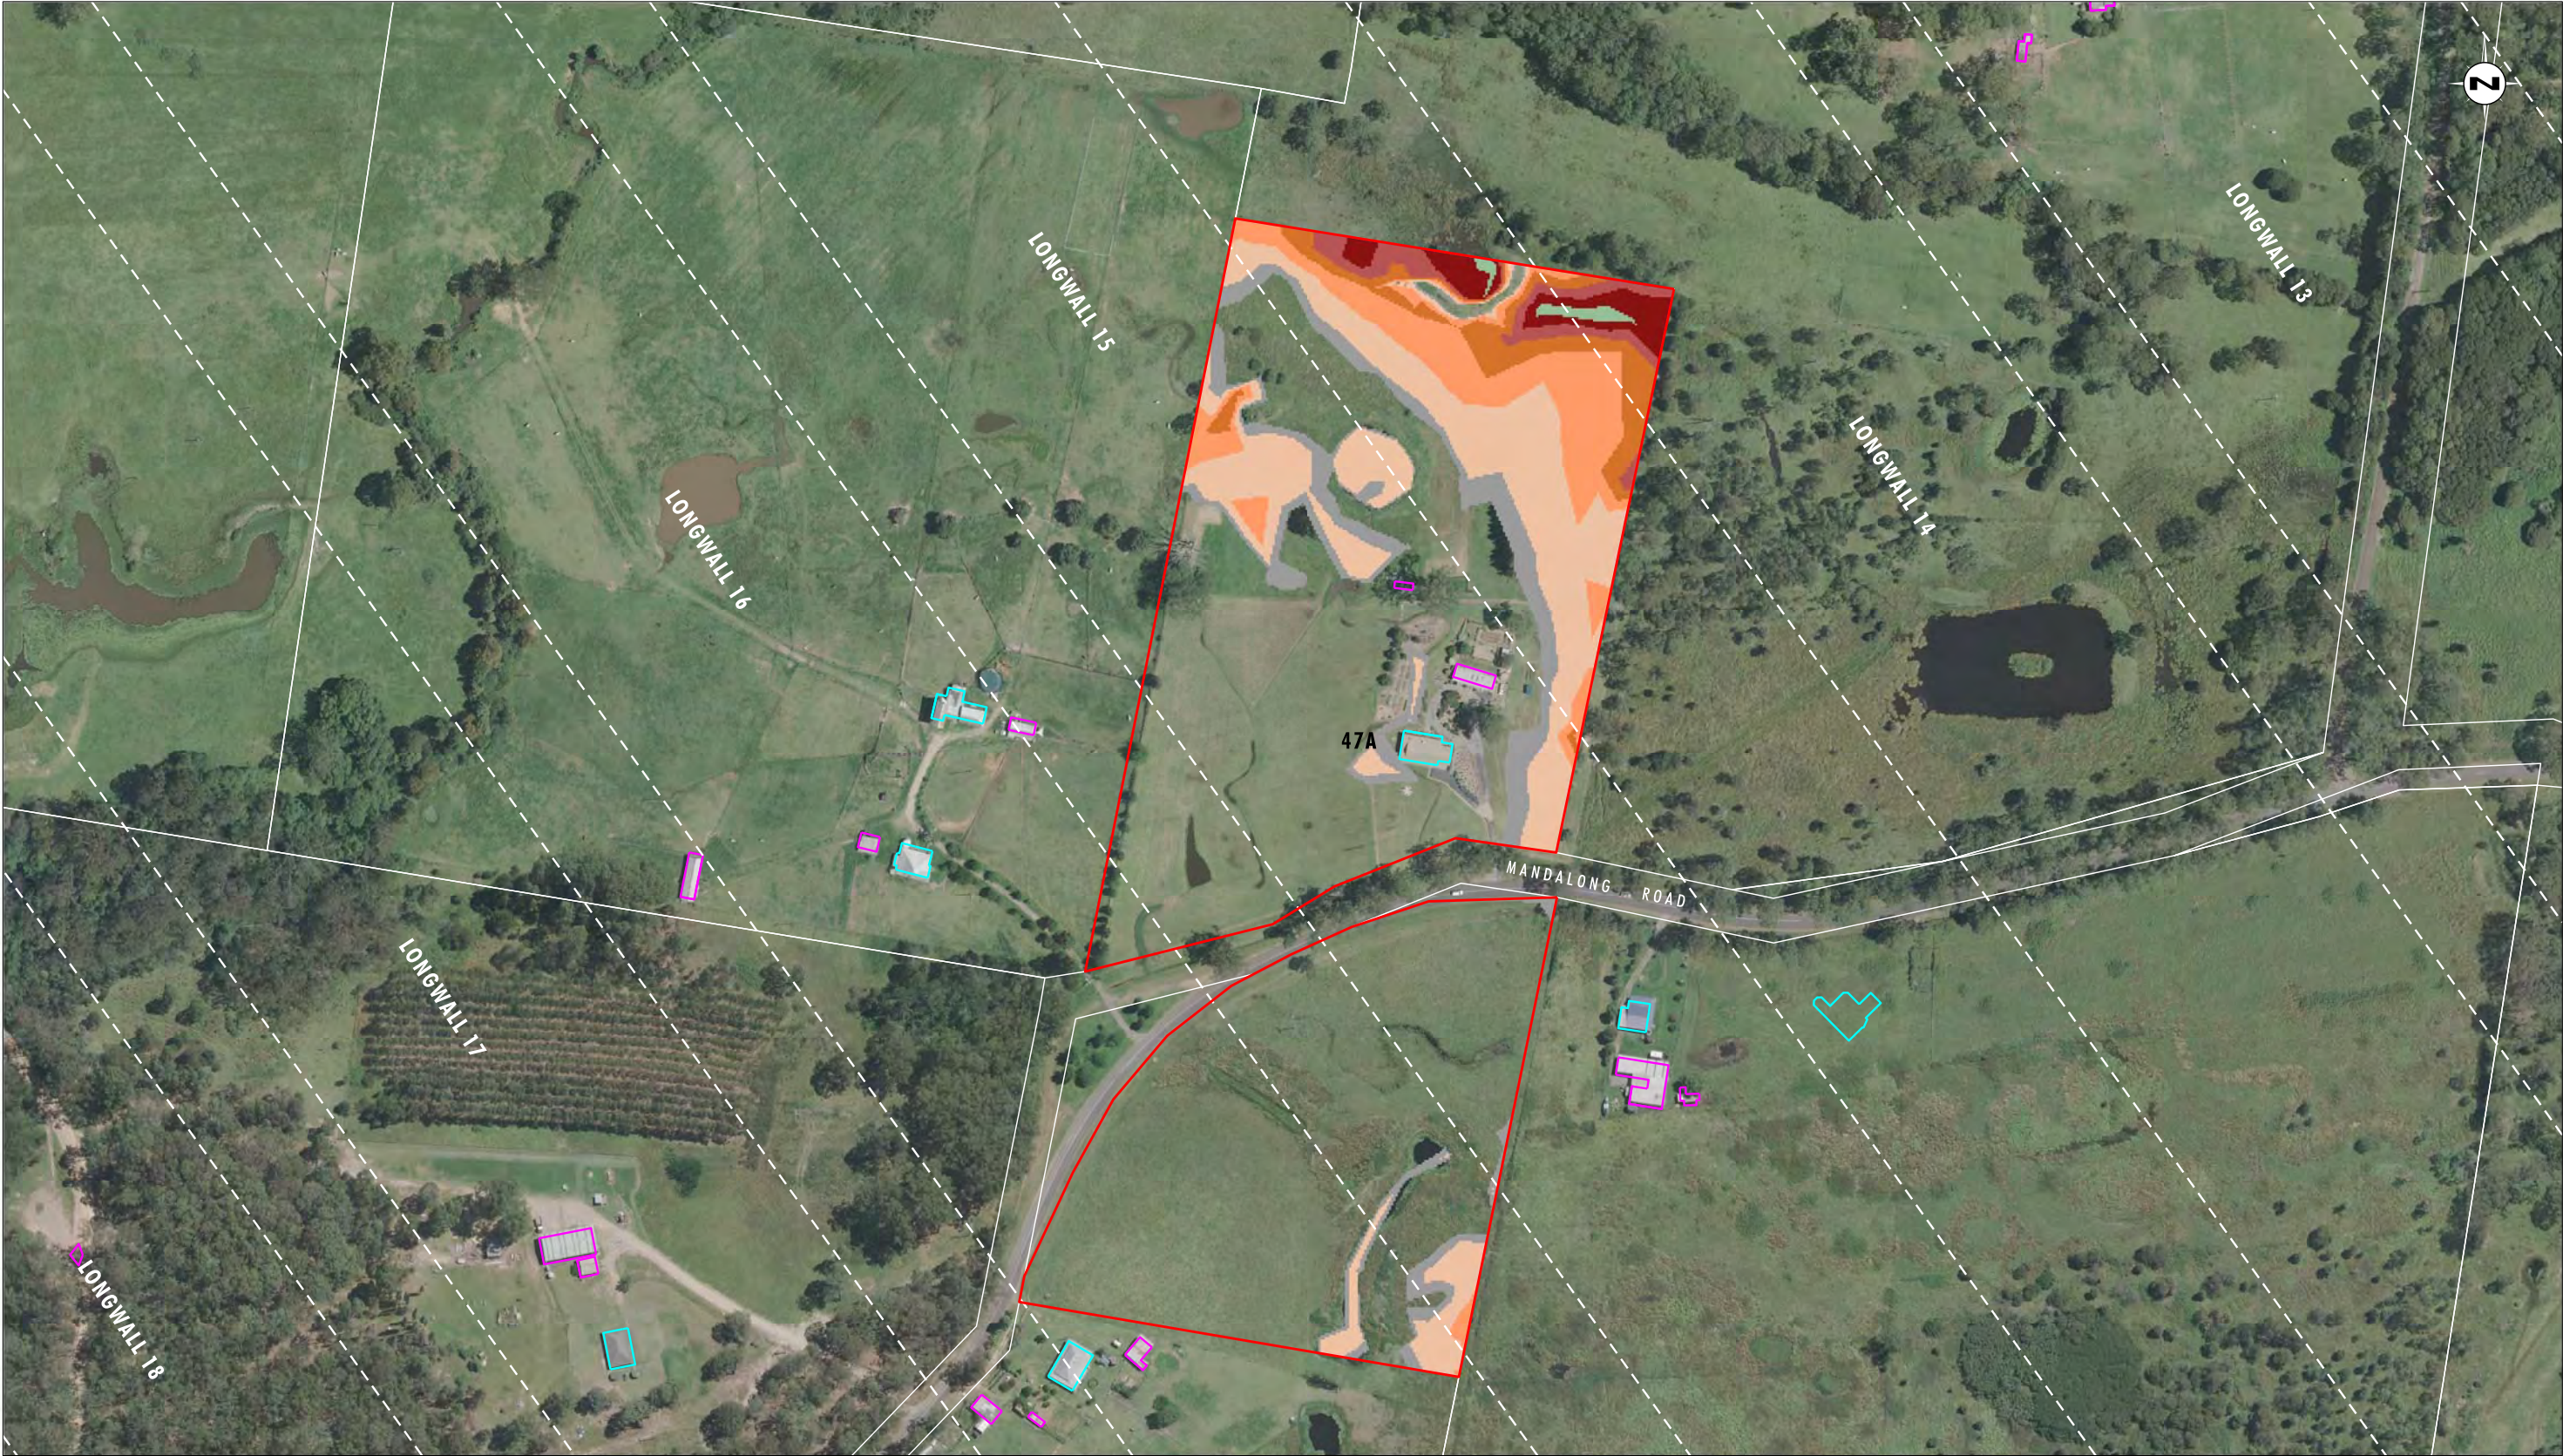
Property 47 - 100 year ARI Storm Event:  
Maximum Flood Depth Post Mining Landform  
(to Longwall 23)

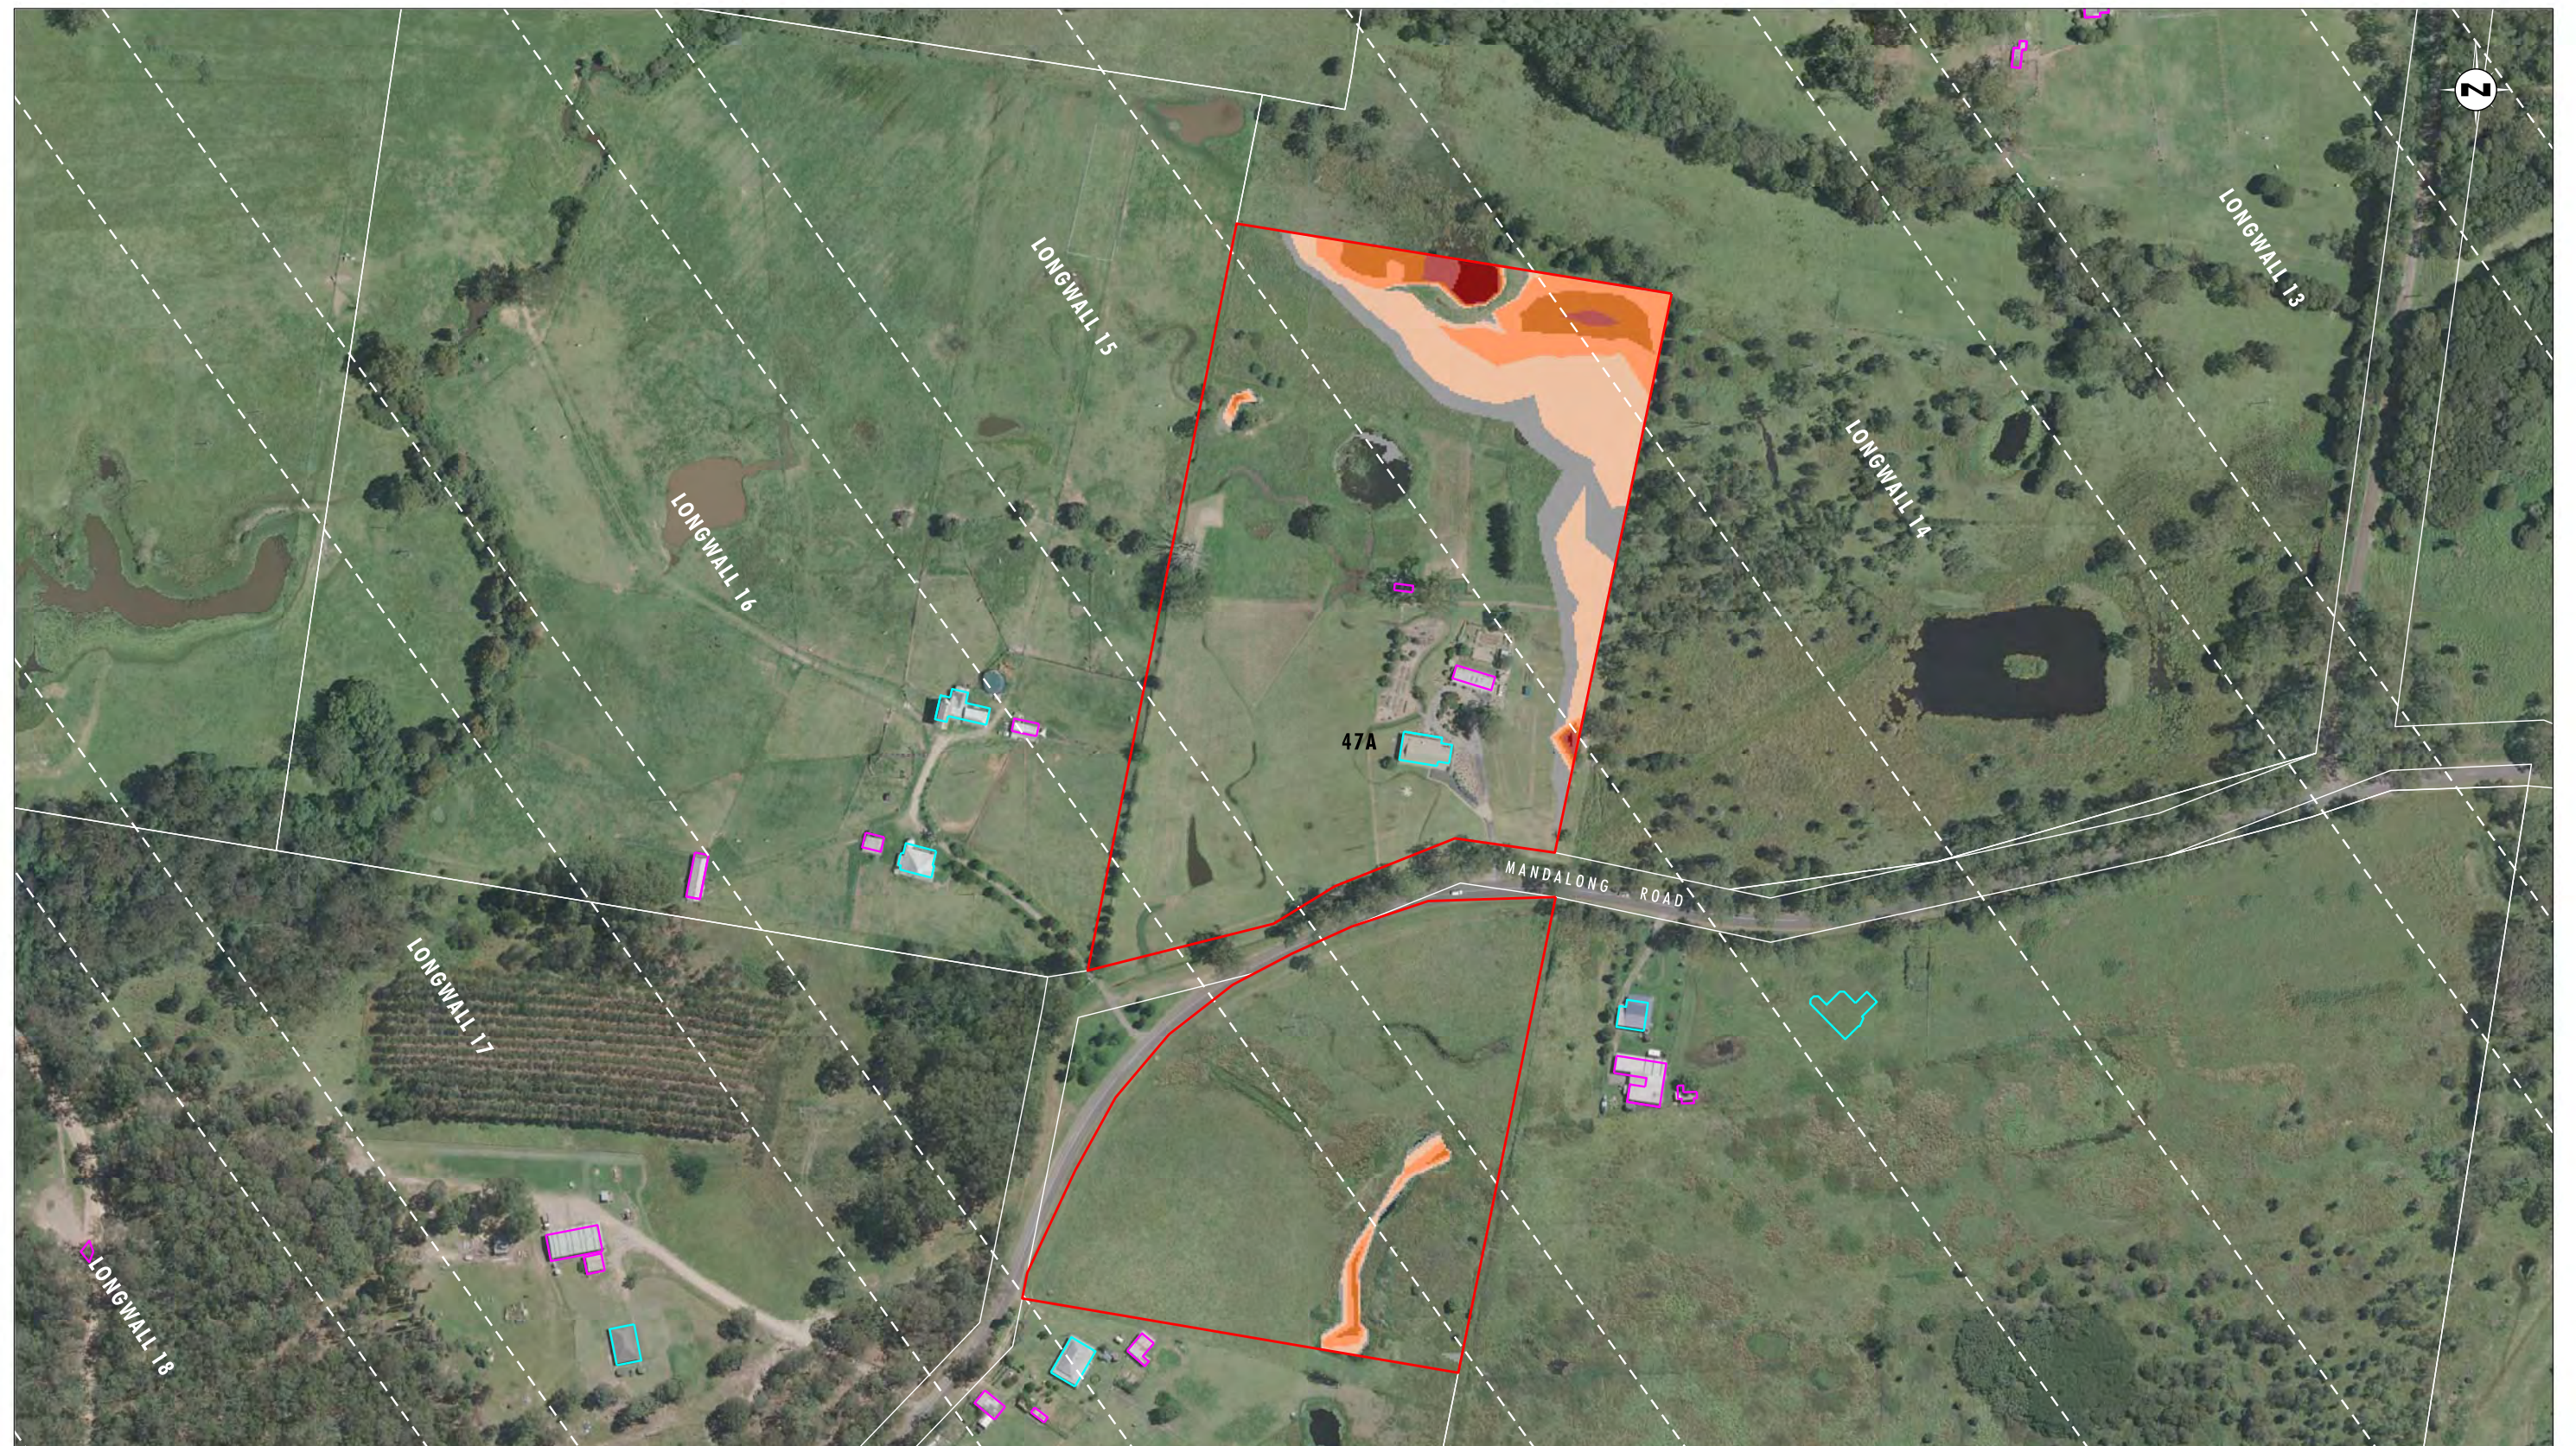
Property 47 - 1 year ARI Storm Event:  
Maximum Flood Depth Pre Mining Landform
