## APPENDIX 13

Flooding Assessment Figures -  
Property 46

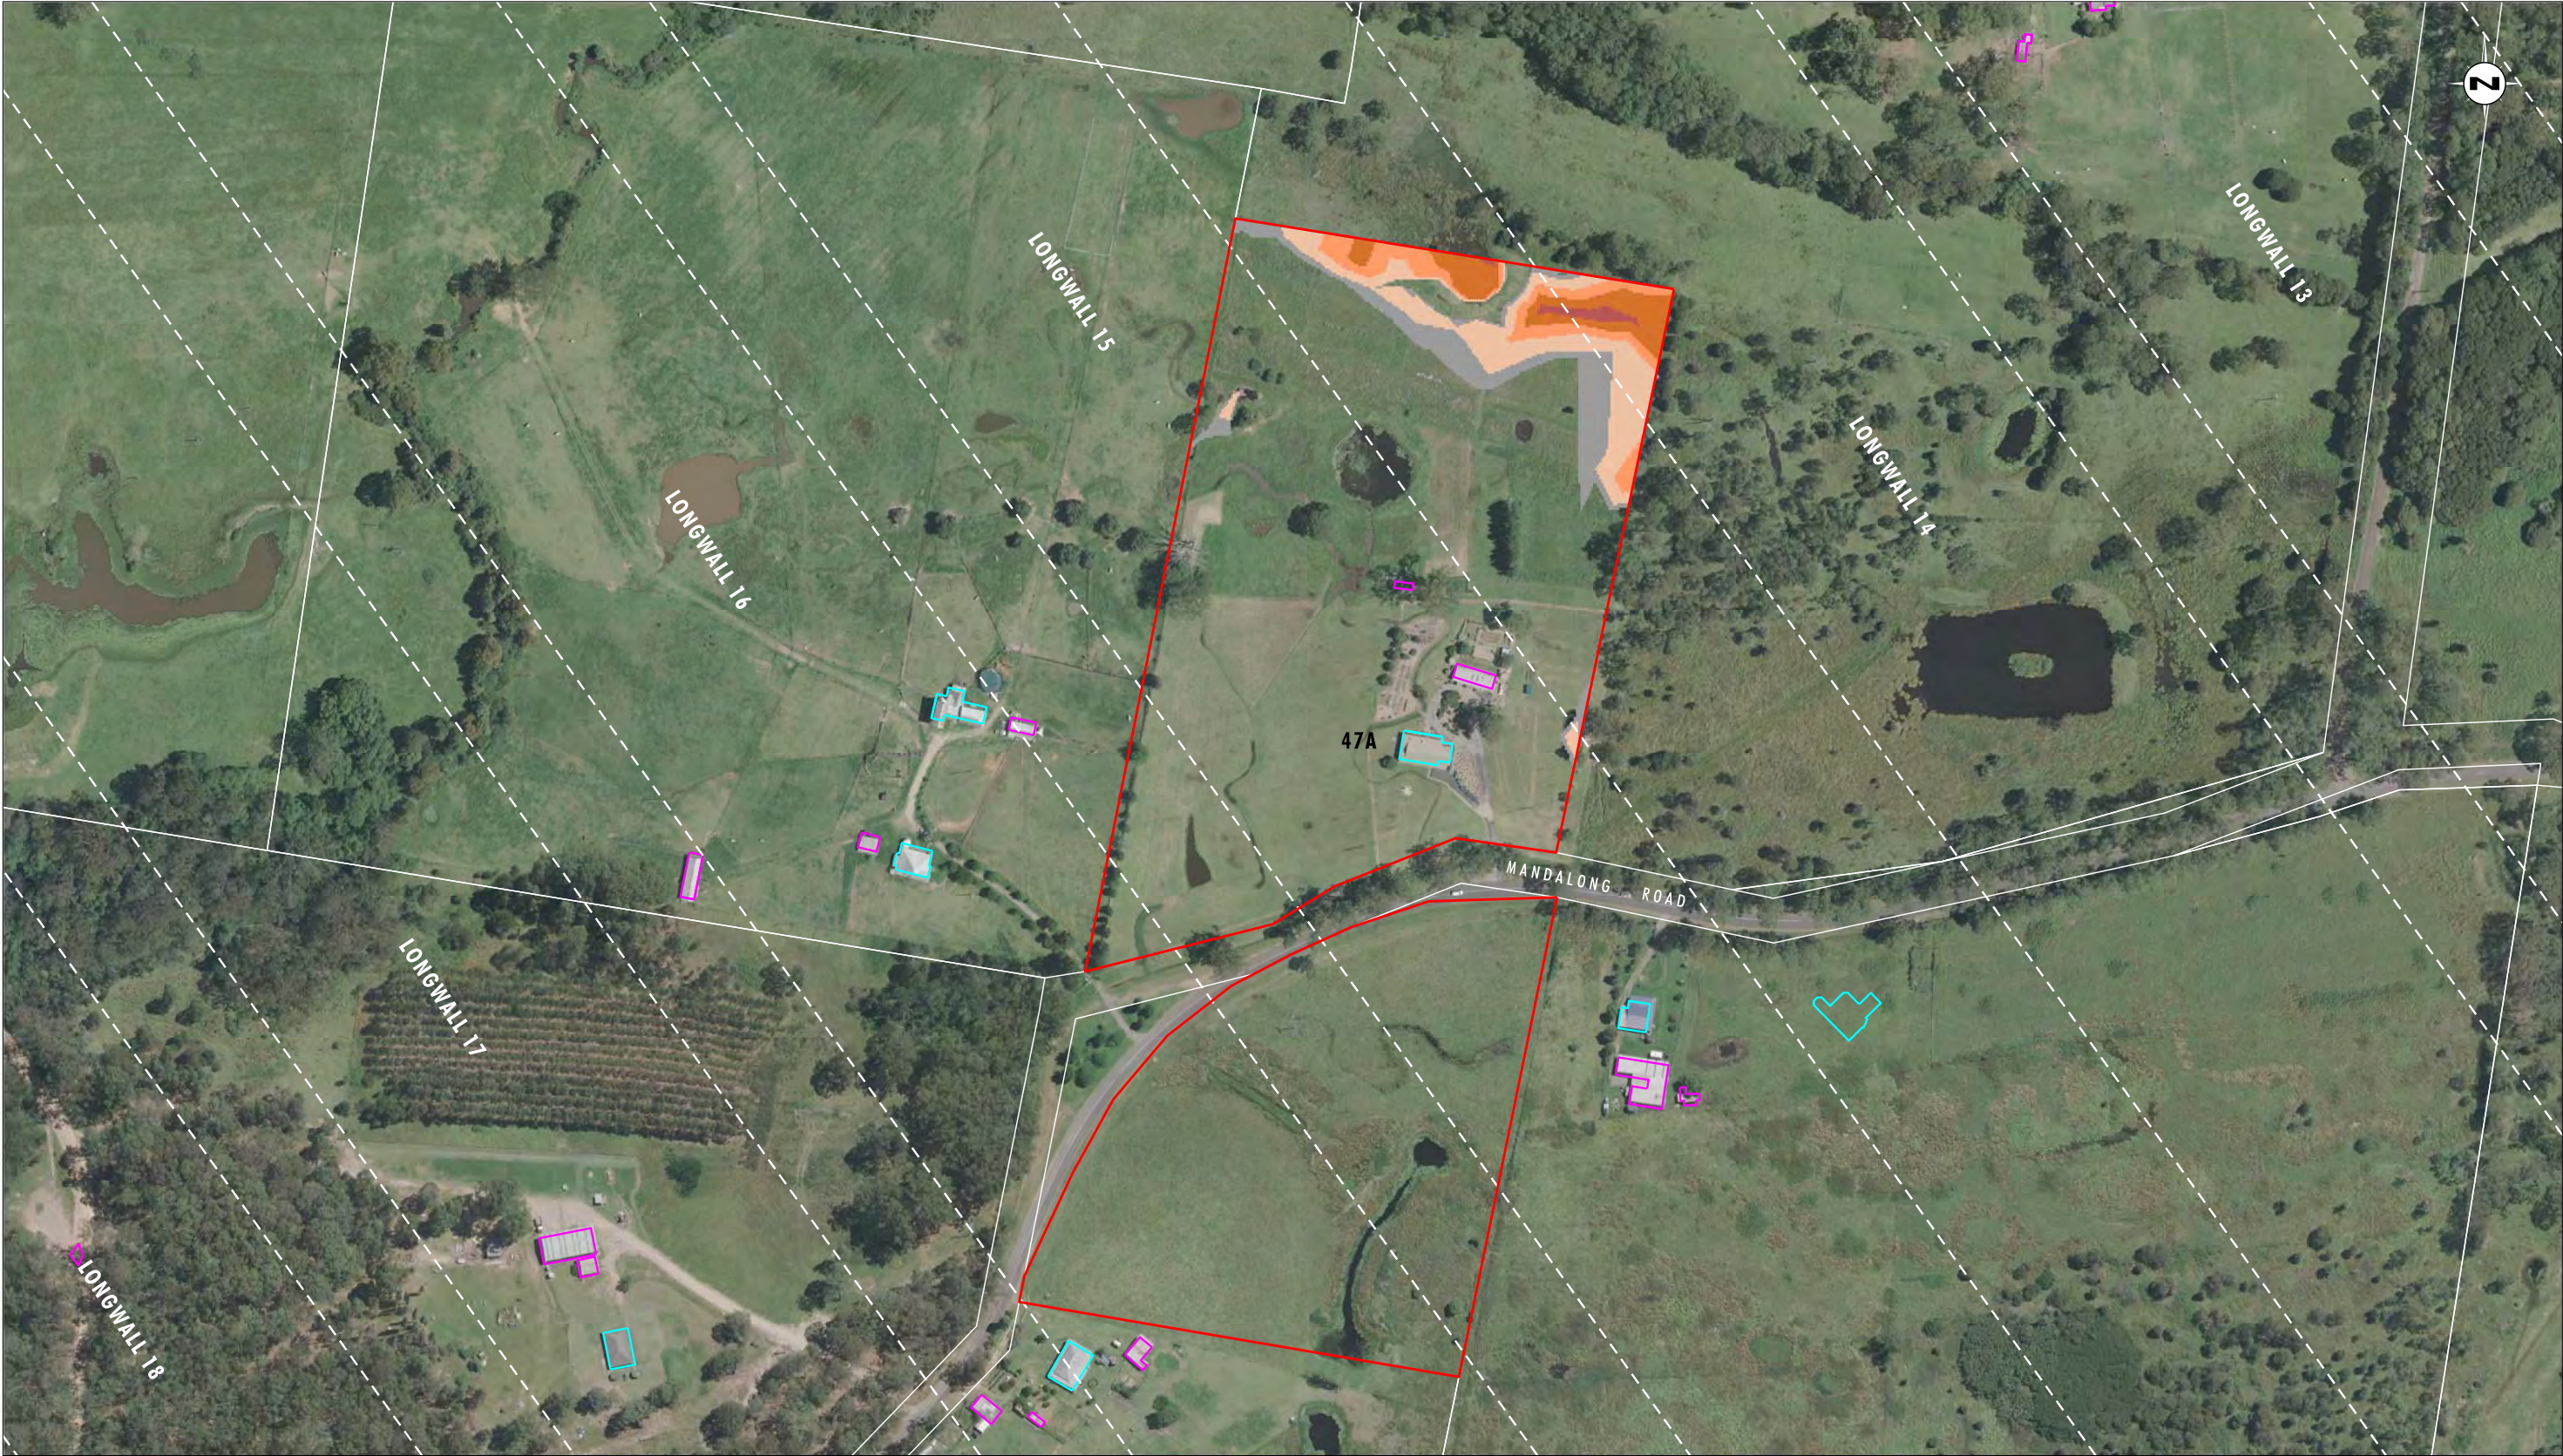
FIGURE 4  
Property 47 - 1 year ARI Storm Event:  
Maximum Flood Depth Post Mining Landform  
(to Longwall 23)

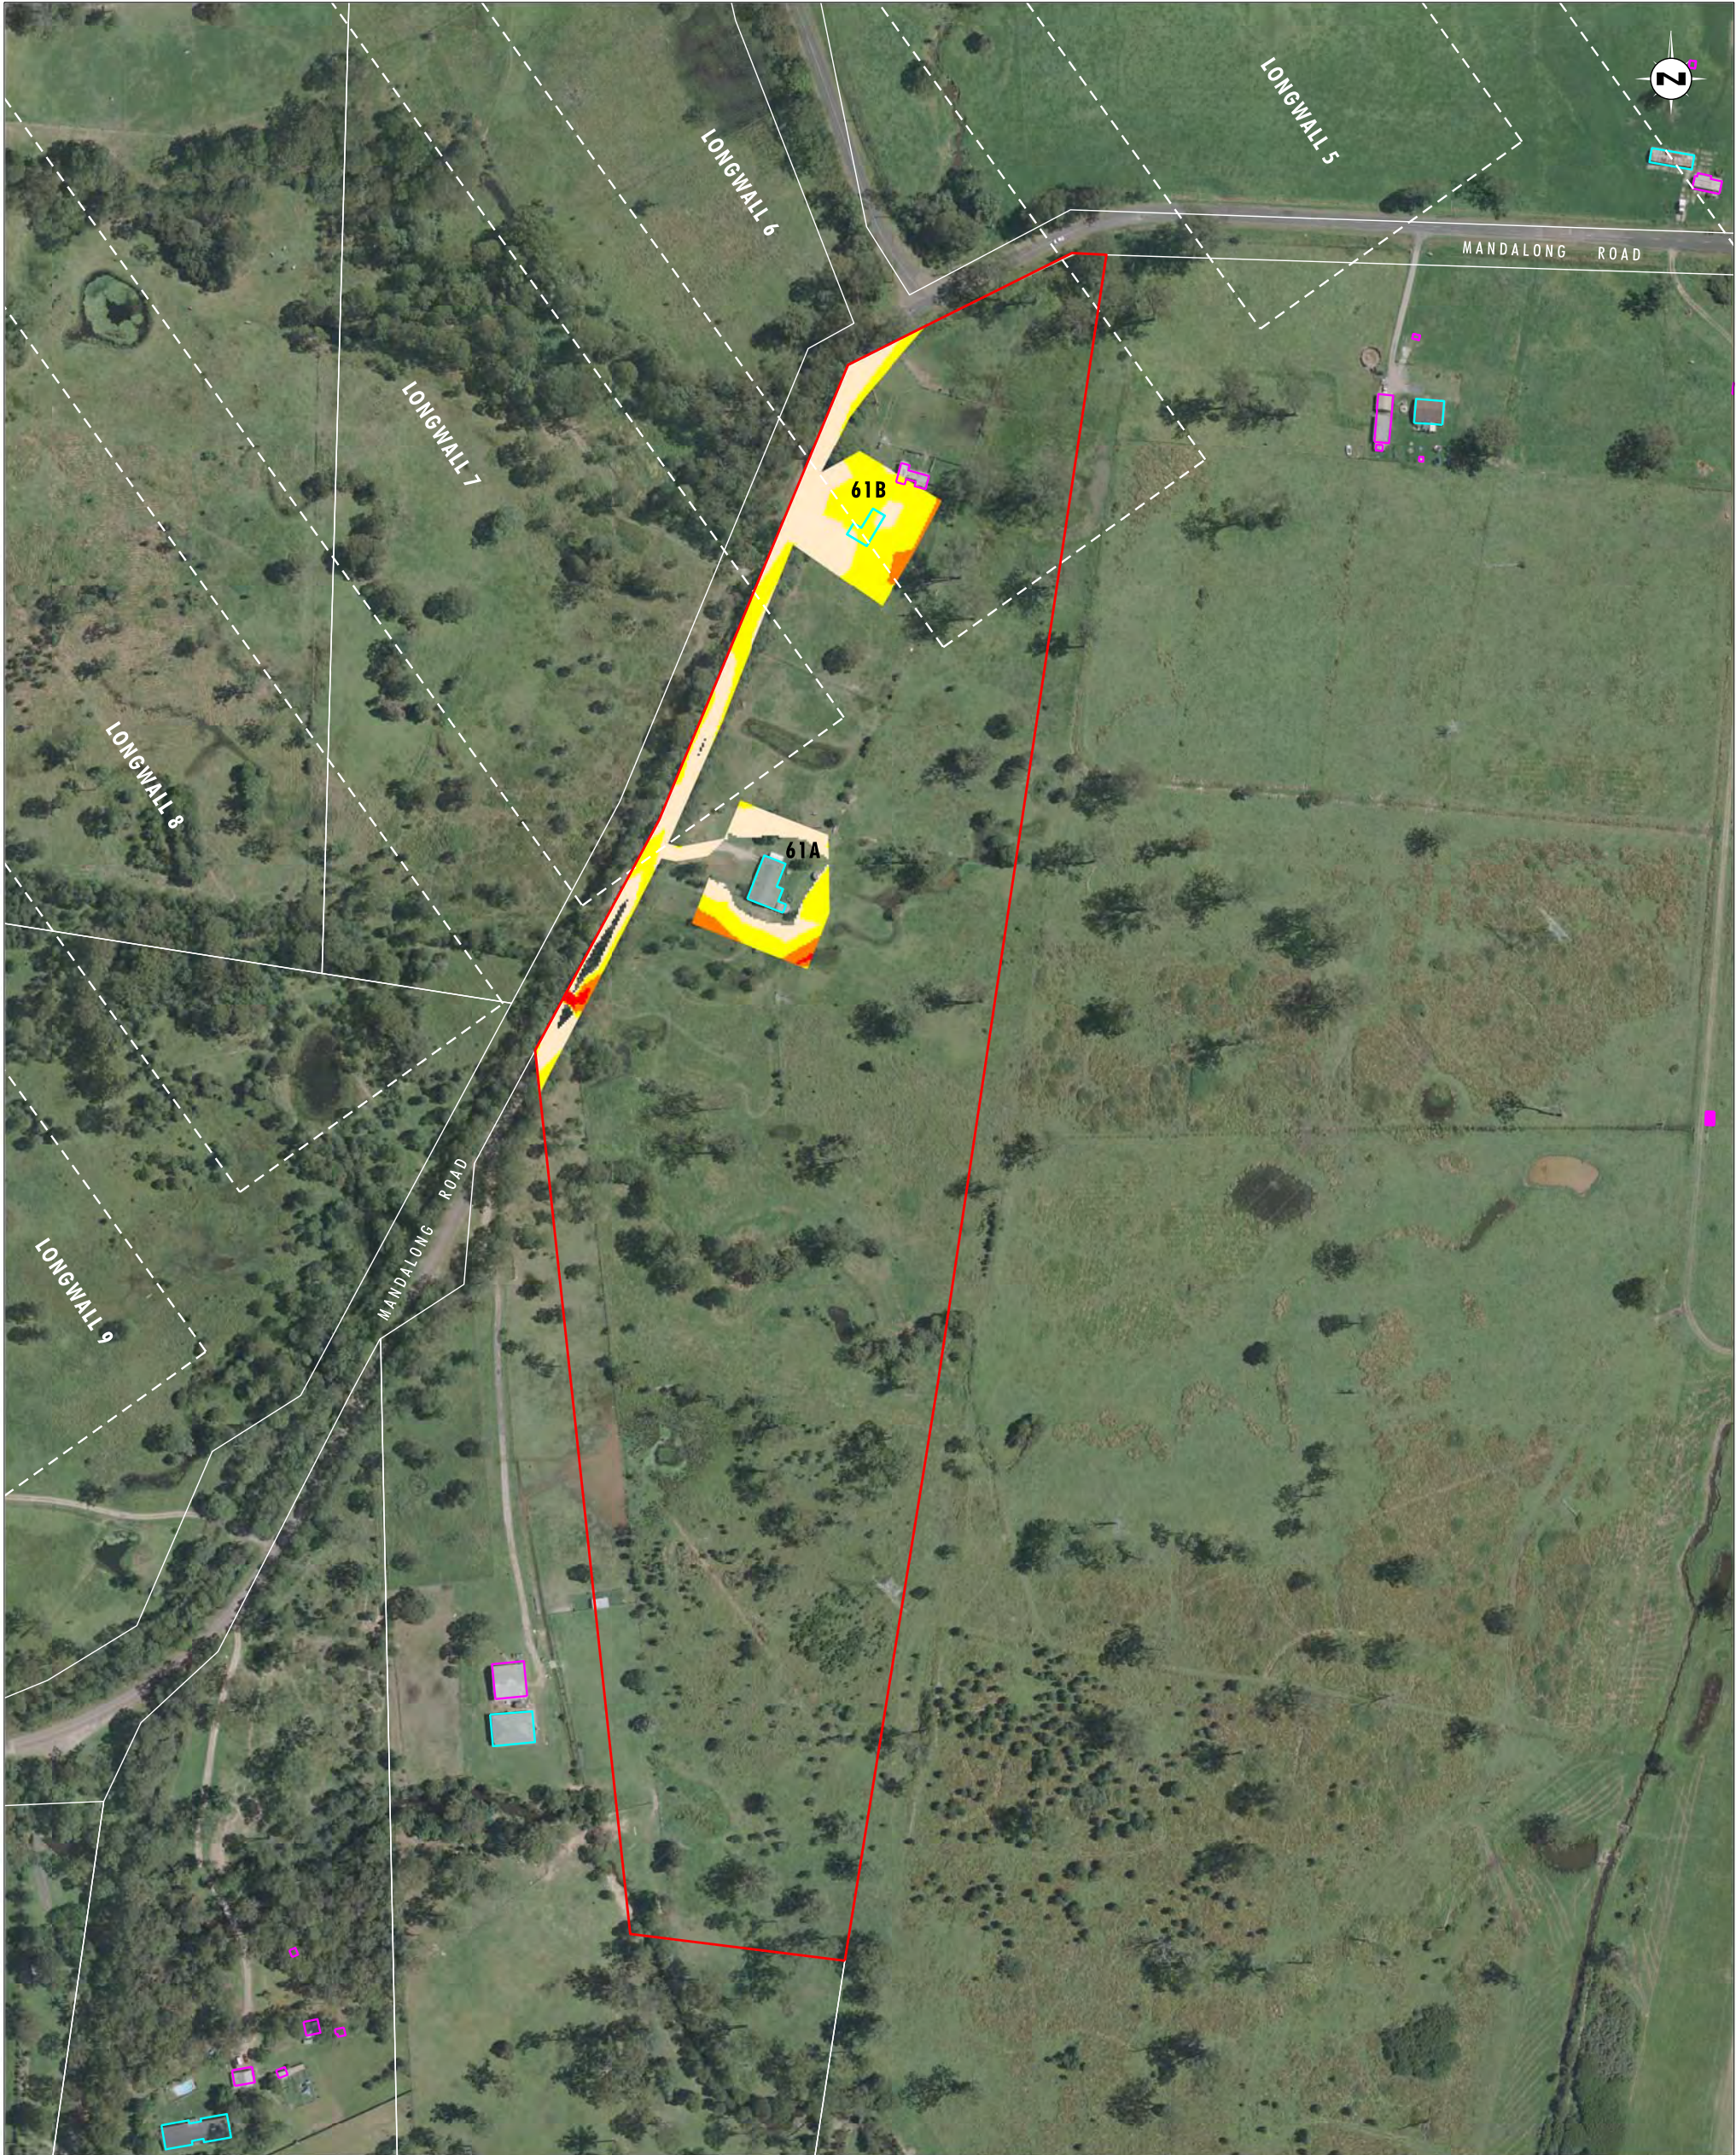
FIGURE 3  
Property 61 - 100 Year ARI Storm Event:  
Maximum Flood Hazard Categories Pre Mining Landform

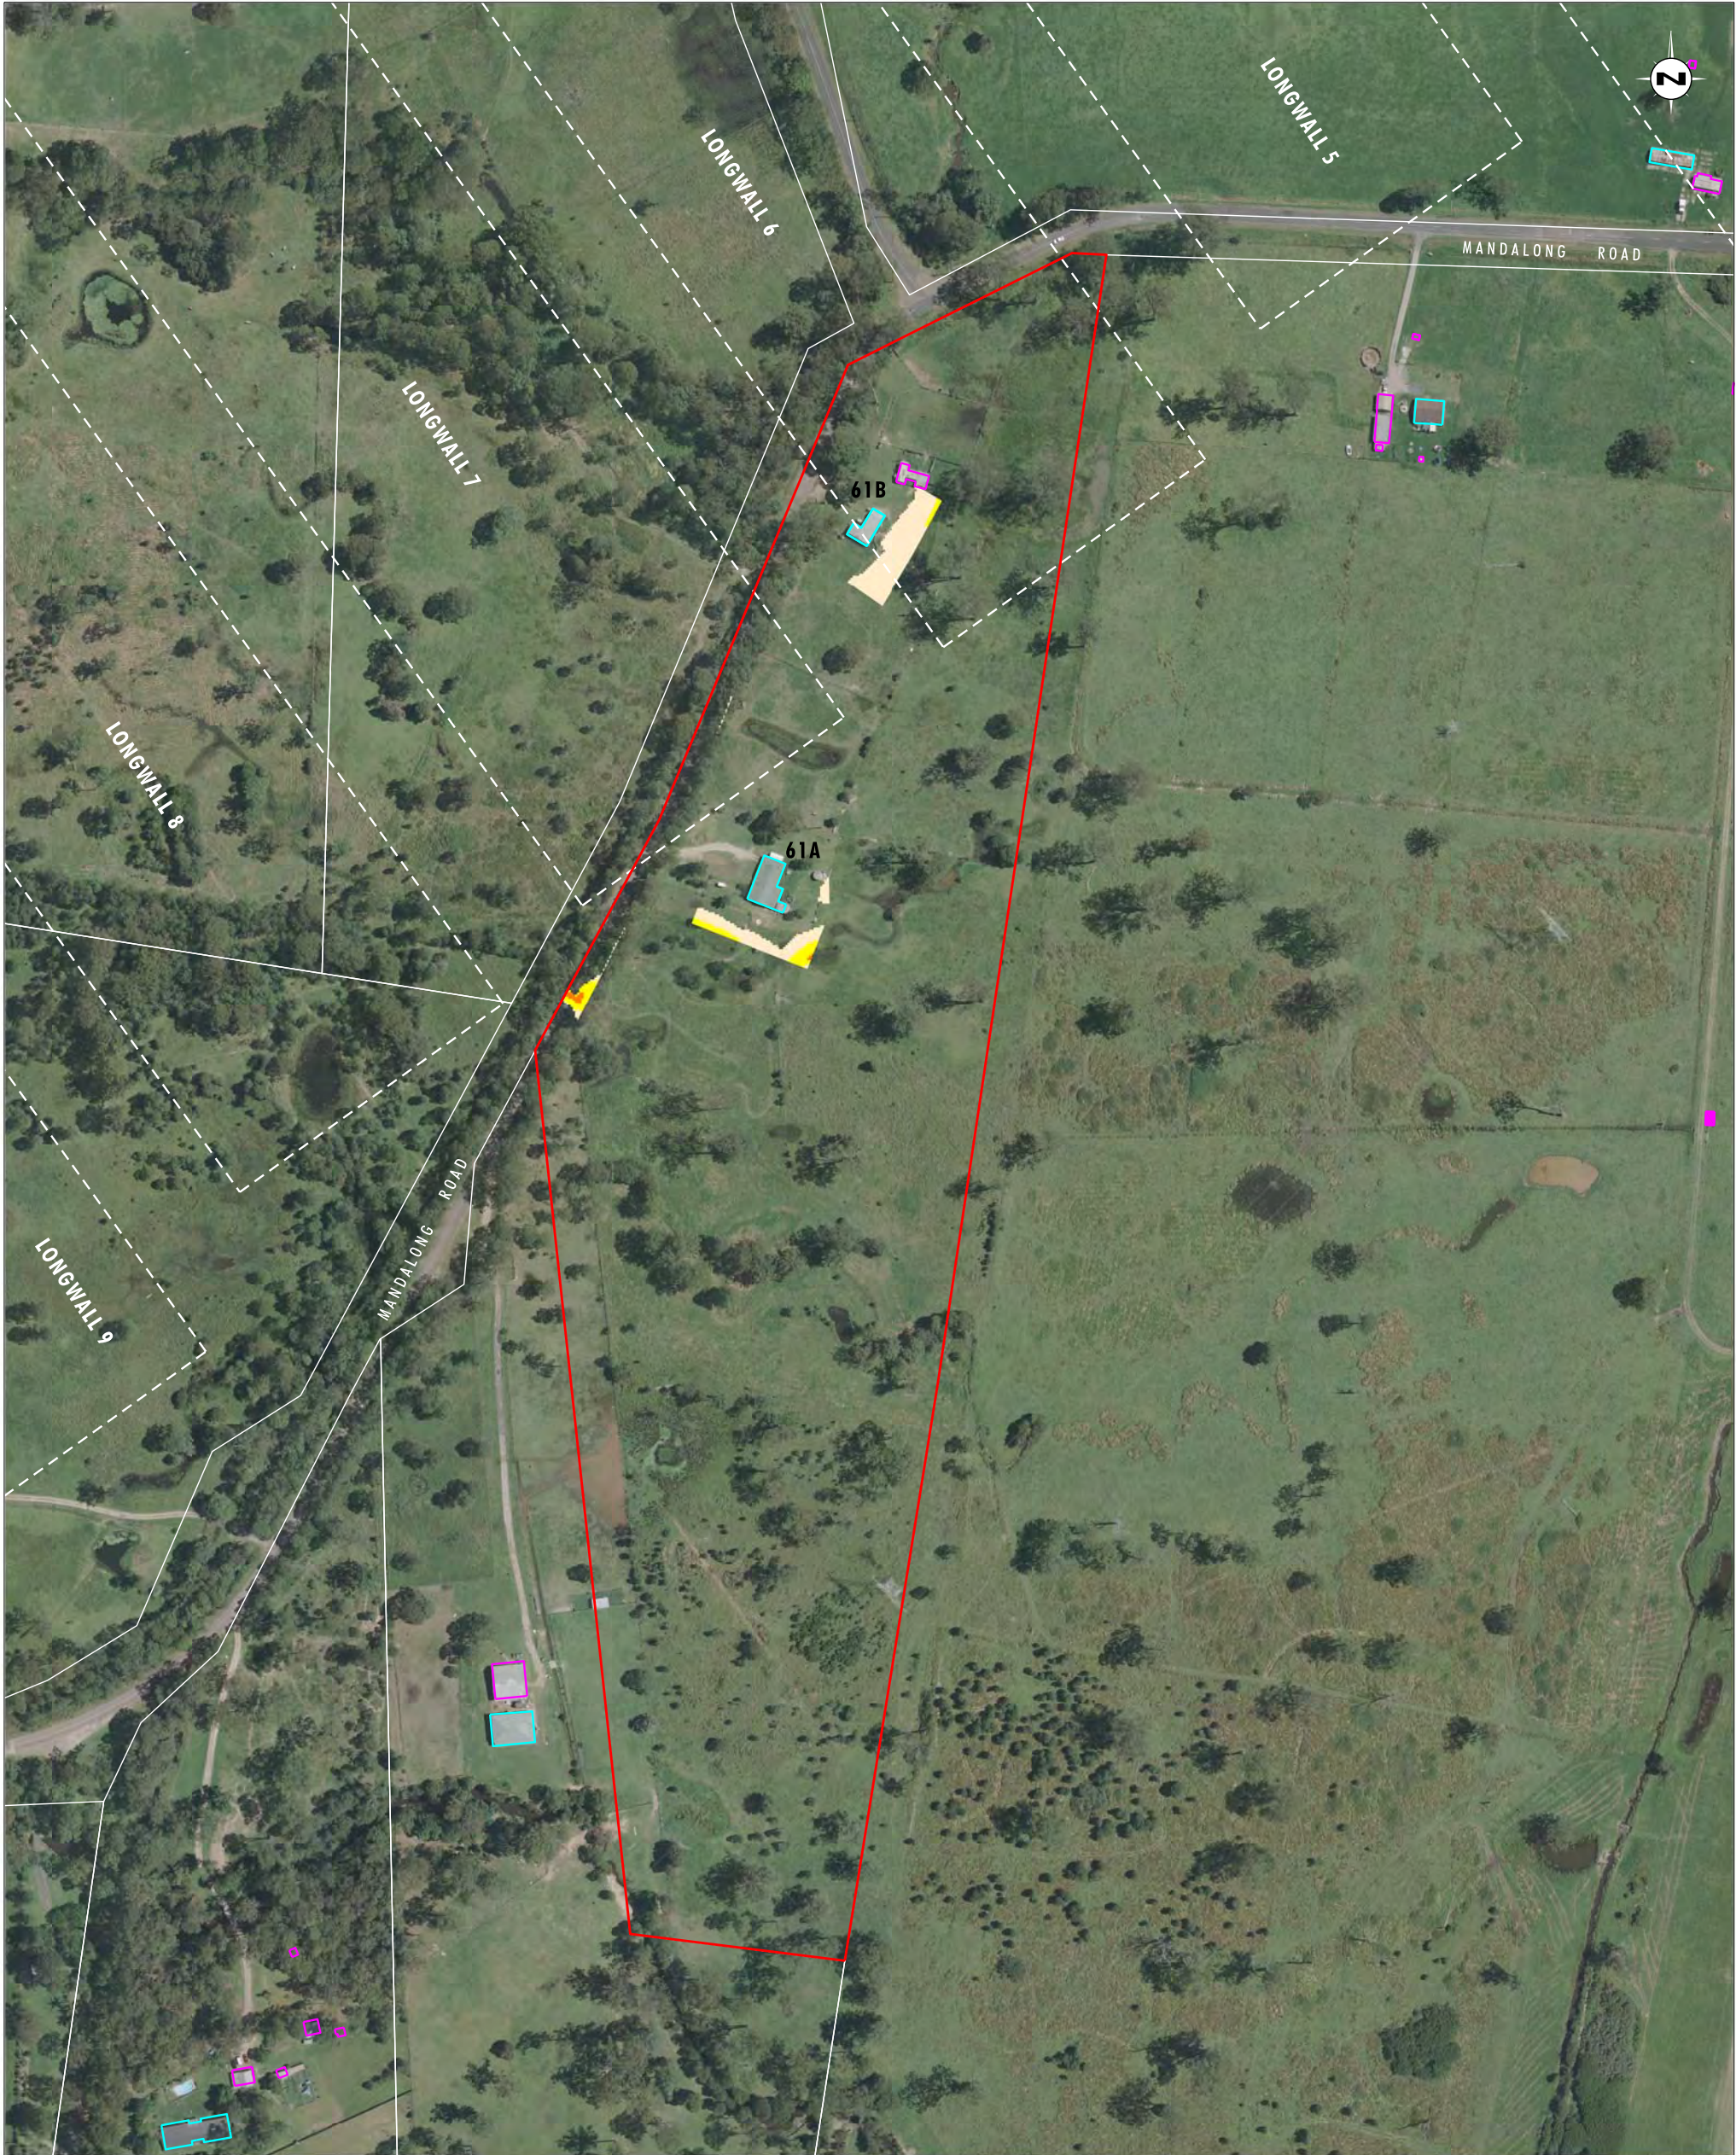
FIGURE 7  
Property 61 - 1 Year ARI Storm Event:  
Maximum Flood Hazard Categories Pre Mining Landform

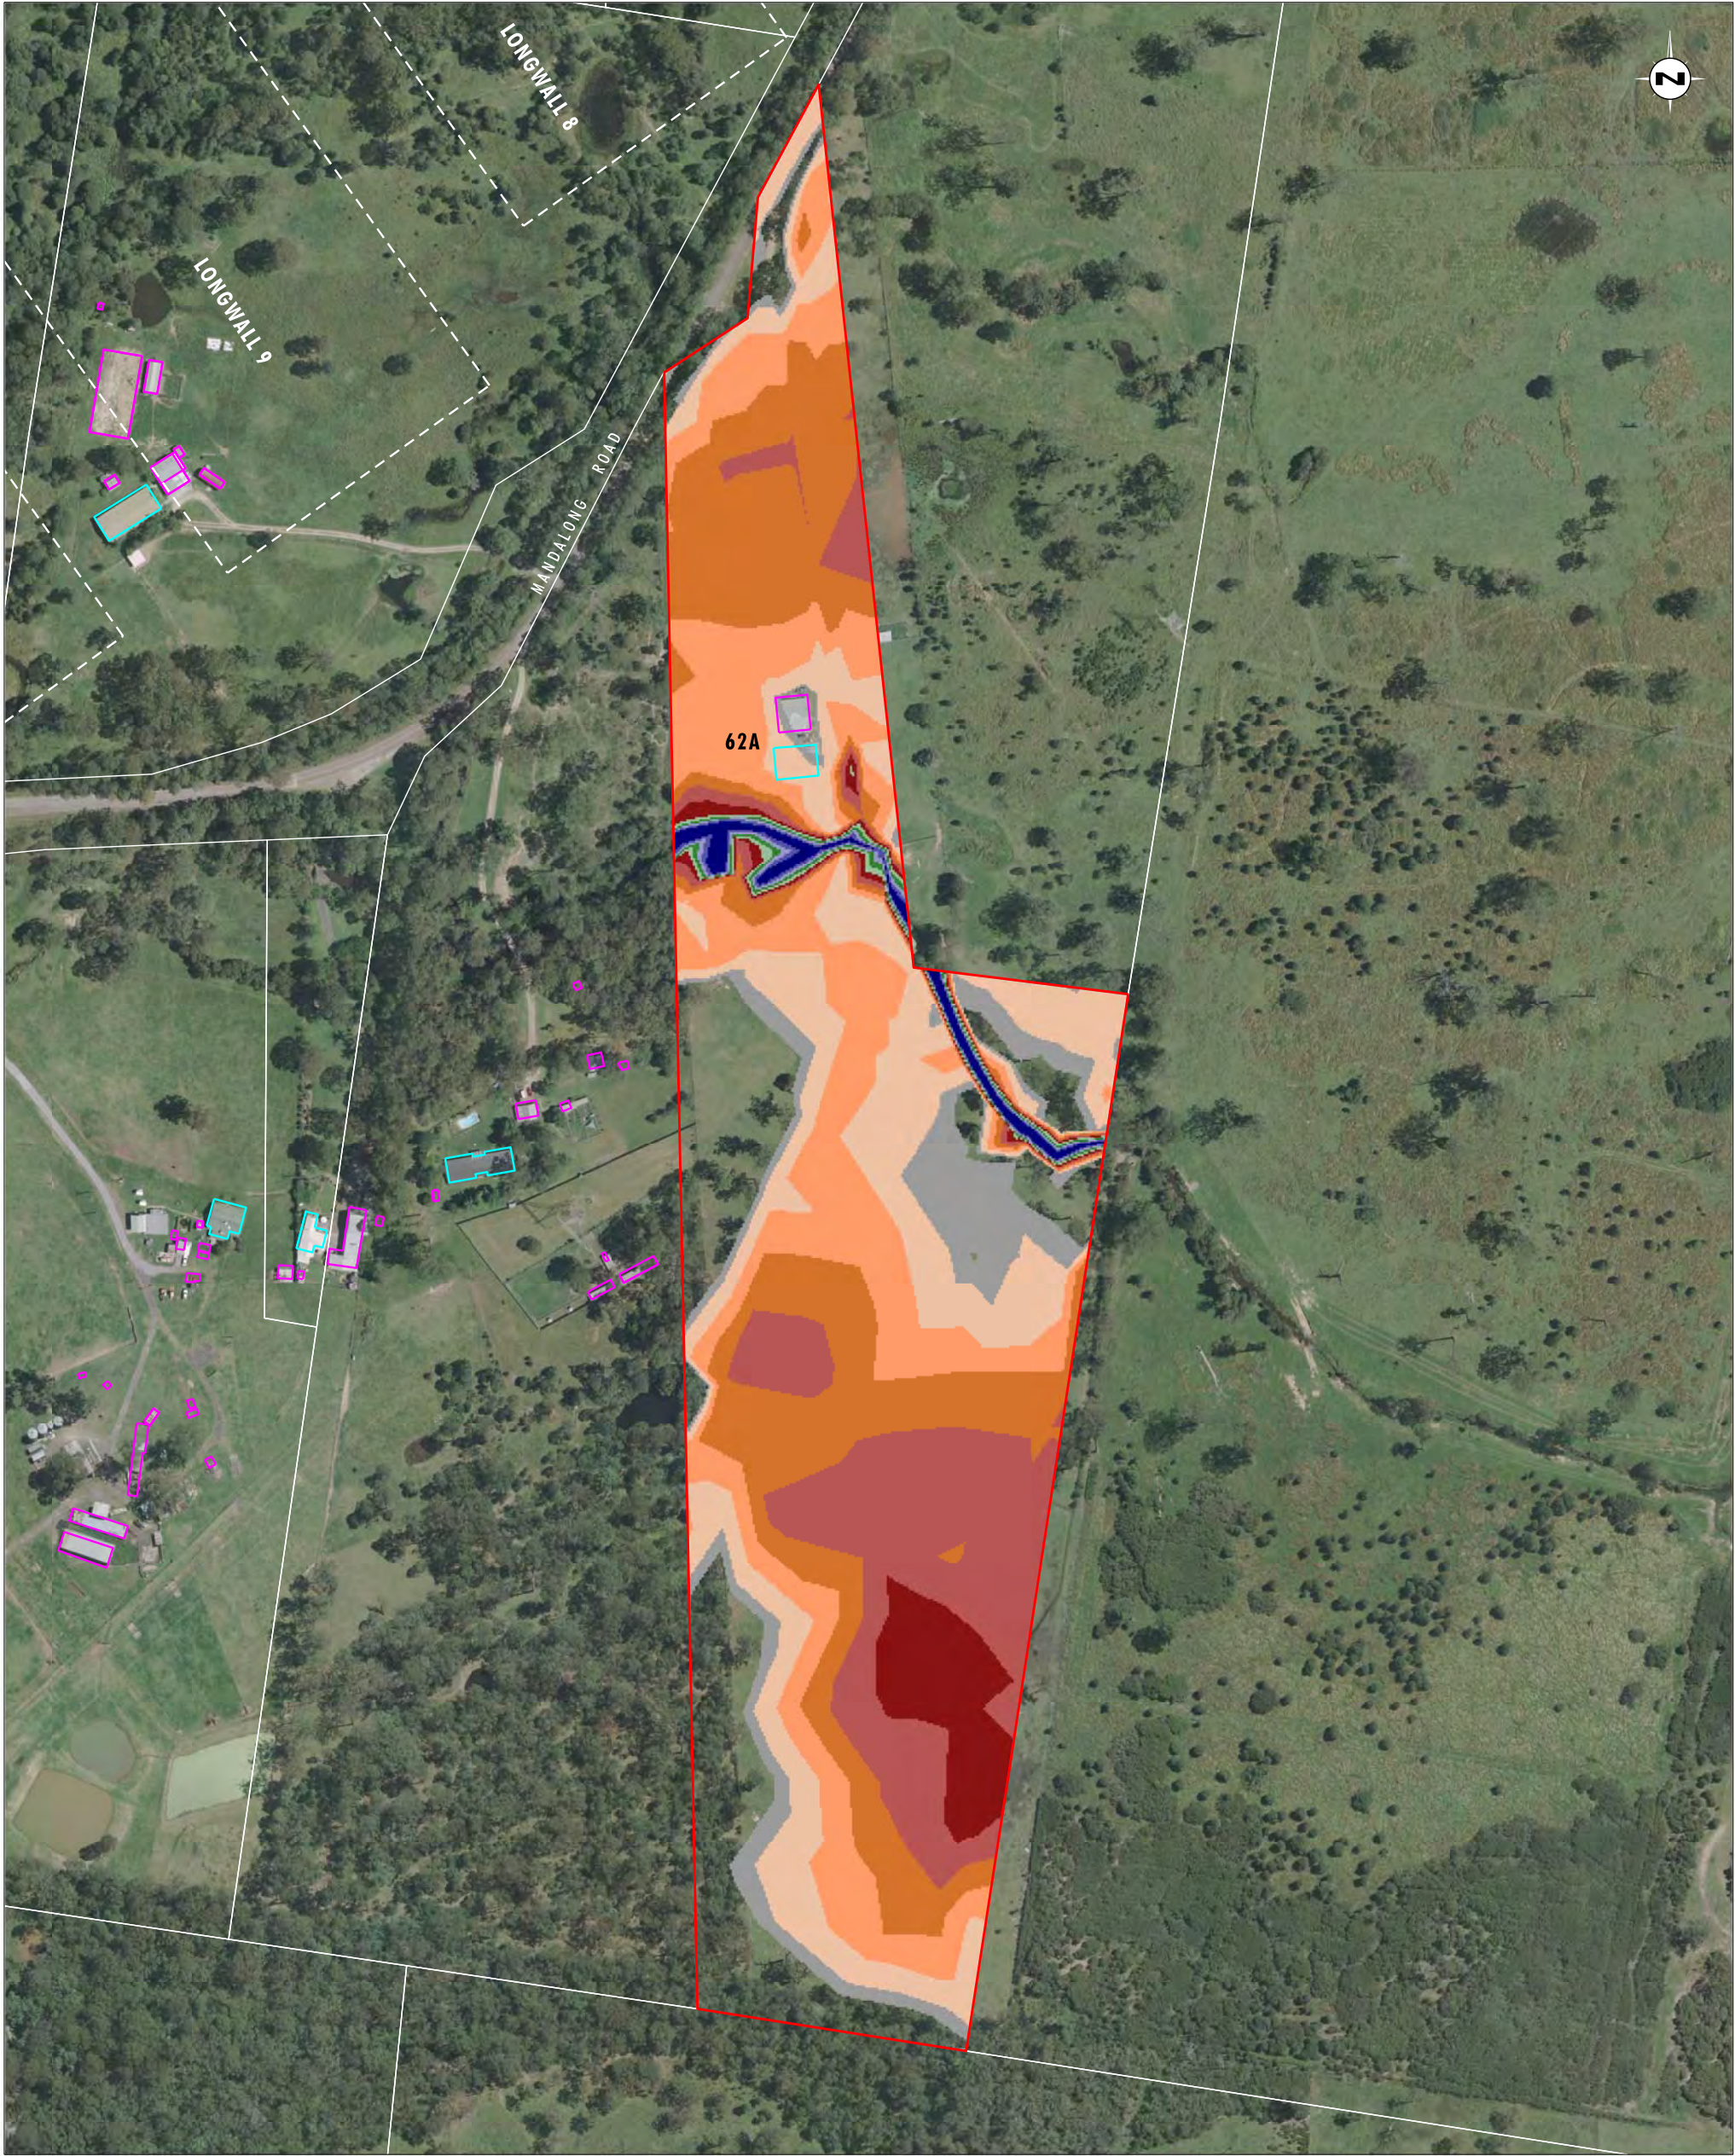
FIGURE 2  
Property 62 - 100 Year ARI Storm Event:  
Maximum Flood Depth Post Mining Landform  
(to Longwall 23)

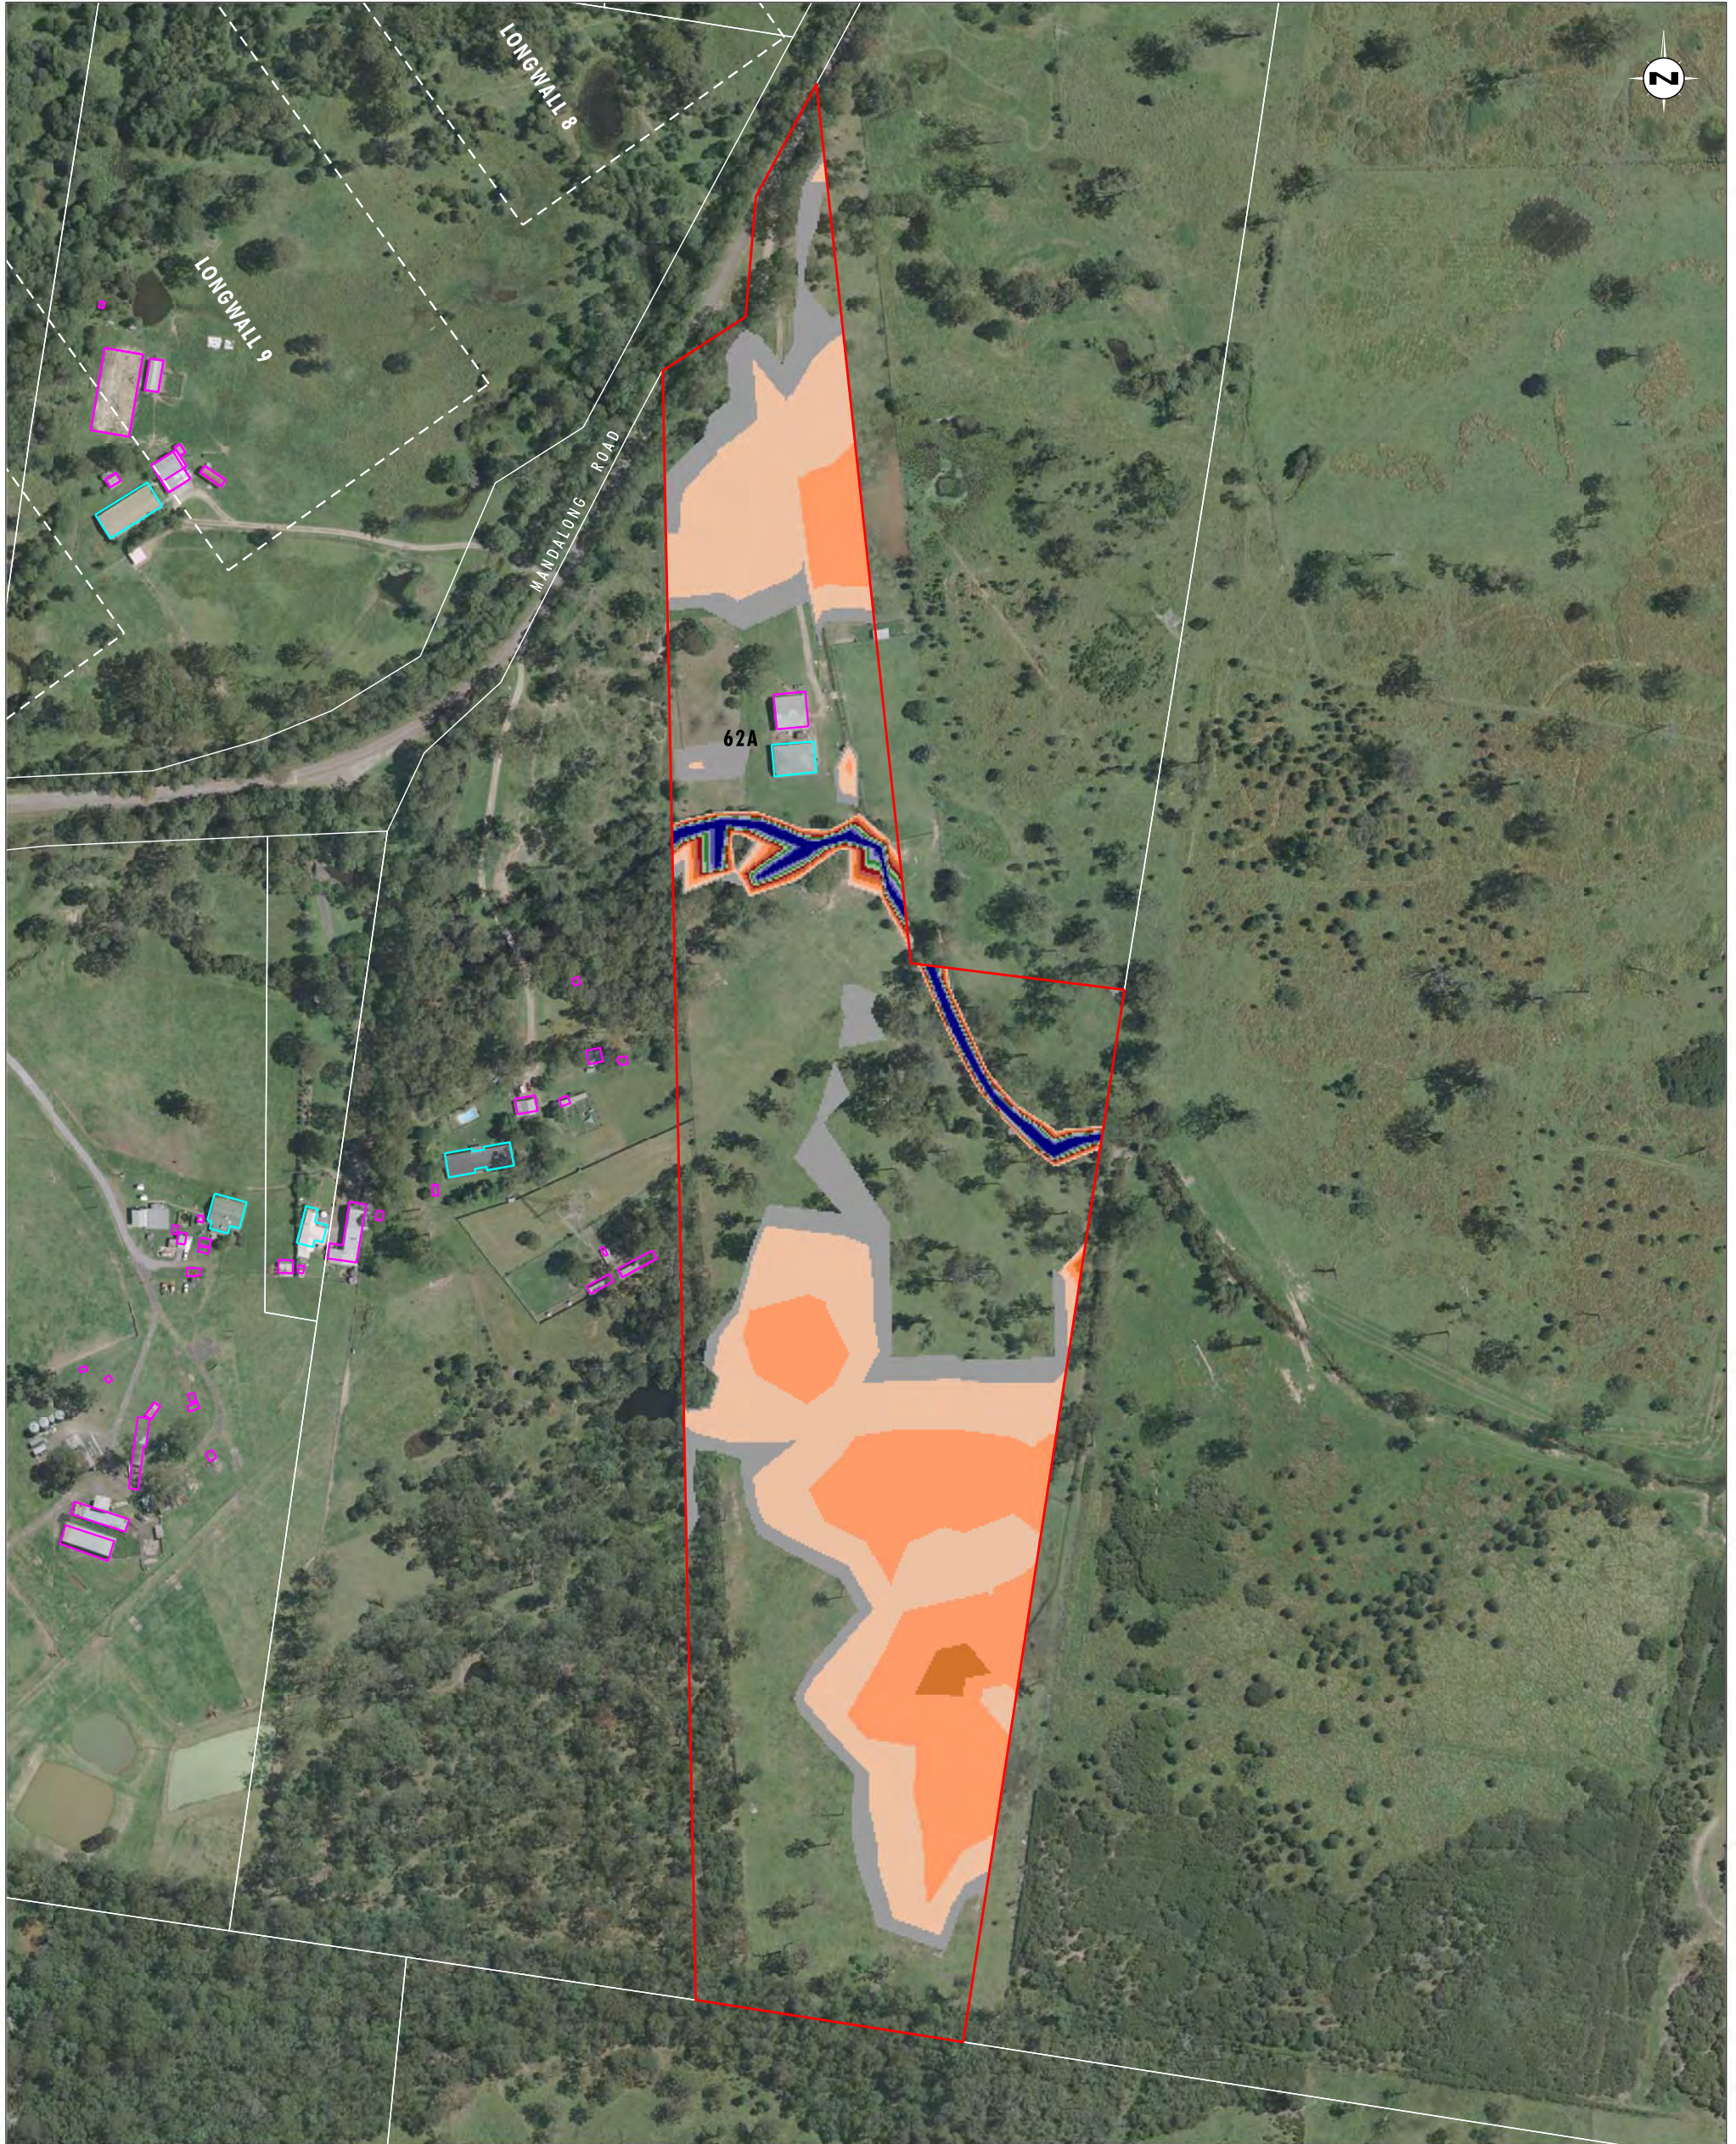
FIGURE 5  
Property 62 - 1 Year ARI Storm Event:  
Maximum Flood Depth Pre Mining Landform

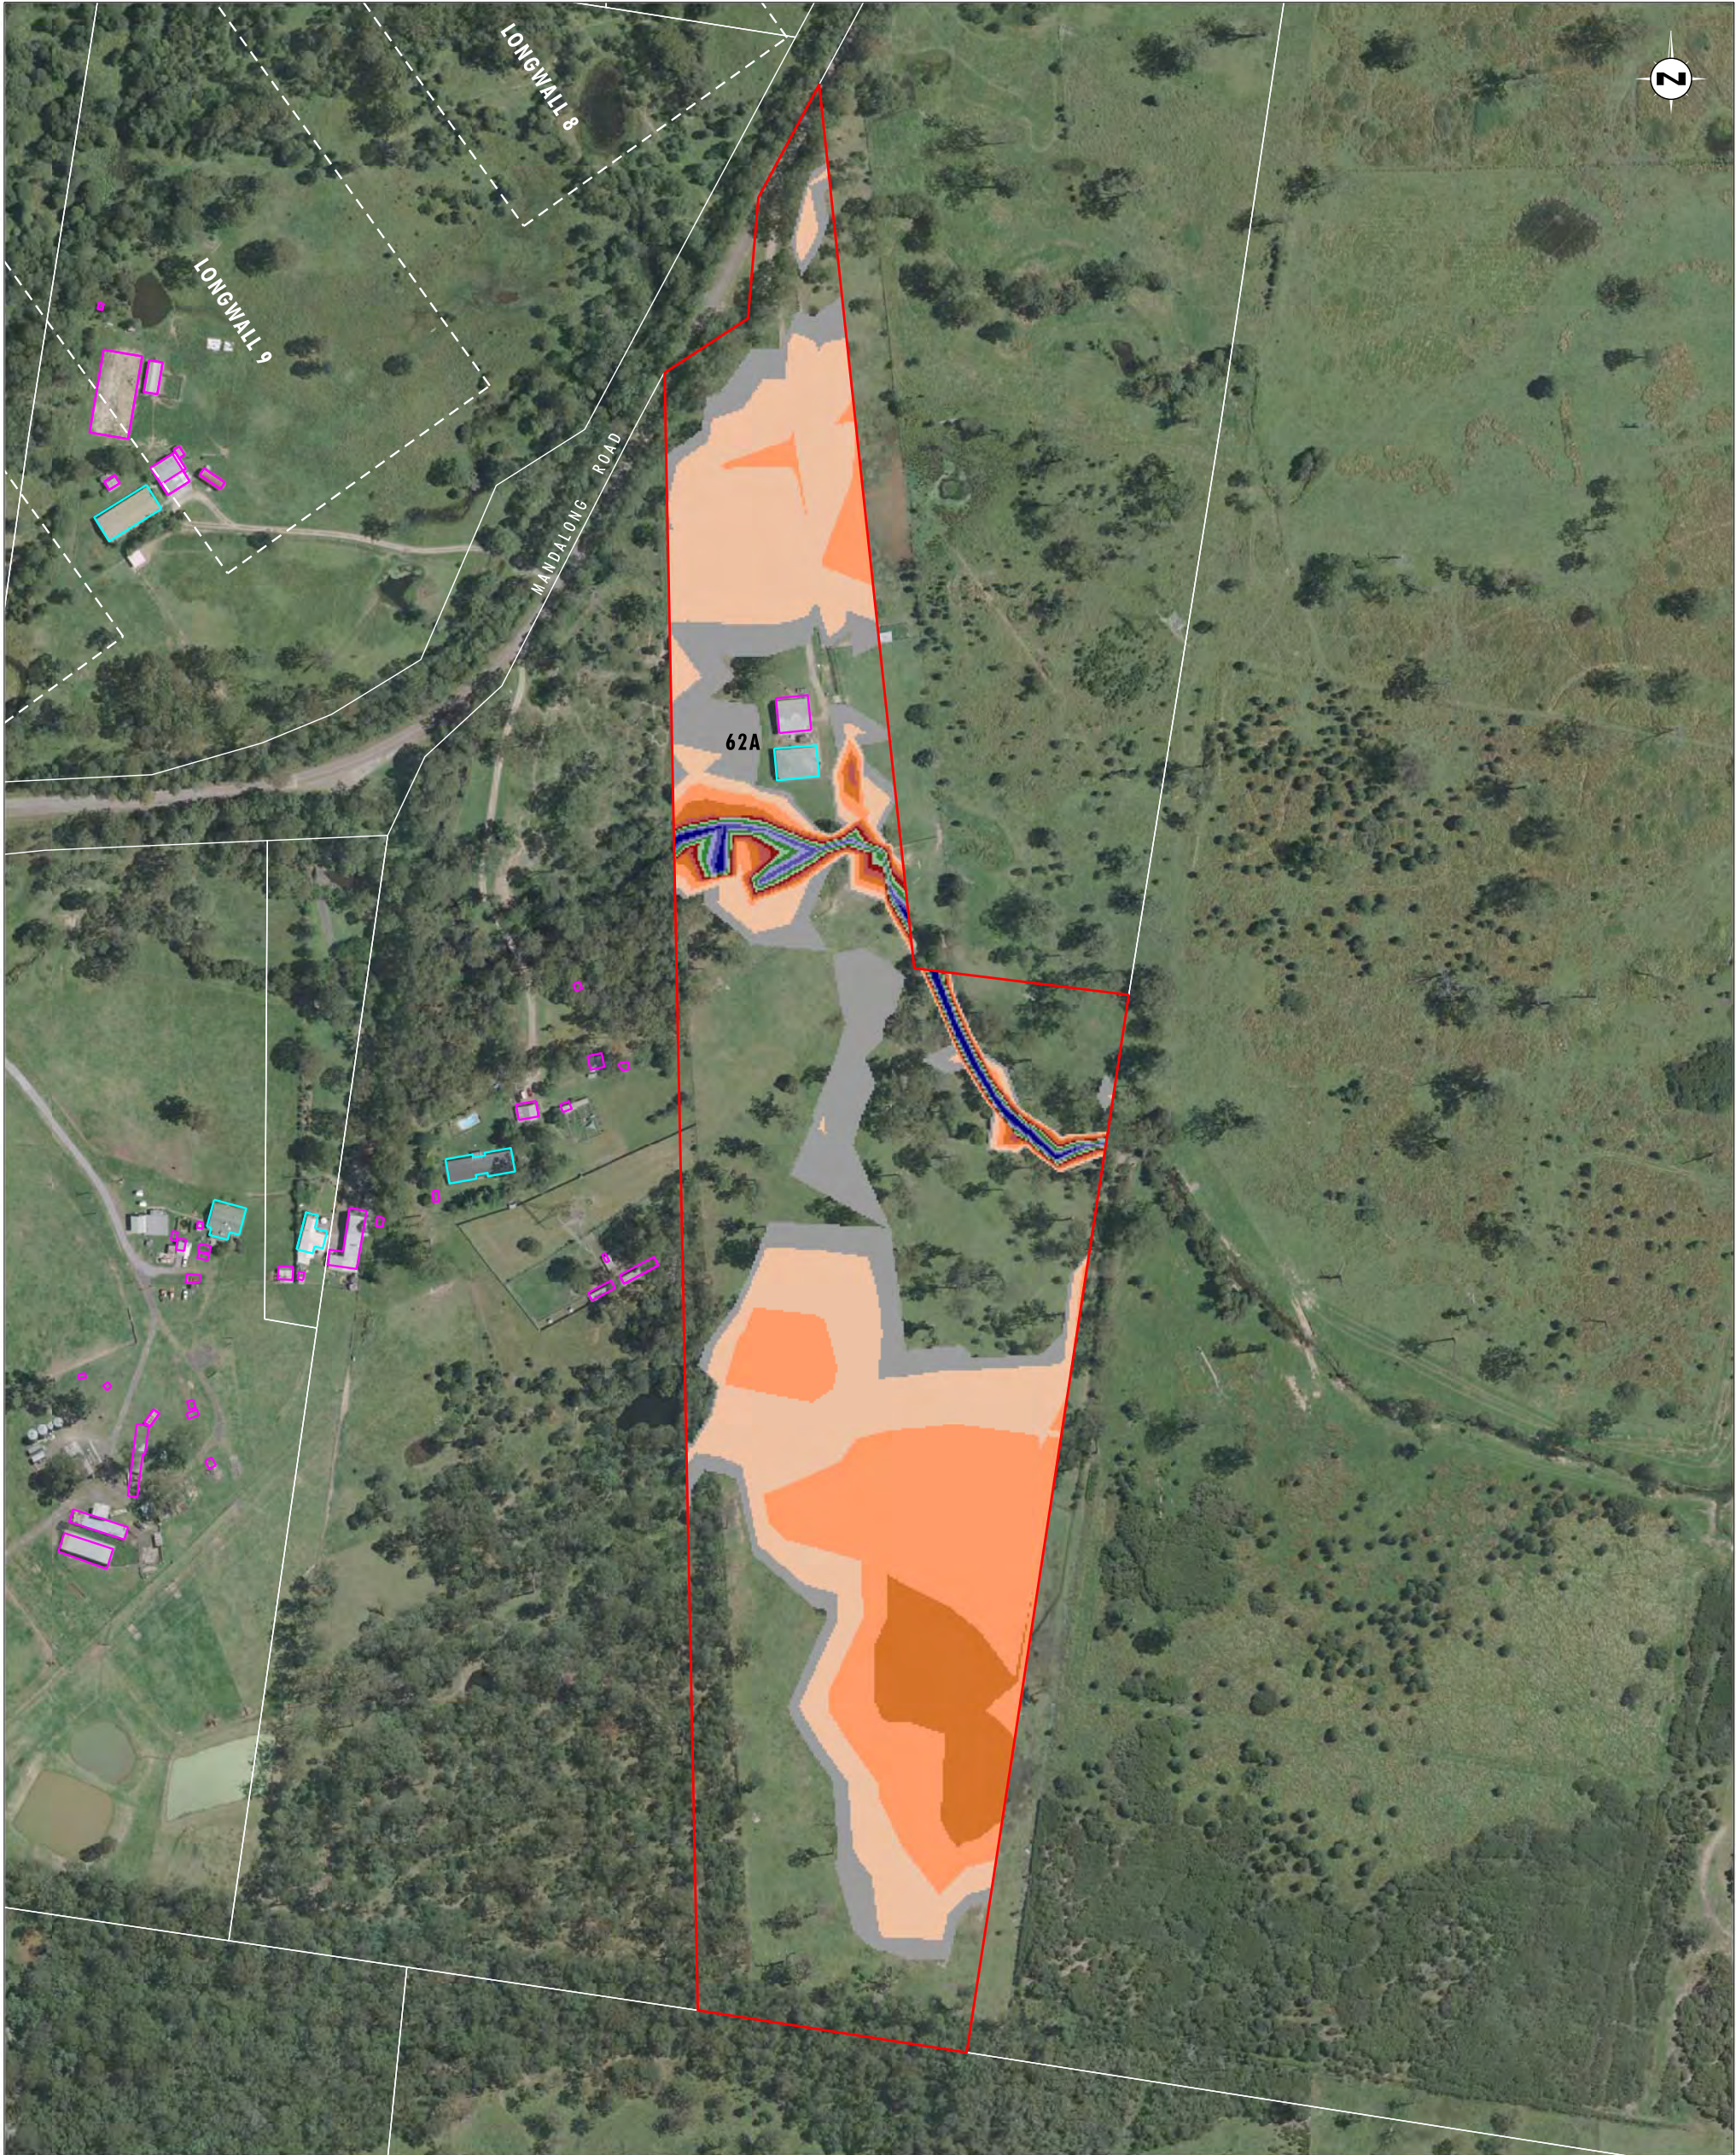
FIGURE 6  
Property 62 - 1 Year ARI Storm Event:  
Maximum Flood Depth Post Mining Landform  
(to Longwall 23)
