## APPENDIX 13

Flooding Assessment Figures -  
Property 46

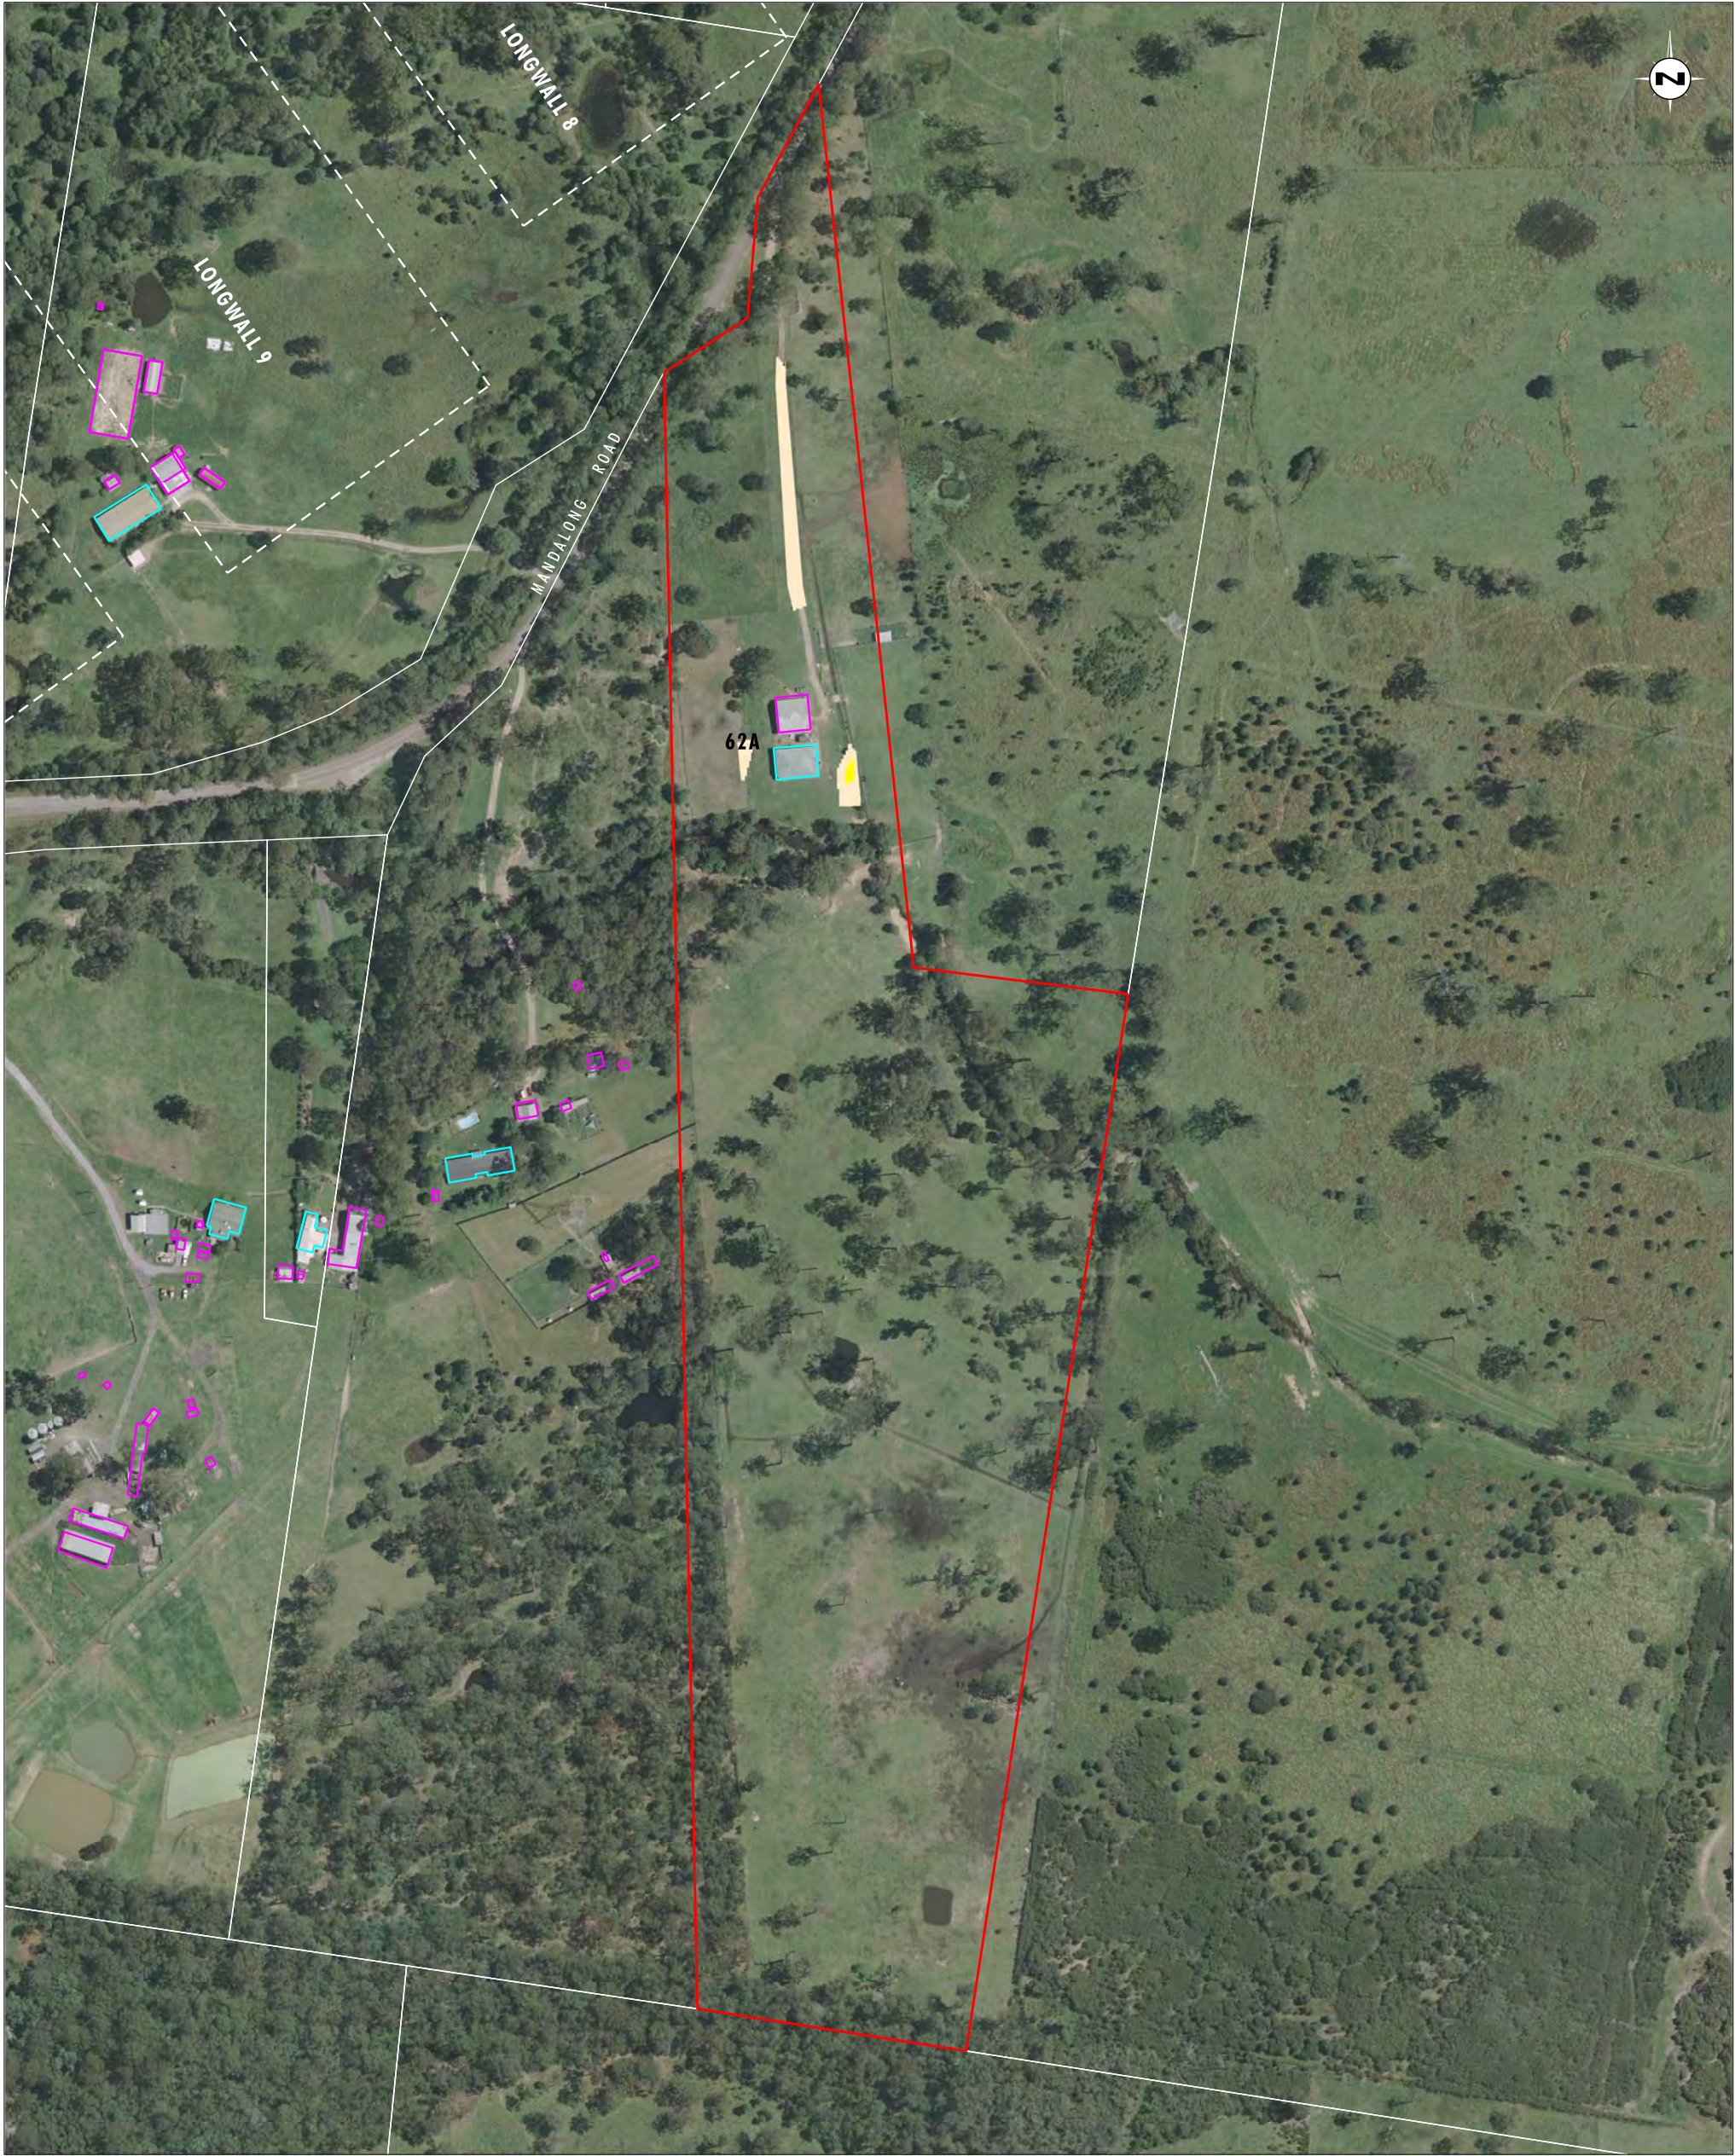
FIGURE 7  
Property 62 - 1 Year ARI Storm Event:  
Maximum Flood Hazard Categories Pre Mining Landform

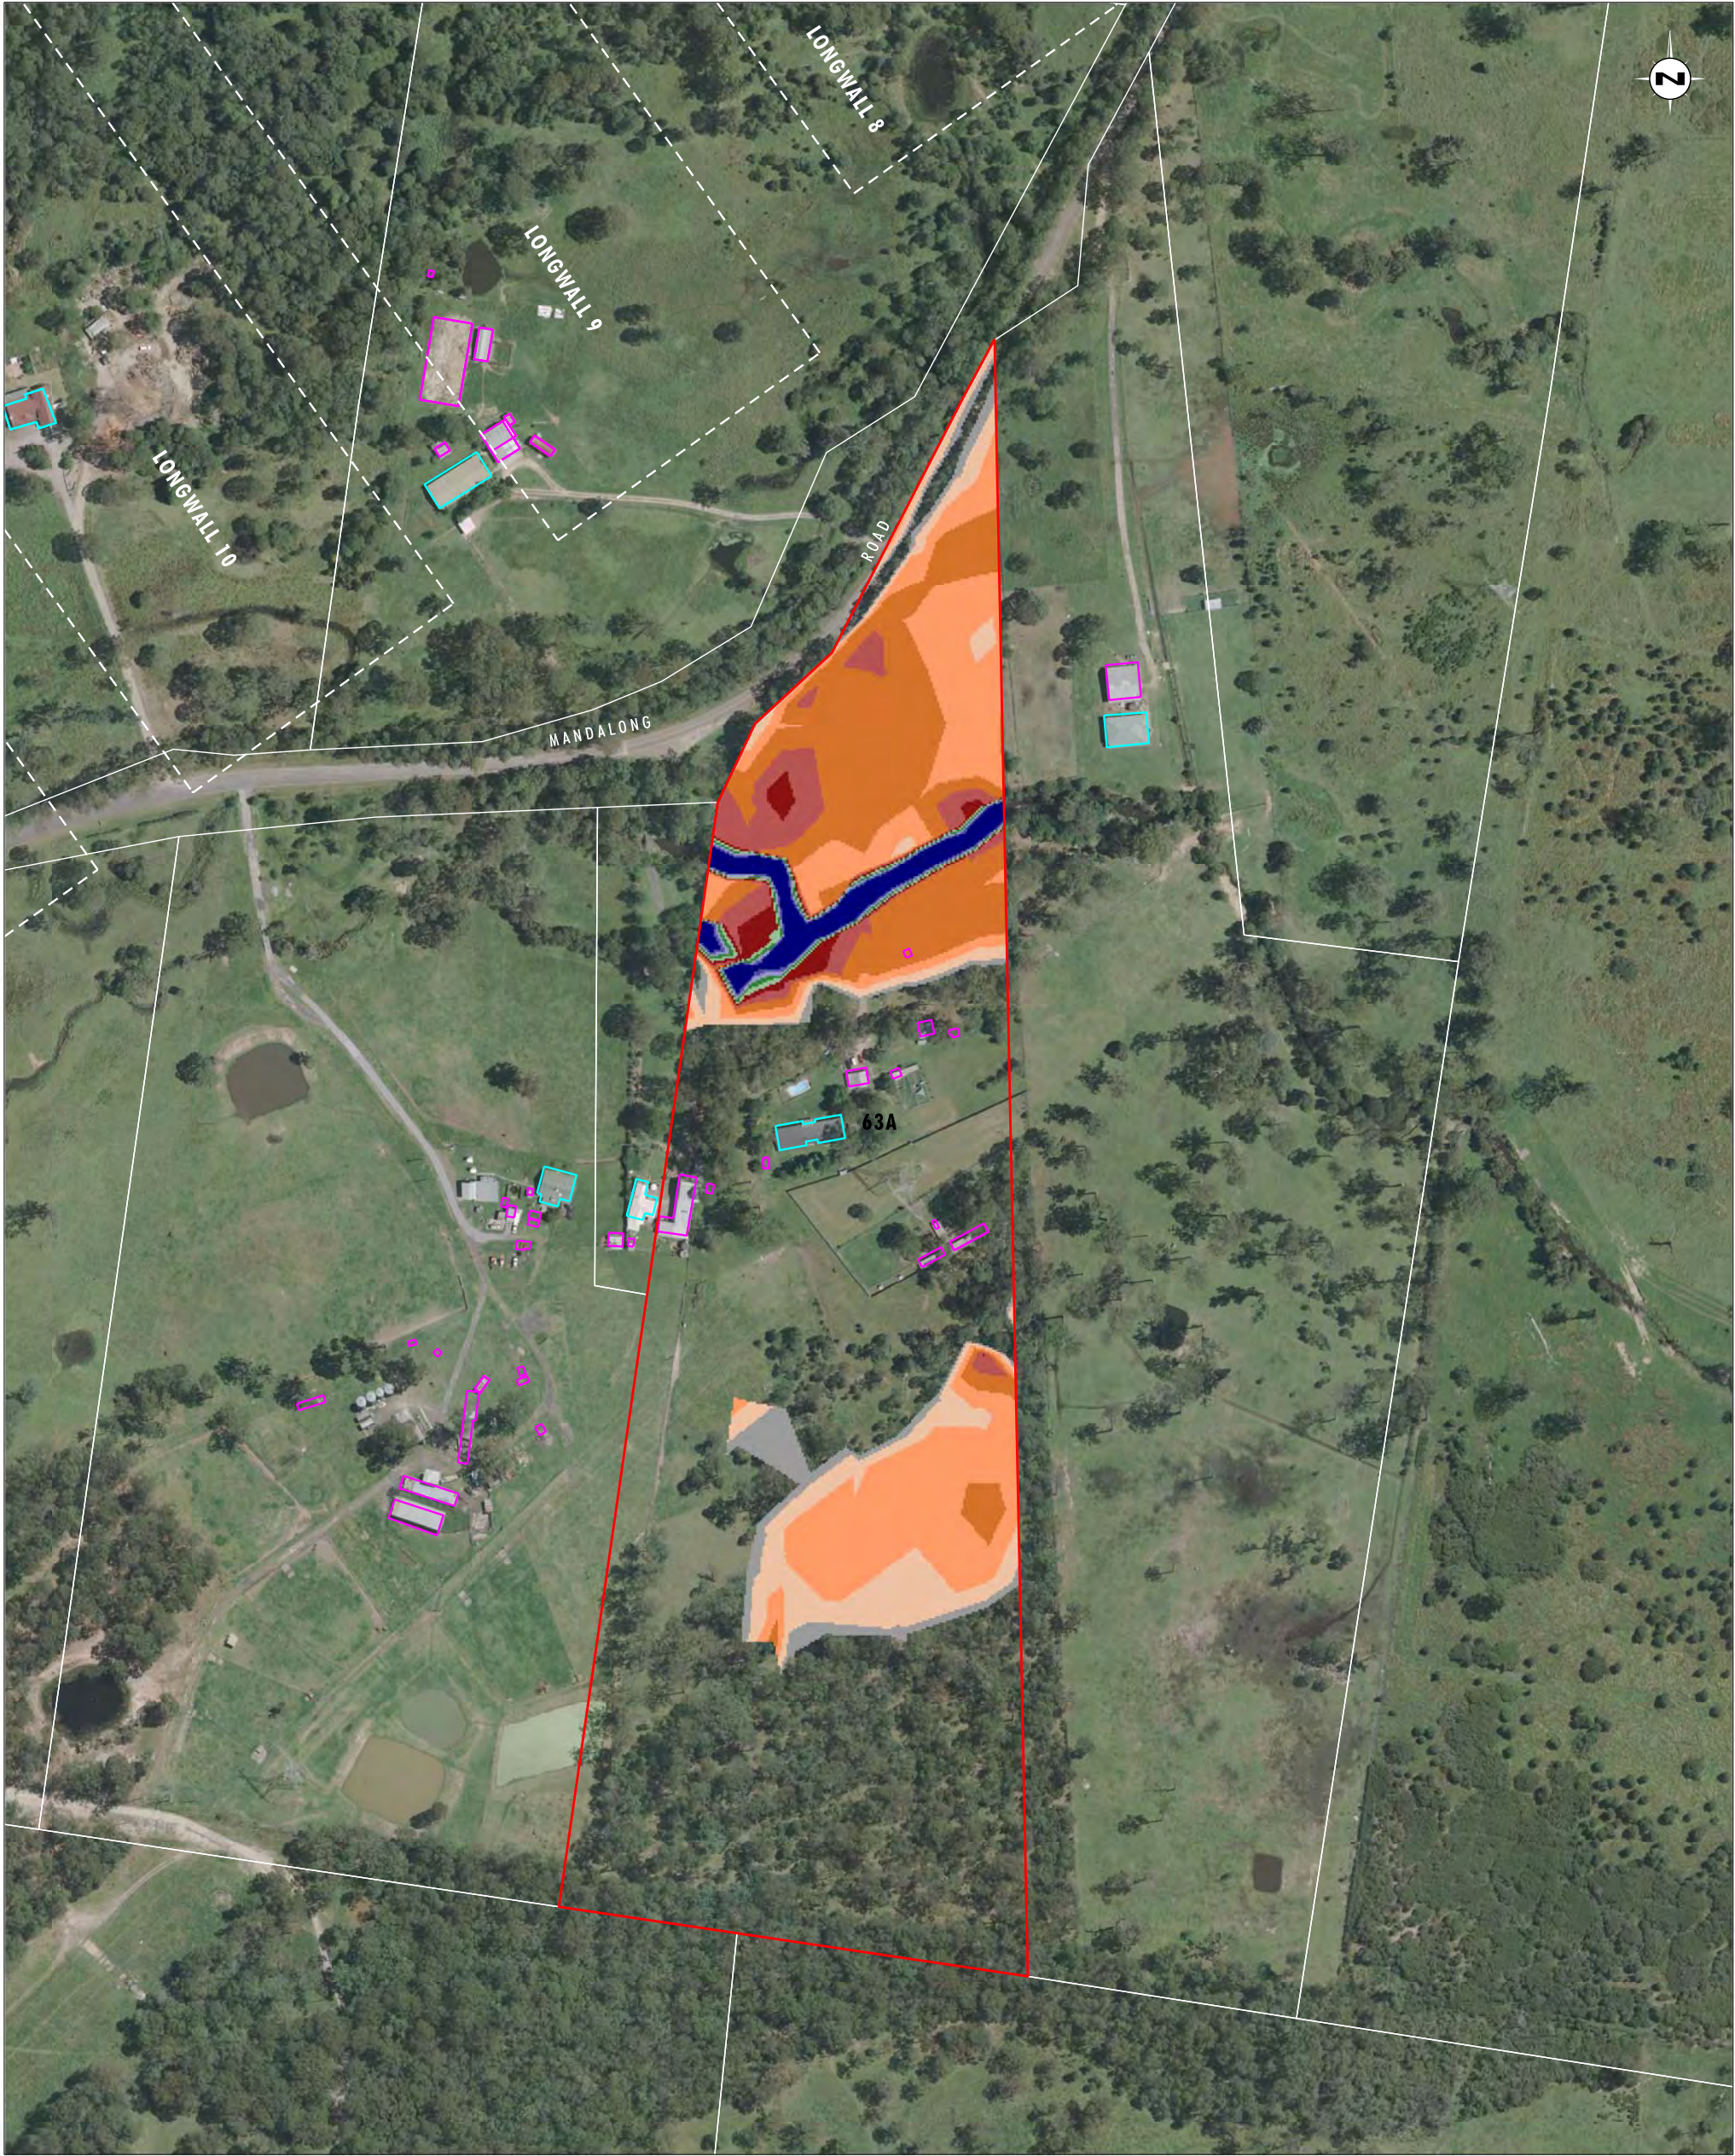
FIGURE 1  
Property 63 - 100 Year ARI Storm Event:  
Maximum Flood Depth Pre Mining Landform

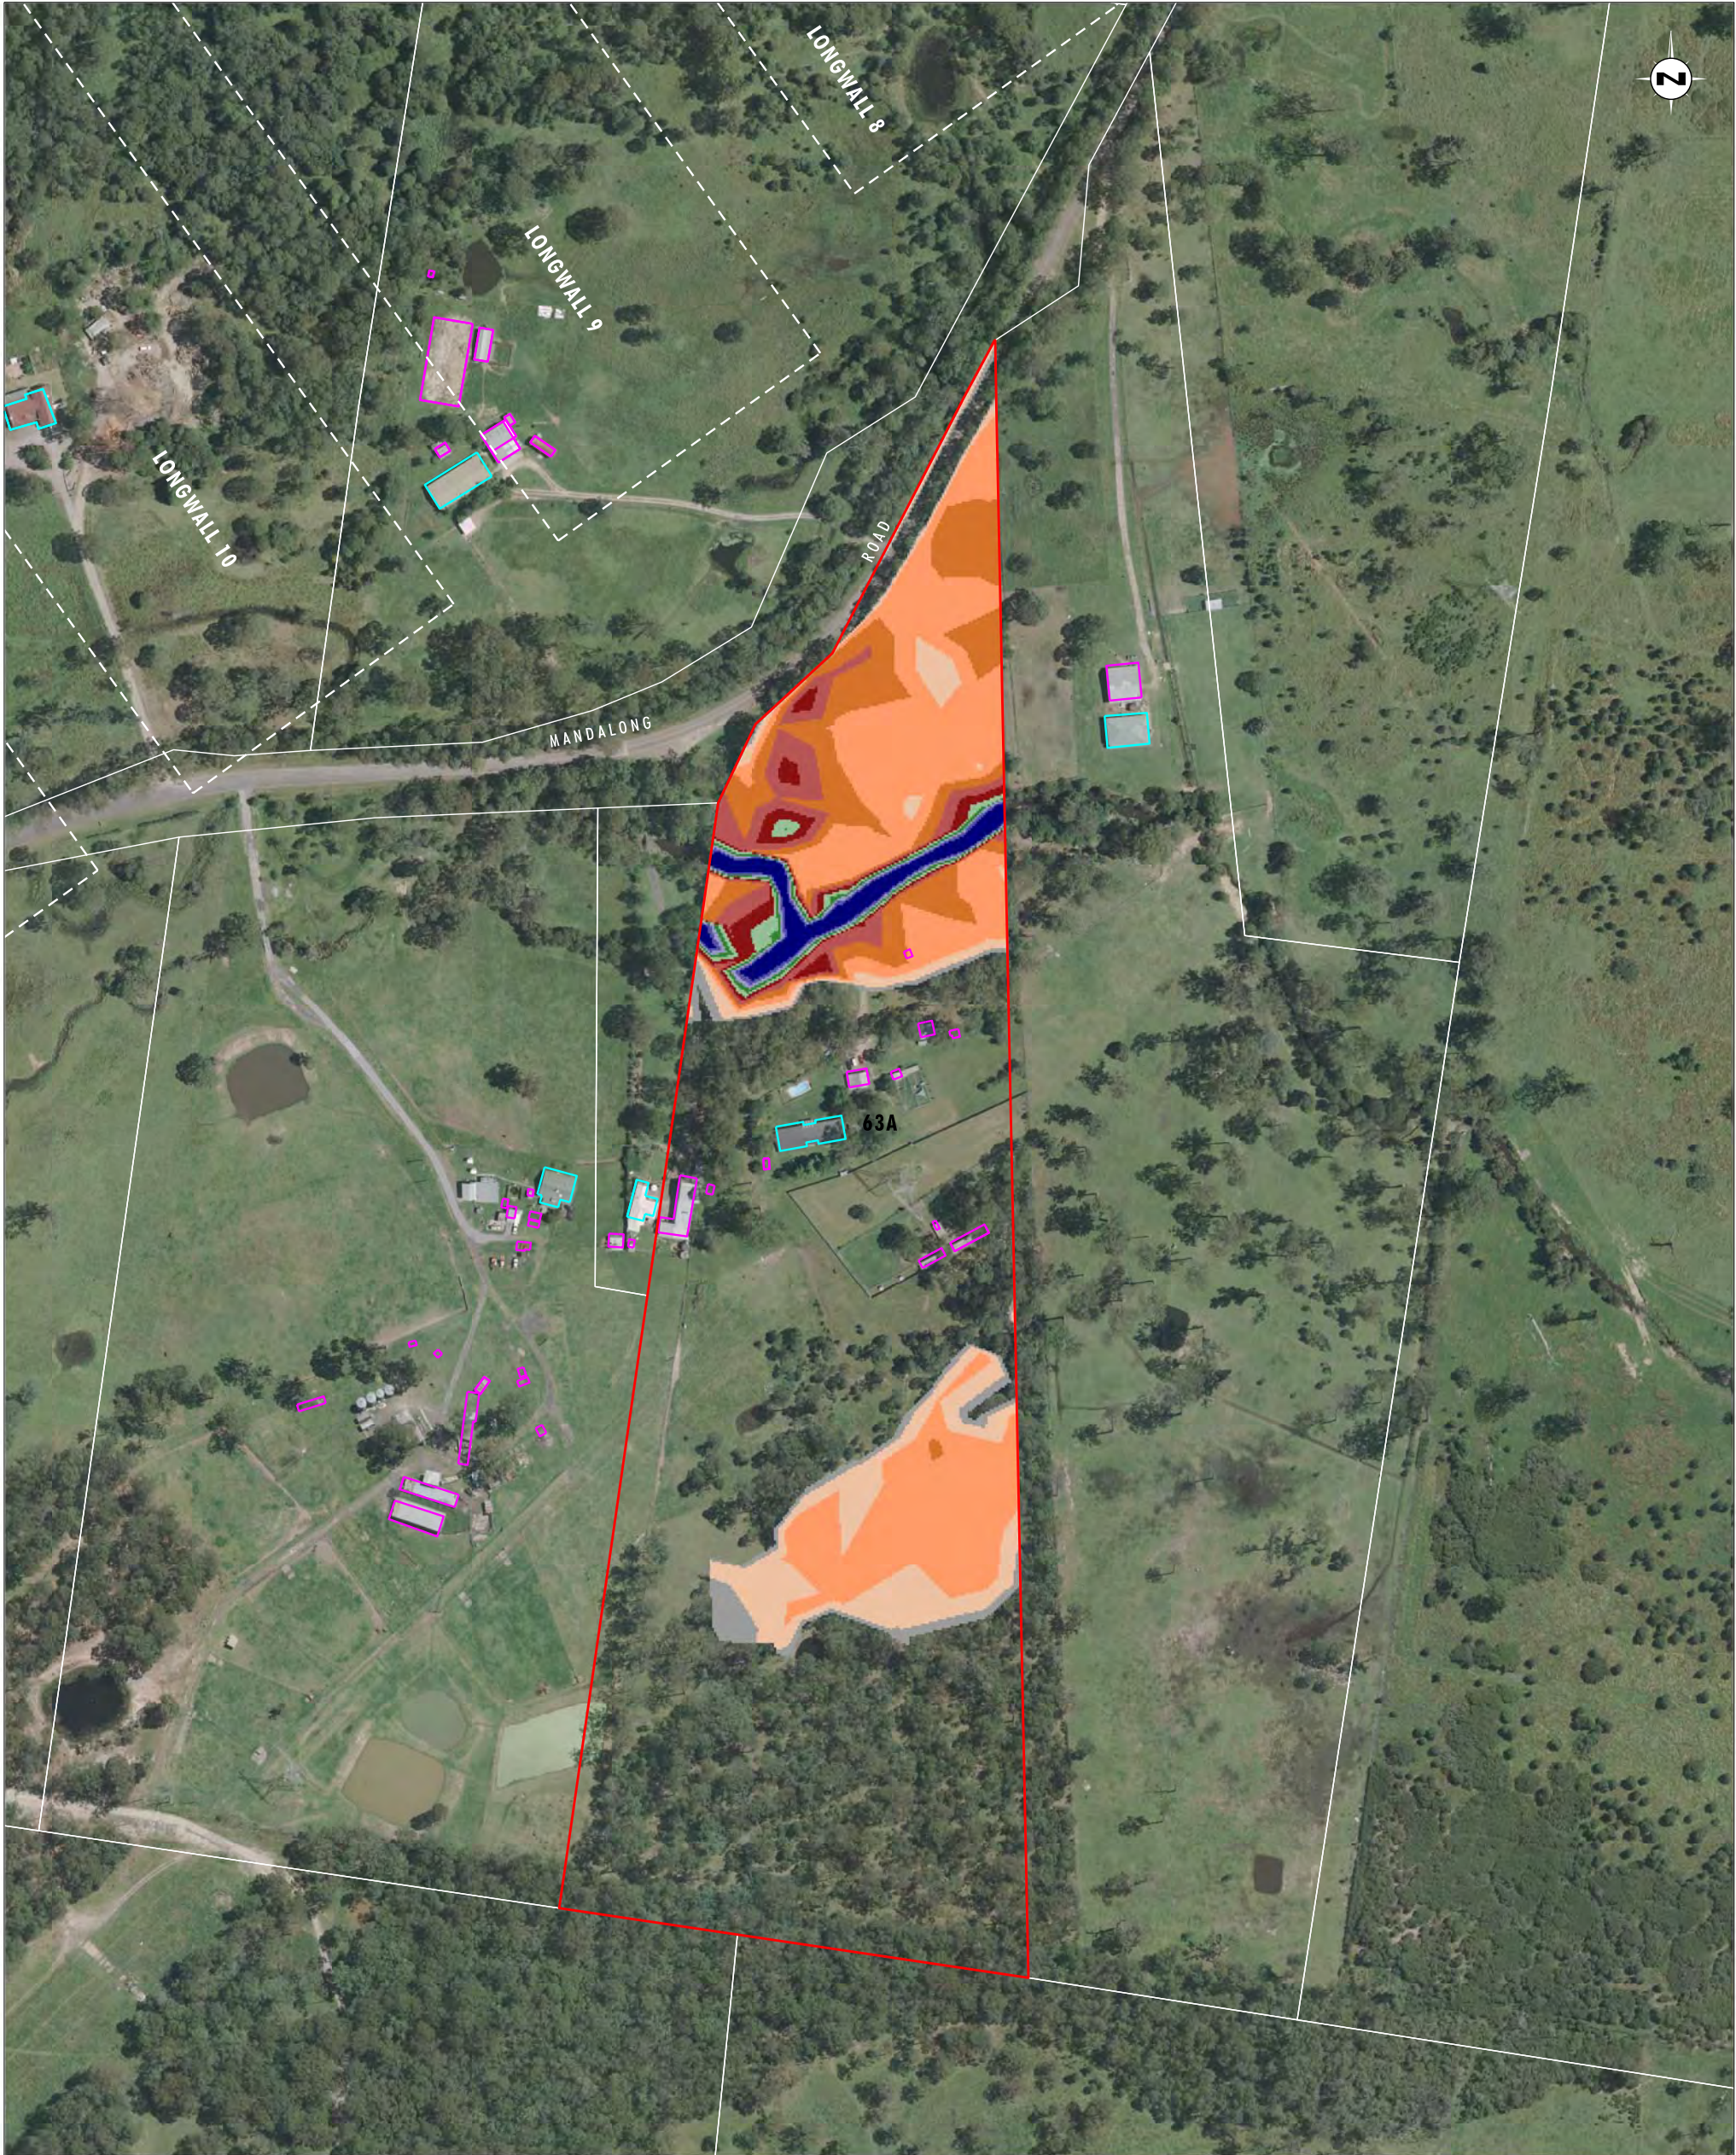
FIGURE 2  
Property 63 - 100 Year ARI Storm Event:  
Maximum Flood Depth Post Mining Landform  
(to Longwall 23)

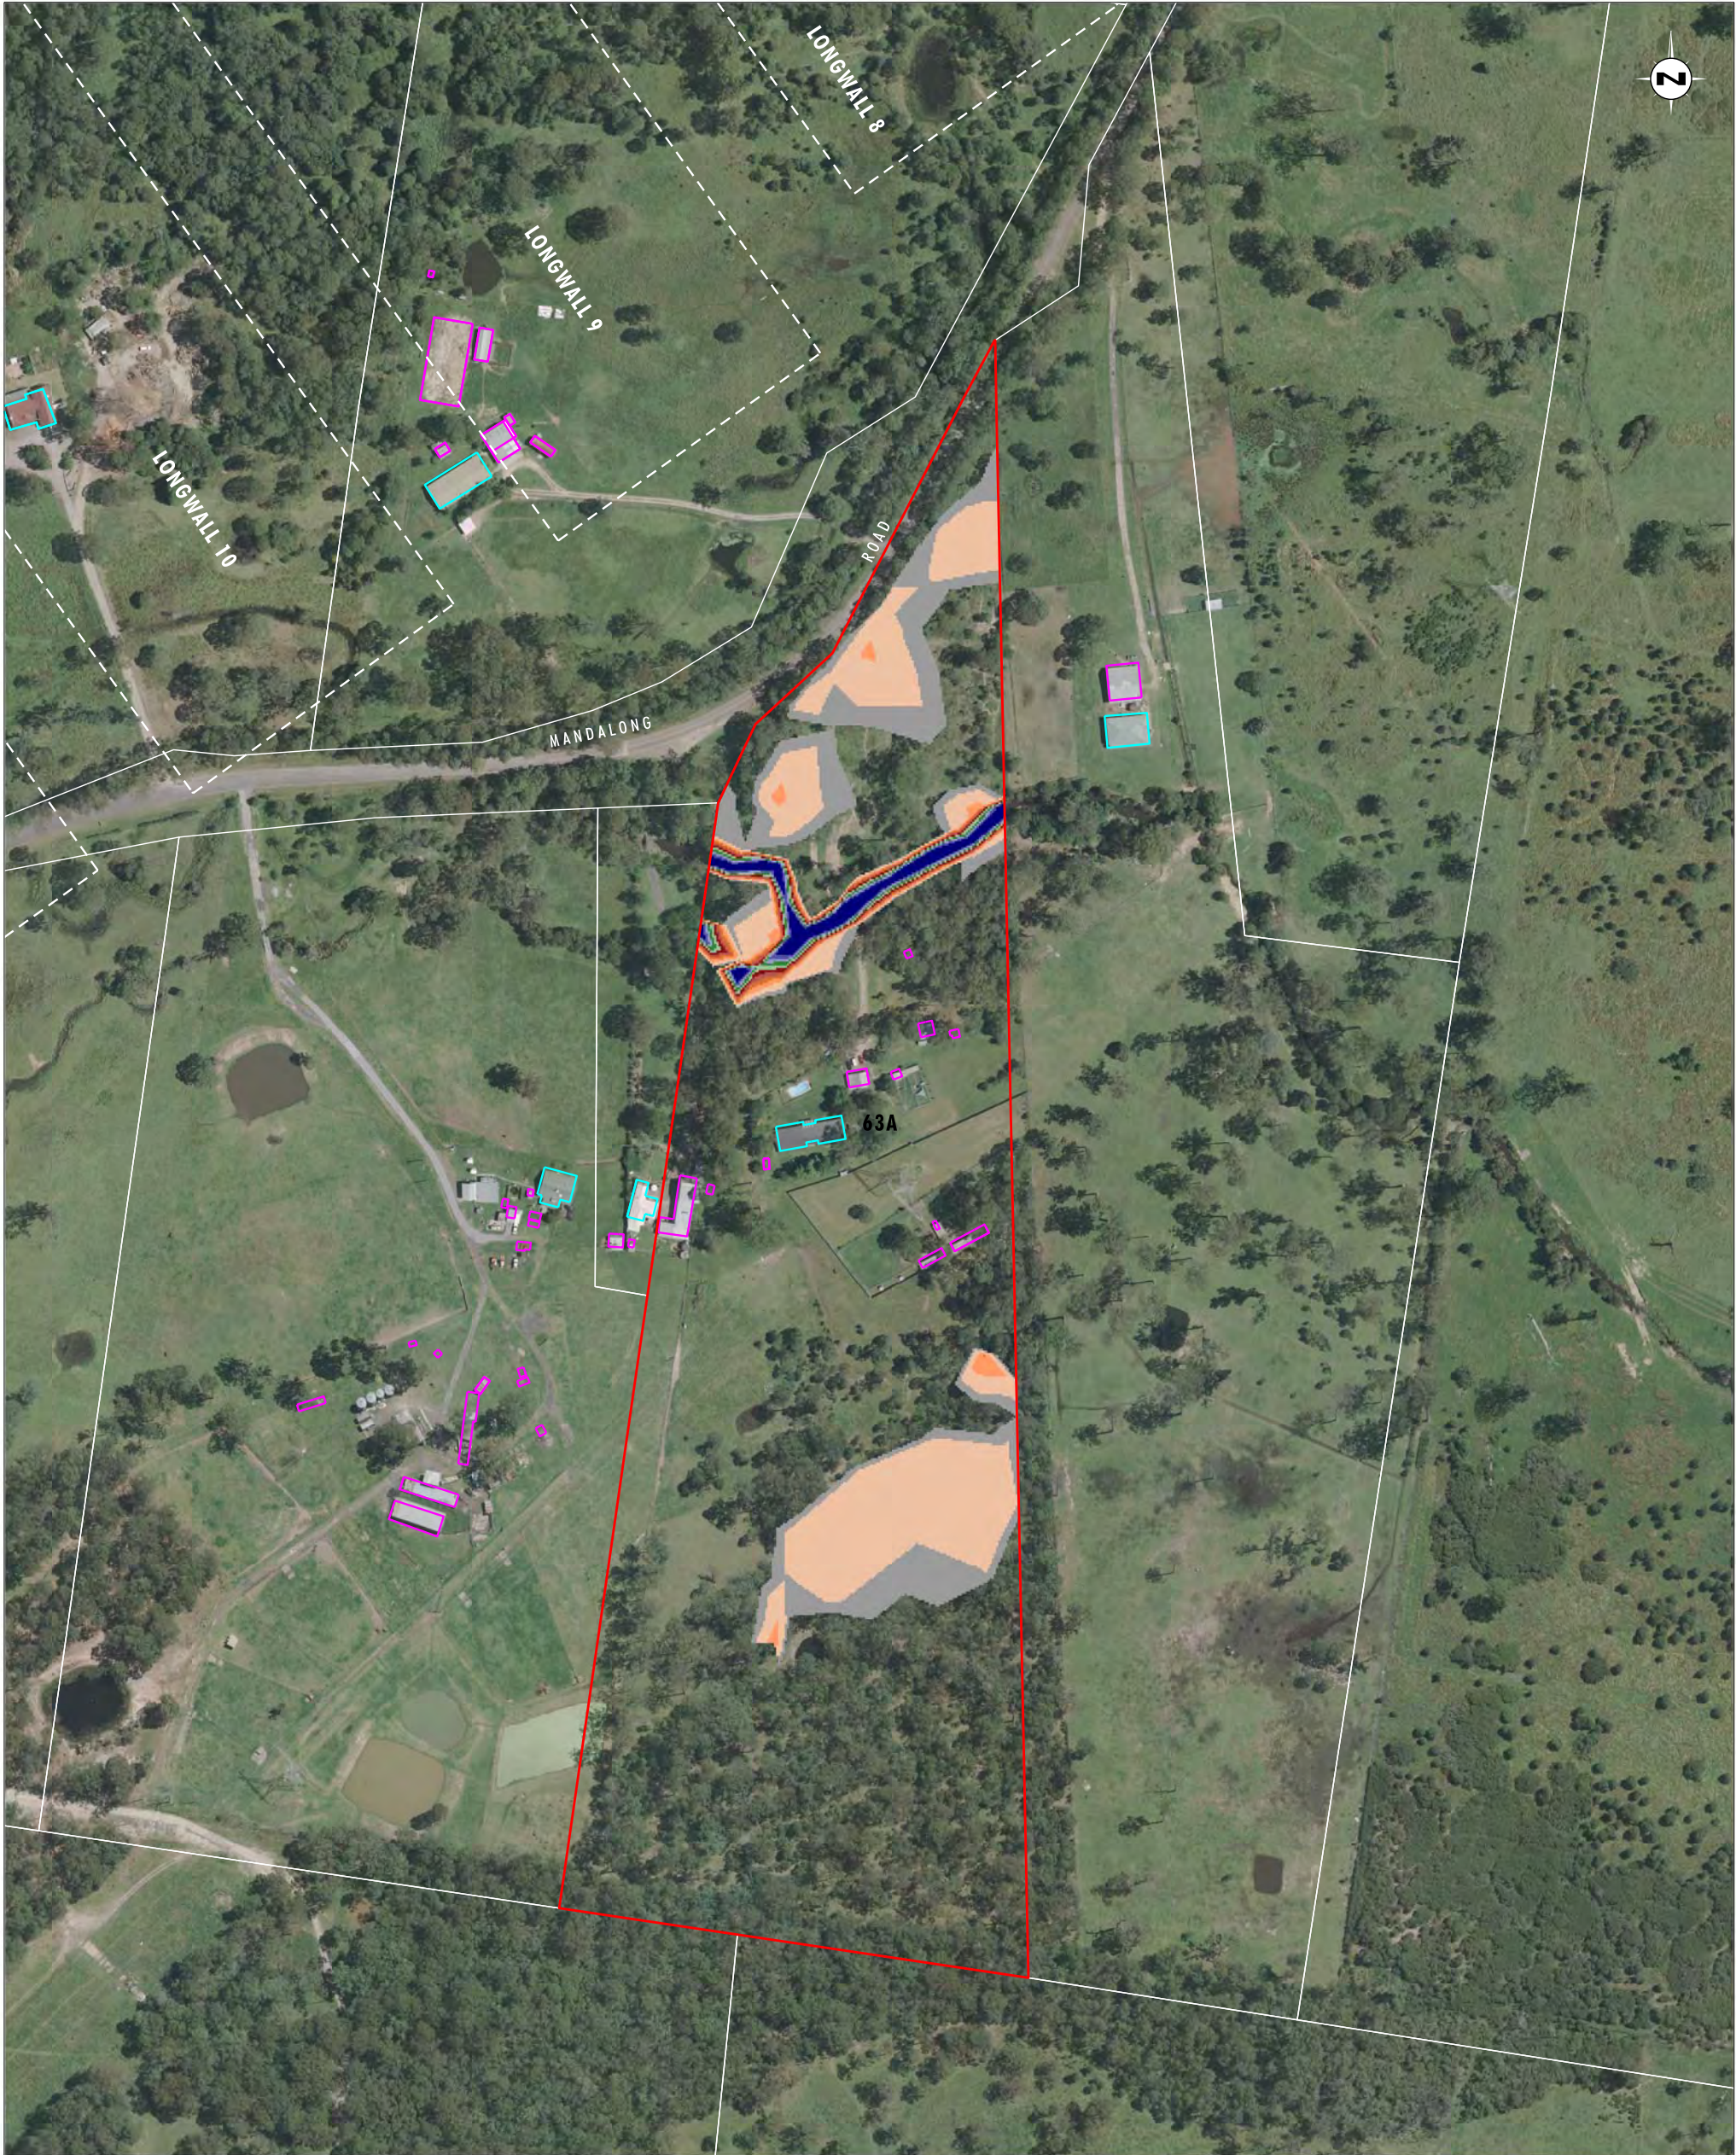
Property 63 - 1 Year ARI Storm Event:  
Maximum Flood Depth Pre Mining Landform

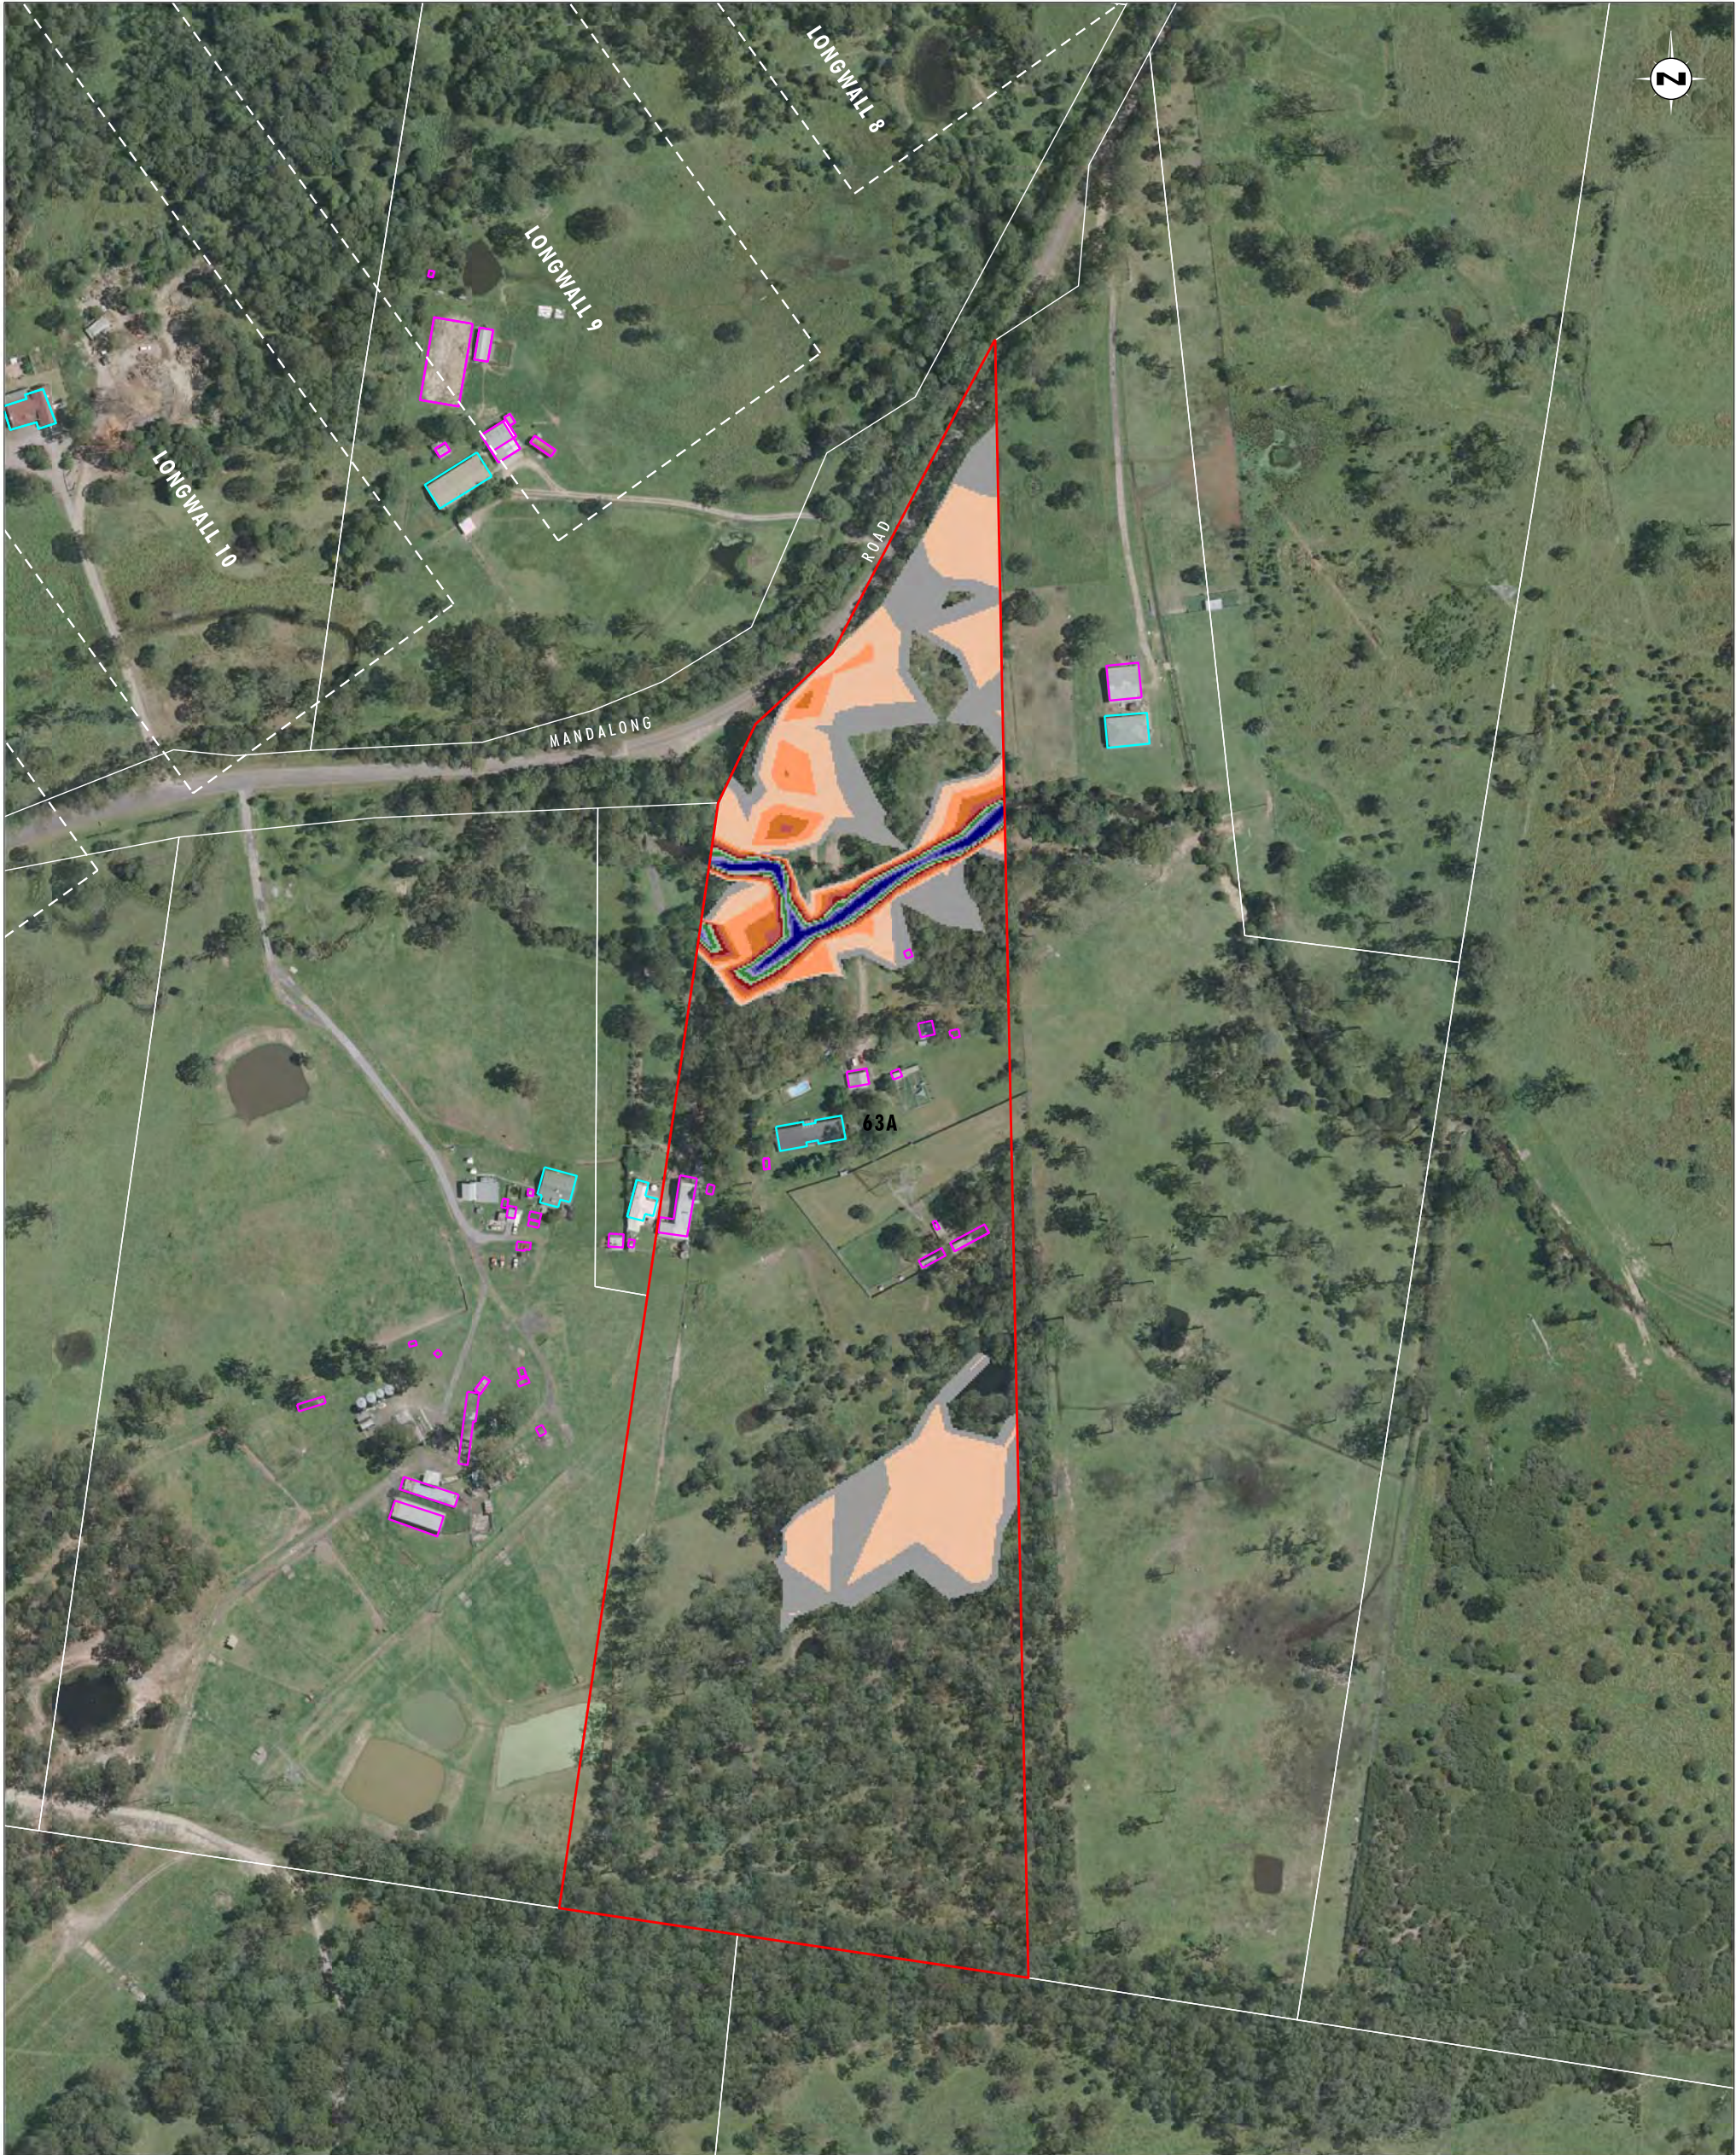
FIGURE 6  
Property 63 - 1 Year ARI Storm Event:  
Maximum Flood Depth Post Mining Landform  
(to Longwall 23)

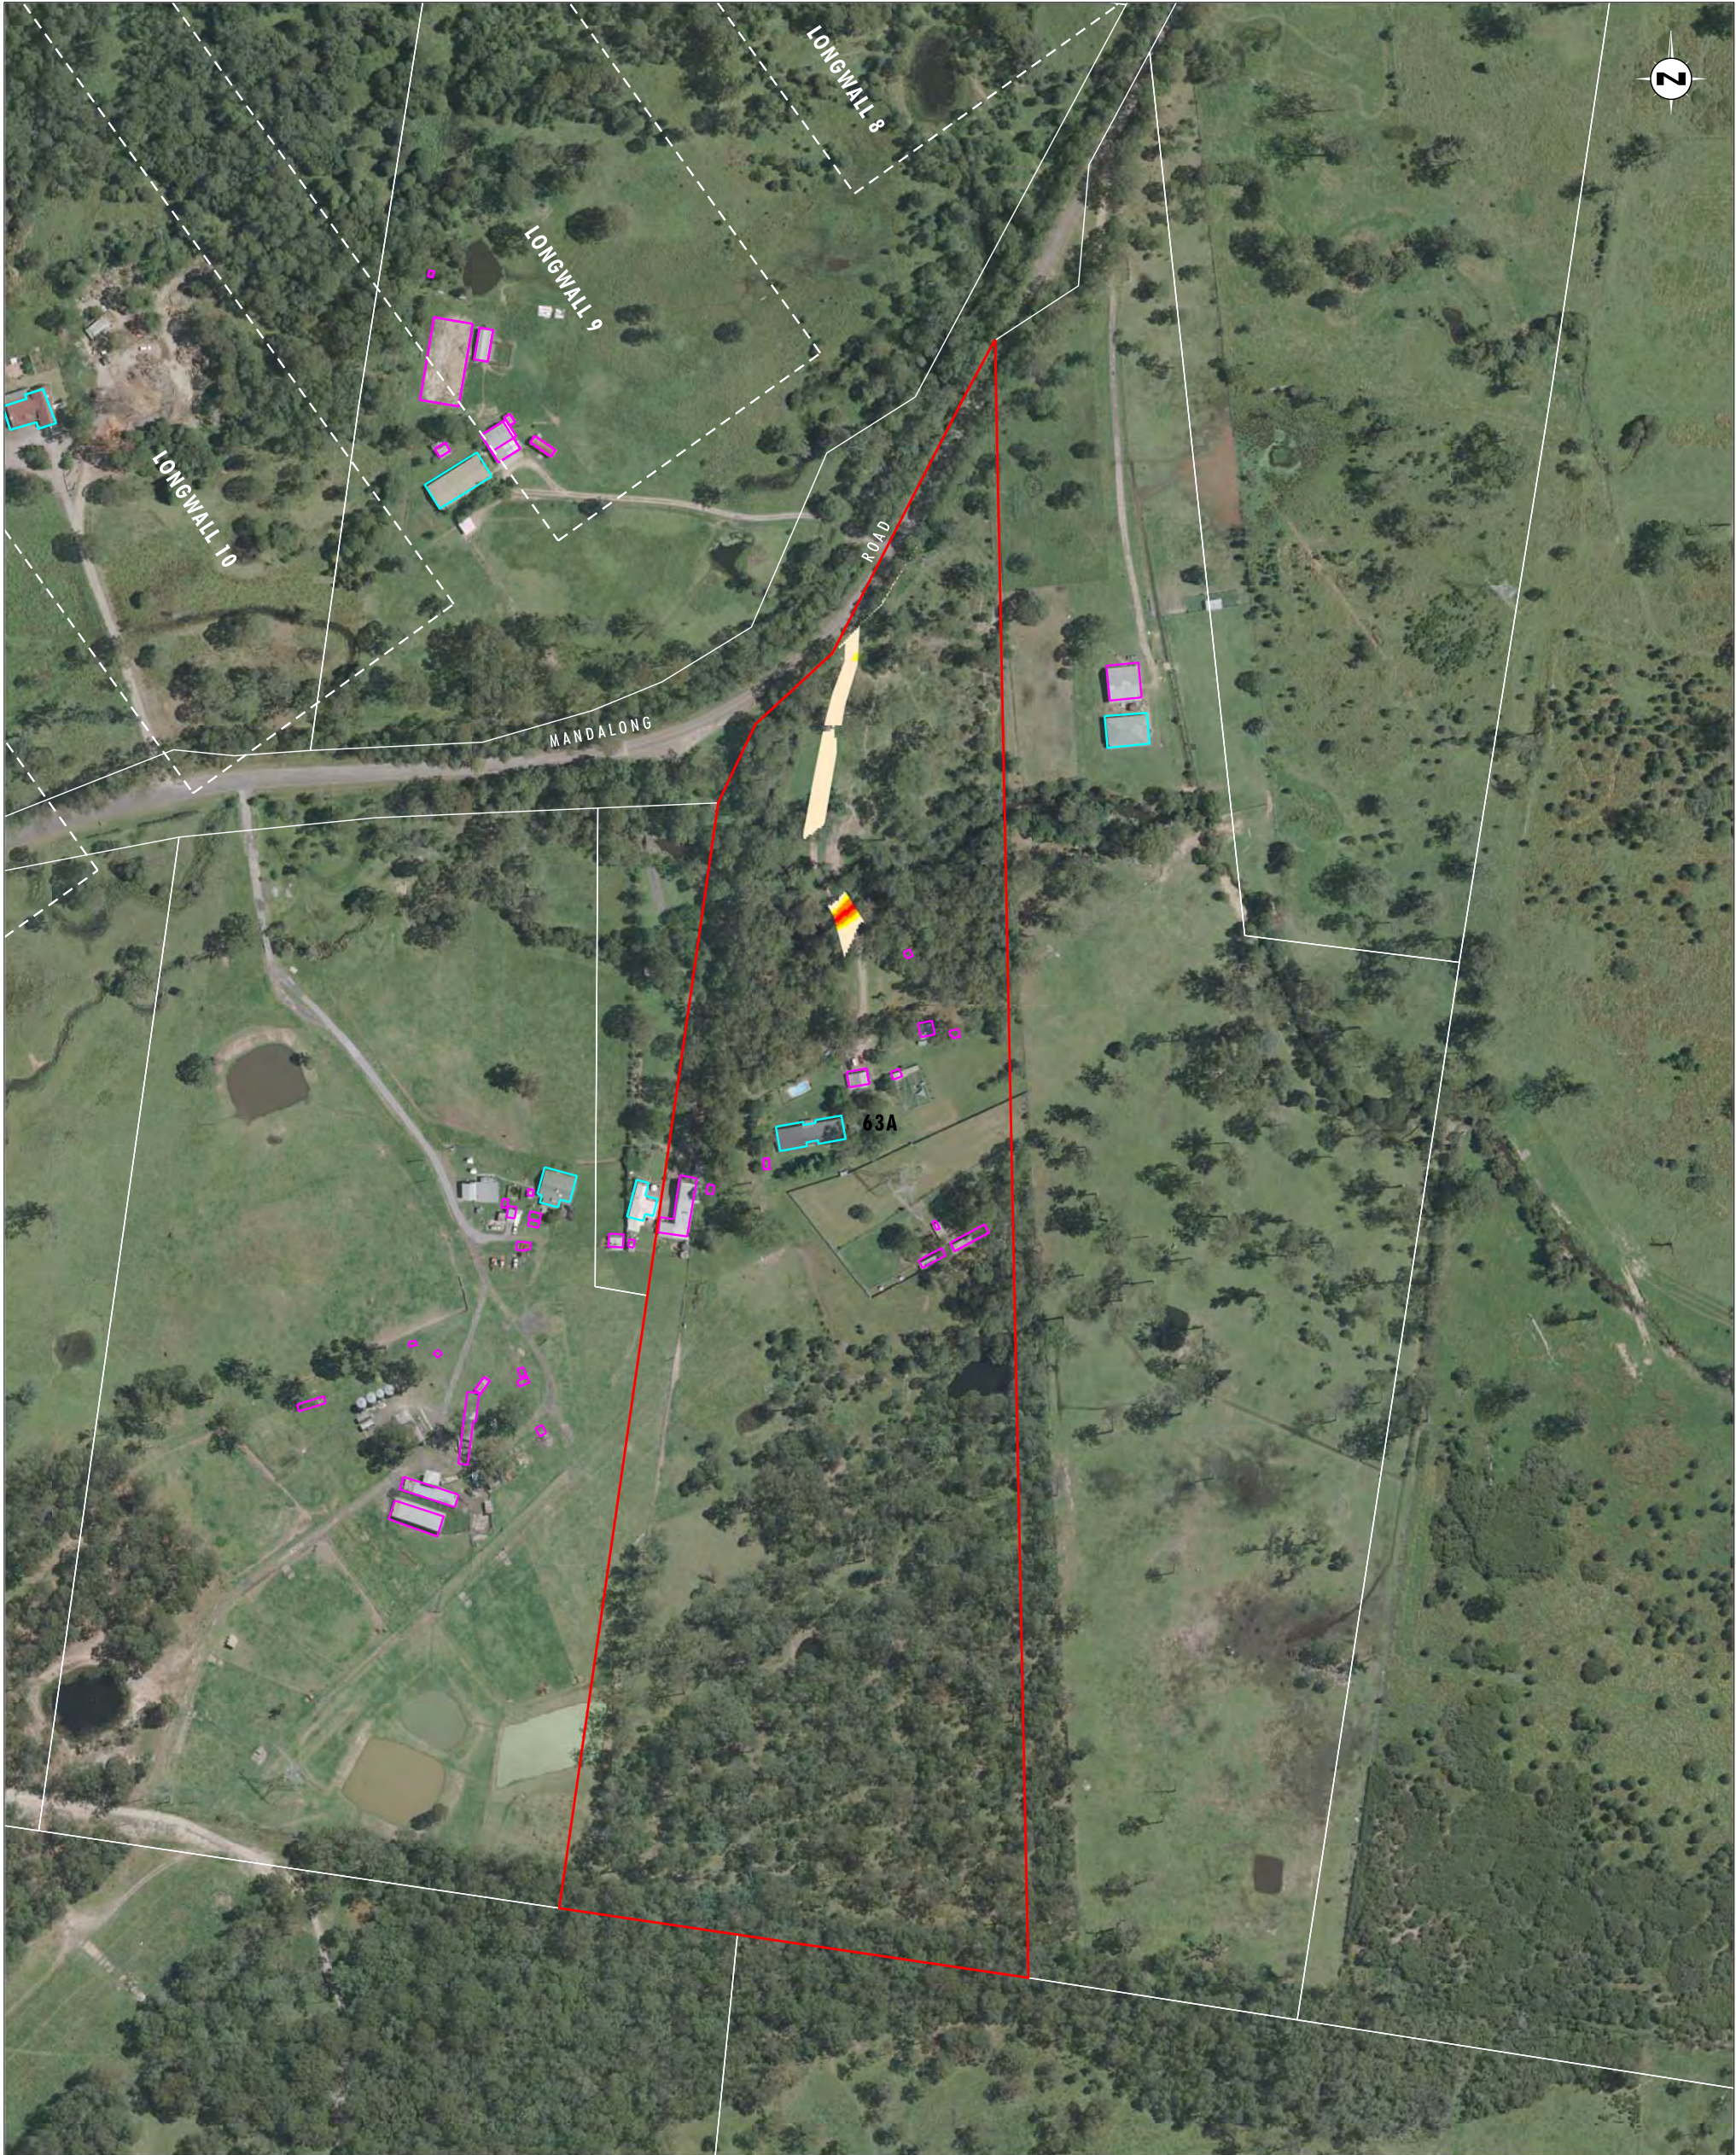
FIGURE 7  
Property 63 - 1 Year ARI Storm Event:  
Maximum Flood Hazard Categories Pre Mining Landform
