## APPENDIX 13

Flooding Assessment Figures -  
Property 46

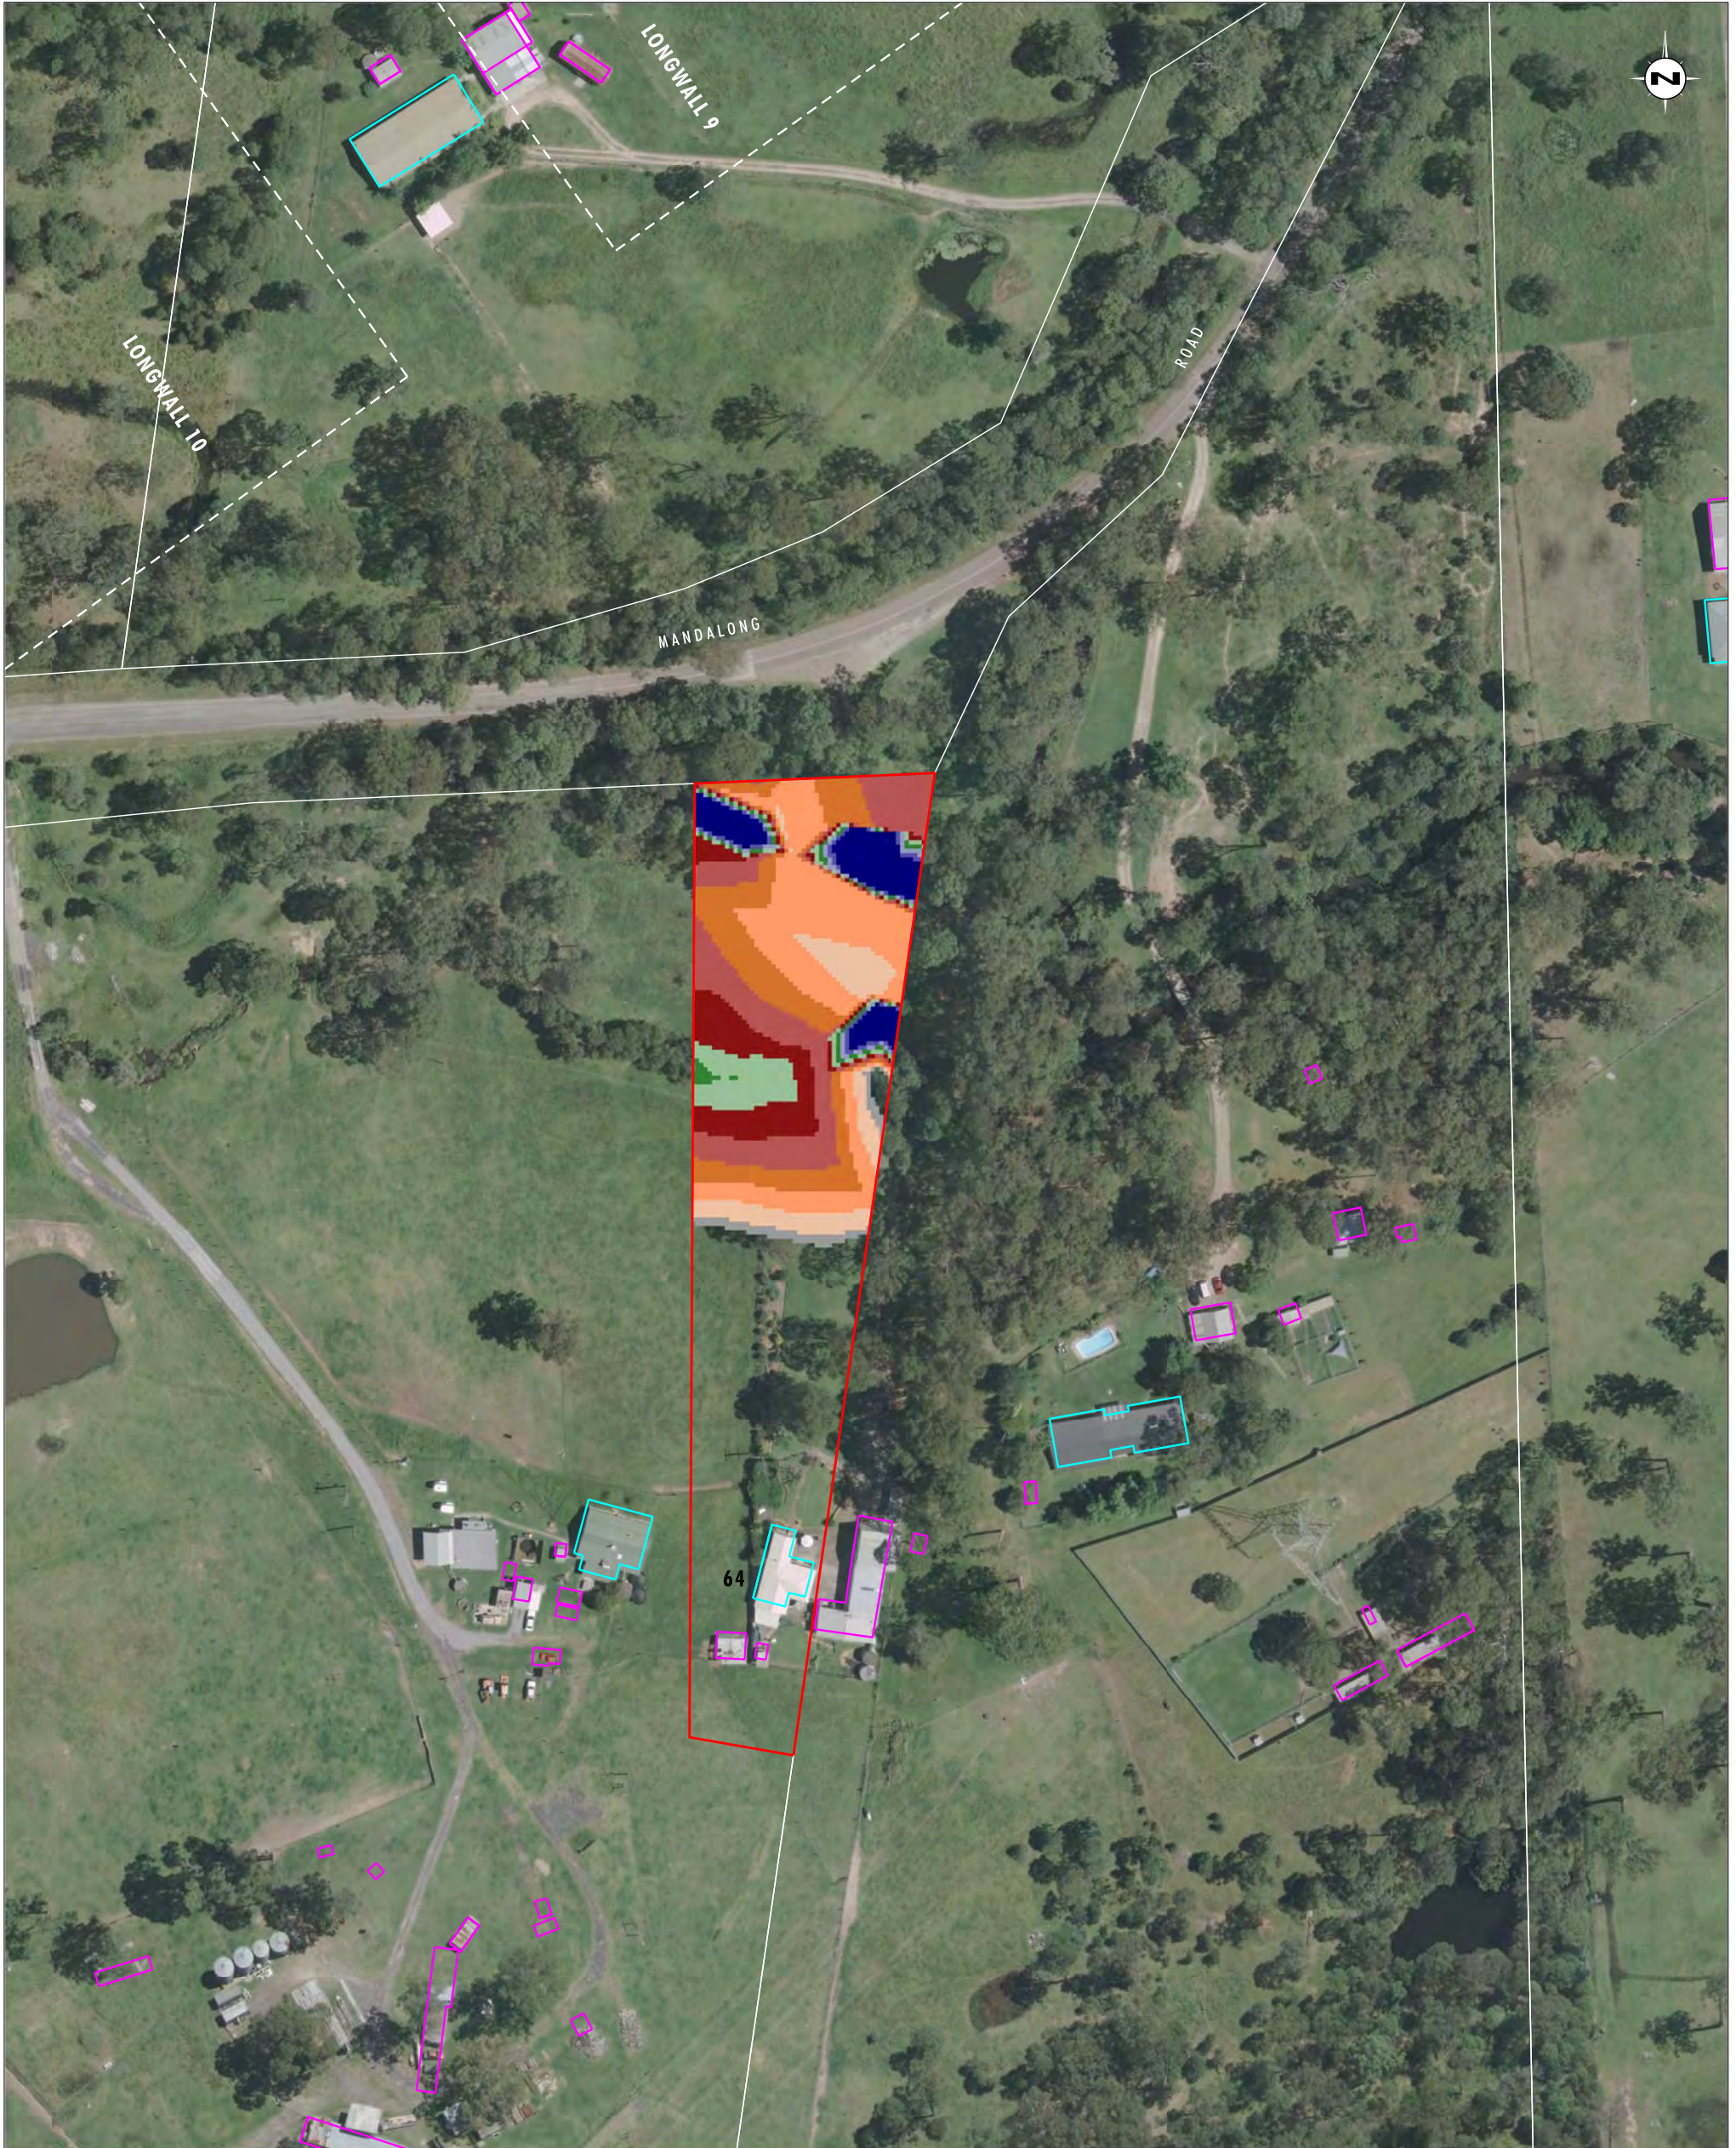
FIGURE 1  
Property 64 - 100 Year ARI Storm Event:  
Maximum Flood Depth Pre Mining Landform

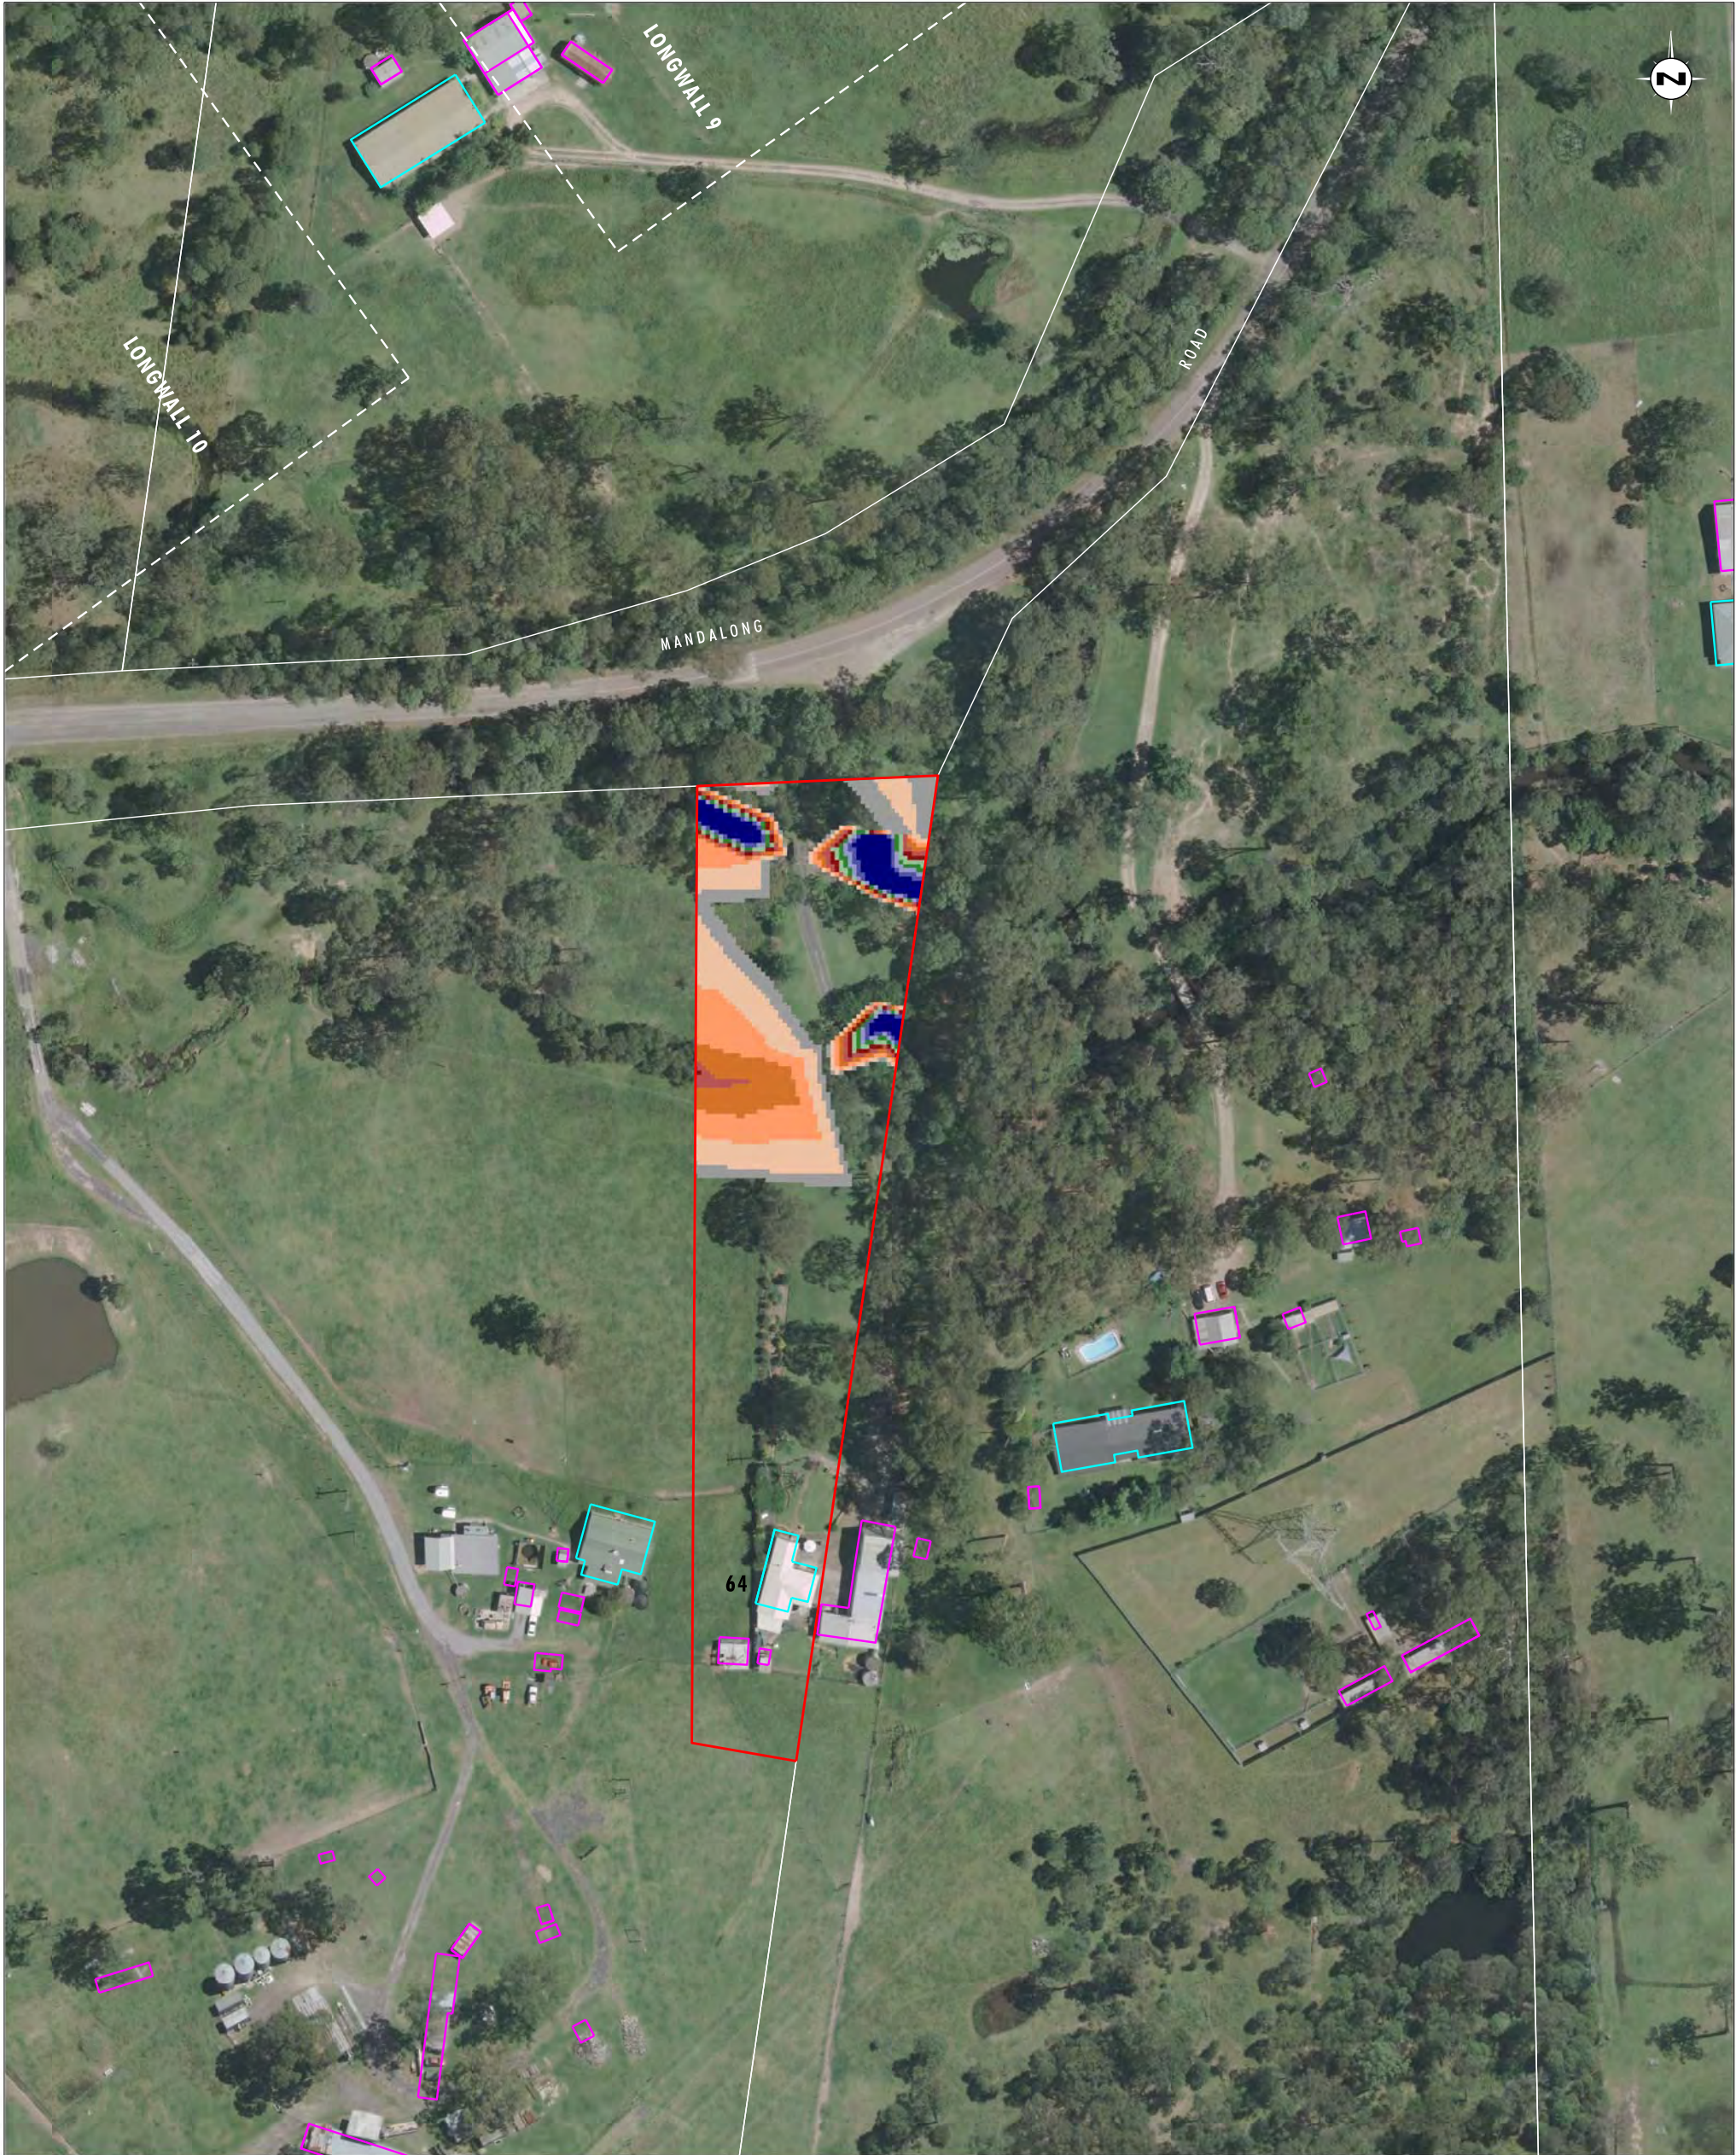
FIGURE 5  
Property 64 - 1 Year ARI Storm Event:  
Maximum Flood Depth Pre Mining Landform

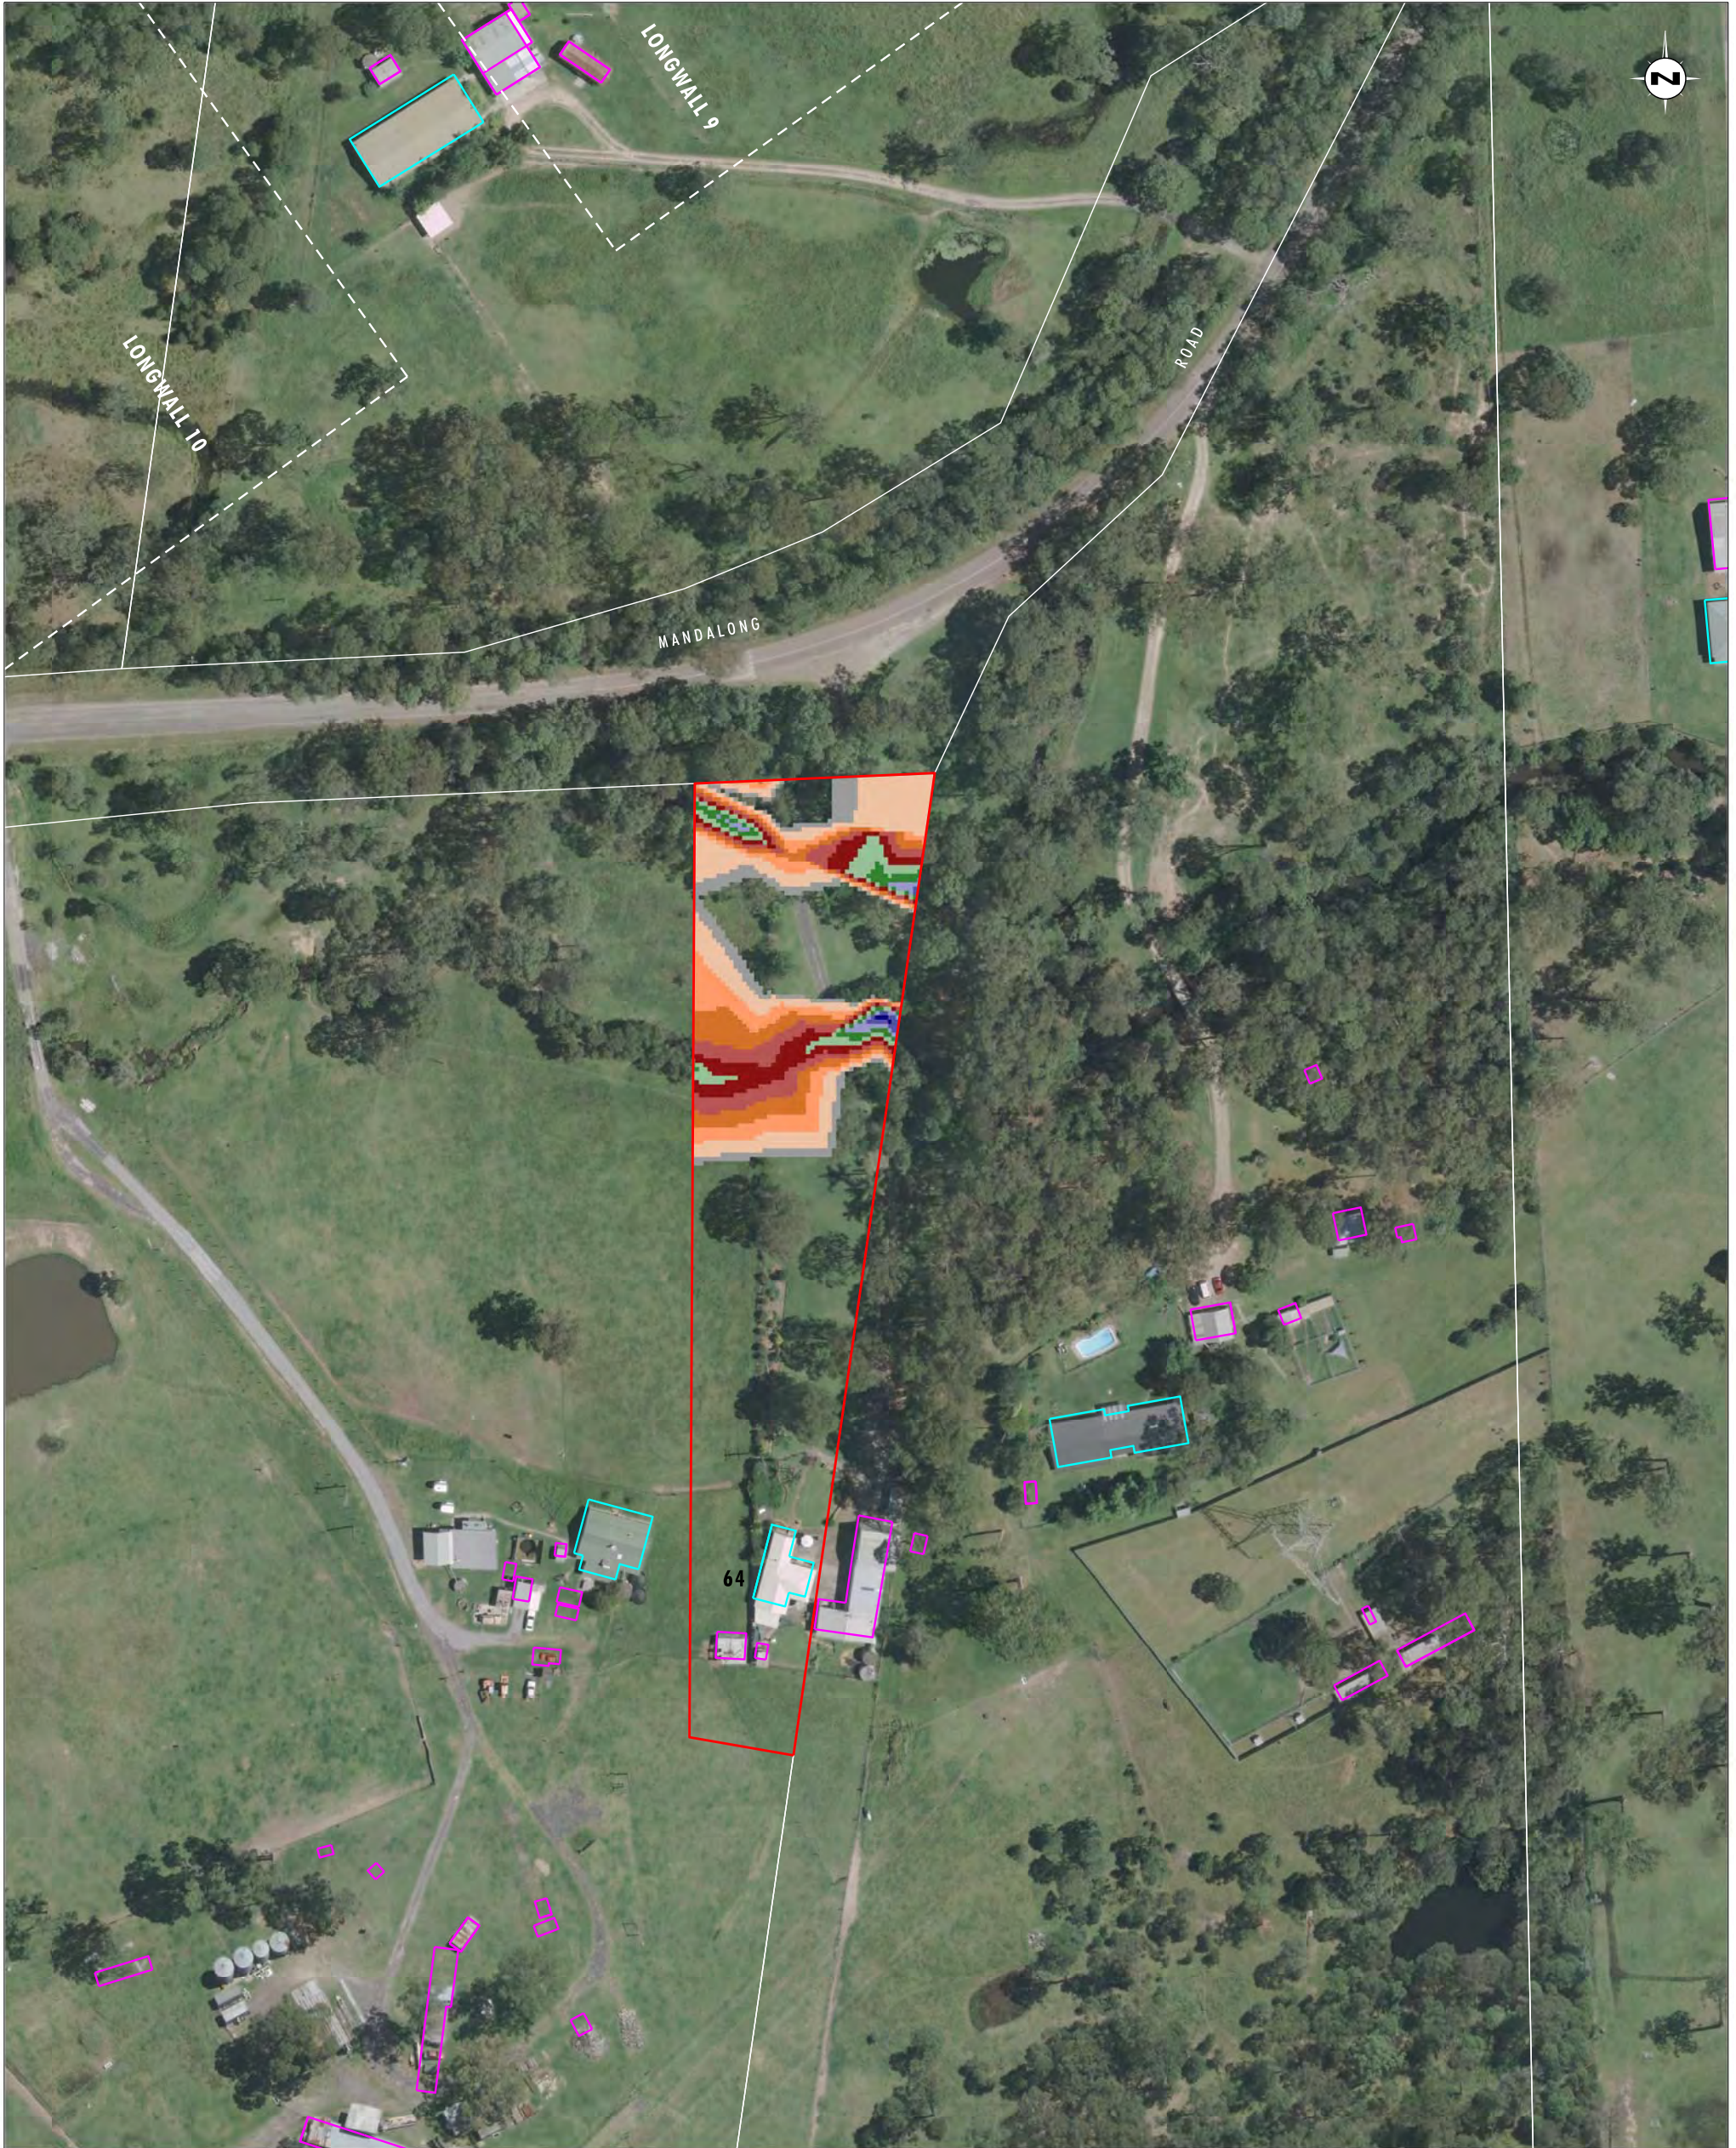
Property 64 - 1 Year ARI Storm Event:  
Maximum Flood Depth Post Mining Landform  
(to Longwall 23)

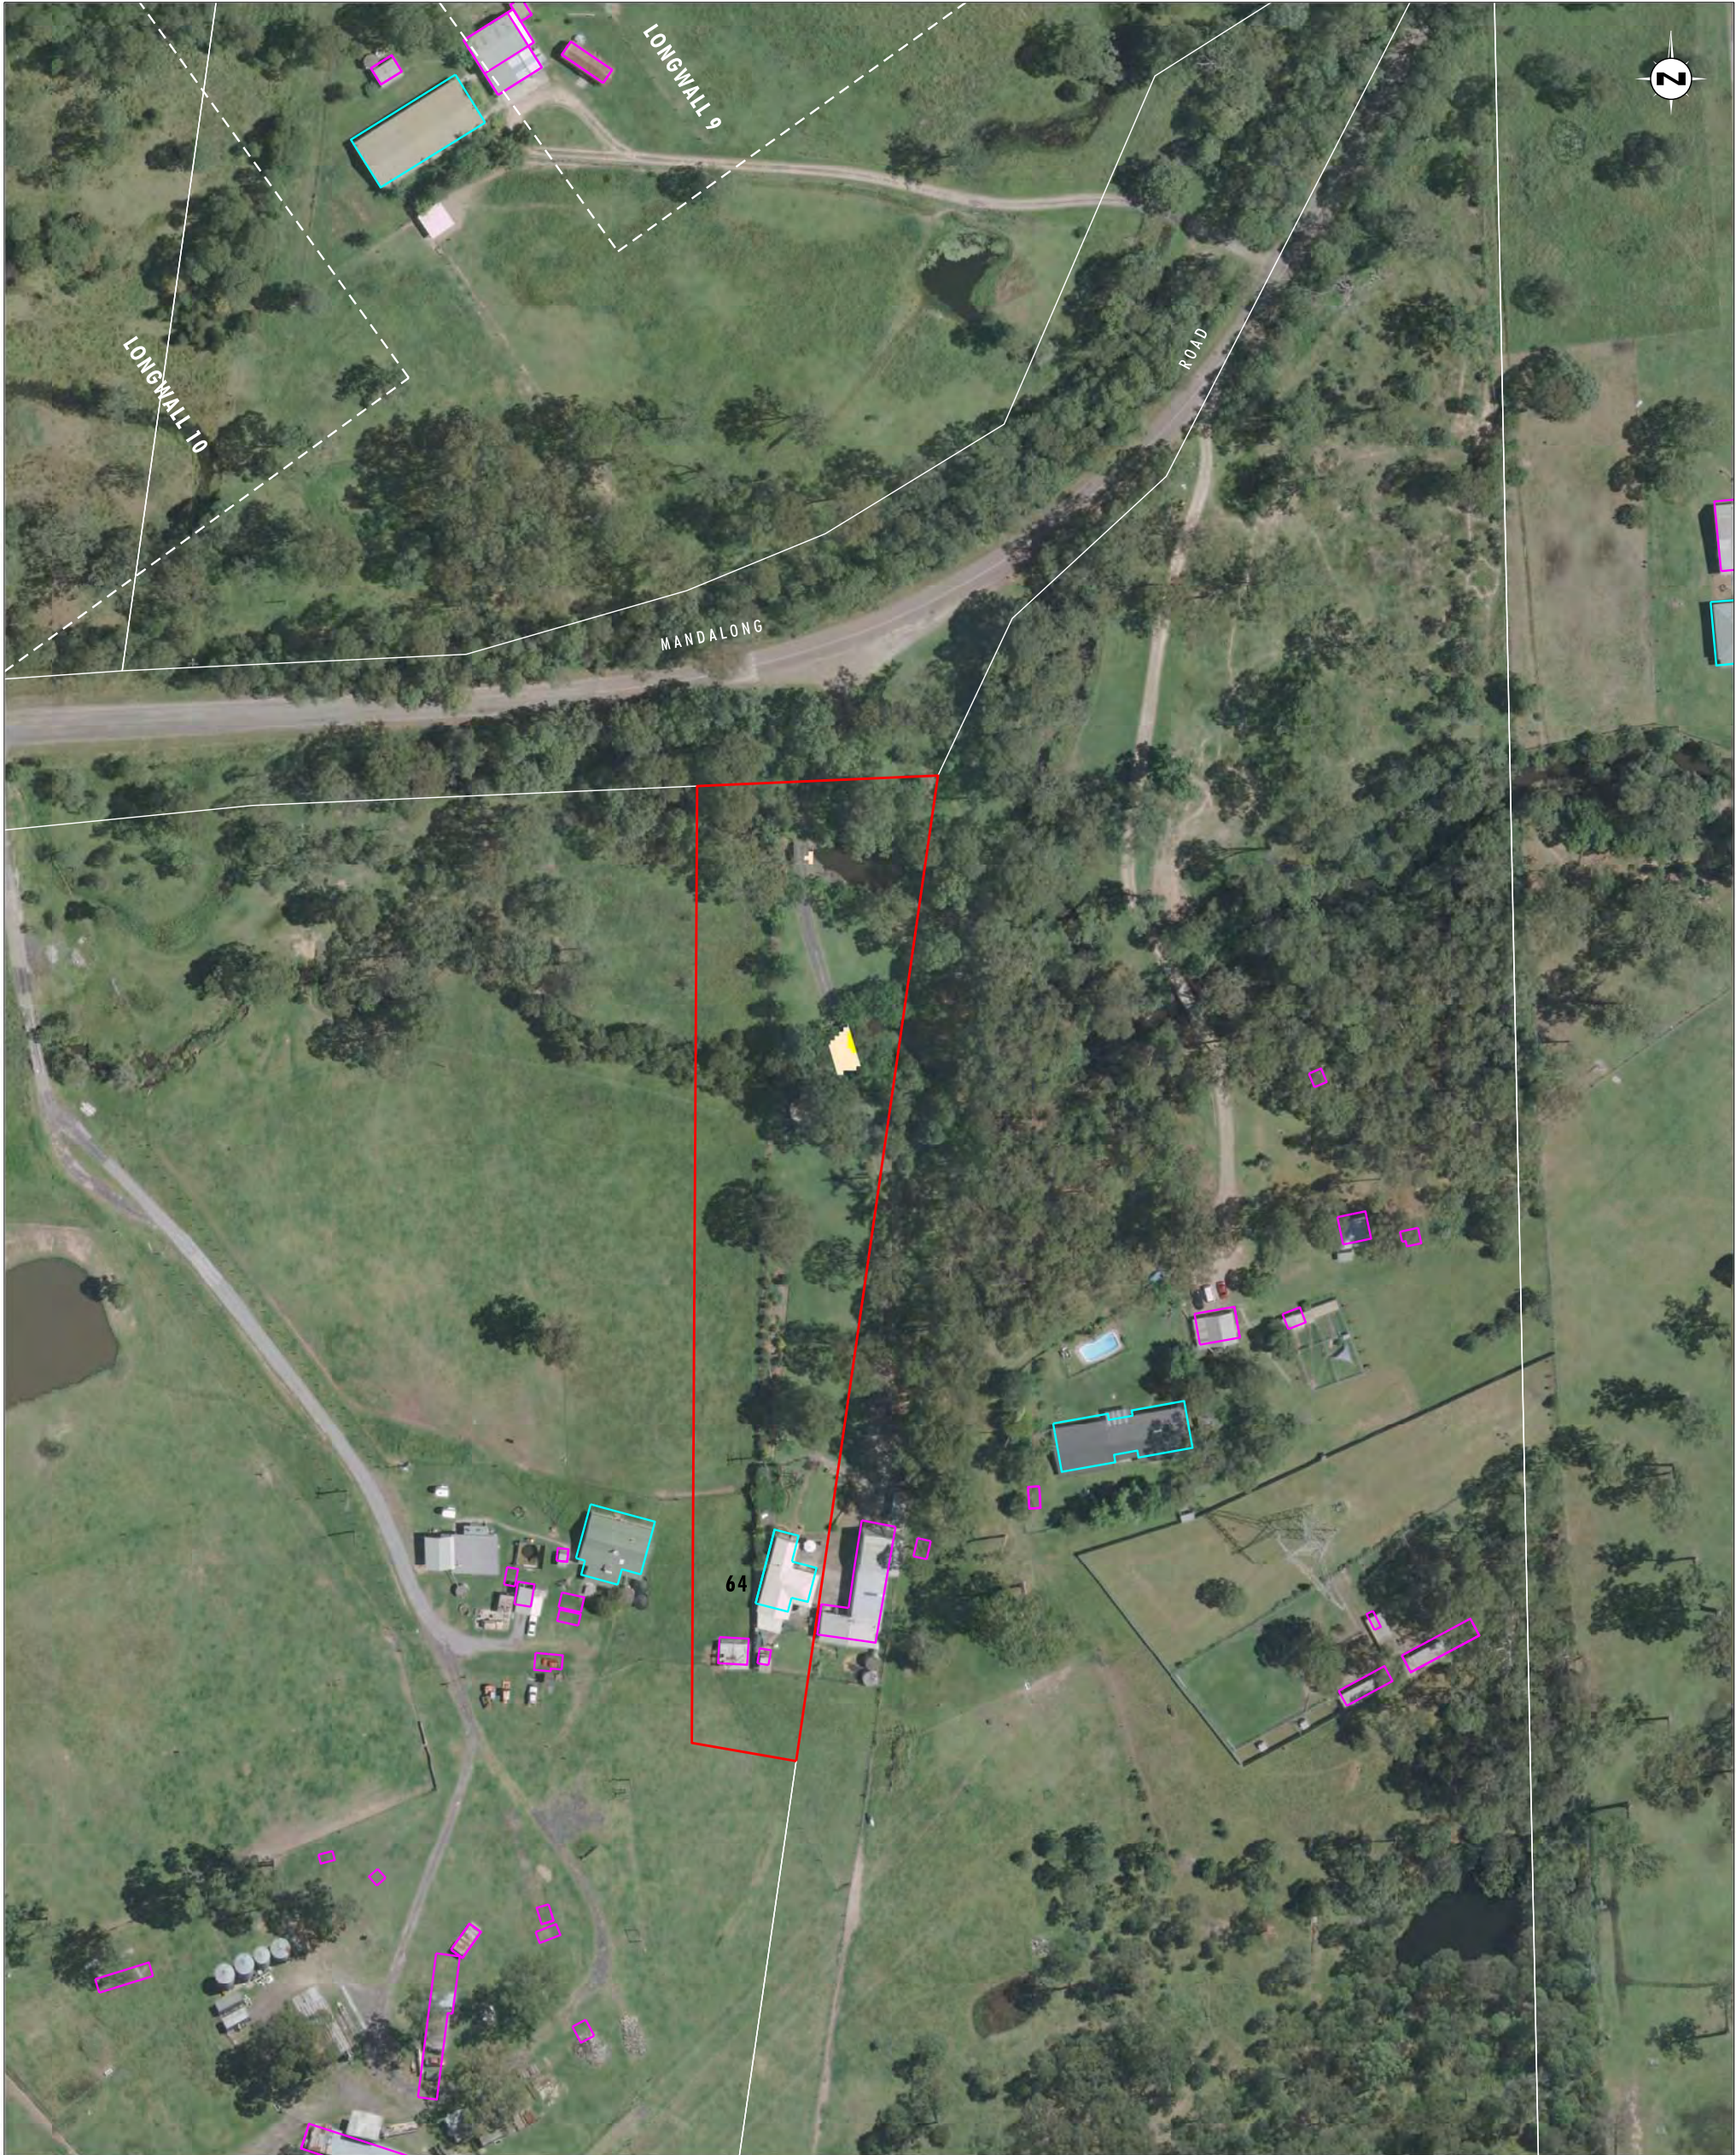
FIGURE 7  
Property 64 - 1 Year ARI Storm Event:  
Maximum Flood Hazard Categories Pre Mining Landform
