***CENTENNIAL COAL
NEWSTAN COLLIERY
ANNUAL REVIEW***

March 2021

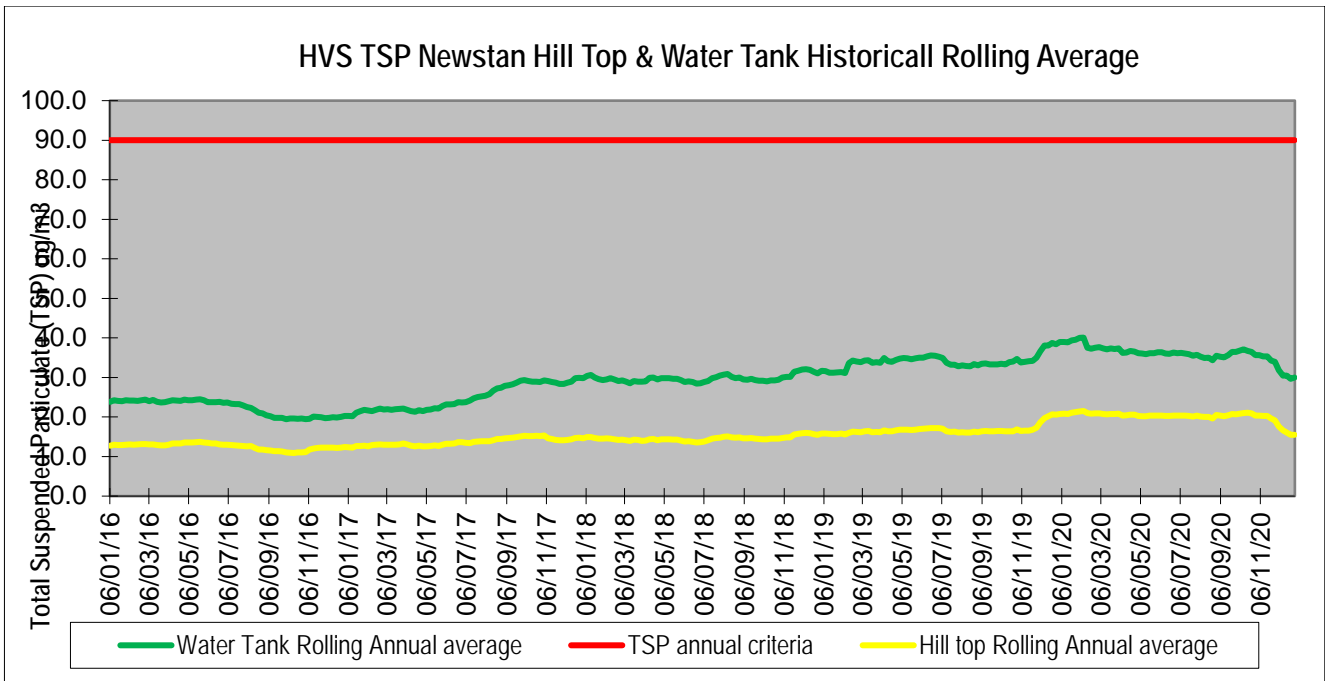
Figure 4 - Newstan Rolling Annual Average for High Volume Dust Sampling for TSP

Annual Average TSP (ug/m ³)		
Year	Hill Top (HVS1)	Water Tank (HVS2)
2016	18.0	20.3
2017	20.1	29.9
2018	23.1	31.1

Annual Average TSP (ug/m3)		
Year	Hill Top (HVS1)	Water Tank (HVS2)
2019	30.4	36.2
2020	23.5	30.0
Newstan Development Consent Criteria (Annual Average)	90 $\mu\text{g}/\text{m}^3$	90 $\mu\text{g}/\text{m}^3$

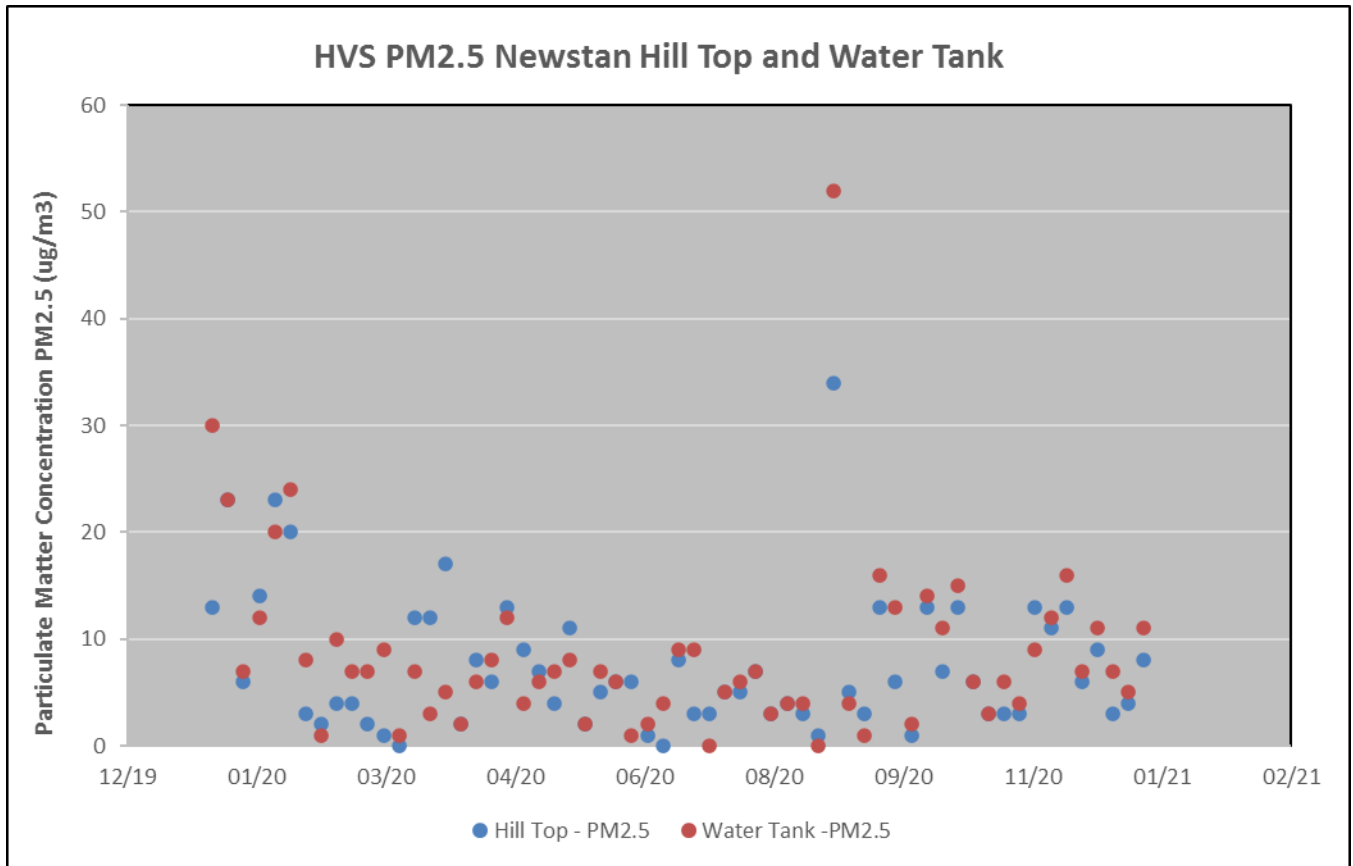
Figure 5 - Newstan High Volume Dust Sampling for PM_{2.5}

Figure 5 displays the 24 hour results for high volume dust sampling results for PM_{2.5} during the reporting period. The annual average high volume dust for PM_{2.5} was 7.5 µg/m³ and 8.5µg/m³ for Hill Top and Water Tank respectively.

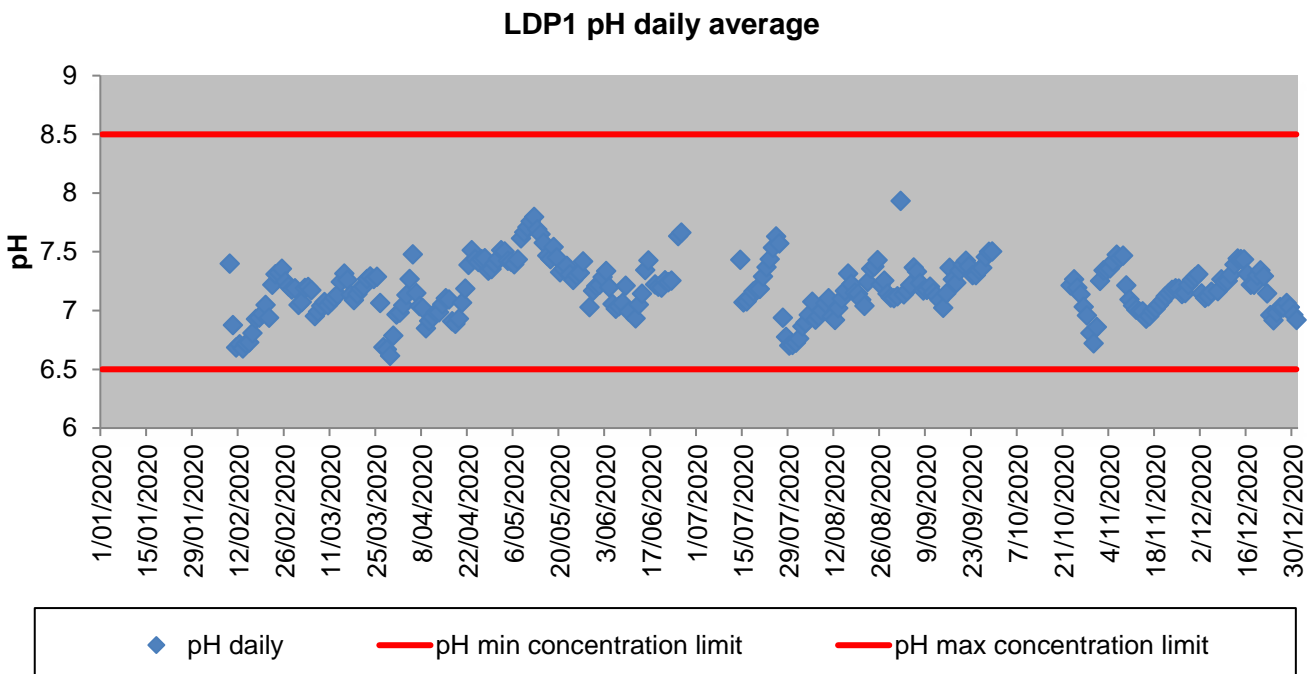
Figure 6 – LDP001 pH 2020

With the increase in LDP001 volume discharge and the installation of the CWP, Newstan Colliery has generally been able to maintain the Fassifern Storage at a low level. Figures 6, 7, 8 and 9 show the pH, total suspended solids (TSS), oil & grease & conductivity for discharge waters through LDP001 in 2019. Note: If results are less than the limit of reporting, a value of 0 is put in for the development of the below graphs.

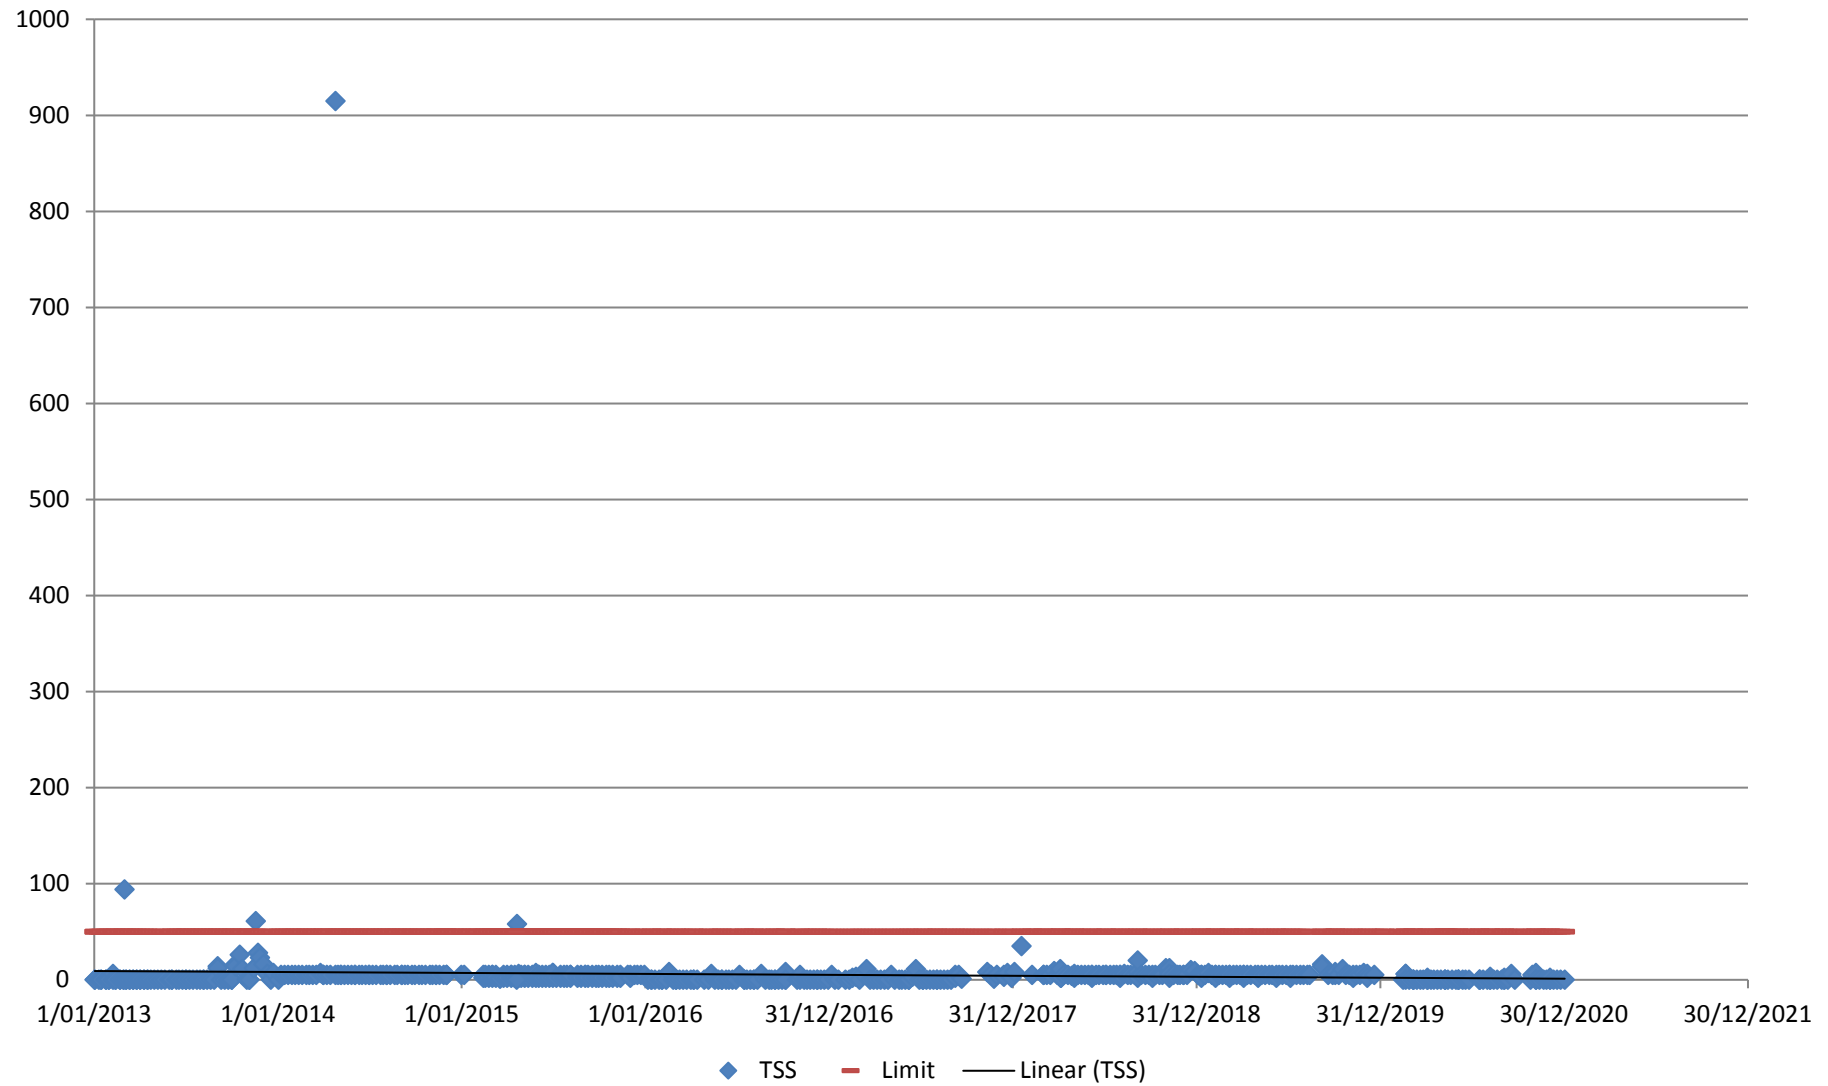
TSS may exceed the limits at times, but this generally aligns with overflows from Graunch's Dam through LDP001, rather than the water discharged from the underground Fassifern Seam.

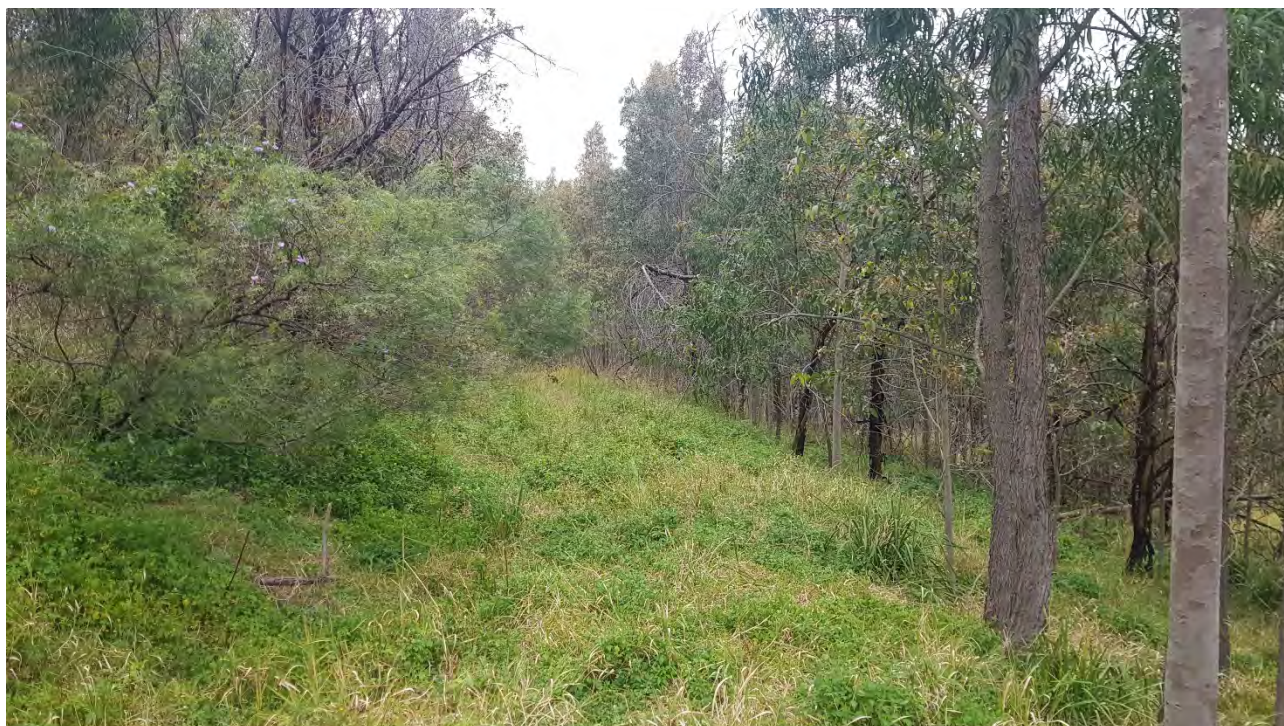
Rehabilitation Site A is situated in an area that has been subject to vegetation rehabilitation through direct seeding. It is the most western site of the three rehabilitation sites and is displayed in **Plate 1**.

Plate 1 **Acacias and non-native grasses at Rehabilitation A**

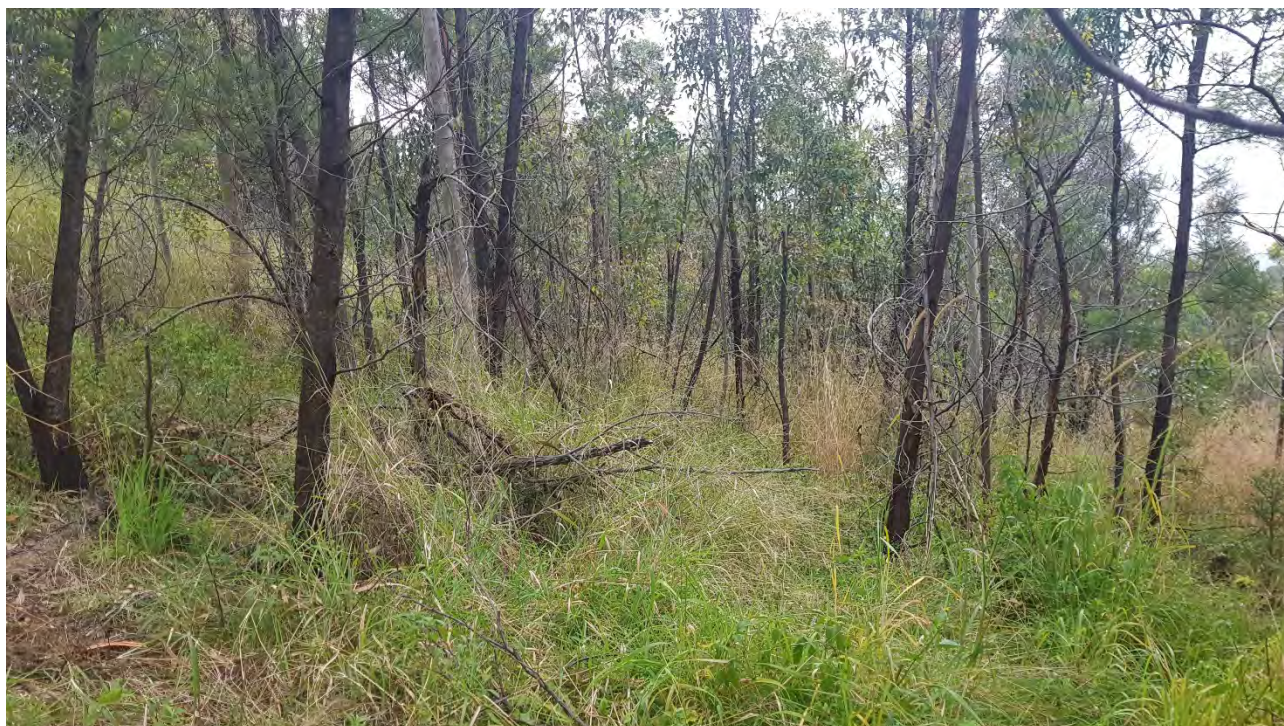
Rehabilitation Site B is situated in an area that has been subject to vegetation rehabilitation through direct seeding. It is situated between Rehabilitation Site A and Rehabilitation Site C and is displayed in **Plate 2**.

Plate 2 Senescing Acacias and grasses at Rehabilitation Site B

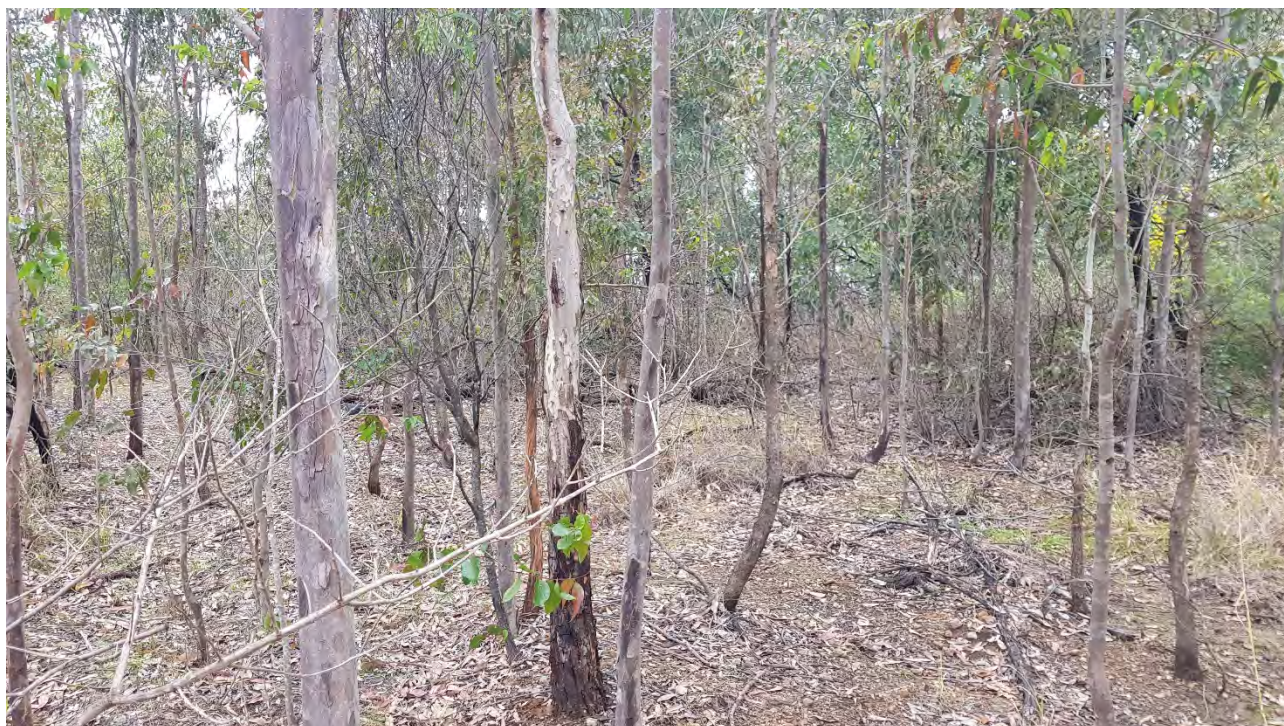
Rehabilitation Site C is situated in the mining rehabilitation area that has been subject to vegetation rehabilitation through direct seeding. It is situated to the east of Rehabilitation Site B and is displayed in **Plate 4**.

Plate 4 **Vegetation at Rehabilitation C**

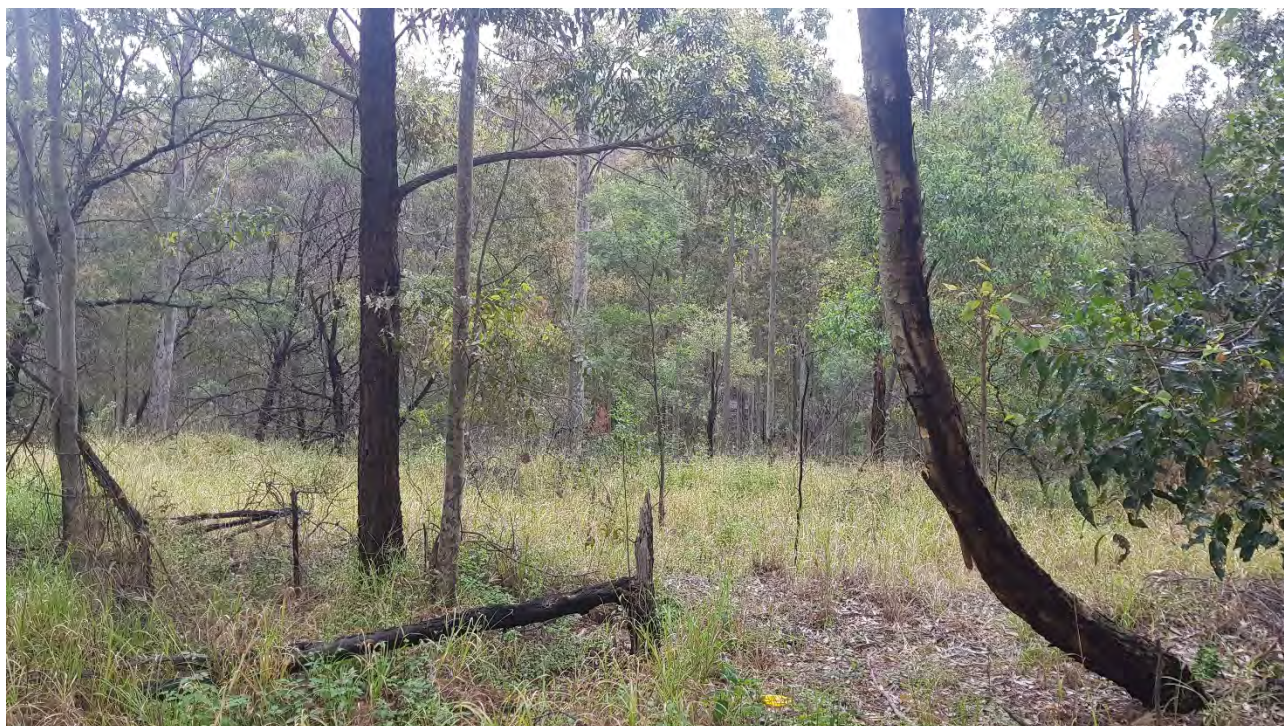
Analogue Site 1 illustrates greater diversity in vegetation structure and species in comparison to the other rehabilitation areas within the monitoring area. It is situated on the western side of the monitoring area boundary in close proximity to Miller Road. **Plate 6** displays vegetation at Analogue Site 1.

Plate 6 Analogue Site 1 Vegetation

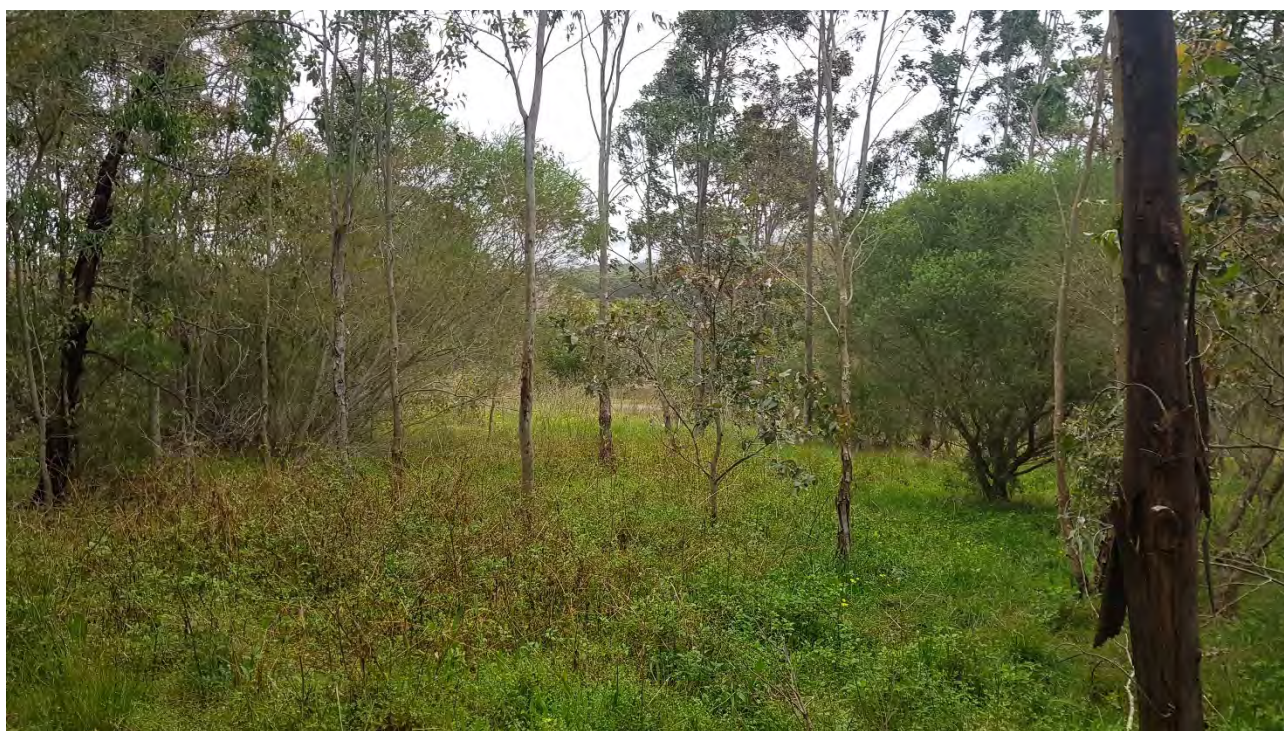
Analogue Site 2 is located outside the Newstan Colliery Consolidated Consent Boundary to the north eastern corner. It is largely a regenerating area aimed at representing MU 30; however, due to its' regenerating nature, it consists primarily of juvenile eucalypts and a layer of native and exotic herbs and grasses. **Plate 8** displays vegetation at Analogue Site 2.

Plate 8 Analogue Site 2 Vegetation

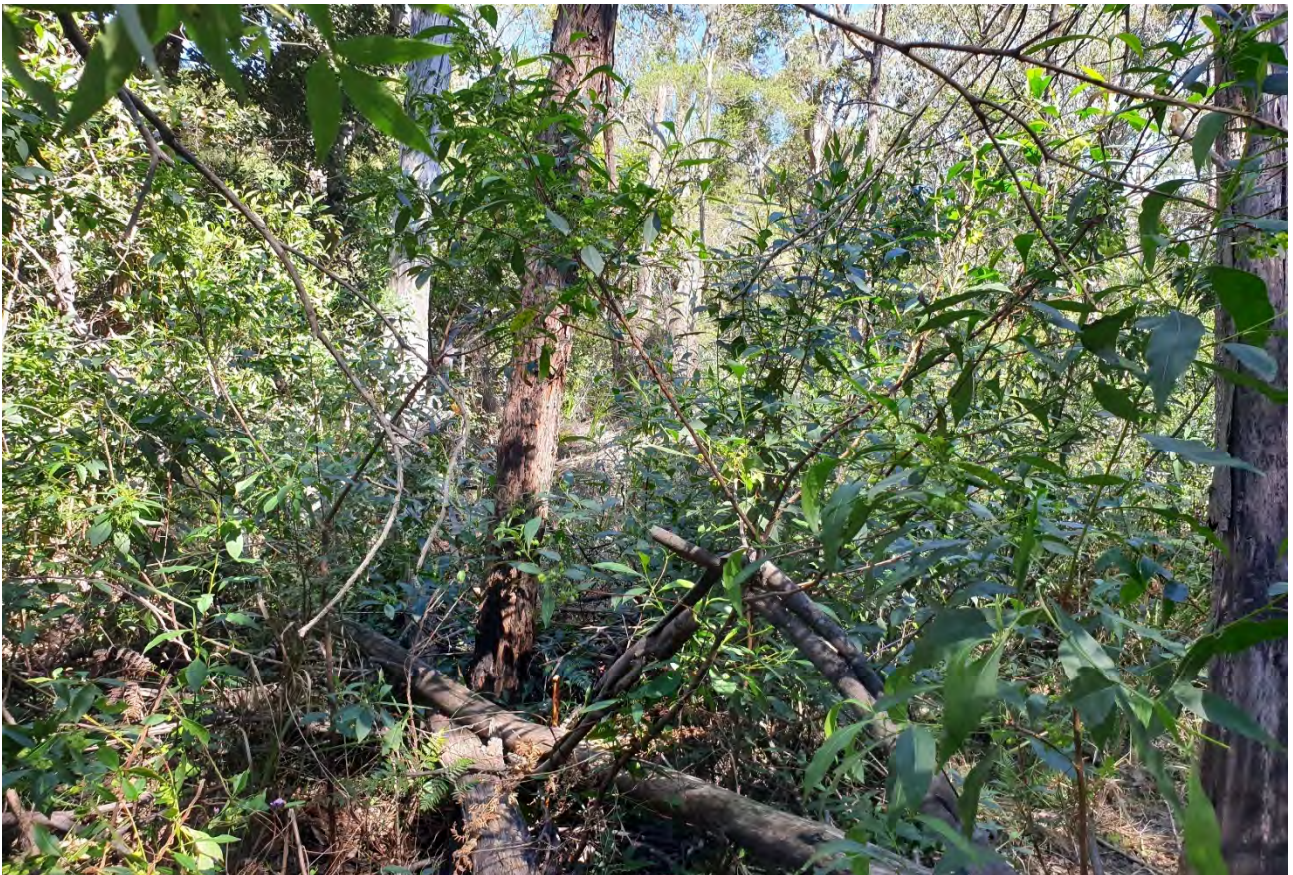
The EEC site is located to the southeast of the mining area and contains riparian vegetation surrounding a permanently inundated area and creek. The broader area is dissected by multiple tracks and an electrical easement. **Plate 9** displays vegetation within the EEC site.

Plate 9 Looking south into the EEC Site

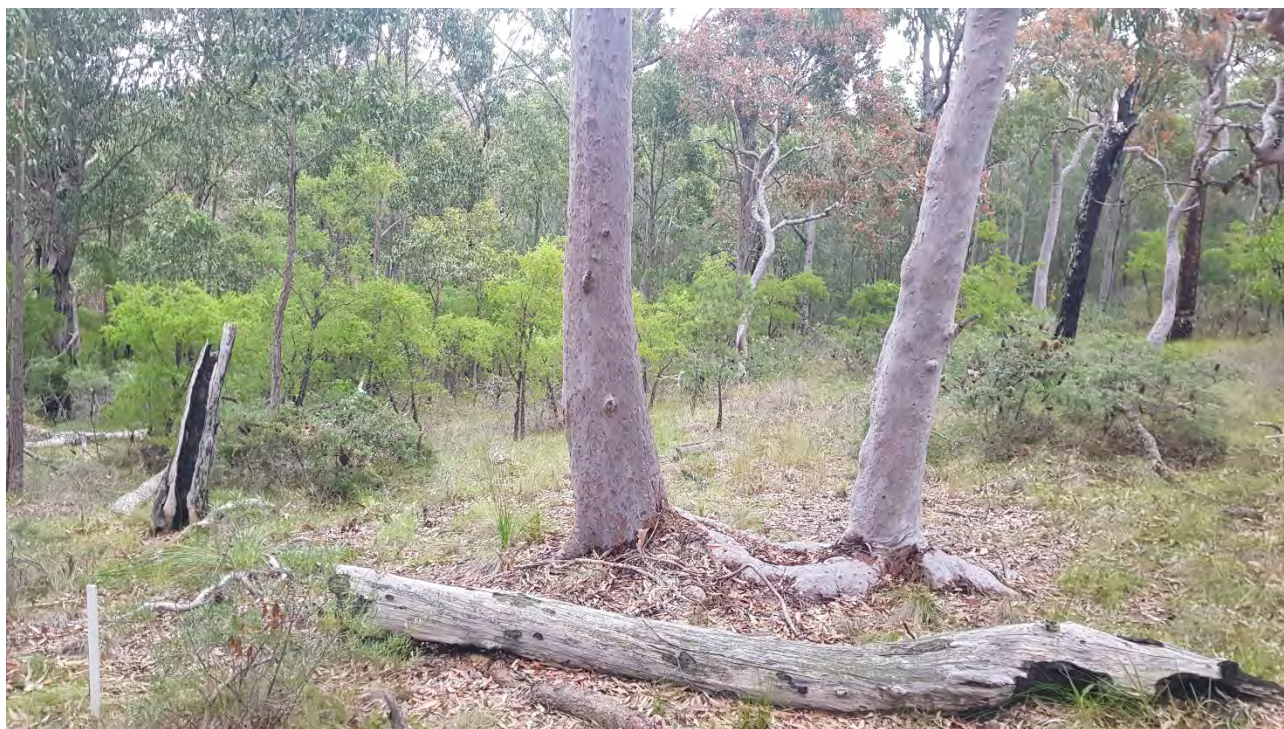
This site is situated outside the monitoring area to the south west, in relatively undisturbed vegetation. Vegetation within the site represents the most dominant vegetation community within the Newstan Colliery Consolidated Consent Boundary, which is MU 30 Coastal Plains Smooth-barked Apple Woodland. **Plate 11** depicts the vegetation within this site.

Plate 11 Dominant Community site with MU 30 vegetation

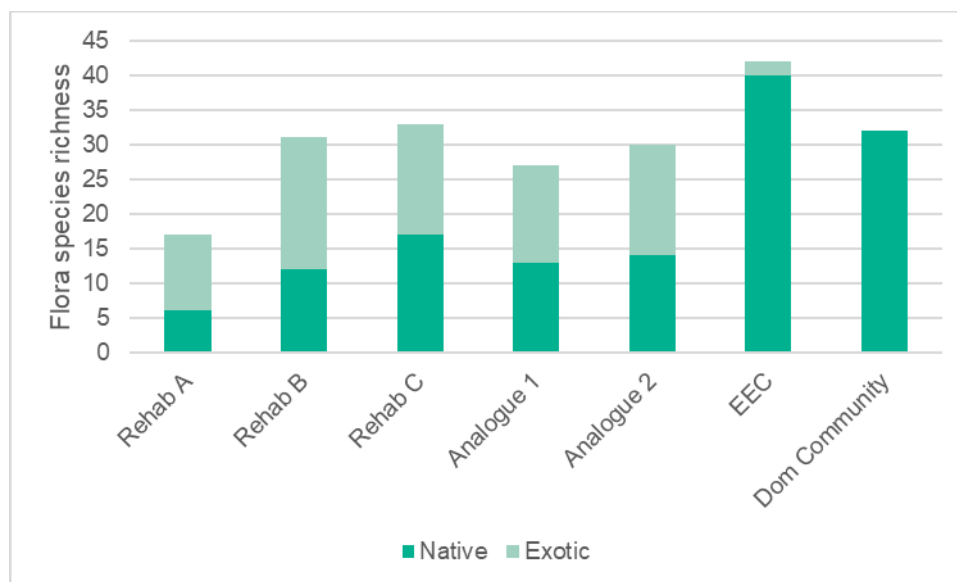
Graph 4 2020 native and exotic flora species richness for each site

A total of 136 flora species were detected from all flora quadrats. A full list of results can be found in **Appendix D**. **Graph 4** shows a breakdown of native and exotic flora species richness for this survey. As expected, the reference sites showed a higher proportion of native species, with Rehab A and Rehab B containing the highest proportion of exotic species.

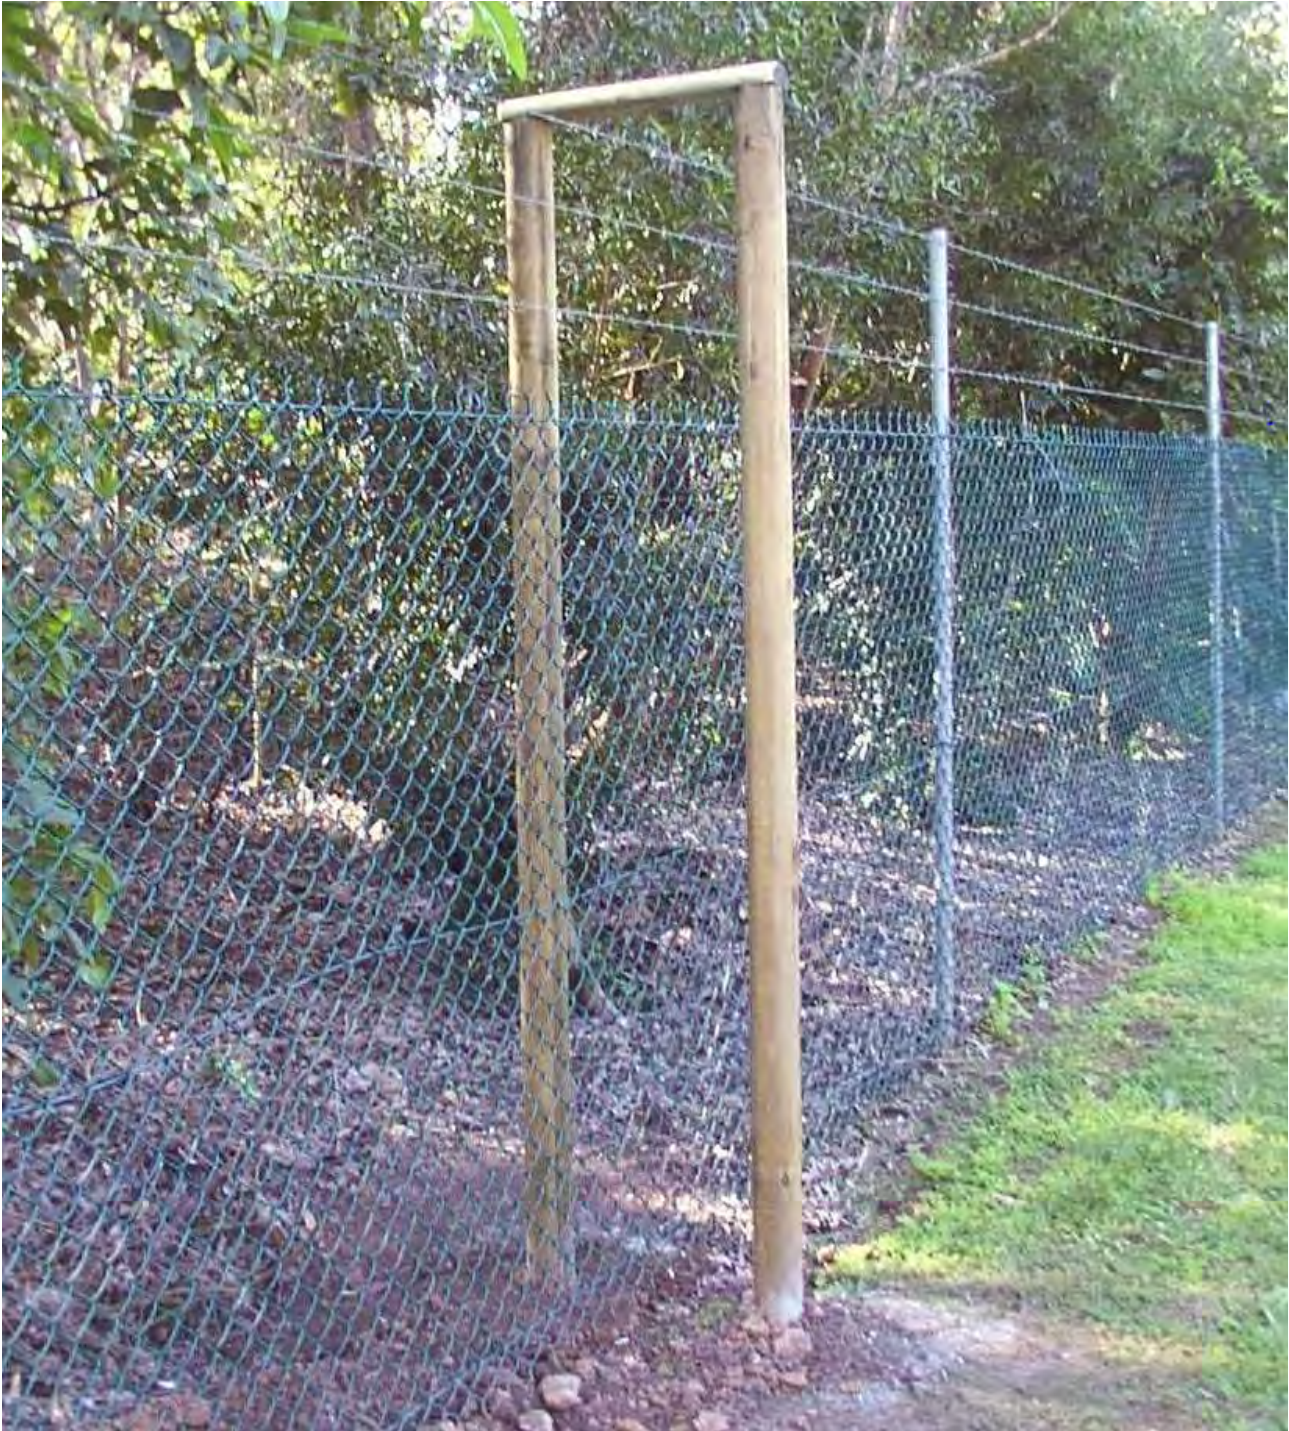
Plate 17: Fauna fencing 'bridge'

barrier potentially representing an opportunity to improve local connectivity. Given that many of these fences appear to be necessary barriers to vehicles or human activity, modifications to be considered may include replacement of barbed wire to avoid entanglement, removal of wires to form a 50cm gap between rails/strands and the ground, small gateways at ground level, installation of poles between two trees on either side of the fence, or construction of pole bridges as pictured in **Plate 17**. Increased connectivity may also increase movement of feral animals within the site, so control of species such as the foxes and goats sighted in this survey is also recommended.

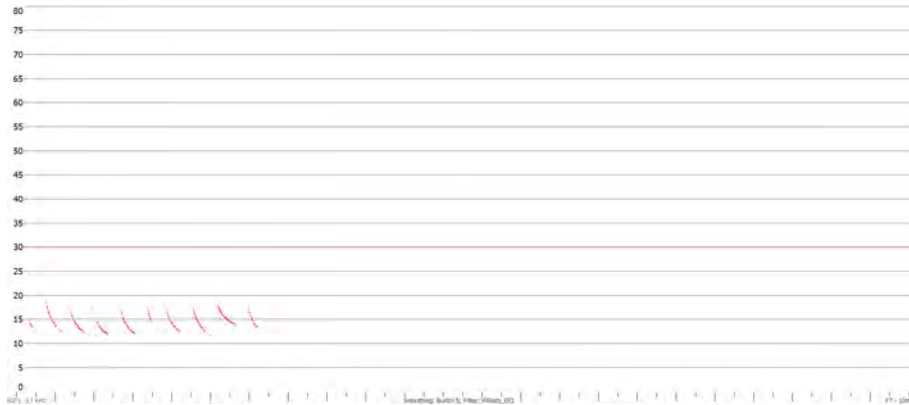
Figure 4-1: *Austronomus australis* definite call

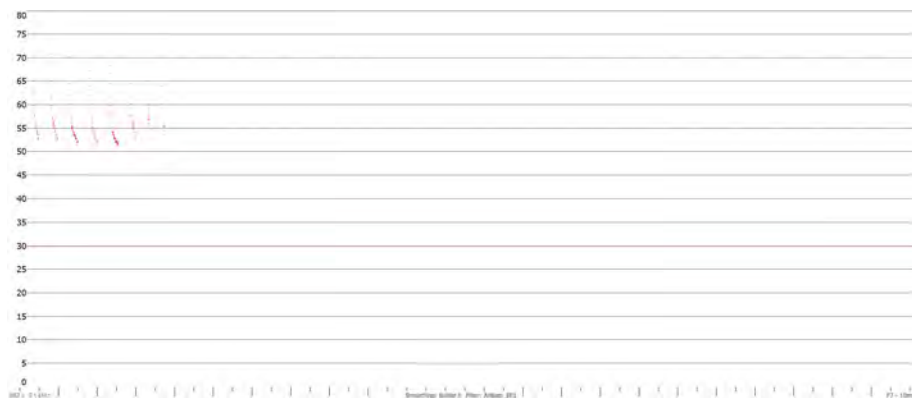
Figure 4-4: *Chalinolobus morio* definite call

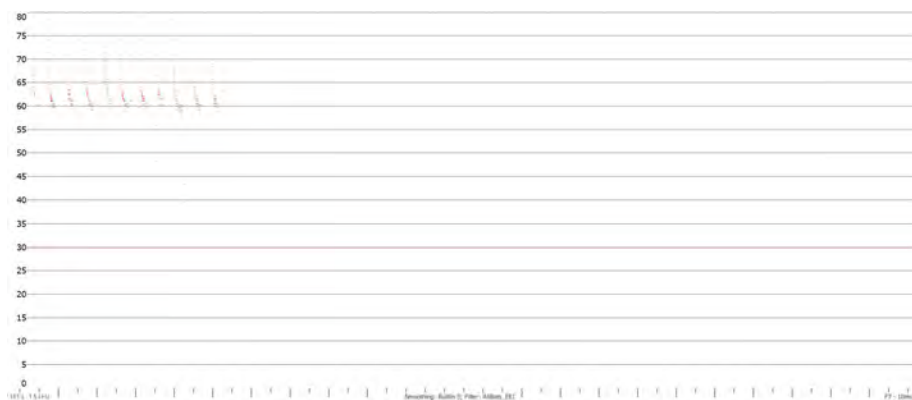
Figure 4-5: *Miniopterus australis* definite call

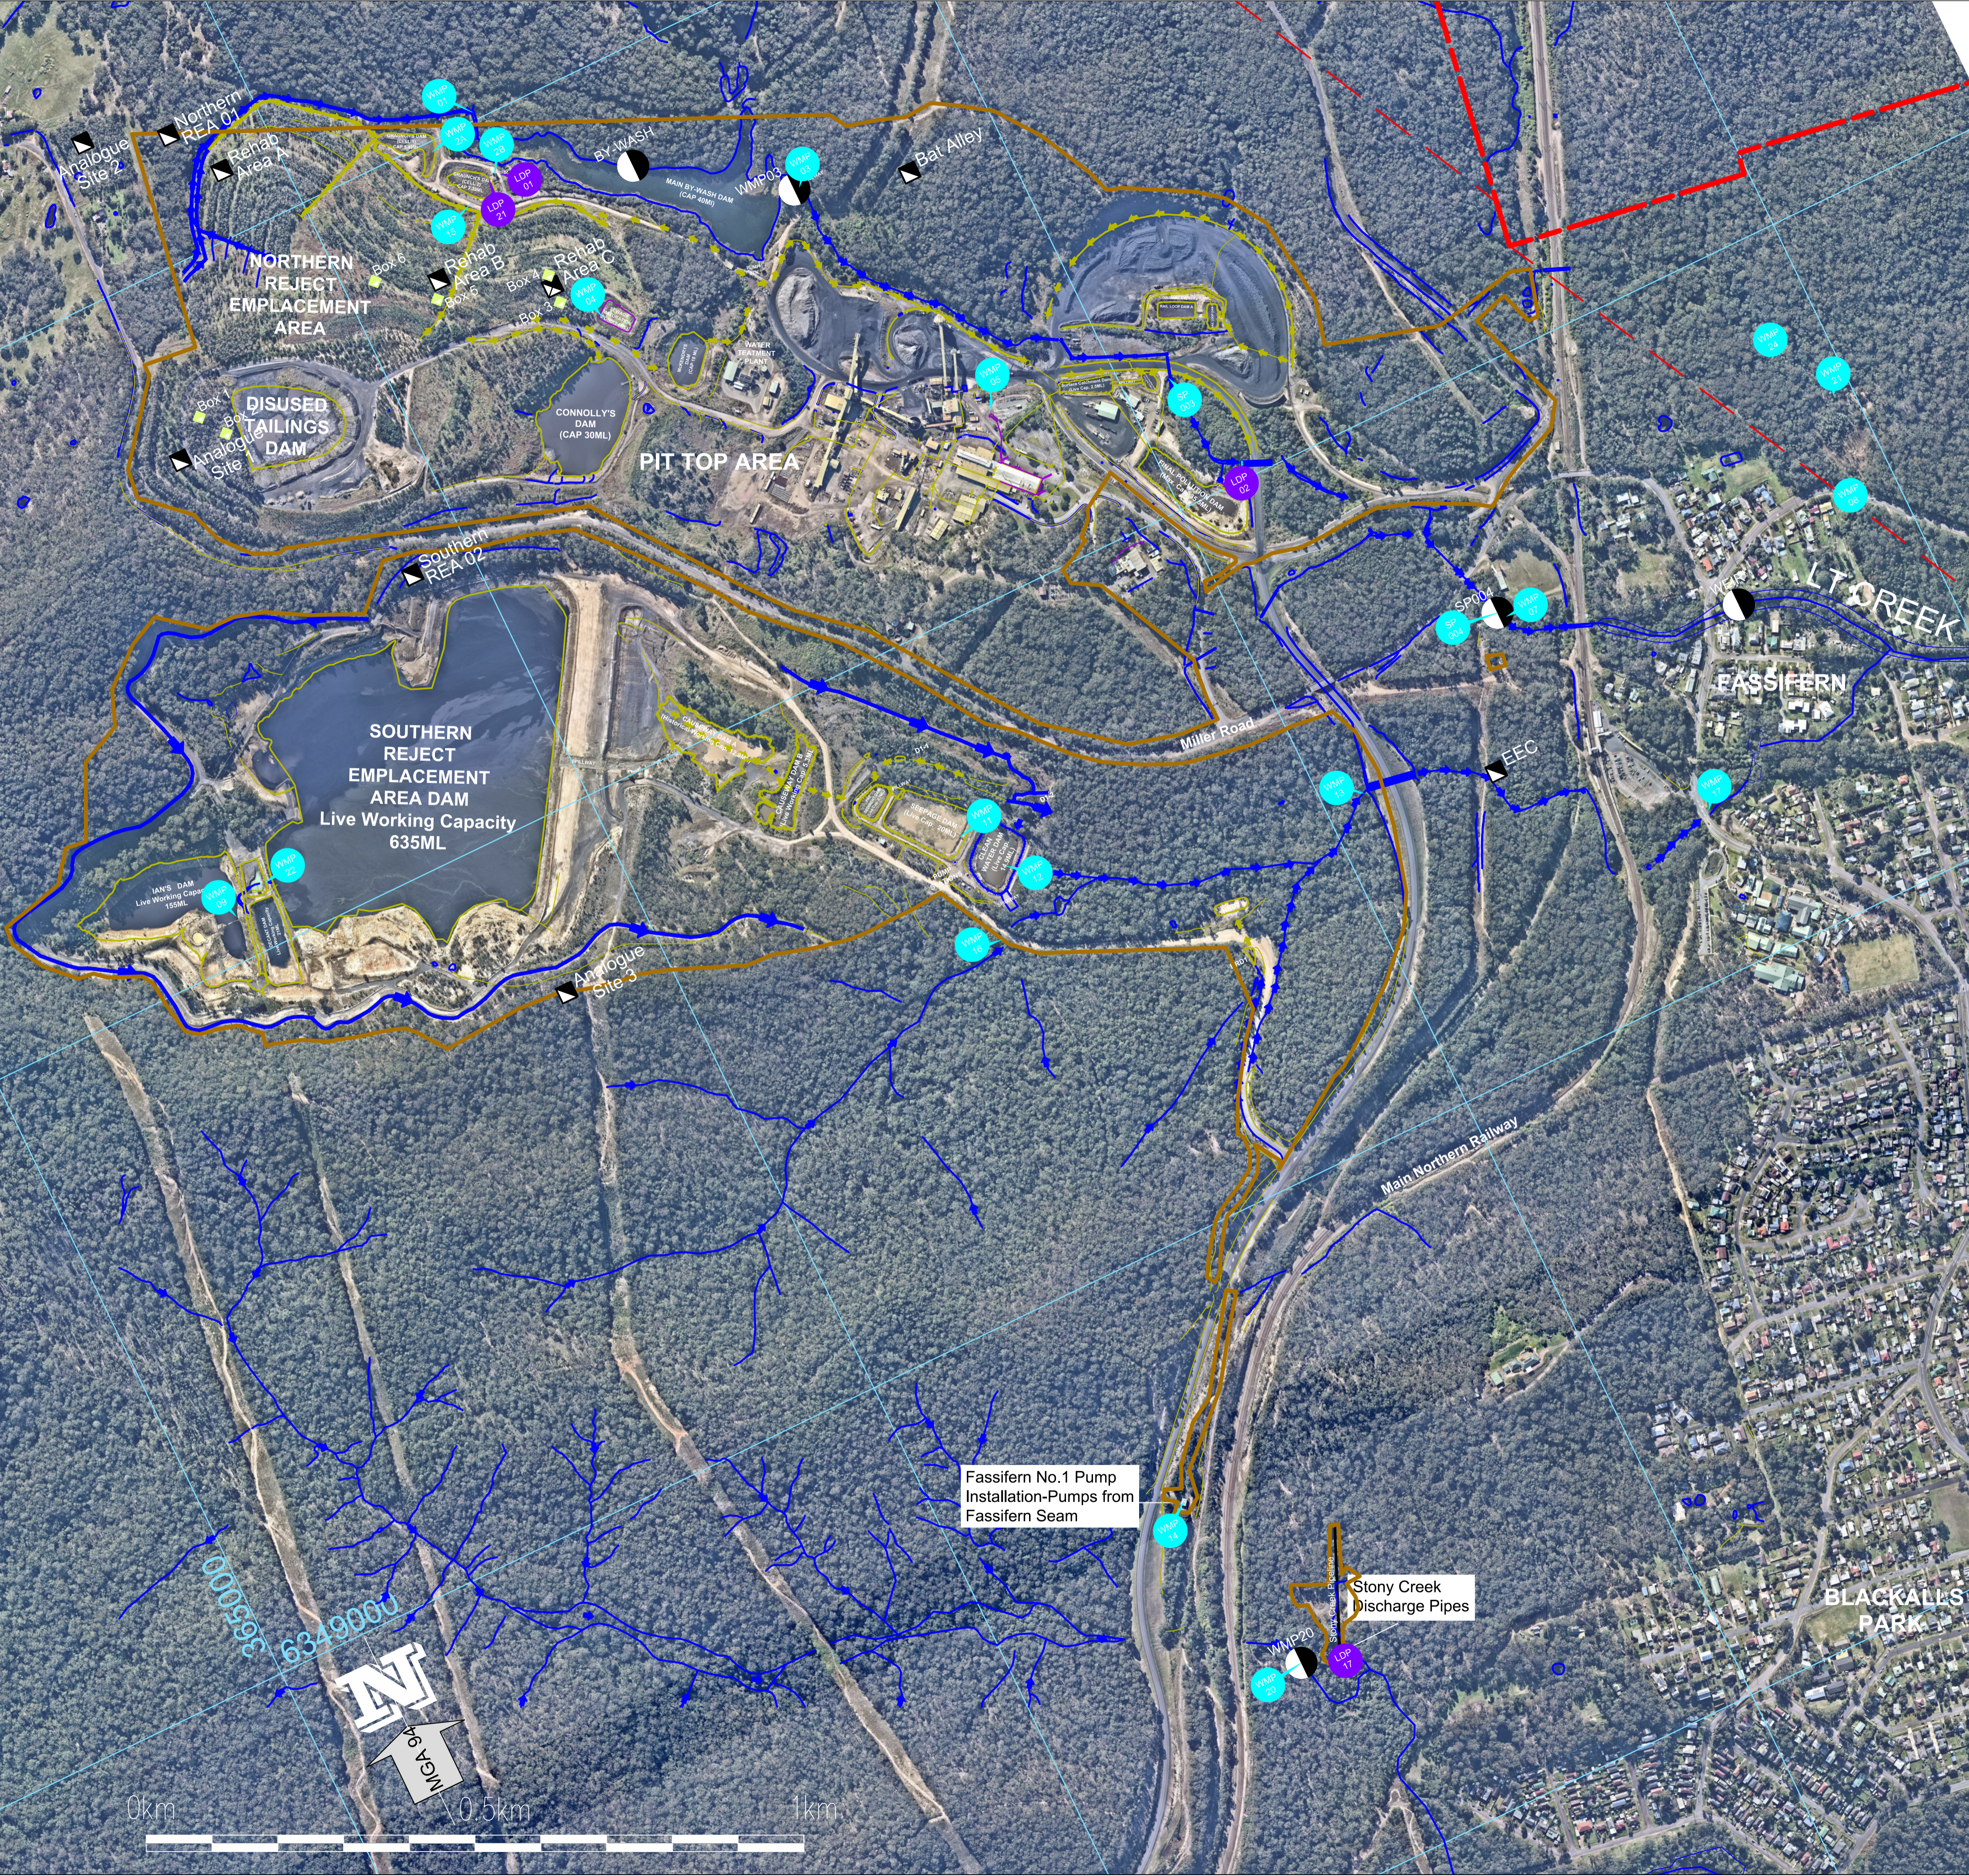
NEWSTAN COLLIERY LICENCED DISCHARGE POINTS				
Name	Easting	Northing	Description	
LDP001	366292	6350908	Below Graunch's Dam - Also known as WMP02	
LDP002	367072	6350010	Below Final Pollution Control Dam - Also known as WMP06	
LDP017	366464	6348332	Stony Creek Pipeline - Also known as WMP19	
LDP021	366271	6350911	Graunch's Dam Overflow Weir	
SURFACE WATER MONITORING POINTS				
Name	Easting	Northing	Description	
WMP01	366287	6351020	Upstream of LDP001	
WMP2A	366211	6350984	Graunch's Dam Cell 1	
WMP2B	366282	6350913	Graunch's Dam Cell 2	
WMP03	366691	6350695	EPL Point 19 - Bywash Dam Weir - Downstream of LDP001	
WMP04	366335	6350646	Sewage Maturation Pond	
WMP05	366806	6350261	Waste Water Treatment Plant	
WMP07	367377	6349639	LT Creek downstream of Colliery U/S of Railway, D/S of Miller Rd	
WMP08	367927	6349578	Seepage from the GNS into tributary of LT Creek sampled South of Macquarie St	
WMP09	365438	6350067	Upstream of the SREA

WMP11	366483	6349698	SREA Seepage Dam	
WMP12	366526	6349628	SREA Clean Water Dam (proposed LDP003)	
WMP13	367063	6349491	EPL Point 6 - Southern branch LT Creek U/S of Eraring Haul Road	
WMP14	366282	6350913	Pump line from Fassifern Seam No.1 Bore	
WMP15	366225	6350887	NREA seepage pipe	
WMP16	366470	6349529	EPL Point 5 - SREA LT Creek Side catchment	
WMP17	367525	6349240	Southern Branch LT Creek below Railway Station	
WMP20	366404	6348341	EPL Point 18 - Located in a tributary of Stony Creek, upstream of WMP19	
WMP21	367970	6349726	Located within the Wetland system, upstream of WMP8	
WMP22	365501	6350094	The decant from Stage 2-4 dam into the Fassi seam	
WMP24	367920	6349844	Seepage from the GNS into tributary of LT Creek sampled North of Macquarie St	
SP003	367071	6350187	EPL Point 3 - Upstream LDP002	
SP004	367366	6349650	EPL Point 4 - Downstream LDP002	
NEWSTAN COLLIERY AQUATIC MONITORING POINTS
