***CENTENNIAL COAL
NEWSTAN COLLIERY
ANNUAL REVIEW***

March 2021

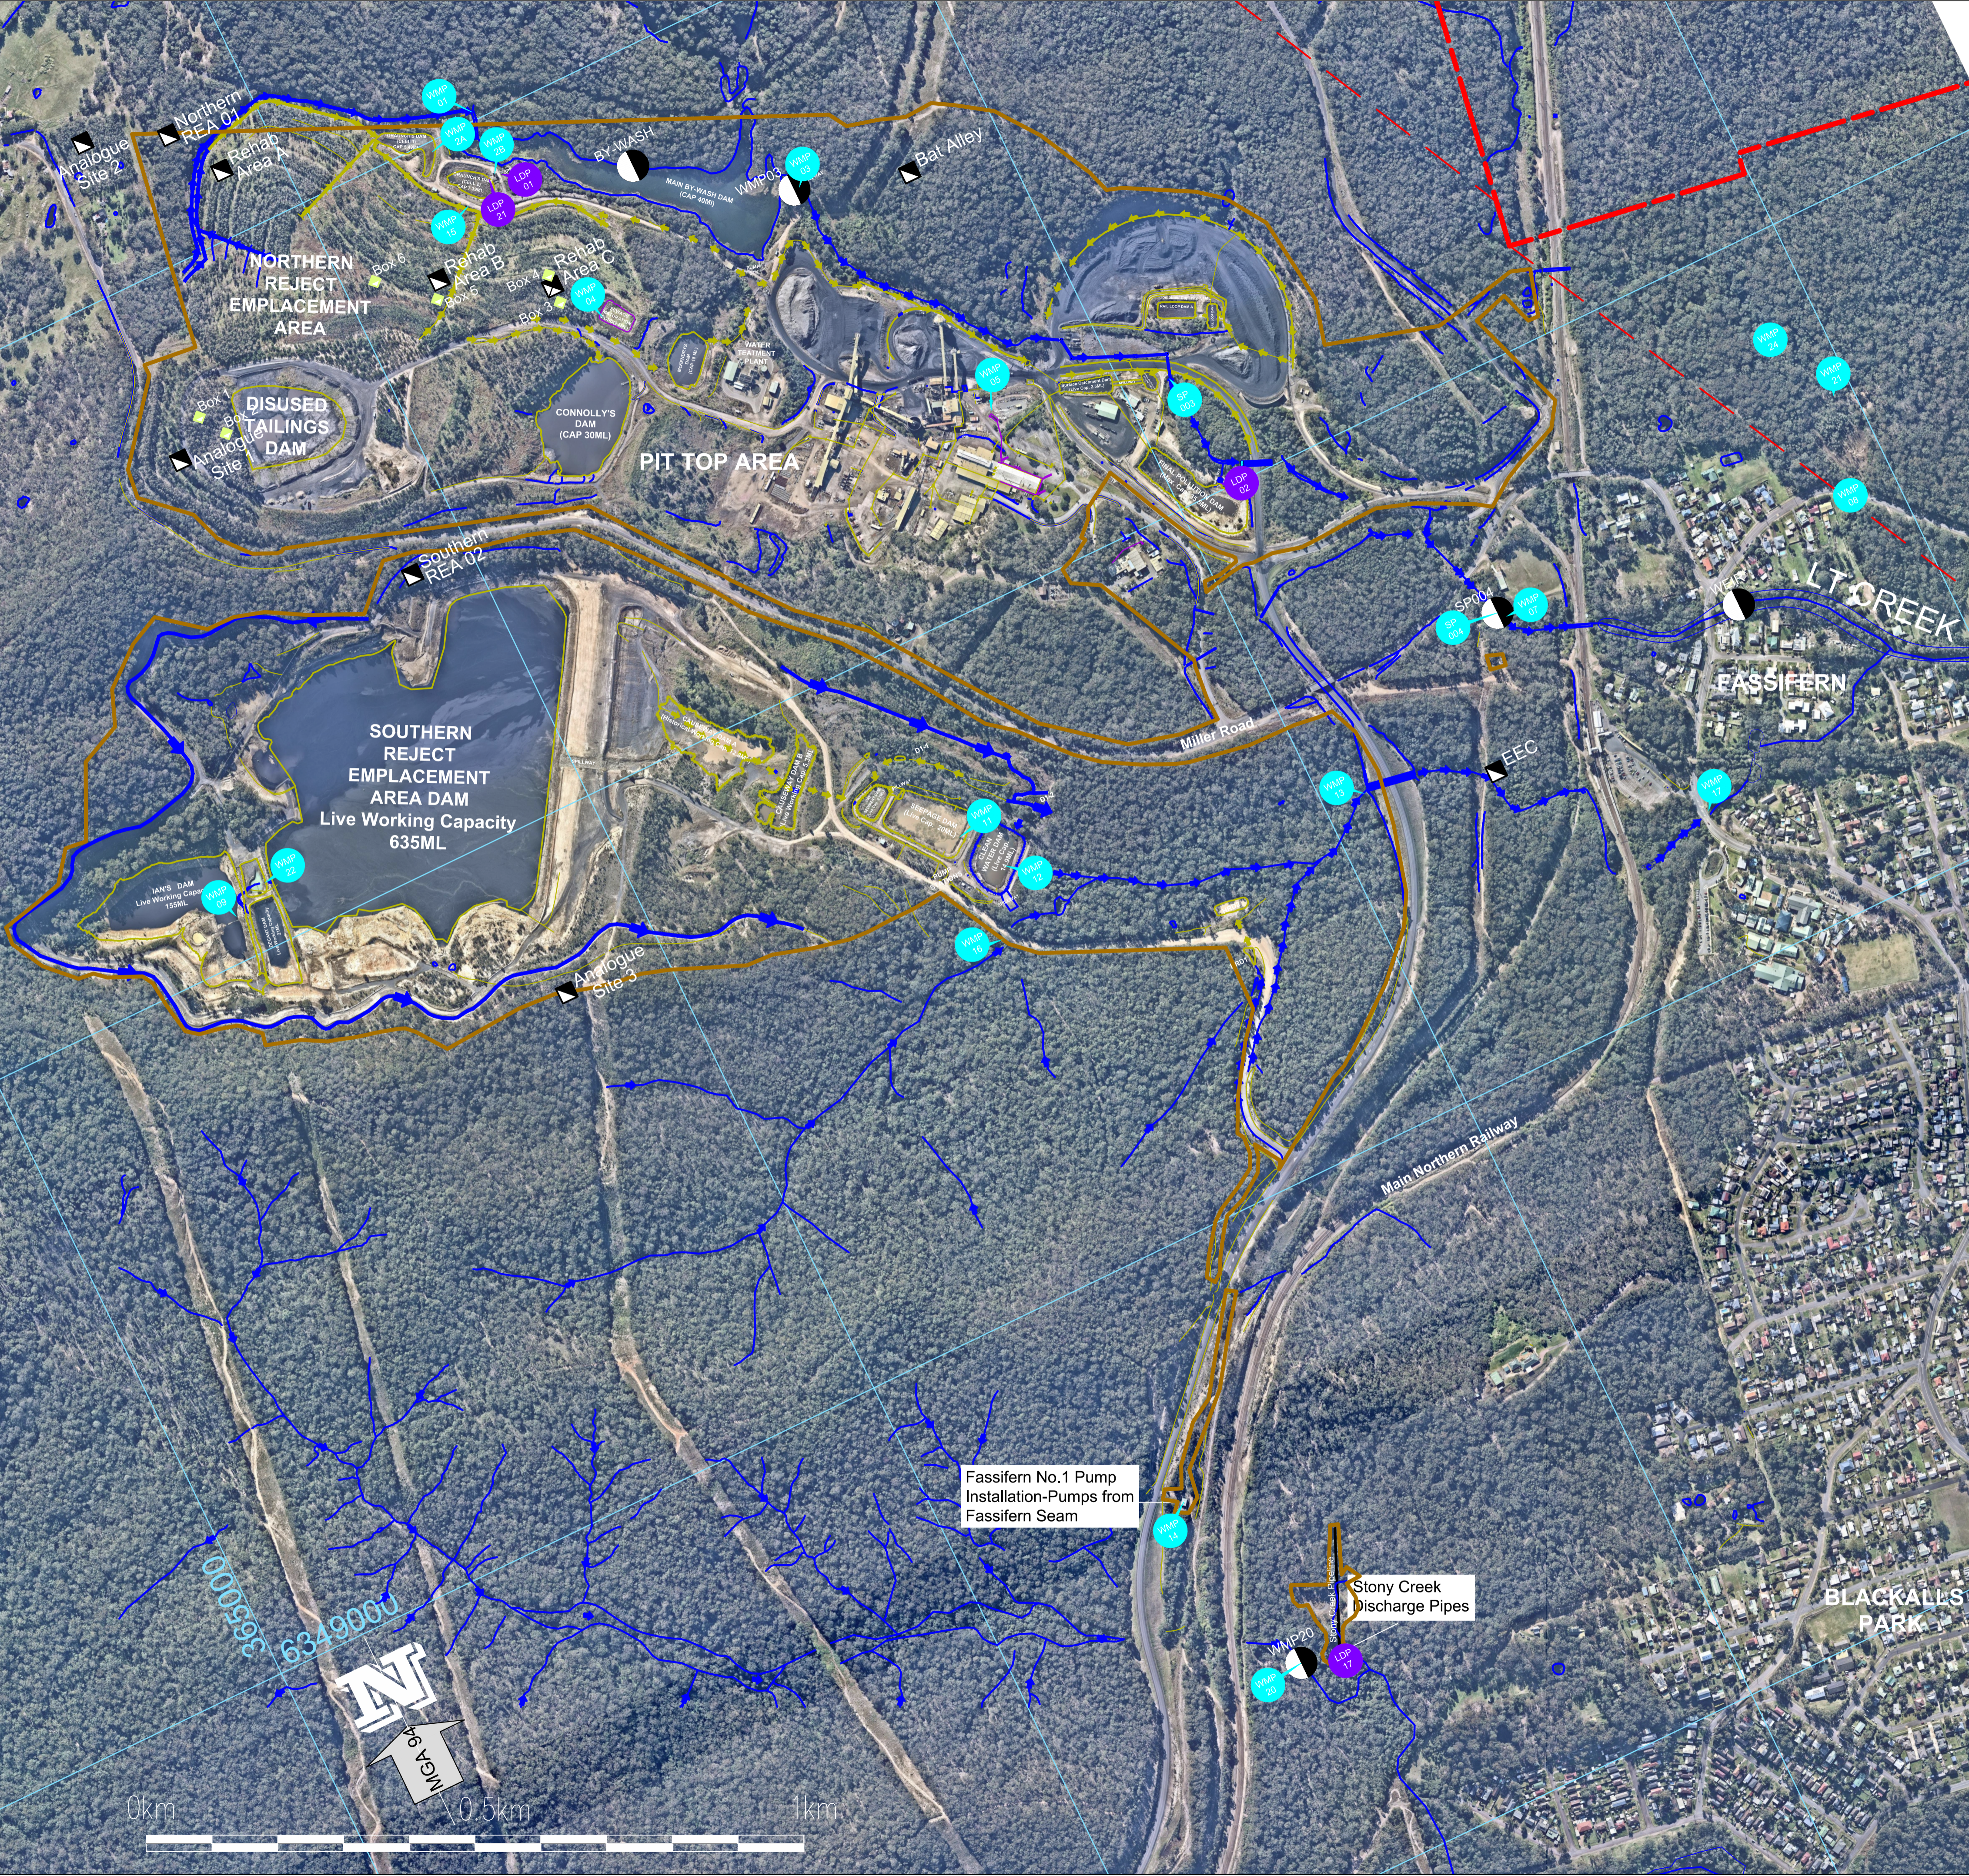
NS3332

NEWSTAN COLLIERY LICENCED DISCHARGE POINTS				
Name	Easting	Northing	Description	
LDP001	366292	6350908	Below Graunch's Dam - Also known as WMP02	
LDP002	367072	6350010	Below Final Pollution Control Dam - Also known as WMP06	
LDP017	366464	6348332	Stony Creek Pipeline - Also known as WMP19	
LDP021	366271	6350911	Graunch's Dam Overflow Weir	
SURFACE WATER MONITORING POINTS				
Name	Easting	Northing	Description	
WMP01	366287	6351020	Upstream of LDP001	
WMP2A	366211	6350984	Graunch's Dam Cell 1	
WMP2B	366282	6350913	Graunch's Dam Cell 2	
WMP03	366691	6350695	EPL Point 19 - Bywash Dam Weir - Downstream of LDP001	
WMP04	366335	6350646	Sewage Maturation Pond	
WMP05	366806	6350261	Waste Water Treatment Plant	
WMP07	367377	6349639	LT Creek downstream of Colliery U/S of Railway, D/S of Miller Rd	
WMP08	367927	6349578	Seepage from the GNS into tributary of LT Creek sampled South of Macquarie St	
WMP09	365438	6350067	Upstream of the SREA

WMP11	366483	6349698	SREA Seepage Dam	
WMP12	366526	6349628	SREA Clean Water Dam (proposed LDP003)	
WMP13	367063	6349491	EPL Point 6 - Southern branch LT Creek U/S of Eraring Haul Road	
WMP14	366282	6350913	Pump line from Fassifern Seam No.1 Bore	
WMP15	366225	6350887	NREA seepage pipe	
WMP16	366470	6349529	EPL Point 5 - SREA LT Creek Side catchment	
WMP17	367525	6349240	Southern Branch LT Creek below Railway Station	
WMP20	366404	6348341	EPL Point 18 - Located in a tributary of Stony Creek, upstream of WMP19	
WMP21	367970	6349726	Located within the Wetland system, upstream of WMP8	
WMP22	365501	6350094	The decant from Stage 2-4 dam into the Fassi seam	
WMP24	367920	6349844	Seepage from the GNS into tributary of LT Creek sampled North of Macquarie St	
SP003	367071	6350187	EPL Point 3 - Upstream LDP002	
SP004	367366	6349650	EPL Point 4 - Downstream LDP002	
NEWSTAN COLLIERY AQUATIC MONITORING POINTS
