Report on
Geotechnical Investigation

Proposed Redevelopment
Wagga Wagga Base Hospital
Edward Street, Wagga Wagga

Prepared for
Health Infrastructure

Project 72320.00
September 2011

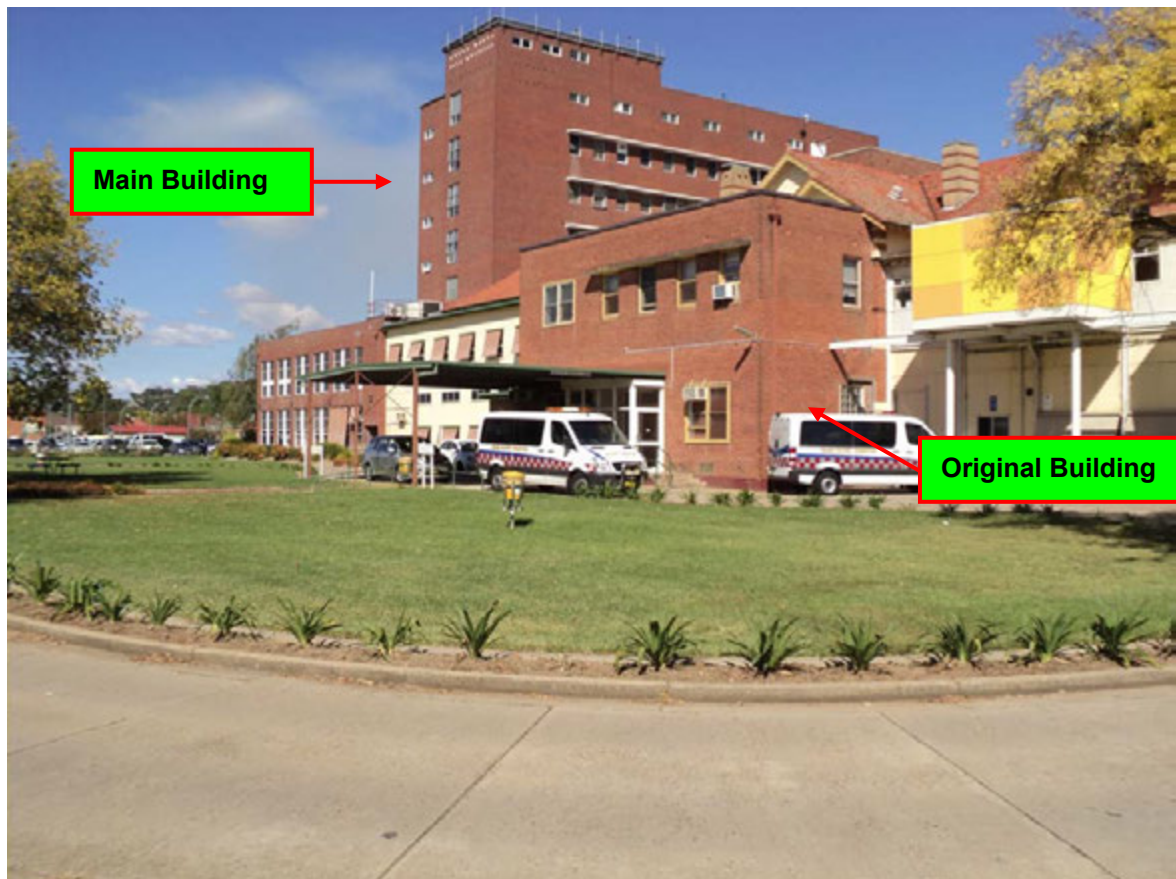
Figure 1: Main Hospital Building and the Original Hospital Building (looking south-east)

The site is currently occupied by a number of separate buildings, some of which date back to the early 1900's. The main hospital building (refer to Figure 1) located within the central part of the site is eight

storeys in height and is understood to have been constructed around the 1960's. The original three storey hospital building located adjacent to the main building (adjacent to the lawn area that fronts Edward Street) is still operational. A number of smaller brick buildings ranging in height from between one and three storeys are located throughout the site and are currently used as university buildings (Harvey House circa 1936), hospital nursing quarters, engineering/ maintenance buildings and hospital specialist buildings. A relatively newly constructed theatre building (CSB building) is located to the south-west of the main building and is between two and three storeys in height. Open asphalt and gravel car parks are located along the eastern side of the site.
