Report on  
Supplementary Geotechnical Investigation

Proposed Redevelopment  
Wagga Wagga Base Hospital  
Edward Street, Wagga Wagga

Prepared for  
Health Infrastructure

Project 72320.03  
October 2011

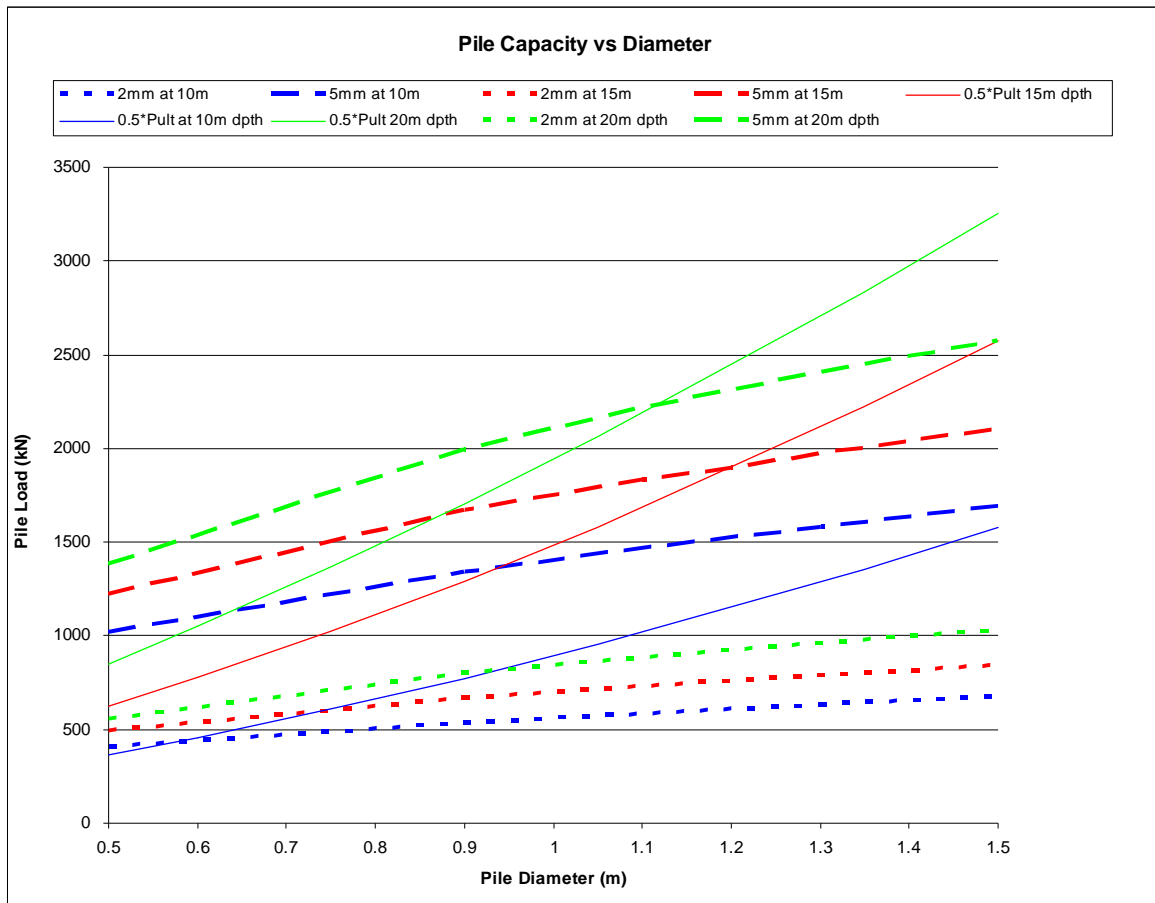
**Figure 2: Pile Settlement Design Chart**

Estimated settlements for piles are provided in the preliminary design chart shown in Figure 2.

By way of example, consider a 1 m diameter pile founded in very stiff to hard clays at a depth of 10 m. In order to limit settlements to about 2 mm, a maximum load of 550 kN could be applied. In order to limit settlements to about 5 mm, a maximum load of 1,400 kN could be applied.

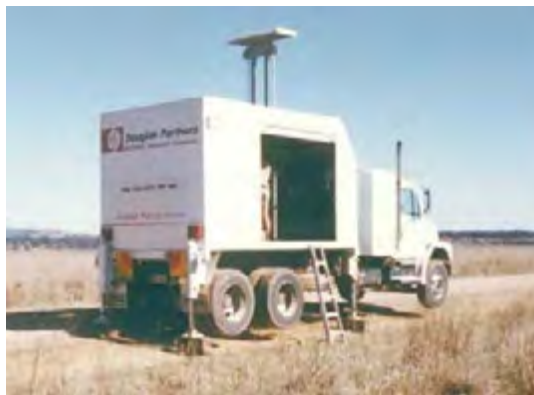
Figure 2: Purpose built CPT rig

The cone is thrust into the ground at a steady rate of about 20 mm/sec, usually using the hydraulic rams of a purpose built CPT rig, or a drilling rig. The testing is carried out in accordance with the Australian Standard AS1289 Test 6.5.1.
