INDEPENDENT ENVIRONMENTAL AUDIT

BINGO INDUSTRIES – OPERATION OF

KEMBLA GRANGE RECYCLING FACILITY

FINAL REPORT

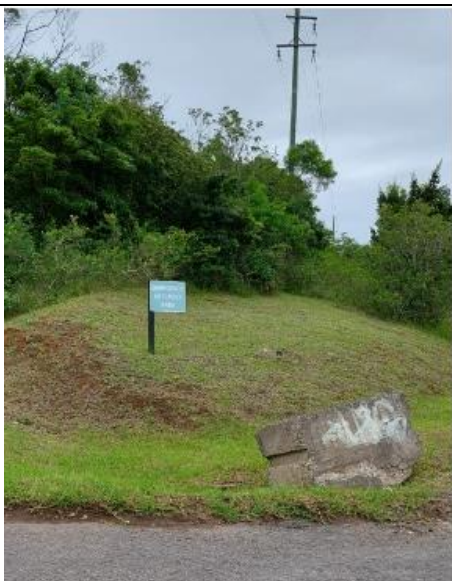
Location of signage – with footings now removed (post audit)
– photo provided by Bingo. (Actions to address NC 4)

4.	B33	<p>The Applicant must install any new signage in consultation with Council.</p> <p>Note: This condition does not apply to signage identified as exempt or complying development in State Environmental Planning Policy (Exempt and Complying Development Codes) 2008.</p>	<p>A development application (DA-2016/290) was submitted by the previous operators (Blackwell), which was conditionally approved, requiring that at the end of 5 years, the applicant/developer must remove the sign at their own cost and reinstate the land to its previous form. This lapsed on 13 April 2021.</p> <p>Correspondence from the Senior Development Project office at Wollongong Council noted <i>“it would appear that this development consent has not been modified and no further application lodged for this signage to date”</i>.</p>	<p>Completed Actions:</p> <ul style="list-style-type: none"> – Signage was removed prior to the audit (footings remained); – Footings for the signage were removed December 2021 (photos sighted). <p>In the future, if signage is required on Council land, Bingo will consult with Council and obtain development consent for the signage prior to installation</p> <p>Due Date: Completed</p>	NC 4	Non-compliant (closed)

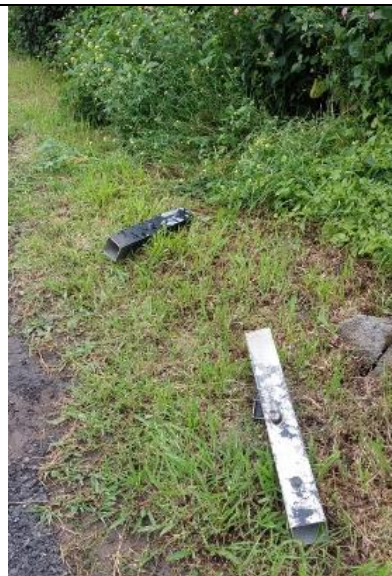
Removed footings (photo provided by Bingo).

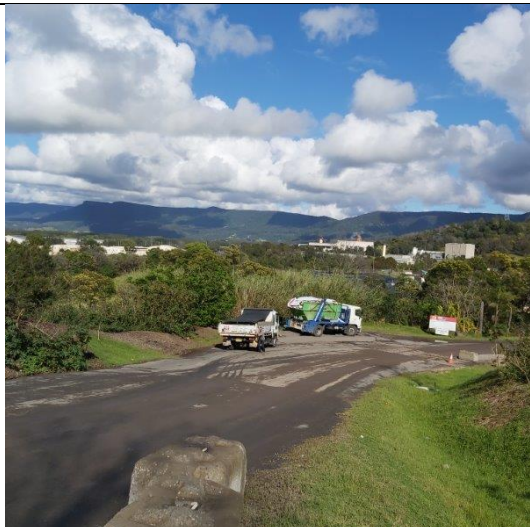
View along site access road – showing untarping area and roadway recently swept.

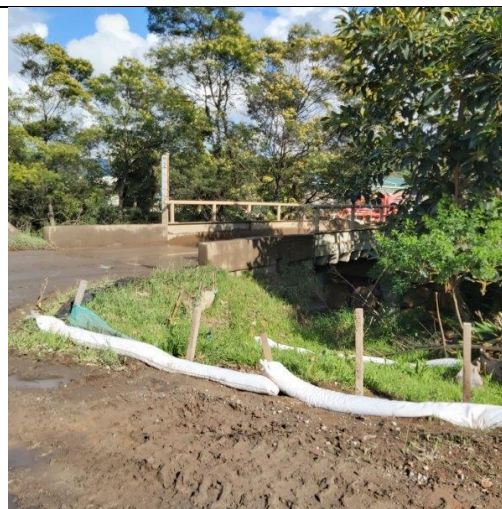
Bridge over creek at entrance to Bingo site. Erosion and sediment controls in the foreground.

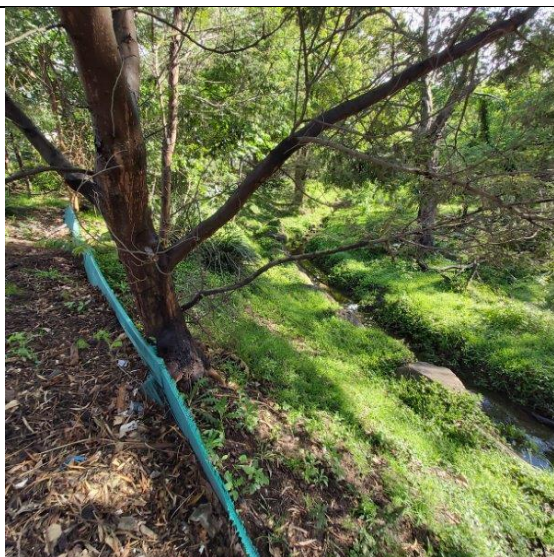
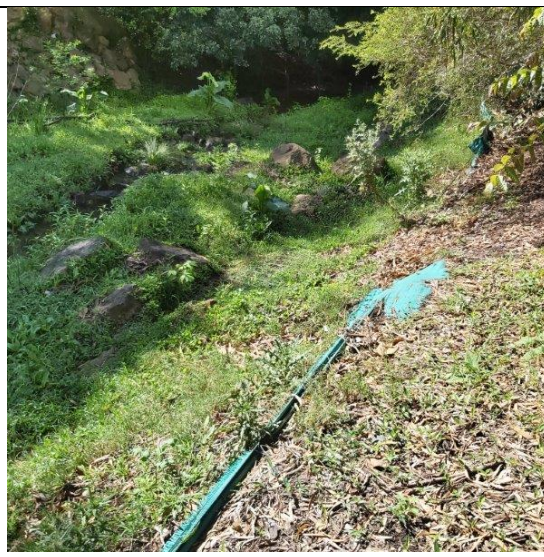
Views of the creek and riparian area. Vegetation appears to be well maintained

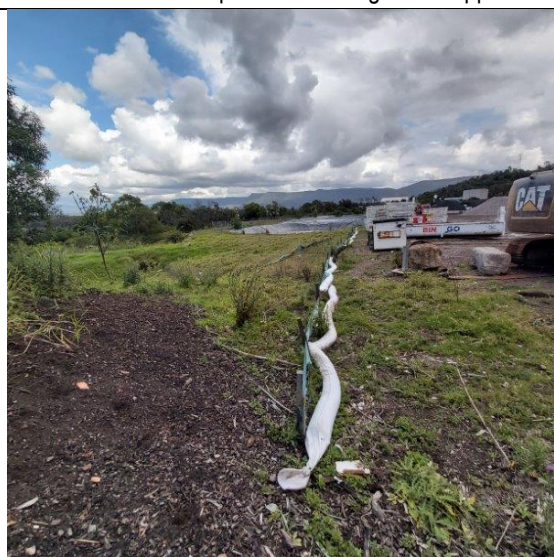
View towards to water quality ponds. EPL discharge point in the grassy area to the left.

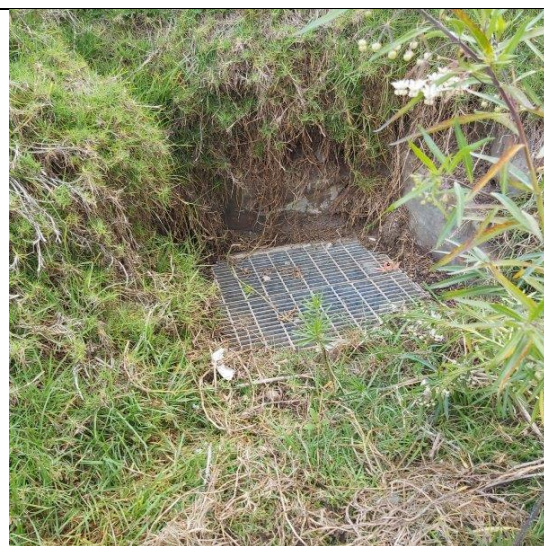
View of discharge point / sampling pit.

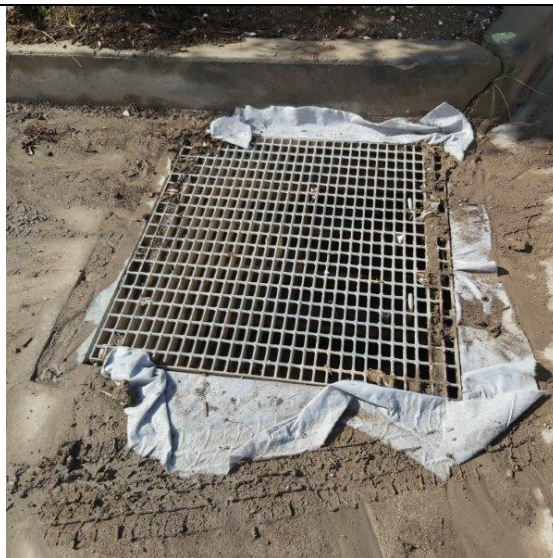
Site drain with geofabric installed to minimise sediment entering the site drains (drains to water quality ponds). Drains sighted during the site inspection were similarly protected.

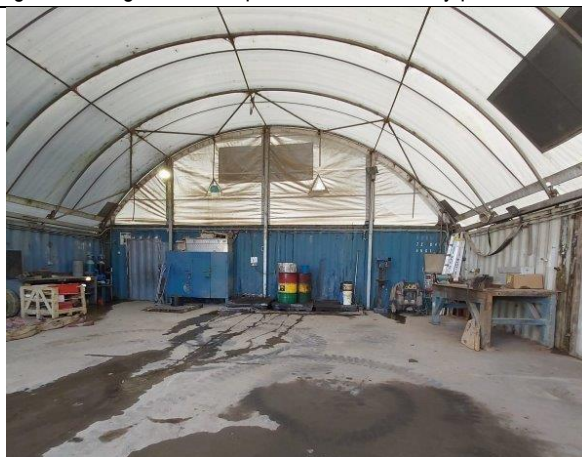
View inside main area of the workshop. Oils were stored on bunded pallets

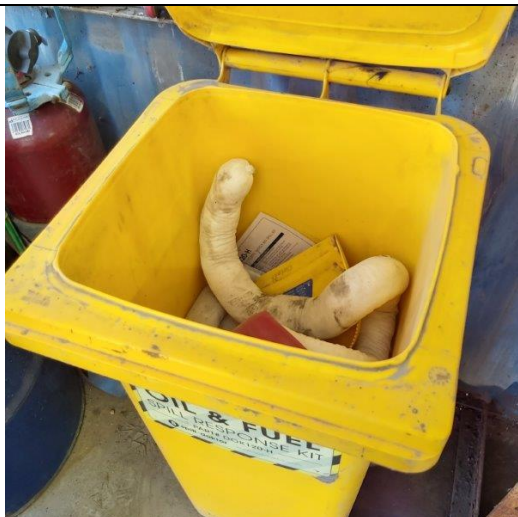
Spill kits not fully stocked, and were not always of the most appropriate type (i.e. – universal kits where oil-based kit should be provided (oil pads ordered during audit)

Improvement Opportunities (IO) related to: spill kit contents not always most appropriate; leaking air hose (energy wastage); recommendation to reinforce use of spill trays when refuelling and ensure OEMP reflects actual practice.

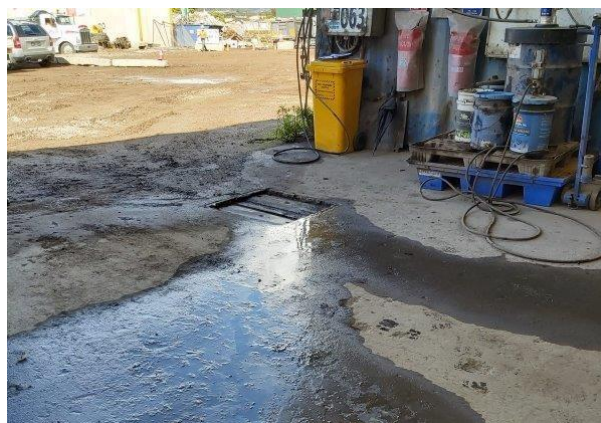
Low point of workshop floor – water flowing to blind sump. Site maintenance is undertaken weekly and cleaned out quarterly by tanker when on site.

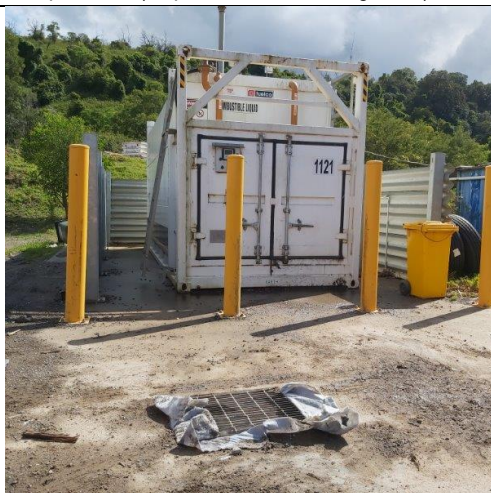
Above ground diesel tank and refuelling area. Noted that drain flows to an interceptor and thence to the water quality ponds. No bund has been installed around concrete pad (NC)

No	Condition / requirement Reference	Requirement	Audit Finding	Recommended / Agreed / Completed / Actions	Finding no. & rating (NC, OBS/ IO)	Compliance Status
				<p>site layout plans, with particular emphasis on ensuring refuelling area is bunded to protect stormwater drains.</p> <p>f) – No action required. Refer to separately raised NCs.</p> <p>Due Date: 30 September 2022</p>

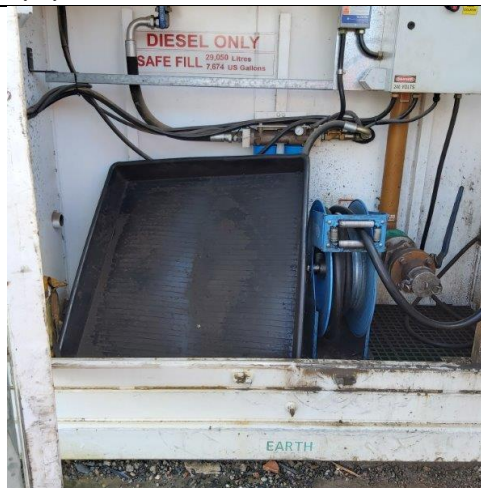
Drip tray stored within the cavity of the above ground diesel tank and used when refuelling vehicles. (Opportunity for improvement – provide more distinct signage and procedure)

16.	SWMP	Site inspection: Refuelling instructions	The required use of the spill tray could be reinforced to site staff	Recommended Action: <ul style="list-style-type: none"> Basic refuelling instructions should be provided at the above ground fuel tank to ensure that the spill tray is used by all persons refilling Completed Date: 21/10/2021 Instructions were posted on the day of the audit.	IO 4	Compliant (Improvement Opportunity)

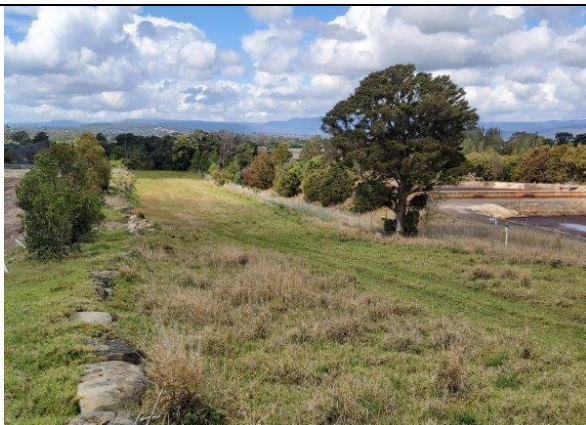
Easement area on the western boundary of the site -boulders prevent access to the easement.

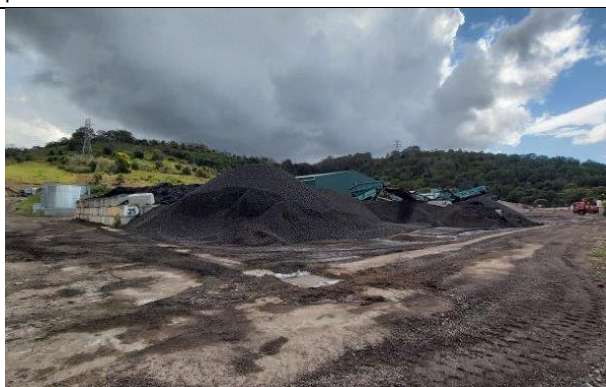
Asphalt processing and storage area – located on the designated green waste shredding area (subject of non-compliance in latest Annual Review Report)

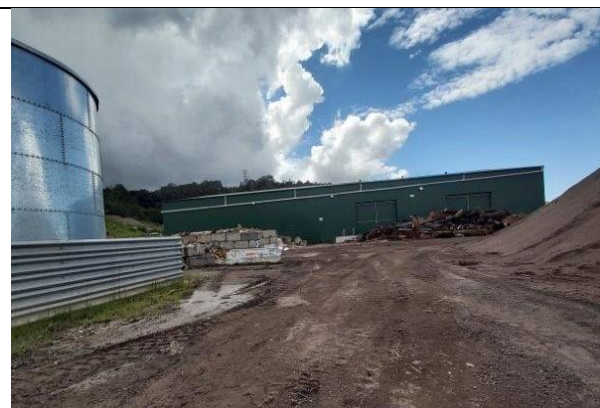
View towards rear of "Indoor Processing and Storage Shed". Timber logs stored in stockpile approximately 3m high (height limit). White marker on left of door shows 3m height limit.

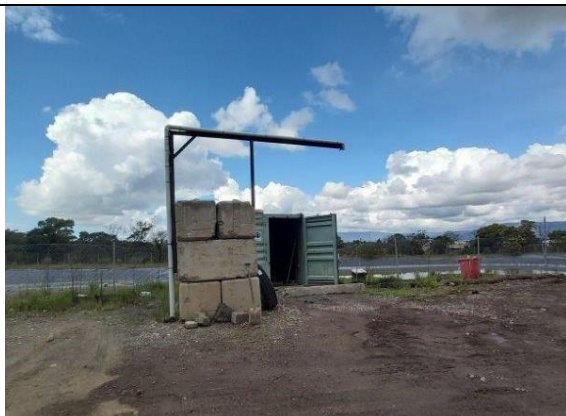
Water filling point – re-use of pond water for dust suppression (tested quarterly for human health risk)

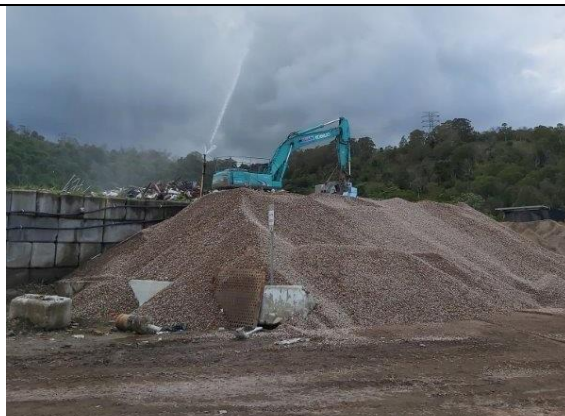
Stockpile of recycled product showing sprinkler system in operation. Sprinklers can be operated manually and through a phone application.

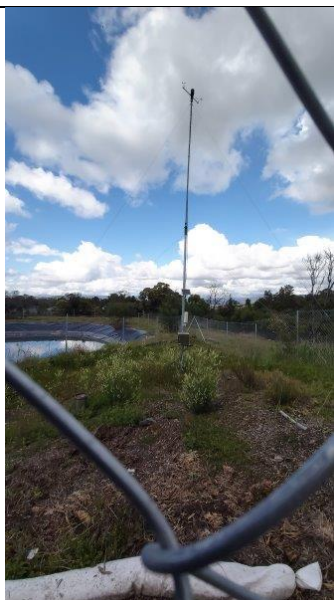
Weather Station installed on site near water quality ponds

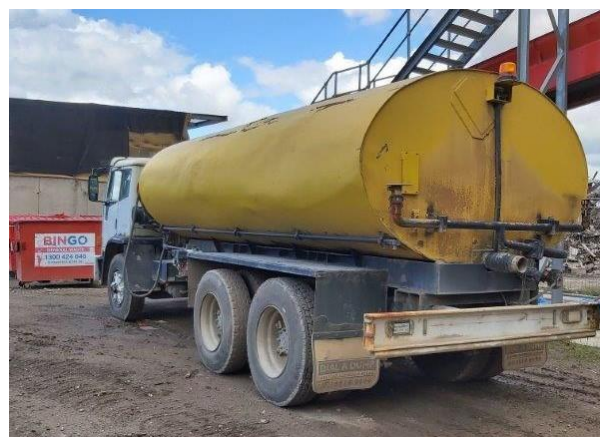
Water cart used for dust suppression on site (supplements the sprinkler system and can be used as back up in case of bushfire)

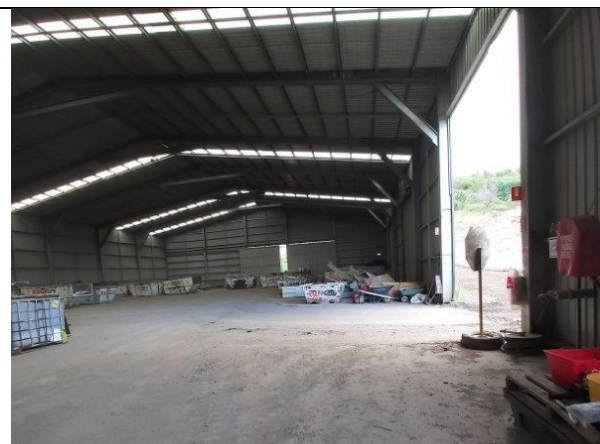
View inside green storage shed. Skips contain non-complying waste which removed from waste streams and transported to facilities that can accept it.

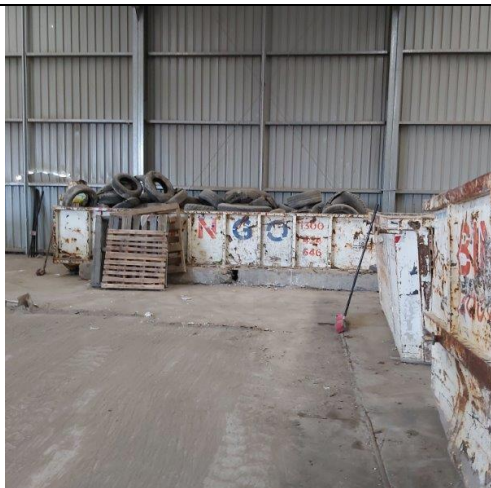
Tyres stored inside shed – to be removed from site and taken to appropriate facility.

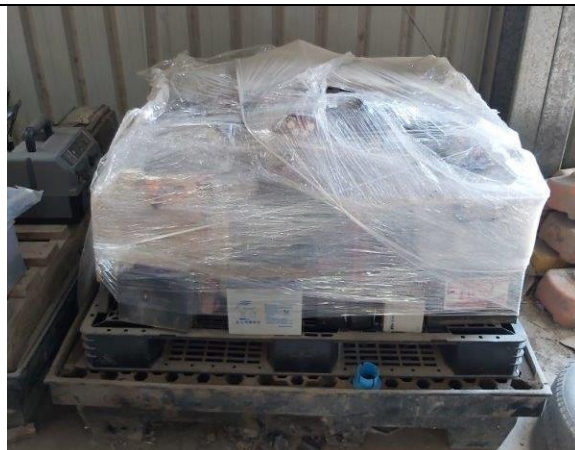
Batteries stored on banded pallet – to be removed from site and taken to appropriate facility.

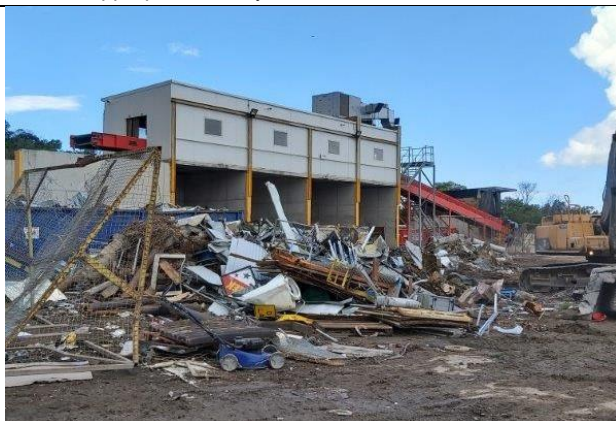
General waste tipping area. Behind the picking station (not operational since 2018 in accordance with the Development Control Order December 2018).

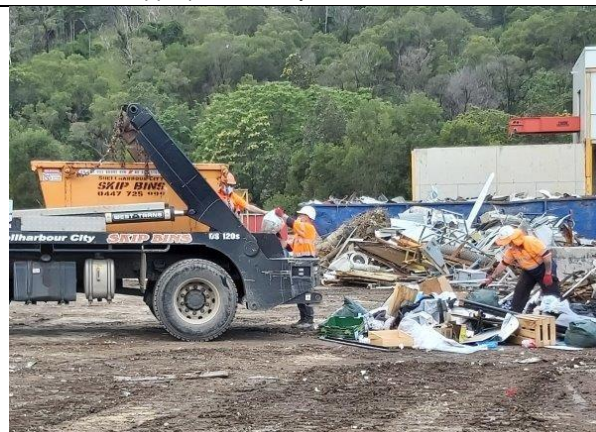
Waste inspection process in operation. Bags of non-conforming waste were located in the tipped waste, and were handed back to the driver for removal from site.

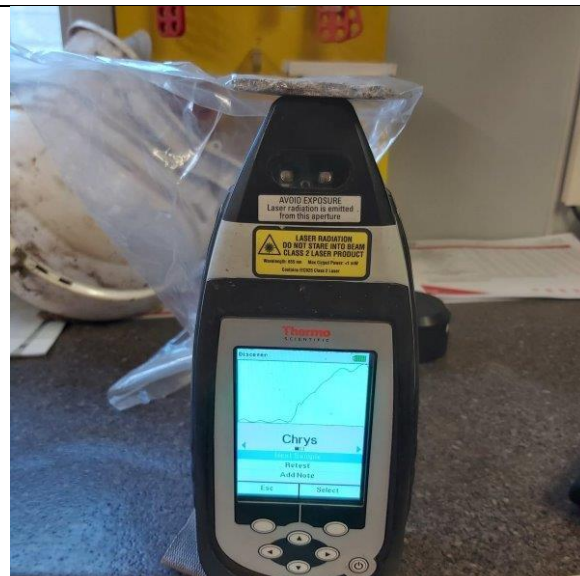
Suspected asbestos was tested on site – confirming material as asbestos. Load was wetted down, reloaded and recorded in the rejected load register.

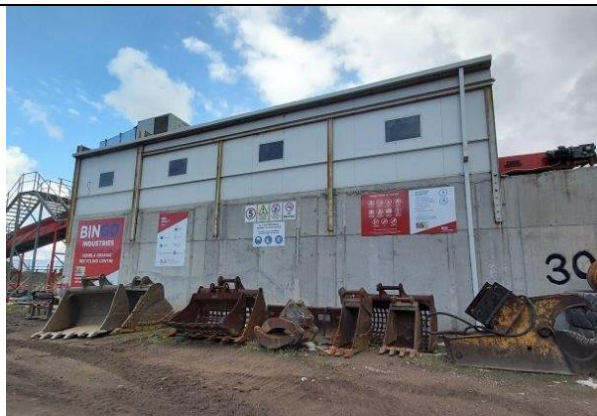
View of the picking station and signage from near the weighbridge. Signage shows 5 km/hr speed limit, Conditions of entry - waste not accepted, and no smoking requirements.
