Remedial Action Plan

CONCRETE RECYCLERS PTY LTD

7 Montore Road, Minto NSW

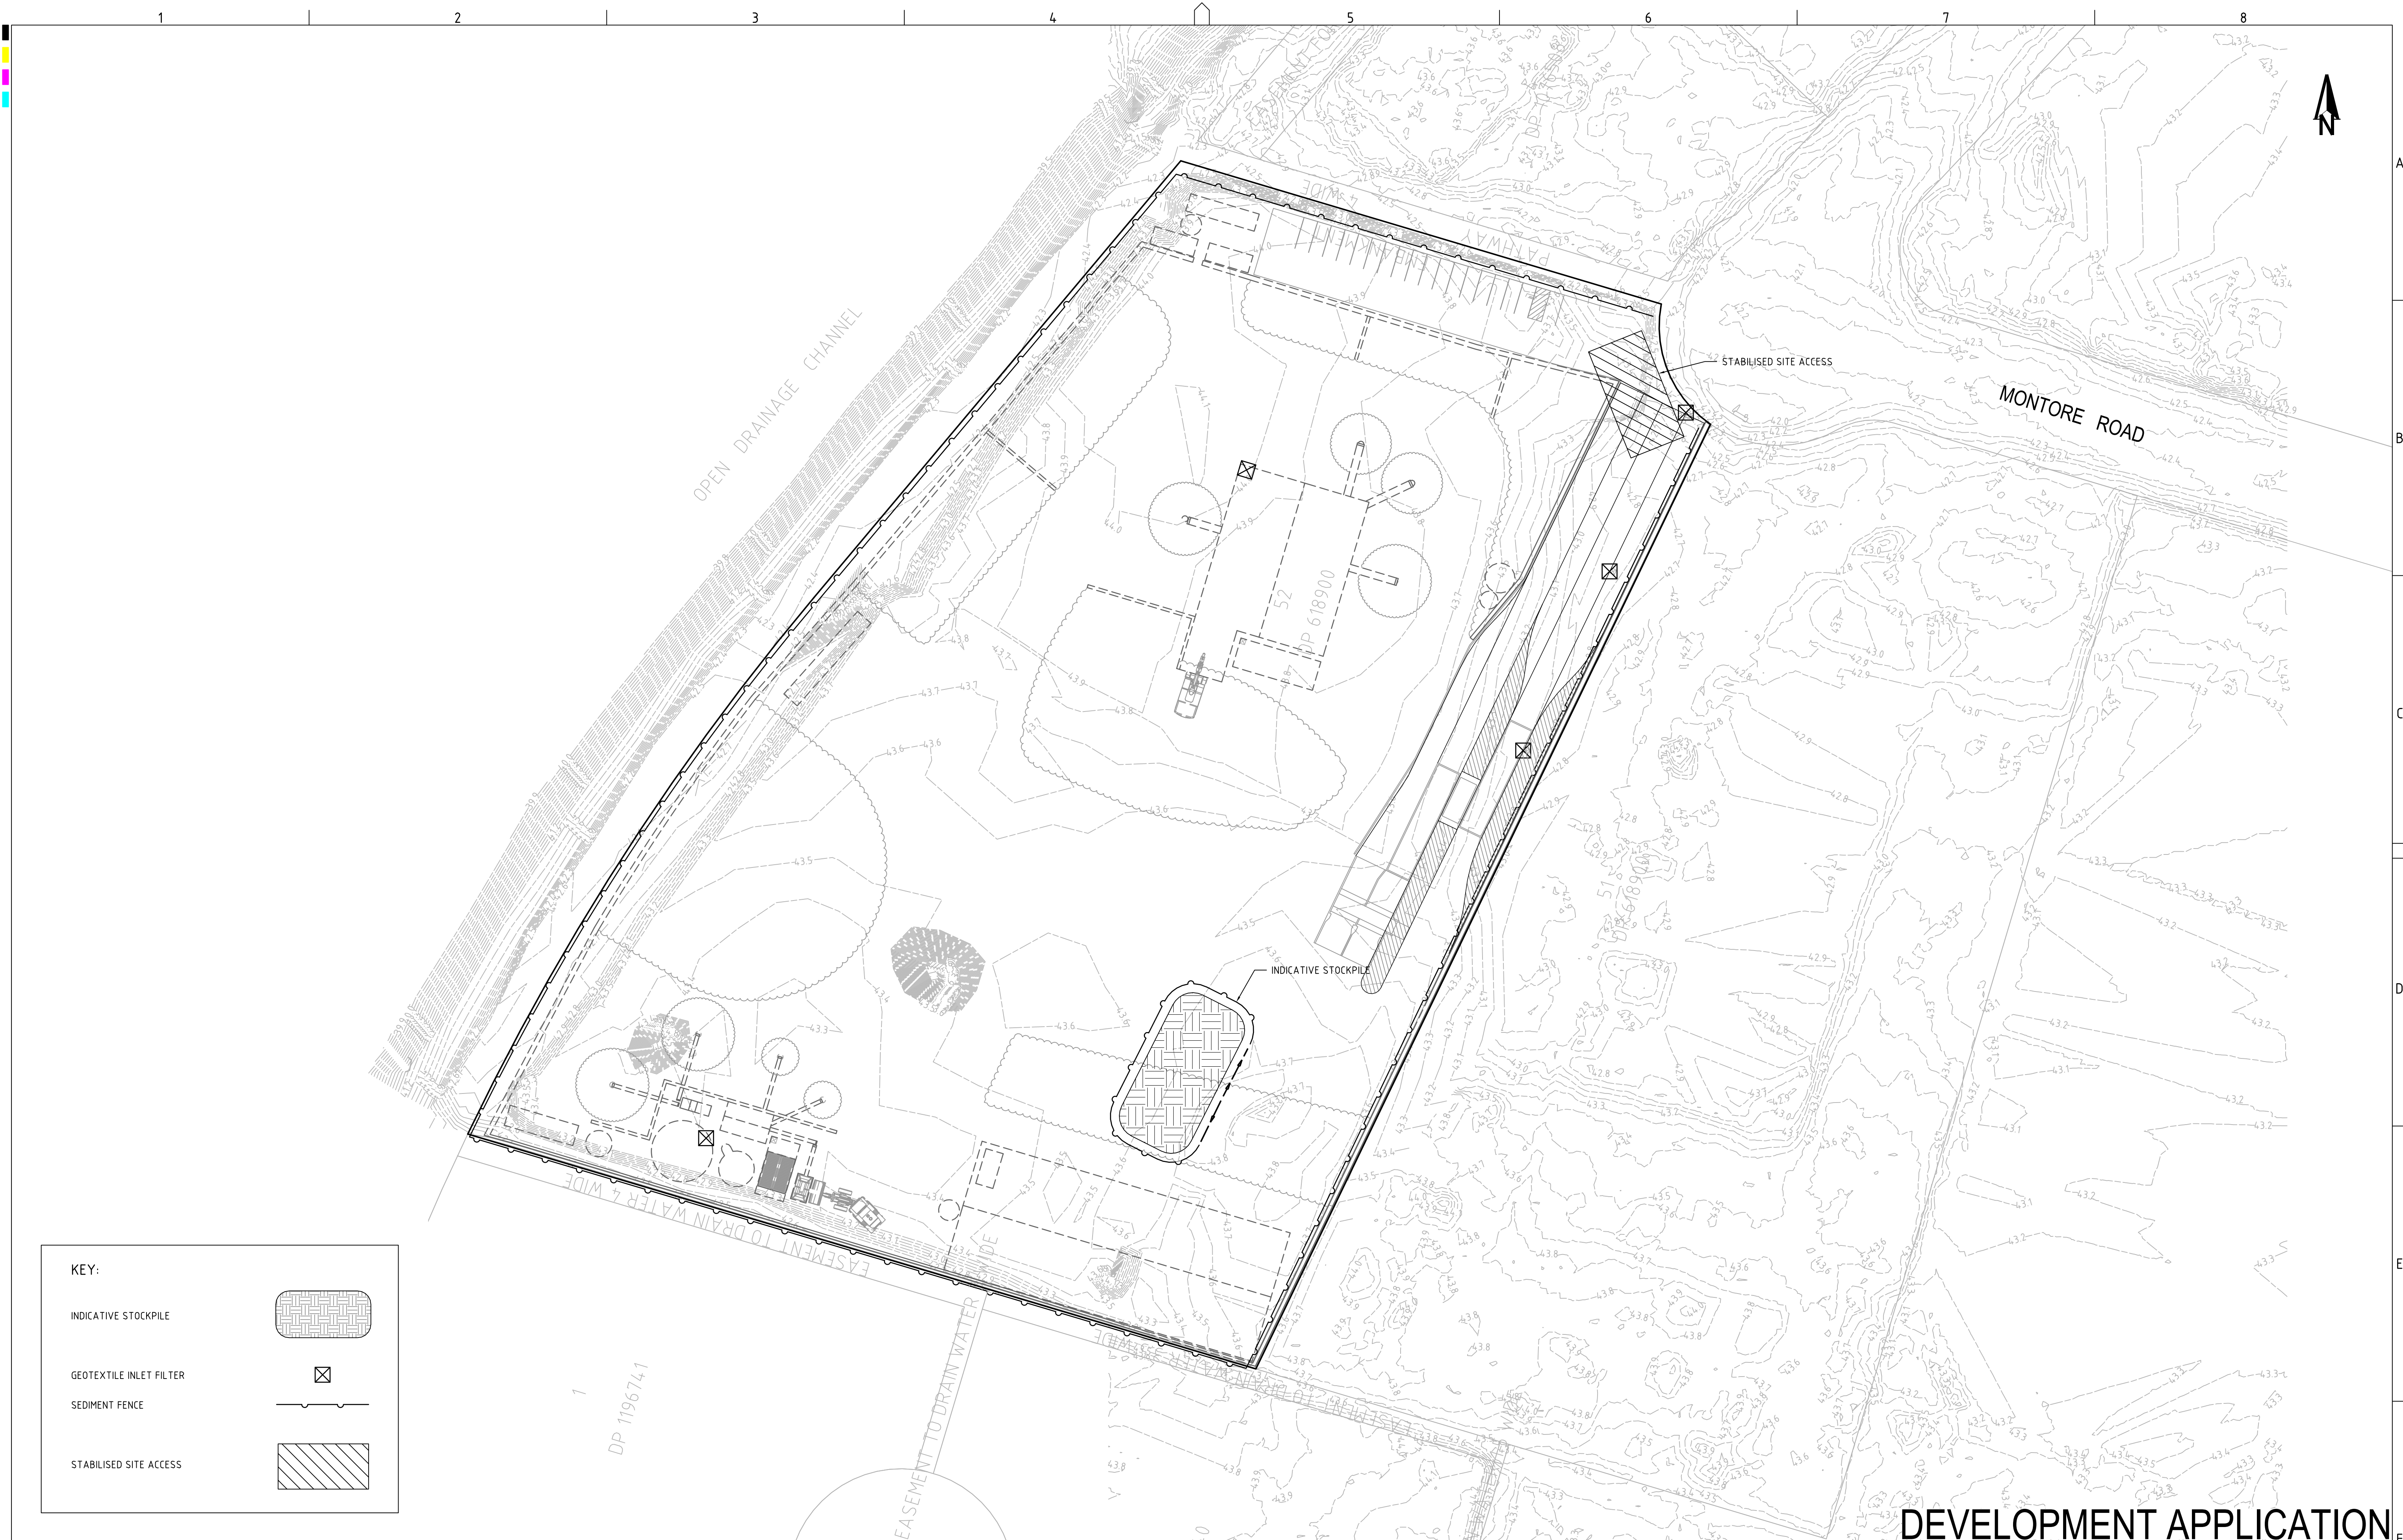
DRAWING ID: P1203464-PS02-R12-A400

KEY:

INDICATIVE STOCKPILE

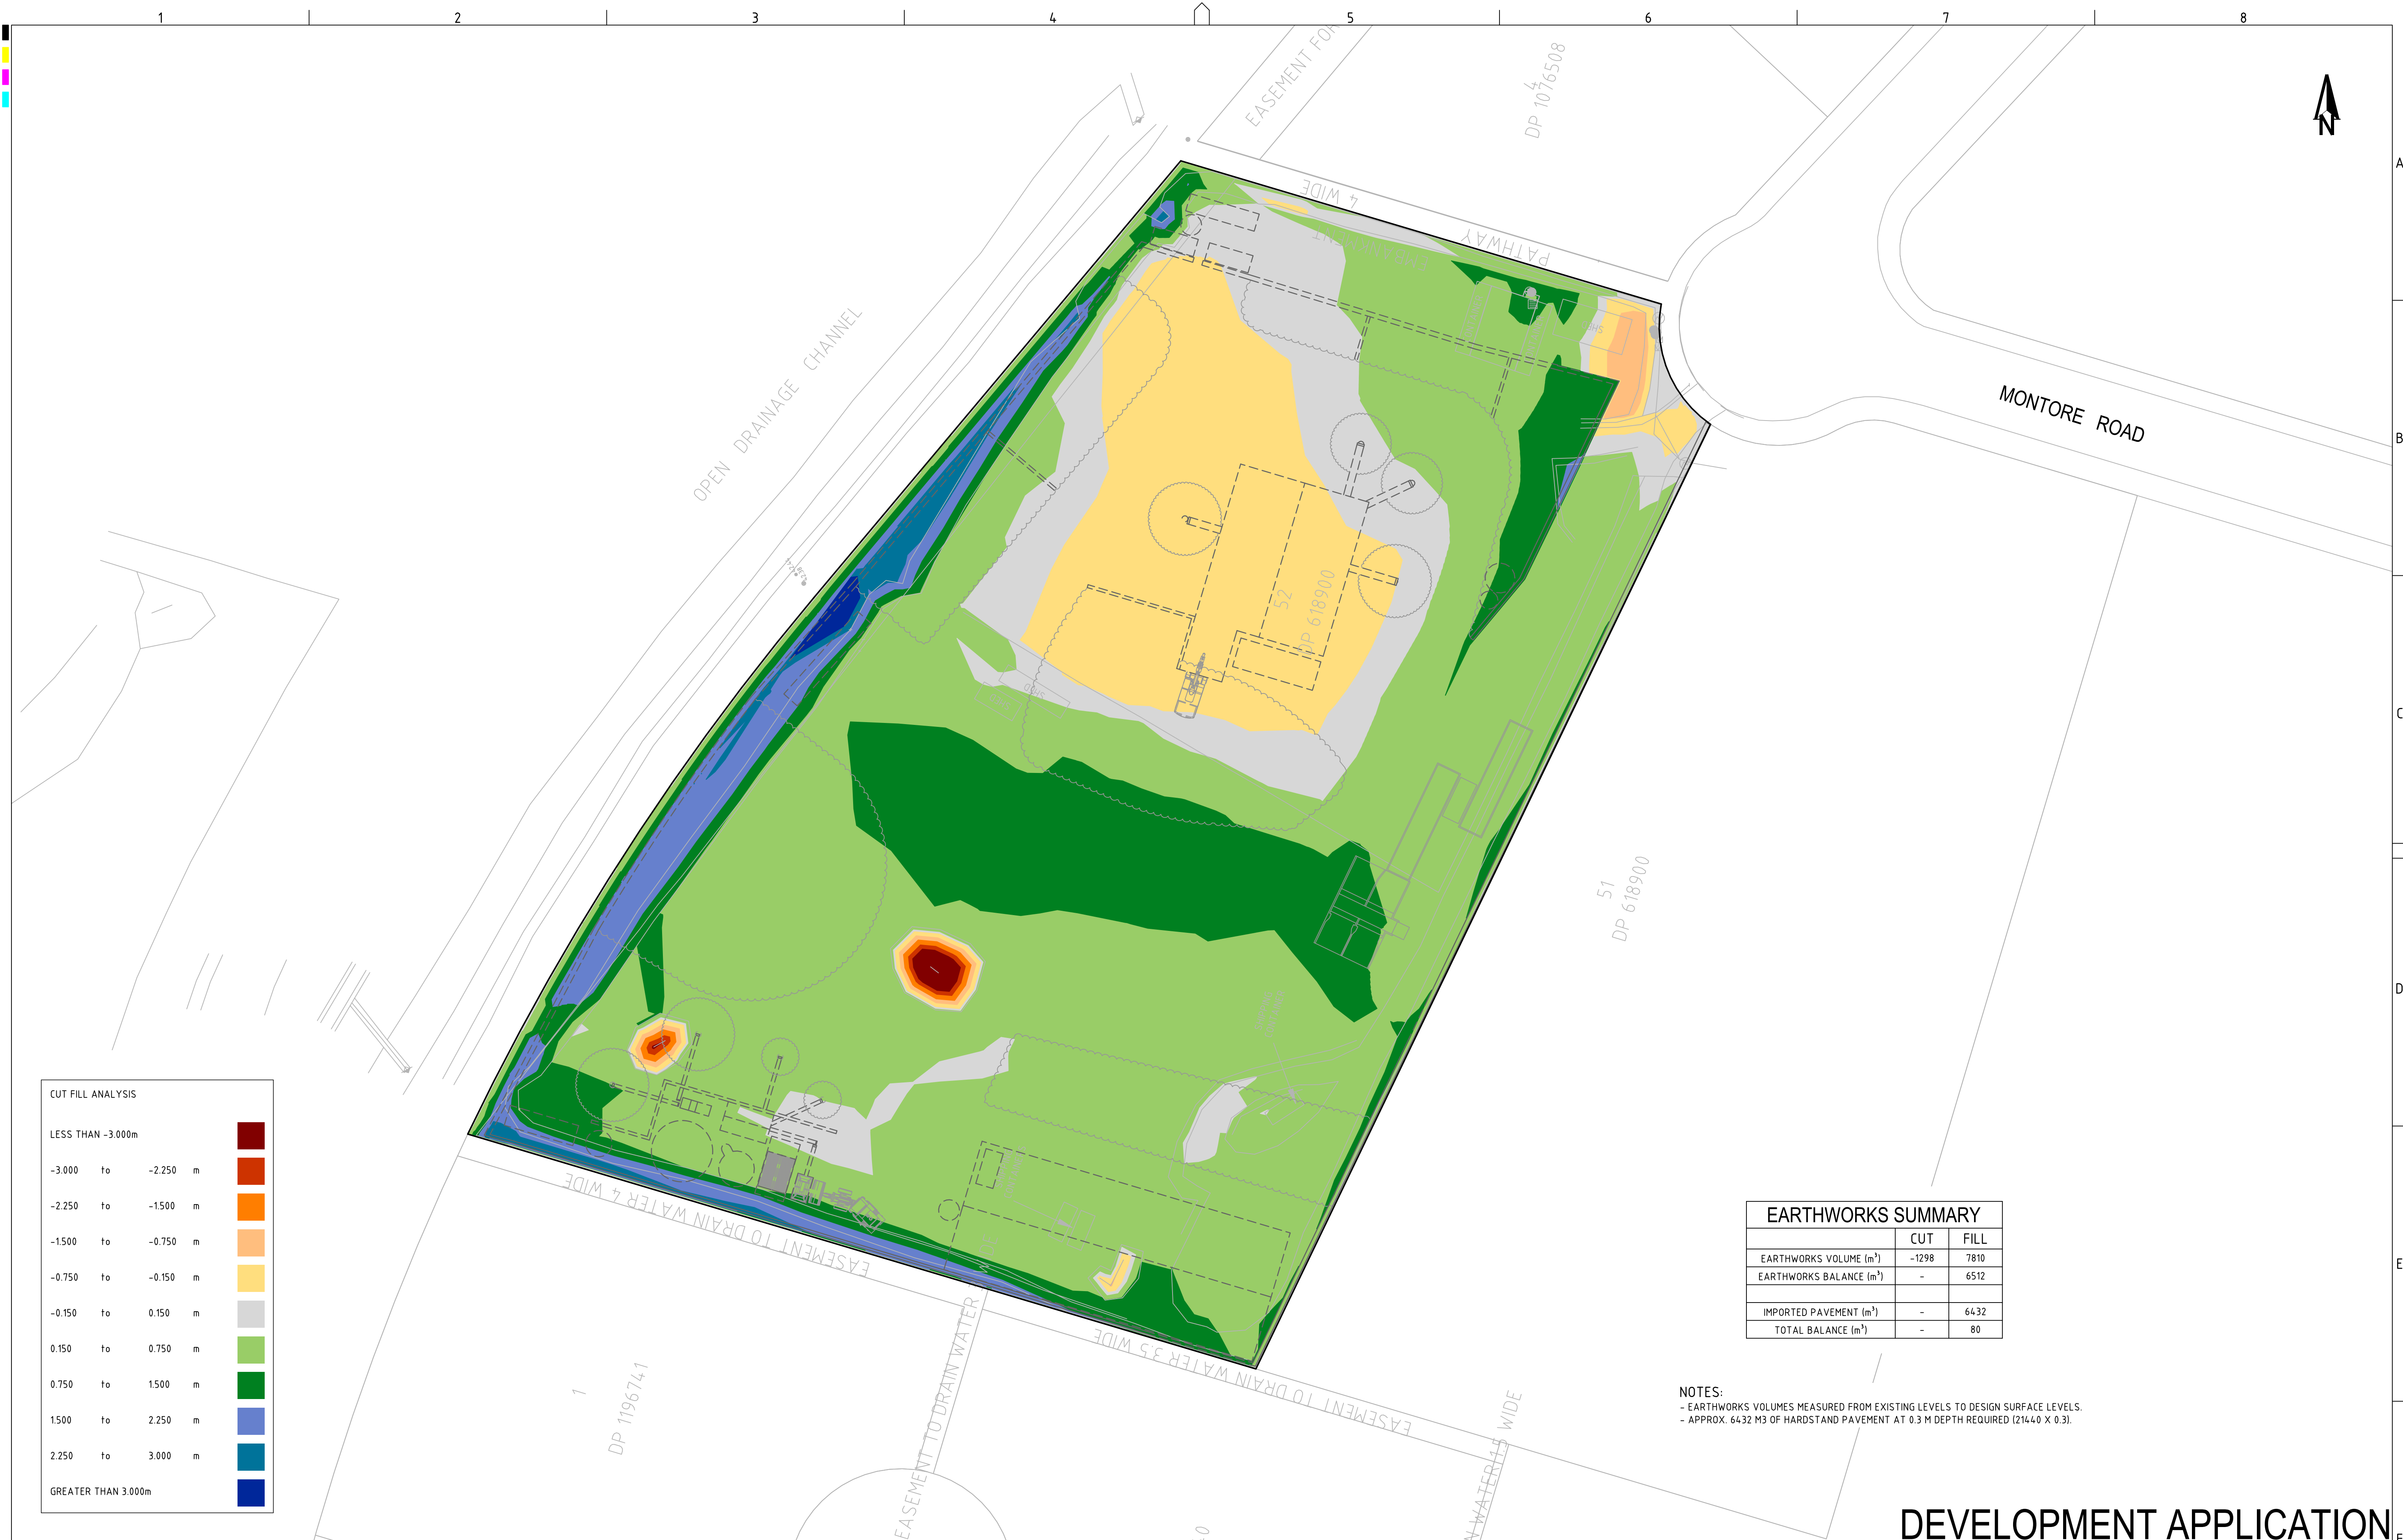
CUT FILL ANALYSIS			
LESS THAN -3.000m			
-3.000	to	-2.250	m
-2.250	to	-1.500	m
-1.500	to	-0.750	m
-0.750	to	-0.150	m
-0.150	to	0.150	m
0.150	to	0.750	m
0.750	to	1.500	m
1.500	to	2.250	m
2.250	to	3.000	m
GREATER THAN 3.000m

EARTHWORKS SUMMARY		
	CUT	FILL
EARTHWORKS VOLUME (m³)	-1298	7810
EARTHWORKS BALANCE (m³)	-	6512
IMPORTED PAVEMENT (m³)	-	6432
TOTAL BALANCE (m³)	-	80

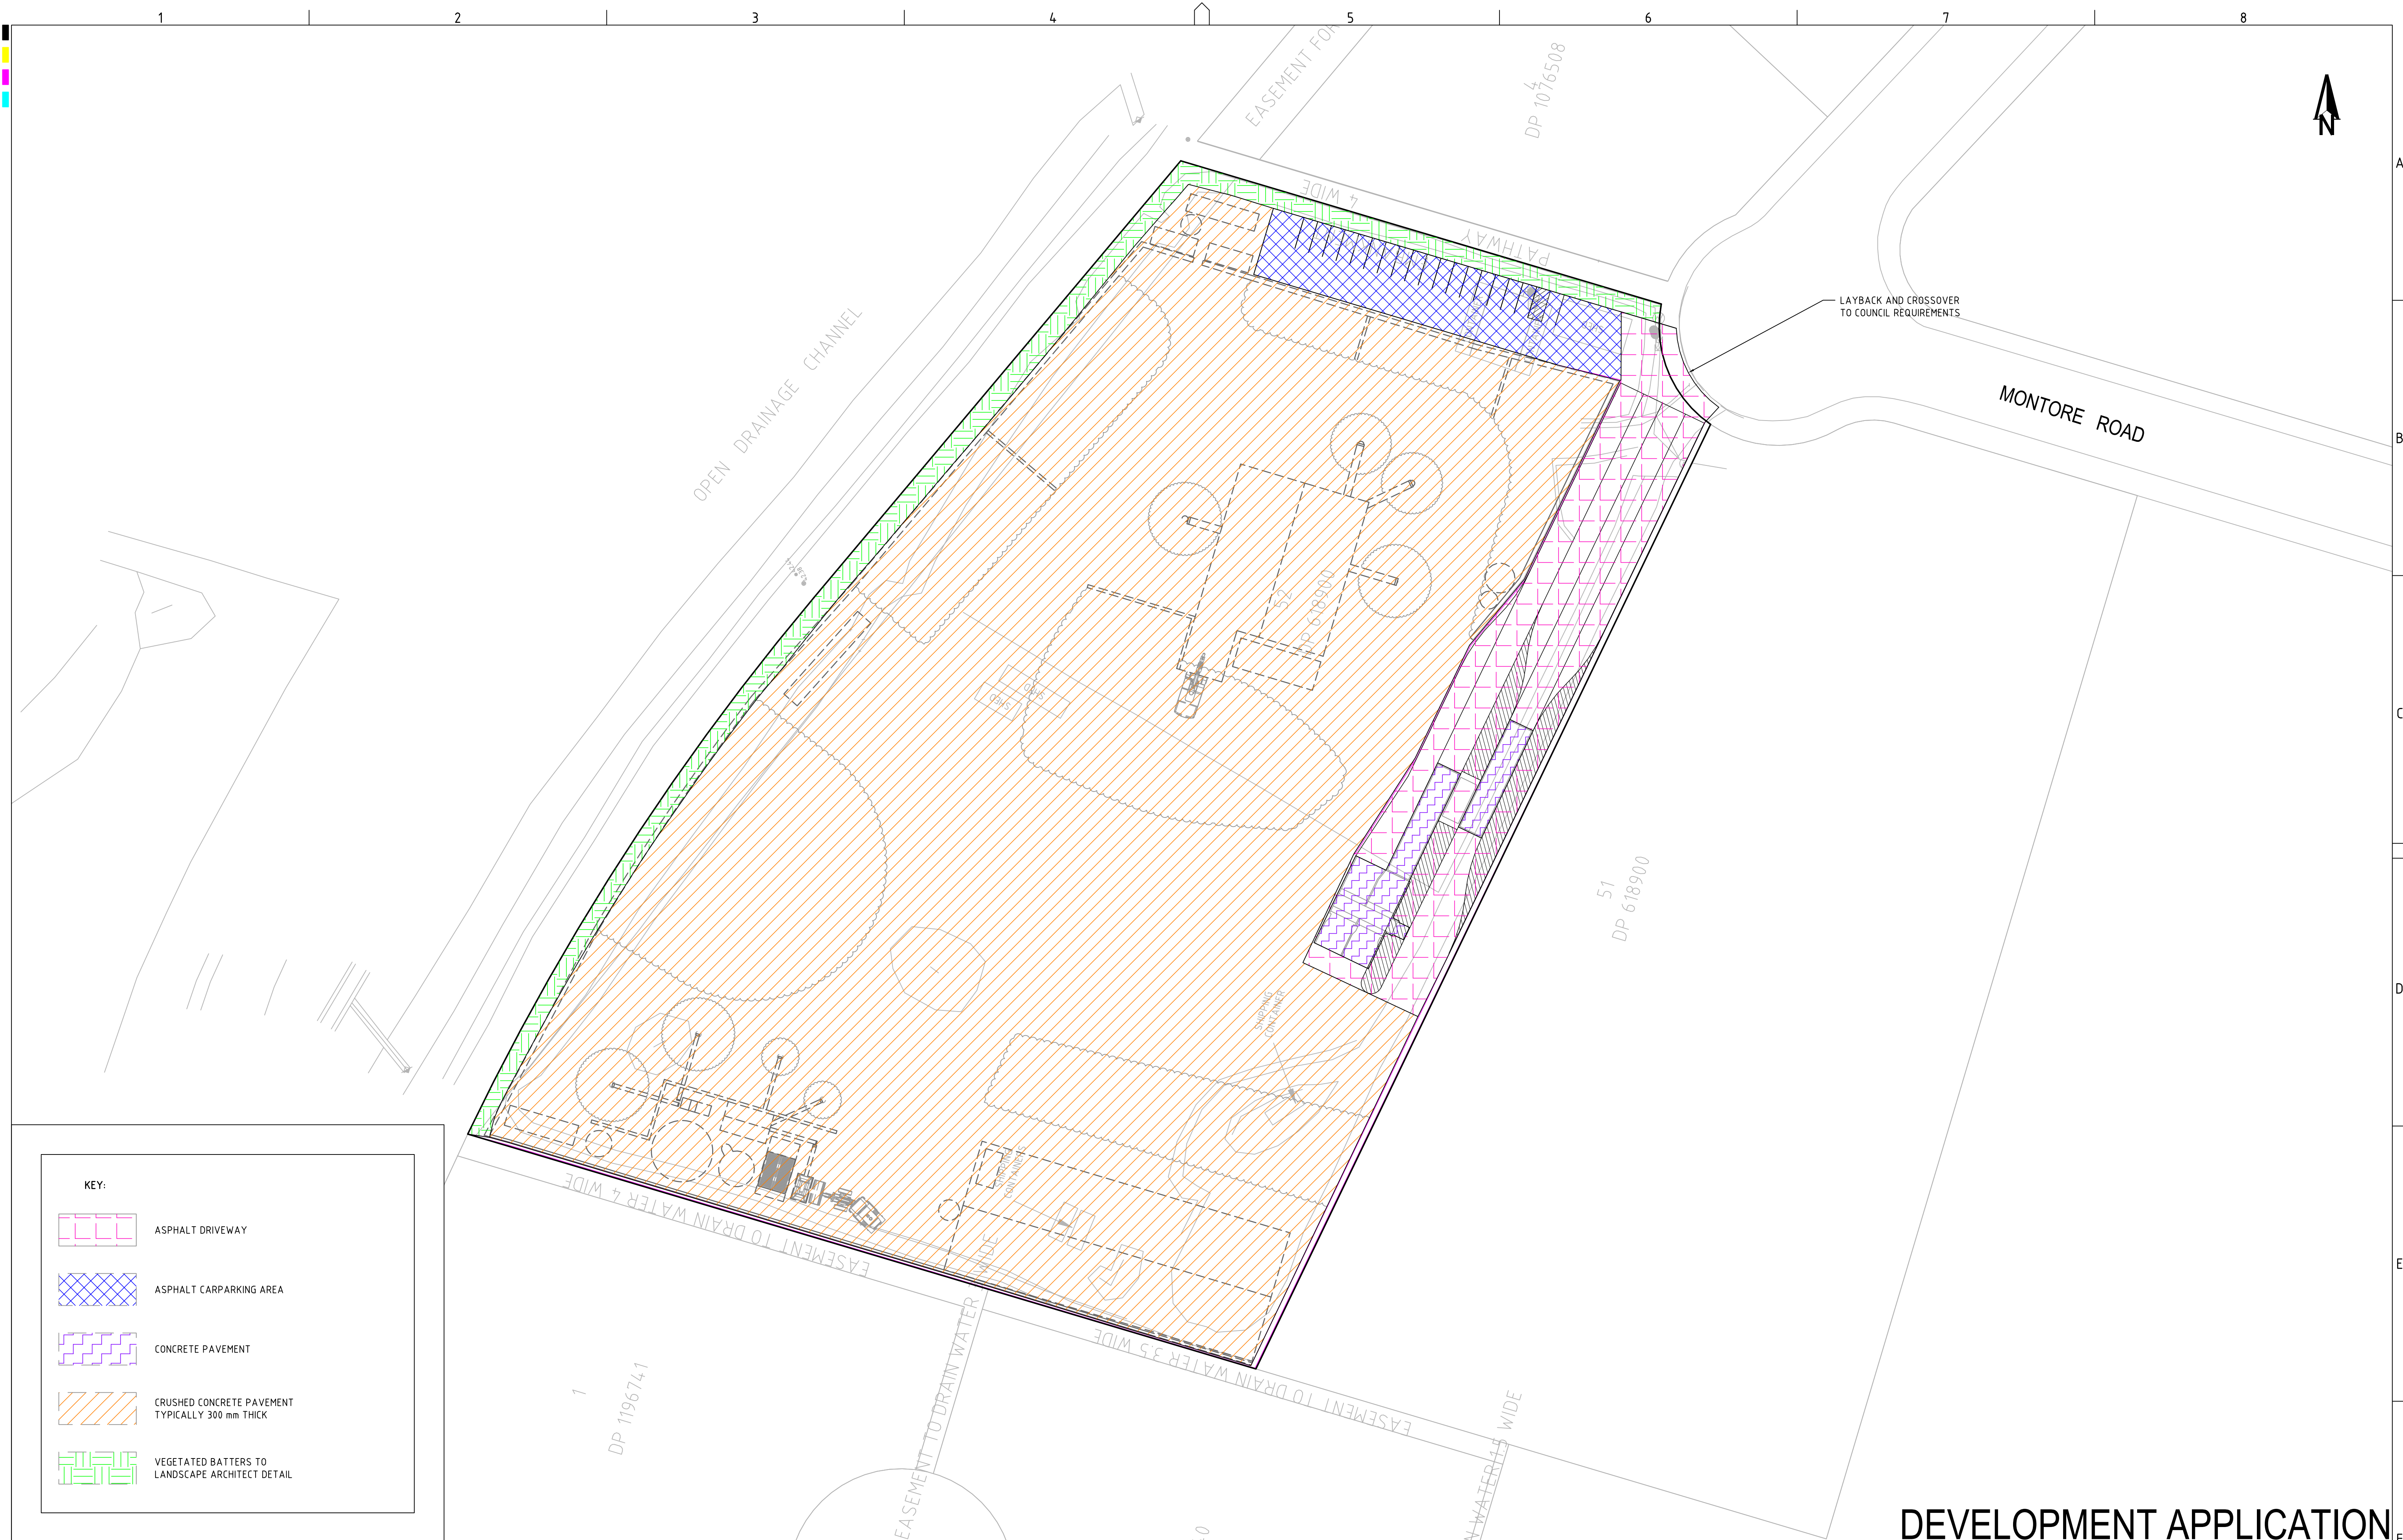
DRAWING TITLE				
PAVEMENT PLAN				
PROJECT NO.	PLANSET NO.	RELEASE NO.	DRAWING NO.	REVISION
P1203464	PS02	R12	PS02-G100	F

- ASPHALT DRIVEWAY
- ASPHALT CARPARKING AREA
- CONCRETE PAVEMENT
- CRUSHED CONCRETE PAVEMENT
TYPICALLY 300 mm THICK
- VEGETATED BATTERS TO
LANDSCAPE ARCHITECT DETAIL

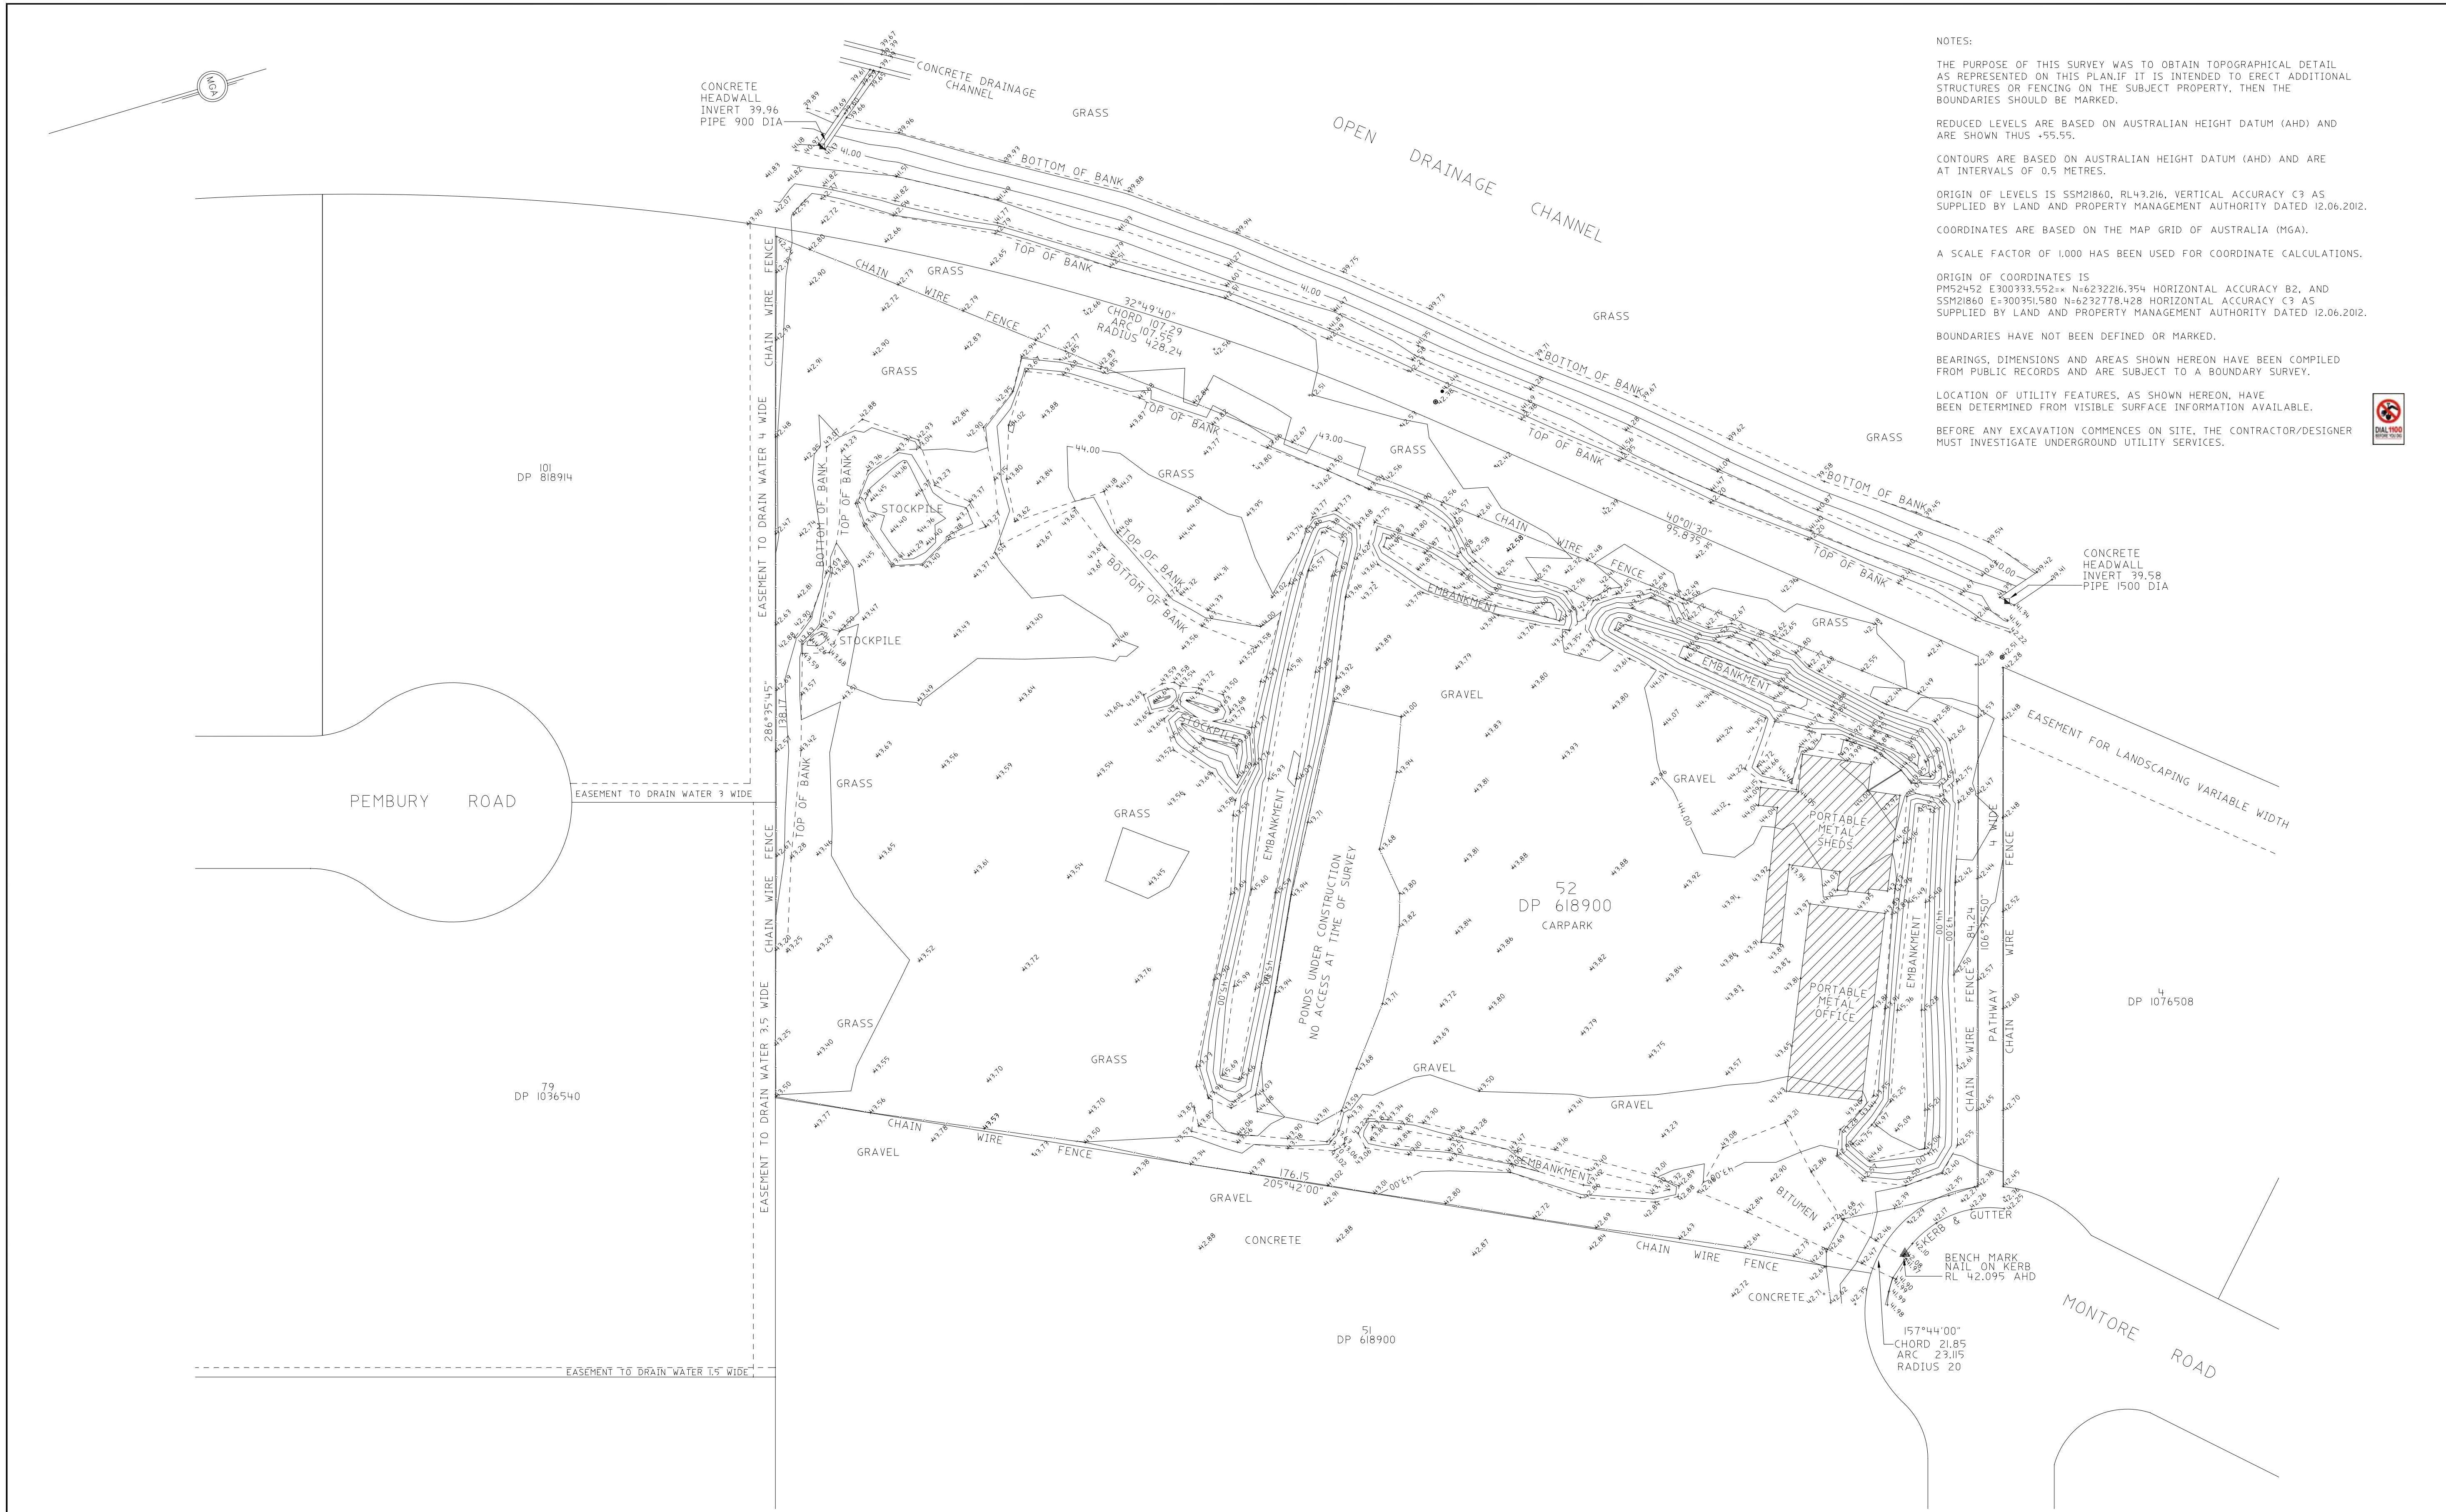
THE PURPOSE OF THIS SURVEY WAS TO OBTAIN TOPOGRAPHICAL DETAIL AS REPRESENTED ON THIS PLAN. IF IT IS INTENDED TO ERECT ADDITIONAL STRUCTURES OR FENCING ON THE SUBJECT PROPERTY, THEN THE BOUNDARIES SHOULD BE MARKED.
