# **GEOTECHNICAL INVESTIGATION REPORT**

## **HORNSBY KU-RING-GAI HOSPITAL REDEVELOPMENT**

### **HEALTH INFRASTRUCTURE C/- THINC HEALTH**

**Report No. GS4661**

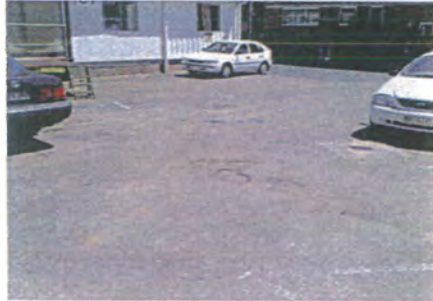
Photograph 3

View facing north-west within Hornsby Ku-ring-gai Hospital  
Location of borehole 3

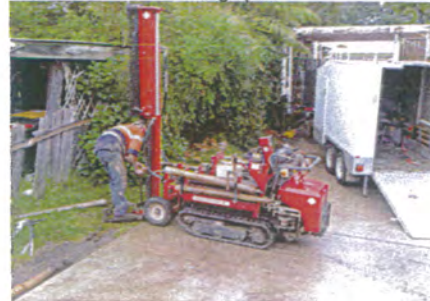
Photograph 4

Drilling equipment in operation at BH 5

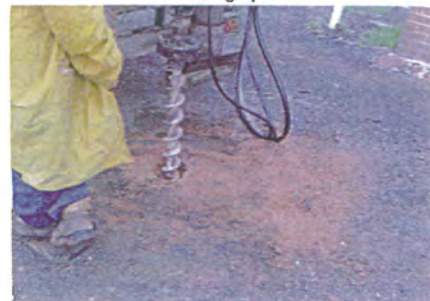
Photograph 6

Drilling equipment in operation at BH 6

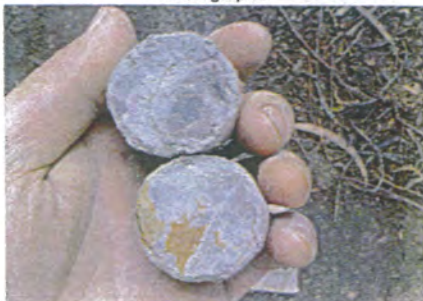
Photograph 7

Iron staining silty clay encountered at BH2
