## PHASE 1 ENVIRONMENTAL SITE ASSESSMENT

Stage 1 and Civil Works Zone Redevelopment Kempsey  
District Hospital, Kempsey NSW

GEOTCOFH03037AA-AD

16 November 2012

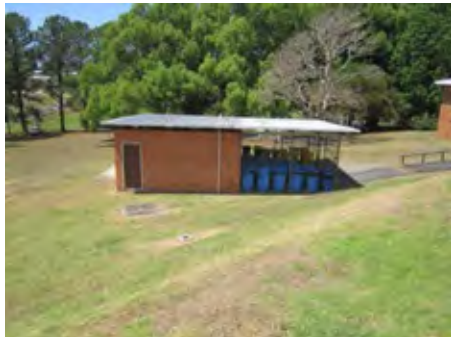
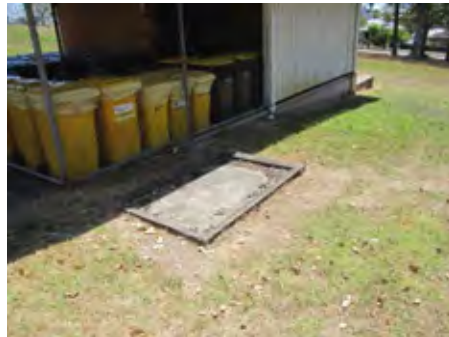
The former incinerator building (Photograph 5 & 6) was located to the south of the boiler and laundry buildings at the base of the embankment within the Stage 1 area. This building is currently used for waste storage and cleaning of bins. There were two small concrete pads observed adjoining to the east and southeast of the building. The southeast pad was a small concrete bund area and the pad on the eastern side of the building appeared to be a wash down area associated with the former incinerator. Suspected asbestos corrugated sheeting was observed on the southern wall of this building and appeared to be in relatively good condition.

Photograph 5 & 6: Shows the former incinerator building now currently used for waste storage. Photograph 6 shows the small concrete bund adjacent to the southern side of the building.

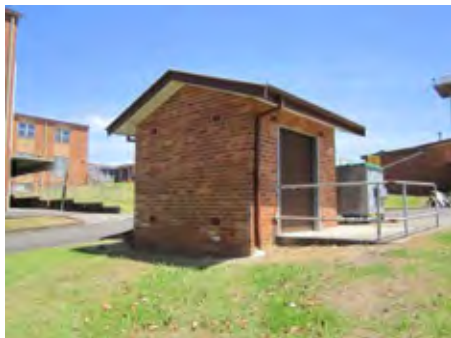
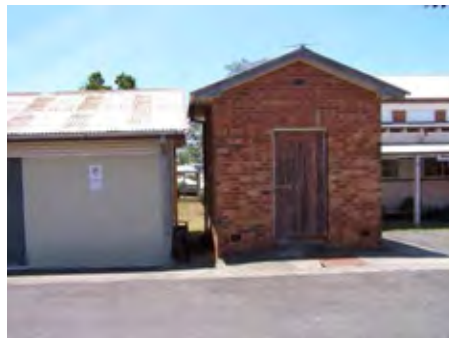
The small building (Photograph 7) located to the southwest of the boiler and laundry building, based on plans viewed in the Council records was understood to be the former coal storage area (coke storage), associated with the former boiler. This building was located within the Stage 1 area and the inside of the buildings was not observed during the site walkover.

Another small building was located to the northeast of the boiler and laundry building (Photograph 8) and was understood to be the former fumigation building. This building was located within the Stage 1 area and the inside of this building was not observed during the site walkover.

All three buildings were located within the Stage 1 area and were constructed with brick walls, corrugated iron roof and fibro sheeting eaves (Coke storage and fumigation buildings). There was no surface staining observed around the perimeter of the three buildings.

Photograph 7 & 8: shows the former coal storage building and fumigation building.

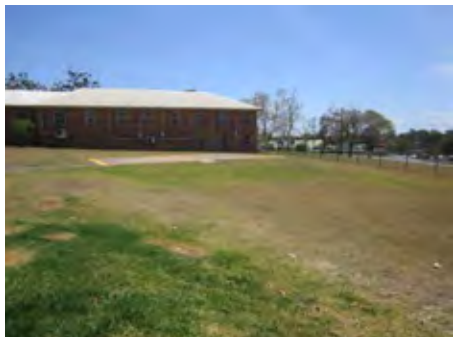
The helipad was located in the northeast Civil Works Zone. There appeared to have been some minor infilling during construction on the eastern and southern portions of the helipad (Photograph 9). The material and the source of the material were unknown.

Photograph 9: shows the helipad with the small fill embankment on the southern and eastern portions of the pad.

AEC	Area	Recommendations
AEC 1	Stage 1 Area	Phase 2 ESA to assess materials within the fill embankment to the southeast of the laundry building and within the helipad area.  Fill Embankment (southeast laundry building)  - Investigation will include 3 boreholes within the fill embankment to assess for presence of contamination and the extent of filling

AEC	Area	Recommendations
	Civil Works Zone	<p>within this area.</p> <p>Helipad Fill Embankment</p> <ul style="list-style-type: none"> <li>- Investigation will include 2 shallow boreholes within the fill embankment to assess for presence of contamination and the extent of filling within this area.</li> </ul>
AEC 2	Stage 1 Area	Phase 2 ESA to assess contamination adjacent to site buildings with the collection of judgemental samples from exposed soils around the perimeter of the laundry, boiler room, incinerator, fumigation and coke storage buildings and the diesel AST.
AEC 3	Stage 1 Area	Phase 2 ESA to assess contamination in surface soils in the vicinity of the former nurse quarters building.
AEC 4	Stage 1 and Civil Works Zone	Phase 2 ESA to screen for potential contamination in surface soils for the remaining areas of the site. Sampling will include; systematic sampling in open areas of the site, judgemental sampling from exposed soils in developed areas of the site, and the collection of environmental samples from fill and residual soils from geotechnical borehole locations. Individual sample locations will be dependent upon location of underground services and access to areas of exposed soils to permit sample collection.

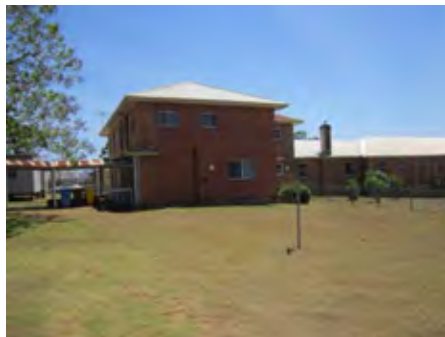
The grassed area located to the west of the helipad fenced area (Stage 1 area) was understood to have been the previous location of the female nurse quarters building (Photograph 10). The year of demolition was not provided, however, the aerial photograph review indicated that it had been demolished between 1979 and 1991. There were remnant concrete footings observed in the site walkover within this area.

Photograph 10: shows the location of the former female nurse quarters building. The building was understood to have extend south from the existing building in the background of the photograph.

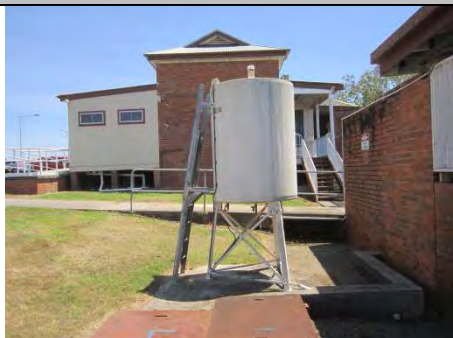
A 1,500L diesel AST (Photograph 11) was observed within the Stage 1 area adjacent to the former boiler and laundry building. The AST is currently used for the hospital diesel powder emergency generator. The AST was not enclosed in a concrete bund, however there was no visible surface staining observed around the AST. There was a small building adjacent to the helipad which was also understood to store fuel drums for the helicopter services.

Photograph 11: Shows the 1,500L diesel AST.

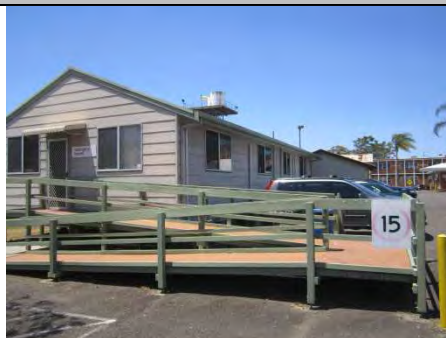
The northern portion of the Stage 1 area and the northeast Civil Works Zone had several demountable buildings present (Photograph 12). The demountable buildings were predominately constructed of timber cladding exterior walls, corrugated iron roofs and raised brick footings. The remaining northern section was predominately sealed car parking and access roads.

Photograph 12: shows one of the demountable buildings observed in the northern portion of the Stage 1 area.
