**Barangaroo**

# Barangaroo Central Waterfront Promenade and Interim Public Domain Archaeological Assessment

Report prepared for Boulderstone  
October 2012

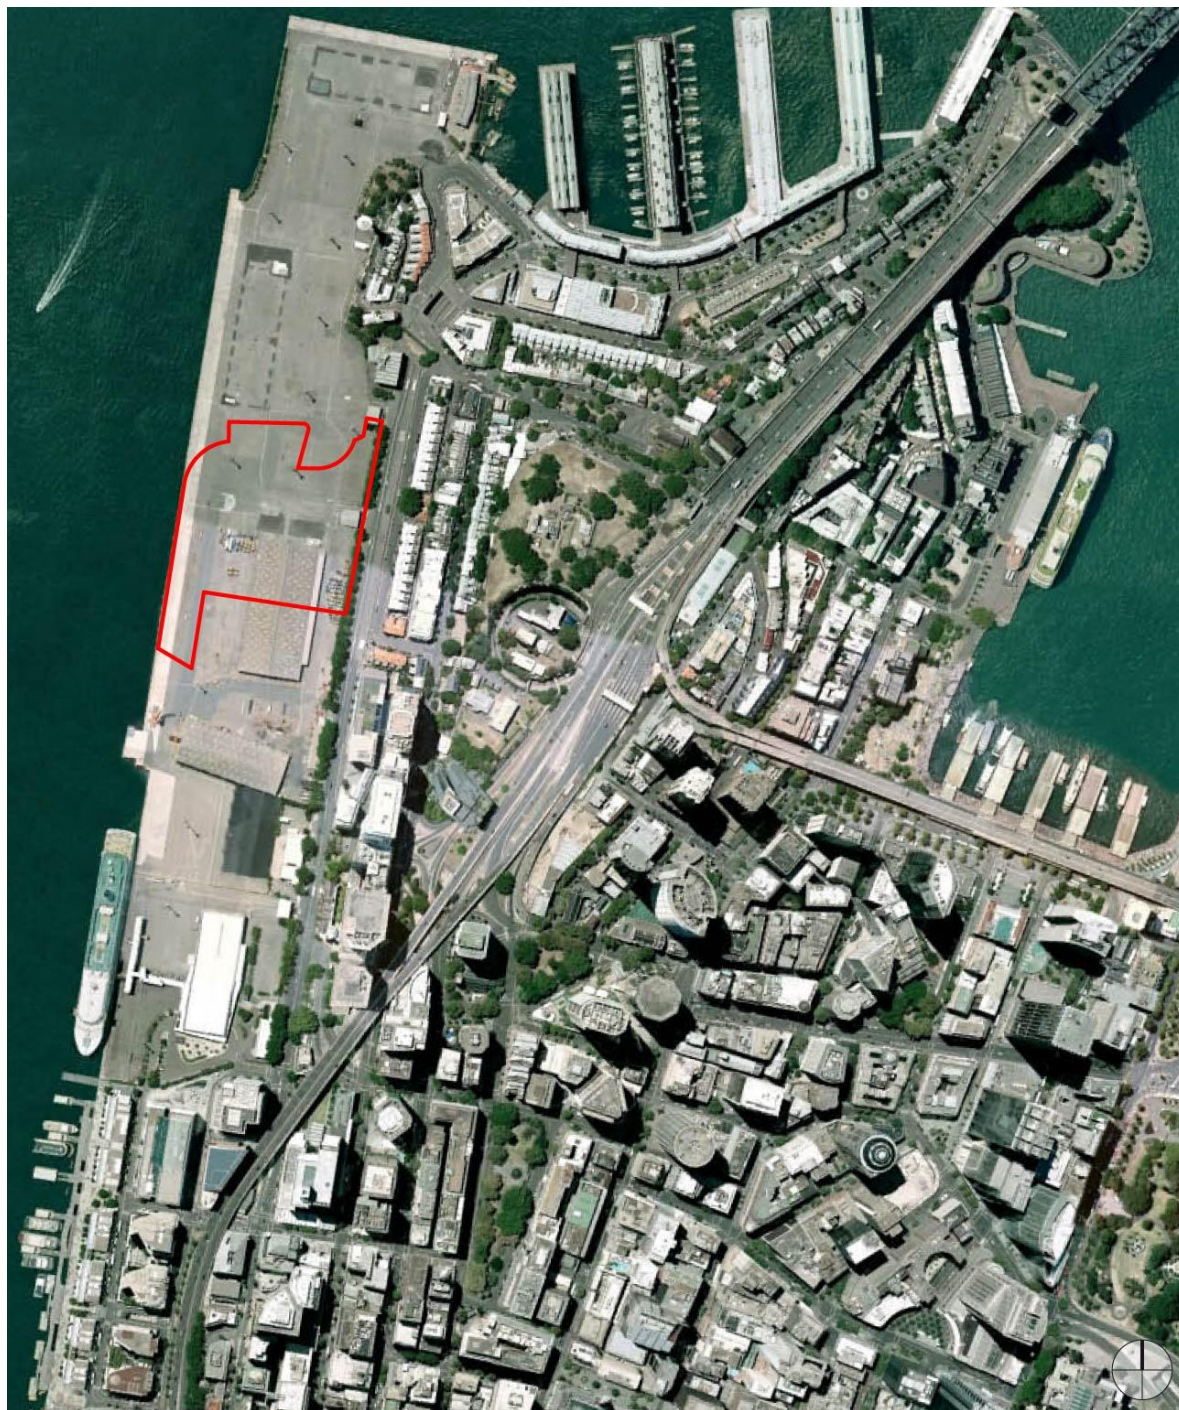
**Figure 1.2** Aerial photograph showing the Barangaroo site in context, with the boundary of the Barangaroo Central Waterfront Promenade and Interim Public Domain outlined in red. (Source: Google with GML additions)

The Barangaroo precinct is located on the northwestern edge of the Sydney CBD on the western side of Hickson Road between Darling Harbour (to the south), Millers Point and The Rocks to the east, and Walsh Bay to the northeast. The Barangaroo Central site is located in the central portion of the Barangaroo precinct (Figure 1.1). The Barangaroo Central Waterfront Promenade and Interim Public Domain (the study area of this report) is bounded by the proposed Northern Cove and Headland Park to the north, the harbour to the west, Hickson Road to the east, and the Lend Lease Temporary Construction Staging Area to the south (Figure 1.2).

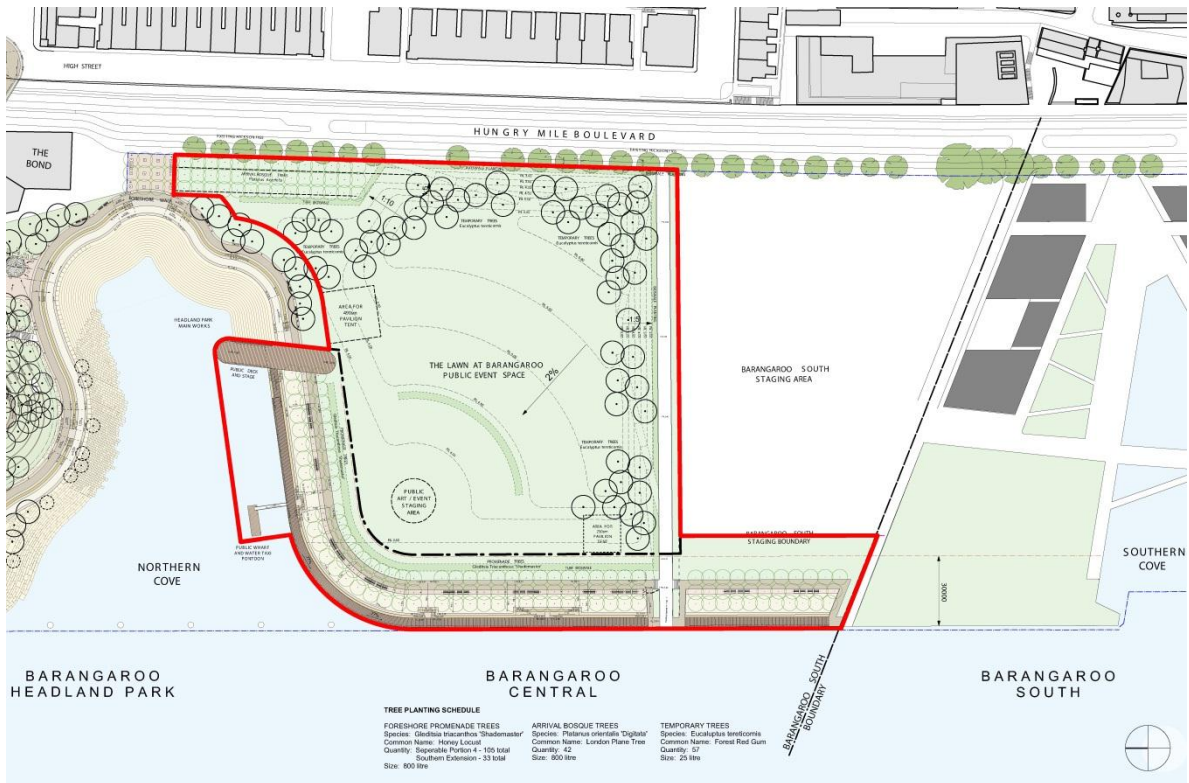
**Figure 1.3** Plan showing details of the Barangaroo Central Waterfront Promenade and Interim Public Domain. (Source: PWP Landscape Architecture, extract from 'Tree Planting Plan', dated 17 September 2012)

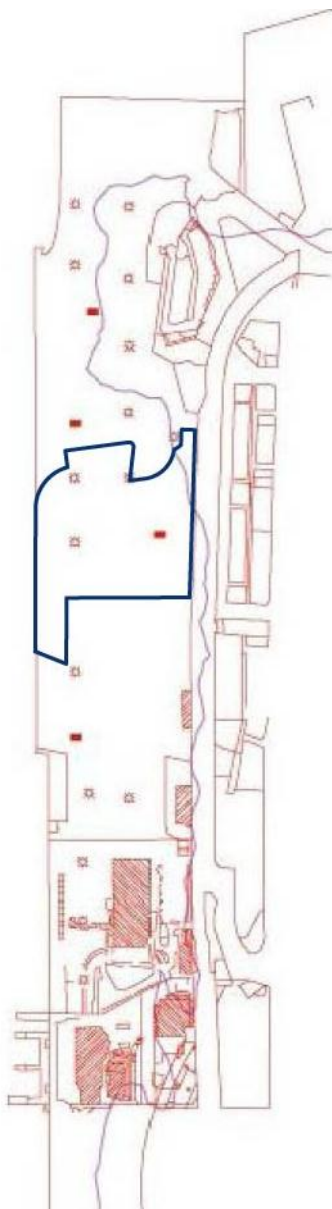
**Figure 2.1** Historical overlay 1788.<sup>19</sup>

The historical overlays of plans from 1788 and 1807 (Figures 2.1 and 2.2) show parts of the foreshore extending into the study area. It should be noted, however, that these very early plans of Sydney are considered relatively spatially inaccurate and provide indicative information about the landforms and site elements only. Later historical plans are much more accurate and show the original shoreline in relation to the current site boundary. Historical overlays of plans from 1831 and 1843 (Figures 2.3 and 2.4) show the study area to be entirely below the water line.

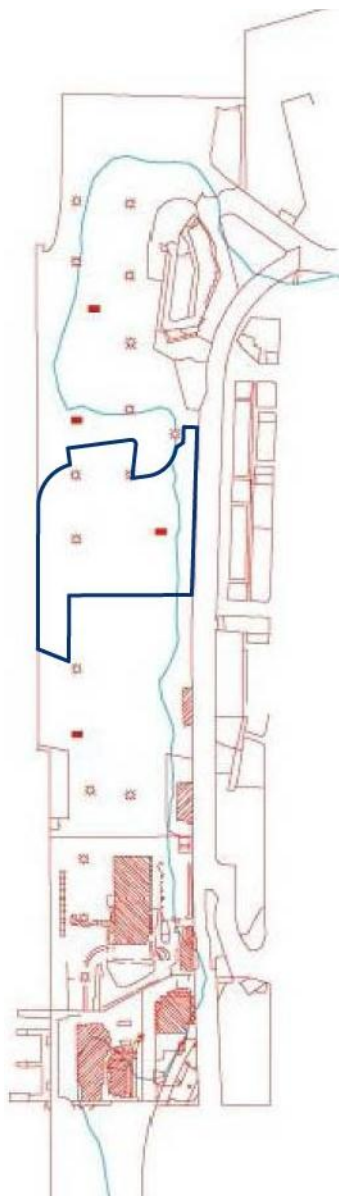
**Figure 2.2** Historical overlay 1807.<sup>20</sup>

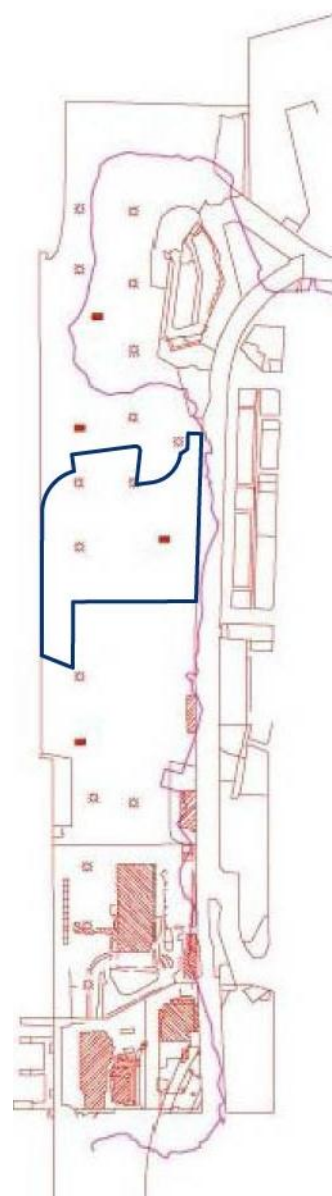
**Figure 2.3** Historical overlay 1831.<sup>21</sup>

— The dark blue line indicates the boundary of the Barangaroo Central precinct

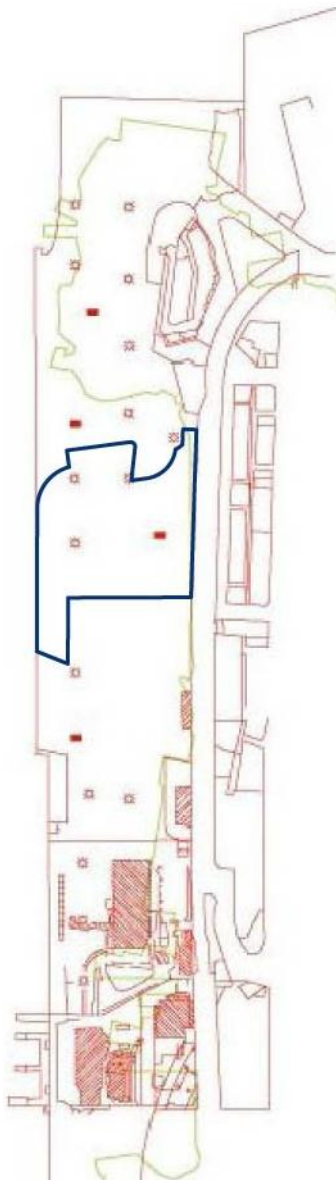
**Figure 2.4** Historical overlay 1843.<sup>22</sup>

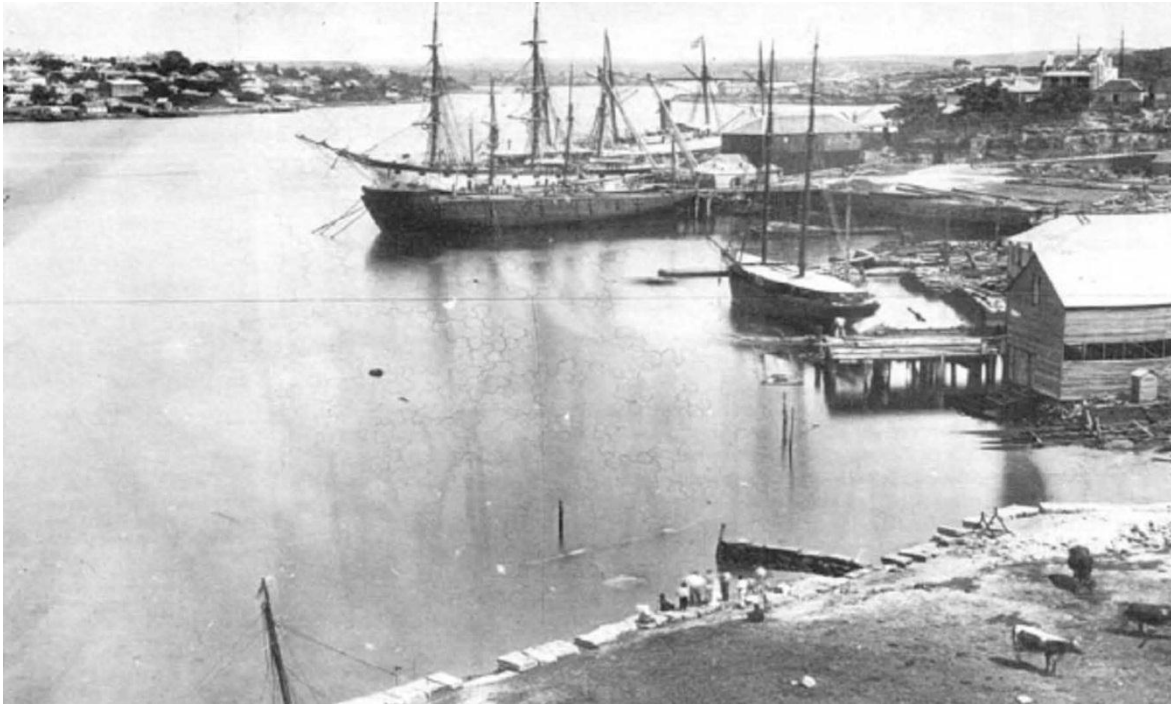
**Figure 2.8** Photograph looking north showing Cuthbert's shipyard in 1873. All of the wharves, sheds and other facilities shown in this photo were probably located to the north of the study area, in the Barangaroo Headland Park precinct. The foreground of this photo may show part of the Barangaroo Central precinct. The foreshore is retained behind a stone retaining wall (noted in the AAMP photo caption as being about three metres high). (Source: Holterman Collection, Mitchell Library, reproduced from 2010 AAMP Figure 3.11)<sup>26</sup>

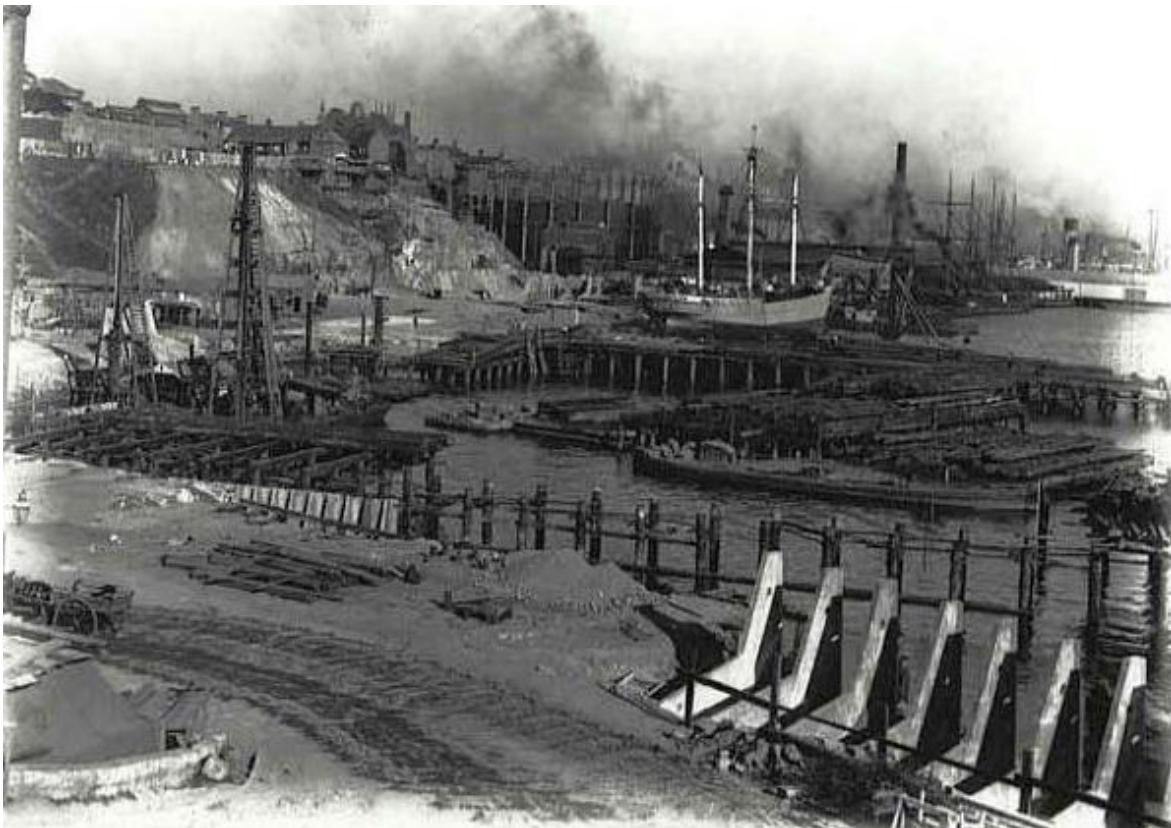
**Figure 2.9** Photograph looking south across the Barangaroo Central precinct c1912, showing the construction of finger wharves in progress. This photo also shows the excavation of the adjacent steep foreshore for the construction of Hickson Road in progress. (Source: State Records ao17-AO17000007, reproduced from 2010 AAMP Figure 3.25)<sup>27</sup>

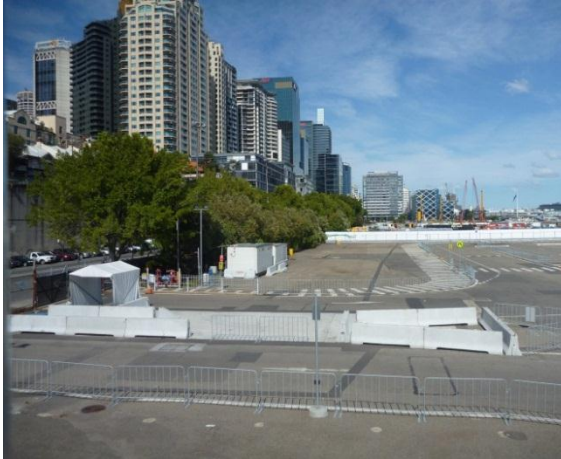
**Figure 3.1** View to the south across the study area. Barangaroo South staging boundary is the white wall in the background.

The study area was inspected by Diana Cowie of GML on 30 August 2012. The entire study area is covered by a flat concrete and bitumen deck that extends from Hickson Road on the east and the water's edge on the west. The concrete deck extends north and south of the Barangaroo Central study area boundary. The concrete deck survives from the former phase of the site's use as a shipping container wharf. Photographs taken during this inspection are included in Figures 3.1–3.4.

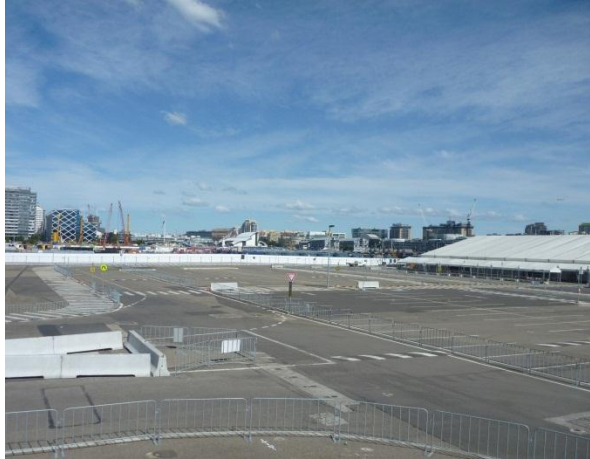
**Figure 3.2** View to the southwest across the study area. Barangaroo South staging boundary is the white wall in the background. The large marque building on the right is the overseas passenger terminal.

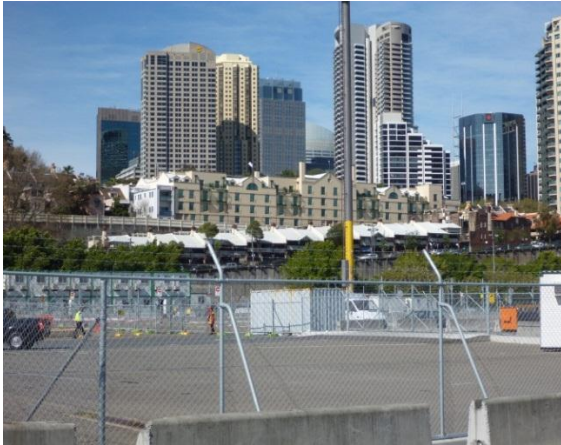
**Figure 3.3** View to the east across the northern part of the study area. The green tree line marks the boundary.

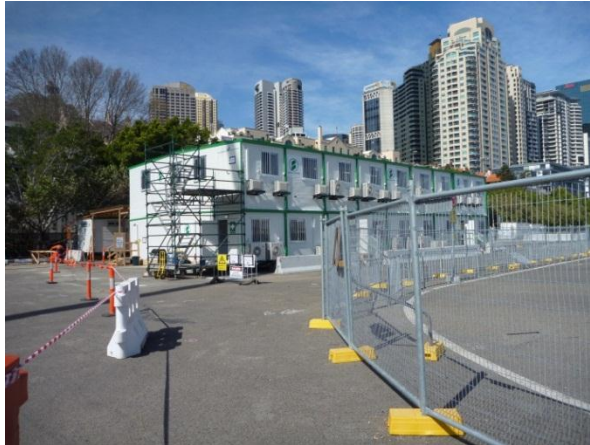
**Figure 3.4** View to the south east from the northern boundary of the study area.

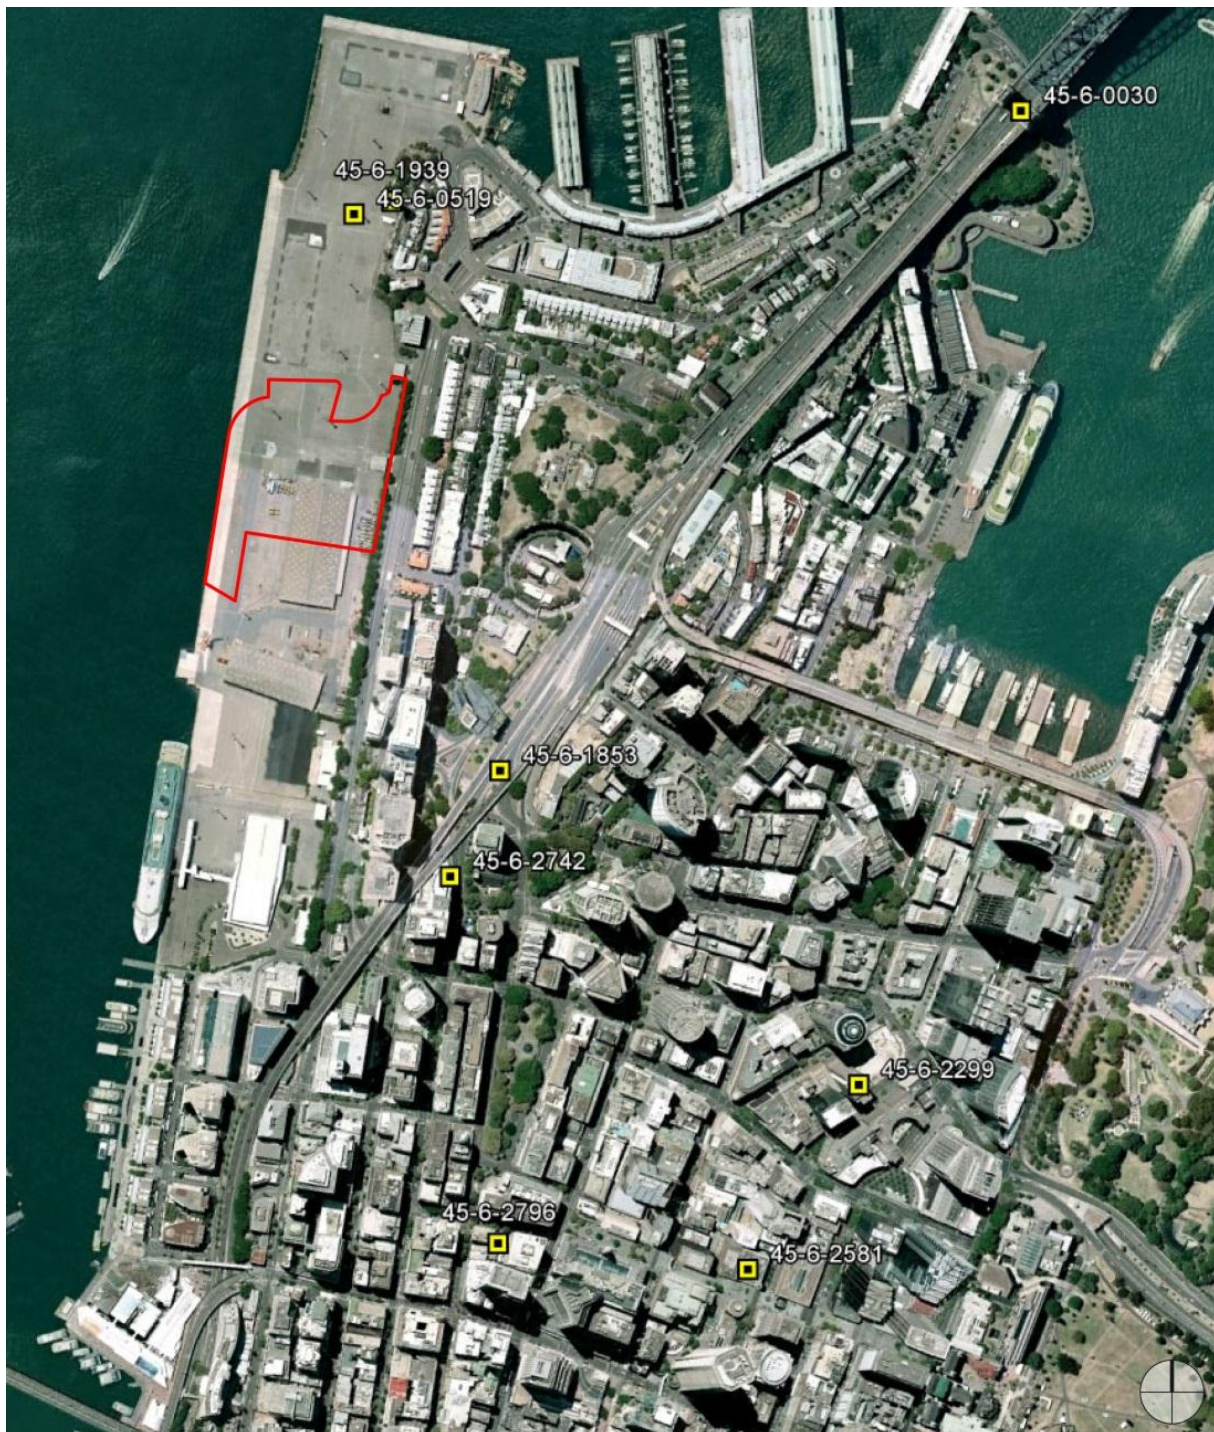
**Figure 4.1** The study area in relation to registered AHIMS sites within the CBD. (Source: Google Earth with GML additions)

A search of the OEH AHIMS database was undertaken on 3 September 2012 for the study area and land surrounding the study area. The results indicate that no previously recorded Aboriginal sites are located within the study area (Figure 4.1). No Aboriginal places have been declared within the search area.

Two Aboriginal sites (45-6-1939 and 45-6-0519) are recorded to the north of the study area, within the Barangaroo Headland Park precinct. One site, 45-6-1939, is a rock engraving which has been destroyed, while 45-6-0519 is an open camp site (artefact site). Two other sites (45-6-1853, a midden with artefacts, and 45-6-2742, a potential archaeological deposit) are located on the sandstone ridge, now the location of the freeway onto the Harbour Bridge (Figure 4.1). Other recorded Aboriginal sites are located elsewhere in the CBD, some distance from the current study area and within different landforms to those surrounding the current study area.

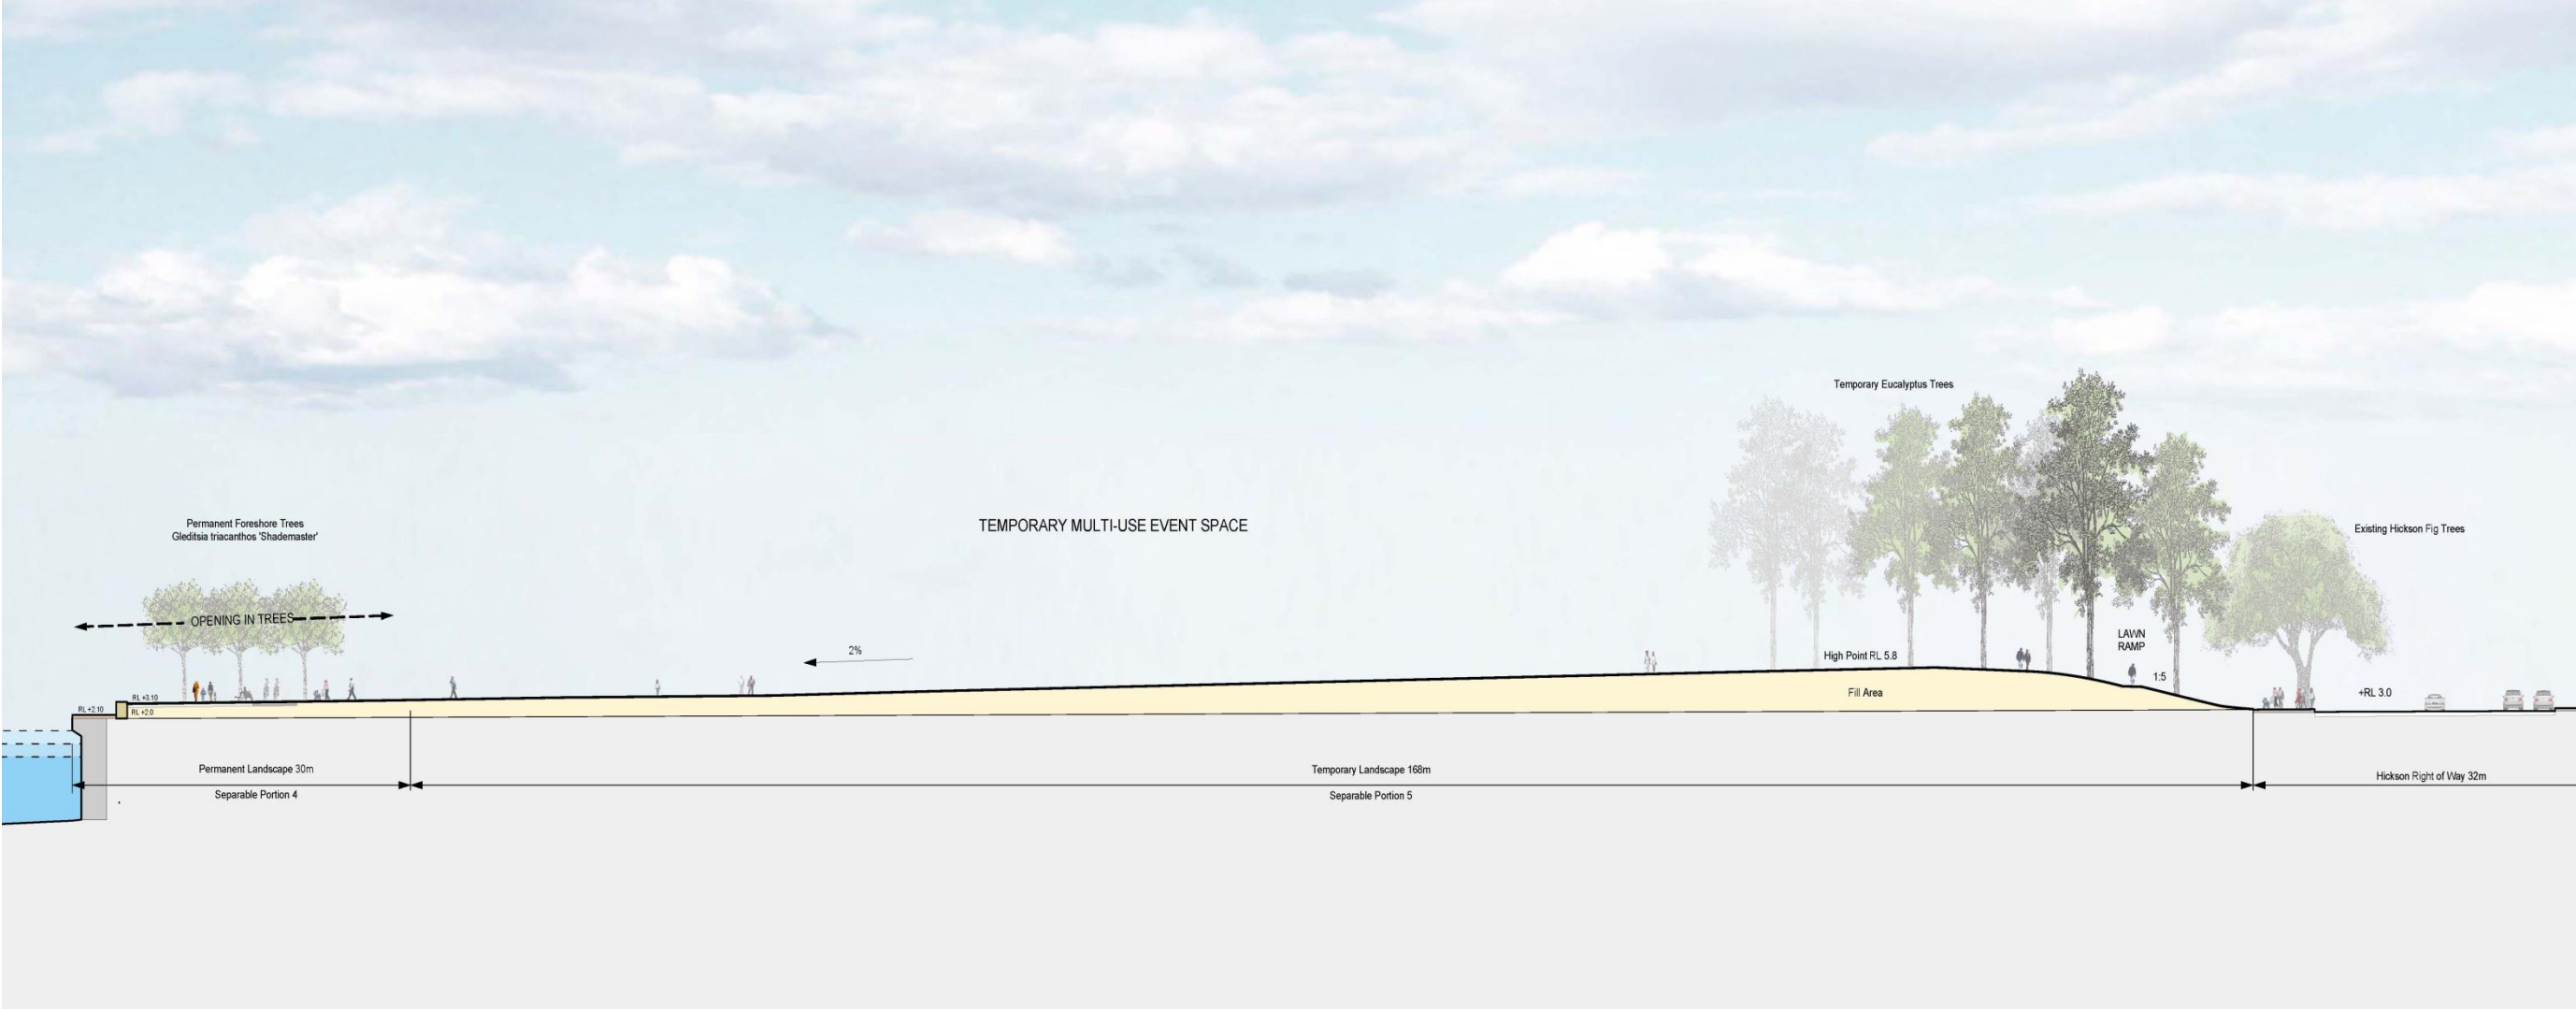
**Figure 6.3** Section drawing showing the proposed profile of the Interim Public Domain. The lawn area will be filled to achieve the required slope. (Source: PWP Landscape Architecture, extract from 'Design Development Stage Two Site Sections—West East Site Section, Drawing No. TE-PWP-L-S3-8002)

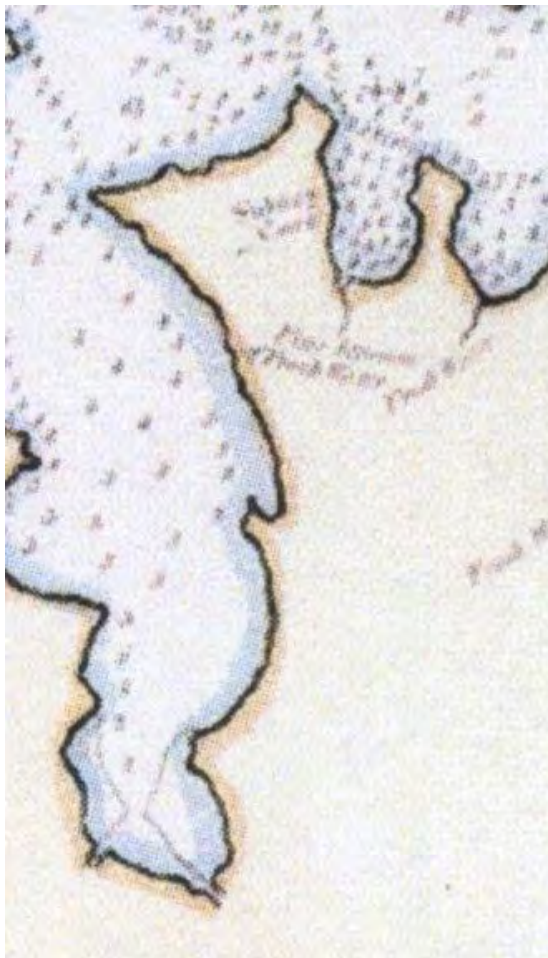
Figure 3.2. Detail of Captain John Hunter's *Plan of Port Jackson, New South Wales* (1788) showing depth of water around Sydney Cove and Darling Harbour (SLNSW ML ZM4 811.15/1788/1)

Various known as Long Bay and Cockle Bay, there are very few references to the eastern shores of Darling Harbour by the early colonial diarists. The name appears to come from European descriptions of the harbour shore, its large piles of shell and the availability of shellfish in the shallow bay. A number of early maps chart the depth of water in the various bays and inlets of Port Jackson. The depth of water around the head of Cockle Bay was between 1.5 – 2 metres (4-6 feet) deep, while the depth of water at Walsh Bay was 2 – 2.5 metres (7-8 feet). The harbour fell sharply into deep water just off shore at the headland making Millers Point accessible to both large and small vessels (Figure 3.2).

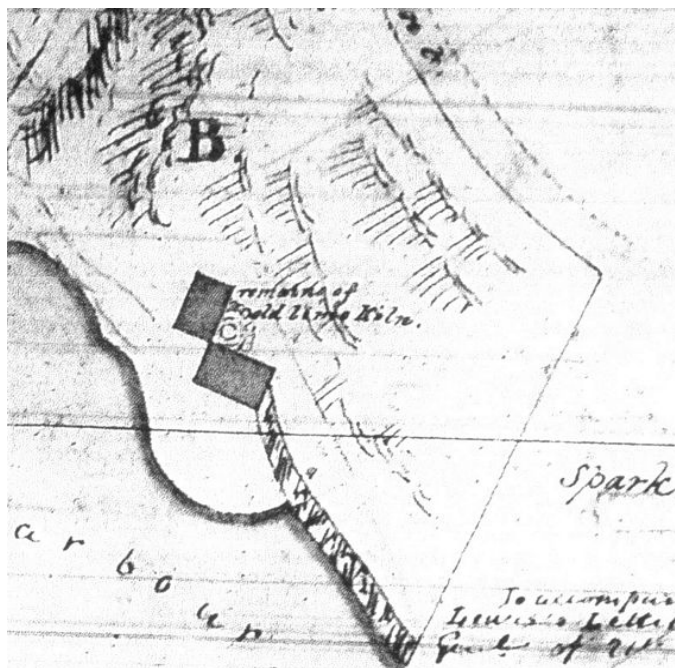
Figure 3.5. Detail of the lime kilns on Munn's property built into the side of an escarpment close to the waters edge. Common shaft kilns had a cylindrical shaped burning chamber with an air inlet in the base. They were usually constructed into an embankment and lined or faced with brick, stone or limestone blocks. The kiln was packed with alternate layers of fuel (timber or coal) and limestone, coral or shell, often covered at the top to control the burn and fired from the base. This layering limited the size of the kiln to 2-4 meters diameter and up to 3 meters in depth. They generally had a turn around time of approximately one week, several days to load and unload and 2-3 days to fire. This type of technology did not require a great deal of skill to operate, but was labour intensive often employing convict labour (Harrington 2000). (Source: State Records maps and plans Parish of St Philip vo1 folios 1-50 reel 2746).

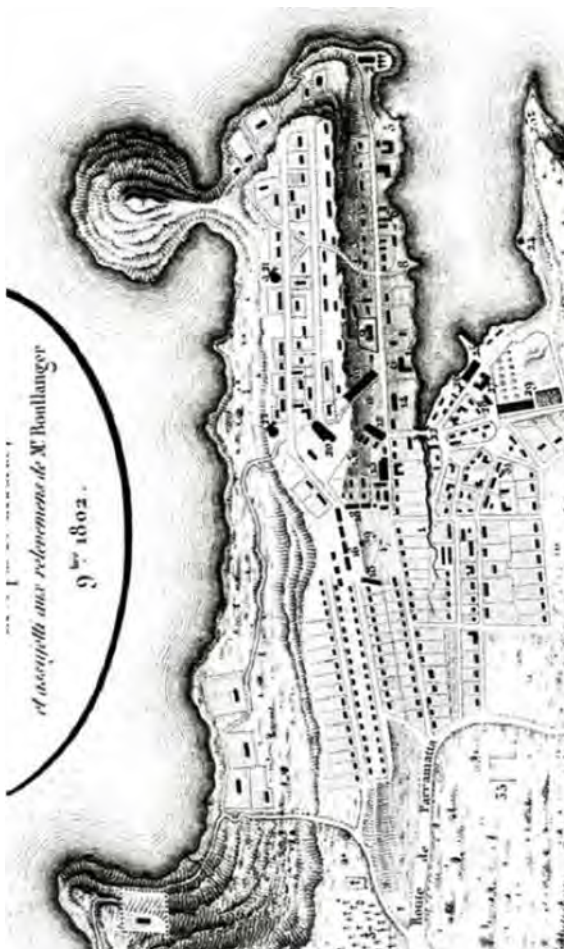
Figure 3.6. Lesueur's map of Sydney 1802 (*De La Ville De Sydney*) (Source Ashton and Waterson 2000:7).

Lesueur's map of Sydney 1802 (Figure 3.6) shows the settlement of Sydney Cove spreading to the south. By this time there were some early allotments, possibly small farms and an access track around the location of Sussex Street at the southern end of the site. However, the rocky ridgeline to the west of Sydney Cove acted as a natural barrier to rapid occupation of Millers Point and the shores Darling Harbour at the northern end of the site. The location of the windmills is shown on Lesueur's map as well as a few buildings and associated tracks on the shores of Walsh Bay.

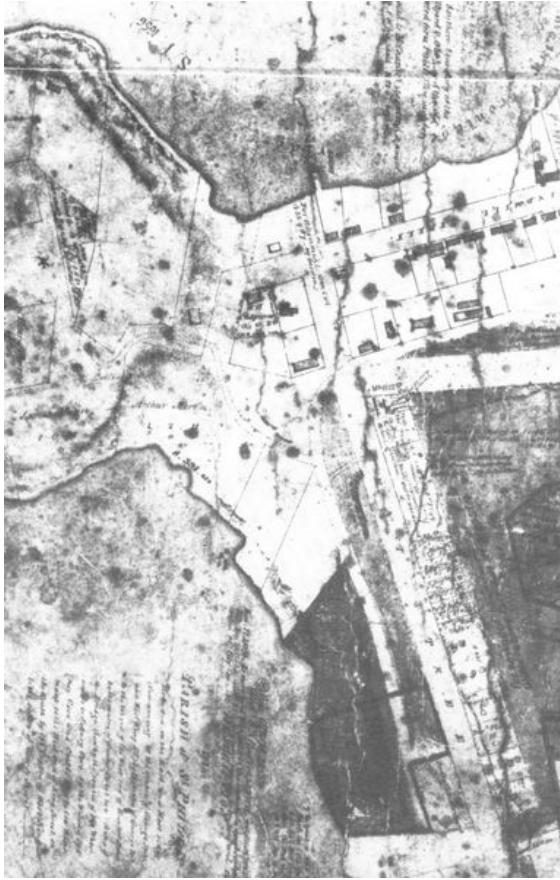
Figure 3.9. Detail of Harpers map which was begun in 1823 and added to later. It is very similar to the later parish map but shows the location of the windmills and buildings on the properties (Source: State Records collection map reproduced in Fitzgerald & Keating, *Millers Point, The Urban Village* 1991).

Harper's map of Sydney started around 1823 (Figure 3.9) establishes the topography and land tenure of Millers Point prior to the official granting of titles (Fitzgerald & Keating 1991:18). The plan shows fence or boundary lines and squarish modified sections of shoreline in the central and southern part of the site that is likely to be indicative of reclamation or wharf construction.

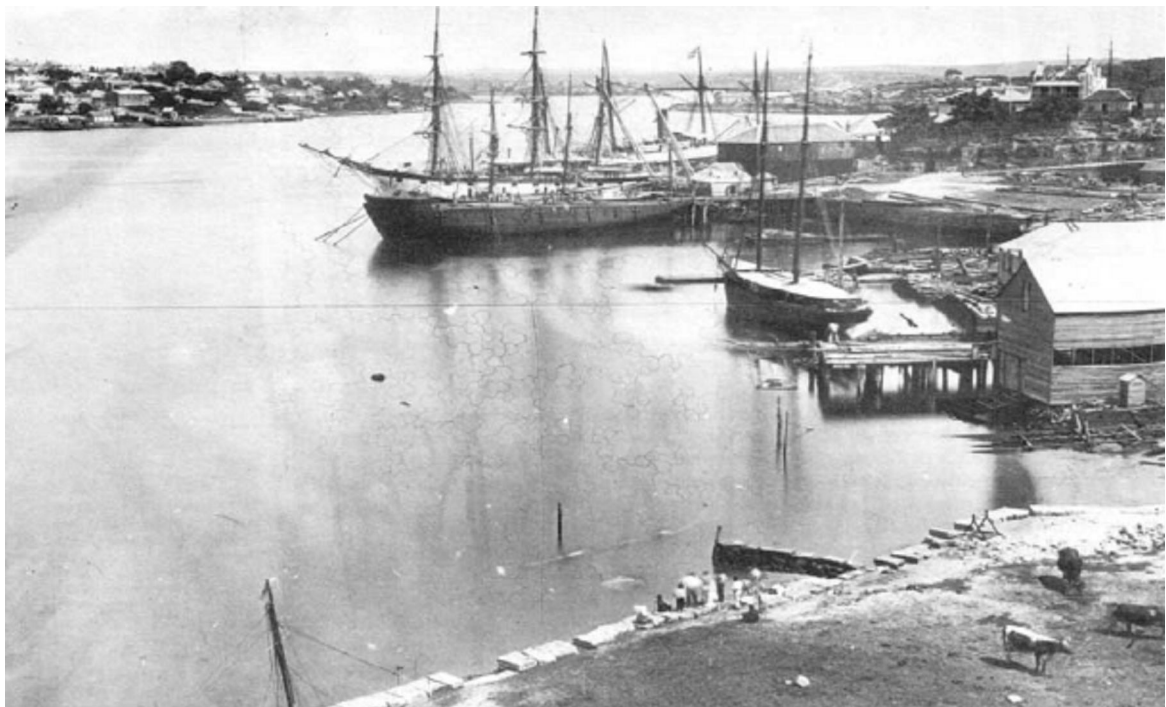
Figure 3.11. Cuthbert's shipyard 1873. The business was replaced by Dibbs wharf within a few years of this photograph being taken. The wharf has been extended out into the harbour at the north west of the property to access deep water. A group of ten people are standing on a stone retaining wall at the bottom of the image. The shore is about three metres below them (Source: Holterman Collection, Mitchell Library).

study area, in the Barangaroo Headland Park precinct. The foreground of this photo may show part of the Barangaroo Central precinct. The foreshore is retained behind a stone retaining wall (noted in the AAMP photo caption as being about three metres high).<sup>11</sup> Overlays of historical plans of this area suggest that the eastern boundary of the Barangaroo Central precinct was located approximately in alignment with this retaining wall. The partially visible ship's mast indicates that wharf or jetty facilities would have been located adjacent of the base of the wall at the water's edge.

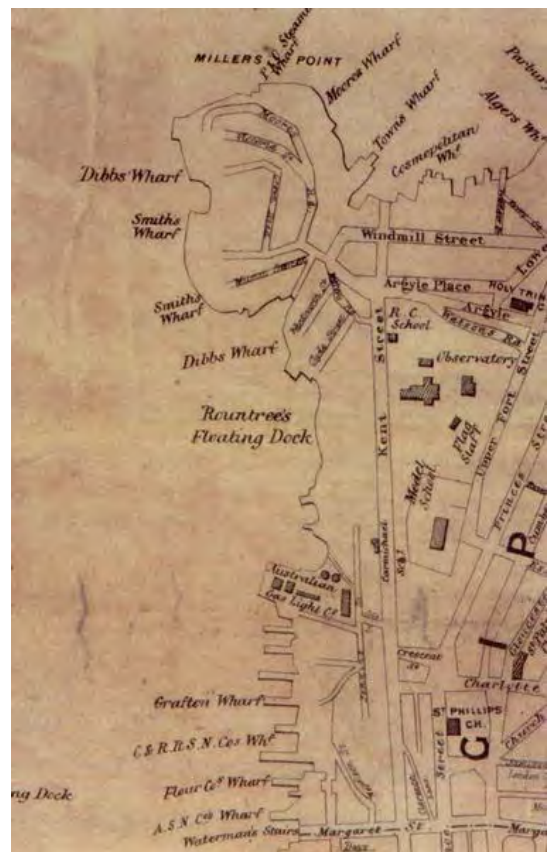
Figure 3.15. 1875 plan illustrated in the *Supplement to Sydney Mail*. This image is almost identical to the 1855 plan by Smith and Gardner. These plans name the more important of the wharves present at the time (Source: Sydney Harbour Foreshore Authority Historic Maps & Plans Collection).

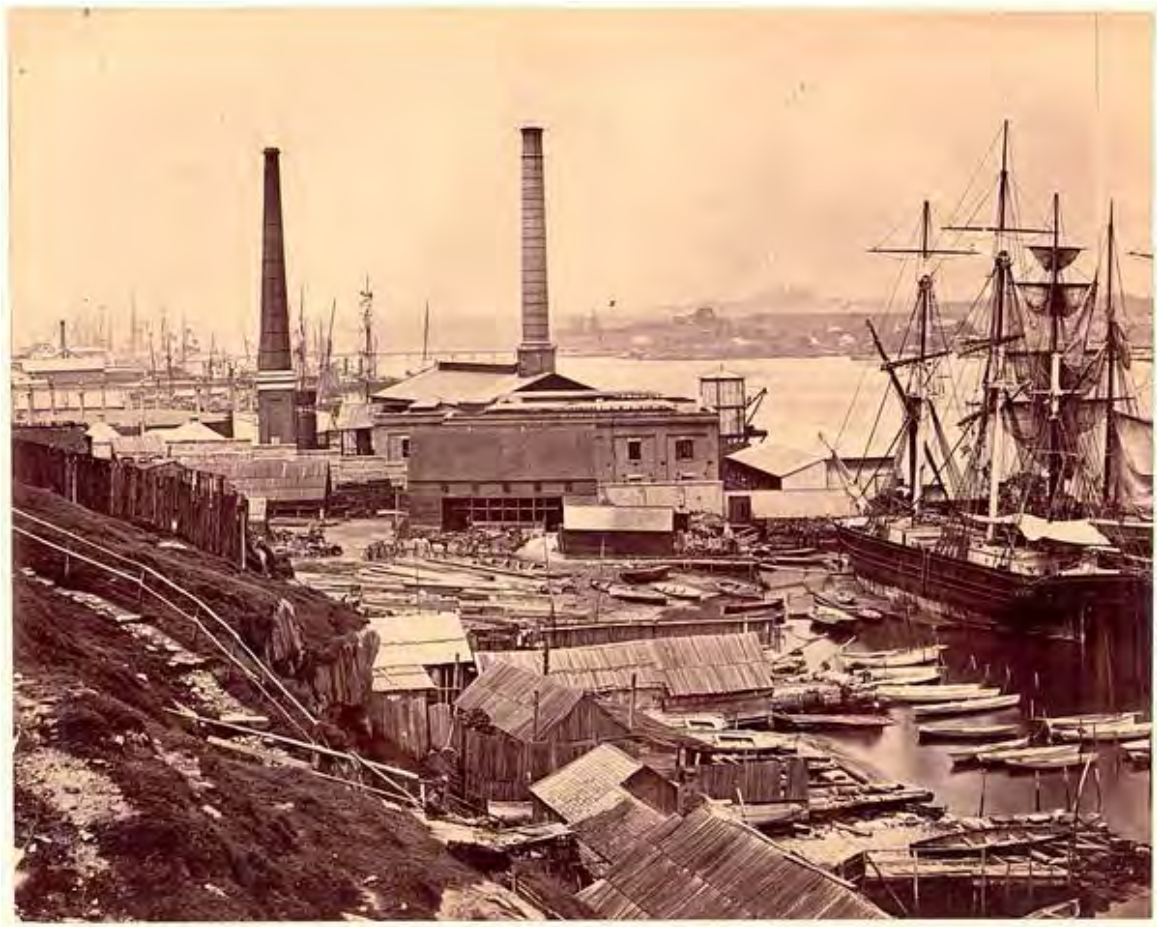
Figure 3.18. View to the south of the gas works around 1870. The large ships are moored at Rowntree's floating dock which was owned for a time by Cuthbert. The steep slope down to the harbour is traversed by stairs and a path with a handrail. Fencing appears to have been constructed around cliff edges. The gas works is constructed on reclaimed land (Source: State Library of NSW)

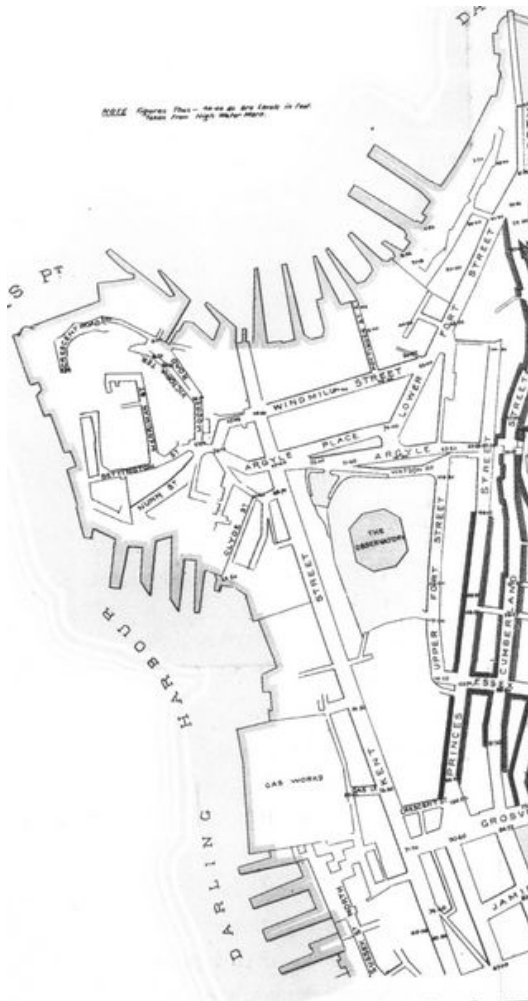
Figure 3.16. *Plan of the North West Portion of the City of Sydney Locally Known as The Rocks with its Surroundings From Darling Harbour to Circular Quay* WA Gullick Government Printer 1900. This image shows the wharf formation prior to government resumption. At this time the gas works had become a very large site, there were at least six wharves at the south of the headland, and the headland had been extensively modified to create long berths on the north and west shores (Source Ashton and Waterson 2000:49).

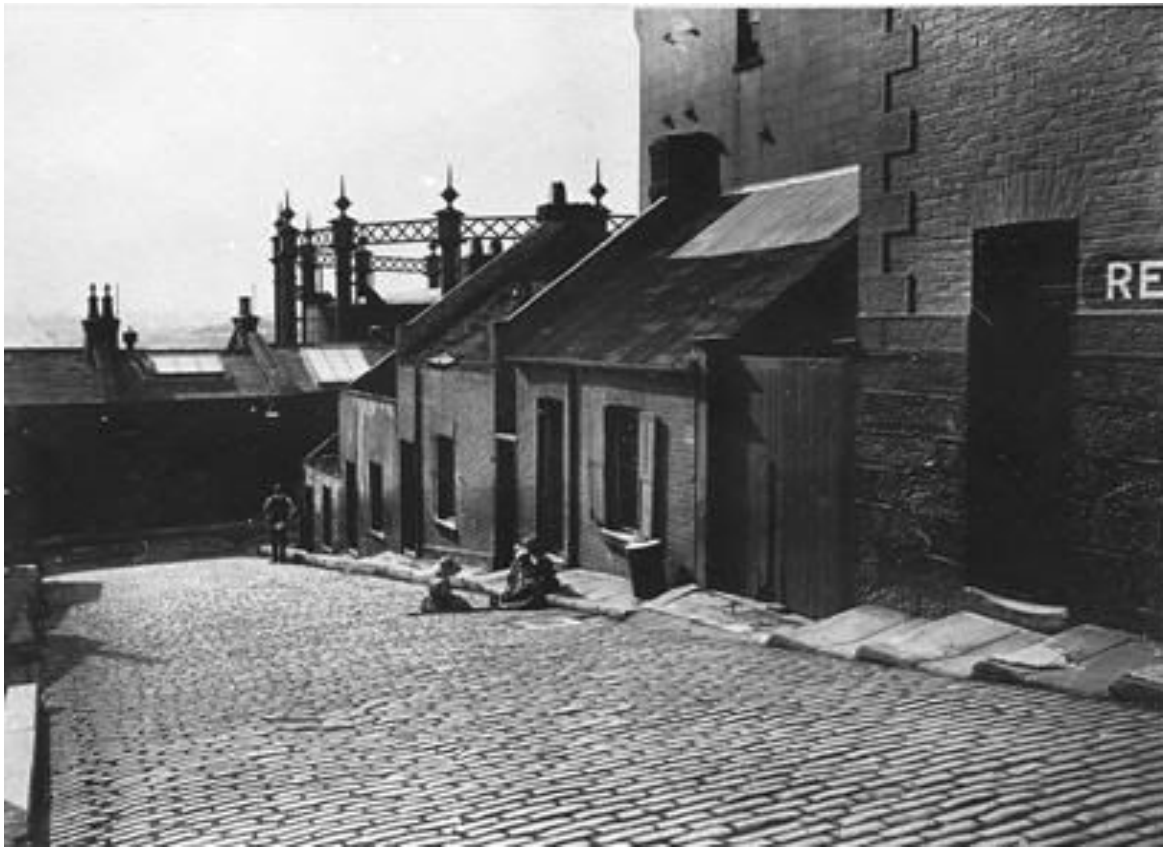
Figure 3.20. Gas Lane 1900 just prior to resumption. This steep street had stepped footpaths and either a cobbled or woodblock surface to aide traction for heavily laden carts. Note the gas holder in the background (Source: Sydney Archives CSR 51 000566).

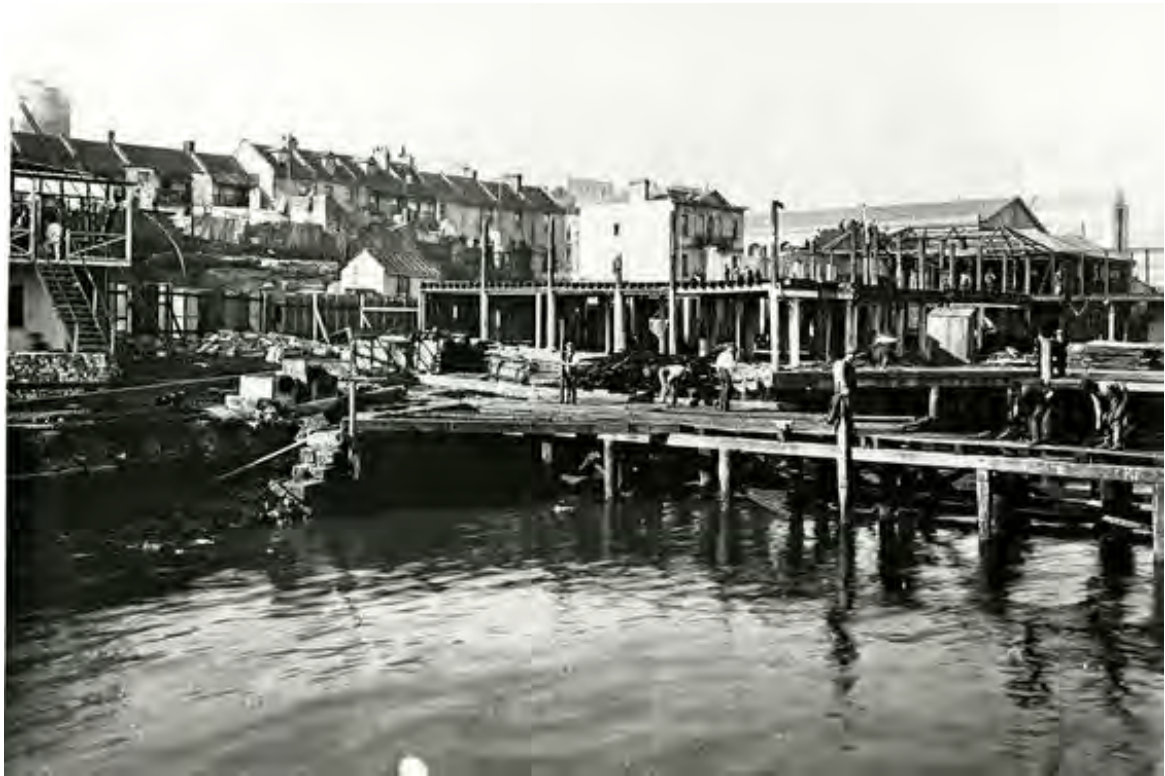
Figure 3.22. Demolition of the AS&N Co wharf 1910. The timbers on the wharfs and surrounding buildings are being lifted and taken away. Much of the timber was reused (Source: State Library of NSW GPO 1-48303)

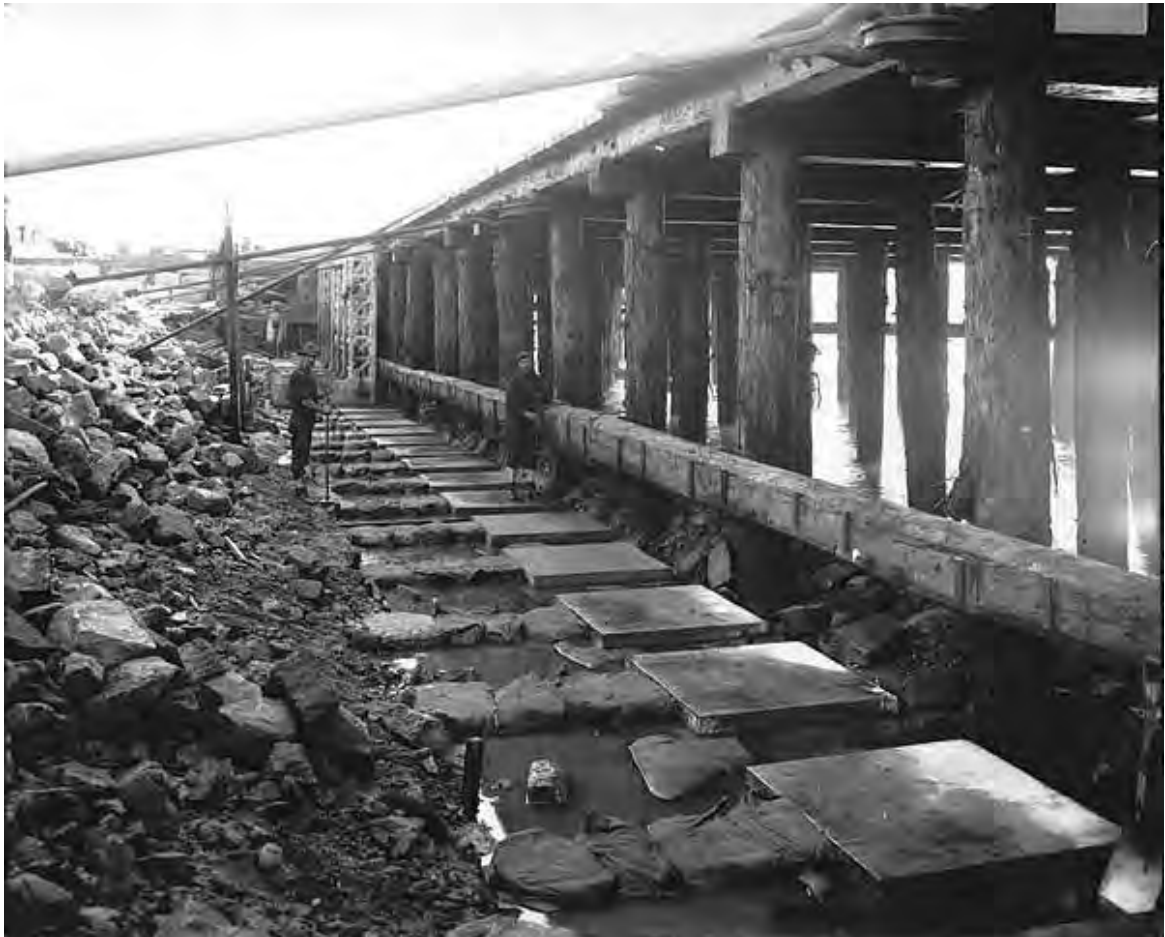
Figure 3.23. Construction of the new wharfs 1911 (Source: State Records ao17-AO17000004).
