**Barangaroo**

# Barangaroo Central Waterfront Promenade and Interim Public Domain Archaeological Assessment

Report prepared for Boulderstone  
October 2012

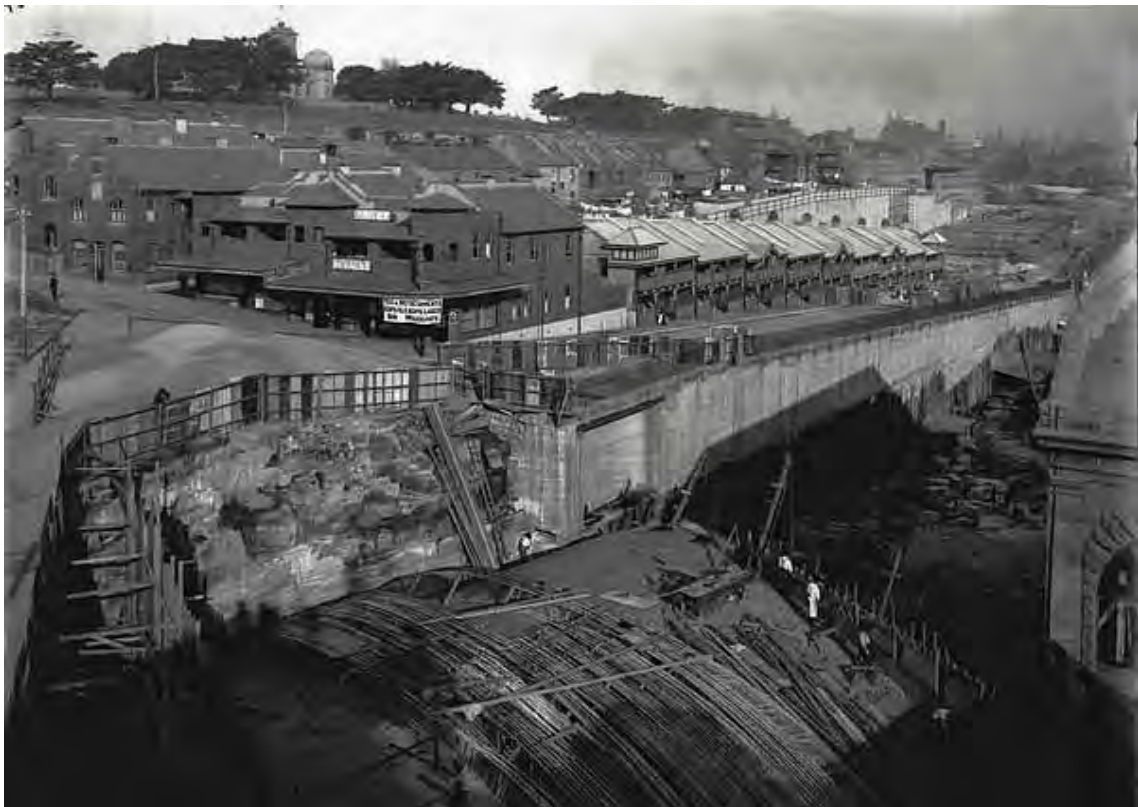
Figure 3.24. Bridge over Hickson Road from Munn Street. The headland has been cut away and new housing constructed along High Street. (Source: State Records ao17-AO17000010).

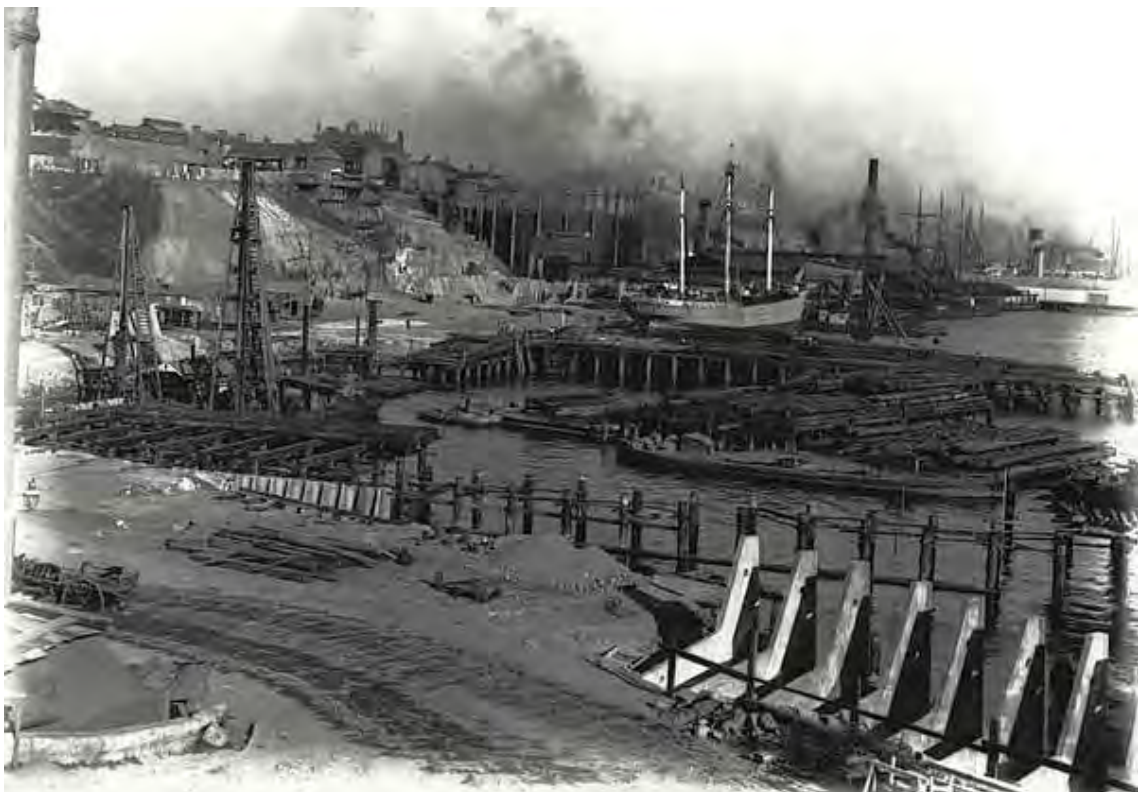
Figure 3.25. Construction of new wharfs at Darling Harbour c1912 with the gas holder and gas works in the background. Land has been reclaimed before the wharfs are constructed. Hickson Road is not yet formed and many of the old wharfs are still in place (Source: State Records ao17-AO17000007).

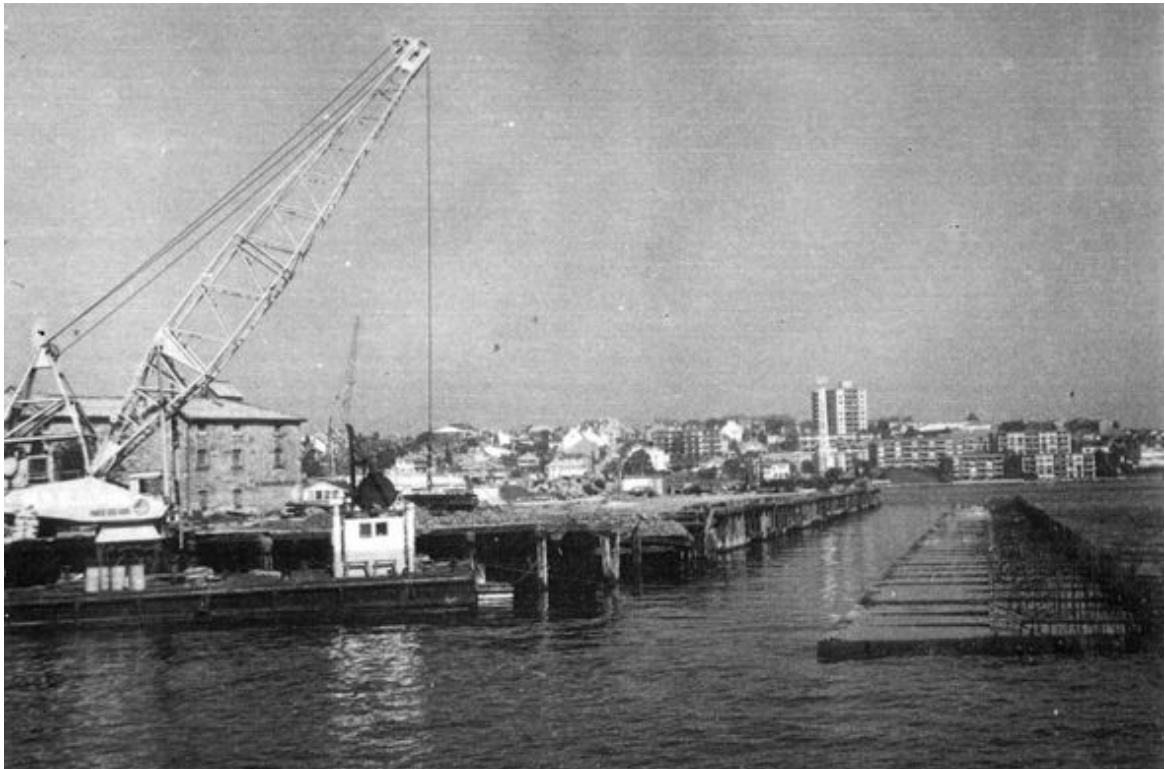
Figure 3.26. Repair of the northern edge of the wharf in the 1970s showing both timber and concrete piles (Source: State Library of NSW MP115).

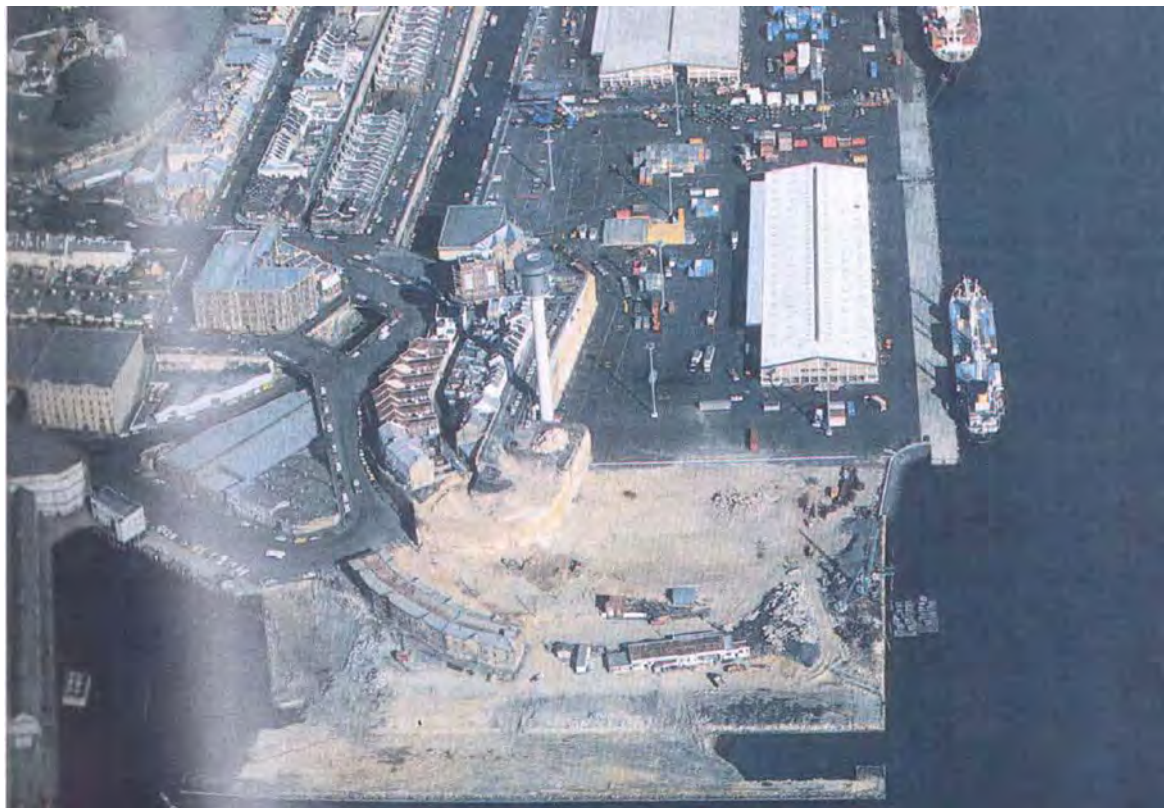
Figure 3.27. Excavation and reconstruction of the headland in the 1970s. Moore's Wharf has not been relocated and the surviving buildings are indicative of the former shape of the headland. (Source: Maritime Services Board Annual Report 1977-78, p 8)

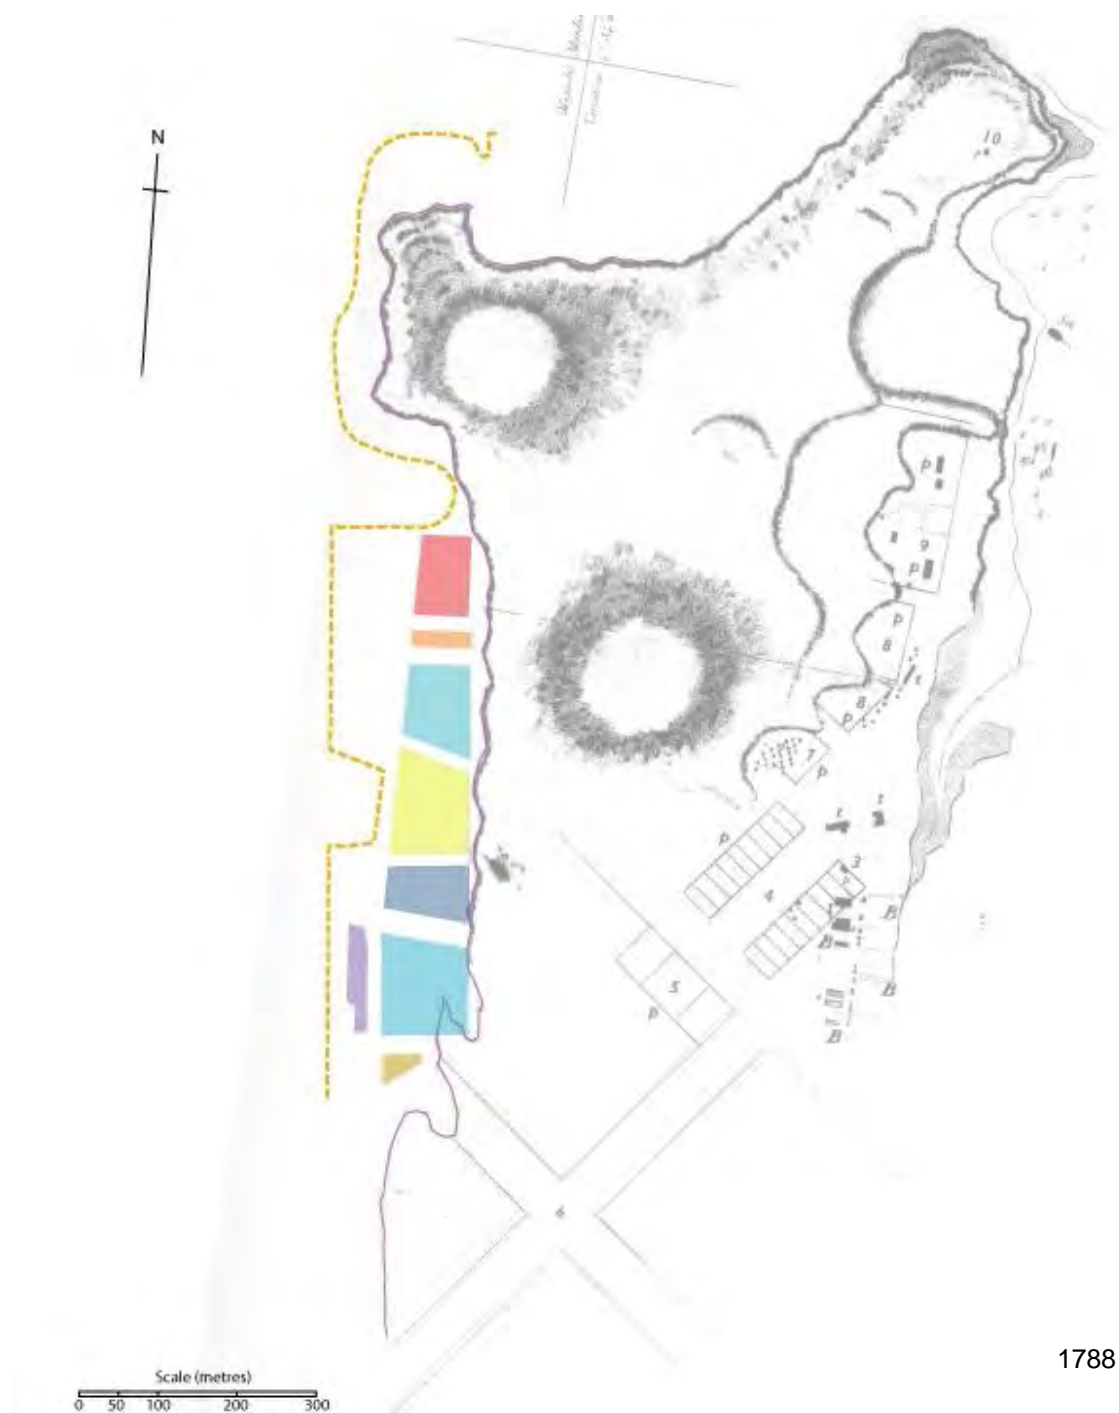
Figure 10.1. Approved Concept Plan shoreline (yellow dotted line) and development blocks (coloured) overlaid onto *Sketch of Sydney Cove, Port Jackson count of Cumberland NSW 1788* by William Dawes and Captain Hunter. (Source Ashton and Waterson 2000:9). This image shows the proposed development to be located predominantly in the harbour and would potentially impact the original shore line at the southern end of the site. William Dawes was an engineer and astronomer who arrived on the First Fleet. He participated in a number of surveys and expeditions beyond Sydney Cove and his plans are well drawn. This image depicts the high points of the geography and the steep ridges on which The Rocks was settled.

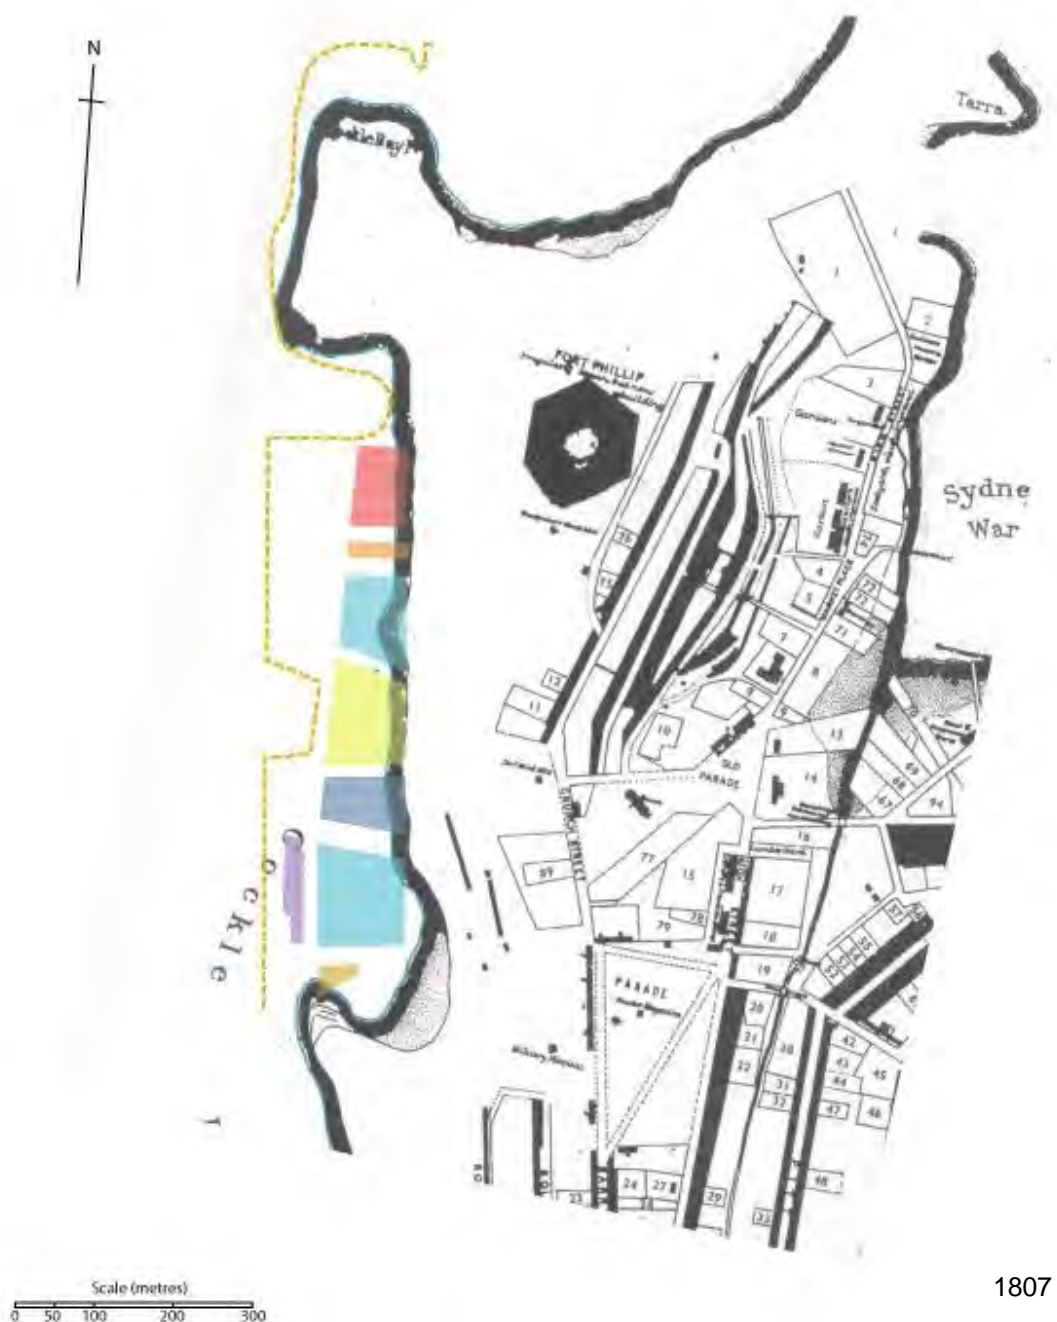
Figure 10.2. Approved Concept Plan shoreline (yellow dotted line) and development blocks (coloured) overlaid onto *Plan of the Town of Sydney in New South Wales 1807* by James Meehan (Source Ashton and Waterson 2000:17). This image is similar to the previous in that the potential impact would affect the original harbour shoreline. The area is already known as Cockle Bay and the northern part of Millers Point is known as Cockle Bay Point. The plan does not depict structures or tracks in the Millers Point area even though a few did exist at this time, but The Rocks and the region around the cove is well developed. Fort Phillip was constructed on a high point to the west of Sydney and although uncompleted when this plan was produced, has been drawn as the finished structure.

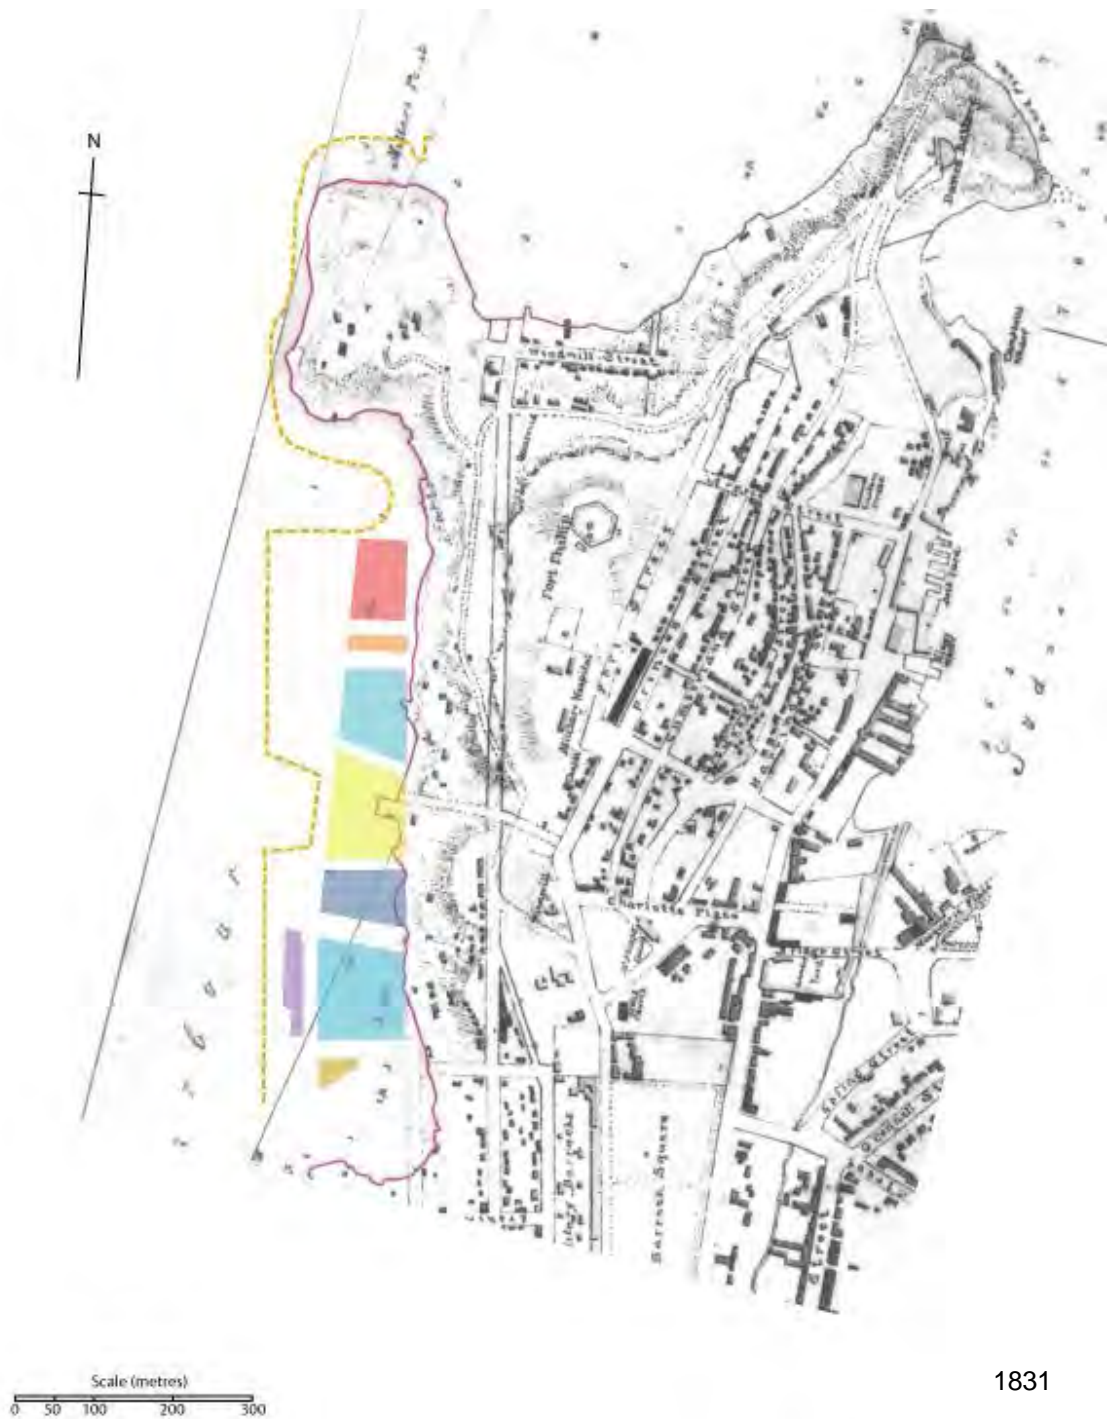
1831

Figure 10.3. Approved Concept Plan shoreline (yellow dotted line) and development blocks (coloured) overlaid onto *Map of the Town of Sydney, 1831*. Lanner and Mitchell (Source Ashton and Waterson 2000:17). This image shows the development of streets in Millers Point, the location of tracks and houses, the alignment of Kent Street, the escarpment around the headland, a wharf and steps around the centre of the site as well as the proposed alignment of Sussex Street. Munn was ship building at this time and a number of small wharves are likely to be present on the southern shore of the headland, but were not illustrated on the map. The headland is now known as Millers Point and Cockle Bay has become Darling Harbour.

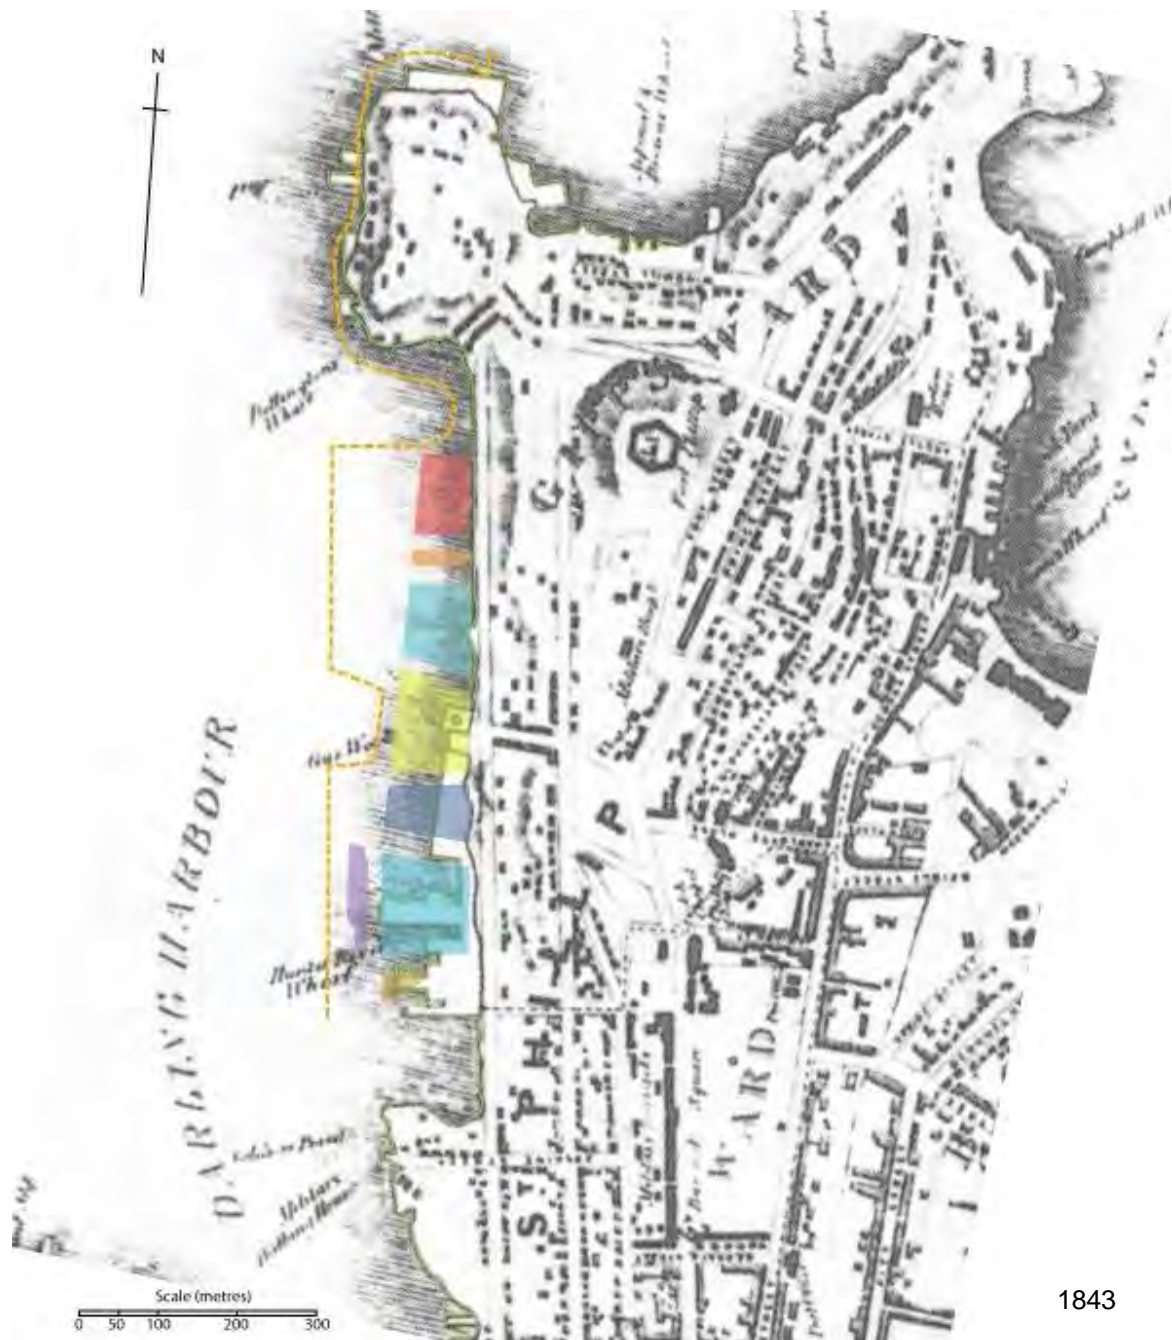
1843

Figure 10.4. Approved Concept Plan shoreline (yellow dotted line) and development blocks (coloured) overlaid onto *Map of the City of Sydney, 1843* William Henry Wells Land Surveyor (Source Ashton and Waterson 2000:25). This map shows the location of the gas works and the Hunter River Wharf to the south and a number of wharves around the headland to the north which have substantially reclaimed land in the harbour. A road parallel to Kent Street is shown on the plan but this road (Hickson Road) did not exist until the redevelopment of the harbour foreshore in the twentieth century. This image clearly demonstrates the potential impact of development blocks 2-5 on the gas works and early wharves.

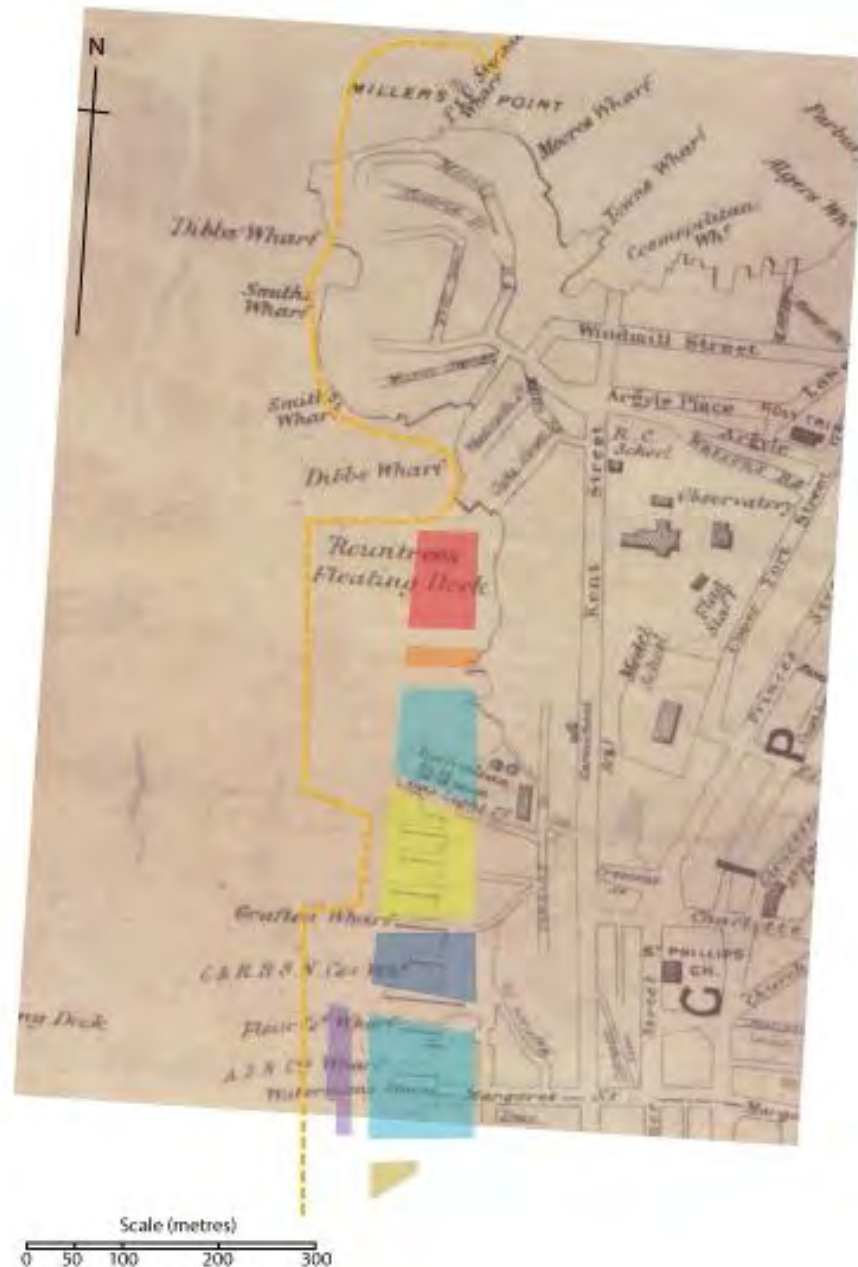
1854-1875

Figure 10.5. Approved Concept Plan shoreline (yellow dotted line) and development blocks (coloured) overlaid onto a 1875 plan illustrated in the *Supplement to Sydney Mail* (Source: Sydney Harbour Foreshore Authority Historic Maps & Plans Collection). This image is almost identical to an 1855 plan by Smith and Gardner and Wollcott and Clarke's Map of the City of Sydney 1854. All of these plans name the more important of the wharves present at the time. These include Smiths Wharf owned by Charles Smith shipping merchant, Dibs's Wharf owned by George Dibs, shipping and wine merchant whose property adjoined Cuthbert's ship building yard, and Rountree's floating dock owned by Thomas Rountree Master Mariner and ship builder.

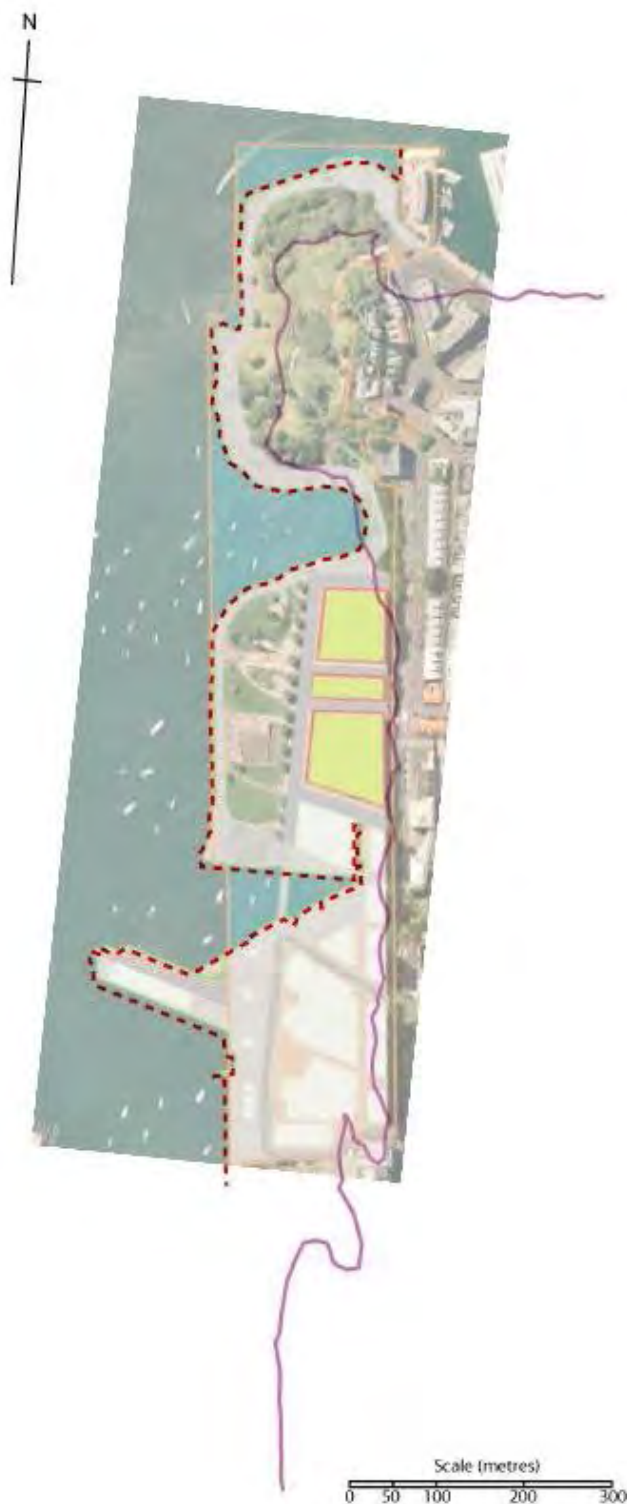
Figure 10.8. Purple outline of *Sketch of Sydney Cove, Port Jackson count of Cumberland NSW 1788 by William Dawes and Captain Hunter*. (Source Ashton and Waterson 2000:9) overlaid onto the proposed plan shoreline (red dotted line) and development blocks (yellow).

This image shows the proposed development to be located predominantly within the current deck apart from the hotel that extends into the harbour. The development has the potential to impact the original shore line at the southern end of the site and within the northern cove..

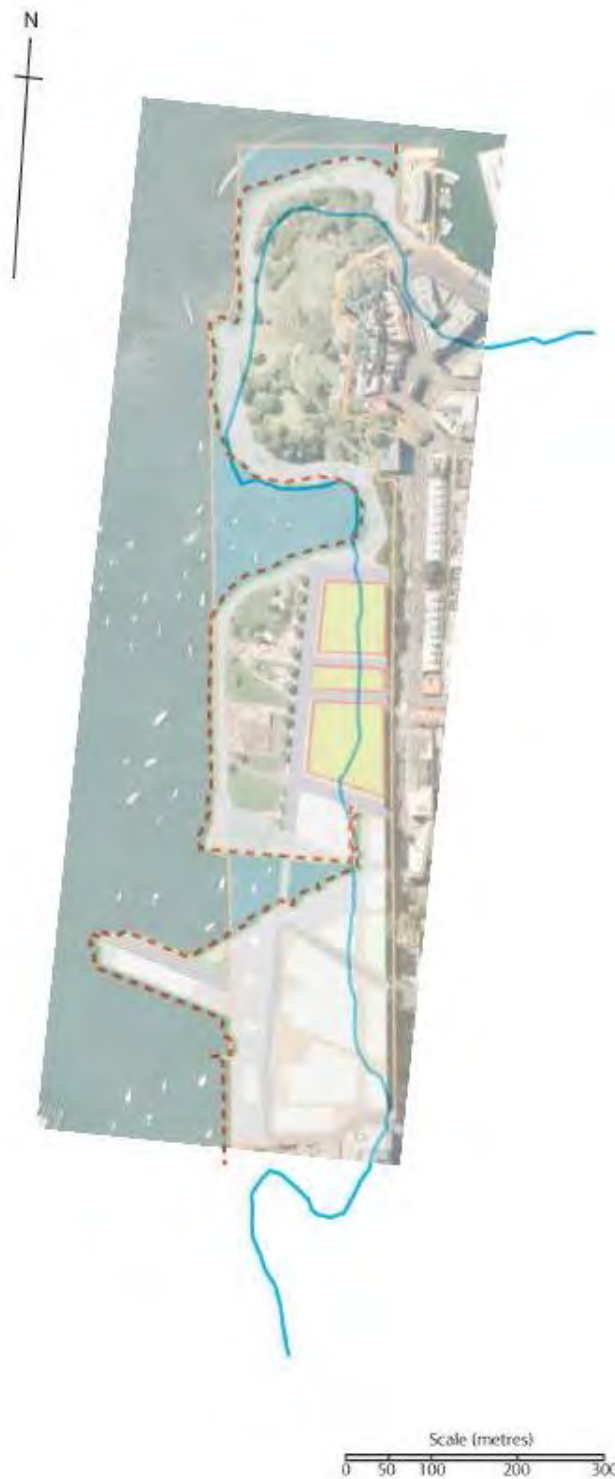
Figure 10.9. Blue outline of *Plan of the Town of Sydney in New South Wales 1807* by James Meehan (Source Ashton and Waterson 2000:17) overlaid onto the proposed plan and shoreline (red dotted line).

This image is similar to the previous in that the potential impact would affect the original harbour shoreline.

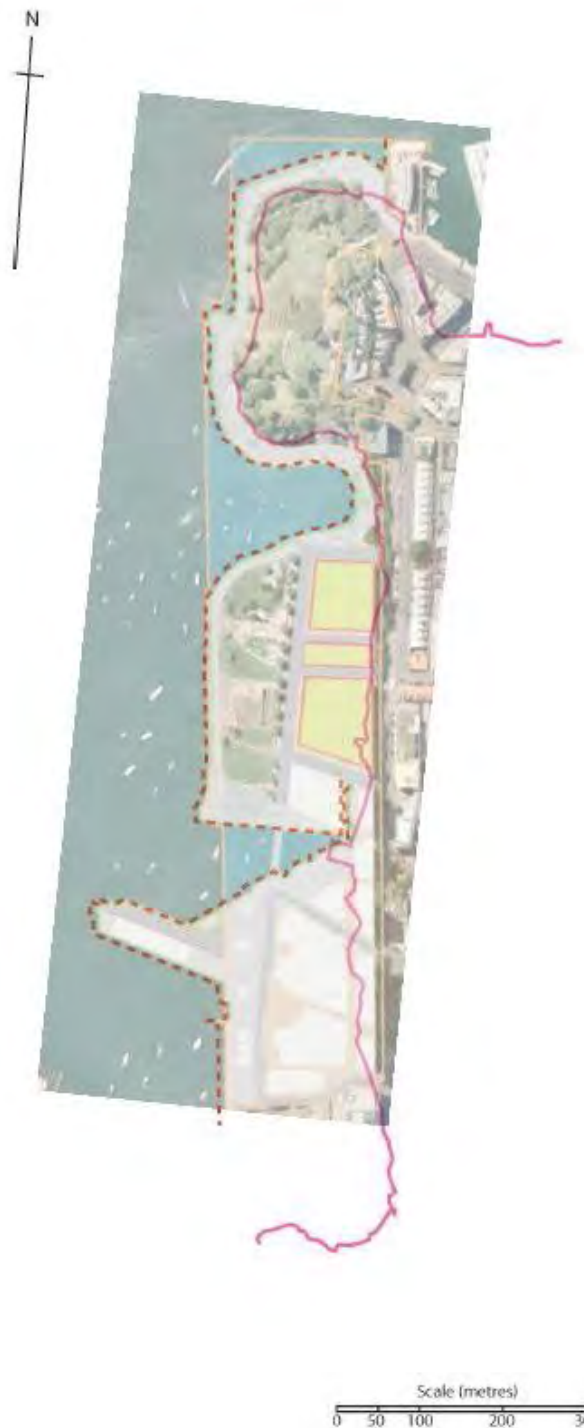
Figure 10.10. The pink outline of *Map of the Town of Sydney, 1831*. Lanner and Mitchell (Source Ashton and Waterson 2000:17) overlaid onto the proposed Plan shoreline (red dotted line) and development blocks.

This image shows the development blocks and the headland park will impact onto the original shoreline and any early modification such as reclamation and construction of wharfs. Streets, paths, subdivided allotments and numerous buildings were present in the area during this time. Munn was ship building at this time and a number of small wharves are likely to be present on the southern shore of the headland.

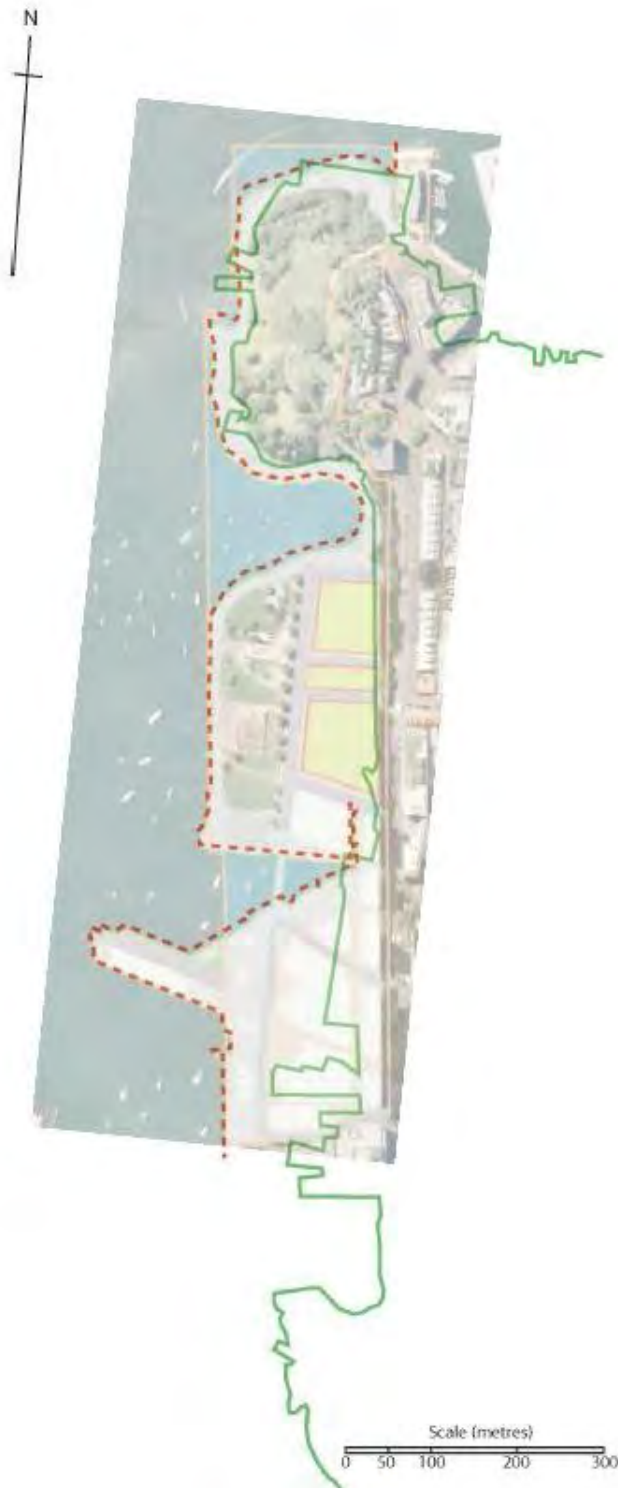
Figure 10.11. Green outline of *Map of the City of Sydney, 1843* William Henry Wells Land Surveyor (Source Ashton and Waterson 2000:25) overlaid onto proposed Plan shoreline (red dotted line) and development blocks.

This map shows the location of the gas works and the Hunter River Wharf to the south of the southern cove and a number of wharves around the headland to the north. The proposed development has the potential to impact on remnants of the original shoreline, wharfage reclamation and industry.

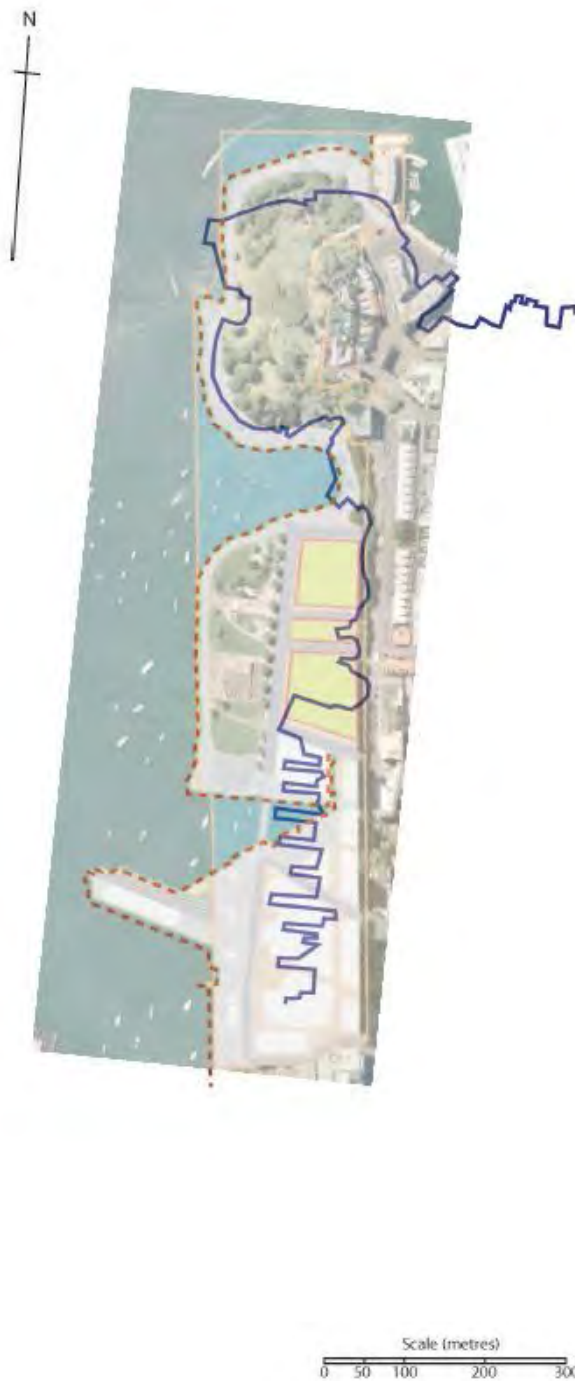
Figure 10.12. Dark blue line represents the shoreline of the 1875 plan illustrated in the *Supplement to Sydney Mail* (Source: Sydney Harbour Foreshore Authority Historic Maps & Plans Collection) overlaid onto the proposed Plan shoreline (red dotted line) and development blocks

This image shows the development of the shoreline with a large number of wharfs occupying the southern part of the site and the extension of the gas works into the harbour. The proposed development has the potential to impact on remnants of the original shoreline, wharfage reclamation and industry.

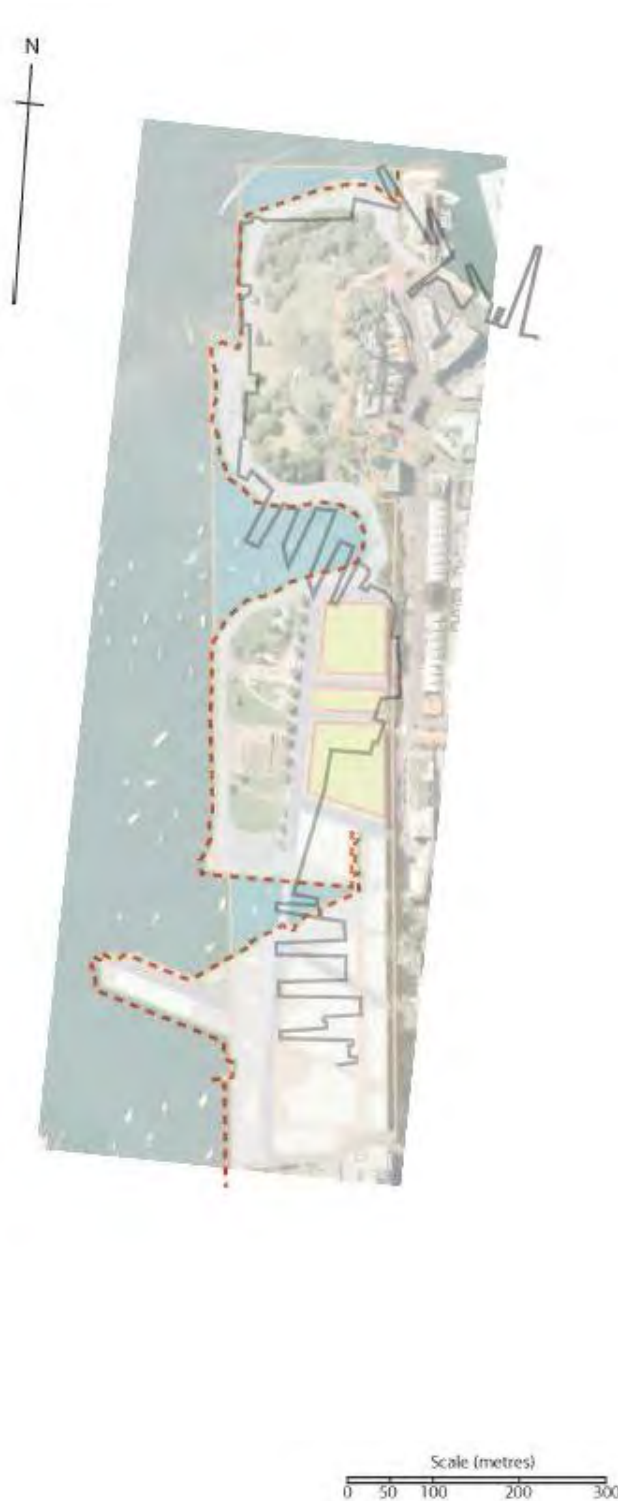
Figure 10.13. Grey outline of *Plan of the North West Portion of the City of Sydney Locally Known as The Rocks with its Surroundings From Darling Harbour to Circular Quay...* WA Gullick Government Printer 1900. (Source Ashton and Waterson 2000:49) overlaid onto the proposed plan shoreline (red dotted line) and development blocks.

This image shows the intensive formation and modification of the wharves as well as the expansion of the gas works prior to government resumption of the Millers Point and Darling Harbour foreshore.

The outline of the proposed plan shows that Northern Cove will impact on the wharves situated at the south of the headland and the southern cove and proposed development at the south of the site will impact on the gas works and wharves.

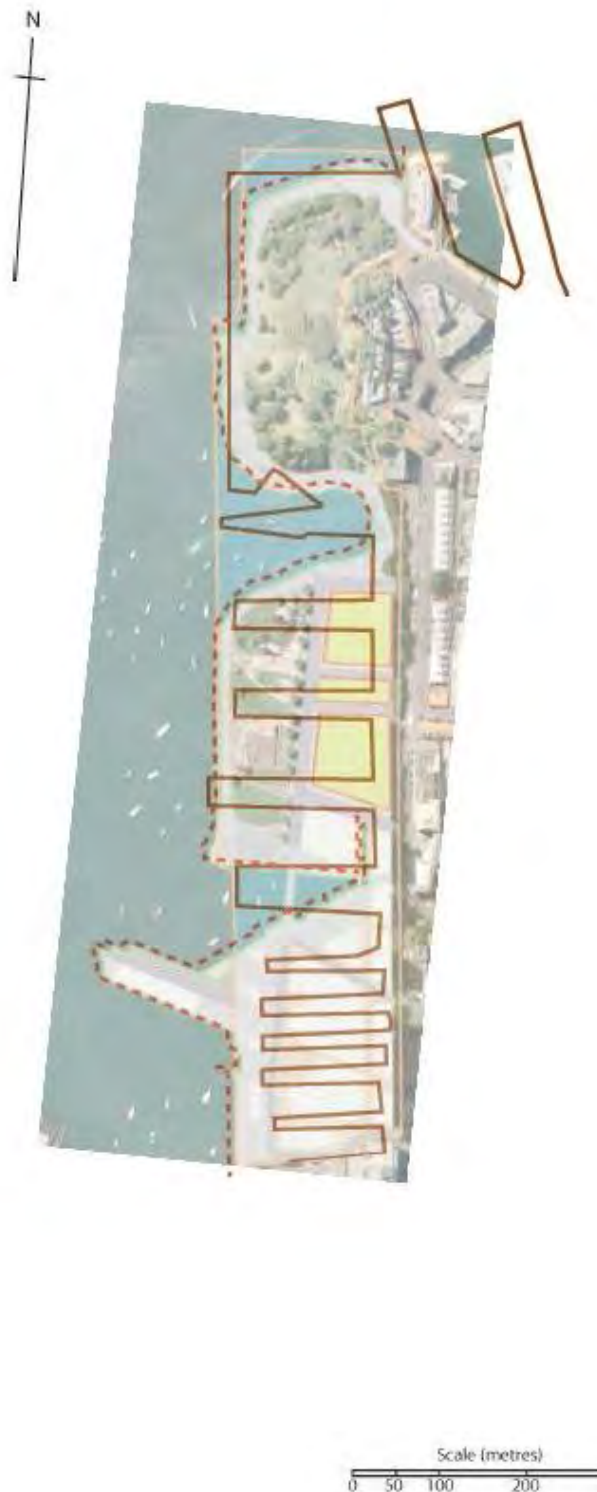
Figure 10.14. Brown outline of 1930 shoreline *Parish of St Philips 1930* (Source Sydney Harbour Foreshore Authority Historic Maps & Plans Collection) overlaid onto Proposed Plan shoreline (red dotted line) and development blocks.

This plan shows further modification has occurred at the northern headland and the post resumption reconstruction of the new SHT wharves between the former headland and the gas works. The development blocks as well as the northern and southern cove of the proposed plan will clearly impact on previous wharfs.

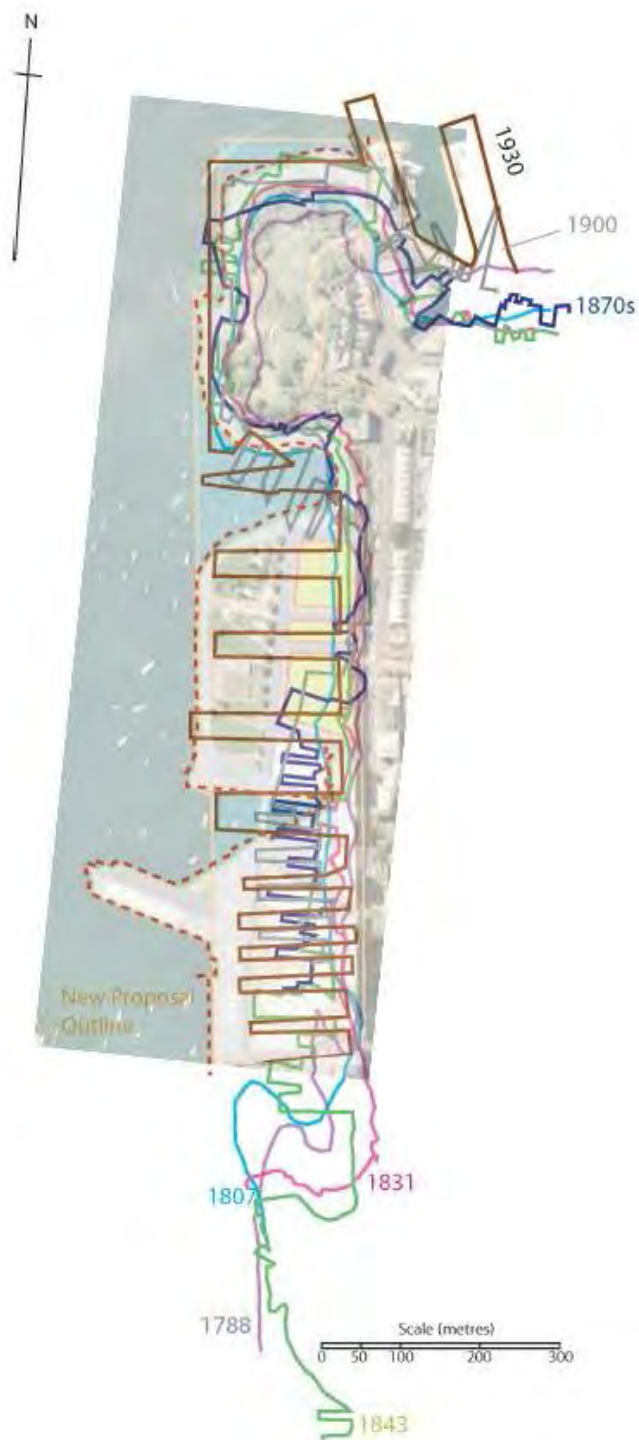
Figure 10.15 Overlay of previous wharf construction onto the proposed plan. This is not intended to be a precise account of change over time but is indicative of the expansion of wharfage and modification of the shoreline, the many layers of history and the impact of the proposed development on the potential archaeological resource.
