Report on Geotechnical Desktop Study

The Ribbon

31 Wheat Street Darling Harbour

> Project 73201.00/Rev.1 November 2012

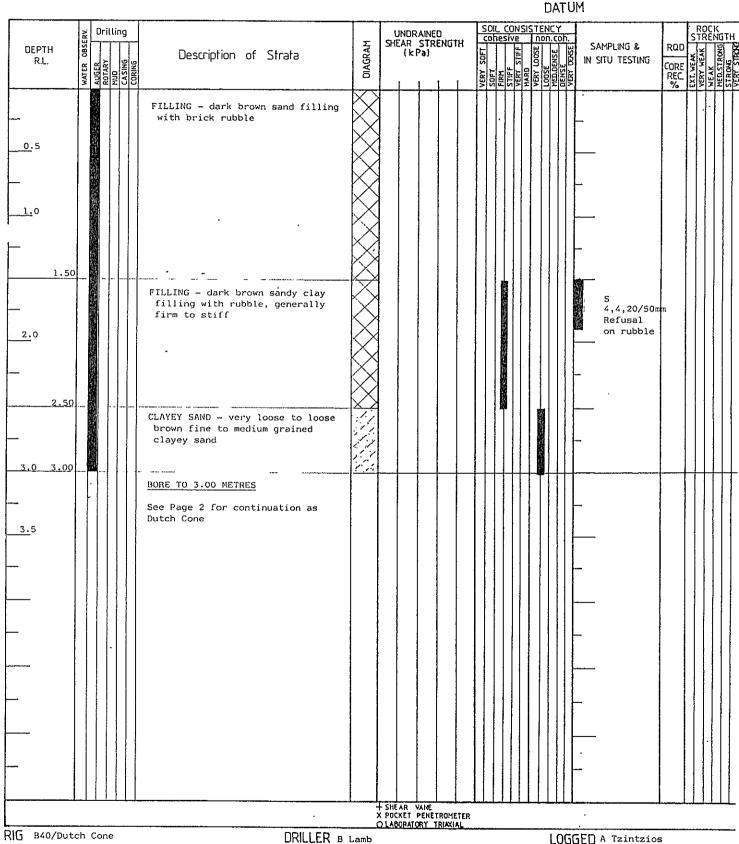
SURFACE LEVEL 2.34 M

REMARKS Borehole drilled to 3.0 m and continued as Dutch Cone to 6.9 m

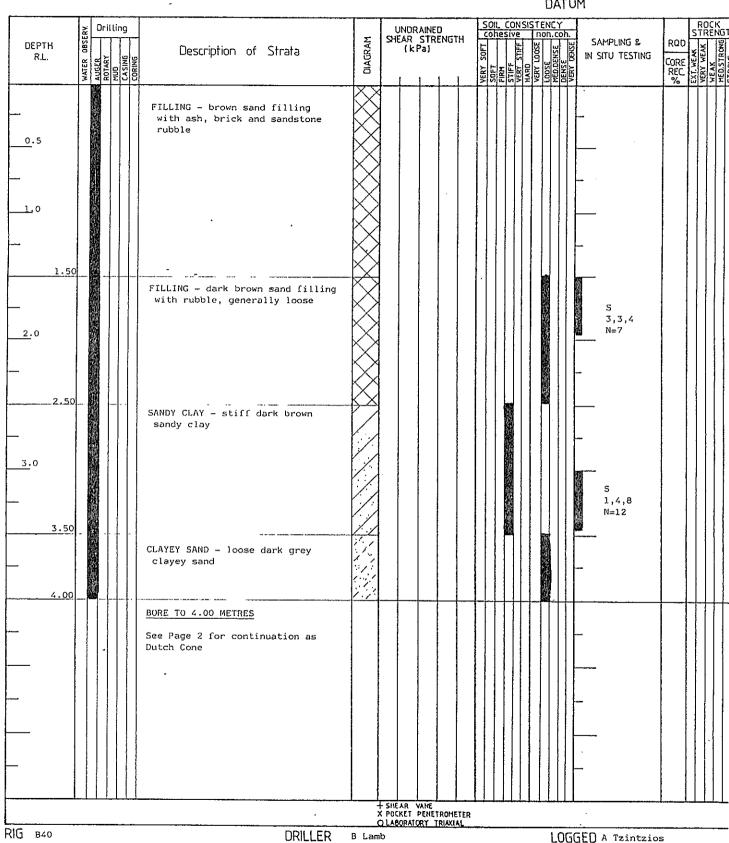
SURFACE LEVEL 2.27 M

REMARKS Borehole drilled to 4.0 m and continued as Dutch Cone to 6.2 m
