WESTERN COAL SERVICES PROJECT

AQUATIC ECOLOGY ASSESSMENT

REPORT PREPARED FOR Centennial Coal

**MARINE POLLUTION RESEARCH PTY LTD
March 2013**

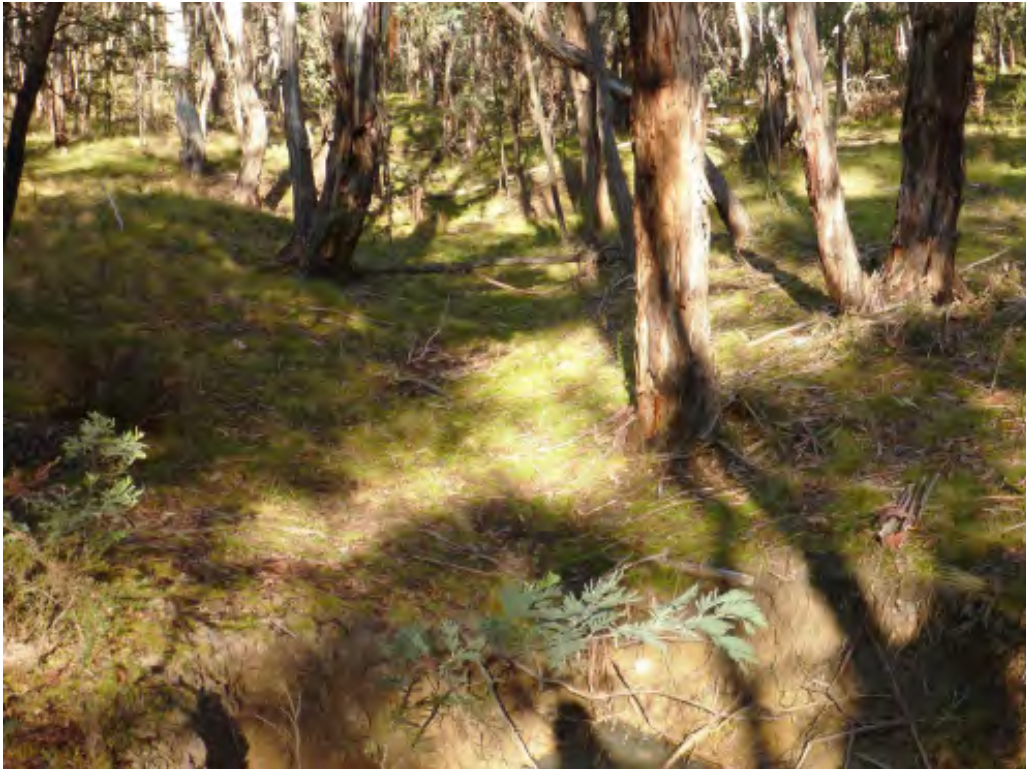
Figure 6 Broad woodland swale with no defined creek structure in Ben Bullen State Forest, Upper Huon Gully.

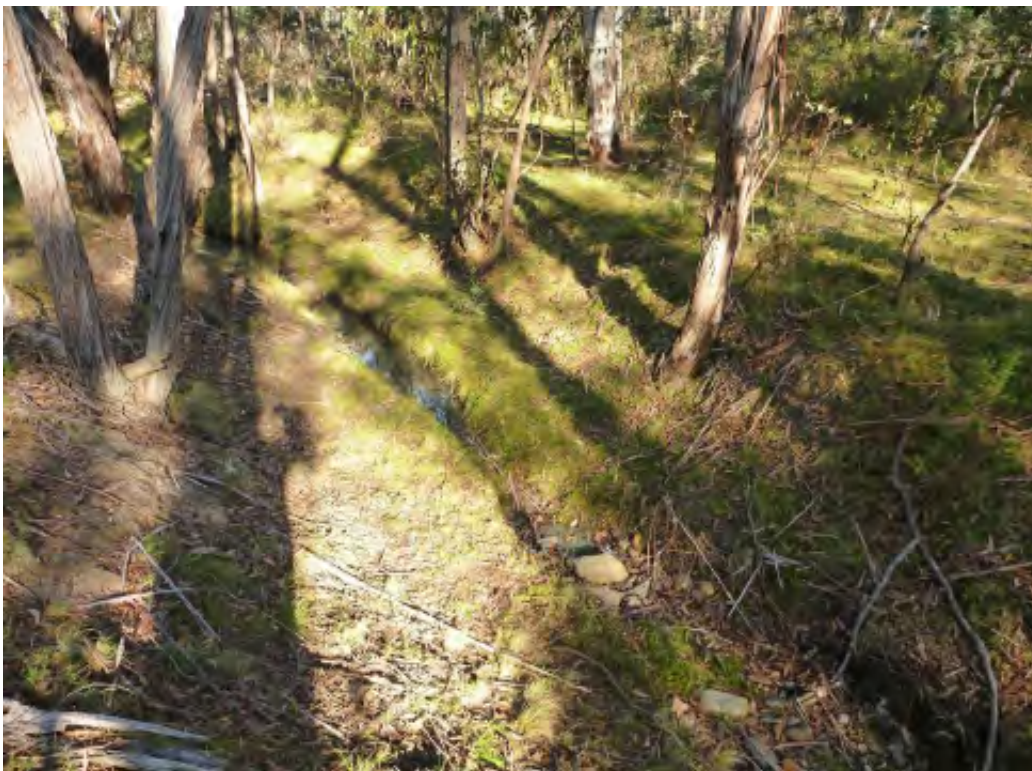
Figure 7 Broad woodland gully with small incised drainage in Ben Bullen State Forest, Upper Huon Gully, just upstream of lower electricity high-tension wire easement service track.

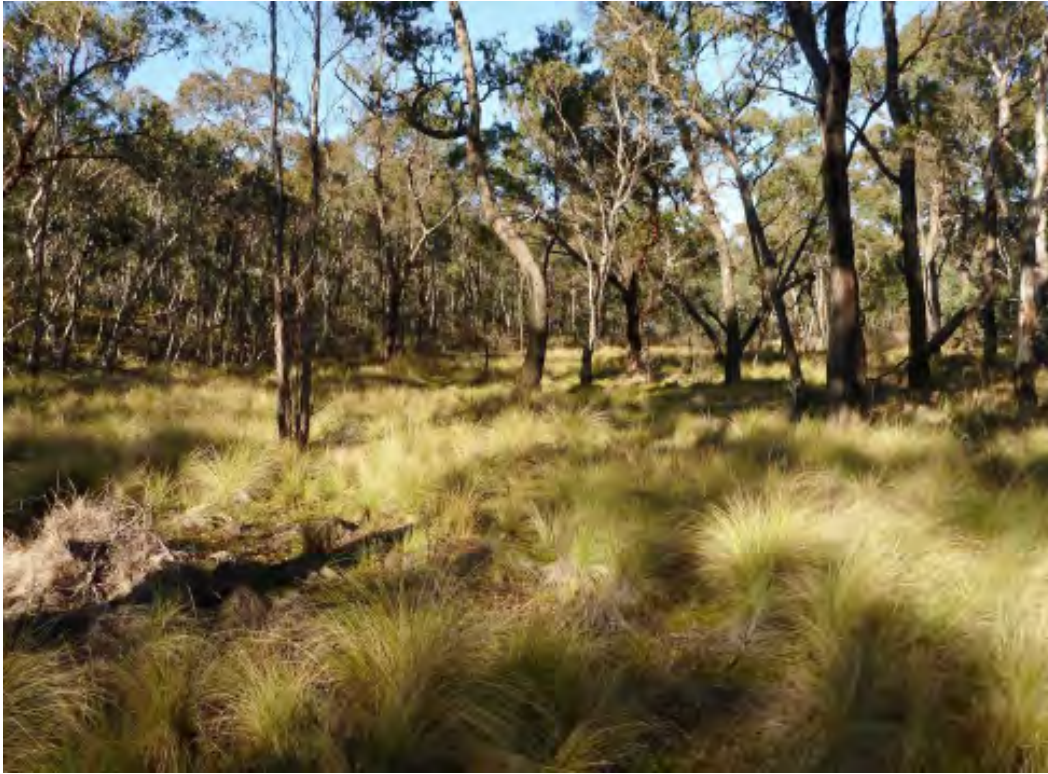
Figure 8 Broad woodland overland flow-path with no defined creek structure in Ben Bullen State Forest, Upper Lambert Gully – east sub-catchment.

From the first electricity easement to the second (northerly) easement, the sub-catchment drainages continue as broad grassy swales with occasional short narrow shallow drains within the broad grassy swale that may hold water for short periods after rain (Figures 8 and 9). Where these swale drainages cross the electricity easements there may also be some additional but temporary ponding of water following rainfall (Figures 10 and 11). There are no semi-permanent aquatic habitats and no indications of emergent vegetation that could indicate swampy meadow habitats.

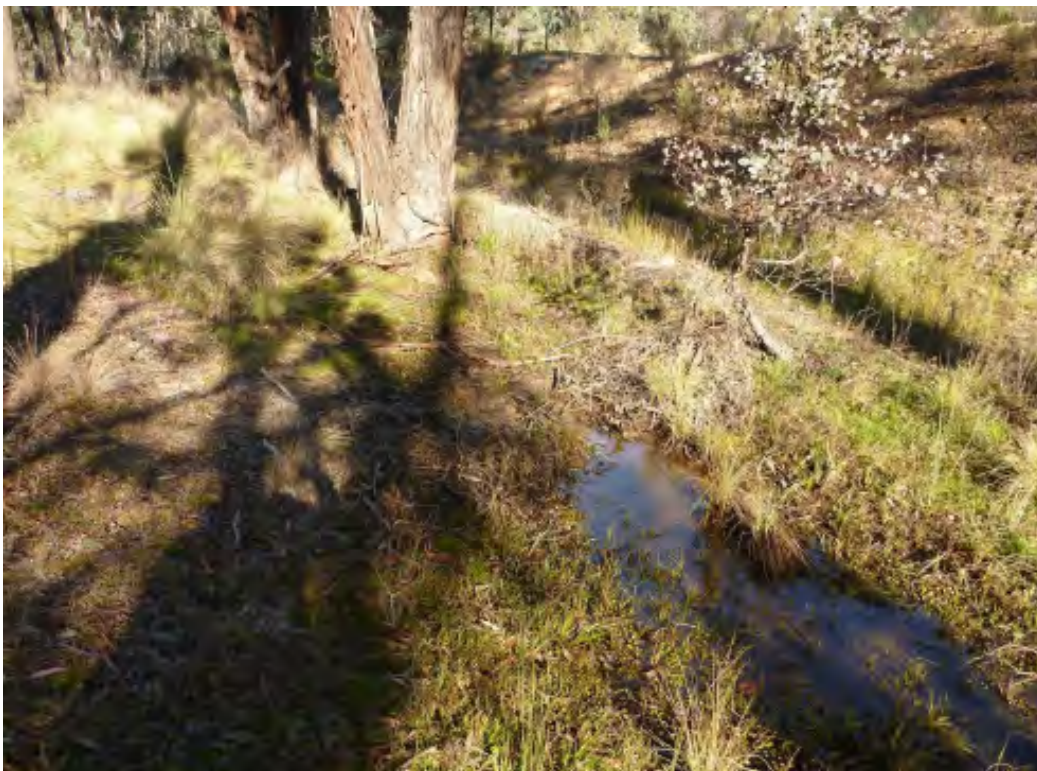
Figure 9 Small ephemeral pond and incised drain just upstream of lower electricity high-tension wire easement service track, Upper Lambert Gully – east sub-catchment.

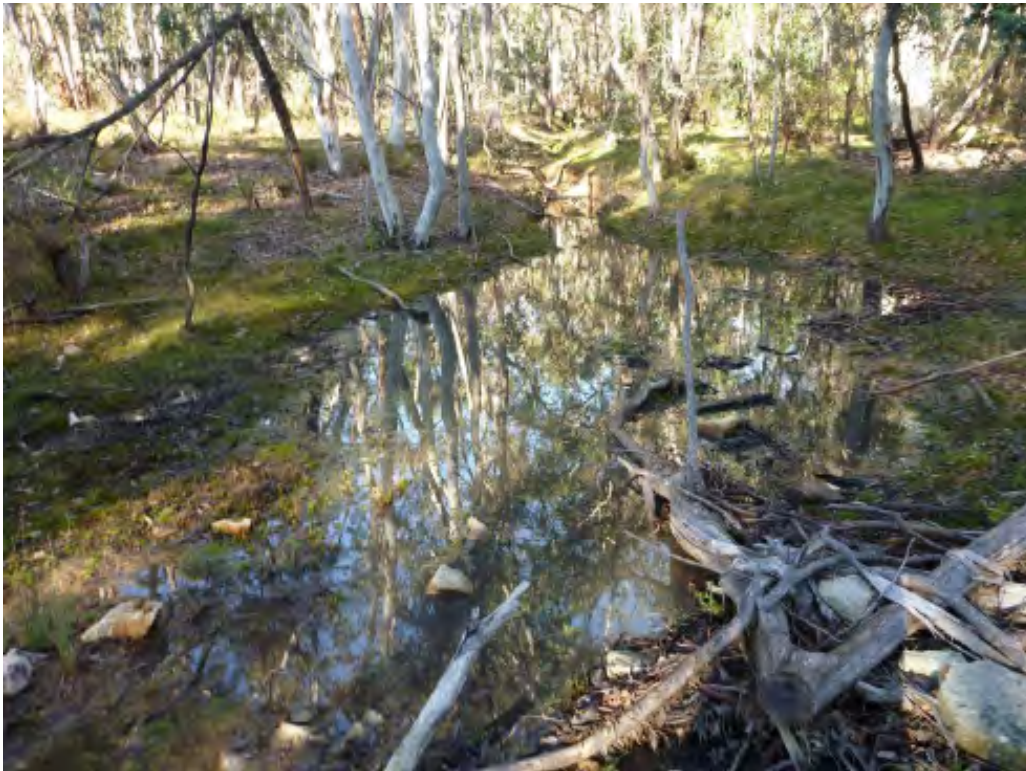
Figure 10 Pool above lower electricity high tension wire easement service track, Upper Huon Gully.

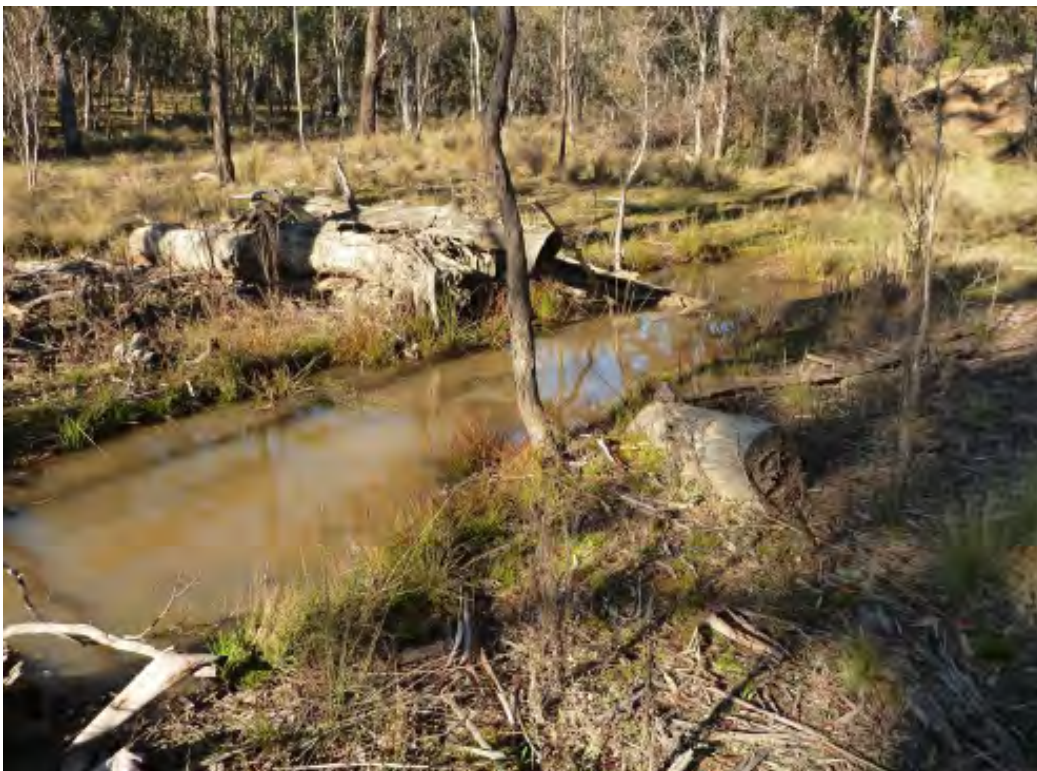
Figure 11 Small dam below lower electricity high tension wire easement service track - Lambert Gully west sub-catchment.

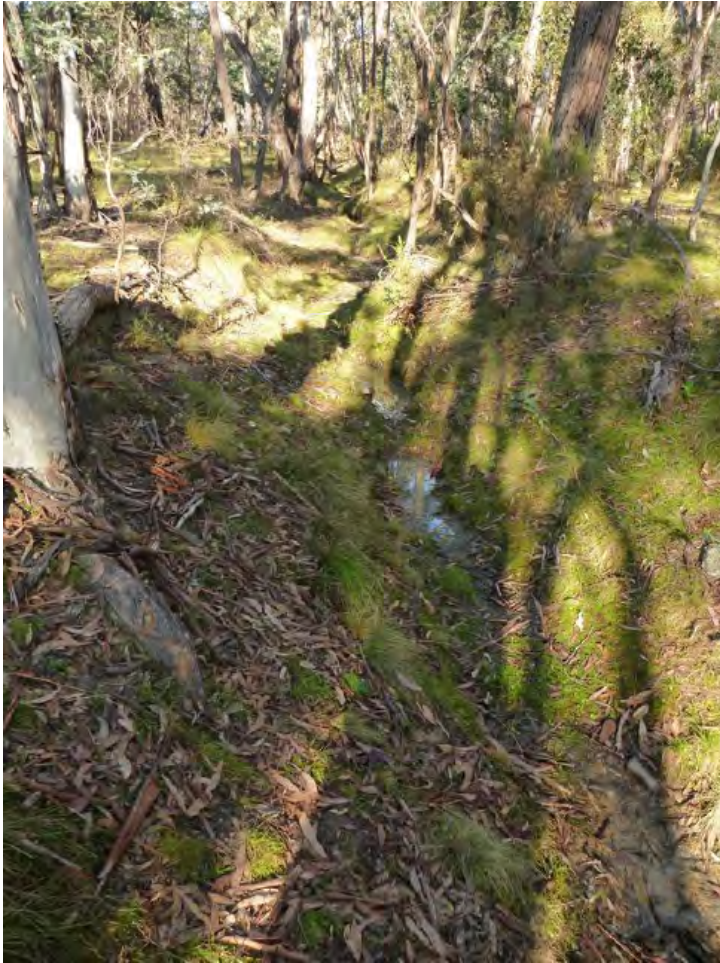
Figure 12 Better defined V shaped gully on Huon Gully below the lower electricity high tension line service track. The incised creek has a more cascade shape with rock and sediment constraints but little rain water retention capacity.

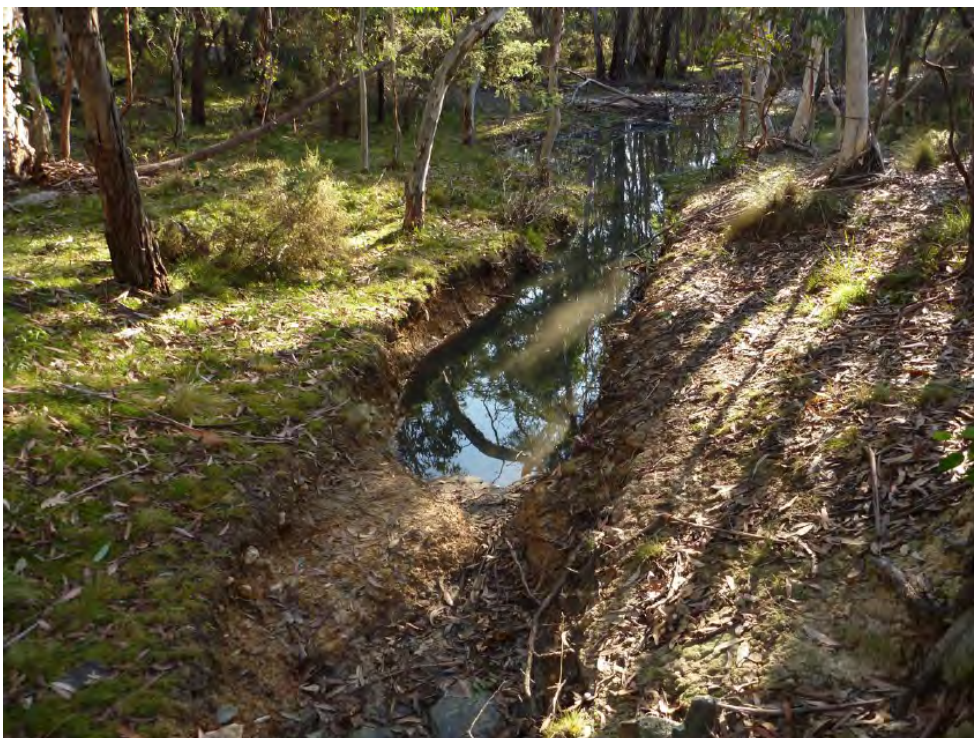
Figure 13 Temporary rain pool in Huon Gully below the lower electricity high tension line service track.

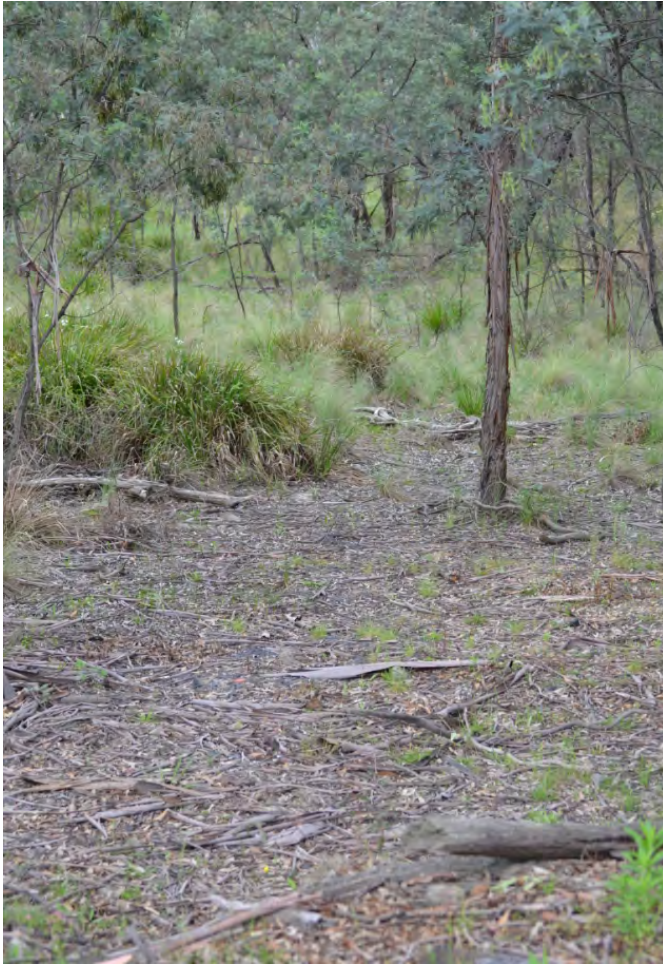
Figure 14 Overland undifferentiated drainage of upper Huon Gully located just upstream of the main conveyor line to Mount Piper Power Station. This drainage line flows to the first constructed sedimentation pond just below the conveyor line (see Figure 15).

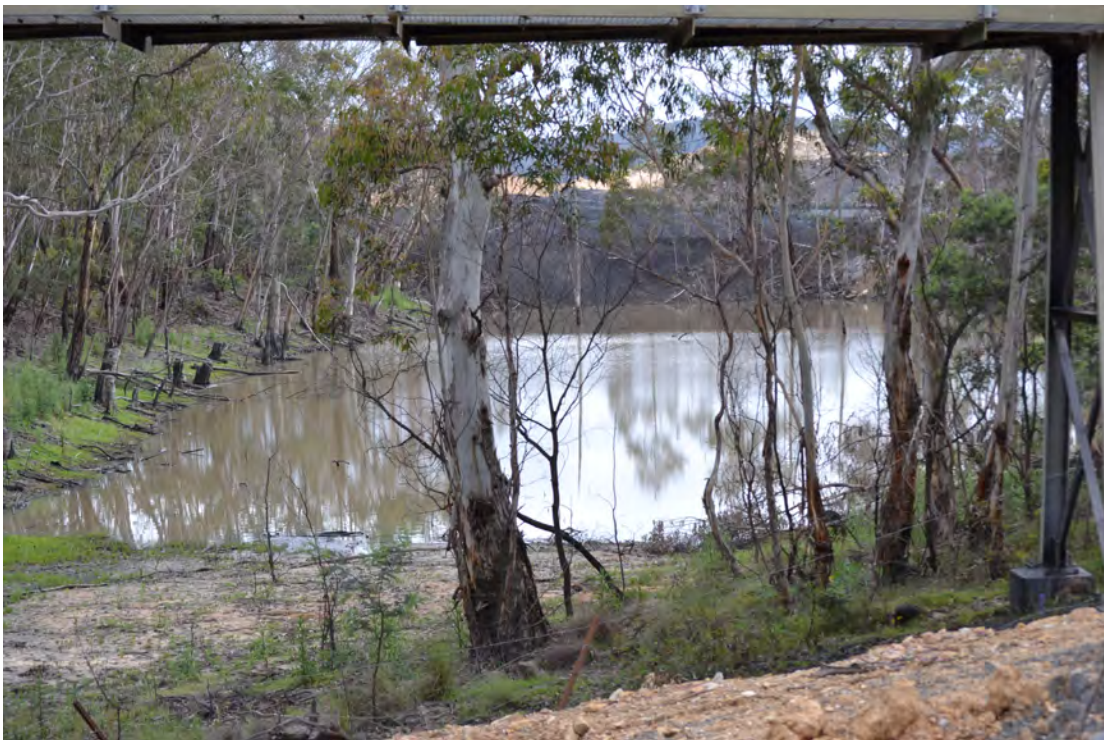
Figure 15 Uppermost Springvale Coal Services constructed sedimentation pond on Huon Gully, located just below the conveyor line to Mount Piper Power Station.

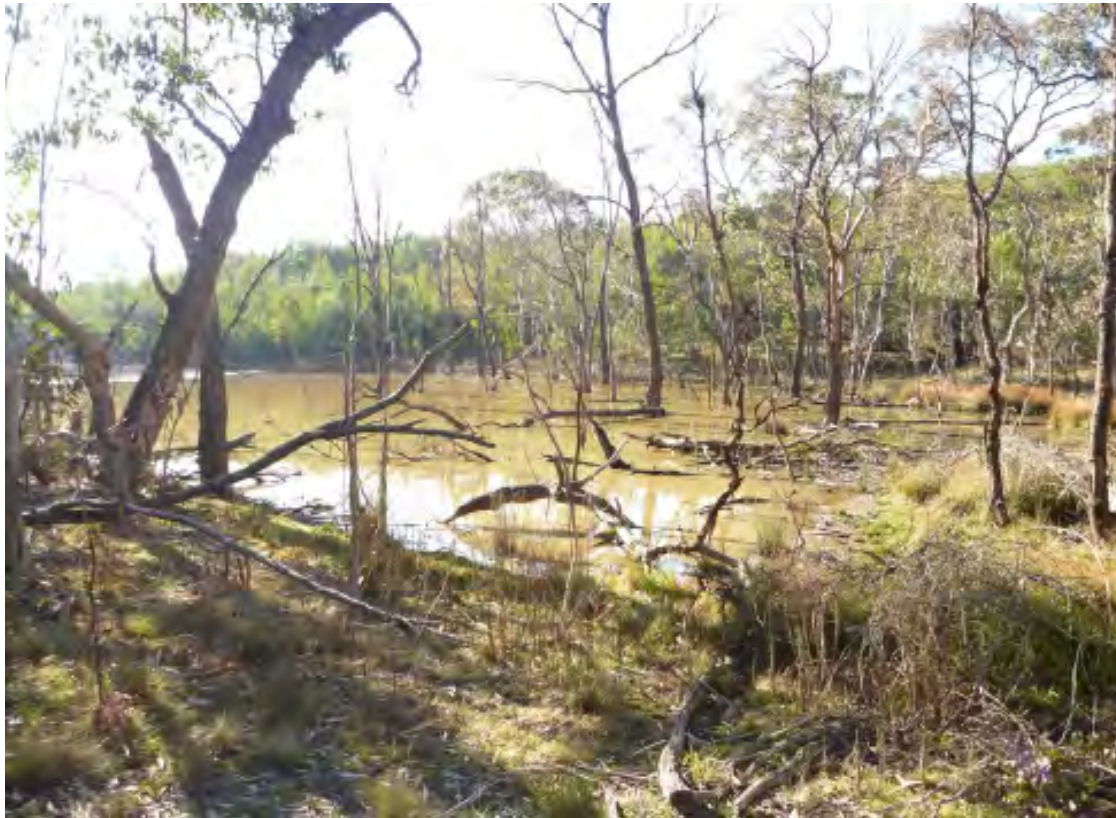
Figure 16 Lamberts Gully – east sub-catchment undefined swale drainage in foreground, draining to uppermost Springvale Coal Services sedimentation pond.

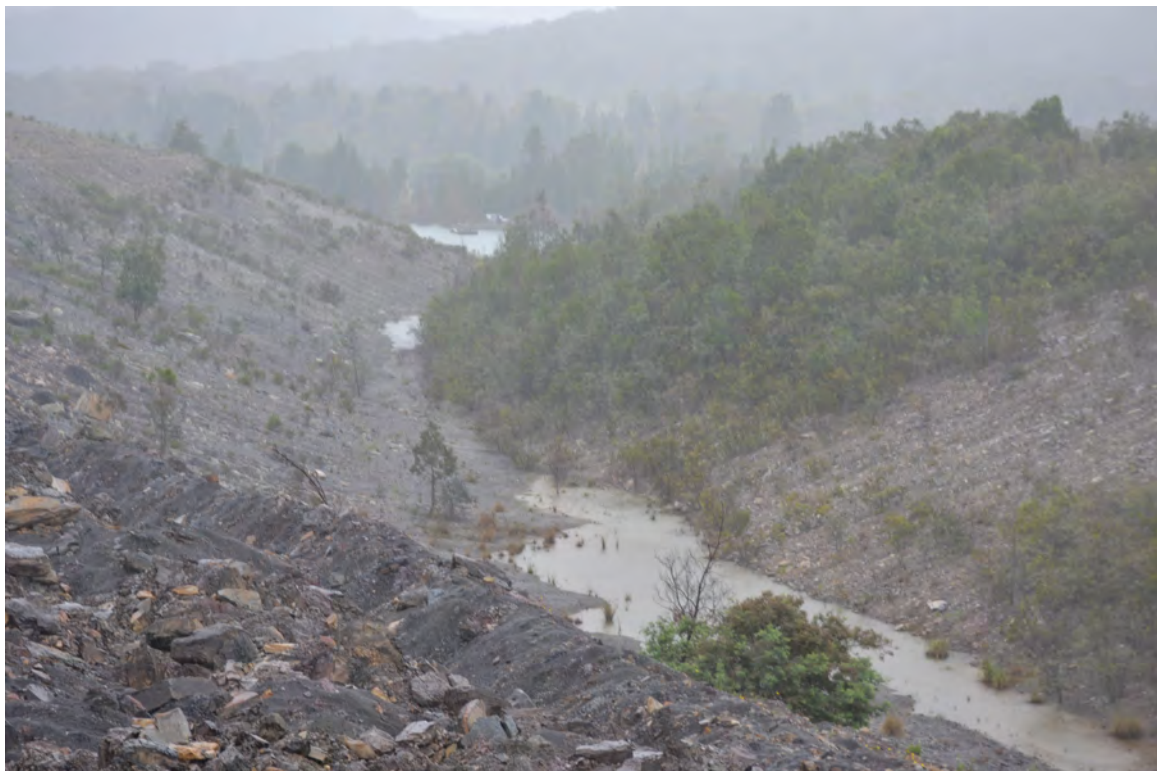
Figure 17 Lower Section of Huon Gully draining to Huon Dam in the background

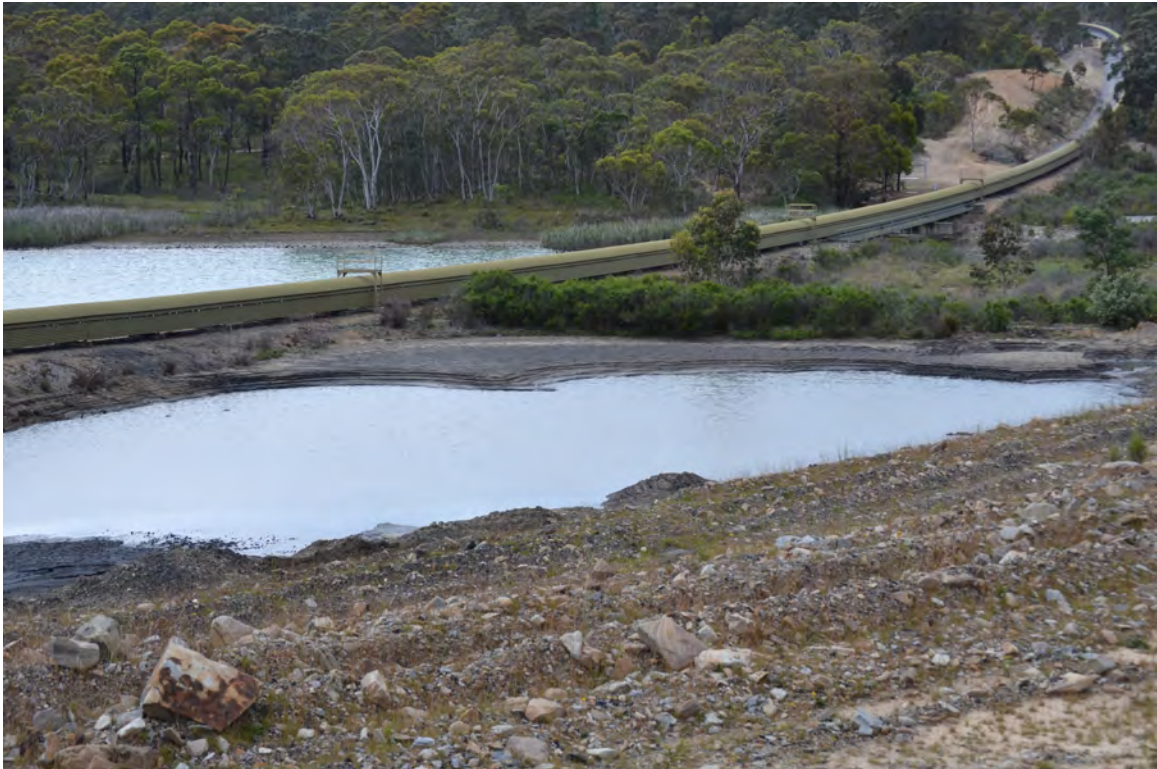
Figure 18 View looking down-slope showing an upper sedimentation dam in Lambert Gully with the conveyor dam in the background.

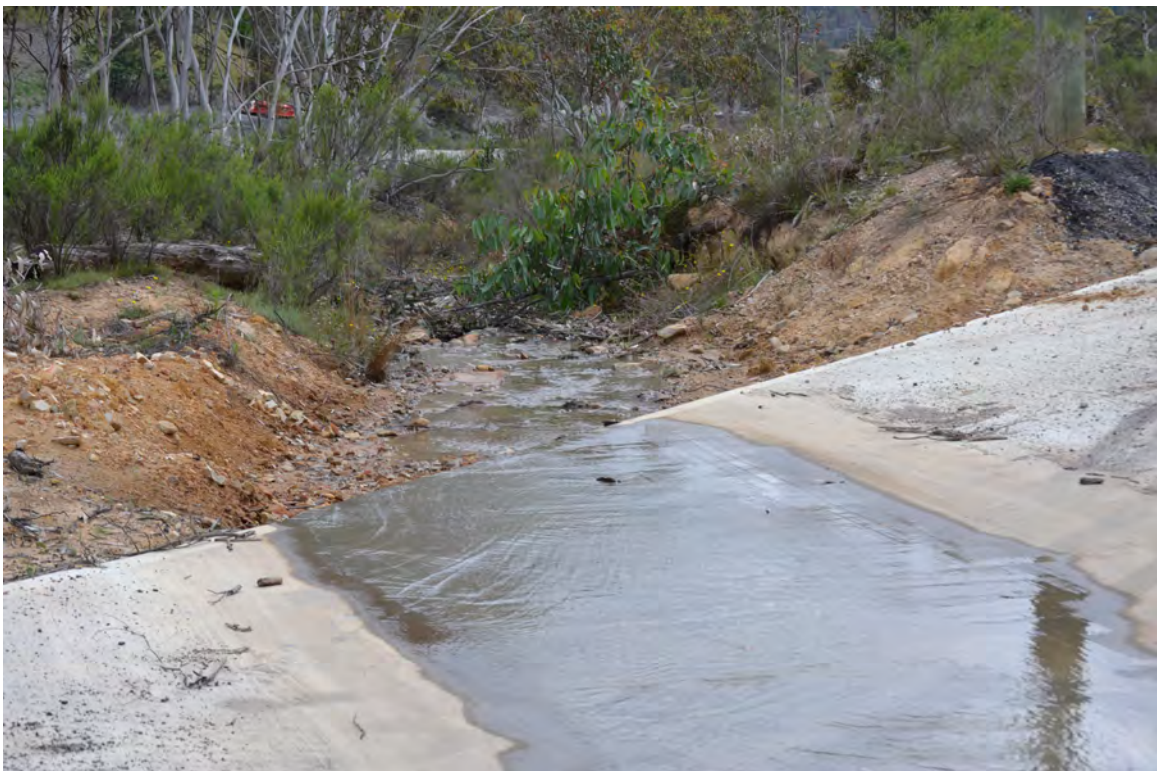
Figure 19 Lambert Gully drainage across a Springvale Coal Services road looking downstream.

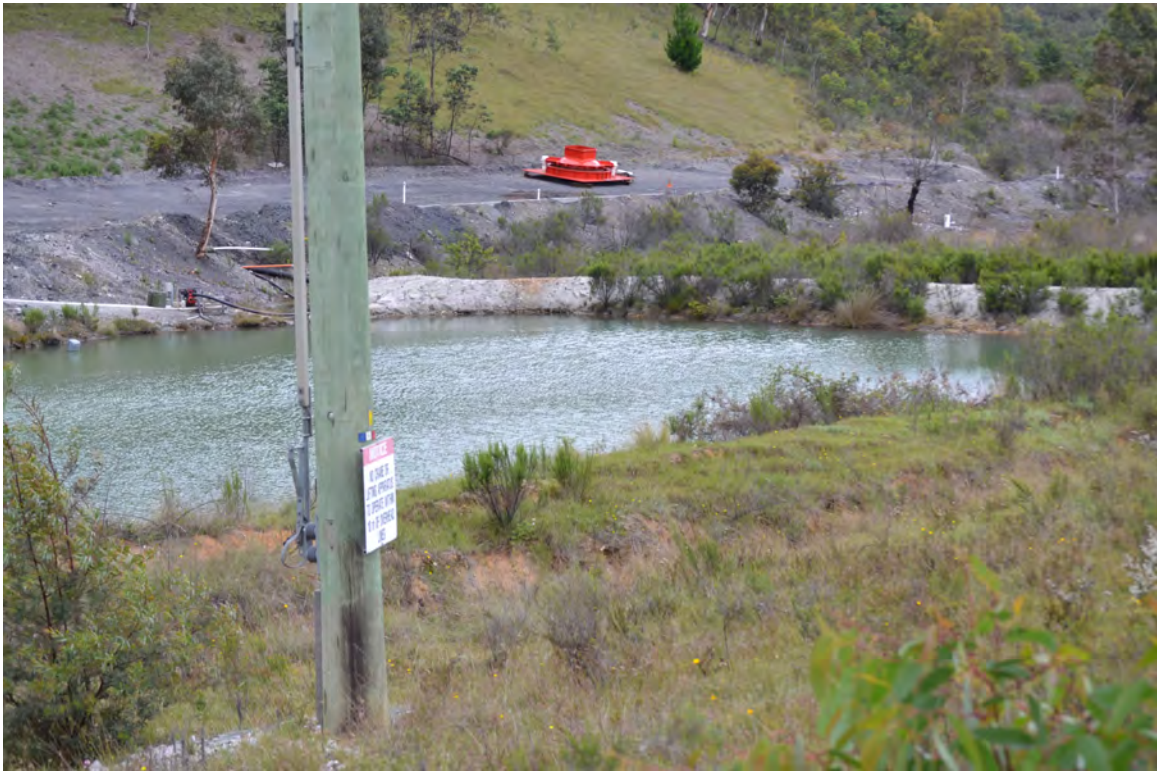
Figure 20 Springvale Coal Services Stockpile Sediment Pond (see Figure 2 for location).

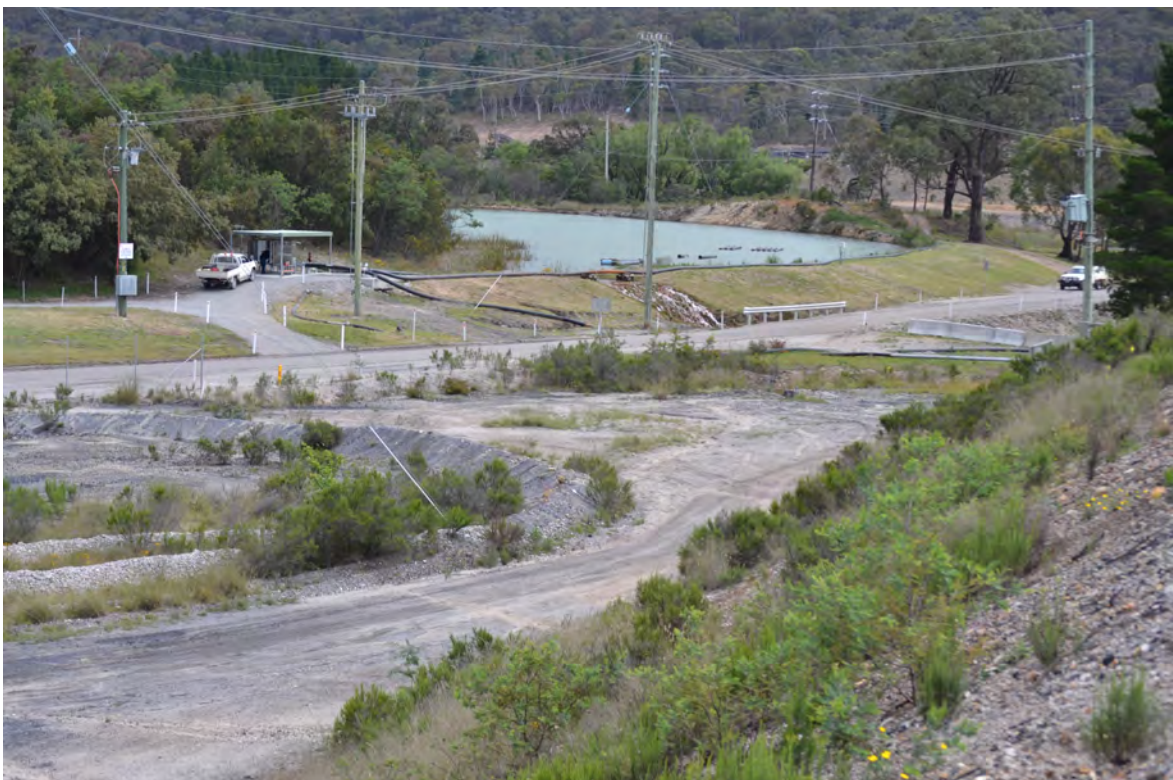
Figure 21 Lambert Gully drainage is in the foreground and is piped to the Retention Dam just out of the photo at the right (see Figure 22). Cooks Dam is in the background and the spillway can be seen at the left hand side of the embankment.

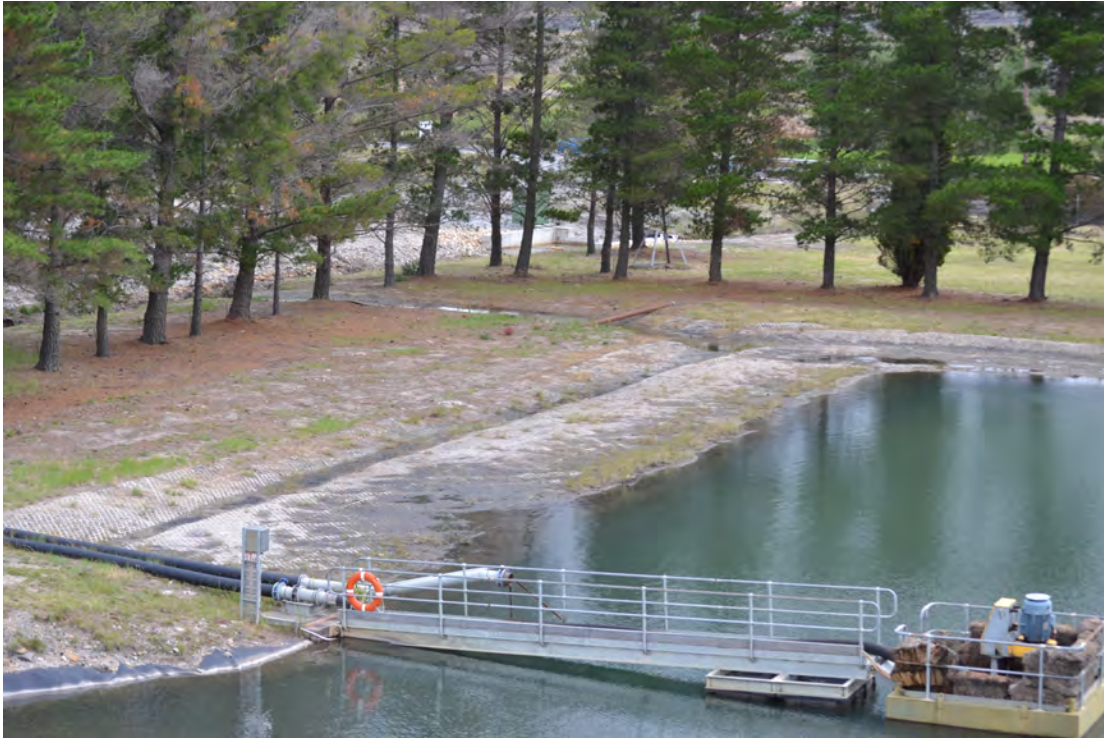
Figure 22 Retention Dam with inlet channel at the lower left corner and the outlet channel at the top left corner of the dam.

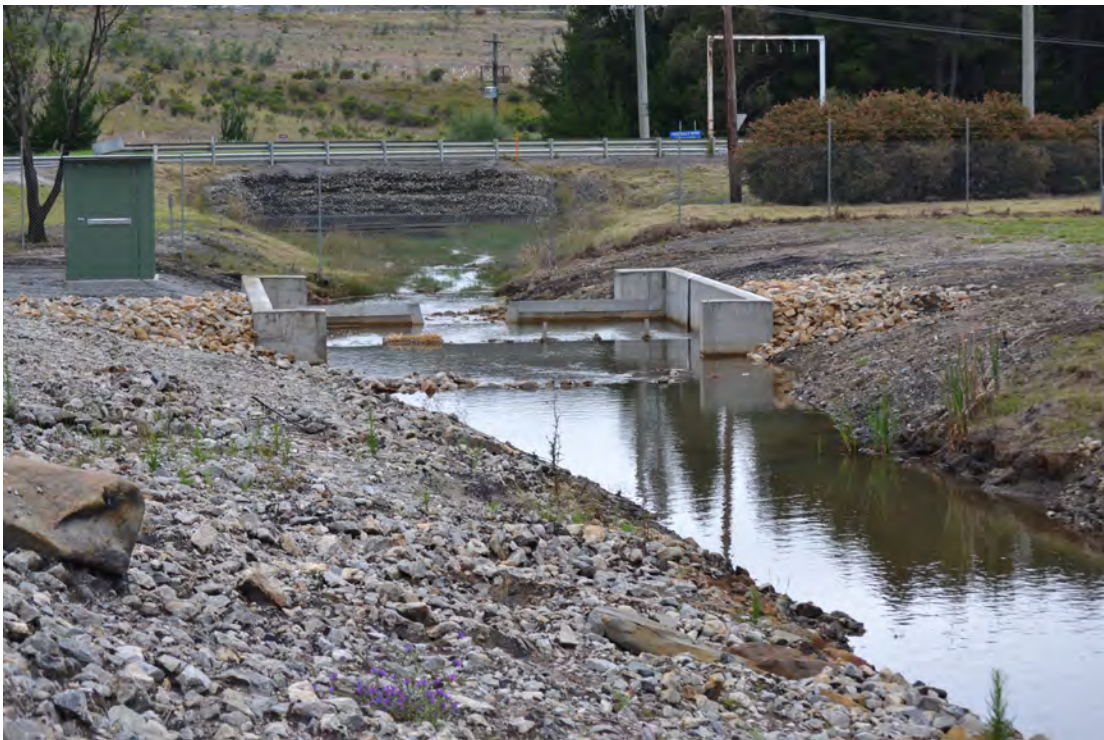
Figure 23 LDP006 at the lower end of Lamberts Gully looking downstream to the Castlereagh Highway culvert pond. The confluence with Wangcol Creek is at the other side of the highway.

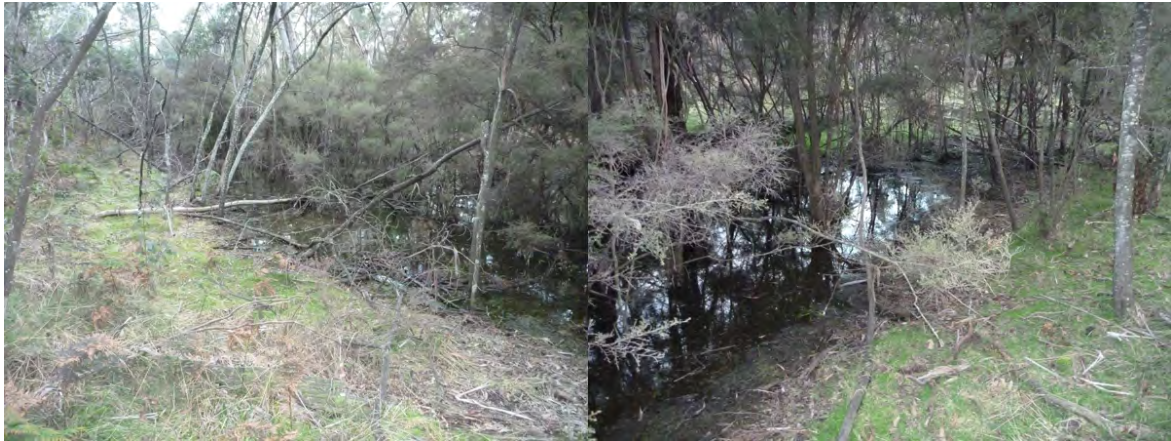
Figure 24 Shallow surface water depression upstream from NC1, looking upstream (left) and lower end terminating (right).

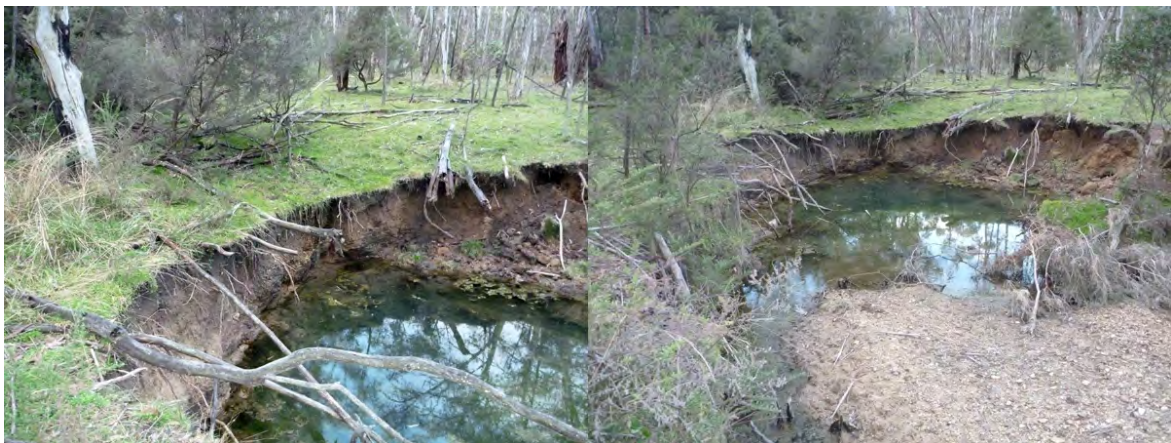
Figure 25 Termination of swamp leading into the upstream end of the erosion hole (left) and looking upstream through the erosion channel (right).

- Figures 25 and 26 compare channel areas between Spring 2011 and Autumn 2012 surveys for the upper sections of NC1 that were dry in 2011. For the Autumn 2012 survey the channel banks were actively eroding and unstable.

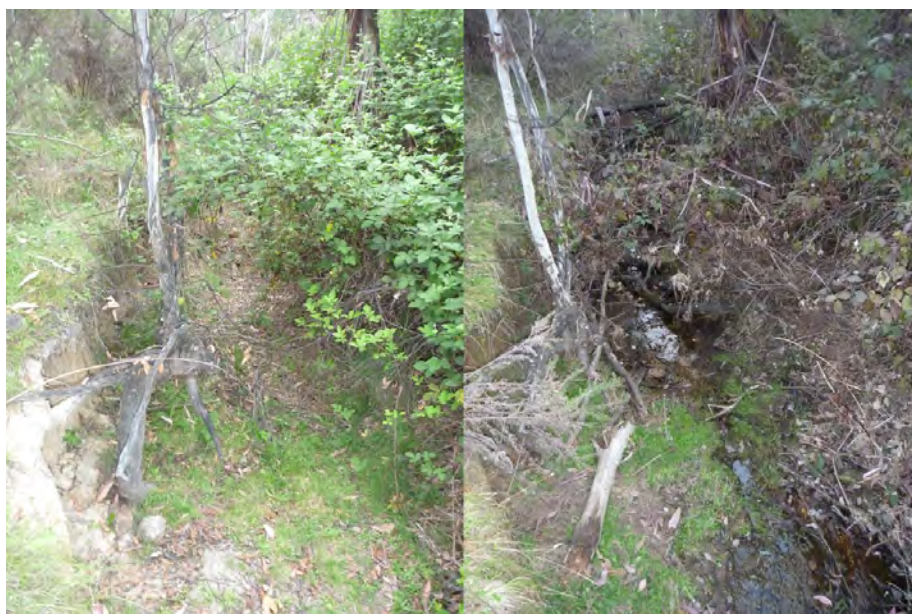
Figure 26
Looking
downstream
from the
upstream end
of NC1 in
Spring 2011
(left) and
Autumn 2012
(right).

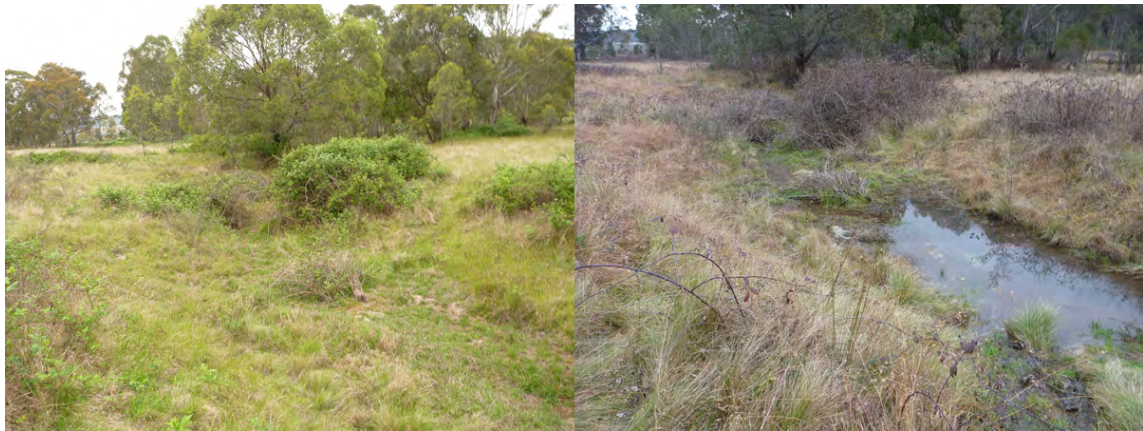
Figure 27 Broad channel area immediately below track crossing during Spring 2011 (left) and Autumn 2012 (right).

It is concluded that these aquatic features are ephemeral and rapidly dry out after rain. This can be seen from inspection of the Spring 2011 survey photographs where the channel was dry and, as indicated by the active wombat hole within the main site pool, the channel is normally dry (see Figures 27 and 28 below).

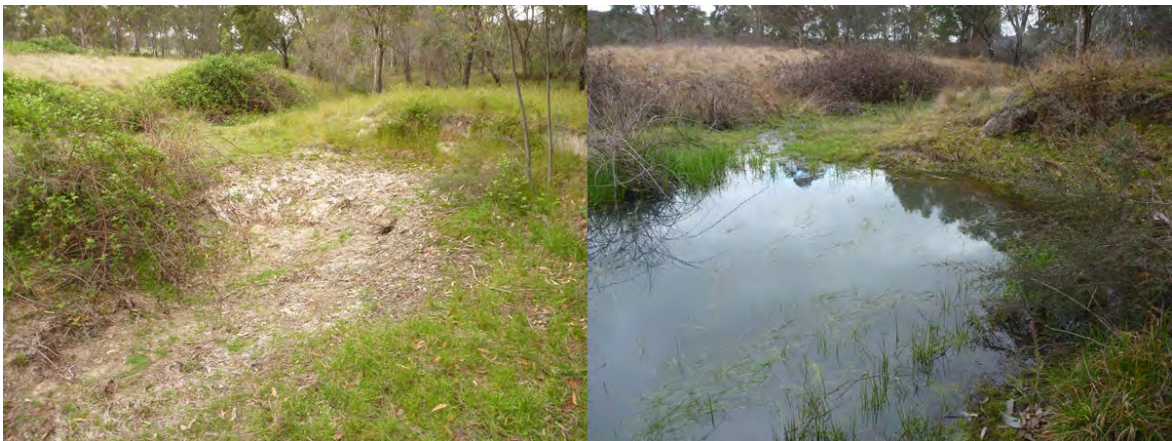
Figure 28 Large pool within channel area below track crossing during Spring 2011 (left) and Autumn 2012 (right). The dark spot in the middle of the left image is a wombat burrow.

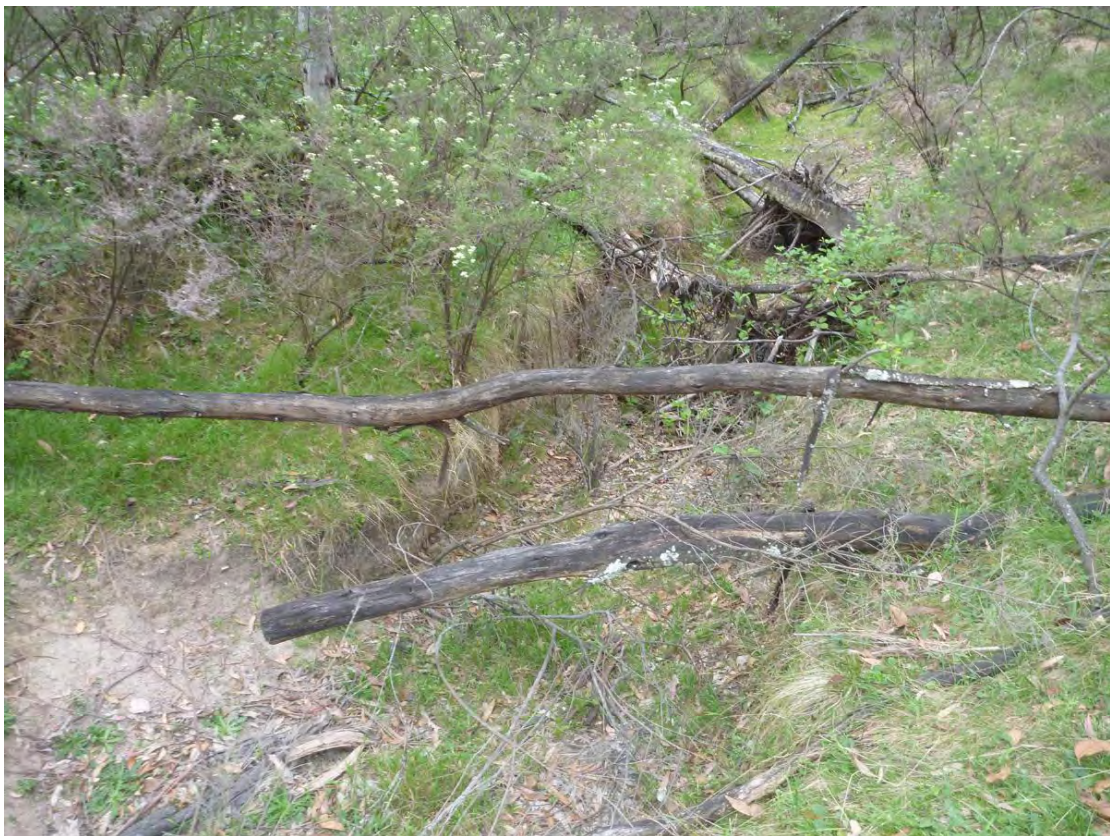
Plate 28: Looking upstream at NC1 Spring 2011.

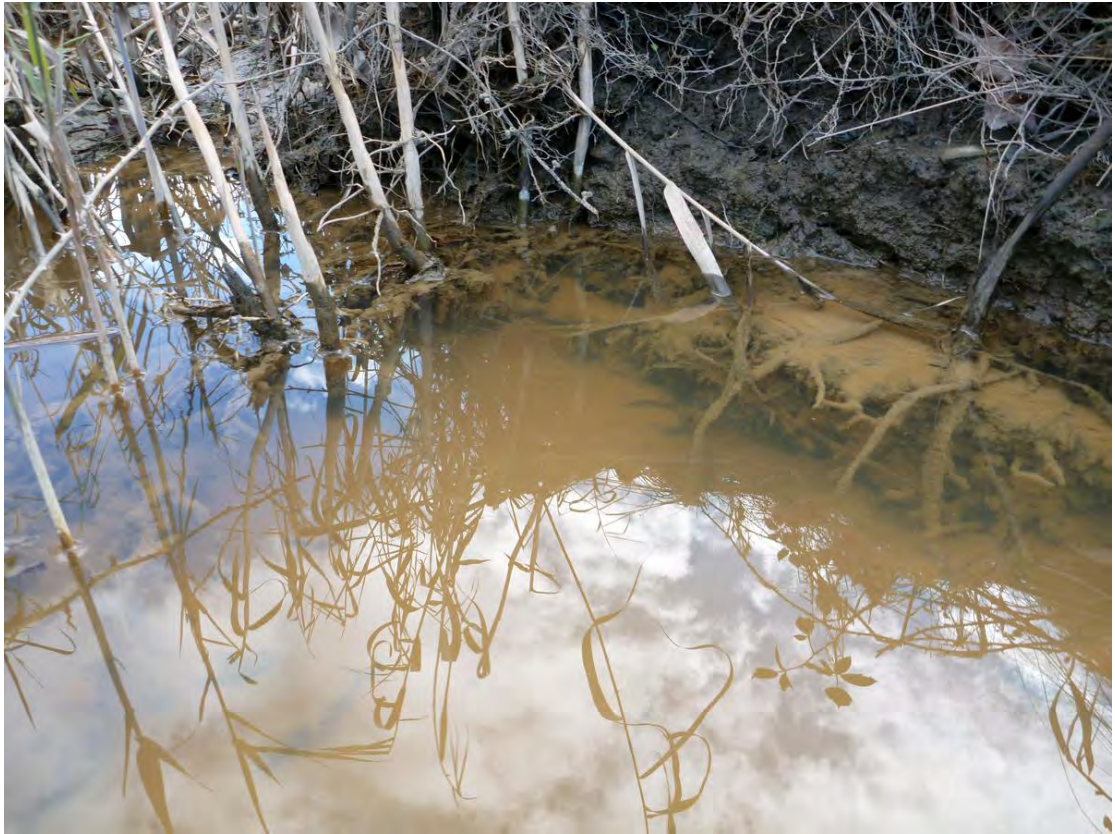
Plate 5: Edge habitats smothered in flocculant at CR4.

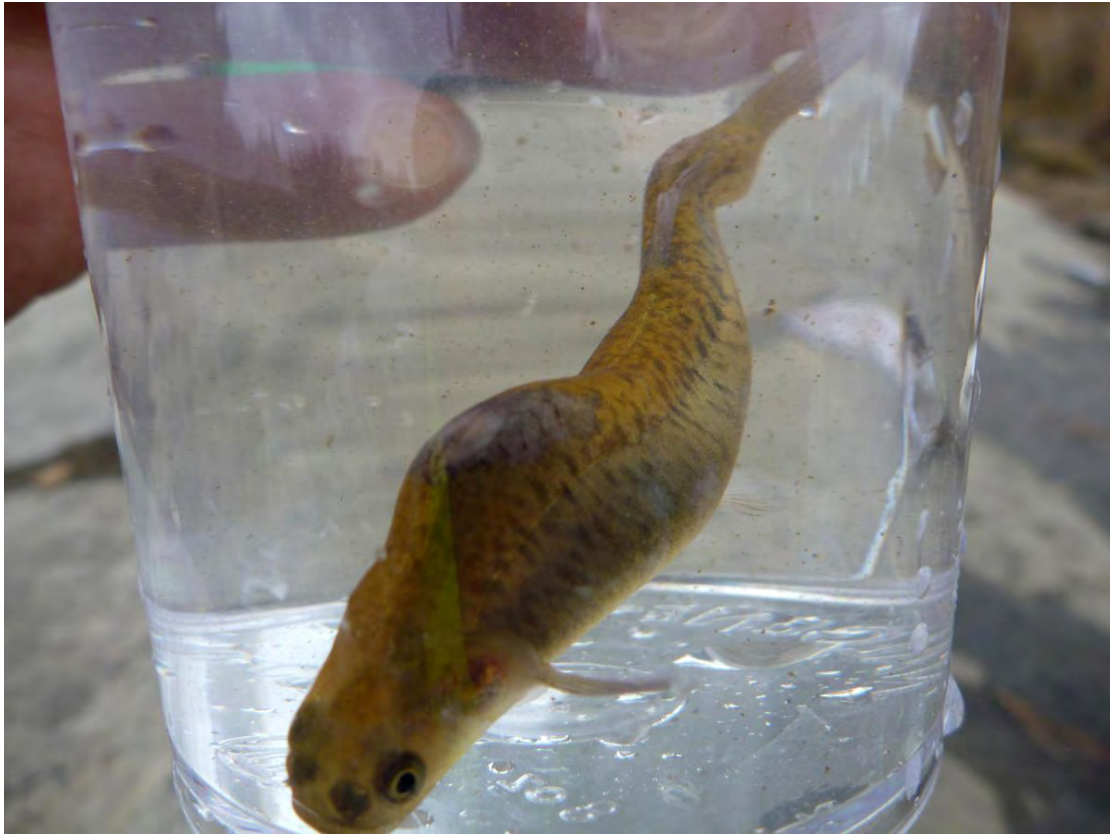
Plate 13: Deformed mountain galaxias from WC1.

- A single large dead flathead gudgeon and a dead yabby (*Cherax destructor*) were found at WC1 and a deformed mountain galaxias was also found at WC1. Both dead fish had scales missing.
- A dying mountain galaxias was found at WC2.
