REPORT
TO
CITY WEST HOUSING PTY LTD
ON
GEOTECHNICAL INVESTIGATION
FOR
PROPOSED BUILDING D4 AFFORDABLE HOUSING
AT
NORTH EVELEIGH PRECINCT,
OFF WILSON STREET, EVELEIGH, NSW

13 March 2013
Ref: 26366SBrpt

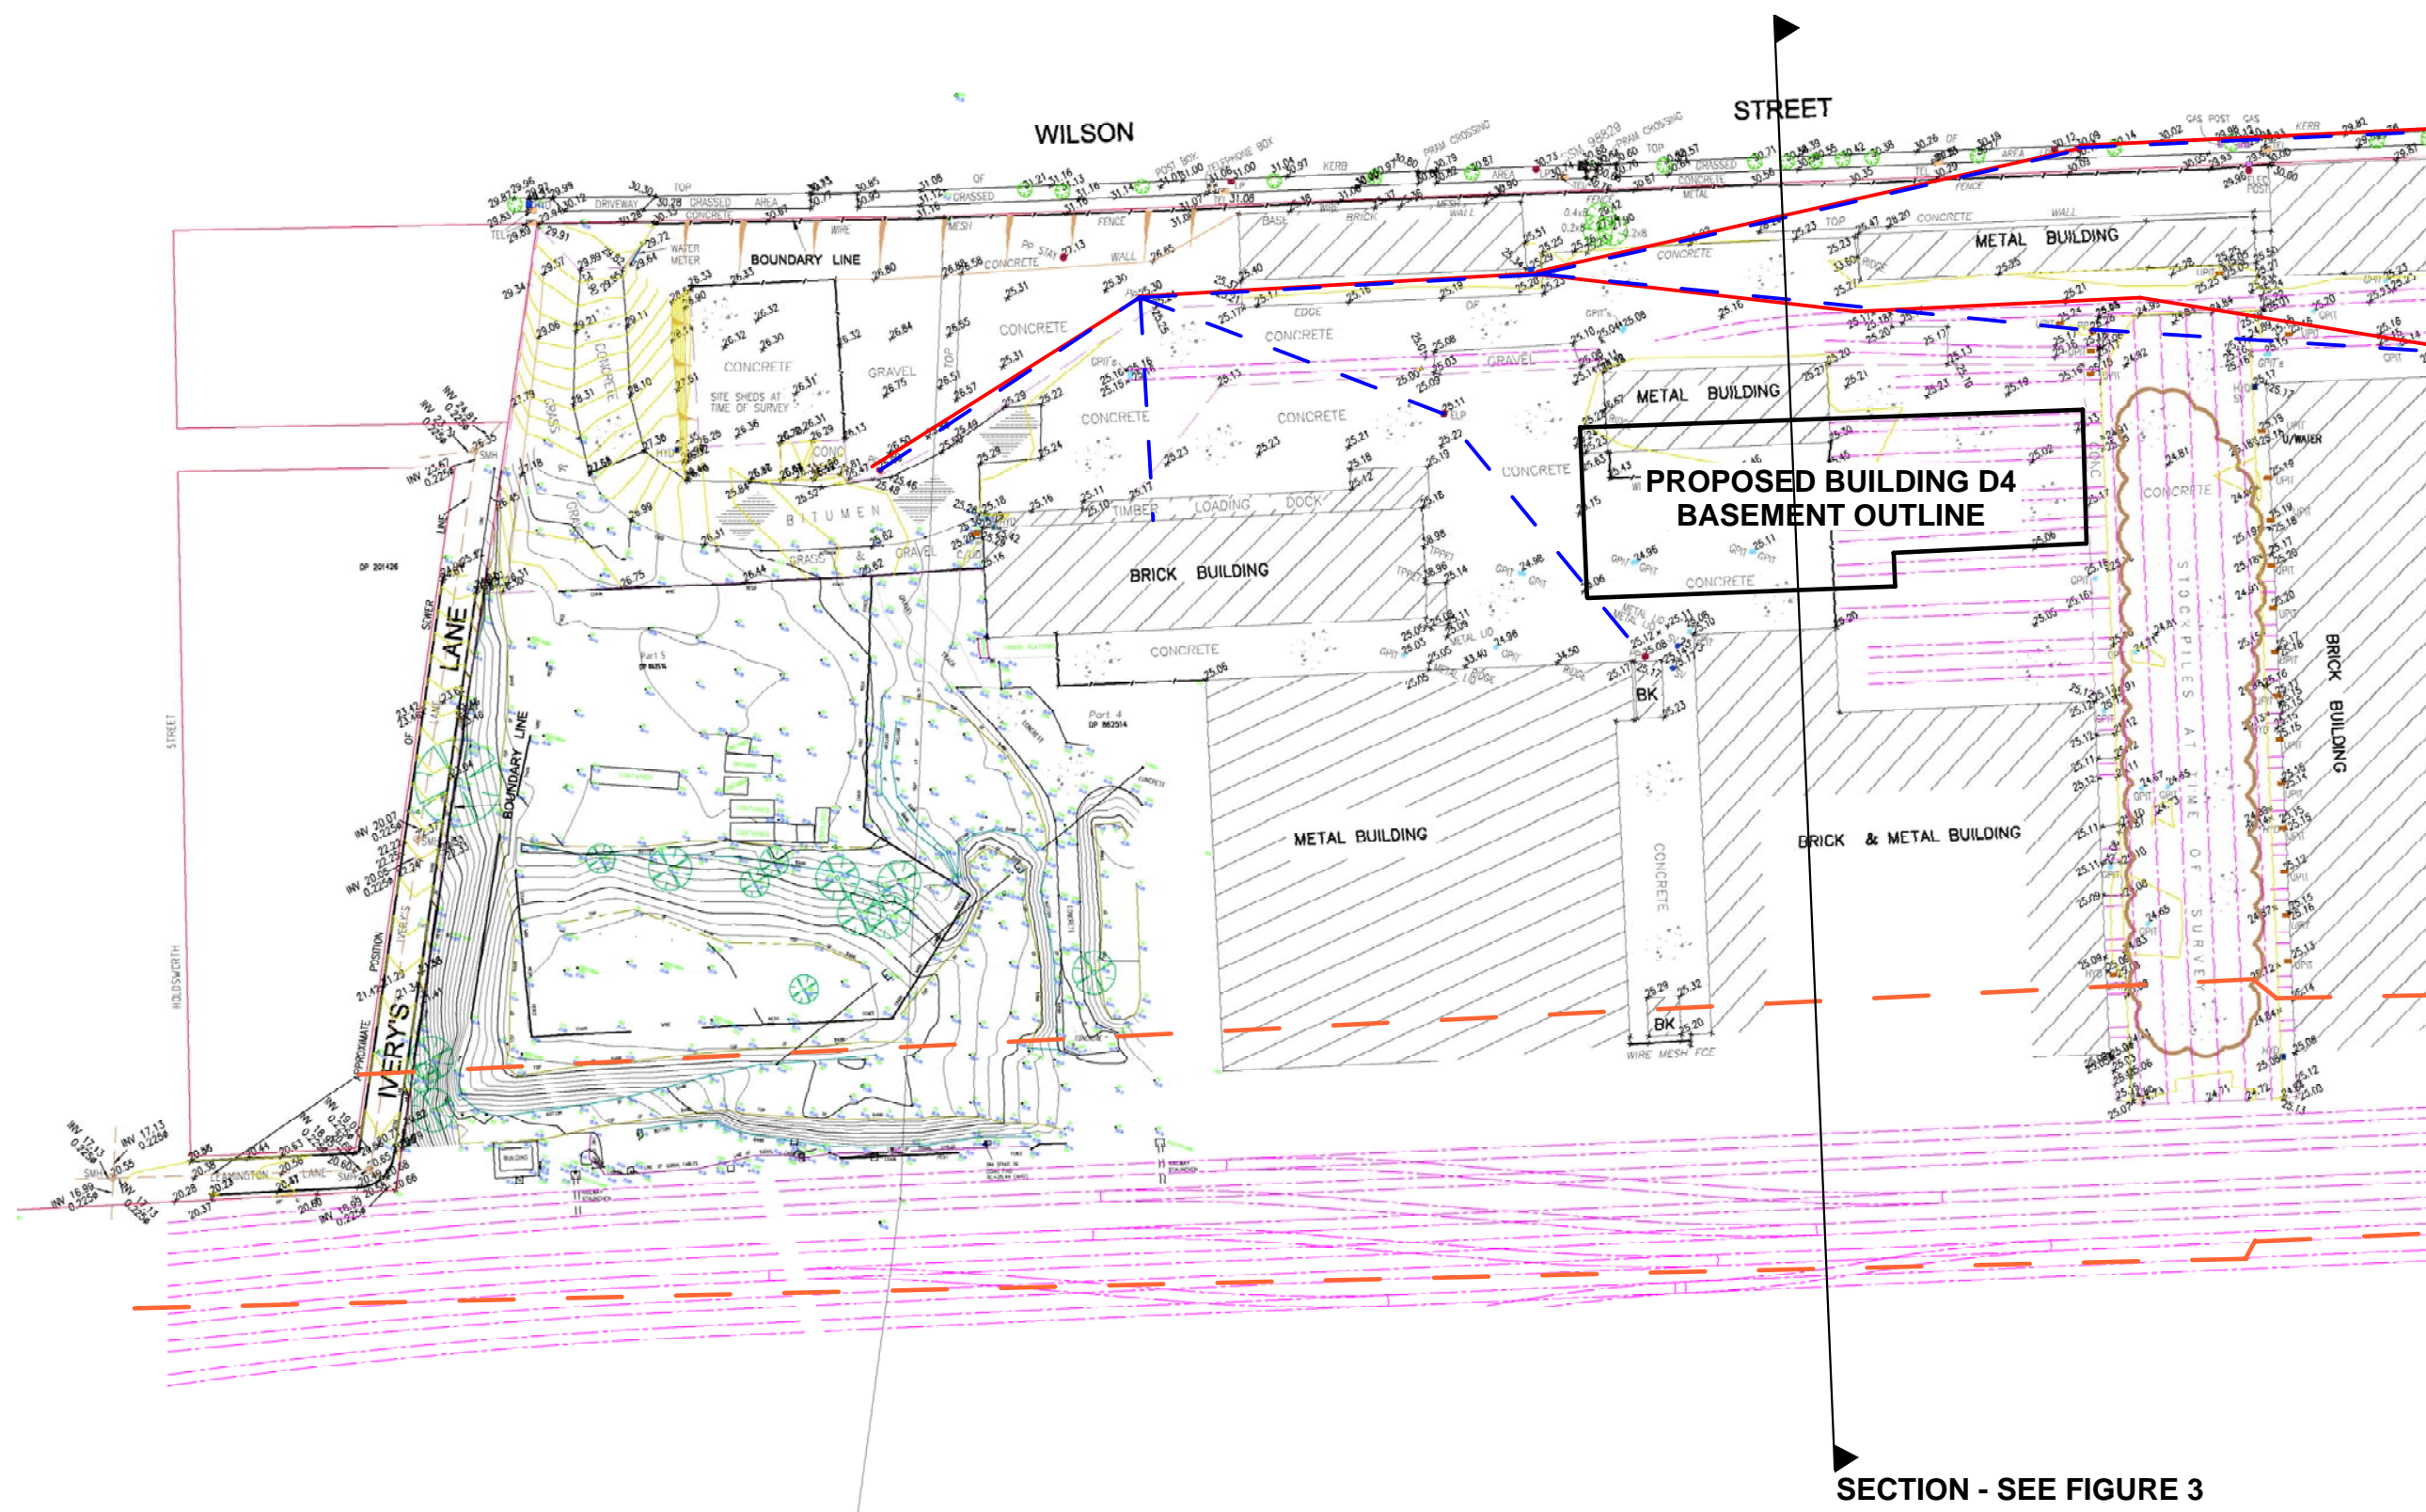
FIGURE 1: SITE PLAN SHOWING SITE LOCATION AND LOCATION OF RAILCORP ASSETS

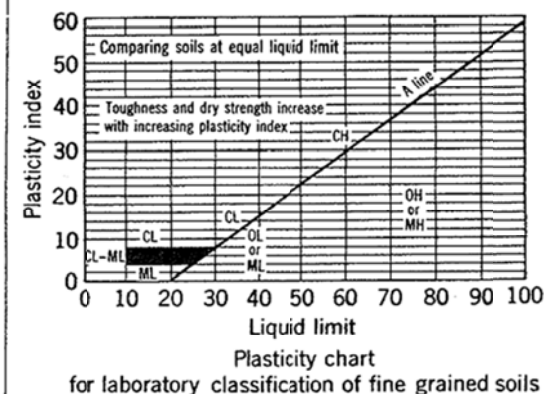
Plasticity chart for laboratory classification of fine grained soils
