Report on
Geotechnical Investigation

Proposed South East Regional Hospital
1614 Tathra Road, Bega

Prepared for
Health Infrastructure

Project 78385.00
August 2012

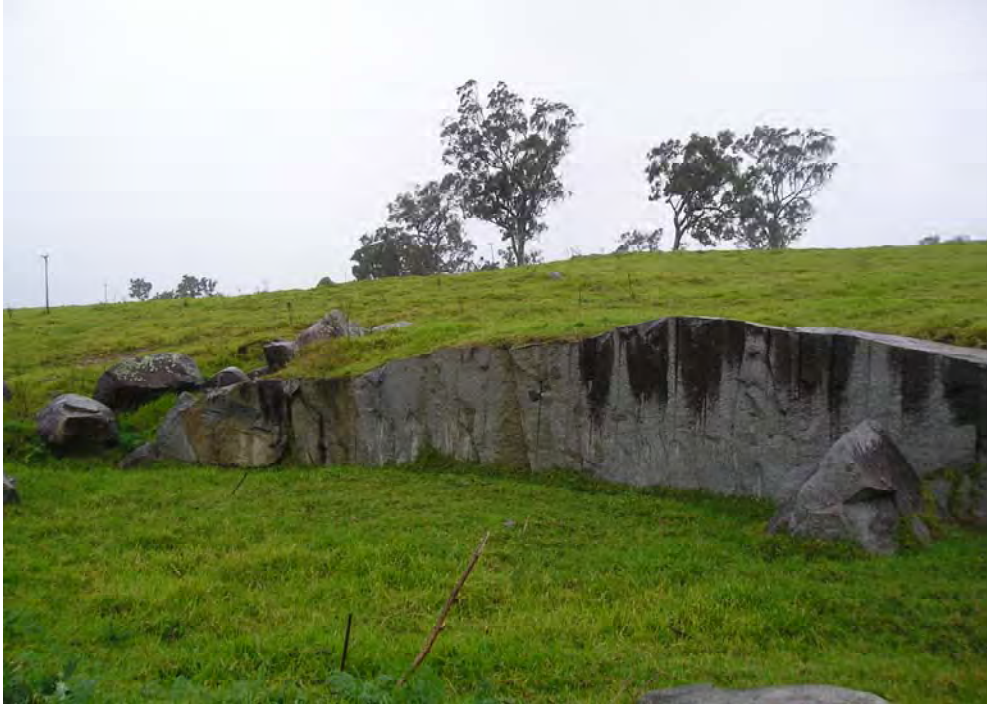
Photo 1 – View south overlooking old stone quarry near TP2

At the time of the investigation, the site was grassed farmland and used for grazing cattle with a few scattered trees noted (refer Photos 1 - 4 in Appendix A). Some outcropping rock and boulders were also present on the site surface (refer Photos 1, 2 and 4).

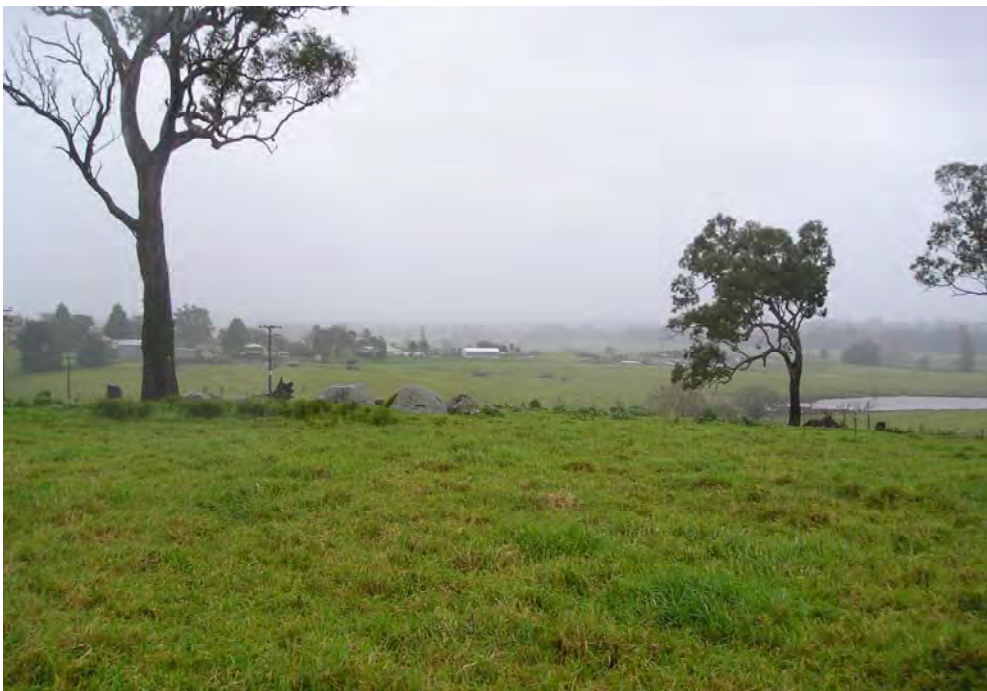
Photo 2 – View north in between TP7 and TP4

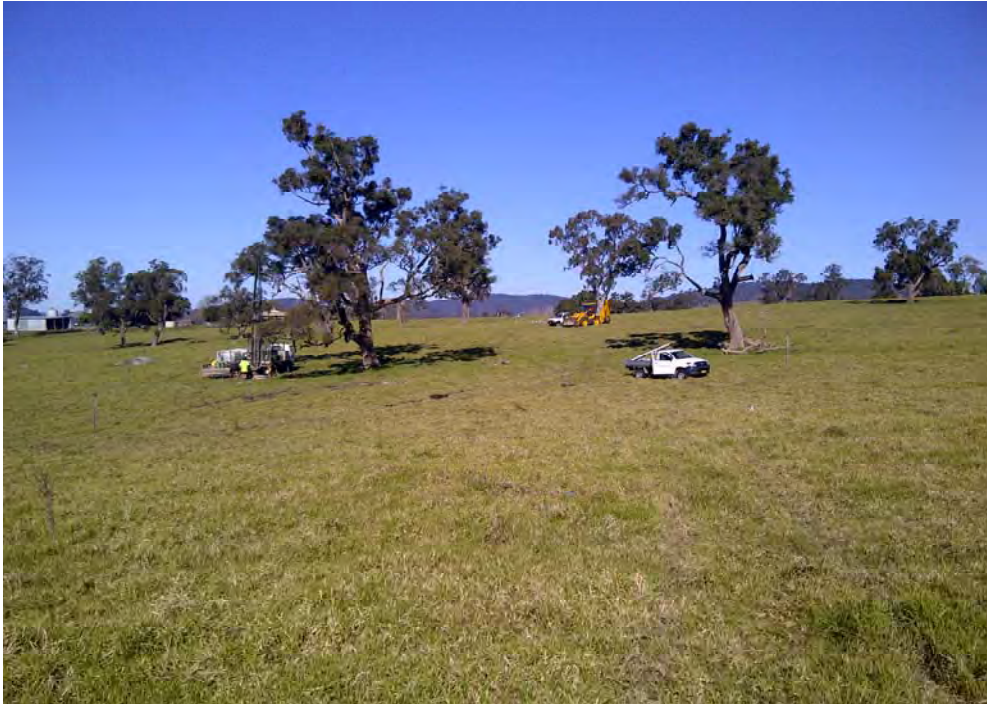
Photo 3 – View south. Drilling rig at BH15

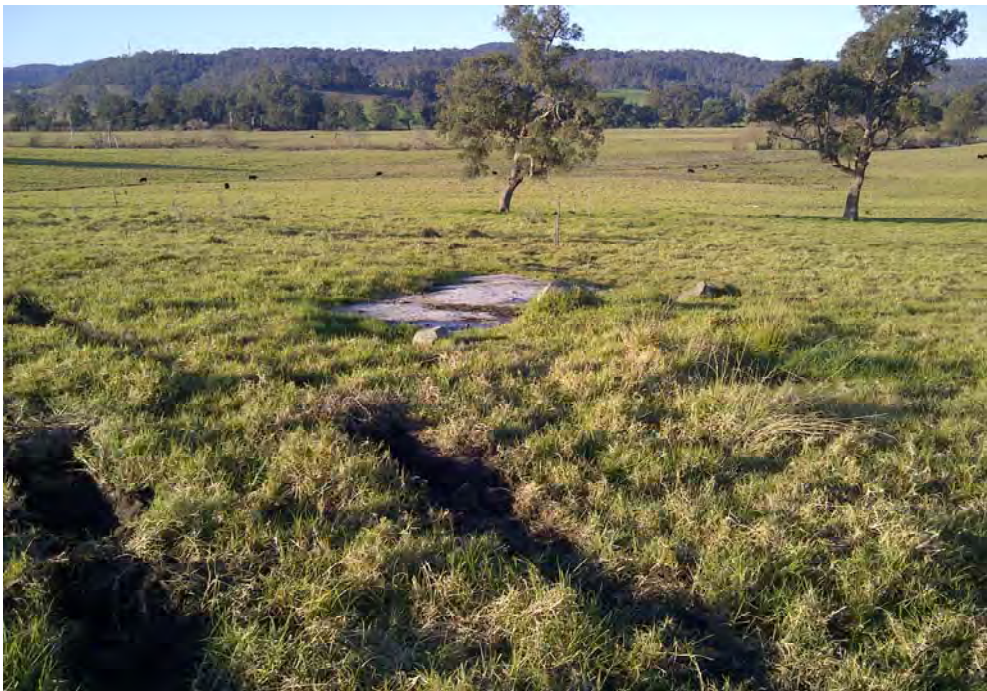
Photo 4 – View east near BH21
