RE: Supplementary Monitoring & Assessment Works - The Haymarket, Sydney

1. Introduction

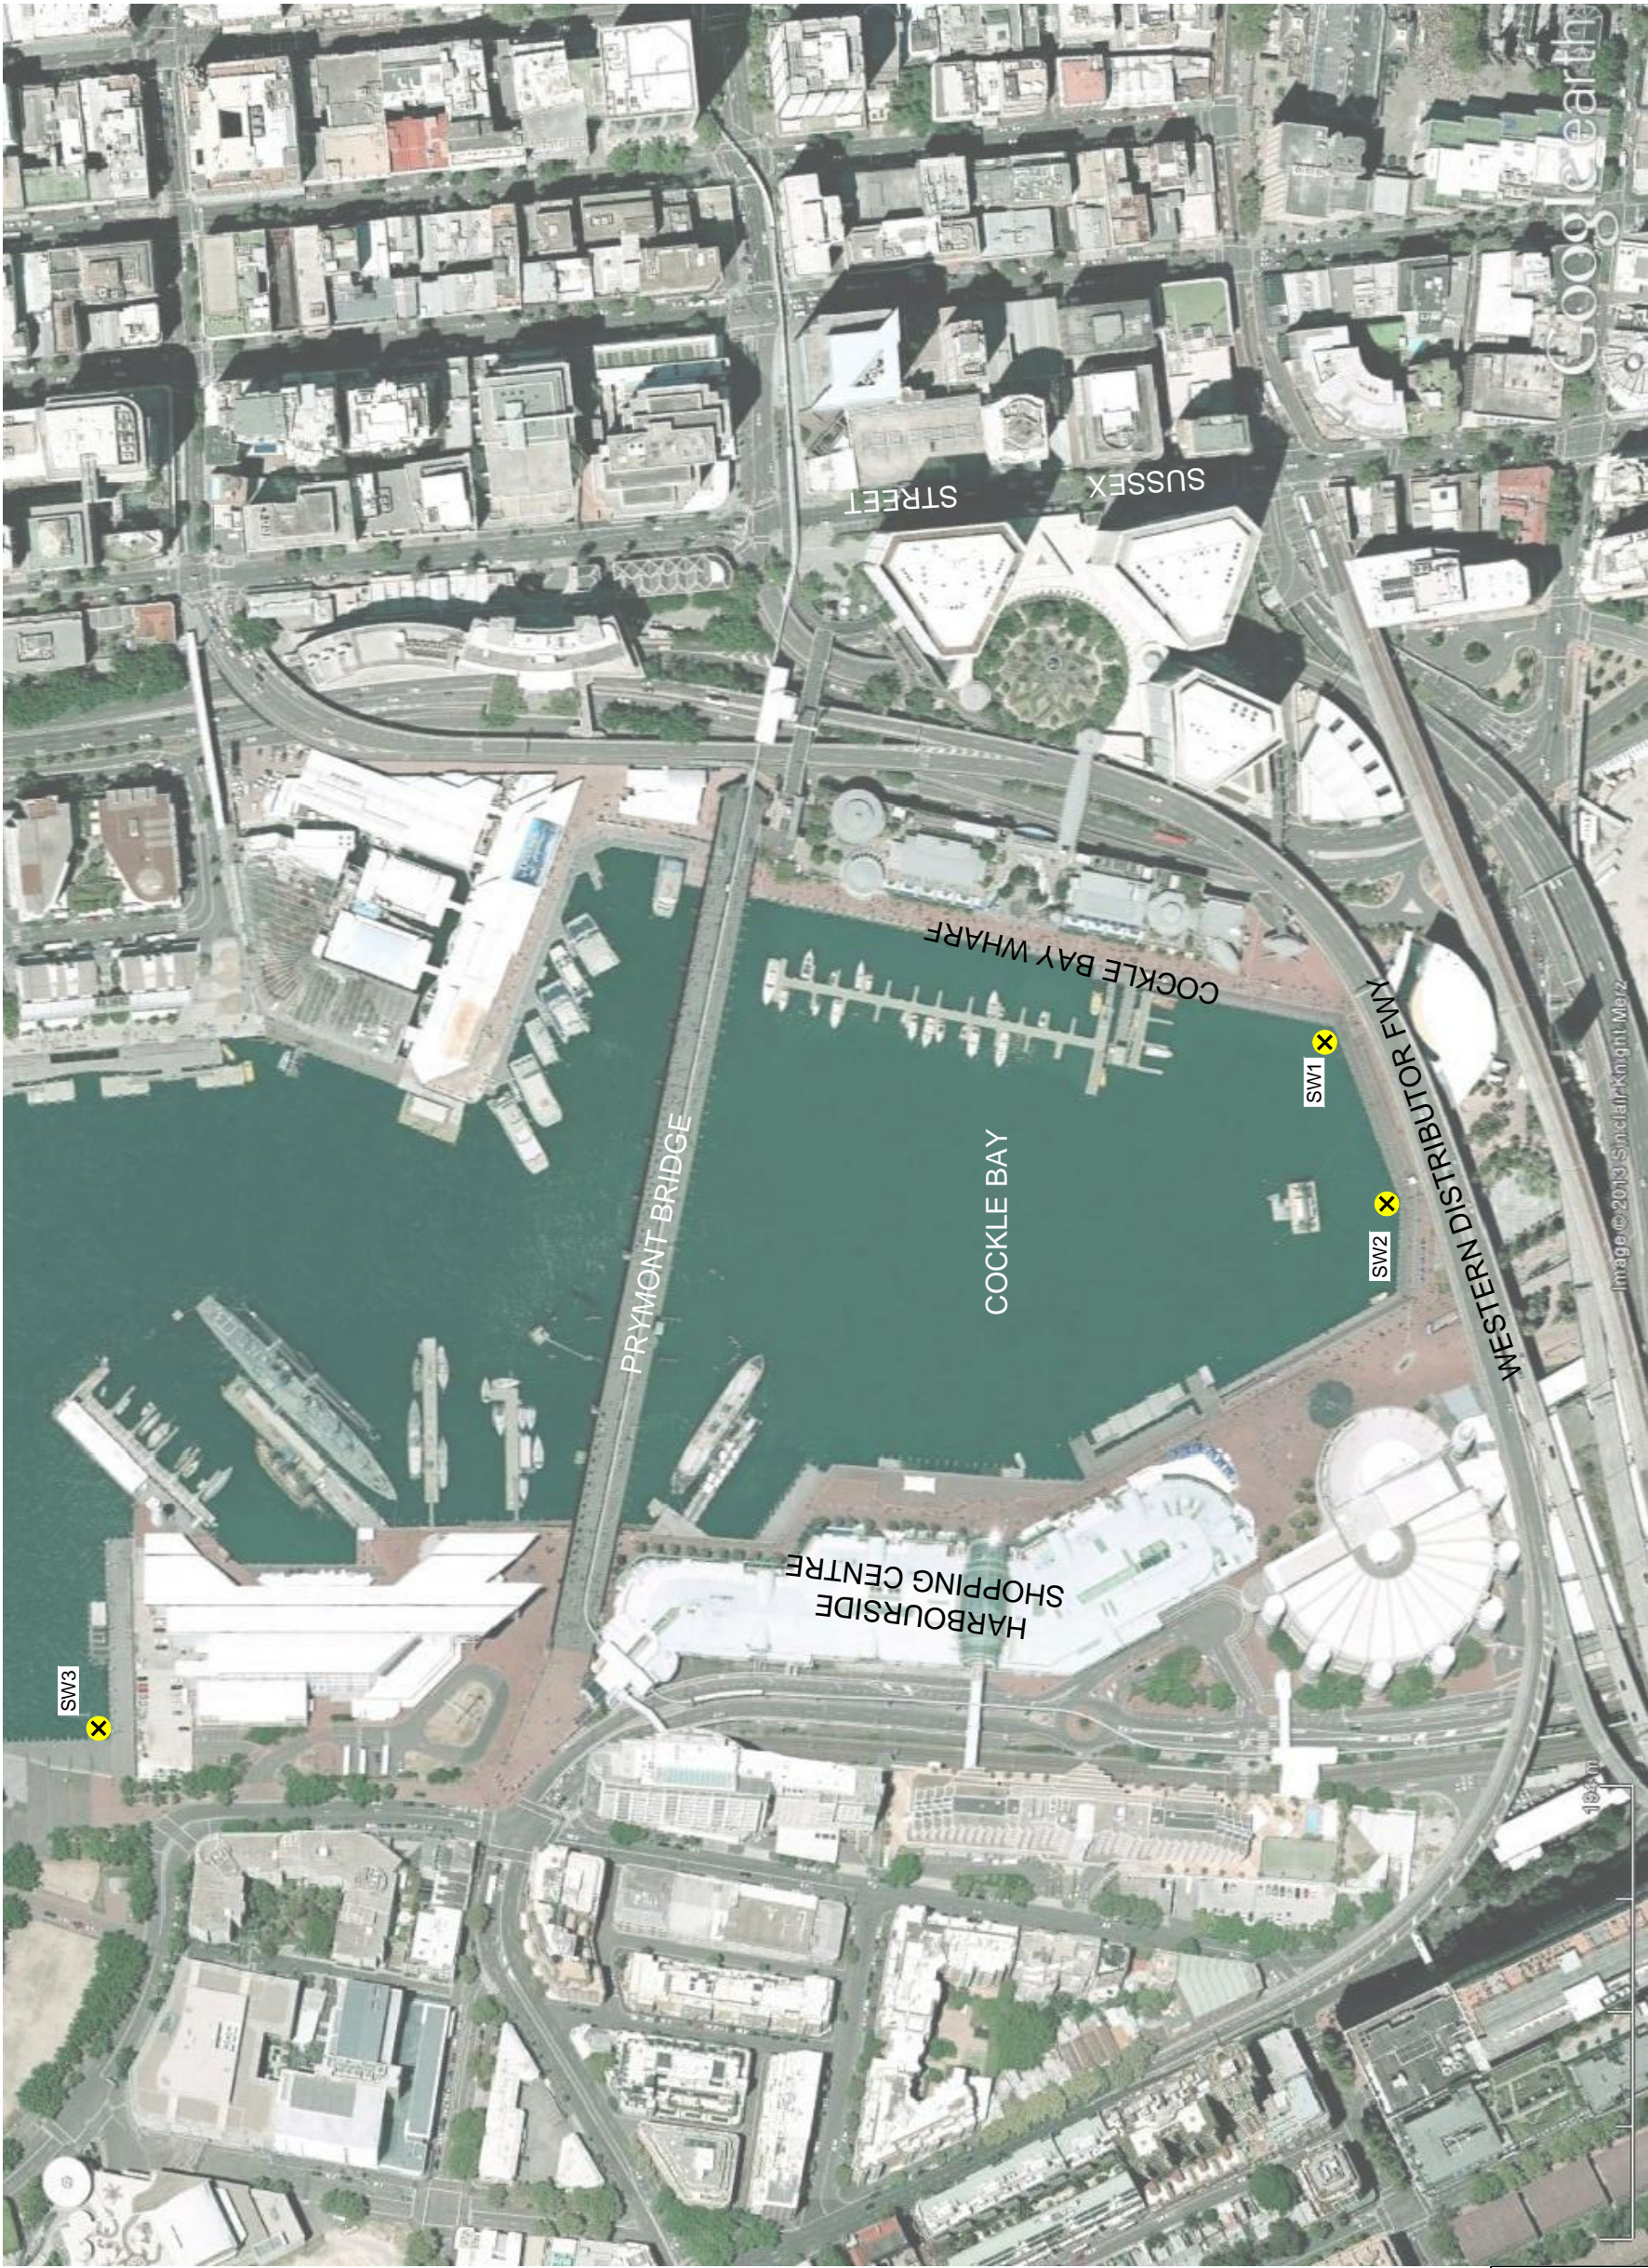
approved	ML	project: SUPPLEMENTARY MONITORING & ASSESSMENT WORKS TO RESPOND TO EPA COMMENTS ON GROUNDWATER THE HAYMARKET, SYDNEY, NEW SOUTH WALES	
						date	03/07/13	title: GROUNDWATER SAMPLING LOCATIONS	
						scale	AS SHOWN	project no: ENAURHOD04498AB-D01	
						original size	A3	figure no: FIGURE 4

- Rising/falling head tests on two ground water monitoring wells (CBH9/MW9 and NBH/MW25) to estimate the hydraulic conductivity of the aquifer;
- Groundwater sampling from existing nine (9) groundwater wells installed within, or immediately adjacent to the Haymarket site. The groundwater wells sampled included BH1, CBH/MW6, CBH/MW9, BH12, BH13, NBH/MW25, NBH/MW30, BH120 and BH124. The location of these groundwater wells is shown in Figure 3; and

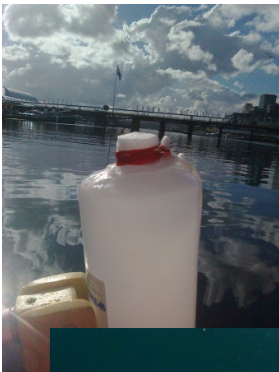
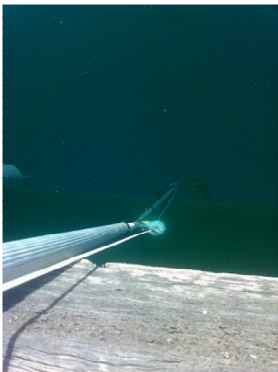
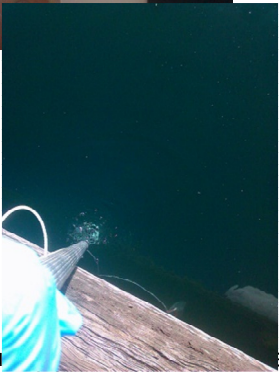
Activity	Detail / Comments
Sampling Method	<p>Surface water samples were collected from three sampling locations shown in Figure 4 using a dedicated long handled Swing Sampler. The pivoting head of the Swing Sampler was fixed so that the sampling bottle was in parallel with the sampler handle. The sample bottle was secured using elastic bands and masking tape.</p> <p>An indicator mark 1m above the top of sample container was made on the extendable handle of the Swing Sampler so that water samples were collected at practically the same depth.</p> <p>A small piece of plastic film was placed over the top of the open sample bottle and secured with an elastic band (refer Picture (a)). The elastic band was attached to a separate length of cord which was held by the environmental scientist carrying out the sampling. Once the plastic cover was in place, the sample bottle was lowered to a depth of approximately 1m below the surface of the water (refer Picture (b)). At the sampling depth, the cord was pulled, which dislodged the plastic film allowing water to enter the sampling bottle (refer Picture (c)).</p> <div style="display: flex; justify-content: space-around; align-items: center;"> <div style="text-align: center;">

<p>(c)</p> </div> </div> <p>Water quality was measured from a sample of the water brought to surface. Surface water sampling records are provided in Appendix C.</p> <p>A primary and field duplicate sample was collected from each sampling location to assess chemical variability between samples. These samples are denoted with the suffix 'A' and 'B'. Each sample was collected using separate laboratory supplied bottles. No sample splitting was carried out. A new piece of plastic film was used when collecting</p>
