Memorandum

То	Lend Lease Building	Johanna Nolan	johanna.nolan@lendlease.com					
From	Peter Oitmaa		Date	22 October 2013				
Subject	Preliminary Geotechnical In 4 Murray Rose Avenue, Syd		Project No.	45153.03

This memorandum provides preliminary geotechnical information for the above project. The geotechnical report is currently being prepared and will expand upon the information contained herein.

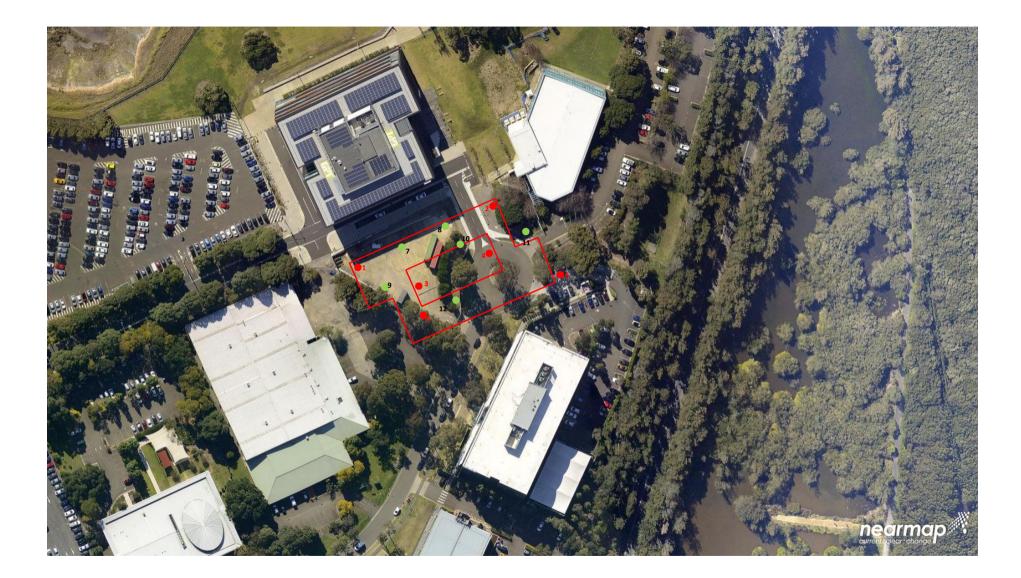
- Five boreholes (BH1 to BH3, BH5 & BH6) were drilled to depths of 15.0 m to 15.2 m for geotechnical investigation purposes. The locations of the geotechnical boreholes are shown in red on the attached aerial photograph. BH4 was not drilled due to access constraints. The conditions encountered in the boreholes are shown on the logs and core photographs which are also attached.

Attachments:	Aerial Photograph
	Borehole Logs
	Core Photographs
