Report on
Detailed Site Investigation (Contamination)

Proposed Commercial Development
4 Murray Rose Avenue, Sydney Olympic Park

Prepared for
Lend Lease Building Pty Ltd

Project 45153.03
November 2013

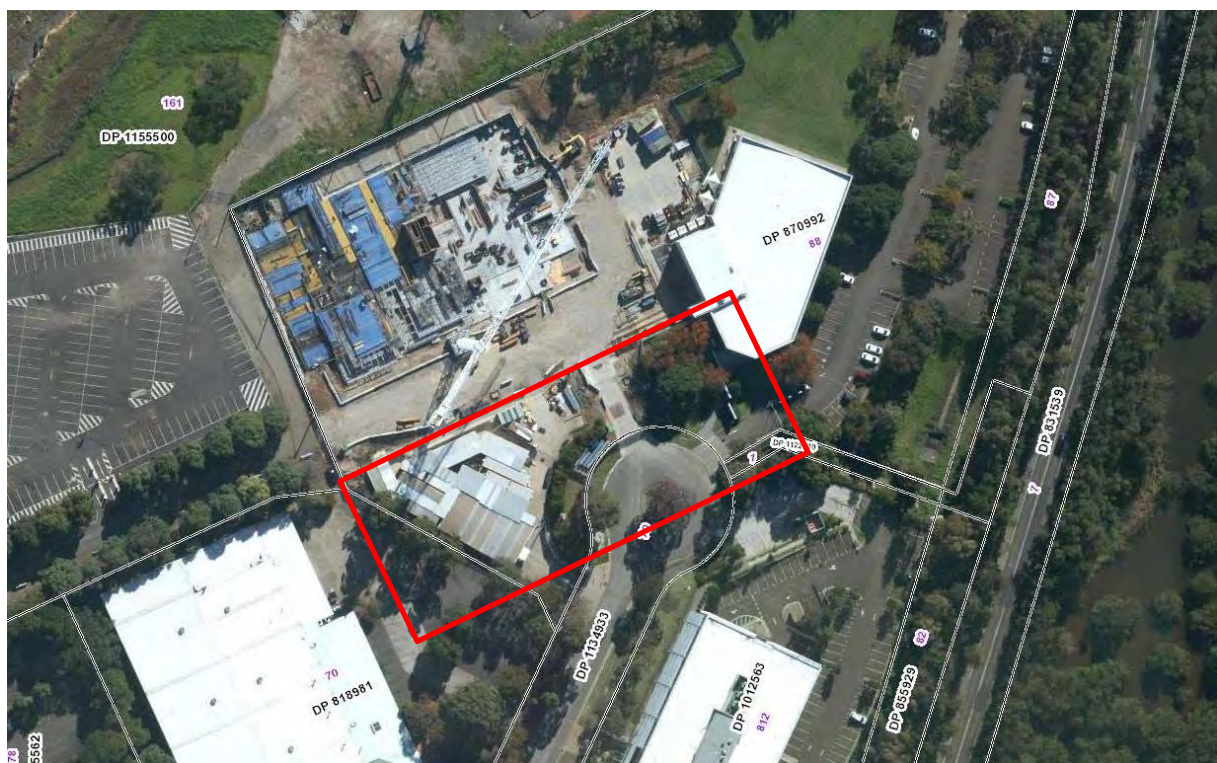
Figure 1: Approximate location of site with respect to current lot boundaries

The site is primarily on part of Lot 88 in Deposited Plan 870992 in the Parish of Concord, County of Cumberland. A small portion of the site is on the adjacent Lot 70 in DP 818981, Lot 70 in DP 1134933 and Lot 1 in DP 1122970, although it is understood that the lot boundaries will ultimately be altered to reflect the layout of the new development. A site location plan is shown in Figure 1.

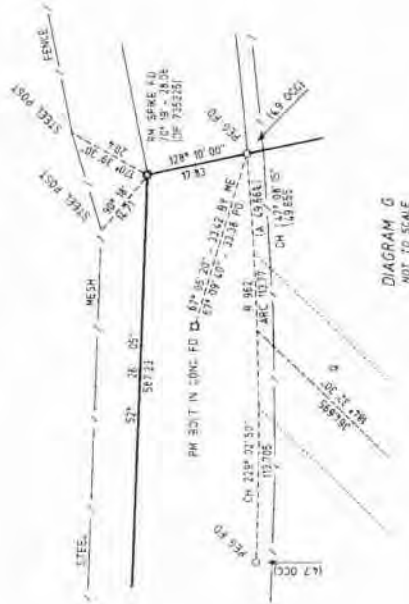
- H EASEMENT FOR WATERMAIN VIDE DP 228640 DEALING K 454256
- J EASEMENT TO DRAIN WATER DEALING K 888355
- Q EASEMENT FOR TRANSMISSION LINE 30 WIDE
- U PROPOSED EASEMENT TO DRAIN WATER 10 WIDE
- U RIGHT OF CARRIAGEWAY 6.1 WIDE VIDE DP 228640

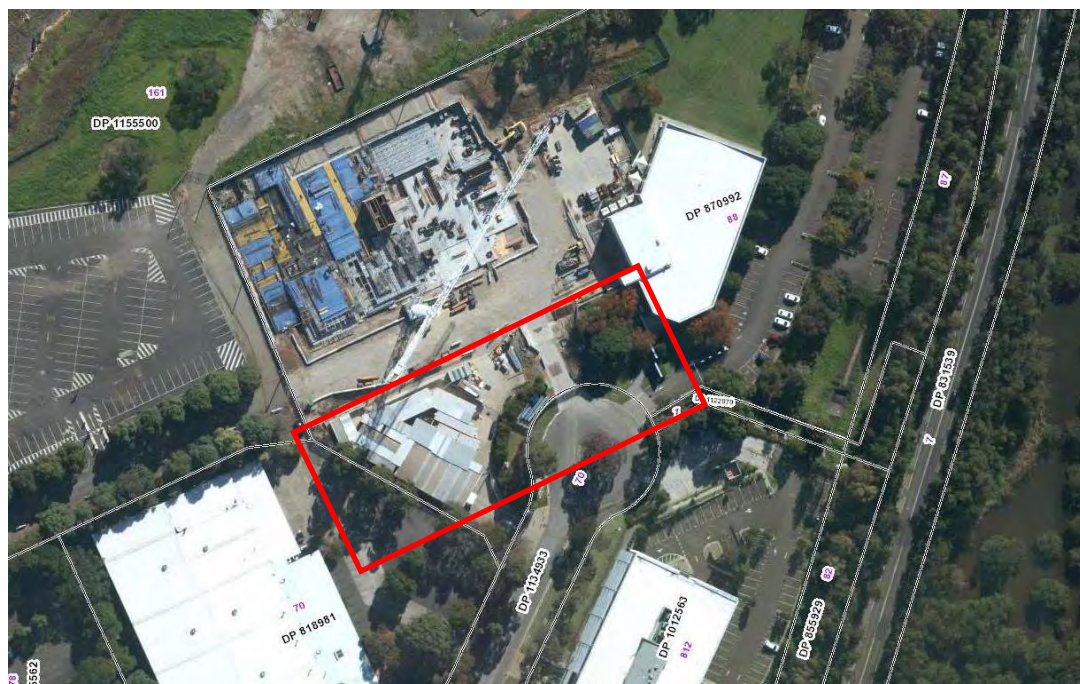
Figure 1: Approximate location of site with respect to current lot boundaries

The site is near-rectangular and approximately 4,000 m² in area. The site is primarily on part of Lot 88 in Deposited Plan 870992 in the Parish of Concord, County of Cumberland. A portion of the site is on the adjacent Lot 70 in DP 818981, Lot 70 in DP 1134933 and Lot 1 in DP 1122970, although it is understood that the lot boundaries will ultimately be altered to reflect the layout of the new development. A site location plan is shown in Figure 1.
