**REPORT  
TO  
FRASERS PROPERTY  
ON  
GEOTECHNICAL INVESTIGATION  
FOR  
PROPOSED DEVELOPMENT AT BLOCK 8  
AT  
CORNER OF ABERCROMBIE STREET AND  
O'CONNOR STREET, CHIPPENDALE, NSW**

**22 January 2014  
Ref: 22905SDrpt8rev1**

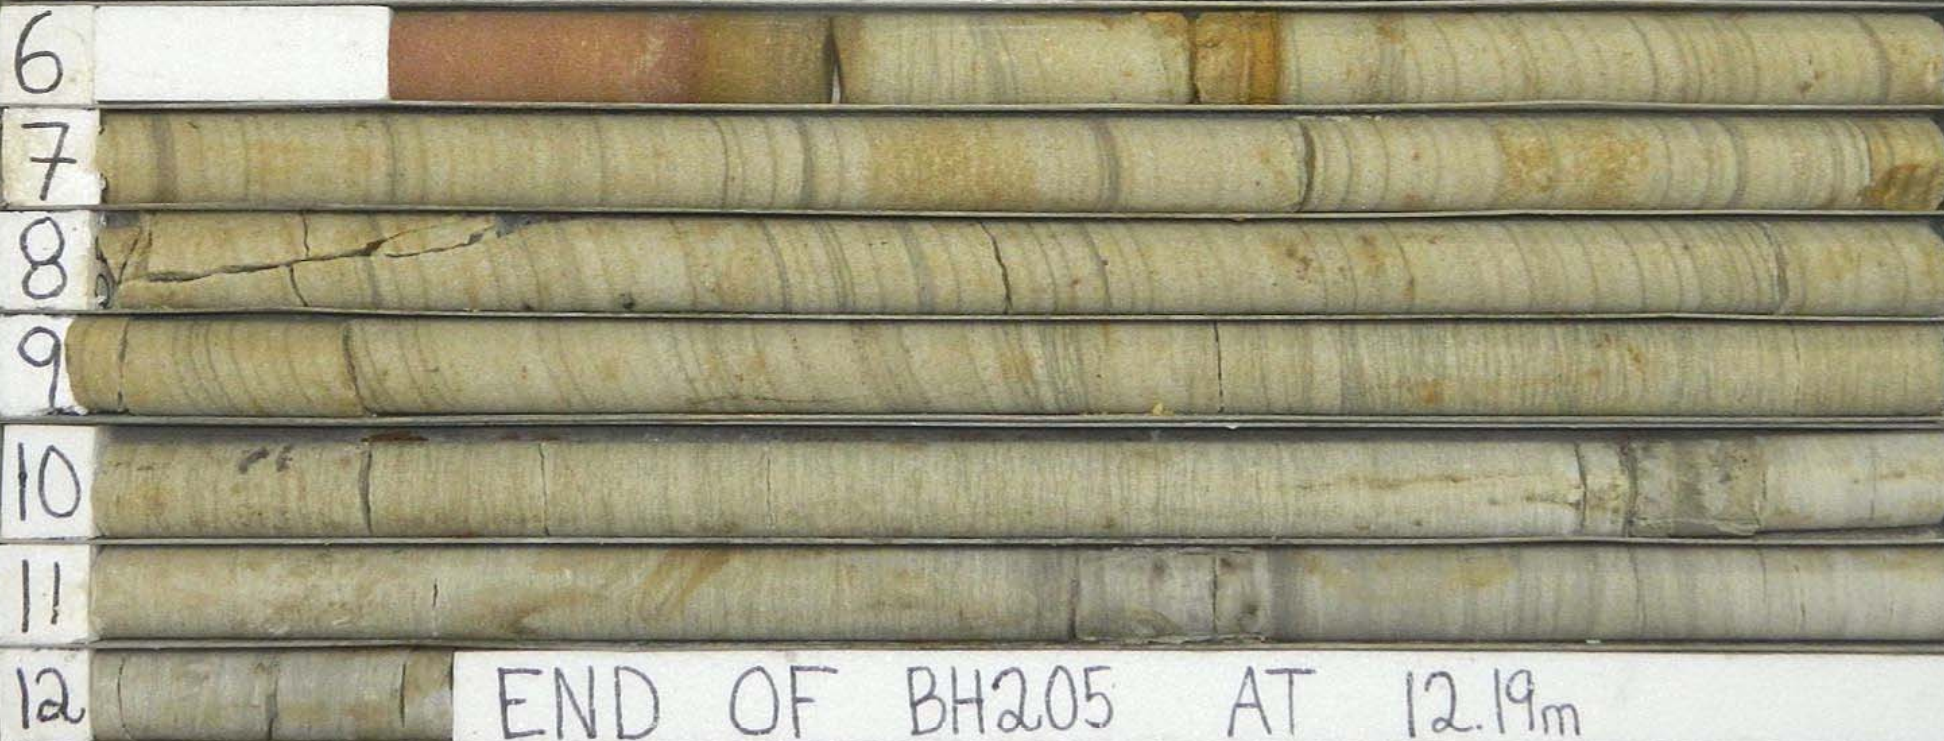
Job No 22905SD BH205 START CORING AT 6.16m

END OF BH205 AT 12.19m

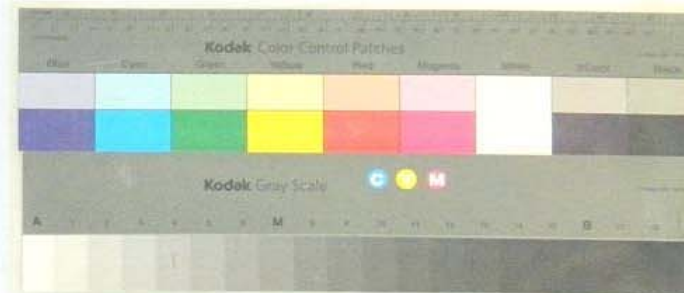
Job No 22905SD BH207 START CORING AT 5.80m

CLIENT: FRASERS PROPERTY  
PROJECT: PROPOSED DEVELOPMENT AT BLOCK 4S  
LOCATION: CORNER OF ABERCROMBIE STREET AND IRVING STREET,  
CHIPPENDALE, NSW
