Prince of Wales Hospital NCCC & AATC Development

Results of Archaeological Testing for European Remains

Report to
WorleyParsons

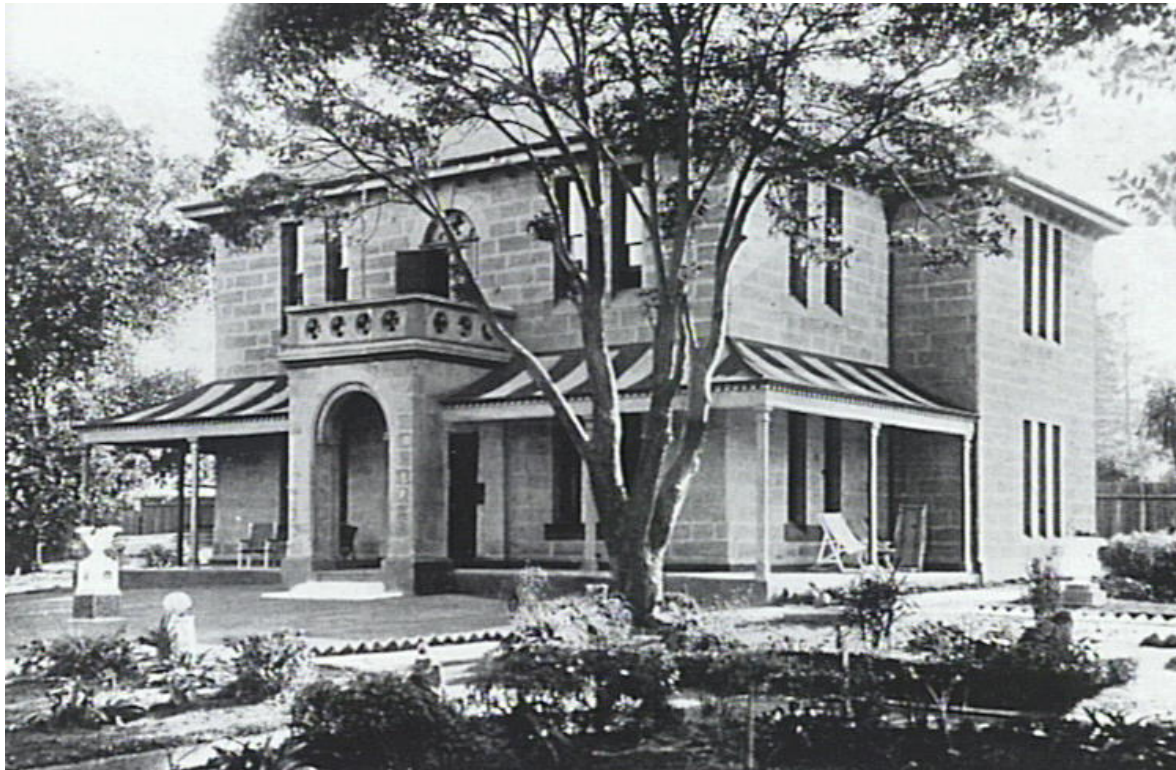
Figure 3: Superintendent's Residence, c1909. Source: Trove.

After a period of decline associated with the gradual decline of the entire Asylum site, an injection of money into the site meant that the Superintendent's Residence received new guttering in 1913. The building would originally have been surrounded by formal lawns to the east with formal hedges and flowering shrubs. A photograph from 1909 (Figure 3) shows tiled garden edging, a lawn sculpture and a large Eucalypt.

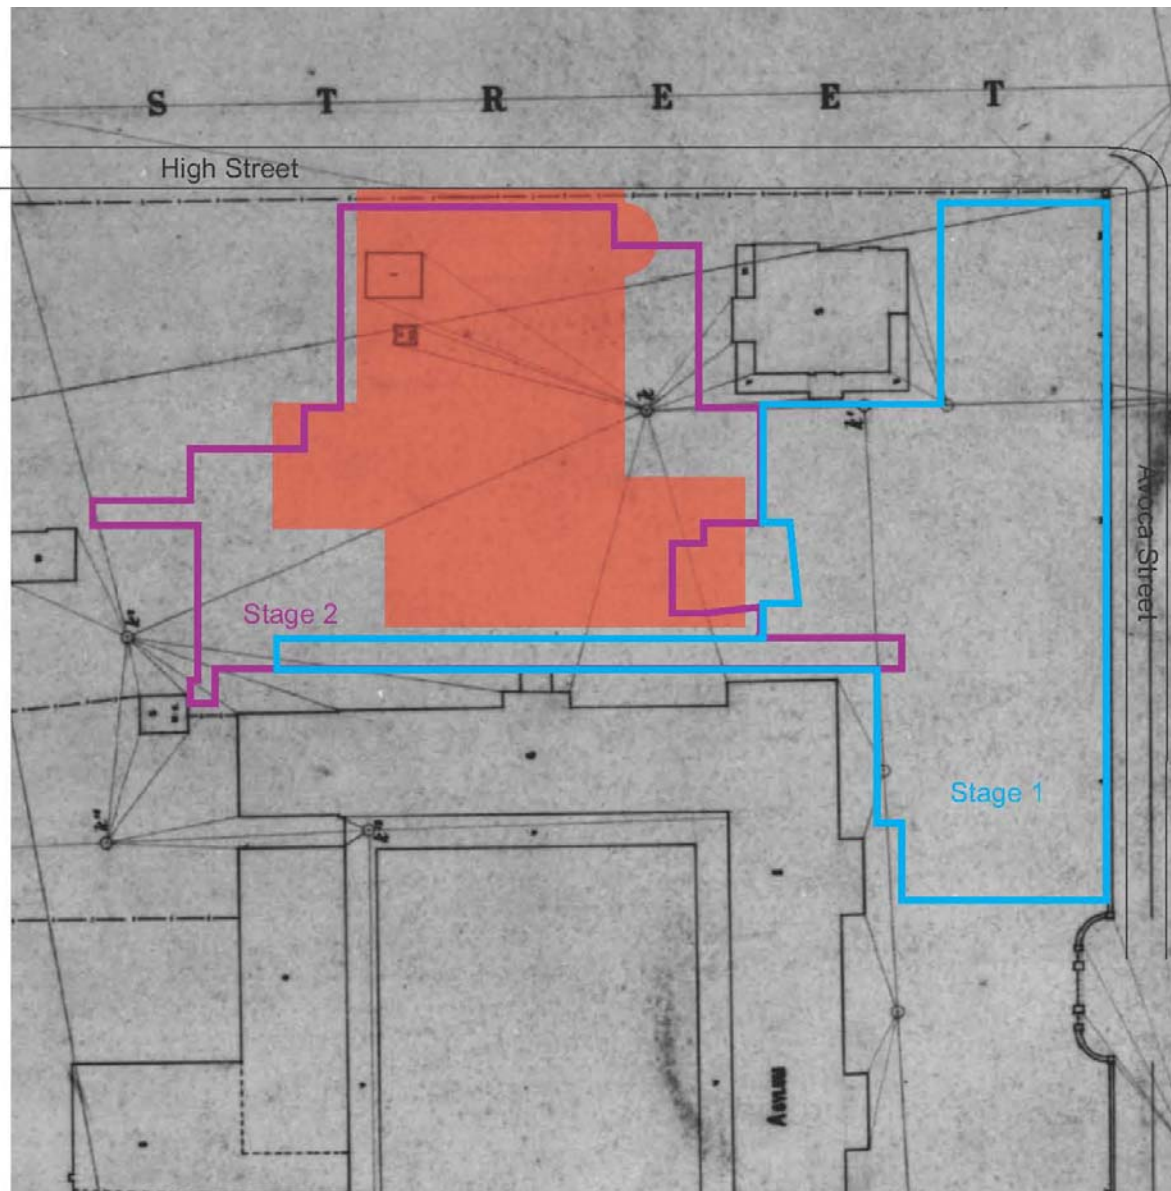
- Proposed radiation building - Stage 2
- Proposed radiation building basement - Stage 1
- Existing 1970s cancer treatment building and basement

Figure 4: Detail of 1891 Randwick, Sheet 37, Sydney Water Plan showing the location of two structures to the west of the Superintendent's Residence, water closet and iron shed, are within the 1970s basement area. Sydney Water plans archive with Casey & Lowe overlay.

Sydney Water survey plans from the 1890s provide more detail. A surveyor's field book from 1890 depicts three buildings located to the west of the Superintendent's Residence. One of the buildings is identified as being a brick water closet. Just to the north of this is a structure listed as being made of iron (corrugated iron). Further to the west of these two structures is a wooden building. The location of these is shown on the final 1891 plan depicting the brick and iron buildings but not the wooden structure (Figure 4).

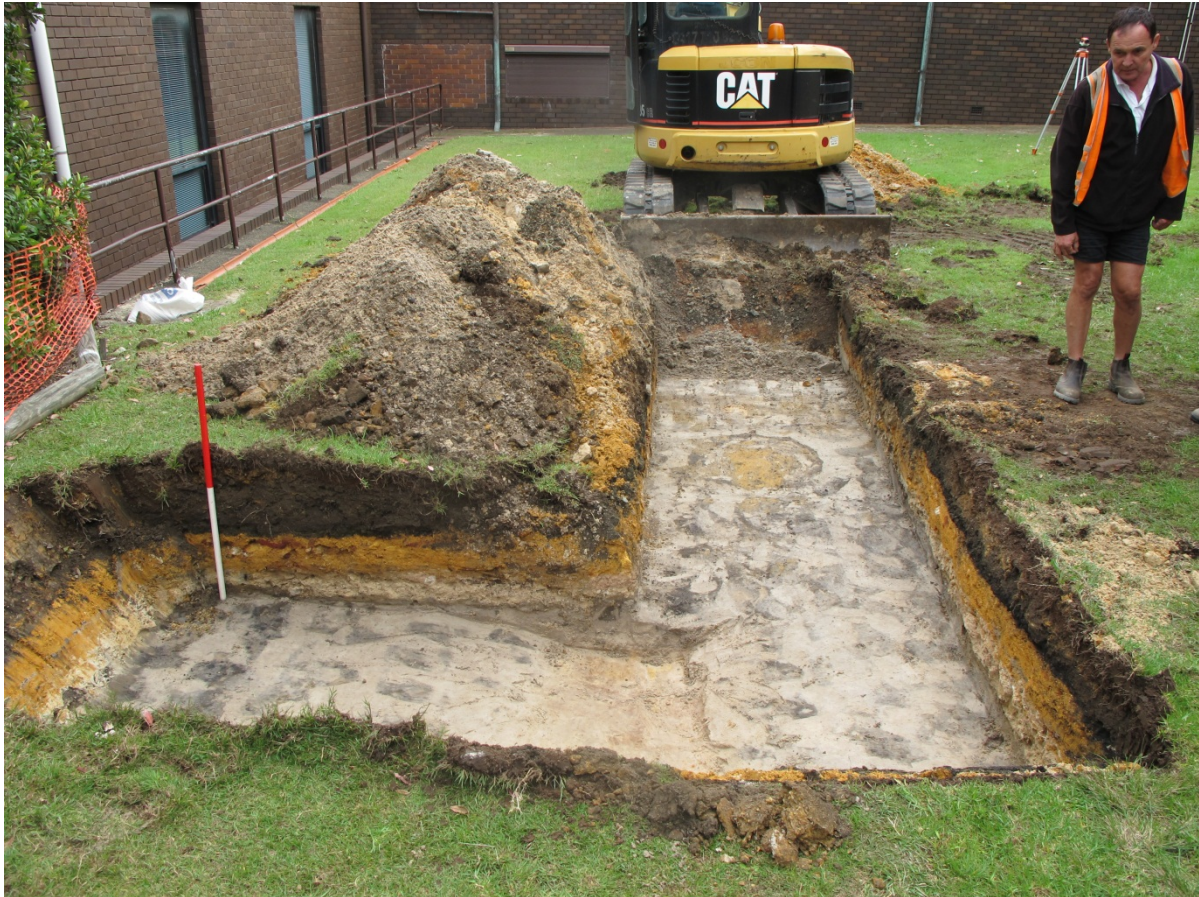
Figure 7: Trench 1 following machine excavation. Semi-regular marks can be seen in the natural sand at the base. Looking west, scale 1m.

The stratigraphy encountered was typical of that found in other trenches with some variation in fill thickness and the presence/absence of some minor fills (Figure 7). The upper 200mm-300mm was dark brown topsoil with a grass layer on top (Figure 8). This topsoil was found in trenches 2, 3, 6A, and 6B where it varied between 150mm and 300mm in thickness. The other trenches were surfaced with bitumen and there was no topsoil here. Beneath this, a c.50mm-thick layer of loose, black asphalt-like material was also common to the trenches. It was interpreted as a mid-late twentieth-century surface that predated the topsoil which was clearly imported. This surface was based on a compact, 120-150mm-thick layer of orange clayey sand with moderate amounts of sandstone mixed throughout. Again this layer was found elsewhere but it varied in colour between yellow, red, and grey and was between 50mm and 150mm thick. This 'preparation' layer to the asphalt surface was typically above either natural layers or redeposited / modified natural layers.

No European archaeological remains were encountered in Trench 1. Regular marks in the natural sands were initially considered to have been possible garden features from the early occupation of the cottage. They were later interpreted as probable impressions from a roller used to compact the ground in preparation for the layer of asphalt in the mid-late twentieth century.

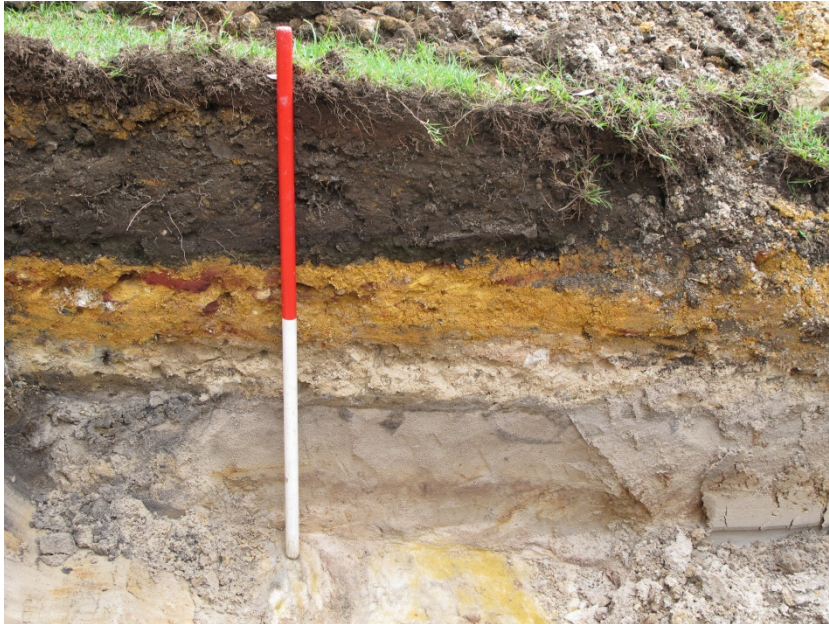
Figure 8: Typical stratigraphy in Trench 1. Scale 1m.

Below the preparation layer described above was a layer of grey sands with occasional, small sandstone gravels and charcoal flecking throughout, up to 100mm thick. This was likely the natural sand that had been mixed or levelled during the various activities that have taken place in the area over time. In some trenches this layer was absent. Bleached sands were under the grey sands and were interpreted as being natural. This layer had very few inclusions, with occasional sandstone, charcoal, and roots throughout. The bleached sands were atop undulating bedrock. In parts where the bedrock was high, the bleached sands were very thin (<50mm), but were up to 300mm+ thick where there were troughs in the bedrock. They were generally c.300mm thick in Trench 1.

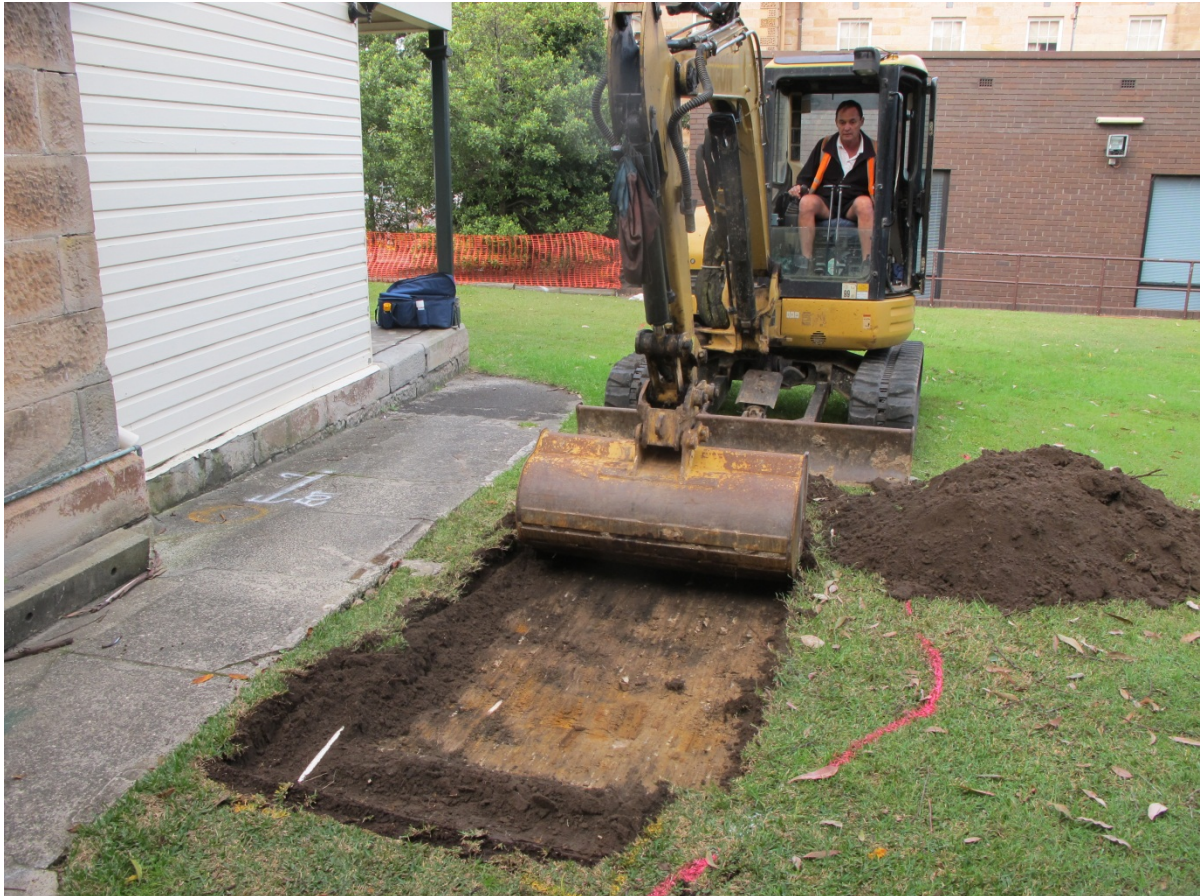
Figure 9: Beginning of excavation in Trench 2. View to the south.

Trench 2 was excavated immediately to the west of the cottage on a rough north-south axis (Figure 9). Services restricted the length of the trench that could be reduced to natural levels to 1.5m. They also forced a slight shift to the east of the trench so that it was almost adjacent to the footpath.

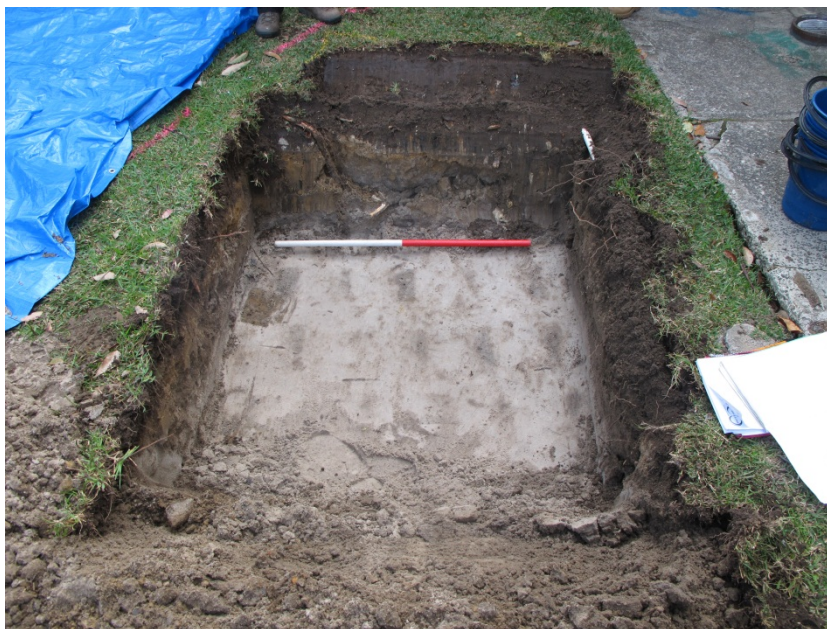
Figure 10: Regular marks can be seen in this view of Trench 2 after the completion of machine excavation. Scale 1m.

A very similar soil profile was encountered to that of Trench 1 (Figure 10). The topsoil was 150mm thick. The orange preparation layer for the asphalt surface was 100mm thick but the surface itself was absent, perhaps because this location was quite close to the cottage and the surface was different here. There were 150mm of mixed sands beneath this which were atop bleached sands. The bleached sands also contained regular marks that appeared to be a result of machine-work.

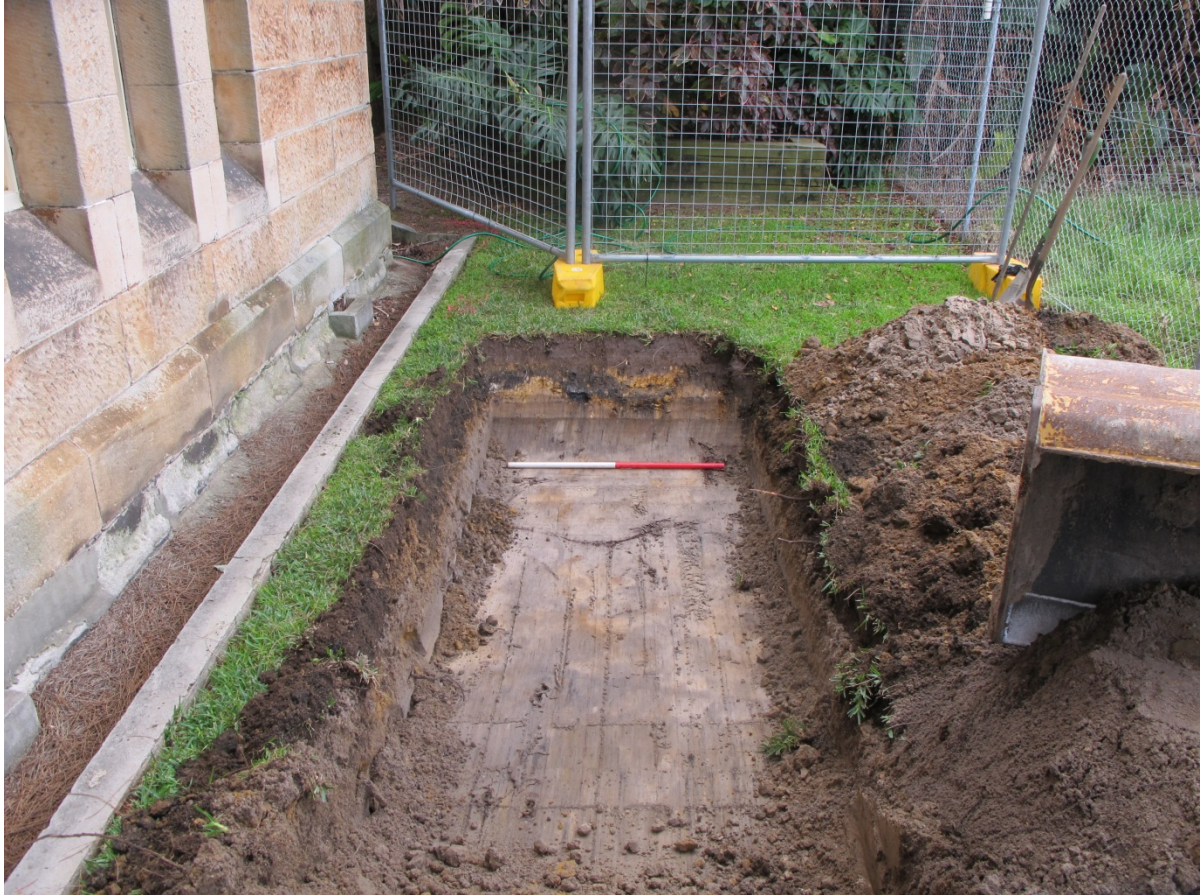
Figure 11: Mid-excavation view of Trench 3 to the north. Scale 1m.

Trench 3 was dug just to the east of the Superintendent's Residence on a north-south axis (Figure 11). The northern 3.3m was excavated which was sufficient to establish the absence of archaeological remains in this area.

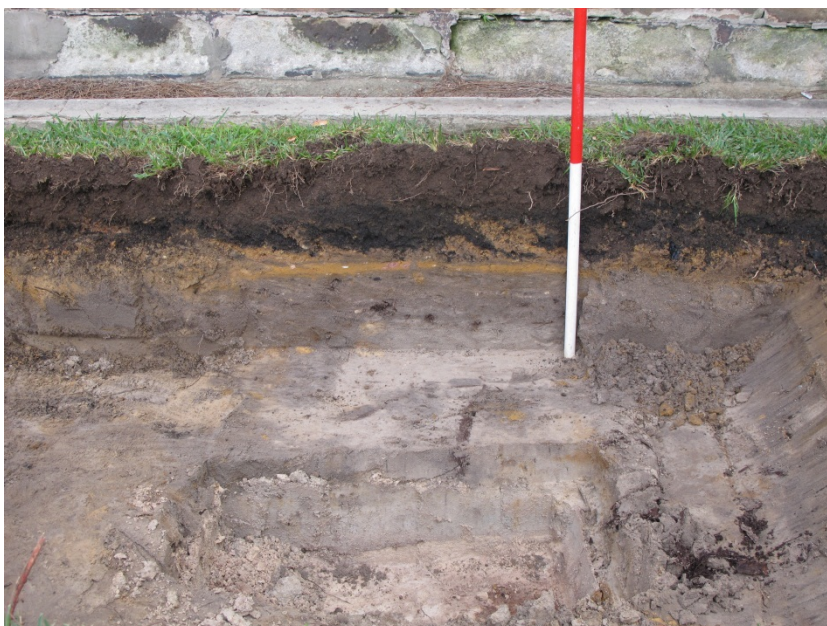
Figure 12: The stratigraphy of Trench 3 can be seen in this view of the east-facing section. Scale 1m.
