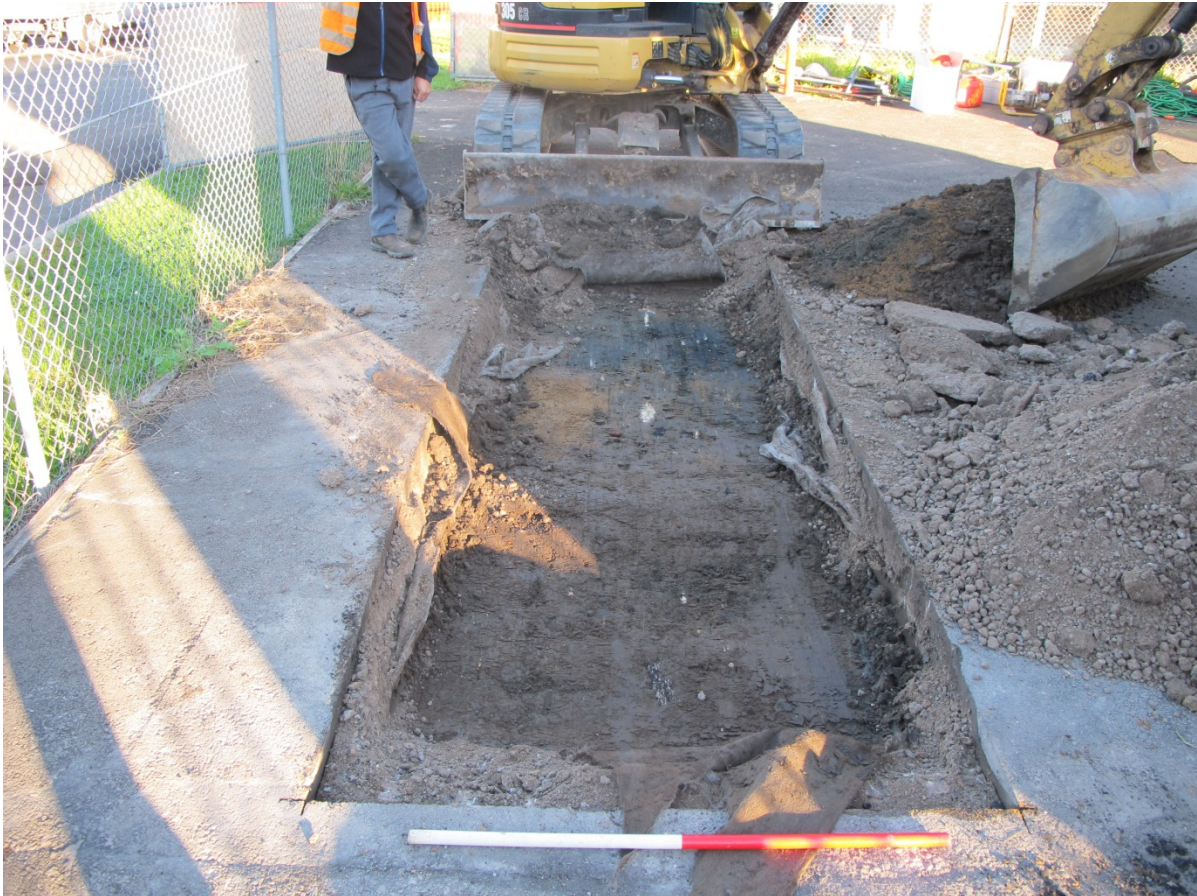
Figure 13: Mid-excavation view of Trench 4 to the west. The bitumen and road base have just been removed. Scale 1m.

The upper 200mm of the trench consisted of bitumen and road base which was separated from earlier fills by a geofabric (Figures 13, 14). Below this was c.100mm of greenish-grey sandy clay that did not appear elsewhere. The black asphalt surface and orange preparation layer appeared below this but the commonality with the stratigraphy found elsewhere was limited to these two layers. Only a heavy grey clay was between the base of the orange layer and bedrock. The latter appeared to have been levelled by machine at some stage.

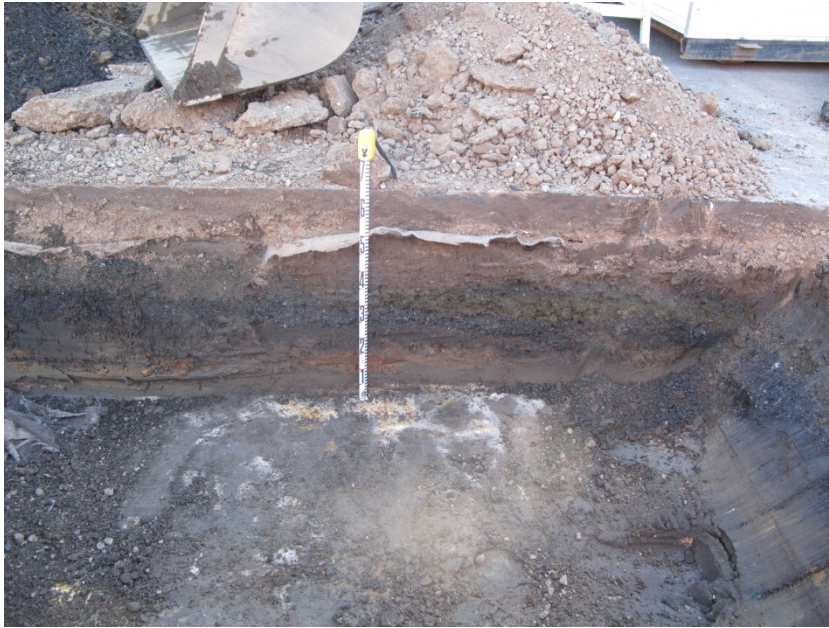
Figure 14: The south-facing section of Trench 4.

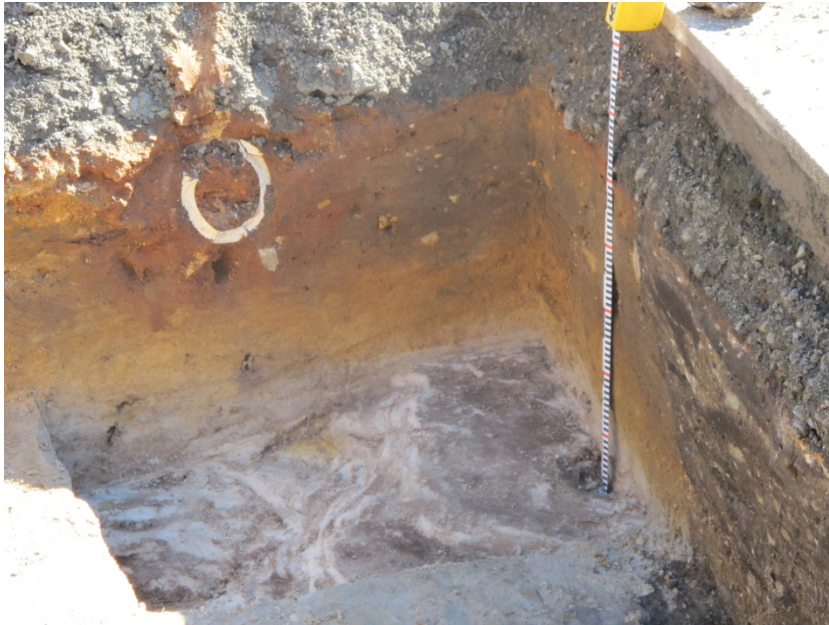
As with Trench 4, there was a bitumen surface and road base but it was c.250mm-thick in the car park. The earlier black asphalt surface was remnant in 5B but not 5A (Figure 16, Figure 17). The orange surface-preparation layer was present in 5A where it was 100mm-150mm thick. In 5B the preparation layer was greyish-brown in colour with moderate sandstone inclusions. Bleached sand was found above bedrock in the base of both trenches. Trench 5A was largely disrupted by service trenches running through it.

Figure 16: This view of the northwest corner of Trench 5A shows part of the cut of a service trench (right side) as well as another service that partly intruded into the trench.

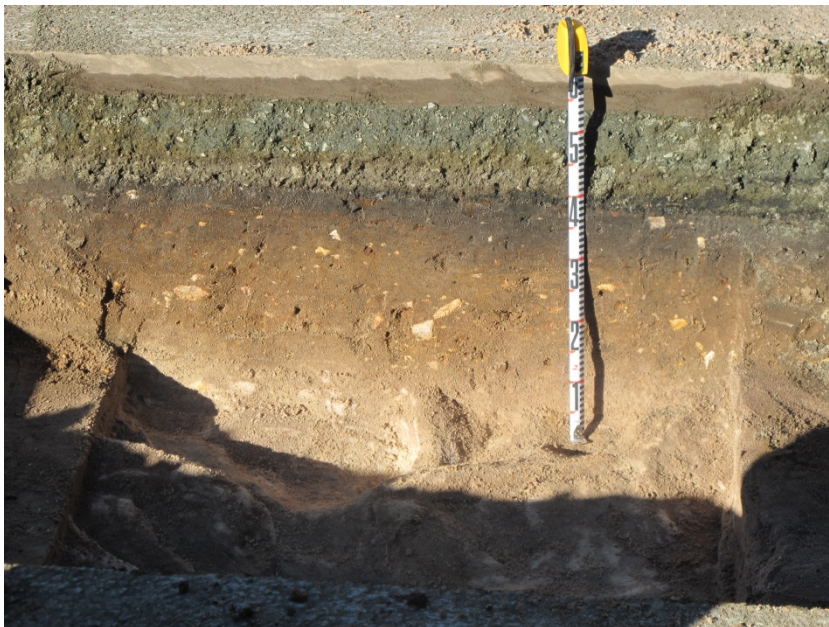
Figure 17: Part of the north-facing section of Trench 5B.

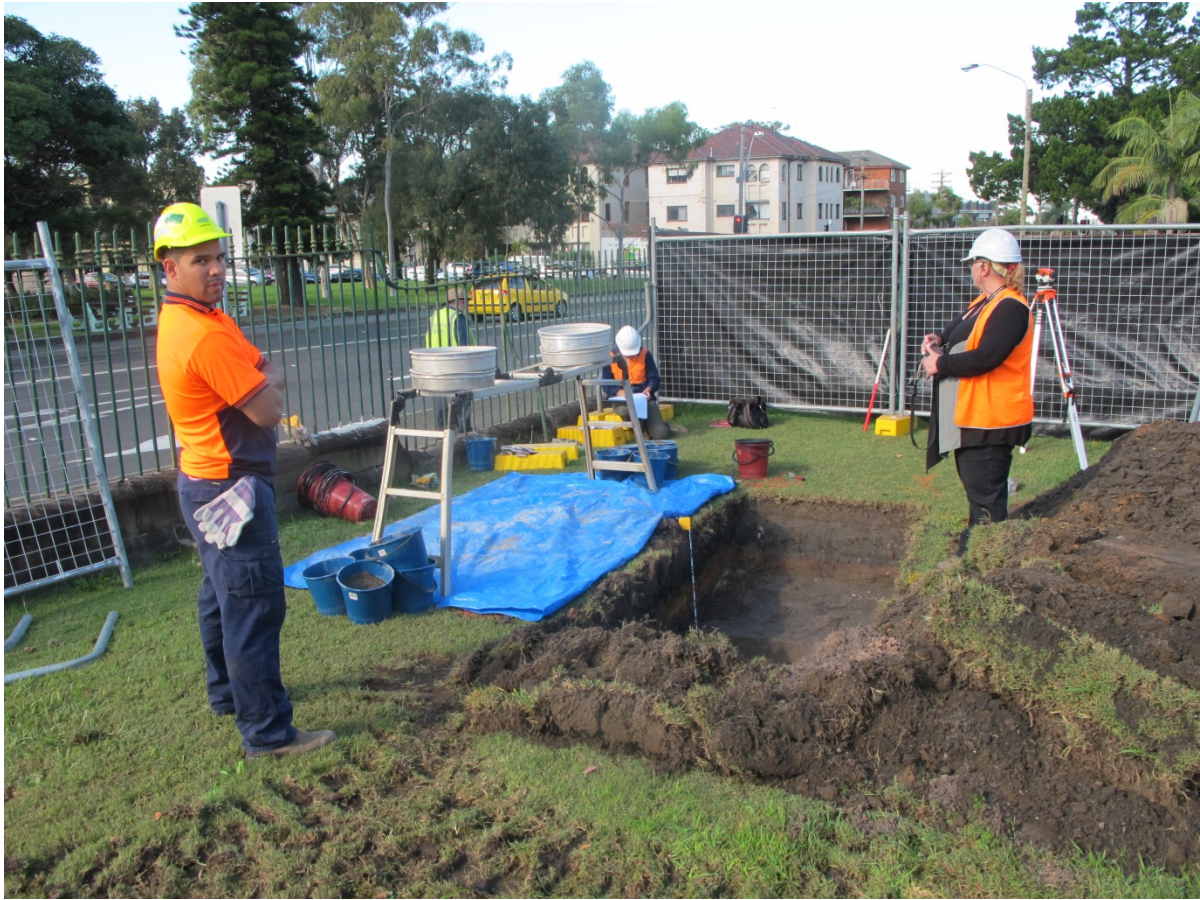
Figure 18: View to the southeast of the indigenous archaeological investigation in Trench 6A.

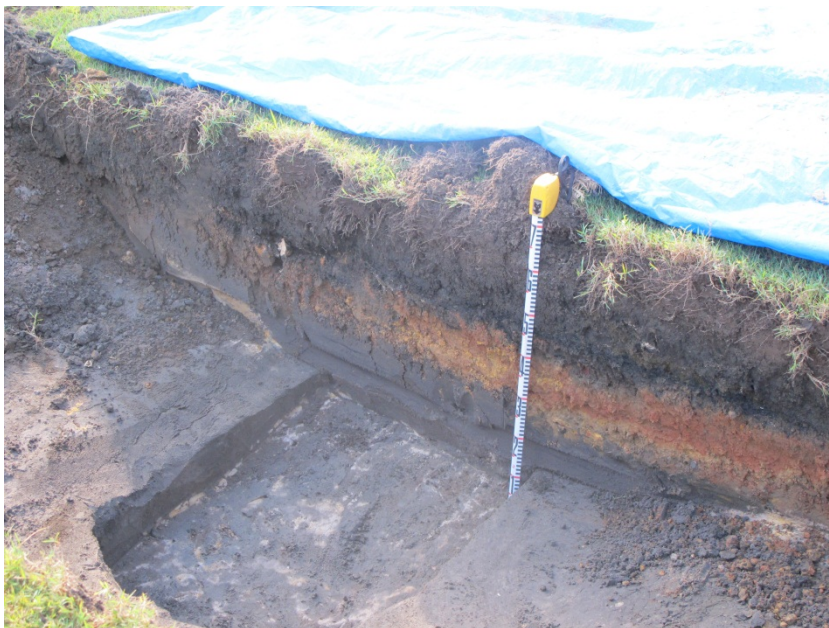
Figure 19: The typical stratigraphy in Trench 6A can be seen in this portion of the west-facing section.

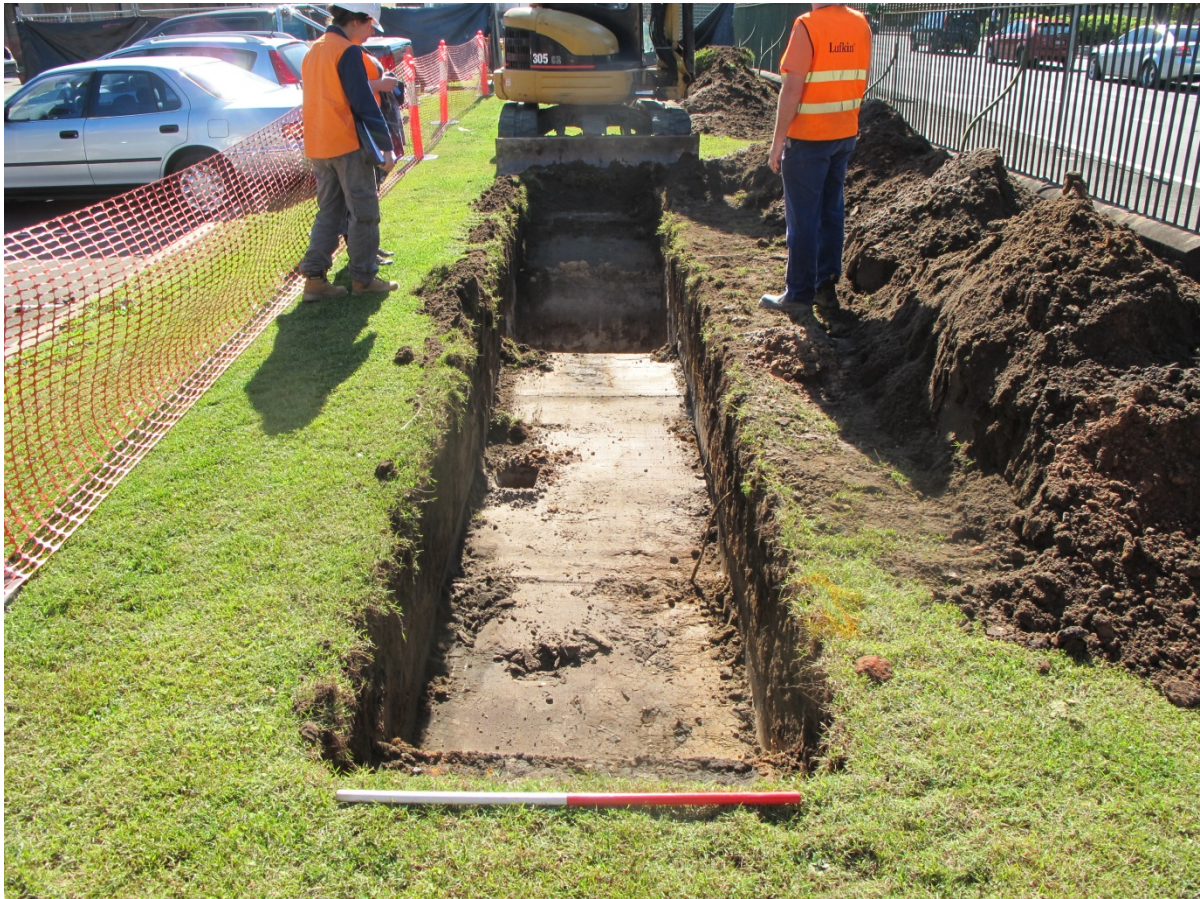
While both Trenches 6A and 6B had a similar stratigraphy to each other and the other archaeological trenches, 6B had substantially thicker fills and natural soils (Figures 20, 21). The typical stratigraphy was found here of topsoil, asphalt surface, surface-preparation layer, mixed sands, intact bleached sands, and finally bedrock. The surface-preparation layer was yellowish brown in Trench 6A rather than the orange encountered in most other trenches and in 6B it was grey clayey sand with moderate sandstone, not dissimilar to that found in 5B. The bleached sands in Trench 6B were 700mm thick. Other than two fragments of ceramics on the surface of the mixed sands in 6A, no archaeological remains were found in either trench.

Figure 20: North-facing view of Trench 6B. Scale 1m.

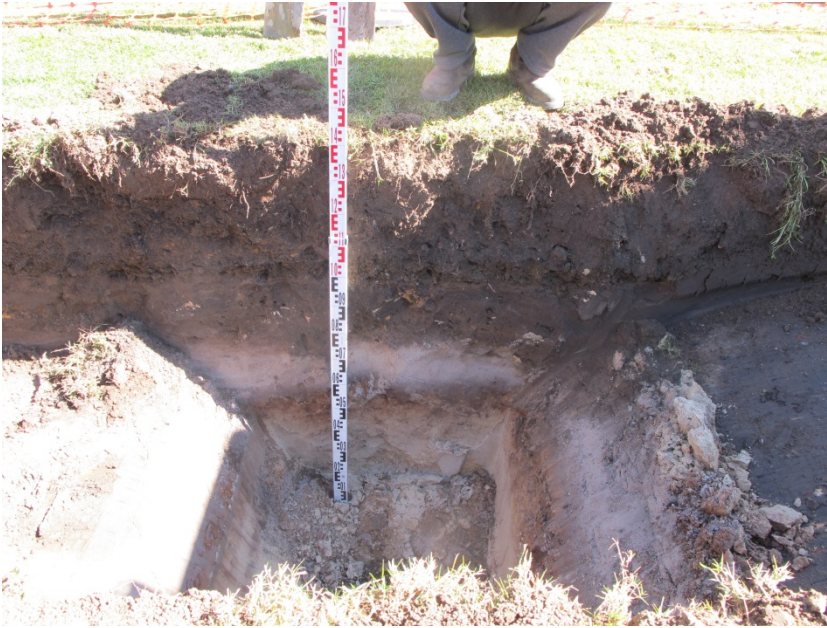
Figure 21: This image of the east-facing section of Trench 6B demonstrates the greater thickness of fills and natural sands in this location.
