Sutton Forest Quarries Pty Ltd

Aquatic Ecology Assessment

Specialist Consultant Studies Compendium

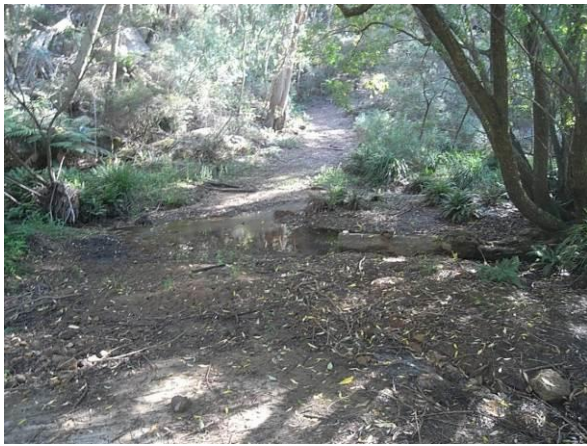
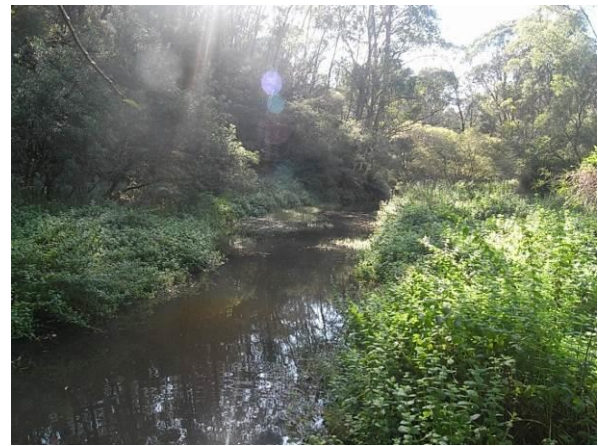
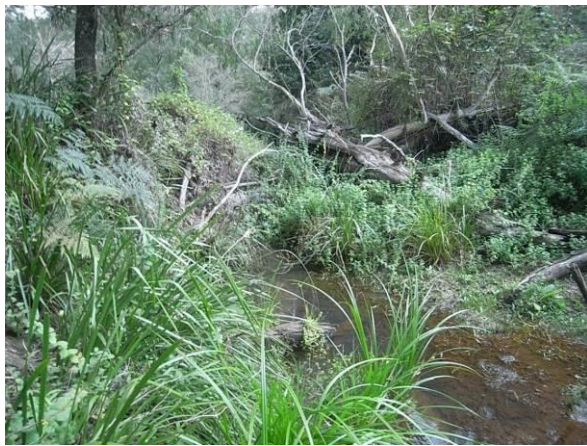
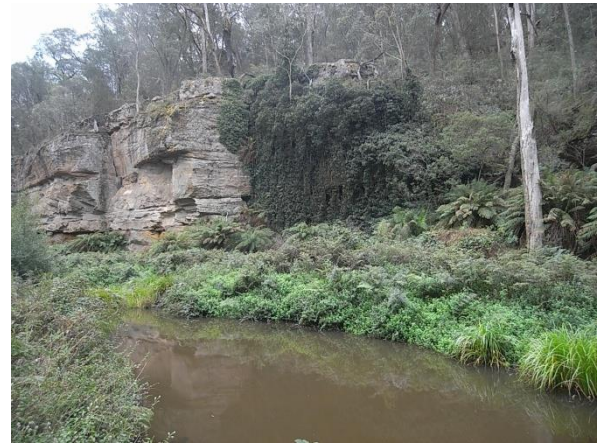
Plate 1a – d.

Long Swamp Creek valley was narrowest at the two sites located furthest upstream (Sites 1 & 2; **Plates 1a–1c**). At Site 1, there was a long shallow pool extending at least 100m upstream of the creek crossing (i.e. a shallow ford) by the dirt track. This would have extended close to the upstream limit of the study area, which could not be accessed later due to the thunderstorm. The crossing itself had a concrete base which showed signs of erosion (**Plate 1a**).

(a) concrete ford water crossing at Site 1; (b) Site 1, view upstream; (c) Site 2, view downstream; (d) Site 3, view downstream.

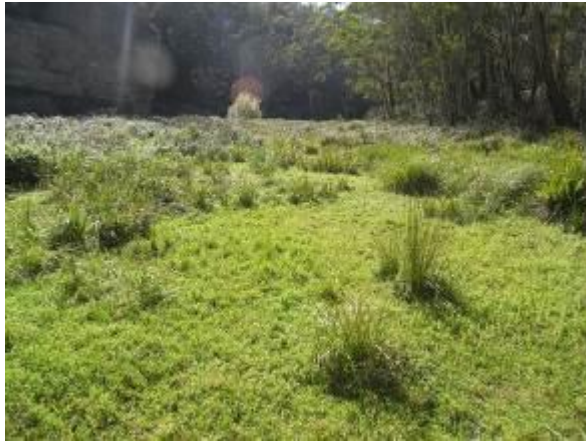
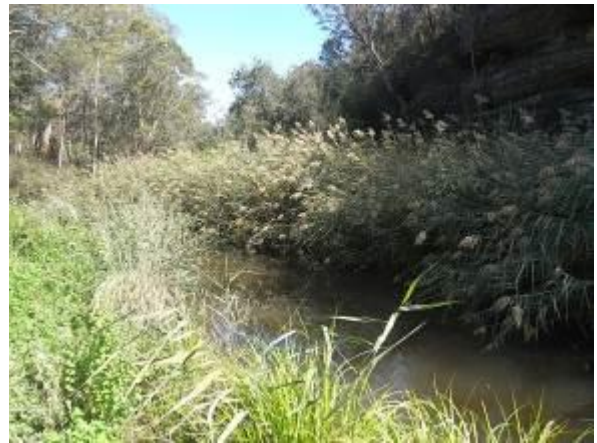
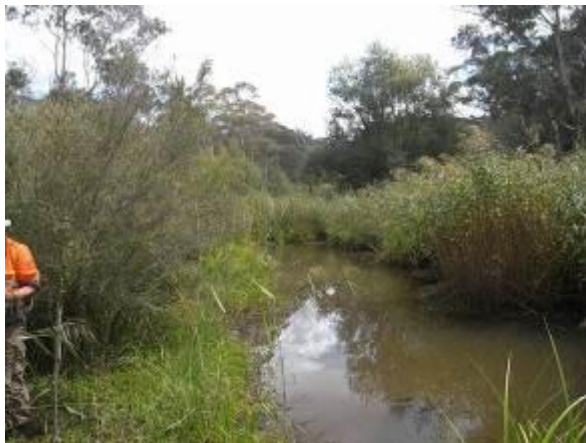
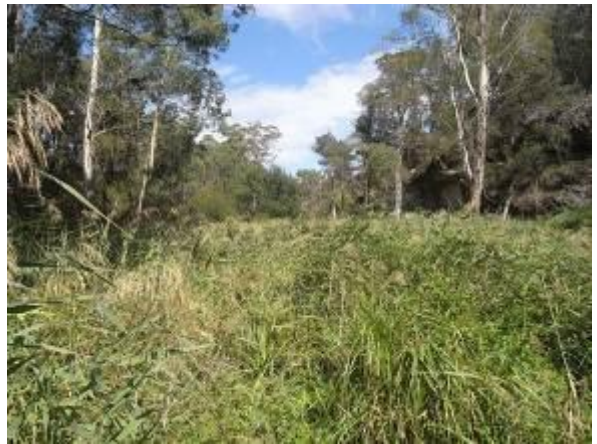
Plate 2a – d.

(a) montane peat swamp habitat at Site 4 on the southern side of the channel; (b) pool habitat at Site 4, fringed by *Phragmites australis* on the northern bank (background) and *Lomandra longifolia* on the southern bank (foreground); (c) Site 5, view downstream; (d) Site 6 dominated by *Phragmites australis*, view upstream.

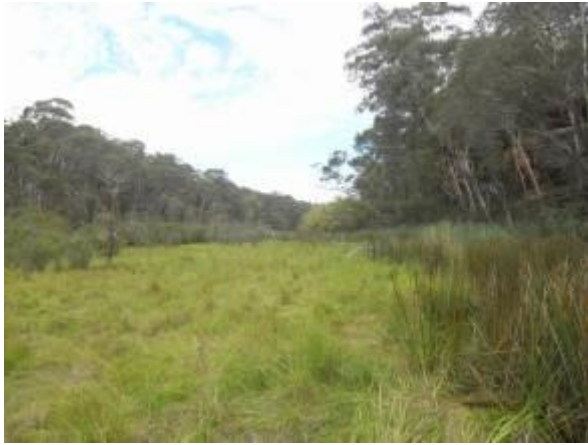
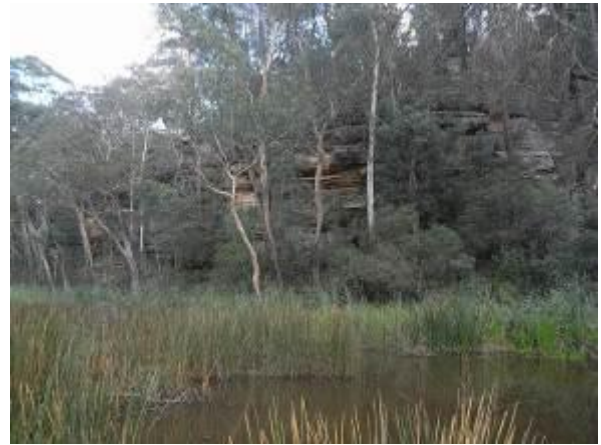
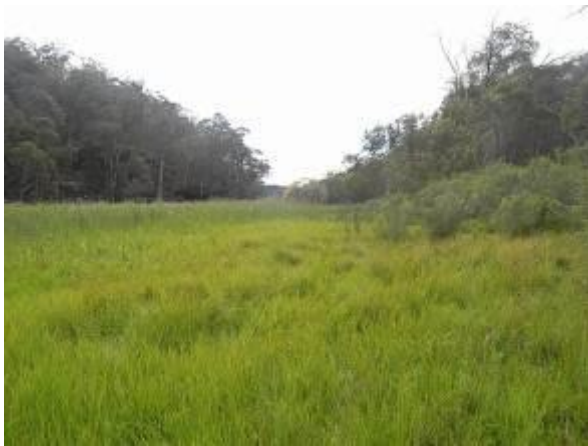
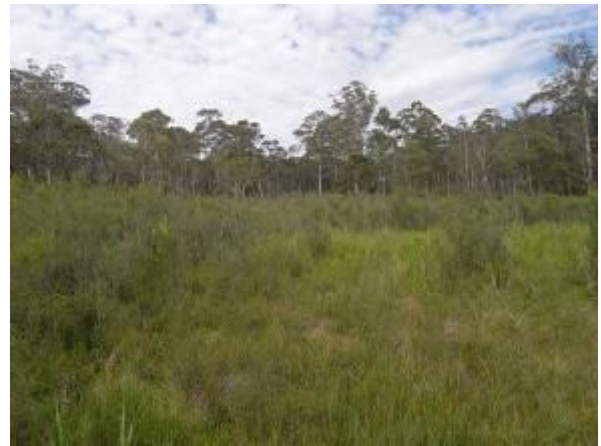
Plate 3a – d.

(a) montane peat swamp habitat at Site 7, view downstream; (b) pool habitat at Site 7 on northern edge of valley floor. Shallow boundaries of pool populated by tall spikerush (*Eleocharis sphacelata*); (c) Site 8, montane peat swamp habitat at confluence of Long Swamp Creek and Watercourse D, view upstream; (d) Site 8, upstream view of Watercourse D at confluence with Long Swamp. The unnamed watercourse lacked an obvious open water channel and was characterized by montane peat swamp habitat.

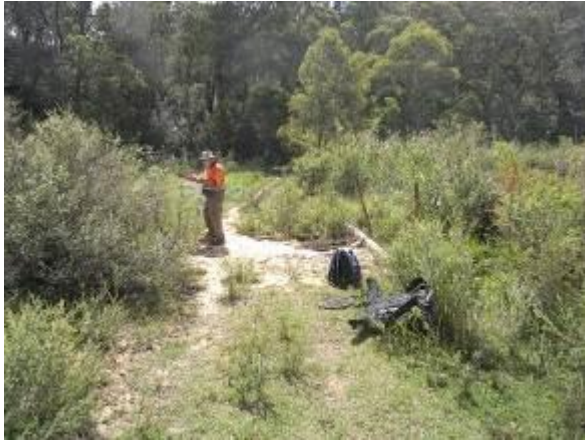
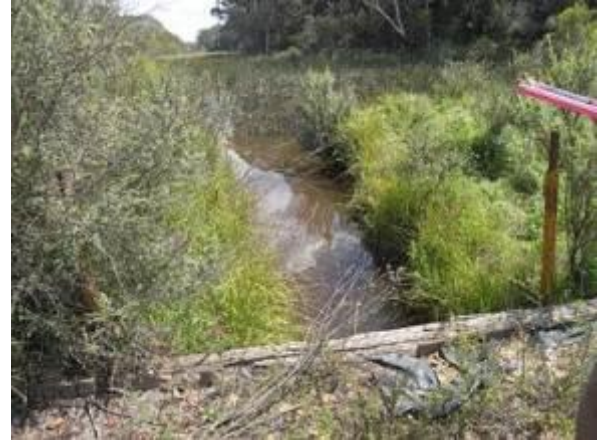
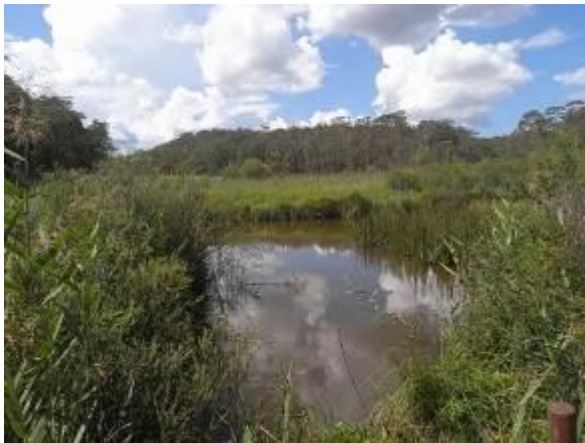
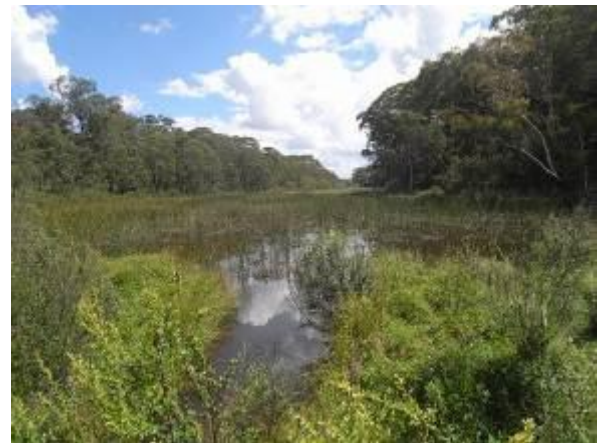
Plate 4a – d.

As the reach of Long Swamp Creek turned to the south west, from Site 6 to Site 9 (**Figure 3.1**) the valley floor broadened further and was dominated by the extensive and contiguous peat flats of Long Swamp (**Plate 4a**) and patchy tea tree stands. Long Swamp Creek was reduced to a series of isolated pools up against the northern valley slope (e.g. Site 7; **Plate 4b**). The pools were deep and fringed by tall spike rush and cumbungi and the fish assemblage was dominated by the introduced eastern gambusia. The most waterlogged soils were found on the northern edge of the valley floor and they supported large stands of common rush. Upstream of Site 7 marked the approximate location where Long Swamp and Long Swamp Creek are no longer adjacent to the proposed Site (**Figure 3.1**).

(a) Earth weir at Site 9 that forms a road crossing over the Long; (b) a low bridge in the weir at Site 9 permits downstream flow via a narrow channel; (c) Site 9, view upstream from the weir bridge. The pool was likely formed by historical peat harvesting and the pool edge (background) represents the upstream extent of the harvesting activity; (d) Site 9, view downstream of weir bridge.

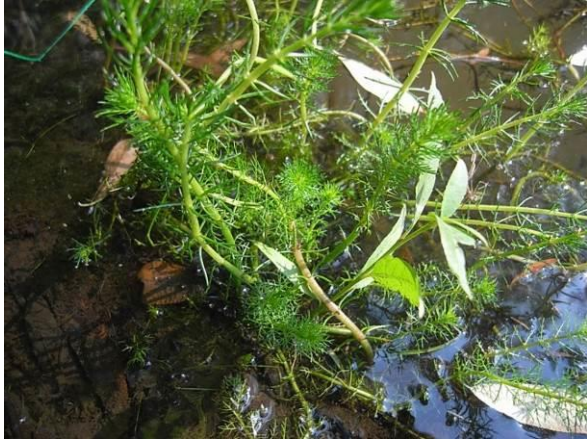
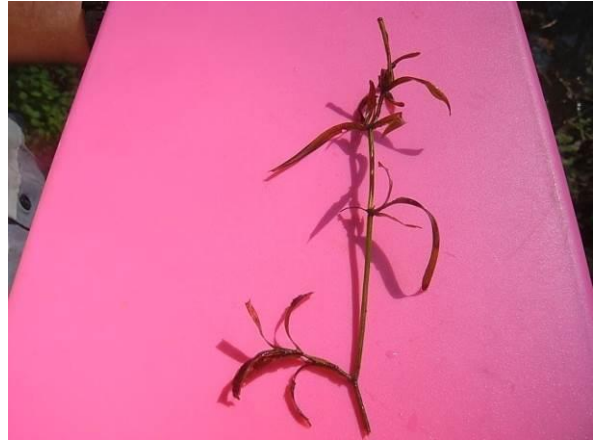
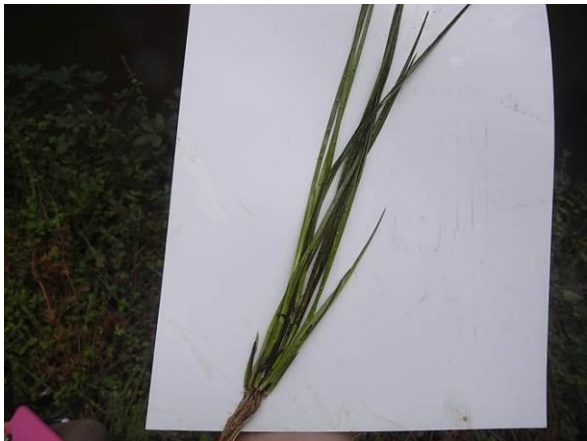
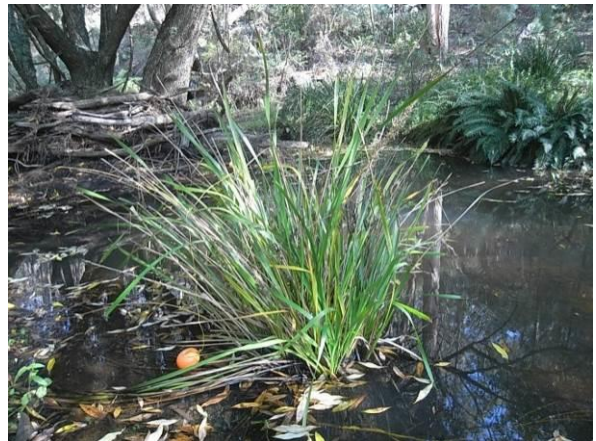
Plate 5a – d.

(a) water millfoil (*Myriophyllum* sp.) at Site 1; (b) blunt pondweed (*Potamogeton ochreatus*) from Site 1; (c) Macrophyte *Lilaeopsis polyantha* from Site 3; (d) *Lomandra longifolia* at Site 1.

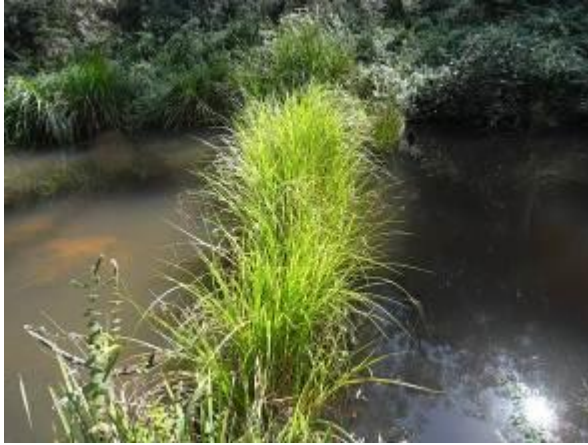
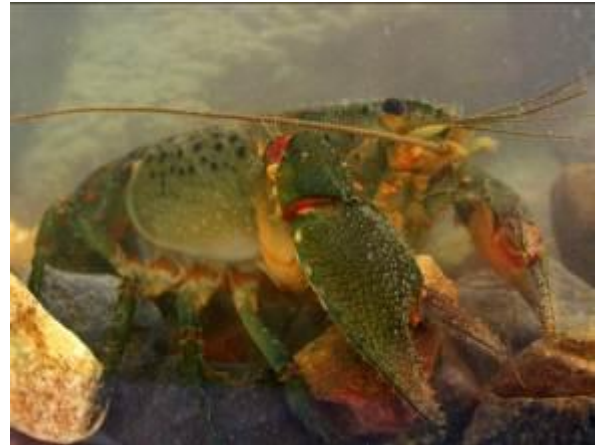
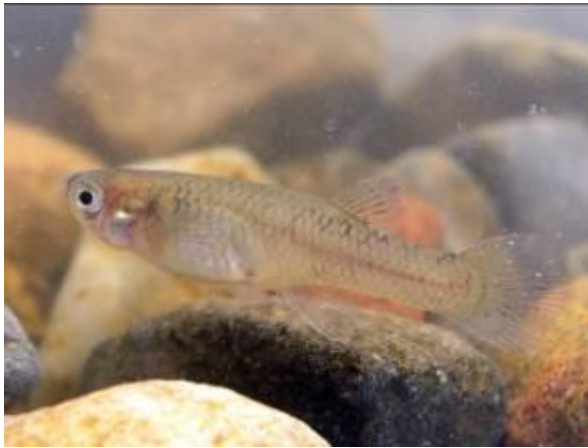
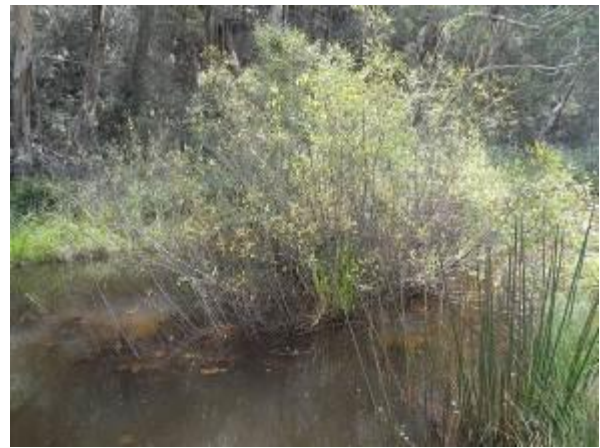
Plate 6a – d.

Plates 6a – d. Macrophytes, Freshwater Crayfish and Introduced Eastern gambusia
