**REPORT
TO
SANDRICK
ON
GEOTECHNICAL INVESTIGATION
FOR
PROPOSED ALTERATIONS AND ADDITIONS
AT
ST CATHERINE'S SCHOOL
ALBION STREET, WAVERLEY, NSW**

**8 November 2013
Ref: 26904ZRpt**

Date: 8 November 2013
Report No: 26904ZRpt
Revision No: 0

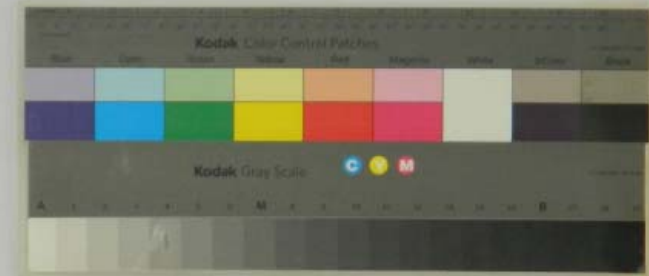
26904ZR BH201 START CORING AT 4.20m

SAND: fine to medium grained brown, with silt. SANDSTONE: fine to coarse grained, light grey. CORE LOSS 0.09m SANDSTONE: fine to coarse grained, light grey, with orange brown staining.	N/A	N/A																	
		6				XW XW-DW	EL-L EL-VL																
		7		CORE LOSS 0.20m SANDSTONE: fine to coarse grained, light grey, with orange brown staining, and fine to medium grained gravel sized sub rounded quartz inclusions	XW-DW	EL-VL

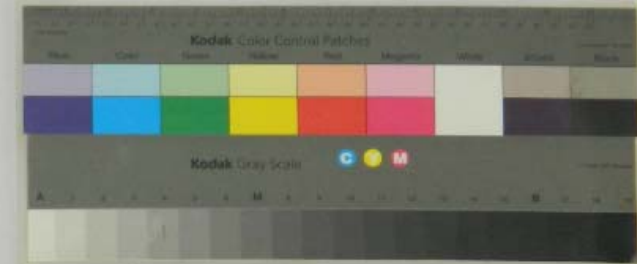
26904ZR BH202 START CORING AT 2.65m

5		SANDSTONE: fine to medium grained, light grey, with occasional orange brown staining.		L		•													
								•													
		6						•

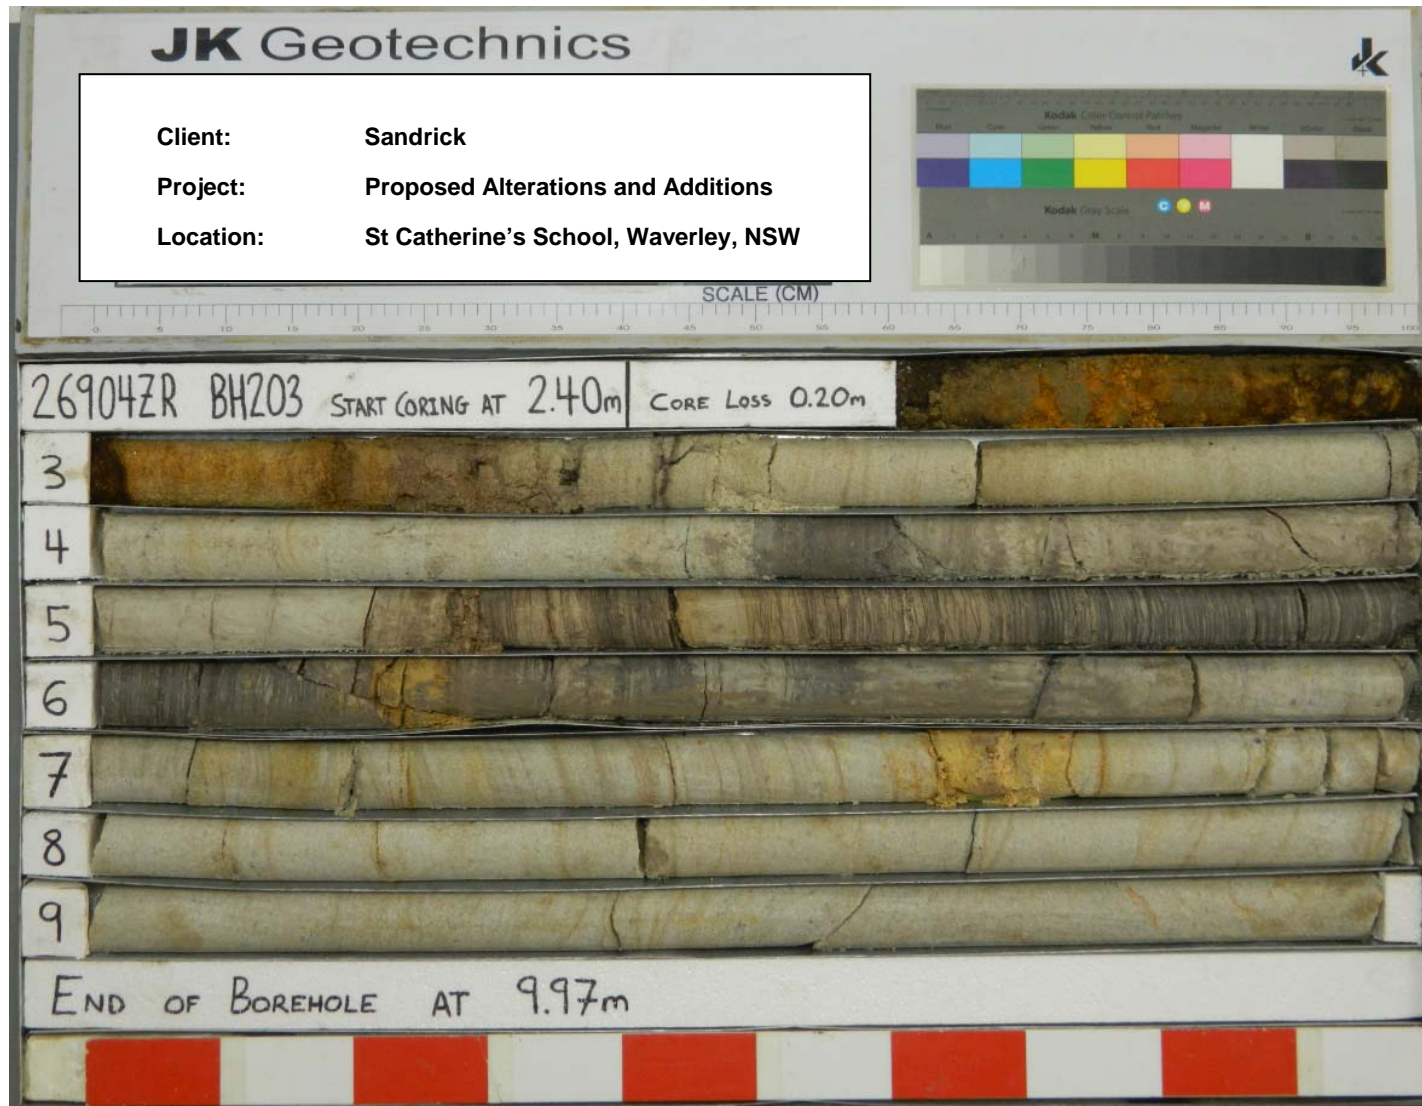
CORED BOREHOLE LOG

Water Loss/Level	Barrel Lift	Depth (m)	Graphic Log	CORE DESCRIPTION Rock Type, grain characteristics, colour, structure, minor components.	Weathering	Strength	POINT LOAD STRENGTH INDEX $I_s(50)$ EL VL L M H VH EH	DEFECT DETAILS	
								DEFECT SPACING (mm)	DESCRIPTION Type, inclination, thickness, planarity, roughness, coating.
		2		START CORING AT 2.40m CORE LOSS 0.20m					
		3		SANDSTONE: fine to coarse grained, orange brown. as above, but light grey.	XW DW	EL VL			- XWS, 0°, 23mm.t - XWS, 0°, 140mm.t - J, 70°, P, R
		4							
		5		INTERBEDDED SHALE: light grey and dark grey banded and SILTY CLAY: high plasticity, light grey and dark bands, with thin DW, VL strength bands, trace of fine grained sand.	RS-XW	(H)-EL			
		6							
		7		SANDSTONE: fine to medium grained, light grey, with grey and orange brown laminae, bedded at 0-5°.	DW	M			- J, 68°, P, S, IS - Be, 20°, P, S
		8		as above, but light grey, with occasional orange brown staining.					- XWS, 8°, 3mm.t - XWS, 0-10°, 60mm.t - XWS, 12°, 3mm.t
