**PRELIMINARY ENVIRONMENTAL SITE
ASSESSMENT**

PROPOSED ADDITIONS AND ALTERATIONS

26 ALBION STREET, WAVERLEY, NSW

27 MAY 2014

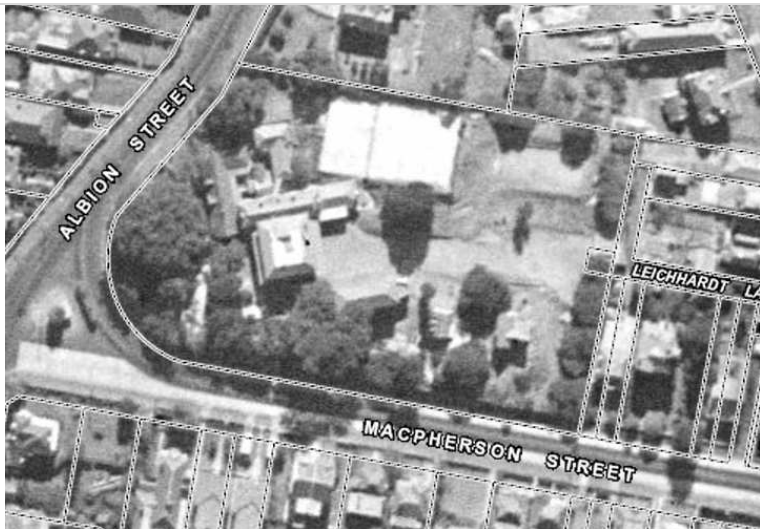
<p>The subject site was relatively vacant and generally appeared similar to the 1930 photograph. The site appeared undulating with a few steep slopes which appeared to fall to the south. The vacant areas appeared to be grassed. A small building was located in the south section of the site. A few trees were scattered across the site. The school buildings were located in the north and west sections of the site.</p> <p>The immediate surrounds appeared similar to the 1930 photograph.</p>
1951	The site and immediate surrounds generally appeared similar to the 1943 photograph. A few additional buildings had been constructed in the north section of the wider school area.

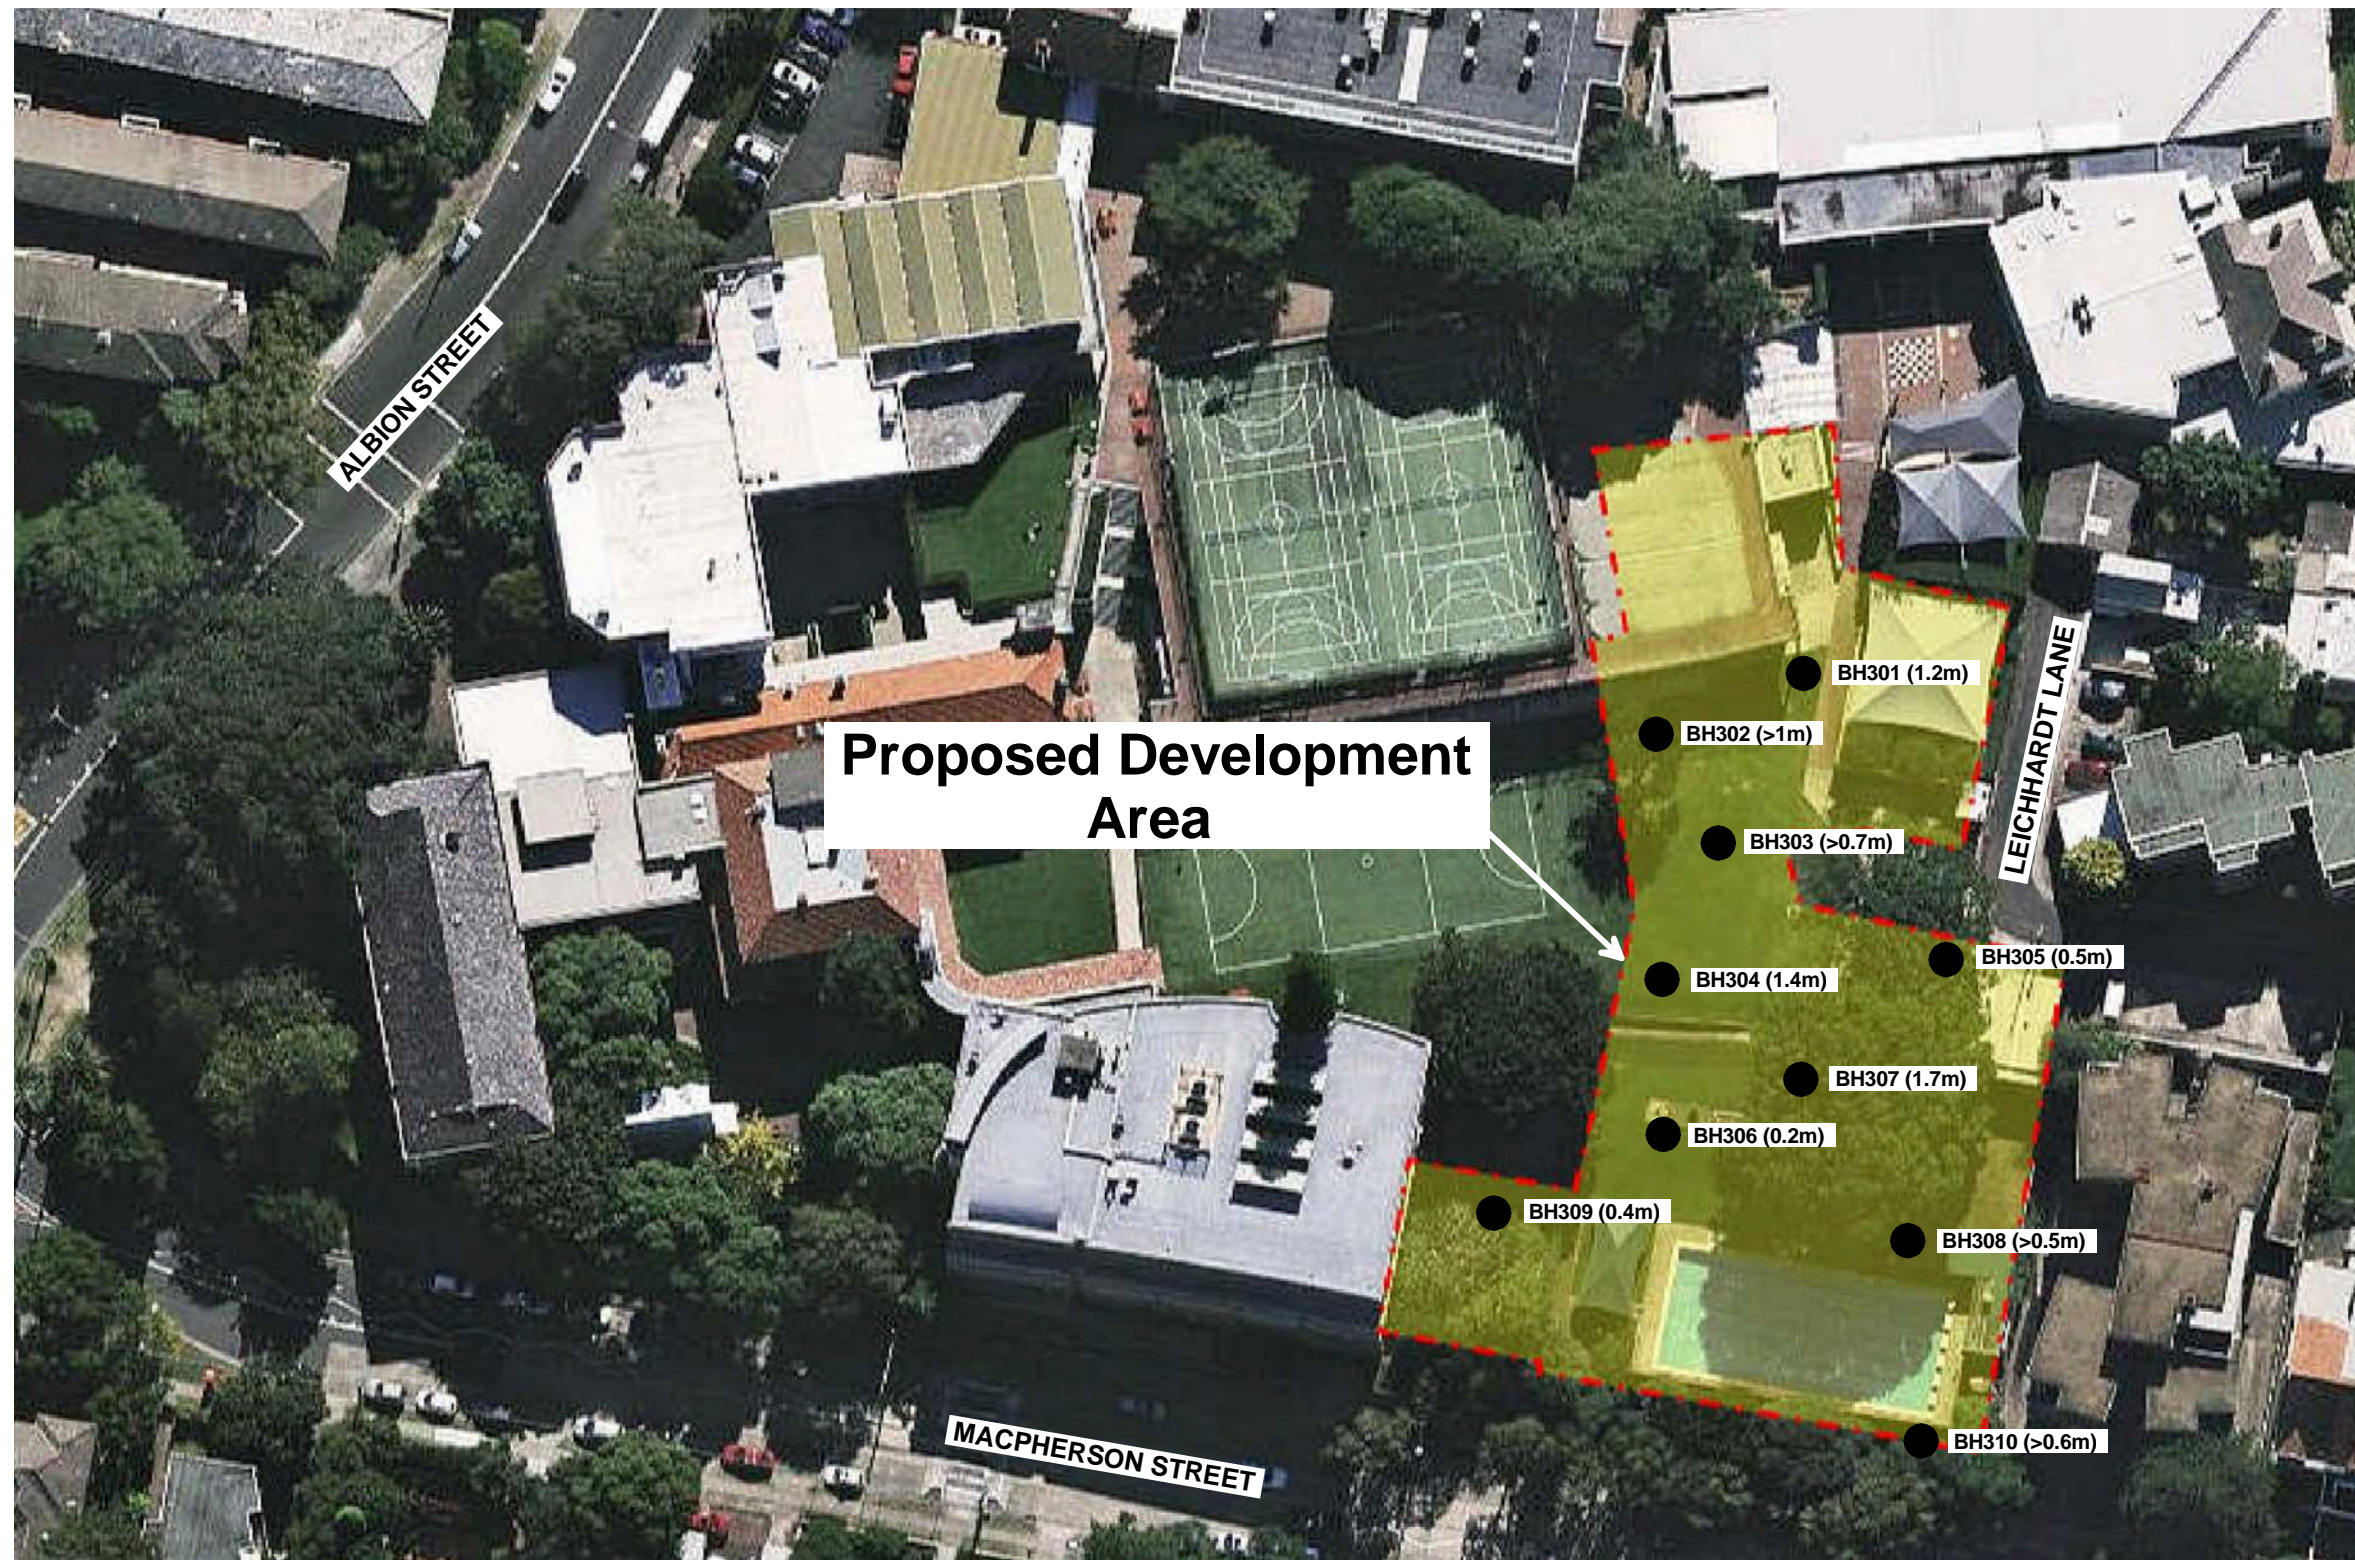
NOTES:
Figure 2 has been recreated from NSW
Department of Lands SIX Maps.

The borehole locations presented on this
plan have been established from site
measurements only and should not be
construed as survey points.

Soil samples for this investigation were obtained from 10 evenly spaced sampling points as shown on the attached Figure 2. This density meets the minimum sampling density recommended by the EPA for the proposed development area.

Samples for this investigation were obtained from 10 evenly spaced sampling points as shown on the attached Figure 2. This density meets the minimum sampling density recommended by the EPA.

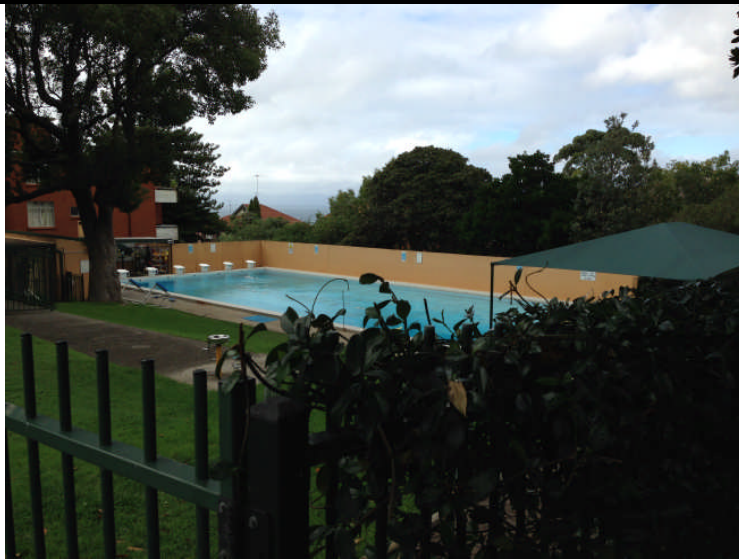
Photograph 1: Taken showing the south section of the site, facing south. The photo shows the above ground swimming pool located at the site

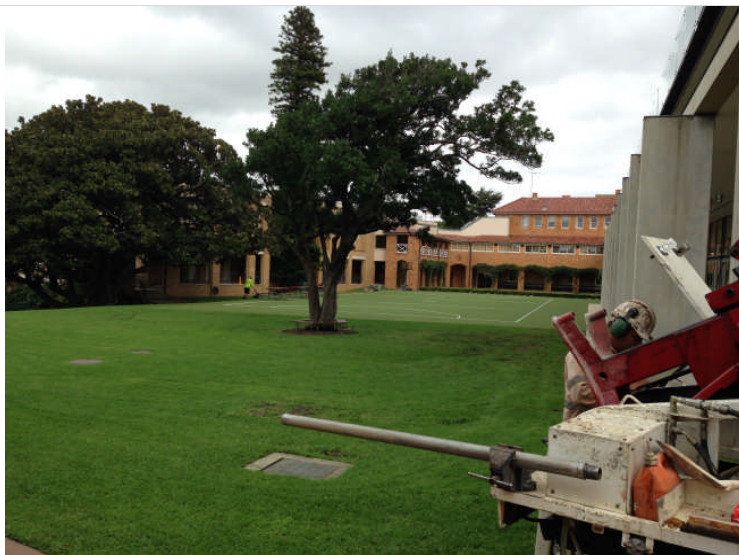
Photograph 2: Taken showing the central court yard area of the site, facing south-west. The photo shows the grass covered court yard and playing field beyond.

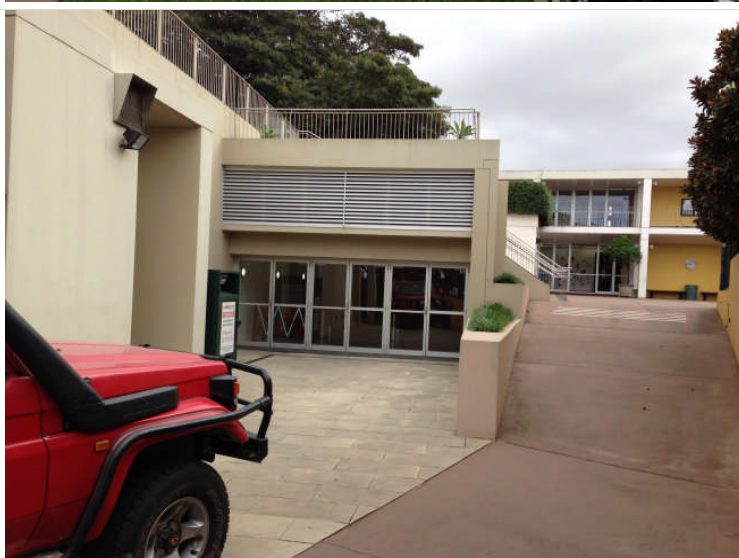
Photograph 3: Taken showing the north section of the site, facing north. The photo shows the existing school buildings in the north section.

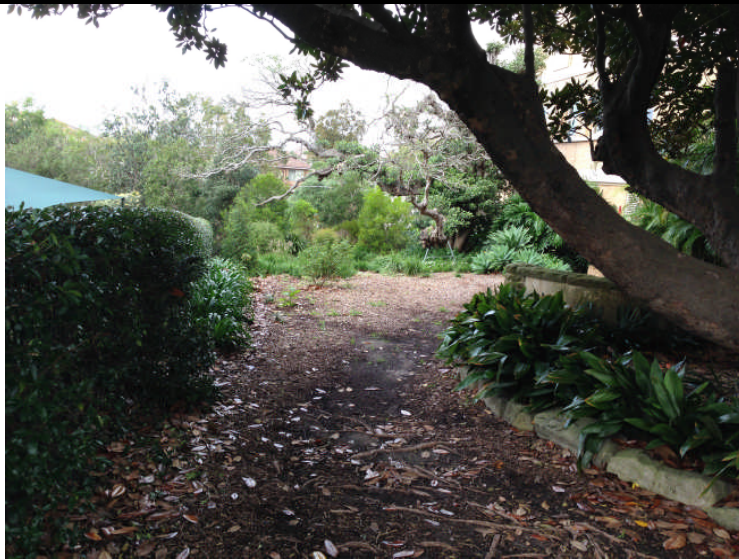
Photograph 4: Taken showing the south-west section of the site, facing south. The photo shows dense vegetation in this section of the site.
