### 3.0 PHYSICAL EVIDENCE

#### 3.1 Outdoor Swimming Pool and Surrounds

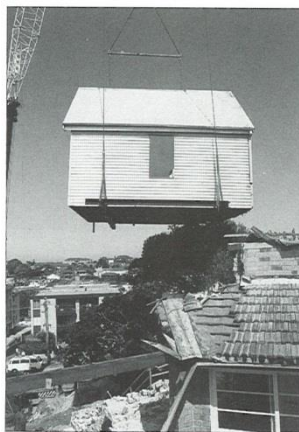
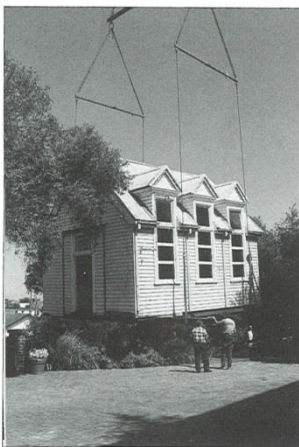
*Figure 42 — The Studio lifted and moved for at least the second time to its new home. (Source: Barbara Croft, St Catherine's School 1856-1996, 1996, p120)*

<ul style="list-style-type: none"> <li>• In 1992 the building was lifted by a crane and placed on top of an air raid shelter to the south-east of the stone Administration Building</li> <li>• Between 1992-1996 it was restored and opened as the School Museum.</li> </ul>

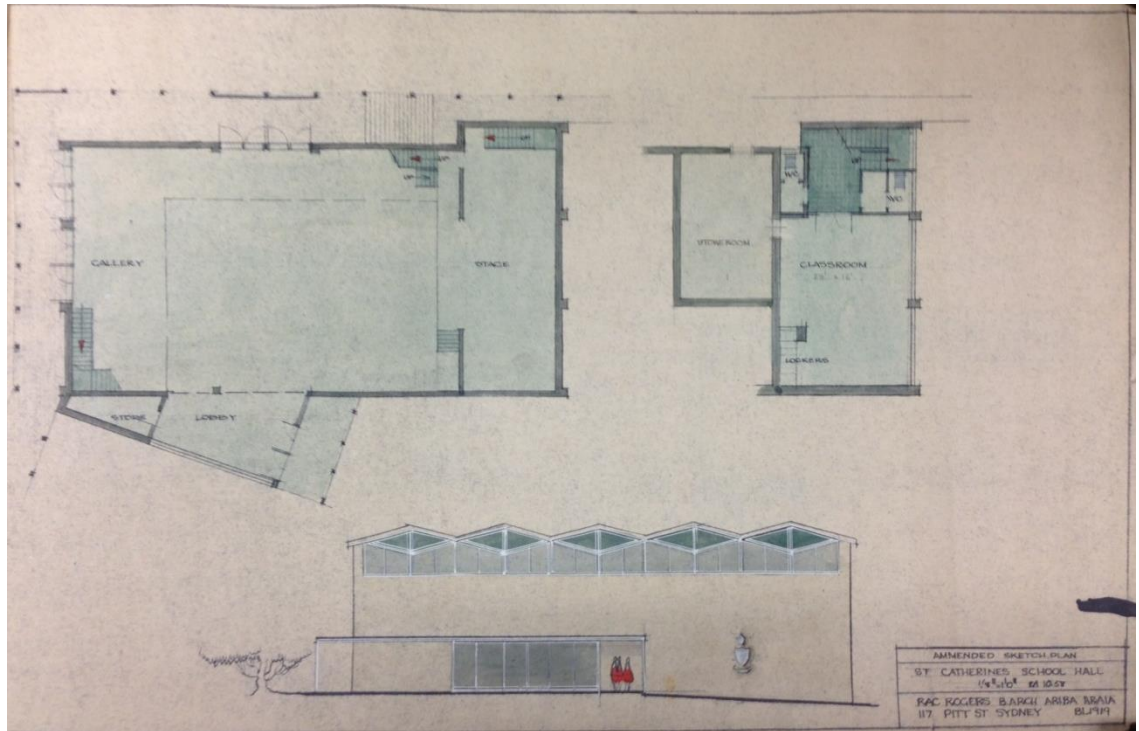
Figure 43 — sample of original plans for the Jane Barker Hall by RAC Rogers

This hall has an elevated stage, stage wings and galleries. The structure consists of steel frame of five bays of transverse gables supported on steel columns, independent of heavy brick walls. It is constructed on reinforced concrete with clinker brick wall cladding. The steel roof is clad with sheet metal and lined on the underside with varnished timber boards. A reinforced concrete elevated walkway connects the doors at the northern gallery with J Block and the St John's Building. The Jane Barker Hall does not have identified heritage significance.

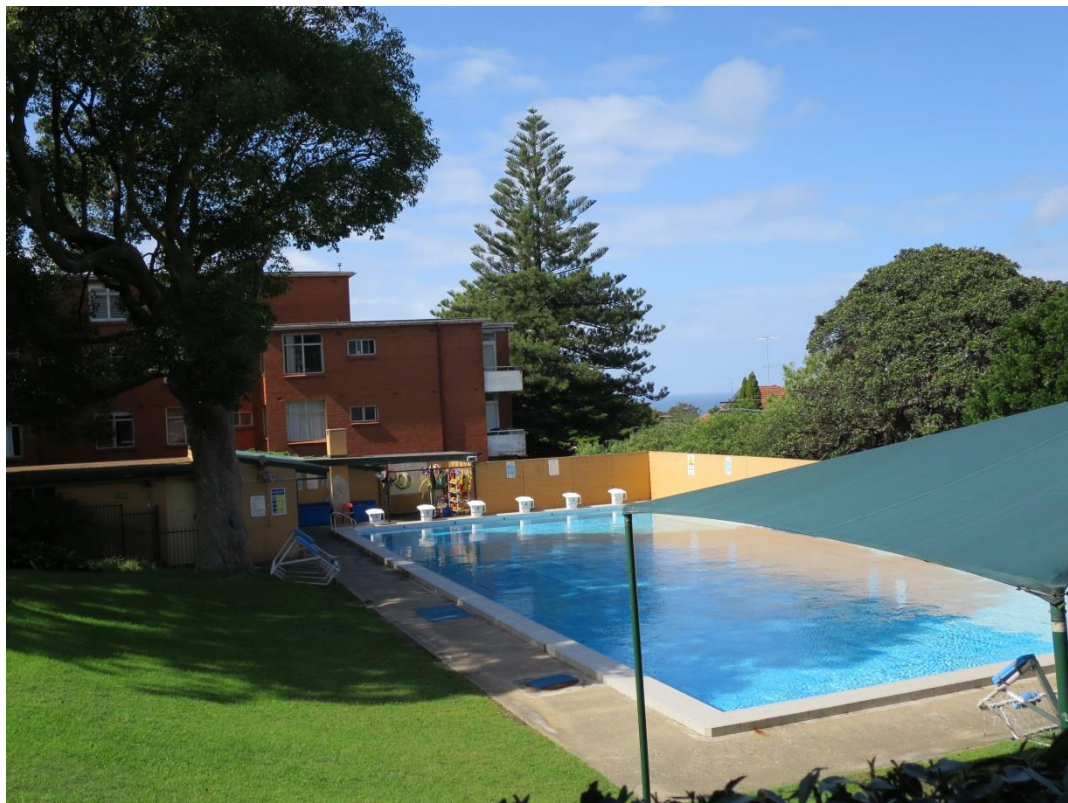
The proposed RPAC development would demolish the reinforced concrete swimming pool that was constructed in 1971. The outdoor swimming pool is a reinforced concrete tank with surrounds covered with concrete slabs; those to the south are cantilevered. A painted concrete block wall provides screening on the southern and eastern sides, offset within the boundary, along with the change rooms to the north of the eastern end of the pool. The swimming pool is typical of innumerable swimming pools constructed by schools and councils in the post-war decades. The cantilevered slabs extend over a narrow boundary garden meeting the boundary with Macpherson Street.

*Figure 45 — the 1971 swimming pool, site of the proposed RPAC development. [NBRS+PARTNERS April 2014]*

- The outdoor swimming pool would be demolished and replaced by RPAC. The 1971 pool does not have identified heritage significance. It would be the subject of a photographic archival record. Part of the heritage significance of this site is its association with the education of girls over a period of 150 years. The proposed continued upgrading of the facilities maintains this use on the site which was established specifically for the purpose. The significance of the early buildings of the School site is enhanced through their ongoing viability as less significant parts of the School site are upgraded to meet contemporary education needs.

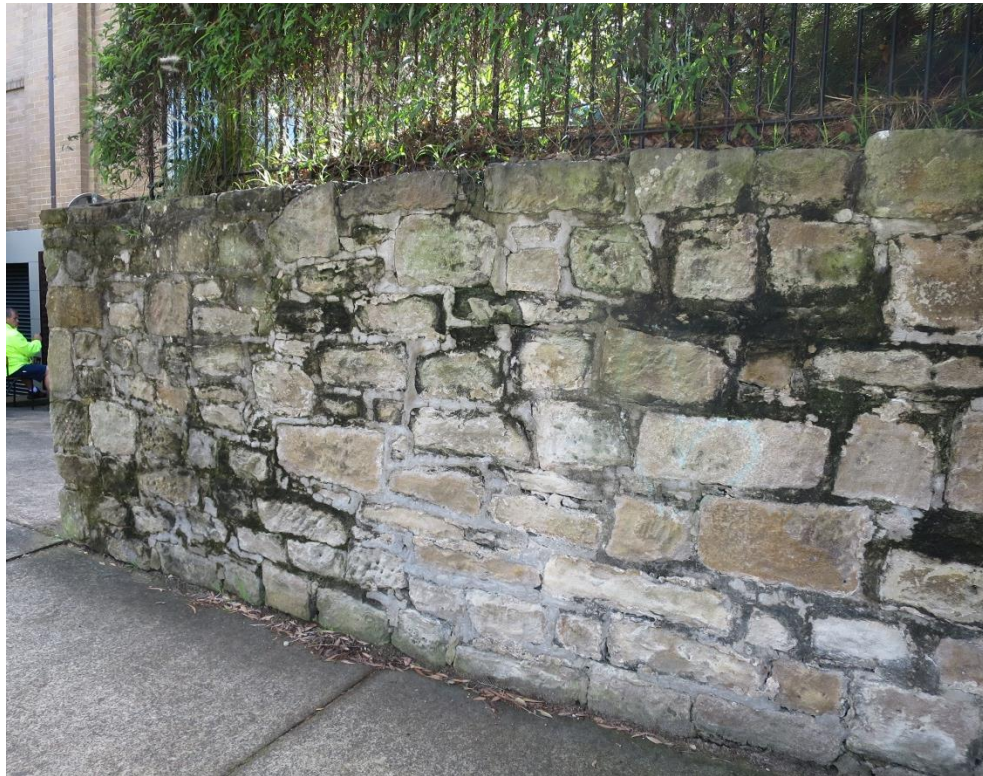
The boundary with Macpherson Street between the Dame Joan Sutherland Centre and the unit block at No. 4 is defined with a retaining wall that is just over a metre high at the east end and rises to approximately 3m at the western end, constructed of sandstone rubble and random coursed blocks bonded with lime mortar. The wall appears to have been rebuilt at the western end in the 1990s to suit the Dame Joan Sutherland Centre. In many places the mortar has been re-pointed with cement and bears several conspicuous cracks. The retaining wall is typical of low-quality construction from the late Nineteenth Century. The sandstone rubble wall on the south side of the existing swimming pool on the Macpherson Street boundary is typical of the poorer quality late nineteenth-century retaining walls in the Eastern Suburbs. It is likely that it was built by 1890 when the Bronte tram line was opened as far as Waverley.

*Figure 46 — detail of the sandstone rubble wall along Macpherson Street, south of the swimming pool. [NBRS+PARTNERS April 2014]*

- The sandstone rubble wall along the Macpherson Street boundary between the Dame Joan Sutherland Centre and No. 4 Macpherson Street would be affected by the works, but the stone would be reinstated in same site and much the form as a retaining wall. The stone in this wall has been adjusted and remodelled in the past. The poor condition of the wall would be addressed by remodelling the stones.

- The retaining wall can be reinstated in its existing location with some adjustment to address the new access to the School from Macpherson Street. This retaining wall is in deteriorated condition with cracking and inappropriate cement re-pointing. Some of the sandstone is a poor quality soft stone. The reassembly of the wall is likely to become necessary for structural reasons, and its reassembly as part of a development of the adjacent site will not necessarily have an adverse heritage impact.

The intrusive cement mortar would be removed. When the wall is reinstated at the end of works for the RPAC, the best quality stones will be used. The new openings will be made at the expense of the poorer rubble stones. These rubble stones will be retained on site as a drainage medium behind the better stones used as facing. The face stones will be bonded with an appropriate lime-cement mortar enabling moisture to evaporate through the joints.

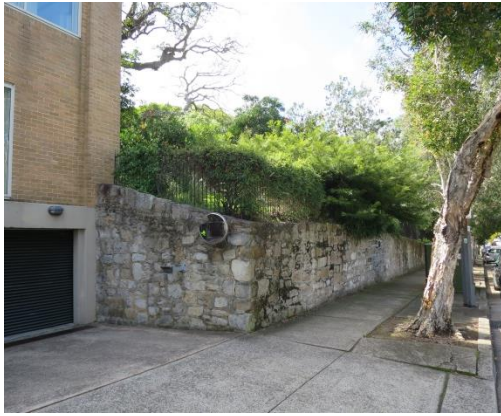
Figure 47 — western end of the sandstone retaining wall.

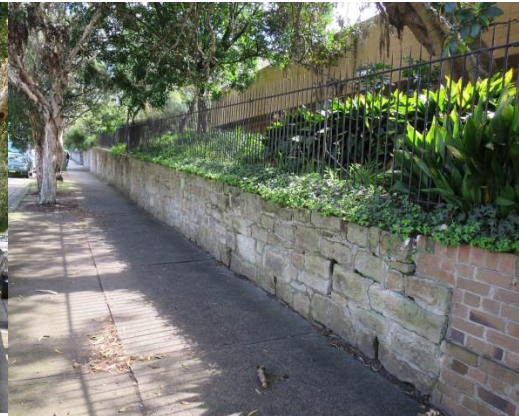
Figure 48 — view of the sandstone retaining wall looking west.

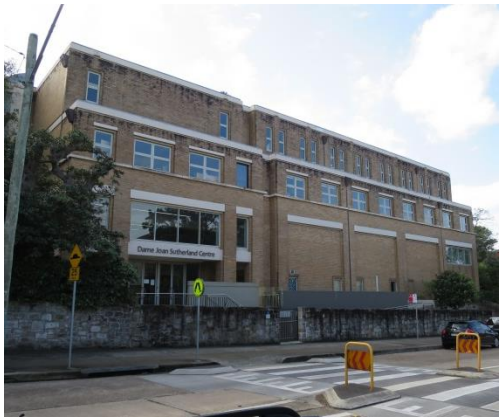
Figure 49 — the Dame Joan Sutherland Centre, seen from Macpherson Street.

The Dame Joan Sutherland Centre (DJSC) would be altered to integrate with the RPAC. The DJSC building was designed by Lawes Taylor in a mildly Post Modern style; it was opened in 1994. This building does not have heritage significance.

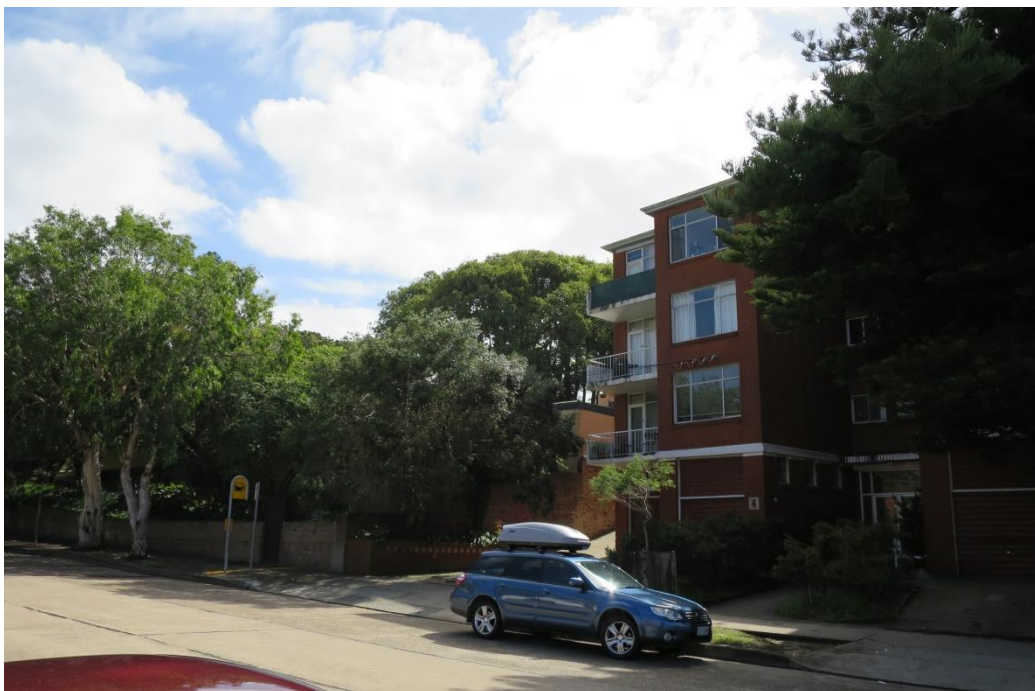
Figure 51 — view looking north-west to the proposed RPAC development site behind the trees. The site is adjacent to the walk-up flats at 4 Macpherson Street seen here on the right. [NBRS+PARTNERS April 2014]

- There is a narrow row of screen planting south of the swimming pool, at the top of the retaining wall containing a Port Jackson fig. The remaining small trees and shrubs in the row are less significant, and typical of post-war planting without any landscape design significance. The existing row of trees at the top of the retaining wall provides a green gap between the flats at No. 4 Macpherson Street and the Dame Joan Sutherland Centre. The replacement deep soil planting of screening trees is intended to replace this green amenity.

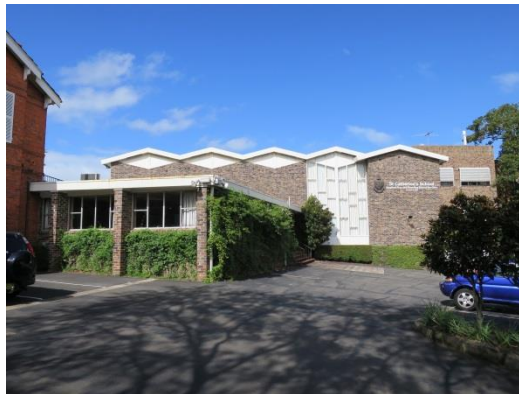
*Figure 52 — The Jane Barker Hall as extended. April 2014*

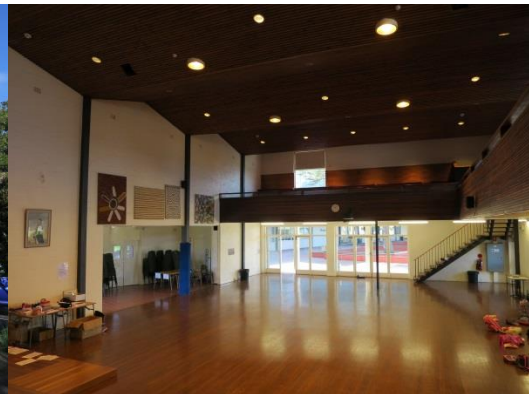
*Figure 53 — interior of the Jane Barker Hall as extended. April 2014*

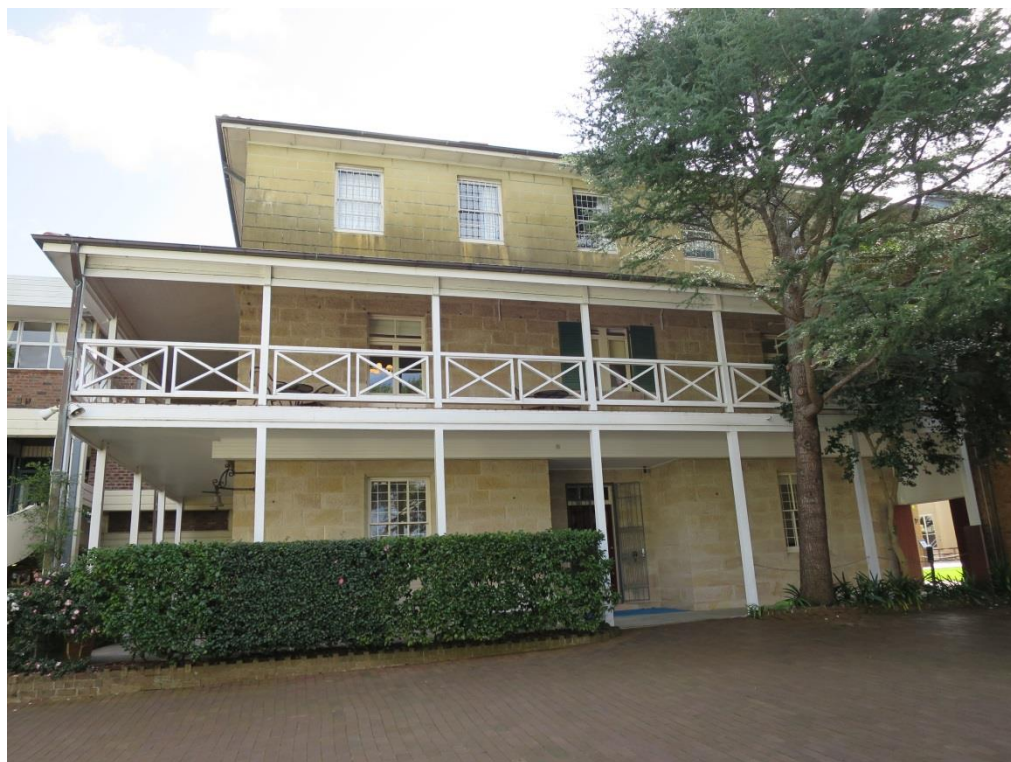
This is the original school building on this site, built 1857–1859, and it is now used for administration in the original lower two storeys, while the third storey was added in 1940 to house boarders, as it continues to do. The building consists of load-bearing masonry walls supporting a timber-framed roof and timber floors at ground and first floors; the second floor has a reinforced concrete floor. The original exterior walls are coursed sandstone blocks with a sparrow-picked surface, bonded with lime mortar. The wider plinth is visible at the lower veranda level. None of the sandstone has decorative carving. The third level is constructed of rendered brickwork, finished to resemble sandstone. The two-storey timber veranda is not original, having taken its approximate current form in the 1920s; originally the veranda was a single storey with cast iron treillage columns and a concave profiled roof clad with corrugated steel. The Administration Building was constructed in a Victorian Georgian style, although the original sash windows used the larger panes of glass that were available in the 1850s.

The front double doors and many of the windows on the original levels are original joinery. The interiors of the lower levels contain some original joinery in the internal doors, architraves and skirtings, some internal plaster work on the walls, ceilings and Victorian Georgian style profiled ceiling ‘roses’ and cornices. The staircase was replaced in 1940 with reinforced concrete and a wrought iron balustrade.

*Figure 54 — the south elevation of the 1859 Administration Building*

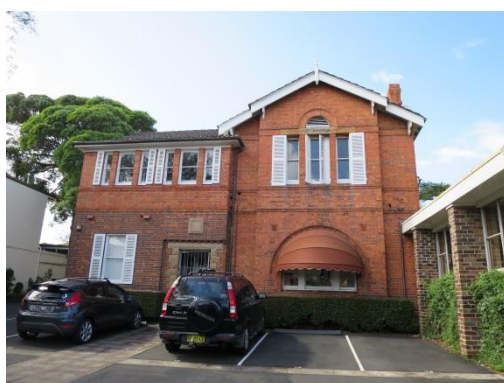
This building is used for staff rooms on the ground floor and a food technology laboratory on the first floor. It was built as an upper middle class house in 1891 and has been adapted for use by the School since the 1950s. It is constructed of load-bearing brickwork and timber framed floors and roof. The roof consists of a gable on the south side extending from the break-front section of the front façade, from this gable, two transverse gables extend across the larger part of the house. The external walls are built of red face bricks with several medallions of terra cotta and sandstone lintels and quoins. The break-front section of the front façade is original, but alterations to in-fill the front veranda have left the brown brick section at the ground floor and relocated windows in relocated brickwork at the first floor. The original sections of the house were built as an early instance of the Federation Queen Anne style, demonstrated by an Arts and Crafts approach to materials, and the Diocletian window in the break-front.

Figure 55 — the St John's Building east elevation.

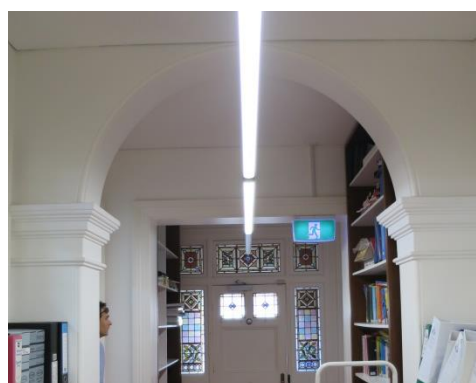
Inside, the more intact rooms are on the ground floor. All of the brick walls are plastered and painted. The joinery includes some original doors with machine profiled architraves, skirtings and picture rails. The original fire places are made of marble slabs with cast iron grates in late Victorian style. Several profiled cornices are original. The original stair has been removed.

Figure 56 — St John's ground floor corridor.

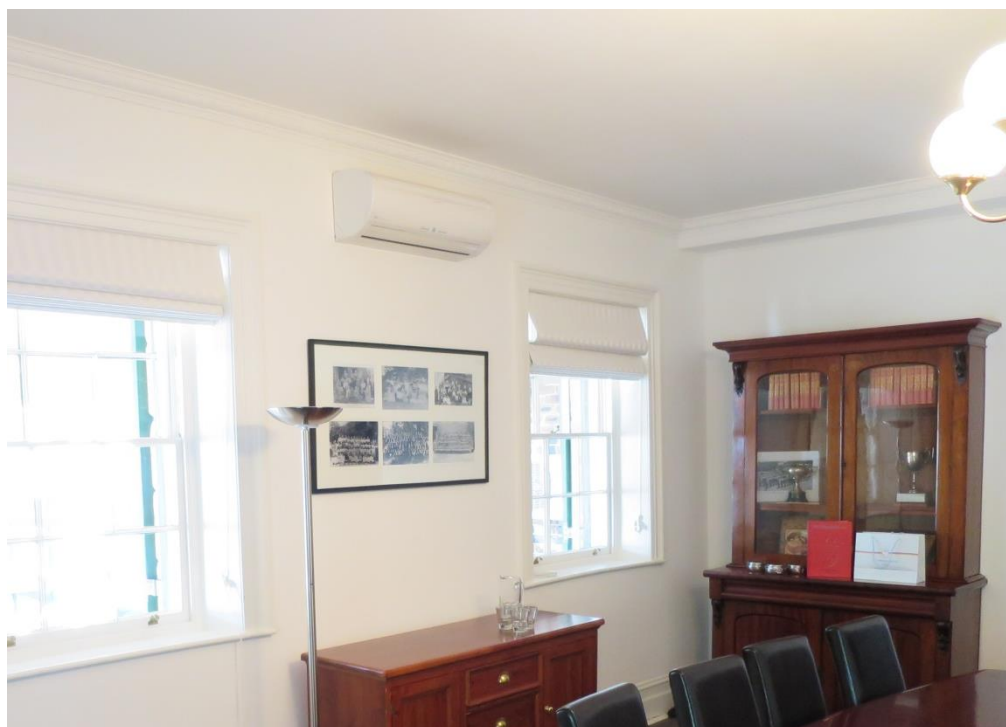
A partition wall within the first floor of the Administration Building would be removed to make a larger space for the main office in the south-west corner. This partition wall is made of recent light-weight fabric. The cornice would not be affected because previous openings in this location have placed a beam underneath to protect the cornice and demonstrate the likely original location of a wall here. This work would not remove any original or early fabric and would leave the apparent original form of the building clear in this location. The removal of a recent intrusive partition across the north-western room of the original section's first floor would restore the original dimension of this room and views of the fire breast, having a positive heritage impact. Several

*Figure 57 — view inside the Administration Building showing the partition wall on the right that would be removed. This wall is a light-weight in-fill. NBRSPARTNERS*

The recent partition walls to be removed from the first floor, will be removed without damage to adjacent original masonry walls. The rendered masonry walls affected by the works will be patched with plaster to match existing.

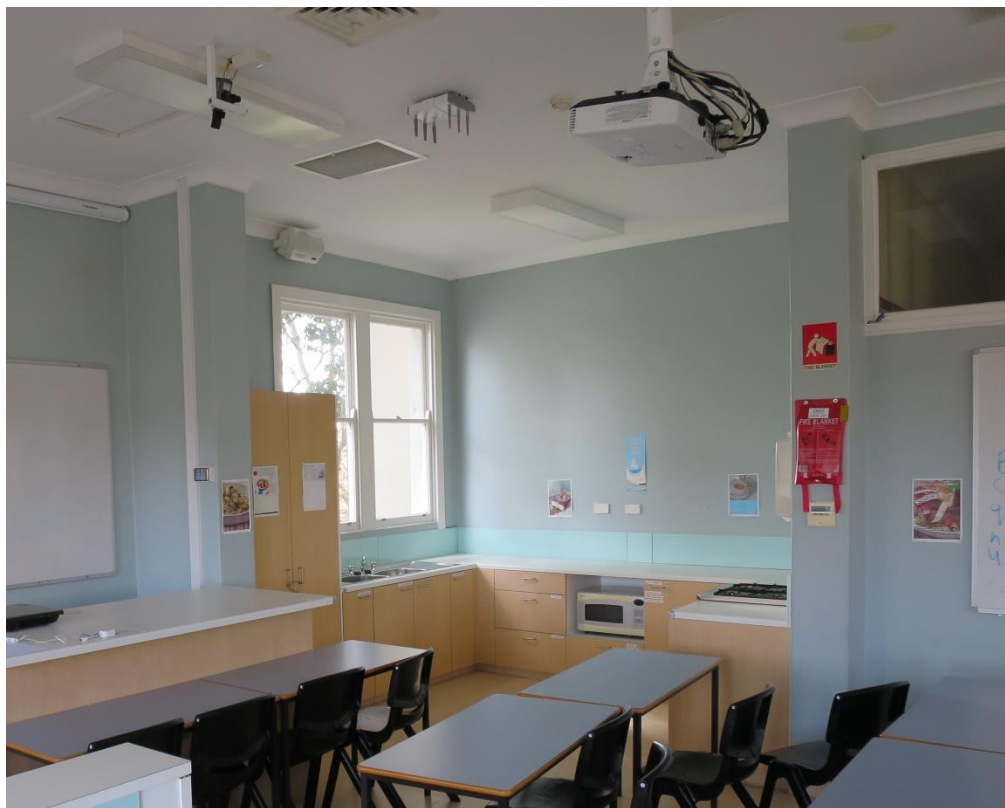
The design detailing of future stages will be guided to minimise removal of original fabric in buildings with heritage significance, particularly the 1857 Administration Building, the attached staff facilities and boarding facilities, and

the St John's Building. These buildings have been altered many times, losing all of their original staircases for instance, but contain many original walls, doors and exterior elements.

*Figure 58 — view inside the first floor of the St John's Building, demonstrating removal of original fabric. The wall on the right would be removed.*  
NBRS+PARTNERS

The twentieth-century partition walls to be removed from the first floor will be removed without damage to adjacent original masonry walls. The rendered masonry walls affected by the works will be patched with plaster to match existing.

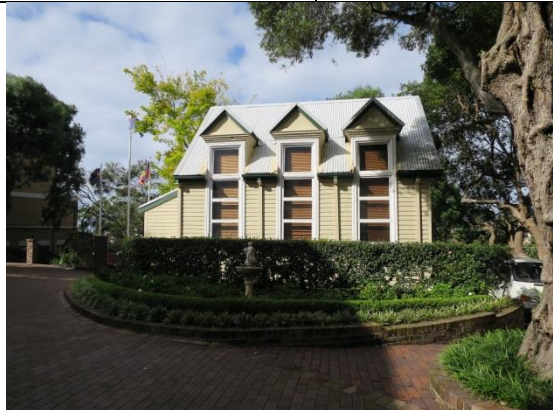
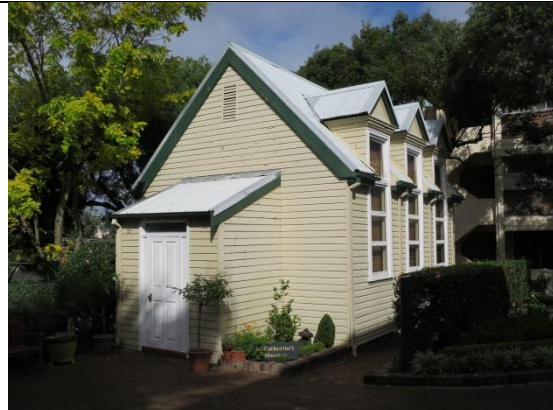
<b>Building Name</b>	The School Museum
<b>Date opened</b>	Circa 1890. Originally built as an art studio and as a gift from the Headmistress Miss Helen Phillip
<b>Architect</b>	Not Known
<b>Alterations</b>	<ul style="list-style-type: none"> <li>• Early 1900's stained glass windows were installed in order to make it a chapel</li> <li>• In 1936 it was moved to the lower field and stained glass windows were removed so that it could become a science lab.</li> <li>• From the 1950's until the 1992 it was converted into a classroom for kindergarten, art rooms and music rooms.</li> </ul>

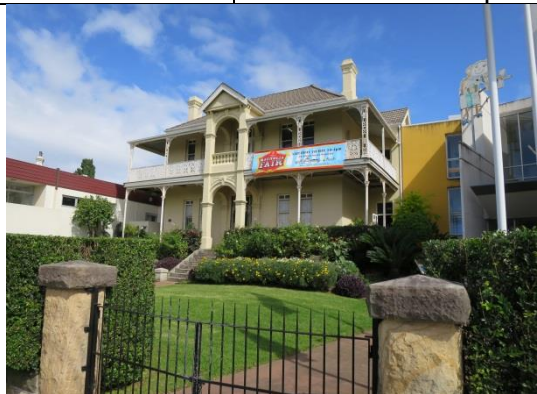
<b>Building Name</b>	The Maccallum Junior School
<b>Date opened</b>	1974
<b>Architect</b>	Edmund Dykes, Coward and Chaplin
<b>Alterations</b>	<ul style="list-style-type: none"> <li>1999 new Junior School designed by Alexander Tzannes Associates Pty Ltd and refurbishment of original Maccallum Junior School and La Vincompte.</li> <li>Joan Sutherland Junior School library was opened in 1979</li> <li>Extension works since opening: 1978, 1985, and 1999.</li> </ul>

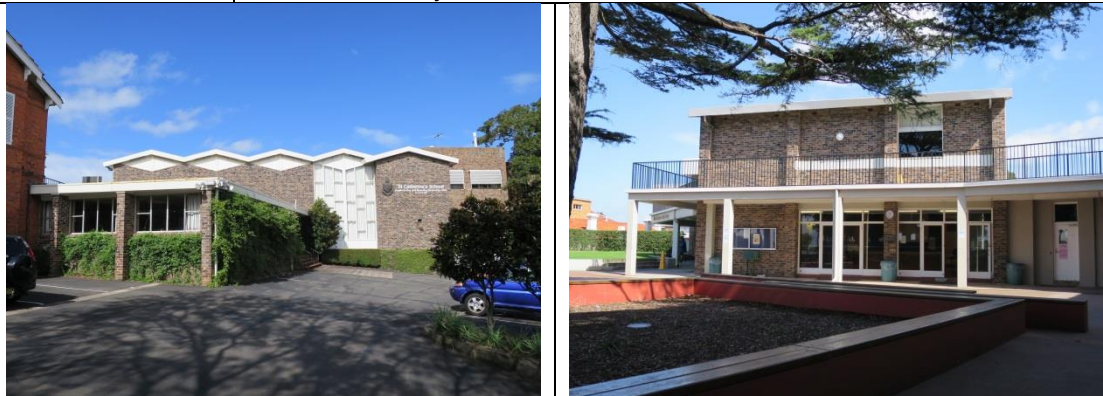
<b>Building Name</b>	Jane Barker Hall
<b>Date opened</b>	March 1960
<b>Architect</b>	A.C. Rogers of 117 Pitt St Sydney Consulting engineers M G Bull of 5 Hamilton St Sydney.
<b>Alterations</b>	<ul style="list-style-type: none"> <li>Extended with the construction of the Green Lab to the north-west in 1972/74, designed by Edmund Dykes, Coward and Chaplin Pty Ltd and consulting engineers Addicoat Hogarth, Wilson Pty Ltd</li> </ul>

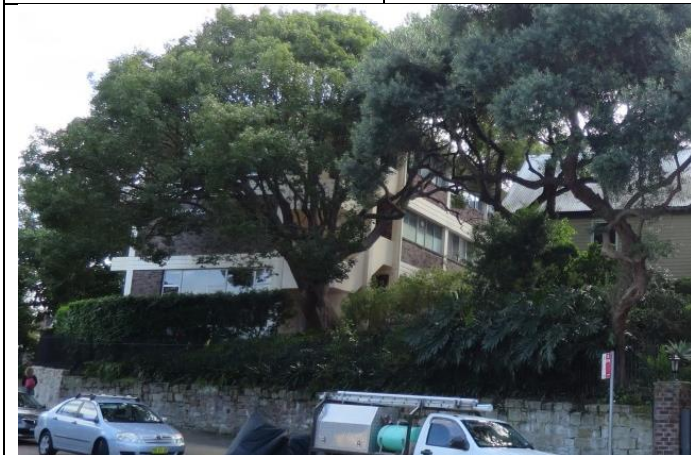
<b>Building Name</b>	Lenthall Building
<b>Date opened</b>	June 1967 as a two level free standing building
<b>Architect</b>	R A C Rogers and Coward
<b>Alterations</b>	<ul style="list-style-type: none"> <li>Extended in 1972 as Stage 2 as a senior study centre for senior years 11 and 12 and library (currently in 2014 the Boarders' common room and boarding facilities) with an undercroft and winding staircase opened in 1972.</li> <li>The Science Labs were converted to art rooms in 1987 when the Central School Development. The new Science Labs were built in 1987.</li> </ul>

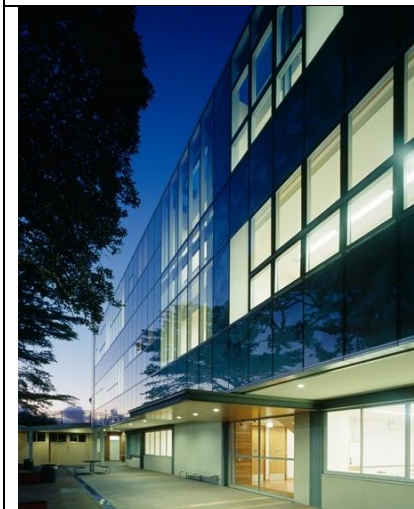
<b>Building Name</b>	Isabel Hall Wing
<b>Date opened</b>	April 1968 originally built as two levels, the ground level was infants school and the second level boarding facilities
<b>Architect</b>	R A C Rogers and Coward
<b>Alterations</b>	<ul style="list-style-type: none"> <li>Extended with additional level in 1982 it was refurbished to make all levels classrooms with a rooftop platform, by Phillip, Coward and Dykes and Partners.</li> <li>Renovation work since opening: Renovations in 2005 and reopened in 2006 (school's 150th anniversary) by Architect Alexander Tzannes Associates Pty Ltd.</li> </ul>

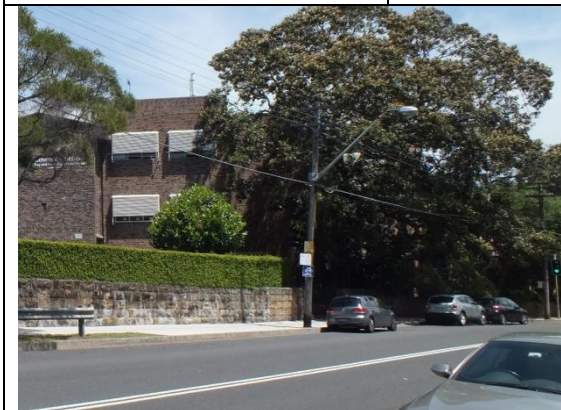
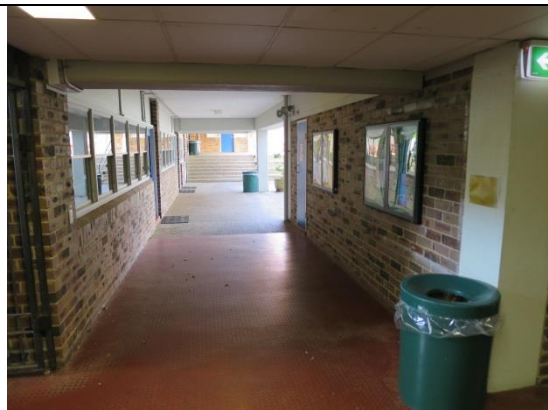
<b>Building Name</b>	J-Block CSD
<b>Date opened</b>	designed August 1985
<b>Architect</b>	Lawes Taylor Pty. Ltd
<b>Alterations</b>	<ul style="list-style-type: none"> <li>Enclosure of a small area to house the photocopier for staff.</li> </ul>

<b>Building Name</b>	Faith Patterson Study Centre, J Floor, Science Classrooms, known as the Central School Development
<b>Date opened</b>	August 1987
<b>Architect</b>	Lawes Taylor Pty Ltd
<b>Alterations</b>	<ul style="list-style-type: none"> <li>none</li> </ul>

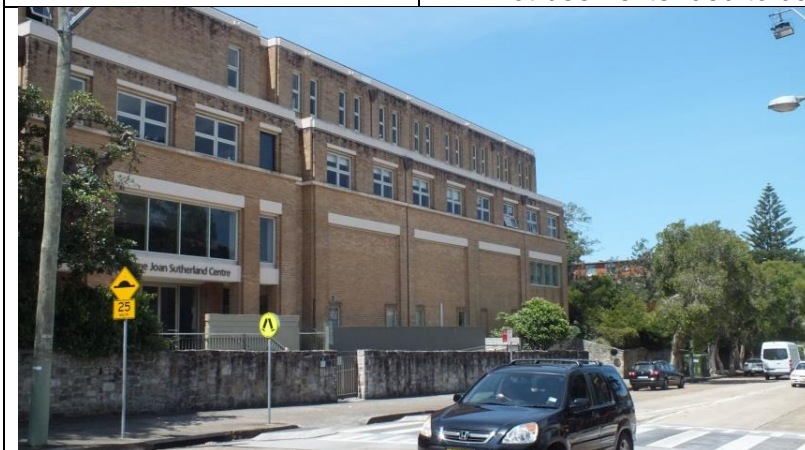
<b>Building Name</b>	Dame Joan Sutherland Centre (DJSC)
<b>Date opened</b>	March 1994
<b>Architect</b>	Architect: Lawes Taylor Pty. Ltd Project Manager: Leo Goldsbro Consulting engineers: George Floth Pty Ltd
<b>Alterations</b>	<ul style="list-style-type: none"> <li>Alterations to the front of the DJSC on Macpherson Street. A ramp was added and the front entrance was altered around 2005. It has not been extended to date.</li> </ul>

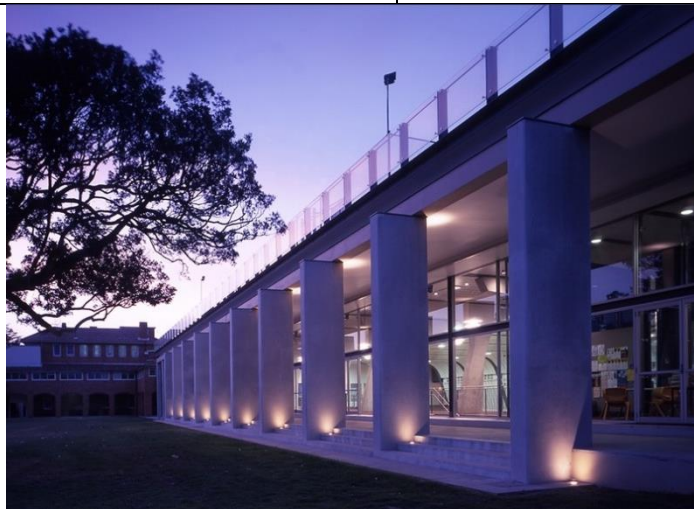
<b>Building Name</b>	Jo Karaolis Sports Centre
<b>Date opened</b>	March 2002
<b>Architect</b>	Alexander Tzannes Associates Pty Ltd
<b>Alterations</b>	<ul style="list-style-type: none"> <li>Resurfacing of the indoor basketball courts and re-surfacing of the outdoor tennis courts on the upper level. The artificial turf in the quadrangle was laid in January 2011 by David Woods, Southwest Greens Australia</li> </ul>
