# Aboriginal Archaeology and Cultural Heritage Impact Assessment

# Bylong Coal Project

### Bylong Coal Project AACHIA - Mid Western Local Government Area

Client Manager: Darrell Rigby  
Report Number: PR113279  
Version / Date: Final March 2015

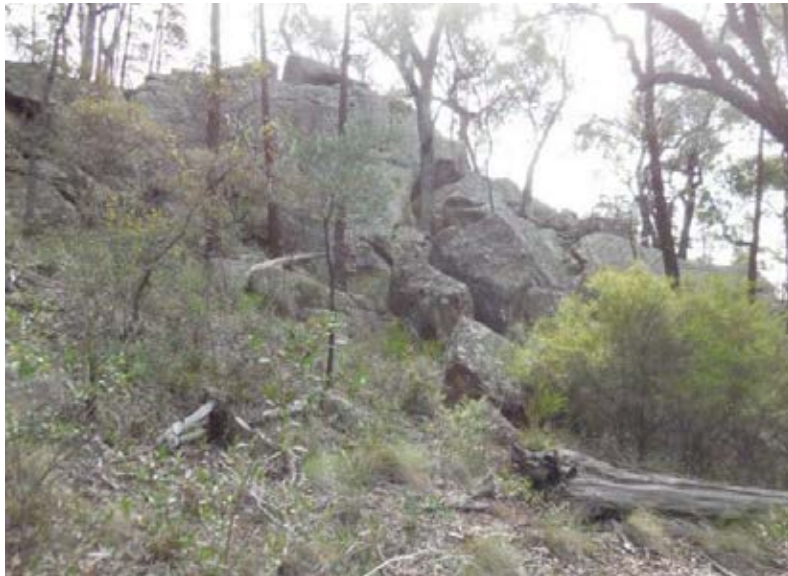
This landform is not conducive to the development of shelters in the sandstone due to water runoff, extensive fracturing, large rock fall and poor quality sandstone. This sandstone is also not suitable for grinding grooves or rock art, due to its friable nature and bands of pebble inclusions. Although there are very small rock cavities in the sandstone along these cliff lines, all were considered unsuitable for sustained Aboriginal occupation, due to the dynamic erosion, water flow runoff and the instability of the sandstone outcrops (**Plate 5**).

**Plate 1 Landform Unit 1 view showing sandstone outcrop in cliff line area and steep slope**

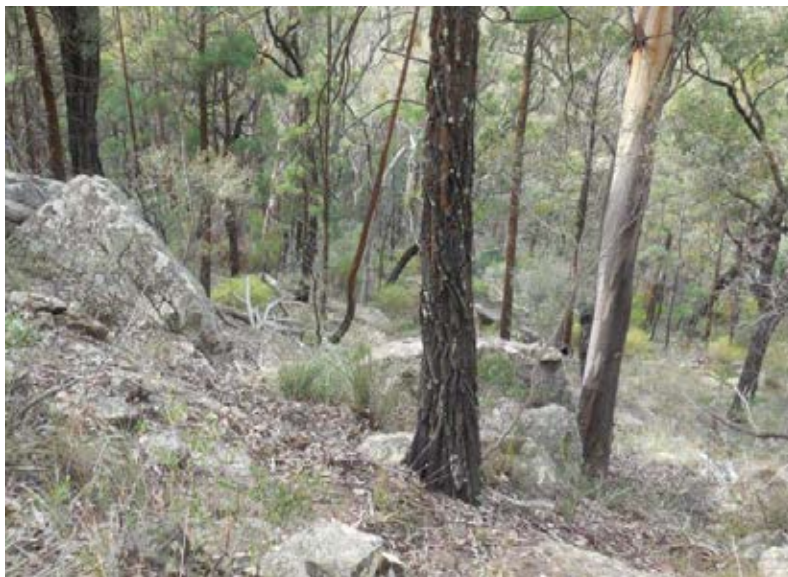
**Plate 2 Landform Unit 1 view showing steep slope and talus slope**

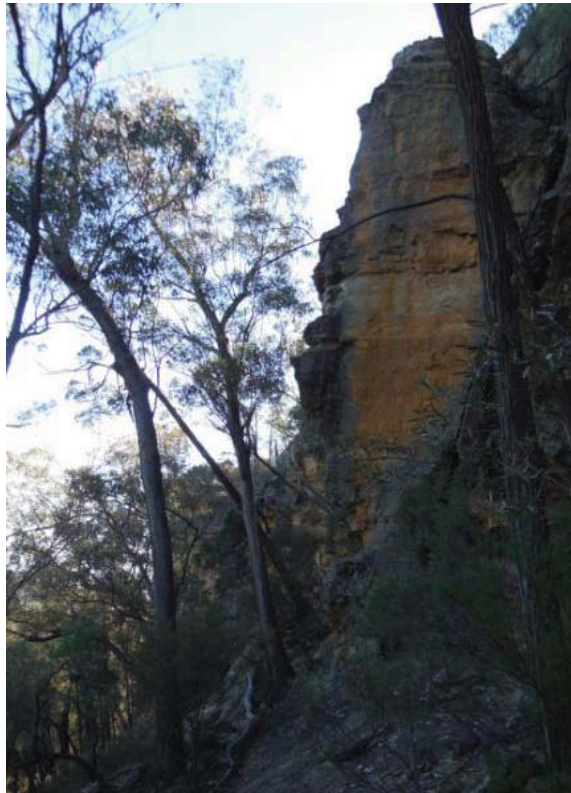
Plate 3 Landform Unit 1 view showing steep cliffs and scree slope

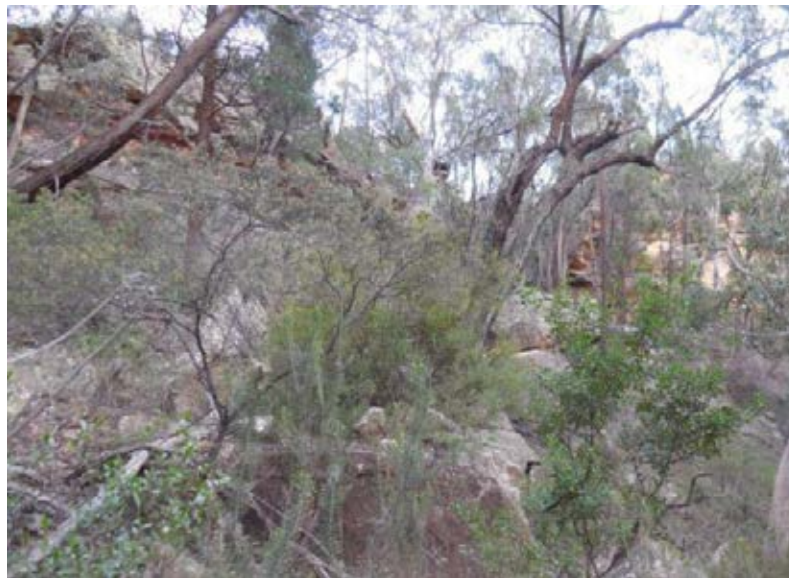
Plate 4 Landform Unit 1 view showing sandstone cliffs and rock fall

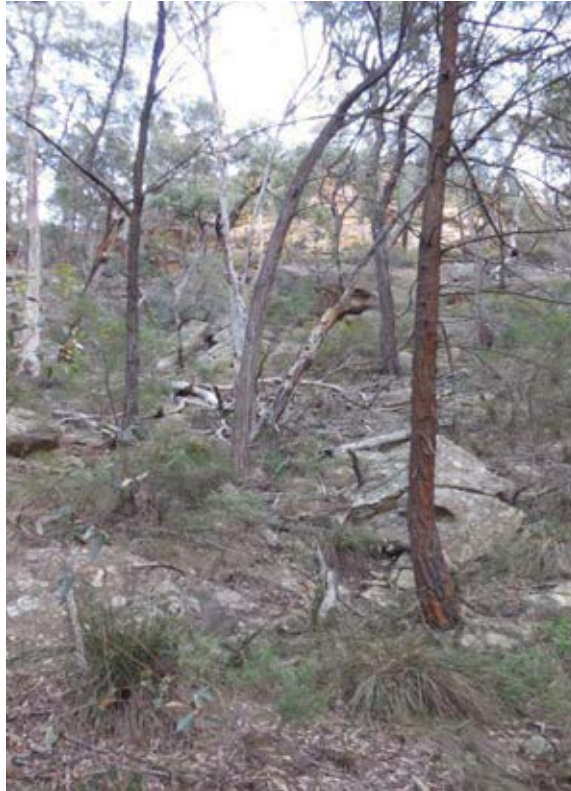
**Plate 5 Landform Unit 1 view showing sandstone boulders on scree slope**

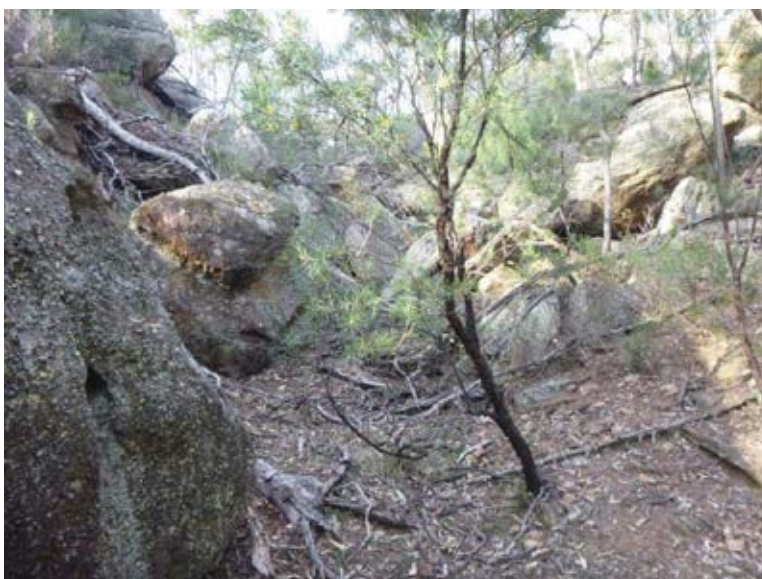
This landform is characterised by active erosion caused by collapse, landslide, sheet flow, creep and channelled stream flow and poor soils in the steeper terrain (**Plate 9**). The area is wooded with mostly immature eucalyptus and mature black cypress pines. There was evidence of previous land clearing in some areas relating to previous farming activities in the area. Access to these areas is also hindered by dense vegetation particularly with an understory of medium sized shrubs, such as acacias. Some native grasses are present in the more open areas. The terrain is difficult to traverse, but is more accessible than the cliff line areas due to the dense vegetation, slopes, sandstone outcropping and rock fall.

Plate 6 Landform Unit 2 - view showing creek line cutting through outcropping sandstone

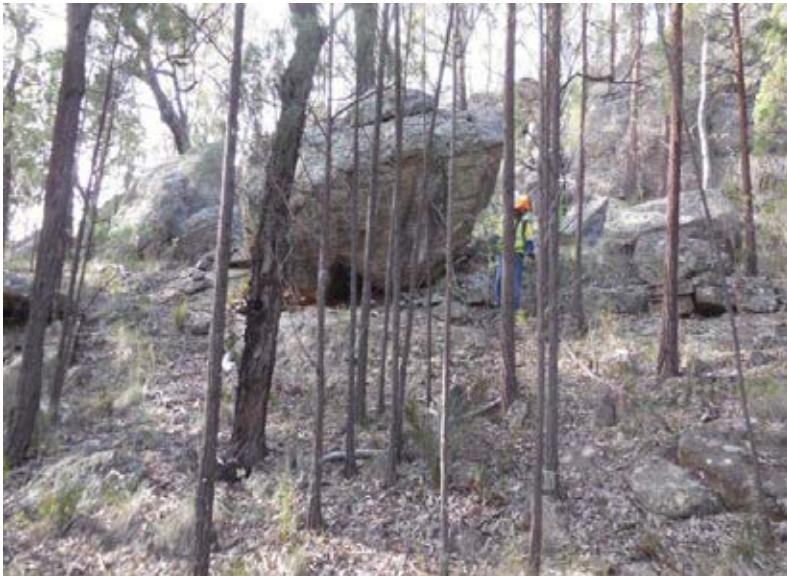
**Plate 7 Landform Unit 2 view showing rock cavity**

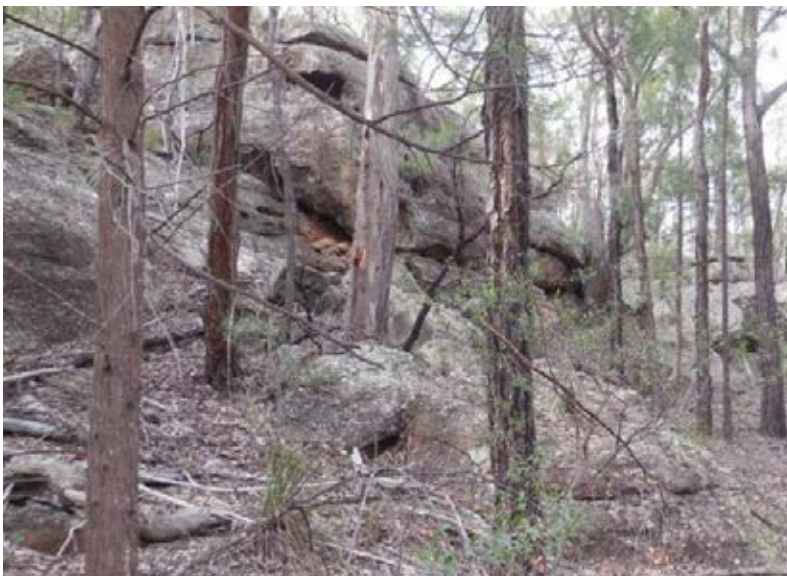
**Plate 8 Landform Unit 2– view showing conglomerate sandstone**

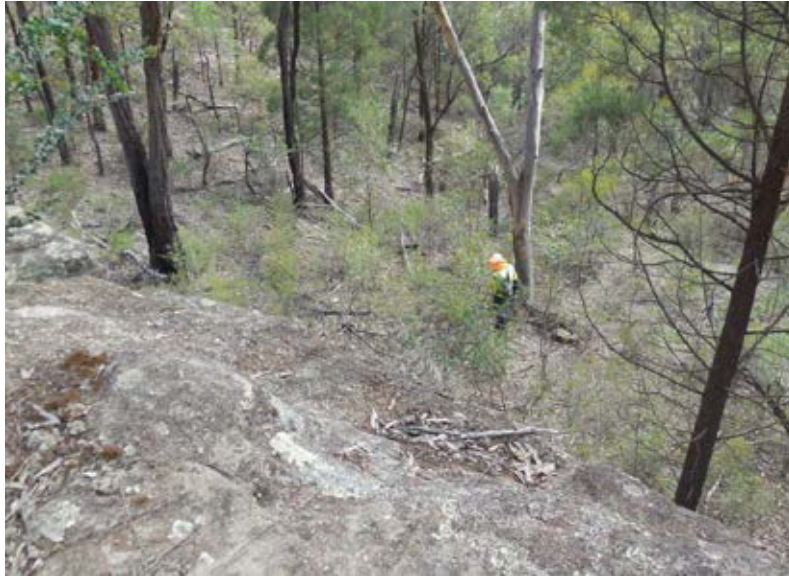
Plate 9 Landform Unit 2 – view showing steep terrain

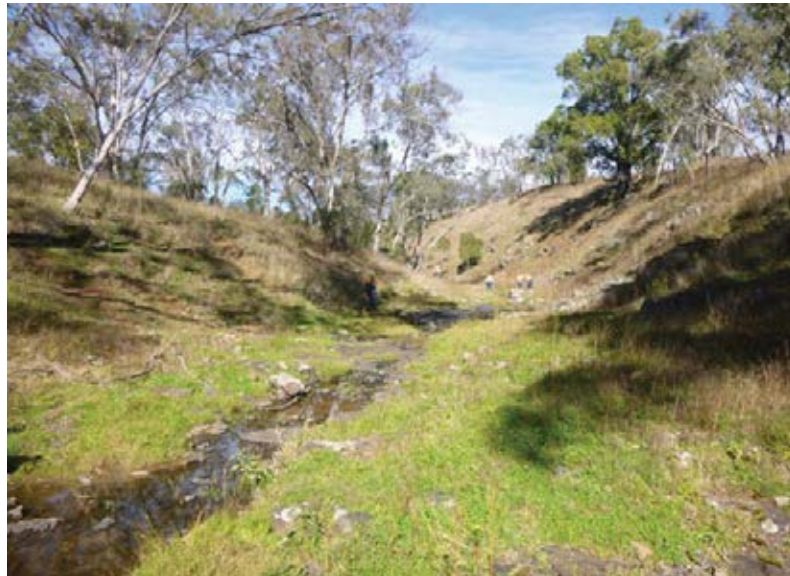
Plate 11 Landform Unit 3 – view showing stepped rocks in the creek bed

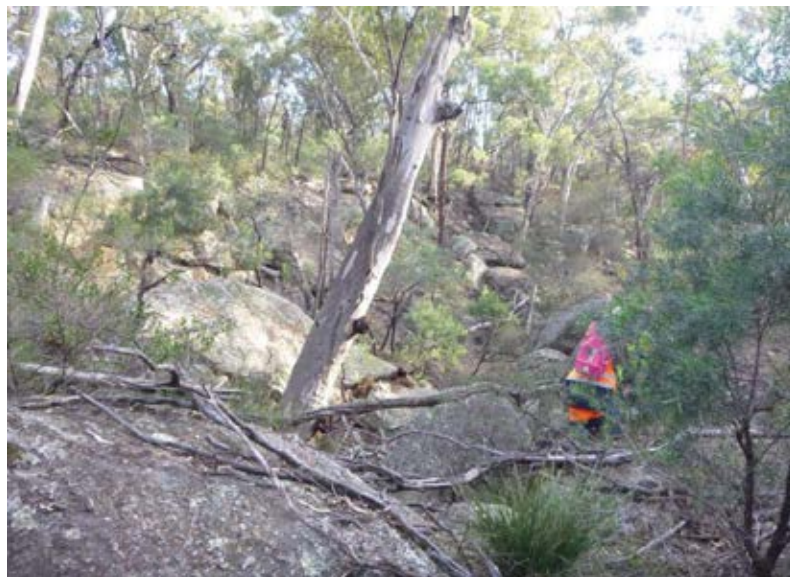
Plate 12 Landform Unit 3 – view showing vegetation in creek bed and along creek banks

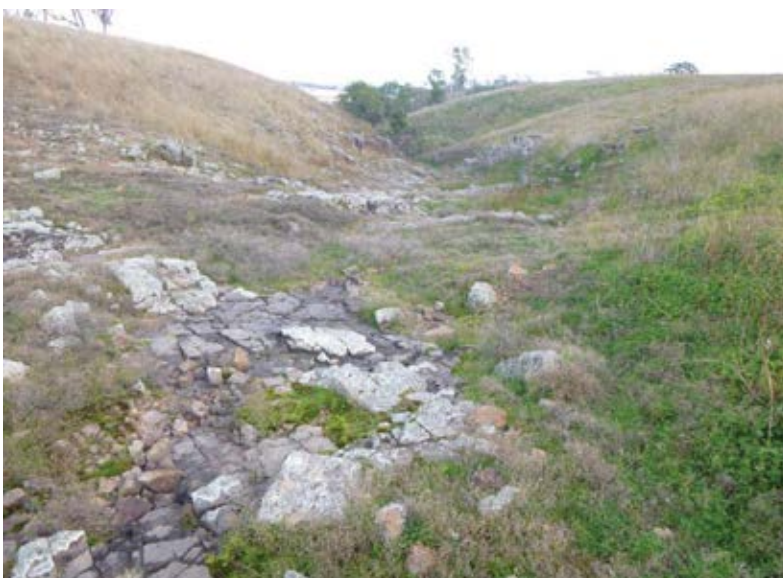
Plate 13 Landform Unit 4 – view showing interlocking spurs and basalt rocks lining the creek bed

This landform unit comprises interlocking spurs and creek lines along the middle catchment area of Dry Creek. Interlocking spurs are formed in v-shaped valleys with lateral erosion undercutting the concave banks of river bends and depositing the load downstream (**Plate 13**). The creek banks are generally fairly steep and the promontories are usually rounded due to the effects of erosion (**Plate 14**). The promontories jut out into the creek lines in staggered formation throughout the landscape and are described as interlocking spurs. Some of the creek beds were lined by basalt rocks (**Plate 13**) and there was evidence of weathering of these rocks to form white clays along the creek banks (**Plate 14**). The areas in this landform unit were cleared grazing land at the base of the Goulburn River State Forest. The surrounding hills densely grassed. A large number of open artefact scatters were identified where soil profiles had been exposed from sheet wash and areas associated with vehicle movements and tracks.

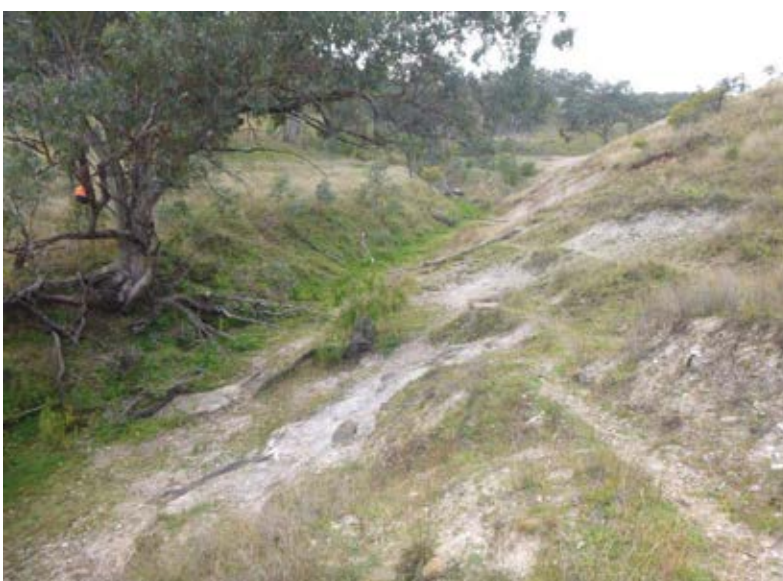
Plate 14 Landform Unit 4 25 June 14 Week 5 – view showing weathering of basalt along creek banks

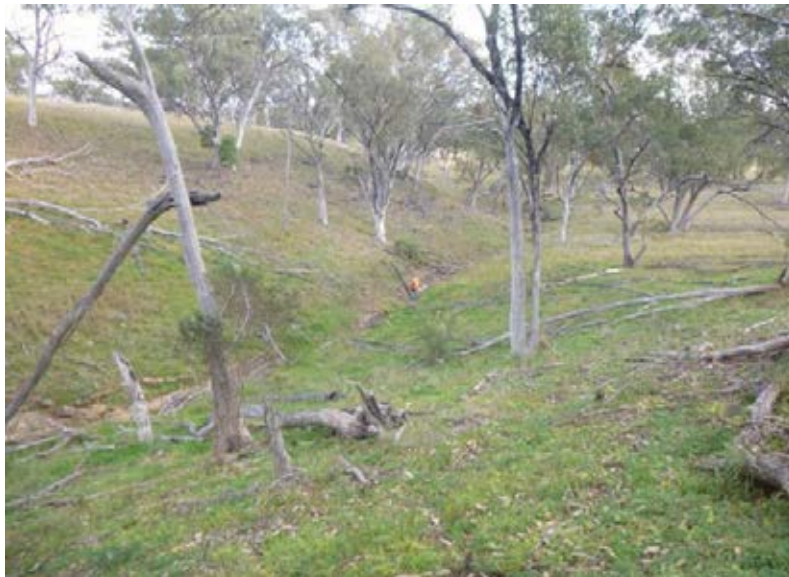
Plate 15 Landform Unit 5 – view showing steep sided rolling hills with rounded crests

The rolling hill landform unit was associated with the eastern tributaries of Dry Creek (**Plate 15 – Plate 17**). This landform unit is characterised by steep to moderate slopes. The crests of the hills are rounded. The eroded drainage channels are moderately spaced and formed a convergent integrated tributary network. Vegetation was predominantly characterised by cleared grassy paddocks and open woodland on some of the slopes. These hills have been eroded by sheet wash, creep and channelled creek flow. Open artefact sites occur infrequently in this landform and grinding grooves were identified in the upper catchment at in one locality. Open artefact sites occurred to the west of these groove sites, creating a complex of associated occupation areas.

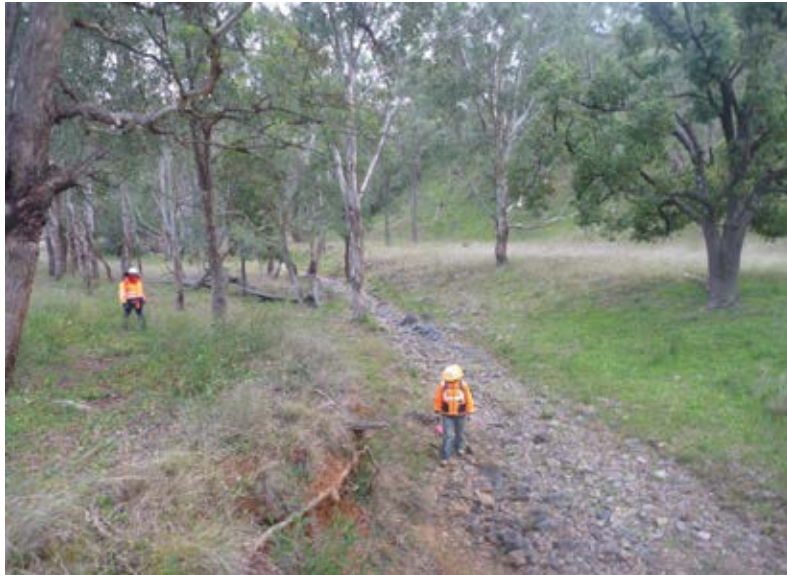
**Plate 18 Landform Unit 6— view showing terraces and cobbles in creek bed**

This landform unit comprises flat creek terraces, many of which are lined with cobbles, adjacent to the main channel of Dry Creek (**Plate 18** and **19**). These cobbles are predominantly derived from basalt and are likely to have been eroded from the extensive columnar basalt and basalt flows in the area to the south west characterised by steep rolling hills. Flat basalt sheeting and eroded columns were identified in the upper catchment of some of these tributaries. This creek line and terracing pattern runs parallel to the Bylong Valley Way on the northern side of the mining lease. The terraces have been formed by erosion and aggradation by overbank flooding. The deepening and enlargement of the creek has then lowered the likelihood of flooding events occurring. The red brown soils lining the creek bed are the result of the weathering of basalt rocks.

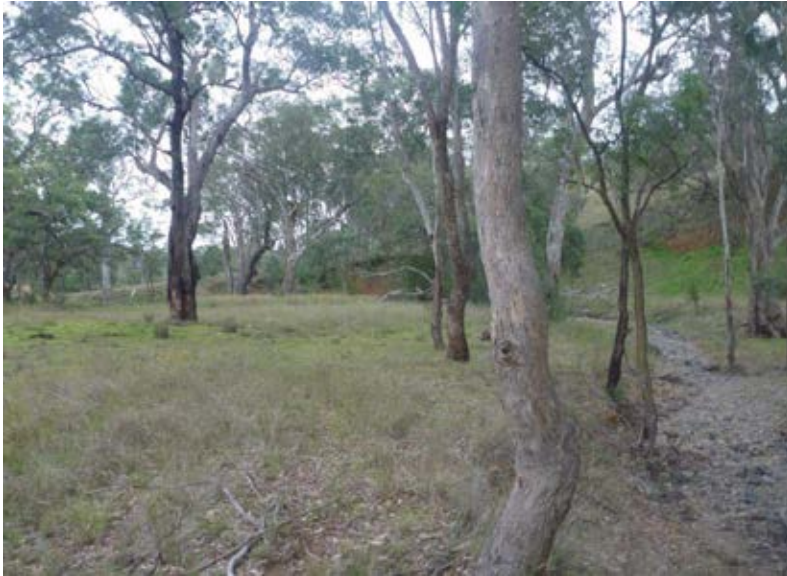
**Plate 19 Landform Unit 6– view showing banks cut by fast flowing water and cobbles in creek bed**

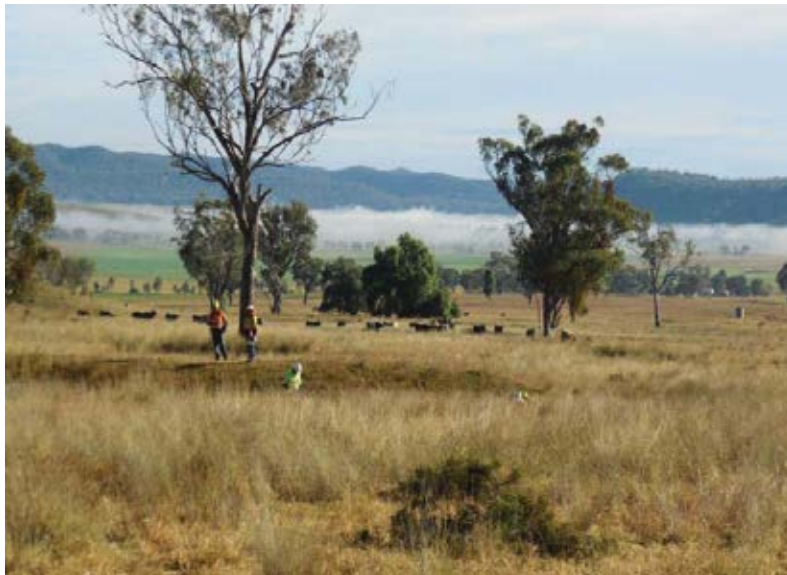
Plate 20 Landform Unit 7– view showing alluvial plain

The alluvial plain was located on Bylong valley floor below the footslopes. This plain was a level landform with extremely low relief (**Plate 20**), and aggradation of alluvium by channelled and overbank stream flow. There is very gradual change in elevation across the area. The alluvial creek channels that have formed this plain are Bylong Creek and Lee Creek and thus drinking water would have been available for Aboriginal occupation and is likely to have supported edible plants and is likely to have been a location for hunting animals. This flat alluvial plain has been extensively pastured and/or cultivated since European settlers came to the Bylong Valley, due to the water resources and alluvial soils present. Highly disturbed artefact scatters and/or isolated finds were present and observed across the plain. These sites were identified mostly in areas of high ground exposure such as farm dam banks, contour banks and graded vehicle access tracks (**Plate 21** and **Plate 22**). Towards the southern end of this landform, a number of possible scarred trees were present in one paddock where the clearance of large old mature eucalyptus had not occurred (**Plate 23**).

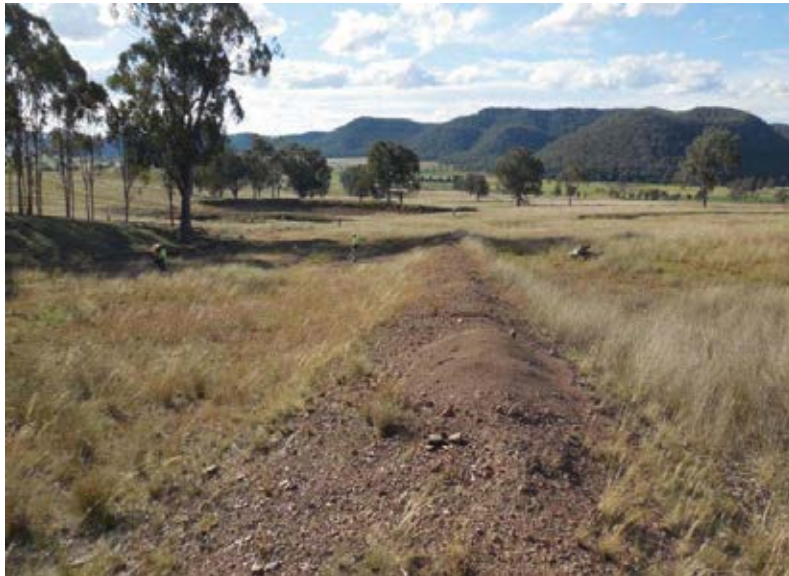
**Plate 21 Landform Unit 7 alluvial plain showing disturbance from pastoral activities**

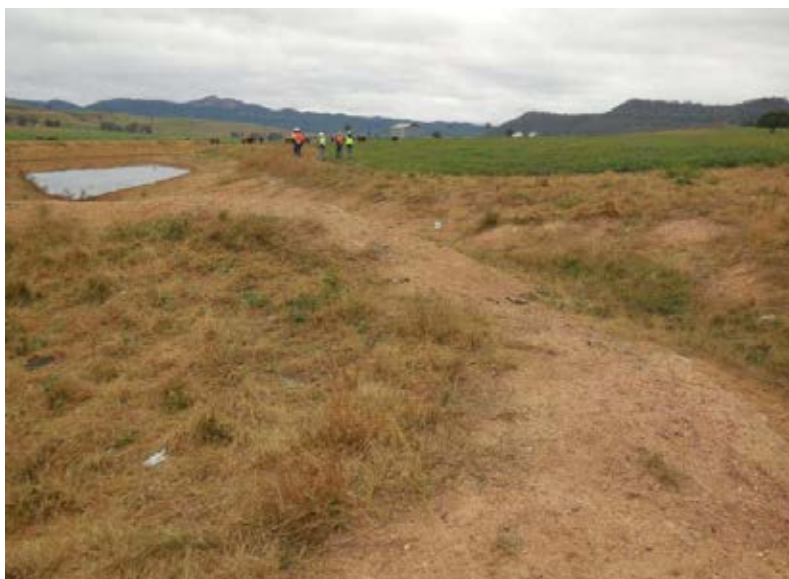
**Plate 22 Landform Unit 7 alluvial plain showing erosion and landform modification**

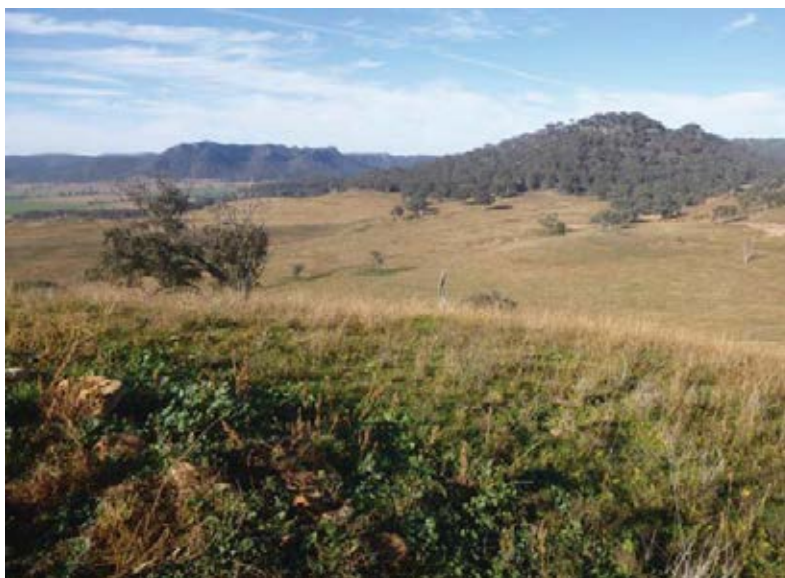
Plate 24 Landform Unit 8 Volcanic capped hills

The volcanic capped hill landform unit comprised undulating hill slopes which correspond to the proposed North Western Overburden Emplacement Area. The slopes were made up of a number of hills, saddled at the northern end of a long steep ridgeline (**Plate 24**). These low gradient slopes, once traversed, offer an outlook across most of the Bylong Valley area and into both surrounding plains. At the end of this spur was a bald hill which offered unparallel views. This rare outlook in the overall region had some potential for Aboriginal use. These slopes have been cleared of native vegetation and been used in more recent times for the grazing of cattle (**Plate 25**). The slopes were covered in very tall and dense pasture grasses. A small number of isolated artefacts were identified on the exposed vehicle access tracks in the area.

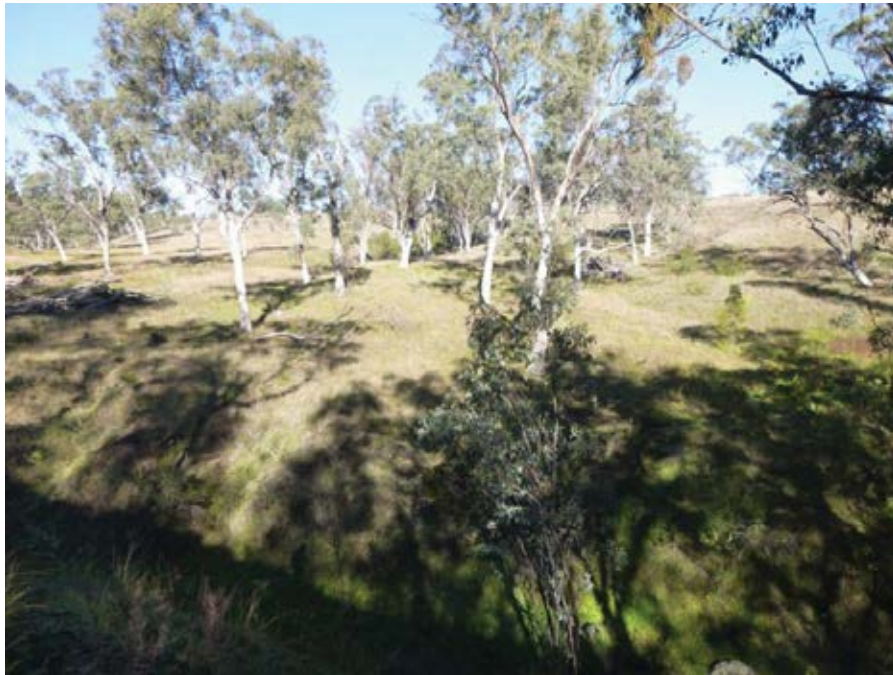
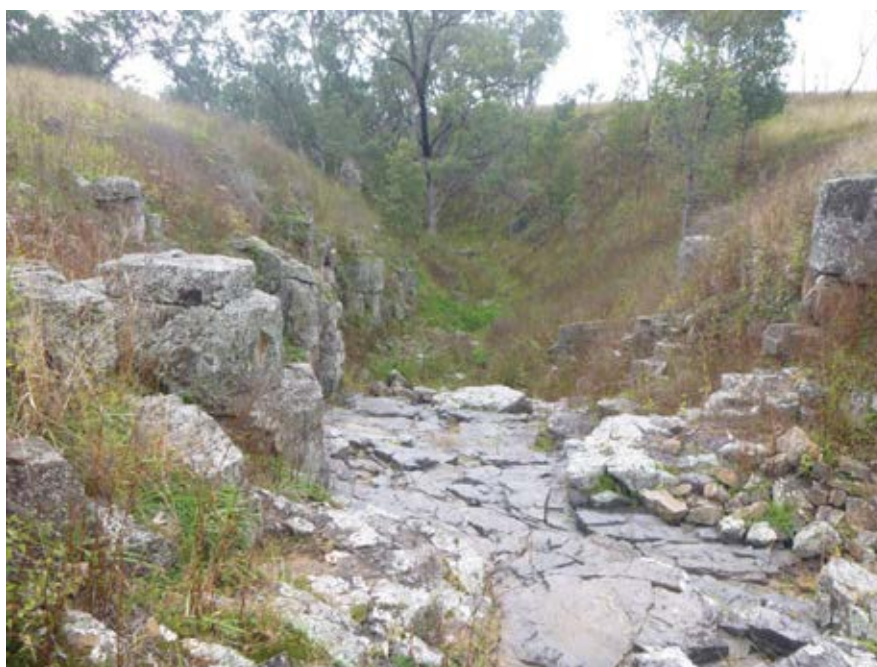
This steep sloped landform unit was encountered in association with deeply incised V-shaped creek lines. In some areas, these creek lines became small gorges. Ground surfaces were sloped and unsuitable for occupation and no Aboriginal sites were identified in these areas (**Plate 30** and **Plate 31**). Vegetation ranged from sparsely wooded (near Dry Creek tributaries) to thickly wooded in the north and eastern areas.

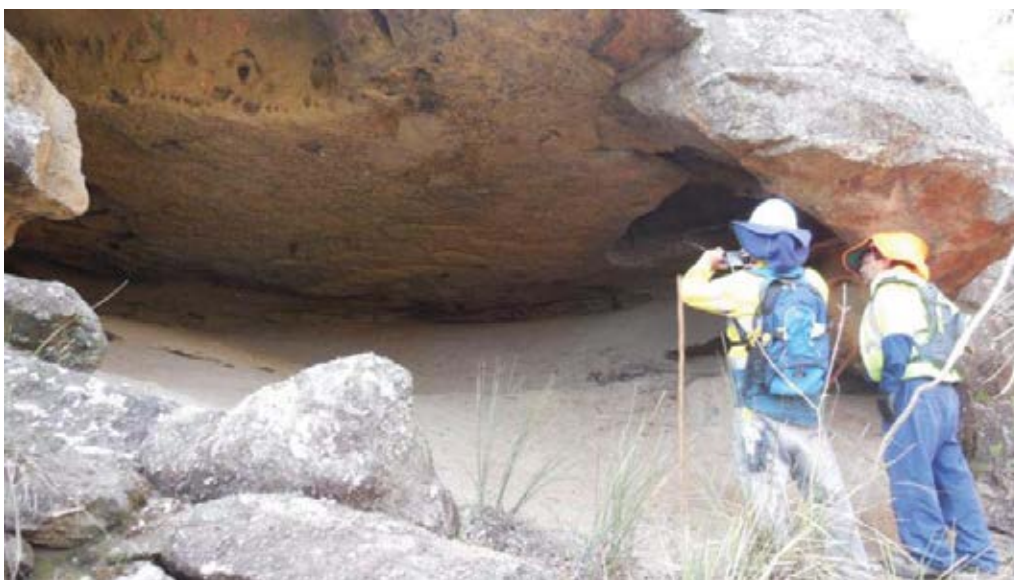
**Plate 33 RS001 (KG002) Rockshelter**

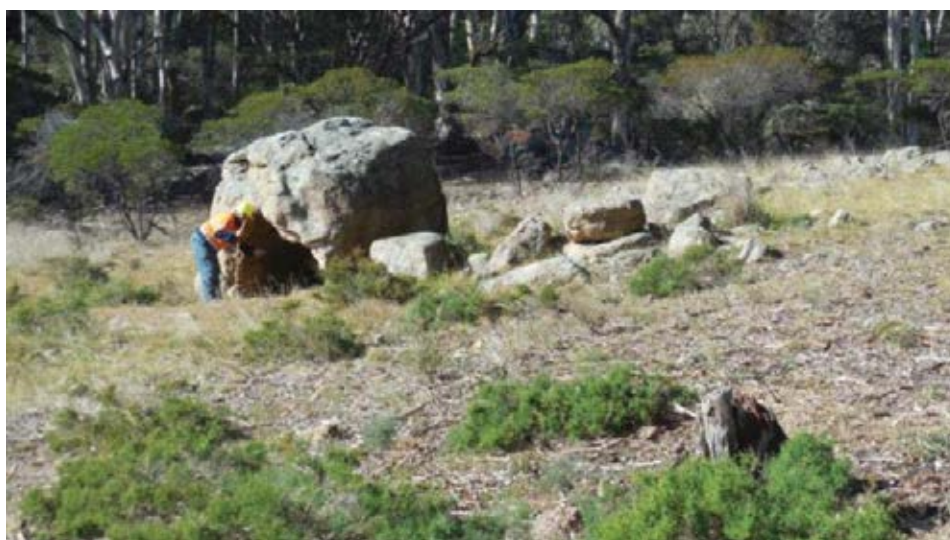
**Plate 37 RPS Bylong RS003 (KG049) Rockshelter**

RPS Bylong RS003 was located to the south of the proposed open cut. This rockshelter and its associated artefact scatter (RPS Bylong AS034) were identified on the 28<sup>th</sup> May 2014. The rockshelter is 2.1 m in height, 2.5 m in width and 2.2 m in depth (**Plate 37**). There was no PAD identified inside the rock shelter, but there was an area of PAD measuring 6 m by 6 m, and considered to be approximately 20 cm in depth, in front of and adjacent to the shelter. This site has north westerly aspect (**Plate 38**). The associated artefact scatter (RPS Bylong AS034) was located to the south east, directly behind the shelter (**Plate 39**) and the artefacts are on the surface of sandy soils **Plate 40**. The GSV and GSE were low in the general area due to the density of the surrounding pasture grasses. The area has eucalypts, black cypress pines and acacia understory along the tree line on the footslopes to the south. There are also native grasses and small shrubs present.

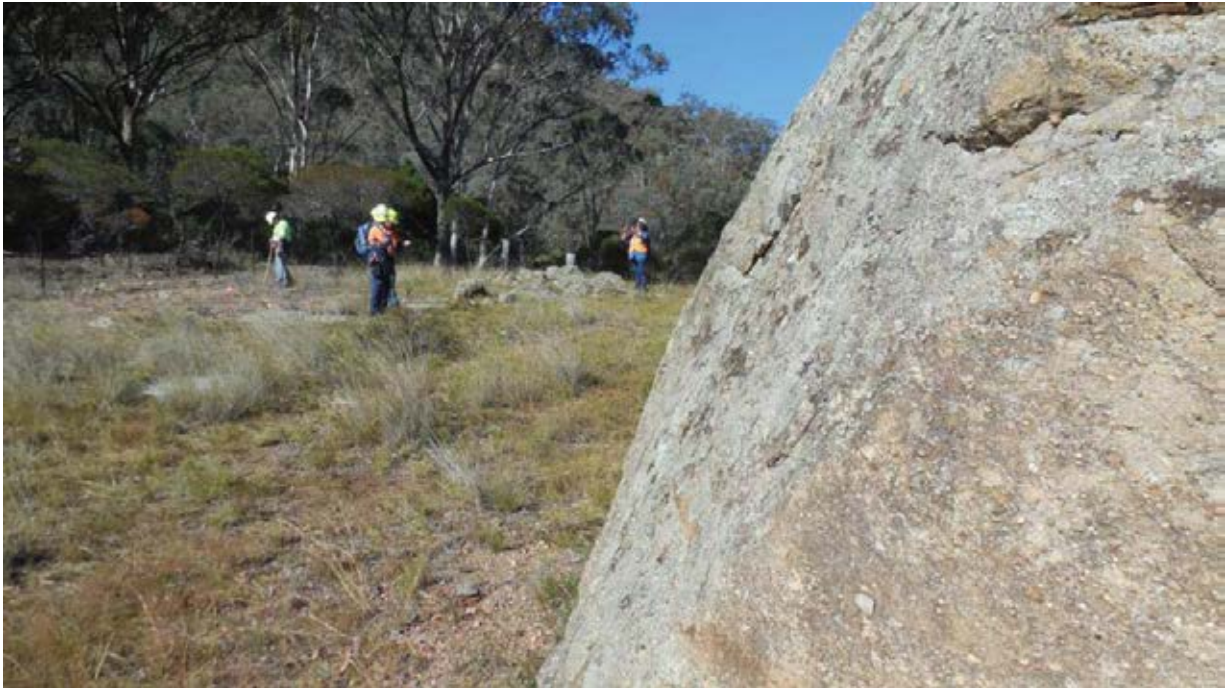
Plate 39 RPS Bylong RS003 (KG049) Rockshelter with Artefact Scatter RPS Bylong AS034 to the south east

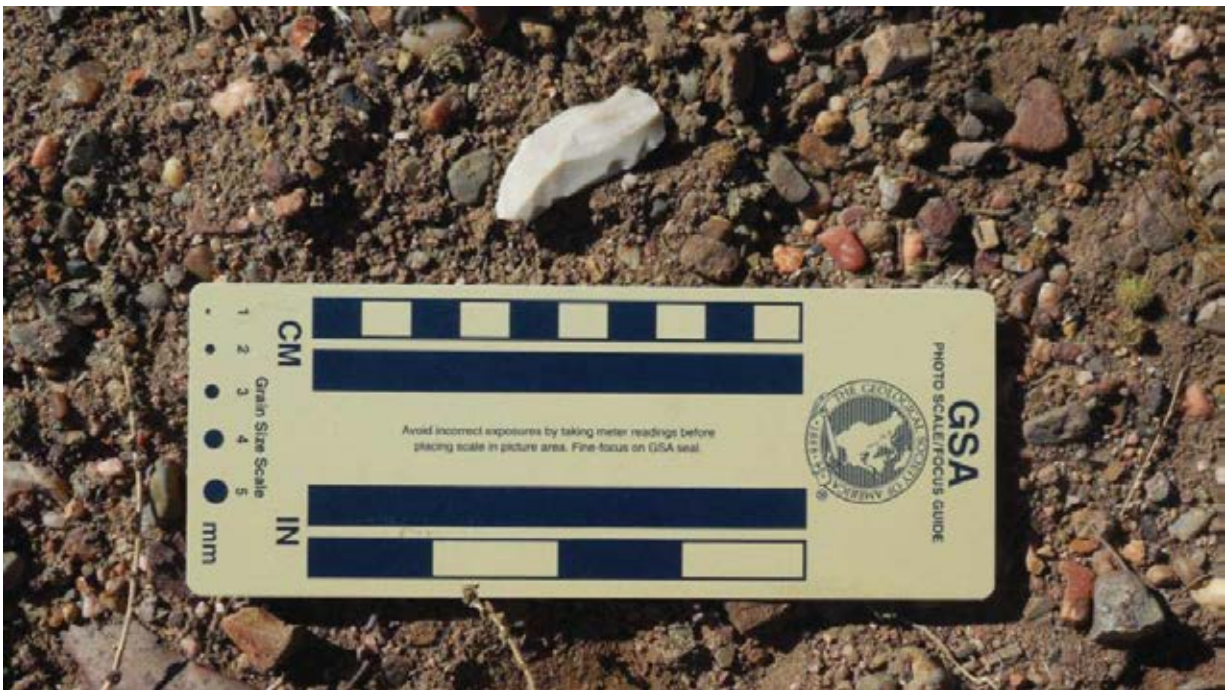
Plate 40 Artefact from associated artefact scatter RPS Bylong AS034

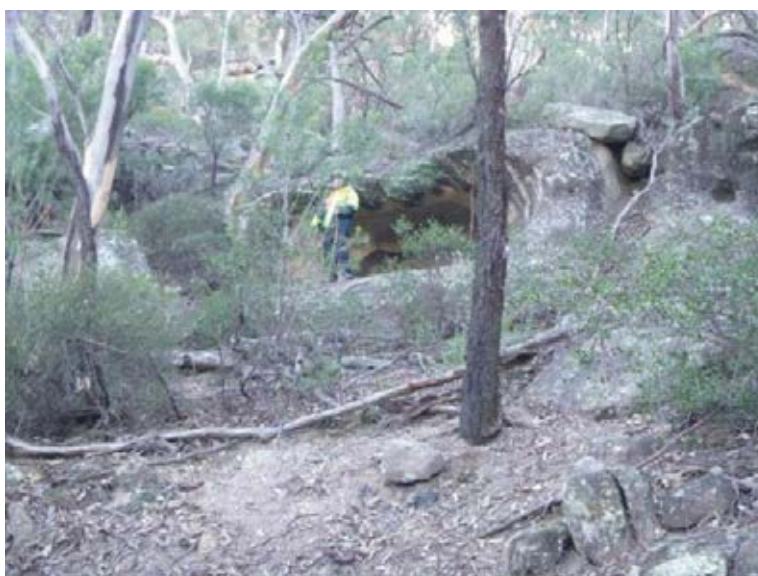
**Plate 41 RPS Bylong RS004 (KG128) Rockshelter**

RPS Bylong RS004 was accessed via a graded access track used for the drilling rigs, which followed the western boundary in the northwest corner of the State Forest. This site was identified on the 26<sup>th</sup> June 2014 in Week 5 of the survey. The rockshelter is 1.3 m in height, 5.1 m in width and 4.2 m in depth (**Plate 41**) and has a north westerly aspect (**Plate 42**). It was estimated that the sediment that formed the floor of the shelter had a depth of at least 10 cm. There were no artefacts associated with this site. The GSV and GSE were low between the site and the graded track due to very dense leaf litter, fallen branches and trees. The vegetation community in the area is characterised by new growth eucalypts, black cypress pines and acacia shrubs. Some native grasses and small shrubs are present in the understorey. This shelter was situated in close proximity to RS005.

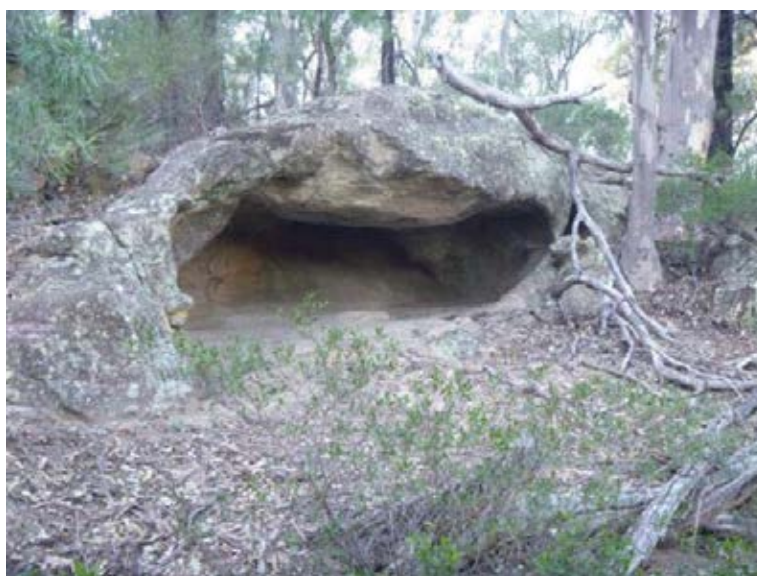
Plate 43 RPS Bylong RS005 (KG129) Rockshelter

RPS Bylong RS005 was accessed via a graded access track used for the drilling rigs, which followed the western boundary in the northwest corner of the State Forest. This site was identified on the 26<sup>th</sup> June 2014 in Week 5 of the survey. The rockshelter is 1.5 m in height, 5.8 m in width and 3.1 m in depth (**Plate 43**) and has a north westerly aspect (**Plate 44**). It was estimated that the sediment covering the floor of the shelter had a depth of at least 10 cm. There were no artefacts associated with this site. The GSV and GSE were low between the site and the graded track due to very dense leaf litter, fallen branches and trees. The vegetation community in the area is characterised by new growth eucalypts, black cypress pines and acacia shrubs. Some native grasses and small shrubs are present in the understorey. This shelter was situated in close proximity to RS004.

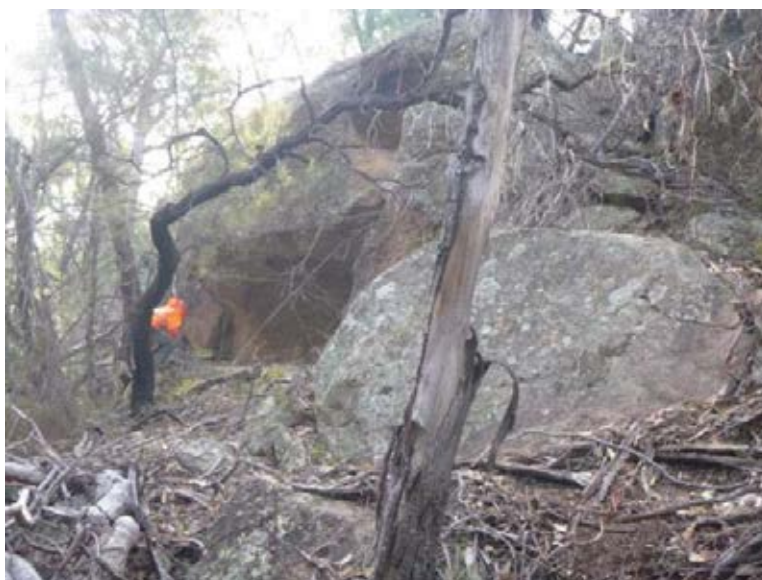
**Plate 45 RPS Bylong RS006 (KG135) Rockshelter**

RPS Bylong RS006 (KG135) was located in a creek line running between Roads 09 and 10 and was accessed using Road 10, a graded access track for the drilling rigs. This site was identified on the 27<sup>th</sup> May 2014 in Week 5 of the survey. The rockshelter is 1.61 m in height, 6.58 m in width and 4.67 m in depth (**Plate 45**) and has a westerly aspect (**Plate 46**). It was estimated that the sediment forming the floor of the shelter had a depth of at least 15 cm. There were no artefacts associated with this site. The GSV and GSE were low between the site and the graded track due to very dense leaf litter, fallen branches and trees. The vegetation community in the area is characterised by new growth eucalypts, black cypress pines and acacia shrubs. Some native grasses and small shrubs are present in the understorey.

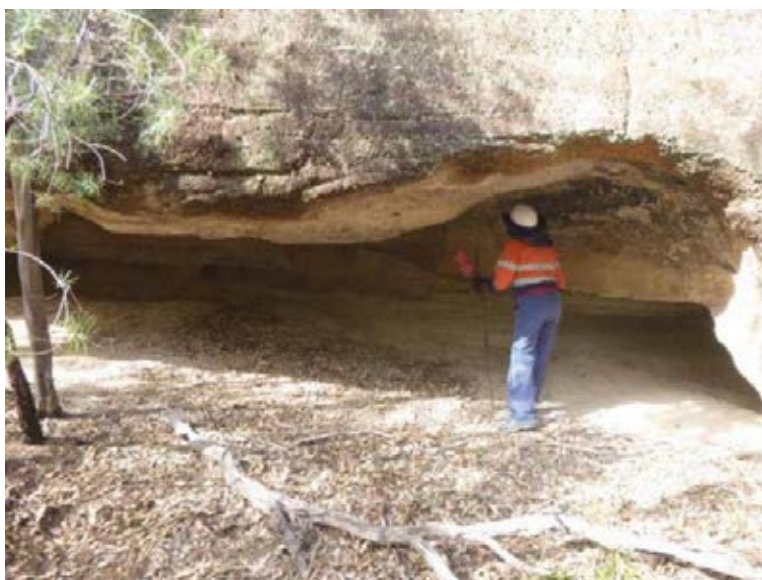
Plate 47 RPS Bylong RS007 (KG136) Rockshelter

RPS Bylong RS007 (KG136) was accessed from Road 07, a graded access track for the drilling rigs. This site was identified on the 27<sup>th</sup> May 2014 in Week 1 of the survey. The rockshelter is 1.83 m in height, 8.84 m in width and 4.82 m in depth (**Plate 47 Plate 50**) and has a northerly aspect (**Plate 48 Plate 49**). The area of sediment that was considered to be a PAD was between 10 and 20 cm throughout the site. There were no artefacts associated with this site. The GSV and GSE were low between the site and the graded track due to very dense leaf litter, fallen branches and trees. The vegetation community in the area is characterised by new growth eucalypts, black cypress pines and acacia shrubs. Some native grasses and small shrubs are present in the understorey.

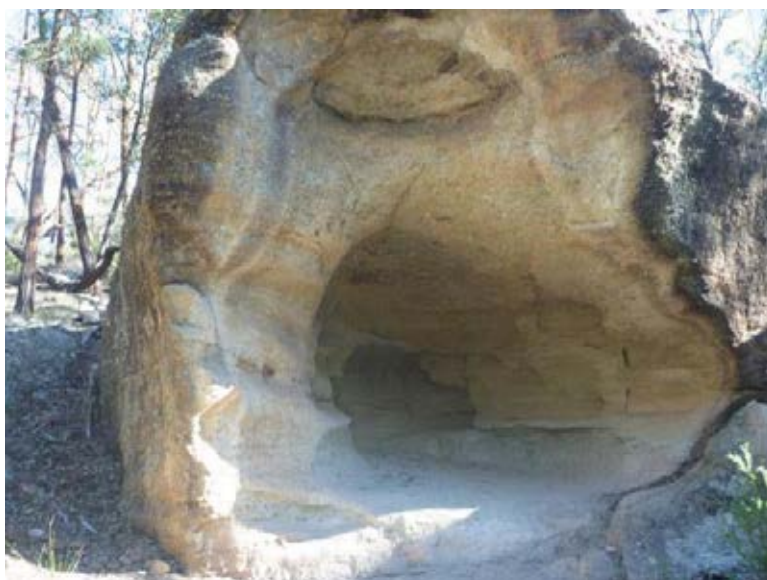
Plate 51 RPS Bylong RS008 (RPS020) Rockshelter

RPS Bylong RS008 was accessed from Road 06, a graded access track for the drilling rigs. This site was identified on the 21<sup>st</sup> May 2014 in Week 1 of the survey. The rockshelter is 2.1 m in height, 3.6 m in width and 3.7 m in depth (**Plate 51**) and has a north easterly aspect (**Plate 52**). There was an area of PAD measuring 3 m by 3 m in front of the shelter. Sediment inside the shelter was less than 5 cm in depth. There were no artefacts associated with this site. The GSV and GSE were low between the site and the graded track due to very dense leaf litter, fallen branches and trees. The vegetation community in the area is characterised by new growth eucalypts, black cypress pines and acacia shrubs. Some native grasses and small shrubs are present in the understorey.

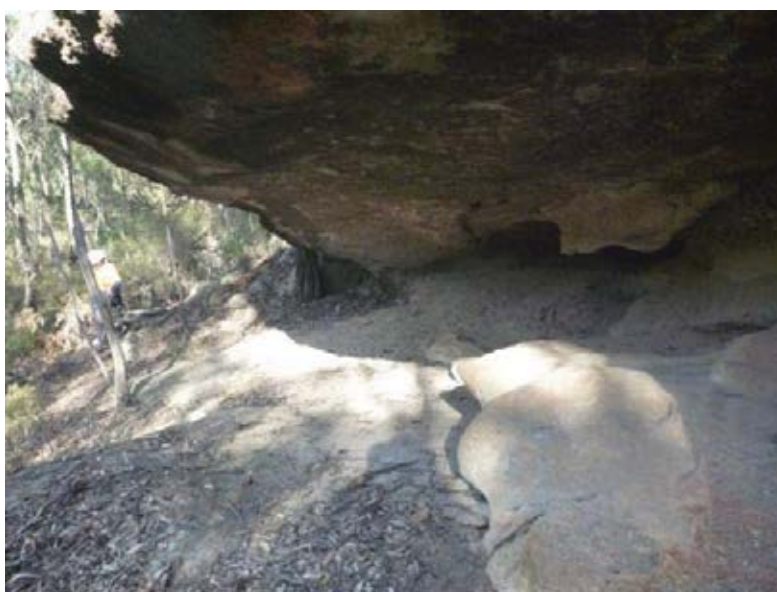
Plate 55 RPS Bylong RS010 (JH021) Rockshelter

RPS Bylong RS010 was accessed from Road 06, a graded access track for the drilling rigs. This site was identified on the 21<sup>st</sup> May 2014 in Week 1 of the survey. The rockshelter is 1.6 m in height, 2.45 m in width and 9.88 m in depth (**Plate 55**) and has a westerly aspect (**Plate 56**). It was estimated that the sediment forming the floor of the shelter had a minimum depth of 10 cm. There were no artefacts associated with this site. The GSV and GSE were low between the site and the graded track due to very dense leaf litter, fallen branches and trees. The vegetation community in the area is characterised by new growth eucalypts, black cypress pines and acacia shrubs. Some native grasses and small shrubs are present in the understorey.

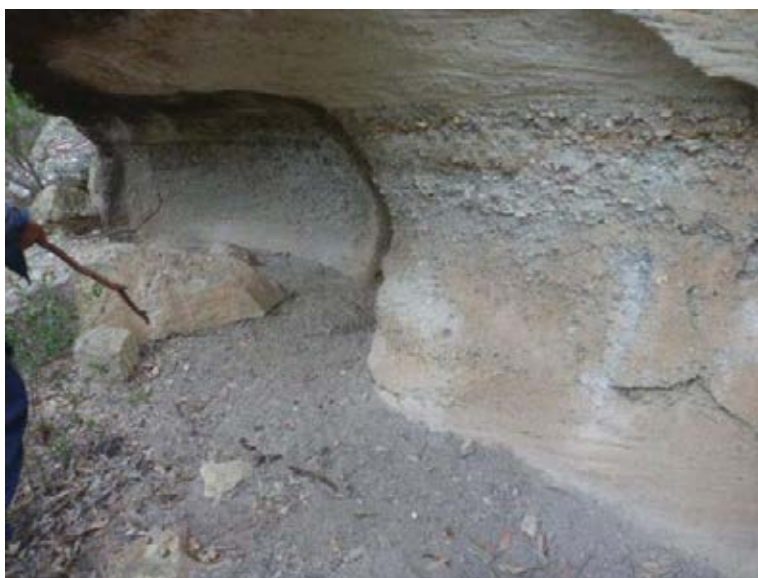
**Plate 57 RPS Bylong RS011 (JH095) Rockshelter**

RPS Bylong RPS011 was accessed from Road 05, a graded access track for the drilling rigs. This site was identified on the 20<sup>th</sup> May 2014 in Week 1 of the survey. The rockshelter is 1.6 m in height, 2.1 m in depth and 7.6 m in width (**Plate 57**) and has a northerly aspect (**Plate 58**). It was estimated that the sediment covering the floor of the shelter had a depth of approximately 5 cm. An isolated artefact (IF012) was associated with this site (RPS Bylong IF012). The GSV and GSE were low between the site and the graded track due to very dense leaf litter, fallen branches and trees. The vegetation community in the area is characterised by new growth eucalypts, black cypress pines and acacia shrubs. Some native grasses and small shrubs are present in the understorey.

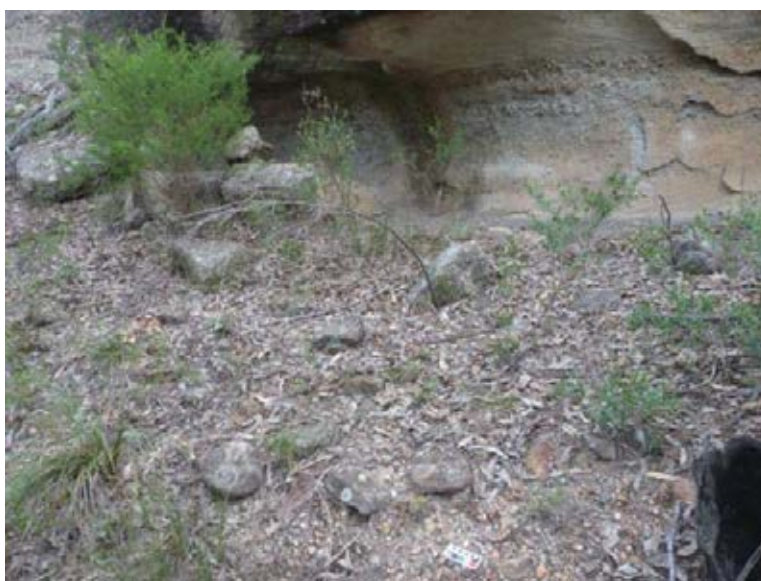
**Plate 58 North aspect from the shelter showing isolated artefact amongst leaf litter in the foreground**

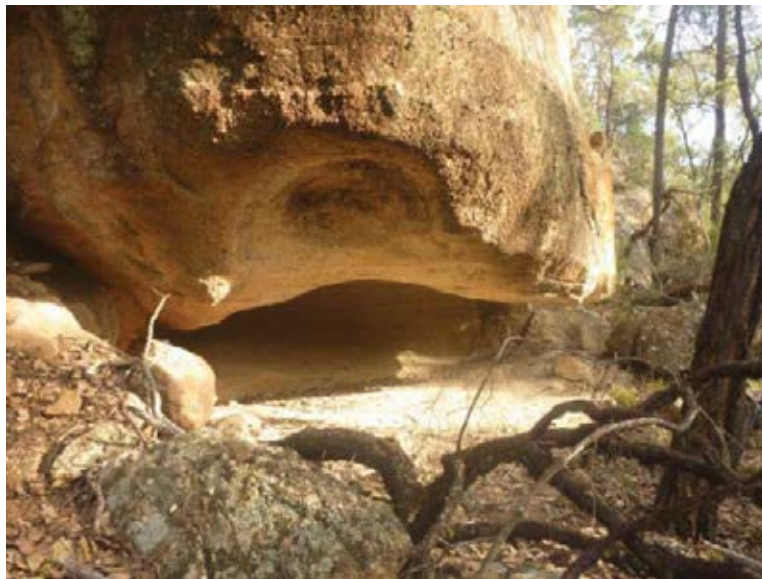
Plate 63 RPS Bylong RS013 (PS126) Rockshelter

RPS Bylong RS013 was accessed from Road 07, a graded access track for the drilling rigs. This site was identified on the 27<sup>th</sup> May 2014 in Week 5 of the survey. The rockshelter is 1.14 m in height, 4.66 m in width and 5.15 m in depth (**Plate 63**) and has a north easterly aspect (**Plate 64**). The sediment forming the PAD was between 5 and 10 cm throughout the site. There were two quartz artefacts located in this rockshelter. The GSV and GSE were low between the site and the graded track due to very dense leaf litter, fallen branches and trees. The vegetation community in the area is characterised by new growth eucalypts, black cypress pines and acacia shrubs. Some native grasses and small shrubs are present in the understorey.

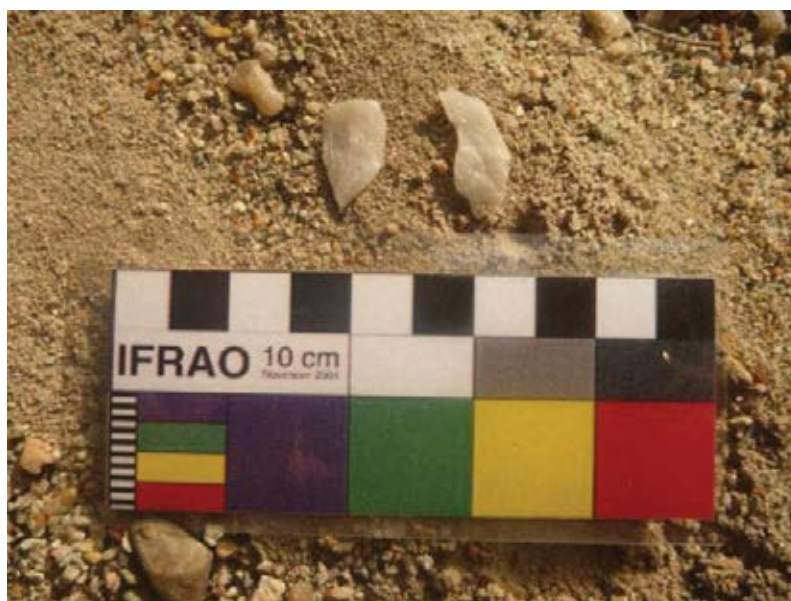
Plate 64 Two quartz artefacts in rockshelter

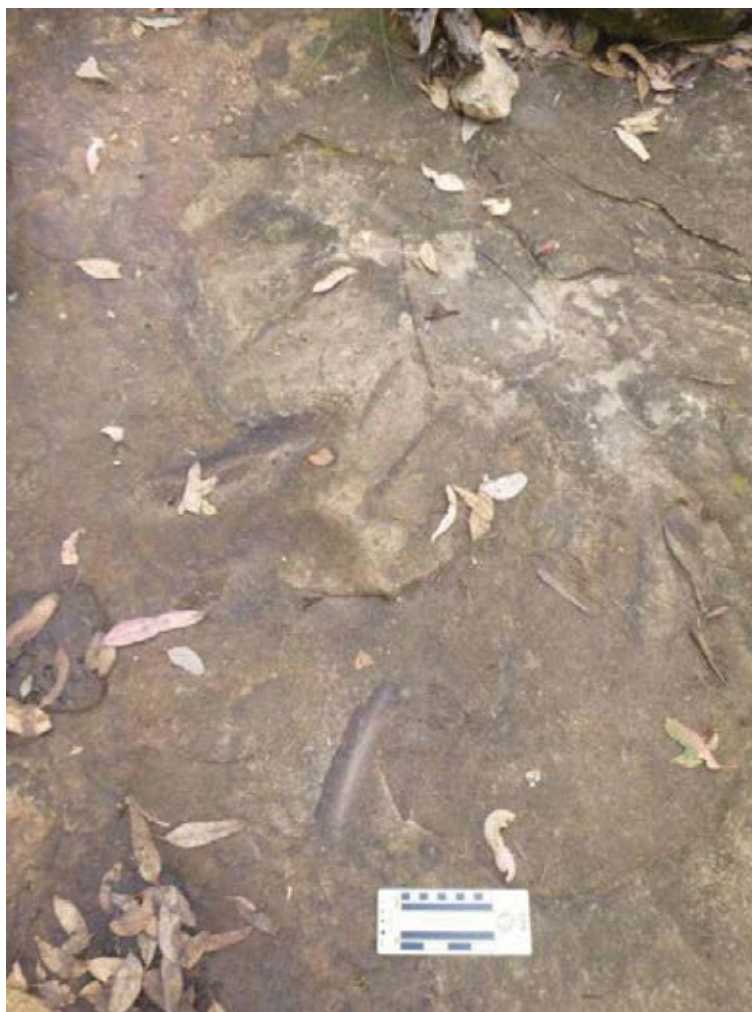
Plate 65 RPS Bylong GG001 (KG073) Grinding Grooves
