# Aboriginal Archaeology and Cultural Heritage Impact Assessment

# Bylong Coal Project

### Bylong Coal Project AACHIA - Mid Western Local Government Area

Client Manager: Darrell Rigby  
Report Number: PR113279  
Version / Date: Final March 2015

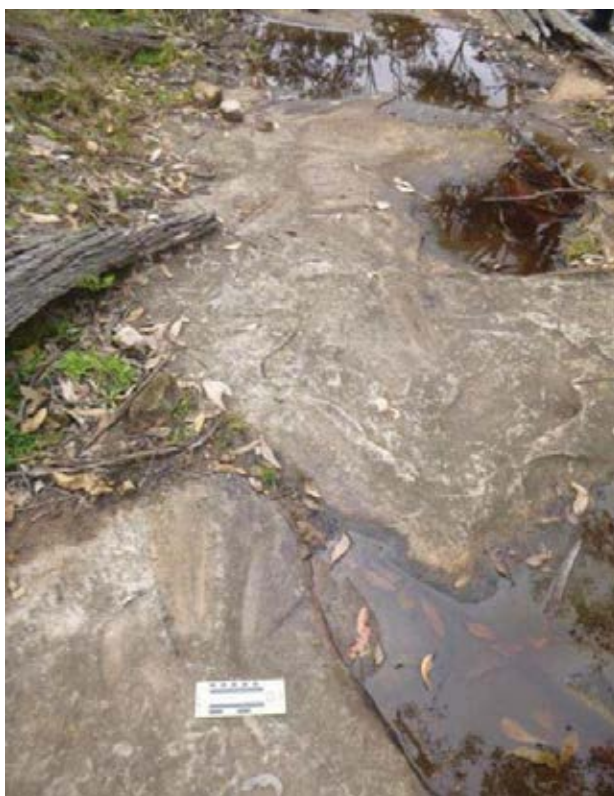
Plate 67 RPS Bylong GG002 (KG074) Grinding grooves and ground basins

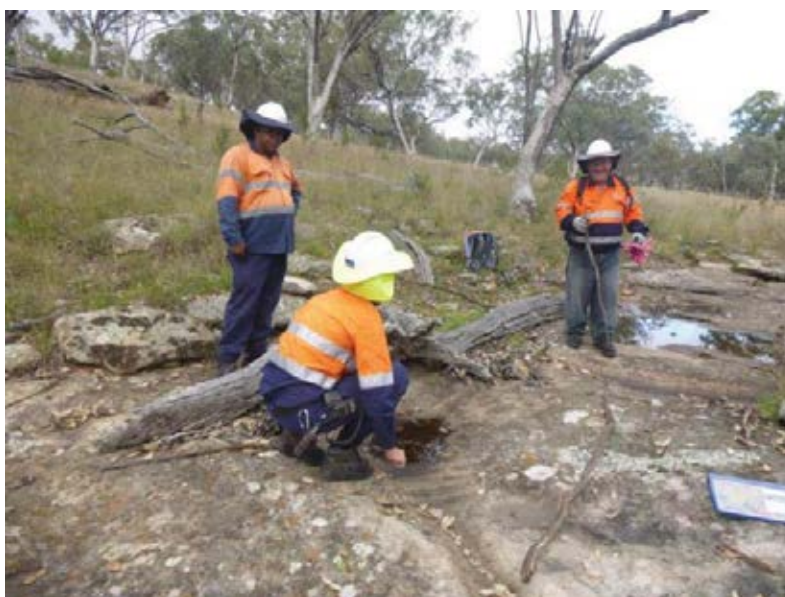
Plate 69 RPS Bylong GG003 (PS072) Grinding Grooves

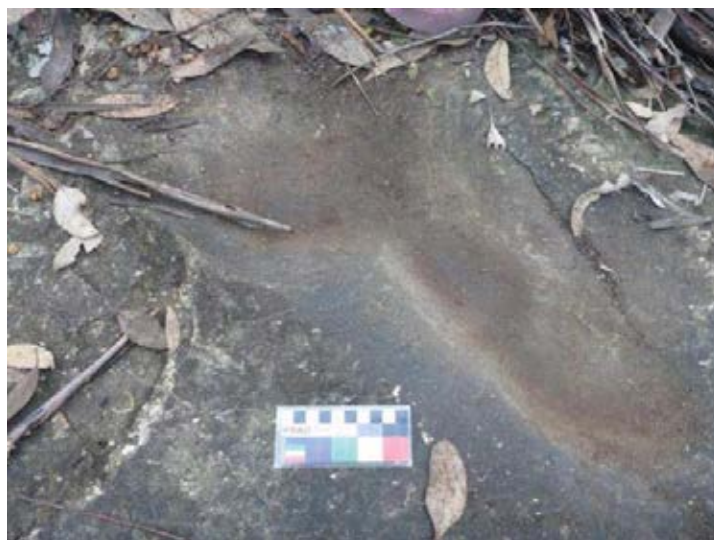
Plate 71 RPS Bylong GG004 (PS109) Grinding grooves

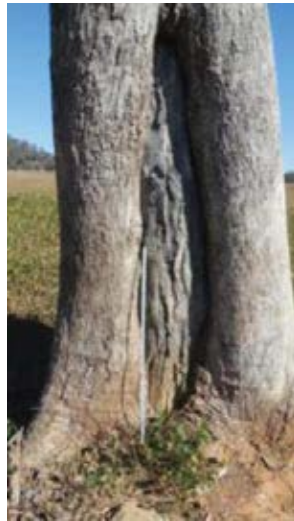
Plate 73 RPS Bylong MT005 Scarred Tree (Cultural Scar)

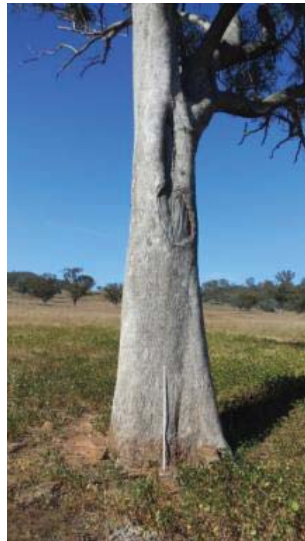
Plate 74 RPS Bylong MT005 Scarred Tree, showing scar resulting from damage (not culturally modified)

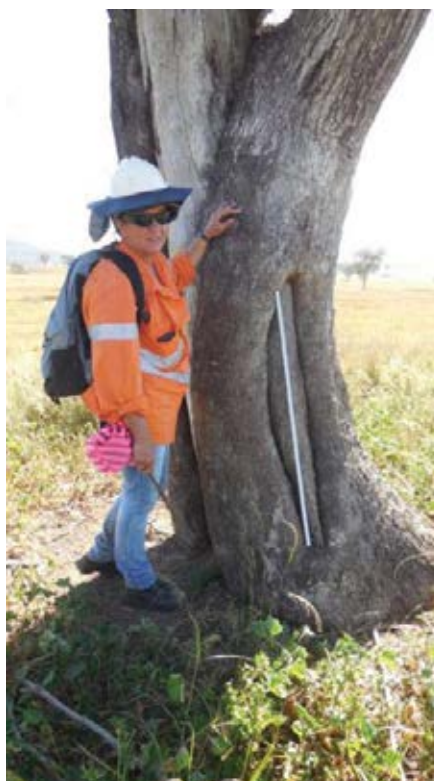
**Plate 75 Scarred Tree MT07 (with Christine Maynard – Mudgee LALC)**

RPS Bylong MT07 is a scarred tree located in a large open paddock on the east boundary, south of Woolley's Rd. The scar is 1.11 metres in height, 23 cms in width, 12 cms in thickness and 22 cms from the base (**Plate 75** and **Plate 76**). The scar has a westerly aspect. The GSV and GSE were low in the general area due to dense pasture grasses. The only exposures in the area were the vehicle access tracks, contour bans and farm dams.

This tree was verified by aborist Danny Draper (25 June 2014), Urban Tree Management Australia.

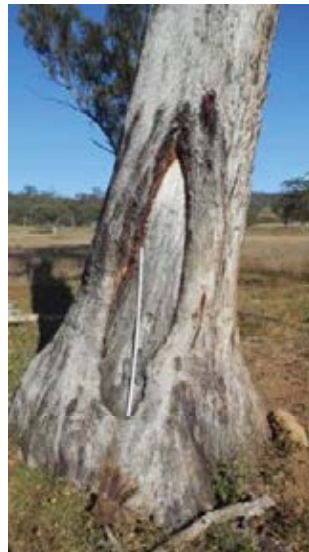
**Plate 77 MT08 Scarred Tree**

RPS Bylong MT08 was a scarred tree located in a large open paddock on the east boundary, south of Woolley's Rd. The scar is 1.54 metres in height, 38 cms in width, 10 cms in thickness and 42 cms from the base (**Plate 77** and **Plate 78**). The scar has a westerly aspect. The GSV and GSE were low in the general area due to dense pasture grasses. The only exposures in the area were the vehicle access tracks, contour bans and farm dams. On the 25<sup>th</sup> of June 2014, Danny Draper, an arborist with UTMA (Urban Tree Management Australia) confirmed that this is a culturally modified scar.

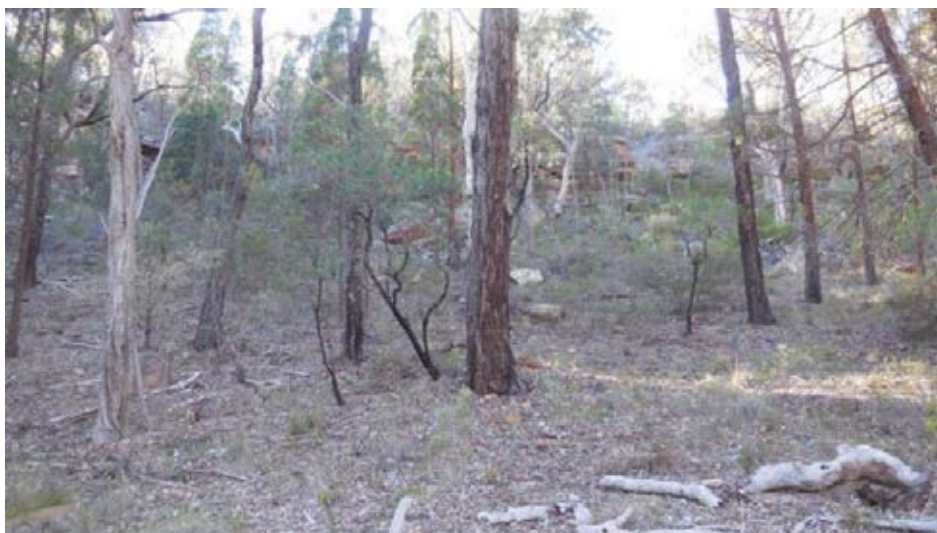
Plate 79 RPS Bylong OQ001 (KG019) in the background of the surrounding landscape

The ochre quarry (RPS Bylong OQ001) has been assessed as being of high regional significance. It is recommended that all reasonable and feasible actions be taken to avoid impacts to this site. If impacts cannot be avoided then engineering solutions to prevent rockfall and cracking are to be considered, in addition to the proposed full archival recording.

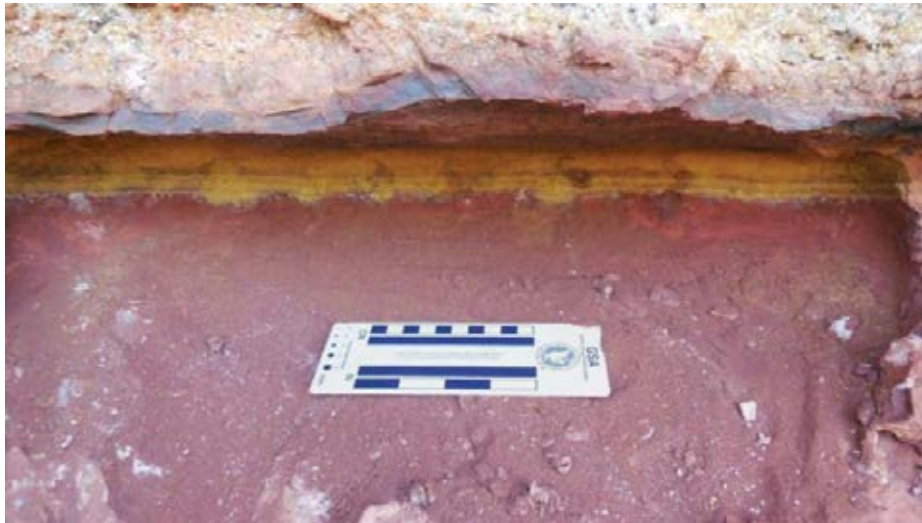
**Plate 81 Close up of ochre**

RPS Bylong OQ001 was accessed via Road 06, a graded access track, across a moderate slope and up onto the ridgeline (**Plate 79**). This site was identified on the 21<sup>st</sup> May 2014 in Week 1 of the survey. The area covered by this site is over 80 m in length and 2 m in width. There were small niches observed where ochre collection had occurred. A number of different coloured ochres occur in this one location, which indicates that this is a site of high significance. There are coloured ochres that have significance to both male and female ceremonial events, such as red ochre for men, and yellow and purple ochre for women. Variations of orange, white and black ochre were also present. The vegetation community in the area is characterised by new growth eucalypts and black cypress pines. Some native grasses and small shrubs are also present on the slope leading up to the ridge where the quarry is located.

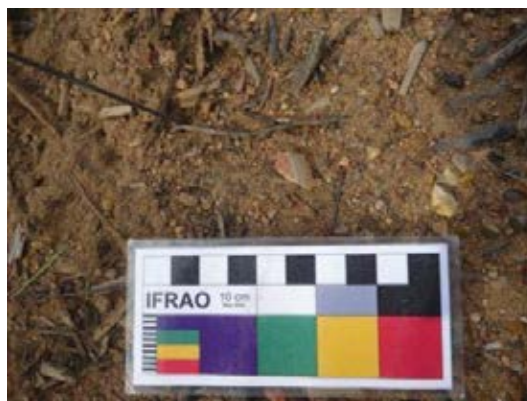
**Plate 84 Artefact identified at RPS Bylong AS016 (JH 005)**

RPS Bylong AS016 is a small artefact scatter, located on Road 04 (**Plate 83**), adjacent to an ephemeral creek. It consists of two mudstone flakes that conjoin, with one fragment measuring 2.5 cm by 2 cm and the other 2 cm by 2 cm (**Plate 84 and Plate 85**). This site has an area of 10 m by 5 m and has a north westerly aspect. The artefacts were situated on exposed clay B horizon soils. The GSV and GSE were high along the road due to grading for drill rig access. Leaf litter in the vegetated areas surrounding the site severely reduced the GSV and GSE. The vegetation community in the area is characterised by eucalypts, black cypress pines and acacia shrubs. All mature trees were inspected for cultural scarring, however no scarred trees were identified. Water runoff was noted on the track, demonstrating the erosion and movement of A horizon soils. Disturbances in the area include the use of the access track and erosion by water.

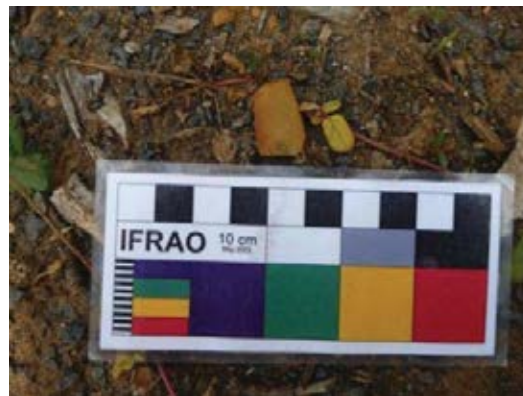
Plate 87 Artefact identified at RPS Bylong IF010  
(JH 007)

RPS Bylong IF010 is an isolated find, located on Road 05 (**Plate 86**), which consists of one mudstone flake, measuring 2.5 cm by 2 cm (**Plate 87**). The site has an extent of 1 m by 1 m. This site has a southerly aspect and the artefact was situated on redeposited A horizon soils. The GSV and GSE were high along the road due to grading for drill rig access. Leaf litter in the vegetated areas surrounding the site severely reduced the GSV and GSE. The vegetation in the area is characterised by by eucalypts, black cypress pines and acacia shrubs. All mature trees were inspected for cultural scarring, however no scarred trees were identified. Water runoff was noted on the track, demonstrating the erosion and movement of A horizon soils. Disturbances include the use of the access track and erosion by water.

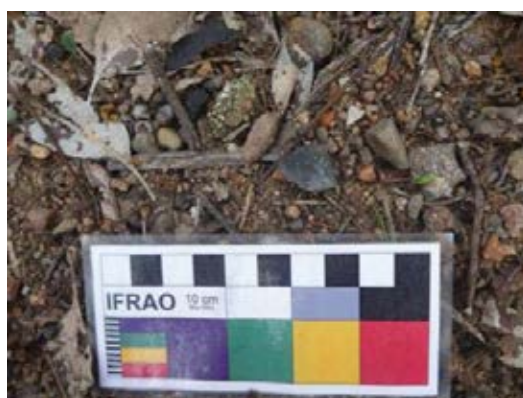
**Plate 89 Artefact identified at RPS Bylong IF011 (JH008)**

RPS Bylong IF011 is an isolated find, located on a mid slope below a ridgeline across from Road 05 (**Plate 88**). It consists of one basalt distal flake, measuring 2.5 cm by 2.5 cm (**Plate 89**). The site has an extent of 1 m by 1 m. The site has a southerly aspect and the artefact was situated on the surface of A Horizon soils. The GSV and GSE were moderate due to trees and shrubs with leaf and branch litter. The vegetation in the area is characterised by eucalypts and a shrubby understorey. No mature trees were present and therefore no culturally scarred trees were identified. The site is situated on a naturally sloping landform with no modifications or disturbance.

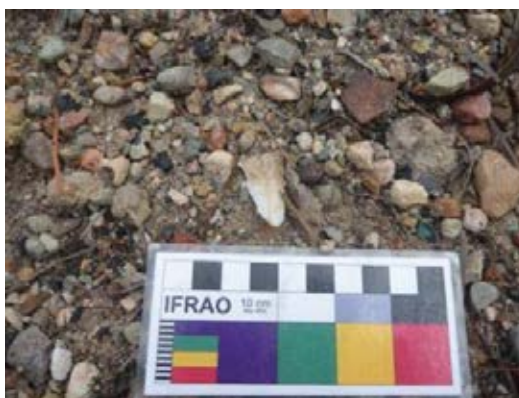
Plate 91 Artefact identified at RPS Bylong IF012 (JH017)

RPS Bylong IF012 is an isolated find, located on a mid slope (**Plate 90**), which consists of one quartz distal flake, measuring 4 cm by 2.5 cm (**Plate 91**). The site has a 1 m by 1 m extent. This site is associated with Rockshelter RPS Bylong RS011. The site has a northern aspect and the artefact was situated approximately 3 m to a rock shelter. The GSV and the GSE were moderate due to new growth trees, with some leaf and branch litter. The vegetation community in the area is characterised by eucalypts, acacias and pines. No mature trees were present and therefore no culturally scarred trees were identified. Water erosion is evident within the rock cavity of RPS Bylong RS011 with possible run off down the slope toward the location of RPS Bylong AS012. Disturbances include sheet wash erosion.

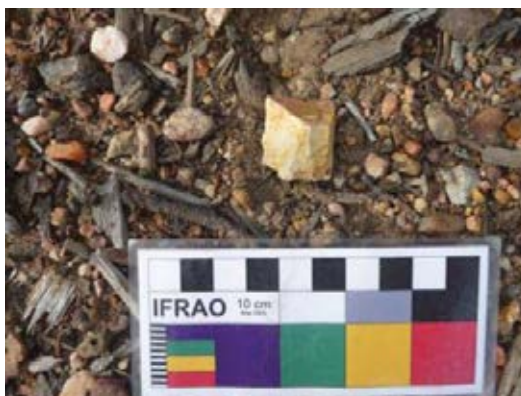
**Plate 93 Artefact identified at RPS Bylong IF013 (JH011)**

RPS Bylong IF013 is an isolated find, located on Road 05 (**Plate 92**), which consists of one mudstone flake, measuring 3 cm by 3 cm (**Plate 93**). The site has an area of 1 m by 1 m and faces north east. The artefact was situated on redeposited A horizon soils. The GSV and GSE were high along the road due to grading for drill rig access. The leaf litter in the vegetated areas surrounding the site severely reduced the GSV and GSE. The vegetation community in the area is characterised by eucalypts, black cypress pines and acacia shrubs. All mature trees were inspected for cultural scarring, however no scarred trees were identified. Water runoff was noted on the track, demonstrating the erosion and movement of A horizon soils. Disturbances include use of the access track and erosion by water.

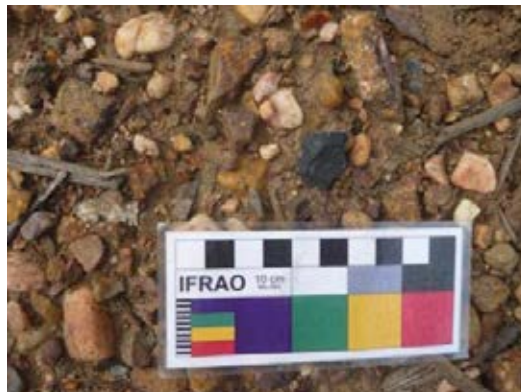
Plate 95 Artefact identified at RPS Bylong IF014 JH012

RPS Bylong IF014 is an isolated find, located on Road 05 (**Plate 94**), which consists of one basalt flake, measuring 3cm in length by 2.5cm in width (**Plate 95**). The site has an extent of 1 m by 1 m and has a northerly aspect. The artefact was situated on clay B Horizon soils. The GSV and GSE were high along the road due to grading for drill rig access. The leaf litter in the vegetated areas surrounding the site severely reduced the GSV and GSE. The vegetation community in the area is characterised by eucalypts, black cypress pines and acacia shrubs. All mature trees were inspected for cultural scarring; however no scarred trees were identified. Water runoff was noted on the track, demonstrating the erosion and movement of A horizon soils. Disturbances include use of the access track and erosion by water.

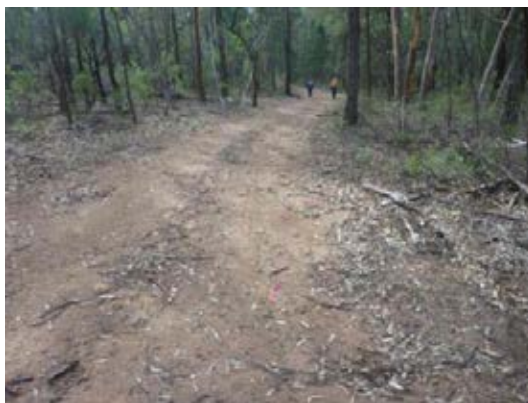
RPS Bylong IF015 is an isolated find consisting of one mudstone flake located on Road 05 (**Plate 96** and **Plate 97**). The site has an extent of 1 m by 1 m., with a northerly aspect, and the artefact was situated on redeposited A horizon soils. The GSV and GSE were high along the road due to grading for drill rig access. Broken branches and leaf litter in the area surrounding this site had severely reduced the GSV and GSE. The vegetation community in the area is characterised by eucalyptus, black cypress pines and acacia shrubs. No mature trees were found to bear signs of cultural scarring or modification. Water run-off was noted along the track, demonstrating the erosion and movement of A horizon soils. Disturbances include access use of the track and erosion by water.

**Plate 96 Site location photo of RPS Bylong IF015 (JH013) view to the north**

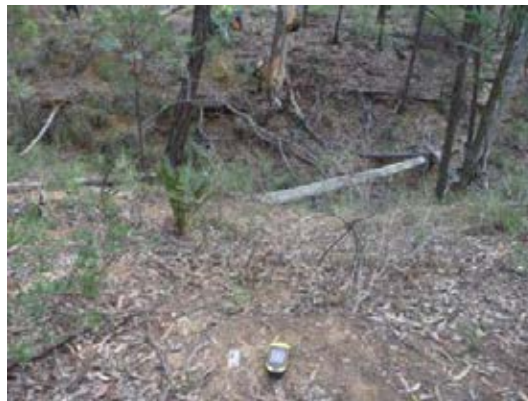
RPS Bylong IF016 is an isolated find, located on a bank adjacent to an ephemeral creek line (**Plate 98**), consisting of one mudstone flake, measuring 4 cm by 5 cm (**Plate 99**). The site has an extent of 1 m by 1 m, with a northerly aspect, and the artefact was situated on redeposited A horizon soils. The GSV and the GSE were moderate due to trees and leaf litter. The vegetation community in the area is characterised by eucalyptus, black cypress pines and acacia shrubs. No mature trees were found to bear signs of cultural scarring or modification. Water run-off was noted along the track, demonstrating the erosion and movement of A horizon soils. Disturbances include use of the access track and erosion by water.

Plate 98 Site location photo of RPS Bylong IF016 (JH014), view to the north

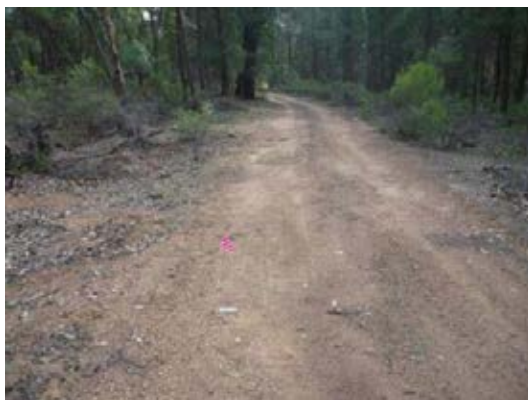
RPS Bylong IF017 is an isolated find, located on Road 05 (**Plate 100**), consisting of one mudstone flake, measuring 4 cm by 3 cm (**Plate 101**). The site has an extent of 1 m by 1 m, with a westerly aspect, and the artefact was situated on redeposited A horizon soils. The GSV and GSE were high along the road due to grading for drill rig access but broken branches and leaf litter in the area surrounding the site had severely reduced the GSV and GSE. The vegetation community in the area is characterised by eucalyptus, black cypress pines and acacia shrubs. No mature trees were found to bear signs of cultural scarring or modification. Water run-off was noted along the track, demonstrating the erosion and movement of A horizon soils. Disturbances include use of the access track and erosion by water.

**Plate 100 Site location photo of RPS Bylong IF017 (JH015), view to the west**

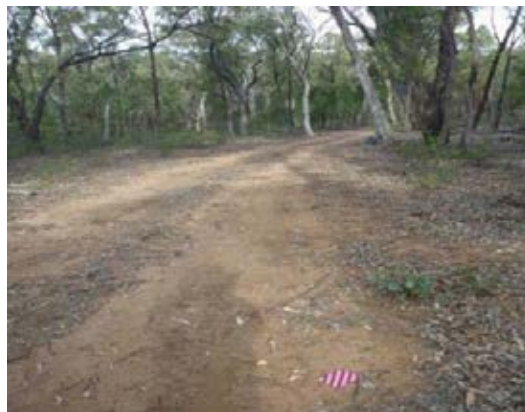
RPS Bylong AS017 was located on Road 05 (**Plate 102**), consisting of one mudstone core measuring 7 cm by 5 cm, two mudstone blades measuring 4 cm by 2 cm and 4.5 cm by 2 cm and four mudstone flakes, two measuring 6 cm by 4 cm and two measuring 2 cm by 2 cm (**Plate 103**). The site has an area of 20 m by 5 m, with a westerly aspect, and the artefacts were situated on exposed clay B horizon soils. The GSV and GSE were high along the road due to grading for drill rig access but broken branches and leaf litter in the area surrounding the site had severely reduced the GSV and GSE. The vegetation community in the area is characterised by eucalyptus, black cypress pines and acacia shrubs. No mature trees were found to bear evidence of cultural scarring or modification. Water run-off was noted along the track, demonstrating the erosion and movement of A horizon soils. Disturbances include use of the access track and water erosion.

**Plate 102 Site location photo of RPS Bylong AS017 (JH016) view to the west.**

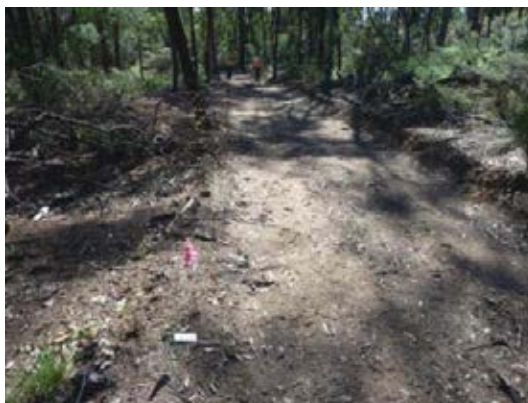
RPS Bylong IF018 was an isolated find, located parallel to Road 05 (**Plate 104**), consisting of one quartz flake measuring 3.5 cm by 2.5 cm (**Plate 105**). The site has an area of 1 m by 1 m, with a northerly aspect, and the artefact was situated on redeposited A horizon soils. Broken branches, tree and rock fall and leaf litter in the area surrounding this site severely reduced the GSV and GSE. The vegetation community in the area is characterised by eucalyptus, black cypress pines and acacia shrubs. No mature trees were found to bear evidence of cultural scarring or modification. Water run-off was noted along the track, demonstrating the erosion and movement of A horizon soils. Disturbances include use of the access track and water erosion, as well as modifications such as the grading of a nearby road.

**Plate 104 Site location photo of RPS Bylong IF018 (JH034), view to the north.**

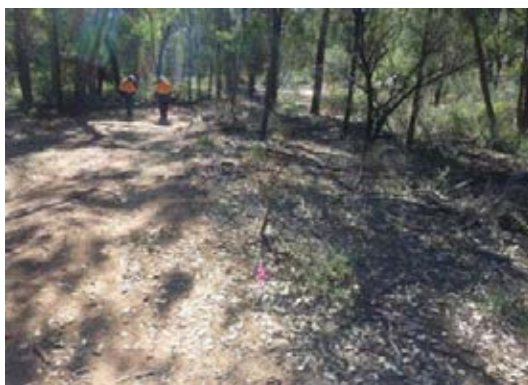
RPS Bylong AS018 is an isolated find, located on Road 06 (**Plate 106**), which consists of one mudstone flake measuring 3.5 cm by 2 cm and one mudstone flake blade 4.5 cm by 2 cm (**Plate 107**). The site has an extent of 5 m by 5 m, with a northerly aspect, and the artefacts were situated on redeposited A horizon soils. The GSV and GSE were high along the road due to grading for drill rig access. Broken branches and leaf litter in the area surrounding this site had severely reduced the GSV and GSE. The vegetation community in the area is characterised by eucalyptus, black cypress pines and acacia shrubs. No mature trees were found to bear evidence of cultural scarring or modification. Water run-off was noted along the track, demonstrating the erosion and movement of A horizon soils. Disturbances include use of the access track and water erosion.

Plate 106 Site location photo of RPS Bylong AS018 (JH018), view to the north.

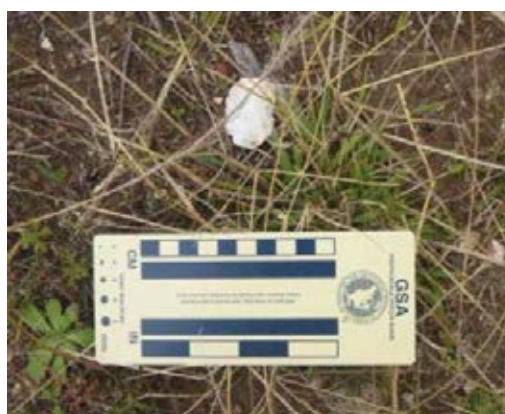
**Plate 109 Artefact identified at RPS Bylong IF019 (KG116)**

RPS Bylong IF019 is an isolated find located on a vehicle access track in the southwest corner of the possible subsidence longwall area (**Plate 108**). This site consists of one mudstone flake, measuring 4 cm in length and 3 cm in width (**Plate 109**). The site has an extent of 1 m by 1 m, with a south-easterly aspect. The artefact was situated on redeposited A horizon soils atop exposed clay B horizon soils. The GSV and GSE were moderate due the exposed B horizon soils on the access track. The GSV and GSE surrounding the site were low, due to the dense pasture grass. Disturbances in the area included land clearance, cattle grazing and access track usage.

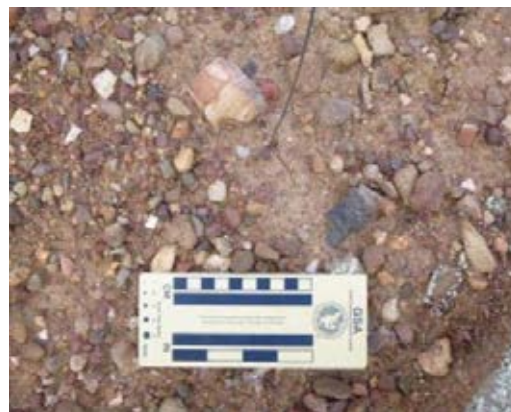
**Plate 111 Example of artefacts identified at RPS Bylong AS019 (KG117)**

RPS Bylong AS019 is a small artefact scatter, located on the slope of a dam north of Bylong Valley Way (**Plate 110**). The scatter consists of three mudstone artefacts, including one mudstone core, measuring 4.5 cm in length and 4 cm in width (**Plate 111**). The site has an extent of 1 m by 1 m, with a westerly aspect. The artefacts were situated on exposed clay 'B' horizon soils and the GSV and GSE surrounding the site were moderate, due to the exposed farm dam banks. Disturbances in the area included the modification of the landscape to create the dam and cattle grazing.

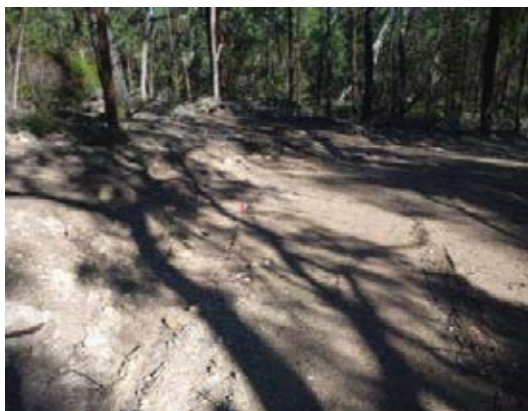
RPS Bylong IF020 is an isolated find, located on Road 02 (**Plate 112**), consisting of one siltstone broken blade measuring 6 cm by 3 cm (**Plate 113**). The site has an extent of 1 m by 1 m, with a westerly aspect, and the artefact was situated on exposed clay B horizon soils. The GSV and GSE were high along the Road due to grading for drill rig access. Broken branches and leaf litter in the area surrounding this site had severely reduced the GSV and GSE. This area is populated with eucalyptus, black cypress pines and acacia shrubs. No mature trees were identified as culturally scarred. Water run-off was noted along the track, demonstrating the erosion and movement of A horizon soils. Disturbance includes access track use and water erosion.

**Plate 112 Site location photo of RPS Bylong IF020 (JH024), view to the west.**

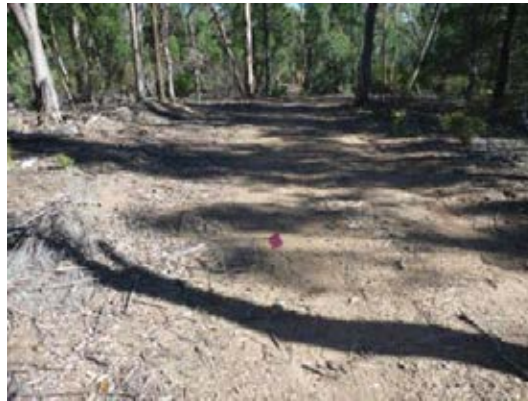
RPS Bylong IF021 is an isolated find, located on Road 02 (**Plate 114**), consisting of one siltstone flake measuring 2 cm by 2 cm (**Plate 115**). The site has an extent of 1 m by 1 m, with a westerly aspect, and the artefact was situated on redeposited exposed B horizon soils. The GSV and GSE were high along the road due to grading for drill rig access. Broken branches and leaf litter in the area surrounding this site had severely reduced the GSV and GSE. The vegetation in the area is characterised by eucalyptus, black cypress pines and acacia shrubs. No mature trees were found to bear evidence of cultural scarring or modification. Water run-off was noted along the track, demonstrating the erosion and movement of A horizon soils. Disturbances include use of the access track and water erosion.

**Plate 114 Site location photo of RPS Bylong IF021 (JH025), view to the west.**

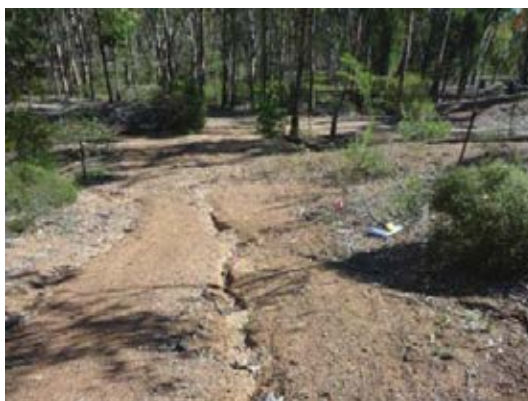
RPS Bylong AS020 is an artefact scatter, located on Road 03 (**Plate 116**), consisting of one mudstone flake, one mudstone core measuring 6.5 cm by 5 cm, and one pair of conjoining pieces measuring 4.5 cm by 4 cm and 4 cm by 2 cm (**Plate 117**). The site has an extent of 20 m by 3 m, with a southerly aspect and the artefacts were situated on exposed clay B horizon soils. The GSV and GSE were high along the road due to grading for drill rig access. Broken branches and leaf litter in the area surrounding this site had severely reduced the GSV and GSE. The vegetation in the area is characterised by eucalyptus, black cypress pines and acacia shrubs. No mature trees were found to bear evidence of cultural scarring or modification. Water run-off was noted along the track, demonstrating the erosion and movement of A horizon soils. Disturbances include use of the access track and water erosion.

**Plate 116 Site location photo of RPS Bylong AS020 (JH026), view to the south.**

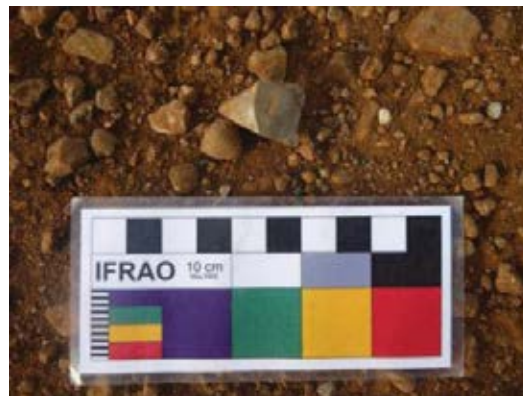
**Plate 119 Artefact identified at RPS Bylong IF022 (JH029)**

RPS Bylong IF022 is an isolated find, located on Road 18 (**Plate 118**), consisting of one volcanic flake measuring 3 cm by 3 cm (**Plate 119**). The site has an extent 1 m by 1 m, with a southerly aspect and the artefact was situated on exposed B horizon soils. The GSV and GSE were high along the road due to grading for drill rig access. The GSV and GSE in the surrounding area were low due to the very dense pasture grasses on either side of the road. Disturbances include use of the access track and water erosion.

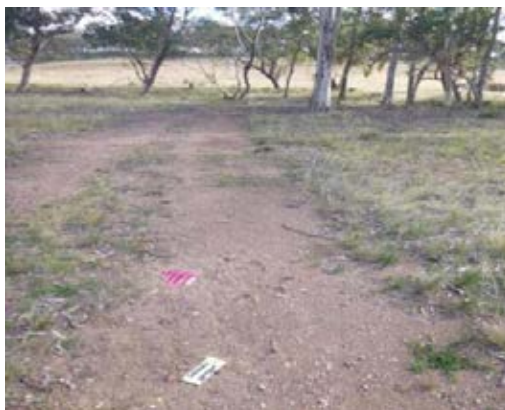
RPS Bylong IF023 is an isolated find located on a well used vehicle access track in the southwest corner of the possible subsidence longwall area (**Plate 120**). It consists of one broken mudstone flake (**Plate 121**). The artefact fragment is 4.5 cm in length and 3 cm in width. The site has an extent of 1 m by 1 m, with a westerly aspect and the artefact was situated on exposed clay 'B' horizon soils, due to use of the vehicle track. While the track was exposed, the GSV and GSE surrounding the site were low, due to dense pasture grasses. Disturbances include the use of the access track and water erosion.

**Plate 120 Site location photo of RPS Bylong IF023 (KG114), view to the west.**

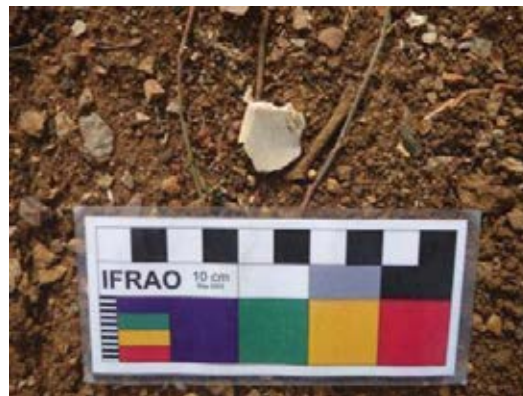
Plate 123 Artefact identified at RPS Bylong IF024 (JH031)

RPS Bylong IF024 is an isolated find located on a vehicle access track to the east of Road 18, at the water tanks (**Plate 122**). It consisted of one chert flake measuring 2.5 cm by 2.5 cm (**Plate 123**). The site has an extent of 1 m by 1 m, with a westerly aspect, and the artefact was situated on exposed B horizon soils. The GSV and GSE were moderate along the access track. The GSV and GSE in the surrounding area were low due to the very dense pasture grasses on either side of the track. Disturbances include use of the access track and water erosion.

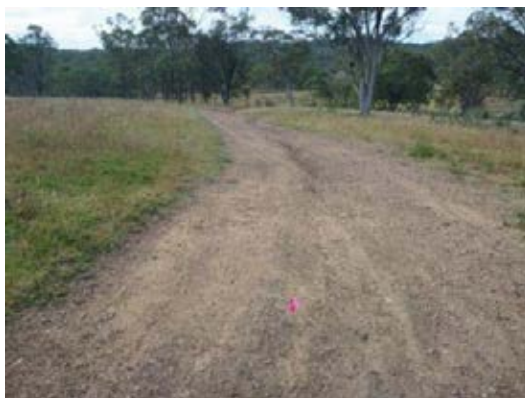
RPS Bylong AS021 is a small artefact scatter, located on a vehicle access track to the east of road 18, at the water tanks (**Plate 124**). It consists of one mudstone core measuring 6 cm by 6 cm and one mudstone flake measuring 3 cm by 2.5 cm (**Plate 125**). The site has an extent of 5 m by 5 m, with a westerly aspect, and the artefacts were situated on exposed B horizon soils. The GSV and GSE were moderate along the track with low GSV and GSE either side of track due to tall, dense pasture grasses. A small number of mature eucalyptus trees were observed in the area but none were observed to possess cultural scarring. Disturbances include use of the access track and water erosion.

**Plate 124 Site location photo of RPS Bylong AS021 (JH032), view to the west.**

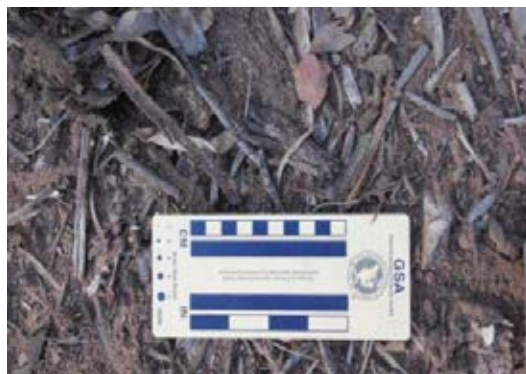
**Plate 129 Example of artefacts identified at RPS Bylong AS023 (KG003)**

RPS Bylong AS023 is a small artefact scatter, located on Road 04 (**Plate 128**), consisting of two mudstone flakes.. One flake had a length and width of 2.5cm (**Plate 129**), while the other had a length of 5.5 cm and a width of 3.5 cm. The site has an extent of 30 m by 5 m, with a northerly aspect and the scatter was situated on exposed B horizon soils. The GSV and GSE were high along the access track but were low off the track, due to the high density of leaf litter, fallen branches and rock tumble. No mature trees were found to bear evidence of cultural scarring or modification. There was evidence of water run-off along the track in the more recent past. Disturbances in the area included the grading of the drill rig access road on which the scatter was observed.

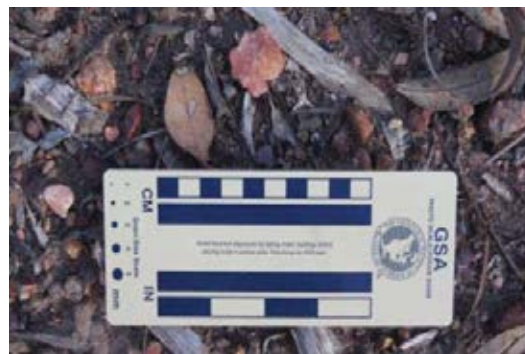
**Plate 131 Artefact identified at RPS Bylong IF025 (KG005)**

RPS Bylong IF025 was an isolated find located on Road 04 (**Plate 130**), consisting of one mudstone flake that measured 3 cm in length and 2.5 cm in width (**Plate 131**). This site has an extent of 1 m by 1 m, with a northerly aspect, and was situated on exposed B horizon soils. The GSV and GSE were high along the road where vegetation had been cleared. In the area near the site, the GSV and GSE were severely reduced, due to dense leaf litter. Water run-off was noted on the track, demonstrating the erosion and movement of A horizon soils. Disturbances in the area included the grading of the drill rig access road on which the scatter was observed.

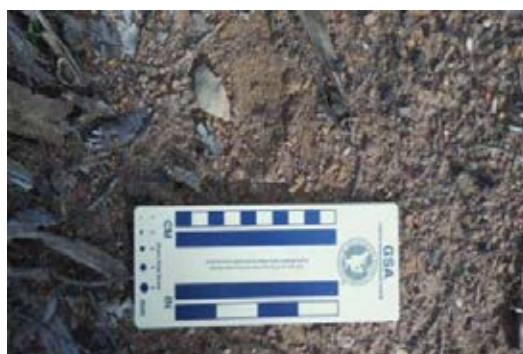
**Plate 133 Artefact identified at RPS Bylong IF026 (KG006)**

RPS Bylong IF026 is an isolated find located on Road 04 (**Plate 132**), consisting of one mudstone flake (**Plate 133**). The artefact measured 3.5 cm in length and 2 cm in width. This site has an extent of 1 m by 1 m, with a northerly aspect, and the artefact was situated on exposed B horizon soils. The GSV and GSE were high along the graded road but the surrounding GSV and GSE were severely reduced due to dense leaf litter and tree fall debris. Water run-off was noted on the track, demonstrating the erosion and movement of A horizon soils. Disturbances were predominantly associated with the graded road, as well as sheet wash erosion.

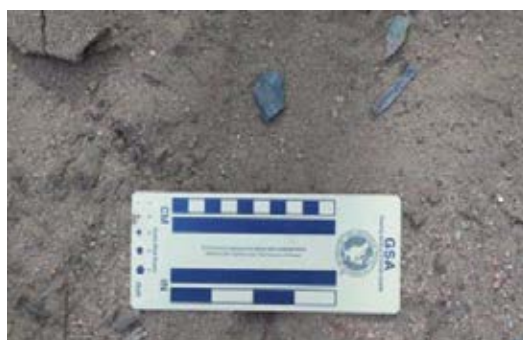
**Plate 135 Artefact identified at RPS Bylong IF027 (KG007)**

RPS Bylong IF026 is an isolated find located on Road 04 (**Plate 134**), consisting of one broken proximal flake (**Plate 135**). The artefact fragment measured 2 cm in length and 2 cm in width. This site has an extent of 1 m by 1 m, with a northerly aspect, and the artefact was situated on exposed B horizon soils. The GSV and GSE were high along the graded road but the surrounding GSV and GSE were severely reduced due to dense leaf litter and tree fall debris. Water run-off was noted on the track, demonstrating the erosion and movement of A horizon soils. Disturbances were predominantly associated with the graded road, as well sheet wash erosion.

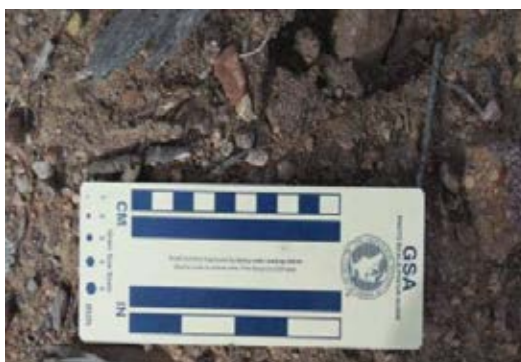
**Plate 137 Example of artefacts identified at RPS Bylong AS024 (KG008)**

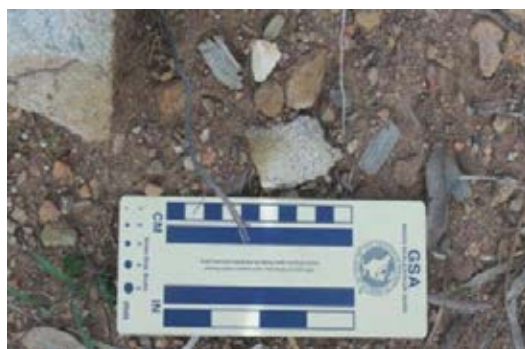
**Plate 139 Example of artefacts identified at RPS Bylong AS025 (KG011)**

RPS Bylong AS025 is a small artefact scatter located on Road 05 (**Plate 138**), consisting of three broken mudstone flakes (measuring respectively 2.5 cm by 2 cm, 3 cm by 1.5 cm and 1.5 cm by 2 cm) (**Plate 139**). This site has an extent of 15 m by 15 m, with a northerly aspect, and the artefacts are situated on exposed B horizon soils. The GSV and GSE were high along the graded road, however the GSV and GSE for the location of the site were reduced due to dense leaf litter and fallen tree debris. Water run-off was noted on the track demonstrating the erosion and movement of A horizon soils. Disturbances were predominantly associated with the graded access road for the drilling rigs, as well as sheet wash erosion.

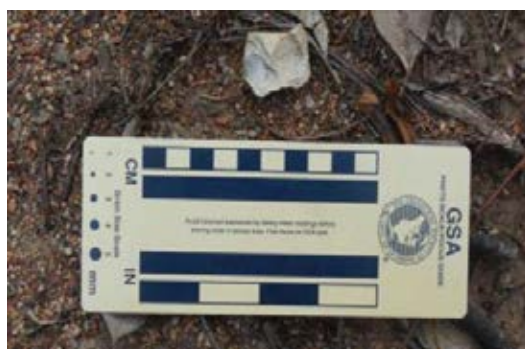
**Plate 141 Example of artefacts identified at RPS Bylong AS026 (KG012)**

RPS Bylong AS026 is a small artefact scatter located on Road 05 (**Plate 140**), consisting of three broken mudstone flakes (measuring length by width respectively 4.5 cm by 2.5 cm, 5 cm by 3 cm and 1.5 cm by 1.5 cm), one quartz flake (1.5 cm by 1 cm) and one mudstone core (measuring 2.5 cm by 4 cm) (**Plate 141**). This site has an extent of 20 m by 5 m, with a north-westerly aspect, and the artefacts were situated on exposed B horizon soils. The GSV and GSE were high along the graded road, however the GSV and GSE in the surrounding area were low, due to leaf litter and fallen tree debris. Water run-off was noted on the track, demonstrating the erosion and movement of A horizon soils. Disturbances include the graded access road for the drilling rig and sheet wash erosion.

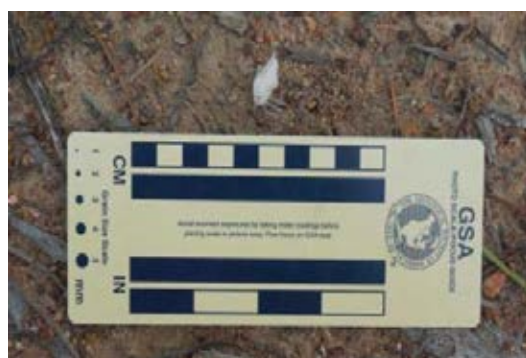
Plate 143 Example of artefacts identified at RPS Bylong AS027 (KG013)

Approximately 50 artefacts were located at this site in approximately 3284 square metres. At the time of recording it, the road on which this site was located was closed.

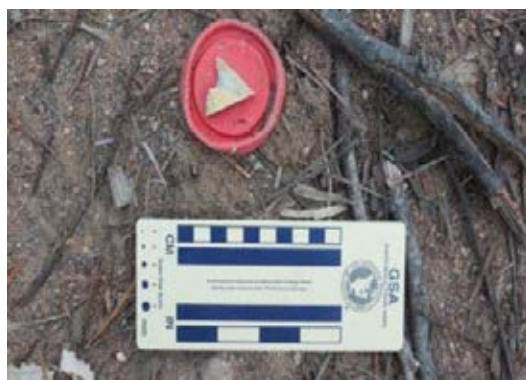
**Plate 145 Example of artefacts identified at RPS Bylong AS028 (KG016)**

RPS Bylong AS028 is a small artefact scatter located on Road 05 (**Plate 144**), consisting of one mudstone flake (measuring 3.5 cm in length and, 2.5 cm in width), one mudstone manuport (7 cm by 5 cm) and one silcrete flake (6 cm by 4 cm) (**Plate 145**). This site has an extent of 80 m by 15 m with a north-west aspect, and the artefacts were situated on exposed B horizon soils. The GSV and GSE were high along the graded track but were reduced in the area of the site due to the presence of leaf litter. Water run-off was noted on the track demonstrating the erosion and movement of A horizon soils. Disturbances include the graded road for the drilling rig and sheet wash erosion.

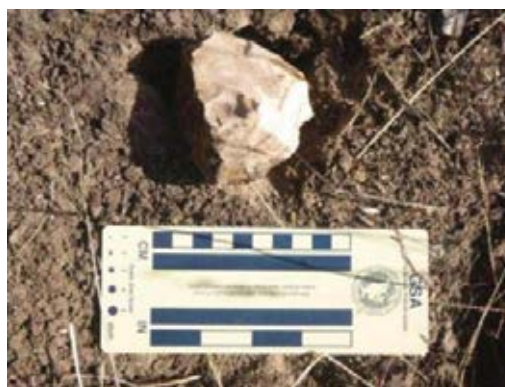
**Plate 147 Artefact identified at RPS Bylong IF028 (KG113)**

RPS Bylong IF028 is an isolated find located on a vehicle access track in the southwest corner of the possible subsidence longwall area (**Plate 146**). It consists of one mudstone core (**Plate 147**). The site has an extent of 1 m by 1 m, with a westerly aspect, and the artefact was situated on exposed clay B Horizon soils. The GSV and GSE were moderate along the track, but were greatly reduced off the track due to dense pasture grasses. Disturbances include vehicle use on the track and extensive cattle grazing.

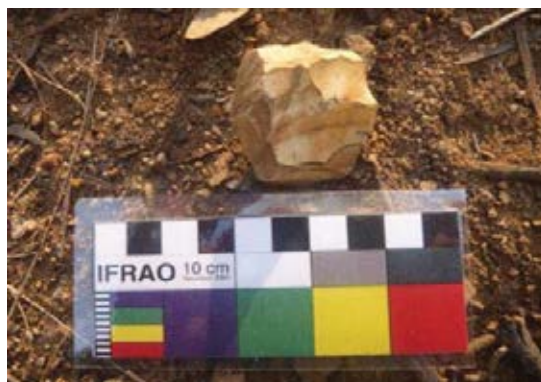
**Plate 189 Artefact identified at RPS Bylong IF042 (PS124)**

RPS Bylong IF042 is an isolated find located on Road 07 on a mid slope (**Plate 188**), consisting of one mudstone core measuring 5.5 cm by 5 cm (**Plate 189**). The site has an extent of 1 m by 1 m with a south westerly aspect, and the artefact was situated on exposed clay B horizon soils. The GSV and GSE were high at the site due to sheet wash erosion and use of the track, which exposed the B horizon soils but were low surrounding the site due to dense vegetation, including eucalyptus and black cypress pines, medium sized acacias and native grasses. Disturbances include use of the vehicle track.

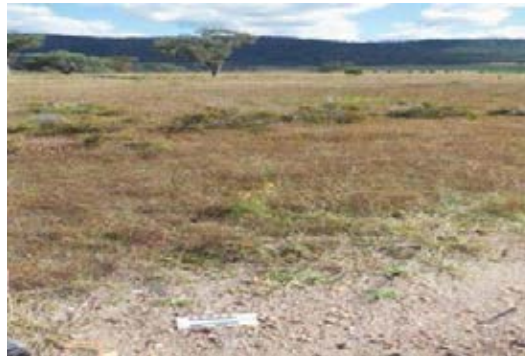
Plate 190 Site location photo of RPS Bylong IF043 (KG055), view to the west.

RPS Bylong IF043 is an isolated find and was located on a vehicle access track in a paddock located along the south edge of Tal Tal Mountain (**Plate 190**). It consists of one tuff proximal flake, measuring 2.5 cm by 1.5 cm (**Plate 191**). The site has an extent of 1 m by 1 m with a westerly aspect and the artefact was situated on exposed clay B horizon soils. The GSV and GSE were moderate across the site area due to exposures of soil on the contour bank. In the surrounding area, the GSV and GSE were low due to dense pasture grasses. Disturbances include the use of the track and extensive cattle grazing.

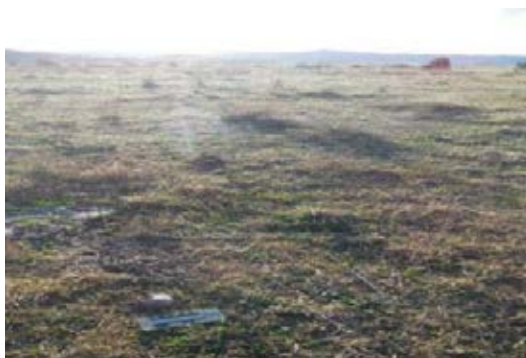
**Plate 192 Site location photo of RPS Bylong IF044 (KG056), view to the north-west.**

RPS Bylong IF044 is an isolated find located in an open field (**Plate 192**), which consists of one mudstone core, measuring 9 cm by 8 cm (**Plate 193**). The site has an extent of 1 m by 1 m with a north westerly aspect and the artefact was situated on A horizon soils. The GSV and GSE were low across the site and the surrounding area due to dense pasture grasses. Disturbances include extensive vegetation clearing for farming purposes and cattle grazing.

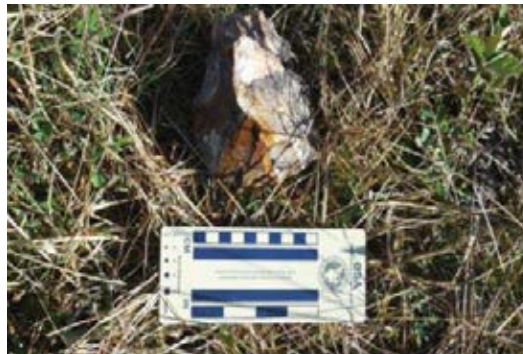
**Plate 194 Artefact identified at RPS Bylong IF045  
(KG057)**

045 is an isolated find located on a sloping overgrown vehicle track, which consisted of one mudstone core, measuring 14 cm by 10 cm (**Plate 194**). The site has an extent of 1 m by 1 m with a westerly aspect and the artefact was situated on A horizon soils. The GSV and GSE were low across the site and the surrounding area due to dense pasture grasses. Disturbances include extensive vegetation clearing for farming purposes and cattle grazing.

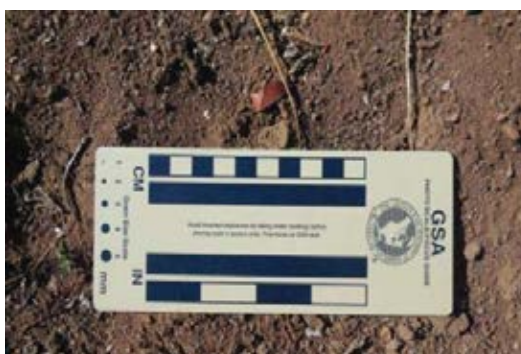
**Plate 196 Artefacts identified at RPS Bylong IF046 (KG059).**

RPS Bylong IF046 is an isolated find located in an open paddock (**Plate 195**), which consists of one mudstone flake, measuring 2 cm by 2 cm (**Plate 196**). The site has an extent of 1 m by 1 m, with a north westerly aspect and the artefact was situated on exposed clay B horizon soils. The GSV and GSE were moderate across the site due to soil exposure, however the GSV and GSE of the surrounding area were low due to dense pasture grasses. Disturbances include extensive vegetation clearing for farming purposes and cattle grazing.

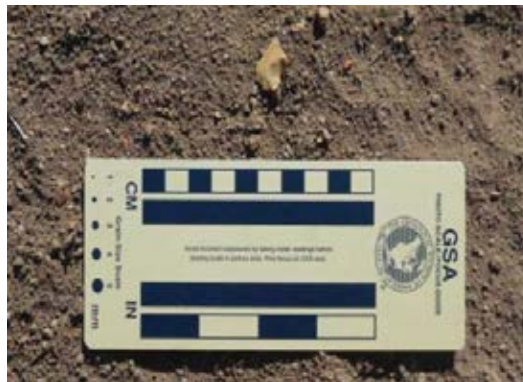
Plate 198 Artefact identified at RPS Bylong IF047 (KG060)

RPS Bylong IF047 is an isolated find located on the main access track to the west of Upper Bylong Road (**Plate 197**), consisting of one mudstone flake, measuring 2.5 cm by 2 cm (**Plate 198**). The site has an extent of 1 m by 1 m with a north westerly aspect and the artefact was situated on exposed clay B horizon soils. The GSV and GSE were high across the site due to the use of the vehicle access track, which has exposed the clay B horizon soils, but were low in the surrounding areas due to the presence of pasture grasses. Disturbances include extensive vegetation clearing, use of the access track and cattle grazing.

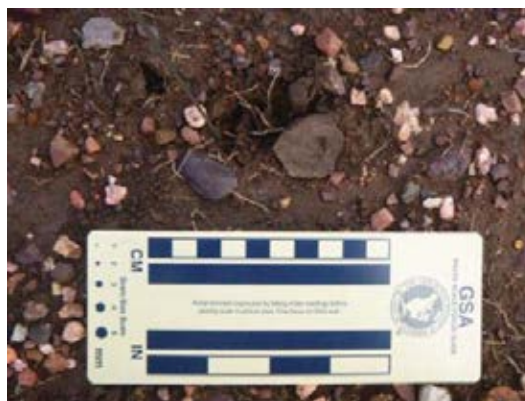
**Plate 200 Example of artefacts identified at RPS Bylong AS036 (KG062)**

RPS Bylong AS036 is a small artefact scatter located on a vehicle access track (**Plate 199**) which consists of two fine-grained volcanic flakes (measuring 3.5 cm by 2 cm and 3 cm by 3 cm) and one chert flake (2.5 cm by 2 cm) (**Plate 200**). The site has an extent of 30 m by 5 m with a northerly aspect and the artefacts were situated on A horizon soils which has been redeposited atop exposed clay B horizon clays. The GSV and GSE were moderate across the track as a result of use by vehicles and low in the surrounding area, due to very tall and dense pasture grasses. Disturbances include extensive vegetation clearance, use of the access track and cattle grazing.

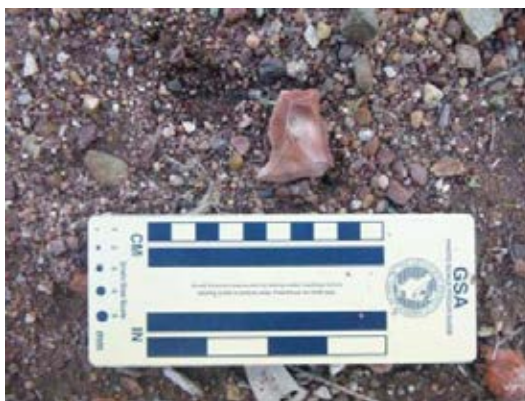
**Plate 204 Example of artefacts identified at RPS Bylong AS037 (KG064)**

RPS Bylong AS037 is a small artefact scatter located on a vehicle access track (**Plate 203**), which consists of two fine-grained volcanic flakes and one mudstone flake, measuring 4 cm by 3.5 cm (**Plate 204**). The site has an extent of 5 m by 5 m with a north westerly aspect and the artefacts were situated on A horizon soils which had been redeposited atop exposed clay B horizon clays. The GSV and GSE were moderate across the track area due to the exposed clay B horizon and were low in the surrounding area due to the presence of leaf litter and dense low grasses. Disturbances include extensive vegetation clearance, use of the access track and cattle grazing.

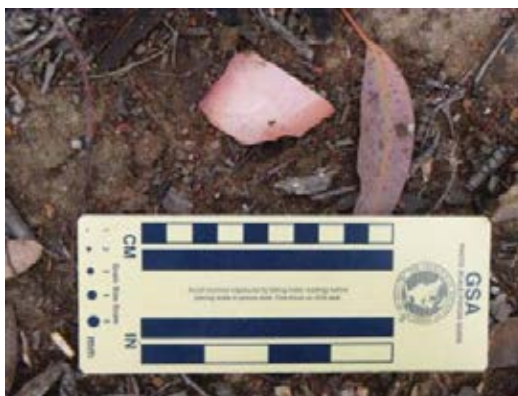
**Plate 208 Example of artefacts at RPS Bylong AS038 (KG066)**

RPS Bylong AS038 is a small artefact scatter located on an overgrown access track (**Plate 207**), which consists of four mudstone flakes. Measurements of two of the flakes were taken, one measuring 4.5 cm by 4 cm and the other 3 cm by 2 cm (**Plate 208**). The site has an extent of 10 m by 10 m, with an easterly aspect, and the artefacts were situated on A horizon soils which had been redeposited atop exposed clay B horizon soils. The GSV and GSE were moderate across the track area as a result of vehicle use, but were low in the surrounding area due to leaf litter and low but densely growing grasses. Disturbances include extensive vegetation clearing, use of the access track and cattle grazing.

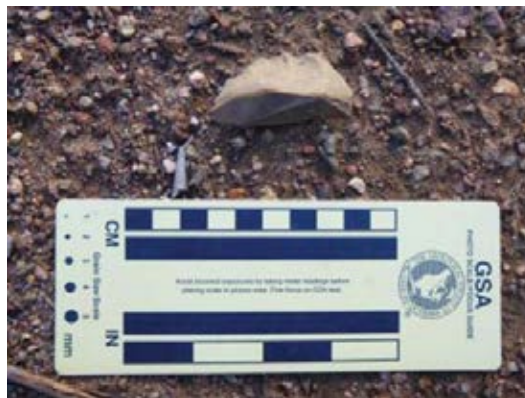
**Plate 210 Example of artefacts identified at RPS Bylong AS039 (KG067)**

RPS Bylong AS039 was a large artefact scatter located on a vehicle access track north west of Roads 01 & 02 (**Plate 209**), consisting of thirty mudstone flakes (**Plate 210**). Some of the artefacts recorded included: one glass flaked artefact measuring 3 cm by 2.5 cm, one mudstone flake measuring 4 cm by 2.5 cm, another mudstone flake measuring 4.5 cm by 2 cm and a mudstone core measuring 6 cm by 4.5 cm. The site has an extent of 120 m by 15 m with a westerly aspect, and the artefacts were situated on A horizon soils which had been redeposited atop exposed clay B horizon soils. The GSV and GSE were high across the track due to use of the area by vehicles and low in the surrounding area due to leaf litter and low growing, dense grasses. Disturbances include extensive vegetation clearing, use of the access track and cattle grazing.

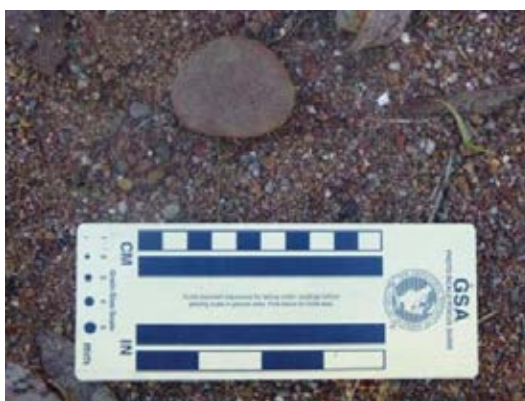
**Plate 212 Artefact identified at RPS Bylong IF050 (KG068)**

RPS Bylong IF050 is an isolated find located on a cattle trail, consisting of one possible sandstone manuport, measuring 5.5 cm by 5 cm. The site has an extent of 5 m by 5 m with a westerly aspect, and the artefact was situated on A horizon soils which had been redeposited atop exposed clay B horizon soils. The GSV and GSE were moderate across the track due to erosion and damage by water and the presence of cattle, but were low in the surrounding area due to leaf litter and low growing, dense grasses. Disturbances include extensive vegetation clearing, use of the access track and cattle grazing.

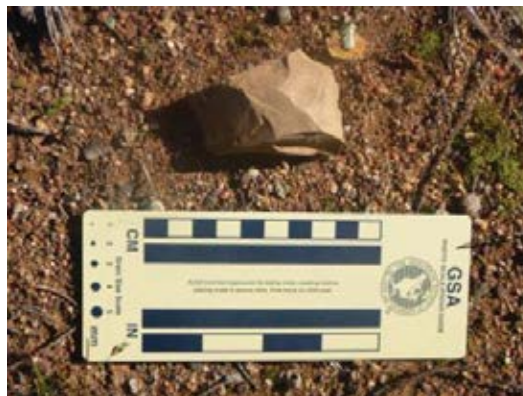
Plate 214 Artefact identified at RPS Bylong IF051 (KG069)

RPS Bylong IF051 is an isolated find located in an open paddock (**Plate 213**), which consists of one mudstone core, measuring 7.5 cm by 5 cm (**Plate 214**). The site has an extent of 1 m by 1 m with a northerly aspect, and the artefact was situated on A horizon soils which had been redeposited atop exposed clay B horizon soils. The GSV and GSE at the site and in the surrounding area were low, due to leaf litter and low growing, dense grasses. Disturbances include extensive vegetation clearance and cattle grazing.

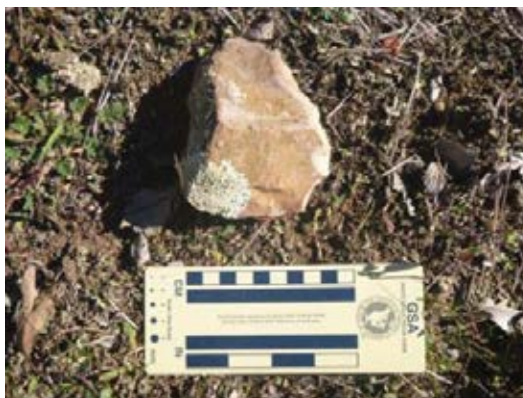
**Plate 216 Artefact identified at RPS Bylong IF052 (KG070)**

052 is an isolated find located in an open area (**Plate 215**), which consists of one mudstone core, measuring 12 cm by 9 cm (**Plate 216**). The site has an extent 1 m by 1 m with an easterly aspect, and the artefact was situated on A horizon soils which had been redeposited atop exposed clay B horizon soils. The GSV and GSE at the site and in the surrounding area were low, due to leaf litter and low growing, dense grasses. Disturbances include extensive vegetation clearance and cattle grazing.
