# Aboriginal Archaeology and Cultural Heritage Impact Assessment

# Bylong Coal Project

### Bylong Coal Project AACHIA - Mid Western Local Government Area

Client Manager: Darrell Rigby  
Report Number: PR113279  
Version / Date: Final March 2015

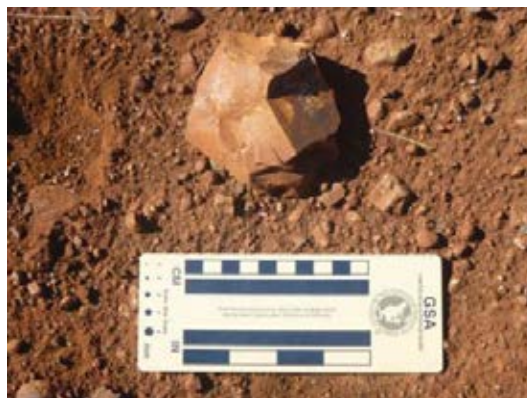
Plate 218 Artefact identified at RPS Bylong IF053 (KG071)

RPS Bylong IF053 is an isolated find located in an open area (**Plate 217**), consisting of one mudstone core, 9.5 cm by 9 cm (**Plate 218**). The site has an extent of 1 m by 1 m with a westerly aspect, and the artefact was situated on A horizon soils which had been redeposited atop exposed clay B horizon soils. The GSV and GSE were high across the track due to erosion, while they were low in the surrounding areas as a result of tall, dense pasture grasses. Disturbances include extensive vegetation clearing and cattle grazing.

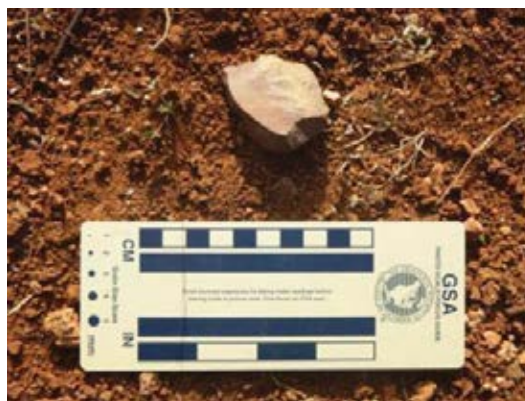
**Plate 220 Artefact identified at RPS Bylong IF054 (KG072)**

RPS Bylong IF054 is an isolated find located on a farm dam embankment (**Plate 219**), which consists of one silcrete flake, measuring 5 cm by 3.5 cm (**Plate 220**). The site has an extent of 1 m by 1 m with a north westerly aspect, and the artefact was situated on A horizon soils which had been redeposited atop exposed clay B horizon soils. The GSV and GSE were moderate around the dam due to the works associated with the dam construction and use of the area by livestock. However, in the surrounding areas, the GSV and GSE low due to dense pasture grasses. Disturbances include the modification of the land for the creation of the dam embankments.

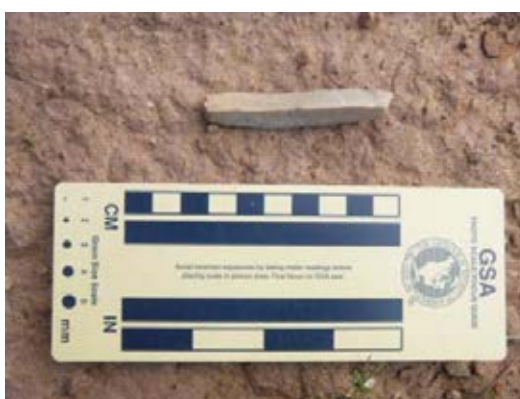
**Plate 222 Example of artefacts identified at RPS Bylong AS040 (KG109)**

RPS Bylong AS040 is a large artefact scatter and PAD (**Plate 221**). The scatter consists of twenty artefacts including quartz, mudstone and chert flakes and blades (**Plate 222**). Some of the artefacts recorded included one quartz core measuring 5 cm by 4.5 cm, one mudstone blade measuring 7 cm by 1.5 cm, one mudstone flake 4 cm by 2.5 cm, another mudstone flake 4 cm by 2.5 cm and one quartz flake 3.5cm by 3cm. The site has an extent of 50 m by 50 m with a westerly aspect, and the artefact scatter was situated on a contour bank with exposed clay B horizon soils. During the construction of the contour bank, a portion of the PAD had been cut, resulting in the presence of surface artefacts along the surface of the bank. The GSV and GSE were moderate on the contour bank but low for the PAD as this area was covered in dense grasses. Furthermore, the GSV and GSE surrounding the site were also low due to the presence of dense grasses. Disturbances include the modification of the land in order to create the contour bank, particularly at the location of the PAD.

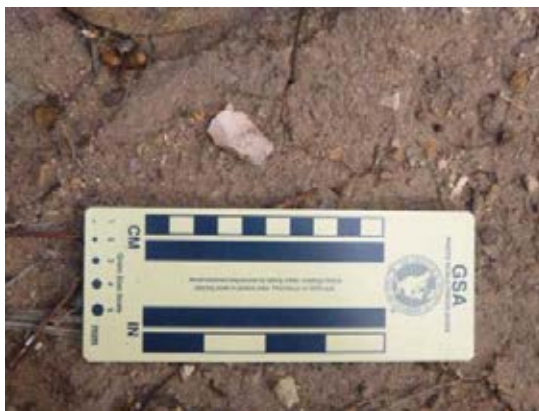
**Plate 224 Example of artefacts identified at RPS Bylong AS041 (KG107)**

RPS Bylong AS041 is a small artefact scatter located on a vehicle access track (**Plate 223**), which consists of three broken mudstone flakes, one of which measures 3 cm by 2.5 cm (**Plate 224**). The site has an extent of 20 m by 5 m with a southerly aspect and the artefacts were situated on exposed clay B horizon soils. The GSV and GSE were moderate at the site due to sheet water erosion and use of the track, which have exposed B horizon soils, however, the GSV and GSE surrounding the site were low due to dense leaf litter, tree fall debris and native grasses and shrubs. Disturbances include sheet water erosion and use of the track by vehicles.

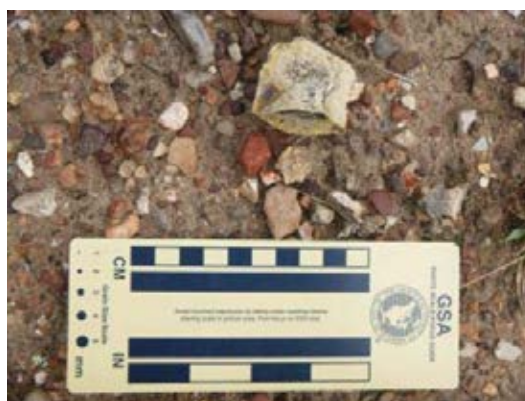
Plate 226 Example of artefacts identified at RPS Bylong AS042 (KG075)

RPS Bylong AS042 is a small artefact scatter located above a first order drainage channel (**Plate 225**), consisting of three mudstone flakes, measuring 4 cm by 4 cm, 3 cm by 2 cm and 4.5 cm by 3 cm (**Plate 226**). This artefact scatter is associated with three grinding groove sites (RPS Bylong GG001, RPS Bylong GG002 and RPS Bylong GG003). The site has an extent of 10 m by 10 m, with a south westerly aspect. The GSV and GSE were low across the site and surrounding areas due to the presence of dense grasses, broken branches and leaf litter. Disturbances include extensive cattle grazing and modification from agricultural practices.

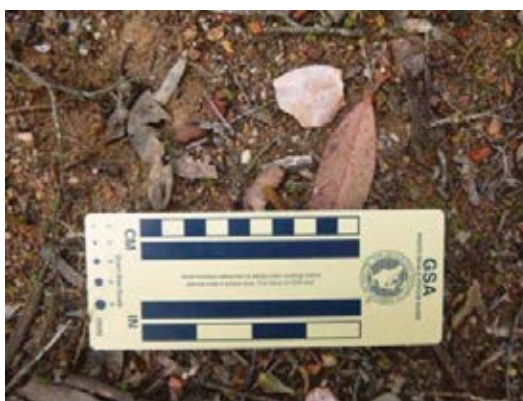
**Plate 228 Artefact identified at RPS Bylong IF055 (KG076)**

RPS Bylong IF055 is an isolated find located along an animal track (**Plate 227**), which consists of one mudstone flake, measuring 3.5 cm by 3.5 cm (**Plate 228**). The site has an extent of 1 m by 1 m, with a westerly aspect, and the artefact was situated on A horizon soils which had been redeposited atop exposed clay B horizon soils. The GSV and GSE were low along the track and in the surrounding areas due to leaf litter, bark, medium sized shrubs and low growing grasses, although there were some patches of exposed B horizon soil.

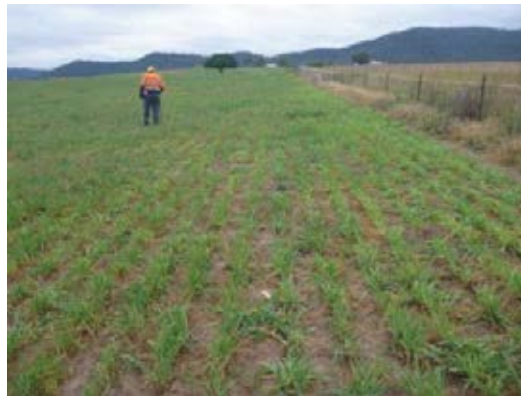
Plate 314 Site location photo of RPS Bylong IF081 (PS059), view to the west.

RPS Bylong IF081 is an isolated find located in the furrows of a harvested oat field (**Plate 314**). It consists of one mudstone flake with usewear measuring 4 cm by 5 cm (**Plate 315**). The site has an extent of 1 m by 1 m with an open aspect and the artefact was situated on exposed soil. The GSV and GSE were low due to the remains of the harvest and the ploughed furrows in the exposed soils. In the areas surrounding the site, GSV and GSE were also very low. Disturbances include cattle grazing and sheet wash as well as modifications to the land resulting from cultivation practices.

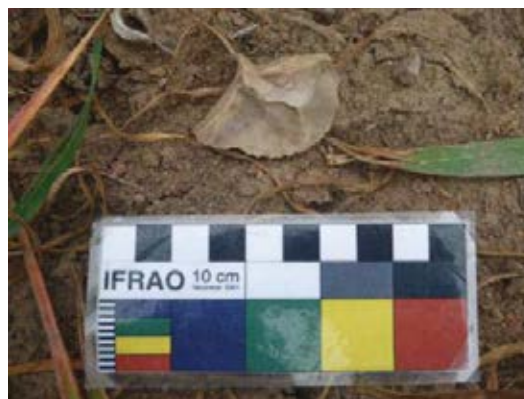
Plate 315 Artefact identified at RPS Bylong IF081 (PS059)

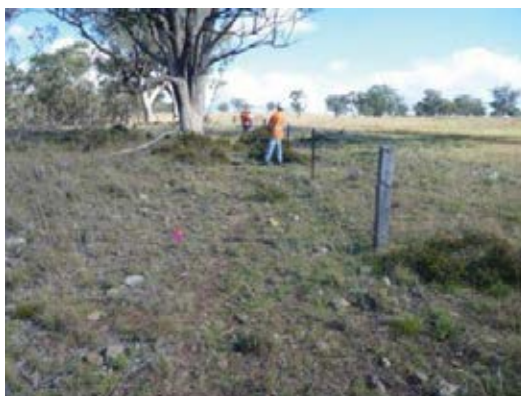
**Plate 316 Site location photo of RPS Bylong IF082 (PS060), view to the north-west.**

RPS Bylong IF082 is an isolated find located on a moderate slope adjacent to a fence line (**Plate 316**), consisting of one mudstone flake measuring 7 cm by 3 cm (**Plate 317**). The site has an extent of 1 m by 1 m with an open aspect and the artefact was situated on A horizon soils which had been redeposited atop clay B horizon soils. The GSV and GSE at the site and in the surrounding areas were low due to dense pasture grasses and leaf litter. Disturbances include the presence of cattle trails and sheet wash.

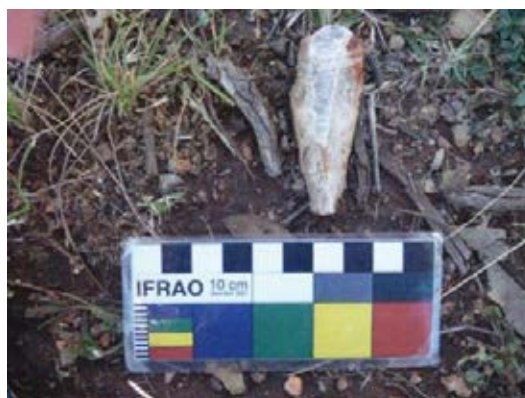
**Plate 317 Artefact identified at RPS Bylong IF082 (PS060)**

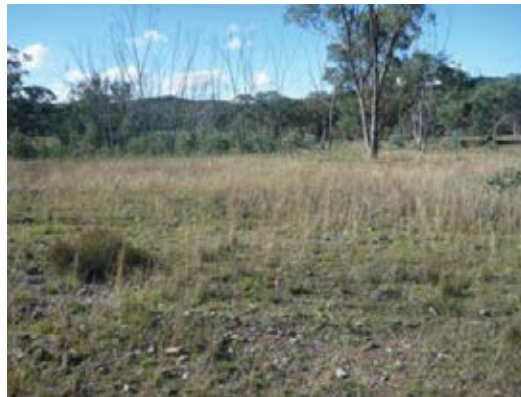
Plate 318 Site location photo of RPS Bylong IF083 (PS061), view to the east.

RPS Bylong IF083 is an isolated find located on a moderate slope adjacent to a fence line (**Plate 318**), which consists of one mudstone flake measuring 7 cm by 6 cm (**Plate 319**). The site has an extent of 1 m by 1 m with an easterly aspect, facing down to a creek line and the artefact was situated on redeposited A horizon soils atop clay B horizon soils. The GSV and GSE at the site and surrounding areas were low due to dense pasture grasses and leaf litter. Disturbances include the presence of cattle trails and sheet wash.

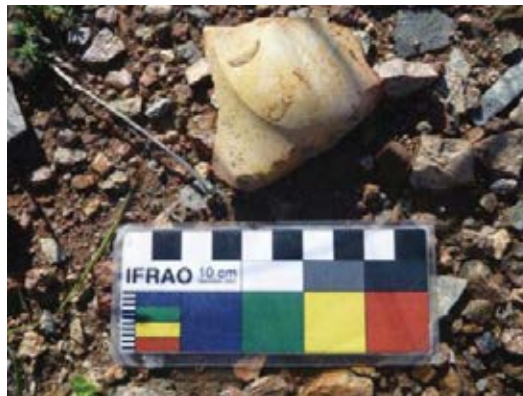
Plate 319 Artefact identified at RPS Bylong IF083 (PS061)

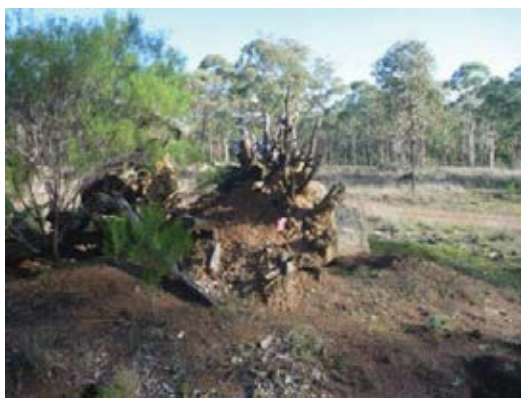
**Plate 320 Site location photo of RPS Bylong IF084 (PS062), view to the north-west.**

RPS Bylong IF084 is an isolated find located at the base of a felled tree next to a vehicle access track (**Plate 320**). The site has an extent of 1 m by 1 m and consists of one mudstone core measuring 3.5 cm by 3 cm by 2 cm (**Plate 321**). The location has a north westerly aspect facing down to a creek line and the artefact was situated on redeposited soil. The GSV and GSE were low at the site and in the surrounding areas due to dense pasture grasses and leaf litter, except along the access track. Disturbances include cattle trails and sheet wash erosion, as well as historical tree felling.

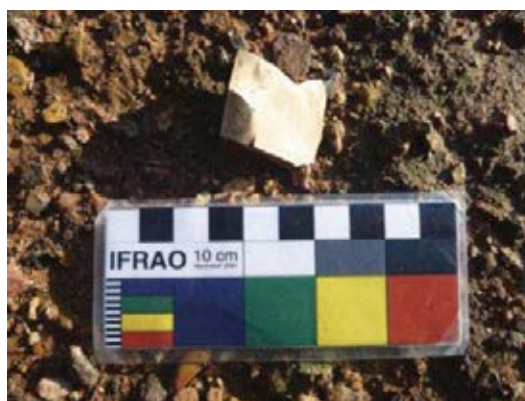
**Plate 321 Artefact identified at RPS Bylong IF084 (PS062)**

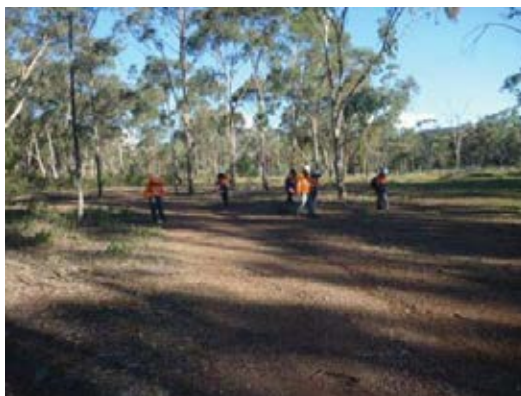
Plate 322 Site location photo of RPS Bylong AS060 (PS063), view to the north.

RPS Bylong AS060 is a large artefact scatter located in the east corner of the proposed longwall subsidence area, on a vehicle access track west of the major roads (**Plate 322**). It consists of twenty flakes, cores and backed blades, although more artefacts may occur in the vicinity (**Plate 323**). Artefacts recorded included two mudstone backed blades measuring 4 cm by 2 cm and 5 cm by 2 cm, one mudstone core measuring 5.5 cm by 4 cm by 3 cm and a basalt core measuring 6.5 cm by 4.5 cm by 3 cm. The site has an extent of 50 m by 50 m with a northerly aspect and the artefacts were situated on exposed clay B horizon soils. The GSV and GSE were moderate due to the exposure of the ground surface by vehicle activity. The areas surrounding the site had low GSV and GSE due to the dense pasture grasses and leaf litter. Disturbances include use of the track by vehicles and sheet wash, as well as historical tree felling.

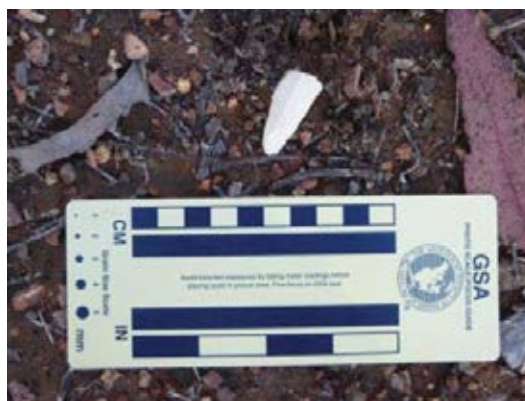
Plate 323 Example of artefacts identified at RPS Bylong AS060 (PS063)

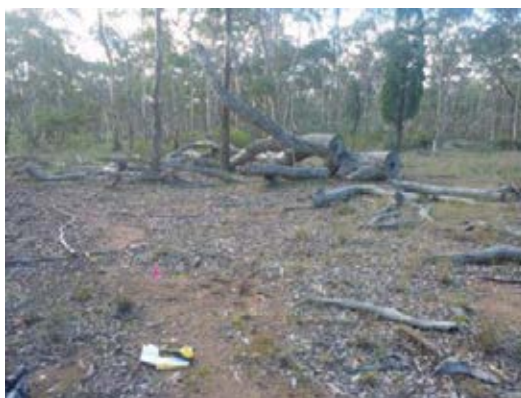
**Plate 324 Site location photo of RPS Bylong IF085 (PS064), view to the north-west.**

RPS Bylong IF085 is an isolated find located on an overgrown access track (**Plate 324**), which consists of one tuff distal flake measuring 5 cm by 3 cm (**Plate 325**). The site has an extent of 1 m by 1 m with a north westerly aspect and the artefact was situated on A horizon soils which had been redeposited atop exposed clay B horizon soils. The GSV and GSE were moderate at the site due to the effects of sheet wash erosion, and low in the surrounding areas as a result of the the dense pasture grasses, fallen tree branches and leaf litter. Disturbances include sheet wash and alterations of the landscape by historical tree felling.

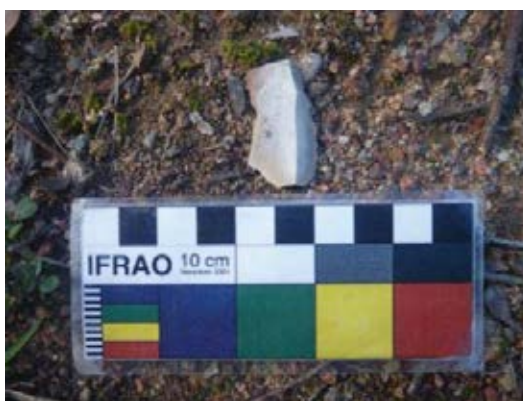
**Plate 325 Artefact identified at RPS IF085 (PS064)**

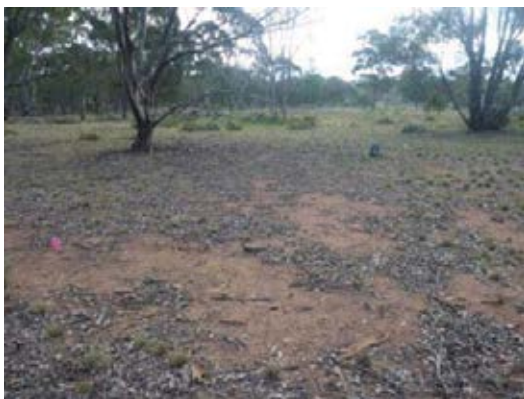
Plate 326 Site location photo of RPS Bylong AS061 (PS065), view to the west.

RPS Bylong AS061 is a small artefact scatter located in a clearing in a forest rehabilitation area (**Plate 326**). It consists of two mudstone flakes measuring 4.5 cm by 4 cm and 2 cm by 2 cm (**Plate 327**). The site has an extent of 15 m by 15 m with a westerly aspect and the artefacts were situated on an exposed area of A horizon soil which had been redeposited atop exposed clay B horizon soils. The GSV and GSE were moderate at the site and low in the surrounding areas due to the dense pasture grasses, fallen tree branches and leaf litter. Disturbances include use of the track by vehicles and sheet wash erosion, as well as alteration of the landscape by historical tree felling.

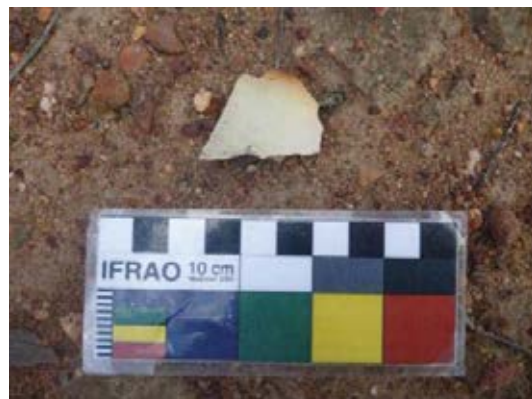
Plate 327 Example of artefacts identified at RPS Bylong AS061 (PS065)

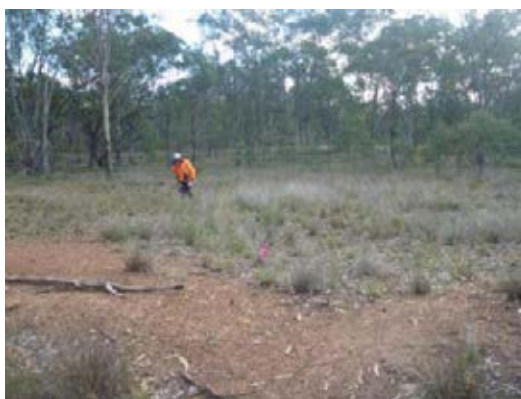
**Plate 328 Site location photo of RPS Bylong AS062 (PS066), view to the west.**

RPS Bylong AS062 is a small artefact scatter located on an ant nest (**Plate 328**), consisting of two quartz flakes measuring 4 cm by 2 cm and 2 cm by 2 cm and one mudstone flake measuring 5 cm by 4 cm (**Plate 329**). The site has an extent of 15 m by 10 m, with a westerly aspect and the artefacts were situated on A horizon soils which had been deposited atop exposed clay B horizon soils. The GSV and GSE were moderate at the site due to ant activity and low in the areas surrounding the site due to the dense pasture grasses, fallen tree branches and leaf litter. Disturbances include sheet wash erosion and the alteration of the landscape by historical tree felling.

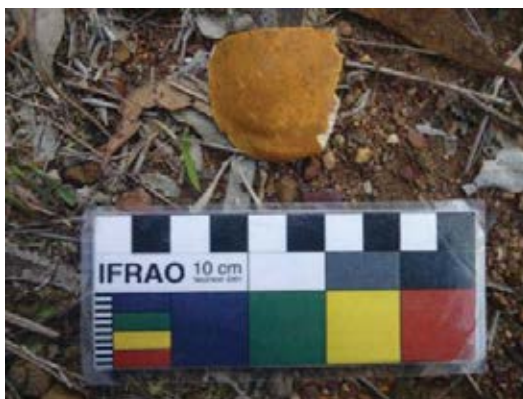
**Plate 329 Artefact identified at RPS Bylong AS062 (PS066)**

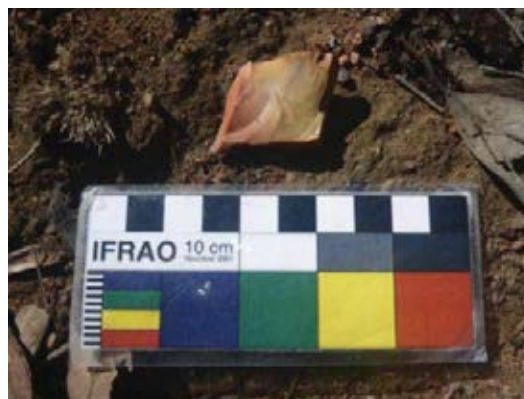
Plate 331 Artefacts identified at RPS Bylong IF086 (PS067)

RPS Bylong IF086 is an isolated find located the side of a small hill (**Plate 330**), which consists of one mudstone flake measuring 4 cm by 4 cm (**Plate 331**). The site has an extent of 1 m by 1 m with a north westerly aspect and the artefact was situated on A horizon soils which had been redeposited atop exposed clay B horizon soils. The GSV and GSE were low at the site and in surrounding areas due to the dense pasture grasses, tree branches and leaf litter. Disturbances include sheet wash erosion and the alteration of the landscape by historical tree felling.

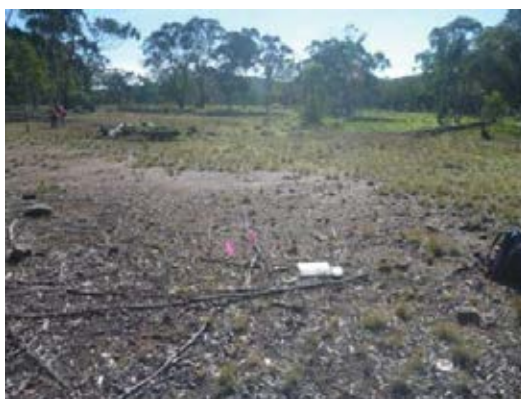
**Plate 332 Site location photo of RPS Bylong AS063 (PS068), view to the north.**

RPS Bylong AS063 is a small artefact scatter located in a clearing in a forest rehabilitation area, on a modified landform (**Plate 332**). The site has an extent of 15 m by 10 m and consists of two yellow mudstone flakes measuring 6 cm by 3.5 cm and 4.5 cm by 3.5 cm (**Plate 333**). The site has a northerly aspect and the artefacts were situated on an exposure in redeposited A horizon soils atop exposed clay B horizon soils. The GSV and GSE were low at the site and in the surrounding areas to the dense pasture grasses, tree branches and leaf litter. Disturbances include sheet wash erosion and the alteration of the landscape by historical tree felling.

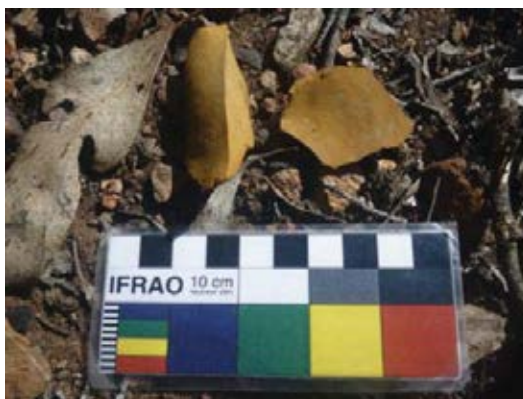
**Plate 333 Artefact identified at RPS Bylong AS063 (PS068)**

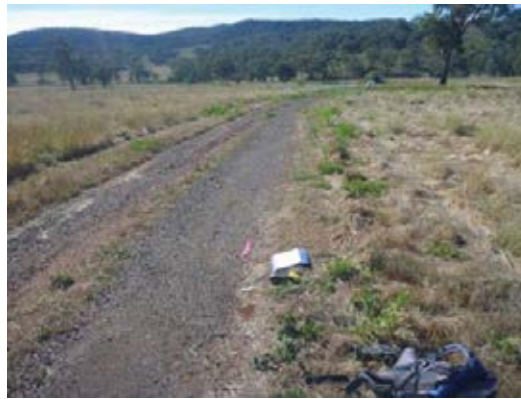
**Plate 334 Site location photo of RPS Bylong IF087 (PS069), view to the north**

RPS Bylong IF087 is an isolated find located near the main gate on Road 17 (**Plate 334**), which consists of one chert core measuring 4.5 cm by 3.5 cm (**Plate 335**). The site has an extent of 1 m by 1 m with a northerly aspect and the artefact was situated on A horizon soils which had been redeposited atop exposed clay B horizon soils. The GSV and GSE were high at the site location due to vehicle activity in the area, but were low in the surrounding areas due to the tall, dense pasture grasses. Disturbances include use of the vehicle track and sheet wash run-off.

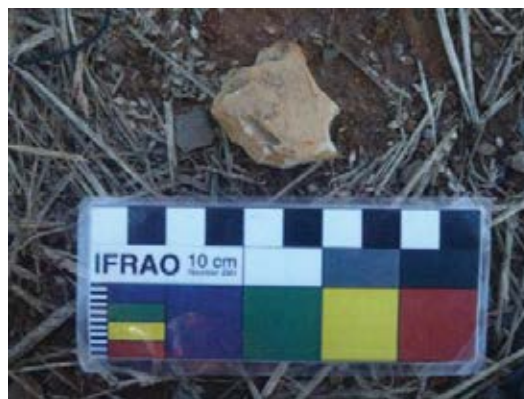
**Plate 335 Artefact identified at RPS Bylong IF087 (PS069)**

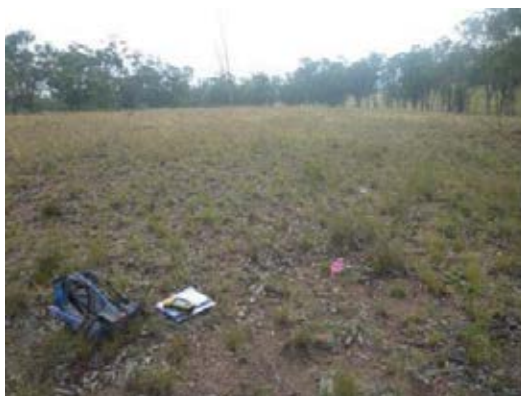
**Plate 336 Site location photo of RPS Bylong IF088 (PS070), view to the east**

RPS Bylong IF088 is an isolated find located on a mid slope on a small hill (**Plate 336**), which consists of one tuff blade measuring 5 cm by 2 cm (**Plate 337**). The site has an extent of 1 m by 1 m with an easterly aspect and the artefact was situated on A horizon soils which had been redeposited atop exposed clay B horizon soils. The GSV and GSE were low at the site and in the surrounding areas due to the dense pasture grasses, fallen tree branches and leaf litter. Disturbances are limited to sheet wash erosion.

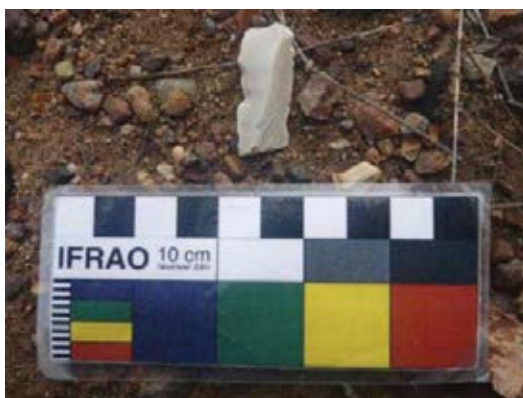
**Plate 337 Artefact identified at RPS Bylong IF088 (PS070)**

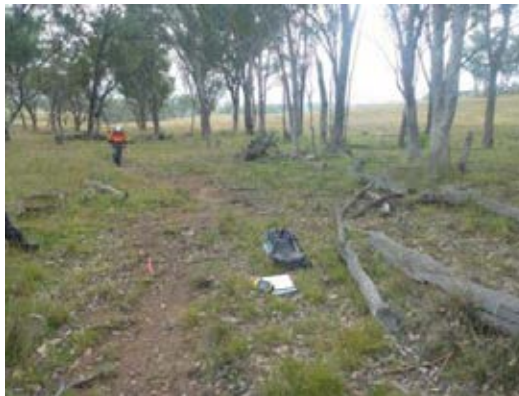
Plate 338 Site location photo of RPS Bylong IF089 (PS071), view to the north

RPS Bylong IF089 is an isolated find located on the bank of a drainage channel bank (**Plate 338**), consisting of one mudstone core measuring 6.5 cm in length and 4.5 cm in width, with a thickness of 2.5 cm (**Plate 339**). The site has an extent of 1 m by 1 m with a northerly aspect and the artefact was situated on exposed clay B horizon soils. The GSV and GSE were low at the site and in the surrounding areas due to the dense pasture grasses, fallen tree branches and leaf litter. Disturbances include sheet wash erosion and erosion processes associated with the ephemeral drainage channel.

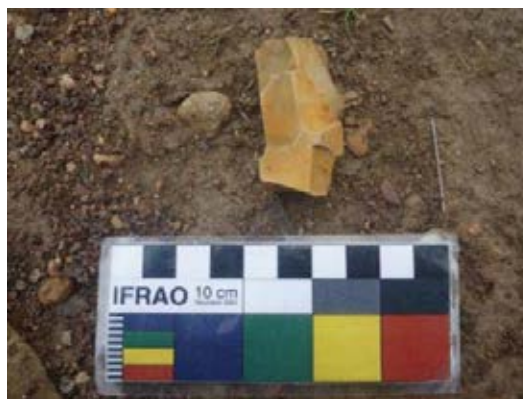
Plate 339 Artefact identified at RPS Bylong IF089 (PS071)

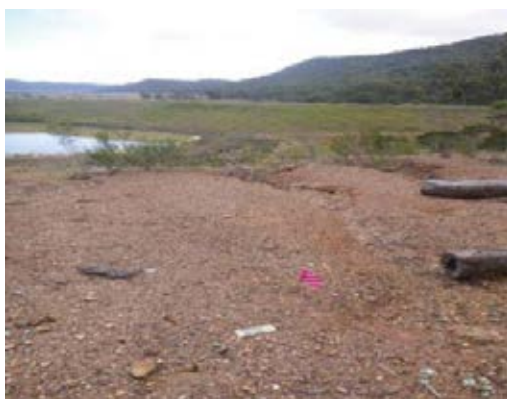
**Plate 340 Site location photo of RPS Bylong AS064 (PS072), view to the east**

RPS Bylong AS064 is a small artefact scatter located on the bank of a large farm dam (**Plate 340**), which consists of two quartz flakes, measuring 2 cm by 1.5 cm and 1.5 cm by 1.5 cm (**Plate 341**). The site has an extent of 5 m by 5 m with a north westerly aspect and the artefacts were situated on exposed clay B horizon soils. The GSV and GSE were high at the site due to erosion along the dam embankments and low in the surrounding areas due to dense pasture grasses to the west and new growth forest to the east. Disturbances include the modification of the landscape during the creation of the dam, as well as erosion of the dam walls and the presence of cattle.

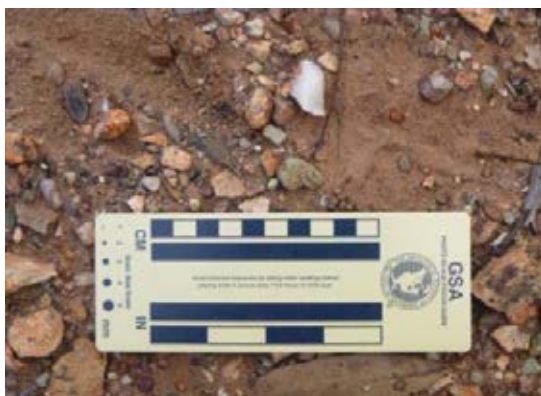
**Plate 341 Example of artefacts identified at RPS Bylong AS064 (PS072)**

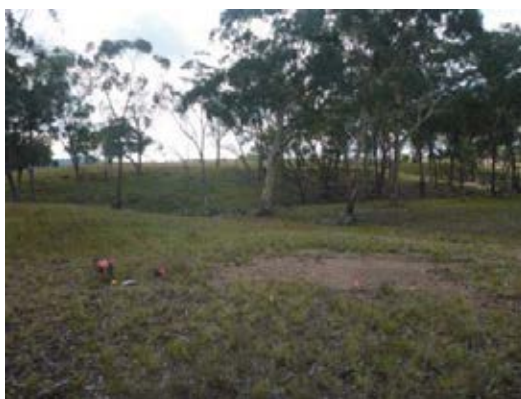
Plate 342 Site location photo of RPS Bylong AS065 (PS073), view to the north

RPS Bylong AS065 is a small artefact scatter located on an ants nest (**Plate 342**), which consists of one mudstone core measuring 6.5 cm by 6 cm by 5 cm and two mudstone flakes, measuring 4 cm by 3.5 cm and 4 cm by 3 cm (**Plate 343**). The site has an extent of 10 m by 10 m with a northerly aspect and the artefacts were situated on A horizon soils which had been redeposited atop exposed B horizon soils. The GSV and GSE at the site were moderate due to the activities of the ants, but were low in the aresas surrounding the site due to the dense pasture grasses. Disturbances include cattle grazing and bioturbation associated with the ant nest.

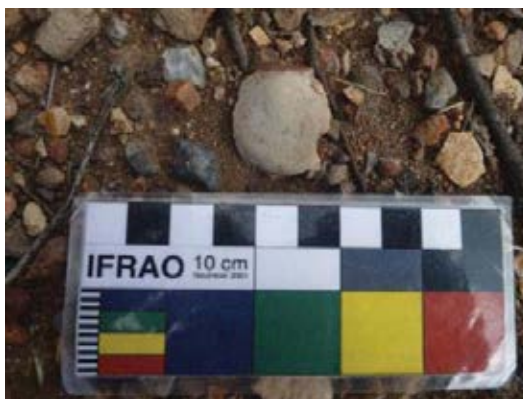
Plate 343 Artefact identified at RPS Bylong AS065 (PS073)

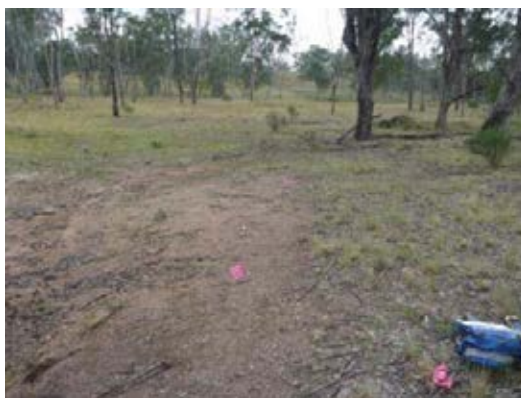
**Plate 344 Site location photo of RPS Bylong AS066 (PS074), view to the north**

RPS Bylong AS066 is a small artefact scatter located on a drainage channel at the base of a small hill (**Plate 344**). It consists of four mudstone flakes measuring 4 cm by 2 cm, 4.5 cm by 4 cm, 6 cm by 5 cm and 7 cm by 4 cm (**Plate 345**). The site has an extent of 5 m by 5 m with a northerly aspect and the artefacts were situated on A horizon soils which had been redeposited atop exposed B horizon soils. The GSV and GSE were low at the site and in the surrounding areas due to the dense pasture grasses, fallen tree branches and leaf litter. Disturbances include sheet wash run-off.

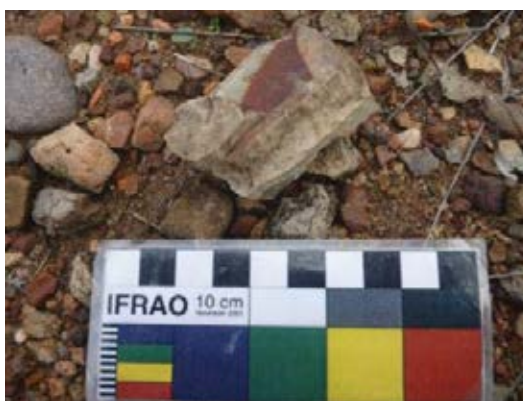
**Plate 345 Example of artefacts identified at RPS Bylong AS066 (PS074)**

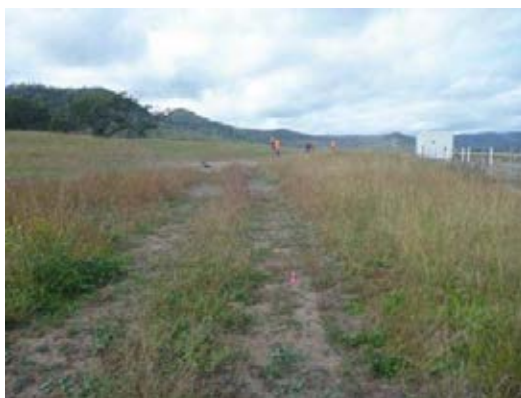
**Plate 346 Site location photo of RPS Bylong AS067 (PS075), view to the east.**

RPS Bylong AS067 is a small artefact scatter located on the access track running parallel with the current rail line in the Rail Link area (**Plate 346**). It consists of two mudstone flakes, both measuring 4.5 cm by 3 cm, and two quartz flakes (**Plate 347**). The site has an extent of 25 m by 10 m with a westerly aspect and the artefacts were situated on exposed B horizon soils. The GSV and GSE were moderate on the access track but were low in the areas surrounding the site due to very dense pasture grasses. Disturbances include use of the track by vehicles and sheet wash run-off.

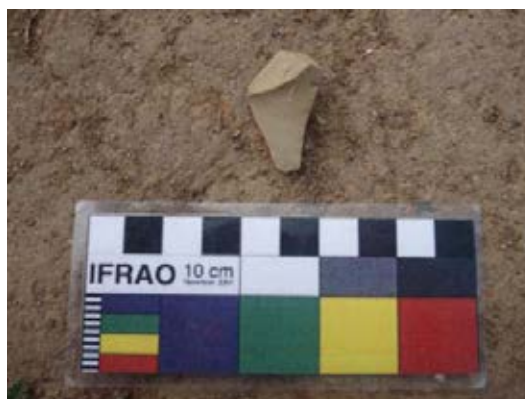
**Plate 347 Artefact identified at RPS Bylong AS067 (PS075)**

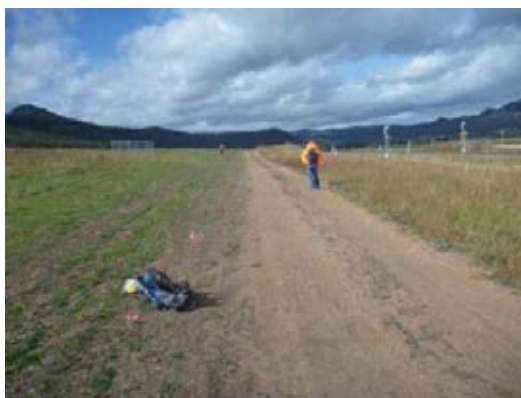
**Plate 348 Site location photo of RPS Bylong IF090 (PS076), view to the north.**

RPS Bylong IF090 is an isolated find located on the access track running parallel with the current rail line in the Rail Link area (**Plate 348**). It consists of one mudstone flake measuring 5 cm by 3 cm (**Plate 349**). The site has an extent of 1 m by 1 m with a westerly aspect and the artefact was situated on exposed clay B horizon soils. The GSV and GSE were moderate along the access track and low in the surrounding areas due to very dense pasture grasses. Disturbances include use of the track by vehicles and sheet wash run-off.

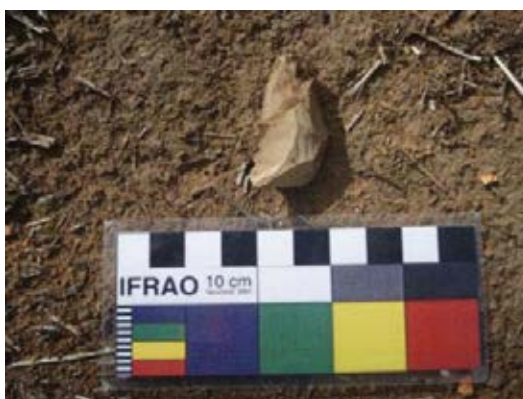
**Plate 349 Artefact identified at RPS Bylong IF090 (PS076)**

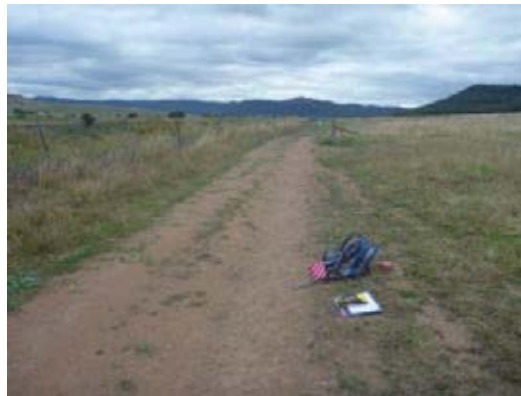
Plate 350 Site location photo of RPS Bylong IF091 (PS077), view to the west

RPS Bylong IF091 is an isolated find located on the access track running parallel with the current rail line in the Rail Link area (**Plate 350**). It consists of one broken mudstone flake measuring 4.5 cm by 4 cm (**Plate 351**). The site has an extent of 1 m by 1 m, with a westerly aspect and the artefact was situated on exposed clay B horizon soils. The GSV and GSE were moderate along the access track and low in the surrounding areas due to very dense pasture grasses. Disturbances include use of the track by vehicles and sheet wash run-off.

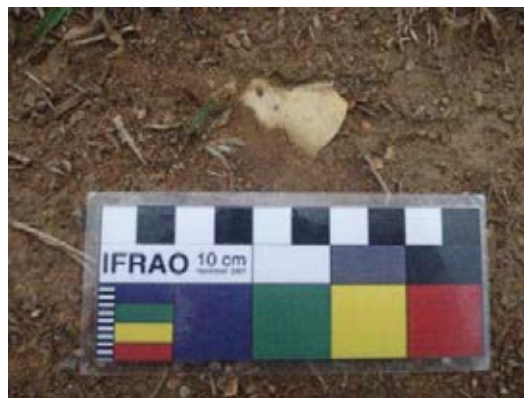
Plate 351 Artefact identified at RPS Bylong IF091 (PS077)

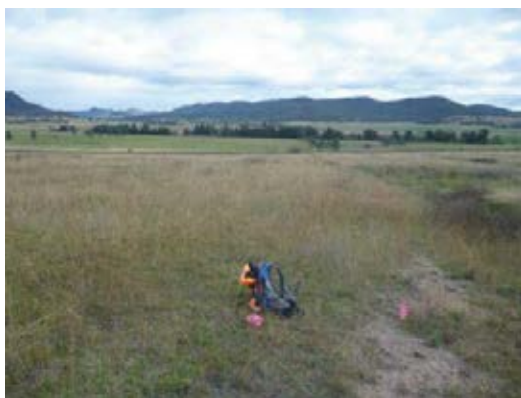
**Plate 352 Site location photo of RPS Bylong IF092 (PS078) view to the south-west**

RPS Bylong IF92 was an isolated find located on the bank of an ephemeral drainage channel (**Plate 352**), which consists of one mudstone flake measuring 4 cm by 2.5 cm (**Plate 353**). The site has an extent of 1 m by 1 m with a south westerly aspect and the artefact was situated on A horizon soils which had been redeposited atop exposed clay B horizon soils. The GSV and GSE were moderate along the exposed bank and low in the surrounding areas due to very dense pasture grasses. Disturbances include water erosion in the drainage channel and sheet wash run-off.

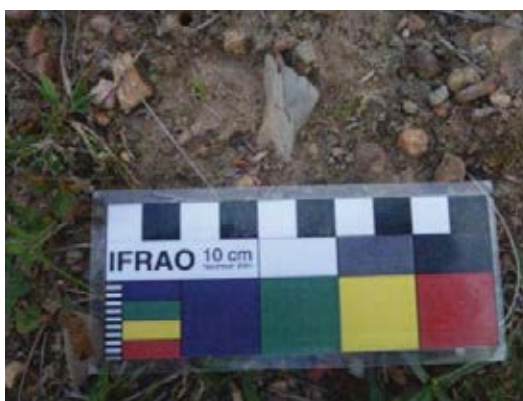
**Plate 353 Artefact identified at RPS Bylong IF092 (PS078)**

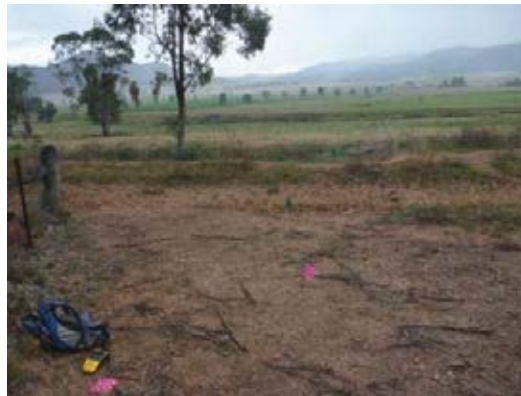
Plate 354 Site location photo of RPS Bylong IF093 (PS079), view to the south-west.

RPS Bylong IF093 is an isolated find located in an open exposure next to a contour bank at the base of a foot slope (**Plate 354**). It consists of one mudstone flake measuring 3 cm by 3 cm (**Plate 355**). The site has an extent of 1 m by 1 m with a south westerly aspect and the artefact was situated on exposed clay B horizon soils. The GSV and GSE were moderate at the site due to the contour bank and the fence line, but were low in the surrounding areas due to very dense pasture grasses. Disturbances include cattle grazing and sheet wash run-off, as well as modification of the landform during the creation of the contour bank.

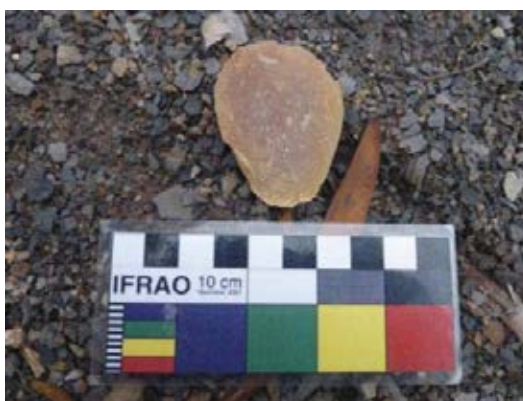
**Plate 395 Artefact identified at RPS Bylong IF103 (PS103)**

RPS Bylong IF103 is an isolated find located on a mid slope in the south end of the proposed south overburden emplacement area (**Plate 394**). It consists of one mudstone flake measuring 5 cm by 5 cm (**Plate 395**). The site has an extent of 15 m by 5 m with a south easterly aspect and the artefact was situated on exposed clay B horizon soils. The GSV and GSE were high at the site due to the effects of sheet wash run-off but were low in the surrounding areas due to dense pasture grasses and debris from the edge of the tree line. Disturbances include cattle grazing and sheet wash erosion.

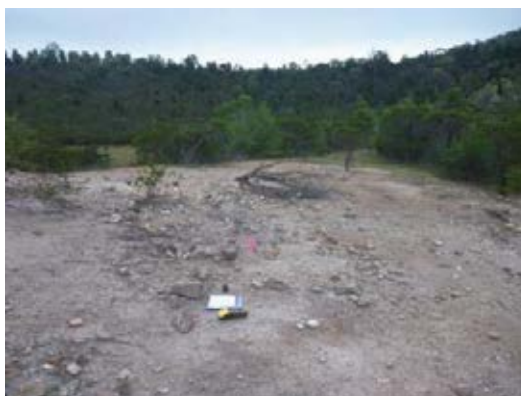
**Plate 396 Site location photo of RPS Bylong IF104 (PS104), view to the north-west**

RPS Bylong IF104 is an isolated find located on a mid slope in the south end of the proposed south overburden emplacement area (**Plate 396**). It consists of one mudstone flake measuring 3.5 cm by 4 cm (**Plate 397**). The site has an extent of 1 m by 1 m with a north easterly aspect and the artefact was situated on exposed clay B horizon soils. The GSV and GSE were high at the site due to the effects of sheet wash run-off but low in the areas surrounding the site due to dense pasture grasses and debris from the tree line. Disturbances include cattle grazing and sheet wash erosion.

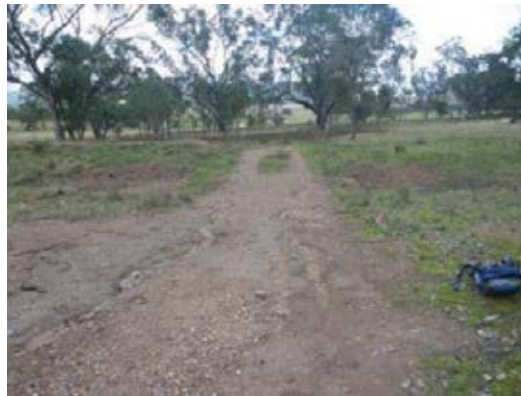
**Plate 398 Site location photo of RPS Bylong IF105 (PS105), view to the north.**

RPS Bylong IF105 is an isolated find located on an access track in the eastern end of the rail link area (**Plate 398**), consisting of one mudstone flake measuring 3.5 cm by 3.5 cm (**Plate 399**). The site has an extent of 1 m by 1 m with a westerly aspect and the artefact was situated on exposed clay B horizon soils. The GSV and GSE were high at the site as a result of the effects of sheet wash run-off and vehicle activity on the track. The GSV and GSE in the areas surrounding the site were low due to dense pasture grasses and debris from the tree line. Disturbances include cattle grazing and sheet wash erosion.

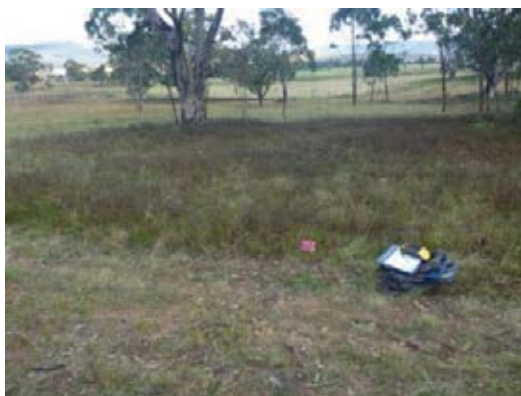
**Plate 400 Site location photo of RPS Bylong IF106 (PS106)**

RPS Bylong IF106 is an isolated find located on an overgrown access track in the eastern end of the rail link area (**Plate 400**), which consists of one mudstone flake measuring 3 cm by 3 cm (**Plate 401**). The site has an extent of 1 m by 1 m with a westerly aspect and the artefact was situated on exposed clay B horizon soils. The GSV and GSE at the site and in the surrounding areas were low due to track being overgrown and the presence of dense pasture grasses and debris from the tree line. Disturbances include cattle grazing and sheet wash erosion.

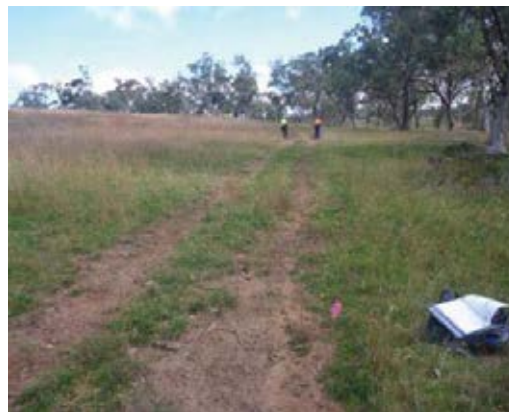
**Plate 402 Site location photo of RPS Bylong AS078 (PS107), view to the north west**

RPS Bylong AS078 is a small artefact scatter located on an undulating landform along a previously existing access track (**Plate 402**), consisting of three mudstone flakes, including two measuring 6 cm by 4 cm and 3 cm by 2 cm (**Plate 403**). The site has an extent of 30 m by 10 m with a northwest aspect and the artefacts were situated on exposed clay B horizon soils. The GSV and GSE were moderate at the site due to the effects of vehicle use of the access track. The GSV and GSE in the areas surrounding the site were low due to the presence of dense pasture grasses. Disturbances include cattle grazing, vehicle use of the track and sheet wash erosion.

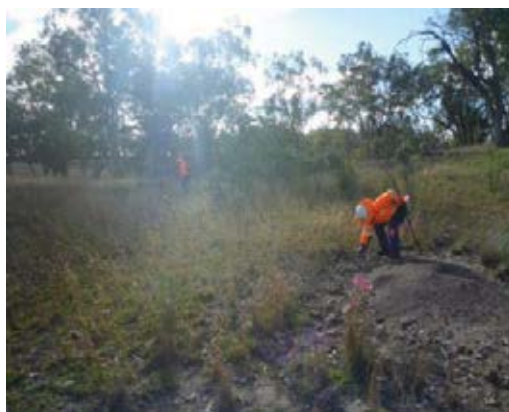
**Plate 404 Site location photo of RPS Bylong AS079 (PS108), view to the west**

RPS Bylong AS079 is a medium sized artefact scatter located on an ants nest along the side of a drainage line (**Plate 404**). It consists of seven mudstone artefacts including: two cores measuring 8 cm by 7 cm and 6 cm by 7 cm and two flakes measuring 3 cm by 3 cm and 3 cm by 4 cm (**Plate 405**). The site has an extent of 25 m by 25 m with a westerly aspect and the artefact was situated on exposed clay B horizon soils. The GSV and GSE were moderate at the site due to the effects of sheet wash erosion and ant activity and low in the surrounding areas due to dense pasture grasses. Disturbances include cattle grazing and sheet wash erosion.

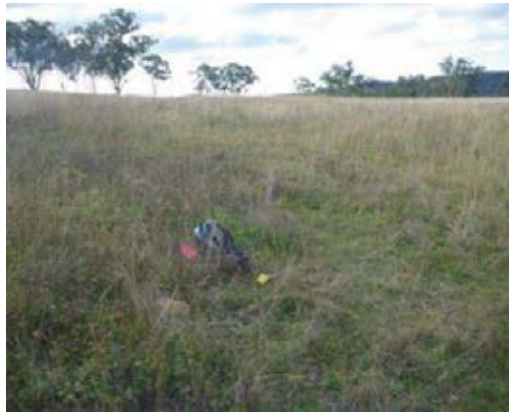
Plate 406 Site location photo of RPS Bylong IF107 (PS110)

RPS Bylong IF107 is an isolated find located on a mid slope (**Plate 406**). It consists of one weathered sandstone piece, possibly used for grinding, measuring 35 cm by 15 cm by 10 cm (**Plate 407**). The site has an extent of 1 m by 1 m with a northerly aspect and the artefact was situated on A horizon soils. The GSV and GSE were low at the site and in surrounding areas due to the dense pasture grasses. Disturbances include cattle grazing and sheet wash erosion.

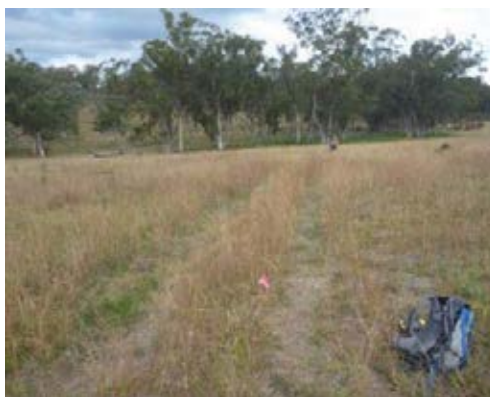
**Plate 408 Site location photo of RPS Bylong IF108 (PS111), view to the north west**

RPS Bylong IF108 is an isolated find located on an overgrown track near a creek line which runs parallel to Bylong Valley Way (**Plate 408**). It consists of one mudstone flake measuring 3 cm by 3 cm (**Plate 409**). The site has an extent of 1 m by 1 m with a north easterly aspect and the artefact was situated on exposed clay B horizon soils. The GSV and GSE were moderate at the site and low in the surrounding areas due to the dense pasture grasses. Disturbances include cattle grazing and sheet wash erosion.

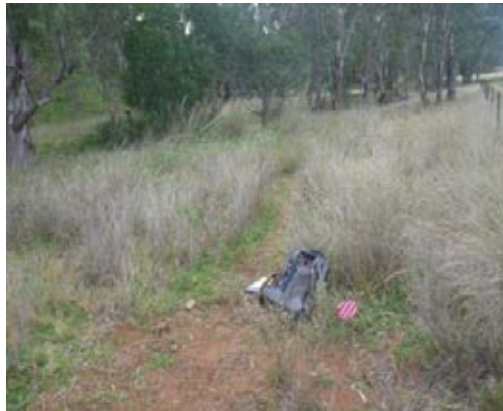
**Plate 410 Site location photo of RPS Bylong AS080 (PS112), view to the south.**

RPS Bylong AS080 is a small artefact scatter located on a creek terrace (**Plate 410**), which consists of two mudstone flakes, including one measuring 5 cm by 4 cm and one quartz flake measuring 1.5 cm by 1.5 cm (**Plate 411**). The site has an extent of 20 m by 10 m with a southerly aspect and the artefact was situated on A horizon soil which had been redeposited atop B horizon soils. The GSV and GSE were moderate at the site due to the exposure from a cattle trail and low in the surrounding area due to the dense pasture grasses. Disturbances include cattle grazing and sheet wash erosion.

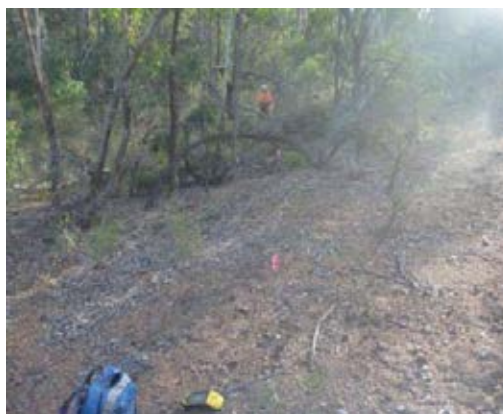
**Plate 412 Site location photo of RPS Bylong AS081 (PS113) view to the south**

RPS Bylong AS081 is a small artefact scatter located on a toe slope along the edge of the creek line parallel to Bylong Valley Way (**Plate 412**). It consists of two mudstone flakes, one of which measures 3 cm by 4 cm and one tuff flake measuring 2.5 cm by 2.5 cm (**Plate 413**). The site has an extent of 15 m by 15 m with a southerly aspect and the artefact was situated on exposed B horizon soils. The GSV and GSE were moderate at the site due to the exposure from a cattle trail and low in the surrounding area due to the dense pasture grasses. Disturbances include cattle grazing and sheet wash erosion.

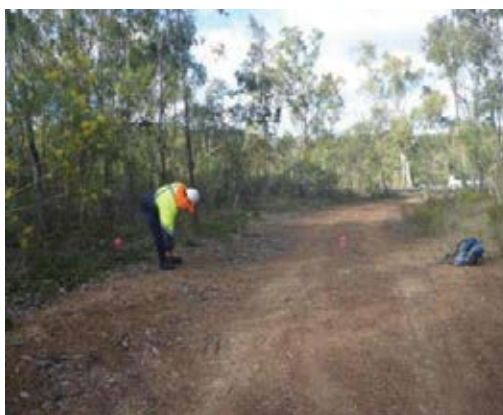
**Plate 414 Site location photo of RPS Bylong AS082 (PS114), view to the north west**

RPS Bylong AS082 is a medium sized artefact scatter located on an access track that joins Bylong Valley Way (**Plate 414**). It consists of eight flakes (**Plate 415**). Artefacts recorded include: four mudstone flakes measuring 4 cm by 4 cm, 4.5 cm by 4 cm, 3 cm by 4 cm and 4 cm by 2.5 cm, one tuff flake measuring 2.5 cm by 2.5 cm and a broken sandstone ground stone measuring 6 cm by 8 cm by 4 cm. The site has an extent of 20 m by 10 m with a southerly aspect and the artefact was situated on exposed B horizon soils. The GSV and GSE were high at the site due to the exposure from the track but were low in the surrounding area due to the dense new growth trees, medium sized shrubs such as acacias and native grasses. Disturbances include use of the track by vehicles and sheet wash erosion.

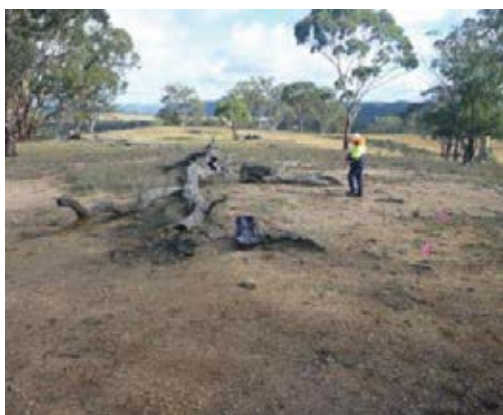
**Plate 416 Site location photo of RPS Bylong AS083 (PS116) view to the north-west**

RPS Bylong AS083 is a large artefact scatter located on the crest of a hill north of the creek line running parallel to Bylong Valley Way (**Plate 416**). It consists of approximately fifty mudstone, quartz and tuff flakes (**Plate 417**). Artefacts recorded included: three mudstone flakes measuring 4 cm by 3.5 cm, 5 cm by 2.5 cm and 4 cm by 2.5 cm, one tuff core measuring 5 cm by 4 cm by 5 cm, one tuff blade measuring 6 cm by 1.5 cm and two quartz flakes measuring 3 cm by 3 cm and 5 cm by 4 cm. The site has an extent of 50 m by 100 m, with a north westerly aspect and the artefact was situated on exposed B horizon soils. The GSV and GSE were moderate at the site and low in the surrounding areas due to the dense pasture grasses. Disturbances include cattle grazing and sheet wash erosion.

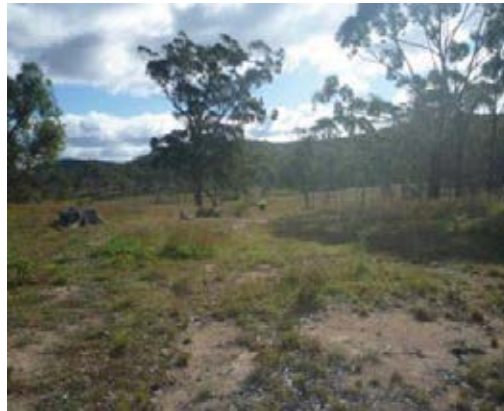
**Plate 418 Site location photo of RPS Bylong AS084 (PS117), view to the north west**

084 is a medium sized artefact scatter located on the crest of a hill north of the creek line running parallel to Bylong Valley Way (**Plate 418**). It consists of ten mudstone flakes, three of which measure: 3.5 cm by 3.5 cm, 4 cm by 3.5 cm and 3.5 cm by 4.5 cm (**Plate 419**). The site has an extent of 30 m by 10 m with a north westerly aspect and the artefacts were situated on exposed B horizon soils. The GSV and GSE were moderate at the site and low in the surrounding area due to the dense pasture grasses. Disturbances include cattle grazing and sheet wash erosion.

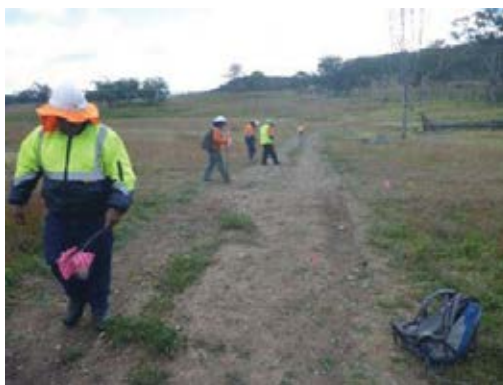
**Plate 420 Site location photo of RPS Bylong AS085 (PS119), view to the south**

RPS Bylong AS085 is a small artefact scatter located on a mid slope along Road 20 (**Plate 419**), which consists of two mudstone flakes and two tuff flakes measuring 6 cm by 4 cm and 3.5 cm by 2.5 cm (**Plate 420**). The site has an extent of 25 m by 25 m with a north westerly aspect and the artefacts were situated on exposed clay B horizon soils. The GSV and GSE were moderate at the site due to sheet wash run-off and track usage. The GSV and GSE in the surrounding area were low due to the dense pasture grasses. Disturbances include cattle grazing, use of the track by vehicles and sheet wash erosion.

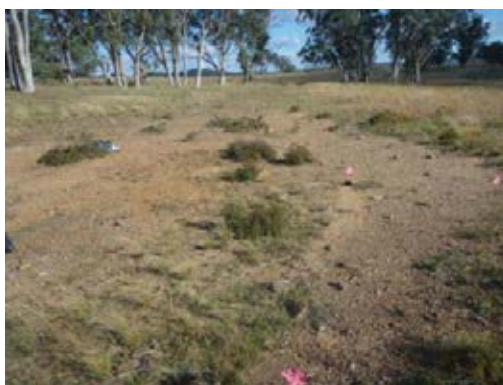
Plate 422 Site location photo of RPS Bylong AS086 (PS120), view to the north west

RPS Bylong AS086 is a large artefact scatter located on a mid slope near the Goulburn River State Forest along Road 20 (**Plate 421**). It consists of fifteen artefacts, including mudstone and quartz flakes. It included one mudstone core measuring 6 cm by 5 cm by 2 cm (**Plate 422**). Other artefacts recorded include: two mudstone flakes measuring 4 cm by 2 cm and 5 cm by 4 cm, one quartz flake measuring 2 cm by 2 cm. The site has an extent of 30 m by 22 m with a north westerly aspect and the artefacts were situated on exposed clay B horizon soils. The GSV and GSE were moderate at the site due to the exposure from sheet wash run-off but were low in the surrounding areas due to the dense pasture grasses. Disturbances include cattle grazing and sheet wash erosion.

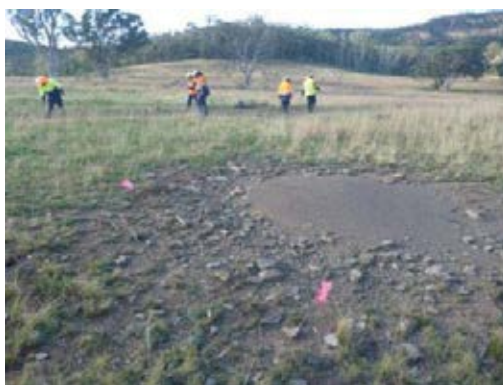
**Plate 424 Site location photo of RPS Bylong AS087 (PS121), view to the north-west**

RPS Bylong AS087 is a large artefact scatter located on a mid slope along Road 20, on top of an ants nest (**Plate 423**). It consists of twenty artefacts including mudstone and tuff flakes and cores (**Plate 424**). Artefacts which were recorded include: one mudstone core measuring 6.5 cm by 6 cm by 3 cm, two mudstone flakes measuring 4 cm by 3 cm and 4 cm by 3.5 cm and two tuff flakes measuring 5 cm by 2.5 cm and 2 cm by 2 cm. The site has an extent of 40 m by 30 m with a north westerly aspect and the artefacts were situated on exposed clay B horizon soils. The GSV and GSE were moderate at the site due to the ant activity and use of the track and low in the surrounding areas due to dense pasture grasses. Disturbances include cattle grazing and sheet wash erosion.

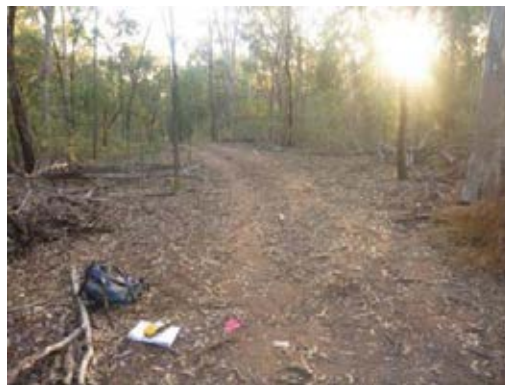
**Plate 426 Site location photo of RPS Bylong AS088 (PS123) view to the north**

RPS Bylong AS088 is a small artefact scatter located on Road 07 (**Plate 425**), which consists of one mudstone core measuring 6 cm by 5 cm by 5 cm and one mudstone flake measuring 5 cm by 6 cm (**Plate 426**). The site has an extent of 30 m by 10 m with a northerly aspect and the artefacts were situated on exposed clay B horizon soils. The GSV and GSE were high at the site due to sheet wash erosion and the presence of the graded access track for the drill rig. In the surrounding areas, the GSV and GSE were low due to dense acacias and leaf litter. Disturbances include use of the track by vehicles and sheet wash erosion.
