# Aboriginal Archaeology and Cultural Heritage Impact Assessment

# Bylong Coal Project

### Bylong Coal Project AACHIA - Mid Western Local Government Area

Client Manager: Darrell Rigby  
Report Number: PR113279  
Version / Date: Final March 2015

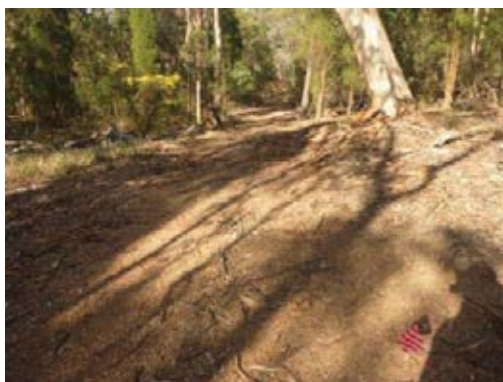
**Plate 428 Site location photo of RPS Bylong AS089 (PS128) view to the south**

RPS Bylong AS089 is a small artefact scatter located on Road 07 (**Plate 427**) consisting of two mudstone flakes measuring 4 cm by 2.5 cm and 2 cm by 2 cm. The site has an extent of 30 m by 10 m with a northerly aspect and the artefacts were situated on exposed clay B horizon soils. The GSV and GSE were moderate at the site due to the graded track access for the drill rig access and low in the surrounding area due to dense acacias and leaf litter. Disturbances include use of the track by vehicles and sheet wash erosion.

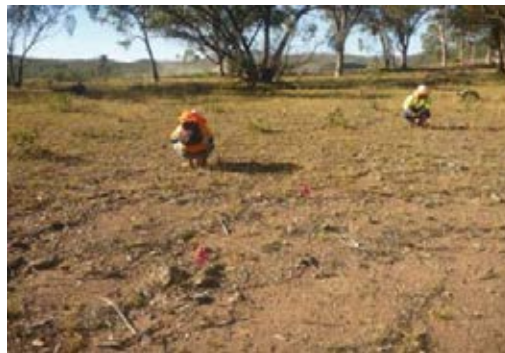
**Plate 430 Site location photo of RPS Bylong AS090 (PS130), view to the south**

RPS Bylong AS090 is a small artefact scatter located on a slope opposite the quarry on the east boundary of the mine lease. It consists of two mudstone flakes measuring 3 cm by 2.5 cm and 6 cm by 4 cm. The site has an extent of 30 m by 25 m with a northerly aspect and the artefacts were situated on exposed clay B horizon soils. The GSV and GSE were moderate at the site and low in the surrounding area due to dense pasture grasses. Disturbances include cattle grazing and sheet wash erosion.

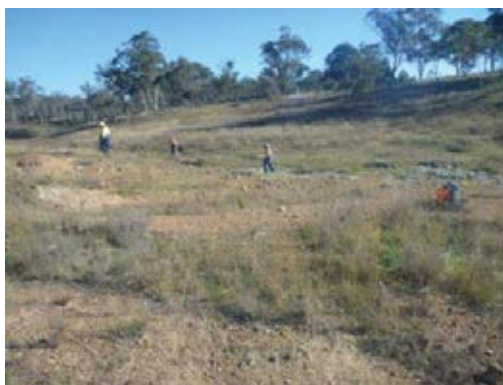
**Plate 432 Site location photo of RPS Bylong AS091 (PS132), view to the north west**

RPS Bylong AS091 is a small artefact scatter located on a lower creek bank, which consists of two mudstone flakes measuring 7 cm by 4.5 cm and 3 cm by 2 cm. The site has an extent of 10 m by 5 m with a northerly aspect and the artefacts were situated on exposed clay B horizon soils. The GSV and GSE were moderate at the site due to the effects of the ephemeral drainage line and low in the surrounding areas due to dense pasture grasses. Disturbances include cattle grazing, water erosion associated with the drainage channel and sheet wash erosion.

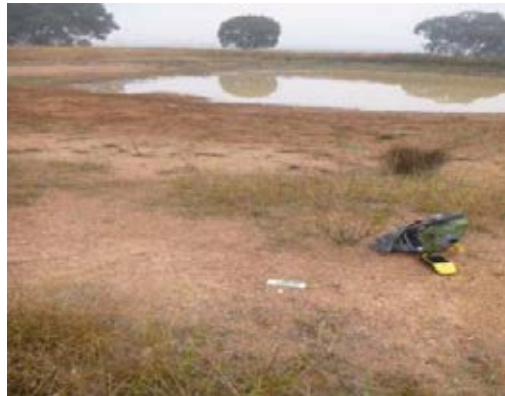
**Plate 434 Site location photo of RPS Bylong AS092 (KG098), view to the west**

RPS Bylong AS092 is a small artefact scatter located on the bank of a farm dam, consisting of two mudstone flakes, measuring 4 cm by 3 cm and 2.5 cm by 2.5 cm. The site has an extent of 5 m by 10 m with a westerly aspect and the artefacts were situated on exposed clay B horizon soils. The GSV and GSE were high on the dam walls due to the effects of sheet wash erosion and low in the surrounding areas due to tall, dense pasture grasses. Disturbances include sheet wash erosion and cattle grazing as well as the modification of the landform during the creation of the dam.

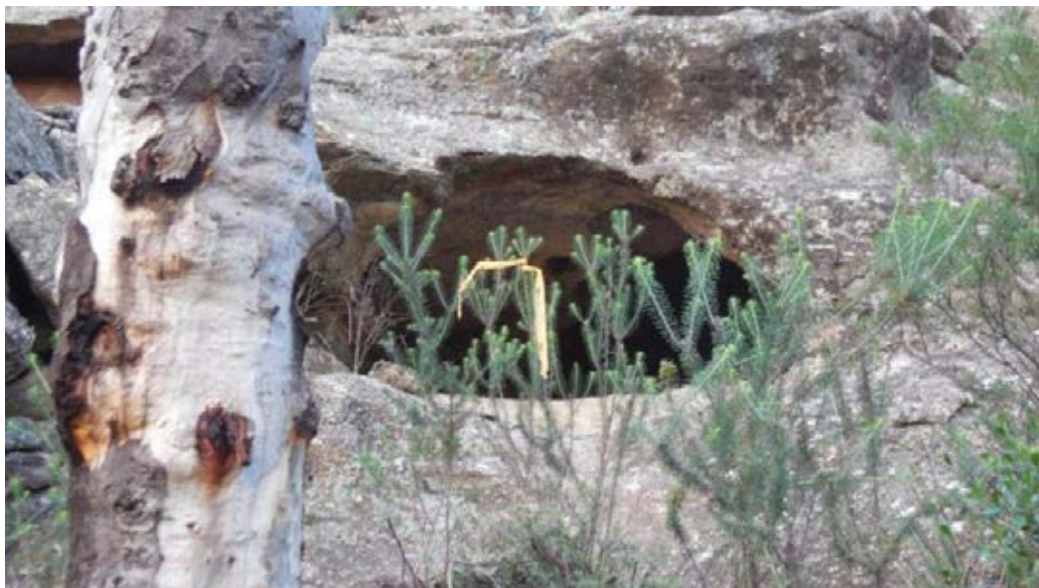
**Plate 481 RPS Bylong CUL008, cultural rockshelter**

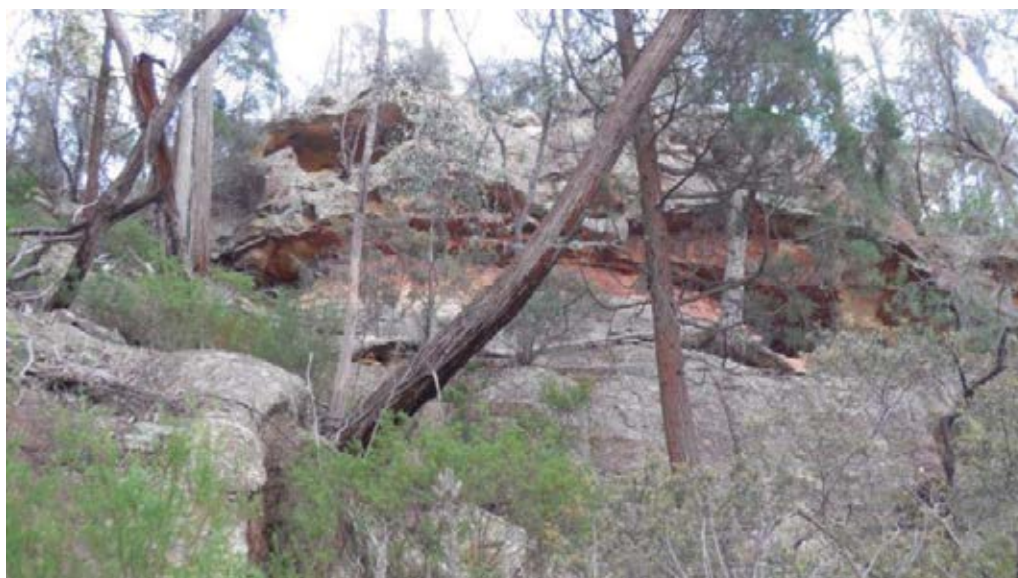
**Plate 484 RPS Bylong CUL009, a series of cavities, possible cultural rock shelters**

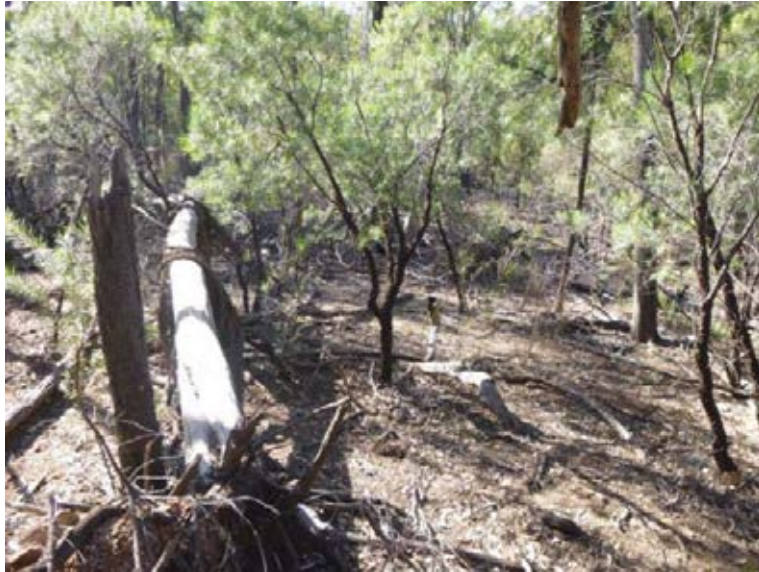
**Plate 518 View from the cavity, facing south east**

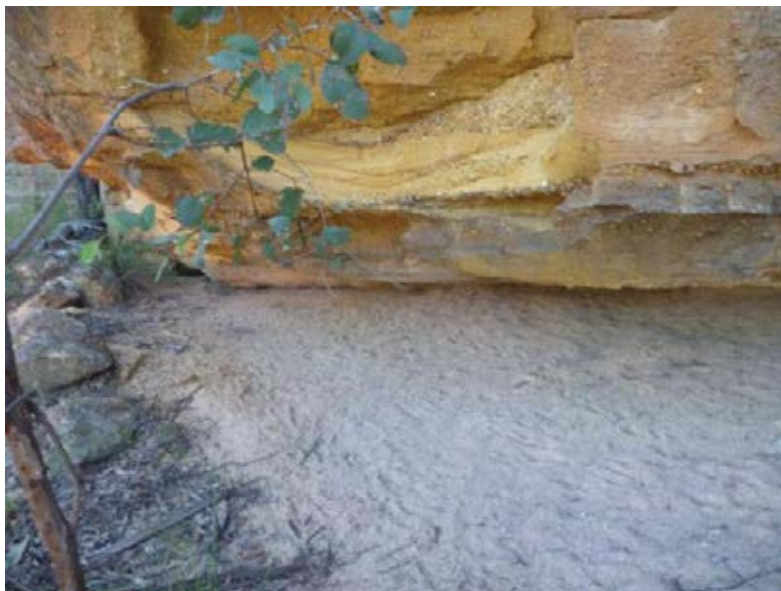
RPS Bylong CUL027 (CRS004) was accessed via Road 06, a graded access track for the drilling rigs and was recorded as a space that may have been used by Aboriginal people as a temporary shelter (**Plate 519**). This cavity is 2.07 m in height, 3.1 m in width and 10.27 m in depth, with a steeply sloping open ground surface. The cultural feature has a westerly aspect (**Plate 520**). The GSV and GSE were low between the site and the graded track due to dense leaf litter, small shrubs, native grasses and fallen branches. The vegetation in the area includes new growth eucalypts, black cypress pines and acacia shrubs. Any mature trees in the survey area were inspected for cultural scarring but no scarred trees were identified. The cultural feature was recorded in Week 1 on the 21<sup>st</sup> of May 2014.

Plate 519 RPS Bylong CUL027 (CRS004), cultural feature

This site was discussed during the cultural values workshop, not all RAPs agreed on this as being a cultural feature, but approximately 70% agreed that it may have some value and should be inspected as part of the AACHMP.

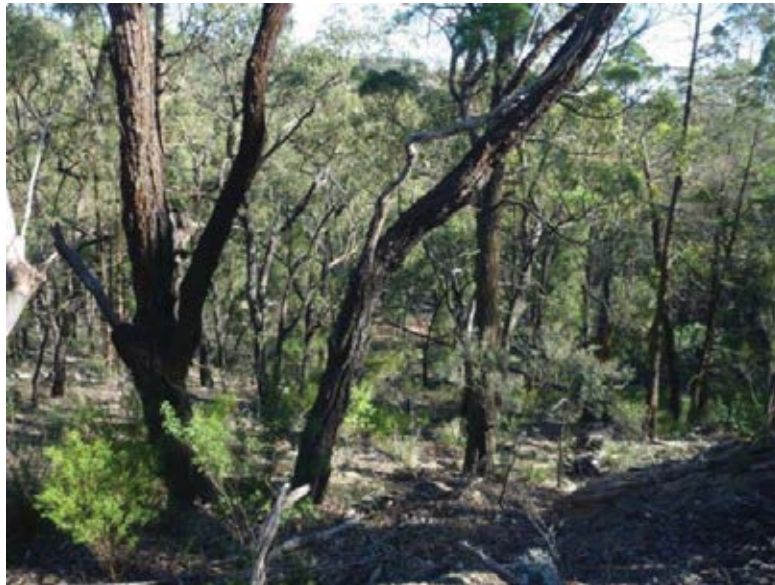
Plate 520 View from the cavity, facing west

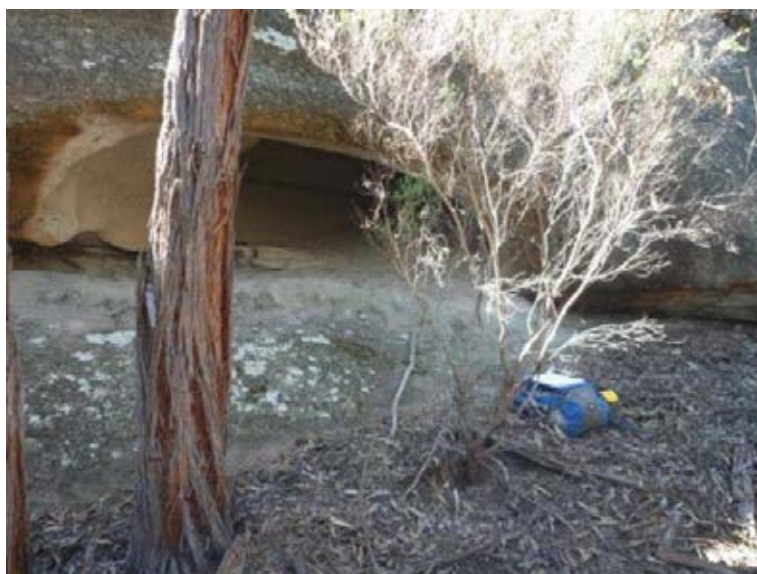
RPS Bylong CUL028 (CRS005) was accessed via Road 06, a graded access track for the drilling rigs and was recorded as a space that may have been used by Aboriginal people as a temporary shelter (**Plate 521**). The cavity is 1.08 m in height, 3.4 m in width and 6.3 m in depth with a sloping ground surface and a southerly aspect (**Plate 522**). The GSV and GSE were low between the site and the graded track due to dense leaf litter, small shrubs, native grasses and fallen branches. The vegetation in the area includes new growth eucalypts, black cypress pines and acacia shrubs. Any mature trees in the survey area were inspected for cultural scarring but no scarred trees were identified. The cultural feature was recorded in Week 1 on the 21<sup>st</sup> of May 2014 of the survey.

Plate 521 RPS Bylong CUL028 (CRS005), cultural feature

This site was discussed during the cultural values workshop, not all RAPs agreed on this as being a cultural feature, but approximately 70% agreed that it may have some value and should be inspected as part of the AACHMP.

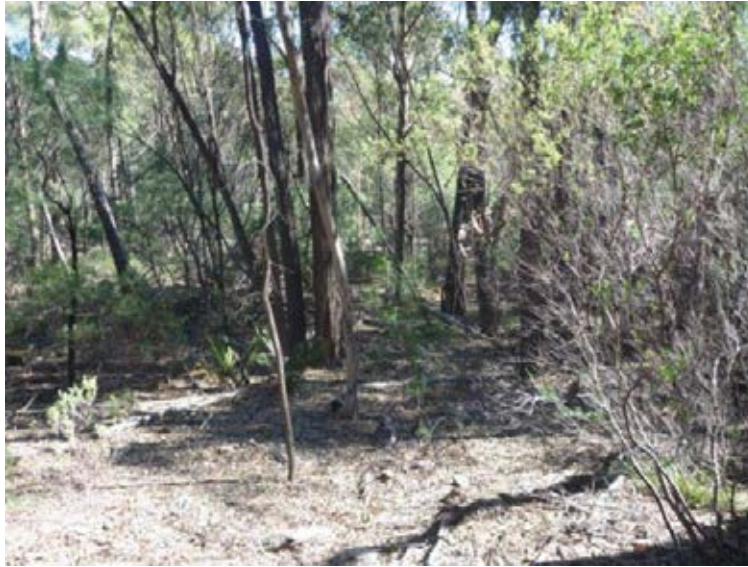
**Plate 522 View form the cavity facing south**

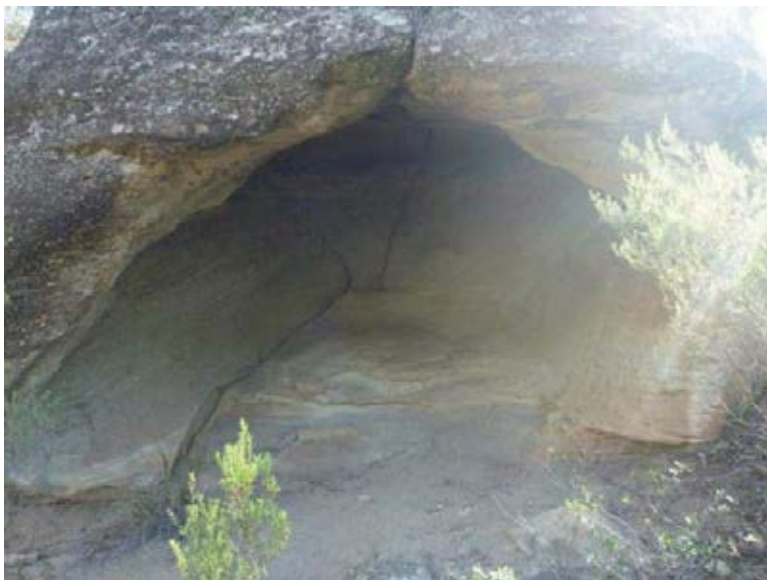
RPS Bylong CUL029 (CRS006) was accessed via Road 06, a graded access track for the drilling rigs and was recorded as a space that may have been used by Aboriginal people as a temporary shelter (**Plate 523**). The cavity is 2.2 m in height, 3.1 m in width and 3.7 m in depth with a sloping ground surface and a north easterly aspect (**Plate 524**). The GSV and GSE were low between the site and the graded track due to dense leaf litter, small shrubs, native grasses and fallen branches. The vegetation in the area includes new growth eucalypts, black cypress pines and acacia shrubs. Any mature trees in the survey area were inspected for cultural scarring but no scarred trees were identified. The cultural feature was reported in Week 1 on the 21<sup>st</sup> of May 2014.

Plate 523 RPS Bylong CUL029 (CRS006), cultural feature

This site was discussed during the cultural values workshop, not all RAPs agreed on this as being a cultural feature, but approximately 70% agreed that it may have some value and should be inspected as part of the AACHMP.

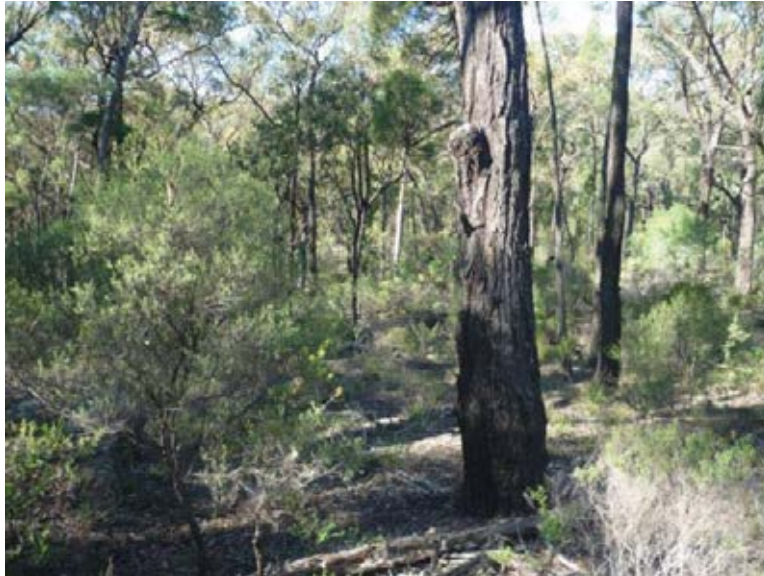
**Plate 524 View from the entrance of the cavity, facing north east**

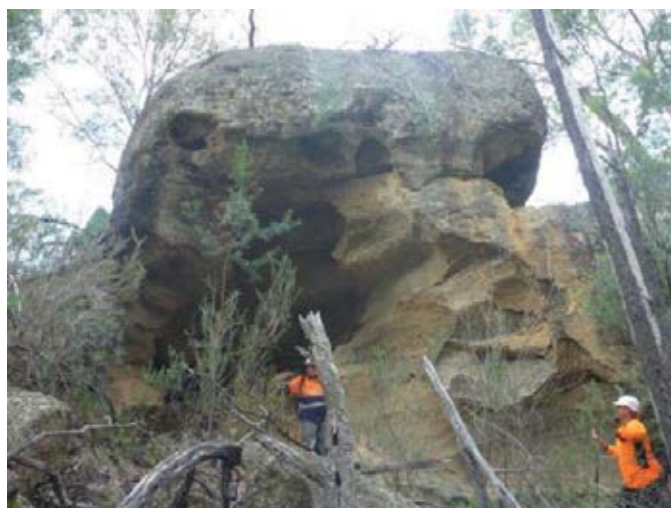
RPS Bylong CUL030 (CPS 015) was located on a rocky, sloped landform surrounded by sandstone outcrops adjacent to a tributary of Dry Creek. The cultural feature had a north westerly aspect (**Plate 525**). RPS Bylong CUL030 was identified as a large sandstone formation containing an overhang, which may have been used by Aboriginal people as a temporary shelter. This formation was approximately 6 m in height, 8 m in width and 7 m in depth (**Plate 526**). The sediment on the ground surface was likely to have been from internal erosion and was no more than 5 cm in depth. The GSE and GSV in the surrounding area were low due to dense leaf litter and fallen branches, sandstone tumble and shrubs. The vegetation in the area includes both mature and new growth eucalypts, scattered shrubs and grasses. No scarred trees were identified. Disturbances in the area included erosion and weathering, as well as the general disturbances caused by wildlife. This cultural feature was recorded in Week 3 survey on the 6<sup>th</sup> June 2014.

Plate 525 RPS Bylong CUL030, cultural feature

This site was discussed during the cultural values workshop, not all RAPs agreed on this as being a cultural feature, but approximately 70% agreed that it may have some value and should be inspected as part of the AACHMP.

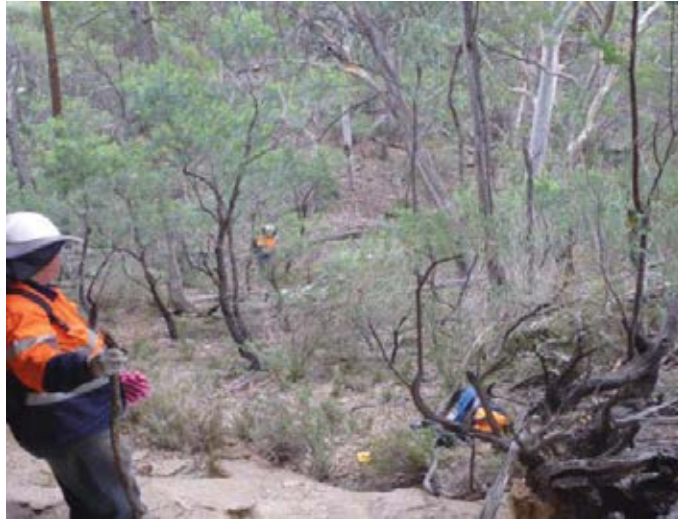
**Plate 526 View to the north west from inside of the cavity**

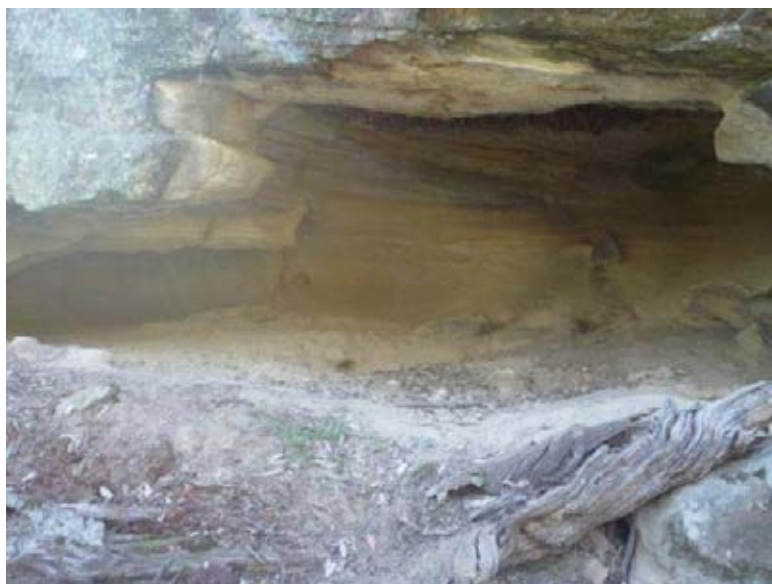
RPS Bylong CUL031 (CRS008) was accessed via Road 02, a graded access track for the drilling rigs and was recorded as a space that may have been used by Aboriginal people as a temporary shelter (**Plate 527**). The cavity is 1.5 m in height, 5.5 m in width and 3.5 m in depth, with a westerly aspect (**Plate 528**). The GSV and GSE were low between the site and the graded track due to dense leaf litter, small shrubs, native grasses and fallen branches. The vegetation in the area includes new growth eucalypts, black cypress pines and acacia shrubs. Any mature trees in the survey area were inspected for cultural scarring but no scarred trees were identified. This cultural feature was recorded in Week 1 of the survey on the 22<sup>nd</sup> of May 2014.

Plate 527 RPS Bylong CUL031 (CRS008), cultural feature

This site was discussed during the cultural values workshop, not all RAPs agreed on this as being a cultural feature, but approximately 70% agreed that it may have some value and should be inspected as part of the AACHMP.

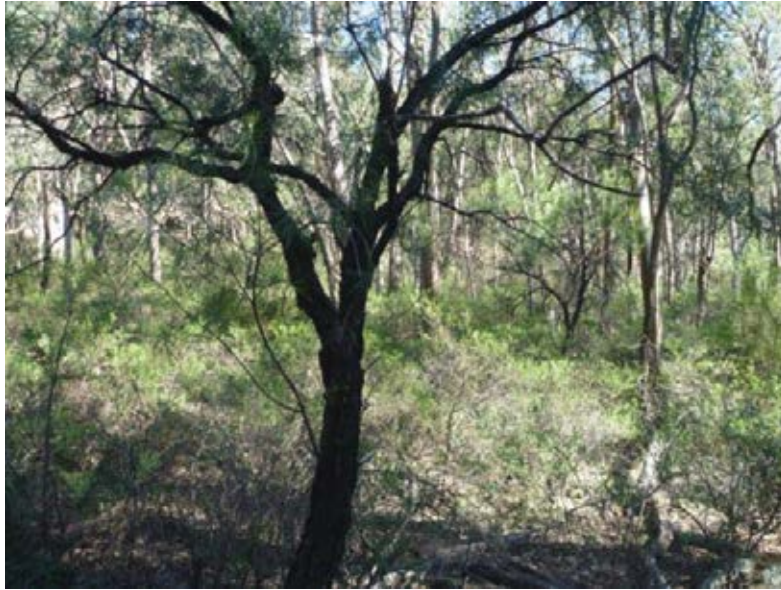
**Plate 528 View from the cavity entrance, facing west**

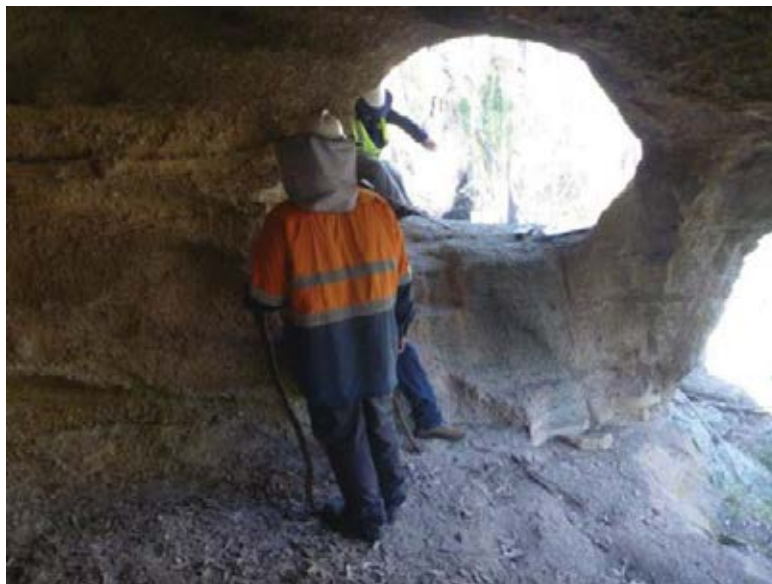
RPS Bylong CUL032 (CRS009) was accessed via Road 02, a graded access track for the drilling rigs and was recorded as a space that may have been used by Aboriginal people as a temporary shelter (**Plate 529**). The cavity is 1.5 m in height, 5.2 m in width and 3.5 m in depth, with a sloping ground surface and a westerly aspect (**Plate 530**). The GSV and GSE were low between the site and the graded track due to dense leaf litter, small shrubs, native grasses and fallen branches. The vegetation in the area includes new growth eucalypts, black cypress pines and acacia shrubs. Any mature trees in the survey area were inspected for cultural scarring but no scarred trees were identified. This cultural feature was recorded in Week 1 of the survey on the 22<sup>nd</sup> of May 2014.

Plate 529 RPS Bylong CUL032 (CRS009), cultural feature

This site was discussed during the cultural values workshop, not all RAPs agreed on this as being a cultural feature, but approximately 70% agreed that it may have some value and should be inspected as part of the AACHMP.

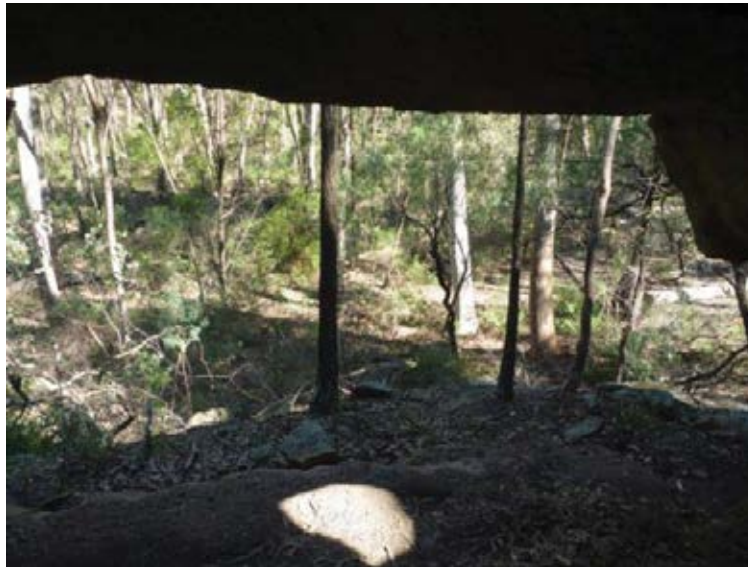
**Plate 530 View from the cavity entrance, facing west**

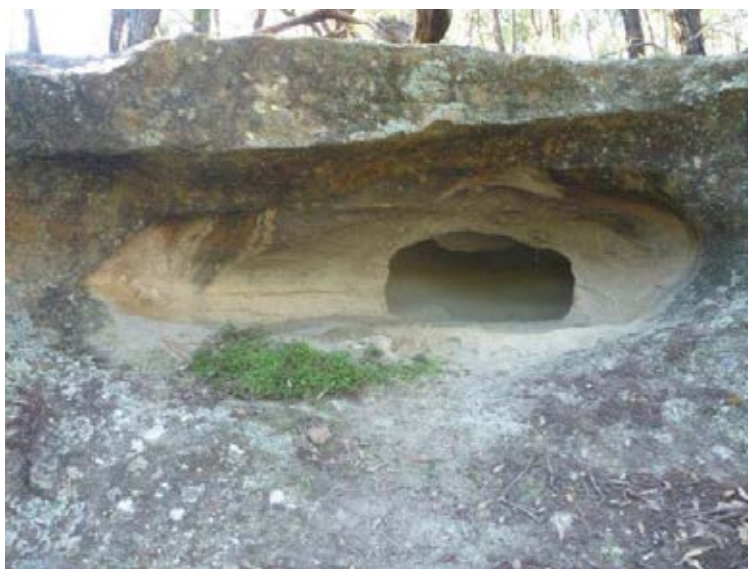
RPS Bylong CUL033 (CRS010) was accessed via Road 02, a graded access track for the drilling rigs and was recorded as a space that may have been used by Aboriginal people as a temporary shelter (**Plate 531**). The cavity is 1.2 m in height, 3.5 m in width and 2.8 m in depth with a sloping ground surface and a westerly aspect (**Plate 532**). The GSV and GSE were low between the site and the graded track due to dense leaf litter, small shrubs, native grasses and fallen branches. The vegetation in the area includes new growth eucalypts, black cypress pines and acacia shrubs. Any mature trees in the survey area were inspected for cultural scarring but no scarred trees were identified. This cultural feature was recorded in Week 1 of the survey on the 22<sup>nd</sup> of May 2014.

Plate 531 RPS Bylong CUL033 (CRS010), cultural feature

This site was discussed during the cultural values workshop, not all RAPs agreed on this as being a cultural feature, but approximately 70% agreed that it may have some value and should be inspected as part of the AACHMP.

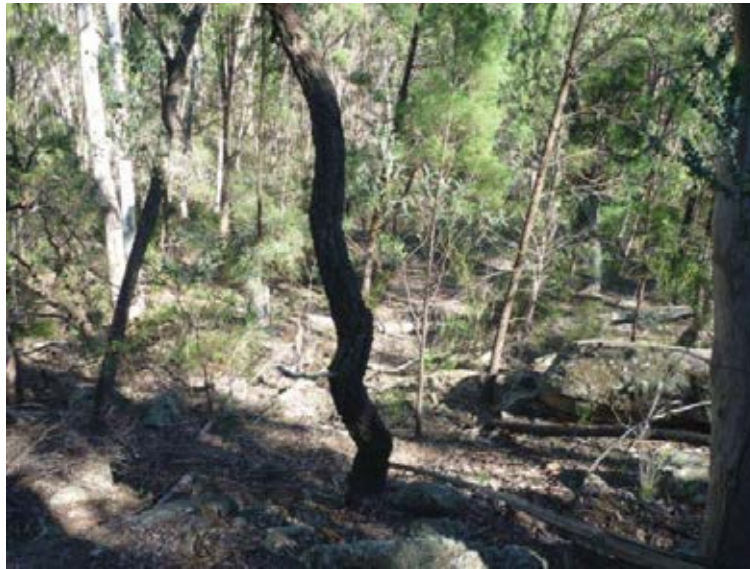
**Plate 532 View from the cavity entrance, facing west**
