MOJECT		
	175-177	175-177 CLEVELAND	
GHAZIAI AII	(JUBA)		
ARCHITECT	HIGHQUAI	HIGH QUALITY BUILDING	
E.office@ahazia.com	anos	DATE	
	1:200	21/05/2014	
THATHFIELD, NSW 2135	DRAWABY	CHECKED 1: C	
	2	GA

APPENDIX B

E14002RED Stage 1 and 2 Environmental Site Assessment Project Name: Project Number:

Location / Site: 175-177 Cleveland Street, Redfern Client: High Quality Building Pty Ltd

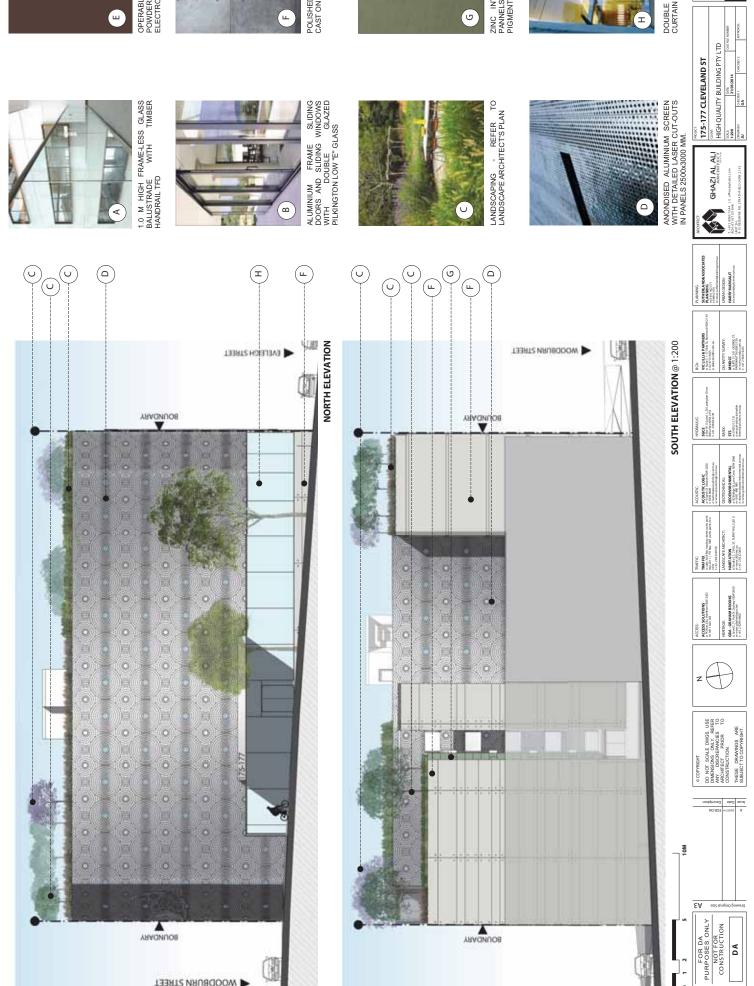
MATERIAL SCHEDULE	03000112031000
DRAWING NUMBER	
DA A1601

ZINC INTERLOCKING CLADDING PANNELS 600x2000MM (VMZINC) -PIGMENTO - LICHEN GREEN

DOUBLE GLAZED LOW E GLASS CURTAIN WALL

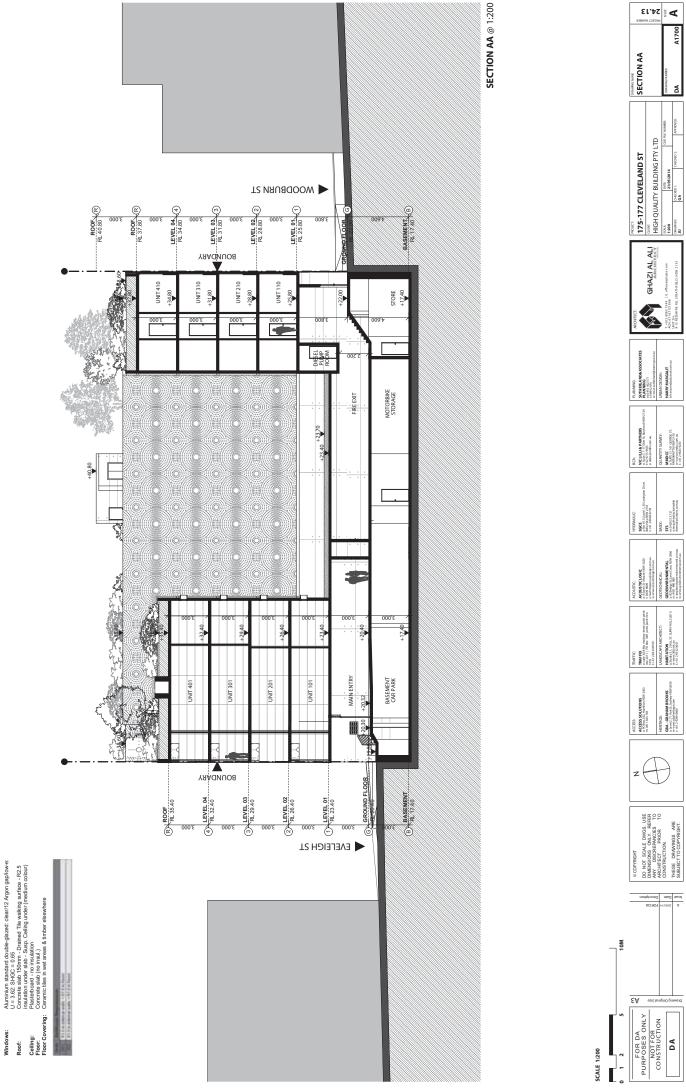
Concrete Block (190mm): air gap: plasterboard (uninsulated) - medium colour

External Walls: Internal Walls:

Within each unit: single skin brick: wet plaster both sides
 Party wall between units: 2 layers of AAC 70mm with R1.0 between. Plasterboard lines both sides

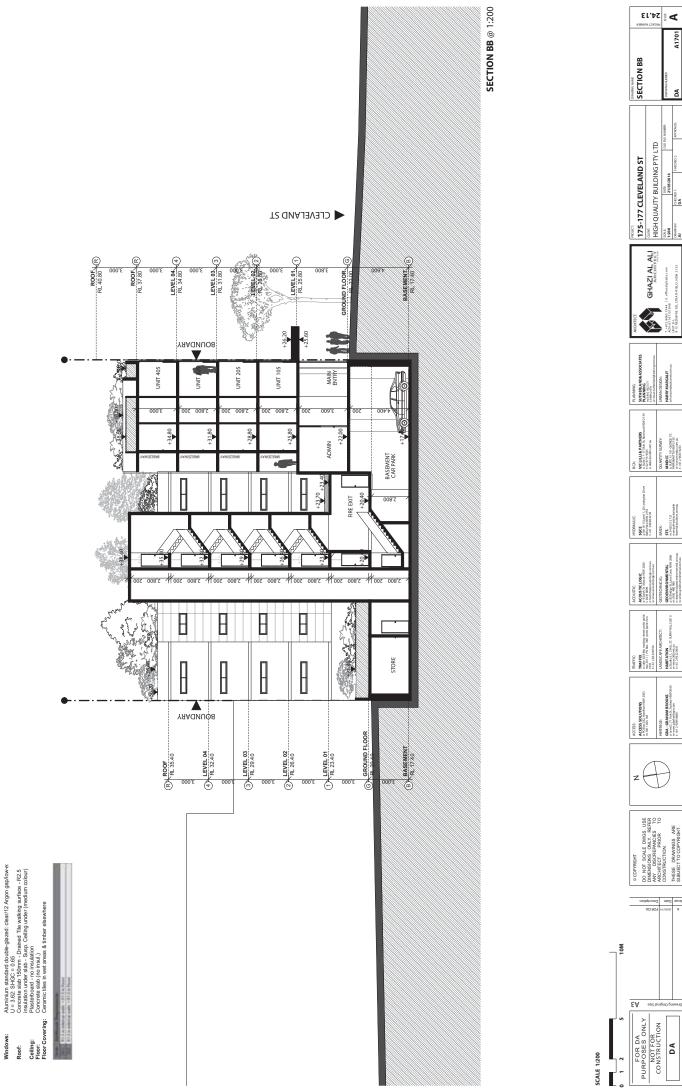
External Walls: Concrete Block (190mm): air gap; plasterboard (uninsulated) - medium colour

Internal Walls:

Within each unit: single skin brick: wet plaster both sides
 Party wall between units: 2 layers of AAC 70mm with R1.0 between. Plasterboard lines both sides
